JAKE HOME INSPECTIONS

RESIDENTIAL REPORT

1234 Main St. Everett WA 98201

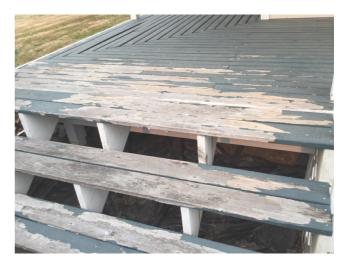
2.5.2 Front Steps

DECK STEPS -PAINT

The finish is peeling off the deck steps.

Have a licensed contractor scrape off the loose paint and then repaint to protect the wood from deterioration.

Contact a qualified painter.

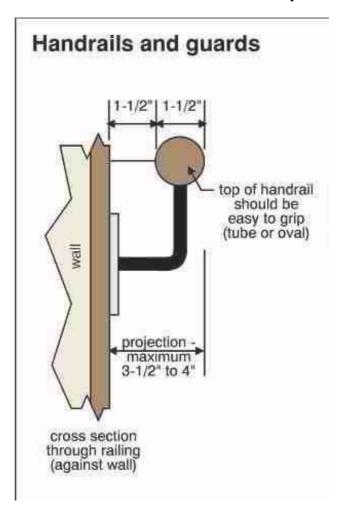
2.5.3 Front Steps

MISSING HANDRAILS

Missing graspable handrails at steps. Have a licensed contractor install a graspable handrail at steps. Handrail should be continuous and uninterrupted.

Contact a qualified deck contractor.

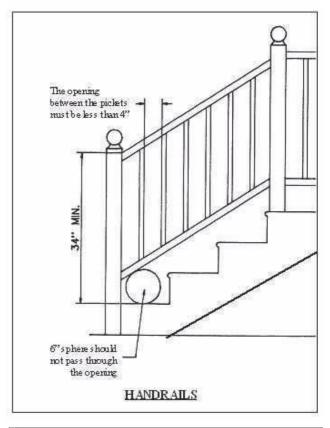
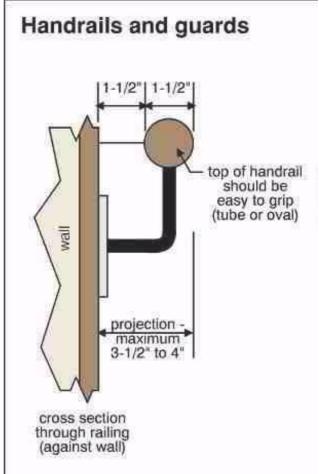
2.14.2 Back Steps

MISSING HANDRAILS

Missing graspable handrails at steps. Have a licensed contractor install a graspable handrail at steps. Handrail should be continuous and uninterrupted.

Contact a qualified deck contractor.

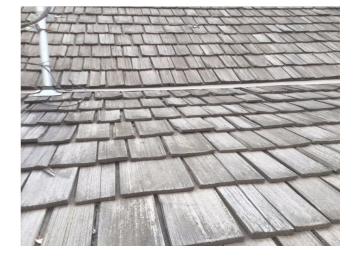
3.1.1 Coverings

AGE

The shingles displayed overall wear.

Recommend having a licensed contractor clean and seal the shingles to help them last longer.

Contact a qualified roofing professional.

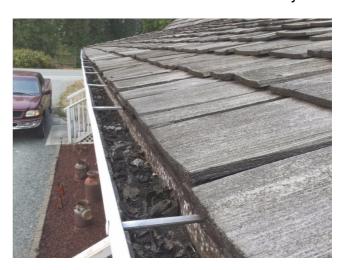
3.2.1 Roof Drainage Systems

DEBRIS IN GUTTER

Debris has accumulated in the gutters. Recommend cleaning to facilitate water flow. Install basket strainers in the downspout openings in the gutters to help prevent debris from clogging the footing drains.

Contact a quality handyman.

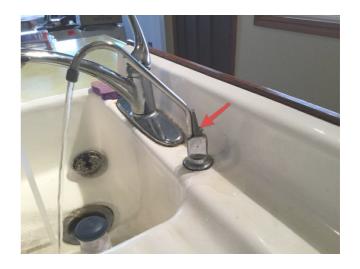
4.3.1 Plumbing Fixtures

FAUCET LEAK

Leaking faucet. The insta-hot faucet is leaking at the handle. Have a licensed contractor repair or replace the faucet.

Contact a quality handyman.

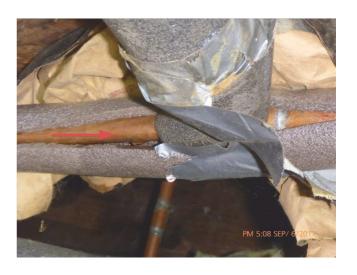
4.3.2 Plumbing Fixtures

LEAKING WATER SUPPLY PIPE

There are water leaks in the water supply lines. It cannot be determined where or how many leaks there are. Have a licensed plumber repair all of the water supply leaks.

Contact a qualified plumber.

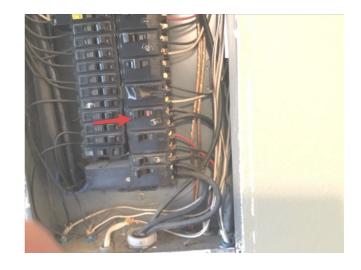
5.2.1 Electric Panel

BREAKER TRIPPING

The range circuit breaker trips when all burners and the oven are turned on. It is unknown if the issue is with the range or with the electric circuit. Have the proper licensed contractor evaluate the issue and make required repairs/replacement.

Contact a qualified electrician.

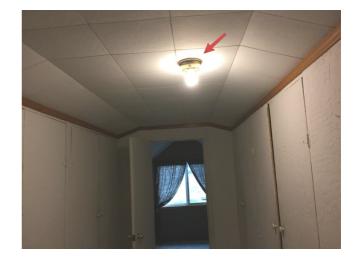
5.4.1 Light Fixtures

MISSING LIGHT SHADE

Install a new light shade to protect the light bulb from breakage.

Recommended DIY Project

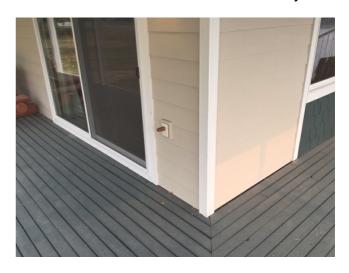
5.7.1 GFCI & AFCI

MISSING GFCI RECEPTACLES AT EXTERIOR

Exterior electrical receptacles should be GFCI protected and be inside weatherproof boxes

Contact a qualified electrician.

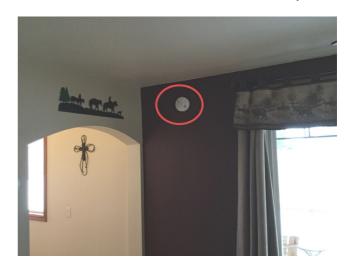
5.9.1 Carbon Monoxide Alarms

DEFECTIVE

Carbon monoxide alarm is connected, but not functioning properly. Recommend replacement.

Recommended DIY Project

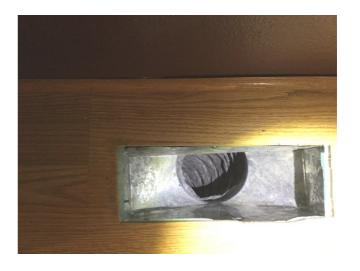
6.2.1 Distribution Systems

DIRTY DUCTS

Ducts are dirty. Have a licensed contractor clean out the duct work.

Contact a qualified professional.

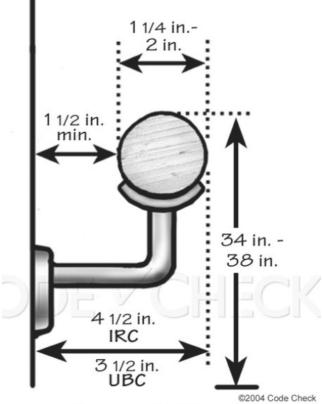
7.4.1 Railings

NO GRASPABLE HANDRAIL

Staircase had no handrails. This is a safety hazard. Recommend a qualified handyman install a graspable handrail.

Contact a quality handyman.

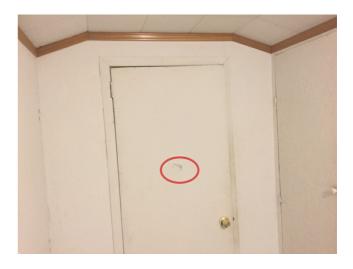
7.7.1 Doors

DAMAGED DOOR

Repair or replace the damaged door.

Contact a quality handyman.

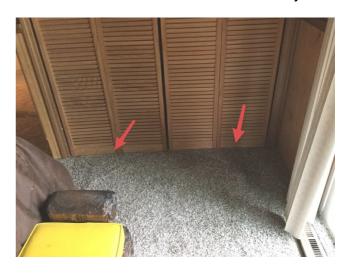
7.7.3 Doors

DOOR RUBBING CARPET

Interior door is rubbing against the carpet.

Have a licensed contractor trim about 1 to 2 inches off the bottom of the door so that there is a gap between the bottom of the door and the carpet.

Contact a quality handyman.

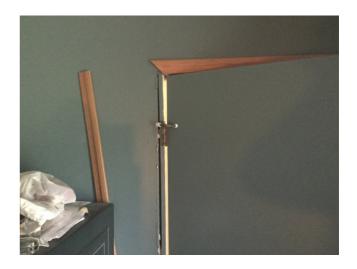
7.12.1 Trim

MISSING TRIM

Trim boards are missing throughout the house. Have a licensed contractor install trim at door frames, window frames, floor base and ceiling.

Contact a qualified carpenter.

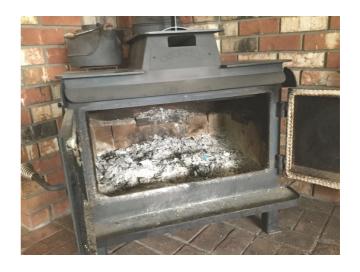
8.1.1 Fireplaces, Stoves & Inserts

FIREBOX DIRTY

Clean out the fire box. Have a licensed contractor check the flue for creosote.

Contact a qualified chimney contractor.

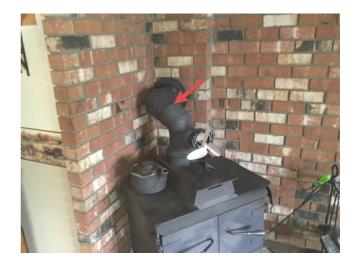
8.3.1 Chimney & Vent Systems

CONDITION OF FLUE UNKNOWN

The chimney flue was not visible for inspection. Have a licensed contractor clean the flue before using the pellet stove.

Contact a qualified chimney contractor.

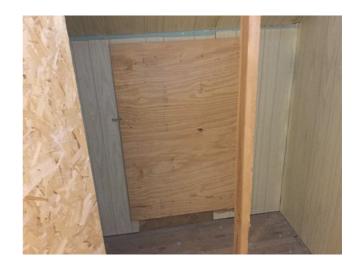
9.1.1 Attic Insulation

ATTIC HATCH

Attic hatch does not fit properly. Attic air is escaping into the living area. Replace the hatch cover with a new one or install weatherstripping around the door opening to make it air-tight.

Recommended DIY Project

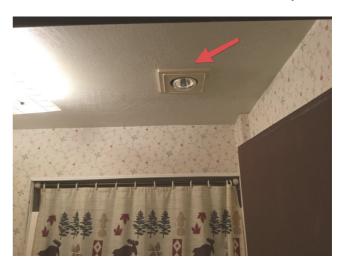
9.4.1 Exhaust Systems

DIRTY EXHAUST FANS

Have a licensed contractor clean all bathroom, laundry and kitchen exhaust fans to ensure they are working effectively at removing excess moisture from the house. Excess moisture in the house can lead to mildew and mold.

Contact a qualified professional.

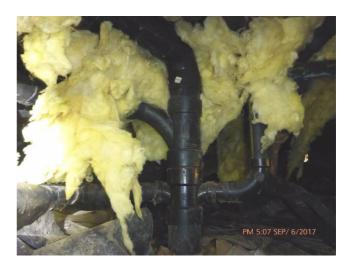
9.5.2 Crawlspace / Basement Insulation

MISSING INSULATION

Insulation is missing from between the floor joists. Install new insulation where missing.

Recommended DIY Project
