FULL CIRCLE HOME INSPECTORS

## HOME INSPECTION REPORT

1234 Main St.  
Apopka Florida 32712

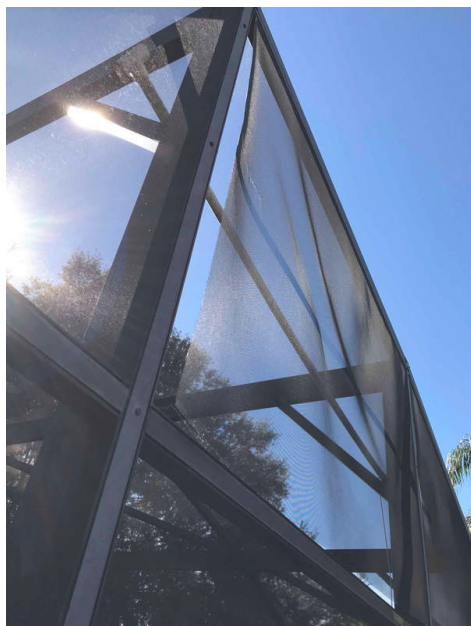
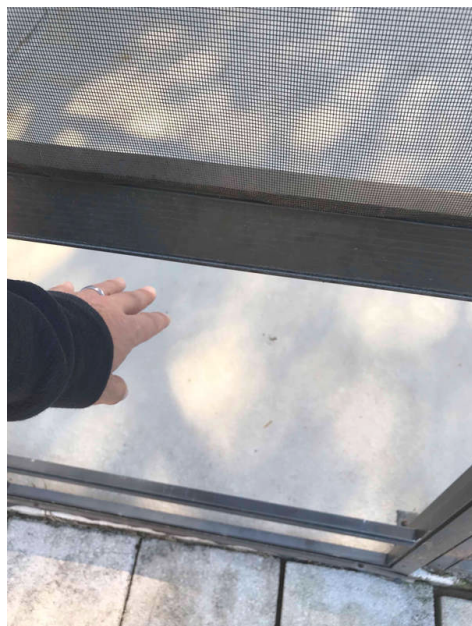
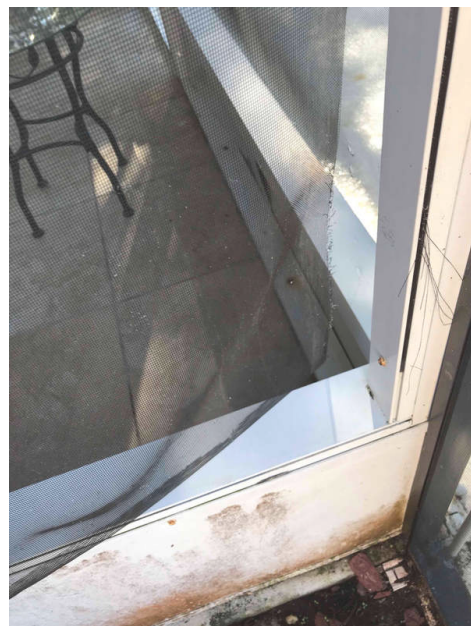
One or more screens are torn or missing in the frame(s) of the screen patio. A certified contractor should make the necessary repairs.

Contact a qualified handyman.

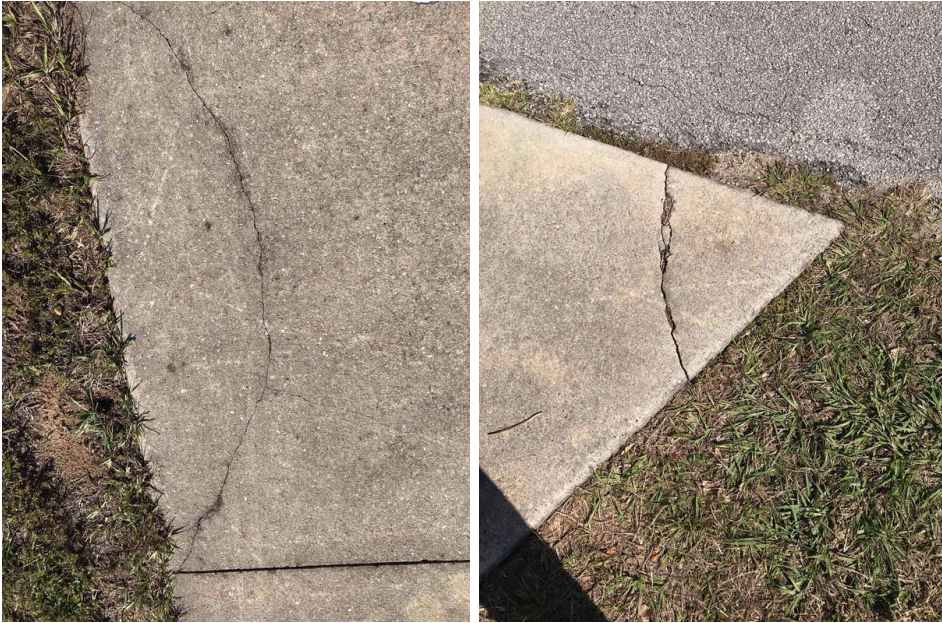
3.2.2 Driveway, Walkway, Patio

### MINOR DRIVEWAY CRACK

Observed one or more hairline cracks in driveway. Should monitor for settlement.

Contact a qualified professional.

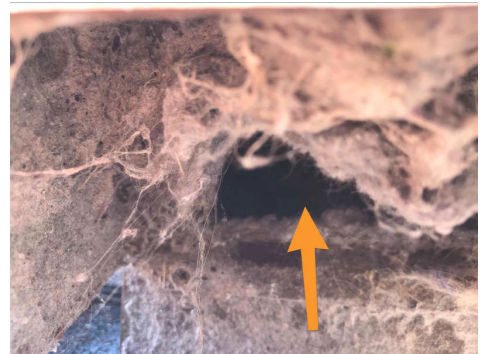
3.3.1 Exterior issues

**DRYER VENT CLOGGED**

The dryer vent is clogged and needs to be cleaned. A clogged dryer vent can lead to dryer failure and extended dry times.

Contact a qualified professional.

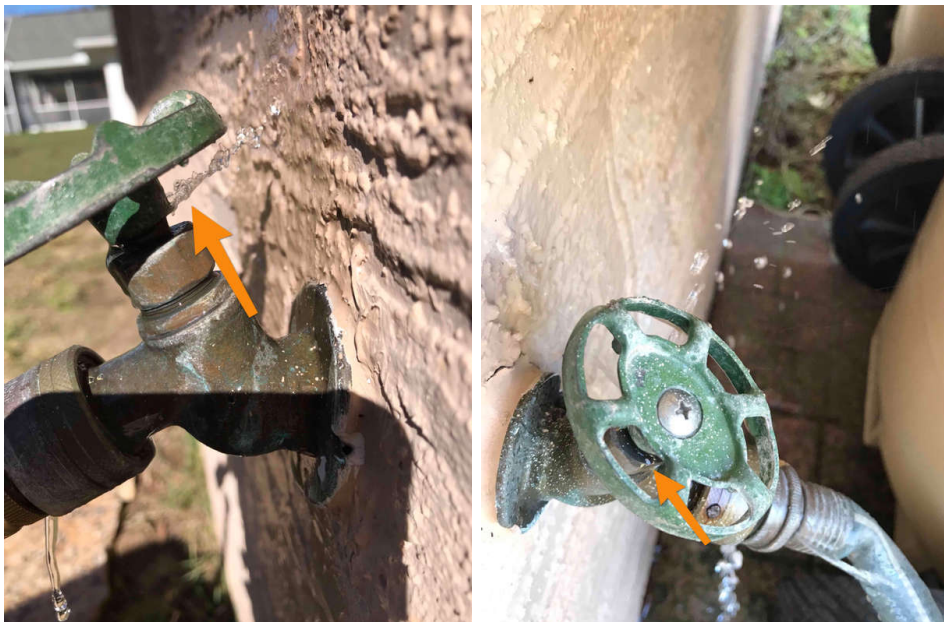
3.3.2 Exterior issues

**HOSE BIBB LEAK**

One or more hose bibbs was observed to leak when in the on position. This is usually from corrosion around the packing nut, recommend repair or tightening upon evaluation from a qualified person.

Contact a qualified professional.

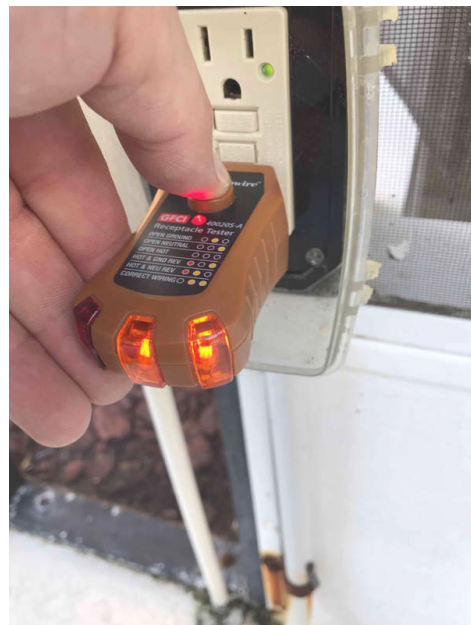
3.4.1 Electrical

**GFCI ISSUE**

One or more ground fault circuit interrupter (GFCI) receptacles (outlets) were not functioning properly (would not trip/would not reset). Recommend a licensed electrical contractor replace with new GFCI outlet.

Contact a qualified electrical contractor.

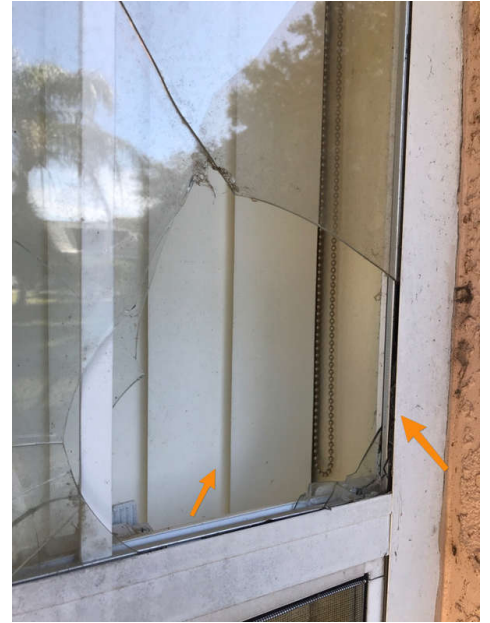
3.5.1 Windows and Door

**BROKEN WINDOW**

There is a broken window for one of the windows. A licensed window repair contractor should replace the glass as needed.

Contact a qualified window repair/installation contractor.

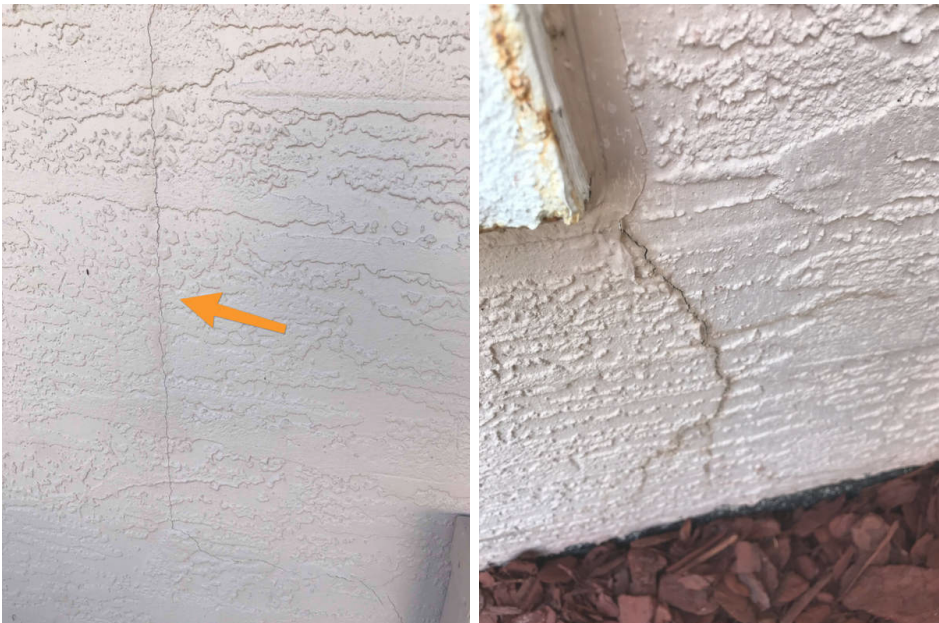
3.8.1 Stucco Walls

**HAIRLINE STUCCO CRACKING**

One or more minor hairline cracks were found in the stucco or wall areas. It is unknown the age of these cracks. At the time of inspection nothing out of the ordinary of normalized cracking was noticed. Recommend caulking and painting these areas, along with monitoring for future movement/widening. Stucco cracks over framing can allow moisture penetration behind wall areas and can potentially damage sheathing/framing. Note that areas concealed behind walls are not able to be evaluated without invasive testing and cannot be evaluated.

Recommended DIY Project

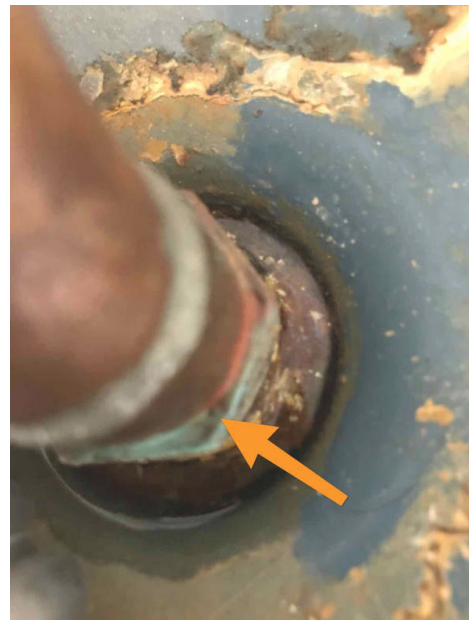
### 5.1.1 Water Heater

#### CORROSION ON FITTING/LINES

Corrosion was found on fittings and/or water supply lines for the water heater. Leaks may exist. A qualified plumbing contractor should evaluate and repair as necessary.

Contact a qualified plumbing contractor.

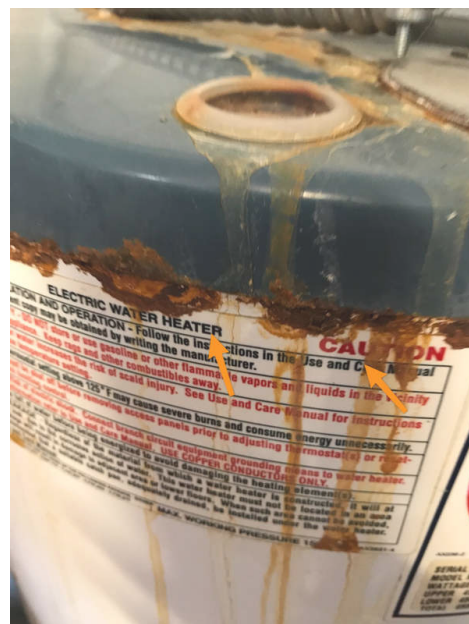
5.1.2 Water Heater

**CORROSION ON TANK**

Corrosion was found in one or more areas on the water heater. The water heater may be failing. A qualified plumbing contractor should evaluate and replace or repair water heater if necessary.

Contact a qualified plumbing contractor.

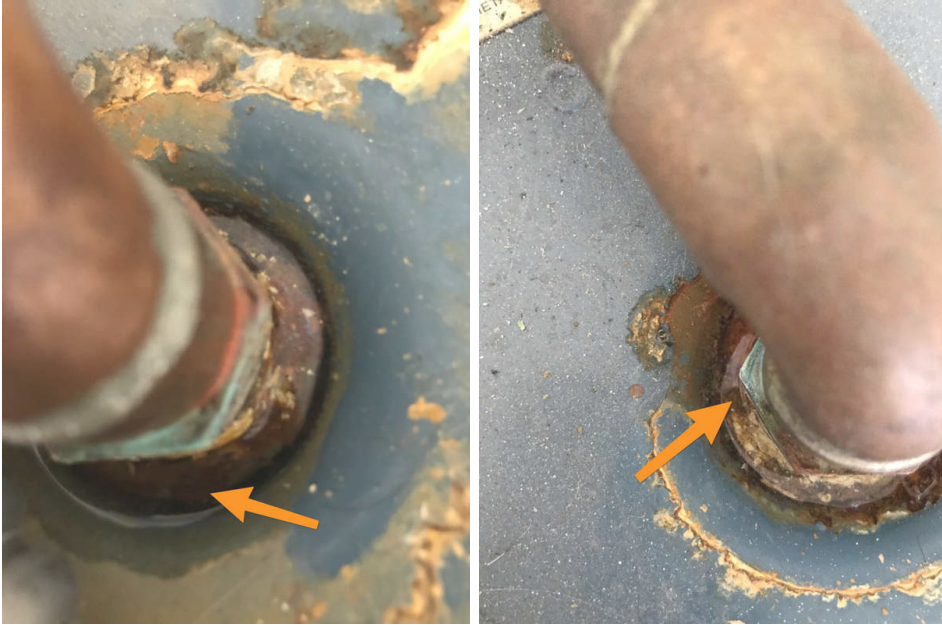
**LEAK SUPPLY PIPE/FITTING**

One or more active leaks were found at the water heater's supply pipes, valves, or fittings. A qualified plumber should evaluate and repair as necessary.

Contact a qualified plumbing contractor.

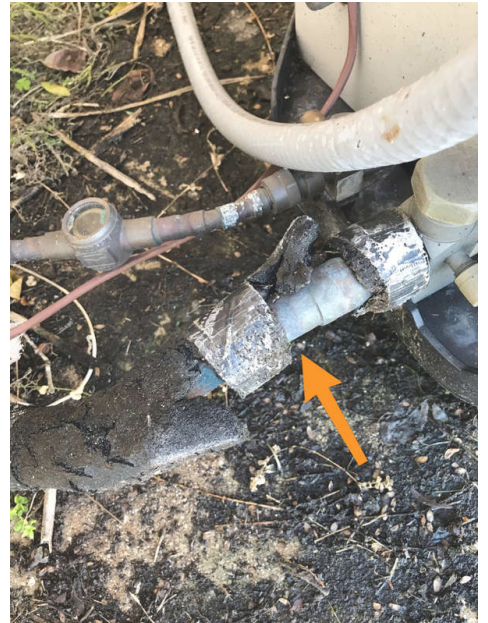
Insulation for the outside condensing unit's refrigerant lines is damaged, deteriorated and/or missing in one or more areas. This may result in reduced efficiency and increased energy costs. A qualified heating and cooling contractor should replace insulation as necessary.

Contact a qualified HVAC professional.

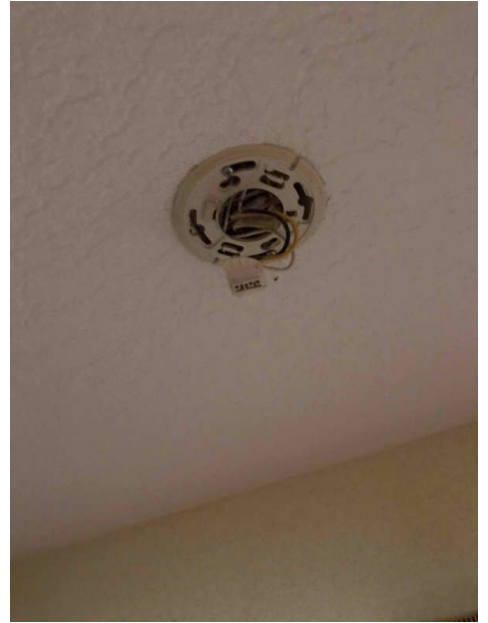
9.3.1 Smoke and CO alarms

Deficiencies**SMOKE ALARM MISSING/DAMAGE**

One or more smoke alarms were damaged, or missing components. Smoke alarms should be replaced as necessary.

Contact a qualified electrical contractor.

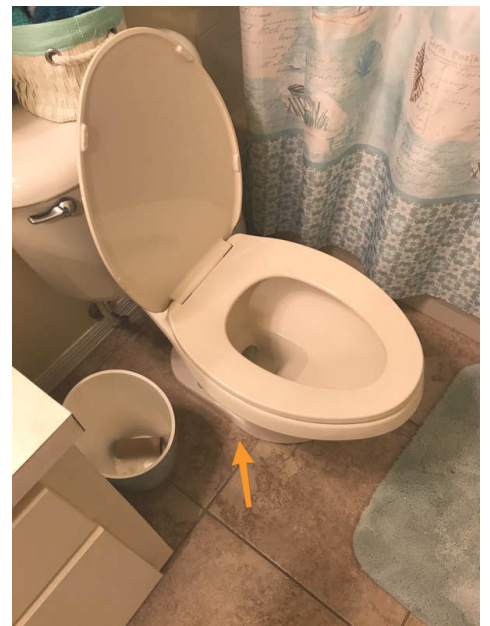
### 10.8.1 Toilets

#### **LOOSE**

One or more toilets are loose. A qualified contractor should remove the toilet(s) for further evaluation and repairs if necessary. A new wax ring should be installed and toilet(s) should be securely anchored to the floor to prevent movement and leaking.

Contact a qualified plumbing contractor.

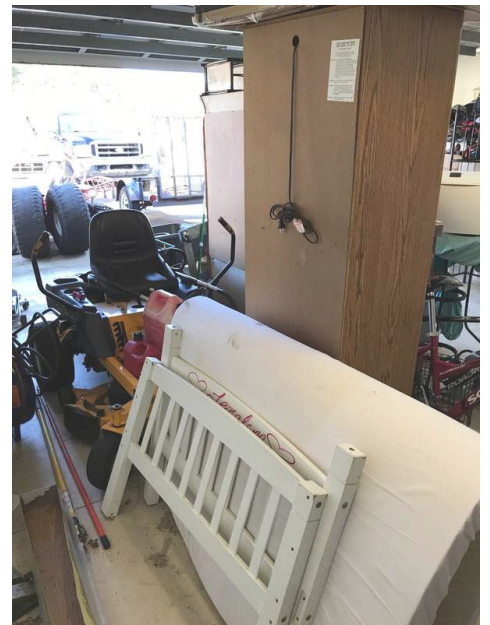
### ITEMS CENTER

Much of the garage center is blocked and can not be evaluated.

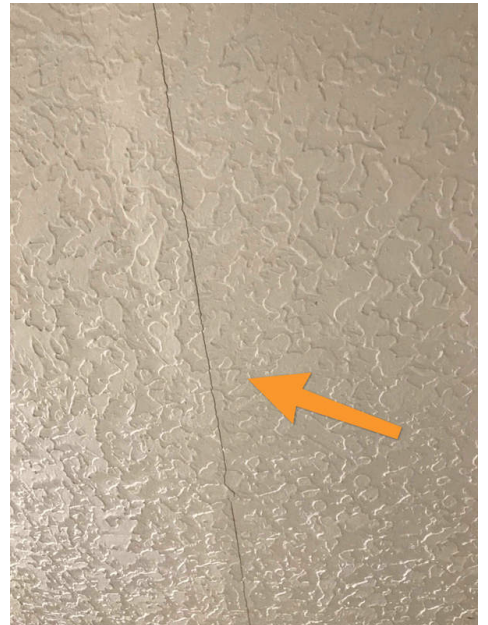
### 11.3.1 Floors, walls, Ceiling

#### MINOR CRACKS CEILING

Minor cracks were found in ceilings in one or more areas. They do not appear to be a structural concern, but the client(s) may wish to repair these for aesthetic reasons.

Contact a qualified professional.

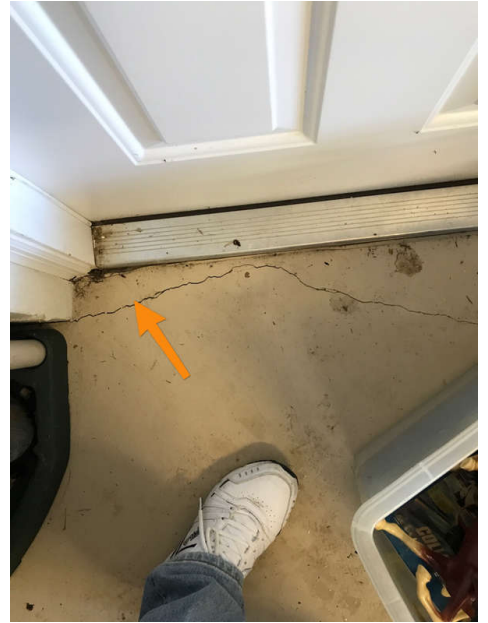
### 11.3.2 Floors, walls, Ceiling

#### MINOR FLOOR CRACKS

The concrete floor of the garage has some minor cracking. These cracks do not appear to be of structural concerns. The client should monitor these cracks.

Contact a qualified professional.

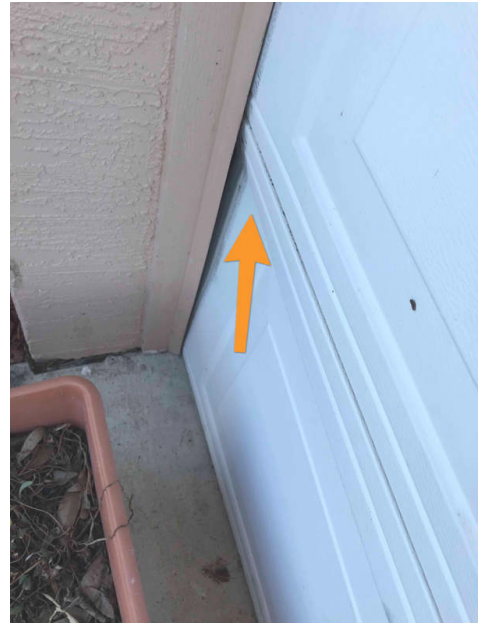
## 11.4.1 Vehicle door

**REPAIR/REPLACE**

The garage vehicle door is damaged or deteriorated. A qualified contractor should evaluate and repair or replace the door if necessary.

Contact a qualified garage door contractor.

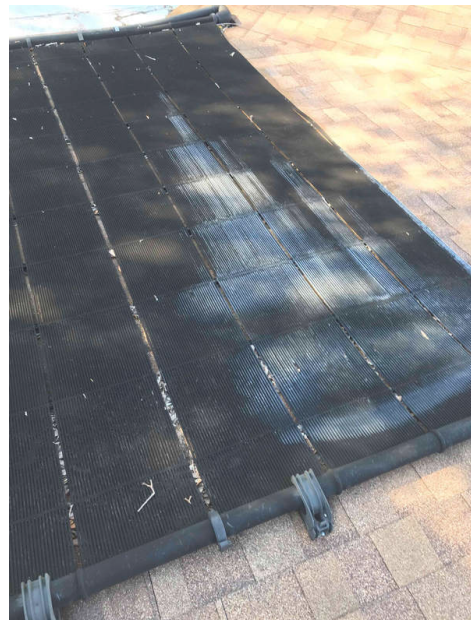
### SOLAR TUBE HEATING

It is beyond the scope of this inspection to be able to properly test solar tube heating units that are installed on the roof. The mixing valve was in the off position. Inspector opened the mixing valve and allowed water to run to the tubes on the roof. No leaks were noted. It can take hours for the water to heat properly to know if the unit works correctly and if there are slow leaks.

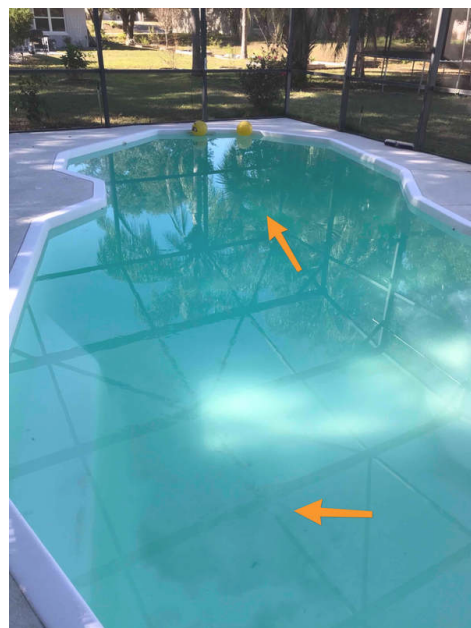
12.3.1 Water

The pool water was cloudy, dull or hazy. This is a potential safety hazard because it can interfere with rescuing swimmers in trouble and reduce divers' depth perception. Cloudy water may be caused by poor filtration and/or sanitation. Recommend consulting with a pool specialist.

Contact a qualified Swimming Pool Contractor

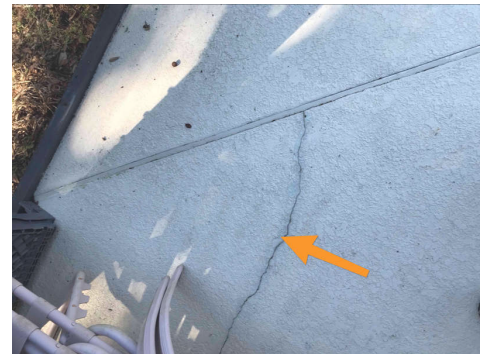
12.4.2 Pool and decking

**DECK CRACKING**

The pool deck has some deck cracking. It does not appear to be structural at this time, but it is recommended to monitor the area(s) in concern in the future.

Contact a qualified concrete contractor.
