KINGDOM INSPECTION (NEW)

1234 Main St.
Moore OK 73160

Buyer Name
01/13/2019 9:00AM

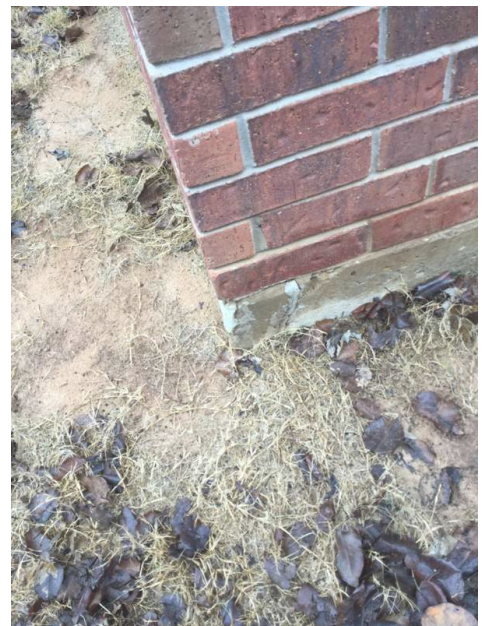
Southwest Corner

CORNER POP

SOUTHWEST CORNER

Corner pop was noted at foundation corner. We recommend having the repaired by a qualified professional.

Contact a foundation contractor.

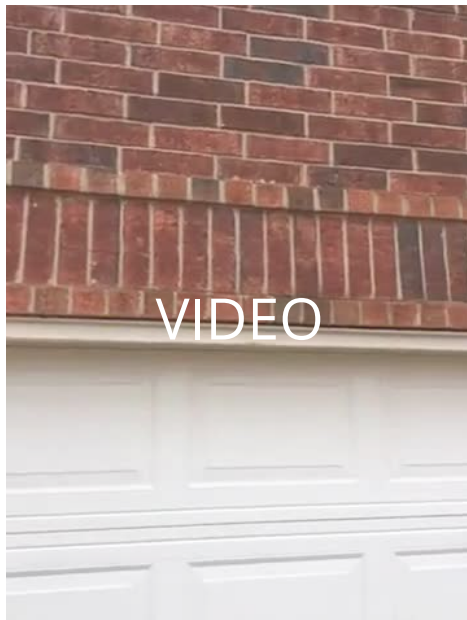
GARAGE WALL MOVEMENT NOTED

ABOVE GARAGE - NORTHEAST CORNER

There was movement noted at the sides of the garage door. This is a common area for cracks and gaps at the brick veneer. This home had movement noted that was patched, the movement has continued above the garage, at the garage door header, along with shifting at the top right corner of the wall. Have evaluated and repaired by a qualified foundation specialist.

Contact a foundation contractor.

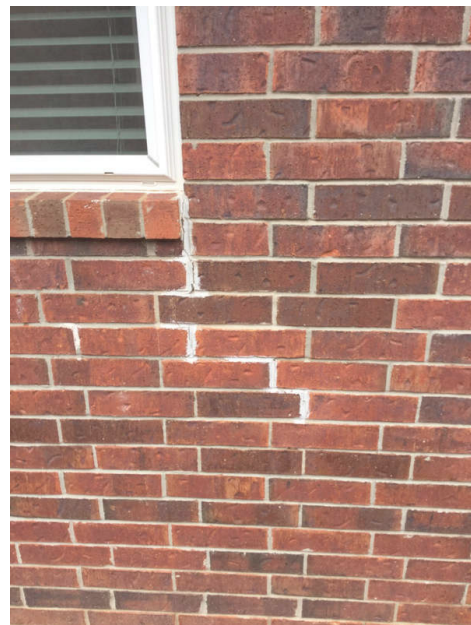
South Wall

STEP CRACK

SOUTH WALL

This typically is an indication of structural movement. We recommend patching and monitoring unless otherwise stated in the structural section of the report.

Contact a qualified masonry professional.

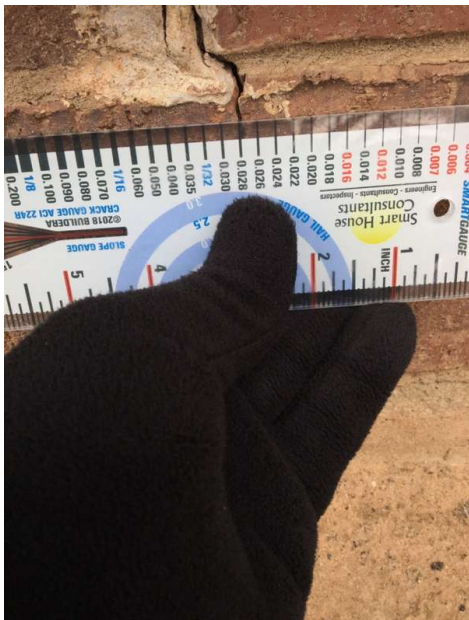
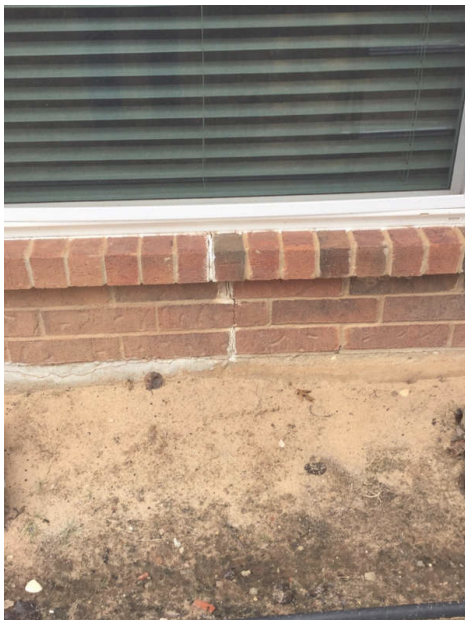
West Wall

MORTAR/BRICK CRACKING - UNDER 1/4"

WEST WALL

Siding showed cracking in one or more places. This cracking appears to be above average for this area. See Structure section under the wall area for recommendations.

Contact a foundation contractor.

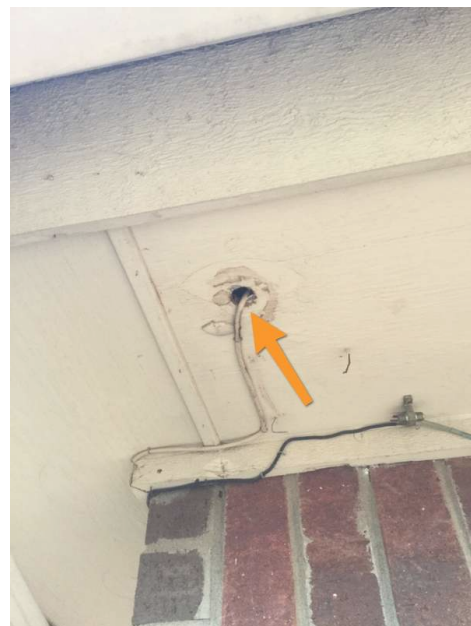
Northwest Corner Soffit

HOLES / GAPS AT EXTERIOR ENVELOPE

NORTHWEST CORNER

A hole was observed in an exterior wall. We recommend having this patched to prevent pest intrusion into.

Contact a handyman or DIY project

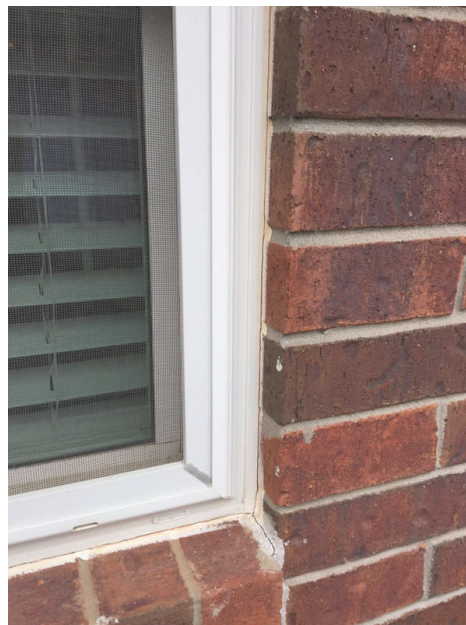
North Wall

Normal Maintenance Item**DETERIORATED CAULK**

ALL AROUND HOUSE

The caulk around the exterior windows was deteriorated. We recommend properly sealing. Exterior caulking is the first energy efficient measures to install. The purpose of exterior caulking is to minimize air flow and moisture through cracks, seams, utility penetrations and openings. Controlling air infiltration is one of the most cost effective measures in modern construction practices, a home that is not sealed will be uncomfortable due to drafts and will use about 30% more heating and cooling energy than a relatively air-tight home. In addition, good caulking and sealing will reduce dust and dirt in the home and prevent damage to structural elements.

Contact a handyman or DIY project

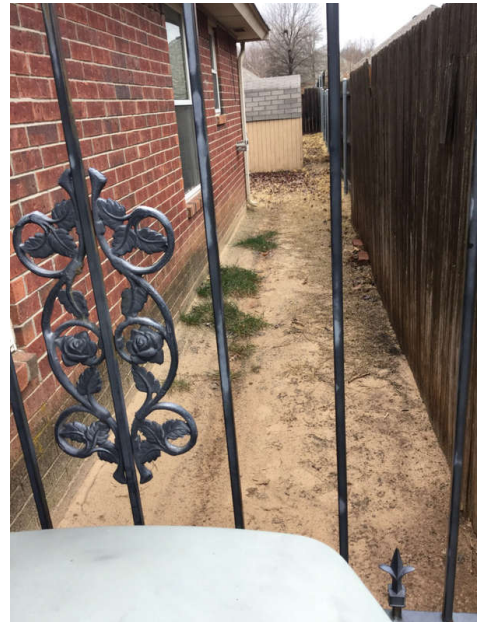
North Wall

Normal Maintenance Item**GRADING IMPROVEMENT NEEDED**

NORTH WALL

The home did not have gutter all around the house causing trenching. The grading in these areas should be improved to promote the flow of storm water away from the house. This can usually be accomplished by the addition/removal of top soil. The ground should slope away from the structure at a rate of six inches in the first ten feet.

Contact a qualified grading contractor.

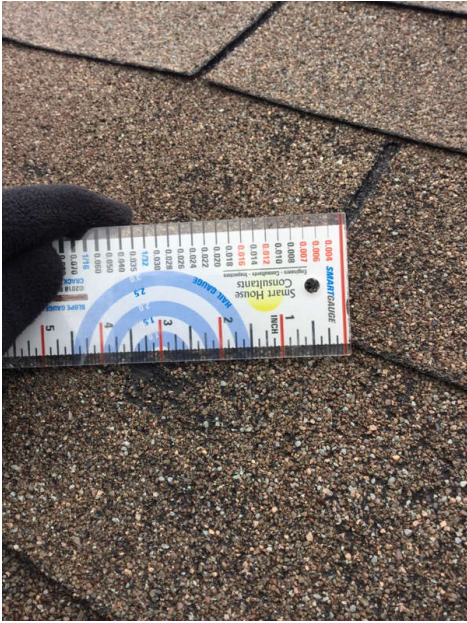
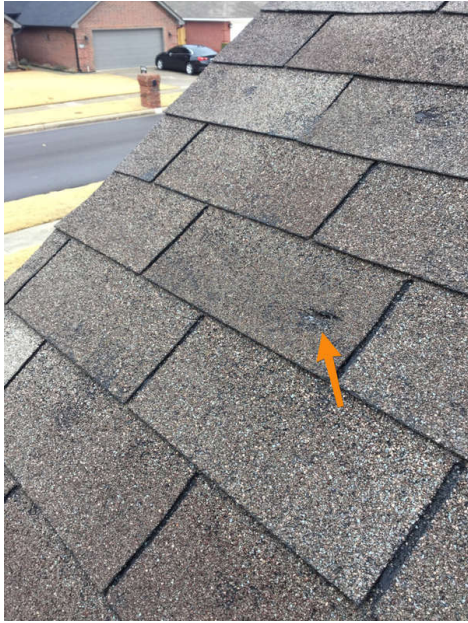
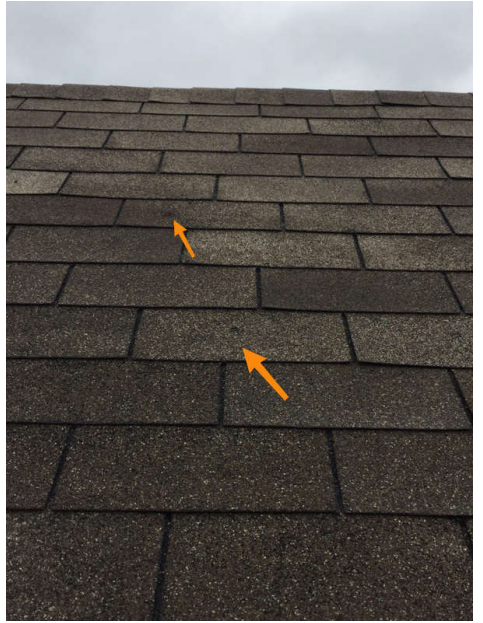
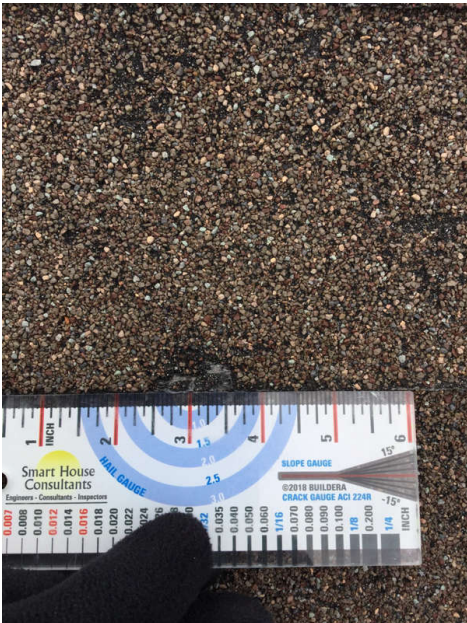
DAMAGED (GENERAL)

Roof coverings showed general shingle damaged with a hole extending to the decking, hail damage, and significant granule loss around the roof. Recommend a qualified roofing professional evaluate and repair.

Contact a qualified roofing professional.

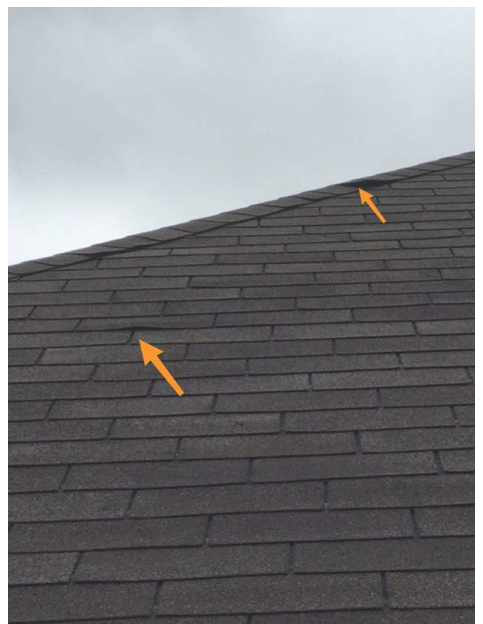
East Slope

NAIL POPS

ALL AROUND ROOF

The roofing material showed signs of nail pops. This is evident by shingles lifting from nails that back out over time. Left un-repaired these will often lead to shingle damage and holes from the nail head. Have these areas repaired as needed

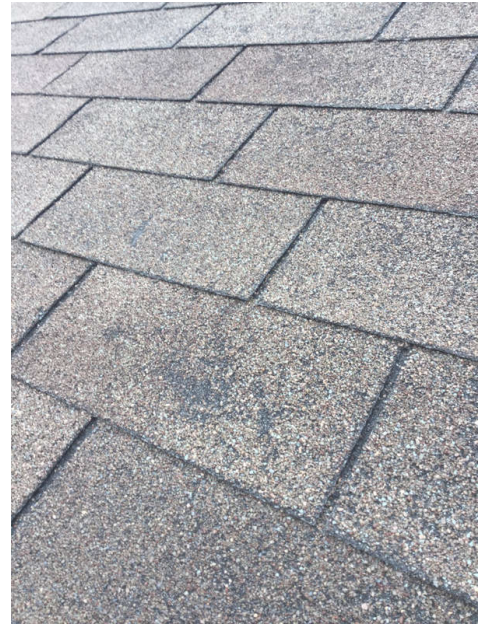
LOSS OF GRANULES

The roofing appears to have severe granule loss noted. Replacement will become necessary in the future. It would be wise to budget for the replacement.

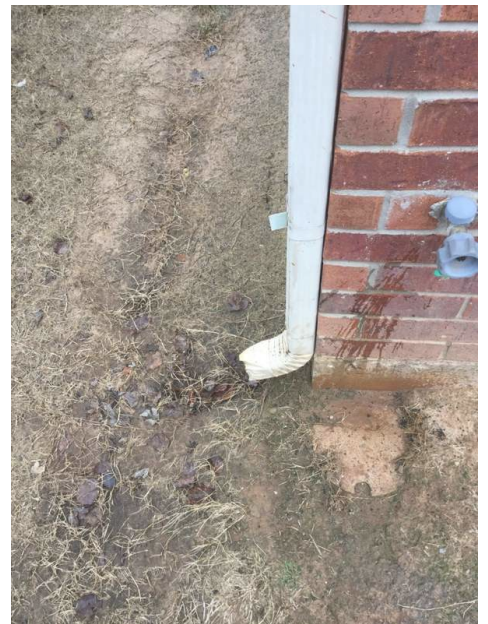
Northwest Corner

One or more downspouts drain too close to the home's foundation. This can result in excessive moisture in the soil at the foundation, which can lead to foundation/structural movement. Recommend a qualified contractor adjust downspout extensions to drain at least 6 feet from the foundation.

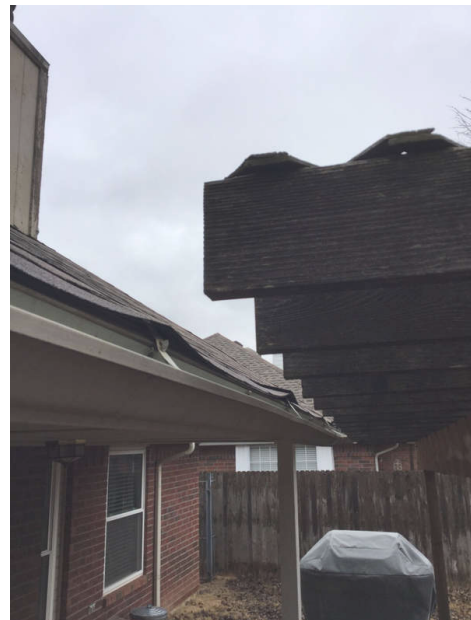
West Wall

GUTTER DAMAGED

Gutters were damaged. This can result in excessive moisture in the soil at the foundation, which can lead to foundation/structural movement. Recommend a qualified contractor evaluate and repair.

Contact a qualified gutter contractor

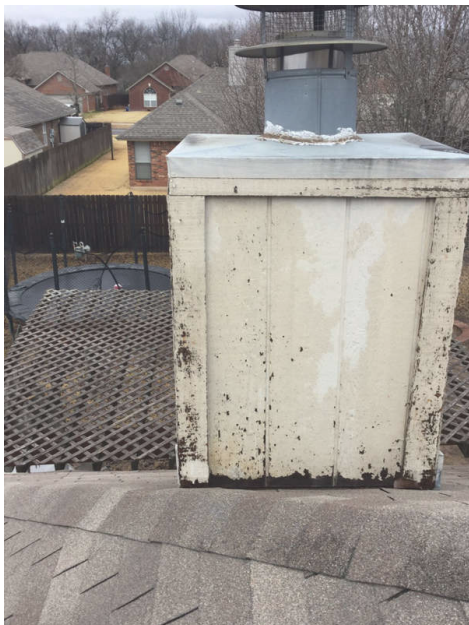
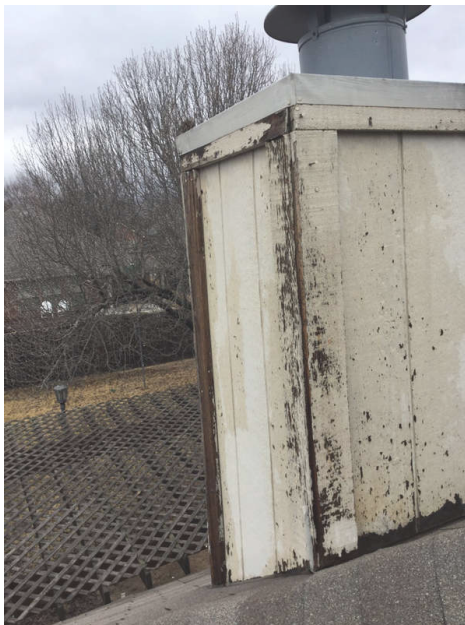
WOOD DECAYING / PEELING PAINT

Wood decay was observed on the fireplace trim. We recommend repairs/replacement to all decayed wood and repainting to properly prevent further deterioration and creating conducive conditions for wood destroying insect activity.

Contact a qualified carpenter.

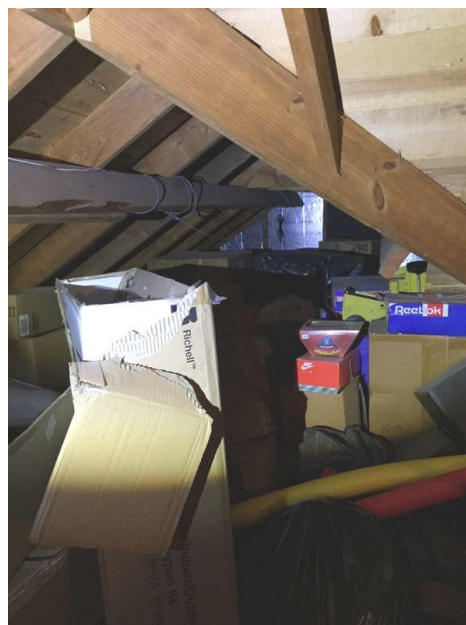
LIMITED INSPECTION (BLOCKED)

There were objects in the way that we were not able to safely get around or over to access all areas of the attic space.

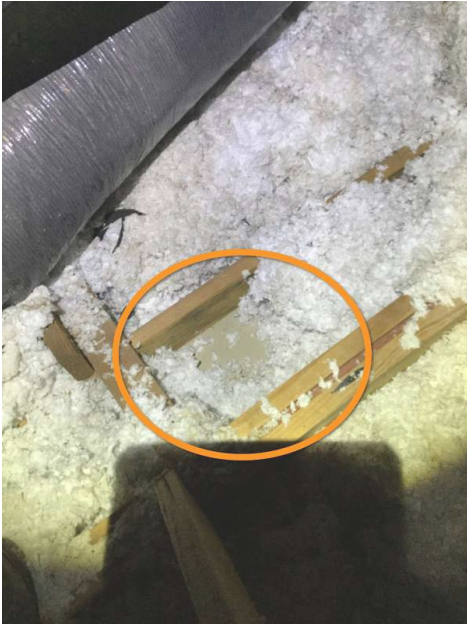
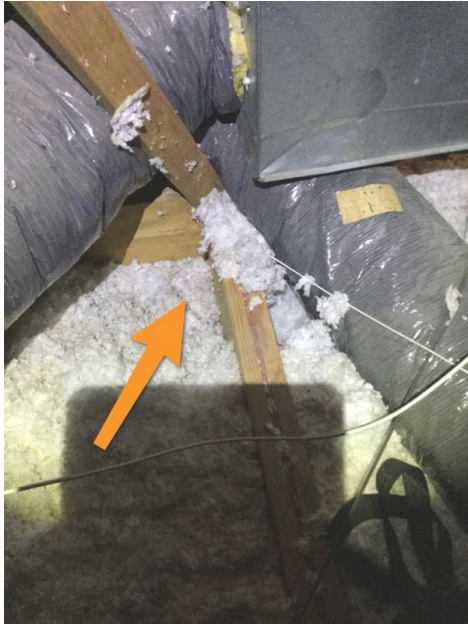
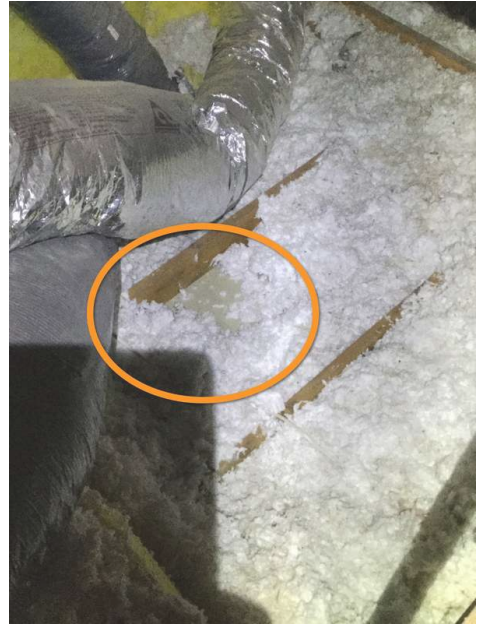
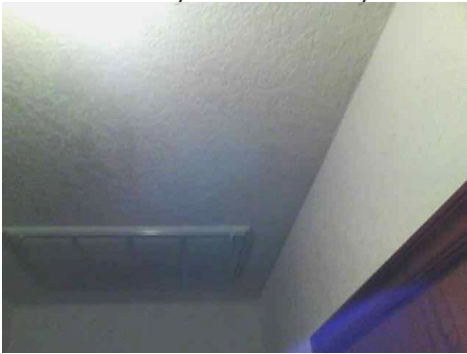
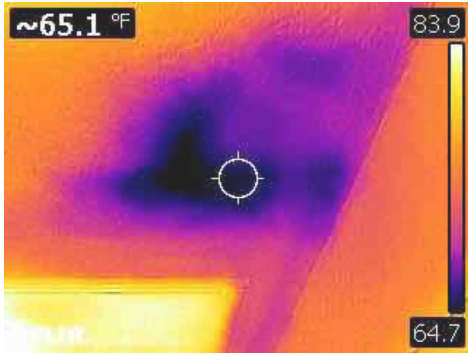
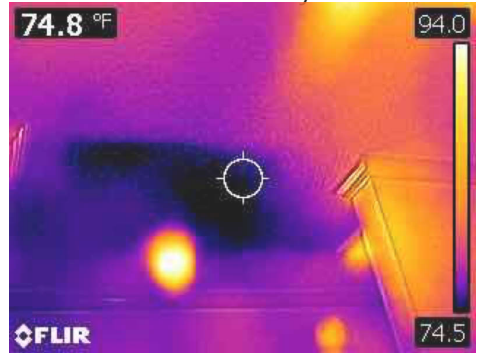
I would recommend additional insulation be installed by a qualified professional to reduce utility costs.

Contact a qualified insulation contractor.

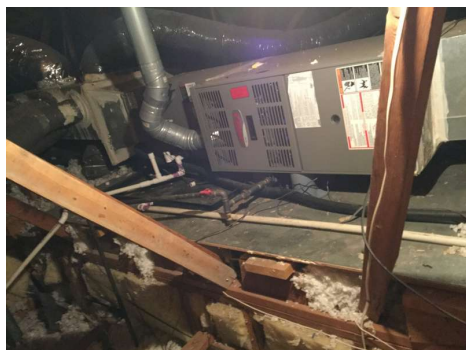
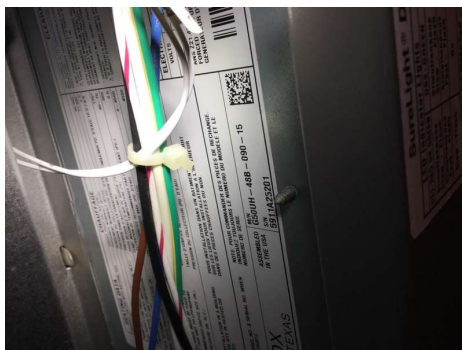
Lennox

Age: 2011

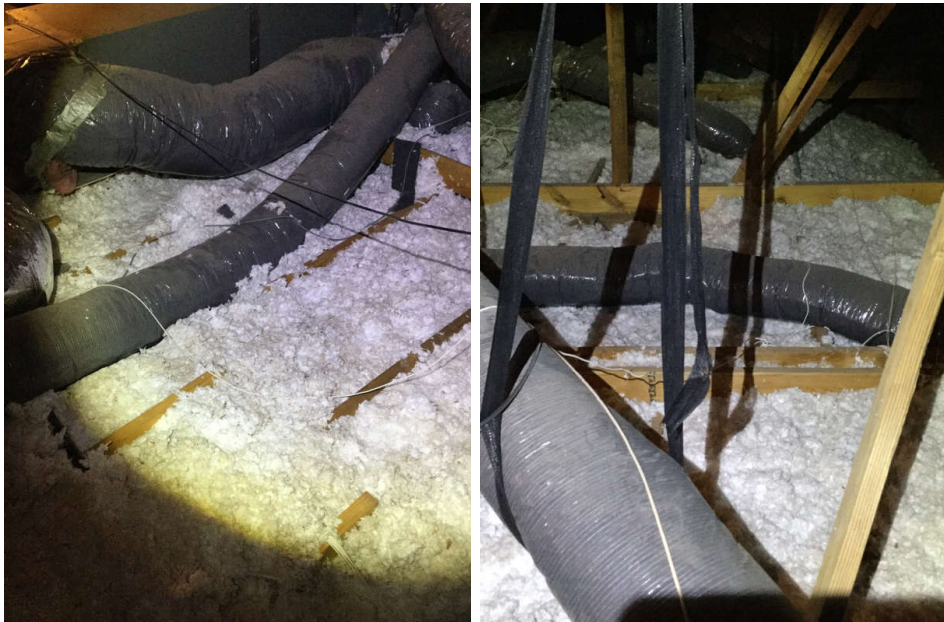
Air ducts were placed on the attic floor. Today's standards do not allow this practice anymore as thermal bridging could create condensation inside the ductwork. We recommend having the strapped and elevated.

Contact a qualified heating and cooling contractor

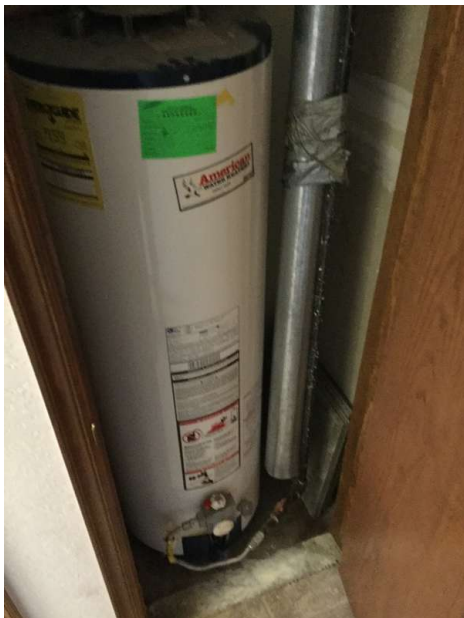
I recommend flushing & servicing your water heater tank annually for optimal performance. Water temperature should be set to at least 120 degrees F to kill microbes and no higher than 130 degrees F to prevent scalding.

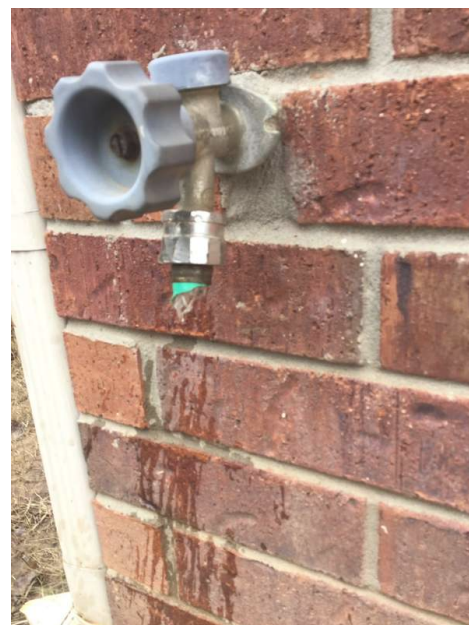
EXTERIOR FAUCET NOT FULLY TESTED

The south wall faucet had a multi port installed that was not working properly, and the west wall had one with a cutoff hose installed. I was unable to remove them by hand during the inspection to test.

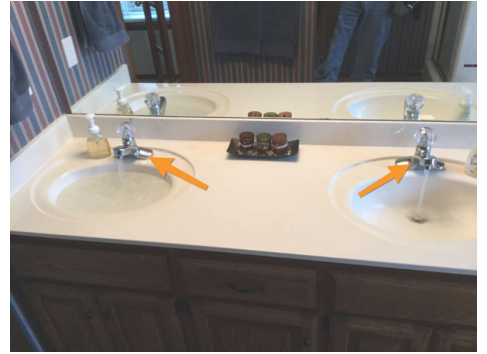
A blocked aerator was noted at a faucet during the inspection. We recommend cleaning to allow for proper flow.

Contact a qualified plumbing contractor.

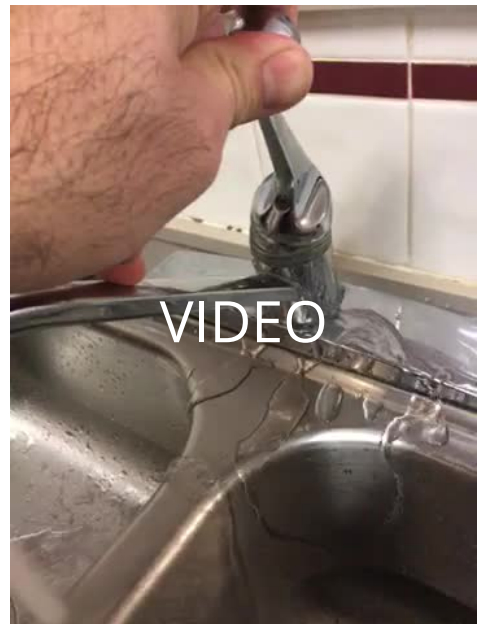
FAUCET STEM LEAKING

The faucet stems were leaking when the tub was operating. This may allow water intrusion into the wall and we recommend this be corrected.

Contact a qualified plumbing contractor.

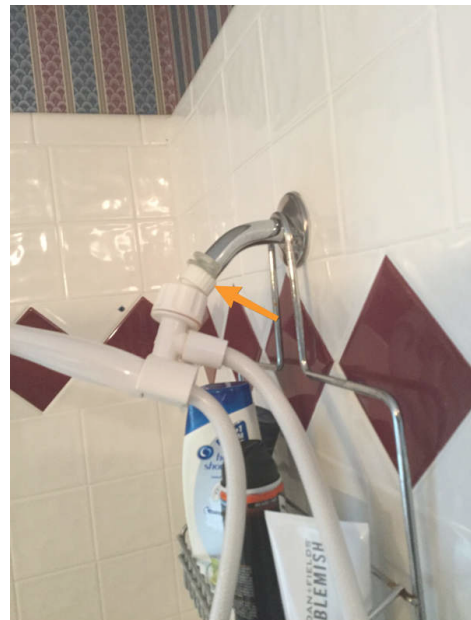
Master Bathroom

LEAK AT SHOWER HEAD

We observed a leak at a shower head at the time of inspection. We recommend having this repaired.

Contact a handyman or DIY project

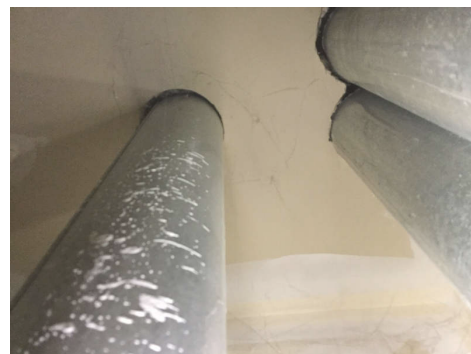
FLUE HAS IMPROPER CLEARANCE

Exhaust flue was improperly installed needs 1" clearance around combustibles. Recommend a qualified Plumbing contractor evaluate and repair.

Contact a qualified plumbing contractor.

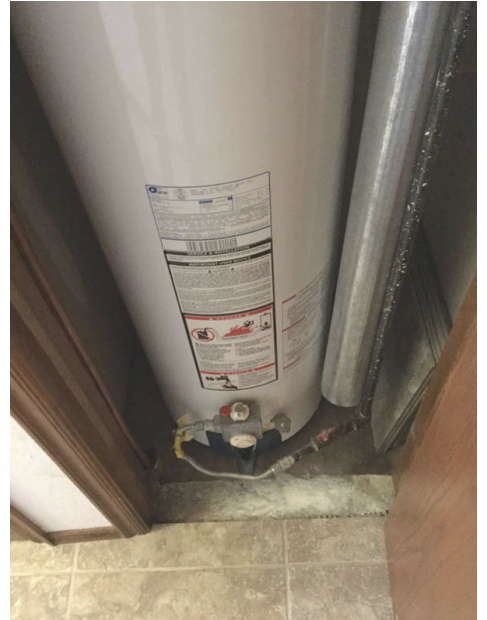
Repair Recommendation
NO DRIP PAN

No drip pan was present. Recommend installation by a qualified plumber.

Contact a qualified plumbing contractor.

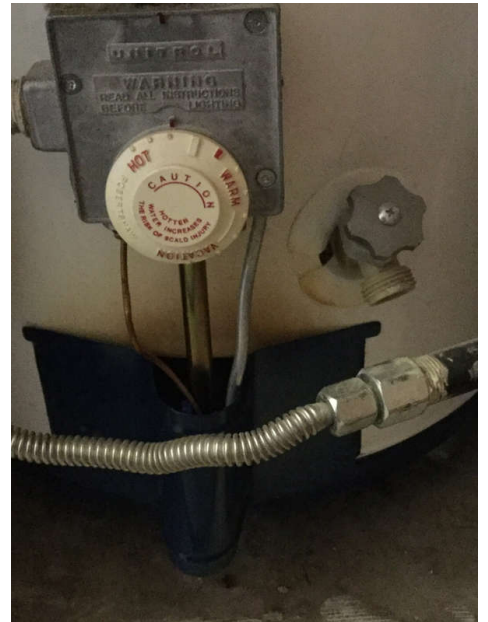
Repair Recommendation
VISIBLE SCORCHING

Scorching of the water heater exterior visible near the burn chamber access cover indicated a need for servicing. We recommend repair.

Contact a qualified plumbing contractor.

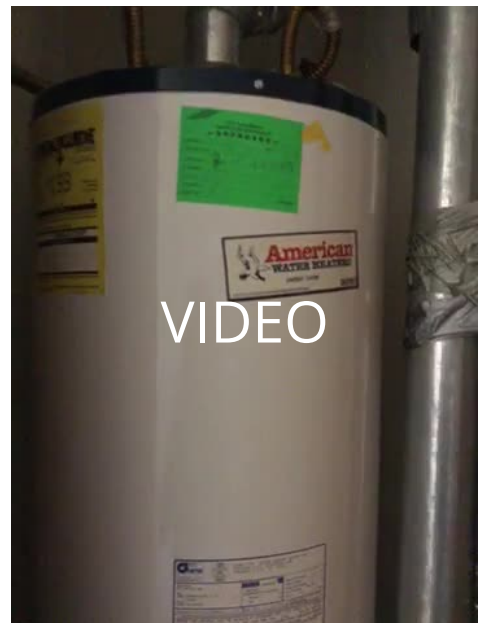
The water heater appeared to be excessively noisy during the inspection with gurgling sounds. This is common with sediment build up on the inside of the water heater. I recommend budgeting for replacement.

Contact a qualified professional.

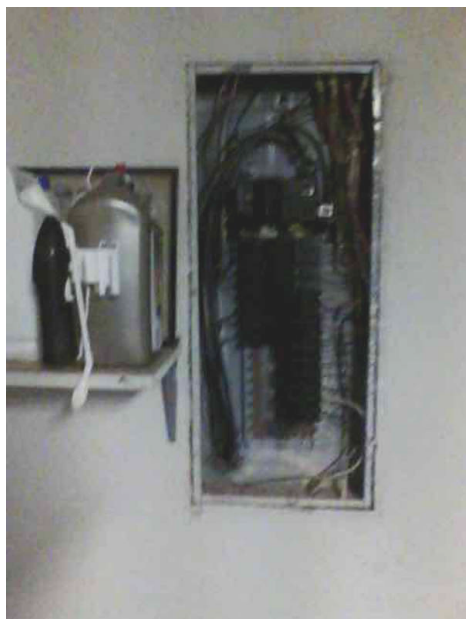
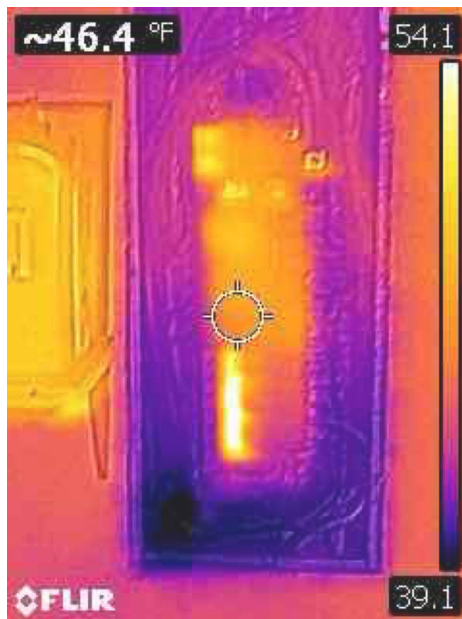
Panel Manufacturer

Garage
Siemens

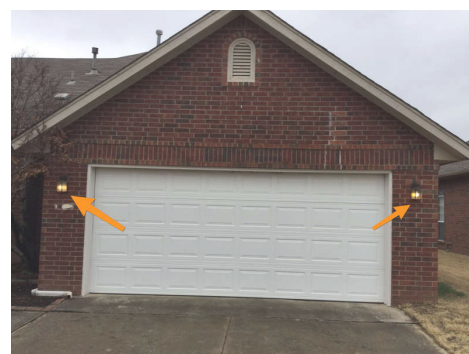
LOOSE EXTERIOR LIGHT FIXTURE

Loose fixtures can result in damage to the wiring for the fixture. Have this securely attached.

Contact a qualified electrical contractor.

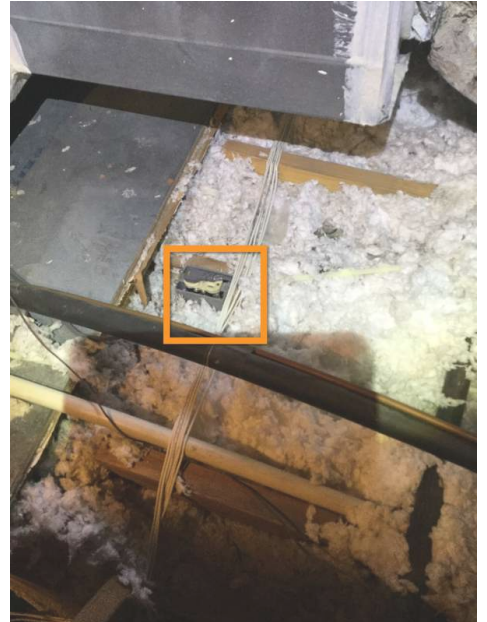
Front right of furnace

COVER PLATES MISSING

One or more receptacles are missing a cover plate. This causes short and shock risk. Recommend installation of plates.

Contact a handyman or DIY project

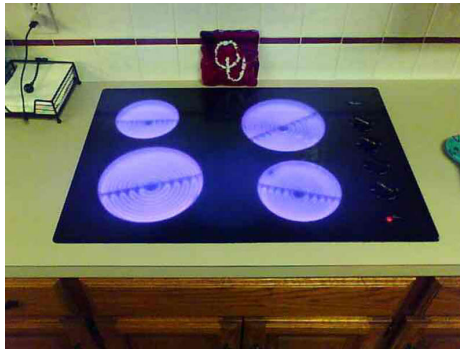
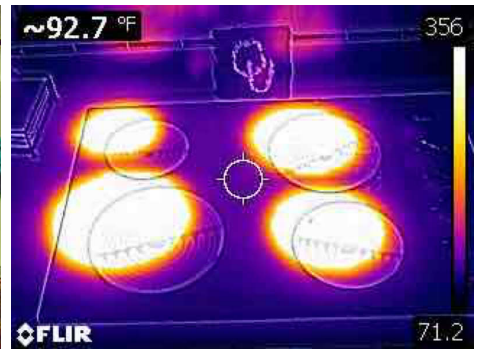
Mechanical Exhaust Vents and Bathroom Heaters: Exhaust Hood Type
Microwave Re-circulating

Garage Door Opener: Inspected

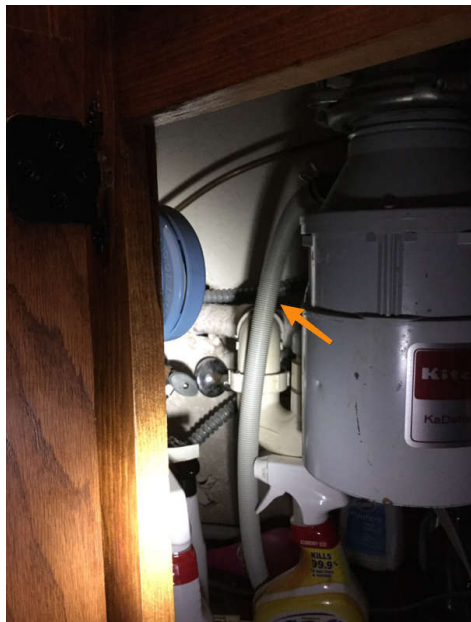
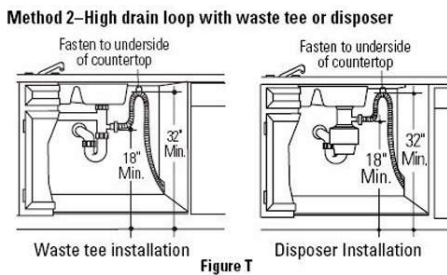
High Loop Examples

The dishwasher drain line (discharge hose) did not have an air gap or a high loop. The dishwasher drain line usually attaches to the garbage disposal. The drain line should either arch above the level of the sink drain, have an anti-siphon valve, or have a vacuum break. This keeps debris in the disposal from siphoning back to the clean dishes. We recommend the drain line be elevated or a back flow device installed.

Contact a qualified appliance repair professional.

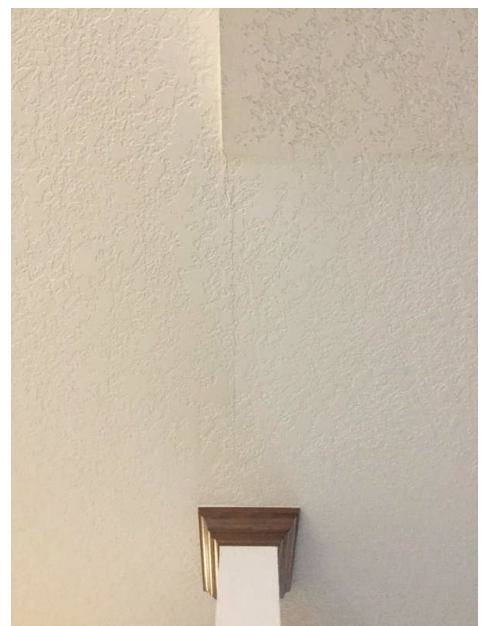
Living Room

HAIRLINE CRACKS

Hairline cracks which were by nature mainly cosmetic were noted on the ceiling. We recommend having these caulked and painted.

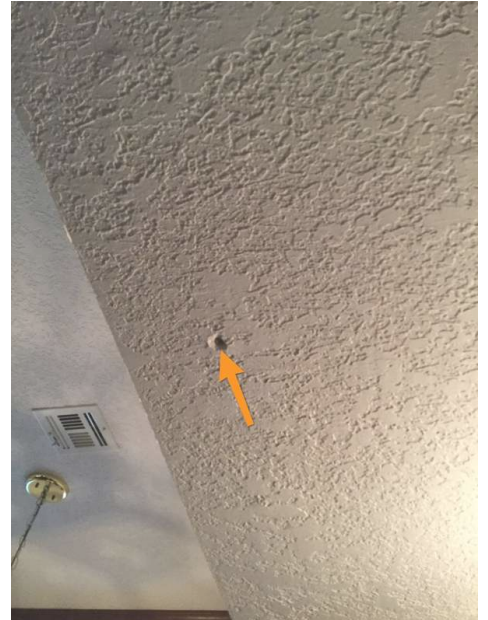
Nailpops which are by nature cosmetic were noted. We recommend these be re-secured, caulked and painted.

Contact a qualified drywall contractor.

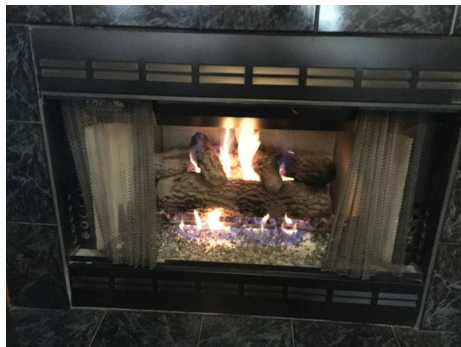
Fuel Type

Gas
