FIRST-IN HOME INSPECTION

1234 Main St.
Uniontown OH 44685

Buyer Name
09/12/2018 9:00AM

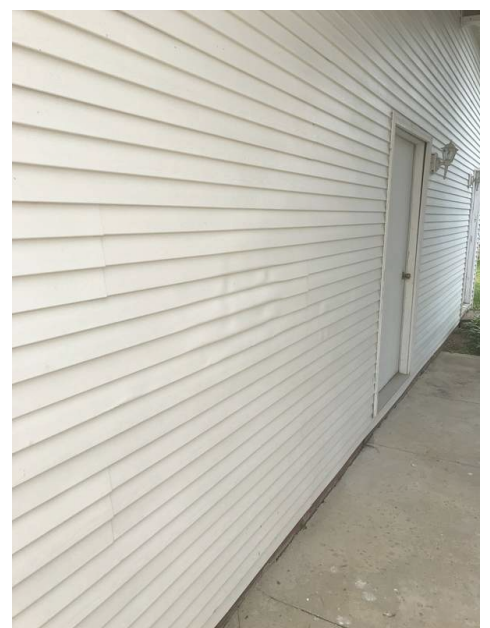
WARPING/BUCKLING

Vinyl siding was warping or buckling in areas. This is often as a result of nailing siding boards too tight to the home, preventing expansion/contraction. Recommend a qualified siding contractor evaluate and repair.

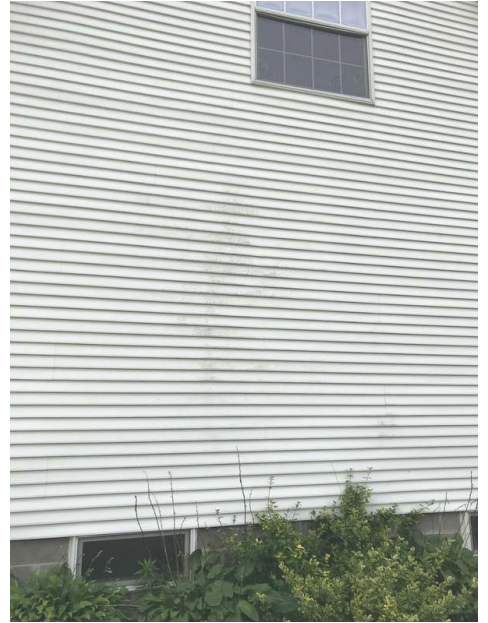
2.5.2 Siding & Trim

Moss/Algae present on exterior covering. Recommend removal to prevent premature wear.

Recommended DIY Project

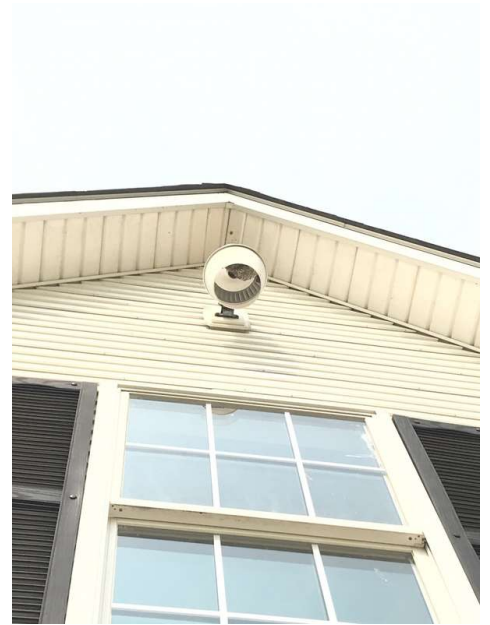
2.5.4 Siding & Trim

Recommend removal of bee nest.

Contact a qualified professional.

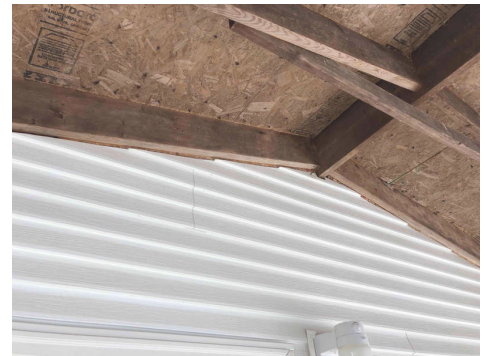
2.5.5 Siding & Trim

MISSING J-CHANNEL AT EXTERIOR SIDING

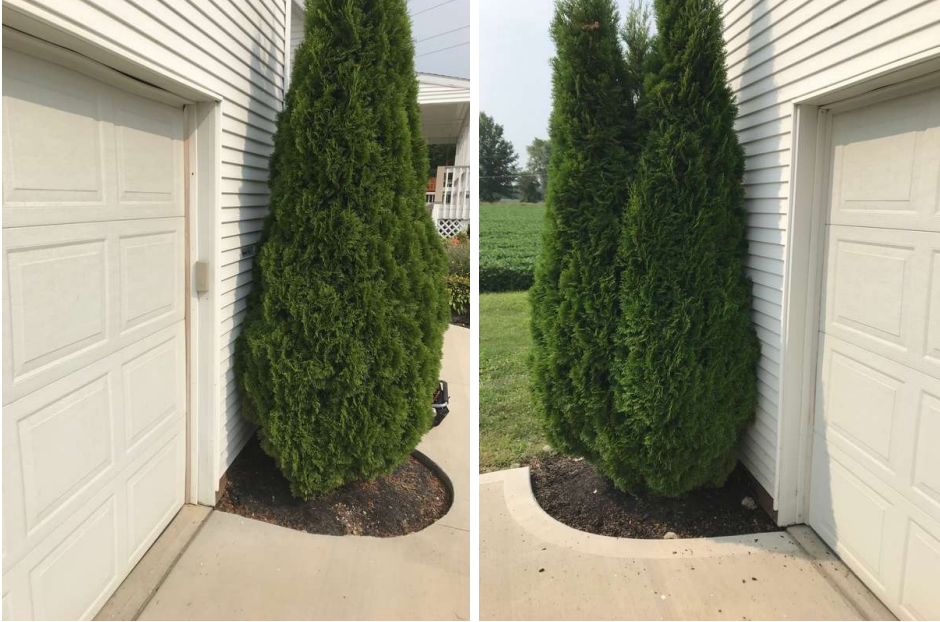
2.14.1 Vegetation

There was vegetation in contact with the exterior of the dwelling. Vegetation in contact with the exterior can cause premature deterioration of roof and siding, and make an easy entry point for pest. Recommend clearance of 12 inches of the vegetation from exterior walls.

Contact a qualified professional.

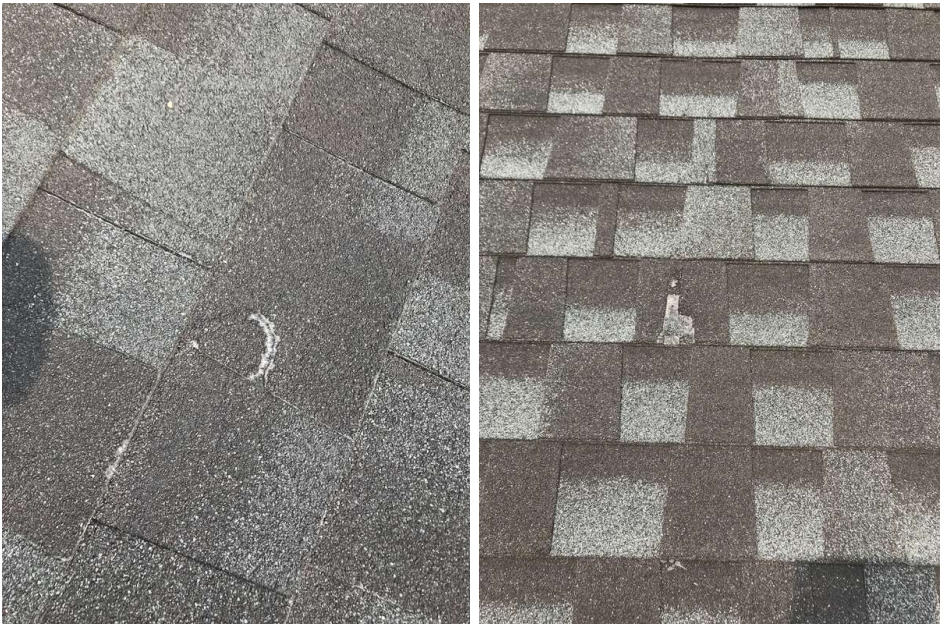
DAMAGE (WIND)***Creased or torn tabs***

The roof had areas of wind damage such as broken adhesive strips and creased or torn shingle tabs. The Inspector recommends replacement of the damaged shingles by a qualified roofing contractor to avoid damage from moisture intrusion.

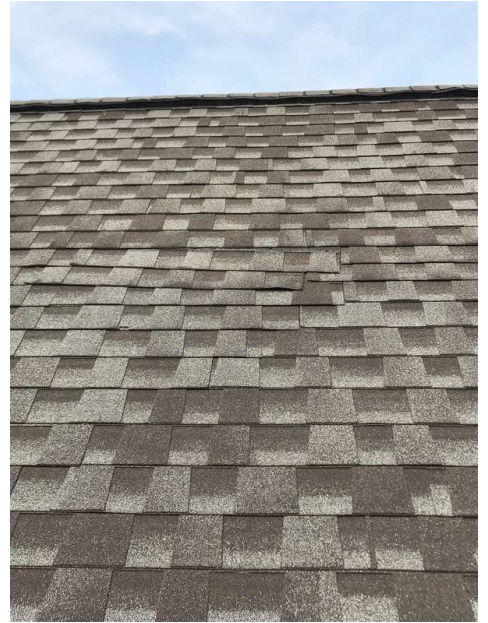
3.1.2 Shingles

LOOSE OR MISSING SHINGLES (WIND)

The roof had loose or missing shingles.

The Inspector recommends replacement of any loose or missing shingles by a qualified roofing contractor to avoid damage from moisture intrusion.

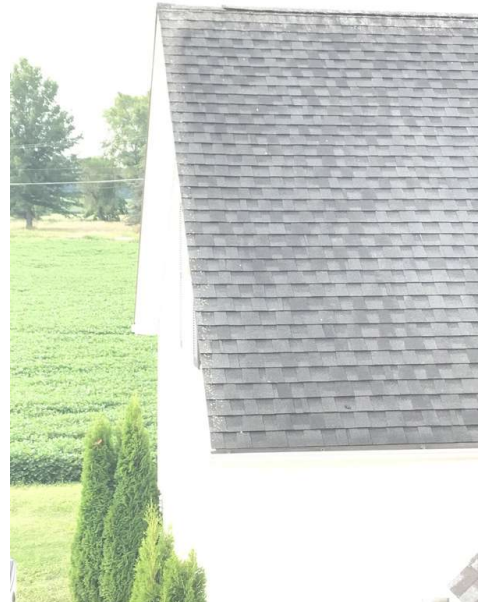
3.1.3 Shingles

MOSS BUILD-UP

Moss build up on the roof usually results from excessive shade and can lead to shortened roof life and increased risk of leaks.

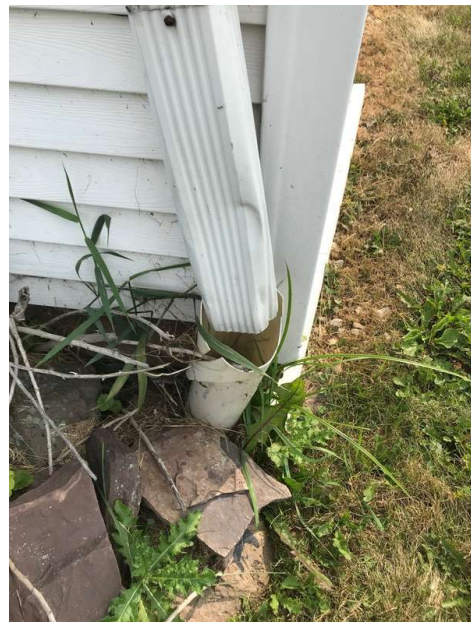
3.6.1 Roof Drainage Systems

GUTTERS (DISCONNECTED)

One or more gutter sections needed to be re-connected in order to properly control roof run-off. This condition can result in excessively high moisture levels in soil at the foundation. Excessive moisture levels in soil near the foundation can effect the ability of the soil to support the weight of the structure above and can cause damage related to soil/foundation movement. The Inspector recommends repair to help protect the home structure and occupants. All work should be performed by a qualified contractor.

Contact a qualified professional.

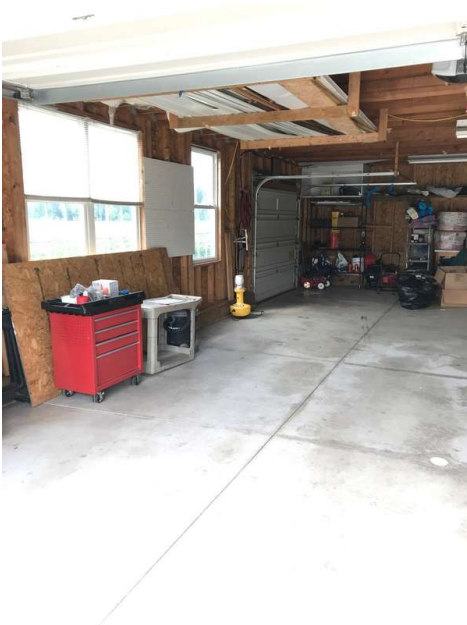
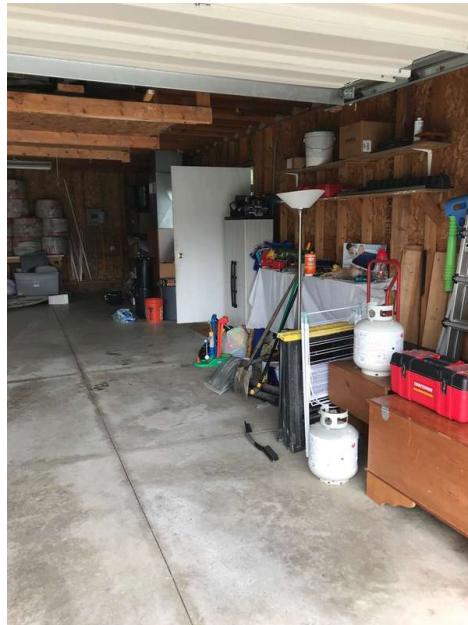
LIMITED VIEW

At the time of the inspection, the occupant's belongings significantly limited the Inspector's view of the garage floor.

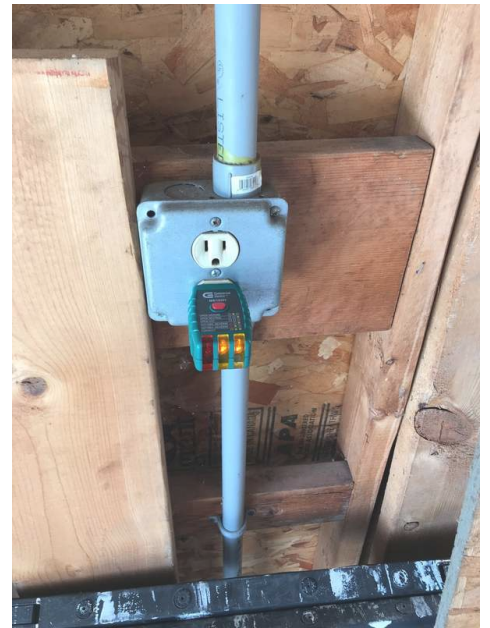
Electrical receptacles in the garage appeared to be in serviceable condition at the time of the inspection but had no Ground Fault Circuit Interrupter (GFCI) protection. Although this condition may have been commonly considered safe or acceptable at the time the home was originally constructed, as general knowledge of safe building practices has improved with the passage of time, building standards have changed to reflect current understanding. Consider having GFCI protection installed as a safety precaution. This can be achieved by: 1. Replacing the current standard receptacles with GFCI receptacles 2. Replacing the receptacle in the garage circuit which is nearest the main electrical service panel with a GFCI receptacle. 3. Replacing the breaker currently protecting the electrical circuit that contains these garage receptacles with a GFCI breaker.

Contact a qualified professional.

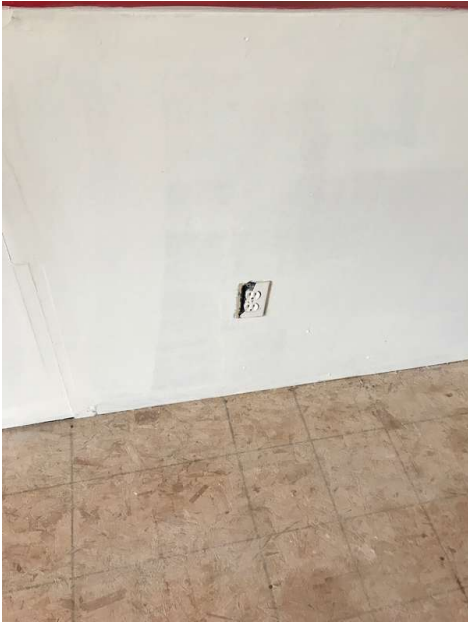
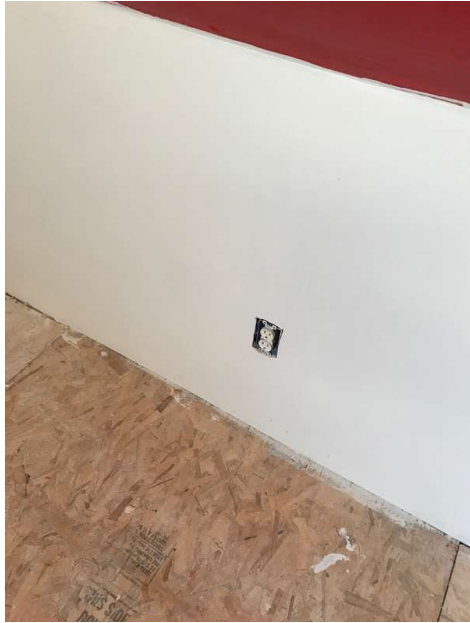
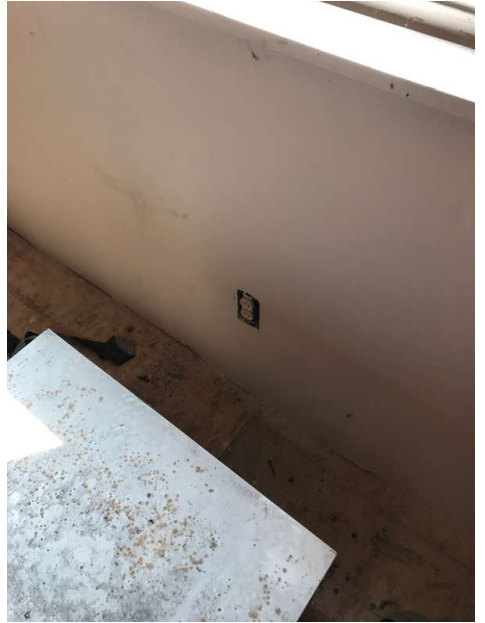
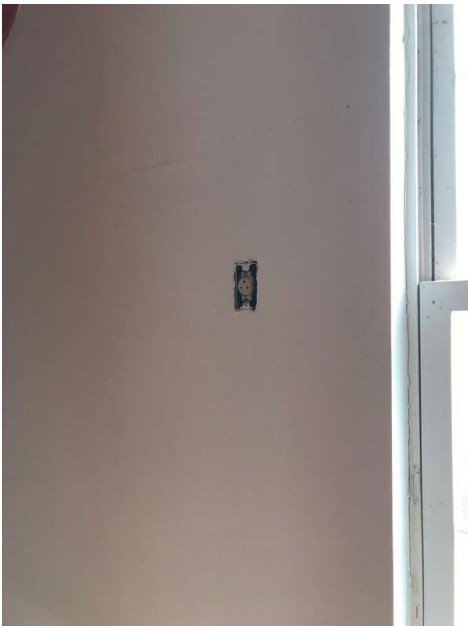
COVER PLATES (MISSING)

At the time of the inspection, electrical receptacle cover plates were missing in the garage. This condition left energized electrical components exposed to touch, a shock/electrocution hazard. The Inspector recommends that cover plates be installed by a qualified contractor.

Contact a qualified professional.

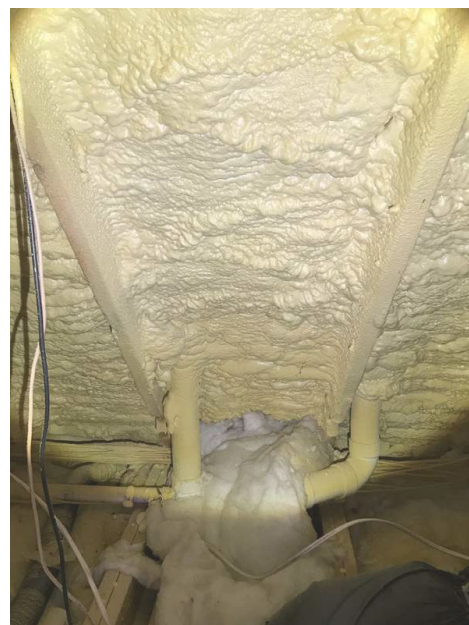
SPRAY FOAM INSULATION

It is not known if the entire attic is insulated with spray foam insulation as there are areas that are not accessible. Recommend adding a second point of entry for inspection to verify installation of spray foam. Spray foam insulation makes the attic "conditioned" and removes the need for ventilation.

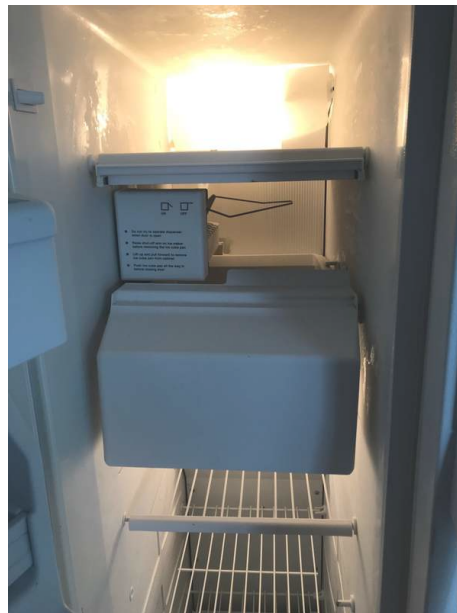
Refrigerator: Ice Maker Turned Off

Refrigerator: Water Dispenser Operated

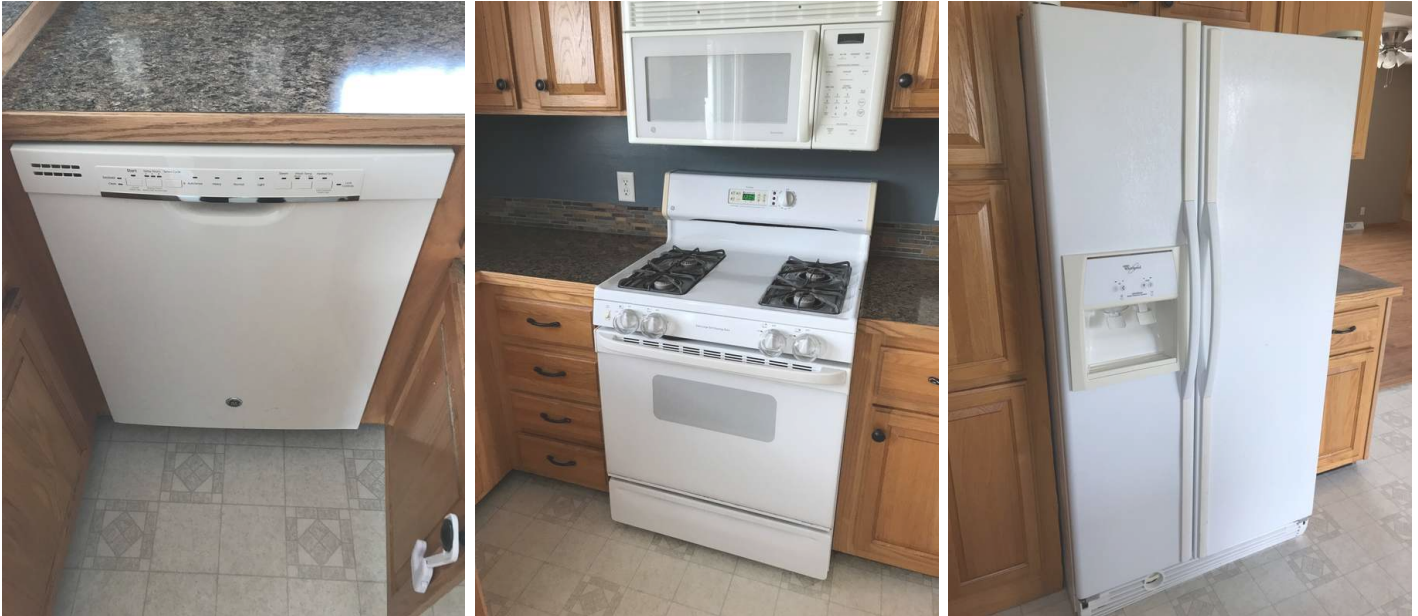
Appliance Photos: Photos

All of the heating elements on the range were turned to "High", and were functional at the time of inspection. No indications of deficiencies were observed unless otherwise noted in this report.

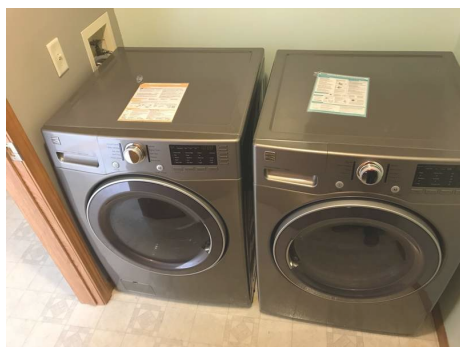
General: Laundry Area Pictures

Gas line present for dryer connection.

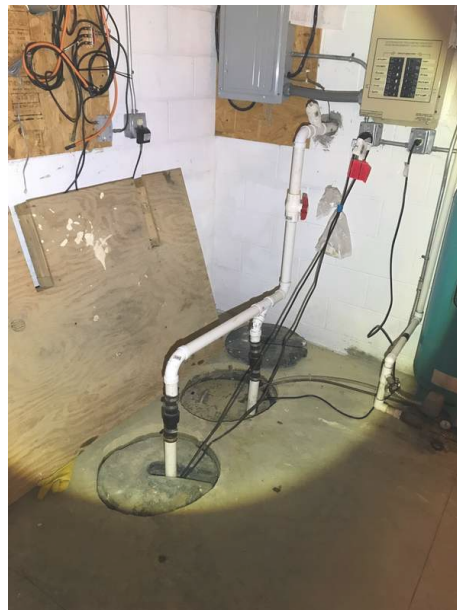
Sump Pumps / Sewage Ejectors: Sump Pump
Present, Tested

Sump Pumps / Sewage Ejectors: Sewage Ejector Pump
Present, Tested, Leaking

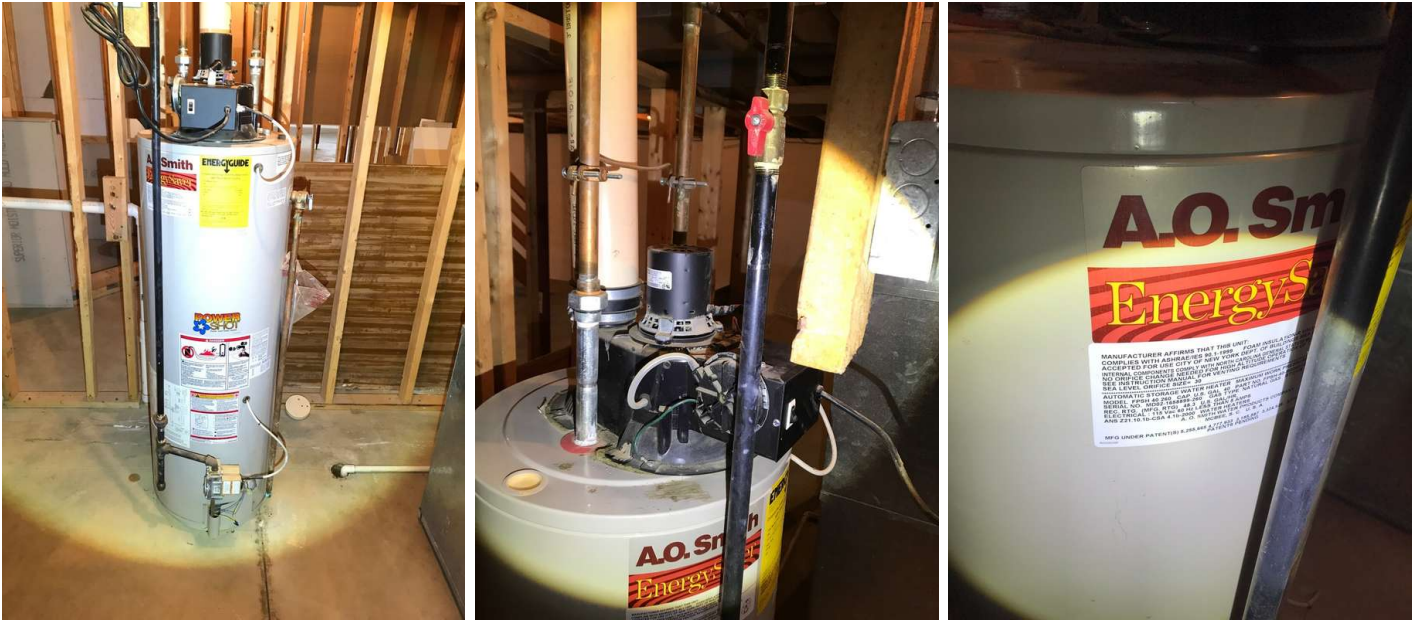
Water Heater: Pictures Of Water Heater

Water Heater: Manufacturer
AO Smith

Water Heater: Model Number
FPSH 40 260

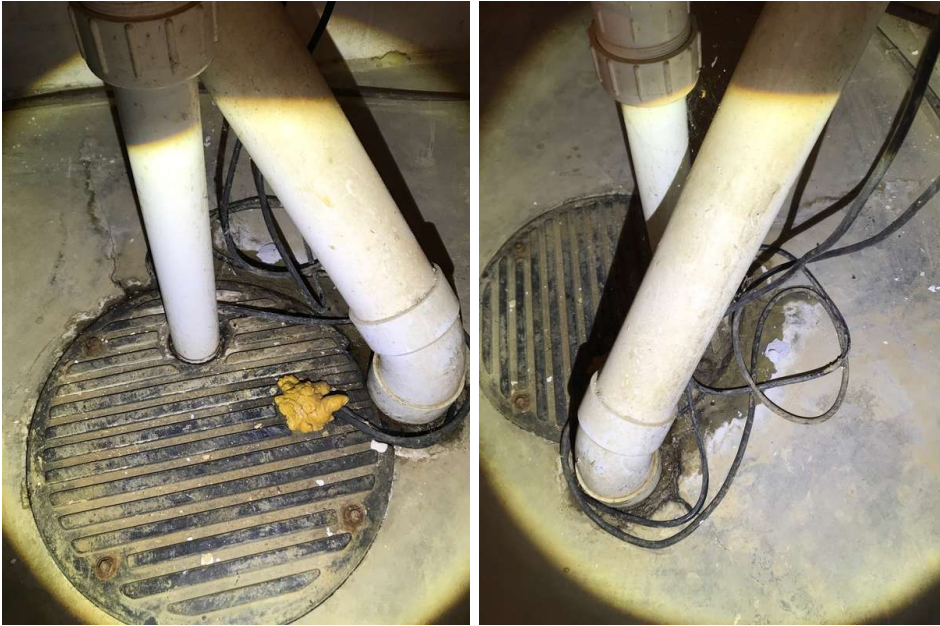
13.4.1 Sump Pumps / Sewage Ejectors

SEWAGE EJECTOR PUMP (LEAKING/FUMES)

Contact a qualified professional.

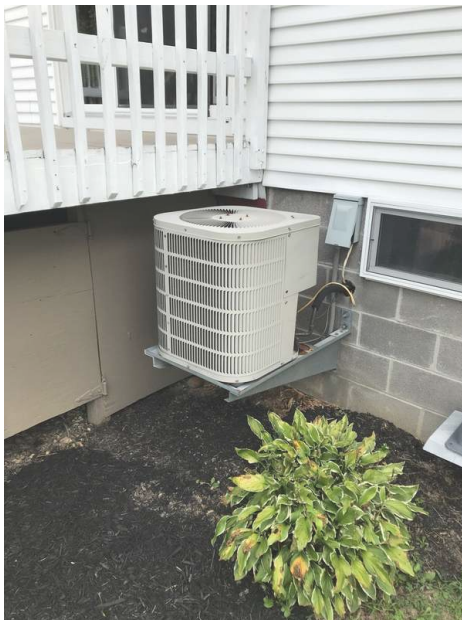
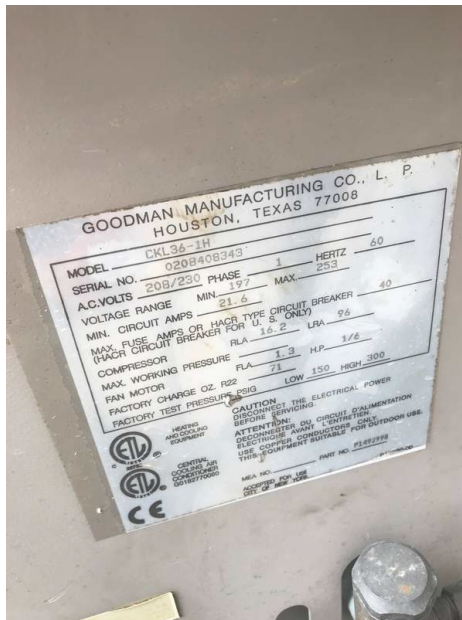
Cooling Equipment: Pictures Of A/C

Cooling Equipment: AC Tested and Operates

The differences in air temperature measured at supply and return registers fell within the acceptable range of between 14 and 22 degrees F.
