RESIDENTIAL REPORT

1234 Main St.
Everett WA 98201

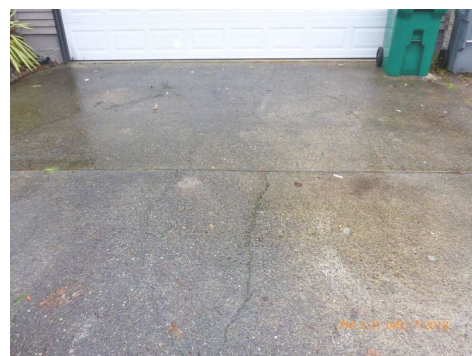
DRIVEWAY CRACK

Water can penetrate the crack and erode the substrate below the concrete. The freeze-thaw cycle during the winters could also further deteriorate the concrete at the crack. Recommend filling the crack with a high-quality caulk or cement filler.

Contact a handyman or DIY project

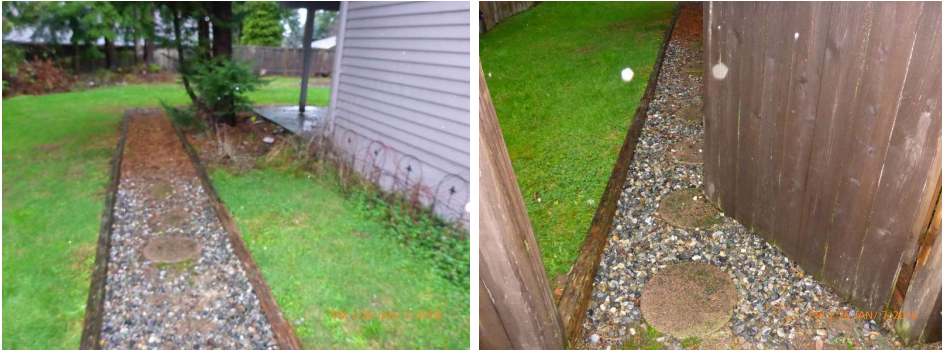
2.2.1 Walkways

TRIP HAZARD - PERIMETER WALKWAY

Uneven surfaces at perimeter walkway could pose a trip hazard. Homeowner could be liable for injuries caused by the trip hazards. Have a licensed contractor repair or replace uneven walking surfaces to eliminate trip hazards.

Contact a qualified landscaper or gardener.

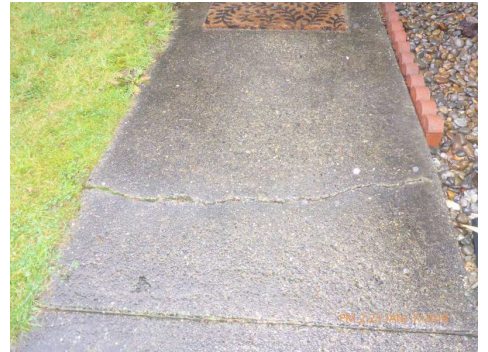
2.2.2 Walkways

WALKWAY CRACKING - MINOR

Minor cosmetic cracks observed. Recommend monitor and/or patch/seal.

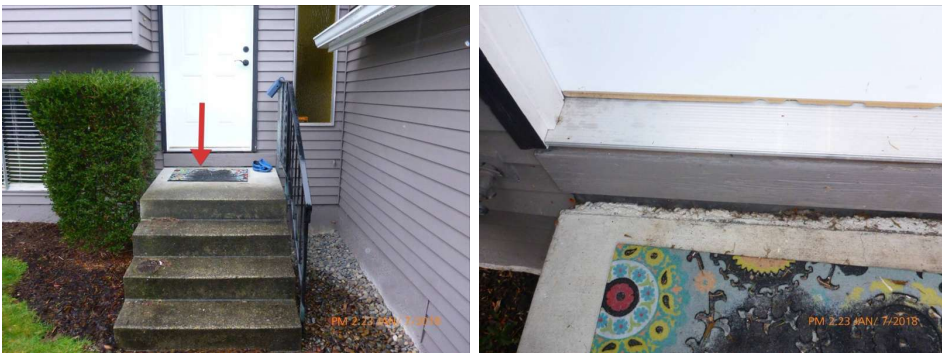
2.5.1 Front Porch

PORCH CONCRETE SHIFTING

The porch is shifting which indicates ground movement. The soil may not have been properly compacted when the house was built and now the porch has settled. The new homeowner should monitor the porch for continued movement. If the porch continues to separate from the house, recommend having a licensed contractor further evaluate and provide repair solutions.

Contact a foundation contractor.

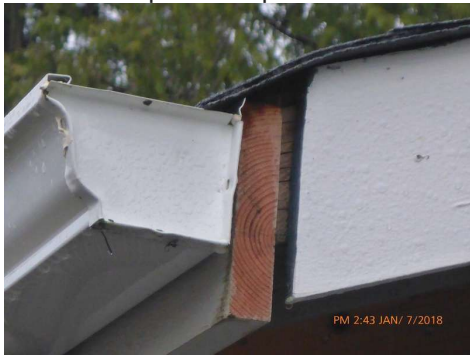
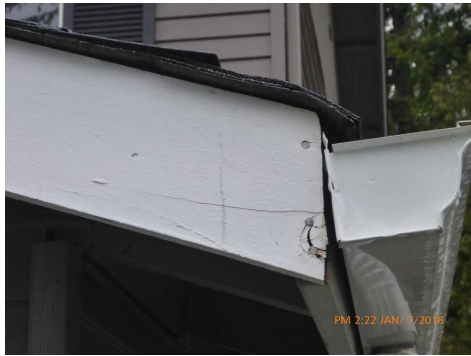
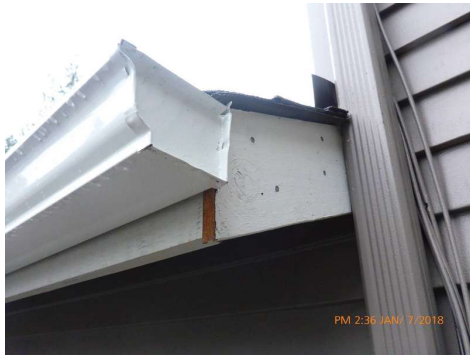
2.7.1 Fascia

NEW FASCIA NOT PAINTED

New fascia board has not been painted. Paint the fascia board to protect the wood from the weather and premature deterioration.

Contact a qualified painter.

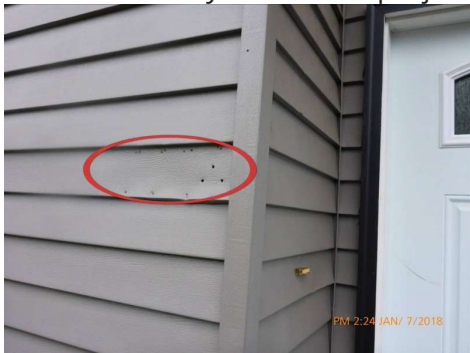
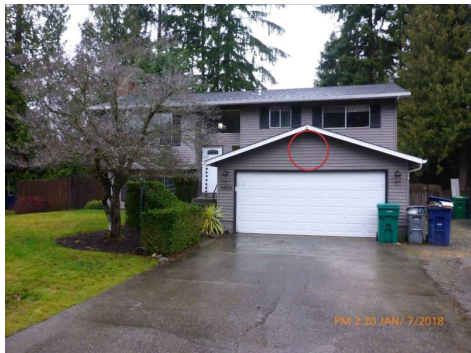
2.10.1 Siding

DAMAGED METAL SIDING

There are several locations where the siding is damaged from hanging items. Fill the holes with a paintable caulk and then paint the patches.

Contact a handyman or DIY project

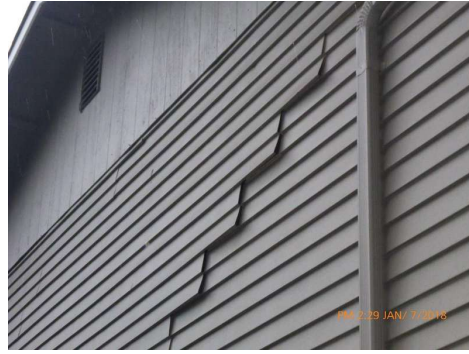
2.10.2 Siding

METAL SIDING WORKING LOOSE

Several panels of siding are working loose. This type of siding is susceptible to working loose during high winds. Have a licensed contractor secure loose slats of siding where needed. The new homeowner should inspect the siding for loose or missing pieces after high wind events.

Contact a qualified siding specialist.

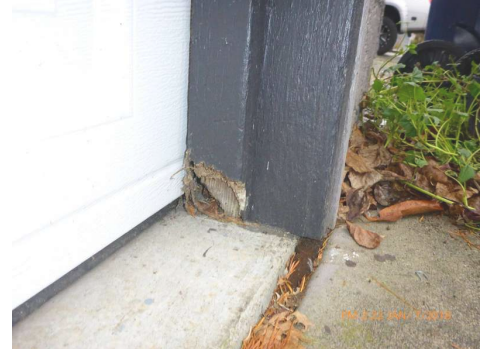
2.12.1 Trim

WOOD TRIM IN CONTACT WITH CONCRETE

Wood trim pieces were in direct contact with concrete. Wood trim contacting concrete surfaces will deteriorate at a faster rate as water is soaked up. Recommend a licensed contractor repair by cutting the bottom of the trim, cutting enough off the end of the trim piece to leave a gap between the trim and the surface of the concrete to allow for air circulation and quick drying.

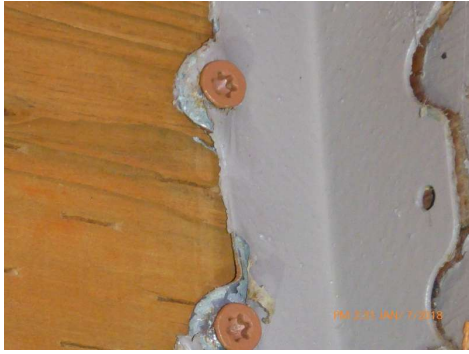
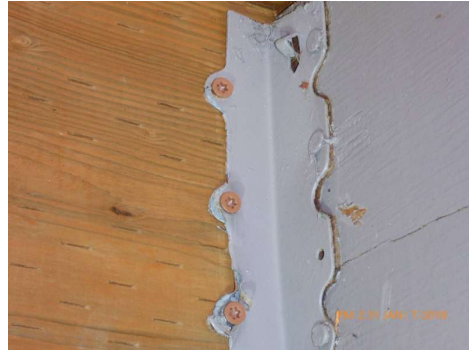
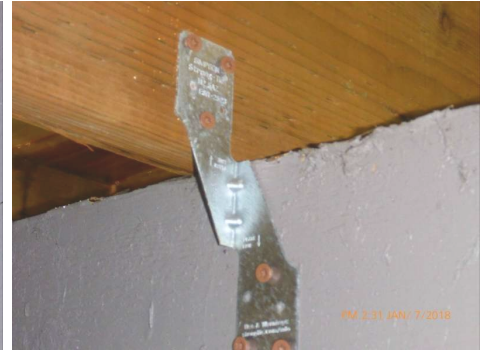
IMPROPER FASTENERS

The deck joists, stair stringers and beam-to-joist brackets are secured with improper fasteners. The existing fasteners are designed for deck boards only and not structural metal brackets, they do not have the same shear strength as dedicated bracket fasteners. Have a licensed contractor replace the existing fasteners with new, proper fasteners as prescribed by the bracket manufacturer.

Joist-to-ledger

Beam-to-joist

Contact a qualified deck contractor.

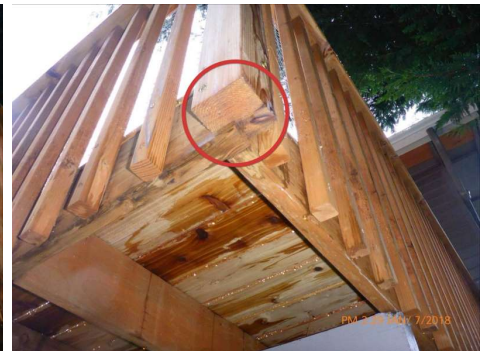
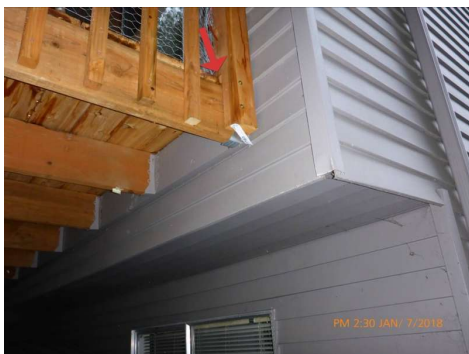
The deck 4x4 guardrail posts have been notched making them weak and in danger of breaking if put under a heavy load such as an adult falling into the guardrail. The posts should be replaced with new posts that are not notched. Have a licensed contractor replace the notched posts with new posts.

Contact a qualified deck contractor.

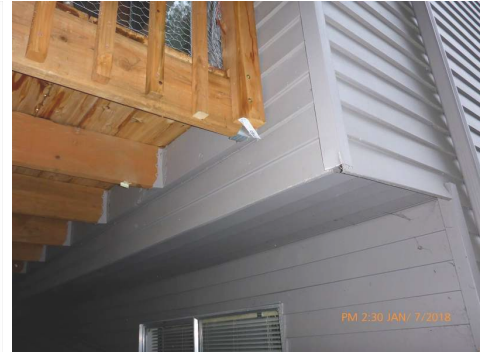
The new deck is attached to the house at a cantilever. This is not recommended deck-building practice. Although the house is almost 40 years old and previous decks may have been built this way, the deck could potentially pull away from the house and cantilever. Recommend installing new vertical deck supports and new beam under the deck near the cantilever to remove the dead weight of the deck off of the house structure.

Preferred method of deck support. Note deck is not attached to the house cantilever.

Existing condition of deck-to-house connection

Contact a qualified deck contractor.

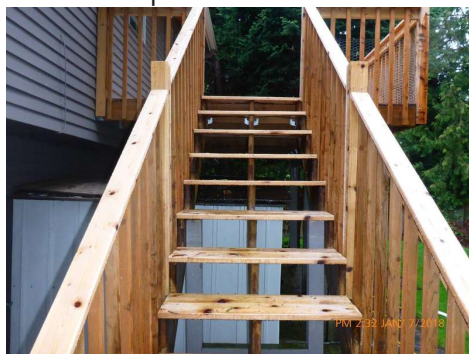
MISSING GRASPABLE HANDRAILS

Missing graspable handrails at steps. Have a licensed contractor install a graspable handrail at steps. Handrail should be continuous and uninterrupted.

Contact a qualified deck contractor.

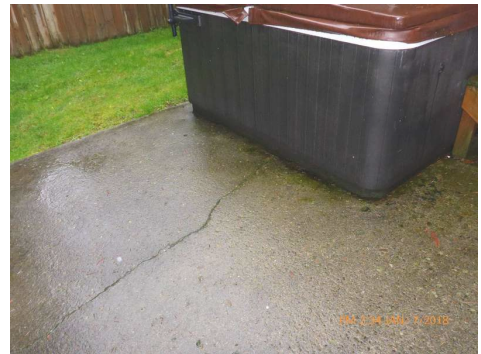
A hot tub sits on top of the patio. If the patio was not designed to support the hot tub, concrete could settle and crack under the weight of the hot tub. Recommend asking seller if special thought was put into the design of the patio where the hot tub sits.

Contact a foundation contractor.

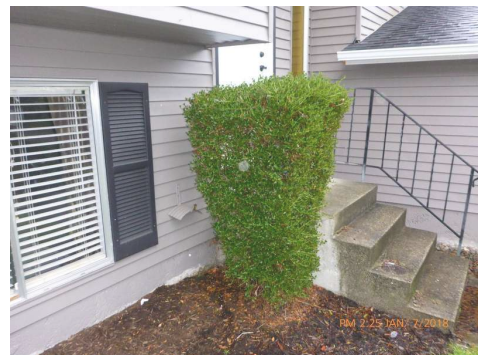
2.20.1 Vegetation

SHRUBS - CONDITIONS CONDUCTIVE FOR WOOD DESTROYING ORGANISMS

Vegetation growing against the house provides food and shelter for potential WDO activity. Recommend cutting back or removing (and relocating if possible) all vegetation growing against the house.

Contact a qualified handyman.

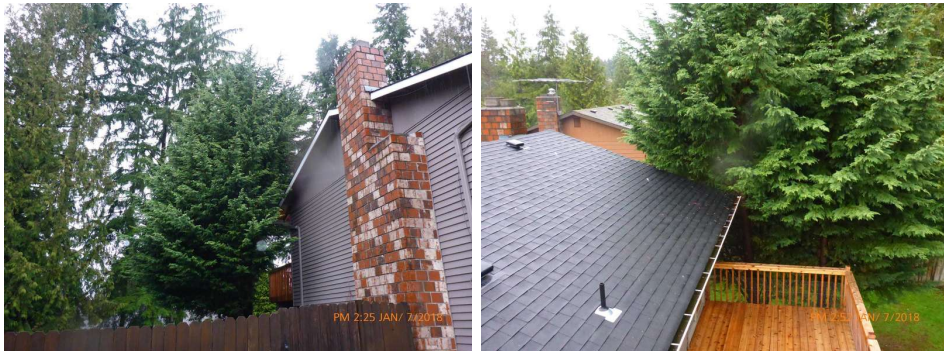
2.20.2 Vegetation

TREES- CONDITIONS CONDUCTIVE FOR WOOD DESTROYING ORGANISMS

Tree(s) growing close to the house and/or over the roofline provide food and shelter and a means for entry into the structure for potential WDO activity. Recommend cutting back trees.

Contact a qualified tree service company.

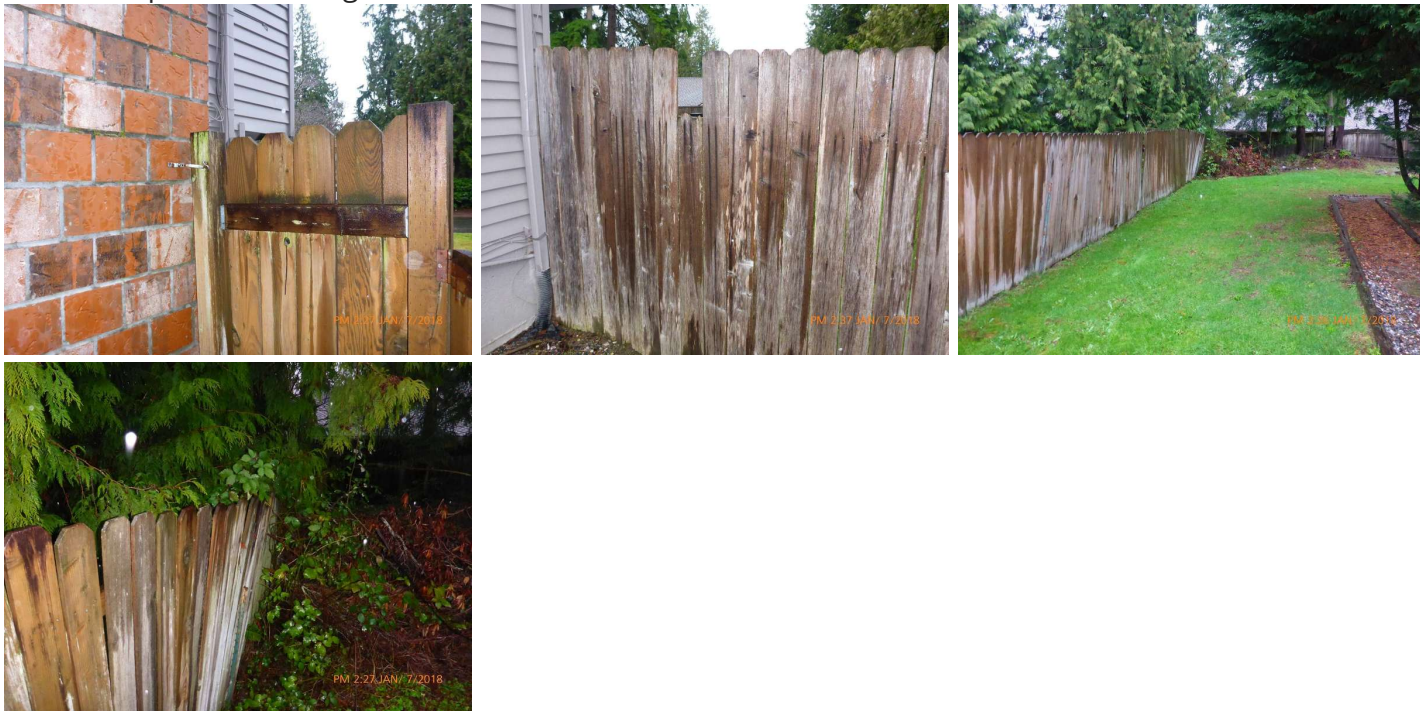
2.21.1 Fencing

FENCE POST DAMAGED/MISSING

A fence panel is leaning due to a broken/missing fence post. Have a licensed contractor repair/replace the broken/missing fence post.

Contact a qualified fencing contractor

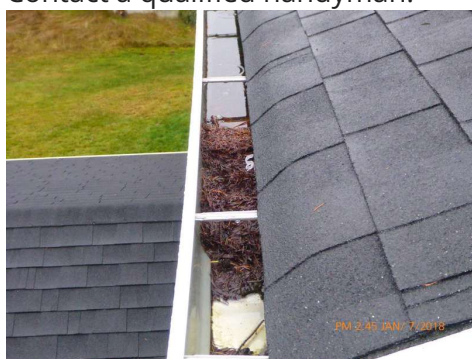
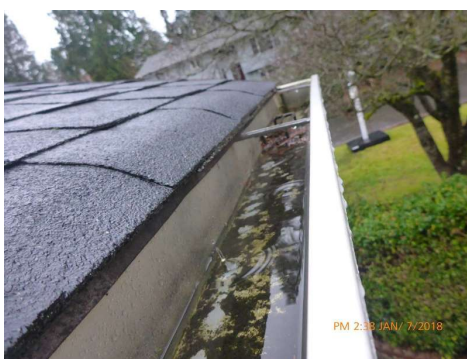
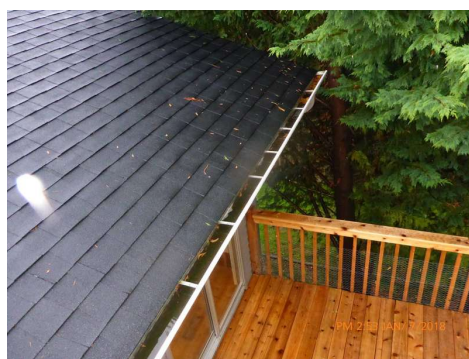
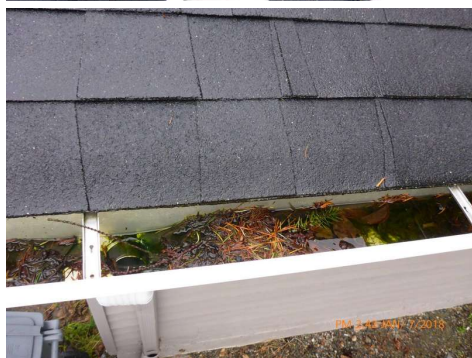
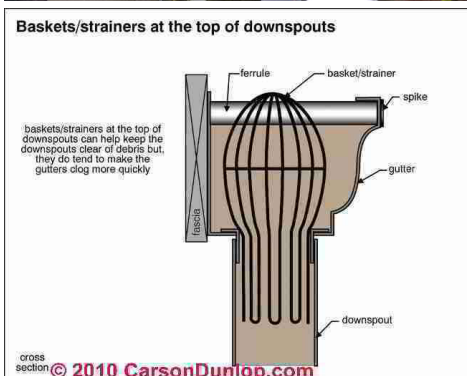
Basket Strainer

Debris has accumulated in the gutters. Recommend cleaning to facilitate water flow. Install basket strainers in the downspout openings in the gutters to help prevent debris from clogging the footing drains.

Contact a qualified handyman.

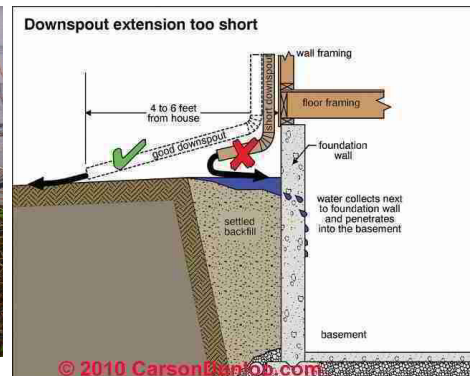
Downspout Extension

One or more downspouts drain too close to the home's foundation. This can result in excessive moisture in the soil at the foundation, which can lead to foundation/structural movement. Recommend a qualified contractor adjust downspout extensions to drain at least 6 feet from the foundation.

Contact a qualified professional.

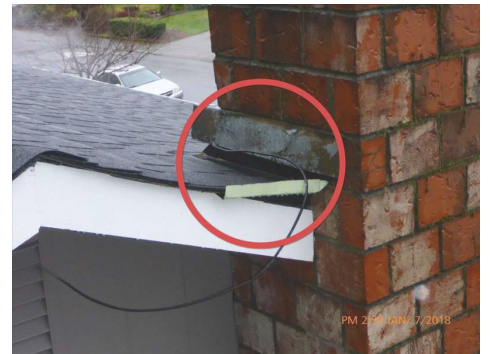
3.3.1 Flashings

The flashing at the chimney is improperly installed. It is making a dam and holding water. That water may be seeping below the shingles and reaching the wood decking. Have a licensed contractor replace the flashing so that water can drain off the roof.

Contact a qualified roofing professional.

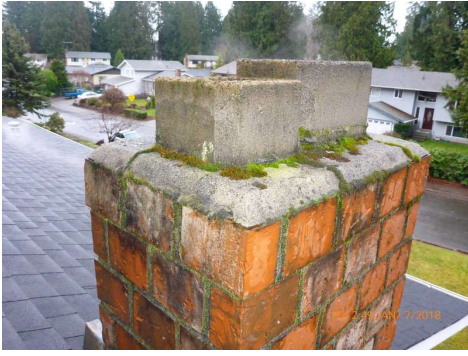
3.4.1 Chimneys

CHIMNEY CAP MISSING

No chimney cap was observed. This is important to protect from moisture intrusion and protect the chimney. Recommend installing a cap over the flue opening.

Contact a qualified roofing professional.

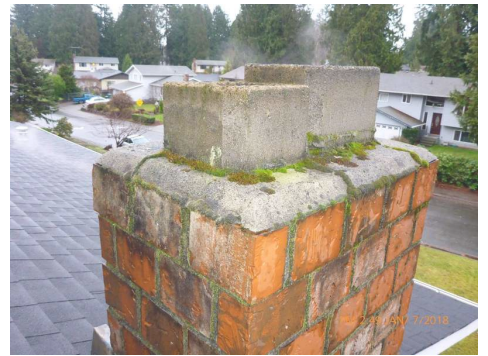
3.4.2 Chimneys

HEAVY MOSS GROWTH

Clean moss off chimney. The moss retains moisture that can deteriorate the mortar joints and crown. Have a licensed contractor power wash the chimney. Cracks in the crown should be caulked with a high-quality caulk.

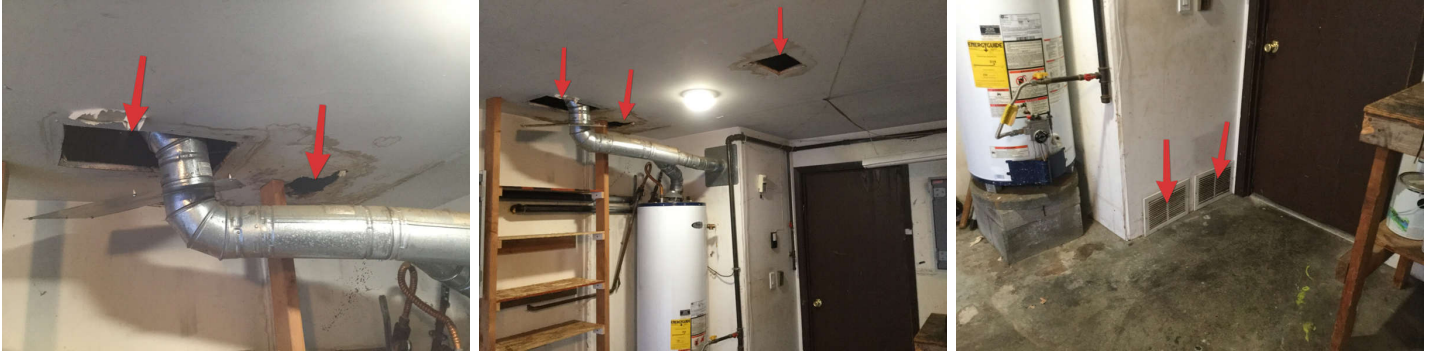
DAMAGED DRYWALL

Damaged drywall at walls and/or ceiling in garage adjacent to the living space is a safety hazard. Smoke, fire and toxic fumes could enter the house through the damaged drywall harming the occupants. Have a licensed contractor fill cracks in the drywall and repair damaged drywall.

Contact a qualified drywall contractor.

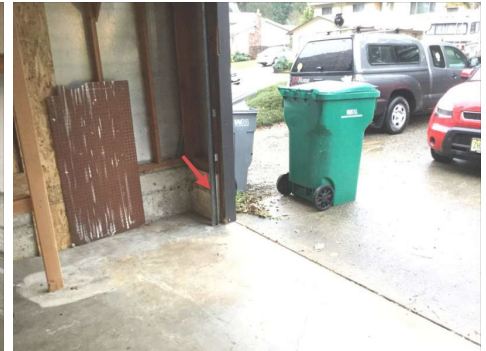
PHOTOELECTRIC SENSORS MISSING OR IMPROPERLY INSTALLED

The overhead garage door is missing photoelectric edge sensors. The sensors work by reversing the door if an obstacle is in the path of the door. People could be injured or property can be damaged without operable sensors. Have a licensed contractor install new photoelectric edge sensors to help prevent personal injuries or property damage.

Photo-electric sensors are at ceiling. They should be at the door rail near the garage floor.

photo-electric sensor should be here. photo-electric sensor should be here

Contact a qualified garage door contractor.

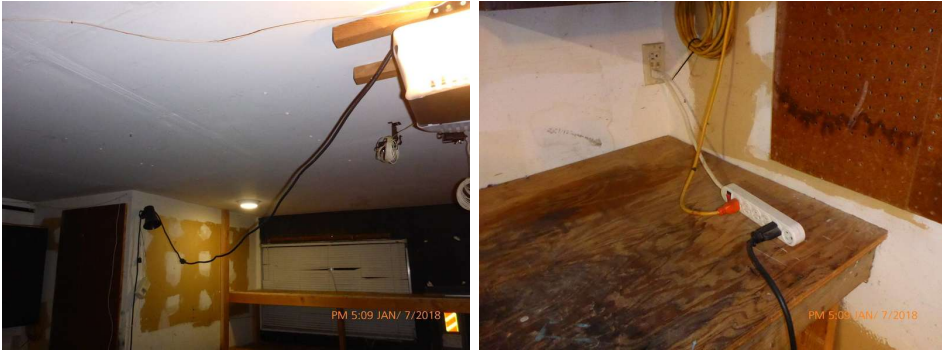
An extension cord is feeding power to the garage door opener. The cord sweeps across a wall and ceiling to reach the opener. Recommend having a licensed contractor install a new outlet close to the opener to eliminate the cord.

Contact a qualified electrical contractor.

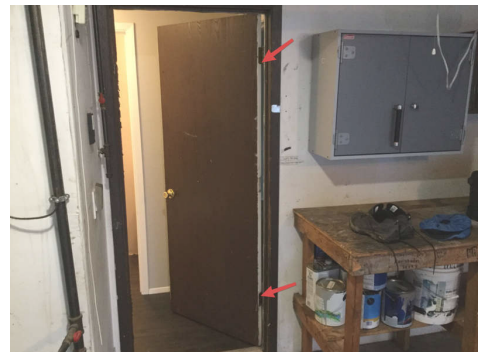
MISSING AUTO-CLOSING HINGES

The pedestrian door is missing auto-closing hinges. Garage sourced gases and fire could spread quickly into the dwelling if the pedestrian door was left open. Have a licensed contractor install new auto-closing hinges on pedestrian door.

Contact a qualified handyman.

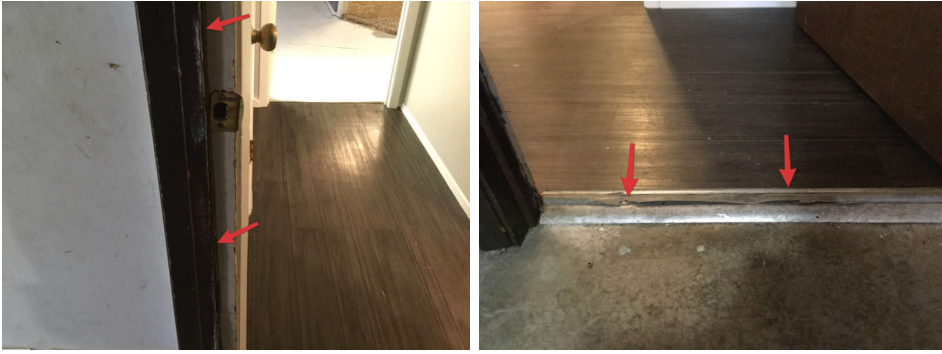
4.5.2 Garage Pedestrian Door

MISSING WEATHERSTRIPPING / THRESHOLD

The garage pedestrian door is missing weatherstripping and/or a threshold. The weatherstripping and threshold help prevent toxic fumes such as CO2 gases, smoke and flames from entering the living space through the garage. Have a licensed contractor install new weatherstripping and/or threshold around the garage door frame.

Contact a qualified handyman.

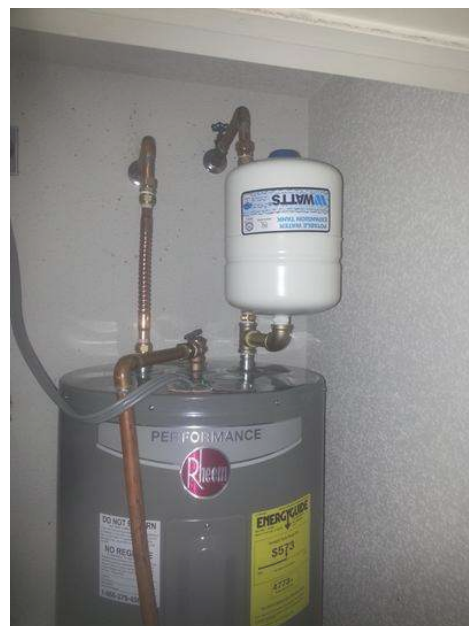
MISSING EXPANSION TANK

Missing an expansion tank at the water heater. A safety device known as a **water heater expansion tank** (sometimes called a thermal **expansion tank**) can help minimize the risk of pressure damage to the plumbing system. ... Since **water** expands when it is heated due to thermal **expansion**, the **water heater** creates extra **water** volume every time it heats **water**. Have a licensed contractor install a new expansion tank.

Example of an Expansion Tank at Water Heater

Contact a qualified plumbing contractor.

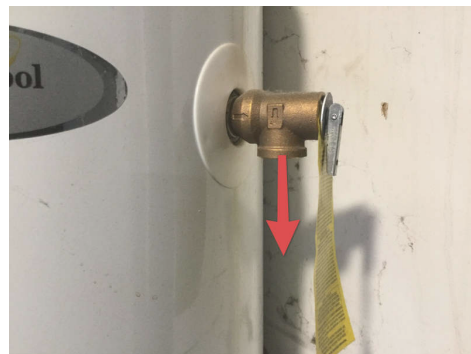
MISSING T&P DISCHARGE PIPE

With discharge/overflow pipe missing or too short; potential for scalding injuries. Have a licensed contractor install a new discharge pipe that terminates within 2 to 6 inches from the floor when the water heater is replaced.

Contact a qualified professional.

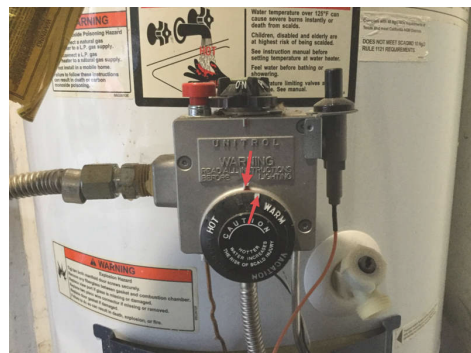
5.1.4 Water Heater

The water temperature is above the recommended water temperature of 120 degrees. Turn the water temperature dial(s) down to 120 degrees to prevent potential scalding injuries. Aligning the white triangles or red markers on the gas control housing and on the dial provide the 120 degree water temperature.

Recommended DIY Project

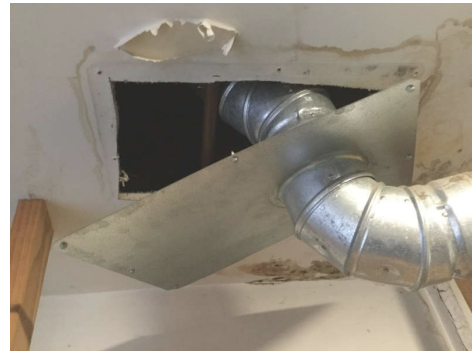
PLATE IS LOOSE

Plate loose. The plate should be reinstalled and fire-caulked to make

Contact a qualified HVAC professional.

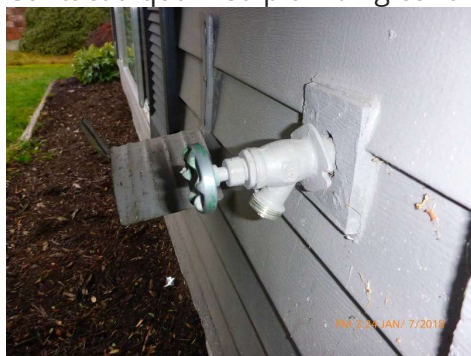
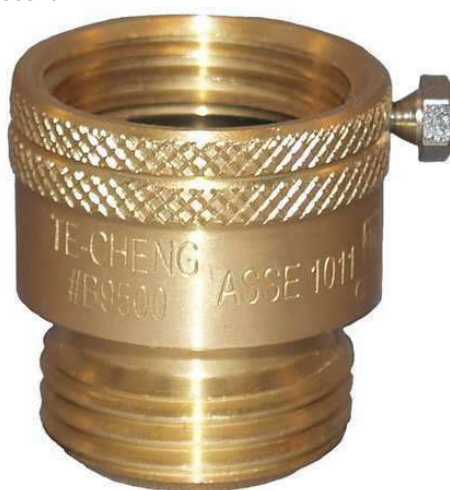
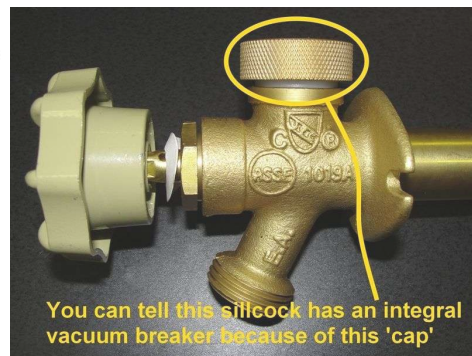
5.2.1 Plumbing Fixtures

HOSE BIBS - ANTI SIPHON

Existing hose bib does not have anti siphon valve. The anti siphon valve prevents potentially contaminated water from being sucked back into the house's potable water supply in the event the municipal water system should lose water pressure. Install a new anti siphon hose bib or install an anti siphon valve at the existing hose bib. They can be found at any home improvement store.

Example of Anti-Siphon Hose Bib

Example of Anti-Siphon Valve added to Existing Hose Bib

Contact a qualified plumbing contractor.

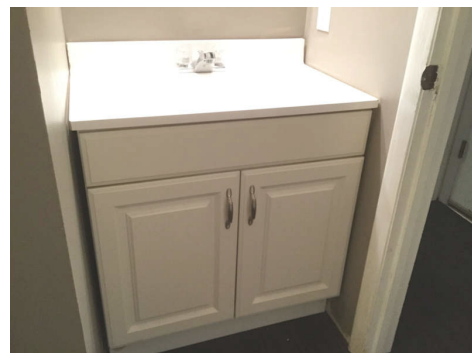
SINK VANITY LOOSE

The vanity is loose. Have a licensed contractor secure it to the wall. A secured cabinet will prevent the plumbing drain and water supply lines from being damaged.

Contact a qualified handyman.

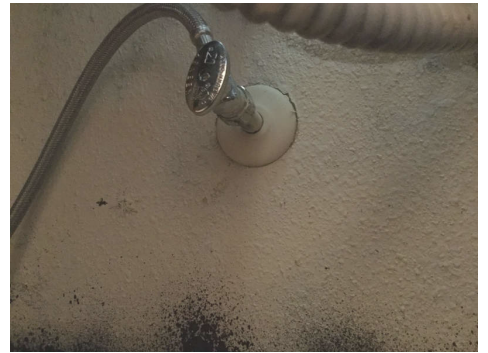
Dishwasher Valve

LEAKING WATER VALVE

Evidence of water leak at water shut off valve. Replace with new valve.

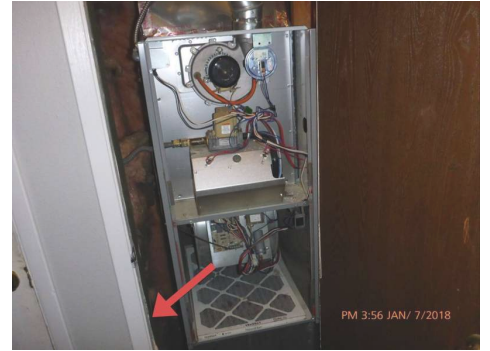
MAKEUP AIR MAY BE CONTAMINATED

Make up air vents on left side of furnace. Direct line to garage.

Contact a qualified HVAC professional.
