TRUSCOPE HOME INSPECTIONS

## YOUR INSPECTION REPORT

1234 Main St.  
Spruce Grove AB T7X 3S2

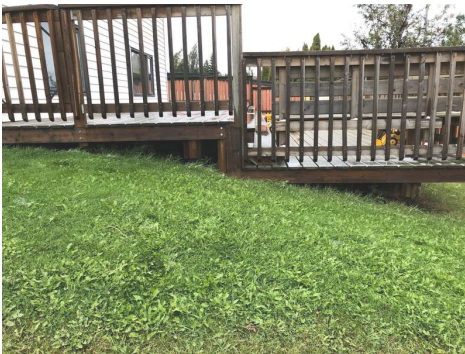
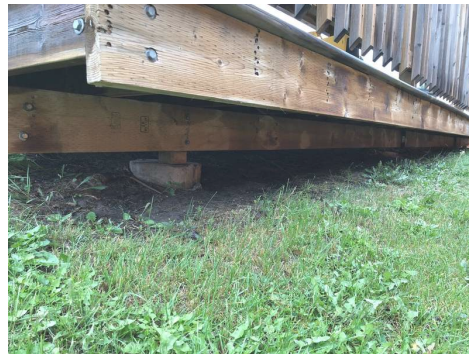
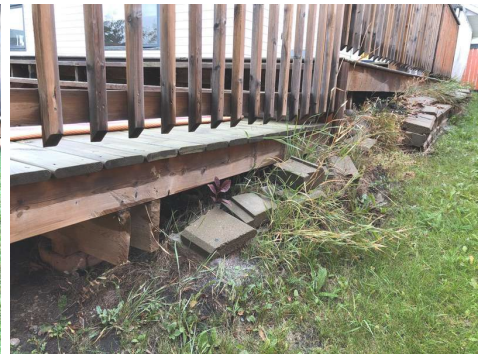
**SUBSTRUCTURE NOT EVALUATED**

Most or all of the deck substructure was inaccessible. This area couldn't be evaluated and is excluded from the inspection.

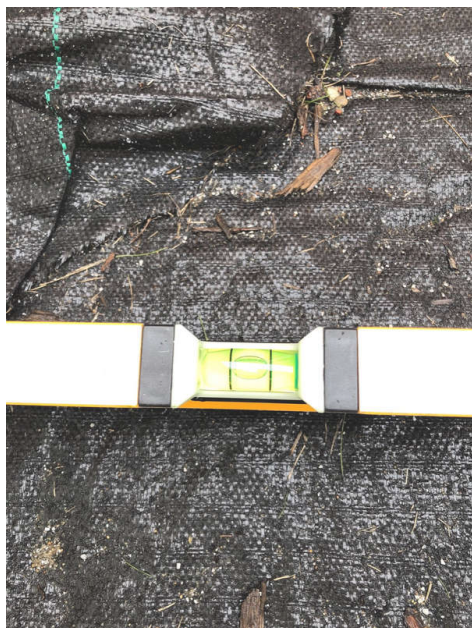
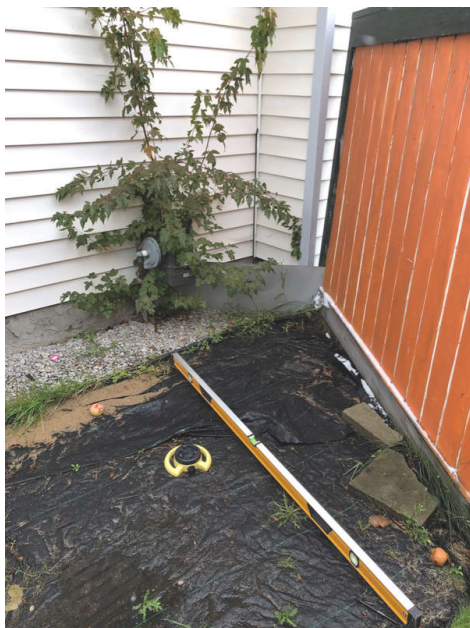
Grading was flat or sloping towards the home in some areas. This could lead to water accumulation. Accumulated water may cause the foundation to settle over time. Recommend qualified landscaper or foundation contractor regrade so water flows away from home.

Contact a qualified landscaping contractor

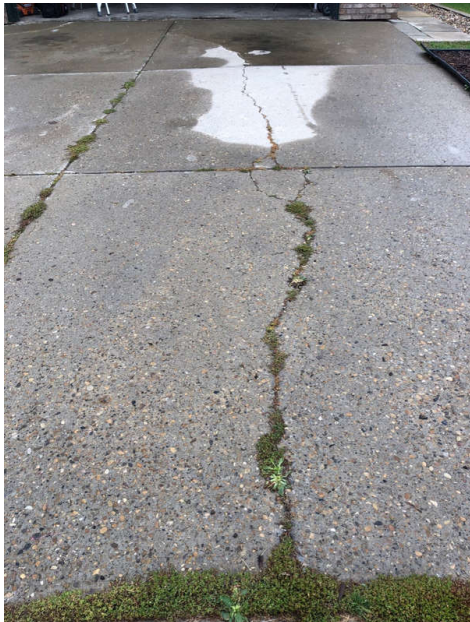
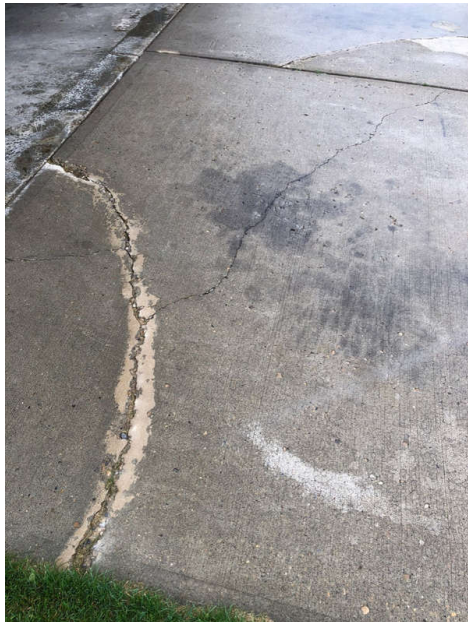
2.5.1 Walkways, Patios & Driveways

**DRIVEWAY CRACKING - MINOR**

Minor cosmetic cracks observed, which may indicate movement in the soil. Recommend monitor and/or have concrete contractor patch/seal.

Contact a qualified driveway contractor.

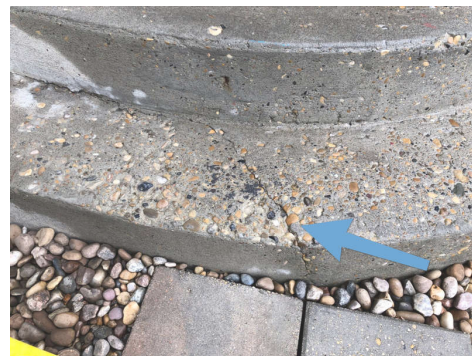
2.5.2 Walkways, Patios & Driveways

**WALKWAY/PATIO CRACKING - MINOR**

Normal settling & cracking observed. Recommend monitor and/or patch/seal.

Contact a qualified professional.

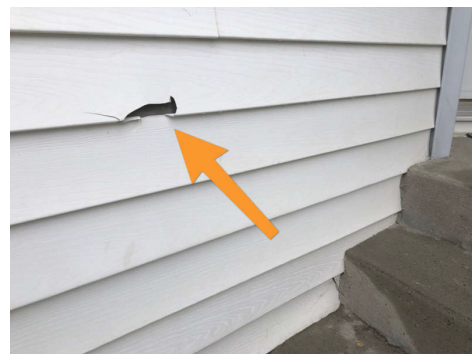
2.6.1 Siding, Flashing & Trim

**HOLES/GAPS**

One or more holes or gaps were found in siding or trim, possibly allowing vermin or water to enter. Recommend that a qualified person repair as necessary.

Contact a qualified professional.

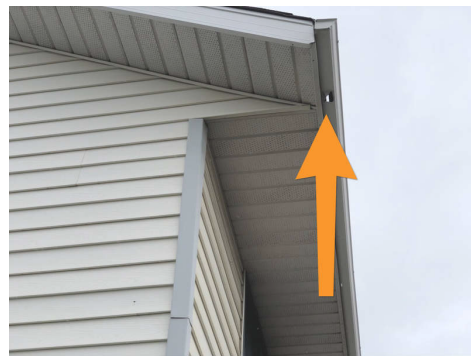
## DOWNSPOUTS MISSING

Home was missing downspouts in one or more areas. This can cause soil erosion and water to accumulate around the home's foundation.

Excessive water around the foundation can lead to structural movement. Recommend a qualified contractor install downspout(s) and extension(s) that drain at least 6 feet from the foundation.

Contact a qualified gutter contractor

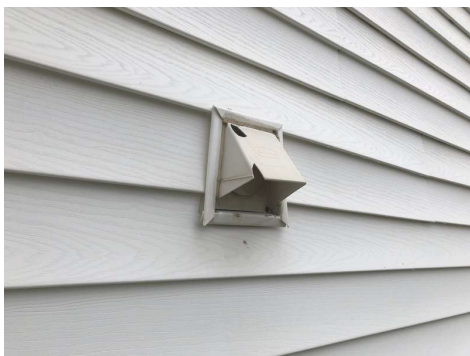
### 2.9.1 Penetrations

## EXHAUST VENT DAMAGED

One or more exhaust duct end caps were missing, loose, damaged, or deteriorated. Their purpose is to prevent unconditioned air from entering the building, and keep out birds, rodents and bugs. Blocked ducts can cause fan motors and/or clothes dryers to overheat and can pose a fire hazard. Recommend that a qualified person repair or replace caps as necessary.

Contact a qualified HVAC professional.

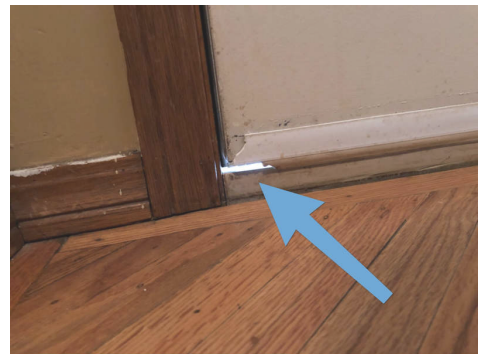
The weatherstrip around one or more exterior entry doors is missing and/or deteriorated. Weatherstrip should be installed where missing and/or replaced where deteriorated, and by a qualified contractor if necessary.

Contact a qualified door repair/installation contractor.

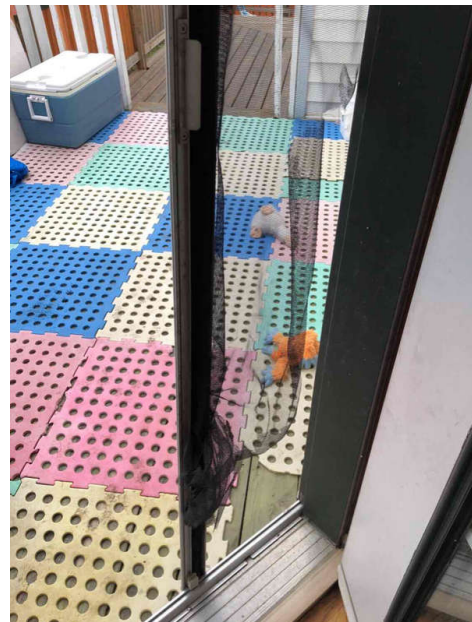
## 2.10.2 Exterior Doors

**SLIDING SCREEN DOOR DETERIORATED**

One or more sliding screen doors are damaged and/or deteriorated. Screen doors should be replaced where necessary.

Contact a qualified door repair/installation contractor.

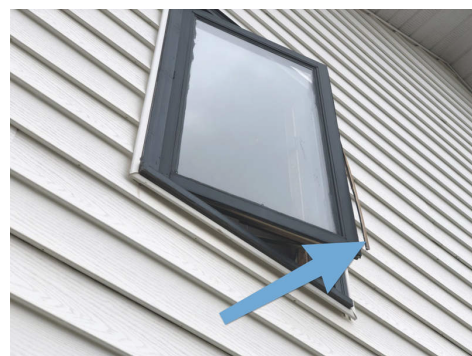
2.11.1 Exterior Windows

**WINDOW BEADS/SEALS**

The seal/bead is missing or deteriorated at one or more windows. It is recommended to have a contractor evaluate and make the necessary repairs.

Contact a qualified window repair/installation contractor.

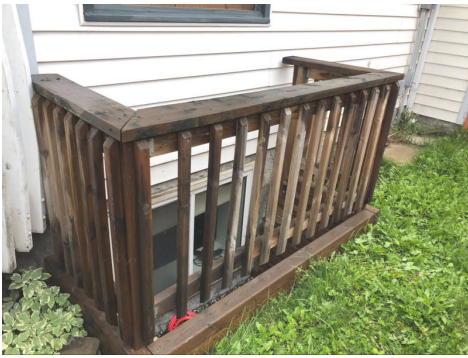
2.11.2 Exterior Windows

**WINDOW EGRESS**

The window well had no means of easy egress in case of an emergency. The railing around the window well provides good safety from falling into the well; however prevents easy exit in case of emergency. Recommend installing means of egress.

Contact a qualified professional.

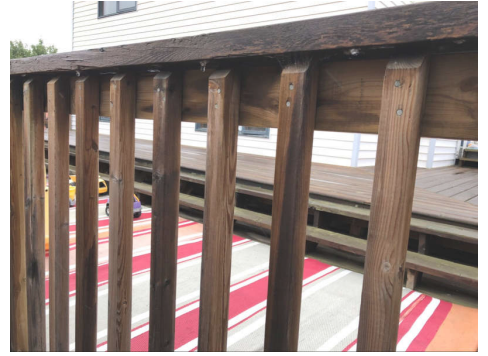
Deficiency**PROTECTION MISSING**

Wooden deck or porch components appeared to have had no paint, stain, or penetrating oil applied. Recommend that a qualified person clean and preserve as necessary.

Contact a qualified professional.

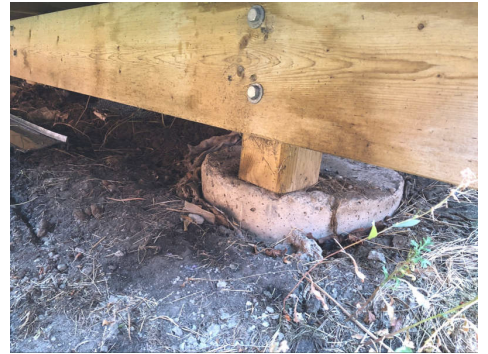
## 2.13.4 Decks, Balconies &amp; Porches

Deficiency**WOOD ON CONCRETE**

Wooden support posts for the deck or porch were resting directly on concrete piers or footings below. Water may wick up into the support post ends and result in elevated levels of moisture in the wooden support post ends. This is a conducive condition for rot. Support posts should rest in metal brackets above concrete piers or footings, or should be separated from the concrete below by impervious membranes such as composition shingle scraps. Even if posts are made of treated wood the cut ends may not have been field-treated, leaving little or no preservative at the post center. Recommend that a qualified contractor repair per standard building practices. For example, by installing an isolation barrier between the posts and the concrete below.

Contact a qualified professional.

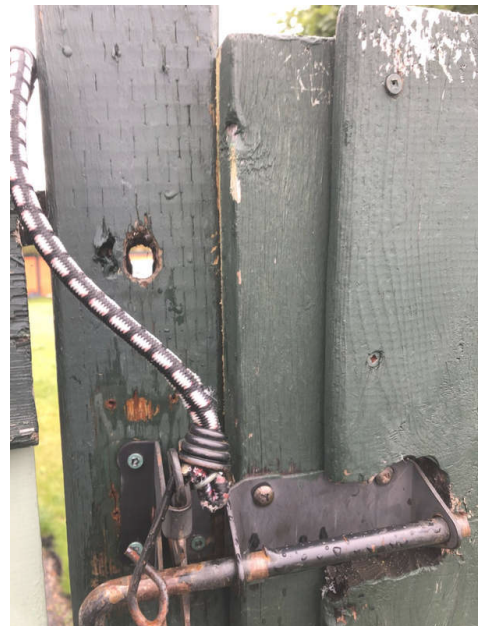
## 2.15.1 Fences and Gates

Gates were difficult to open and close and need repair.

Contact a handyman or DIY project

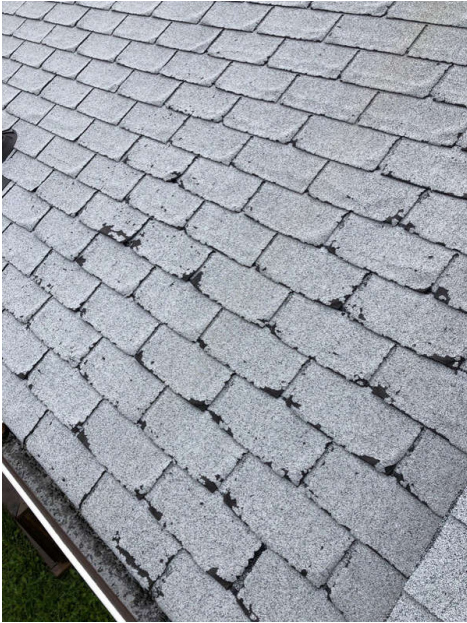
#### 3.3.1 Shingles

##### SHINGLE DETERIORATION

One in there of the roofing shingles are deteriorated (i.e. Missing or deteriorated granules). A qualified roofing contractor should evaluate and make the necessary repairs.

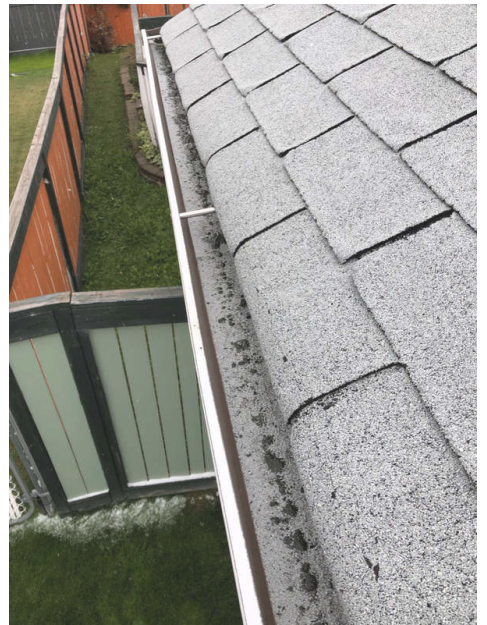
Debris had accumulated in the gutters. This can lead to clogged gutters and downspouts. If this happens, gutters can overflow and cause water to come in contact with the building exterior, or water can accumulate around the foundation. This can be a conducive condition for wood-destroying organisms. Accumulation around the foundation can lead to structural movement. Recommend cleaning gutters and downspouts now and as necessary in the future.

Contact a handyman or DIY project

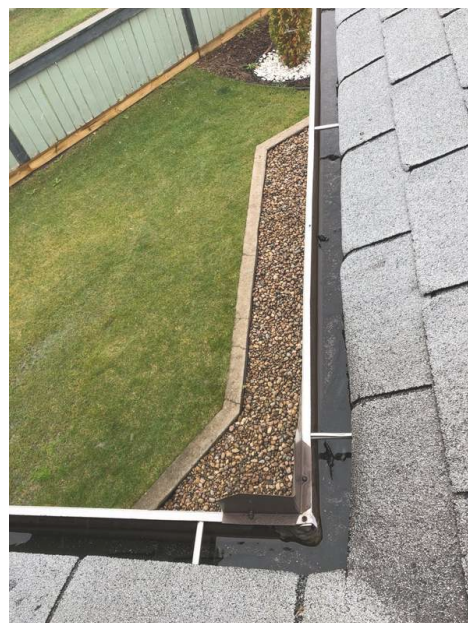
### 3.4.2 Gutters

#### CLOGGED GUTTERS/DOWNSPOUTS

Significant amounts of debris have accumulated in one or more gutters or downspouts. Gutters can overflow and cause water to come in contact with the building exterior, or water can accumulate around the foundation. This can be a conducive condition for wood-destroying organisms. Accumulation around the foundation can lead to structural movement. Recommend cleaning gutters and downspouts now and as necessary in the future.

Water not draining out

Contact a handyman or DIY project

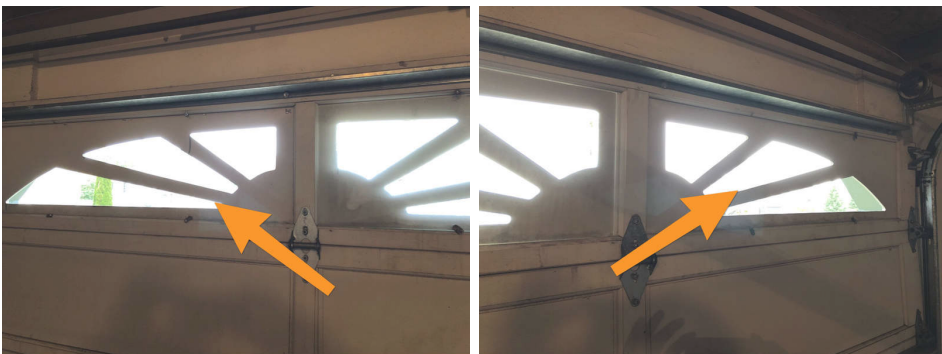
#### **GARAGE DOOR WINDOW MISSING**

One or more panels from the overhead garage door were missing. Recommend having windows replaced.

Contact a qualified professional.

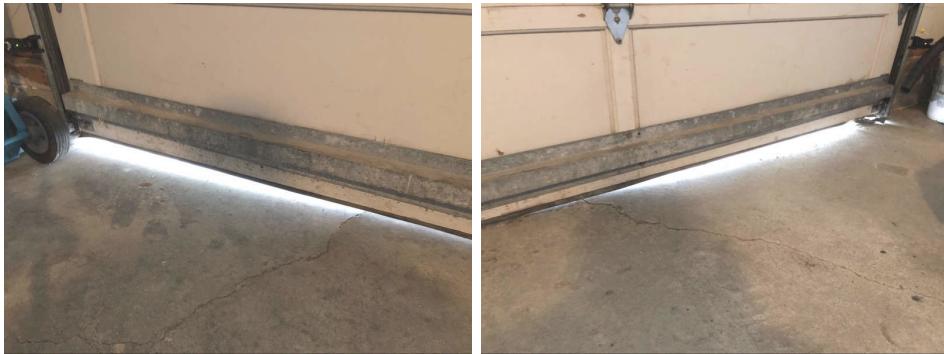
4.3.1 Floors

Garage floor shows signs of settling in the soil beneath the slab. Recommend a qualified professional evaluate for potential repairs.

Contact a qualified professional.

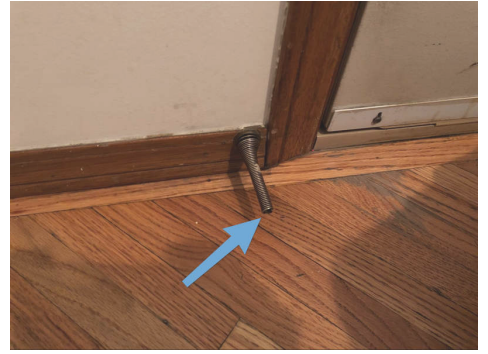
Rubber missing

Recommendation

Contact a handyman or DIY project

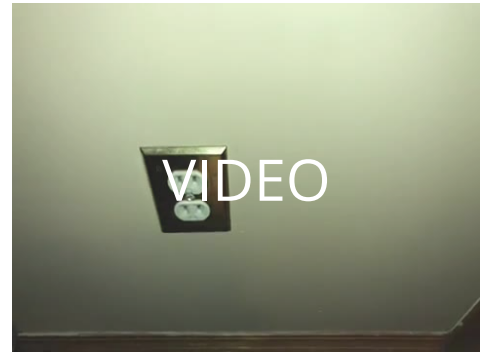
#### RECEPTACLE LOOSE

Contact a qualified electrical contractor.

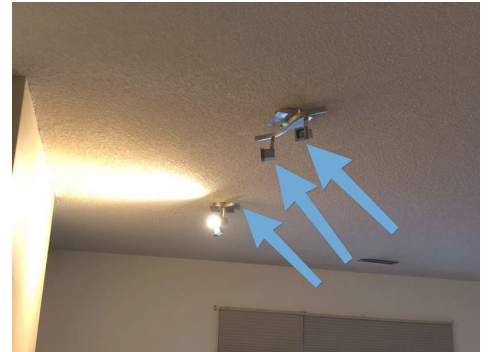
8.7.2 Lighting Fixtures, Switches & Receptacles

**LIGHT MISSING BULB**

One or more light fixtures had missing bulbs and could not be fully evaluated. Bulbs may simply need to be installed, however repairs or replacement may be necessary.

Contact a qualified professional.

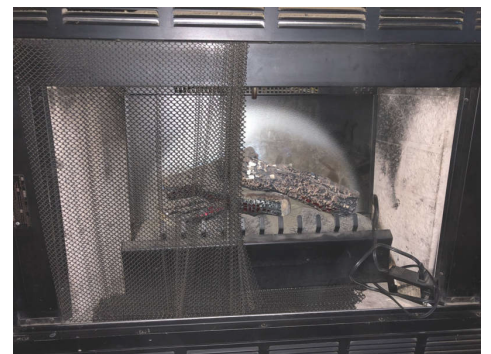
Fireplace or wood stove was not accessible at time of inspection due to being obstructed by furniture and/or storage and therefore is excluded from this inspection.

Electric insert

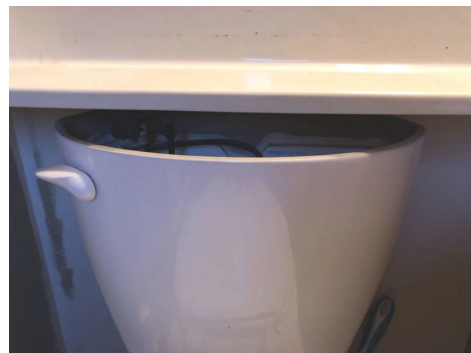
### 11.2.1 Toilets

#### MISSING TANK LID

The toilet tank lid was missing. Lid(s) should be replaced as necessary.

Contact a qualified plumbing contractor.

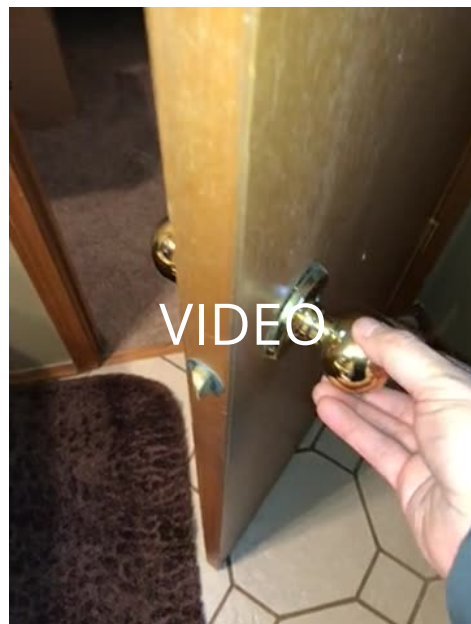
### 11.10.1 Doors

#### LOCKSET LOOSE

One or more locksets were loose and should be tightened, repaired and or replaced as necessary.

Contact a handyman or DIY project

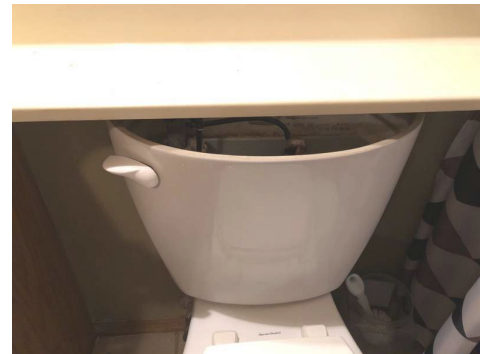
##### MISSING TANK LID

The toilet tank lid was missing. Lid(s) should be replaced as necessary.

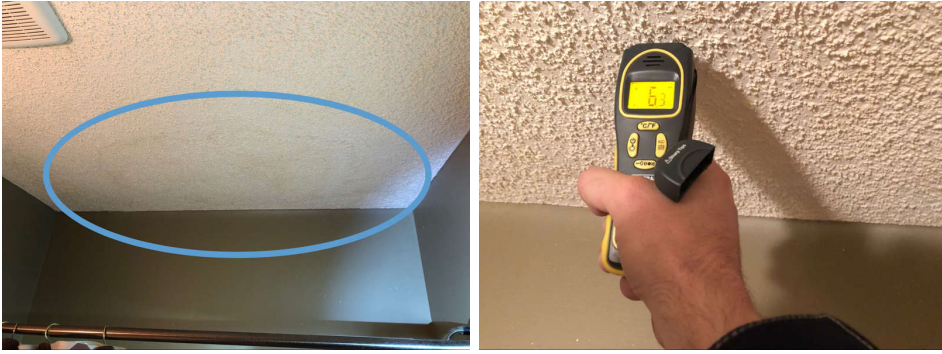
#### 12.10.1 Ceilings

##### DRY STAINS

Staining was found in one or more ceiling areas. However, no elevated levels of moisture were found. The staining may be due to past roof and/or plumbing leaks. Recommend asking the property owner about this, and monitoring the stained area in the future, especially after heavy or prolonged rain. If elevated moisture is found in the future, a qualified contractor should evaluate and repair as necessary.

Recommend monitoring.

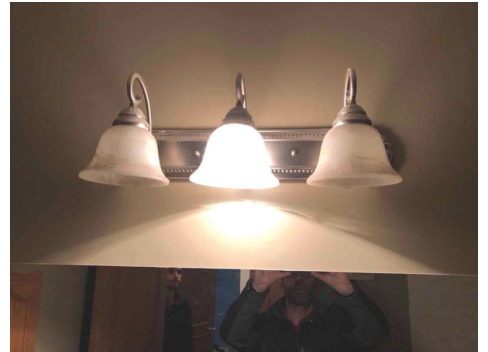
### 12.13.1 Lighting Fixtures, Switches & Receptacles

#### **LIGHT MISSING BULB**

One or more light fixtures had missing bulbs and could not be fully evaluated. Bulbs may simply need to be installed, however repairs or replacement may be necessary.

Contact a qualified professional.

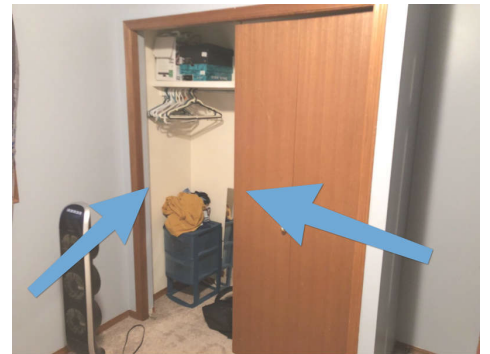
**DOOR MISSING**

One of the interior doors is missing and should be replaced.

Contact a qualified professional.

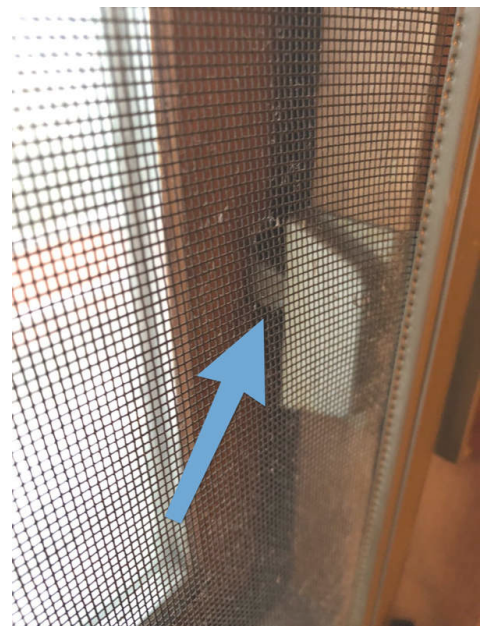
13.6.1 Windows

**LOCK INOPERABLE**

Lock mechanisms on one or more windows were missing and/or damaged so that they were inoperable. Repairs should be made by a qualified contractor or service technician so that windows lock and unlock easily.

Contact a qualified window repair/installation contractor.

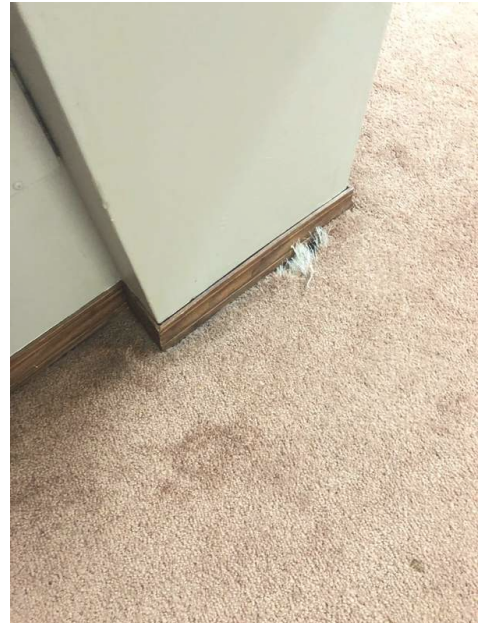
16.2.1 Floors

### CARPET DETERIORATED

Carpeting in one or more rooms was damaged and/or significantly deteriorated. Recommend replacing carpeting where necessary.

Contact a qualified flooring contractor

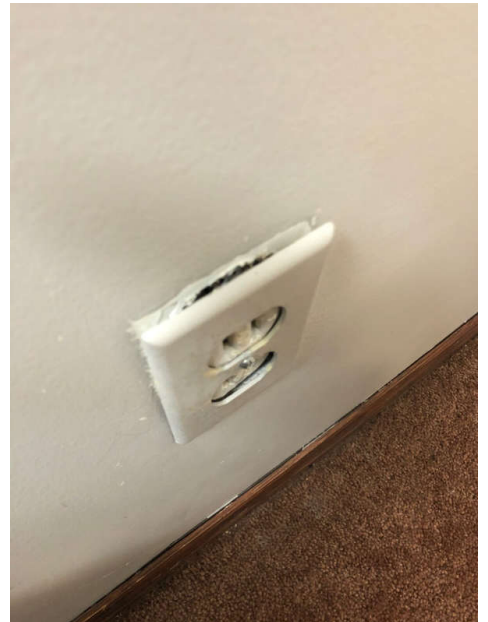
16.7.1 Lighting Fixtures, Switches & Receptacles

### RECEPTACLE LOOSE

One or more electric receptacles and/or the boxes in which they were installed were loose and/or not securely anchored. Wire conductors can be damaged due to repeated movement and/or tension on wires, or insulation can be damaged. This can become a shock and fire hazard. Recommend that a qualified electrical contractor repair as necessary.

Contact a qualified electrical contractor.

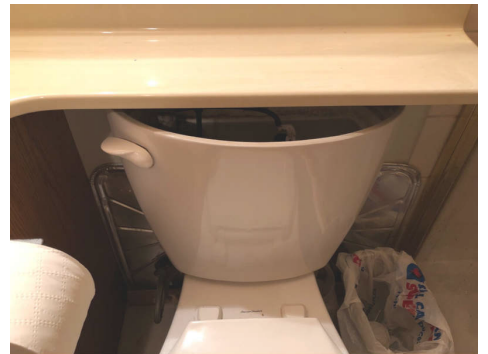
### 17.2.1 Toilets

#### MISSING TANK LID

The toilet tank lid was missing. Lid(s) should be replaced as necessary.

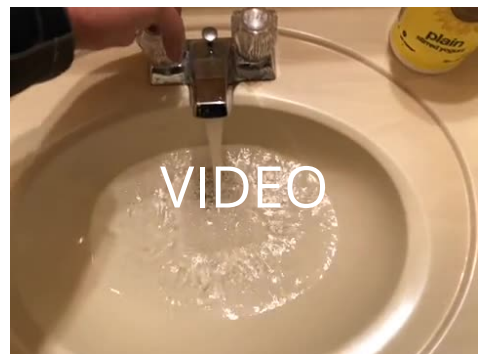
### 17.6.1 Sink/countertop

#### SINK DRAINS SLOW

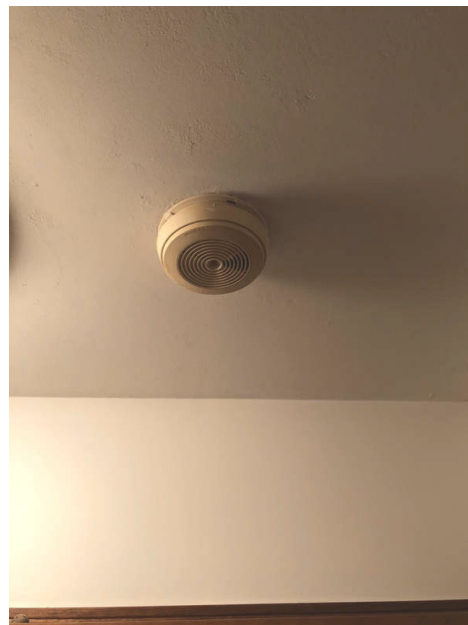
Based on the age of this structure and the appearance of existing smoke alarms, the alarms may have been installed more than 10 years ago. According to National Fire Protection Association, aging smoke alarms don't operate as efficiently and often are the source for nuisance alarms. Older smoke alarms are estimated to have a 30% probability of failure within the first 10 years. Newer smoke alarms do better, but should be replaced after 10 years. Unless you know that the smoke alarms are new, replacing them when moving into a new residence is also recommended by NFPA.

Contact a qualified electrical contractor.

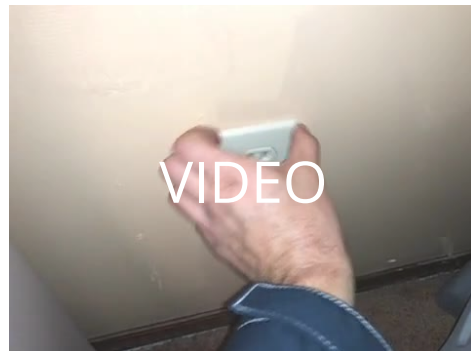
**RECEPTACLE LOOSE**

One or more electric receptacles and/or the boxes in which they were installed were loose and/or not securely anchored. Wire conductors can be damaged due to repeated movement and/or tension on wires, or insulation can be damaged. This can become a shock and fire hazard. Recommend that a qualified electrical contractor repair as necessary.

Contact a qualified electrical contractor.

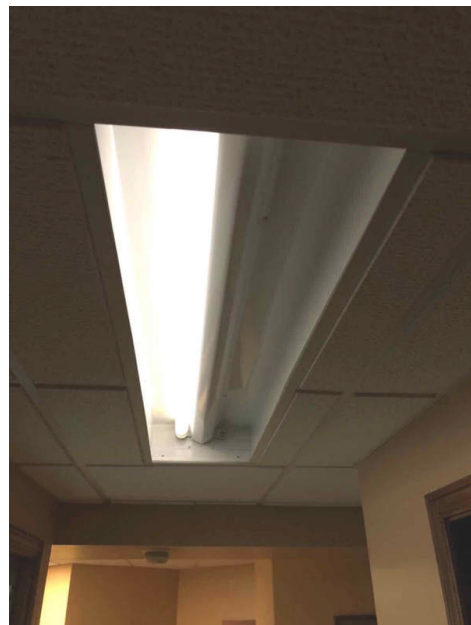
18.10.2 Lighting Fixtures, Switches & Receptacles

**LIGHT MISSING BULB**

One or more light fixtures had missing bulbs and could not be fully evaluated. Bulbs may simply need to be installed, however repairs or replacement may be necessary.

Contact a qualified professional.

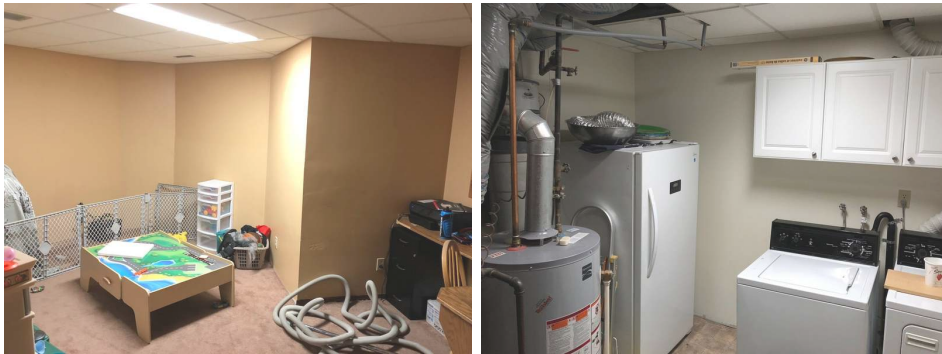
**DEVELOPED BASEMENT**

The basement was fully finished. Interior foundation, insulation, framing, floor structure, etc. could not be inspected and is excluded from this inspection.

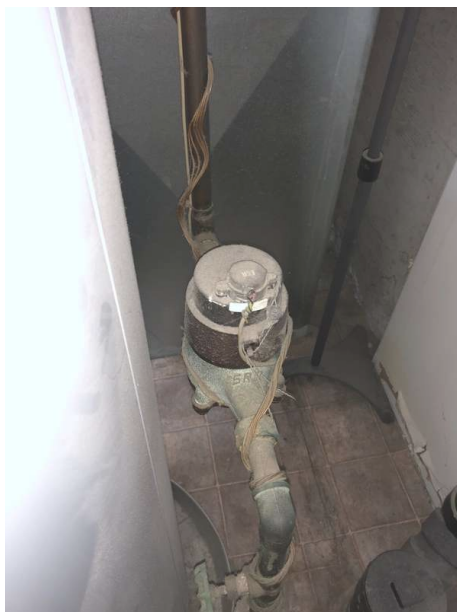
**General: Interior Supply piping**  
Copper

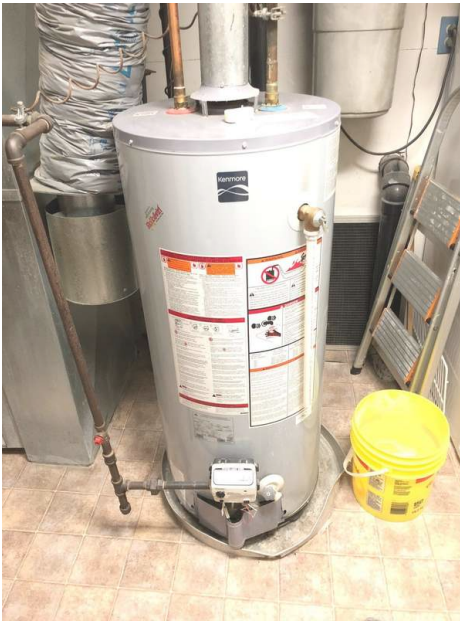
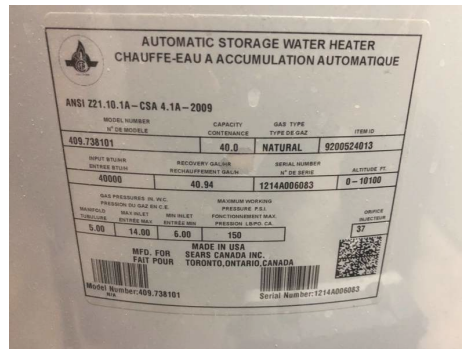
### Water Heater: Pictures

**Water Heater: Location**  
Laundry room, Utility room

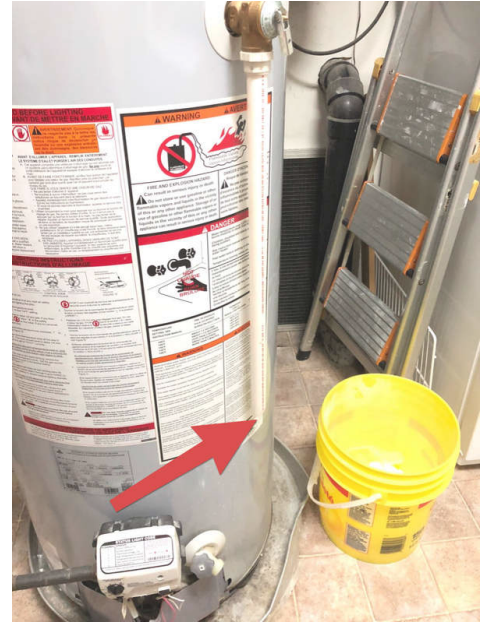
TPR extension for the water heater is too short. This is a potential safety hazard due to the risk of scalding if someone is standing next to the water heater when the valve opens. A qualified plumber should install an extension line as per standard building practices. For example, extending to 6 inches from the floor, or routed so as to drain outside.

Contact a qualified plumbing contractor.

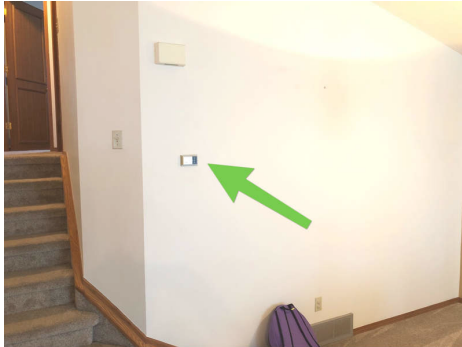
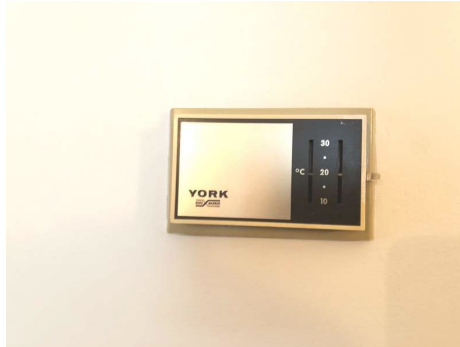
**Thermostat: Thermostat Location**

Living Room

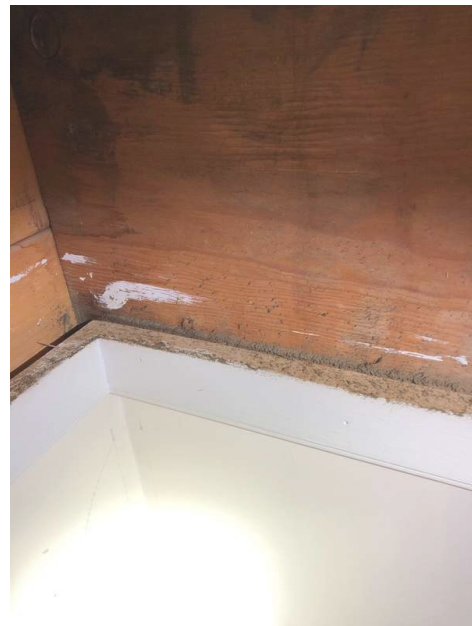
No weatherstrip is installed around the attic access hatch. Weatherstrip should be installed around the hatch to prevent conditioned interior air from entering attic.

Contact a qualified handyman.
