NORTH OHIO PROPERTY INSPECTION 330-604-0544 kurt@northohiopropertyinspection.com http://www.northohiopropertyinspection.com

HOME INSPECTION REPORT

1234 Main St. Medina OH 44256

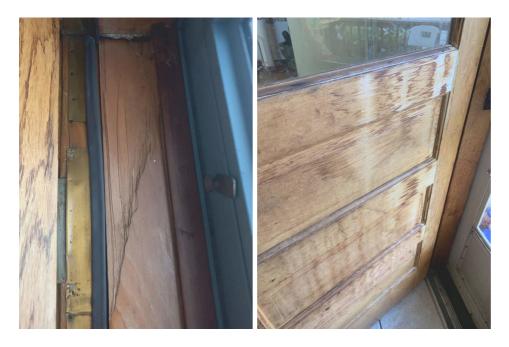
4.2.1 Exterior Doors EXTERIOR DOOR DAMAGE- GENERAL

DAMAGE TO FRONT DOOR FRAME, BACK DOOR NEEDS REFINISHING

There is general damage to one or more doors. I recommend making proper repair or replacing the affected doors.

Recommendation

Contact a qualified handyman.

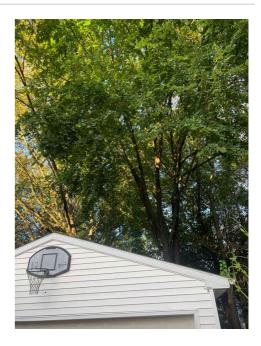
Trees observed overhanging the roof. This can cause damage to the roof and prevent proper drainage. I recommend having a tree service trim to allow for proper drainage and to prevent damage.

Recommendation

Contact a qualified tree service company.

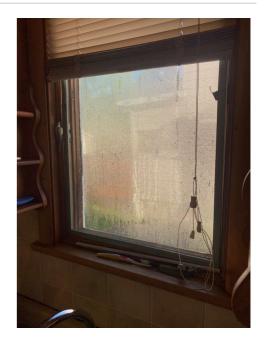
A window sticks and is difficult to open. I recommend evaluation/repair.

Recommendation Contact a qualified window repair/installation contractor.

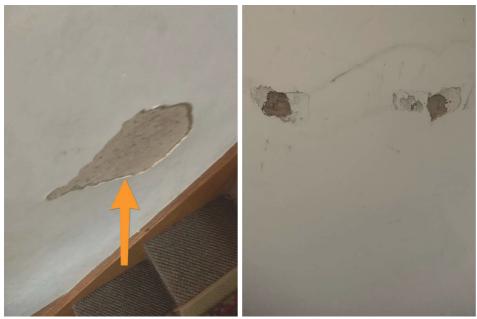
6.4.1 Walls DAMAGED DRYWALL/PLASTER

There was physical damage to drywall or plaster. I recommend repairing and repainting the affected areas.

Recommendation

Contact a qualified drywall contractor.

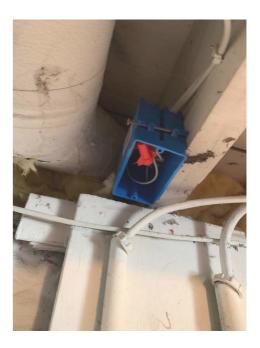
COVER PLATES MISSING

One or more receptacles are missing a cover plate. This exposes the hot terminals on the side of the receptacle and causes short and shock risk. This may also create an issue during the appraisal process. Recommend installation of cover plates on all outlets in the home that are missing them.

Recommendation Contact a handyman or DIY project

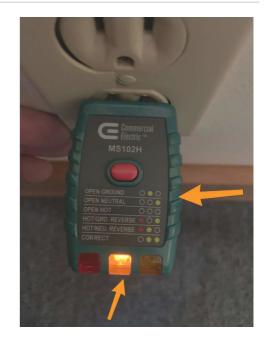
8.4.2 Lighting Fixtures, Switches & Receptacles

UNGROUNDED RECEPTACLES

VARIOUS LOCATIONS THROUGHOUT HOME

One or more receptacles are ungrounded. To eliminate safety hazards, all receptacles in kitchen, bathrooms, garage & exterior should be grounded. Replacing 3 prong ungrounded outlets with GFCI outlets or reverting to 2 prong is considered to be a suitable replacement. Contact a qualified electrical contractor.

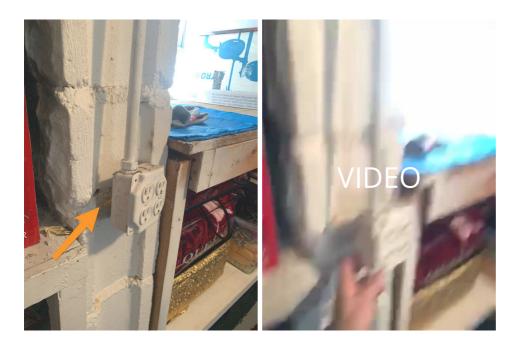
8.4.3 Lighting Fixtures, Switches & Receptacles
LOOSE FIXTURE
BASEMENT
A fixture is loose. I recommend securing the fixture properly.
Recommendation
Contact a handyman or DIY project

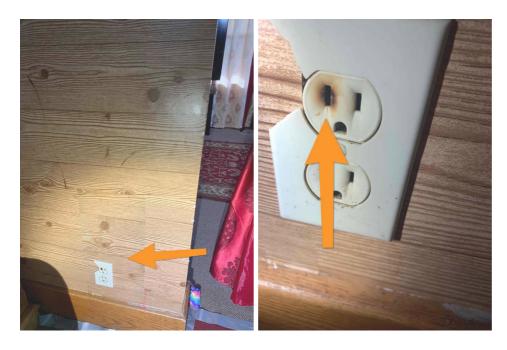
8.4.4 Lighting Fixtures, Switches & Receptacles

SCORCHED RECEPTACLE

There was scorching present on the front plate of a receptacle. Usually this is caused by a loose connection between the outlet and whatever is plugged into it but occasionally it can be something more. I recommend evaluation/repair.

Recommendation

Contact a qualified electrical contractor.

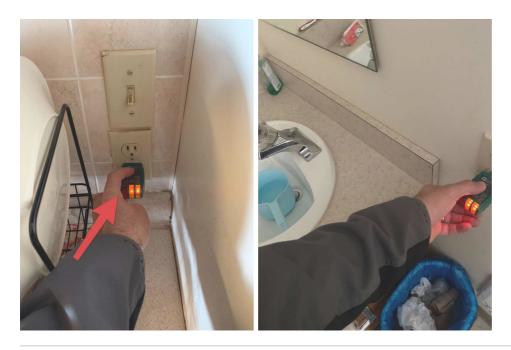
8.5.1 GFCI & AFCI NO GFCI PROTECTION INSTALLED

One or more outlets in a required area did not have GFCI protection. Although GFCI protection may not have been required at the time the home was built, for safety reasons, it is recommended that electrical receptacles located in basements, crawlspaces, garages, the home exterior, and interior receptacles located within 6 feet of a plumbing fixture be provided with ground fault circuit interrupter (GFCI) protection in good working order to avoid potential electric shock or electrocution hazards. I recommend installing GFCI protection.

Recommendation

Contact a qualified electrical contractor.

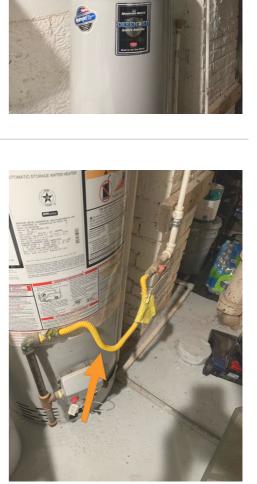
There was flex line connecting the hot water tank to the gas supply. This is not the recommended method of connecting a hot water tank (solid black pipe is recommended). I recommend evaluation/correction.

Should be a straight pipe- also bonding is required

Recommendation

Contact a qualified plumbing contractor.

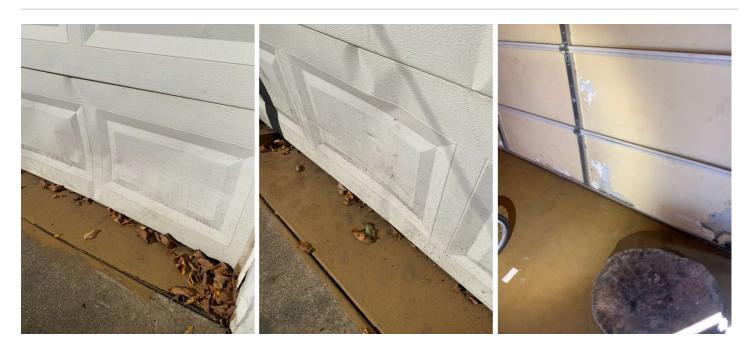
13.4.1 Garage Door PANEL DAMAGE BOTTOM PANEL OF GARAGE DOOR IS DAMAGED

Garage door panel is damaged and may need repair/replacement. Recommend a qualified garage door contractor evaluate.

Recommendation Contact a qualified garage door contractor.

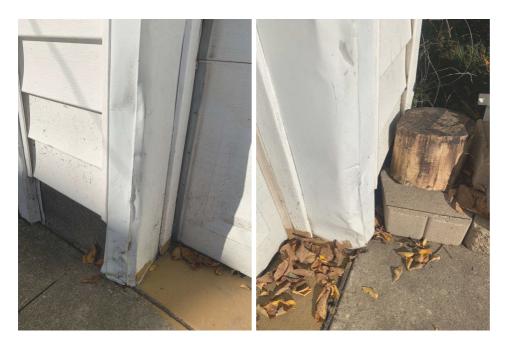
13.4.2 Garage Door DAMAGE AROUND OUTSIDE FRAME OF GARAGE DOOR

There is damage to the outside frame of the garage door. I recommend repairing or replacing the trim.

Recommendation

Contact a qualified general contractor.
