TEXAS PROFESSIONAL INSPECTIONS, LLC

PROPERTY INSPECTION REPORT

Concerning: 1234 Main St. College Station TX 77845
(Address or Other Identification of Inspected Property)

By: Steve Jolly - TREC #7002 10/18/2018 9:00AM
(Name and License Number of Inspector) (Date)

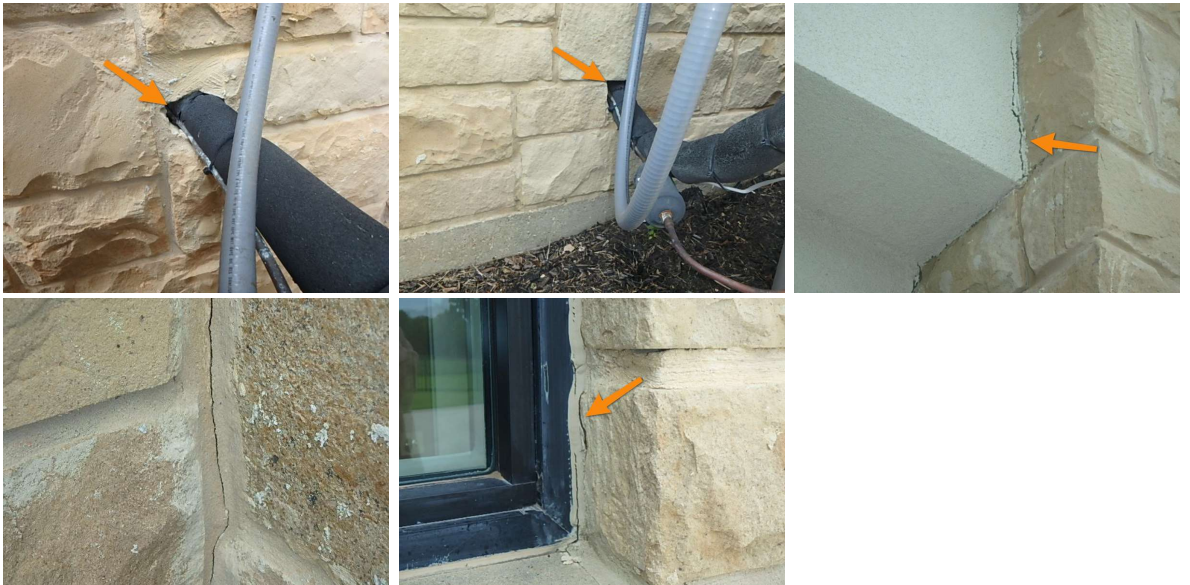
1: Gaps At Exterior Wall

AC Refrigerant Pipes, Various Exterior Wall Joints

Small gaps were noted at window and door frame joints, and at other wall joints. Seal all gaps at joints and utility penetrations to prevent moisture and pest intrusion.

Recommendation: Contact a qualified professional.

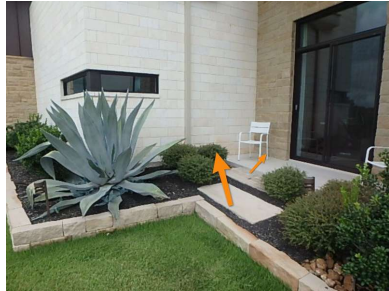
2: No Weep Holes At Masonry Walls

Walls Outside Office

When water gets through a masonry wall it collects at the bottom and is released through "weep holes," small openings in the bottom of the masonry wall. 3/16-inch-diameter weep holes should be installed every 33 inches at minimum.

Recommendation: Contact a qualified masonry professional.

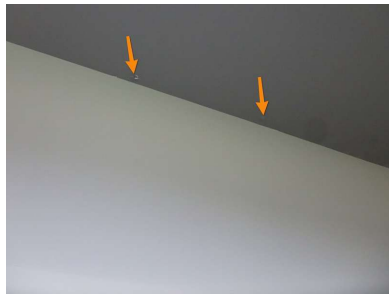
1: Ceiling - Minor Damage

Master Bathroom

Several nail pops were noted in the ceiling at small closet entry. Appears to be the result of structural settling. Cosmetic repairs needed.

Recommendation: Contact a qualified drywall contractor.

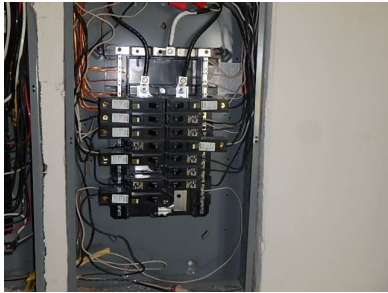
Subpanels: Located in garage

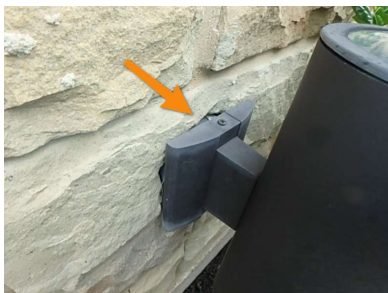
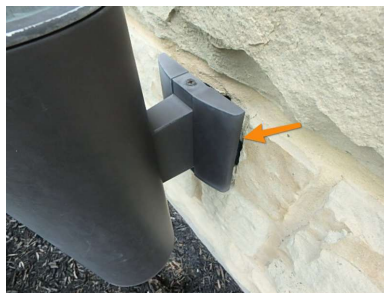
1: Gaps At Exterior Fixture Base

Various

Seal around the base of exterior light fixtures to prevent water penetration into wiring box.

Recommendation: Contact a handyman or DIY project

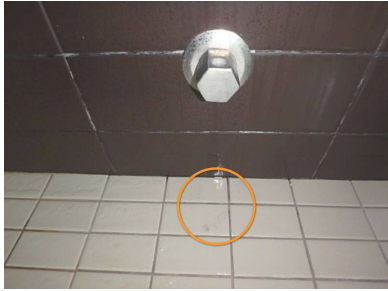
2: Debris At Steam Jet In Master Shower

Small amount of debris was emitted from one of the steam jets when the steam sauna was activated. The system should be evaluated by the installer or a qualified plumber.

Recommendation: Contact a qualified professional.

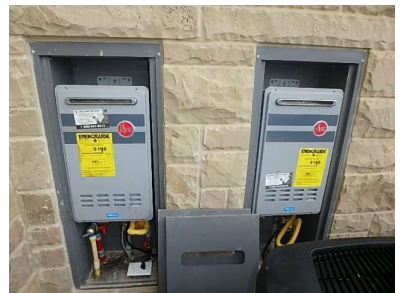
Observations: 1-5 Years Old, Good condition, Performing as intended

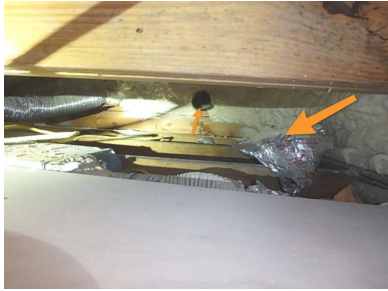
1: Damaged Duct In Attic

Above First Floor Middle Bedroom

Bathroom exhaust fan duct is damaged and vents to the attic instead of to the exterior, which will cause excessive moisture buildup on the framing. Replace damaged duct and attach to the damper assembly on the side wall.

Recommendation: Contact a qualified professional.

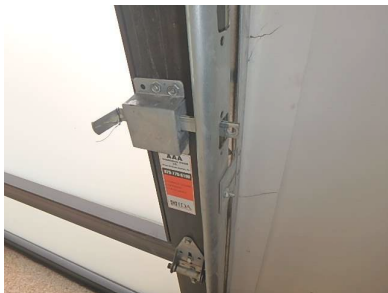
1: Disable Manual Locks

Garage overhead door lock need to be made inoperable in the open position or removed when opener is installed to prevent damage if opener is operated when lock is engaged.

Recommendation: Contact a handyman or DIY project
