(1) APPLE TREE INSPECTIONS RESIDENTIAL

1234 Main St.
Greenville South Carolina 29615

Buyer Name
01/23/2019 9:00AM

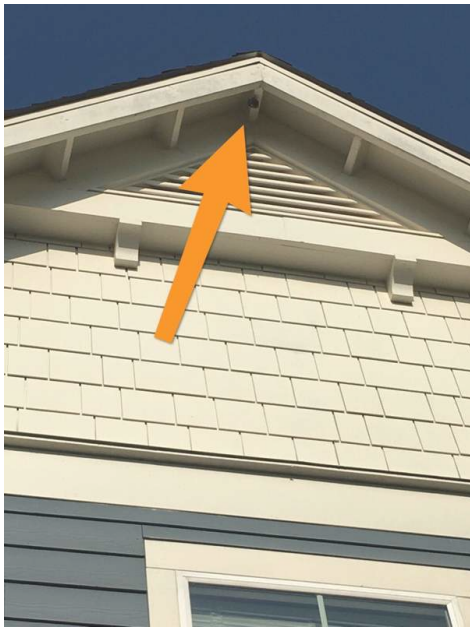
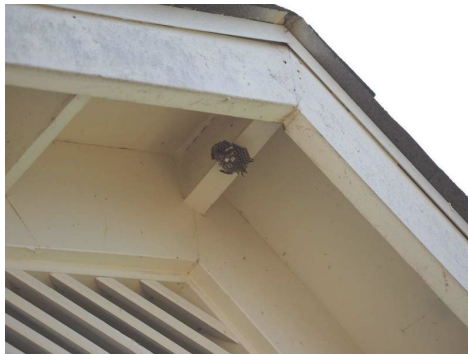
WASPS NEST

Wasp / bee nests were visible under the soffits or eaves and were seen entering the soffit area. (see photos) I suggest removal of any nests and sealing entry points.

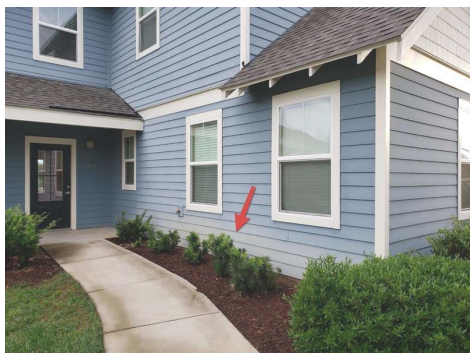
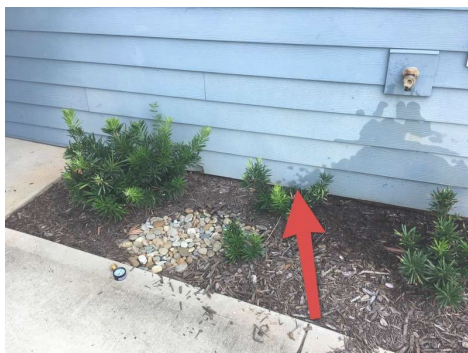
IMPROVE DRAINAGE

Ideally the finish grading would slope away from the home 6 inches in the first 10 feet. This provides a way for surface runoff water to drain safely away from the structure and foundation. Consider improving the grading to help prevent or correct any water related problems. (see photos) **This is simple maintenance suggestion.**

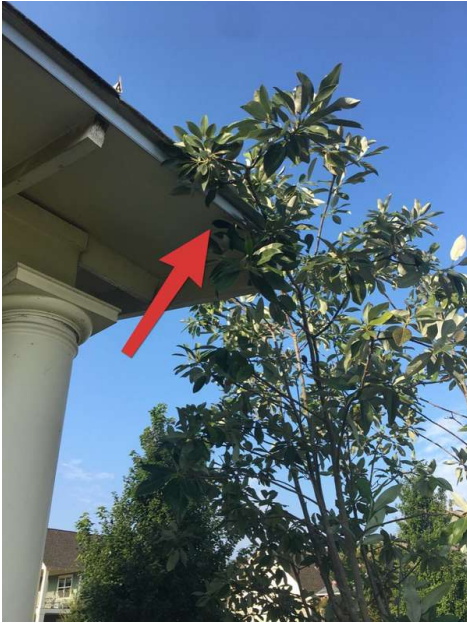
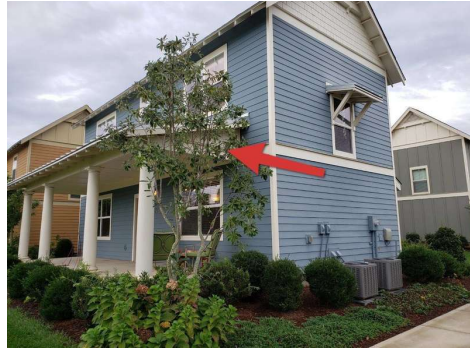
2.3.1 Trees and Vegetation

Tree limbs (as shown in the attached images) should be kept trimmed away from the home to help prevent damage to the roof and / or eaves. No damage to the home in this area was observed at the time of the inspection. Here is a link to a helpful article online [Tree Branches Over Roof](#)

Contact a handyman or DIY project

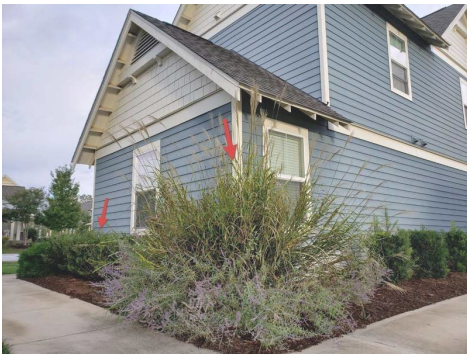
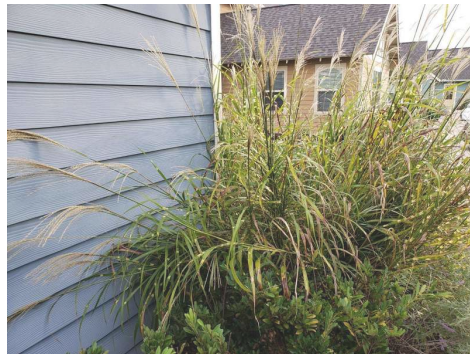
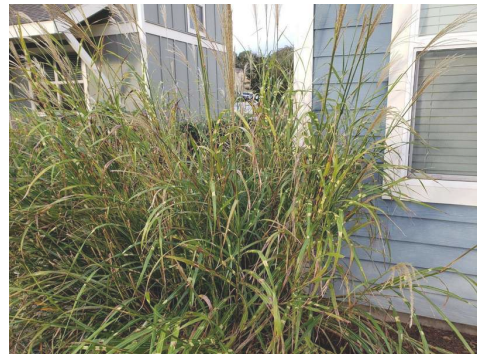
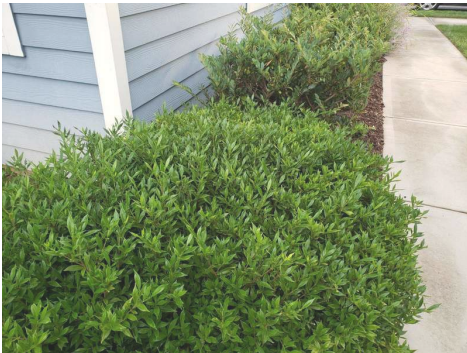
2.3.2 Trees and Vegetation

Vegetation which is close to or touching the home should be trimmed back because it can hold moisture against the building, and may cause damage the building materials. Heavy foliage also limits the inspectors ability to visually observe the exterior surfaces in these areas. This is a simple **maintenance suggestion**, and **no damage was observed in this area at the time of the inspection**.

Contact a handyman or DIY project

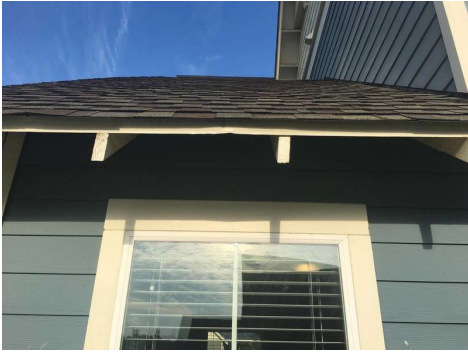
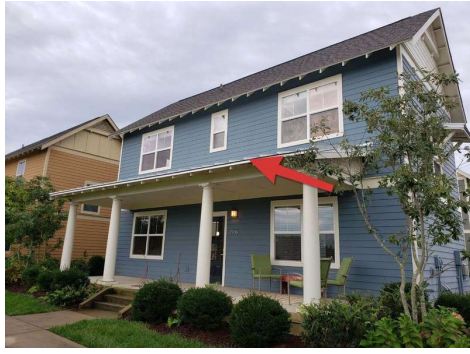
Grading and drainage could be improved with the installation of rain gutters. Gutters are encouraged **(as an optional upgrade)** because they collect rain water from the roof and direct it away from the building.

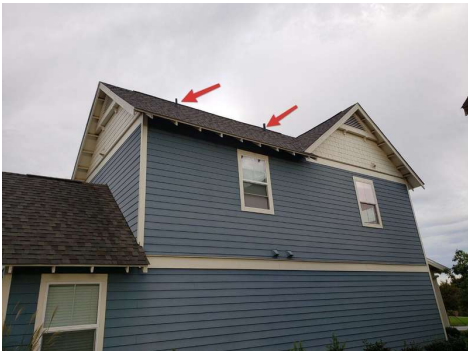
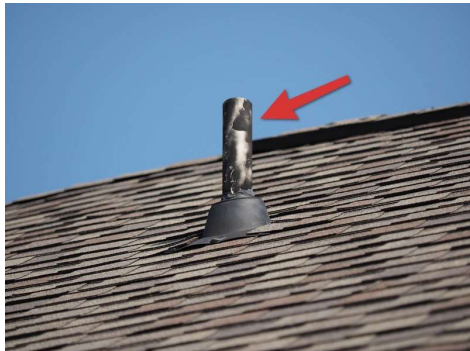
PAINT PLUMBING VENTS

PVC plumbing vents are susceptible to premature degradation from sunlight and exposure to UV radiation. Consider painting the roof plumbing vents or wrapping them with an appropriate protective material to extend the life of the vent(s). **This is a maintenance suggestion.** Here is a link to a helpful article online [Paint Vents](#)

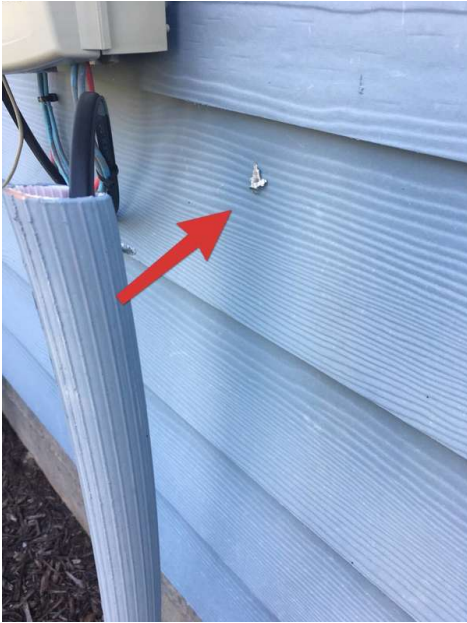
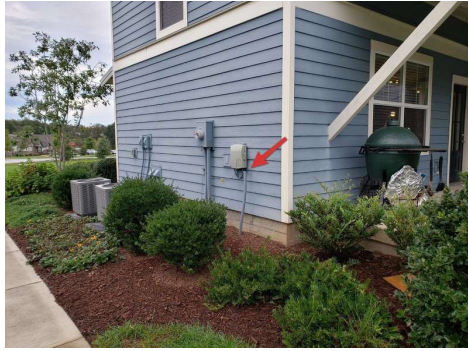
LOOSE CONDUIT

An electrical conduit for the home has pulled away from the building and is not properly secured. (see photos) I recommend that the conduit be properly fastened to the building to help protect the wiring and connections.

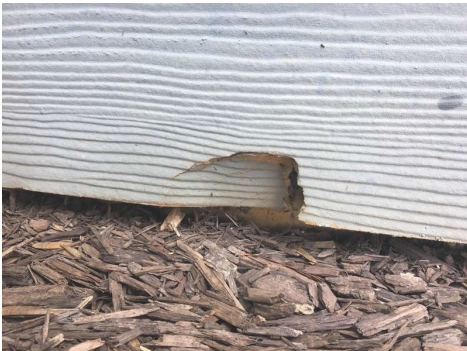
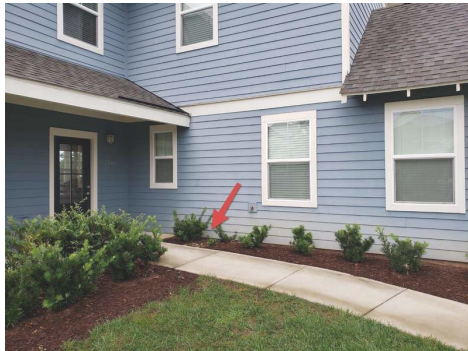
DAMAGED SIDING

There is a very small area of damage to the exterior siding (*shown in the attached images*).

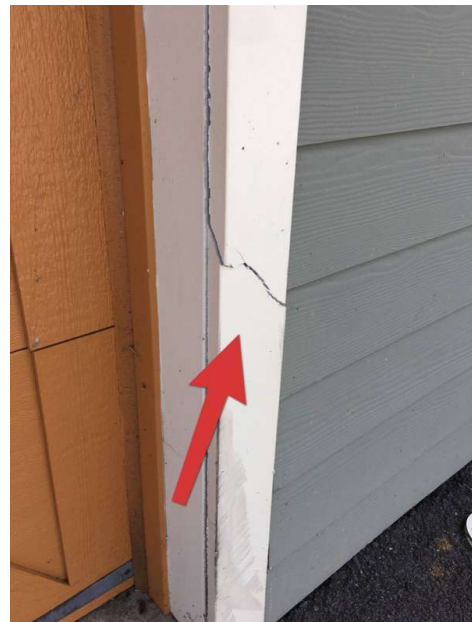
DAMAGED TRIM

There is some damage or deterioration to the exterior trim (*mainly shown in the attached images*). Consider repair or replacement as needed.

Contact a handyman or DIY project

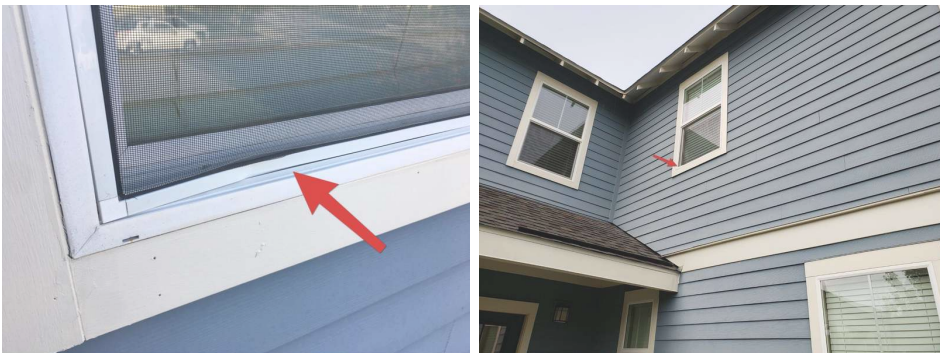
DAMAGED OR MISSING WINDOW SCREENS

Damaged or missing window screens were observed at one or more windows. *(see photos)* Window screens help protect window glass from minor impact damage and help prevent insects from entering the home.

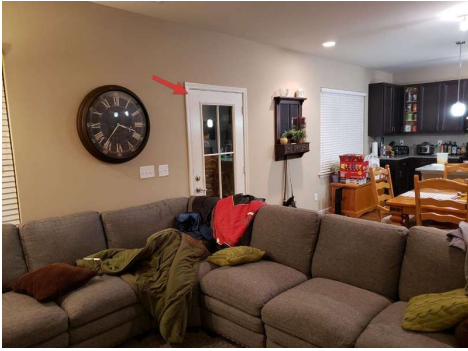
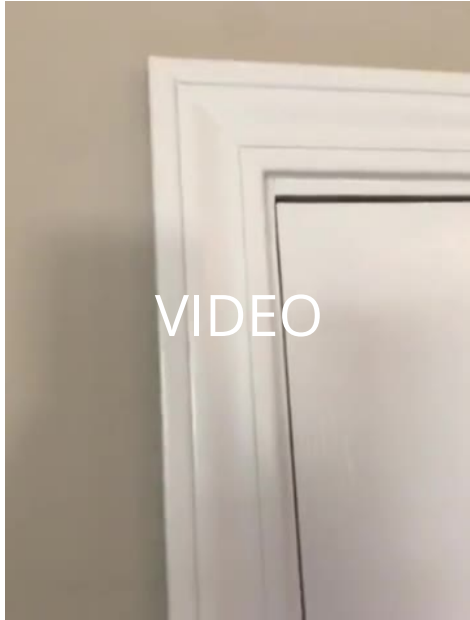
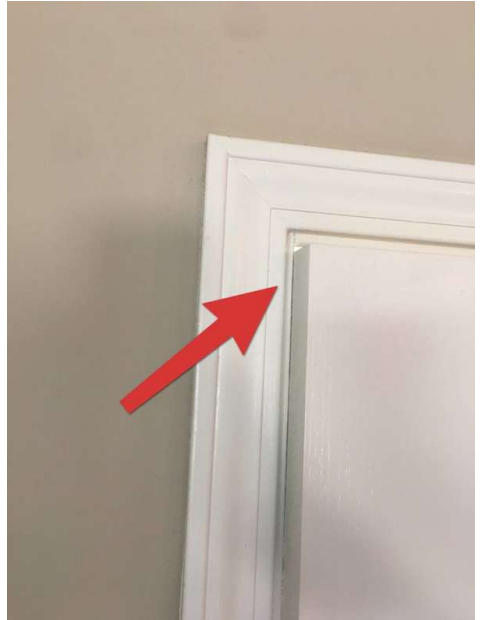
DOOR HITS / STICKS

One or more exterior doors rubs, hits, or sticks in the frame and was in need of adjustment at the time of the inspection. *(see photos)* Here is a link to a helpful article online [Article Link](#)

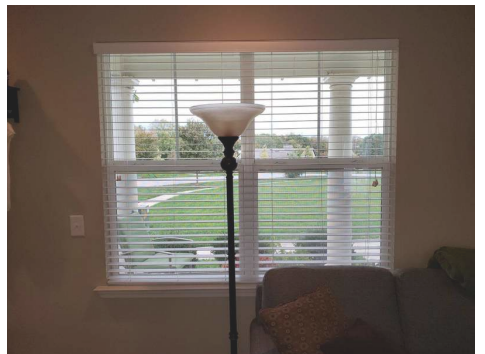
DIFFICULT TO OPERATE (VINYL WINDOW)

The vinyl windows in the home were operable, but were generally stiff and difficult to open and close. Often, a good cleaning and an application of spray silicone to the vinyl frames improves the windows operation.

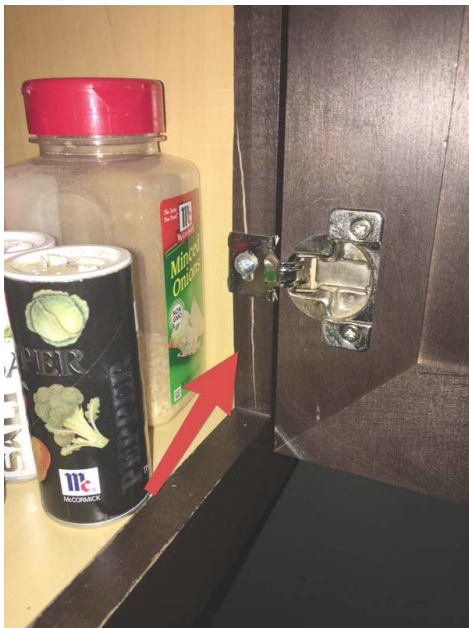
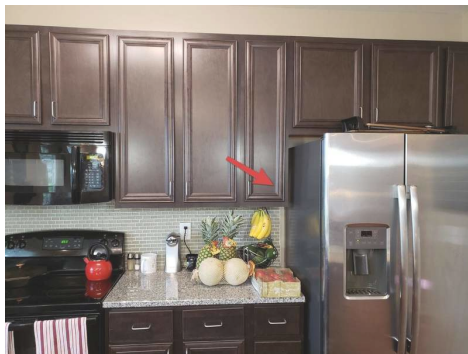
CABINETS DAMAGED

There was damage observed to the kitchen cabinets in one area. *(see the attached images)* The damage did not affect the operation of the cabinet door.

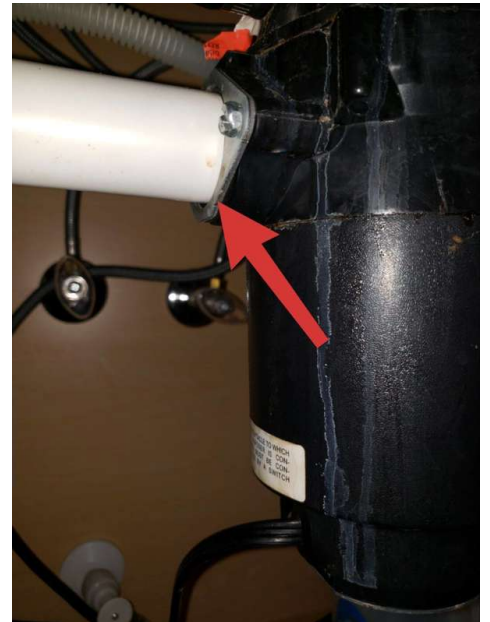
DISPOSAL LEAKING

The leak which was observed at the garbage disposal appeared to be the result of poor attachment at the sink drain or drain line connection. (see photos) I recommend correction to help prevent water damage to the cabinet and surrounding materials.

Contact a qualified professional.

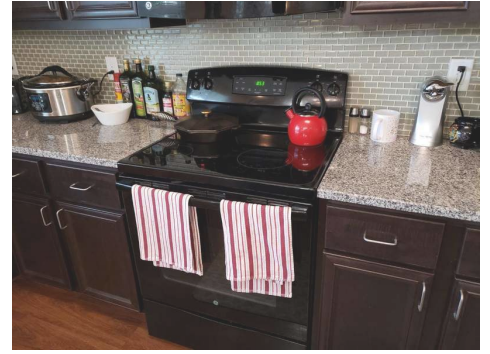
RANGE ANTI - TIP BRACKET

I recommend that the range be fastened to the floor with a anti tip bracket. An anti tip bracket is a safety device installed on the back leveling foot of the range. It is intended to prevent the range from tipping over if a child were to stand on the open oven door. Here is an link to a helpful article online [Article Link](#)

Contact a handyman or DIY project

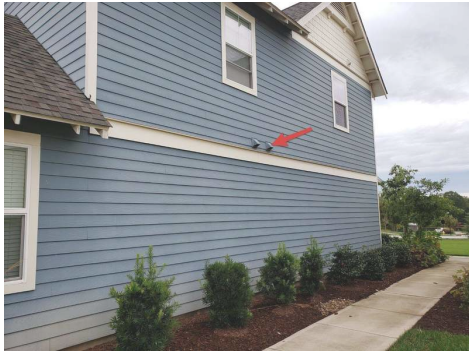
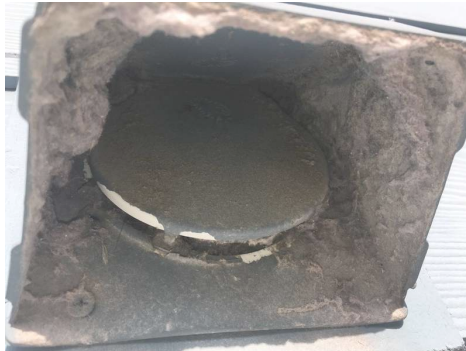
Lint and other debris should be removed from the dryer vent cover and duct work. Although cleaning is a relatively minor maintenance / repair item, it is classified as a *(Material Defect)* because this item is a **safety concern**. Here is a link to a helpful article online [Article Link](#)

Contact a handyman or DIY project

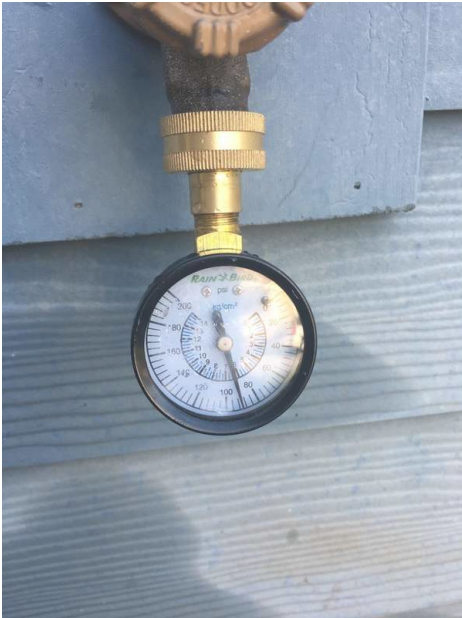
80-90 psi

Water pressure below 40 psi or above 80 psi is improper and should be further evaluated and corrected as needed.

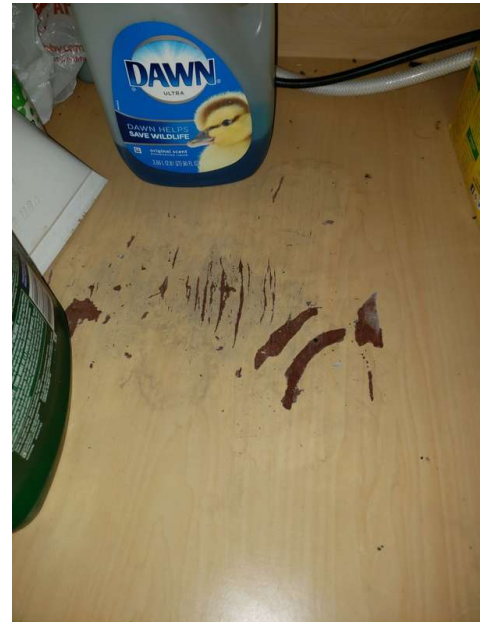
WATER DAMAGE KITCHEN SINK CABINET

Water damage was observed inside the kitchen sink cabinet. (see photos) There was a leak at the garbage disposal which is likely responsible for the water damage.

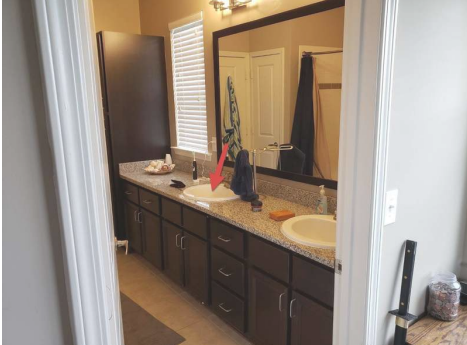
SINK SLOW TO DRAIN

The bathroom sink(s) (*shown in the attached images*) was slow to drain. This condition is usually the result of a partially clogged p-trap. I suggest cleaning the p-trap under the sink. If drainage does not improve after ensuring that the p-trap is clear, you may wish to have this condition investigated by a plumbing contractor.

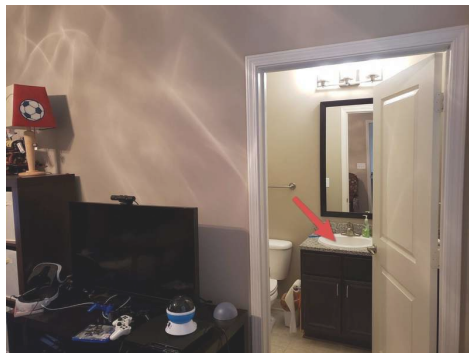
DRAIN STOP MISSING / INOPERABLE

The bathroom sink(s) drain stop was missing or not operating as intended at the time of the inspection. (see photos) Here is an link to a helpful article online [Article Link](#)

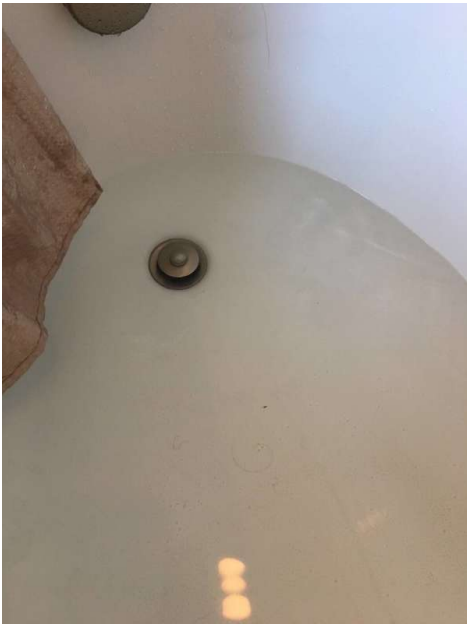
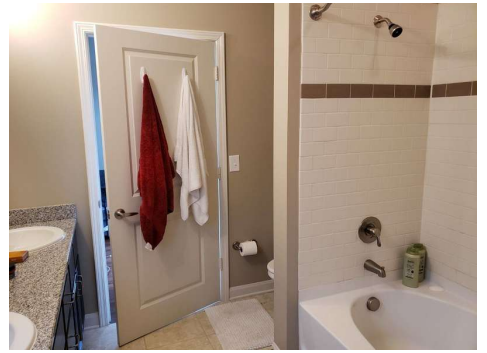
BATH TUB SLOW TO DRAIN

The bathtub(s) (shown in the attached images) was slow to drain. This condition is usually the result of a partially clogged p-trap. If drainage does not improve after ensuring that the p-trap is clear, you may wish to have this condition investigated by a plumbing contractor.

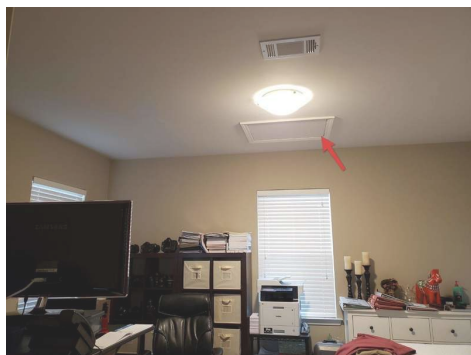
ATTIC HATCH LID NOT INSULATED

The attic access hatch cover (as shown in the attached images) was not insulated. Consider insulating the attic access hatch cover to help reduce unwanted heat loss / gain.

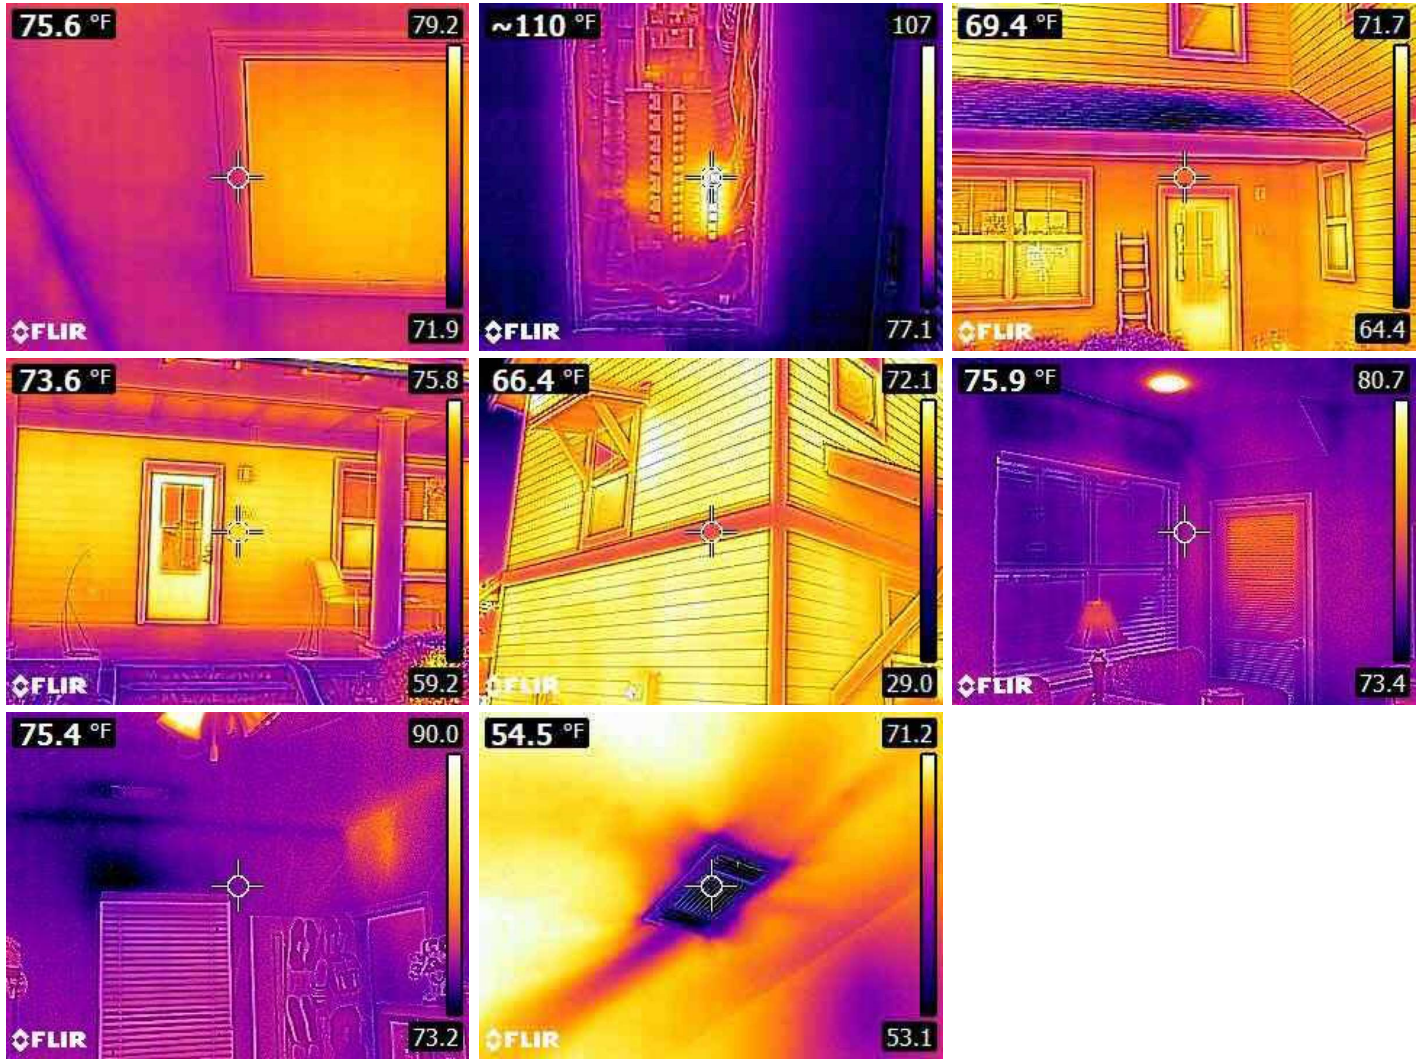
Thermal Images Interior

Thermal images included in this inspection report are provided as a courtesy, are limited to certain portions of the home. The inspector chooses the portions of the home to be scanned or photographed and photographs are included in the report at the Inspector's sole discretion.
