THAT PLACE HOME INSPECTIONS, LLC

RESIDENTIAL REPORT

1234 Main St.
Pearisburg VA 24134

01/23/2019 9:00AM

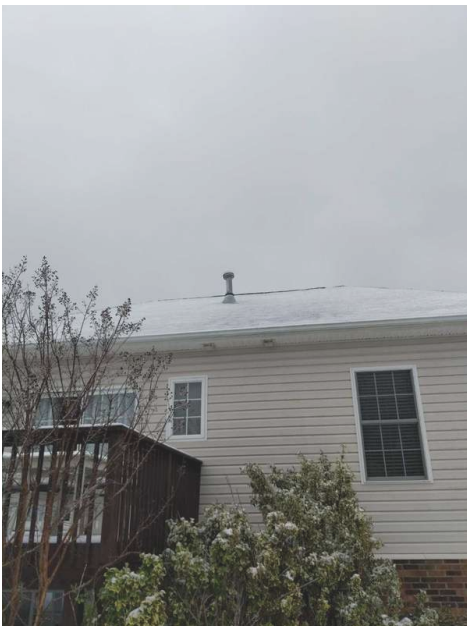
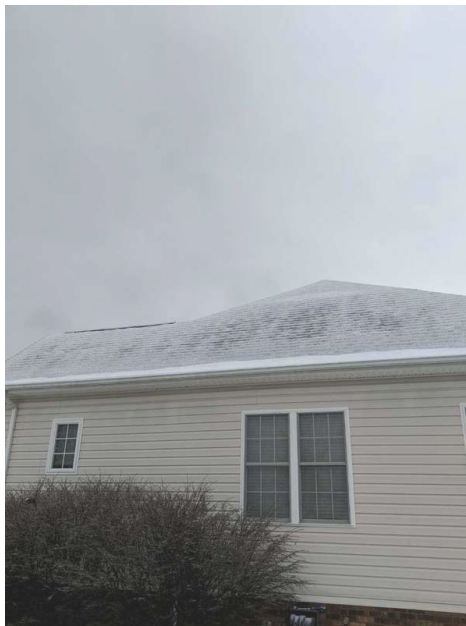
SNOW / ICE

One or more of the roofing components could not be inspected due to the roof being covered with snow and/or ice.

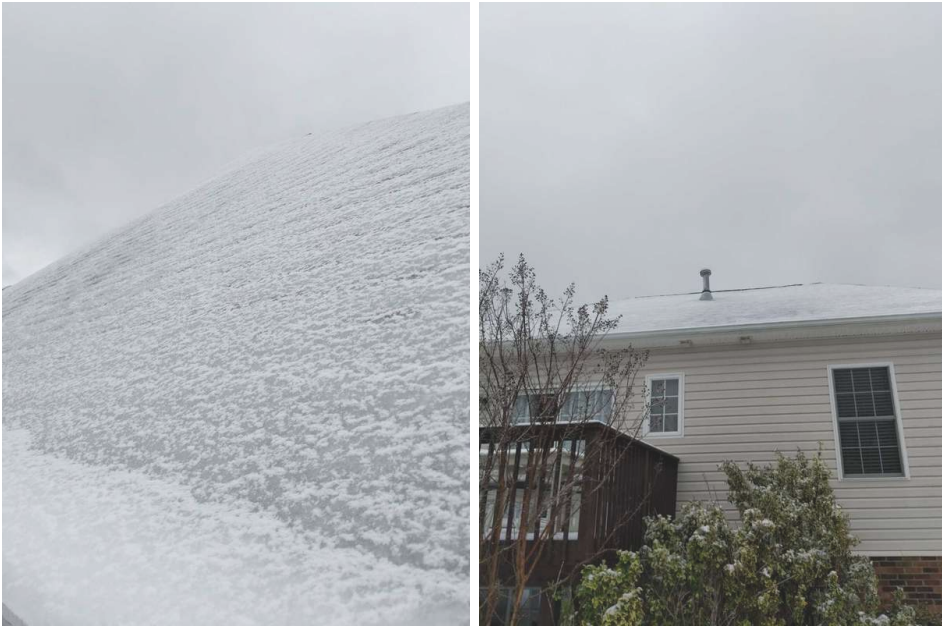
SNOW

Roof was not visible due to snow

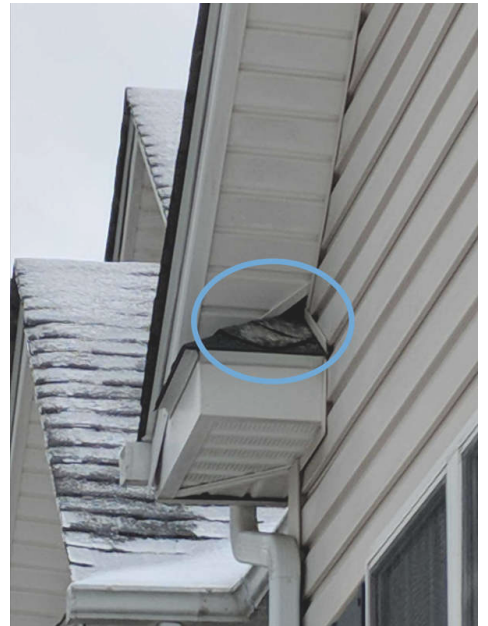
2.1.1 Coverings

Roof shingles were discolored, which can be caused by moisture, rust or soot. Recommend a qualified contractor evaluate to find the source causing this discoloration and repair or replace as needed.

Contact a qualified professional.

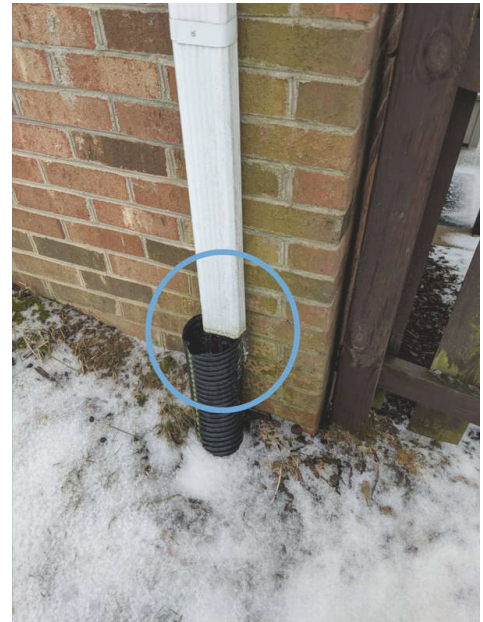
South

2.2.1 Roof Drainage Systems

One or more downspouts drain too close to the home's foundation. This can result in excessive moisture in the soil at the foundation, which can lead to foundation/structural movement. Recommend adjusting downspout extensions to drain at least 6 feet from the foundation.

Contact a handyman or DIY project

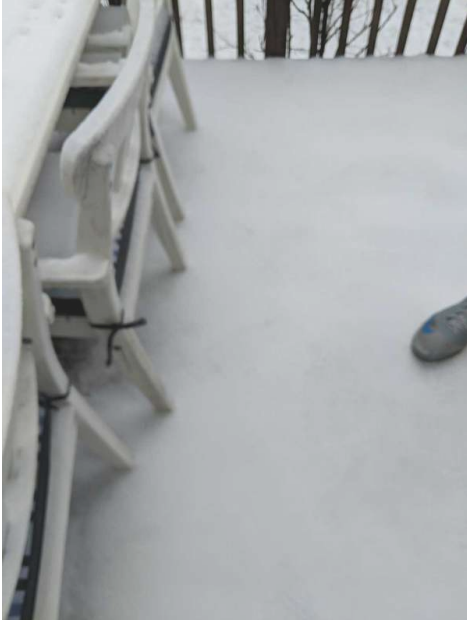
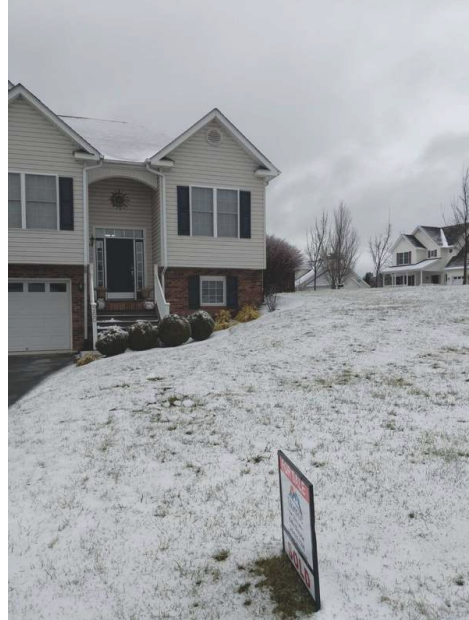
SNOW

One or more of the Exterior components could not be inspected due to snow. Components such as patios, decks, walks, steps, and drives were not fully visible

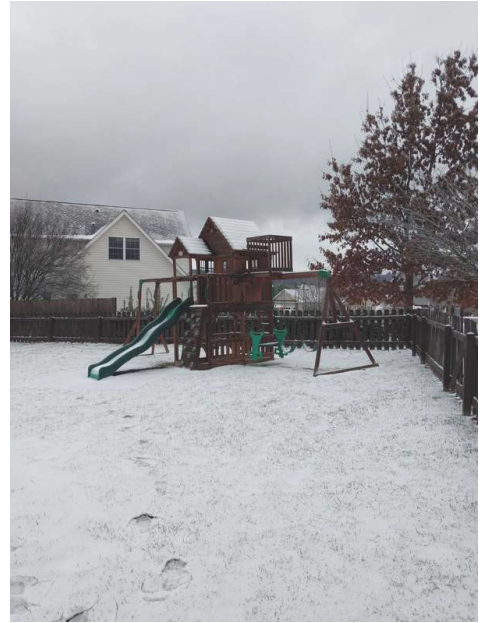
STRUCTURES NOT INSPECTED

The property included one or more detached structure (structures not attached to the home) which were not included as part of a General Home Inspection and were not inspected. The Inspector disclaims any responsibility for providing any information as to their condition. Consider having these structures inspected by a qualified inspector for safety reasons.

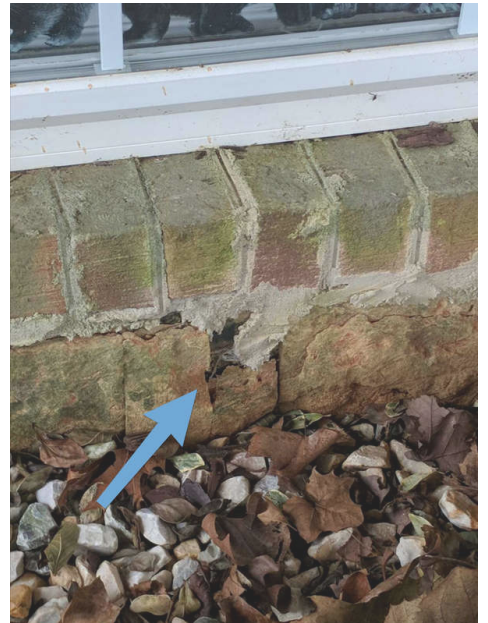
3.1.1 Siding, Flashing & Trim

PARGE COAT CRACKING

The parge coat is cracking and showing signs of deterioration. A parge coat is generally for decorative / aesthetic purposes but may also lead to water intrusion. Recommend repair or re-coat.

Contact a qualified professional.

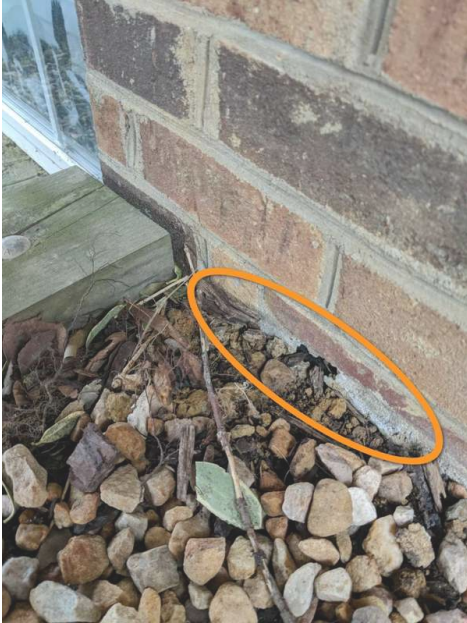
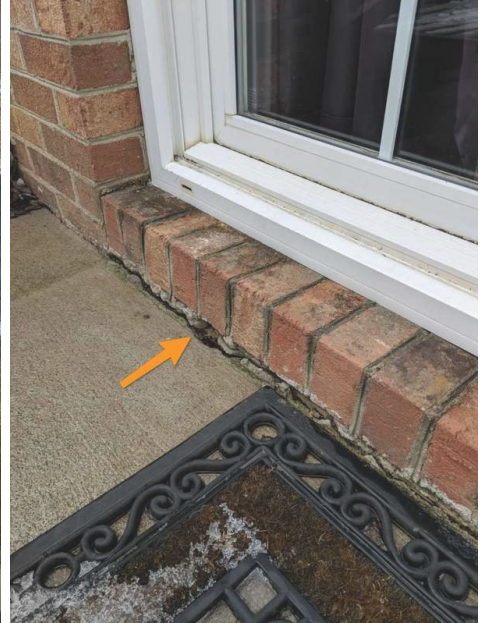
3.1.2 Siding, Flashing & Trim

BRICK/MORTAR CRACKING

The brick exterior walls had cracking visible in one or more locations around the home in areas where the brick meets the ground. Recommend further evaluation and repair as needed.

Contact a qualified professional.

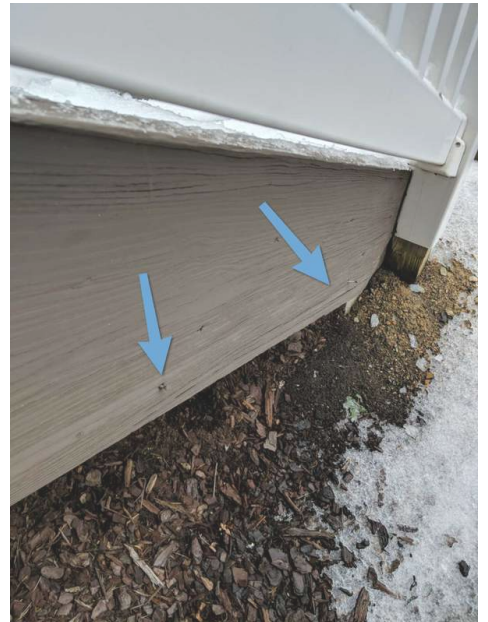
3.3.1 Decks, Balconies, Porches & Steps

One or more nails were observed to be exposed. Recommend nails be reset.

Contact a handyman or DIY project

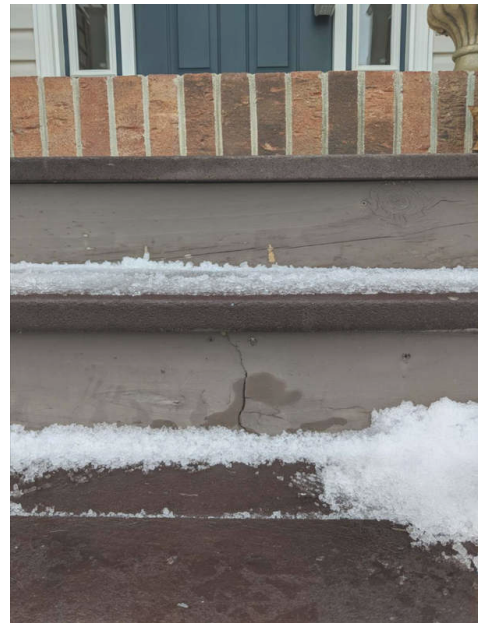
3.3.2 Decks, Balconies, Porches & Steps

DECK - DAMAGED BOARDS

One of the stair risers had been damaged and repaired. This is a cosmetic issue and client may wish to replace damaged board(s).

Contact a handyman or DIY project

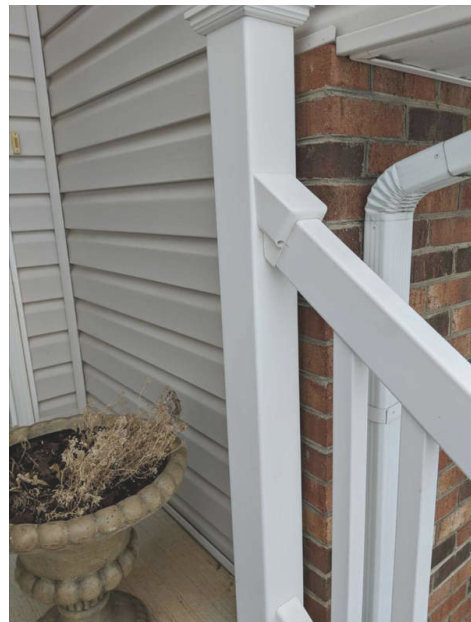
3.3.3 Decks, Balconies, Porches & Steps

LOOSE NEWEL POST

A newel post at this staircase was loose at the time of the inspection. For safety reasons, the Inspector recommends that the newel post be made secure by a qualified contractor.

Contact a qualified professional.

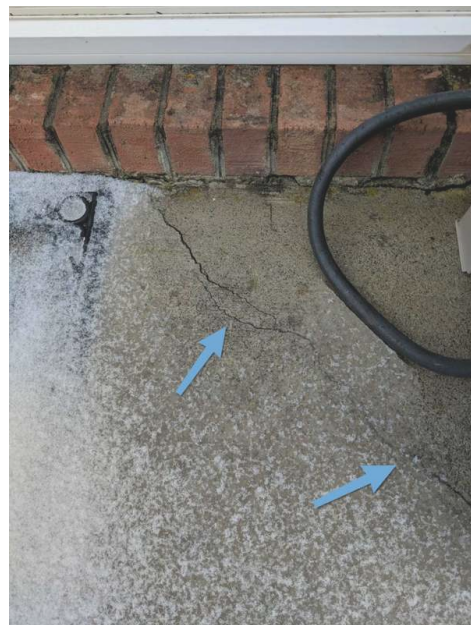
3.3.4 Decks, Balconies, Porches & Steps

COMMON CRACKS

Common cracks (1/4-inch or less) were visible in the concrete porch floor at the time of the inspection. Cracks should be filled with an appropriate sealant to avoid continued damage to the concrete porch floor surface from freezing moisture.

Contact a handyman or DIY project

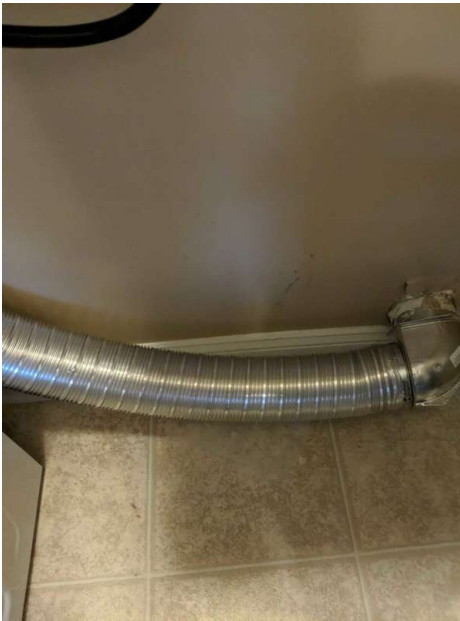
Vent visual inspection

A dryer vent connection was installed. The dryer vent was examined visually only. A visual examination will not detect the presence of lint accumulated inside the vent, which is a potential fire hazard. The Inspector recommends that you have the dryer vent cleaned at the time of purchase and annually in the future to help ensure that safe conditions exist. Lint accumulation can occur even in approved, properly installed vents.

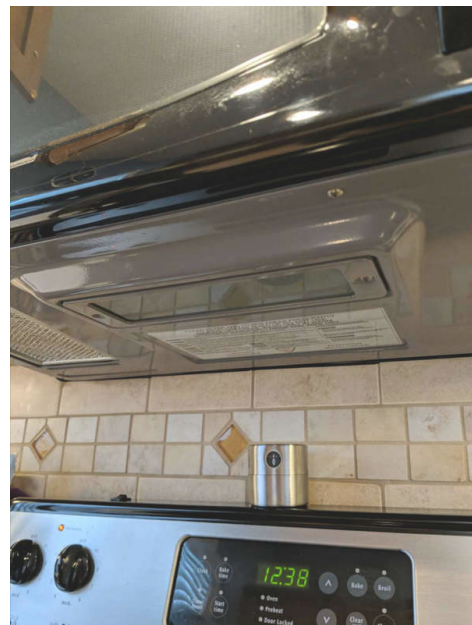
4.3.1 Range/Oven/Cooktop

Range hood lights were inoperable at the time of the inspection. The bulb may be burned out, or there may be a problem with the switch, wiring or light fixture. If after replacing the bulb the light fixture still does not respond, the Inspector recommends service by a qualified contractor.

Contact a qualified professional.

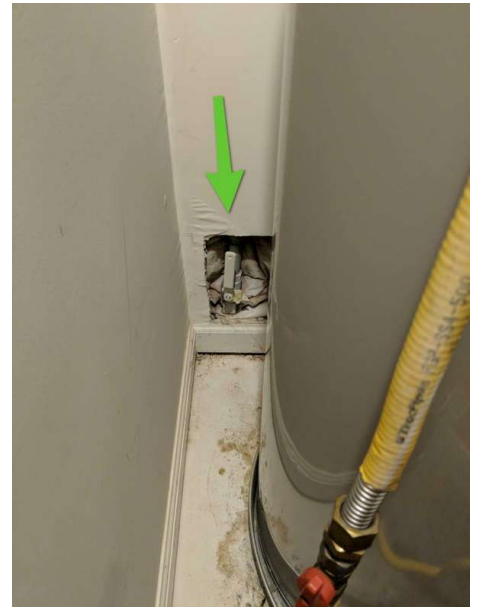
Location

Basement, Utility room / closet

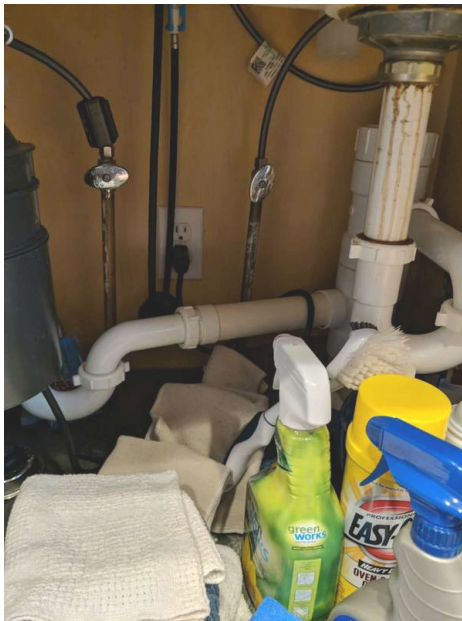
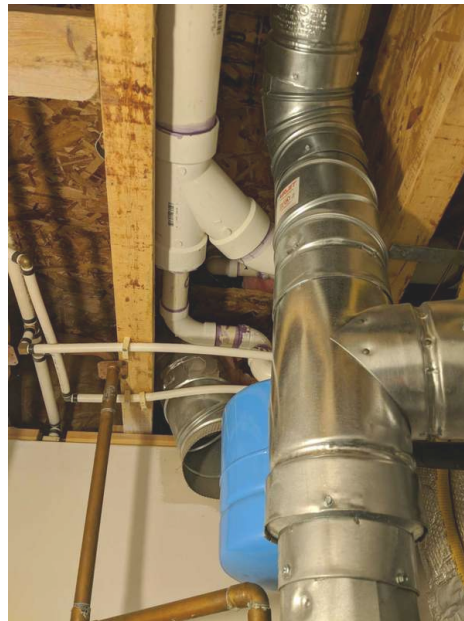
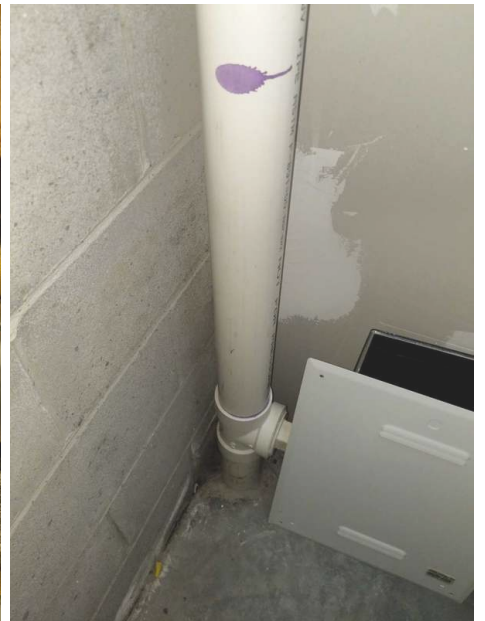
Drain, Waste, & Vent Systems: DWV Material

PVC, Plastic

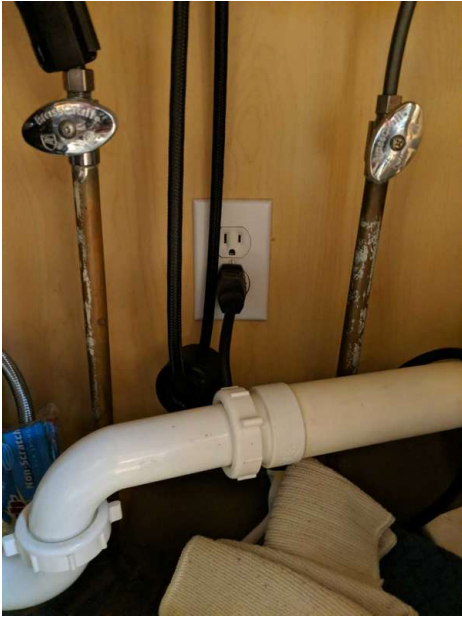
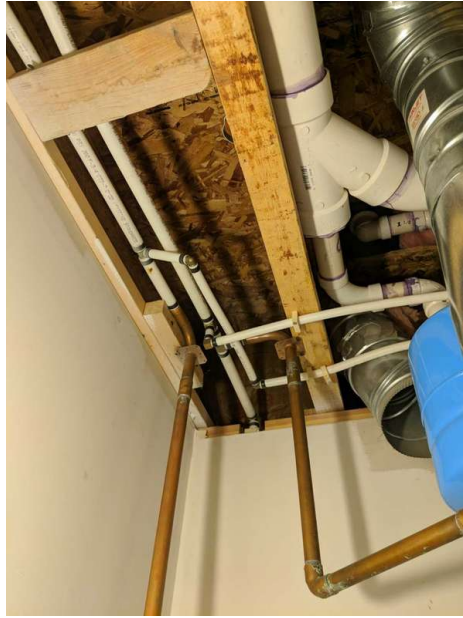
Water Supply, Distribution Systems & Fixtures: Distribution Material

Copper, Pex

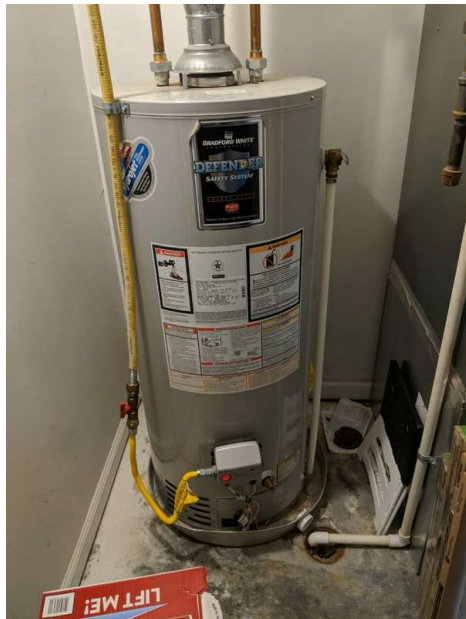
Hot Water Systems, Controls, Flues & Vents: Manufacturer

Bradford & White

Manufactured 2013

I recommend flushing & servicing your water heater tank annually for optimal performance. Water temperature should be set to at least 120 degrees F to kill microbes and no higher than 130 degrees F to prevent scalding.

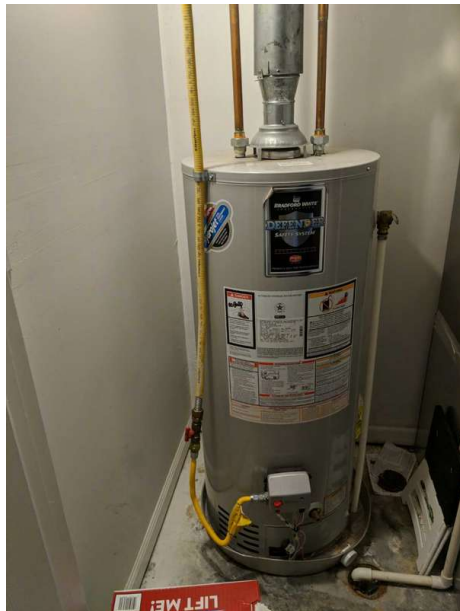
Hot Water Systems, Controls, Flues & Vents: Location

Basement

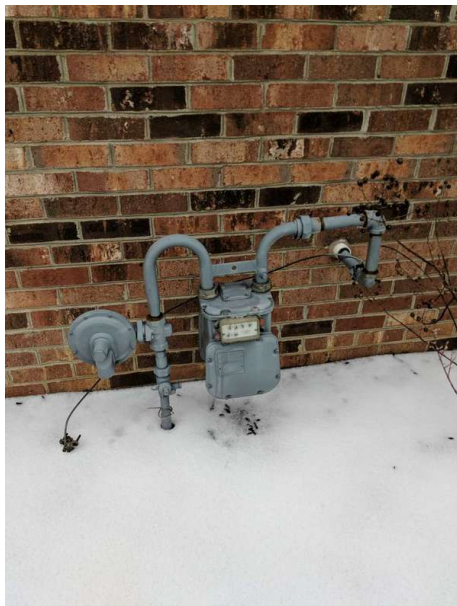
Fuel Storage & Distribution Systems: Main Gas Shut-off Location

Gas Meter

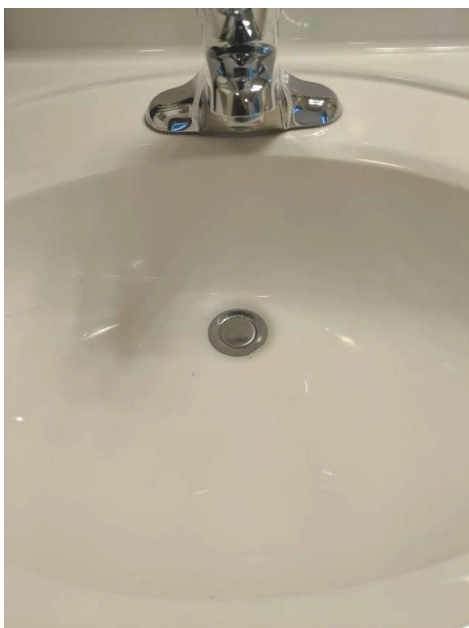
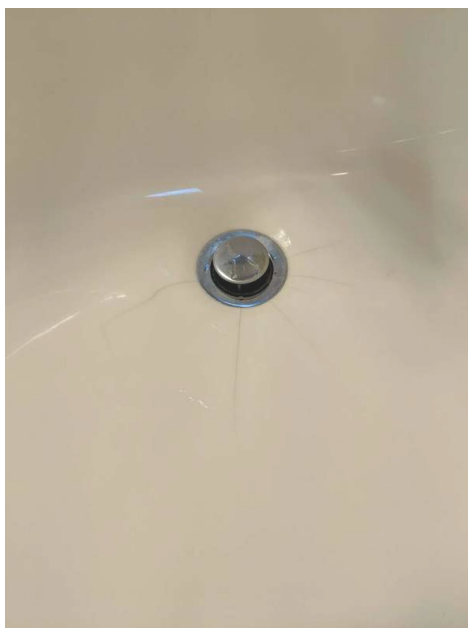
FIXTURE - DAMAGED OR MISSING HARDWARE

The sinks in the master bathroom were damaged or in disrepair. The sink on the left and a drain stopper that was inoperable and limited the inspection of that sink. Recommend repairing the mechanism. The sink on the right had cracks in the basin. Although not leaking at the time of the inspection, these cracks may lead to leaking or further damage. Recommend to repair or replace the sink / countertop. The Inspector recommends repair or replacement by a qualified contractor.

Contact a qualified professional.

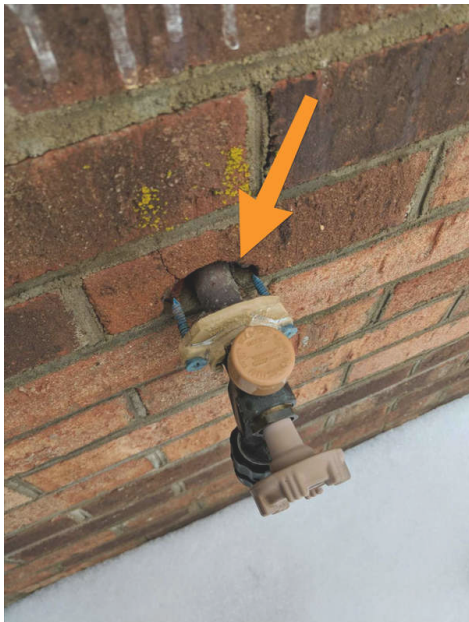
5.3.2 Water Supply, Distribution Systems & Fixtures

FIXTURE LOOSE

The fixture was loose and needed maintenance. All work should be performed by a qualified contractor.

Contact a qualified professional.

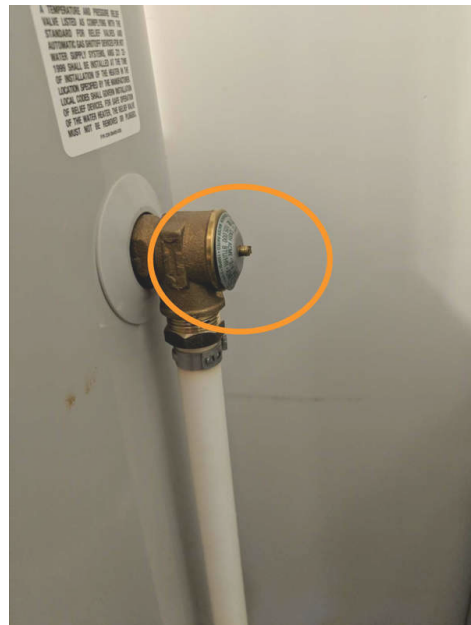
TPR VALVE - DAMAGED

The easing lever on the TPR valve was broken off or has been removed. Here is a link to a video explaining [TPR Valve](#) . Recommend further evaluation from a qualified plumber and repair or replace as needed.

Contact a qualified plumbing contractor.

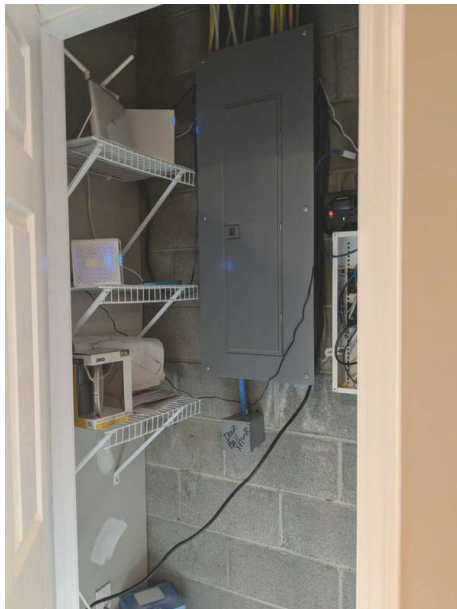
Main & Subpanels, Service & Grounding, Main Overcurrent Device: Main Panel Location
Basement, Utility Room / Closet

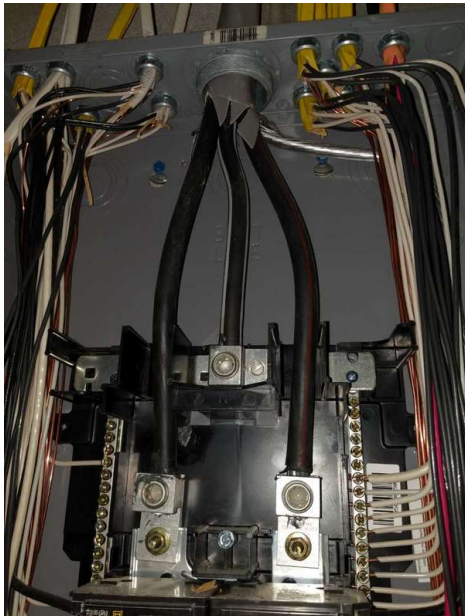
Main & Subpanels, Service & Grounding, Main Overcurrent Device: Panel Manufacturer
Square D

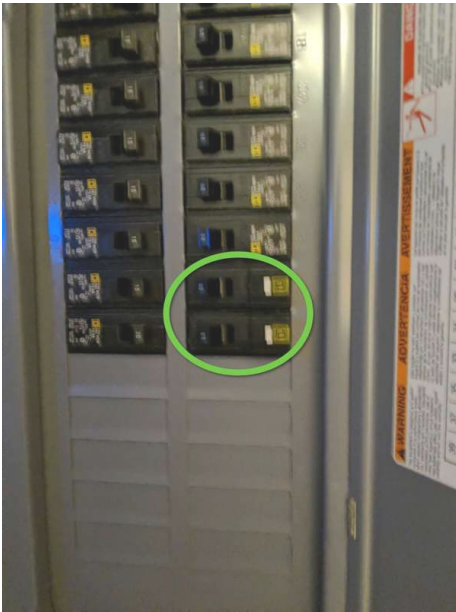
GFCI & AFCI: AFCI

At Main Panel

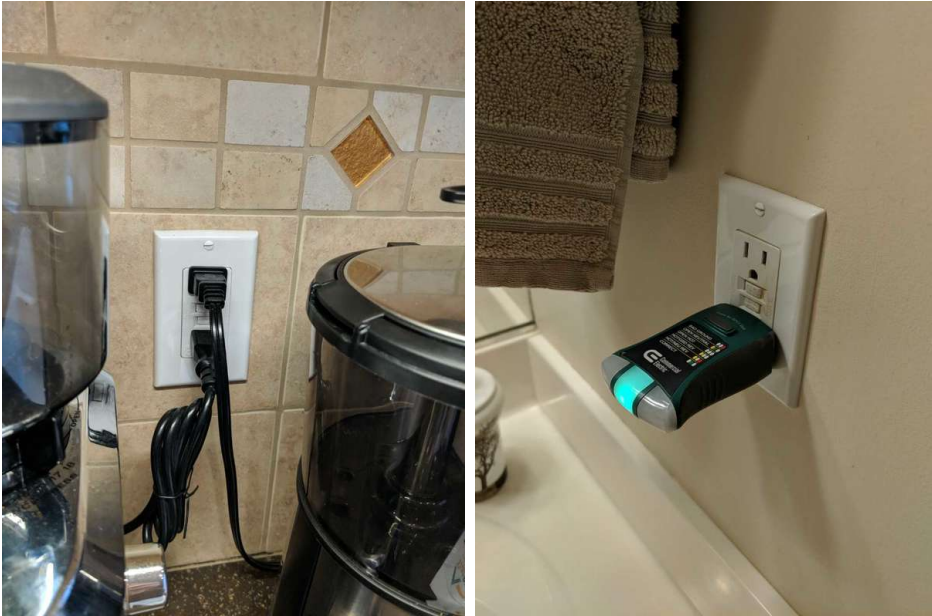
GFCI & AFCI: GFCI

At Receptacle

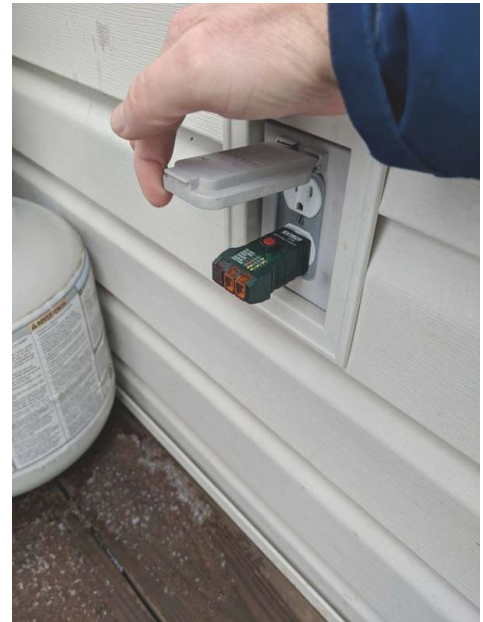
6.5.1 GFCI & AFCI

For safety reasons, the Inspector recommends that receptacles located within 6 feet of a plumbing fixture or located on the exterior of the home to be provided with ground fault circuit interrupter (GFCI) protection in good working order to avoid potential electric shock or electrocution hazards.

Recommend licensed electrician upgrade by installing ground fault receptacles in all locations.

Contact a qualified electrical contractor.

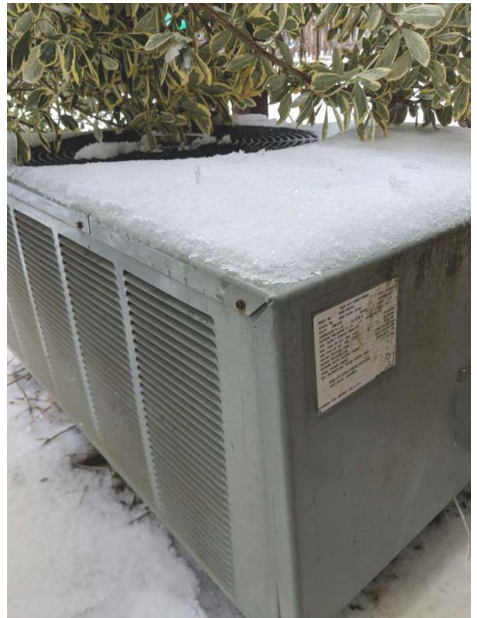
Equipment: Brand

Ruud

Manufactured 2004

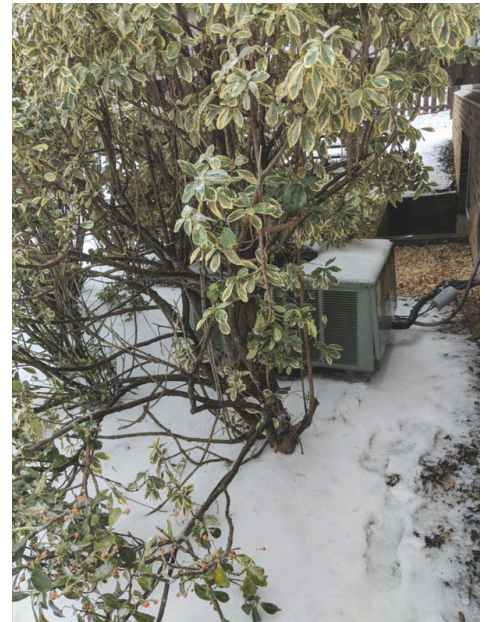
7.1.2 Equipment

Vegetation was too close to the compressor, which can limit heat dissipation and limit effectiveness. Recommend cutting back vegetation to avoid overheating compressor.

Contact a handyman or DIY project

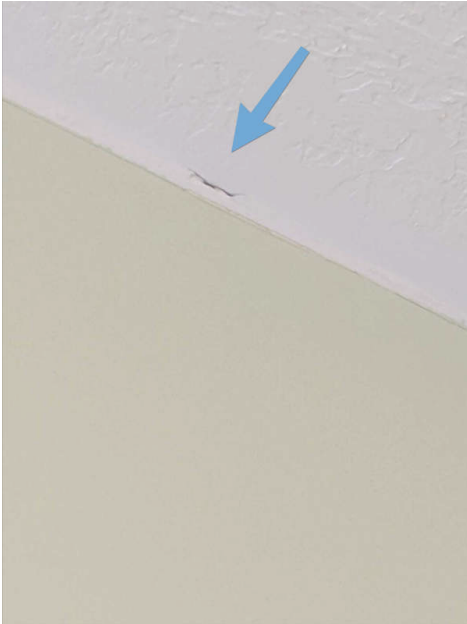
MINOR CRACKS

Minor cracks were observed in several place throughout the home, especially in areas where the wall meets the ceiling. Appeared to be the result of long-term settling. Some settling is not unusual in a home. Client may wish to patch and paint for aesthetic purposes. Recommend monitoring for future movement. If movement continues, recommend further evaluation by a qualified contractor.

Contact a qualified professional.

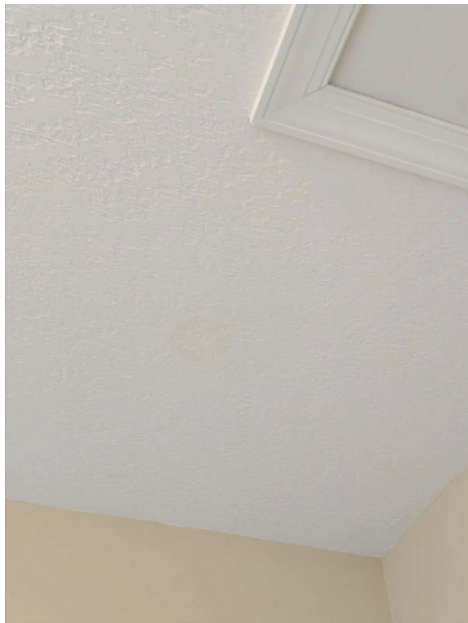
WATER STAIN - DRY

Stains were found in one or more ceiling areas. However, no elevated levels of moisture were found. The stain(s) may be due to past roof and/or plumbing leaks. Recommend asking the property owner(s) about this, and monitoring the stained area(s) in the future, especially after heavy or prolonged rain. If elevated moisture is found in the future, a qualified contractor should evaluate and repair as necessary.

Recommend monitoring.

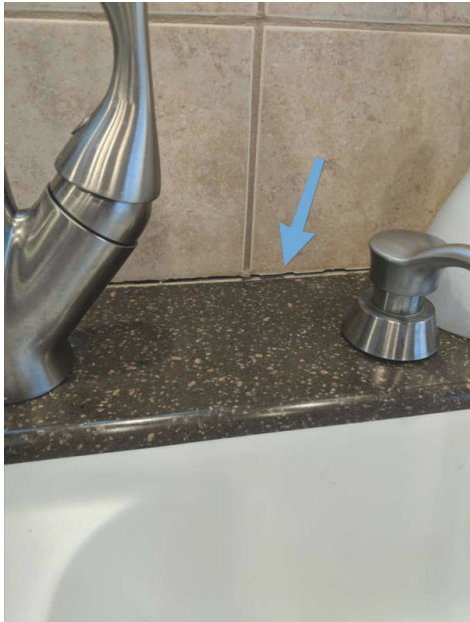
8.6.1 Countertops & Cabinets

POOR/MISSING CAULK

Countertop was missing sufficient caulk/sealant at the wall. This can lead to water damage. Recommend adding sealant at sides and corners where counters touch walls.

Contact a handyman or DIY project

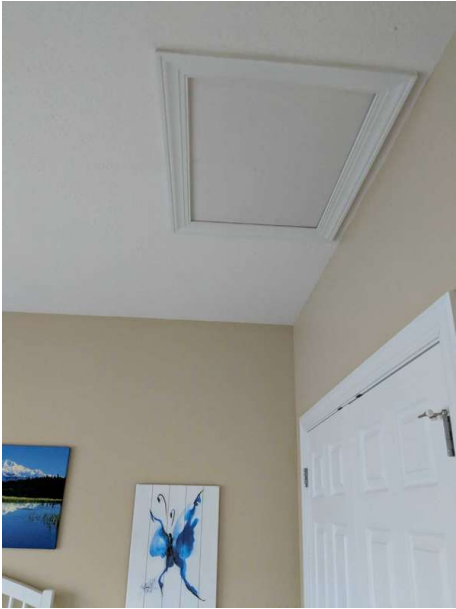
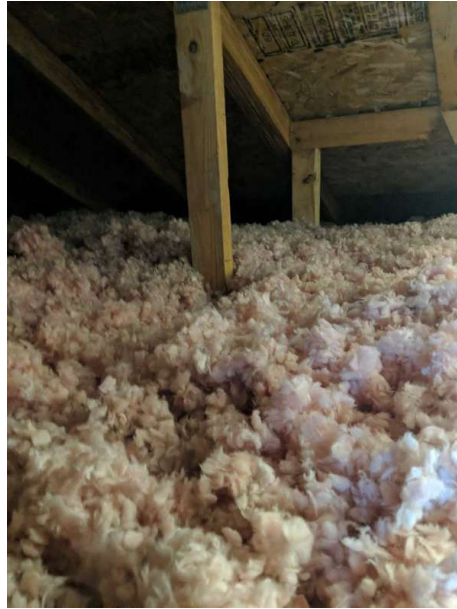
Attic Insulation: Insulation Type
Batt, Loose-fill, Unknown

Attic Insulation: Approximate Average Insulation Depth
9 inches

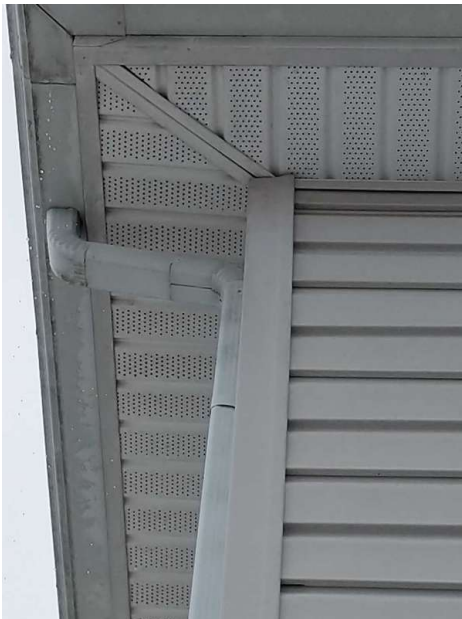
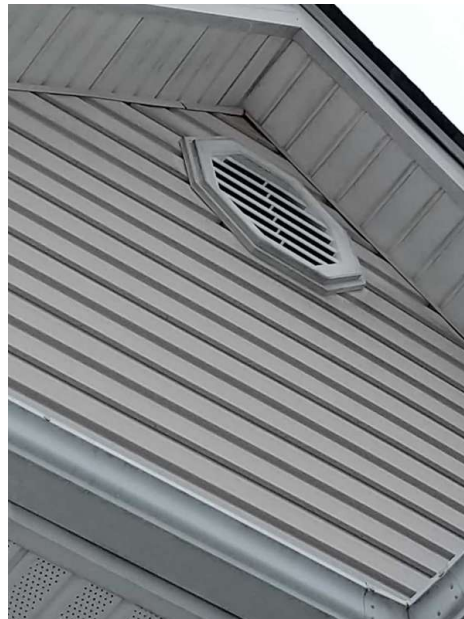
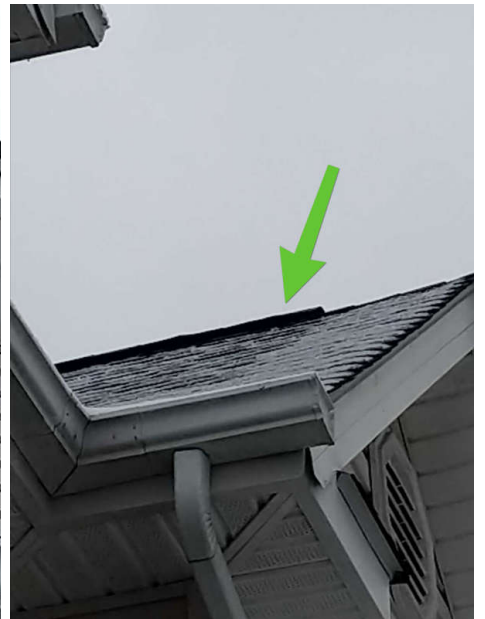
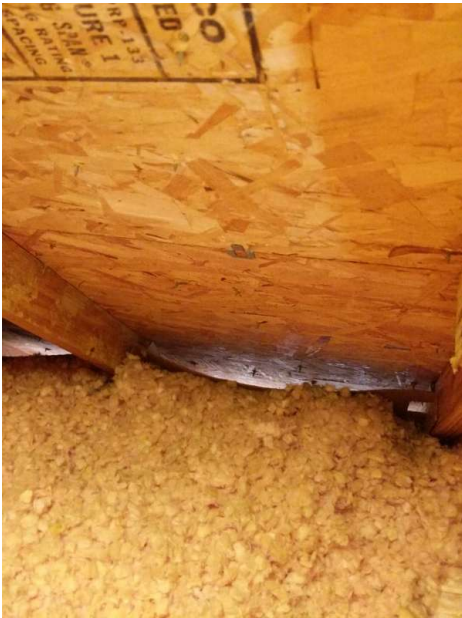
Inspection of attic venting was limited due to snow and ice on the roof and no walk way in the attic. Inspector observed what appeared to be ridge venting when inspecting the roof from the ground with binoculars. While inspecting the attic, it was difficult to see this feature but it appeared that the gap for proper venting on a ridge vent system was inadequate. There were no signs of elevated moisture in the attic. Client should monitor the attic throughout the seasons and during times of high humidity.

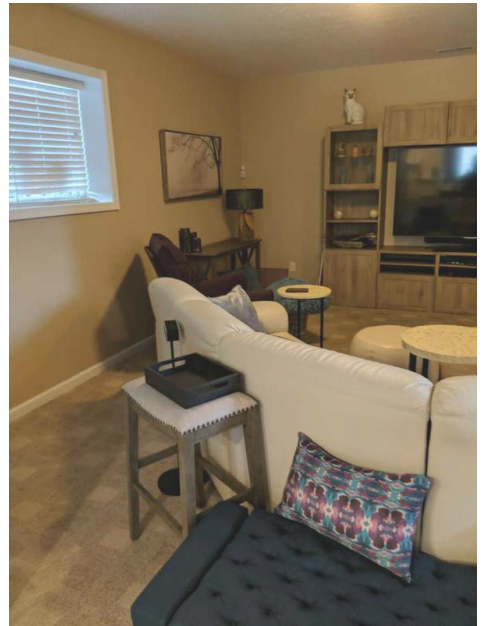
This house has a basement that is finished. Many of the components of the house could not be inspected due to being hidden behind walls, ceilings, and finished flooring.

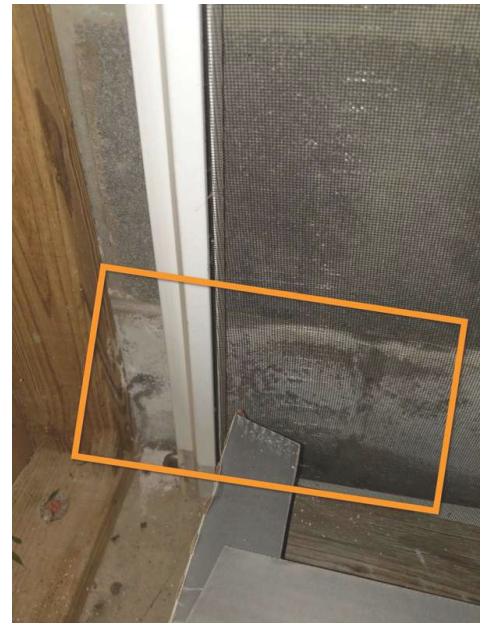
Basement Bedroom Closet

Efflorescence noted on the basement foundation wall surface. This is a white, powdery deposit that is consistent with moisture intrusion. This can compromise the soil's ability to support the home structure and/or lead to mold growth. Recommend a qualified contractor identify source or moisture and correct.

Contact a qualified professional.

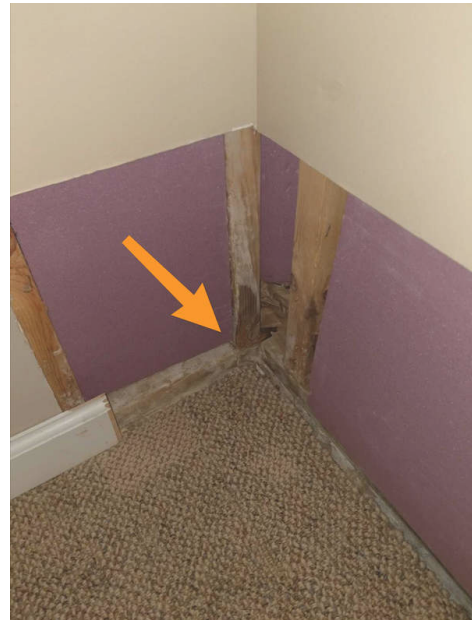
Northeast Basement

Wall structure showed signs of water intrusion, which could lead to more serious structural damage. It appeared that the home owner has made recent attempts to address this situation. This area was inspected using a moisture meter and elevated levels of moisture were found at this location. Recommend a qualified contractor identify source or moisture and remedy.

Contact a qualified professional.

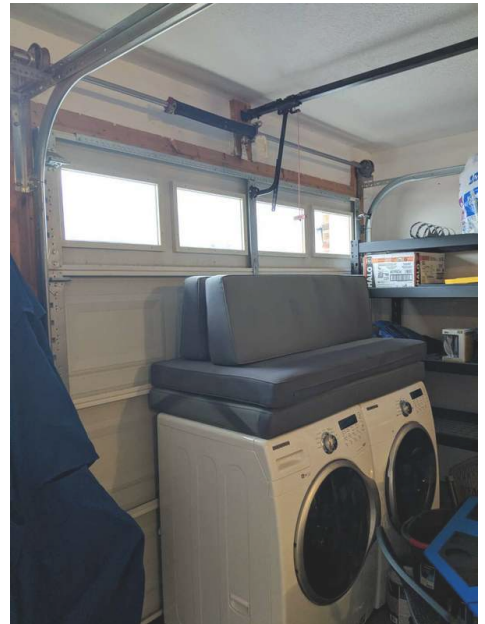
ACCESS BLOCKED

One or more of the Garage components could not be inspected due to occupants belongings.
