BLACKSTONE PROPERTY INSPECTIONS

YOUR HOME INSPECTION REPORT

1234 Main St.
Apache Junction AZ 85120

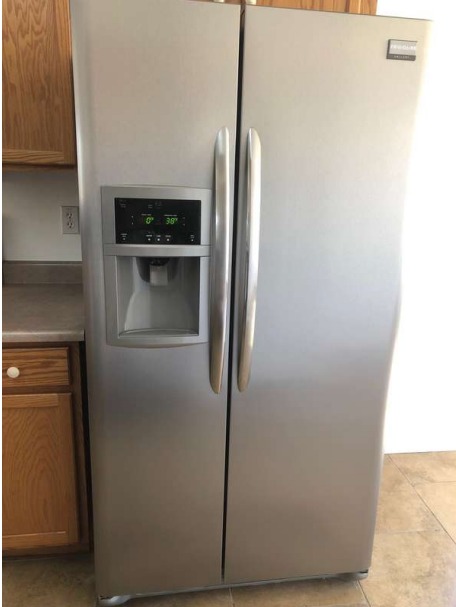
Refrigerator: Picture of Fridge

Refrigerator: Fridge-Acceptable

The fridge was functional and achieved acceptable fridge and freezer temperatures. This is a limited courtesy fridge inspection you should ask the sellers about its full operation. You should make sure to set your fridge at appropriate temps.

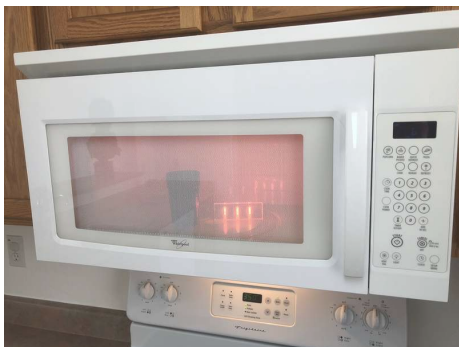
Built in Microwave: Picture of Microwave

Built in Microwave: Microwave-Acceptable

The built in microwave was functional during the inspection, but I did not test it for leakage, which would require a specialized instrument. However, their power diminishes over time, and the specific measurement of the microwaves, as well as their containment within the unit, requires specialized instruments, which is beyond the scope of our service.

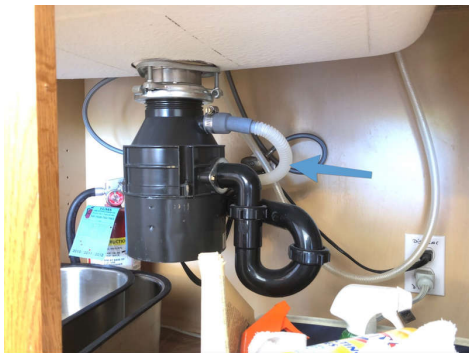
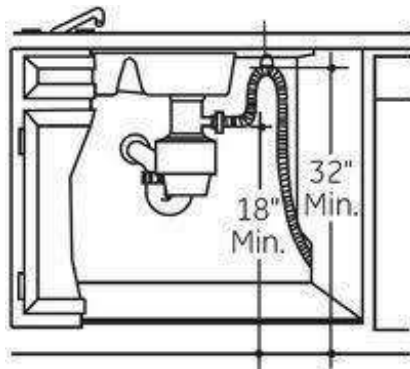
Dishwasher drain pipe was installed without a "high loop" to prevent cross-contamination. Recommend a handyman or DIY to repair. This will also prevent smells from accumulating from a low spot.

Contact a handyman or DIY project

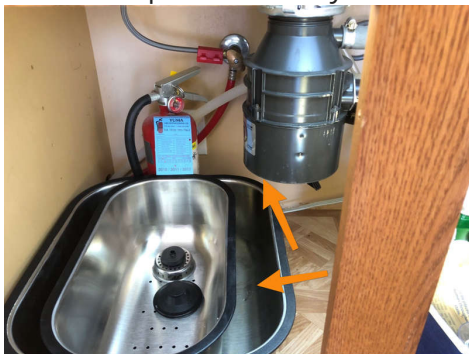
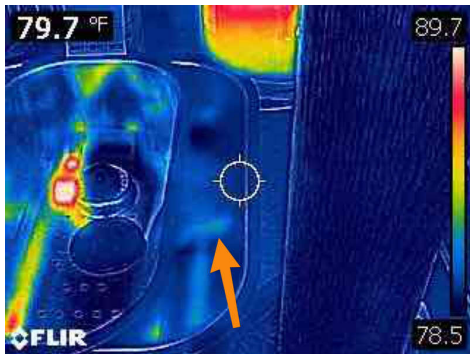
3.4.1 Garbage Disposal

LEAKING GARBAGE DISPOSAL

The garbage disposal is leaking or has been in the past and requires repair or replacement as necessary from a qualified technician.

Contact a qualified handyman.

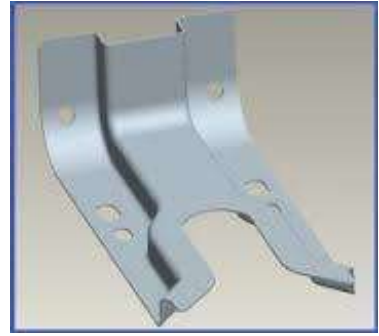
The Anti Tip Device is missing from the range and one should be installed for safety.

Contact a qualified handyman.

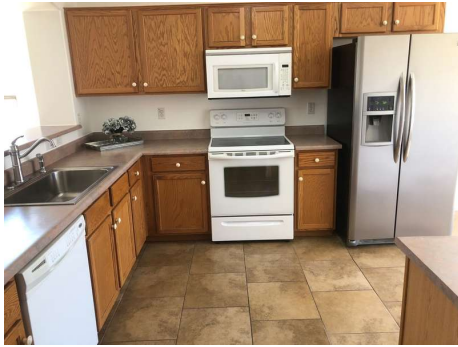
Picture of kitchen: Kitchen-PICTURE

Sink and Faucet: Sink and Faucet-Acceptable

The kitchen sink and faucet are functional.

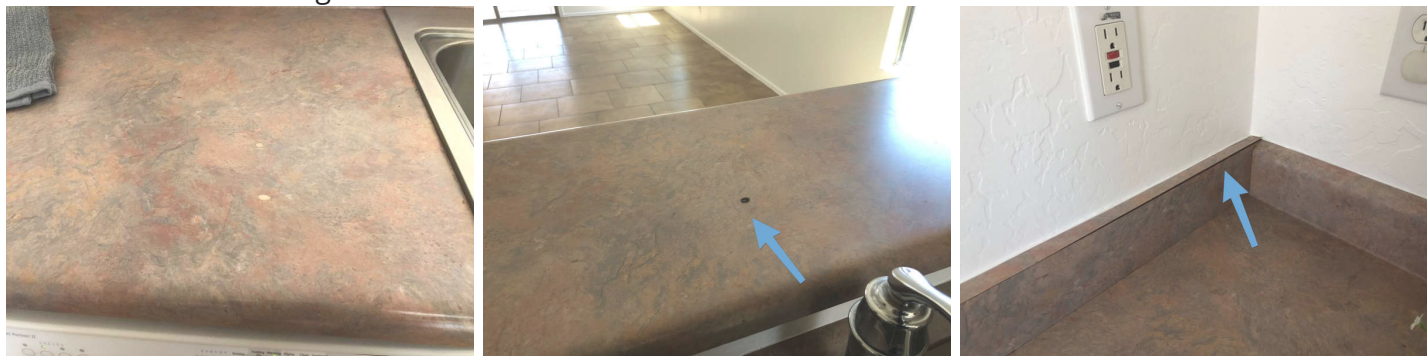
TYPICAL WEAR AND TEAR

The kitchen countertop showed typical wear and tear, or cosmetic damage that you should view for yourself.

Recommend monitoring.

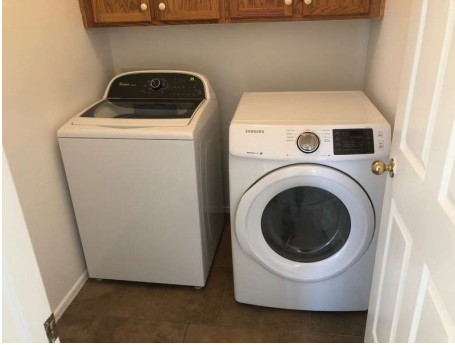
Washer & Dryer: Equipment photos

Washer & Dryer: Washer acceptable

At the time of inspection the washer was working. It was ran momentarily on one cycle and appeared to be working correctly. This is a limited washer inspection and you should ask the seller about all the appliances and ask about any issues.

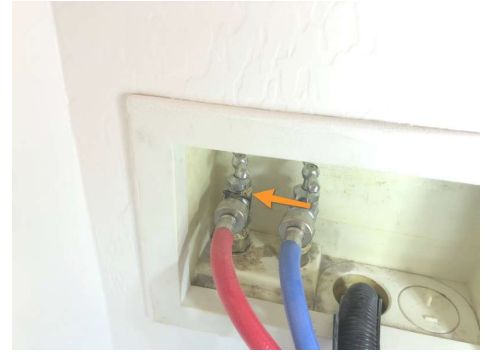
CORROSION LEFT SHUT-OFF VALVE

Corrosion and/or mineral build-up was observed on the left shut-off valve . This corrosion or build-up may prevent the shut-off valve from working properly, especially if emergency shut-off is needed. I recommend a qualified, licensed plumber should evaluate and repair or replace this valve or connection as necessary.

Recommendation
Recommend monitoring.

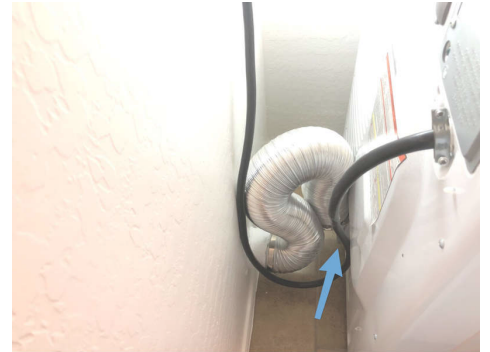
5.15.1 Dryer Vent

SEPARATED BEHIND THE DRYER

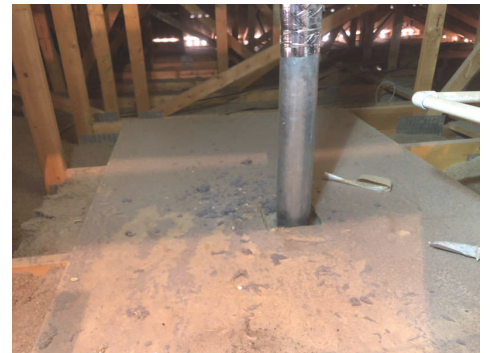
5.15.2 Dryer Vent

DRYER LINT IN THE ATTIC

There is a lot of dryer lint in the attic which can indicate a clogged or damaged dryer vent. I recommend further evaluation or service as necessary from a qualified technician.

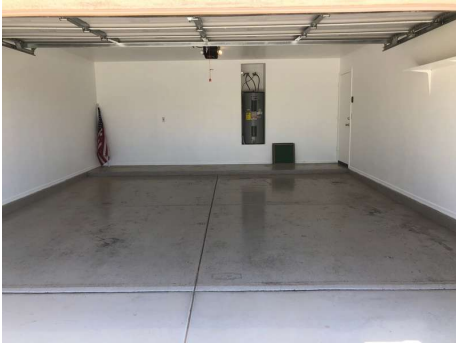
Double Car Garage

The garage and its components were evaluated

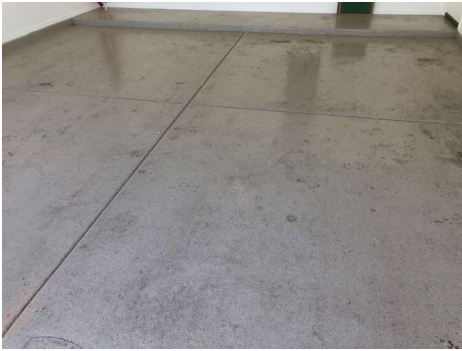
Slab Floor: Visible Slab-Acceptable

The visible garage slab floor is in acceptable condition. Small cracks are common and result as a consequence of the curing process, seismic activity, common settling, or the presence expansive soils, but are not structurally threatening.

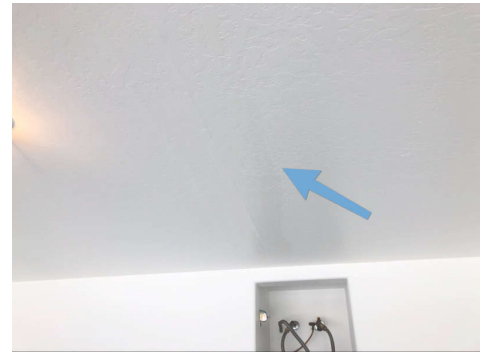
**TYPICAL SETTLEMENT CRACKING
ON WALLS AND CEILINGS**

Observed typical settlement type cracking on walls and ceilings.

Recommend monitoring.

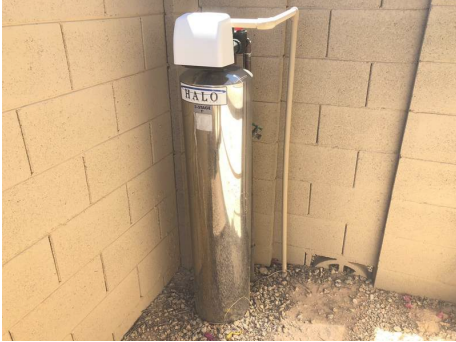
Water Softener: Picture Of Soft Water System

Water Softener: Water softener inspected For leaks only

We inspected the soft water system for leaks only you should ask the sellers for documentation and its functionality.

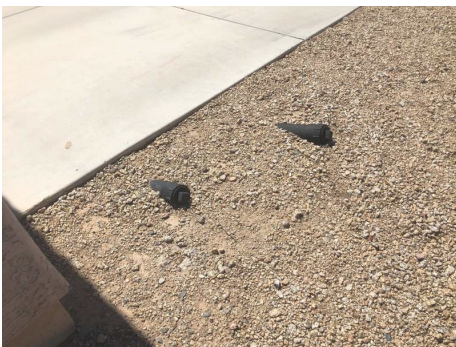
Drain, Waste, & Vent Systems: Picture of clean outs

Drain, Waste, & Vent Systems: Clean Out Location

Front

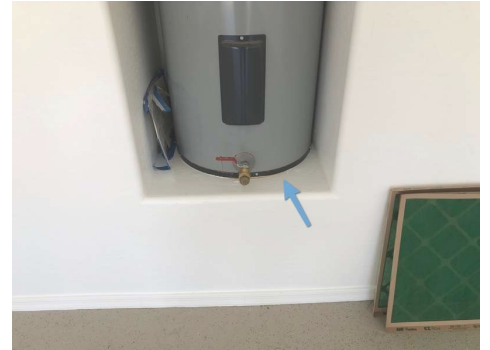
The water heater is not equipped with a drain pan and a discharge pipe, which is designed to prevent water damage from a leak. Nevertheless, the water heater should be periodically monitored for any signs of a leak we recommend having one installed if feasible when the water heater is replaced.

Contact a qualified professional.

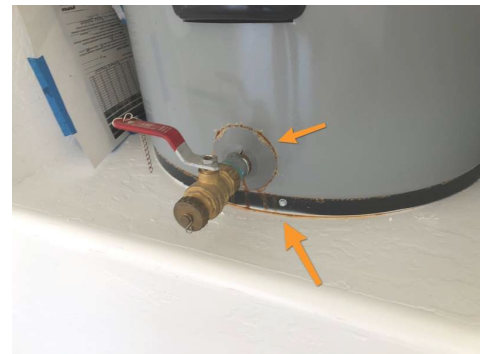
7.1.2 Hot Water System 1

WATER STAINS, RUST-LEAKAGE

Water stains, or rust were observed beneath water heater, indicating a past or present leak. Recommend further evaluation and repair or replacement by a qualified plumber.

Contact a qualified plumbing contractor.

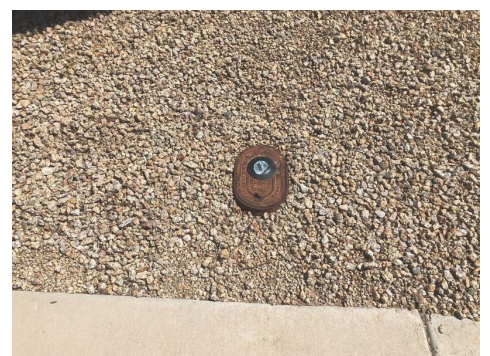
7.3.1 Main Water Shut-Off, Distribution & Supply

The water meter box appears locked and we were unable to view the water meter. Recommend the water meter be inspected when access is available.

Contact a qualified professional.

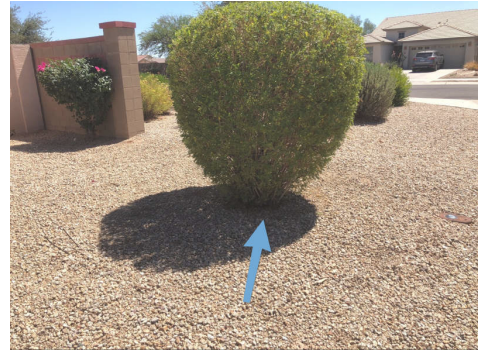
7.5.1 Irrigation

MISSING DRIP HEADS

There are missing drip heads or cracked drip lines on the irrigation system that need service or replacement. They are currently spraying uncontrolled in the yard when the system is turned on.

Contact a handyman or DIY project

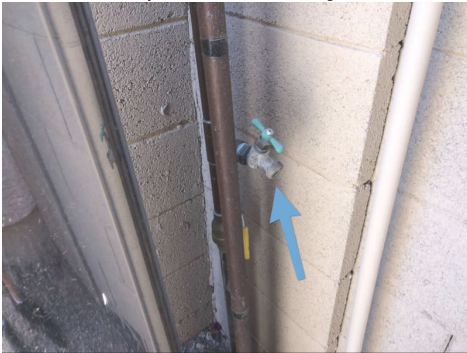
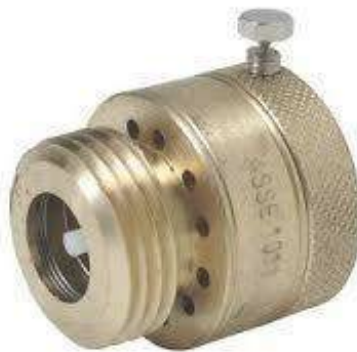
7.6.1 Hose Bibs

NO ANTI-SIPHON VALVES

Contact a qualified handyman.

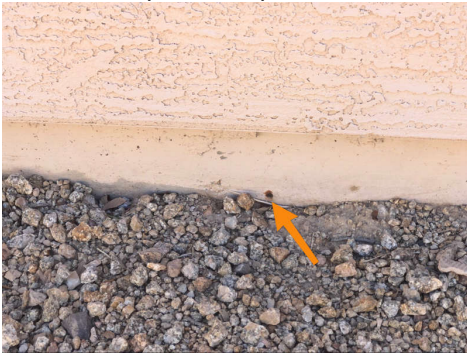
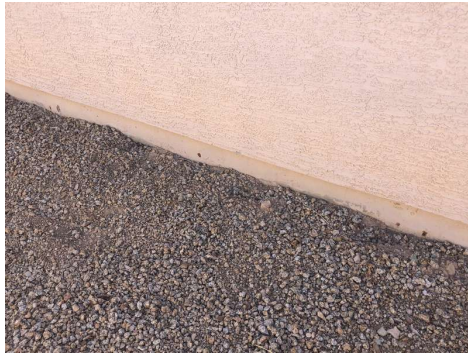
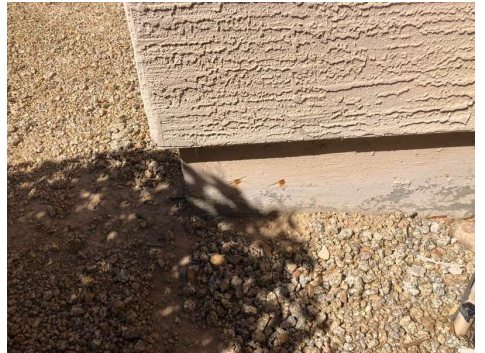
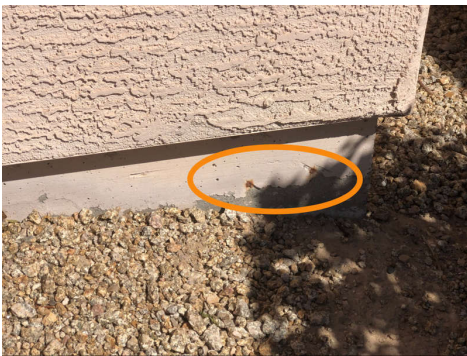
8.2.1 Foundation / Stem walls

The exposed metal at one or more location(s) around the stemwall should be covered/sealed to prevent corrosion and deterioration.

Contact a qualified professional.

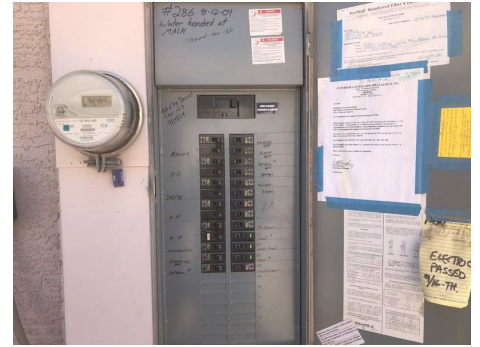
Panel Size & Location: Picture of panel

Panel Size & Location: Panel Amps, Location

200 AMP, Left Side

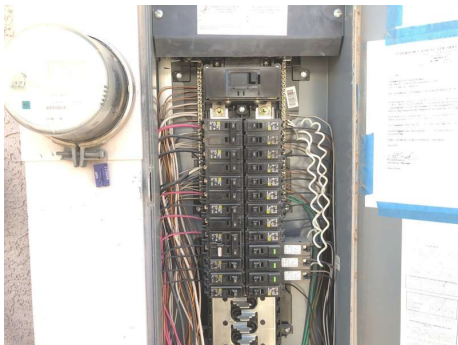
Wiring Observations: Picture of wiring.

Wiring Observations: Electrical Service Conductors

Copper, 120/240 volt

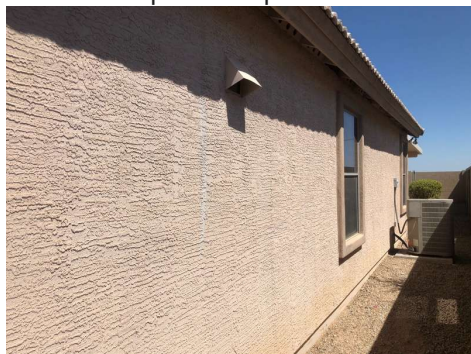
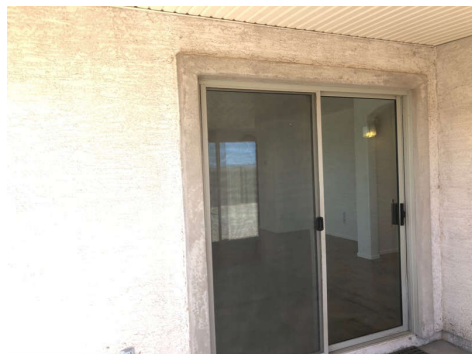
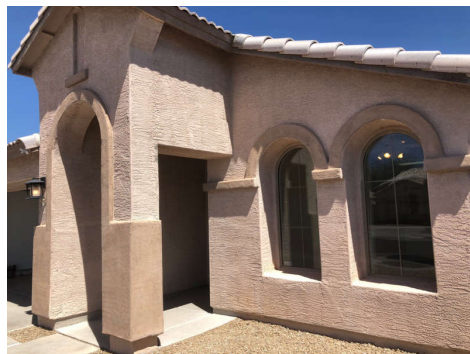
-   10.2.1 Exterior - House Wall Finish: Paint is discolored
-   10.2.2 Exterior - House Wall Finish: Damaged siding or stucco
-   10.6.1 Exterior - Lights: Some exterior lights did not work.

Contact a qualified painter.

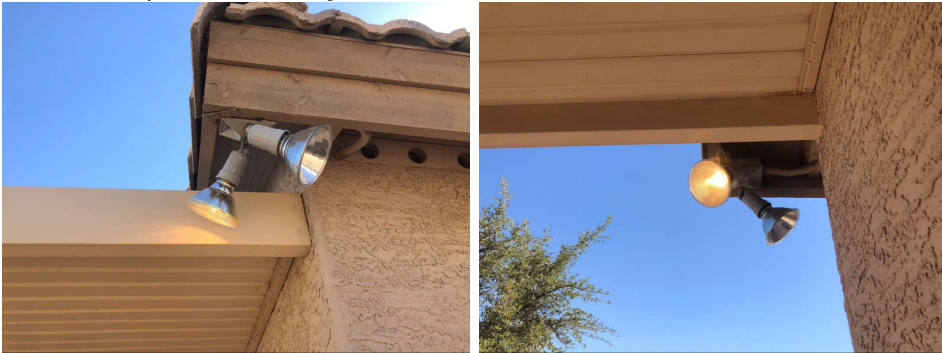
10.6.1 Lights

SOME EXTERIOR LIGHTS DID NOT WORK.

Contact a qualified handyman.

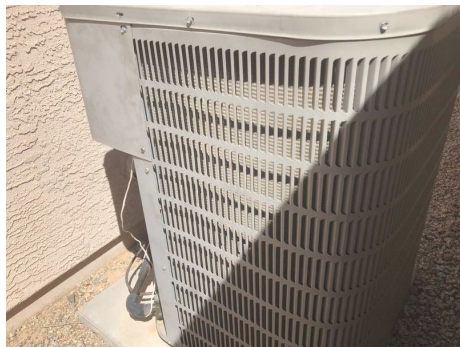
Condensing Coil (outside): Coil fins acceptable - picture

The fins were in acceptable condition.

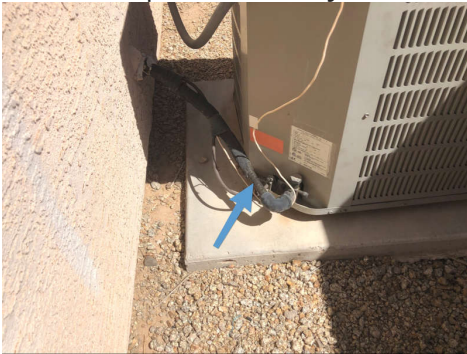
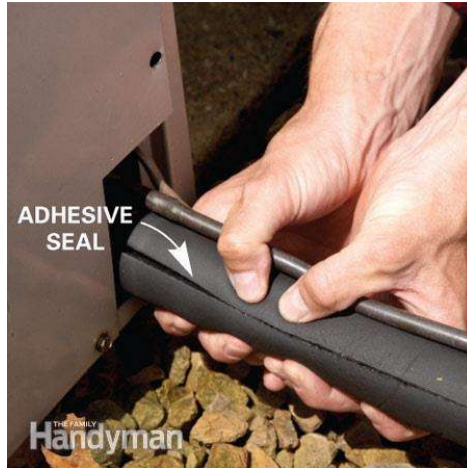
11.6.1 Refrigerant Lines

INSULATION MISSING

Add insulation to refrigerant lines

Contact a qualified handyman.

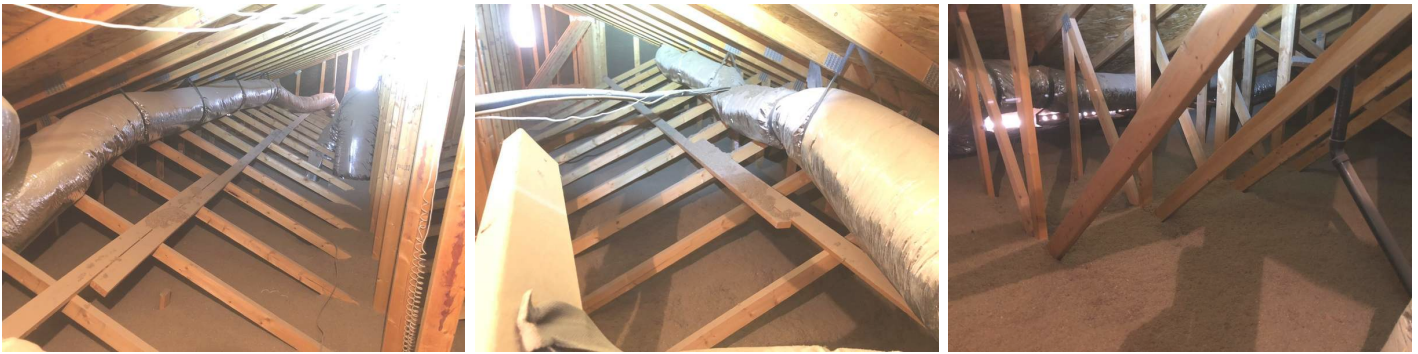
Method of Evaluation: 3 Pictures Of Attic

Method of Evaluation: Access

The attic was evaluated by direct access to easily accessible areas, and viewed from easy vantage points near the catwalk if it has one.

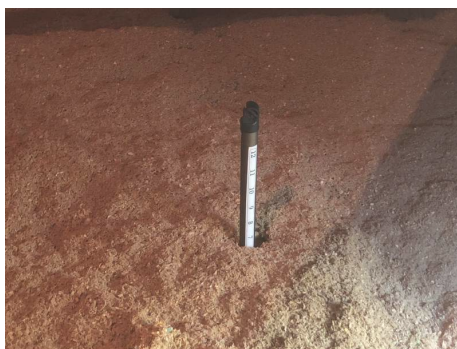
**Insulation: Insulation Type
Blown, Cellulose****Insulation: Acceptable With
Picture****Other Observations: OK.**

Insulation is acceptable

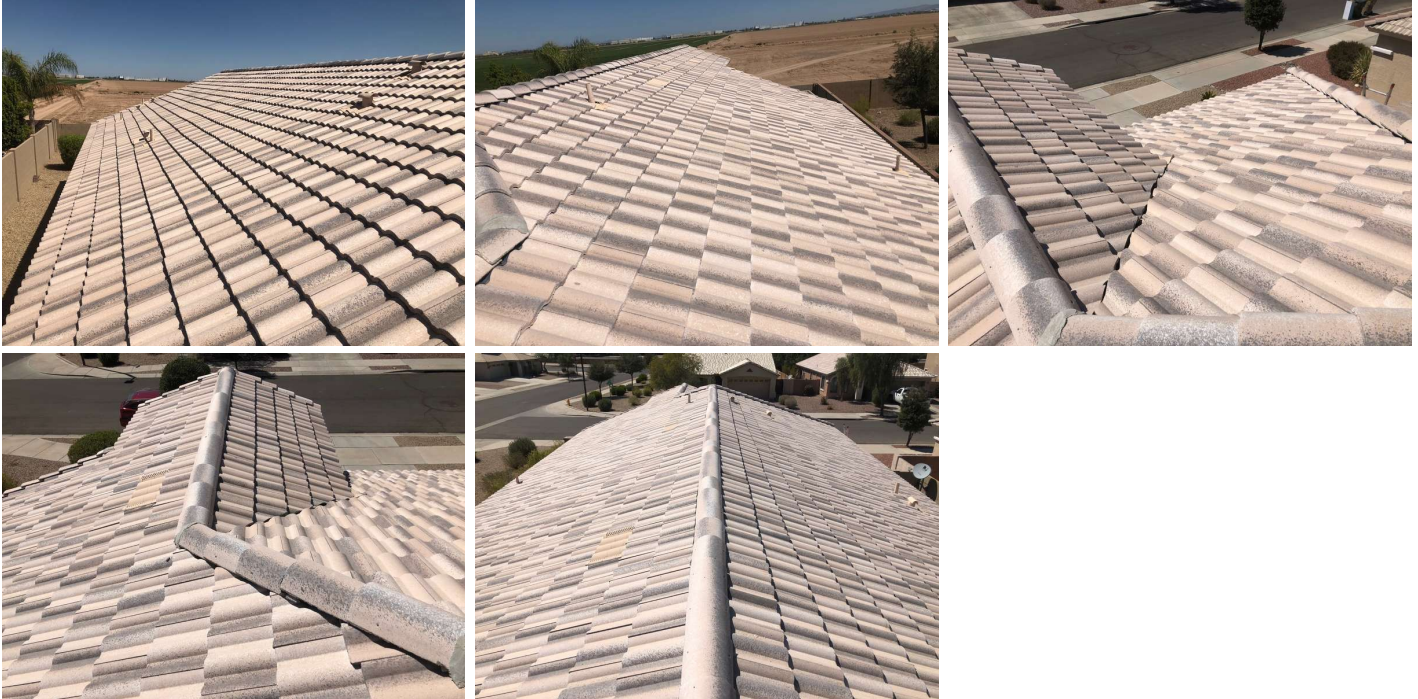
Method of Evaluation: 5 Pictures of roof

Method of Evaluation: Method of Evaluation

Walking on its surface

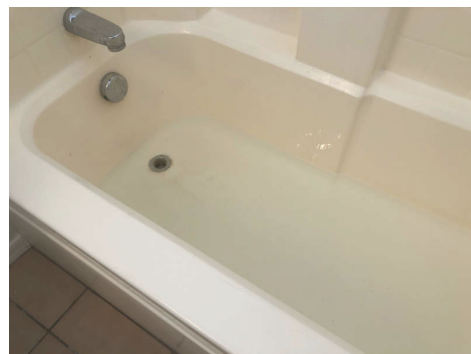
17.12.1 Tub-Shower

TUB STOPPER IS MISSING

Contact a qualified plumbing contractor.

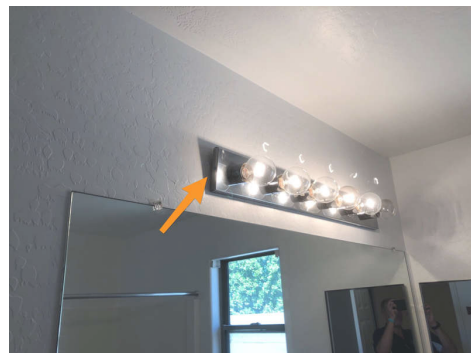
17.15.1 Lights, Wall Switches

LIGHT FIXTURE IS LOOSE

Contact a qualified handyman.

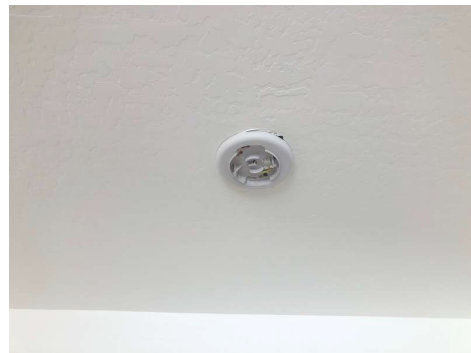
18.7.1 Smoke Detectors

THE SMOKE DETECTORS MISSING

Contact a qualified handyman.

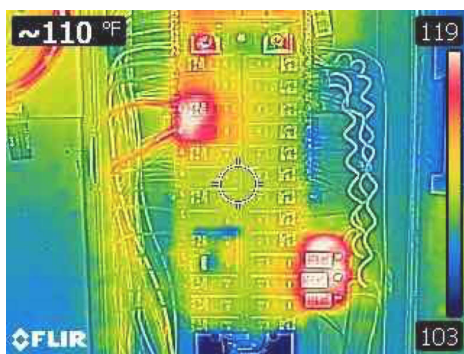
Electrical: Normal W AFCI

The thermal image of the electrical breakers and electrical wires within the panel are in use but within normal temperature range. The hot area are the Arc Fault breakers, which run hotter than the others but within normal specs.

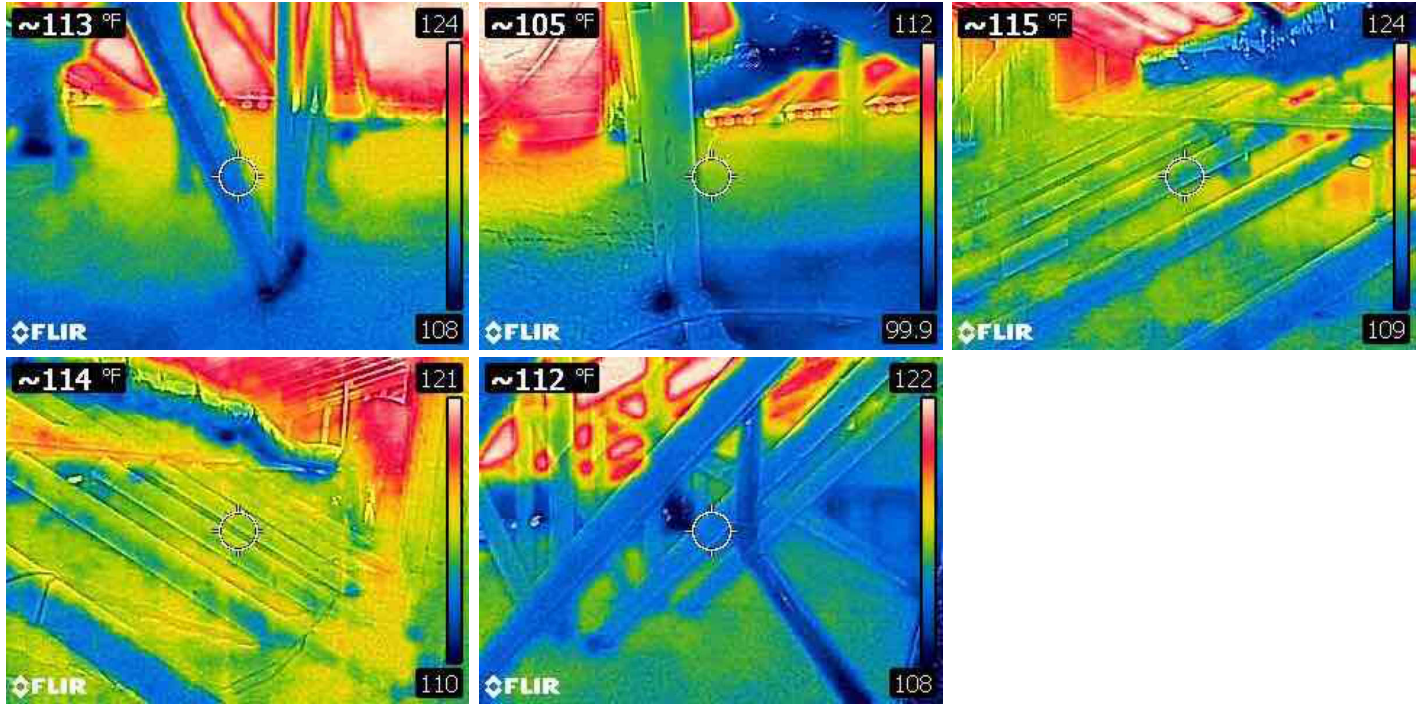
Attic: Attic ok

Components within the attic was scanned by thermal camera and they appear to all be working as normal, with no immediate signs of rodents, abnormal leaking HVAC pipes, wet spots etc.

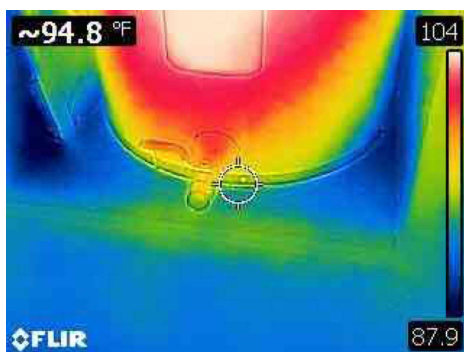
Water heater base: Acceptable

The base of the water was scanned with the thermal imager and no leaking was noted.
