EQUITY BUILDING INSPECTION

PROPERTY INSPECTION REPORT

1234 Main St.
Torrance California 90501

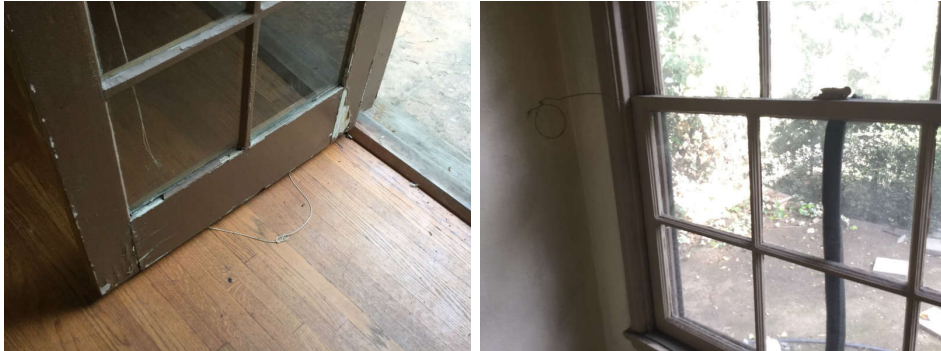
Moderate**DAMAGED DOOR**

One or more of the exterior doors is deteriorated or damaged. We recommend repair or replacement by a qualified technician or handyman. (Guest house entry)

Contact a qualified general contractor.

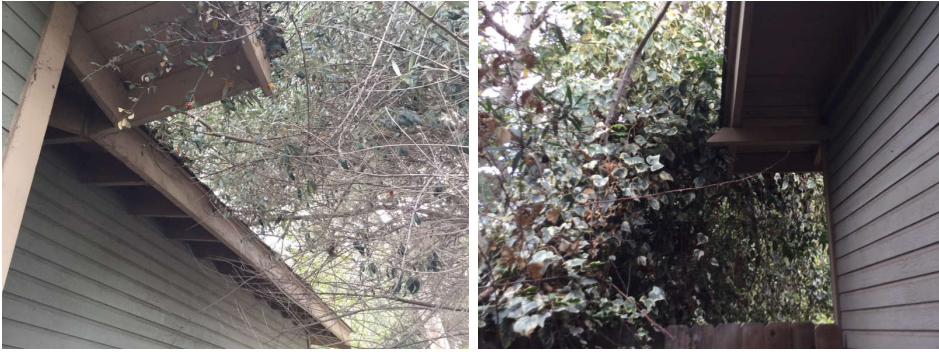
Trees were in contact with or were close to the building at one or more locations. Damage to the building can occur, especially during high winds, or may have already occurred (see other comments in this report if applicable). Recommend that a qualified tree service contractor or certified arborist remove trees as necessary to prevent damage to the building exterior.

Contact a qualified tree service company.

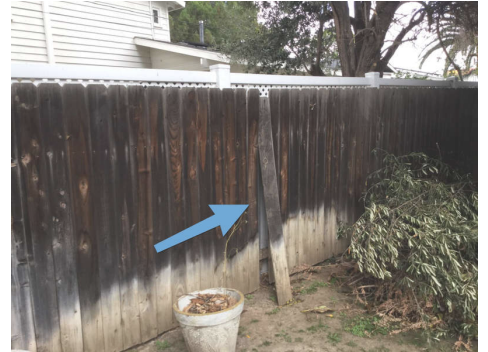
FENCE REPAIR - MINOR

Fences and/or gates are damaged and/or deteriorated in some areas. Make repairs or replace sections as necessary.

Contact a handyman or DIY project

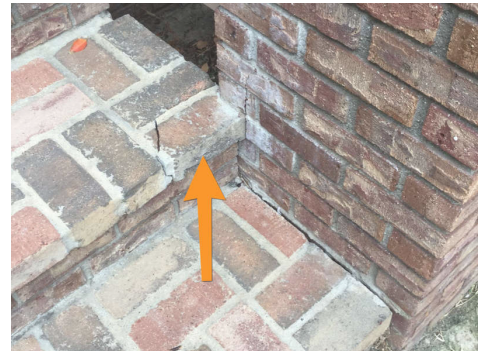
DAMAGED STAIRS

We found deterioration at one or more of the stair or stairway. Recommend that a qualified contractor evaluate and repair as necessary. All rotten wood or damaged materials should be replaced.

Contact a qualified deck contractor.

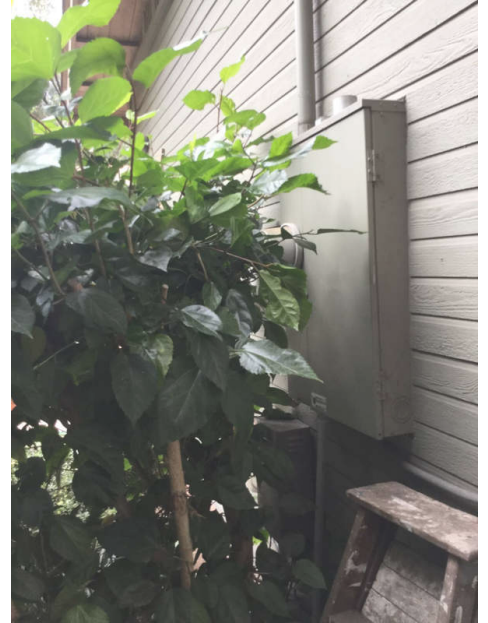
Access to the panel was limited due to vegetation. We recommend the vegetation be eliminated for safe and convenient access to the panel.

Contact a qualified professional.

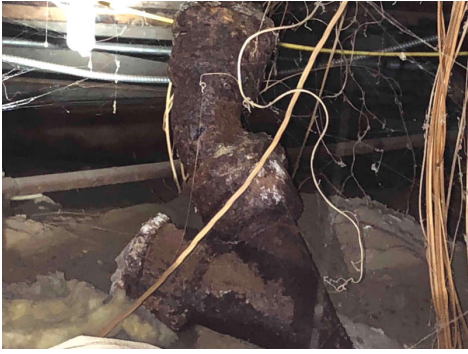
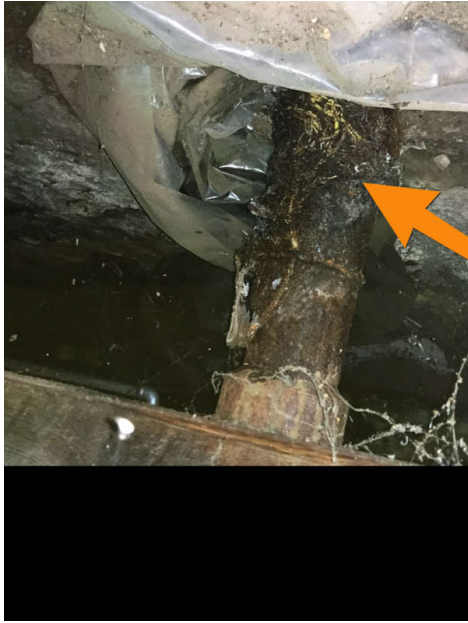
Moderate**DRAIN / WASTE DAMAGED**

One or more drain or waste pipes or fittings were damaged or highly corroded and one of the is leaking. Recommend that a qualified plumber evaluate and repair as necessary and per standard building practices.

Contact a qualified plumbing contractor.

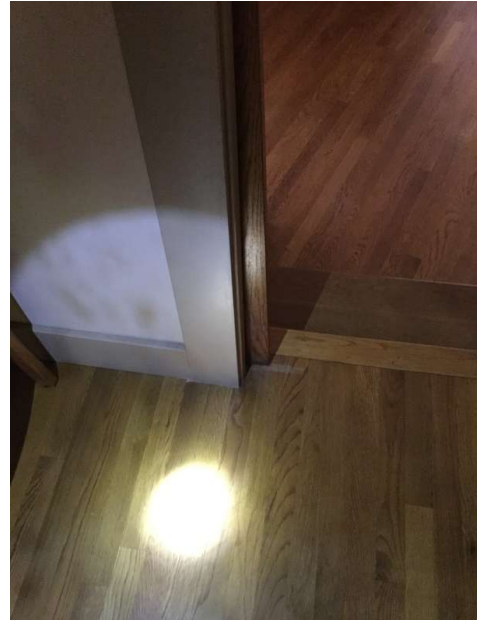
The dining room pocket doors in one or more locations were off track. Recommend repair for proper functionality.

Contact a qualified handyman.

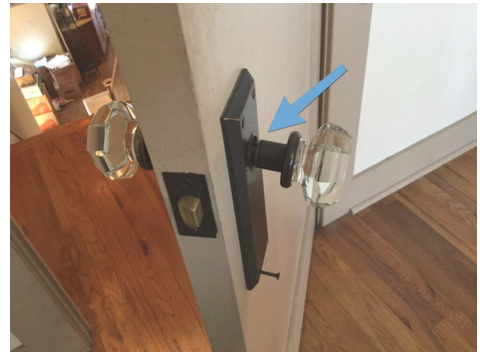
HARDWARE LOOSE / DAMAGED / MISSING

Some interior door hardware (locksets, hinges and/or pulls) were inoperable, damaged, loose and/or missing. Recommend that a qualified person repair or replace as necessary.

Contact a handyman or DIY project

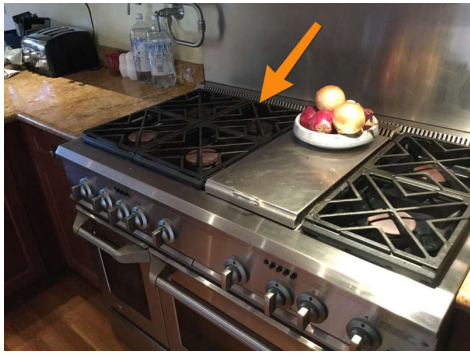
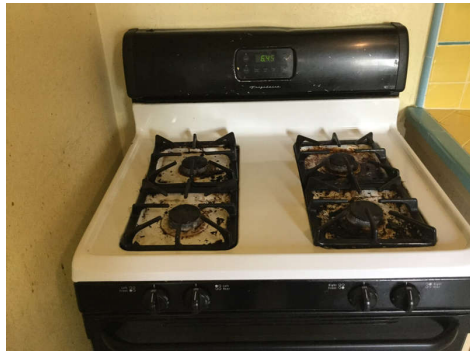
1 / 2 / 3 / 4 cooktop *burner(s) / element(s)* were inoperable. Recommend that a qualified person repair as necessary.

(Number 2 burner and. All burners in guest house kitchen)

Contact a qualified appliance repair professional.

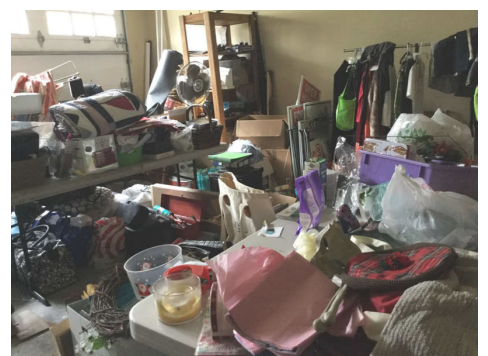
PERSONAL BELONGINGS

We could not fully inspect the garage due to the amount of personal belongings. We recommend further inspection of the garage once it is vacant.

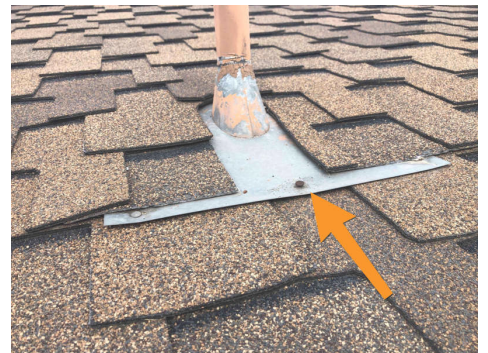
FLASHING IMPROPERLY INSTALLED / SUBSTANDARD

Flashing has improperly installed and/loose or substandard. Leaks can occur as a result. This is a conducive condition for wood-destroying organisms. Recommend that a qualified person repair as necessary.

Contact a qualified roofing professional.

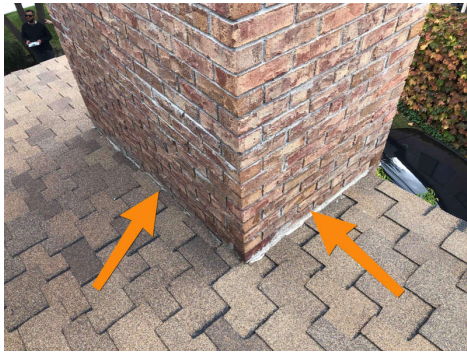
CHIMNEY COUNTER FLASHING MISSING, LOOSE, DAMAGED AND/OR SUBSTANDARD

Contact a qualified roofing professional.

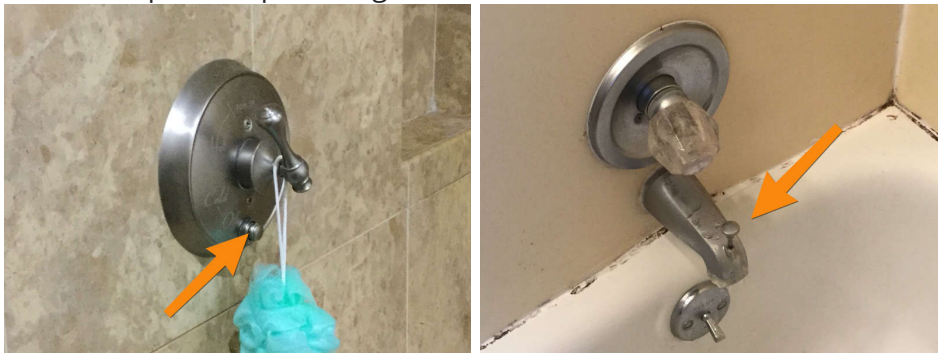
DIVERTER PULL DAMAGED

Contact a qualified plumbing contractor.

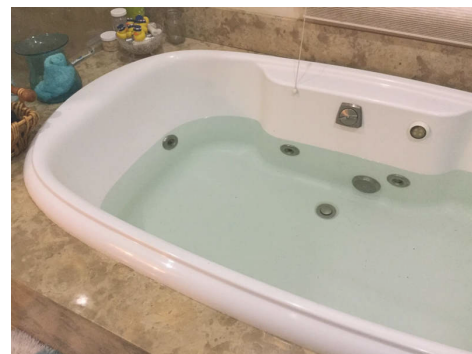
JETTED TUB / MOLD FROM JETS

Debris came out of the jets when the jetted bathtub was turned on. Some jetted tub designs allow water to stagnate in pipes, resulting in mold or bacteria growth that is expelled from jets. It's unlikely that repairs or modifications can be made to prevent this if it is occurring. It may be possible to prevent such biological growth by running hot water and bleach or dishwasher soap (low sudsing) through the jetted bathtub periodically.
