PEOPLE'S CHOICE HOME INSPECTIONS, LLC

RESIDENTIAL INSPECTION

1234 Main St.
Charleston SC 29412

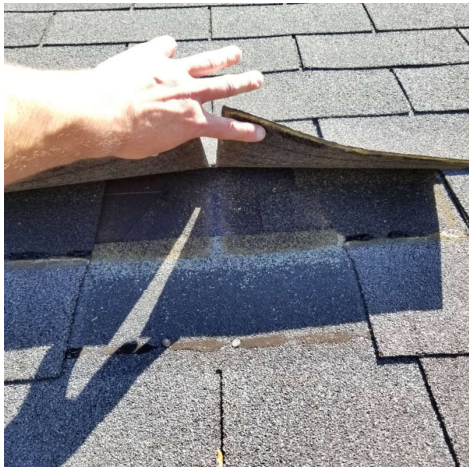
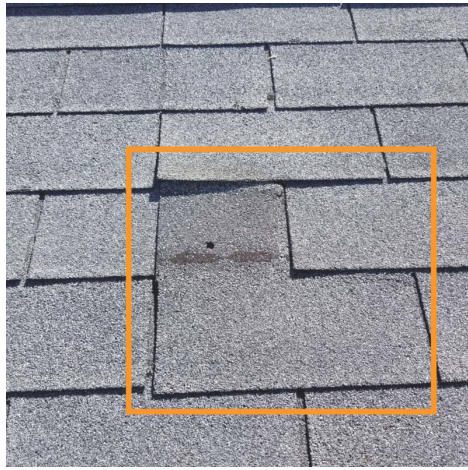
SHINGLES DAMAGED

One or more composition shingles were Damaged. Recommend that a qualified roofing professional make needed repairs as necessary.

Contact a qualified roofing professional.

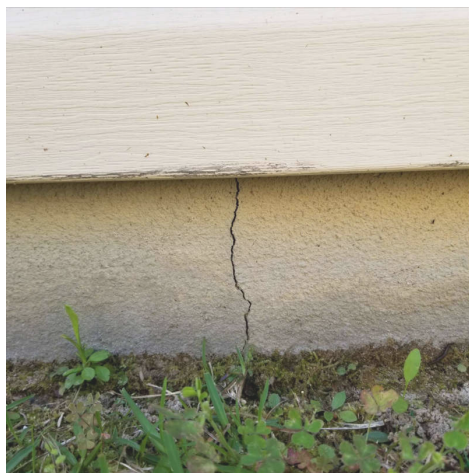
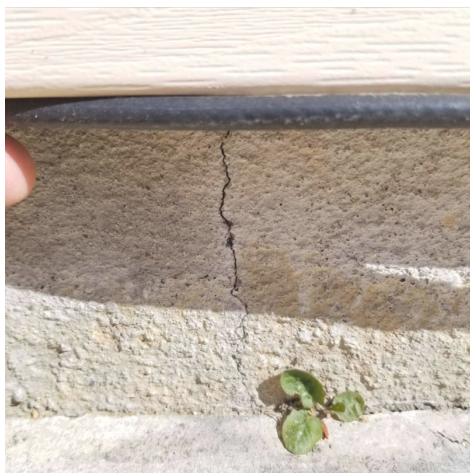
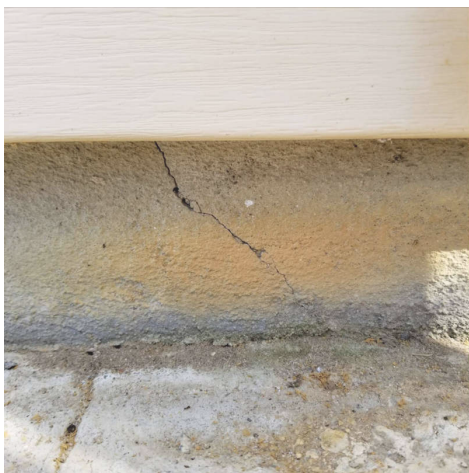
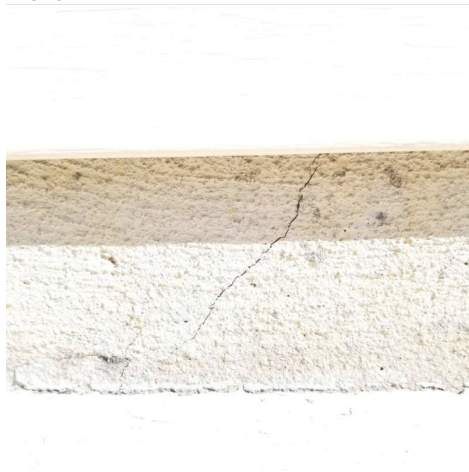
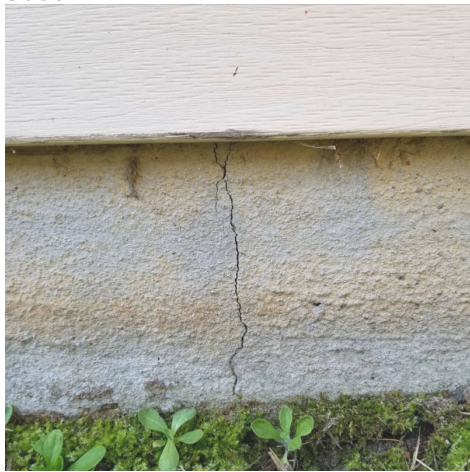
COMMON CRACKING

Common cracks were visible in the floor slab. This type of cracking can have several causes:

- Concrete shrinkage, which is a normal part of the concrete curing process and not a structural concern:
- Post-construction settling due to inadequate compaction of the soil beneath the slab during construction. This also is not an unusual condition and this type of cracking ceases after the first few years after original construction as the soil beneath the slab becomes stable: or
- Heaving of the soil due to the presence of expansive soils.

Determining the cause of cracking lies beyond the scope of the General Home Inspection.

Recommend monitoring.

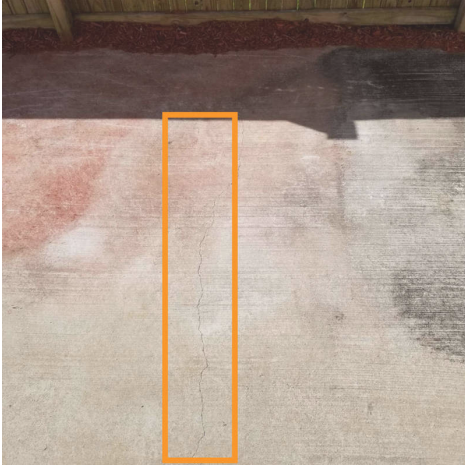
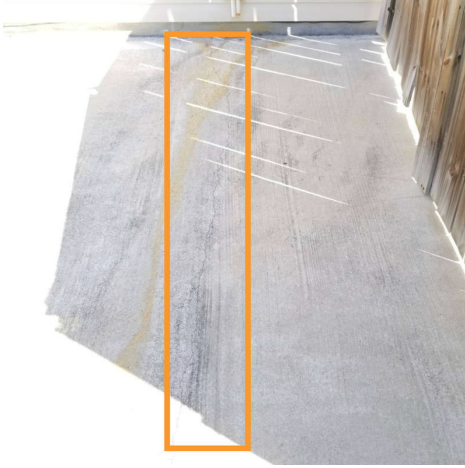
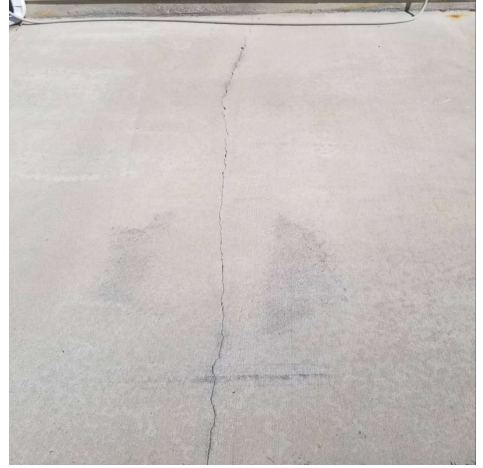
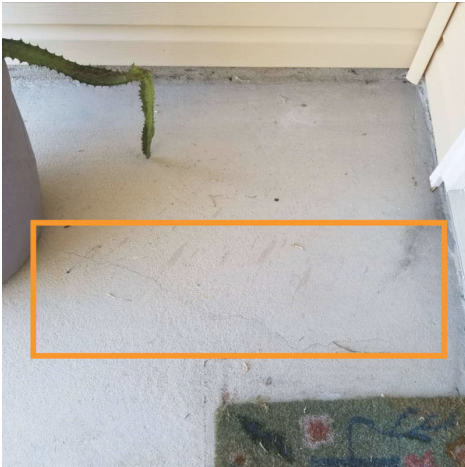
MINOR DAMAGE-DRIVEWAY,SIDEWALK,PATIO

Minor deterioration (cracks, chips, holes, settlement, heaving) was found in driveways, sidewalks or patios, but no trip hazards were found. The client may wish to have repairs made for cosmetic reasons.

Contact a qualified professional.

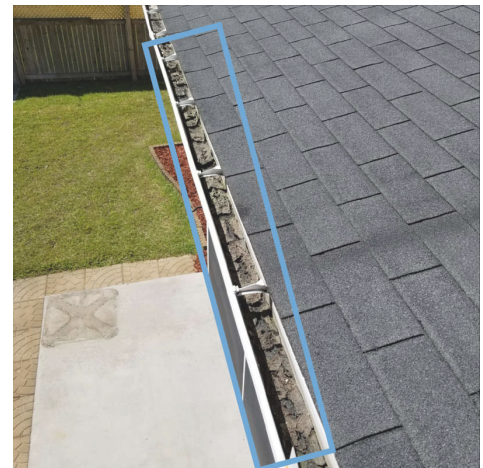
3.7.1 Gutters and Flashing

Debris has accumulated in the gutters. Recommend cleaning to facilitate water flow.

Contact a handyman or DIY project

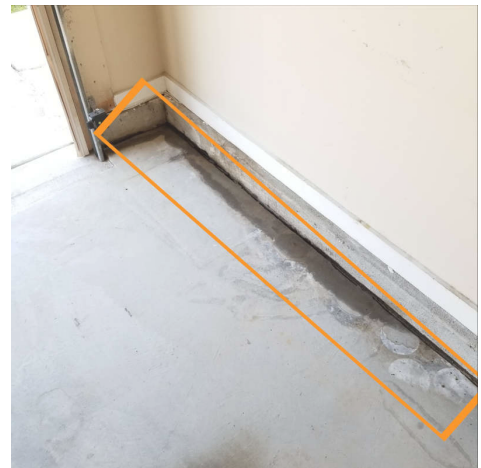
MOISTURE INTRUSION

Garage floor showed signs of moisture intrusion. Recommend a qualified contractor evaluate and find source of moisture to prevent further damage and/or mold.

Contact a qualified professional.

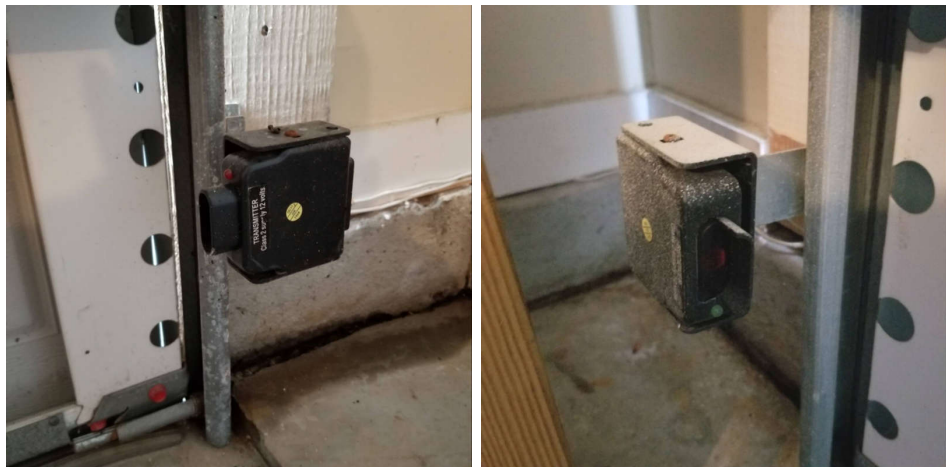
4.4.1 Vehicle door

The infrared "photo eye" devices that trigger the vehicle door opener's auto-reverse feature were inoperable during the inspection. This is a safety hazard, especially for small children. A qualified contractor should evaluate and make repairs or replace components as necessary.

Contact a qualified garage door contractor.

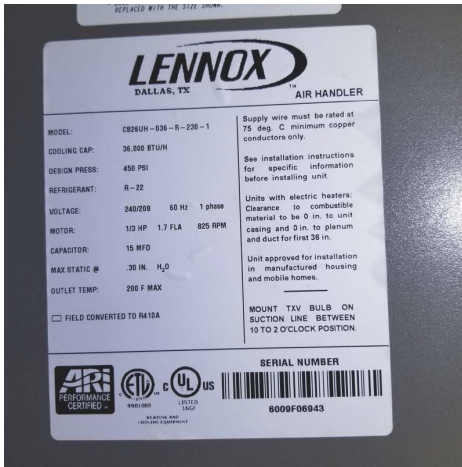
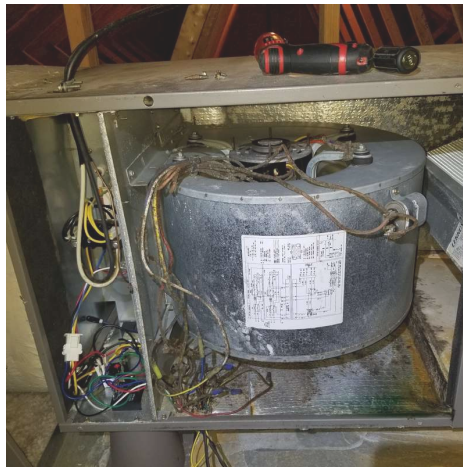
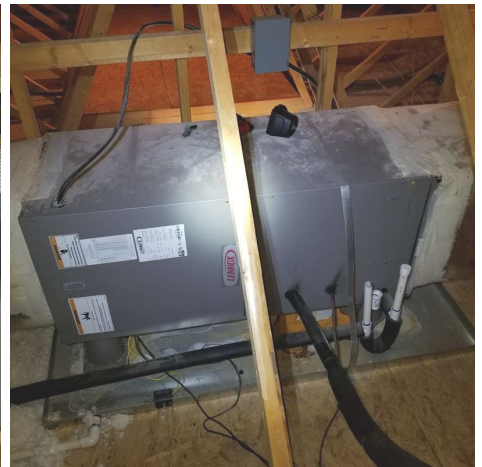
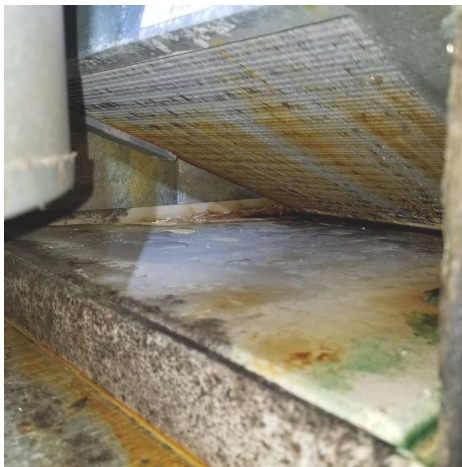
Air Handler: Pictures of unit

Air Handler: Unit in Good Condition

The air handler appeared in good condition. The unit ran hot and cold as expected.

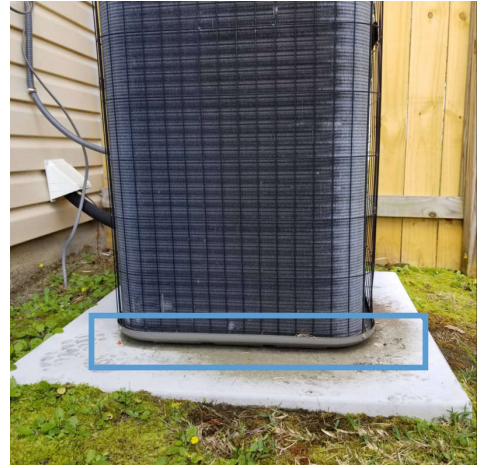
The outside unit is not anchored to the concrete pad. It is recommended to have a certified contractor anchor the unit to the concrete pad to keep it from moving and causing damage.

Contact a qualified professional.

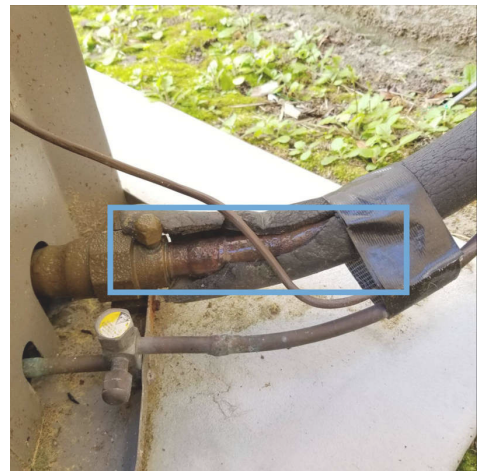
5.5.2 Heat Pump

Insulation for the outside condensing unit's refrigerant lines is damaged, deteriorated and/or missing in one or more areas. This may result in reduced efficiency and increased energy costs. A qualified heating and cooling contractor should replace insulation as necessary.

Contact a qualified professional.

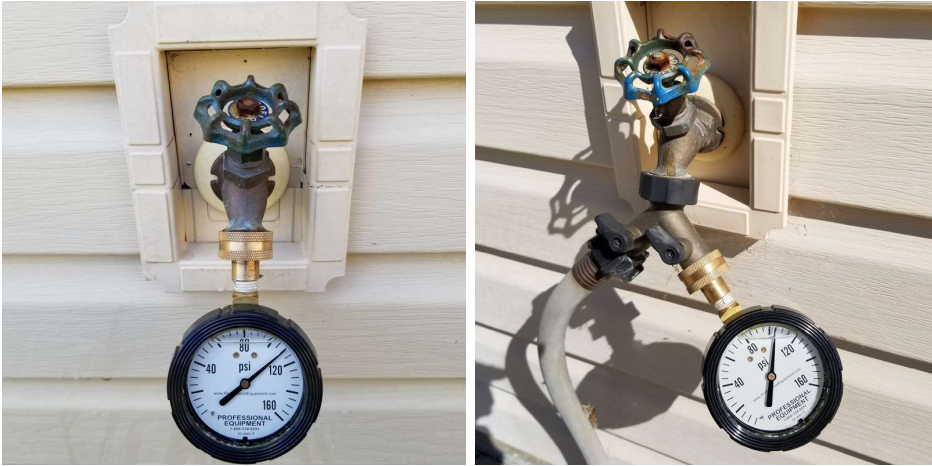
General: Water Pressure

110 PSI

The water supply pressure is greater than 80 psi. Pressures above 80 psi may void warranties for some appliances such as water heaters or washing machines. Flexible supply lines to washing machines are more likely to burst with higher pressures. Typically the pressure cannot be regulated at the water meter. Recommend having a qualified plumber evaluate and make modifications to reduce the pressure below 80 psi. Installing a pressure reducing valve on the main service pipe is a common solution to this problem. If one exists, then it should be adjusted for lower pressures.

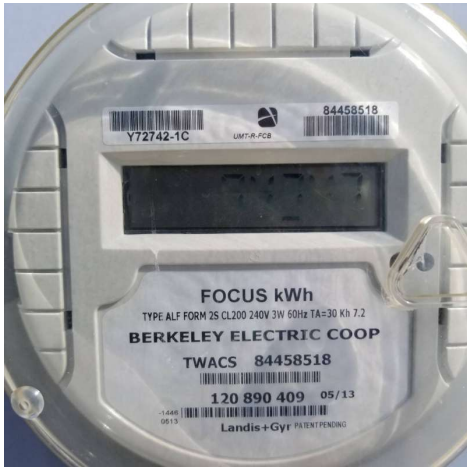
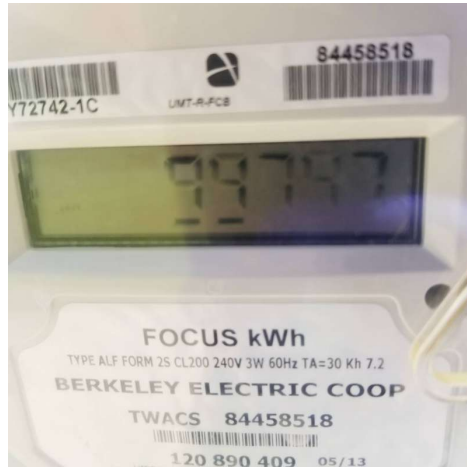
The meter cover plate is damaged or faded and not readable. Recommended asking the utility company if this is something they are to repair.

Contact your local utility company

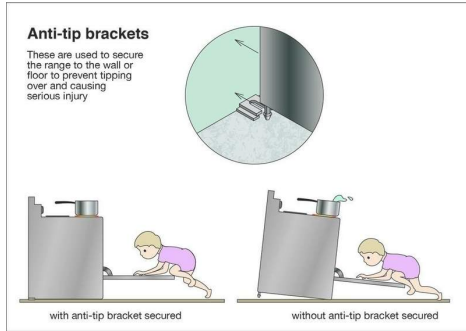
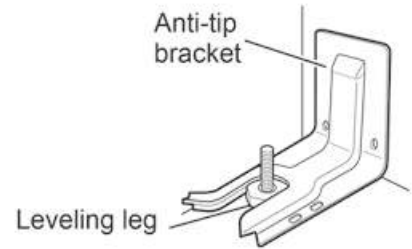
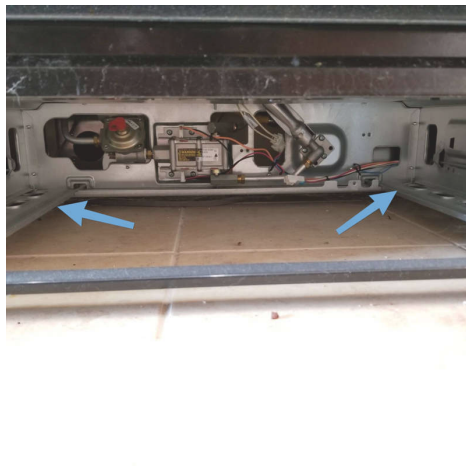
The range can tip forward, and no anti-tip bracket appears to be installed. This is a safety hazard since the range may tip forward when weight is applied to the open door, such as when a small child climbs on it, or if heavy objects are dropped on it. Anti-tip brackets have been sold with all free standing ranges since 1985. An anti-tip bracket should be installed to eliminate this safety hazard. For more information, visit <https://www.nachi.org/anti-tip.htm>

Contact a qualified appliance repair professional.

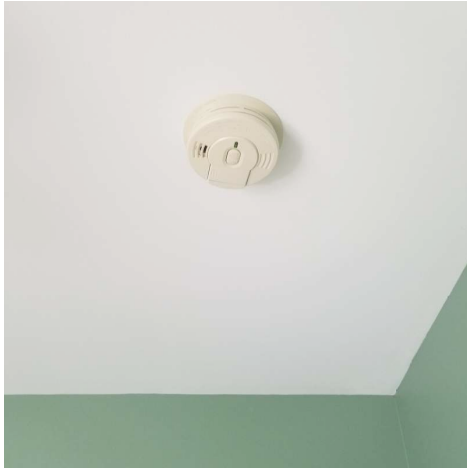
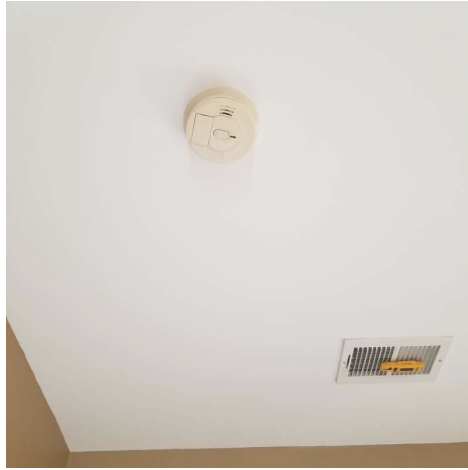
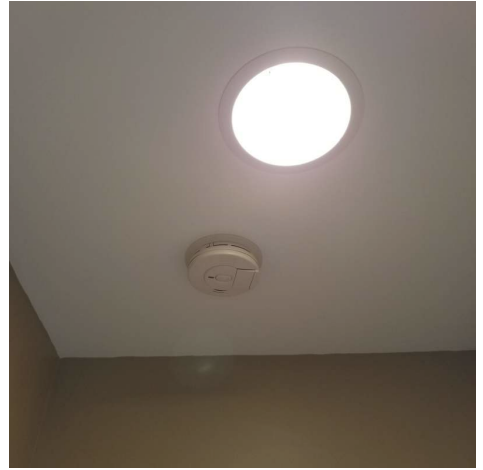
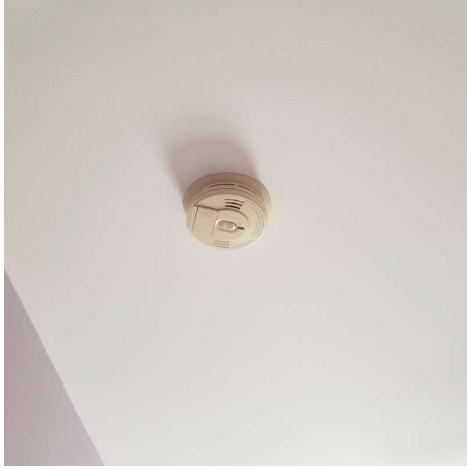
Based on the age of this structure and the appearance of existing smoke alarms, the alarms may have been installed more than 10 years ago. According to National Fire Protection Association, aging smoke alarms don't operate as efficiently and often are the source for nuisance alarms. Older smoke alarms are estimated to have a 30% probability of failure within the first 10 years. Newer smoke alarms do better, but should be replaced after 10 years. Unless you know that the smoke alarms are new, replacing them when moving into a new residence is also recommended by NFPA.

Contact a qualified electrical contractor.

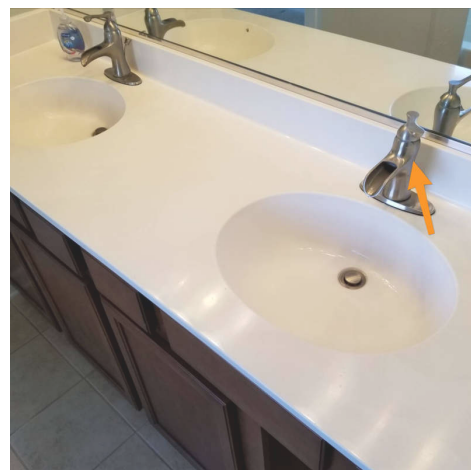
Master Bathroom

One or more sink stopper(s) mechanisms are missing, or need adjustment or repair. Stopper mechanisms should be installed where missing and/or repairs should be made so sink stoppers open and close easily.

Contact a qualified plumbing contractor.

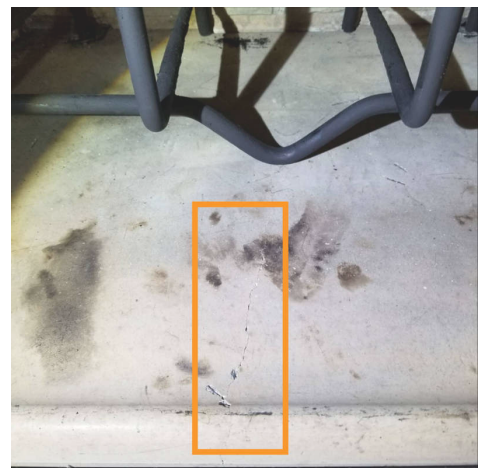
14.3.1 Hearth

DETERIORATED

One or more fireplace and/or woodstove hearths are damaged and/or deteriorated. For example, loose or broken tiles and/or bricks. A qualified contractor should evaluate and make repairs as necessary.

Contact a qualified fireplace contractor.
