COCHRAN HOME INSPECTIONS, LLC

RESIDENTIAL INSPECTION REPORT

1234 Main St.
Mountain Home AR 72653

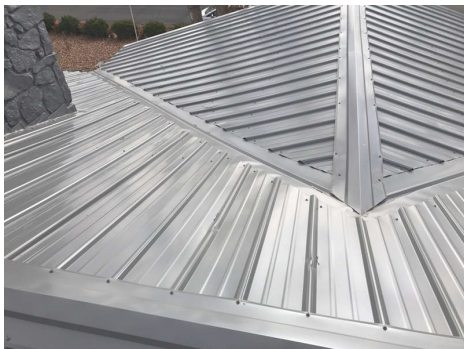
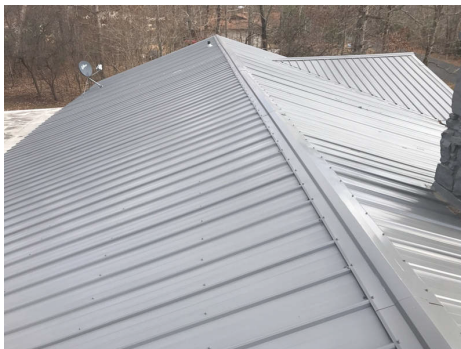
Looking South

Roof Walked

Inspector walked the entirety of the roof and found the decking and structure to be stable.

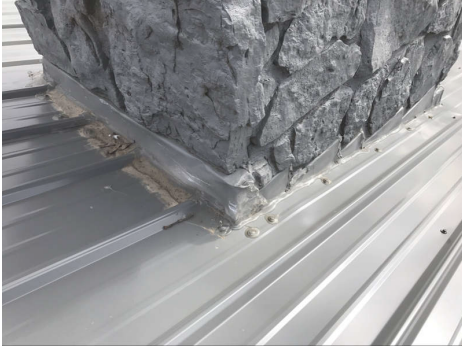
Flashing

The Inspector observed no or minor deficiencies in the condition of the portion of the chimney that extended above the roof. Any discrepancies will be noted in report.

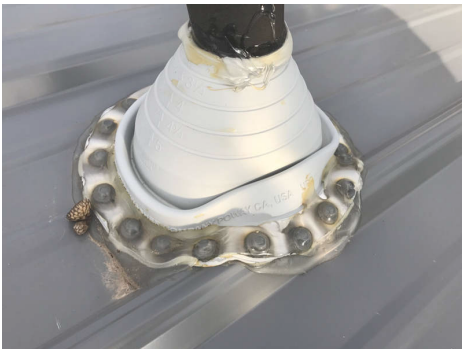
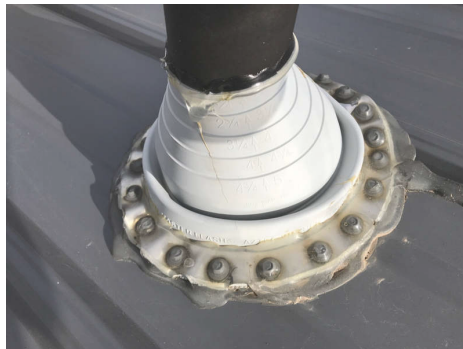
Vents had proper flashing and the gaskets were in good condition. Only a few up close pictures for perspective on flashing/gaskets condition.

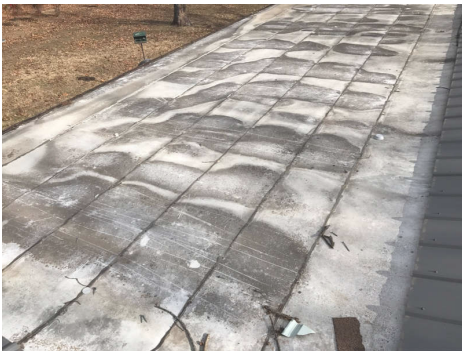
North

No or minimal deficiencies were noted with the low sloped or flat roof. Roof had rolled and overlapping roof coverings; material unknown. No current leaking points noted. Any discrepancies will be noted.

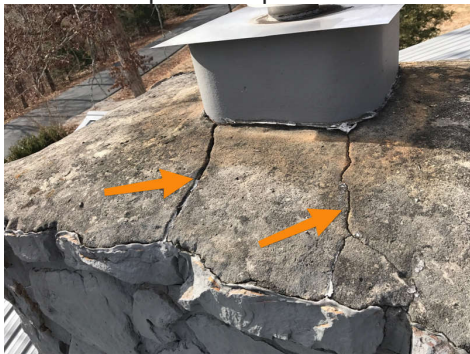
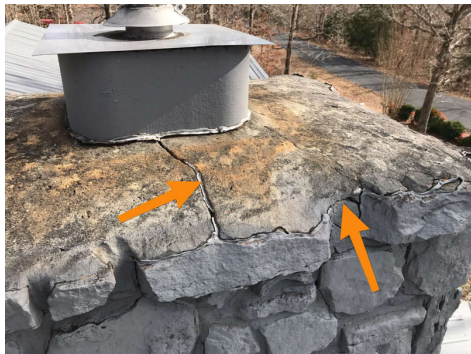
CHIMNEY CROWN CRACKING - MINOR

Minor cracking noted in the chimney crown which could allow water/moisture intrusion down chimney. Recommend reseal cracks and monitor.

Contact a qualified professional.

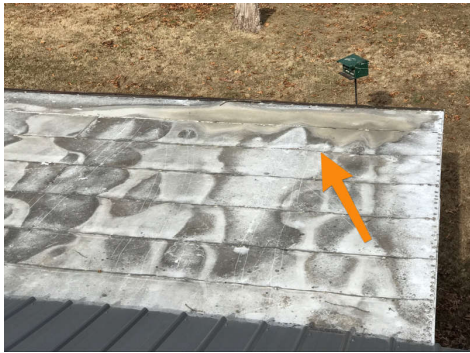
North

Observed indications of ponding in one or more areas of roof. Ponding can lead to accelerated erosion and deterioration. Recommend a qualified roofing contractor evaluate and repair.

Contact a qualified roofing professional.

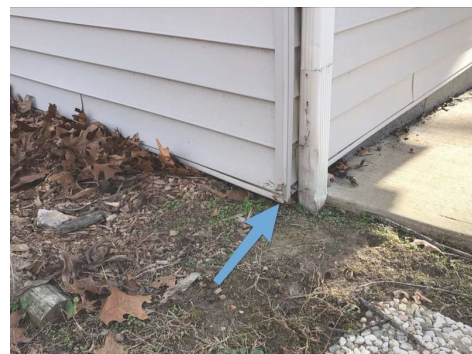
Northwest

VINYL SIDING DAMAGED

The vinyl siding was damaged in noted locations. Moisture intrusion can damage materials siding was protecting. Recommend monitor.

Contact a qualified handyman.

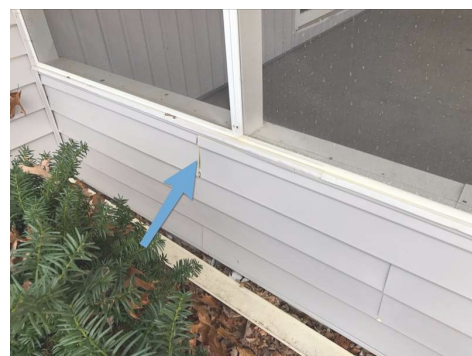
North

One or more areas of the vinyl siding shows signs of a gap where panels have separated which will allow water to penetrate to supportive wall material. Recommend panels slid back together or replace if the gap cannot be closed.

Contact a qualified professional.

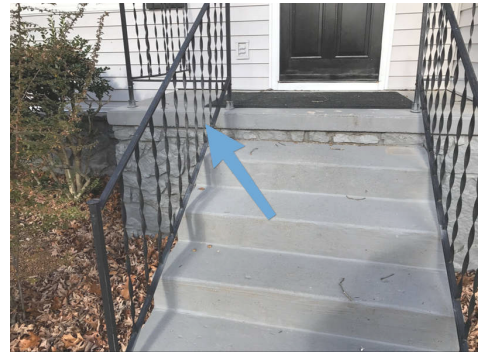
South

**RAILINGS LOOSE**

Railings fasteners were loose in noted areas. Recommend tightening current fasteners or replace, tighten and monitor.

Contact a qualified handyman.

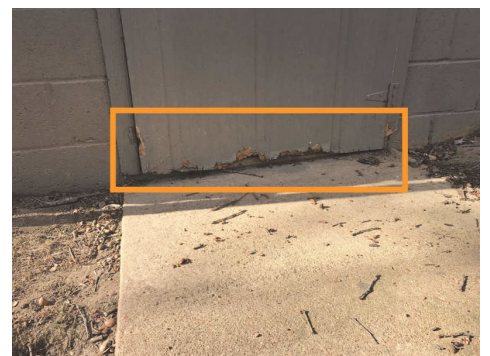
Southeast

CRAWLSPACE DOOR - DETERIORATED

The crawlspace door is deteriorated which could allow pests access to the crawlspace. Recommend door is repaired or replaced.

Contact a qualified handyman.

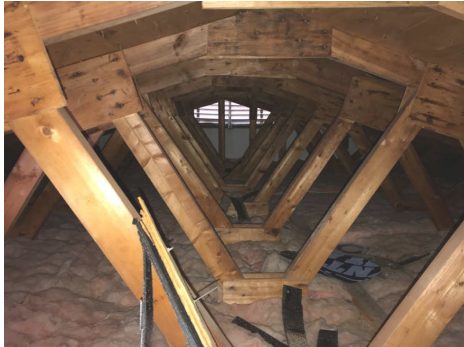
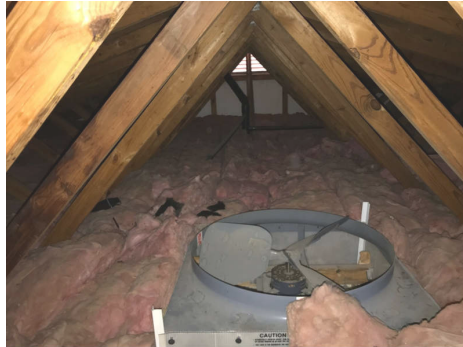
Looking North

At the time of the inspection, the Inspector observed no deficiencies or minor deficiencies in the condition of the attic.

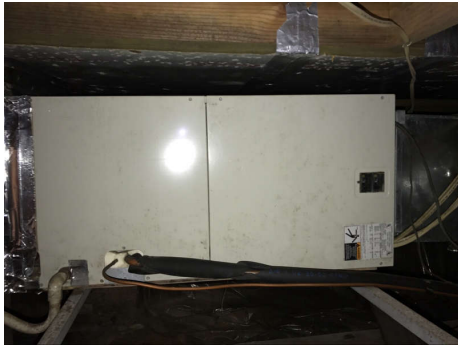
Central Crawlspace

HVAC Heat Pump Equipment: Air Handler / Evaporator Brand
Heil

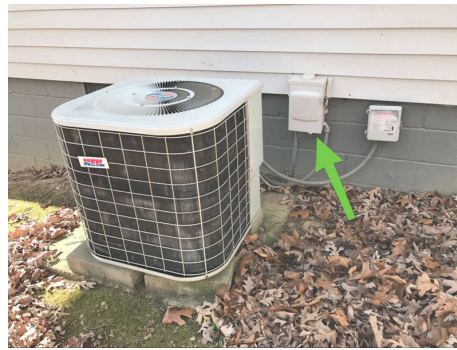
Condenser w/ cut off

HVAC Heat Pump Equipment: Condenser Unit Brand
East
Heil

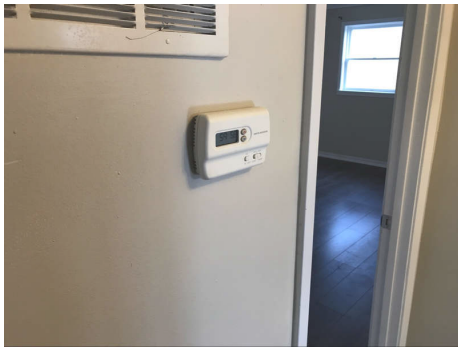
Hallway

Normal Operating Controls: Thermostat Brand
White-Rodgers

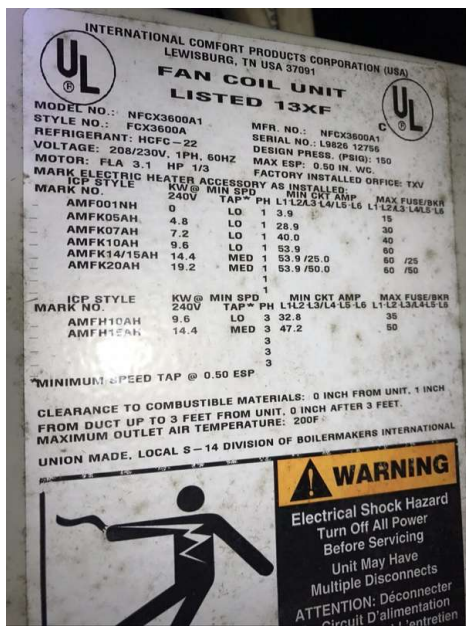
Air Handler/ Evaporator built in 1998 (19 years old). Unit is late service life of a standard industry recognized 12-15 years lifespan.

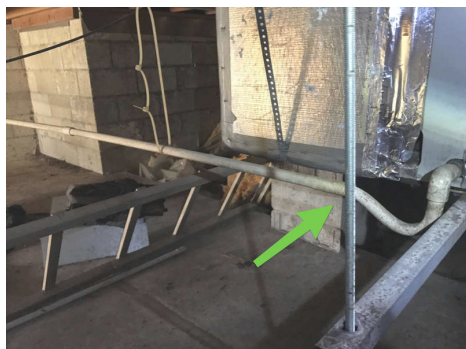
Central Crawlspace

Condensation line was inspected and found to be properly installed with trap and fall. However, A/C was not active and proper drainage could not be ascertained. Recommend before A/C is used clean condensation line and clean line at least once a year to minimize chances of buildup or blockage.

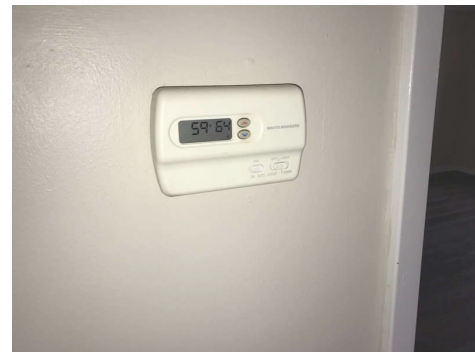
Hallway

THERMOSTAT DEGRADED

Thermostat was not working optimally at time of inspection. The increase heat button was difficult to increase when pushed. Eventually, after multiple tries the heat temp was raised on the thermostat. Recommend repair or replace.

Contact a qualified HVAC professional.

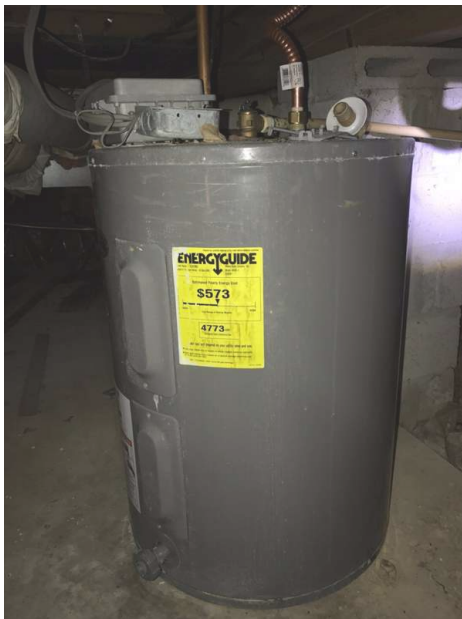
East Crawlspace

I recommend flushing & servicing your water heater tank annually for optimal performance. Water temperature should be set to at least 120 degrees F to kill microbes and no higher than 130 degrees F to prevent scalding.

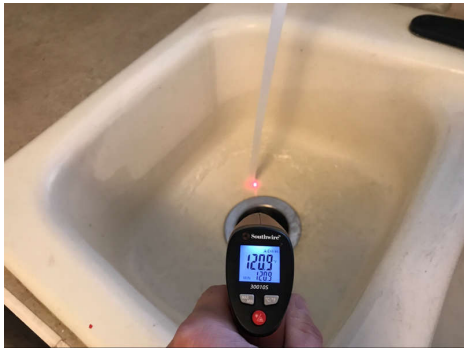
Kitchen

Hot Water Systems, Controls, Flues & Vents: Water Temp

120

Inspection only verifies water heater is able to heat water above ambient temps. Water temperature can vary depending on settings.

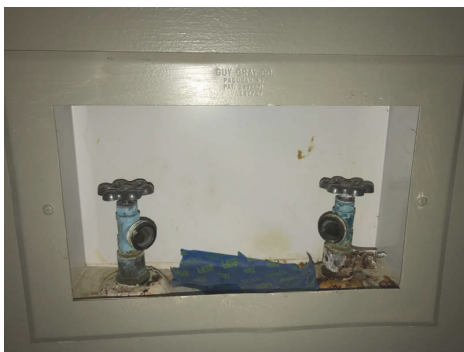
Laundry Room

Washer Connections / Drain Pipe: Water Connections Marginal

Issues were noted with the washer connection and drain pipe. Items will be listed under observations.

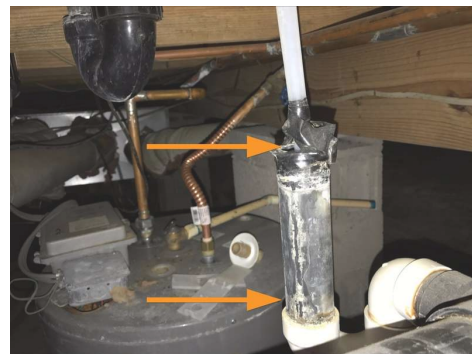
East Crawlspace

IMPROPER CONNECTION - CONDITIONER DISCHARGE

An improper connection from a whole house conditioner line was observed at a drain pipe. Indications of overflow were noted which will cause moisture problems in crawlspace. Recommend further evaluation and repair by installing a proper discharge connection fitting.

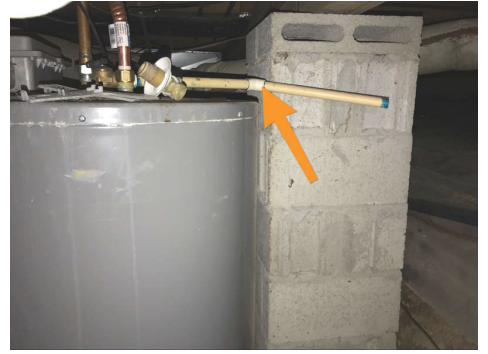
East Crawlspace

Prioritized Observation
TPR DISCHARGE PIPE IMPROPERLY INSTALLED

The temperature/pressure relief (TPR) valve had a discharge pipe that was not properly installed in a crawlspace area. Discharge pipe should be facing down towards the ground preferably over a drip pan and approx. 6 inches off of the ground. Recommend TPR discharge pipe is installed correctly.

Contact a qualified professional.

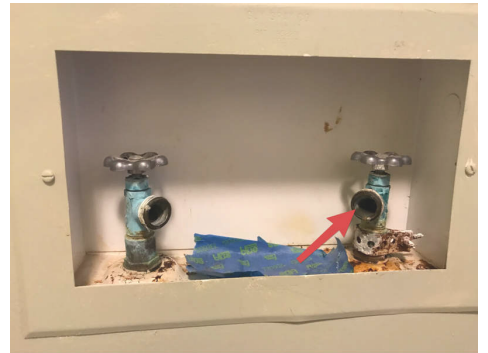
Laundry Room

Immediate/Safety Item
LEAKING NOZZLE

One or more of the washer nozzles were leaking at the time of the inspection. Recommend further evaluation and repair/replacement.

Contact a qualified plumbing contractor.

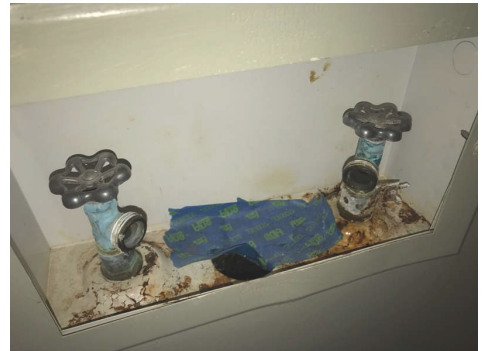
Laundry Room

Prioritized Observation
RUSTY/DEGRADED BOX

Laundry box was noted as degraded with visible rust which could lead to leaking into wall. Recommend laundry box is replaced.

Contact a handyman or DIY project

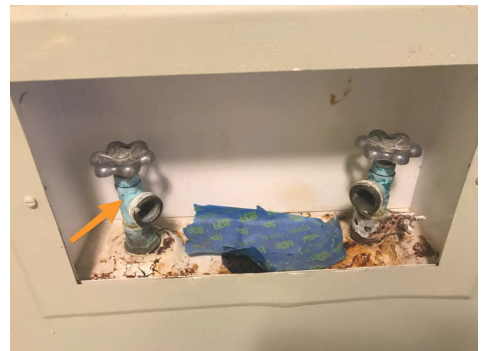
Laundry Room

Maintenance Item
VALVE CORROSION

Corrosion noted on washer supply valves; not actively leaking. Recommend monitoring the valve and replacing as needed.

Contact a qualified plumbing contractor.

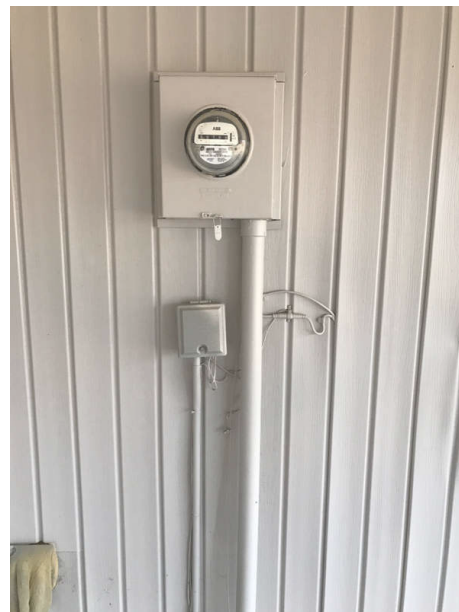
North

Service Entrance Conductors: Electrical Service Conductors

Below Ground, 240 volts,
Aluminum

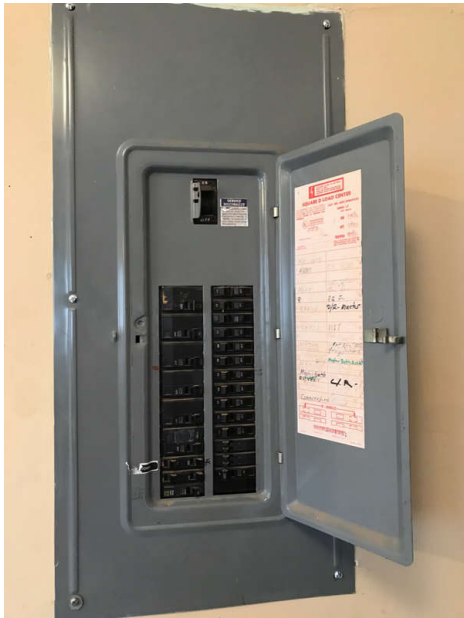
External

Main Service Panel, Service & Grounding, Main Overcurrent Device: Main Service Panel Satisfactory North Garage Utility Room

At the time of the inspection, the Inspector observed no deficiencies or minor deficiencies in the condition of the main service panel.

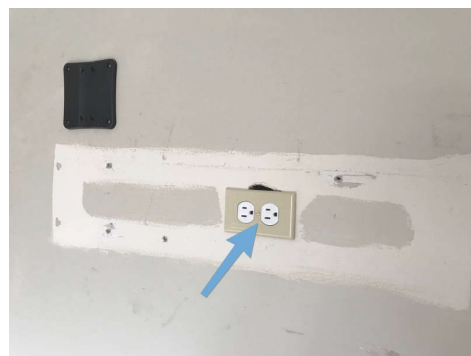
Living Room

A receptacle or switch box had a cover that did not fully cover box which could allow objects to be inserted likely causing a shock. Recommend installation of a larger cover plate to full cover any access points.

Recommended DIY Project

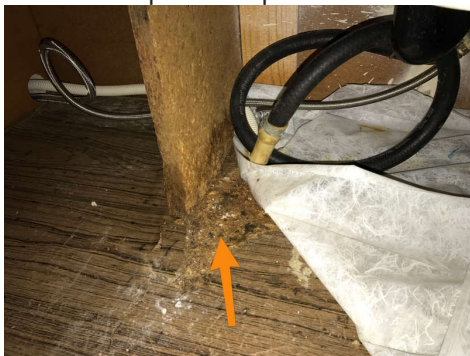
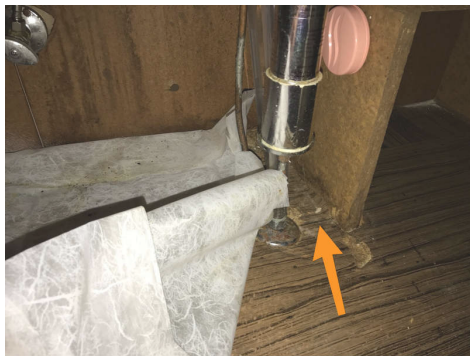
Moisture damage to sink base cabinet noted; active leak at countertop is causing left side damage; cause of right side damage unknown. Recommend surface is kept dry from further deterioration.

Contact a qualified professional.

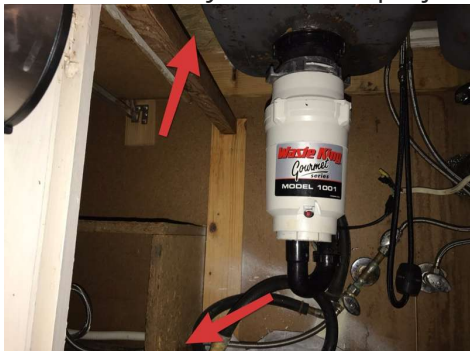
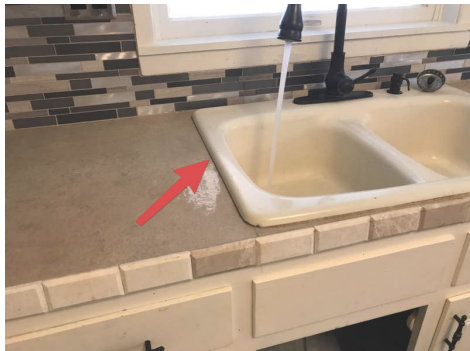
Sink at countertop was noted leaking into the sink base. Recommend sealing sink at countertop to stop leaking into base.

Contact a handyman or DIY project

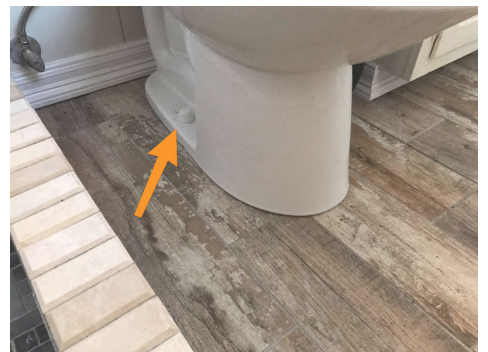
Master Bathroom

Either connections that secure the toilet base to the flange or the flange itself are loose which could allow wax seal to be broken and water to leak. Recommend tightening bolts at base of toilets to secure to floor; if this does not work then there is a problem with the flange and must be repaired.

Contact a qualified handyman.

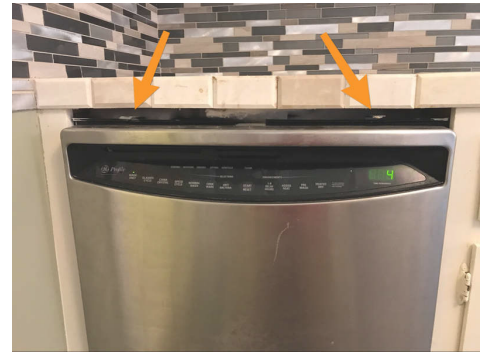
Kitchen

Dishwasher was not properly secured to countertops/cabinets.
Recommend properly fastening unit.

Contact a qualified handyman.

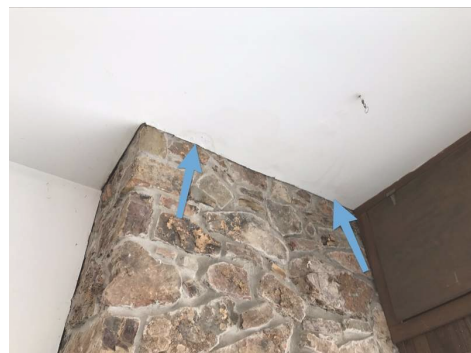
Garage

CEILING DISCOLORATION - NOT ACTIVE

Ceiling showed signs of previous water damage; not active at time of inspection. Likely from older water leak from roof (replaced). Recommend monitor.

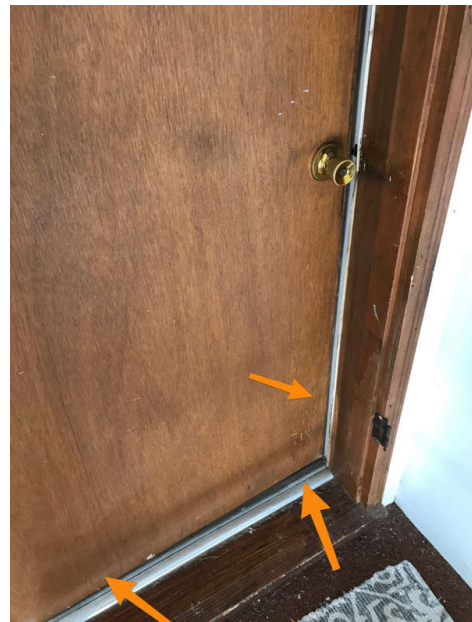
Garage

Door was difficult to open and close likely due to bottom jam gasket. Recommend further evaluation and repair.

Contact a qualified handyman.

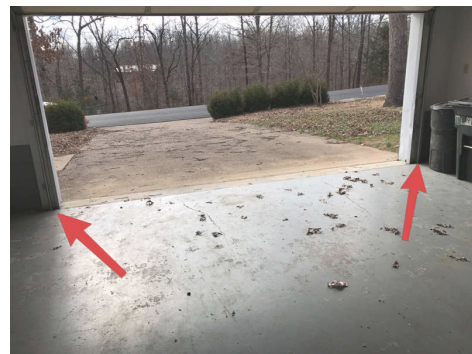
Garage

The overhead garage door was not equipped with a photoelectric sensor. Photoelectric sensors are devices installed to prevent injury by raising the vehicle door if the sensor detects a person on a position in which they may be injured by the descending door. Installation of photo sensors in new homes has been required by generally-accepted safety standards since 1993. The Inspector recommends installation of a photo sensor by a qualified contractor or technician for safety reasons.

Contact a qualified professional.
