HOME INSPECTION

1234 Main St.
Beaumont TX 77706

PROPERTY INSPECTION REPORT

Concerning: 1234 Main St. Beaumont TX 77706
(Address or Other Identification of Inspected Property)

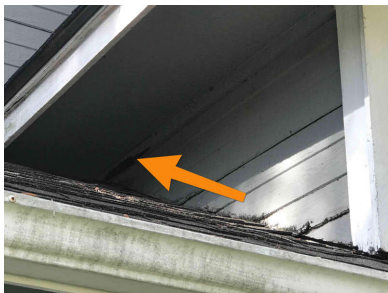
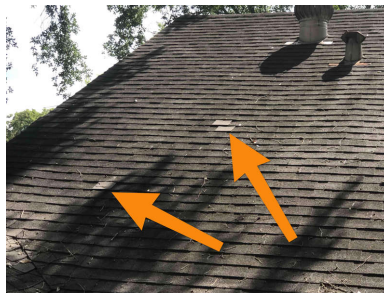
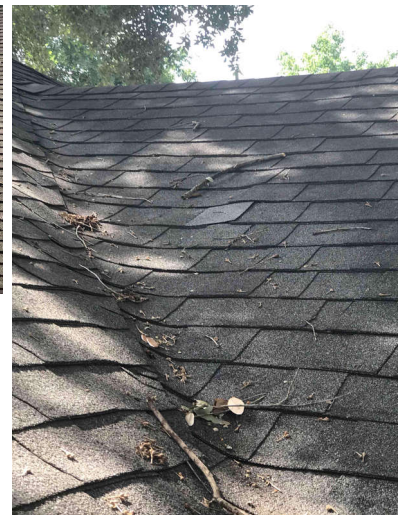
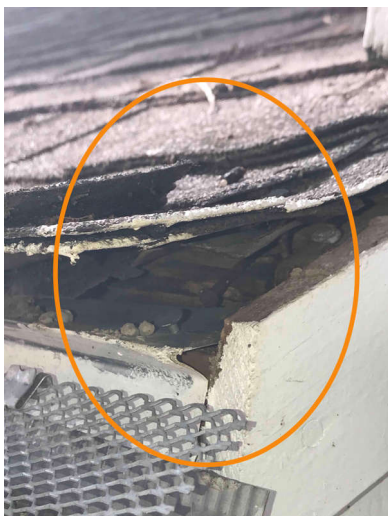
1: Damaged Coverings

Roof coverings exhibited general damage that could affect performance. Recommend a qualified roofer evaluate and repair.

Roof shingles were discolored, which can be caused by moisture, rust or soot. Recommend a qualified roofing contractor evaluate and remedy with a roof cleaning or repair.

Recommendation: Contact a qualified roofing professional.

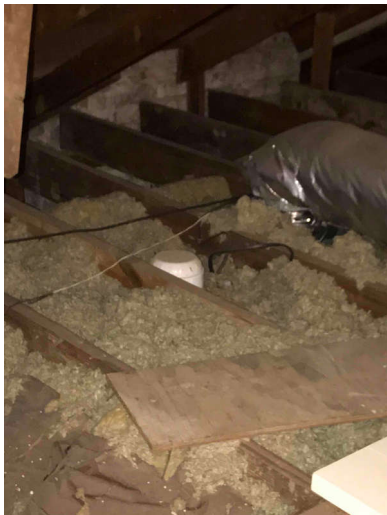
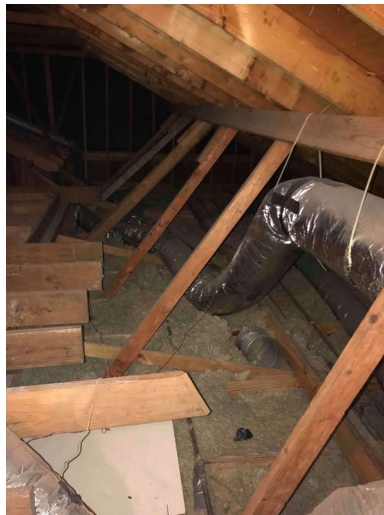
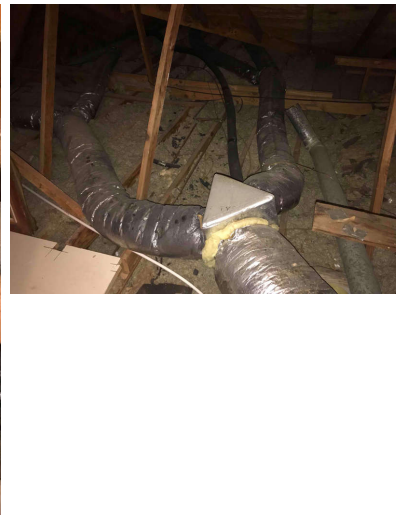
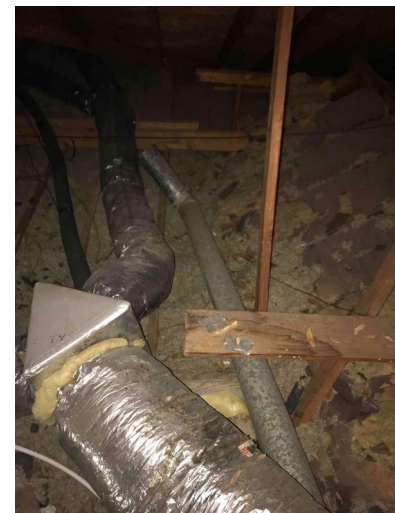
1: Insufficient Insulation

*Approximate Average Depth of Insulation: 0 R-value -
Blown in cellulose*

Insulation depth was inadequate. Recommend a qualified attic insulation contractor install additional insulation.

Recommendation: Contact a qualified insulation contractor.

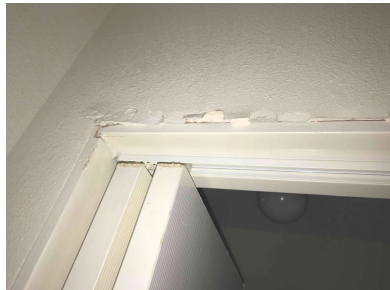
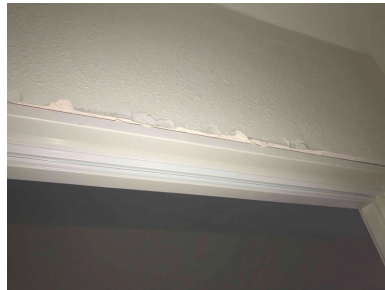
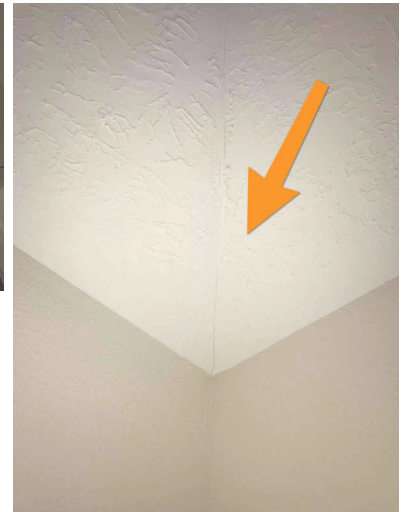
1: Ceiling - Minor Damage

Minor damage or deterioration to the ceiling was visible at the time of the inspection.

Recommendation: Contact a qualified drywall contractor.

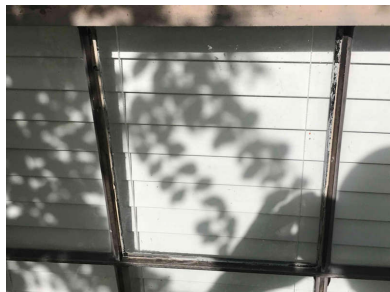
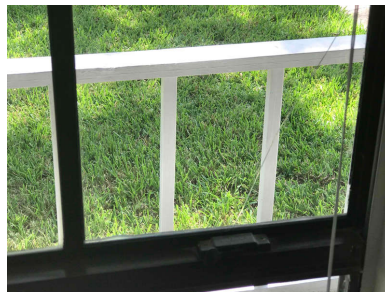
1: Damaged

One or more windows appears to have general damage, but are operational. Recommend a window professional clean, lubricate & adjust as necessary.

Recommendation: Contact a qualified window repair/installation contractor.

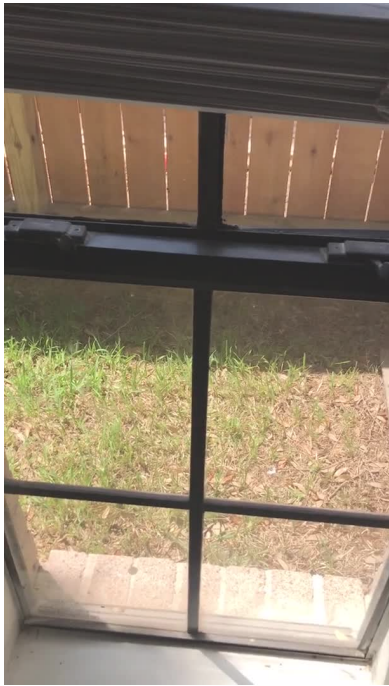
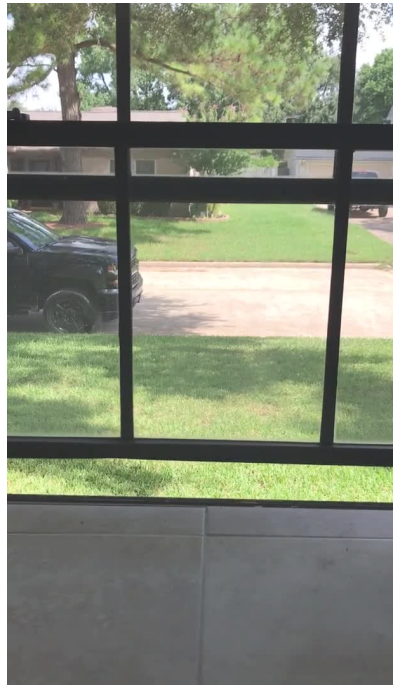
2: Improper Installation

Windows in the kitchen appear to not be operating properly due to substandard installation. Recommend window specialist evaluate.

Recommendation: Contact a qualified window repair/installation contractor.

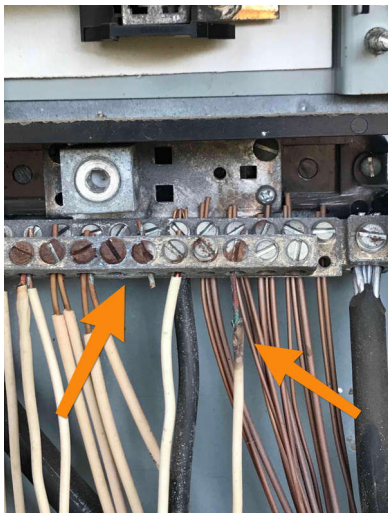
1: Frayed Sheathing

The Service panel was made by federal Pacific. Federal Pacific service panels are reputed to have a high rate of circuit breaker failure which can result in a fire or shock/electrocution.

The Neutral wires are double lugged at the bus bar in the electrical main panel.

Wires on service entrance are damaged or frayed. Recommend contacting your electric utility company or a qualified electrician to evaluate and repair.

Recommendation: Contact a qualified electrical contractor.

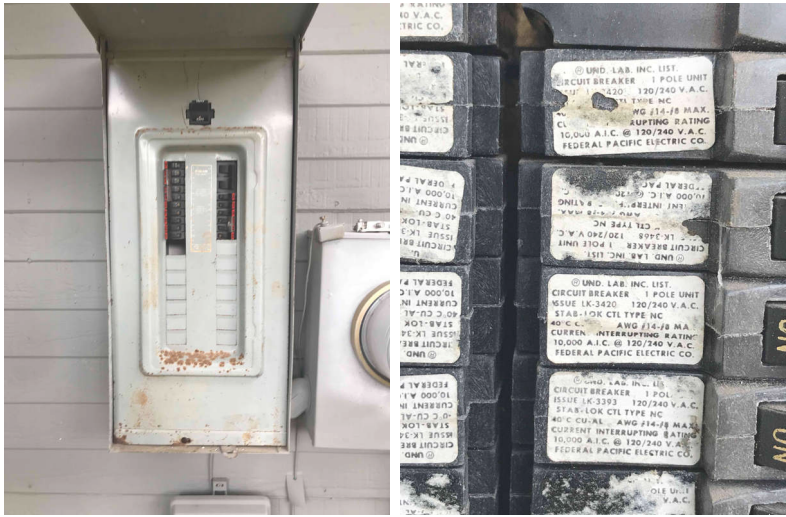
2: Panel Missing Labels

Electrical panel does not have labels. Recommend a qualified electrician test and properly label all switches.

Recommendation: Contact a qualified electrical contractor.

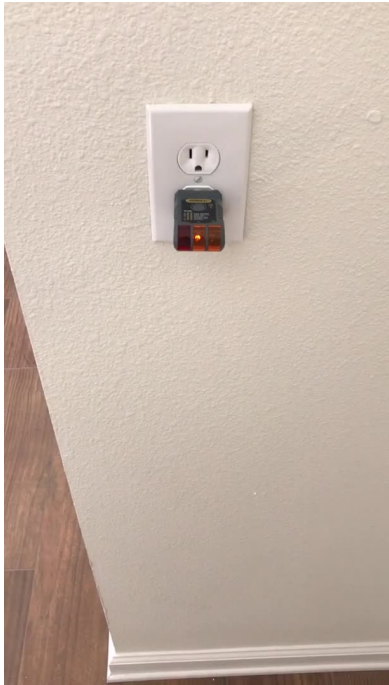
1: Improper Wiring

Improper wiring was observed at the time of inspection. Recommend a licensed electrician evaluate and repair. In the bedroom closest to the front yard, the receptacles had an open ground.

Recommendation: Contact a qualified electrical contractor.

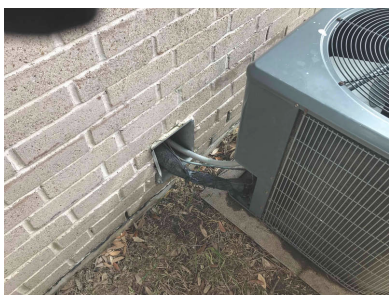
1: Insulation Missing or Damaged

Missing or damaged insulation on refrigerant line can cause energy loss and condensation.

Recommendation: Contact a qualified HVAC professional.

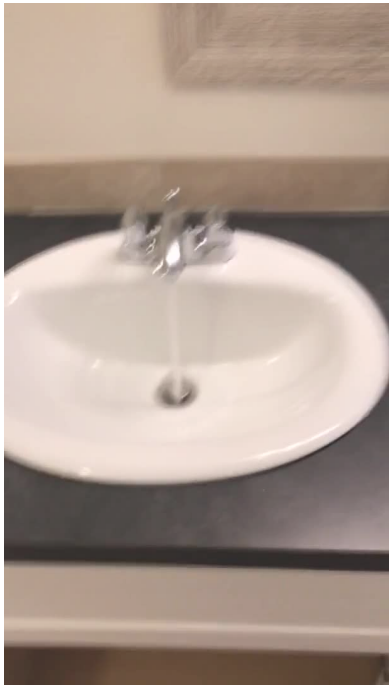
1: Poor/Slow Drainage

Poor/slow drainage was observed at time of inspection. Recommend a qualified plumber evaluate and repair.

Recommendation: Contact a qualified plumbing contractor.

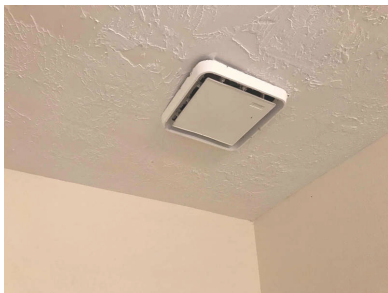
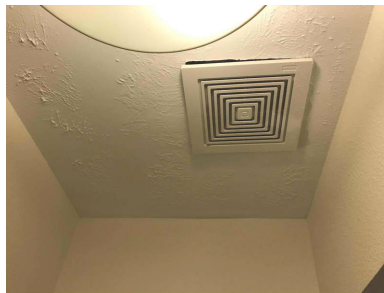
1: Bathroom vents

Recommend that Bathroom vents be cleaned.

Recommendation: Contact a qualified professional.
