PACWEST HOME INSPECTIONS

## RESIDENTIAL REPORT

1234 Main St.  
Beaverton OR 97006

Buyer Name  
04/25/2018 9:00AM

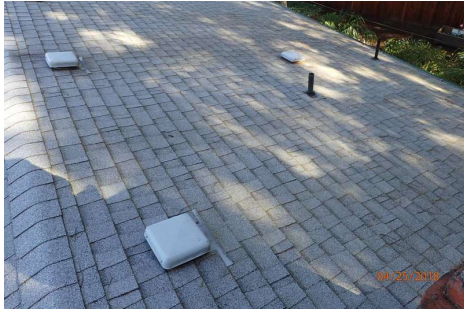
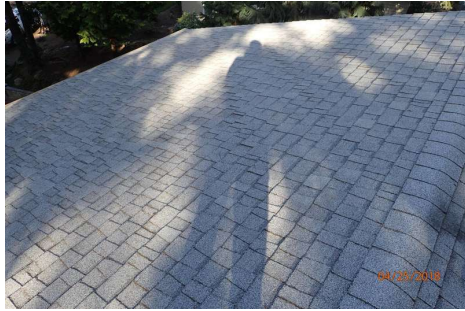
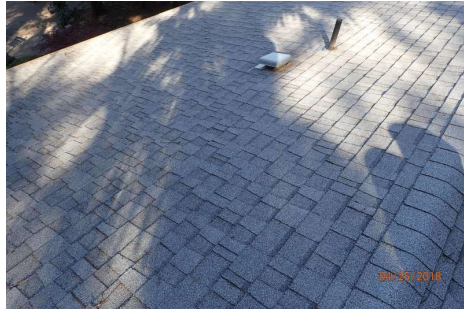
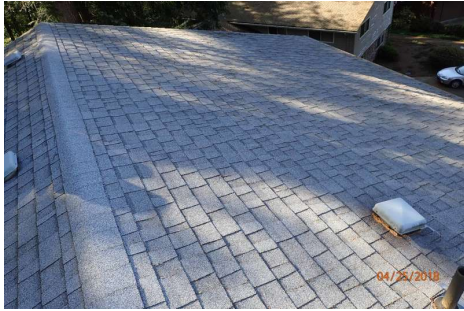
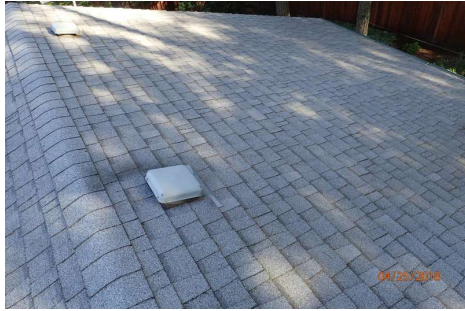
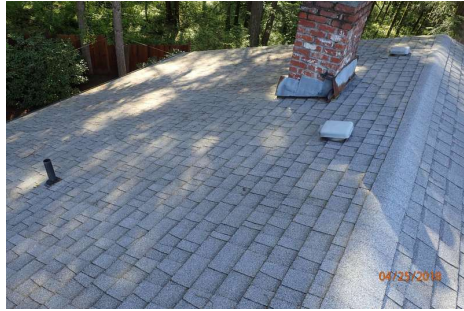
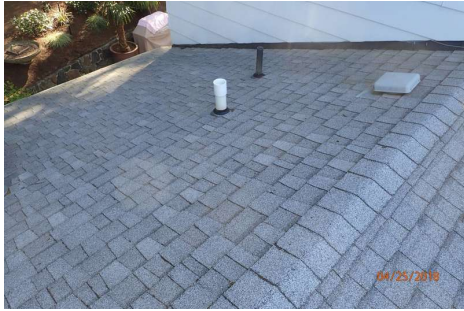
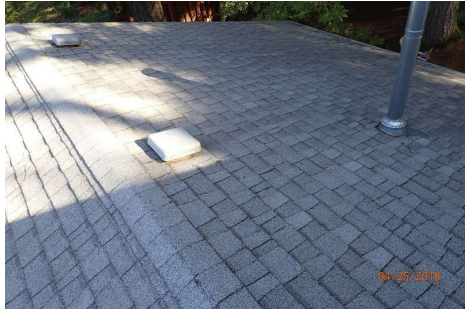
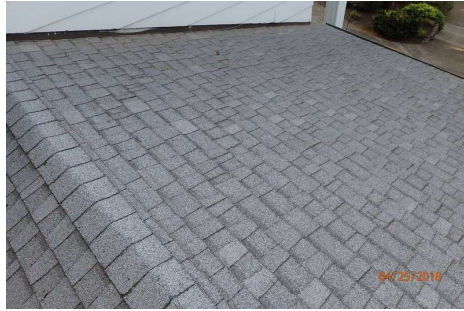
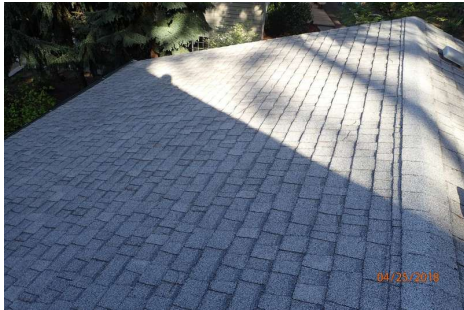
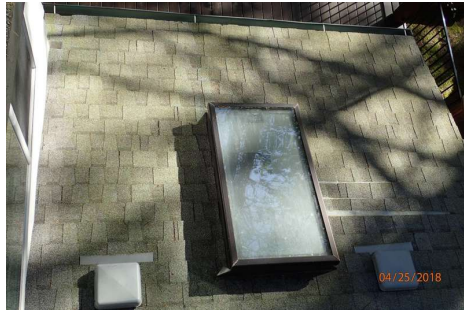
**Coverings: Material**  
Asphalt, 30 Yr. Architectural

18 - 19 Year(s)

Within the last 20% of the roofs life the chance of a leak may increase tenfold. Recommend inspecting at least once a year at this point.

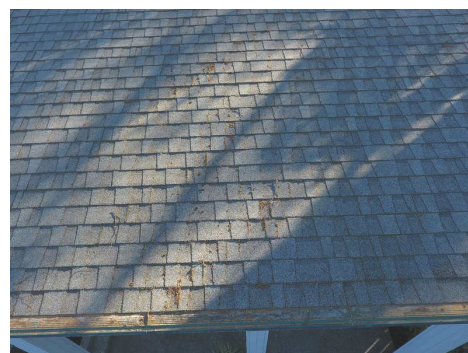
Recommend cleaning any debris off of the roof to prevent water from pooling. For safety, recommend a licensed professional for steeper or high roofs.

Contact a handyman or DIY project

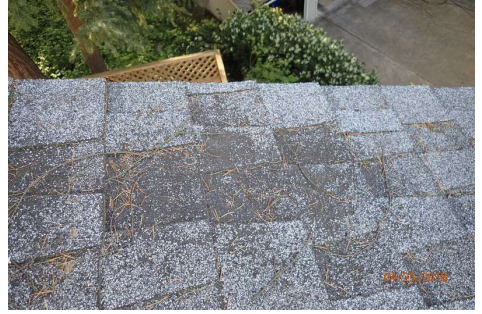
## 2.1.2 Coverings

Granule loss is a common occurrence and naturally happens over time. As the shingles are walked on, age, or expose to extreme elements, the granule loss can increase. As the granule loss occurs the likely hood of a leak increases. Recommend monitoring and consulting with a licensed roofer as the loss continues.

Contact a qualified roofing professional.

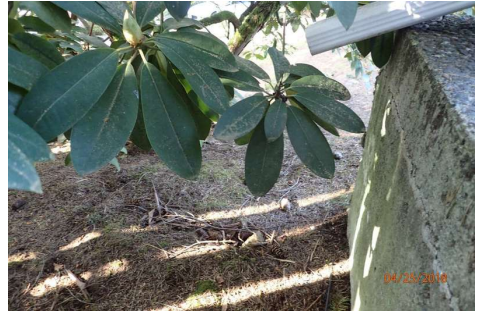
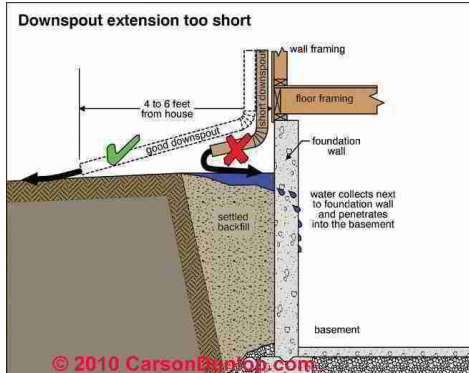
2.2.1 Roof Drainage Systems

**DOWNSPOUT - DISCHARGE NEAR HOUSE**

One or more downspouts drain too close to the home's foundation. This can result in excessive moisture in the soil at the foundation, which can lead to foundation/structural movement. Recommend a qualified contractor adjust downspout extensions to drain at least 6 feet from the foundation.

Contact a handyman or DIY project

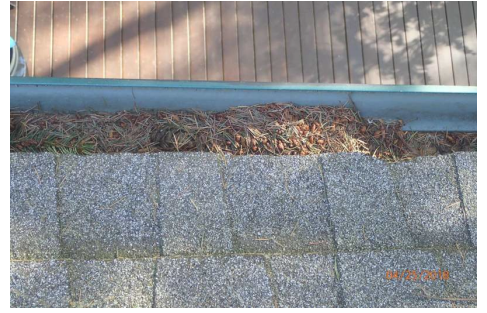
2.2.2 Roof Drainage Systems

Debris has accumulated in the gutters. Recommend cleaning to facilitate water flow.

Contact a handyman or DIY project

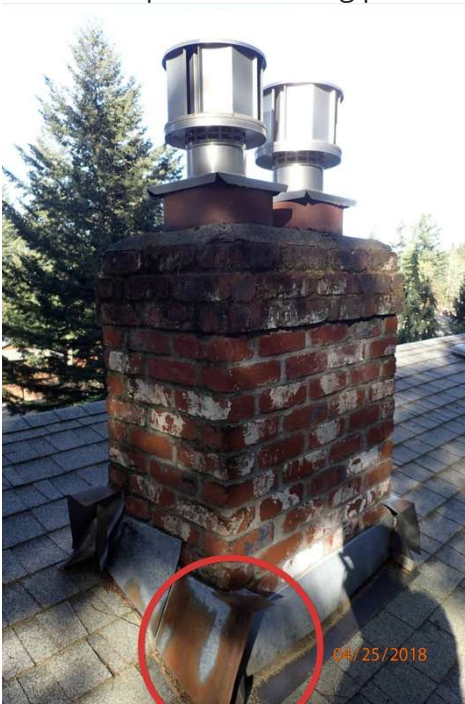
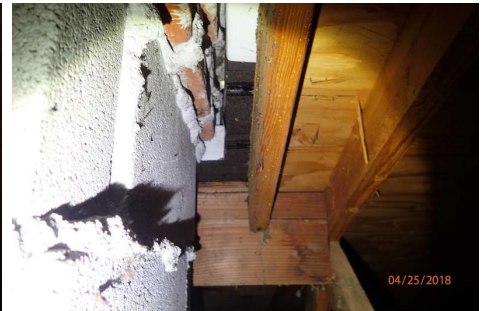
2.3.1 Flashings

**RECOMMEND ADDITIONAL FLASHING**

Flashing around the chimney was found to be inadequate. There are currently no signs of any leaks but daylight can be seen into the attic around the chimney.

Contact a qualified roofing professional.

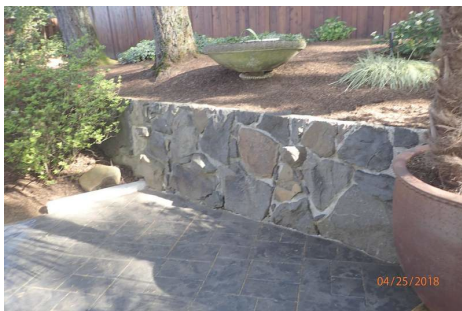
The condition of the retaining wall during the inspection was considered to be acceptable. With time retaining walls may begin to lean, sag, or buckle. Further evaluation from a specialist should always be considered.

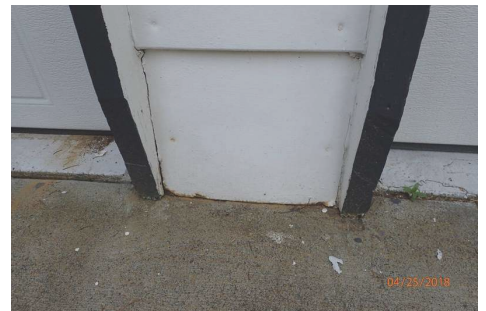
Inadequate clearance between siding and ground. Recommend a minimum ground clearance between bottom of siding and ground of 4". Siding in contact with the ground or soil is a serious concern because that condition can provide direct access for wood destroying insects and consistent contact with moisture.

Contact a qualified siding specialist.

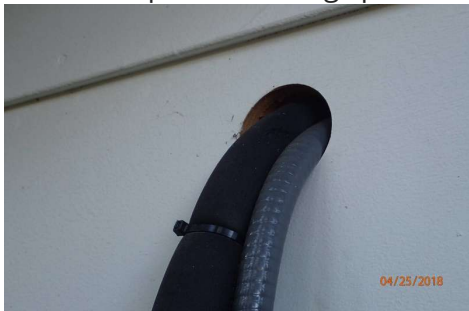
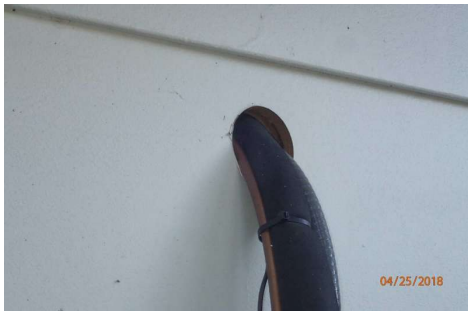
### 3.1.3 Siding

#### **SIDING - MINIMAL DETERIORATION**

Contact a qualified siding specialist.

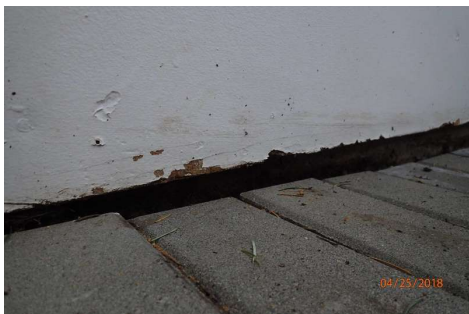
Siding in some locations is showing signs of age and minimal deterioration. These areas will likely need additional maintenance and potentially replacement in the future.

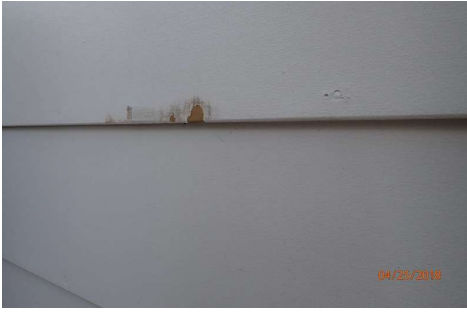
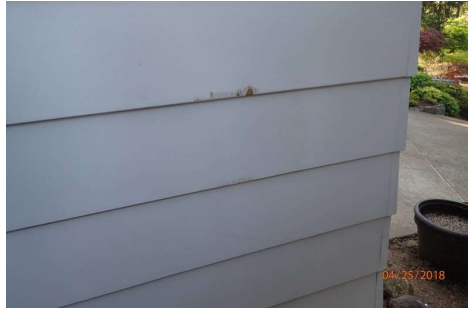
3.1.5 Siding

**SIDING - ROT-**

Moderate Recommendations

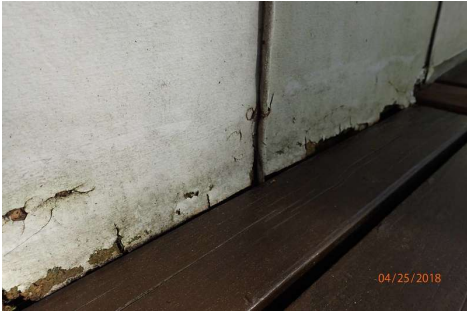
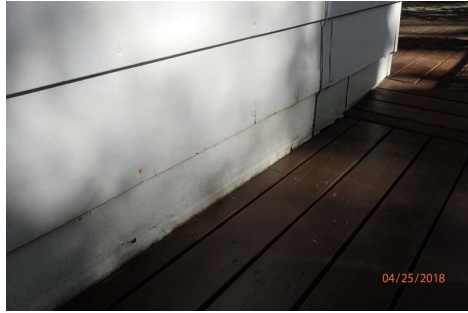
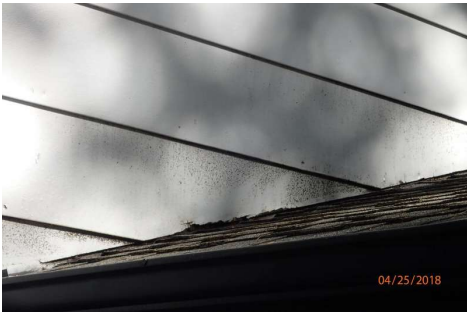
3.2.1 Trim & Flashing

**CAULKING**

Minor/Maintenance Issues

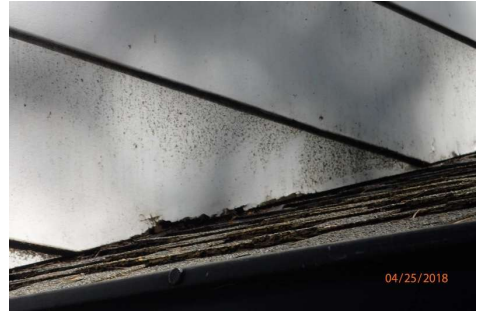
One or more locations of siding is rotten. Recommend a licensed siding contractor or qualified handyman to repair or replace as needed.

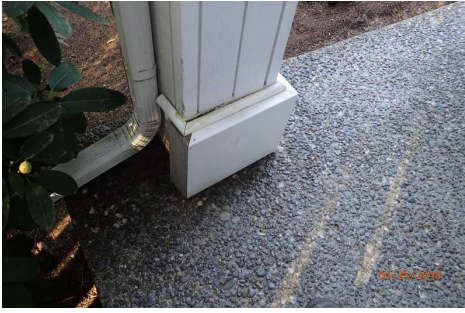
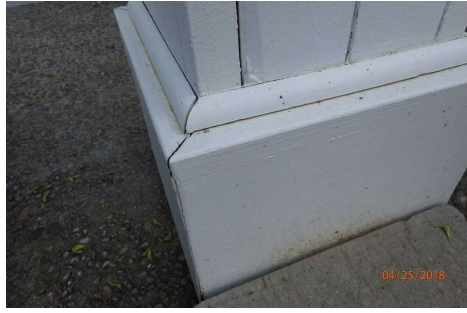
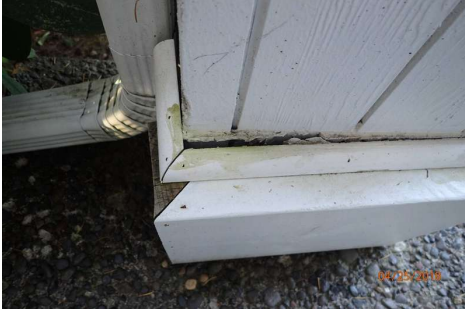
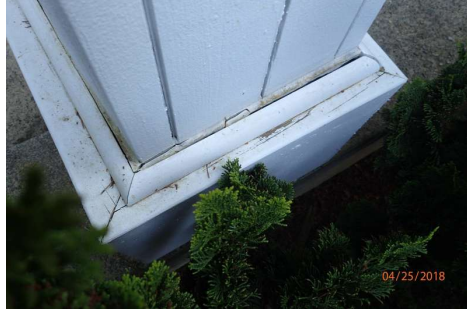
3.2.2 Trim & Flashing

**FLASHING - LOOSE**

Minor/Maintenance Issues

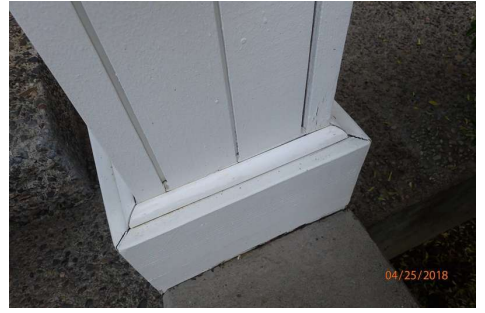
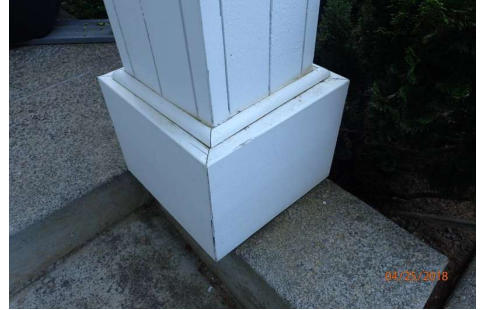
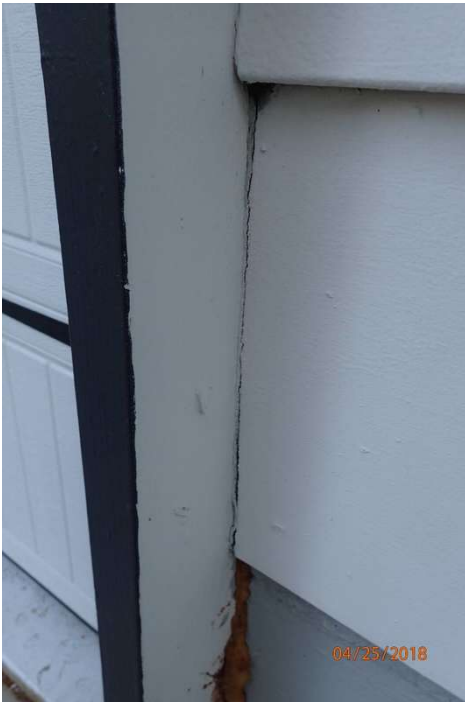
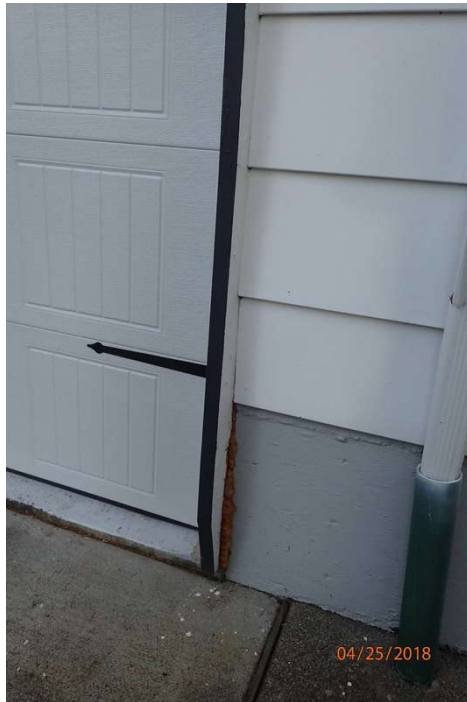
The caulking has failed and/or is needed in several areas. Recommend trimming, cleaning, and re-applying an exterior based product such as Vulkem. If desired recommend hiring a licensed siding or painting contractor.

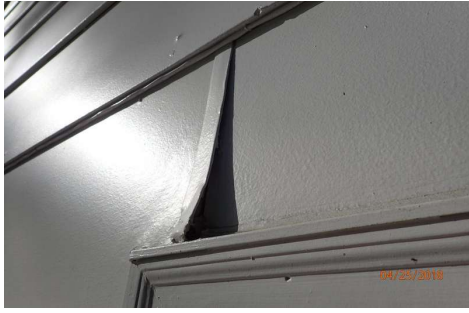
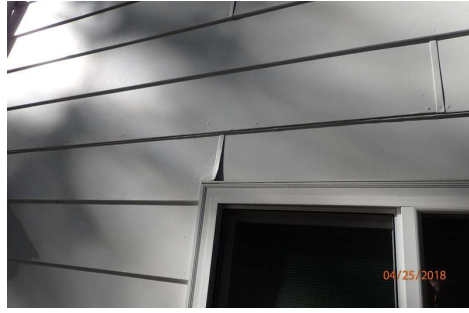
3.3.1 Exterior Doors

**DOOR SILL/TRIM**

Contact a qualified carpenter.

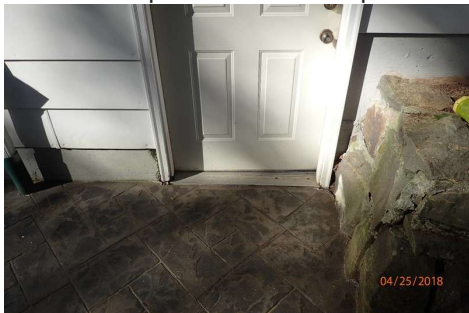
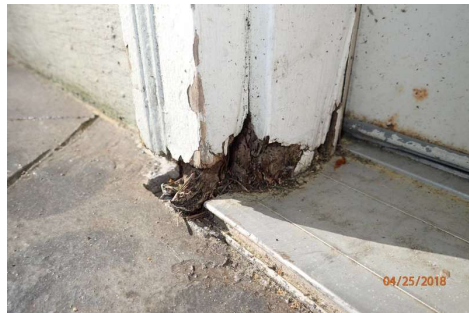
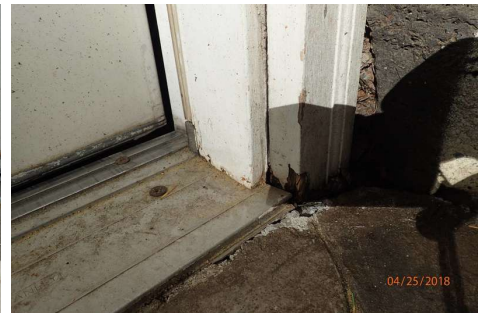
Door sill and/or trim is loose, deteriorated or worn and repair or replacement should be considered.

Contact a qualified door repair/installation contractor.

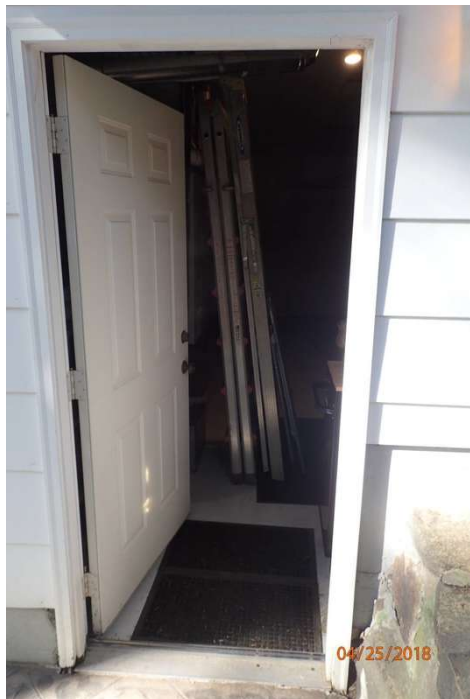
3.3.2 Exterior Doors

**DOOR - STIFF**

One or more of the exterior doors is stiff and difficult to use. Recommend a licensed carpenter or door installer to further evaluate and repair.

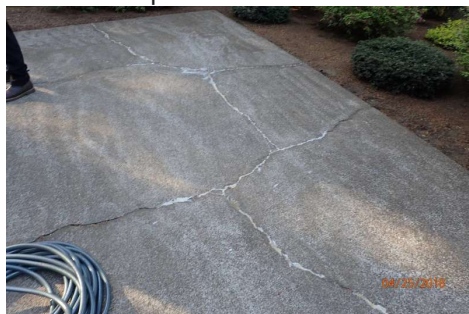
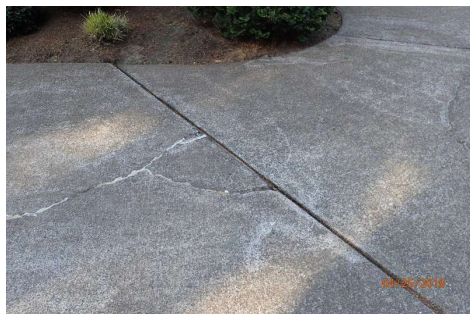
3.5.1 Driveways, Walkways, & Front Porches

**DRIVEWAY CRACKING-**

Minor cosmetic cracks observed, which may indicate movement in the soil. Recommend monitor and/or have concrete contractor patch/seal.

Contact a qualified concrete contractor.

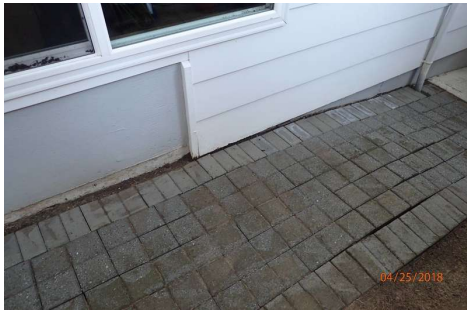
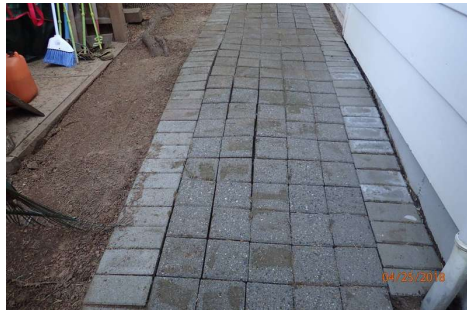
Tree roots have begun to uplift the walkway. Recommend an arborist to further evaluate and repair as need. If the roots can not be address, the walkway may need to be adjusted.

Contact a qualified landscaping contractor

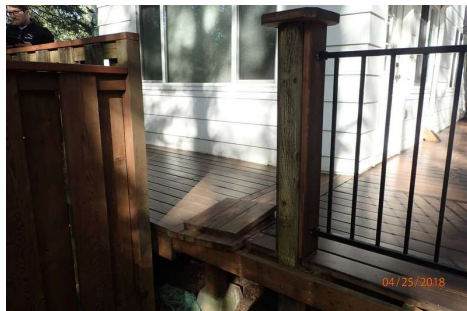
3.6.1 Decks, Balconies, & Patios

**RAILING - MISSING**

An area or section of railing is missing, recommend a licensed carpenter or decking contractor to install/complete railing.

Contact a qualified professional.

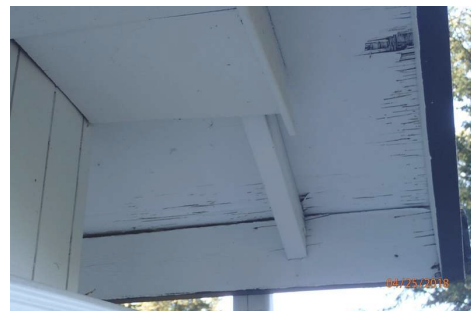
3.7.1 Eaves, Soffits & Fascia

**EAVES - PAINT DETERIORATING**

The eaves are showing signs of deteriorating paint. This can lead to rot, buckling, and delamination of plywood type products. Recommend a licensed painter to further evaluate and repair.

Contact a qualified painter.

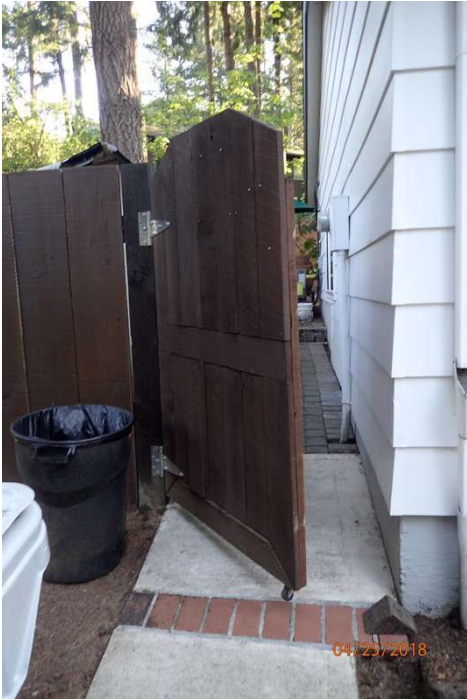
One or more of the gates need an adjustment to allow for proper use. Over time certain gates based on size and design will begin to sag. Depending on the designs there are many ways to easily adjust. Recommend contacting a handyman or fencing contractor if desired.

Contact a handyman or DIY project

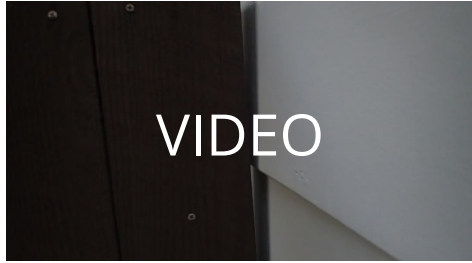
3.9.1 Fence

**GATE - ADJUSTMENT NEEDED**

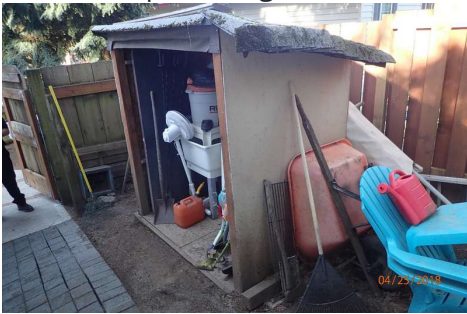
3.11.1 Shed/Out Building

**GENERAL DISREPAIR**

The outbuilding is in general disrepair. Recommend a complete evaluation to determine its structural safety and list of repairs.

Contact a qualified general contractor.

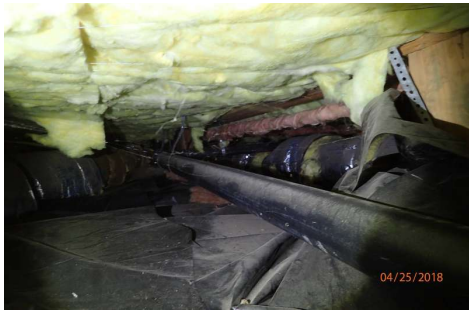
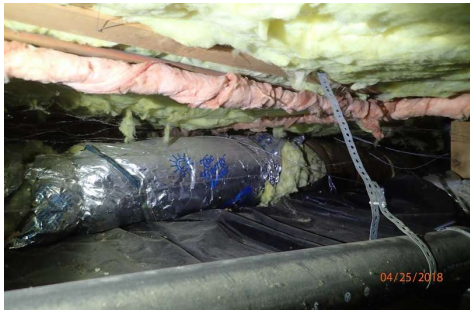
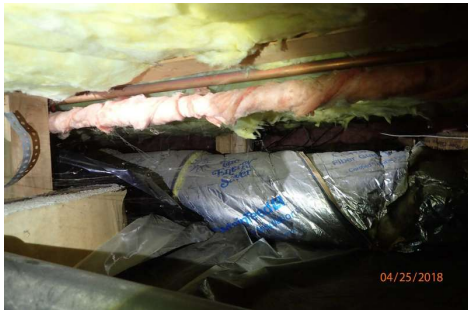
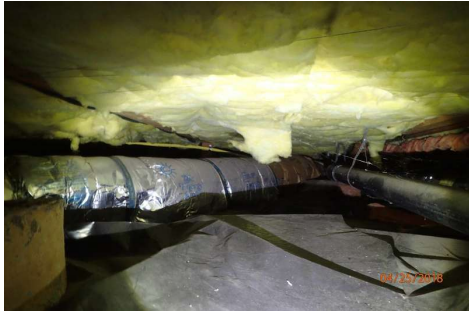
#### **LIMITED ACCESS**

The crawl space inspection was limited by inadequate access from hvac and other plumbing in the way. 15-20% not accessible.

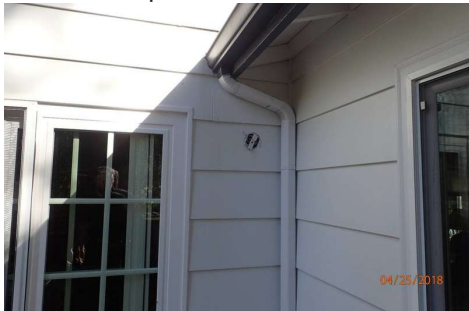
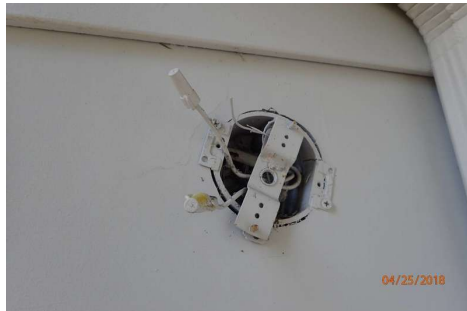
### 5.4.1 Outlets, Switches, Fixtures & Junction Boxes

#### JUNCTION BOX - MISSING COVER

One or more junction boxes is missing its cover. This can allow debris, flammable material, and/or body extremities such as finger inside. Recommend covering for safety.

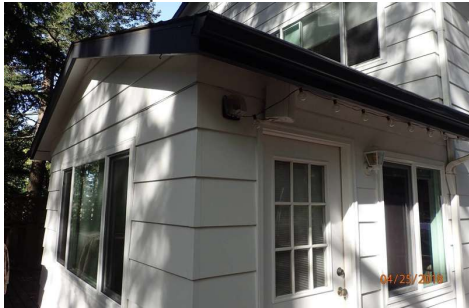
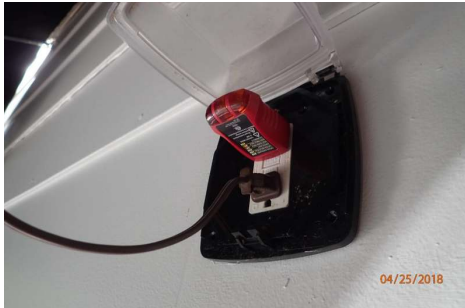
5.5.1 GFCI & AFCI

GFCI is faulty. Recommend licensed electrical contractor to further inspect and make repairs / replace. GFCI's not tripping when tested.

Contact a qualified electrical contractor.

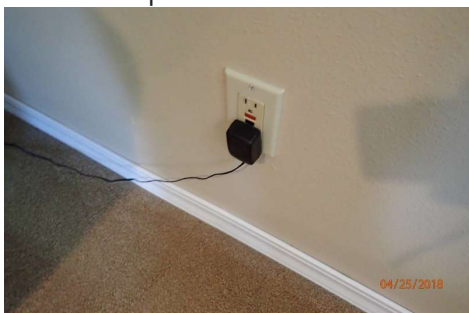
5.5.2 GFCI & AFCI

Multiple GFCI's have been found on the same circuit. This does not reduce the safety of the system but can become a nuisance as both or many GFCI's may have to be reset in a specific series in order to restore power to the protected outlets. There are ways to wire GFCI's on the same circuit without interfering with each other. Recommend a licensed electrical contractor to further evaluate and repair at your convenience.

Contact a qualified electrical contractor.

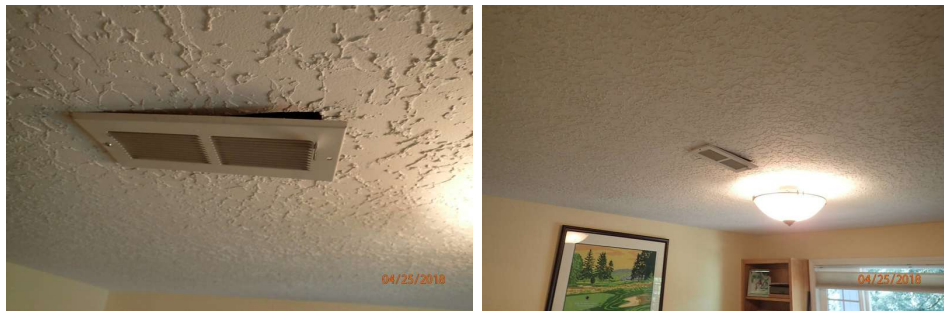
6.3.1 Distribution Systems

**CEILING REGISTER - LOOSE**

Recommend properly securing the ceiling register to prevent damage or injury in the case of it falling.

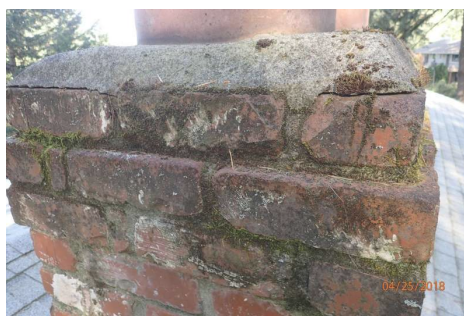
#### **DETERIORATING MORTAR-**

Some of the mortar on the chimney is beginning to deteriorate. The type of deterioration found is minimal and from common wear and tear. Recommend repairing at your earliest convenience and as needed.

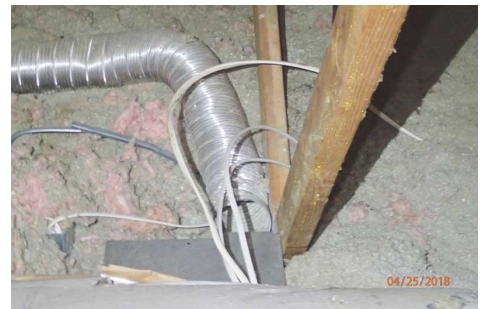
8.6.1 Exhaust Systems

Bathroom fan vents into the attic, which can cause moisture and mold. Recommend a qualified attic contractor property install exhaust fan to terminate to the exterior.

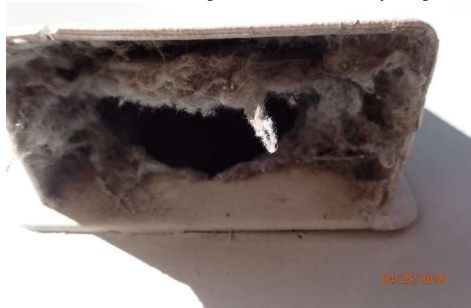
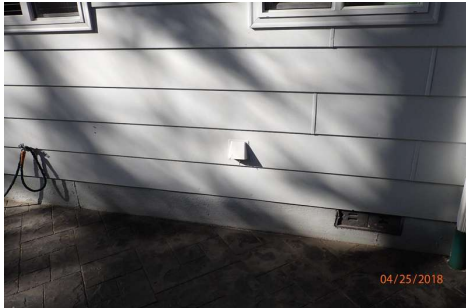
The dryer venting to the exterior has noticeable lint clogging the pipe. This can reduce the effectiveness of the dryer, increase the chance of a fire, and allow pests to enter the venting if the end cap is propped open from lint. Recommend cleaning on a regular basis.

Contact a handyman or DIY project

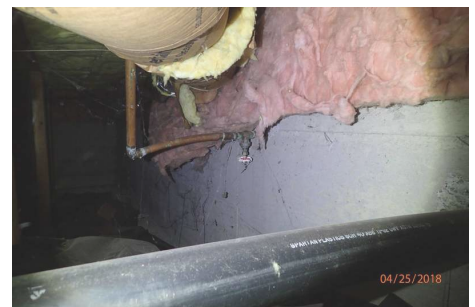
### Water Shut-off Device: Main Water Shut Off

Crawlspace, Meter

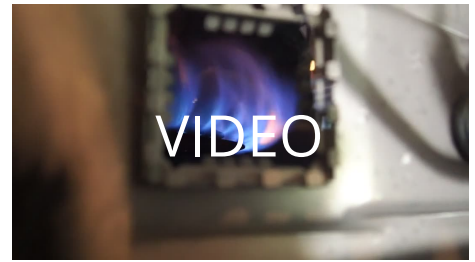
**Water Heater: Power Source/Type**

Gas

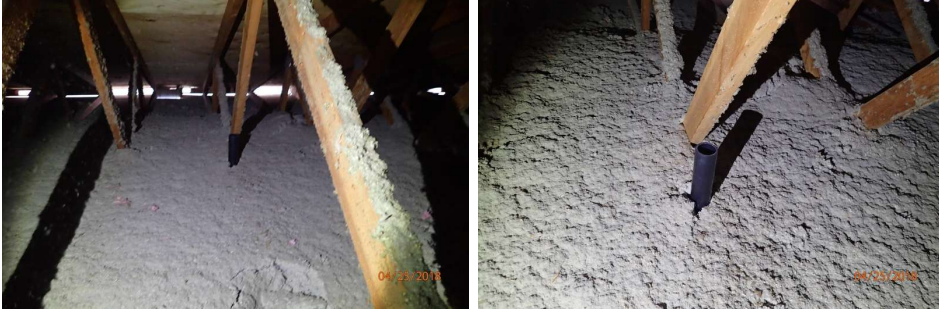
### 9.2.1 Drain, Waste, & Vent Systems

There is pipe venting in the attic that is disconnected. Recommend a licensed plumber to verify it is still in use and properly vented to the exterior.

Contact a qualified plumbing contractor.

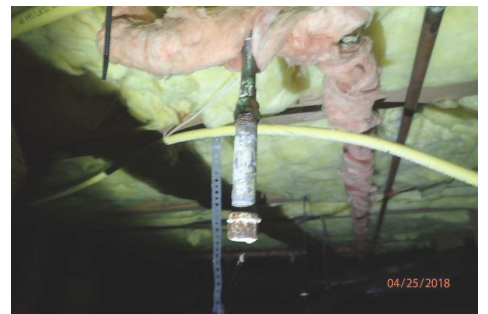
### 9.3.1 Water Supply, Distribution Systems

Corrosion between copper and steel has been found during the inspection. These joints required a dielectric union to prevent premature failure of the plumbing. Recommend a licensed plumbing contractor to further evaluate and repair as needed.

When copper and steel pipes are connected, which happens often at the fittings near a water heater, an electrolytic reaction begins. Water is the electrolyte, and the combination of two metals and water essentially becomes a battery. It happens slowly over many months. A small amount of electric current starts flowing nowhere near enough to shock you and atoms from one metal begin to break off and cling to the other metal. The result is a crumbling, white powder buildup on the galvanized steel pipe, which is called galvanic corrosion.

Contact a qualified plumbing contractor.

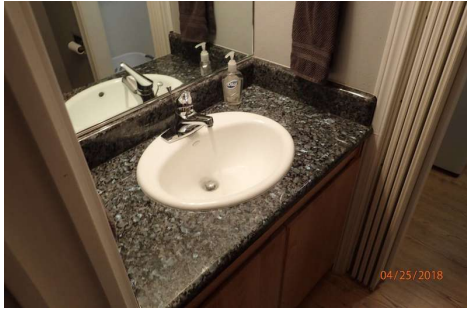
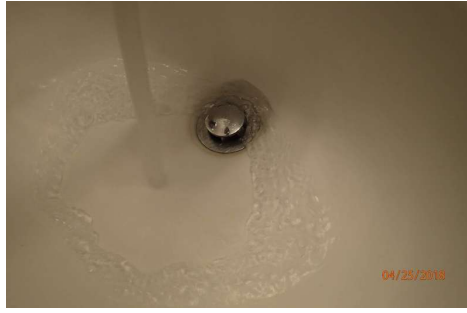
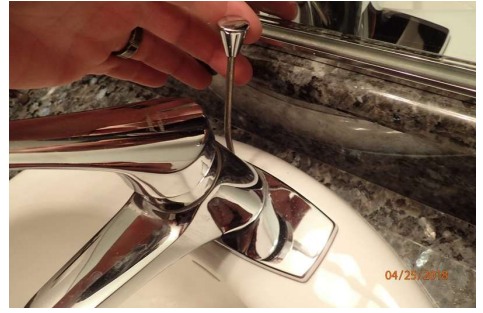
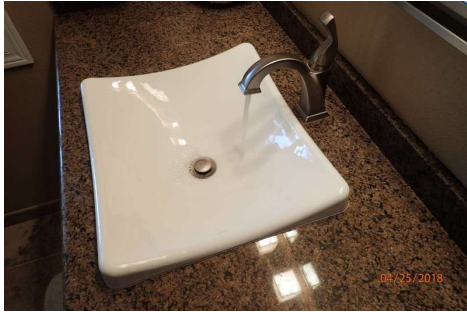
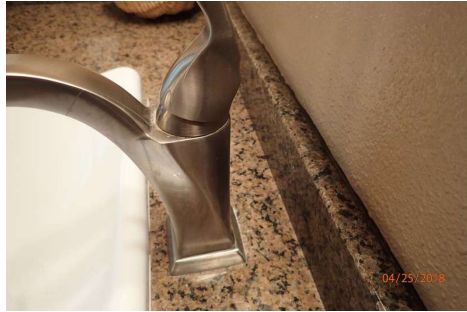
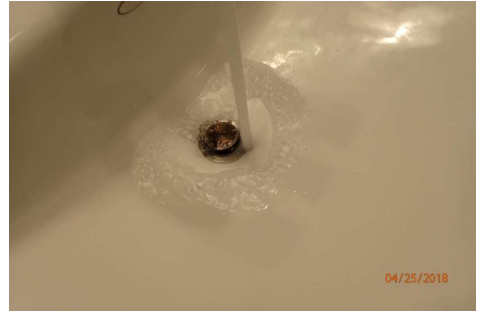
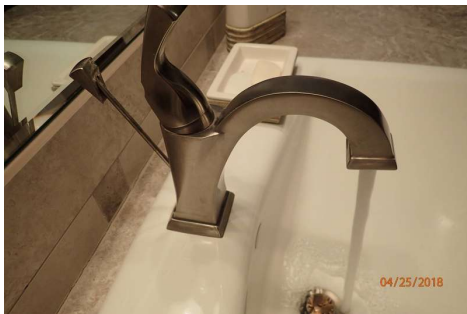
9.4.2 Sink, Basin, Laundry Tub

**FIXTURE - HOT AND COLD REVERSED**

The hot and cold for one of the faucets is reversed. This can generally be repaired by swapping the hot and cold hook ups under the sink.

Contact a qualified plumbing contractor.

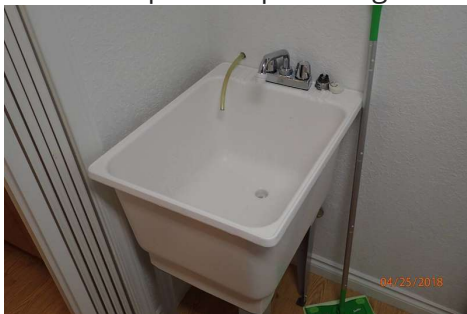
9.4.3 Sink, Basin, Laundry Tub

**SINK - NOT SECURED**

Recommend properly securing the cabinet and/or sink to prevent movement and potential leak in the drain line.

Contact a handyman or DIY project

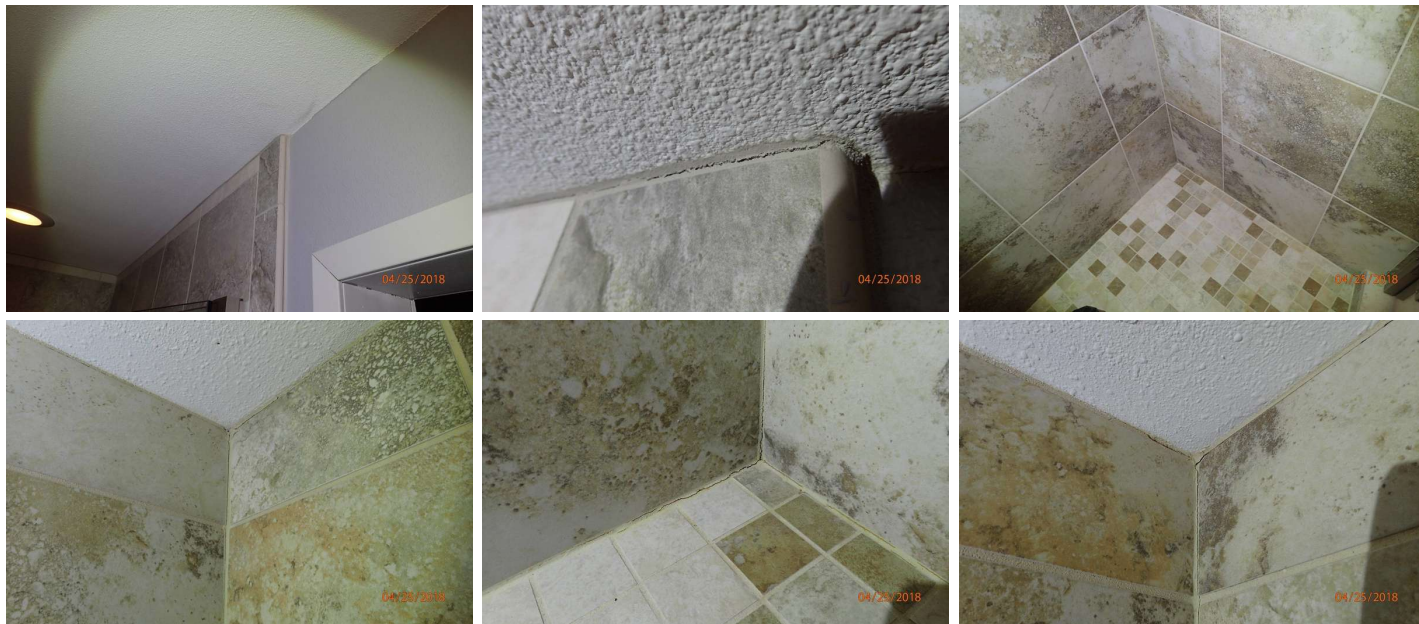
### 9.6.2 Tub / Shower

## SHOWER/BATHTUB - CAULKING/GROUT FAILING

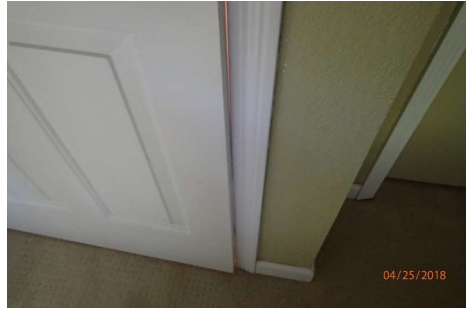
10.1.2 Doors

**DOOR - FRAME DAMAGE**

Minor frame damage was found on one or more doors.

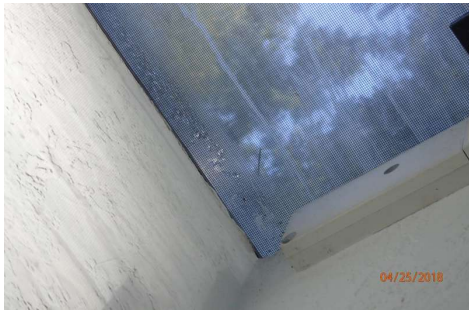
10.5.1 Ceilings

**LOOSE / DETERIORATING CEILING TEXTURE**

The ceiling in one or more areas has failing ceiling texture that is peeling and delaminating from the ceiling. This may be from a previous moisture source. Recommend a licensed drywall contractor to further evaluate and repair or replace is needed. Depending on age, the texture may contain asbestos, recommend having this tested prior to repair/removal.

Contact a qualified drywall contractor.

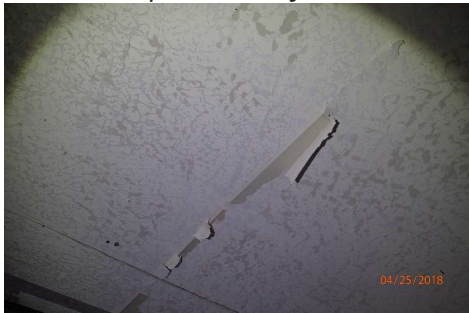
10.5.2 Ceilings

**MINOR DAMAGE**

Minor damage or deterioration to the ceiling was visible at the time of the inspection.

Contact a qualified drywall contractor.

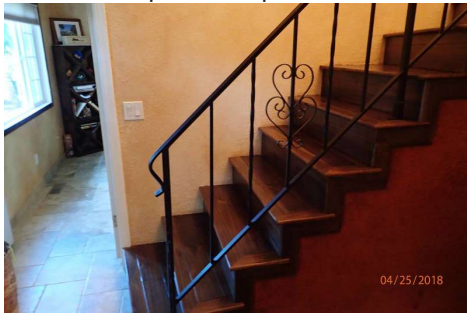
10.8.1 Trim

**TRIM DAMAGE/DETERIORATION- MINOR**

Trim exhibited minor cosmetic damage/deterioration.

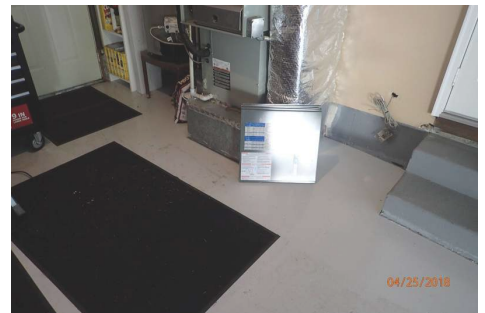
## 11.4.1 Occupant Door (From garage to inside of home)

Door from garage to home should have self-closing hinges to help prevent spread of a fire to living space. Recommend a qualified contractor install self-closing hinges.

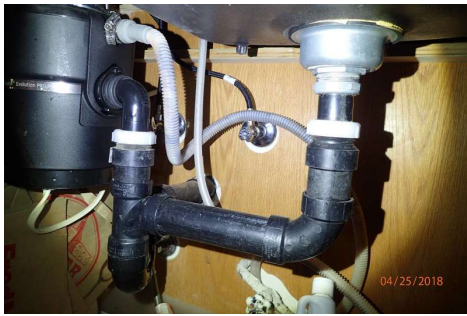
**IMPROPERLY INSTALLED DRAIN PIPE**

## Back-flow Prevention Missing.

It is recommended for your dishwasher to have a back flow prevention device. Such a device or "system" prevents water that could back flow from a clogged sink into a dishwasher and flood the dishwasher. Many dishwashers today have a system built in but they are typically impossible to view with the dishwasher installed. Because your inspector is not able to verify the presence and functionality of a back flow device, it is recommended to install one. There are several methods but we recommend a simple "Drain Loop" or "Air Gap".

### Drain Loop

Many dishwashers use an even simpler system to stop most backups from reaching the dishwasher. Dishwashers include enough drain hose to form a higher inverted U underneath the sink. Strapping the hose to the cabinet at the highest possible point beneath the sink places the bend above all but the worst sink backups. The sink must fill completely to pour water back through the hose. This can be the easiest method of back-flow prevention but because the bend lacks a true air gap, it does not prevent siphoning if water overflows the bend.

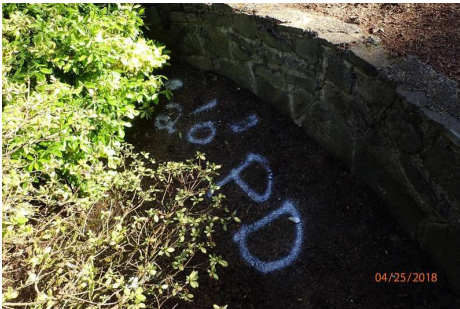
At 46' there is a deformation in the pipe. This has been located to just under the front retaining wall. The deformation is at the top of the pipe and does not appear to have affected the performance of the pipe yet. At some point the pipe may break or collapse. A repair should to be considered before that happens.
