IINSPECT RESIDENTIAL REPORT

1234 Main St.
Jefferson GA 30549

01/05/2019 9:00AM

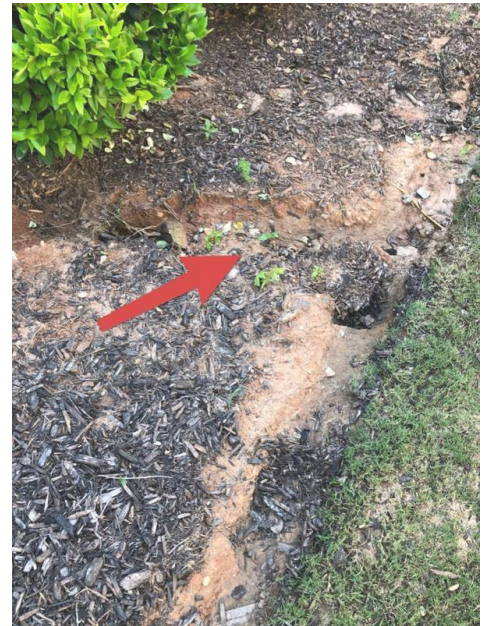
Right

SERVICE / REPAIR: Erosion noted at time of inspection. Have ground area restored and make efforts to control rain water runoff to prevent reoccurrence. Some local and state municipalities can invoke fines on property owners for storm water silt runoff responsible for filling streams.

Recommendation

Contact a qualified landscaping contractor

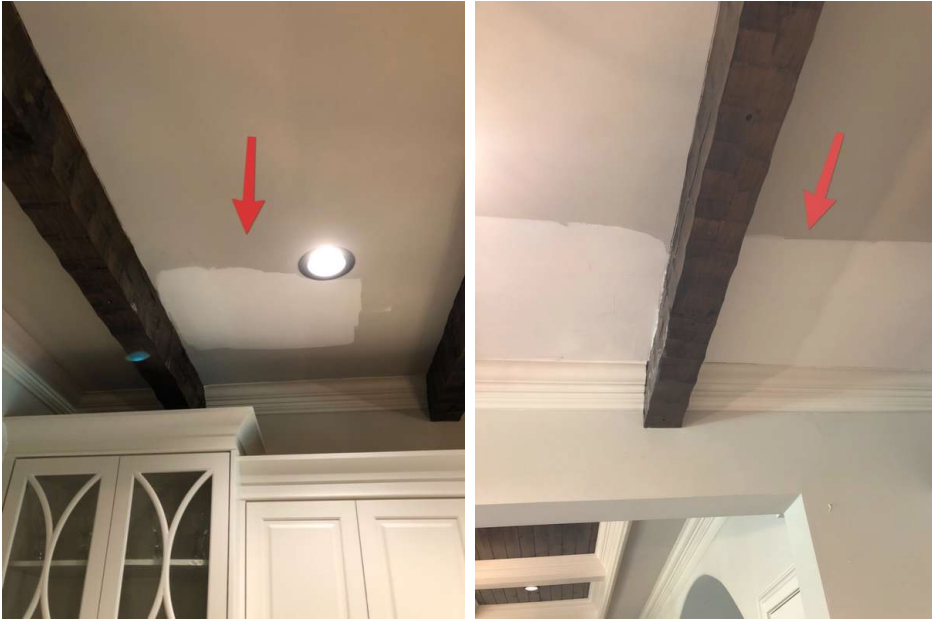
Kitchen

GENERAL NOTE: Touch ups and repairs noted in ceiling(s) during inspection. Seller to disclose the source of problem, including extent of repairs made. This information may be needed for buyer's future reference. Usually requires full area painting to reduce obvious conditions.

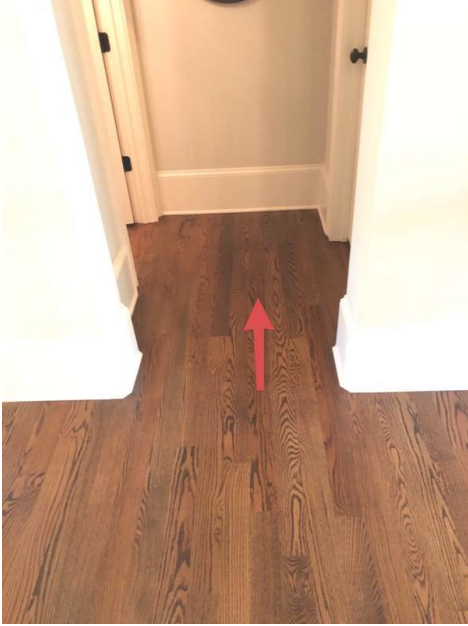
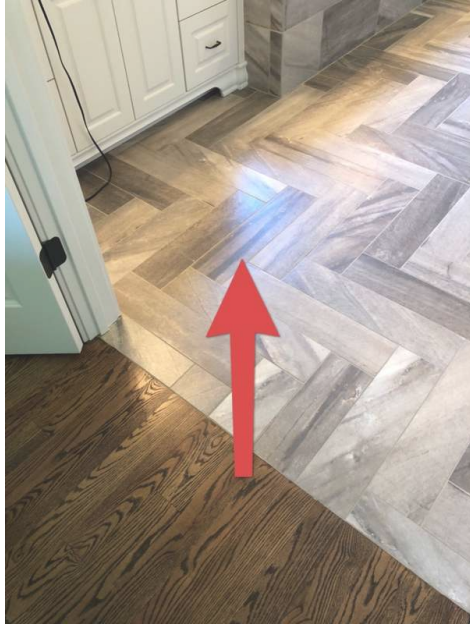
SERVICE / REPAIR: Observed uneven floor slope. Have qualified contractor evaluate and repair as necessary.

Recommendation

Contact a qualified flooring contractor

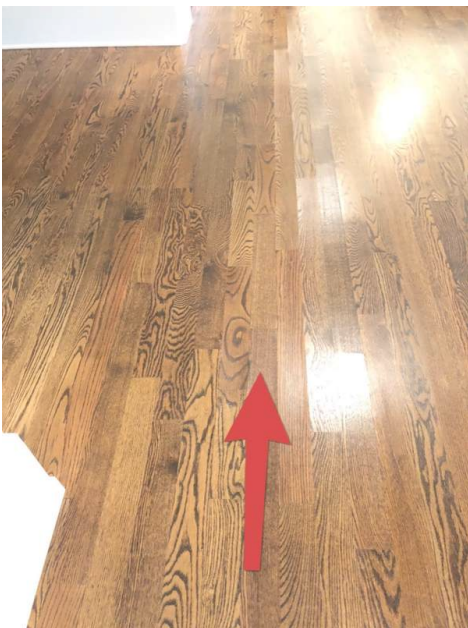
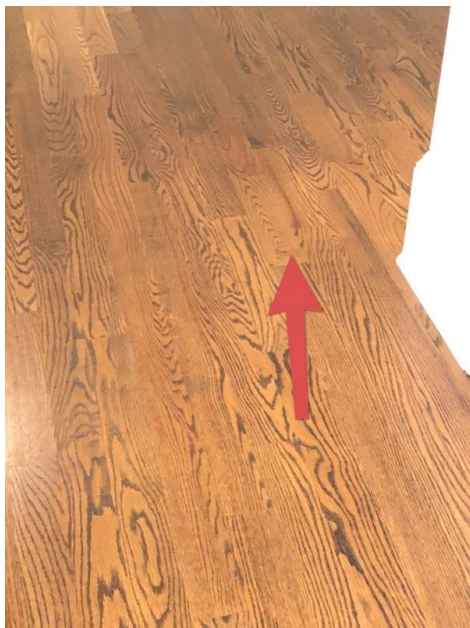
Family Room

DAMAGED

SERVICE / REPAIR: Damaged areas of flooring observed. Have a professional flooring contractor evaluate and repair or replace the flooring as needed.

Recommendation

Contact a qualified flooring contractor

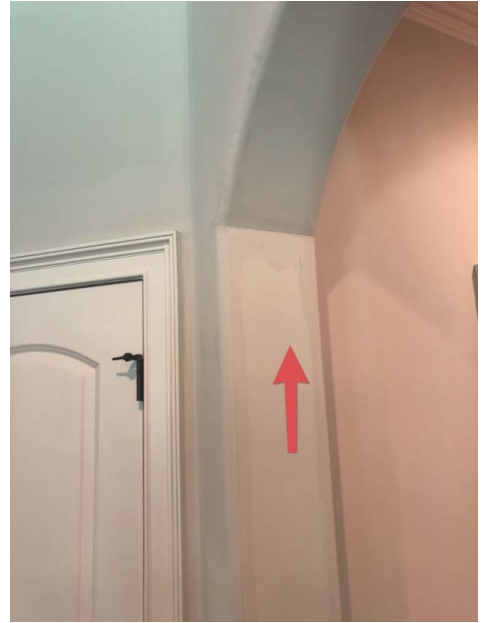
Basement

GENERAL NOTE: The ceiling/wall is water damaged. Infrared scan indicated no moisture above the ceiling and moisture meter indicates low moisture content(dry) at the time of this inspection. Have qualified contractor repair as needed.

Recommendation

Contact a qualified painter.

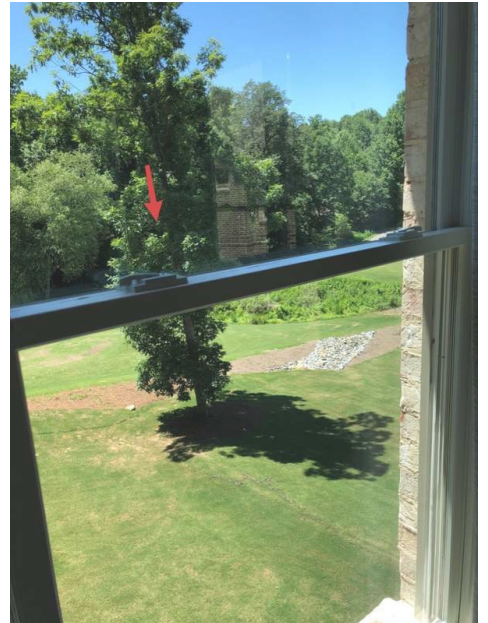
Master Bedroom

SERVICE / REPAIR: A number of windows are painted shut. Have contractor repair as needed to ensure proper egress.

Recommendation

Contact a qualified window repair/installation contractor.
