STRILER HOME INSPECTIONS, INC.

## YOUR INSPECTION REPORT

1234 Main St.  
Raynham, MA 02767

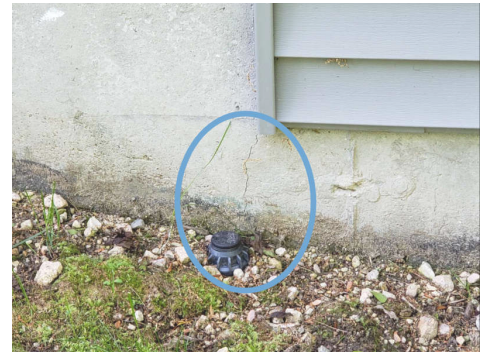
### 5.15.1 Foundation (Exterior)

### SHRINKAGE CRACK

One or more walls have hairline cracks. They appear to be shrinkage cracks. Shrinkage cracks are caused by the evaporation of water in the mix. This is a normal condition. As the concrete cures and dries it "shrinks" leaving hairline cracks. Seventy-five percent of all shrinkage cracks appear in the first year. Monitor and repair if needed.

Right

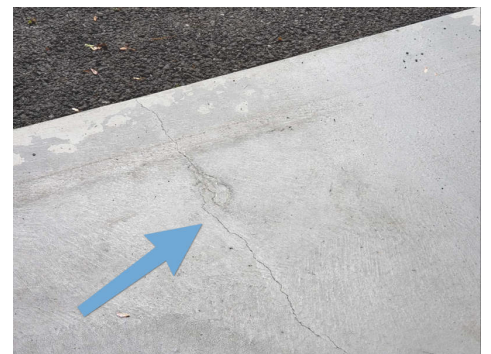
### CRACKS (TYPICAL)

Typical cracks were noted. Seal as needed.

Contact a handyman or DIY project

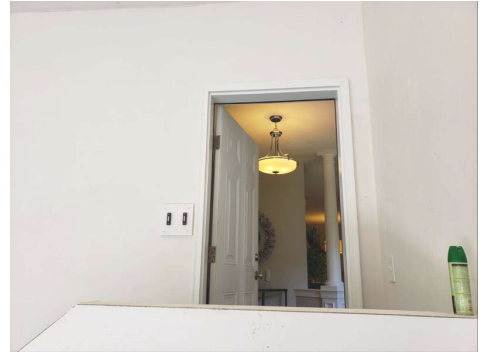
7.8.1 Occupant Door (From Garage To Home)

The door from the garage to the home should have self-closing hinges to help prevent the spread of a fire to living space. Recommend installing self-closing hinges.

Contact a qualified handyman.

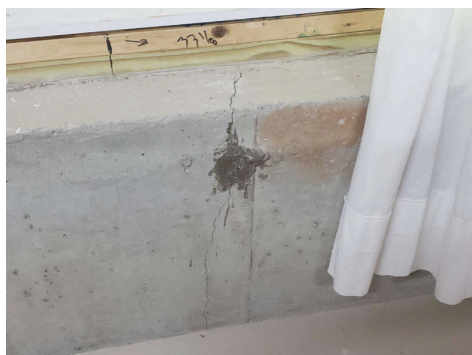
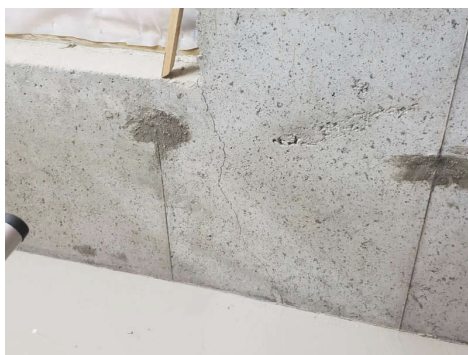
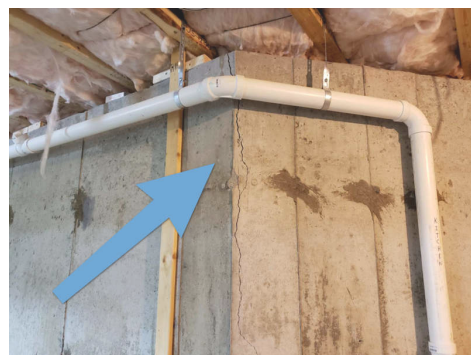
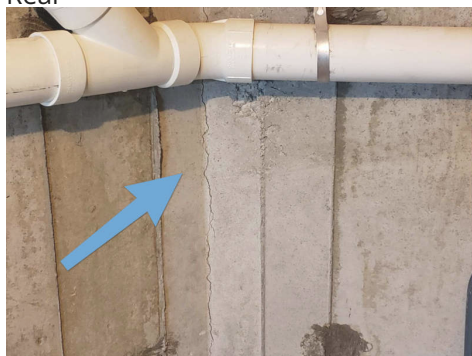
8.2.1 Interior Foundation

**POURED CONCRETE (-1/4 INCH CRACK)**

One or more cracks less than 1/4 inch were noted in the foundation walls. Consider sealing and monitoring for future cracking.

Contact a handyman or DIY project

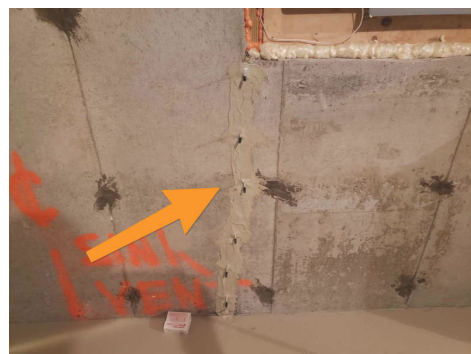
8.2.2 Interior Foundation

**FOUNDATION (CRACKS REPAIRED)**

Epoxy repairs have been made, consult owner for warranty.

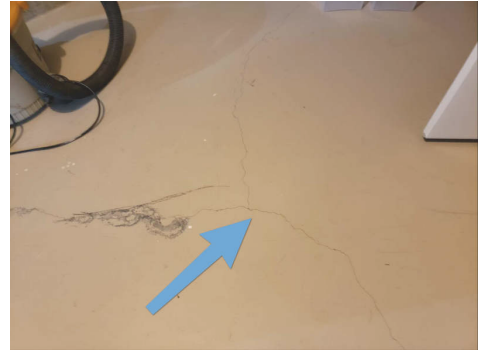
## 8.4.1 Floor

**COMMON CRACKS**

Common cracks were visible in the basement floor. This type of cracking can have several causes

- concrete shrinkage, which is a normal part of the concrete curing process and not a structural concern
- post-construction settling due to incomplete compaction of the soil beneath the slab during construction. This also is not an unusual condition and typically would not continue.
- heaving of the soil due to the presence of expansive soils.

Determining the cause of cracking lies beyond the scope of the General Home Inspection. Consider repairing cracks as needed and monitor.

Contact a handyman or DIY project

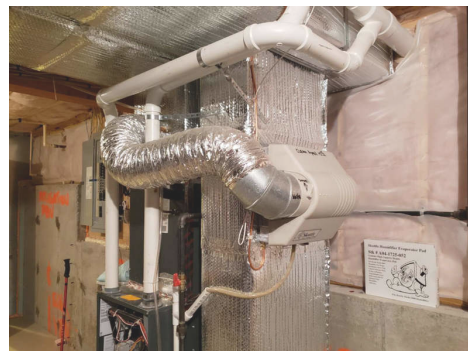
**SHEET METAL (HUMIDIFIER INSTALLED)**

The ductwork has a humidifier installed in the plenum. Humidifiers can increase interior home comfort in the winter if maintained properly. If no maintenance information is available from the homeowner, then we recommend checking online for information about your particular model and it's operation.

Recommended DIY Project

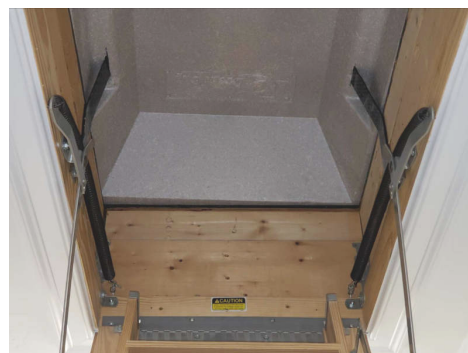
The cover to the attic hatch was physically sealed and we were unable to remove it without causing damage. No comment on any items related to the attic or ventilation is possible.
