THAT PLACE HOME INSPECTIONS, LLC

RESIDENTIAL REPORT

1234 Main St.
Pearisburg, VA 24134

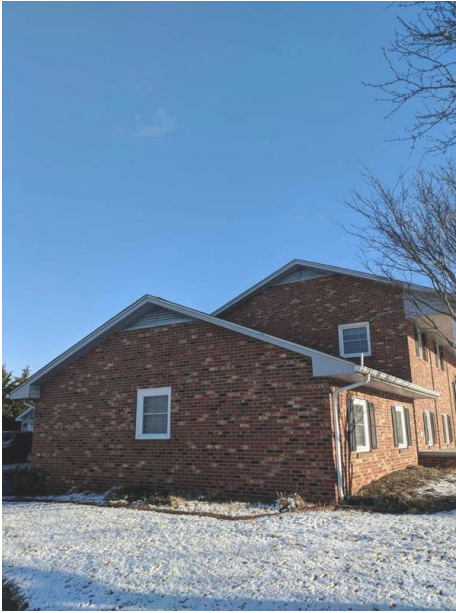
Roof Type/Style

Gable

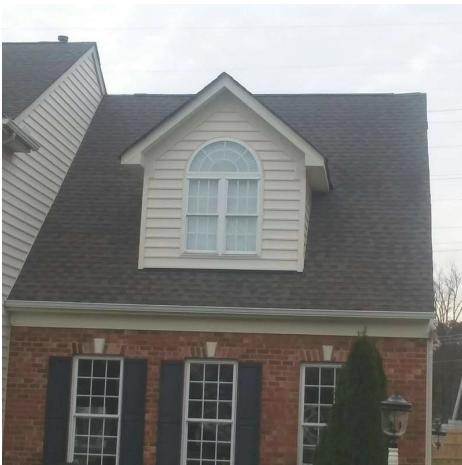
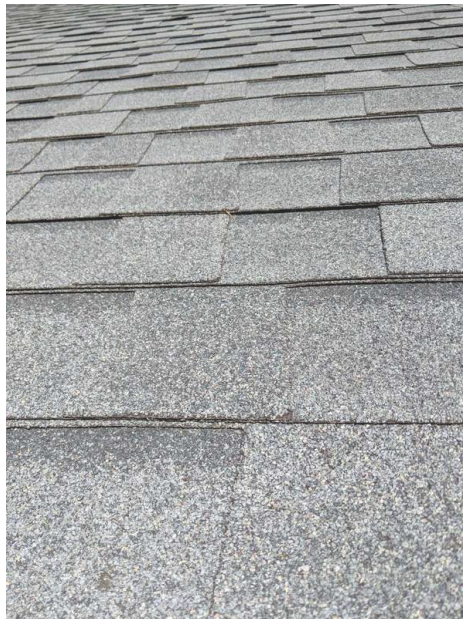
Coverings: Material

Asphalt, Architectural

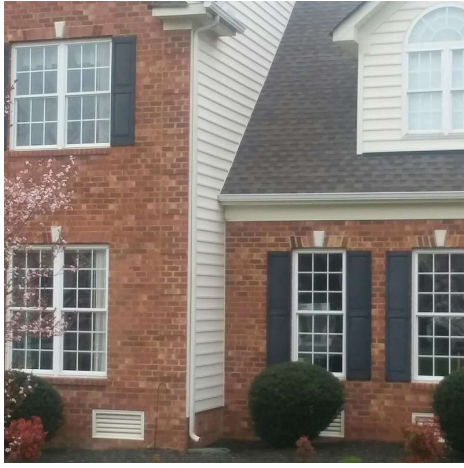
Roof Drainage Systems: Gutter Material

Aluminum

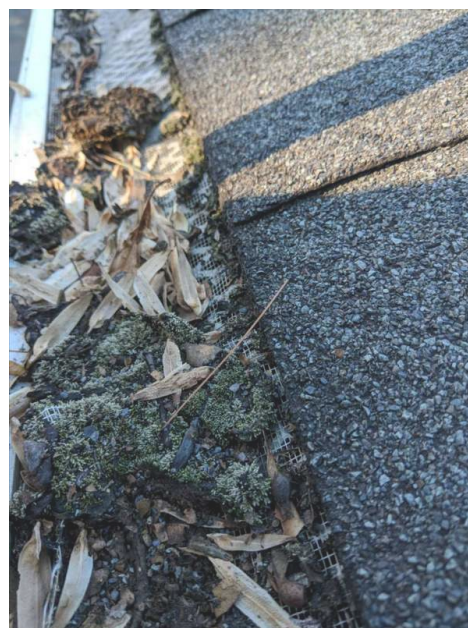
South

Debris has accumulated in the gutters. Recommend cleaning to facilitate water flow.

Contact a handyman or DIY project

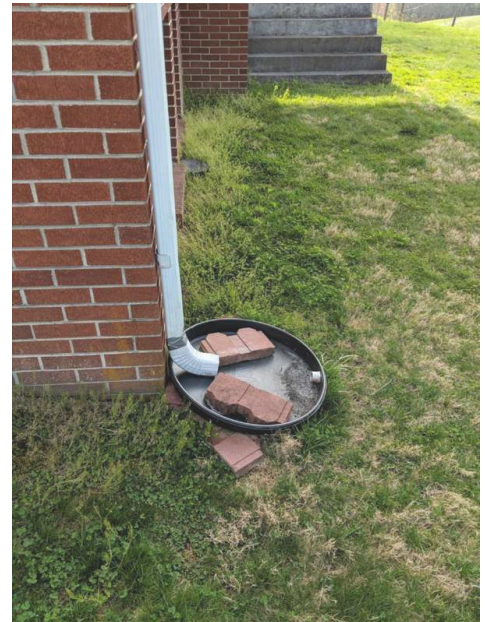
Southwest

One or more downspouts drain too close to the home's foundation. This can result in excessive moisture in the soil at the foundation, which can lead to foundation/structural movement. Recommend adjusting downspout extensions to drain at least 6 feet from the foundation.

Contact a handyman or DIY project

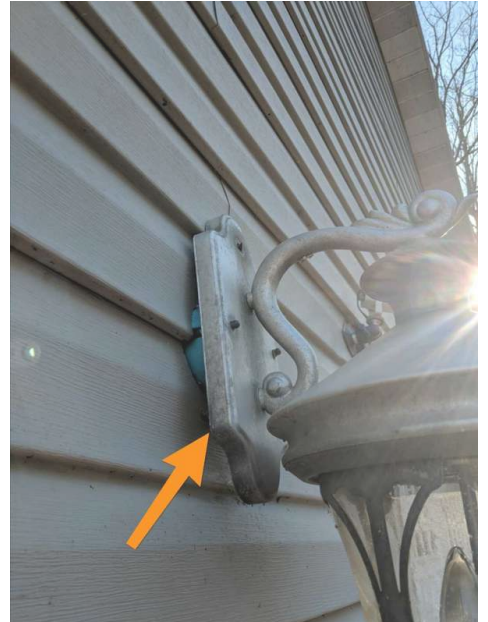
East

J-block/mounting block was not installed on one or more fixture penetrations. This can lead to water penetration and may not allow for proper expansion and contraction of the siding. Recommend further evaluation by a qualified contractor and repair or replace as needed.

Contact a qualified professional.

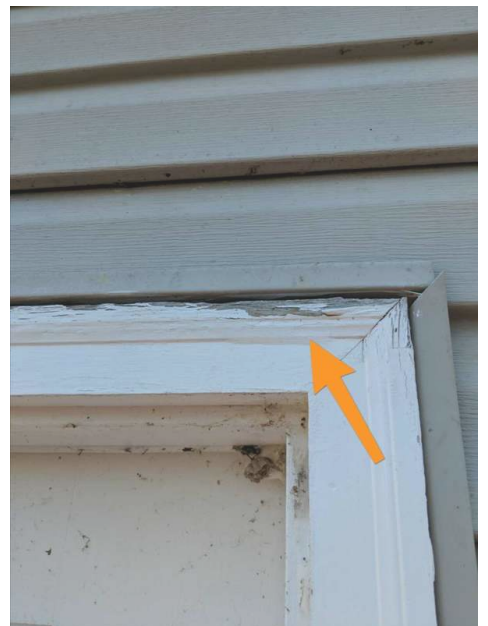
East

The paint in some areas was failing (e.g. peeling, faded, worn, thinning). Siding and trim with a failing finish can be damaged by moisture. Recommend that a qualified contractor prep (e.g. clean, scrape, sand, prime, caulk) and repaint the building exterior where necessary and per standard building practices. Any repairs needed to the siding or trim should be made prior to this.

Contact a qualified professional.

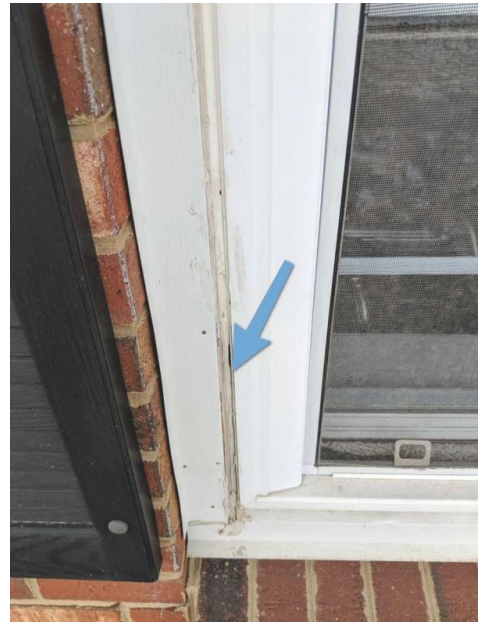
West

MISSING OR DAMAGED CAULK

Caulk was missing, damaged, or showing signs of deterioration in one or more areas around the doors and windows of the home. Caulking should be regularly monitored and should be removed and reapplied as needed.

Contact a handyman or DIY project

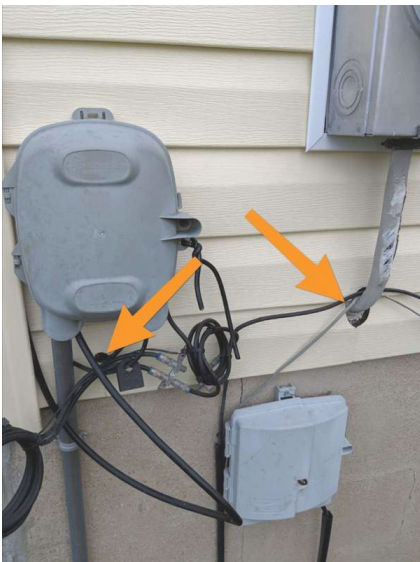
South

Exterior wall penetrations had gaps that should be sealed with an appropriate sealant to prevent moisture and insect entry. All work should be performed by a qualified contractor.

Contact a handyman or DIY project

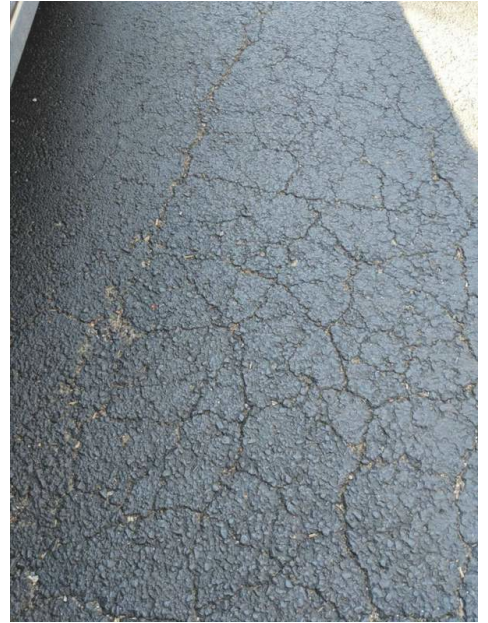
DRIVEWAY CRACKING

The asphalt driveway surface was worn and is prone to developing cracks from water penetration. Recommend that a qualified person reseal the driveway.

Contact a handyman or DIY project

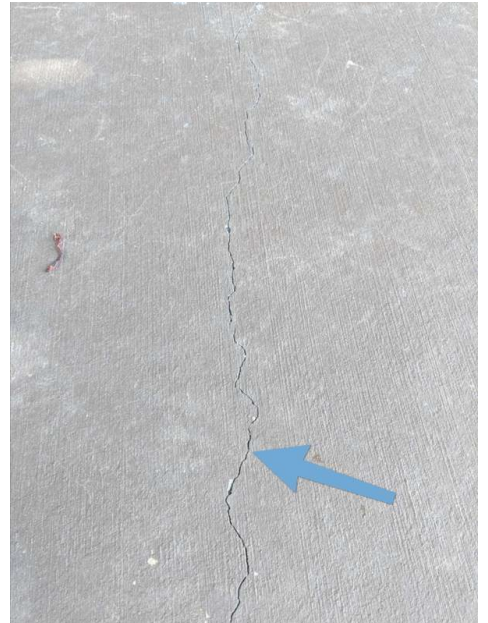
South

PATIO CRACKING

Normal settling & cracking observed. Recommend monitor and/or patch/seal as needed.

Contact a handyman or DIY project

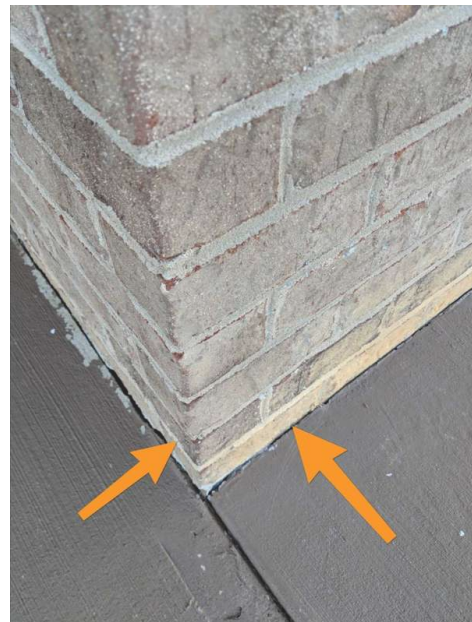
Southwest

CRACKING AT EDGE OF CONCRETE AND HOME

The concrete of the patio or drive has cracked and separated where it meets the home/garage. This is common due to uneven settling between poured concrete and the foundation of the home. Recommend to fill/seal this crack line to avoid future water/moisture intrusion to the foundation of the home/garage. Continue to monitor this area as future regular maintenance.

Contact a handyman or DIY project

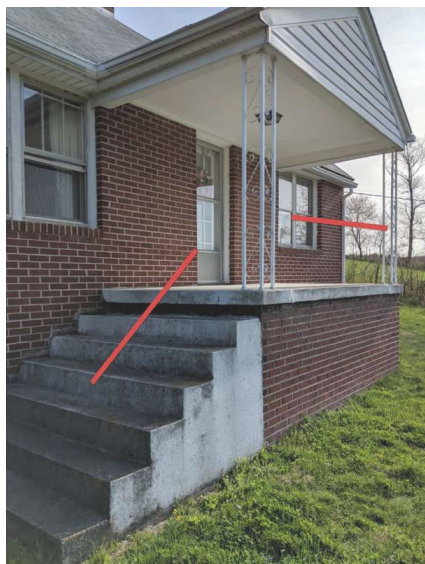
South

RAILING MISSING

Contact a qualified professional.

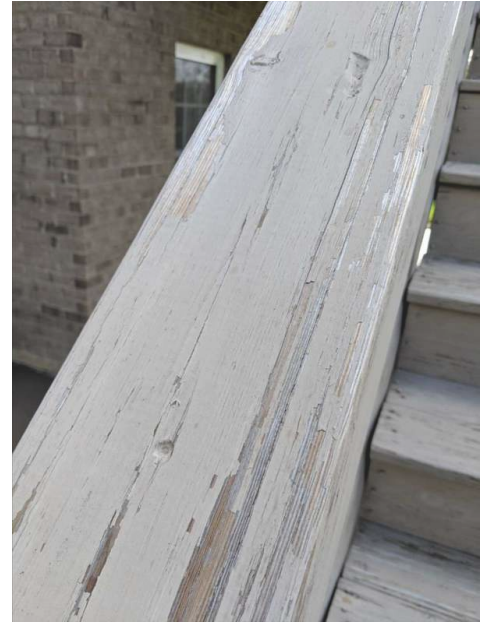
South

Deck was showing signs of weathering and/or water damage. Recommend water sealant/weatherproofing be applied.

Contact a handyman or DIY project

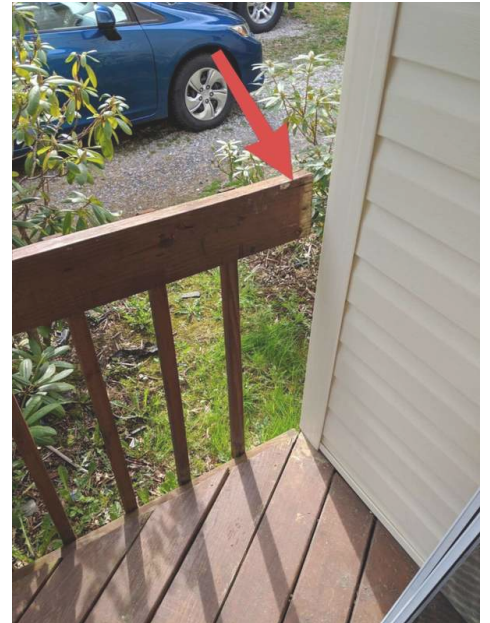
East Deck

RAILING LOOSE

Based on the inspector's past experience, the handrail assembly did not appear to be of adequate strength to safely protect the deck/stairs. Physical testing for compliance with any building standards or building codes lies beyond the scope of the General Home Inspection. The Inspector recommends that additional support be installed by a qualified contractor.

Contact a qualified deck contractor.

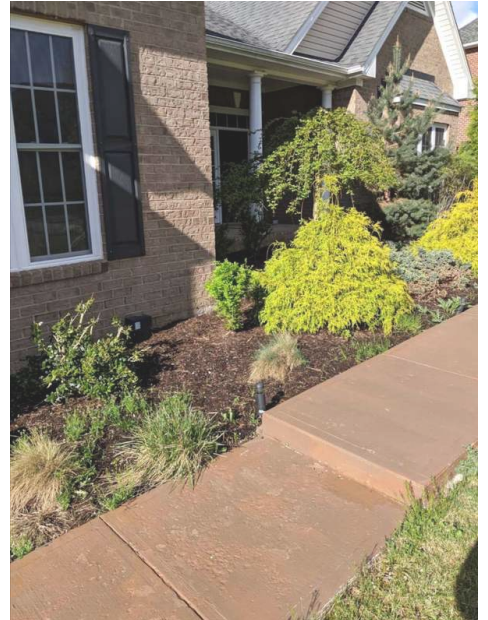
North

A flower bed, mulch or soil was observed to be in contact or close proximity to the home. This can lead to moisture intrusion in one or more of the components of the home. Recommend removing or addressing this landscaping feature to reduce the probability of moisture intrusion on the home and its components.

Contact a handyman or DIY project

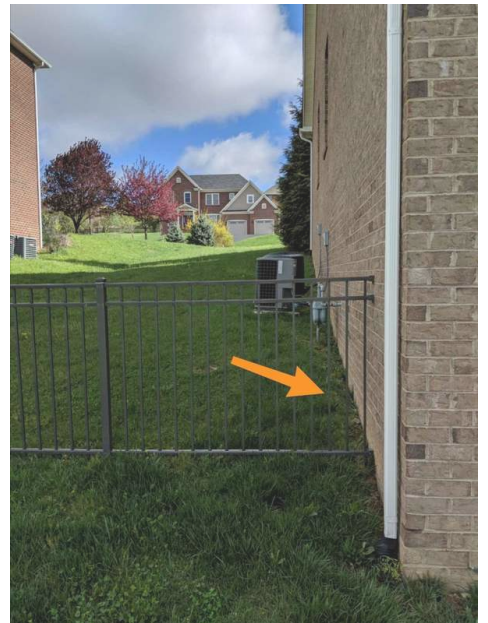
West

Grading is sloping towards the home in some areas. This could lead to water intrusion and foundation issues. Recommend qualified landscaper or foundation contractor regrade so water flows away from home.

Contact a qualified landscaping contractor

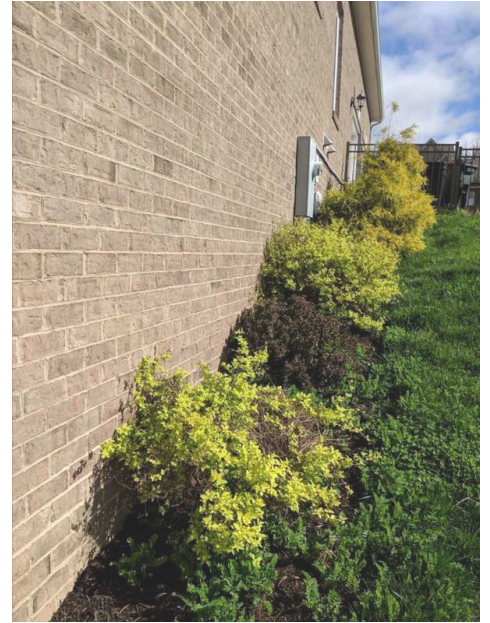
East

Vegetation was observed to be in contact or close proximity to the home. This can lead to moisture intrusion in one or more of the components of the home. Recommend removing or cutting back vegetation.

Contact a handyman or DIY project

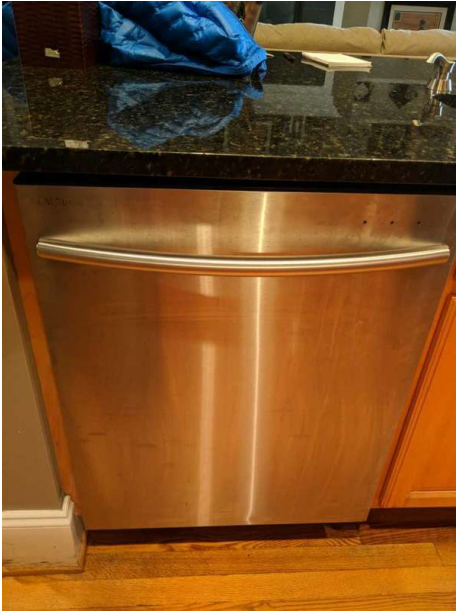
Dishwasher: Brand

Samsung

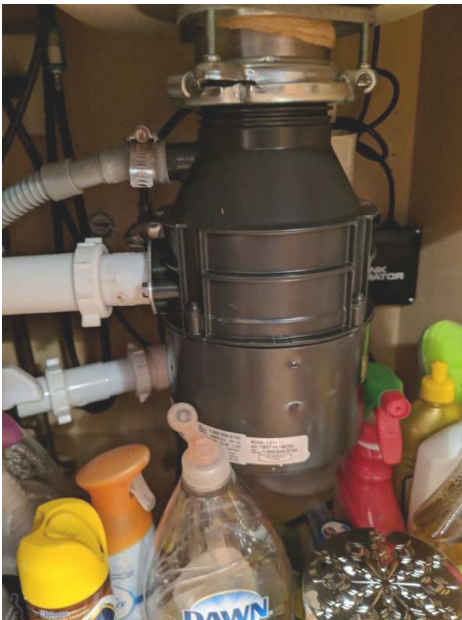
**Garbage Disposal: Garbage Disposal**

Installed

Garbage disposals can be a problem when used in homes on septic systems. You should learn the limitations of your septic system and use the garbage disposal appropriately. Long-term, inappropriate use can cause expensive-to-repair damage to septic systems.

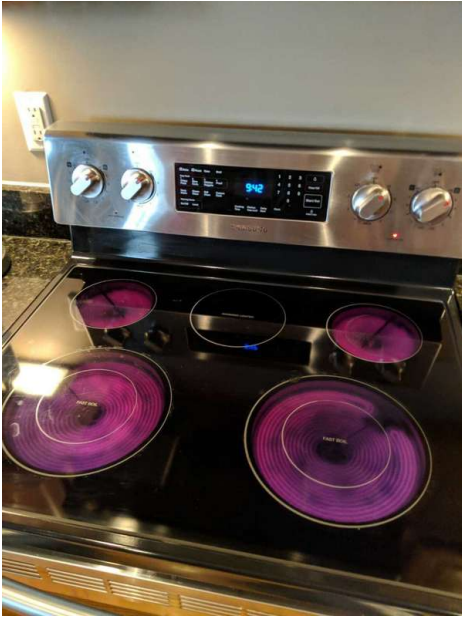
**Range/Oven/Cooktop: Range/Oven Energy Source**

Electric

Inspection of range/oven is limited to basic functions, such as testing of the range-top burners, and bake/broil features of the oven. Self-cleaning & convection function is not inspected

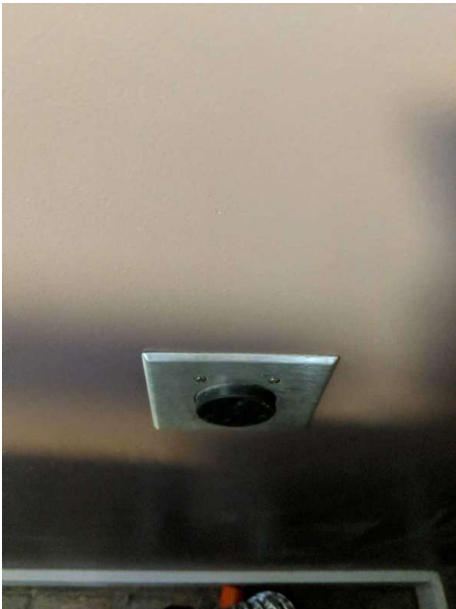
Washer / Dryer: Dryer Power Source

240 Electric

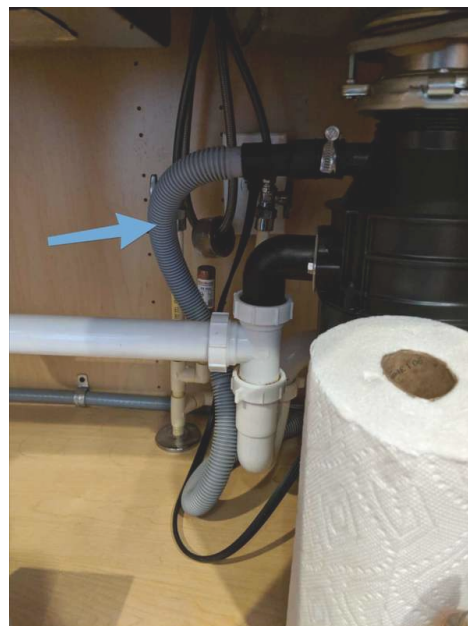
Dishwasher drain does not have a "high loop". Recommend checking the installation recommendations from the manufacturer for this dishwasher and adding a high loop to dishwasher drain tube as needed.

Contact a handyman or DIY project

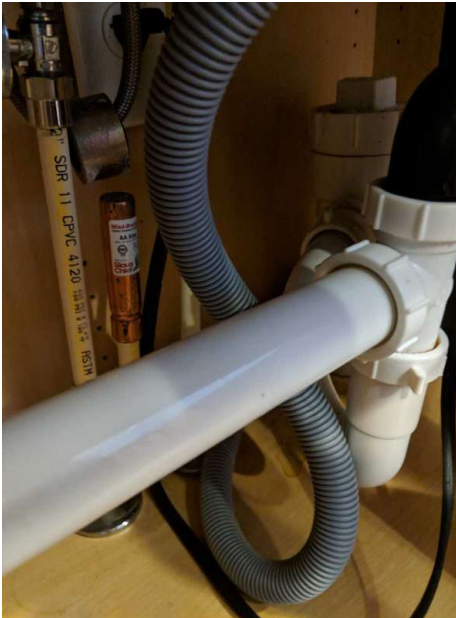
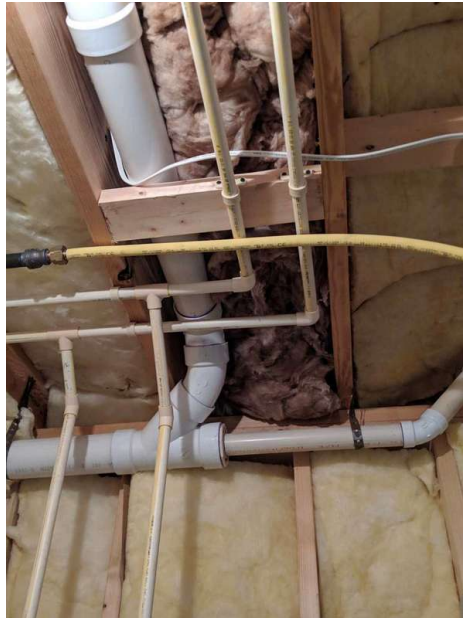
Drain, Waste, & Vent Systems: DWV Material

PVC, Plastic

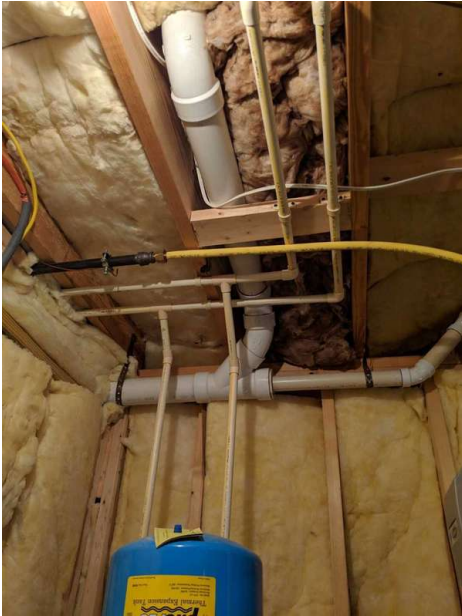
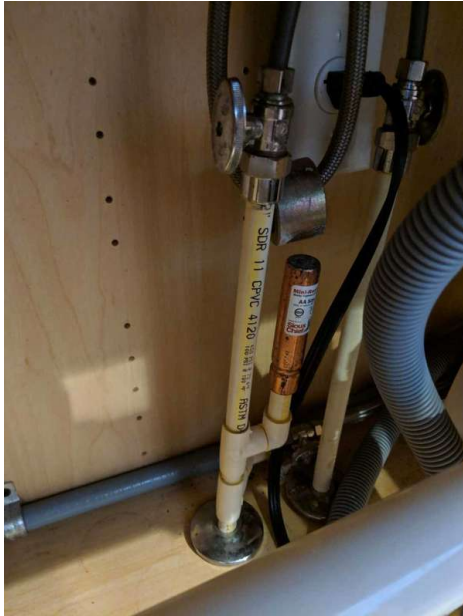
Water Supply, Distribution Systems & Fixtures: Distribution Material

CPVC

Inspector recommends that plumbing distribution material running through unconditioned spaces should be insulated. Insulating plumbing pipes might aid in the prevention of freezing pipes and helps to limit condensation forming on the pipes which might lead to other moisture issues in the home.

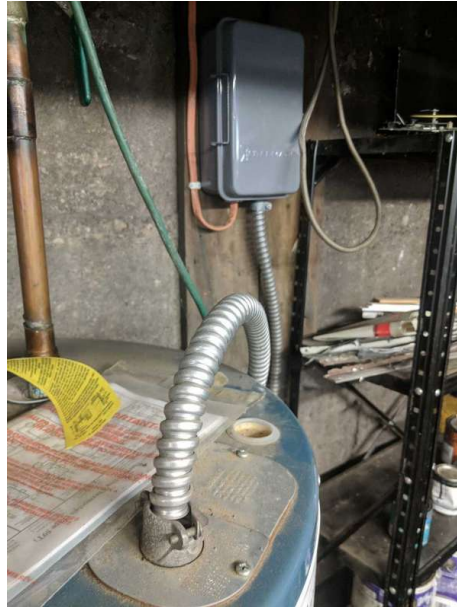
Hot Water Systems, Controls, Flues & Vents: Power Source/Type

Electric

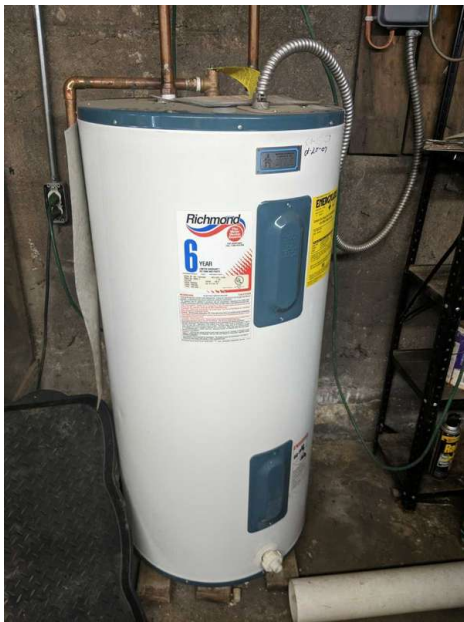
Hot Water Systems, Controls, Flues & Vents: Manufacturer

Richmond

I recommend flushing & servicing your water heater tank annually for optimal performance. Water temperature should be set to and not higher than 120 degrees F to kill microbes and to prevent scalding.

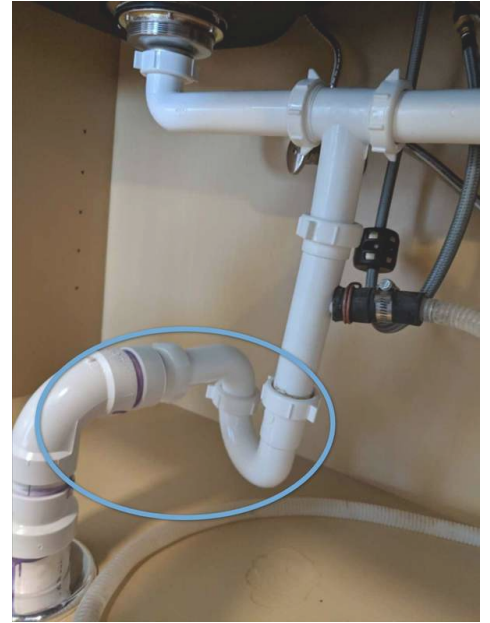
Kitchen

A trap beneath the sink was of a type that is no longer allowed to be installed in new construction for safety reasons. Although this type of trap may have been commonly considered safe at the time the home was originally constructed, as general knowledge of safe building practices has improved with the passage of time, building standards have changed to reflect current understanding. Unless otherwise noted, there was no leak and no odor detected at the time of the inspection. The Inspector recommends that you consider updating the existing traps to meet generally-accepted current standards by installing P-traps. All work should be performed by a qualified plumbing contractor.

Contact a qualified plumbing contractor.

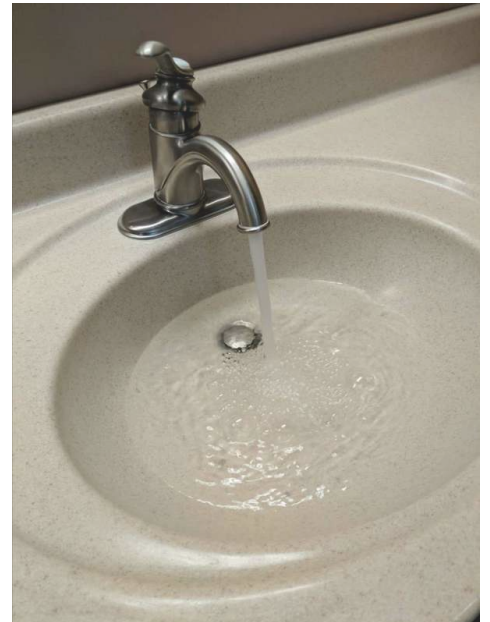
Master Bathroom

Sink had slow/poor drainage. Recommend a qualified plumber repair.

Contact a qualified plumbing contractor.

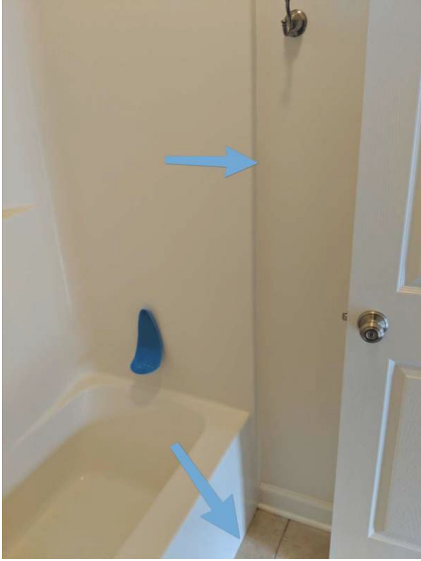
2nd Floor Bathroom

Loose or missing caulking around fixture. Recommend re-caulking.

Contact a handyman or DIY project

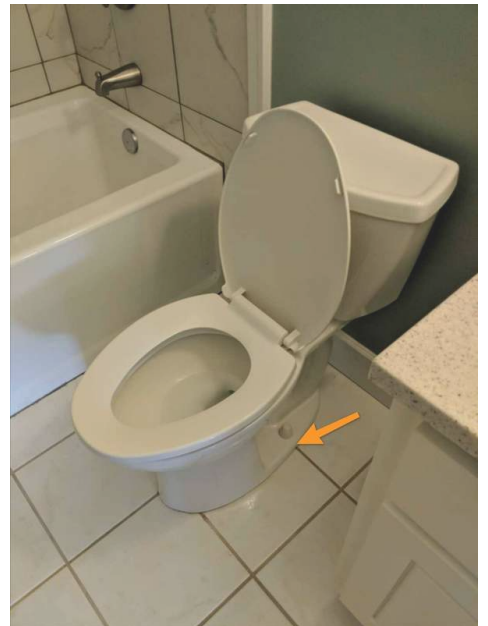
2nd Floor Bathroom

TOILET LOOSE

In this bathroom, the toilet was loose at the floor and should be re-attached by a qualified plumbing contractor.

Contact a qualified plumbing contractor.

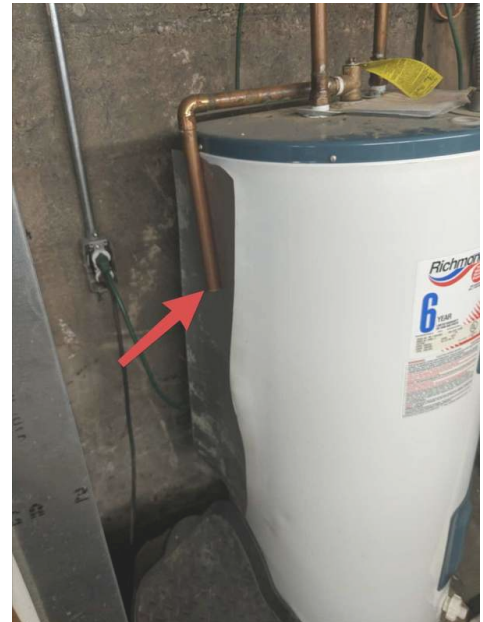
The TPR discharge pipe was missing or had an improper installation. This is a potential safety hazard due to the risk of scalding if someone is standing next to the water heater when the valve opens. A qualified plumber should install a drain line as per standard building practices.

Contact a handyman or DIY project

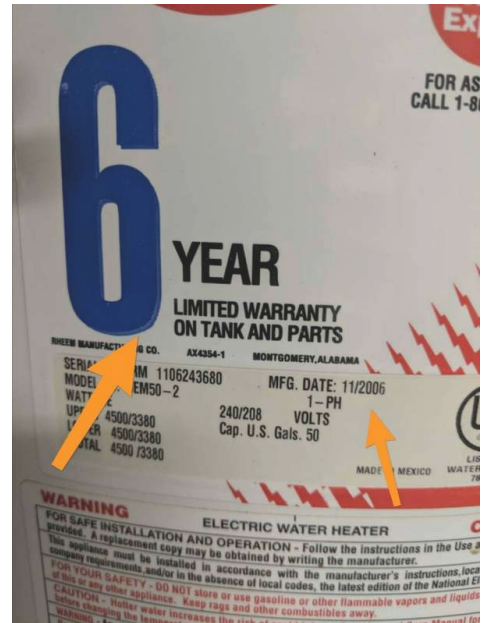
Manufactured 2006

The estimated useful life for most water heaters is 8 to 12 years. This water heater was functional at the time of inspection but appears to be approaching or is beyond this age and may need replacing at any time. Recommend budgeting for a replacement in the near future.

Contact a qualified plumbing contractor.

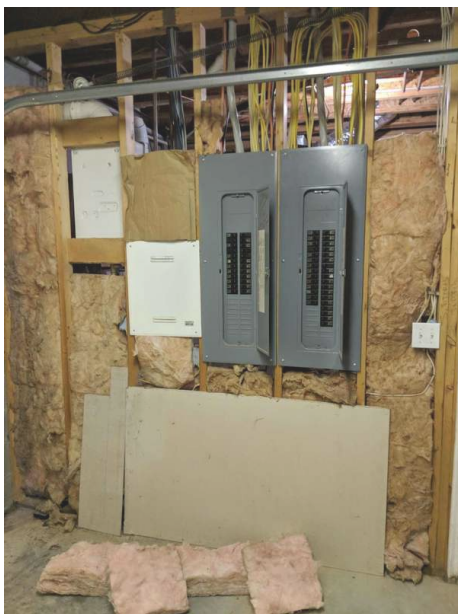
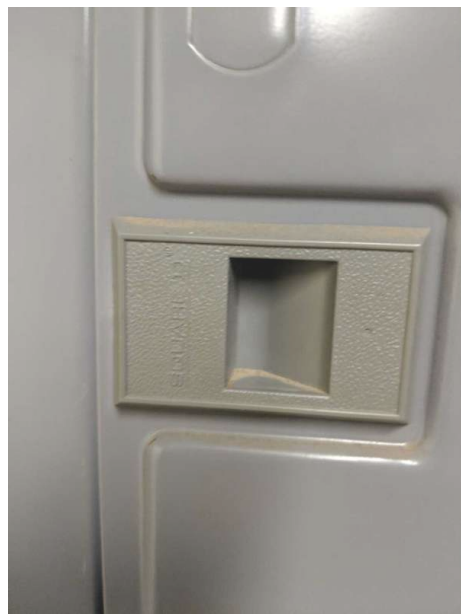
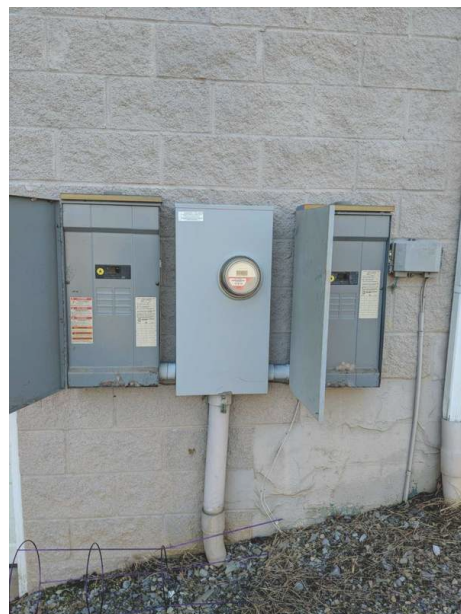
Main & Subpanels, Service & Grounding, Main Overcurrent Device: Main Panel Location
Basement

Main & Subpanels, Service & Grounding, Main Overcurrent Device: Panel Manufacturer
Square D

Main & Subpanels, Service & Grounding, Main Overcurrent Device: Panel Capacity
400 AMP

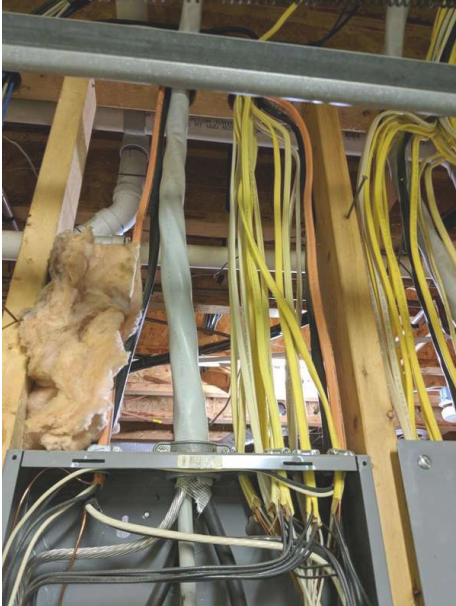
Branch Wiring Circuits, Breakers & Fuses: Wiring Method

Non-Metallic

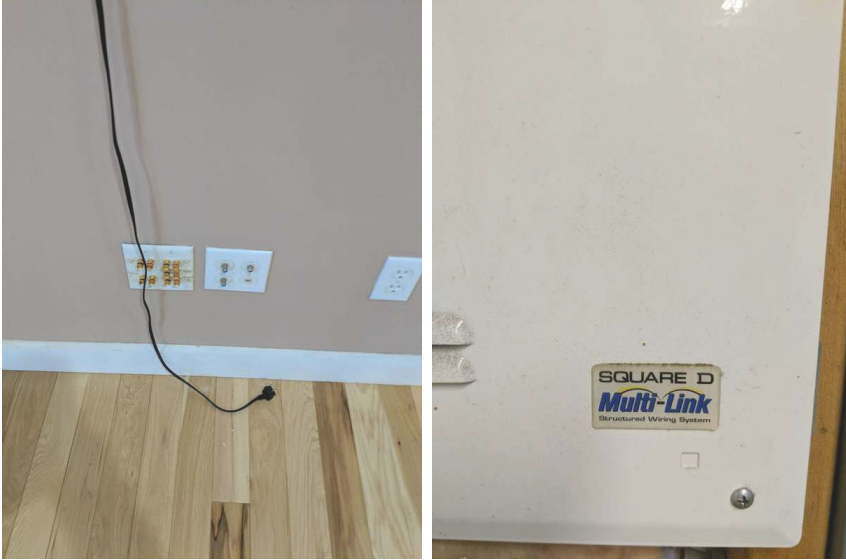
LOW VOLTAGE SYSTEM

This home has a low voltage system. These systems include things such as phone, communication, TV and entertainment, computer and networking, alarms and more. Inspection of a low voltage system is beyond the scope of a home inspection. Recommend communicating with the home owner to learn more about this system.

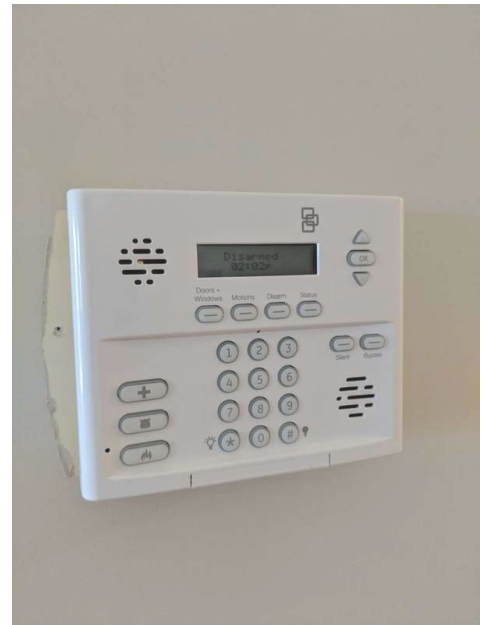
CENTRAL ALARM SYSTEM

Smoke detectors not checked due to the presence of a central alarm system. Testing may lead to a call to emergency response agencies. Check with the alarm monitoring company for instructions on proper testing.

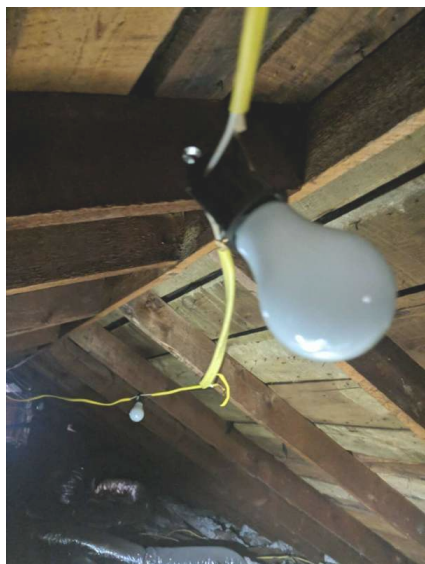
Electrical wires had splices exposed to touch. Splices should be contained within an approved junction box with a listed cover installed. The Inspector recommends correction by a qualified electrical contractor.

Contact a qualified electrical contractor.

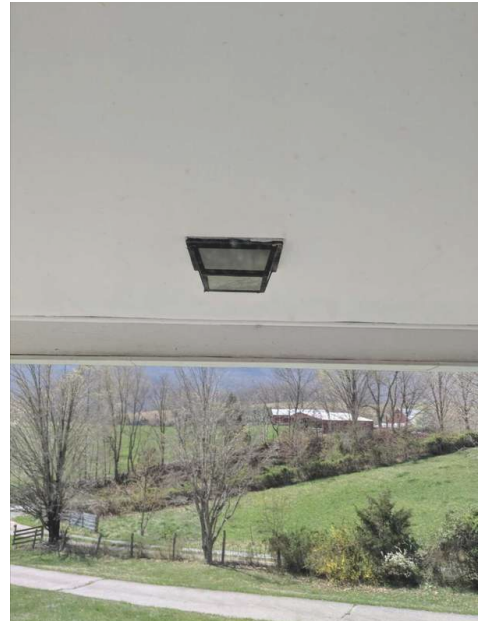
One or more light fixture(s) did not respond to the switch. The bulb(s) may need to be replaced or there may be a problem with the switch, wiring or light fixture(s). If after the bulb(s) is/are replaced this/these light(s) still fail(s) to respond to the switch, this condition may represent a potential fire hazard and the Inspector recommends that an evaluation and any necessary repairs be performed by a qualified electrical contractor.

Contact a qualified electrical contractor.

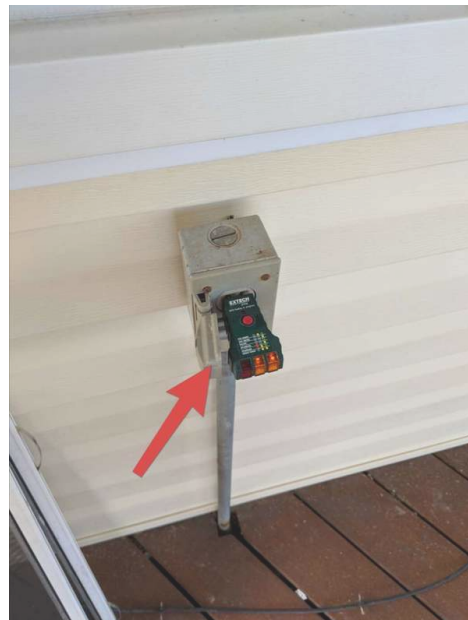
No GFCI protection was observed in all locations.

For safety reasons, the Inspector recommends that receptacles located within 6 feet of a plumbing fixture, in garages, in crawlspaces, in unfinished basements, in laundry/utility rooms/closest, and on the exterior of the home to be provided with ground fault circuit interrupter (GFCI) protection in good working order to avoid potential electric shock or electrocution hazards.

Recommend licensed electrician upgrade by installing ground fault receptacles in all locations.

Contact a qualified electrical contractor.

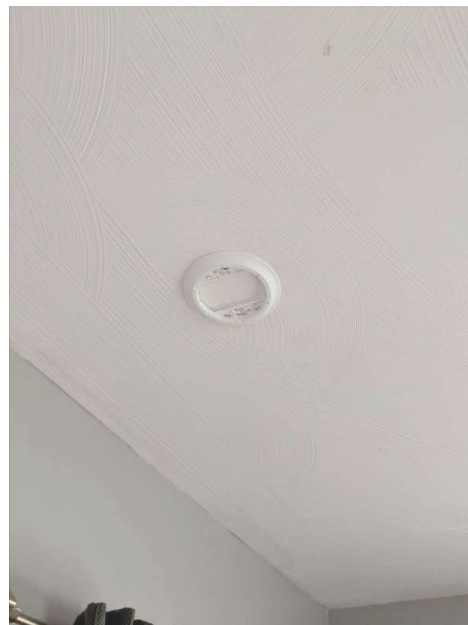
Inspector observed no or too few smoke detectors. Recommend adding smoke detectors following manufacturer and National Fire Protection Association direction. A link has been provided to the NFPA in the information section, above.

Recommended DIY Project

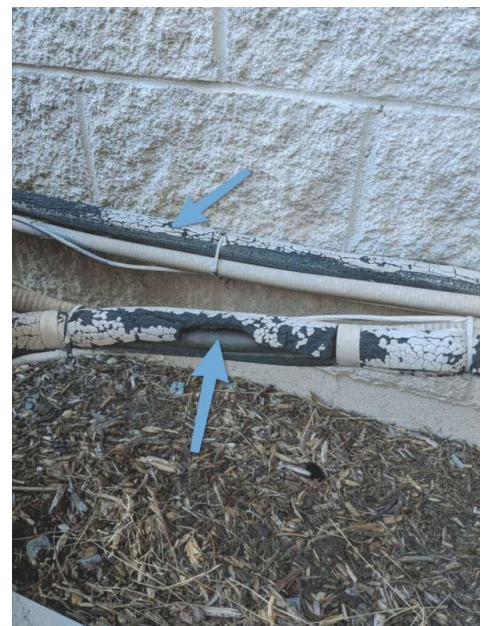
INSULATION MISSING OR DAMAGED

Missing or damaged insulation was observed on the refrigerant line. This can cause energy loss and condensation. Recommend replacing.

Contact a handyman or DIY project

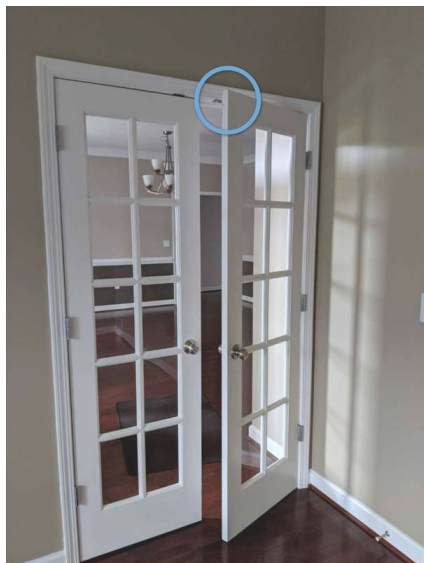
This door did not latch properly. Recommend handyman repair latch and/or strike plate.

Contact a handyman or DIY project

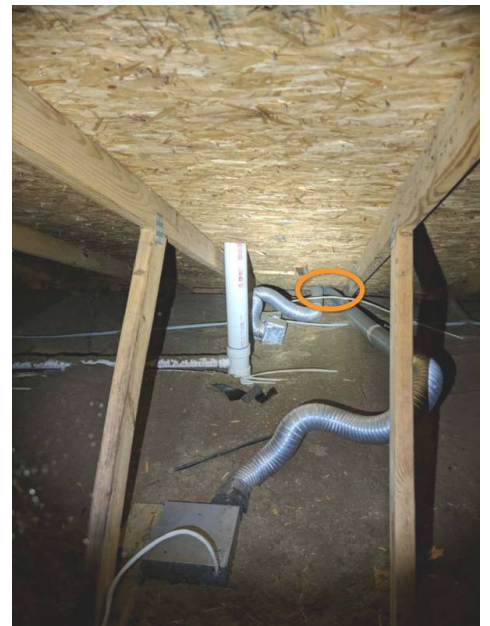
Bathroom fan vented into the attic, which can cause moisture and mold. Recommend a qualified contractor properly install exhaust to terminate to the exterior.

Contact a qualified professional.

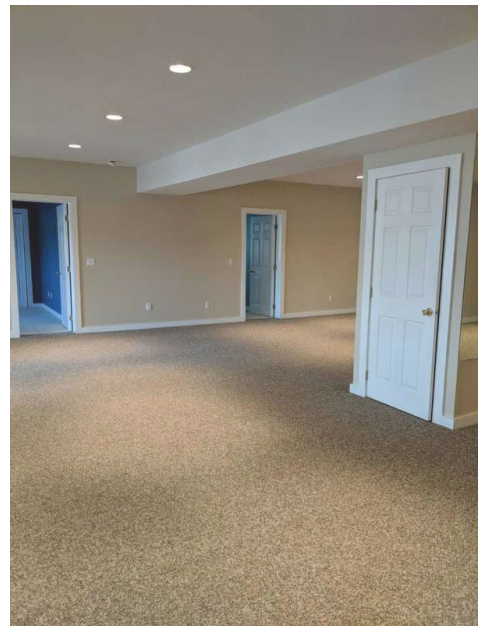
FINISHED BASEMENT

This house has a basement that is finished. Many of the components of the house could not be inspected due to being hidden behind walls, ceilings, and finished flooring.
