1234 Main St.
Kingwood TX 77339

PROPERTY INSPECTION REPORT

Concerning: 1234 Main St. Kingwood TX 77339
(Address or Other Identification of Inspected Property)

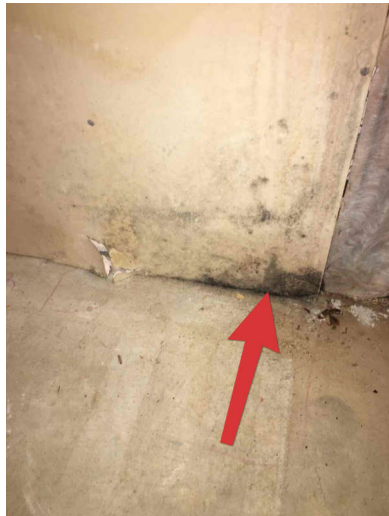
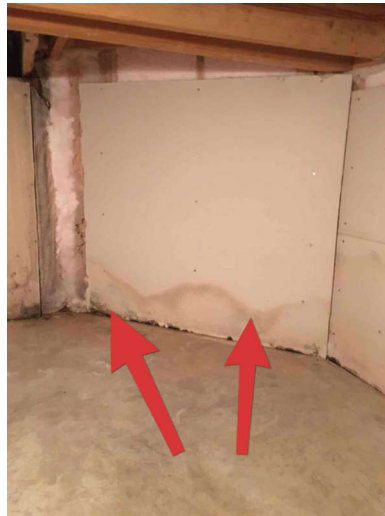
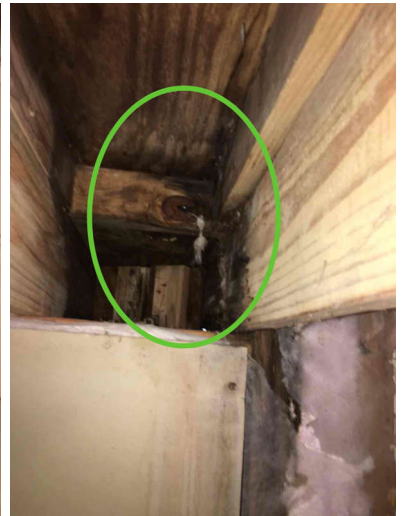
Under stairs storage area

1: Water penetration

Crawl/storage space under the interior staircase show signs of water penetration.

Recommendation: Contact a foundation contractor.

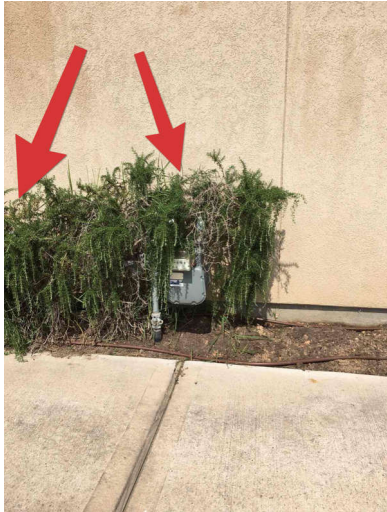
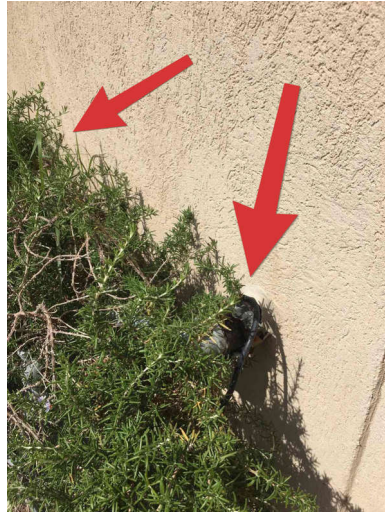
East side of house

- B. Grading and Drainage**
Plants rubbing against house. :

Several plants are brushing against the stucco siding. Plants rubbing up against siding such as stucco can lead to moisture intrusion.

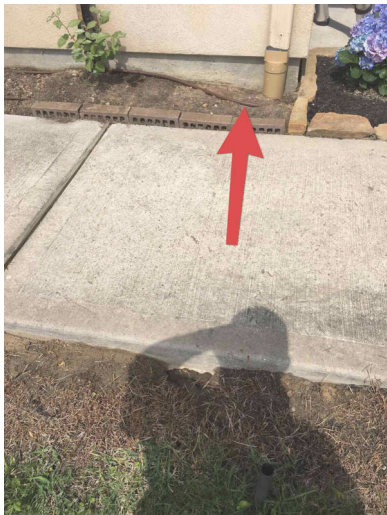
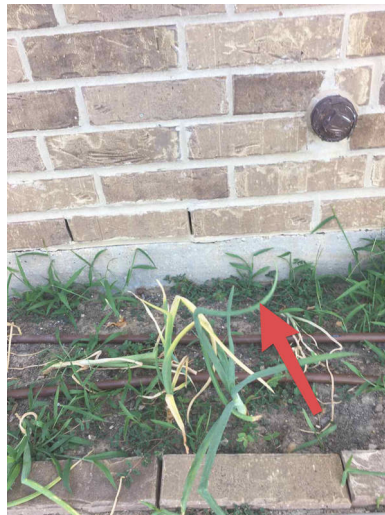
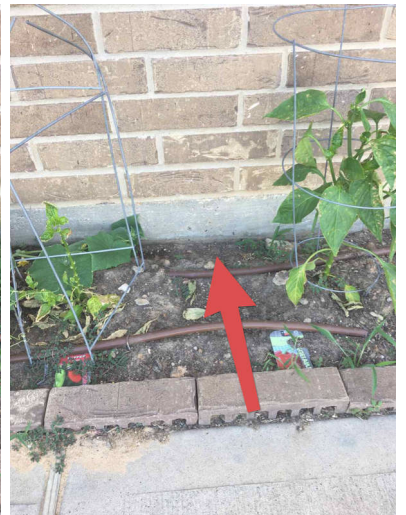
East side of house

1: Negative grading

Negative grading on the east side of building

Recommendation: Contact a qualified landscaping contractor

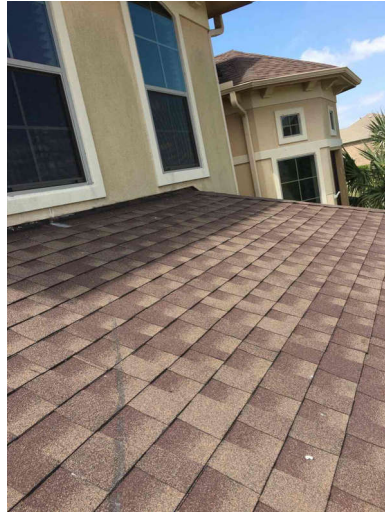
Viewed From: Roof, Roof surface (walked)

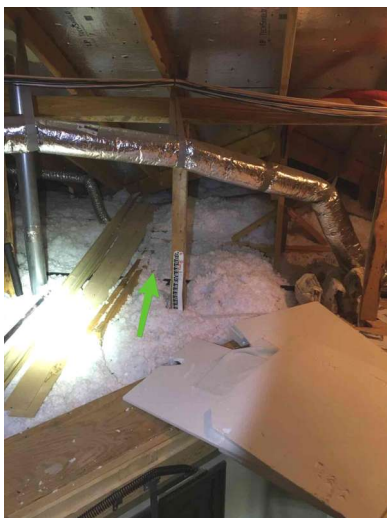
- D. Roof Structure & Attic**
Material: Wood
Type: Gable
Approximate Average Depth of Insulation: 10 Inches

Viewed From: Attic

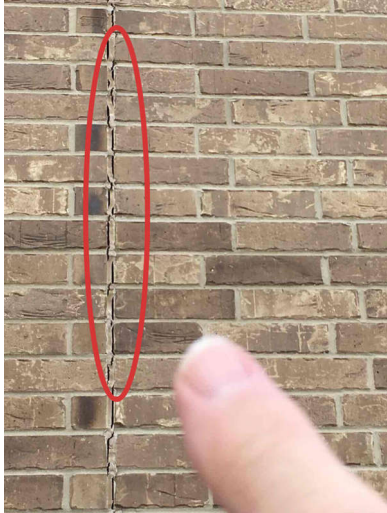
Southwest wall

The caulk in the expansion joint on the south west side of the building should be replaced.

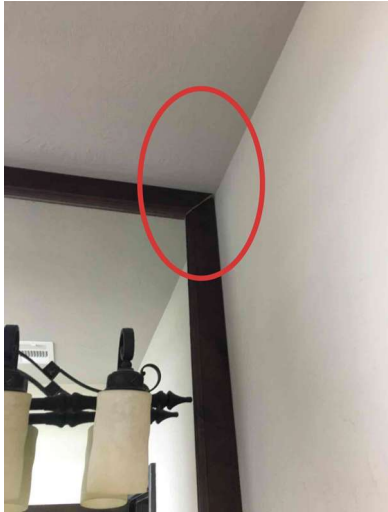
Mirror cracked:

Crack in the mirror the top corners in the master bedroom over the vanity

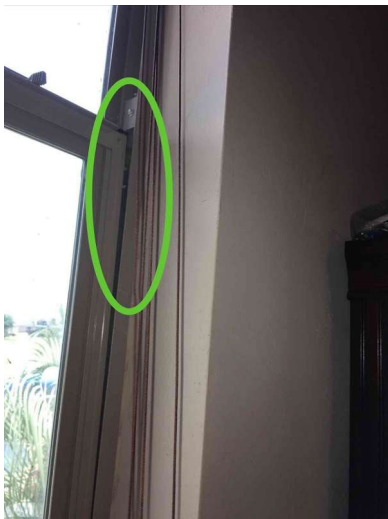
Bedroom SW side of house

Bedroom window:

When the window was open the top right part of the window leans to the left. The window is not connected properly.

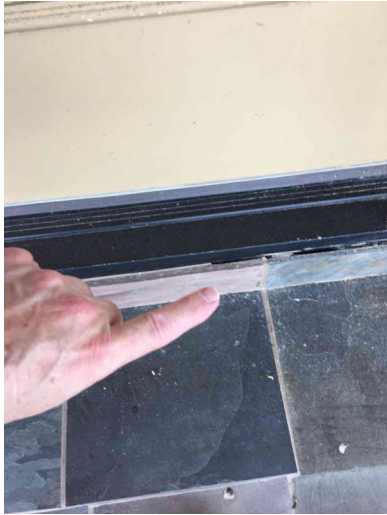
1: Step trim upper porch

Step trim upper porch below the center 2 doors is loose and should be repaired.

Recommendation: Contact a qualified deck contractor.

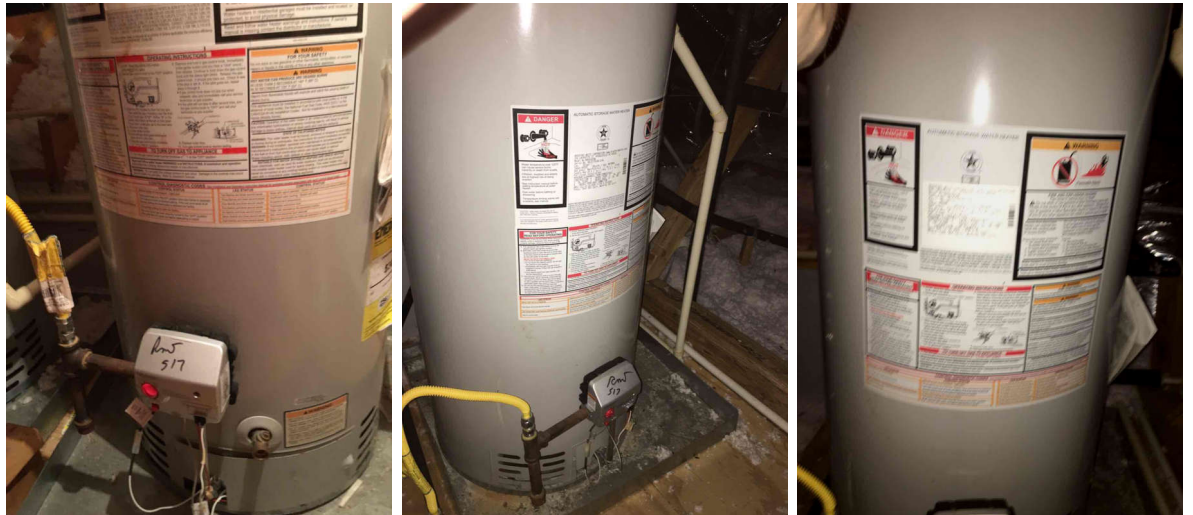
Attic

Water heaters:

There are a total of 3 water heaters in the attic. 2 are 40 gal and 1 is 50 gal.
