KEY INSPECTION SERVICES, LLC
#1 Home Education and Inspection Company

1234 Main St.
Snohomish WA 98296

11/07/2018 9:00AM

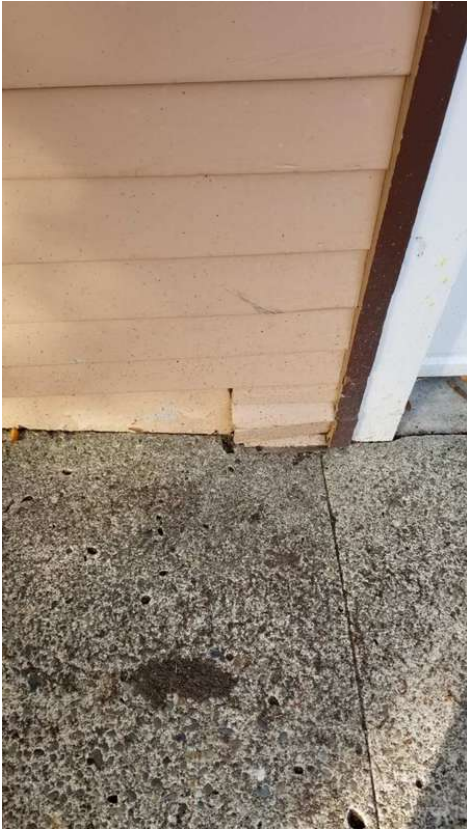
Front

DAMAGED SIDING

Siding appears to be damaged numerous locations budget for repairs. I recommend evaluation and repair as needed.

Contact a qualified siding specialist.

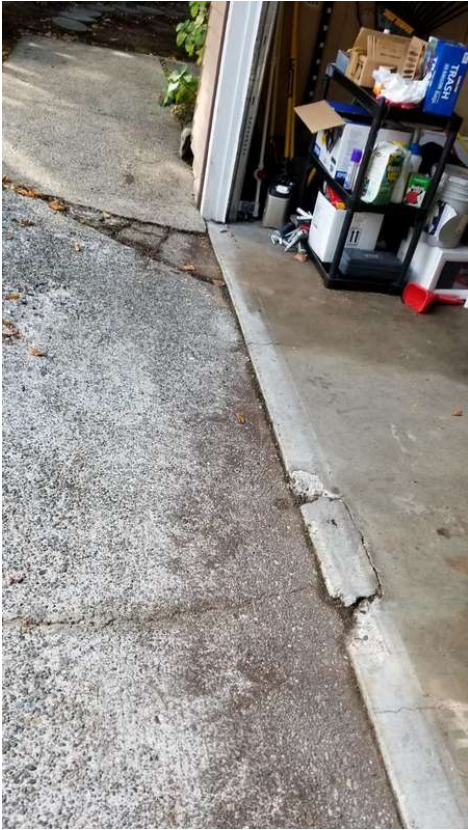
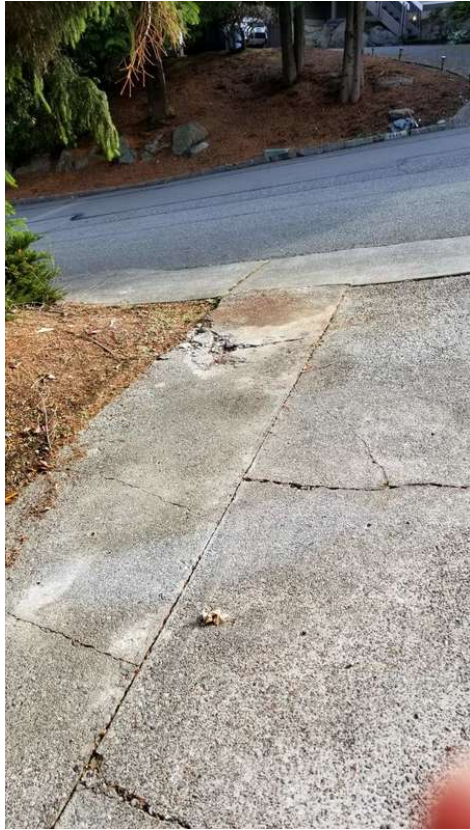
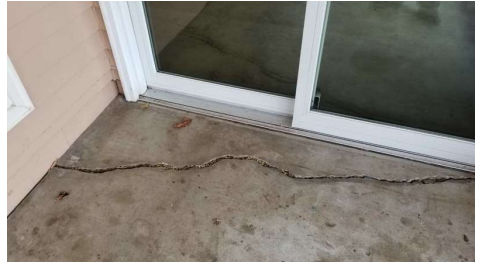
DRIVEWAY TRIP HAZARD

Trip hazards observed. Patch or repair recommended.

Recommended DIY Project

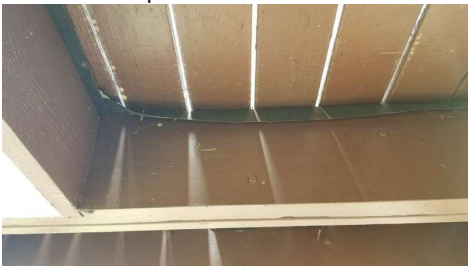
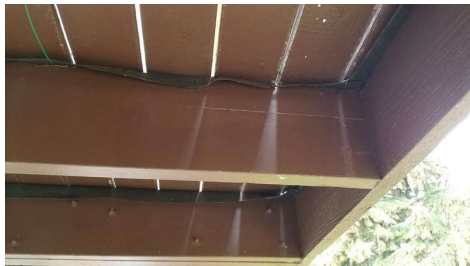
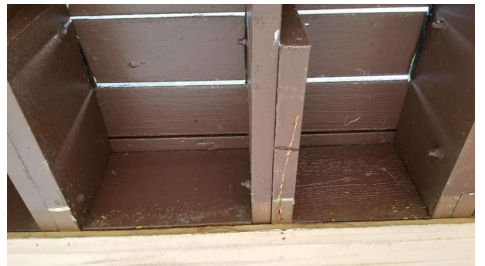
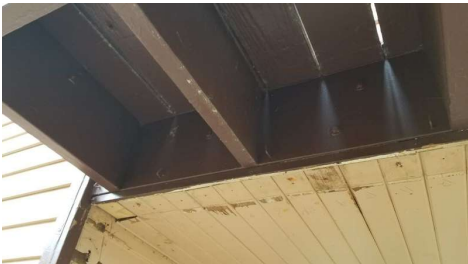
2.4.1 Decks, Balconies, Porches & Steps
NON-STANDARD INSTALLATION

Cantilever decking improper installation with sistered joists this can trap moisture and cause rot. Appears a structure was built on top of a deck. Recommend a 2nd story decking contractor evaluate for repair/replacement.

Contact a qualified deck contractor.

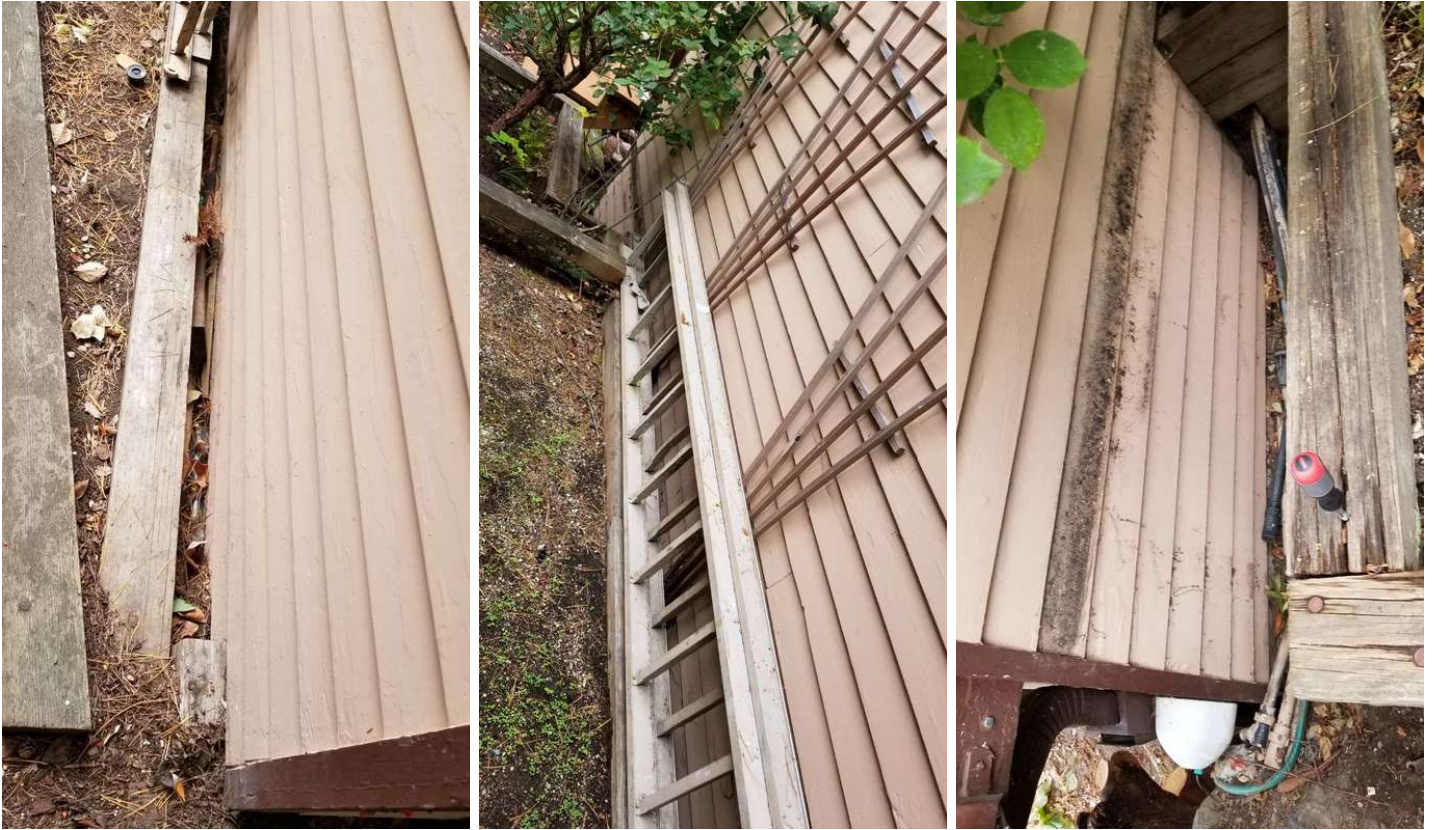
2.6.3 Vegetation, Grading, Drainage & Retaining Walls

There appears to be soil to wood contact. This is a conducive condition to potential rot. I recommend a qualified landscape professional to repair or replace as necessary.

Contact a qualified landscaping contractor

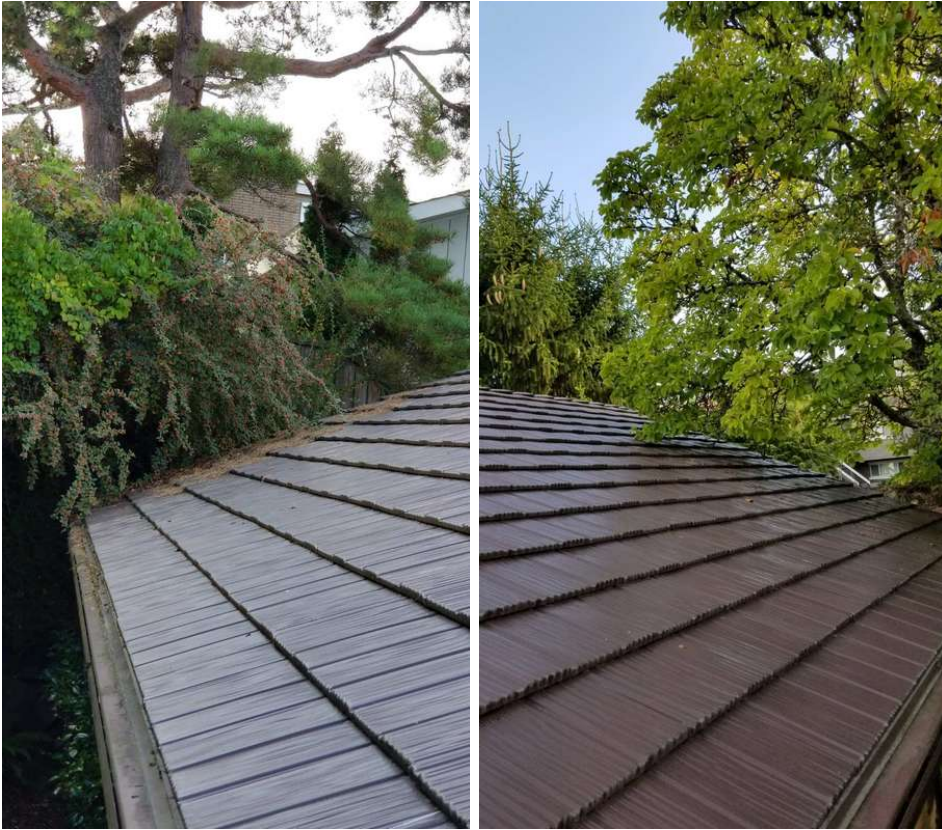
Trees hanging over roof need to be cut back to prevent damage to the structure.

Contact a qualified professional.

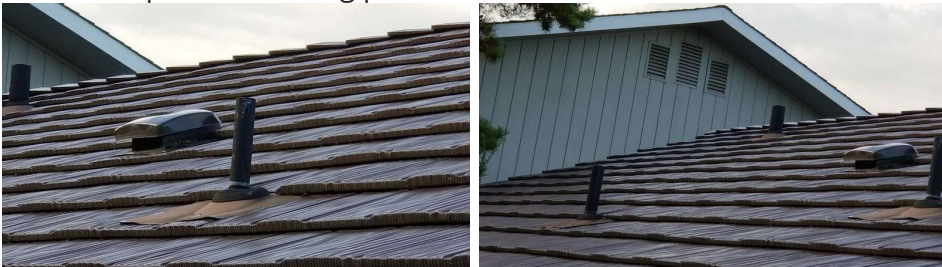
3.2.1 Roof Drainage Systems

IMPROPER FLASHING SYSTEM

Poor flashing system installed on rubber boots for plumbing. Signs of inverted flashing system budget for repairs.

Contact a qualified roofing professional.

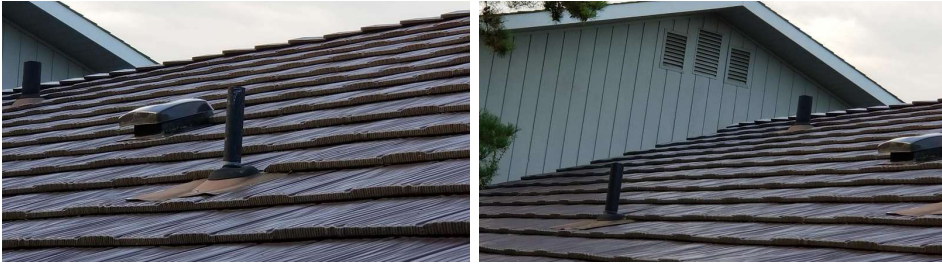
3.3.1 Flashings

IMPROPER FLASHING SYSTEM

Contact a qualified roofing professional.

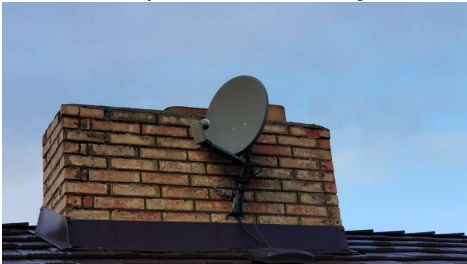
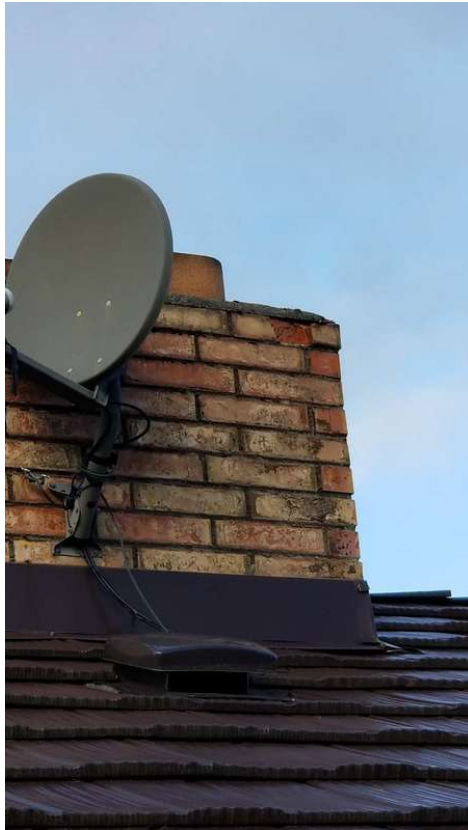
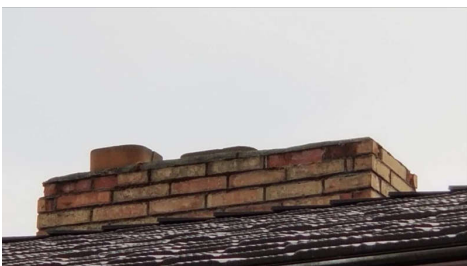
MISSING SPARK ARRESTOR

Missing spark arrestor on top of chimney. A missing spark arrestor can allow pest entry into the chimney, allow water to enter the chimney and freeze, potentially damaging the firebox/damper/chimney/etc., as well as allowing fire embers to exit the home, potentially leading to fire hazards. Recommend a qualified chimney sweep evaluate for cleaning and repairs.

Cracked bricks recommend further review.

Contact a qualified chimney contractor.

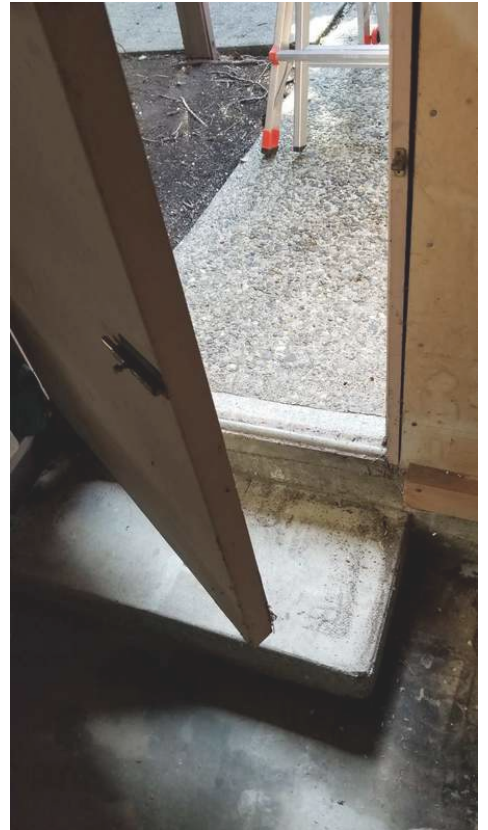
4.4.2 Occupant Door (From garage to inside of home)

The garage door opens over a step down. This is a potential safety hazard due to the possibility of a person entering without knowing a step is there. I recommend repair for increased safety.

Contact a qualified door repair/installation contractor.

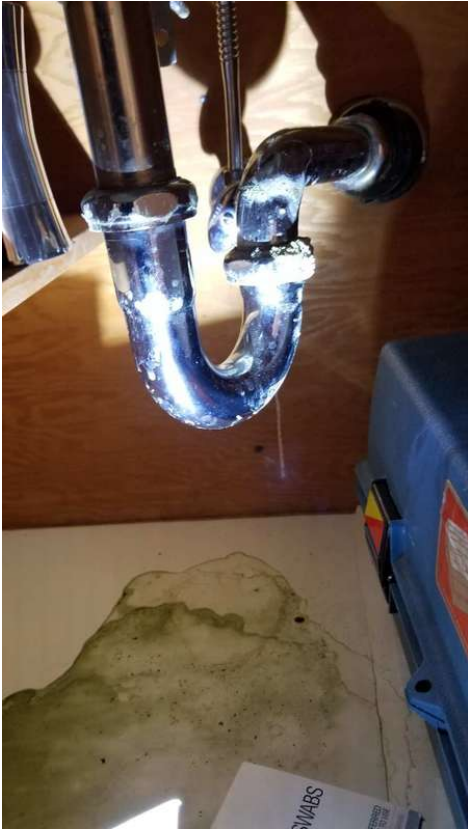
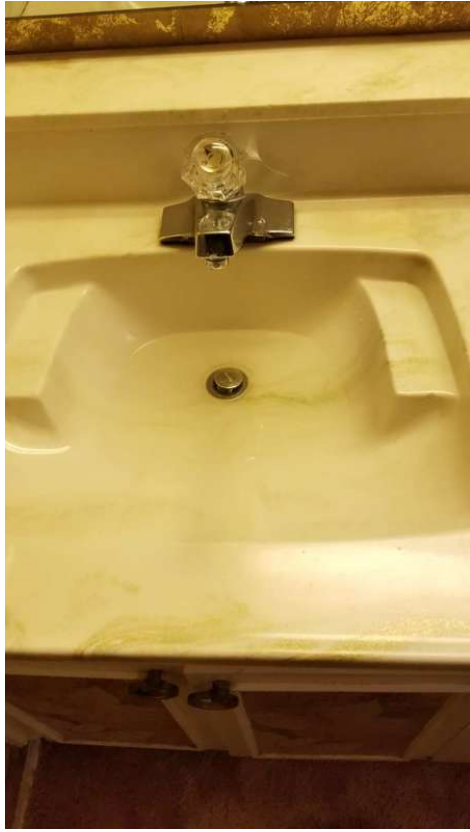
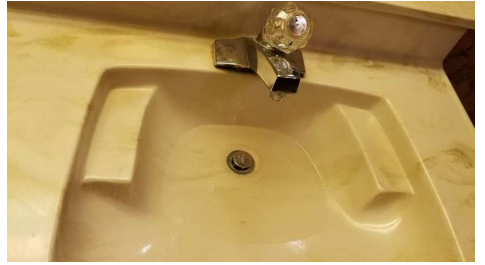
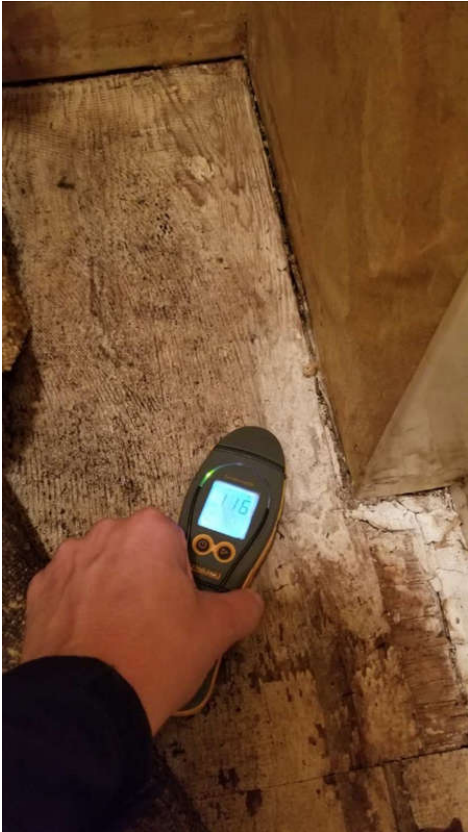
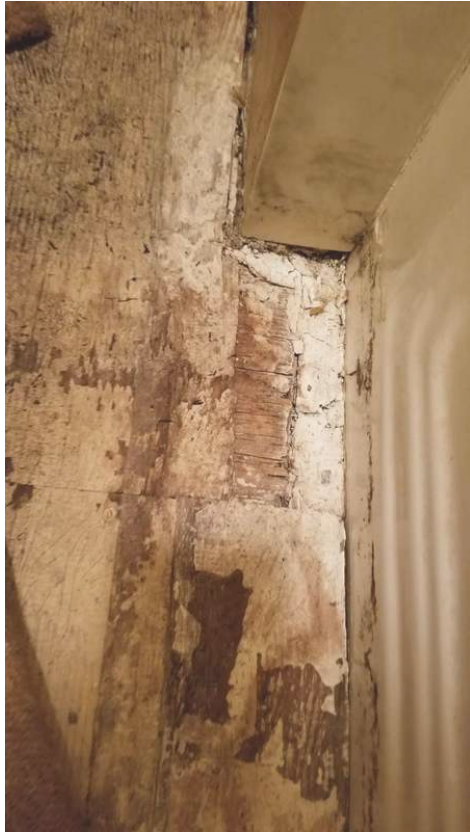
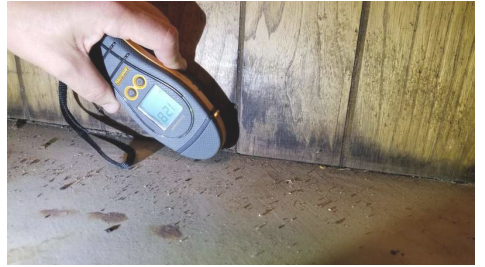
Master bathroom

DRAIN LEAKS

Leak noticed in the drain lines in the bathroom sinks. We recommend a qualified plumbing contractor evaluate and repair/replace as needed.

Rotting floor master

Contact a qualified plumbing contractor.

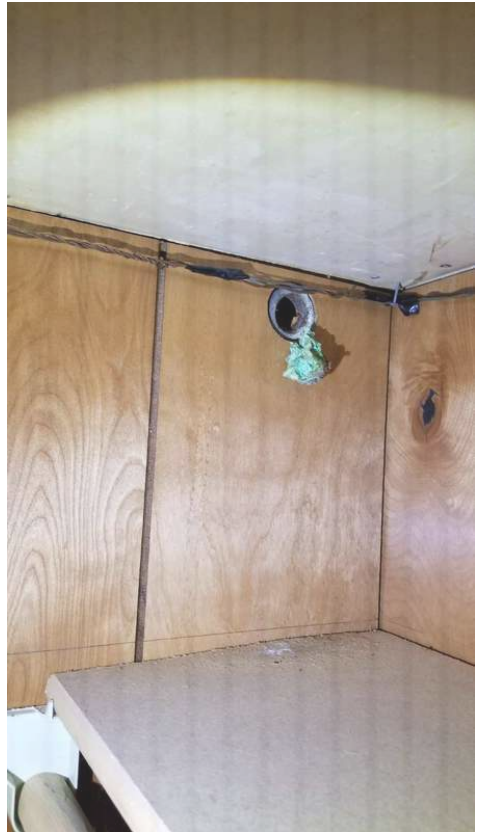
6.1.2 Drain, Waste, & Vent Systems

Unknown plumbing-venting room in the front right of the basement. This is not a proper living space as there is not proper ingress-egress due to fire safety standards. Inquire with seller for further details on history of repairs.

Contact a qualified professional.

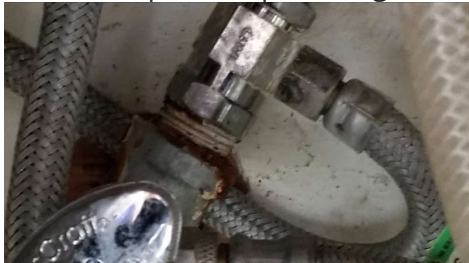
Kitchen

DISTRIBUTION PIPE LEAKING

Distribution pipe appeared to be leaking. Recommend a qualified plumber evaluate and repair. Aged galvanized plumbing with signs of corrosion and leakage throughout the home. Recommend budgeting for complete replacement.

Contact a qualified plumbing contractor.

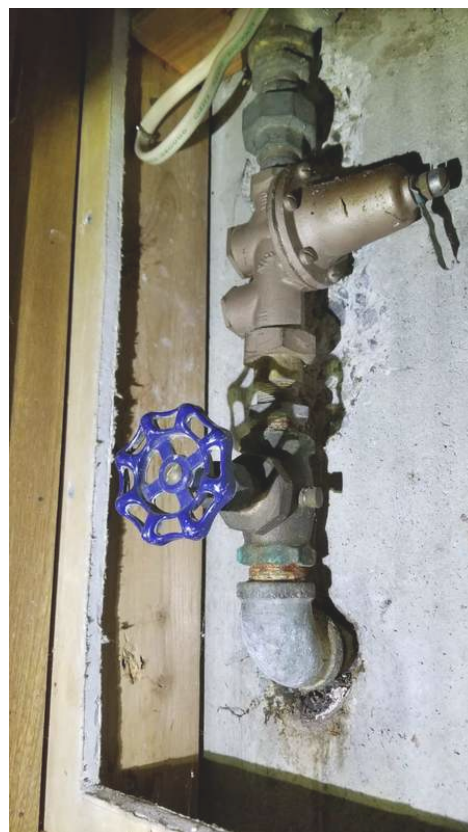
Safety Hazard**MAIN WATER SUPPLY PIPE CORRODED**

Main water supply pipe was heavily corroded. This can lead to shortened lifespan of the pipe. Recommend a qualified plumber repair.

Contact a qualified plumbing contractor.

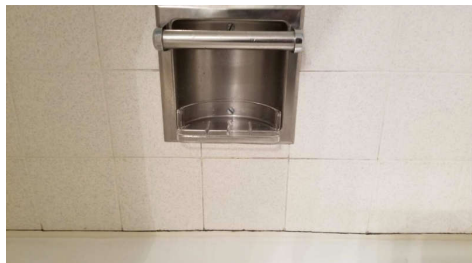
Shower showing signs of moisture intrusion. High likelihood of rot damage behind the wall due to the construction methods of the time period (i.e. sheetrock only). We recommend budget for rebuilding the shower surrounds.

Guest bath tile movement

Contact a qualified tile contractor

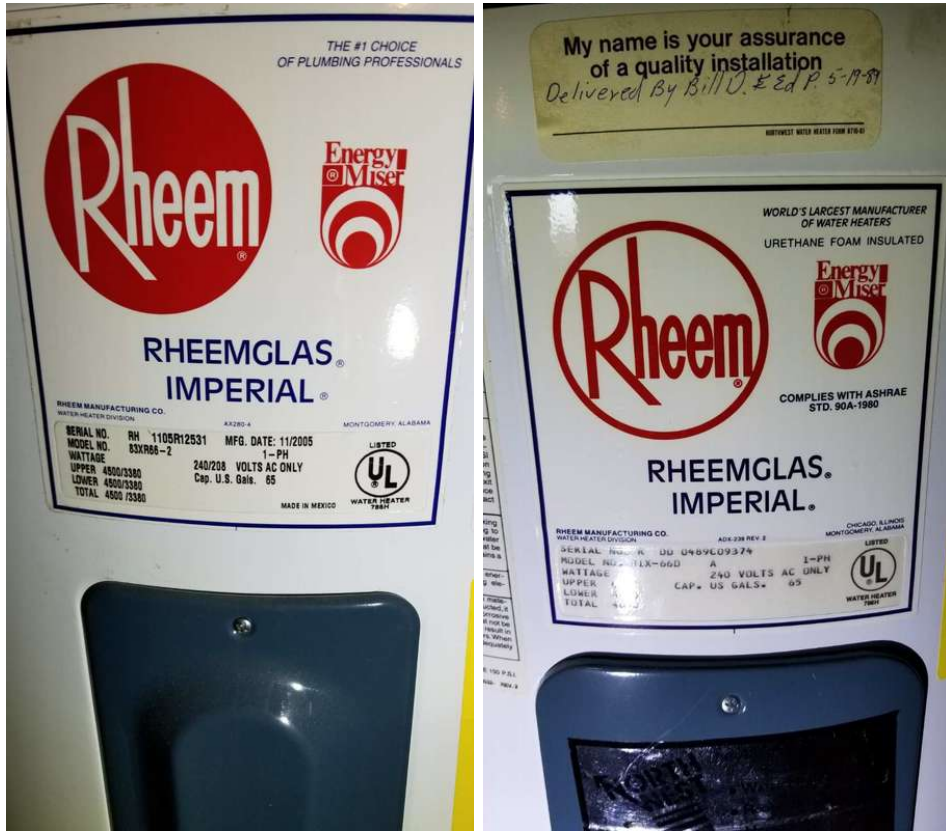
6.3.1 Hot Water Systems, Controls, Flues & Vents

The water heater is nearing the end of its design life. Standard life is 8-12 years this water heater appears to be 12 & 19 years old. No obvious leaks or rust at time of inspection. I recommend budgeting for repair/replacement.

Contact a qualified plumbing contractor.

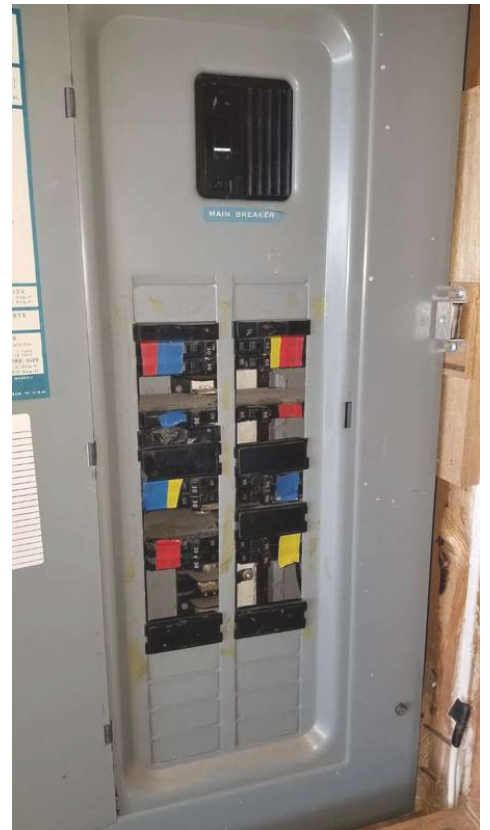
7.2.1 Main & Subpanels, Service & Grounding, Main Overcurrent Device

TWIST OUTS MISSING

Twist-outs/knock-outs missing at electrical panel. This has a potential for improper human contact. Generally, a simple fix by a qualified professional but does pose a safety hazard. Immediate correction is recommended.

Contact a qualified electrical contractor.

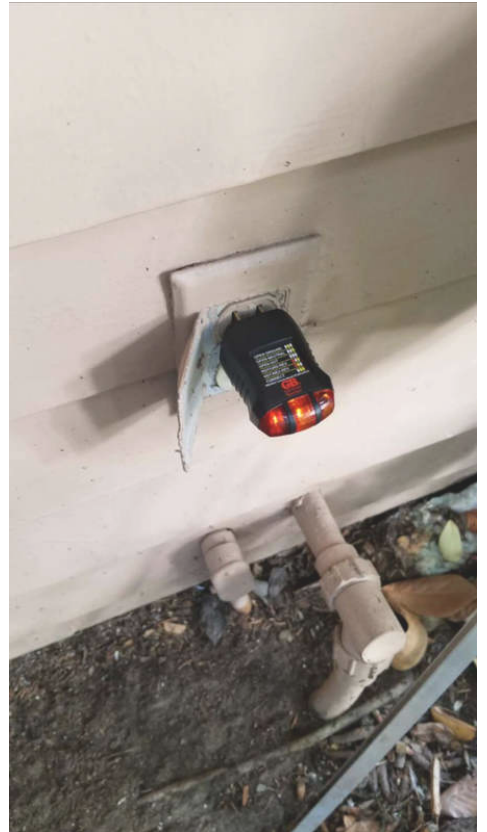
Front reverse polarity

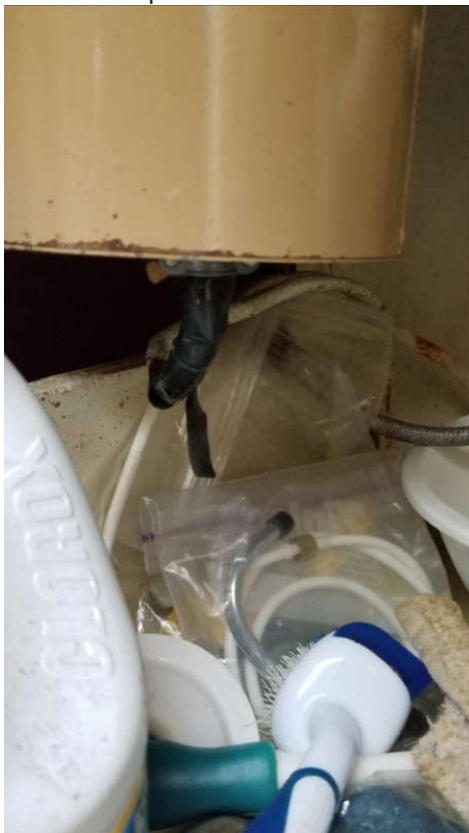
Kitchen

Safety Hazard**EXPOSED WIRE IN CABINET**

All exposed wiring for the lights in the cabinets should be properly protected with conduit. I recommend a qualified electrical contractor repair/replace as needed for increased safety.

Contact a qualified electrical contractor.

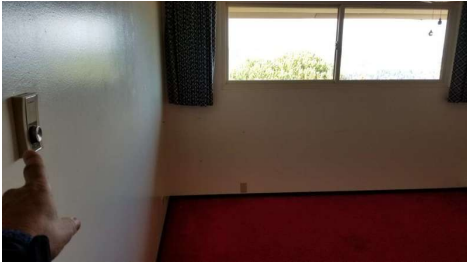
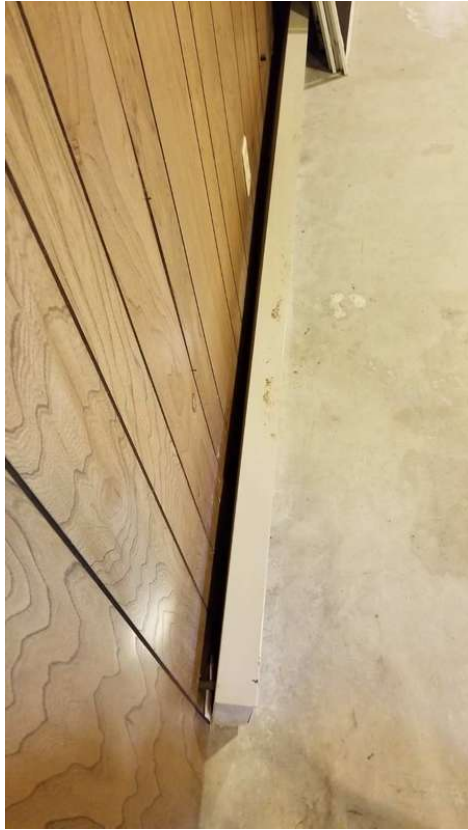
The room appears to be missing any heat source at the time of inspection. I recommend a qualified electrician to repair replace as necessary. Unable to verify operation of electric heat, in ceiling, floors or walls. The aged baseboard heating system was detached from the wall numerous location and not tested due to safety hazard potential. Recommend a qualified HVAC contractor reevaluate the entire heating system for repair/replacement. Hydronic heating may be a great upgrade.

Contact a qualified electrical contractor.

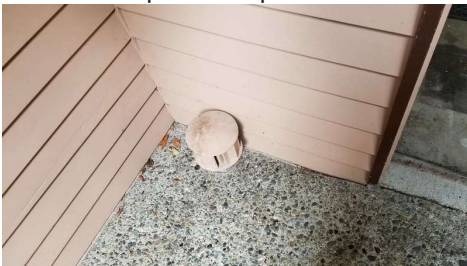
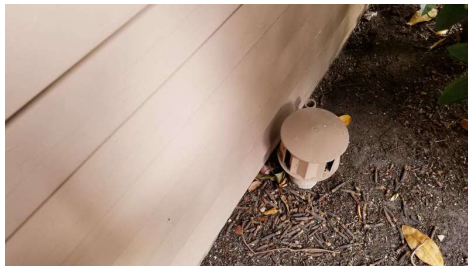
8.3.1 Vents, Flues & Chimneys

NONSTANDARD LOCATION

Contact a qualified professional.

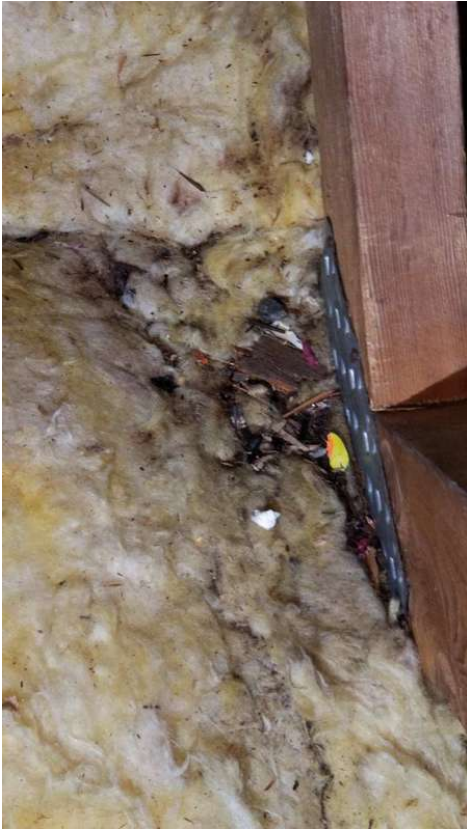
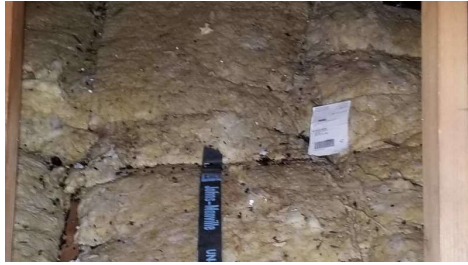
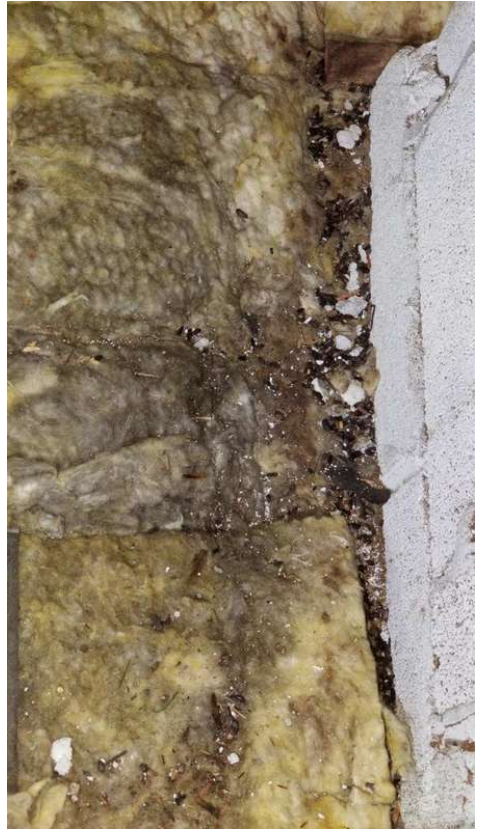
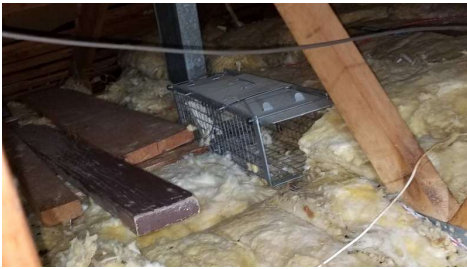
Rodent activity noted in the attic area. I recommend contacting a qualified Pest Control Operator to remedy the situation and re-inspect the area. This will include but not limited to removing all rodents, rodent droppings, repairing/replacing, all damaged materials <i.e. insulation, electrical, etc.>, inquiring with the sellers on the history of rodent activity/infestation. Followed by taking the proper steps to ensure no future infestation will occur. Due to the common nature of rodent accessing different areas of the home I recommend these steps also be taken in any other areas where pest activity/infestation has occurred.

Contact a qualified pest control specialist.

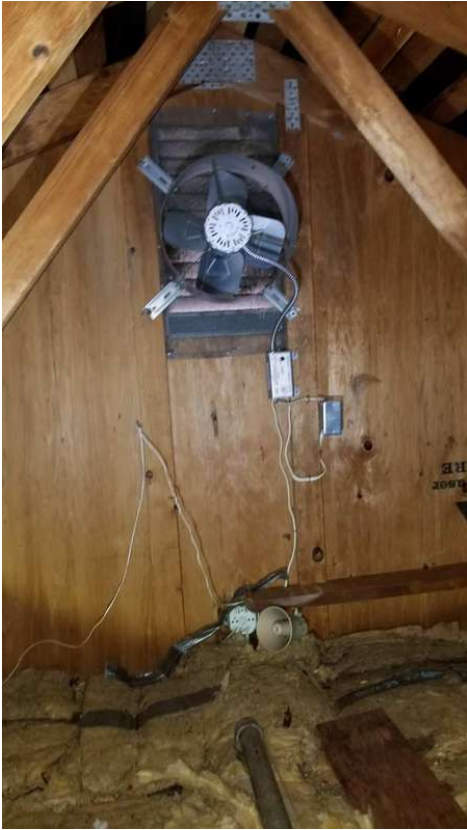
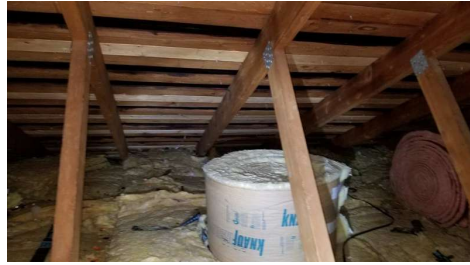
9.3.1 Ventilation

NON-OPERABLE FAN

The fan appeared to be non-operable at the time of Inspection. I recommend a qualified HVAC technician to repair/replace.

Soffit vents not installed. Non-standard electrical installation in attic. Refer to electrician for repair/replacement.

Contact a qualified HVAC professional.

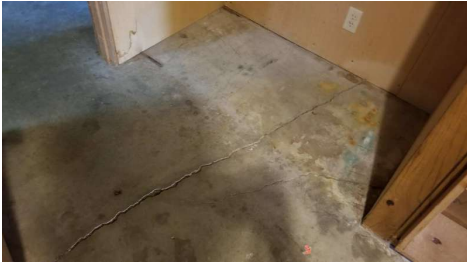
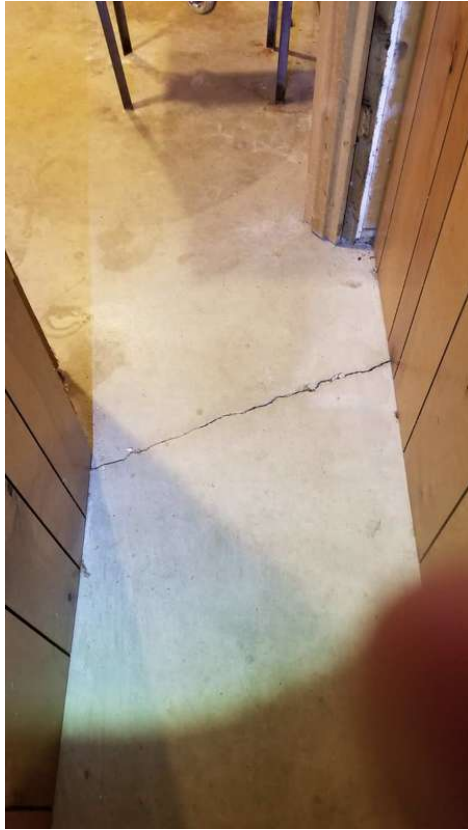
10.1.1 Foundation, Basements and crawlspace.

10.1.1 Basement, Foundation, Crawlspace & Structure - Foundation, Basements and crawlspace.: Foundation Cracks - Minor
-

Contact a qualified structural engineer.

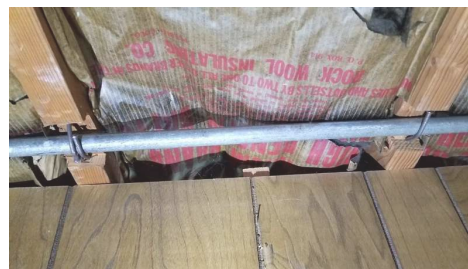
10.4.1 Structural System (Walls-Ceilings-Floors)

10.4.1 Basement, Foundation, Crawlspace & Structure - Structural System (Walls-Ceilings-Floors): Floor joist notched
-

Contact a qualified general contractor.
