ROYAL INSPECTIONS LLC

RESIDENTIAL REPORT COPY

1234 Main St.
Salem OR 97301

Buyer Name
07/08/2018 9:00AM

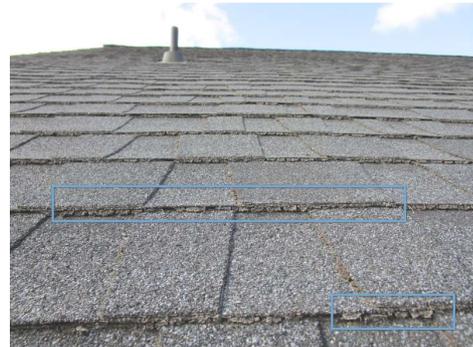
2.1.1 Coverings

The front roof section of the house had minor moss accumulation. This type of moss is trying to get underneath the shingles and lift them off of their mastic strip. When this type of moss is allowed to develop, it ruins your roof and causes you to have to prematurely replace it. It looks as if it may have been treated at one time and may not be alive, but should still be removed.

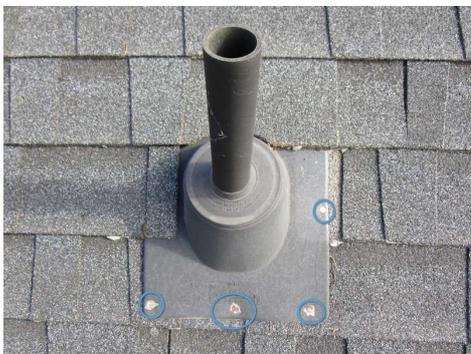
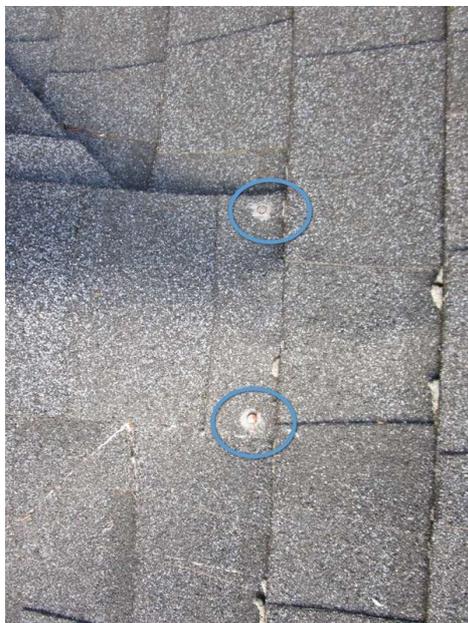
2.1.2 Coverings

RUSTY NAIL HEADS

There were several nail heads that had rusted, and the caulking / sealant had worn away. I recommend resealing these nails to prevent water damage.

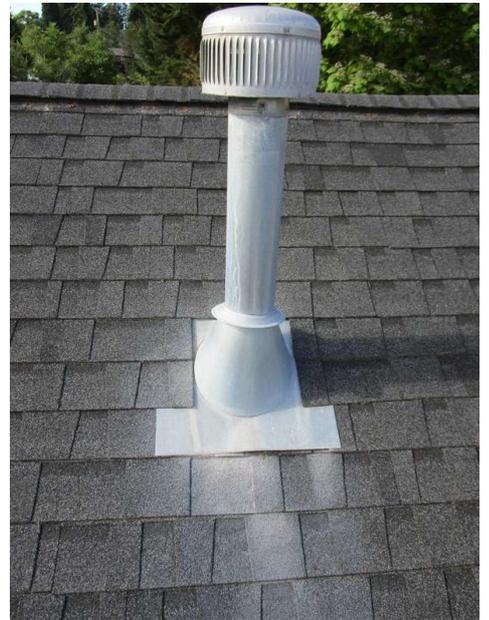
2.3.1 Skylights, Chimneys & Other Roof Penetrations

WHITE ROOF STAIN UNDER EXHAUST VENT

White deposits on combustion vents, or on the roof below them, are evidence that excessive condensation has been forming. The roof stain does not appear to have damaged the roofing material. I recommend monitoring the stain below the vent, and if it gets much bigger calling an HVAC professional for an evaluation.

Contact a qualified professional.

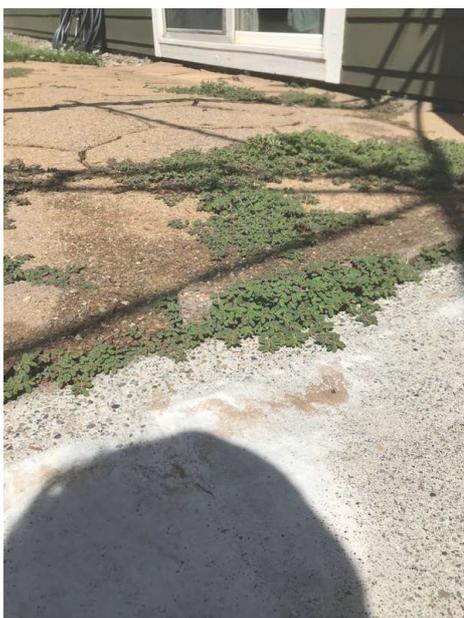
Vegetation, Grading, Drainage & Retaining Walls: Grading / Lot Drainage

Grading is inspected to determine that it allows rainwater to adequately drain away from the structure. The soil is recommended to slope away from the home 6 inches in elevation within the first 10 feet from the structure (5% grade). Any flat or low areas around the home should be backfilled and sloped away from the foundation to prevent potential moisture infiltration into areas below grade.

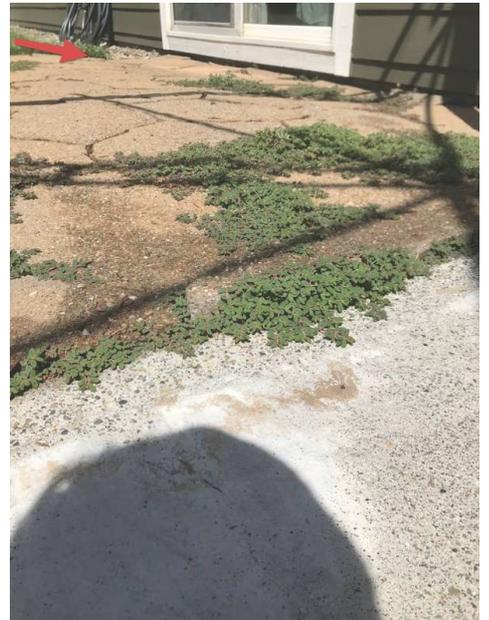
3.1.1 Walkways, Patios & Driveways

The walkway has a negative slope and drains towards the structure. Recommend repair.

Contact a qualified professional.

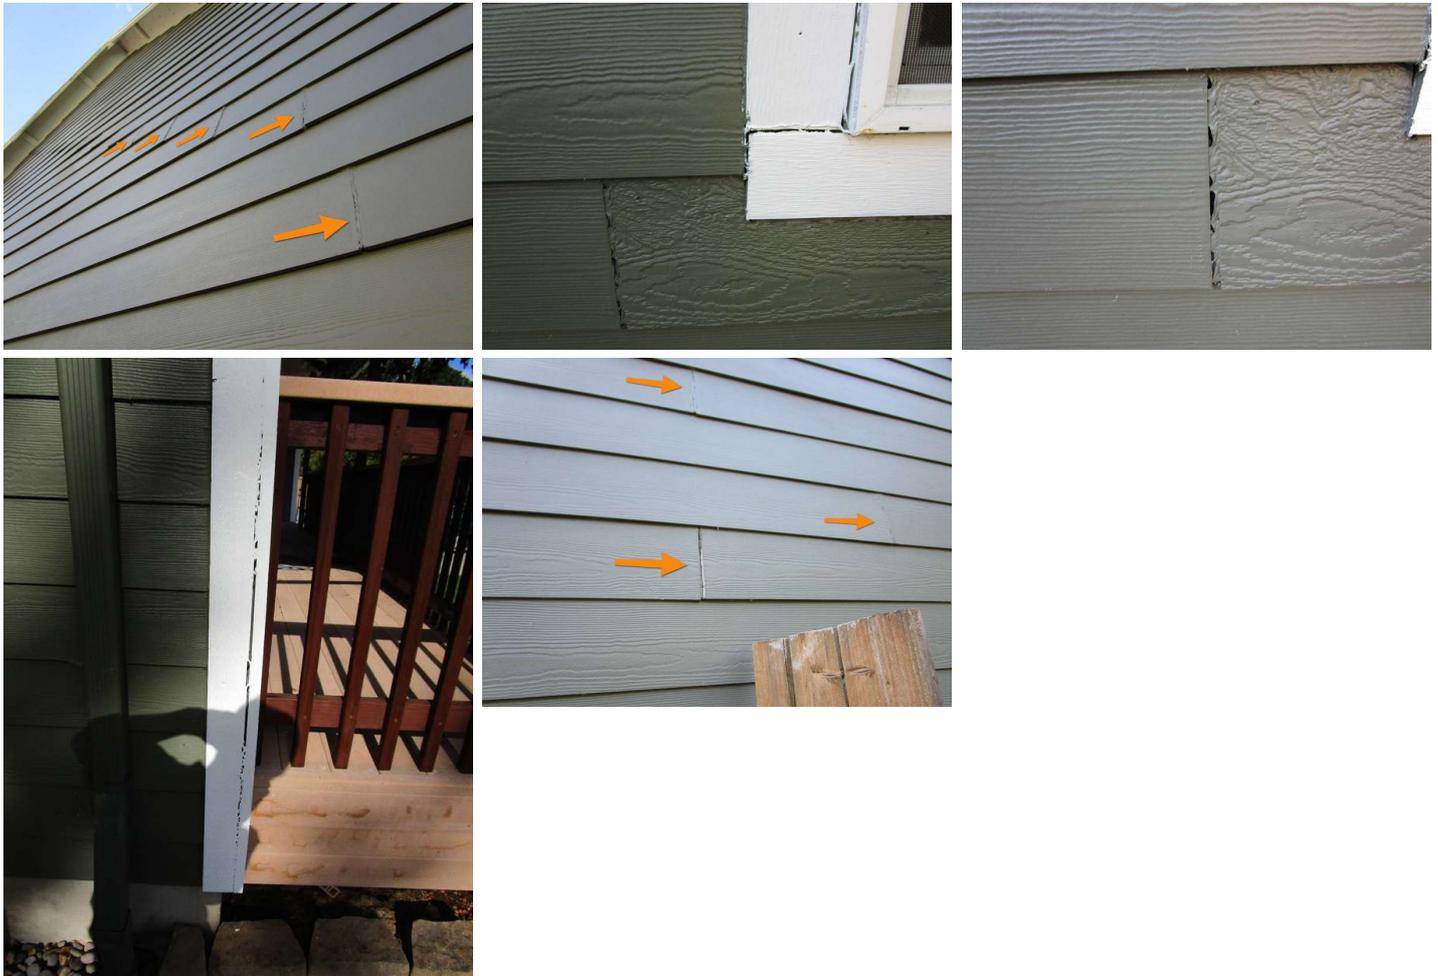
CAULKING FAILURE

Caulking around windows and doors and / or siding joints was failing in some areas. This is common, but is an entry point for water which can deteriorate wood and potentially create structural insufficiencies. It is recommended that the failing caulking be cut out and new caulking reapplied and painted.

Contact a qualified siding specialist.

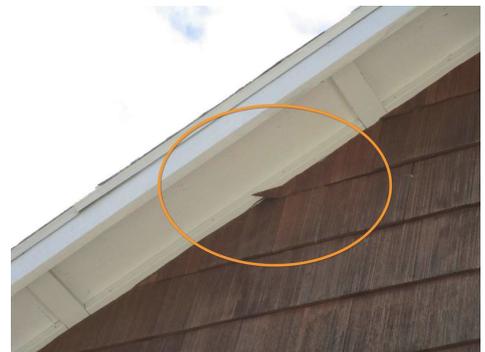
4.1.2 Siding, Flashing & Trim

LOOSE BOARDS

One or more siding boards were loose, which could result in moisture intrusion. Recommend repair.

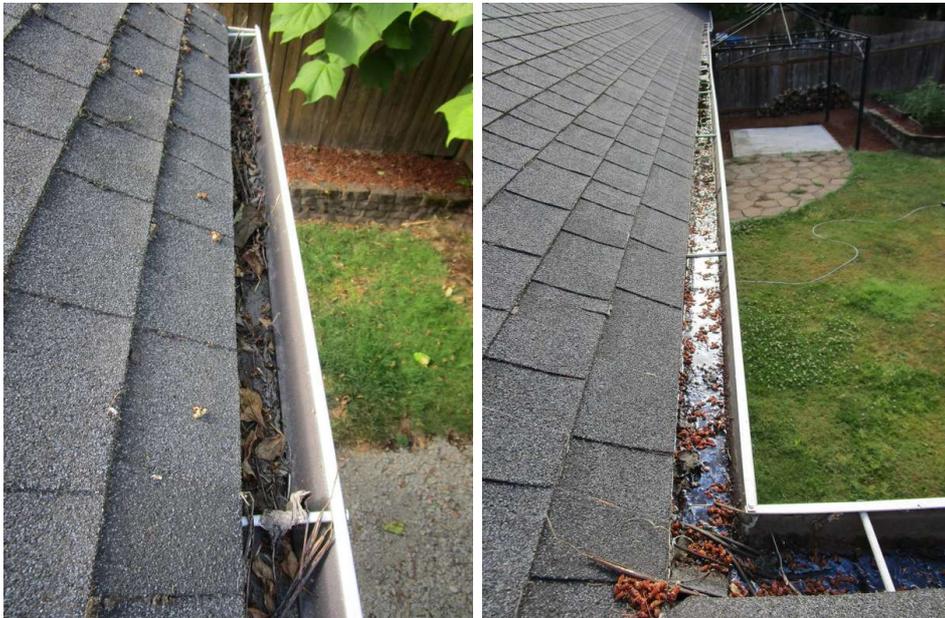
4.3.1 Roof Drainage Systems

DEBRIS

Debris has accumulated in the gutters. Recommend cleaning to facilitate water flow.

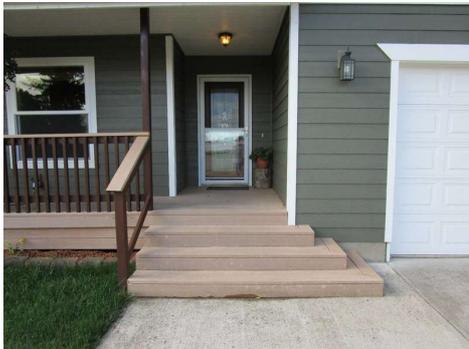
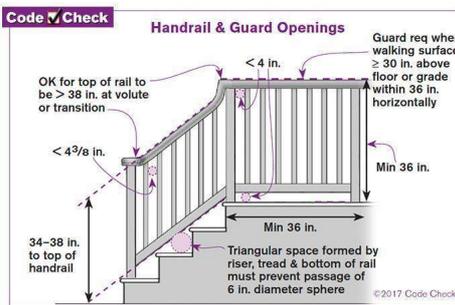
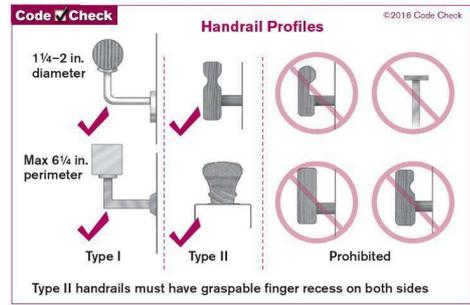
4.4.1 Decks, Balconies, Porches & Steps

RAILING UNSAFE

There is an unsafe opening in the railing. The spacing on the rail should not exceed 4". An opening greater than 4" is a safety hazard especially for children as their head or other body part can become trapped or fall through. The stair hand rail also needs to be graspable. Recommend Repairs to the front porch hand rail.

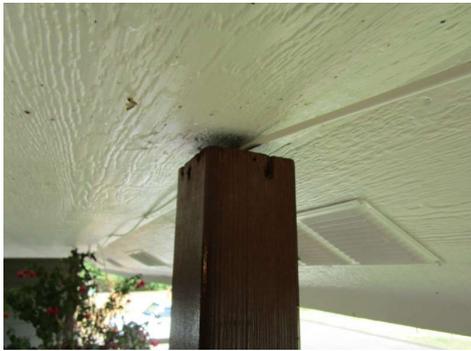
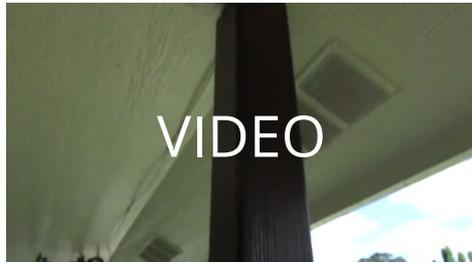
4.4.2 Decks, Balconies, Porches & Steps

The tops of the 4x4 posts on the front porch are not attached / secured to the ceiling structure. Recommend repair by a qualified professional.

Contact a qualified professional.

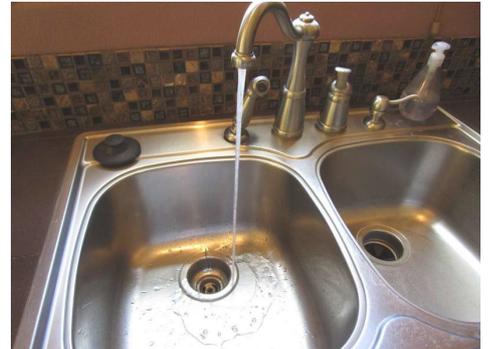
POOR WATER FLOW

The kitchen sink appeared to have low water flow at the time of the inspection. Other fixtures had proper flow which leads me to believe it is just a plugged aerator on the end of the spout. Recommend cleaning.

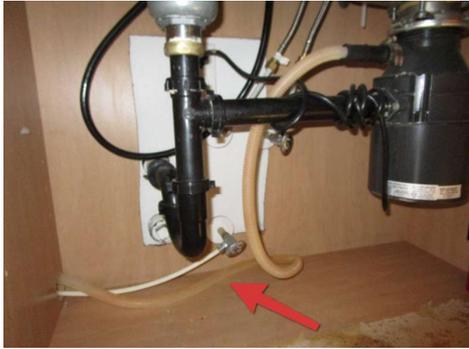
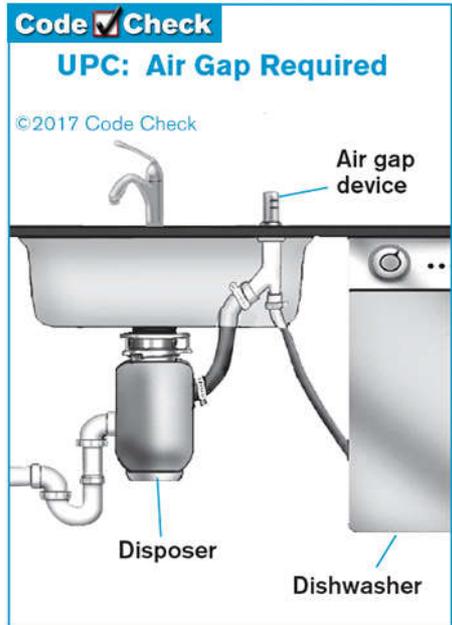
5.1.2 Kitchen Overview

IMPROPER AIR GAP

Recommend adding / repair of air gap between kitchen sink and dishwasher. This is to prevent dirty water from the dishwasher from backing up into the sink.

Contact a qualified plumbing contractor.

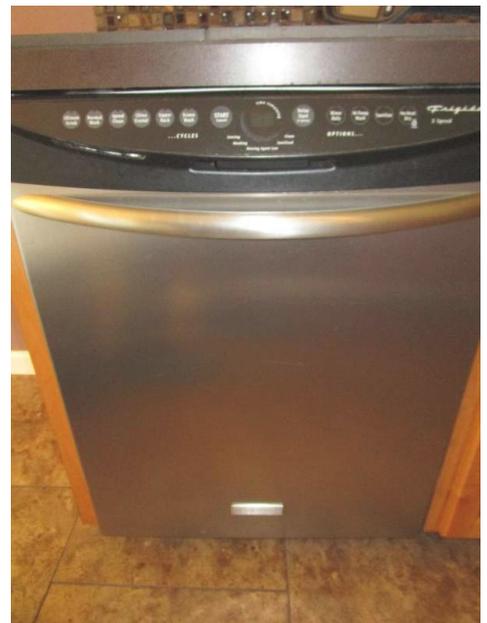
5.3.1 Dishwasher

INOPERABLE

Dishwasher was inoperable using standard controls. The unit would only display a CL code and would not begin it's wash cycle. Upon further research the CL code stands for door ajar. I recommend asking the home owners if they had any problems with the dishwasher not operating correctly and recommend a qualified person to repair as needed.

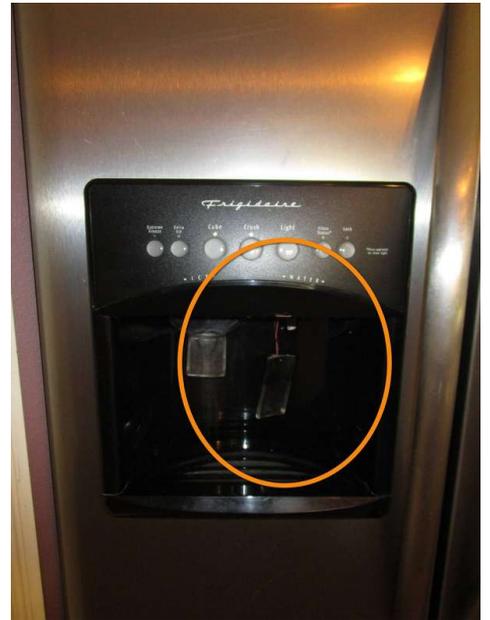
5.5.1 Refrigerator

WATER DISPENSER BROKEN

The water dispenser was clearly broken and dangling by it's electrical wires. Recommend a qualified person repair.

Contact a qualified professional.

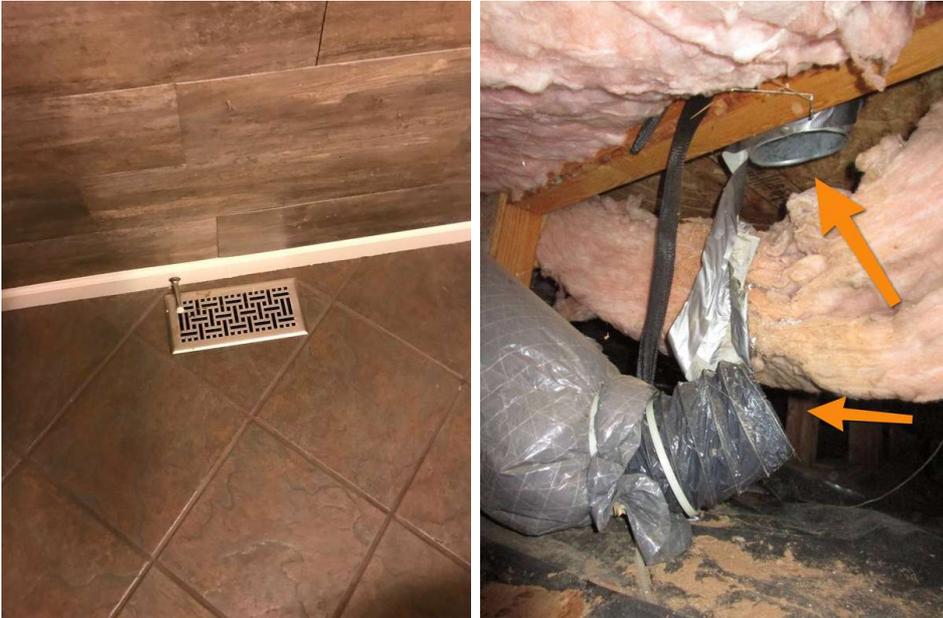
The ducting under the house to the hall bath had fallen off the heat register and was blowing cold / hot air under the house. Recommend Repair.

Contact a qualified professional.

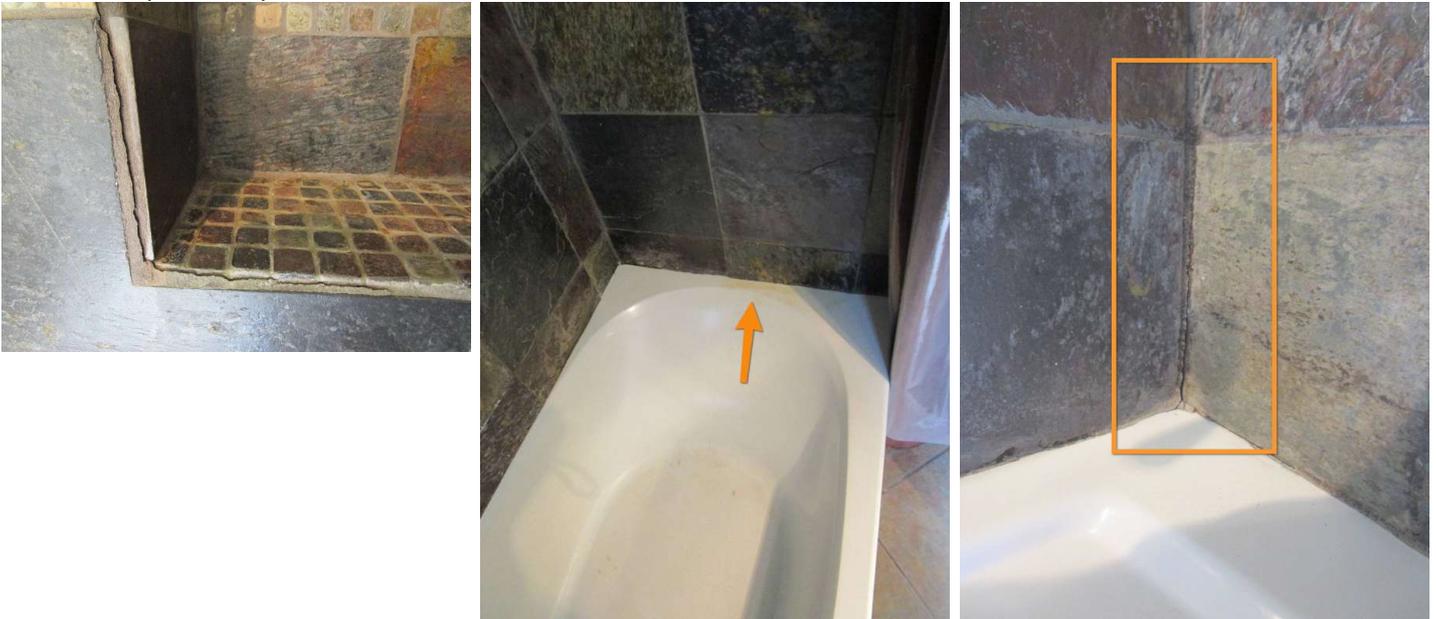
6.7.1 Shower(s)

Cracks in grout in some areas of tiled shower in master bath. Recommend sealing these areas so water does not penetrate into the wall causing further damage.

Contact a qualified professional.

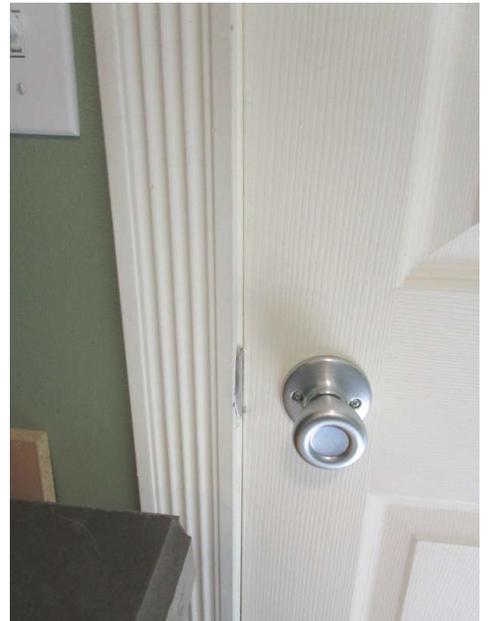
7.1.2 Doors

Door sticks and is tough to open. Recommend sanding down offending sides.

[Here is a helpful DIY article](#) on how to fix a sticking door.

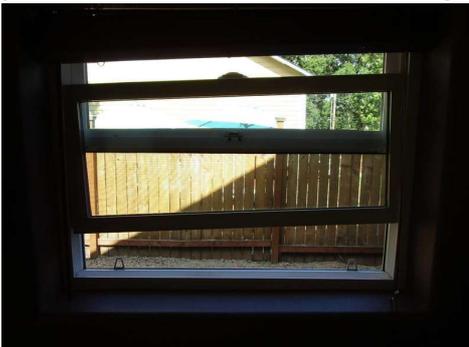
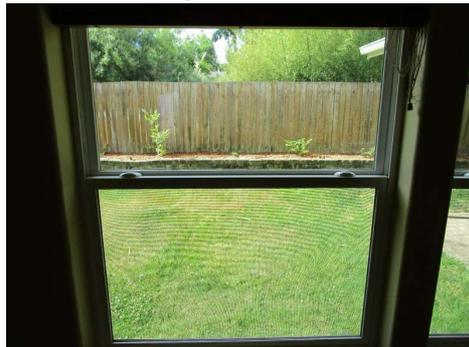
7.2.1 Windows

DAMAGED

One or more windows appears to have general damage, but are operational. Recommend a window professional clean, lubricate & adjust as necessary.

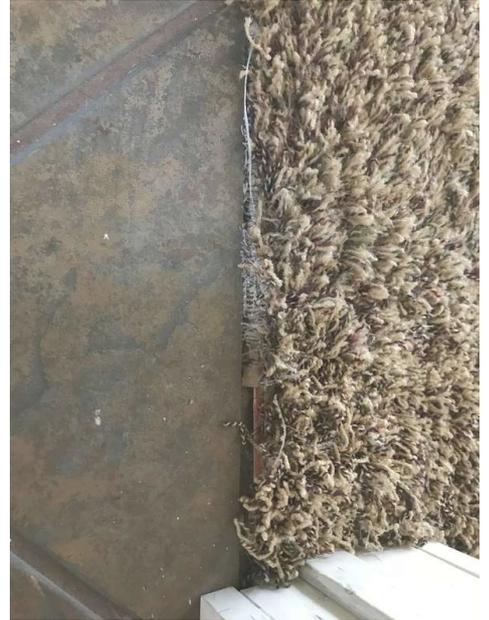
7.3.1 Floors

MASTER BEDROOM

The carpet had pulled off the tack strip in one or more areas. Recommend service by a qualified contractor.

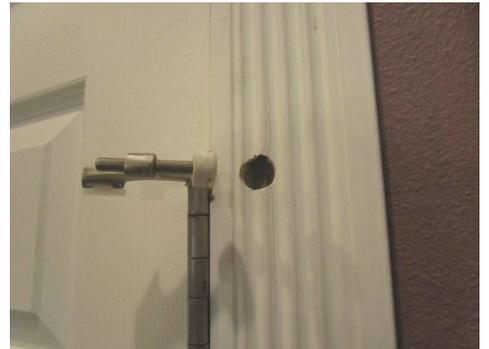
7.7.1 Walls

DOORSTOP HOLE

Wall had damage from doorstop. Recommend a qualified handyman or drywall contractor repair.

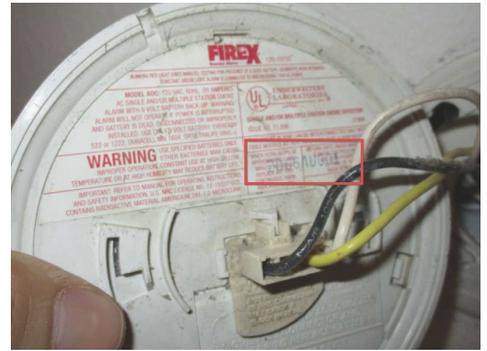
REPLACE SMOKE ALARMS

It is recommended to replace smoke alarms every ten years. The smoke alarms in this house are 12 years old.

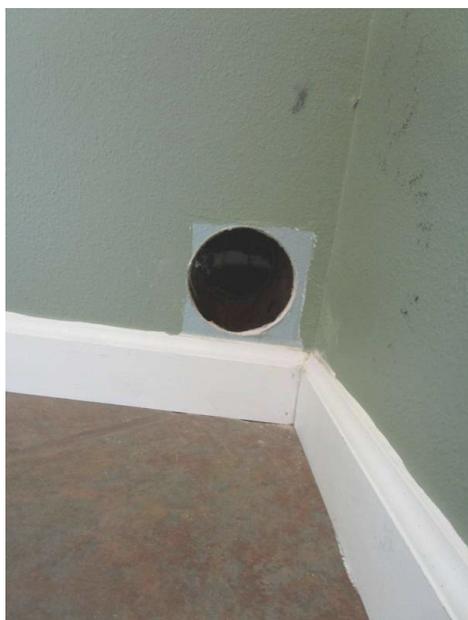
Dryer : Dryer Vent

Hole to exterior dryer vent.

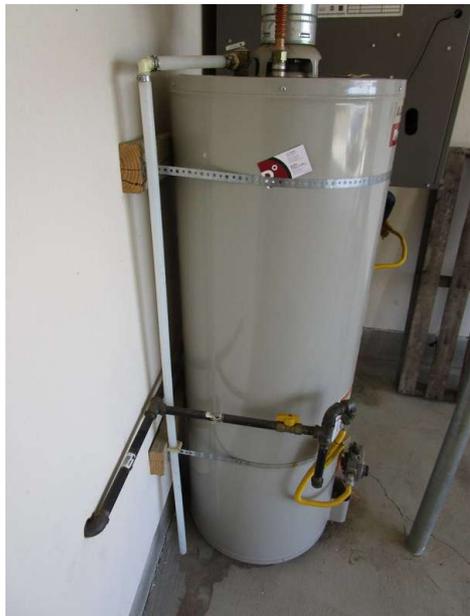
I recommend flushing & servicing your water heater tank annually for optimal performance. Water temperature should be set to at least 120 degrees F to kill microbes and no higher than 130 degrees F to prevent scalding.

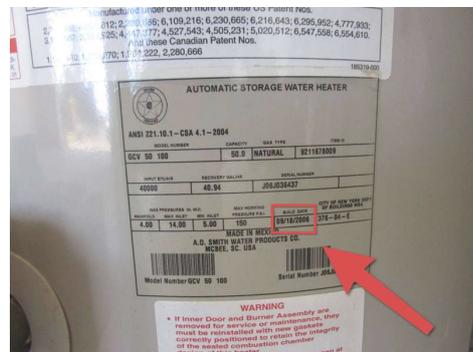
9.1.1 Hot Water Systems, Controls, Flues & Vents

NEAR END OF LIFE

The typical life span for a water heater is 10 to 15 years. This water heater is 12 years old. Recommend monitoring it's effectiveness and budgeting for its replacement in the near future.

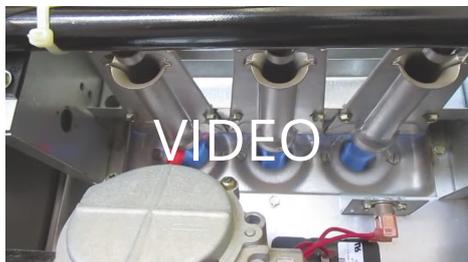
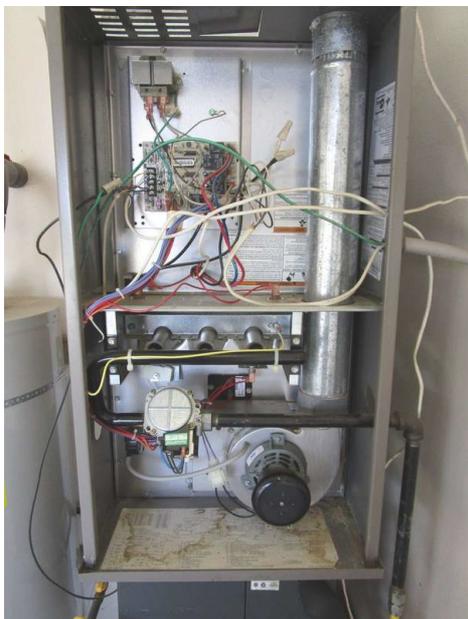
HVAC Testing Information

The inspection of the HVAC system is limited to the response of the system at the thermostat in both heating and cooling modes; a visual observation of the equipment, and the removal of any access panels made for removal by a homeowner. If a more thorough inspection is desired, an HVAC contractor should be consulted.

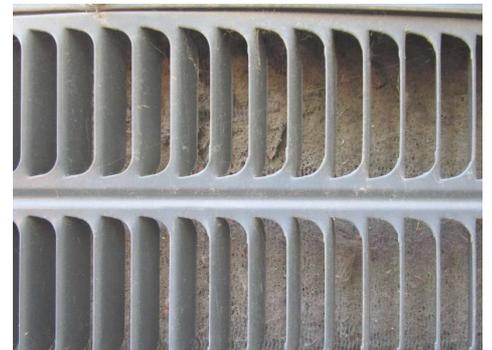
AIR FLOW RESTRICTED

Air flow to the air conditioner condenser was restricted. This may result in inefficient operation. Recommend cleaning dirt and/or debris from unit.

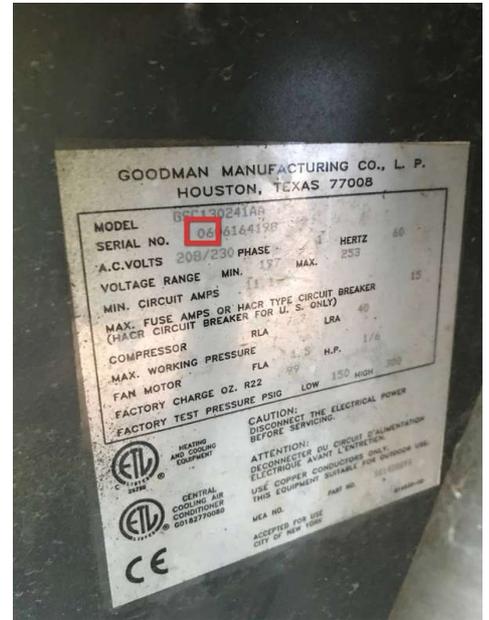
11.1.2 Cooling Equipment

AC NEAR END OF EXPECTED LIFE

This AC works as it should but appears to be near the end of its typical life expectancy. Recommend budgeting for a new AC unit for the near future.

This units manufacture date is 2006

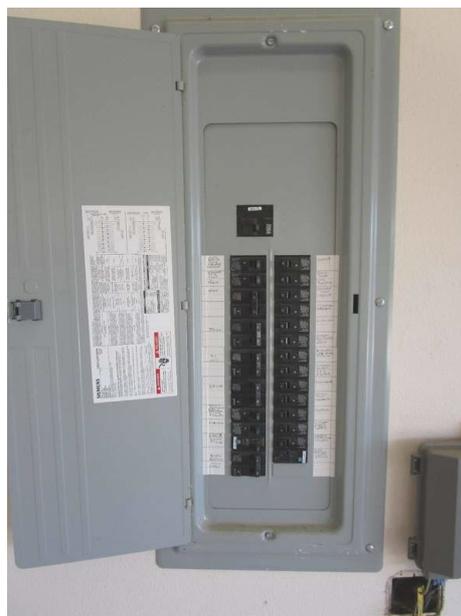
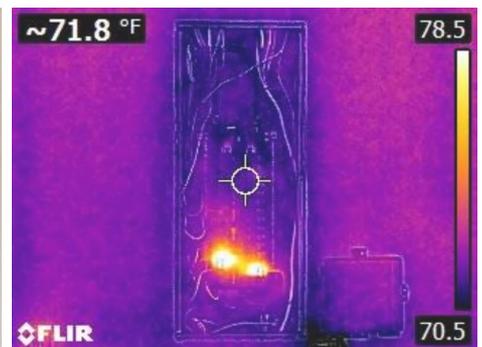
**Main & Subpanels, Service & Grounding, Main Overcurrent Device: Main Panel Location /
Information**

Hot spots appear to be within normal heat capacities.

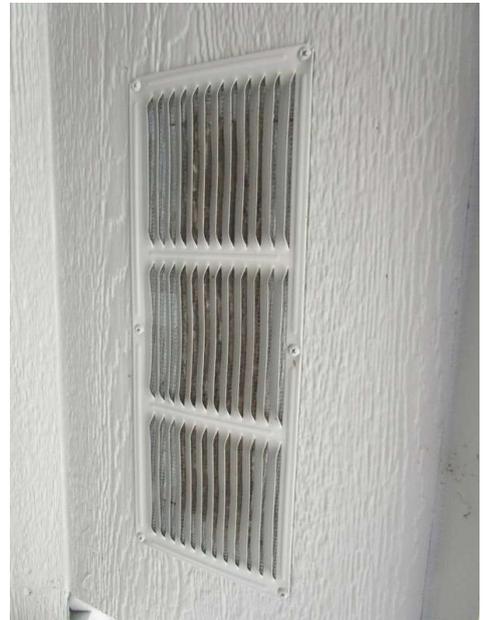
14.3.1 Ventilation

SOFFIT VENT BLOCKED

It appears that materials from the attic have covered the vent, making it inoperable. Recommend moving back materials from attic vents to allow for proper ventilation.

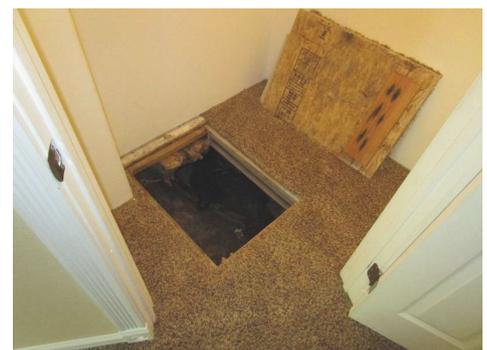
CRAWLSPACE ACCESS

Crawlspace Access was not insulated. Recommend insulating crawlspace access door to prevent energy loss.

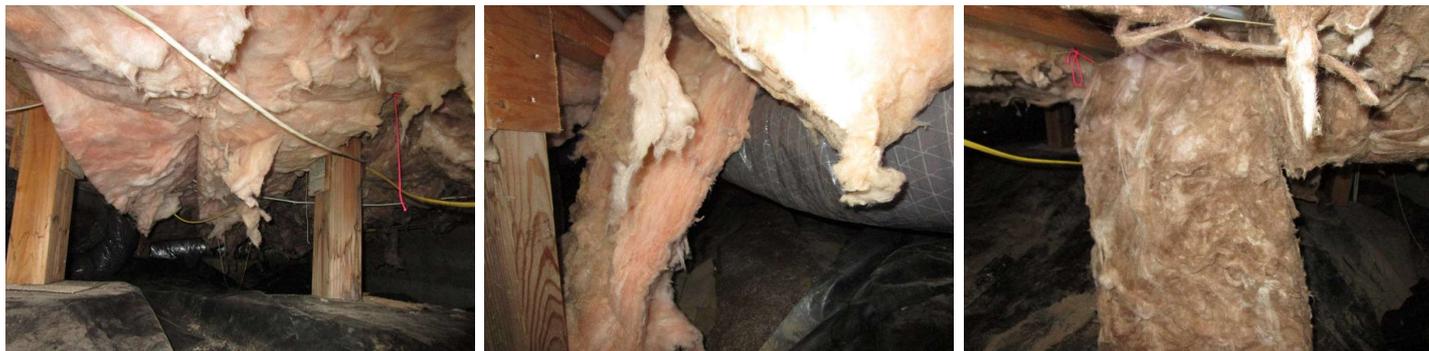
CRAWLSPACE

One or more areas in the floor structure had insulation falling from the floor. It appears that there may have been previous water damage in some areas, soaking the insulation and making it fall from between the joists. Recommend re-installing / replacing insulation as needed.
