COOPER INSPECTION SERVICES LLC

HOME INSPECTION

1234 Main St.
Hillsborough NJ 08844

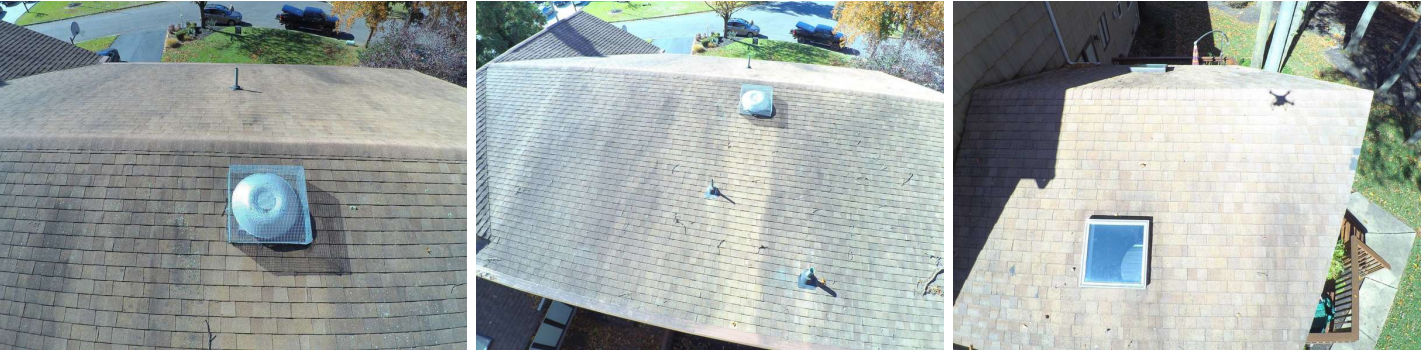
2.1.1 Coverings

Portions of the asphalt shingles covering the roof of the home had lichens growing on them. Lichens are plant like organisms that may do long term, very mild damage to the shingles. They are generally a cosmetic concern only. Efforts to remove them may result in granule loss where they were attached to the shingles. Recommend removal by a licensed contractor if so desired.

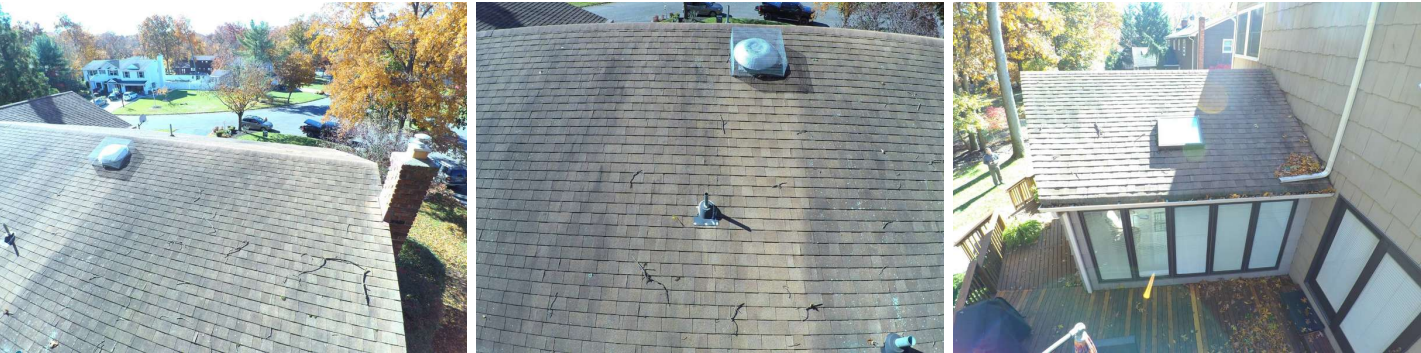
2.1.2 Coverings

ROOF DEBRIS

Debris accumulated on the roof at the time of the inspection may damage roof covering materials by retaining moisture. Clearing the roof of debris should be included in annual maintenance.

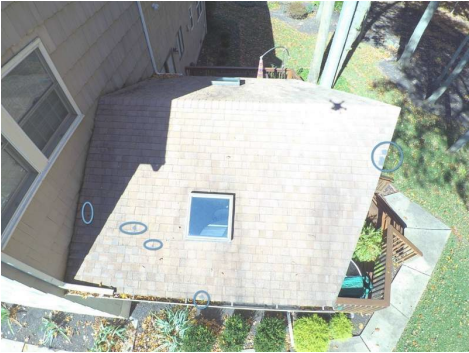
2.1.3 Coverings

EVIDENCE OF PRIOR REPAIR

One or more roof areas showed evidence of prior repair. Recommend monitoring the areas for future issues with repairs made as needed by a licensed roofing contractor.

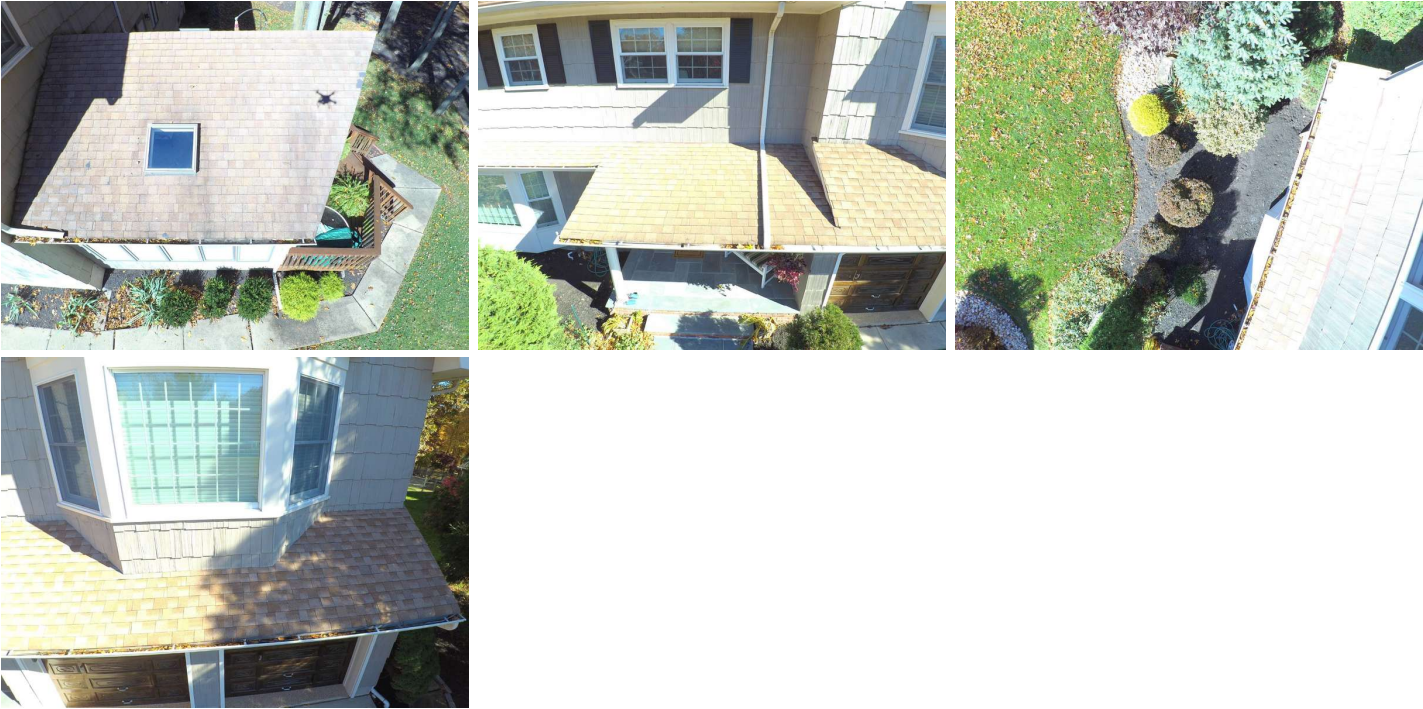
2.2.1 Roof Drainage Systems

DEBRIS IN GUTTERS

One or more areas of the gutter system had visible debris. This could result in the gutters not being able to properly carry water away from the house resulting in water damage and possible water intrusion. Recommend cleaning of the gutter system by a licensed contractor.

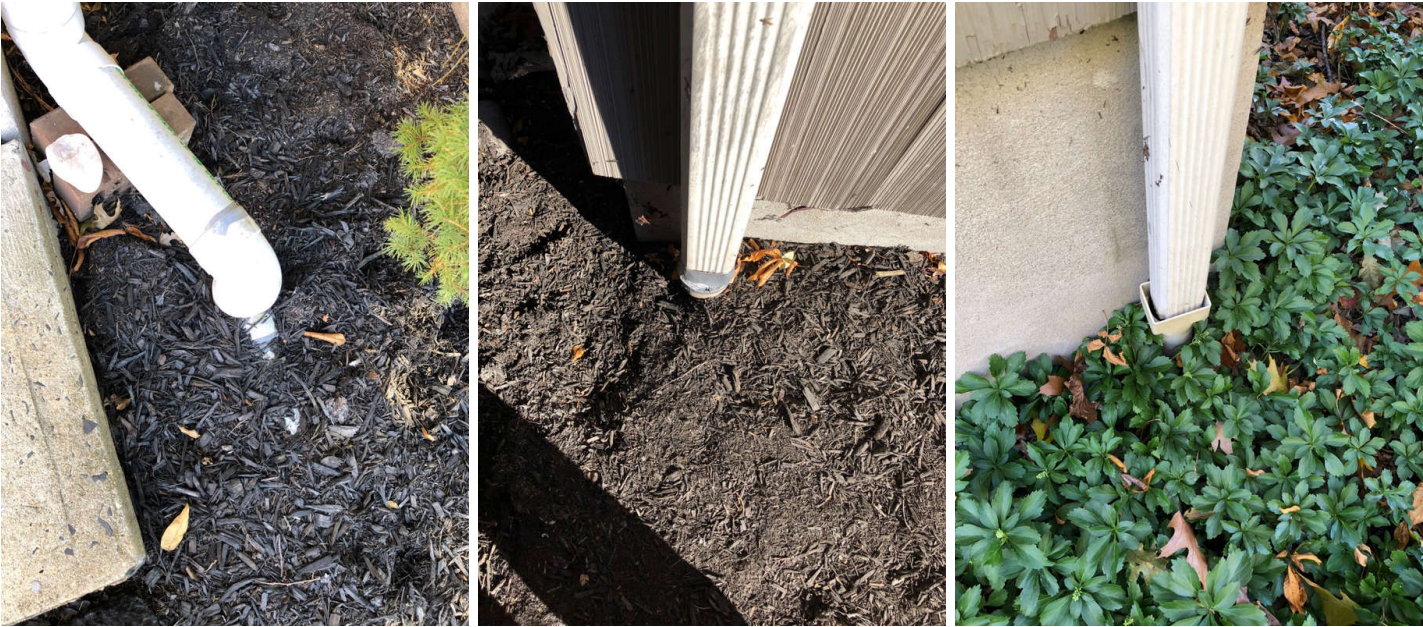
2.2.2 Roof Drainage Systems

DOWNSPOUTS DRAIN INTO UNDERGROUND SYSTEM

One or more downspouts drain into underground piping. The destination of the water after its entry into the ground is unknown. Recommend discussing drainage and piping with the owner. An evaluation of the underground pipes can not be made since the interior of the pipe is not visible.

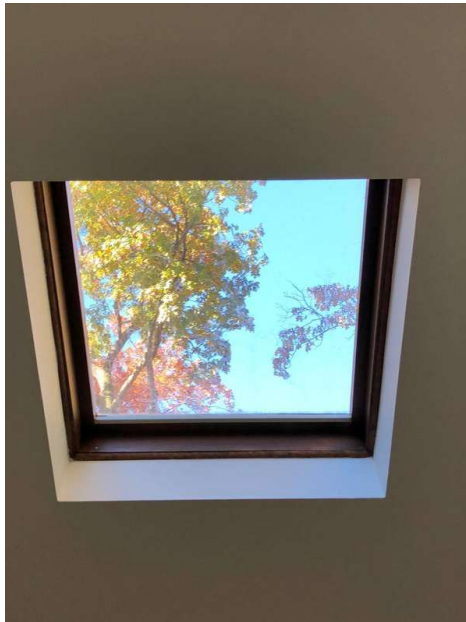
2.4.2 Skylights, Chimneys & Other Roof Penetrations

PRESENCE OF SKYLIGHTS

Several skylights are installed in the home. They should be monitored for future leaks and rectified if leaks do occur in the future. Evidence of current leaks was not found during the inspection. Skylights are common roofing leak areas.

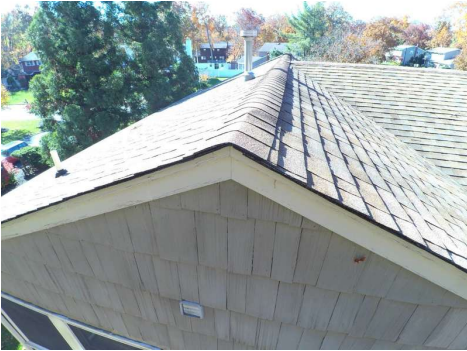
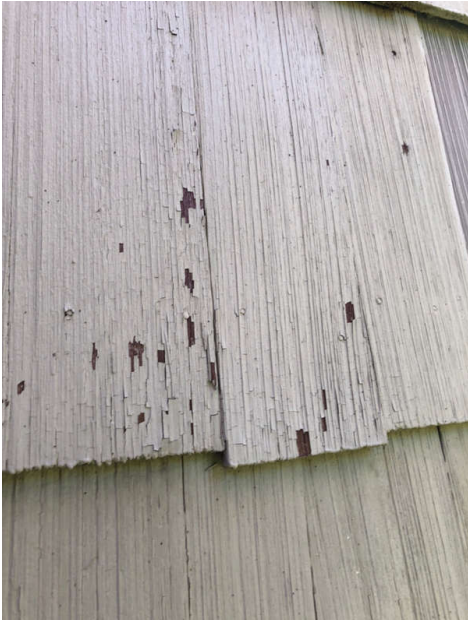
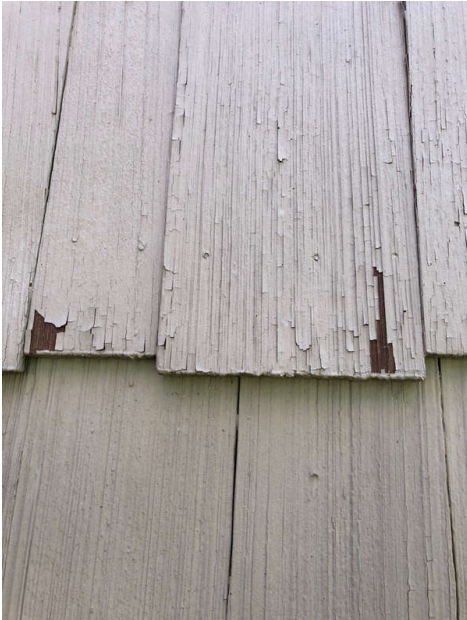
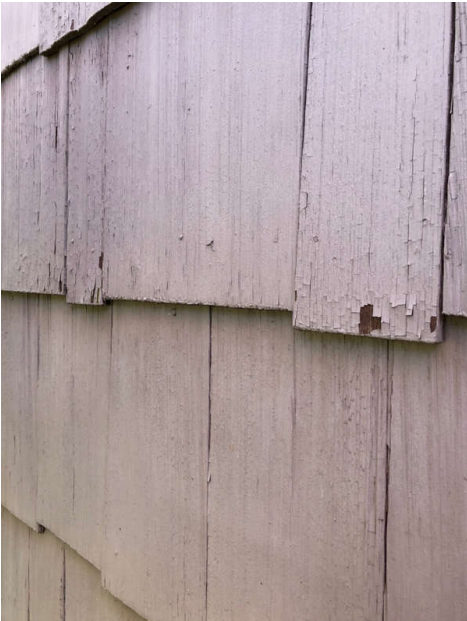
3.1.1 Siding, Flashing & Trim

PAINT CRACKING AND/OR PEELING ON SIDING & EXTERIOR TRIM

The paint or stain finish in some areas was failing (e.g. peeling, faded, worn, thinning). Siding and trim with a failing finish can be damaged by moisture. Recommend that a licensed contractor prep (e.g. clean, scrape, sand, prime, caulk) and repaint or restain the building exterior where necessary and per standard building practices.

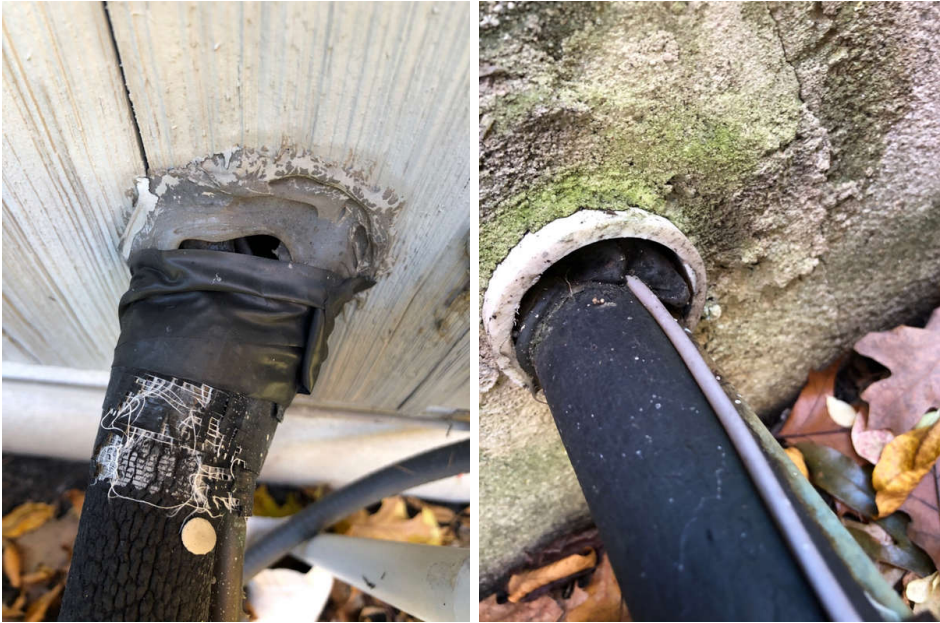
3.1.2 Siding, Flashing & Trim

SIDING/WALL PENETRATION(S) NOT SEALED

One of more siding penetrations were not sealed properly. This could lead to moisture intrusion and damage to the underlayment and interior finishes of the home. Recommend having the hole repaired by a licensed contractor.

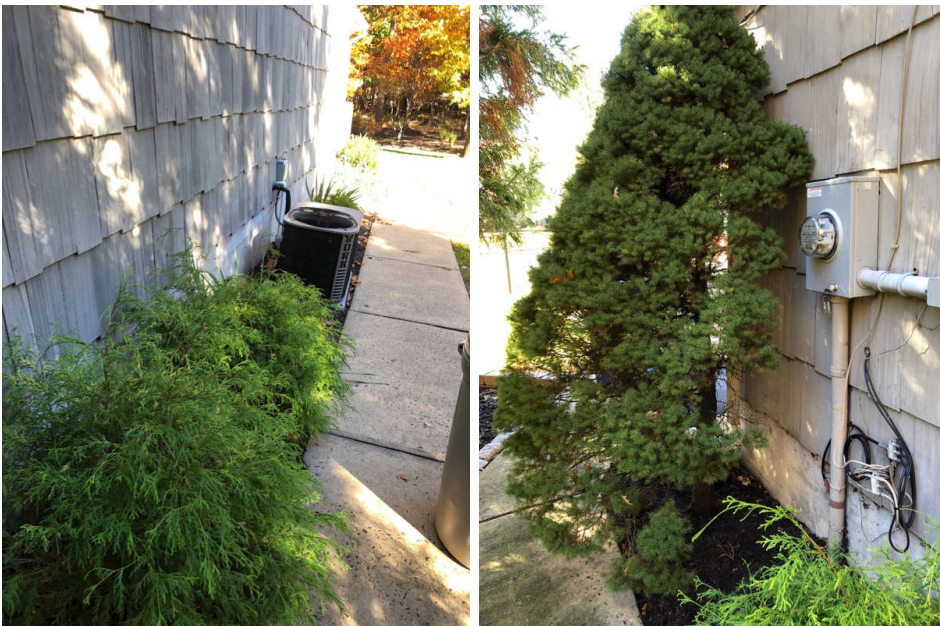
3.1.3 Siding, Flashing & Trim

VEGETATION TOO CLOSE TO HOME

Vegetation such as trees, shrubs and/or vines was in contact with or close to the building exterior. Vegetation can serve as a pathway for wood-destroying insects and can retain moisture against the exterior after it rains. This is a conducive condition for wood-destroying organisms. Recommend pruning, moving or removing vegetation as necessary to maintain at least 6 inches of space between it and the building exterior.

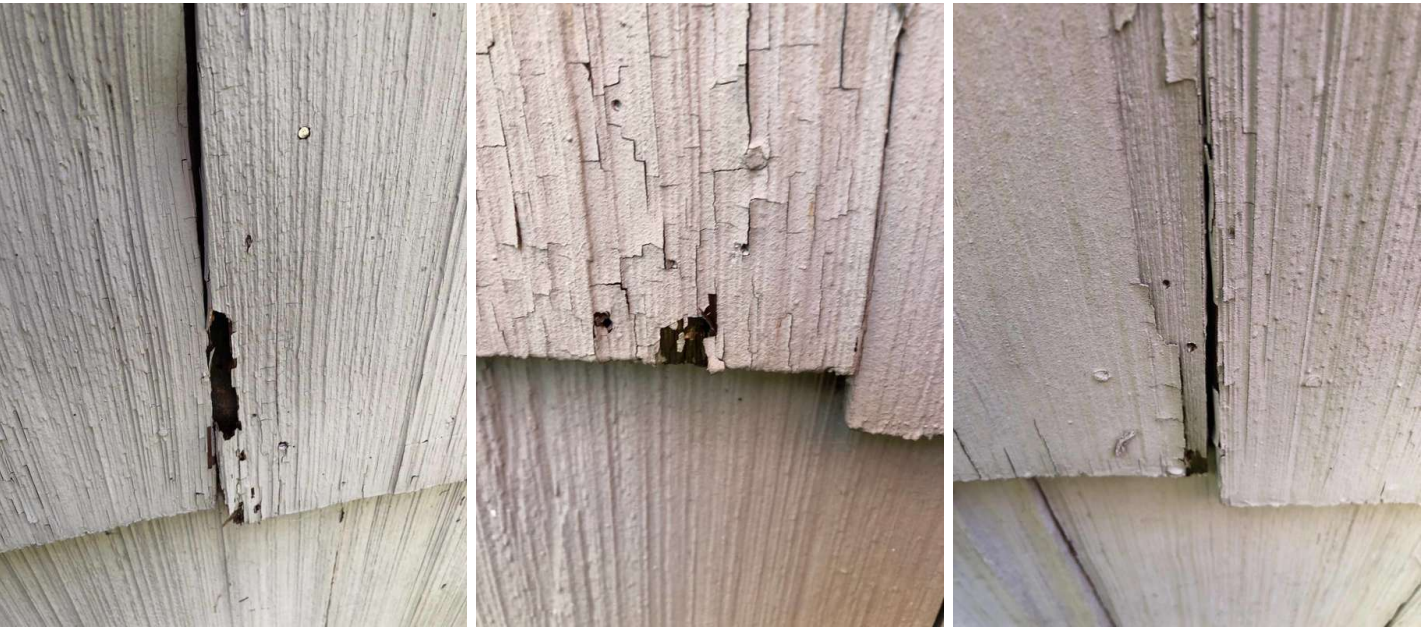
3.1.4 Siding, Flashing & Trim

SIDING-LOCALIZED ROT

Siding has localized rot. Following repair of the damaged areas (which should be combined with exterior painting/maintenance), proper maintenance of the siding and control of water from roof or surface runoff can avoid further damage.

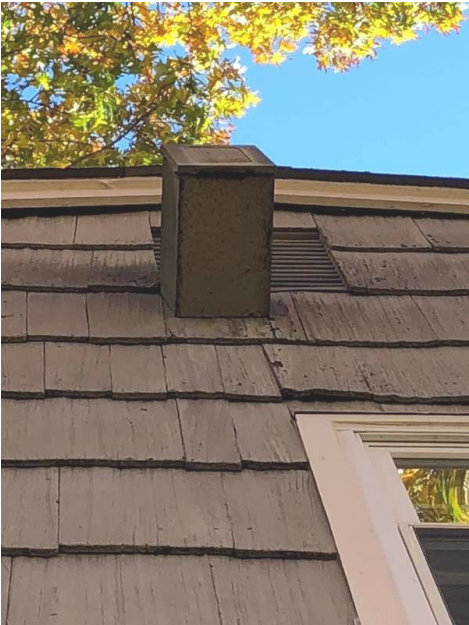
3.1.5 Siding, Flashing & Trim

UNIDENTIFIABLE WALL PENETRATION

What appeared to be a metal box or vent was protruding from the left side of the house just below the gable vent. That area of the attic was inaccessible so the inspector was not able to identify it from the other side of the wall. The inspector recommends inquiring about the function of the box with the homeowner prior to closing.

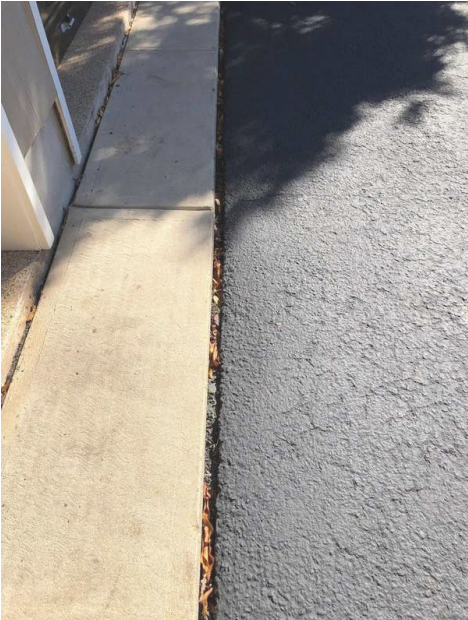
3.3.1 Walkways, Patios & Driveways

GAP-DRIVEWAY TO GARAGE APRON

A large gap was noted where the driveway meets the concrete saddle for the garage. Water can travel into this gap, seeping down into and under the foundation and leading to foundation problems in the future. Recommend repair by a licensed contractor.

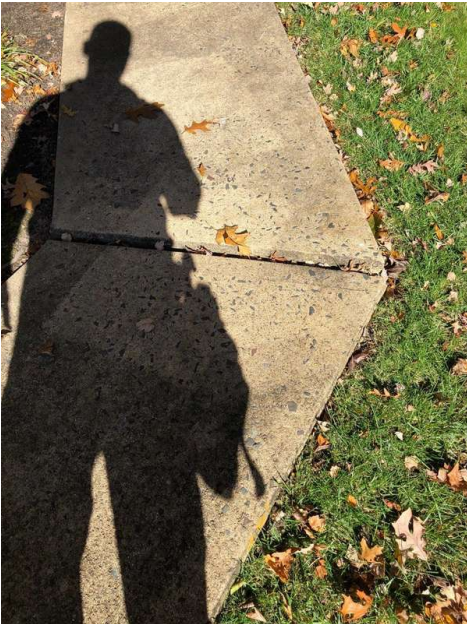
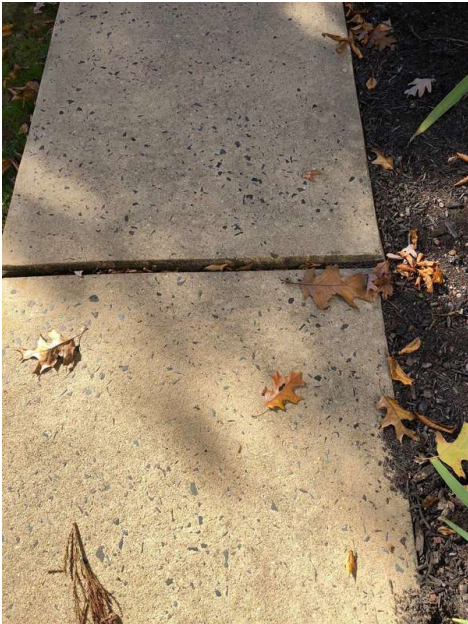
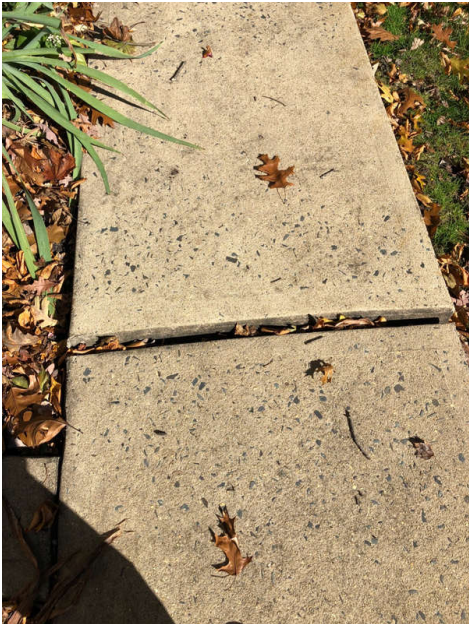
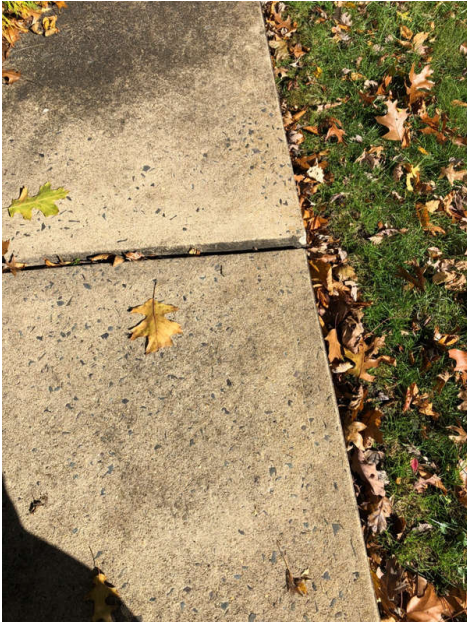
3.3.2 Walkways, Patios & Driveways

WALKWAY SETTLED

One or more walkway areas have settled or heaved . This is a trip/fall hazard. It is recommended to have a licensed contractor repair the walkway.

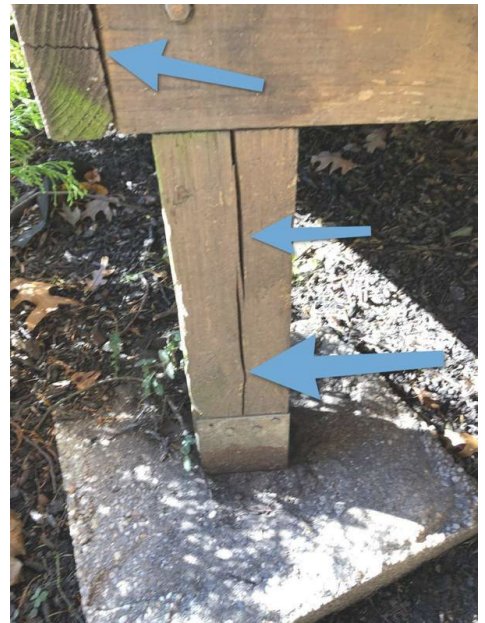
3.4.1 Decks, Balconies, Porches & Steps

DECK BOARDS/POST SPLITTING

One or more deck boards and/or posts was splitting but appeared to be stable. Recommend monitoring the cracks and if they grow larger in the future, the boards should be replaced by a licensed contractor.

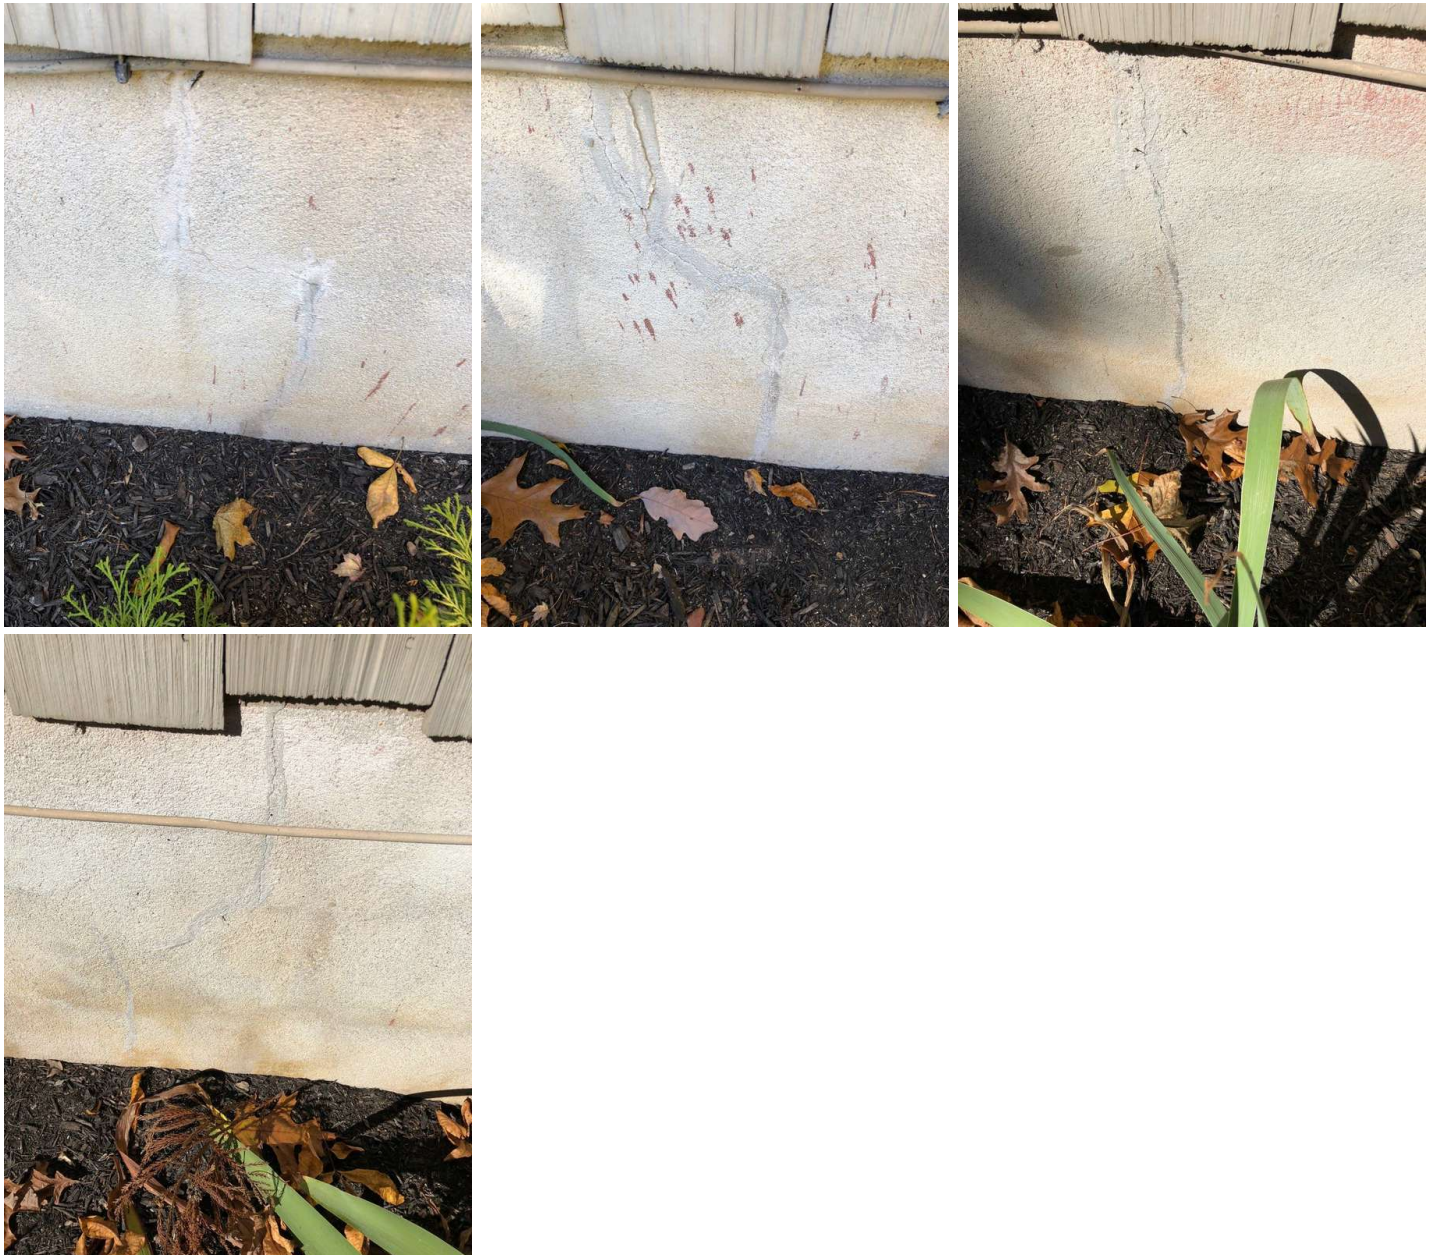
4.1.1 Foundation

PARGE COAT CRACKING

One or more cracks were observed in the masonry parge coating. Recommend monitoring the cracks for future expansion and repairs made as necessary by a licensed masonry contractor if the cracks become larger.

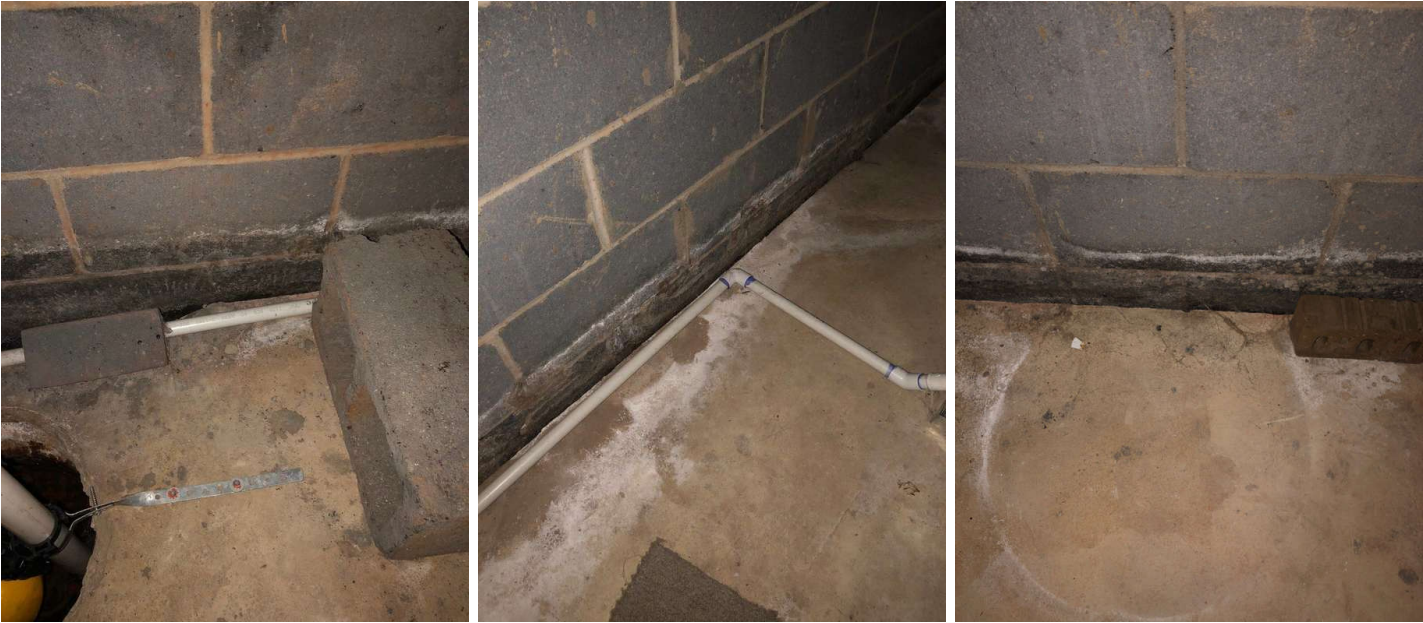
4.2.1 Basements & Crawlspace

EFFLORESCENCE

Efflorescence noted on the crawlspace surface. This is a white, powdery deposit that is consistent with moisture intrusion. This can compromise the soil's ability to support the home structure and/or lead to mold growth. Recommend a qualified contractor identify source of moisture and correct.

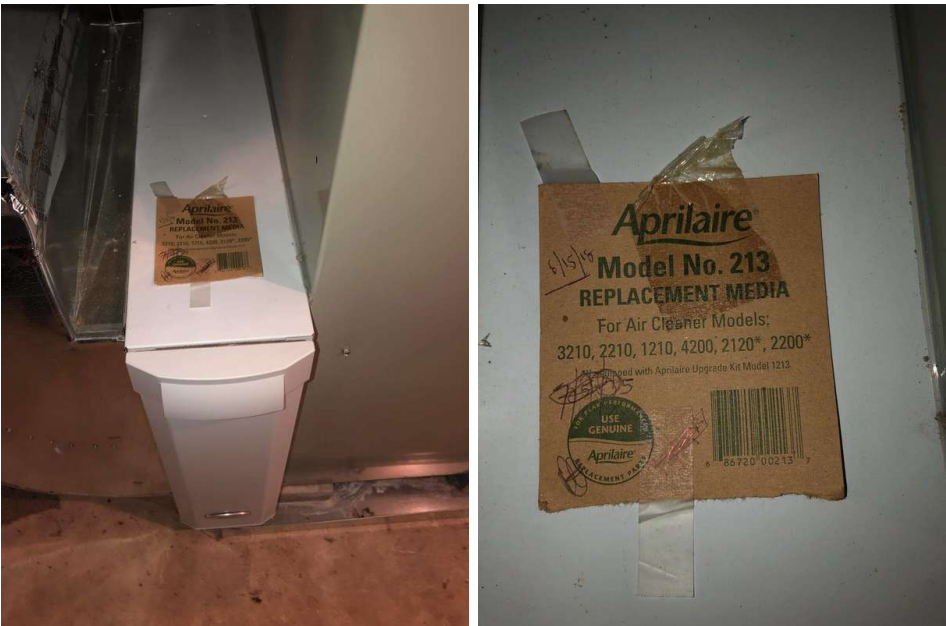
ELECTRONIC AIR CLEANER INSTALLED

The forced air system had an electronic air cleaner installed instead of a standard filter. Electronic air cleaners are beyond the scope of a NJ Home Inspection. An electronic air filter has special maintenance requirements. Failure to perform the required maintenance will result in poor filter performance and may affect the performance of the heating system or result in unhealthy conditions due to poor indoor air quality. You should read the manual for the filter to become familiar with these requirements.

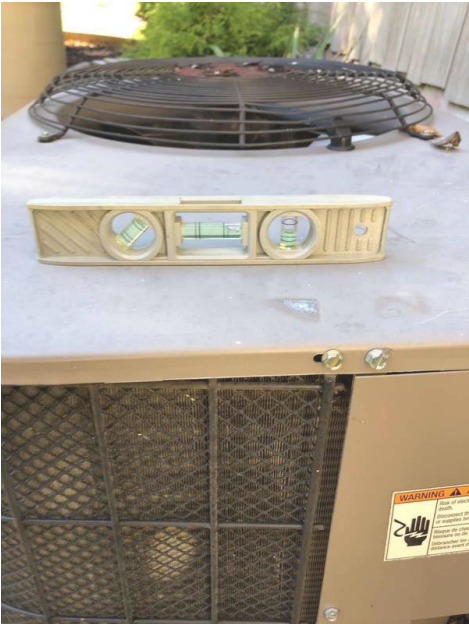
UNIT NOT LEVEL

The pad supporting the outdoor condensing unit is not level. This can cause accelerated deterioration of components. Recommend licensed HVAC contractor level the unit.

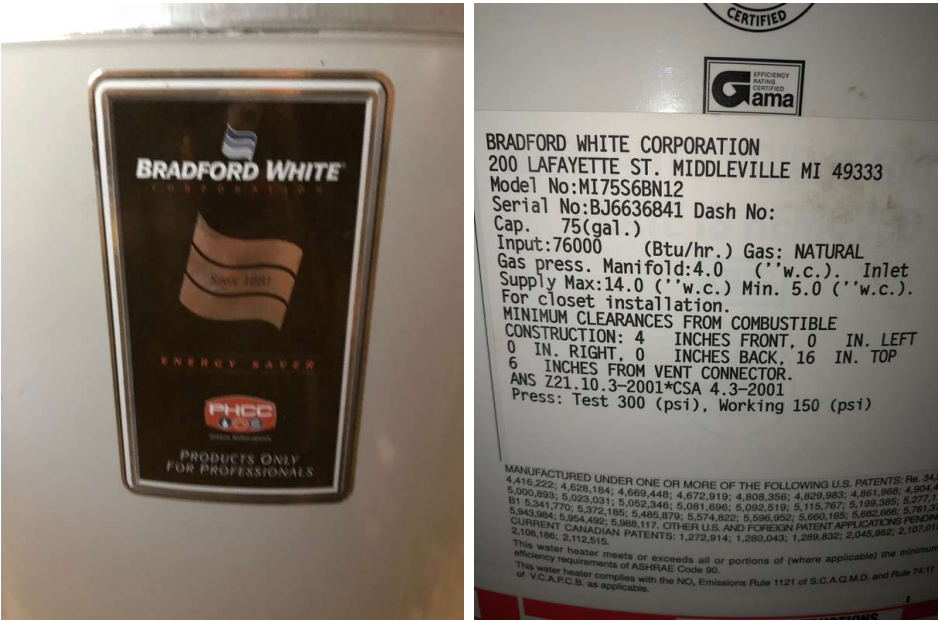
The hot water heater was produced in 2005. Hot water heaters have a typical service life of 8-12 years. This unit will most likely need replacement in the near future.

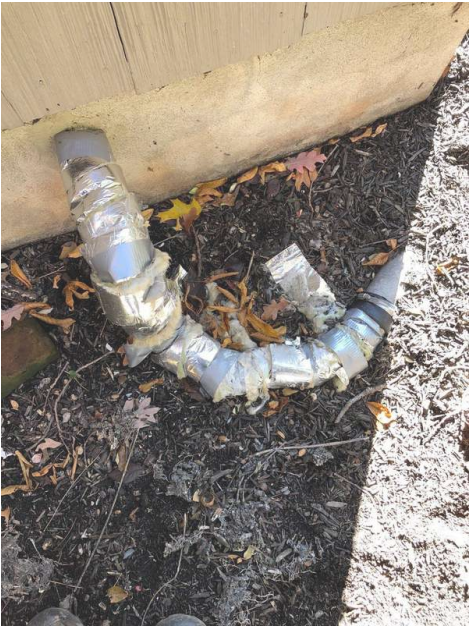
7.6.1 Sump Pump

The sump pump discharged into underground piping. The destination of the water after its entry into the ground is unknown. Recommend discussing drainage and piping with the owner. An evaluation of the underground pipes can not be made since the interior of the pipe is not visible.

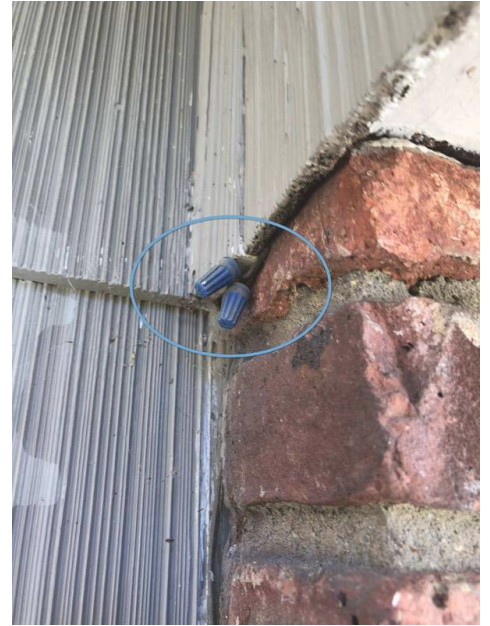
8.3.1 Branch Wiring Circuits, Breakers & Fuses

EXPOSED TERMINATION-EXTERIOR

Two wire nuts were observed on the upper left side of the front porch where the siding meets the brick veneer. The wires were not live at the time of inspection and could be low voltage. The inspector recommends finding out from the homeowner what the wires were previously used for.

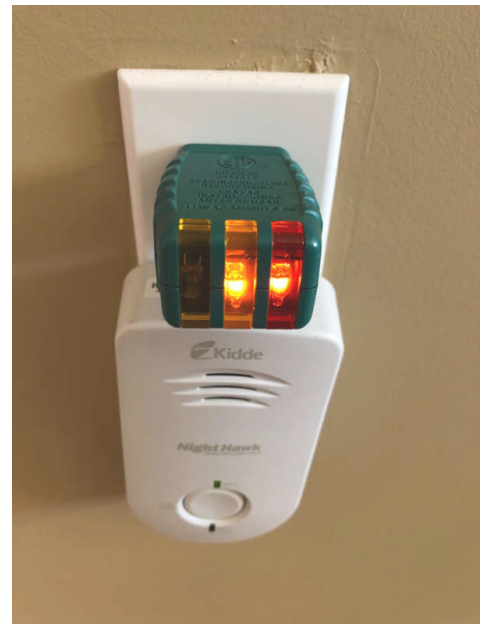
8.4.1 Lighting Fixtures, Switches & Receptacles

INCORRECT WIRING-REVERSE POLARITY

One or more electric receptacles had reverse-polarity wiring, where the hot and neutral wires were reversed. This is a shock hazard. Recommend that a licensed electrician repair as necessary.

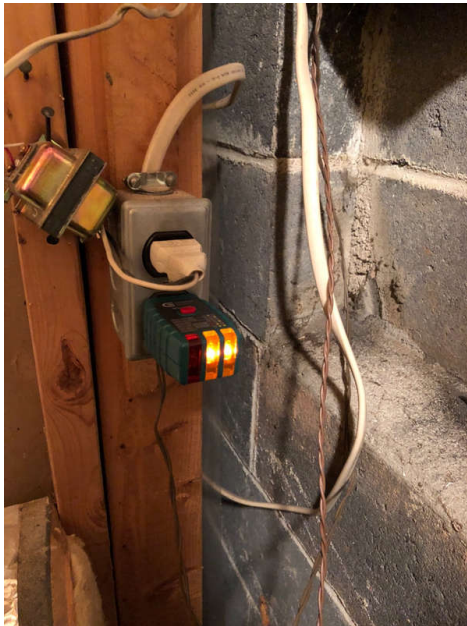
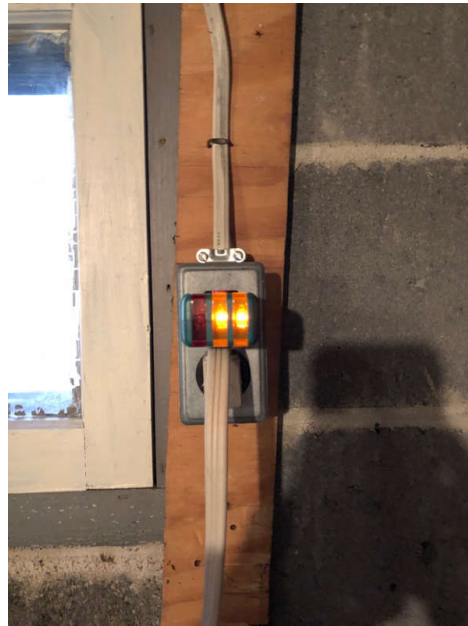
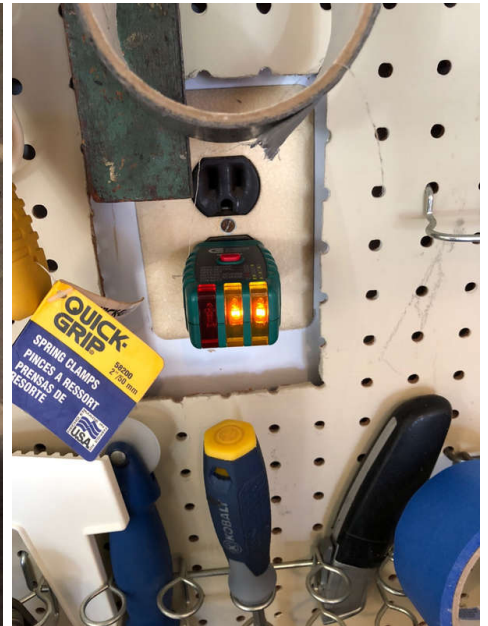
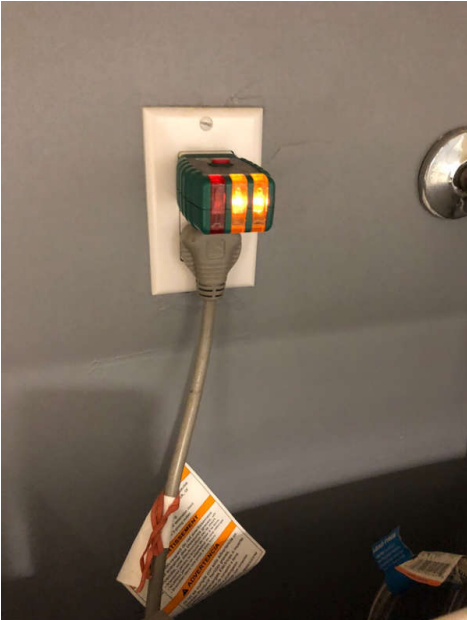
8.5.1 GFCI & AFCI

NO GFCI PROTECTION INSTALLED

The Inspector recommends updating the existing exterior electrical circuits to include GFCI protection by a licensed electrician.

This can be achieved by:

1. Replacing the current standard outlets with GFCI outlets.
2. Replacing the electrical circuit outlet located closest to the main electrical service panel with a GFCI outlet.
3. Replacing the breaker currently protecting the electrical circuit that contains these outlets with a GFCI breaker.

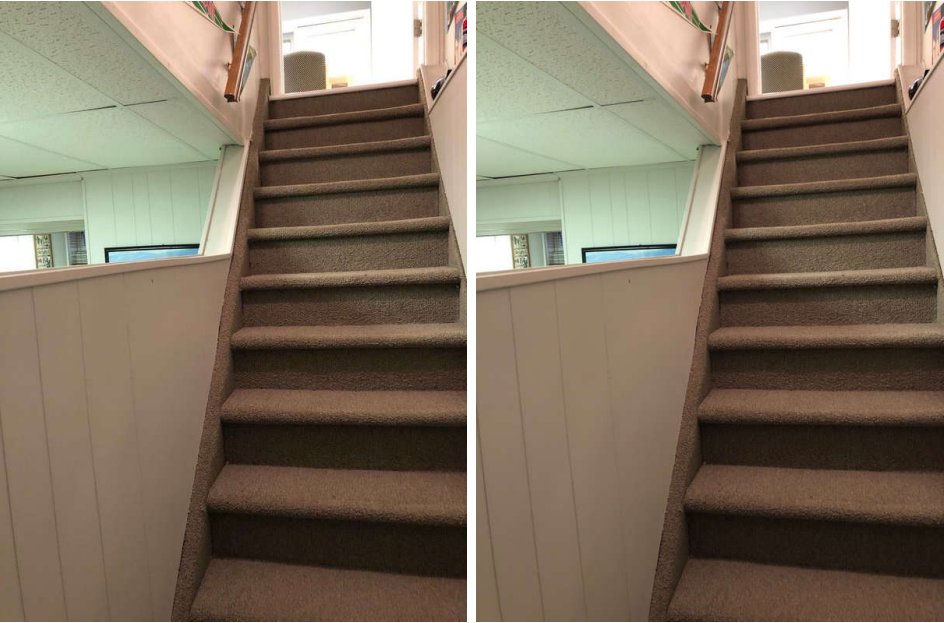
The handrail to the basement was not continuous for the entire length of the stairway. This is a fall hazard. Recommend installation of a continuous handrail to the top of the stairway by a licensed contractor

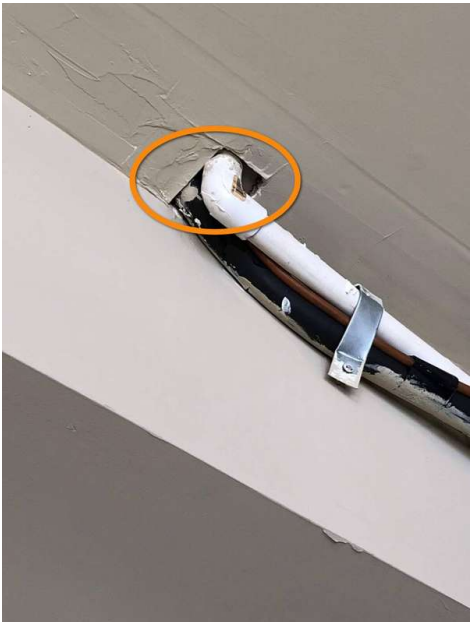
12.1.1 Ceiling

One or more holes were observed in the garage ceiling. This could lead to carbon monoxide entering the attic or living areas of the home. The inspector recommends repair and sealing of the holes by a licensed contractor.
