RESIDENTIAL REPORT

1234 Main St.
Edmonton AB T5T3E9

Buyer Name
10/06/2018 9:00AM

Inspector
Banti Shaw
InspecUs
7808623549
bantishaw@inspecus.ca

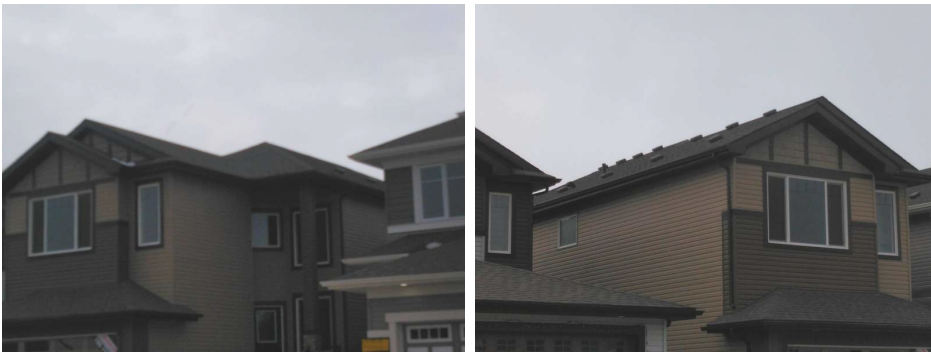
Coverings: Roof shingles lifespan

Observed 1 years old Shingles to be functional at the time of inspection although according to manufacturer recommendation roof shingles lifespan 25 years.

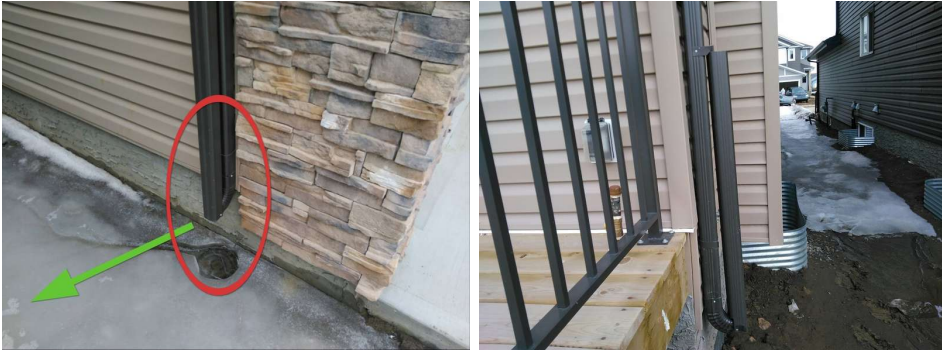
2.2.1 Roof Drainage Systems

DOWNSPOUTS DRAIN NEAR HOUSE

NORTH SOUTH WEST EAST

One or more downspouts drain too close to the home's foundation. This can result in excessive moisture in the soil at the foundation, which can lead to foundation/structural movement. Recommend Homeowner to adjust downspout extensions to drain at least 6 feet from the foundation.

[Here is a helpful DIY link](#) and video on draining water flow away from your house.

Contact a qualified roofing professional.

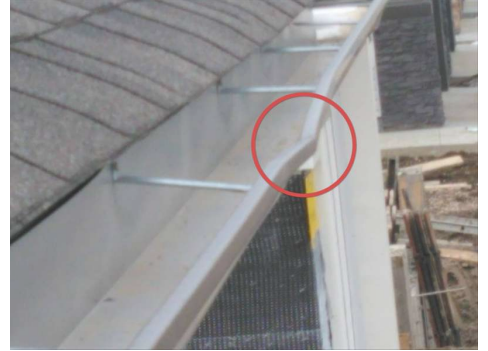
2.2.2 Roof Drainage Systems

MINOR GUTTER DAMAGE

GARAGE

Observed minor dent on the Gutter above Garage, recommend repair seal to avoid immature deterioration.

Contact a qualified professional.

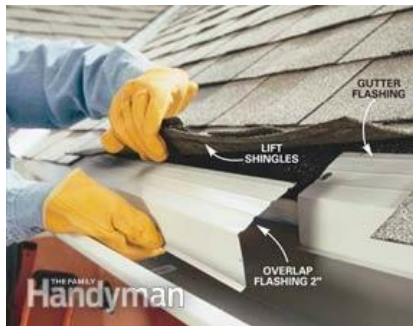
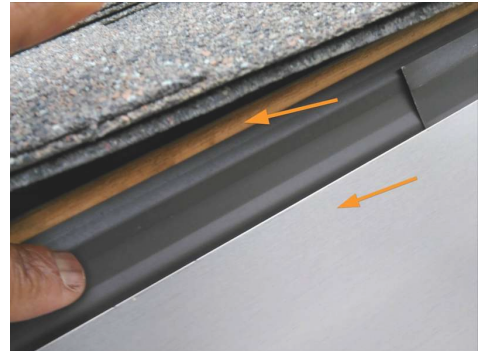
2.3.1 Flashings

MISSING

ROOF

Overlay/Drip edge flashings were missing at time of inspection. Flashings provide protection against moisture intrusion and to avoid premature deterioration of roof board and Eavestrough corrosion, Recommend a qualified roofing contractor evaluate and remedy.

Example: Overlay/Drip edge

Contact a qualified roofing professional.

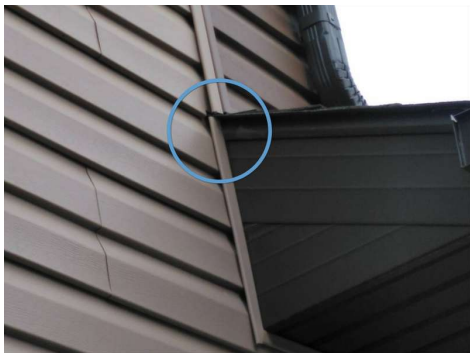
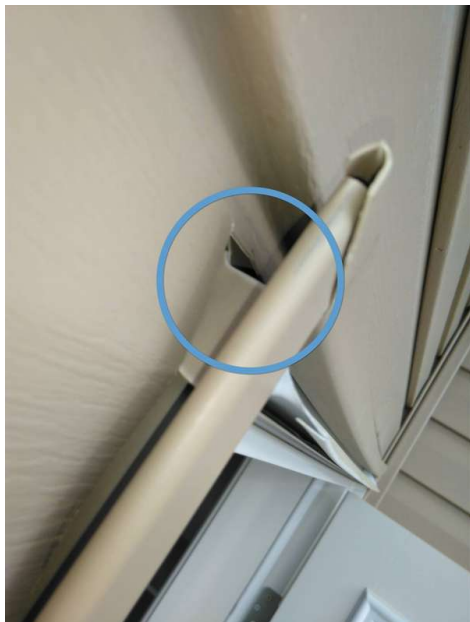
3.1.1 Siding, Flashing & Trim

EXTERIOR PENETRATION

Observed missing exterior sealant , recommend sealing all opening to void moisture intrusion.

Recommended DIY Project

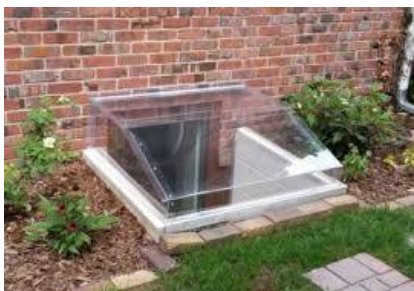
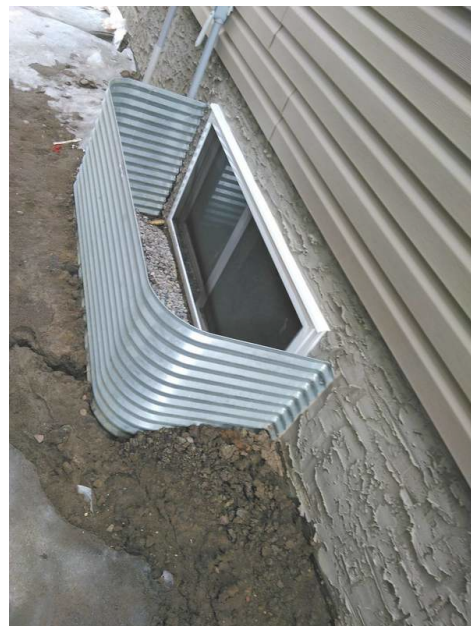
3.2.1 Exterior Doors

EGRESS WINDOW

NORTH SOUTH WEST EAST

Observed Egress windows functional, recommend upgrading with window well covering to avoid too much moisture accumulating and trip hazards.

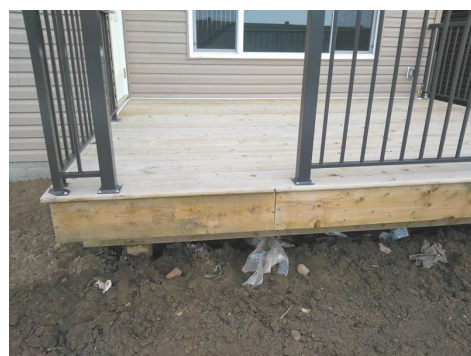
3.4.1 Decks, Balconies, Porches & Steps

MISSING STEPS

SOUTH

Missing Steps near deck, steps required if deck heights more than 9" and handrail must be provided with 3 or more steps, Recommend installing.

Also some of the nails were pushed into the plank, which damage the wood and creates penetration area for moisture intrusion & premature deterioration. Recommend sealing all over hammered nails.

Contact a qualified deck contractor.

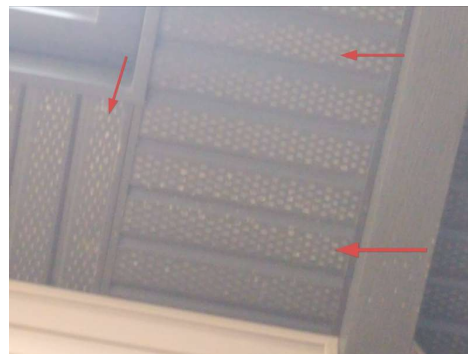
3.5.1 Eaves, Soffits & Fascia

CLOSED SOFFITS

NORTH

Observed some of soffits above front door were covered with insulations, soffits provide ventilation to the roof, recommend further investigation and corrections.

Contact a qualified professional.

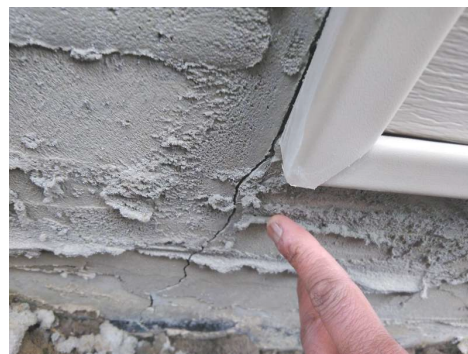
4.1.1 Foundation

FOUNDATION CRACKS - MINOR

Minor cracking was noted at the foundation. This is common as concrete ages and shrinkage surface cracks are normal. Recommend monitoring for more serious shifting/displacement.

Recommend monitoring.

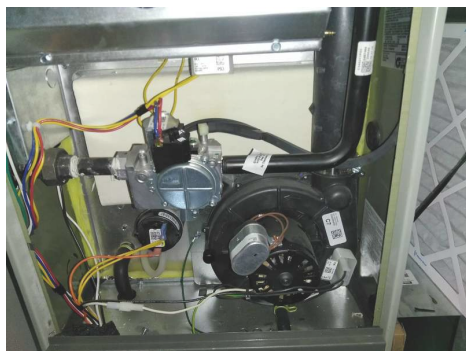
Equipment: furnace life expectancy

observed operational at the time of inspection, The Life Expectancy is about 15 to 20 years.

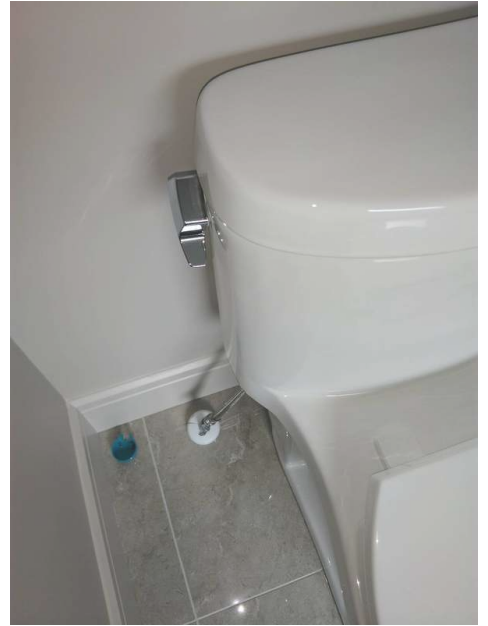
6.3.1 Water Supply, Distribution
Systems & Fixtures

TOILET KNOB DAMAGE

ENSUITE BATHROOM

Observed Toilet Knob Damage/not operational recommend
correction.

Contact a qualified professional.

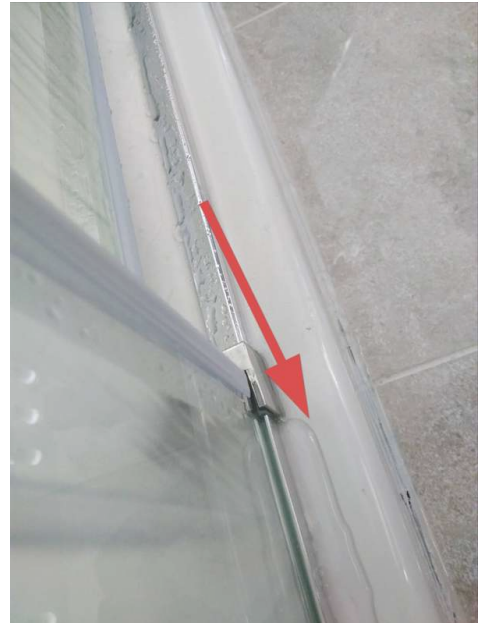
6.3.2 Water Supply, Distribution
Systems & Fixtures

SHOWER GLASS DOOR

ENSUITE BATHROOM

Observed shower glass door not properly align, recommend
correction.

Contact a qualified professional.

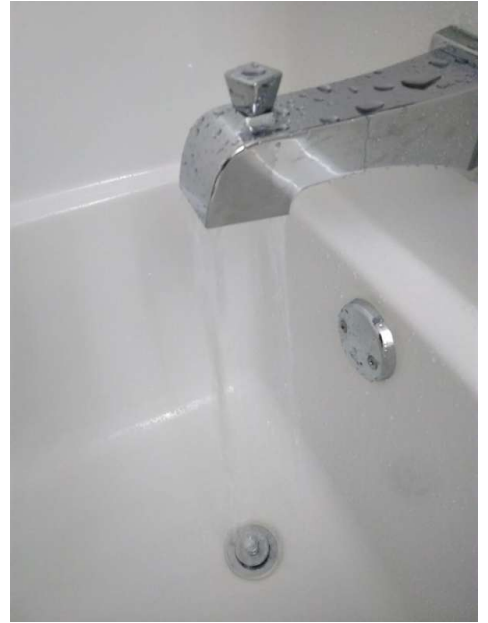
6.3.3 Water Supply, Distribution Systems &
Fixtures

LOW WATER PRESSURE

FULL BATHROOM

Observed low water pressure on bathtub faucet, recommend finding
the source and remedy.

Contact a qualified plumbing contractor.

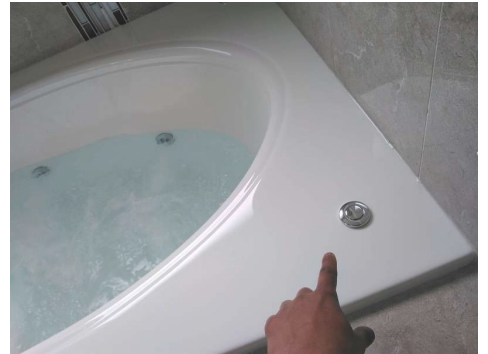
6.3.4 Water Supply, Distribution
Systems & Fixtures

SAFETY SWITCH

ENSUITE BATHROOM

Inspector unable to locate safety switch for jacuzzi or missing, it's a serious safety hazard as it will be easily accessible to the kids. Recommend installing another master switch far from the jacuzzi.

Contact a qualified electrical contractor.

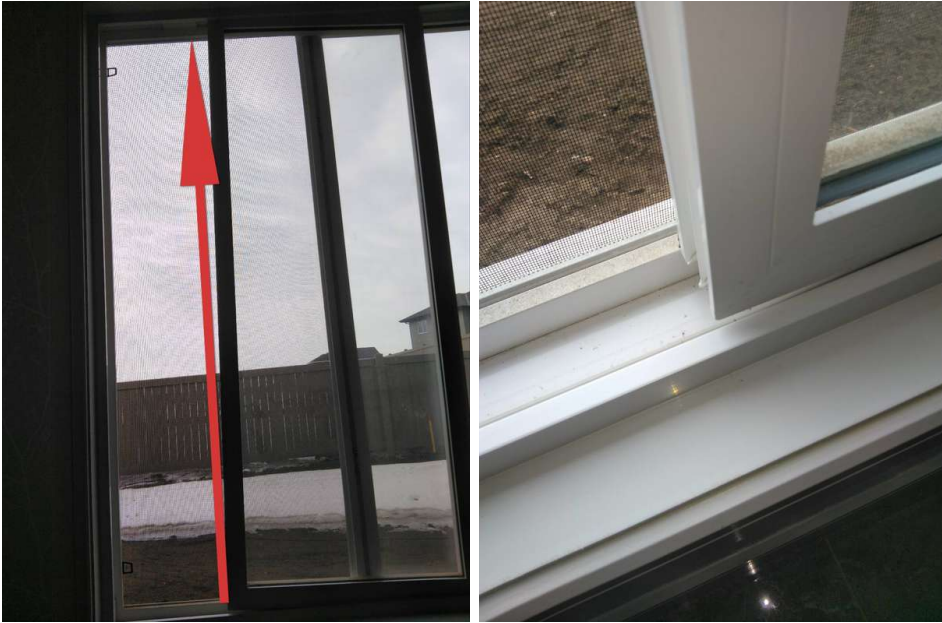
9.2.1 Windows

IMPROPER INSTALLATION

ALL WINDOWS

Windows appear to not be operating properly due to substandard installation or missing channel, Recommend window specialist evaluate.

Contact a qualified window repair/installation contractor.

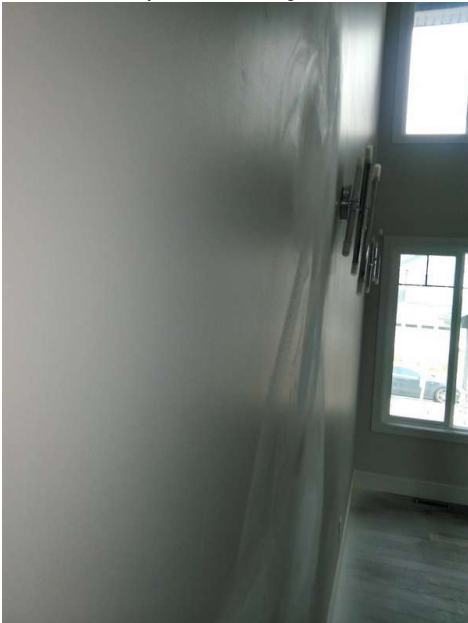
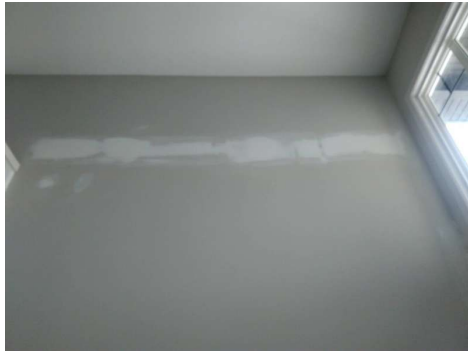
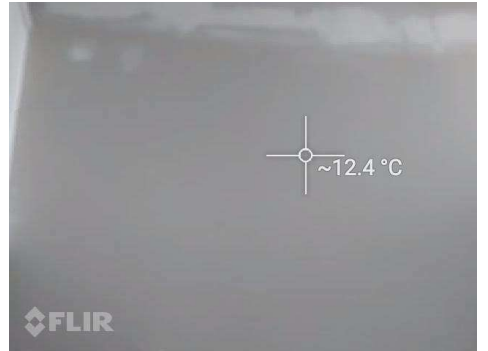
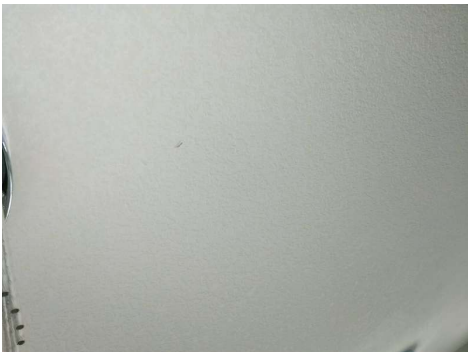
9.4.1 Walls

POOR PATCHING

unfinished drywall patching observed at time of inspection. Recommend professional finishing.

Contact a qualified drywall contractor.

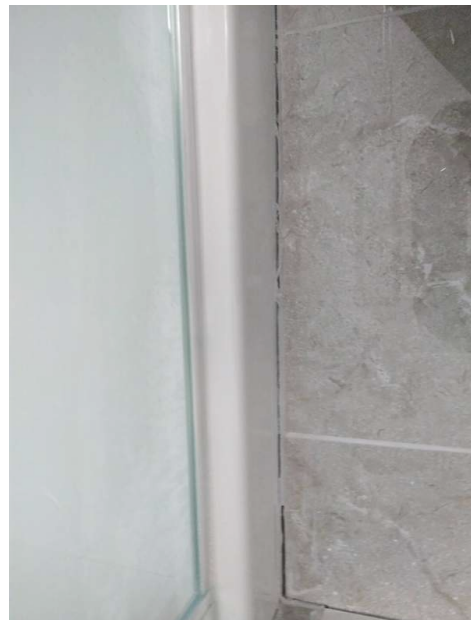
9.7.1 Countertops & Cabinets

**POOR/MISSING CAULK**

ENSUITE BATHROOM HALF BATHROOM FULL BATHROOM

Bathroom tiles was missing sufficient caulk/sealant, This can lead to water damage. Recommend adding sealant at sides and corners where counters touch walls.

Recommended DIY Project

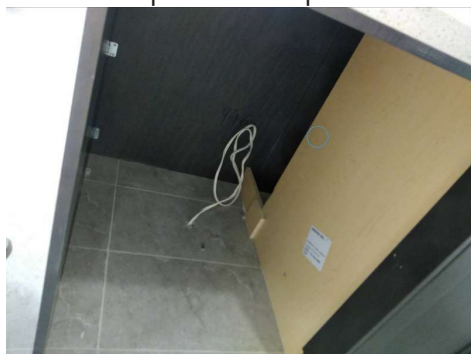
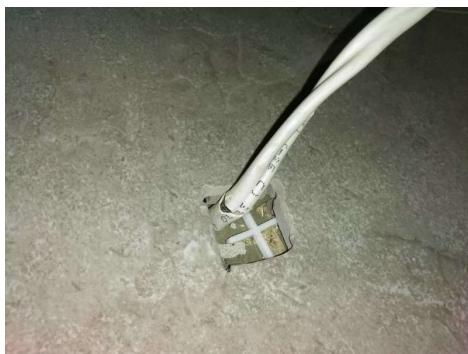
10.1.1 Dishwasher

DISHWASHER

MAIN FLOOR KITCHEN

Observed unfinished wire connection/receptacle for the dishwasher connection.

Also observed missing access whole for drainage line of the dishwasher.

Recommend correction.

Contact a qualified carpenter.
