FULL CIRCLE HOME INSPECTORS

1234 Main St.
Apopka Florida 32712

05/22/2018 9:00AM

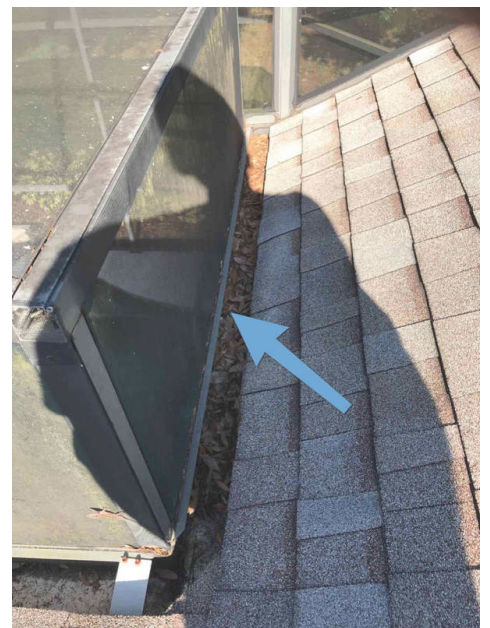
2.1.1 General

DEBRIS ON ROOF

Significant amounts of debris such as roofing cement, tile pieces, leaves, needles, seeds, etc. have accumulated on the roof surface. Water may not flow easily off the roof, and can enter gaps in the roof surface. Leaks can occur as a result. This is a conducive condition for wood-destroying organisms. Recommend cleaning debris from the roof surface now and as necessary in the future.

Recommended DIY Project

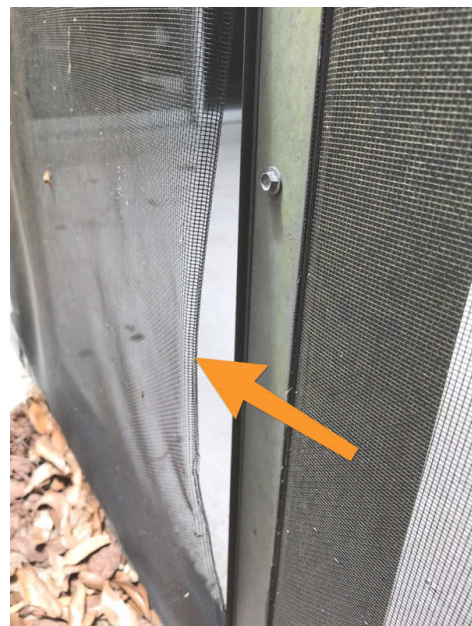
3.2.1 Driveway, Walkway, Patio

SCREEN ENCLOSURE-SPLINE ISSUE

The spline is coming loose or missing at one or more sections of the screen patio. The spline is what secures the screen in the frame. It is recommended to have a qualified contractor make the necessary repairs.

Contact a qualified handyman.

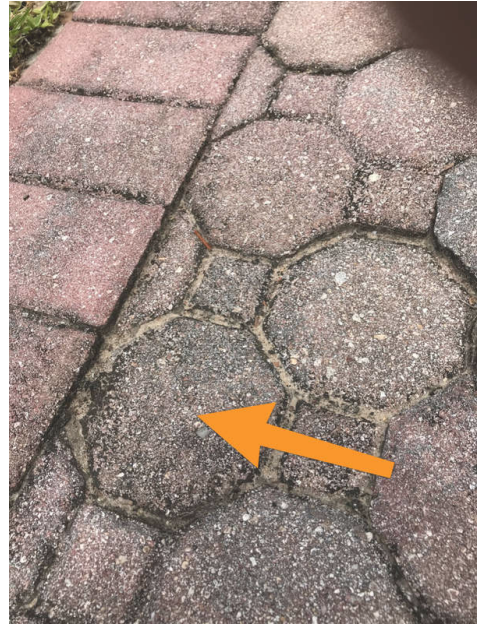
3.2.2 Driveway, Walkway, Patio

Deficiencies**NEED REPAIR-SIDEWALK**

Cracks, holes, settlement, heaving and/or deterioration were found in sidewalks and/or patios. Recommend that qualified contractor repair as necessary.

Contact a qualified professional.

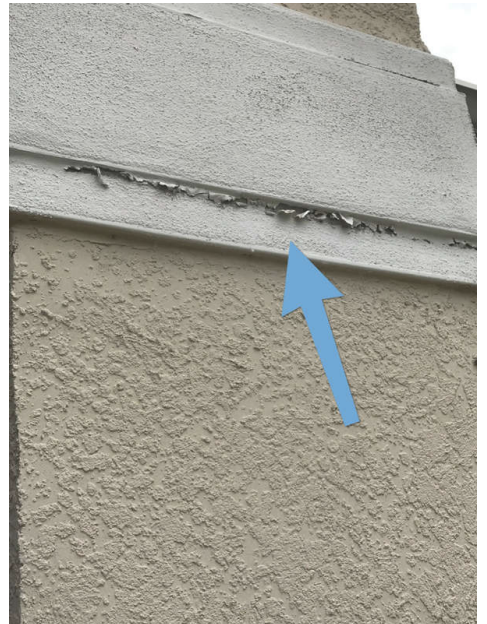
3.3.1 Exterior issues

Maintenance/Monitor**PAINT FAILING**

The paint or stain finish in some areas was failing (e.g. peeling, faded, worn, thinning). Siding and trim with a failing finish can be damaged by moisture. Recommend that a qualified contractor prep (e.g. clean, scrape, sand, prime, caulk) and repaint or restain the building exterior where necessary and per standard building practices. Any repairs needed to the siding or trim should be made prior to this..

Contact a qualified painter.

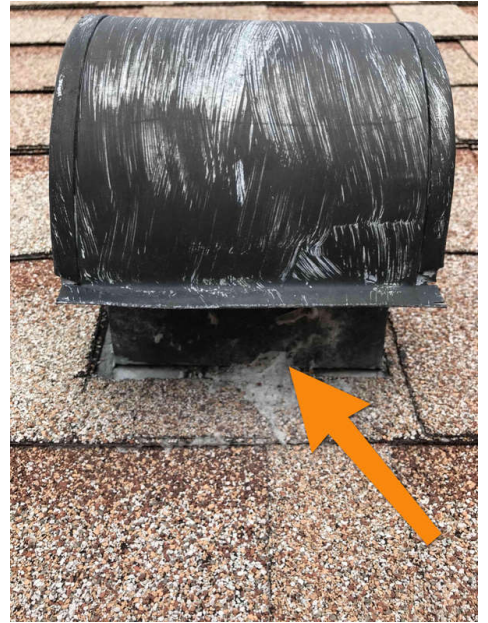
3.3.2 Exterior issues

Deficiencies**DRYER VENT CLOGGED**

The dryer vent is clogged and needs to be cleaned. A clogged dryer vent can lead to dryer failure an extended dry times.

Contact a qualified professional.

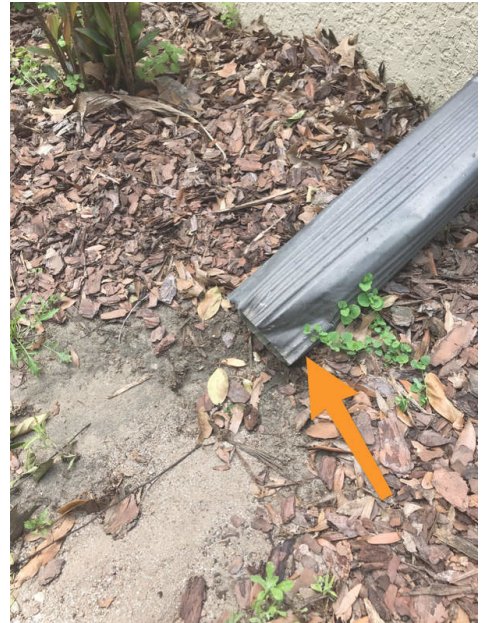
3.7.1 Gutters and Flashing

DOWNSPOUT EXTENSIONS

Extensions such as splash blocks or drain pipes for one or more downspouts were *missing / poorly sloped / misaligned / clogged / substandard / damaged*. Water can accumulate around the building foundation or inside crawl spaces or basements as a result. Recommend that a qualified person install, replace or repair extensions as necessary so rainwater drains away from the structure.

Contact a qualified professional.

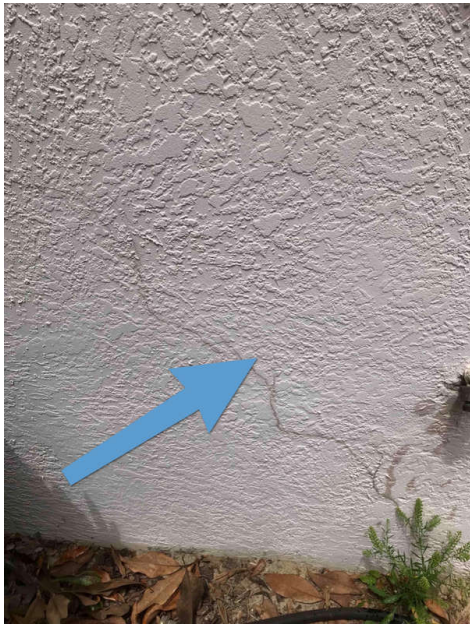
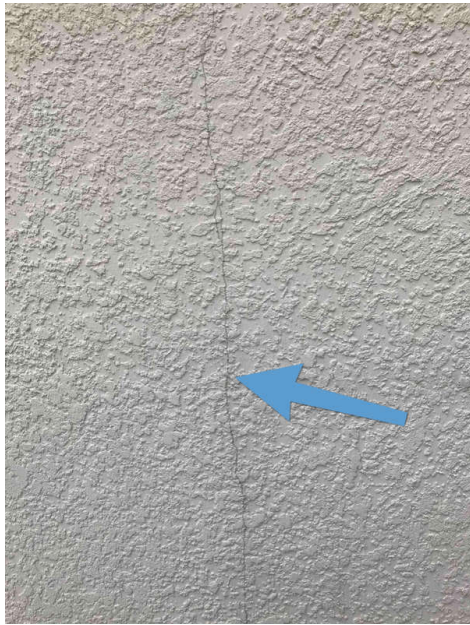
3.8.1 Stucco Walls

HAIRLINE STUCCO CRACKING

One or more minor hairline cracks were found in the stucco or wall areas. It is unknown the age of these cracks. At the time of inspection nothing out of the ordinary of normalized cracking was noticed. Recommend caulking and painting these areas, along with monitoring for future movement/widening. Stucco cracks over framing can allow moisture penetration behind wall areas and can potentially damage sheathing/framing. Note that areas concealed behind walls are not able to be evaluated without invasive testing and cannot be evaluated.

Recommended DIY Project

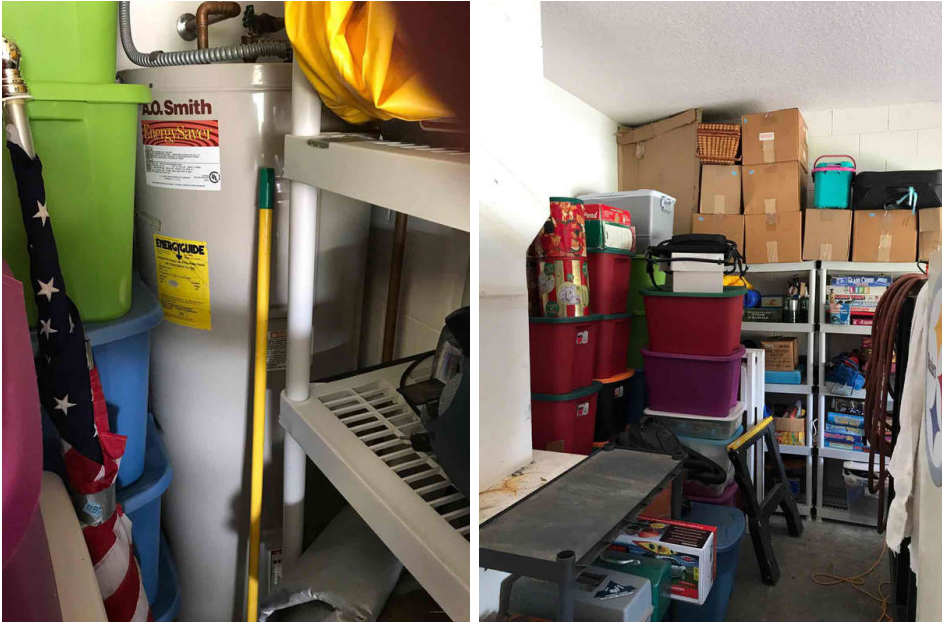
Water Heater

STORED ITEMS

Stored items, furnishings and/or debris blocked access to the water heater. The inspector was unable to fully evaluate the water heater.

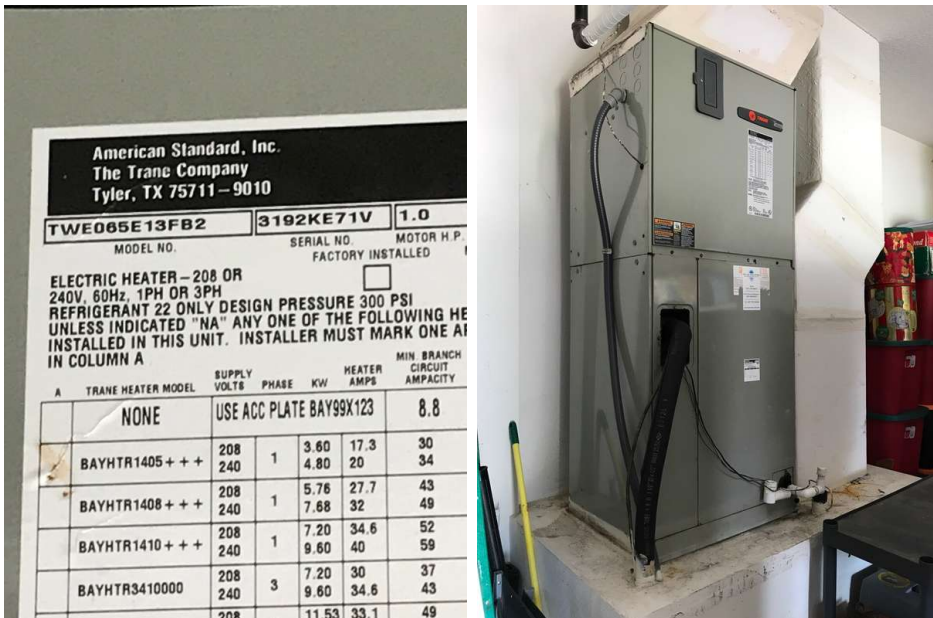
Air Handler: Unit in Good Condition

The air handler appeared in good condition. The unit ran and cold as expected.

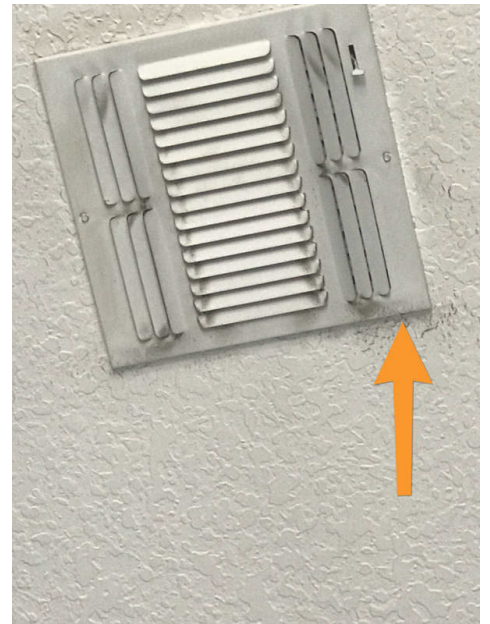
Significant amounts of debris, dirt and/or dust are visible in one or more sections of supply and/or return air ducts. This can be a health hazard, especially for those with allergies or respiratory problems. The Environmental Protection Association (EPA) recommends considering having ducts professionally cleaned when "ducts are clogged with excessive amounts of dust and debris and/or particles are actually released into the home from your supply registers". At a minimum, the visible debris should be thoroughly cleaned. Recommend having a qualified contractor clean the ducts if concerned.

Contact a qualified HVAC professional.

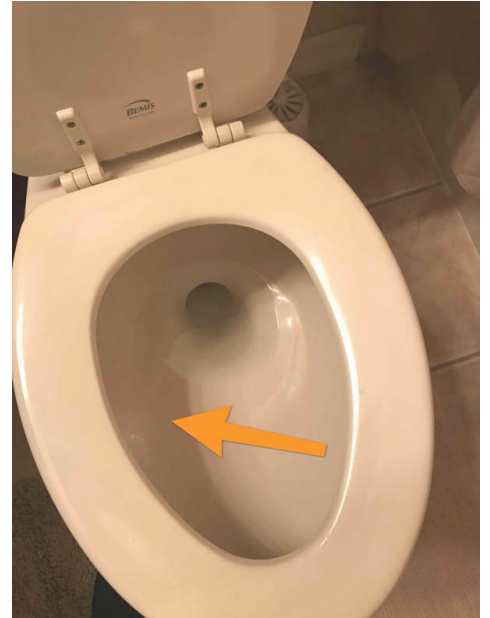
10.8.1 Toilets

The "flapper valve" in one or more toilets did not reseat after flushing. Significant amounts of water can be lost through such leaks. A qualified plumber should evaluate and repair or replace components as necessary.

Contact a qualified plumbing contractor.

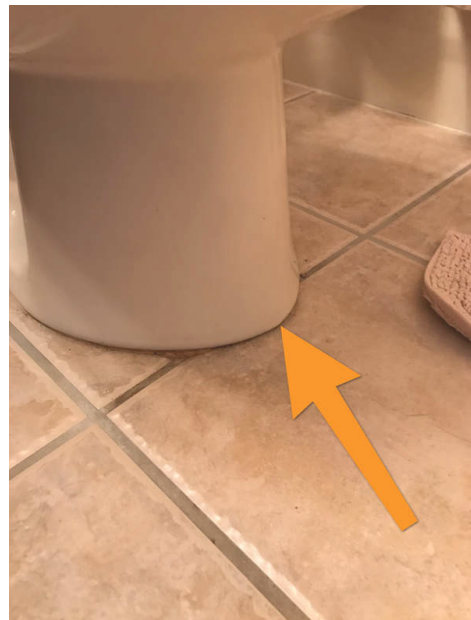
10.8.2 Toilets

Caulk around the base of the toilet was missing, substandard and/or deteriorated. Modern standards require caulk to be installed around the entire toilet base where it meets the floor for sanitary reasons. Without it, soiled water can soak into flooring and sub-floor materials if the toilet overflows. Condensation from the toilet can also soak into the flooring. Recommend that a qualified person caulk around toilet bases per standard building practices.

Recommended DIY Project

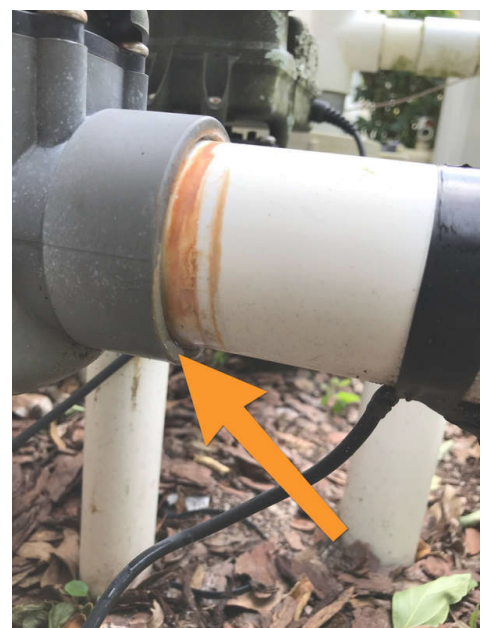
LEAK

There is a leak at the pool equipment. This will cause water loss. The equipment should be evaluated and any leaks repaired to help prevent unwanted water loss.

Contact a qualified Swimming Pool Contractor

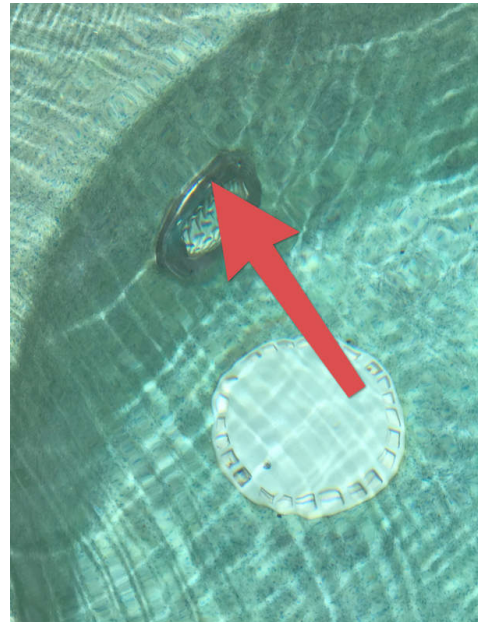
12.1.2 Pool Equipment

LIGHT INOPERABLE

One or more pool lights does not function, which can be a safety hazard. Nighttime swimmers may not be visible.

Contact a qualified Swimming Pool Contractor
