NEST CHECK HOME INSPECTION

1234 Main St.
Raeford, NC 28376

Buyer Name
06/12/2019 9:00AM

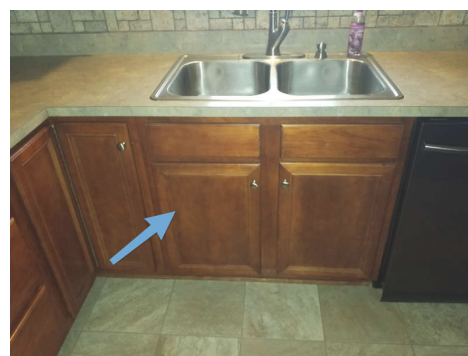
CABINET HINGE LOOSE

One or more cabinet hinges were loose. Recommend a qualified handyman or cabinet contractor repair.

Loose hinge

Contact a handyman or DIY project

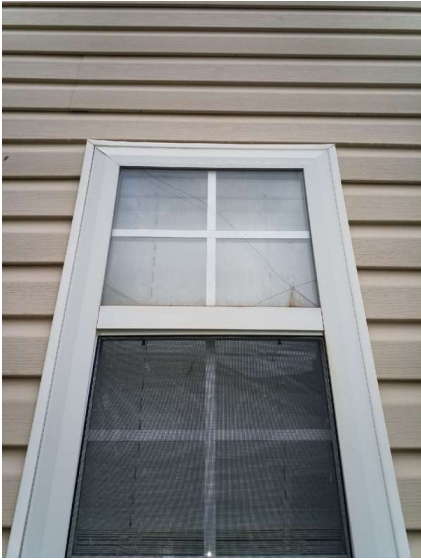
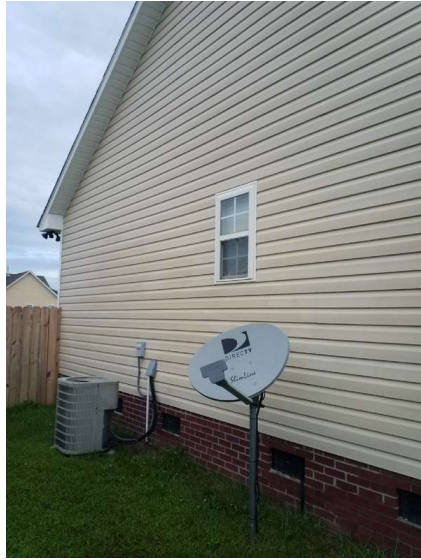
2.7.1 Windows

BROKEN/CRACKED GLASS

Some windows showed signs of damage in the form of cracked or broken glass panes. This poses a potential safety hazard to anyone using the windows or in the event of a need for egress. Also this reduces the efficiency of the windows. Recommend contacting window specialist for repair and replace as required.

Contact a qualified window repair/installation contractor.

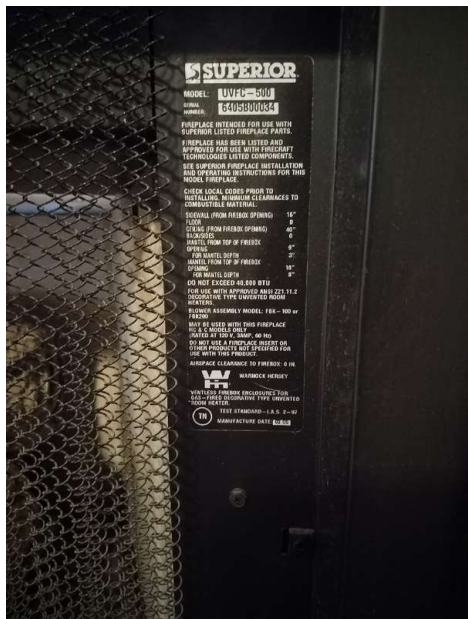
House has a ventless fireplace installed. Recommend following all manufacturer instructions for safe operation of ventless fireplace. Also ensure all carbon monoxide detectors remain operational to alarm occupants in the event of unsafe conditions.

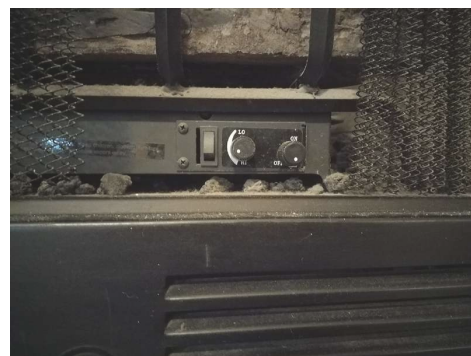
Fire place evaluation was limited due to no fuel or fuel being off. Recommend following manufacturer instructions and guidance prior to first use to ensure safety.

System is off

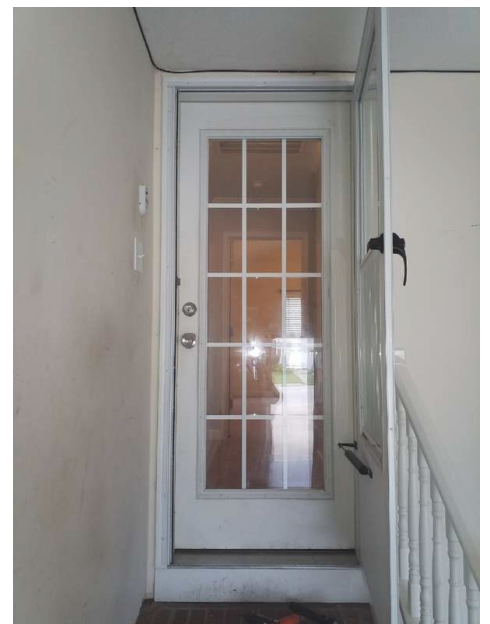
Safety Though not required at the time of building, the door separating the garage and home does not meet current safety standards. Doors in firewalls must be at least 1 3/8-inch thick, metal/steel or solid core wood, or a 20-minute fire-rated door, and sealed to keep vehicle gases from home. Recommend correction by installing a fire separation approved door with proper weather seals to keep garage environment out of home.

Contact a qualified door repair/installation contractor.

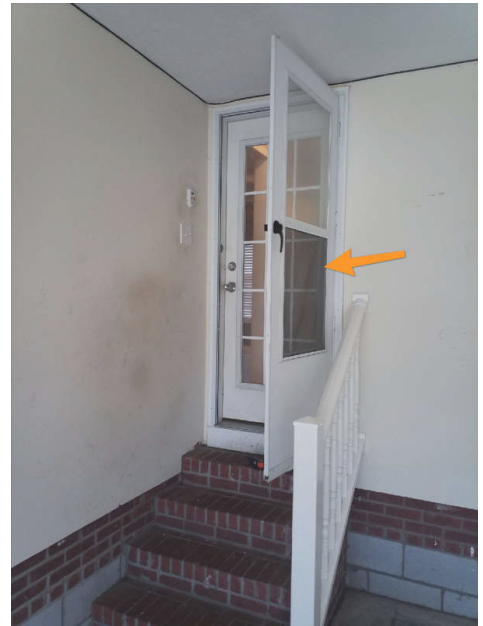
7.2.2 Occupant Door (From garage to inside of home)

Outward swinging door with no landing was noted at the garage steps leading to the home. This could pose a penitential safety hazard if the door is opened while someone is on the steps. Recommend removing outward screen door as a minimum and or have steps reconstructed to add appropriate landing to enhance safety.

Outward swinging door

Contact a qualified general contractor.

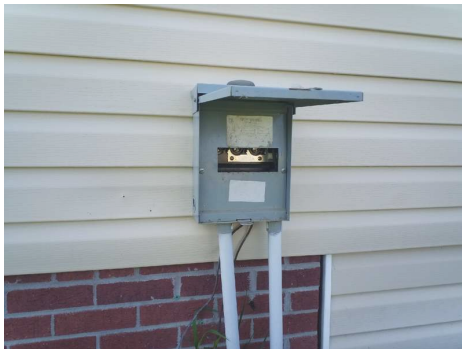
Breaker box on rear exterior of the home was noted as inactive at the time of the inspection. This box appears to have been used for a previously installed hot tub/Spa.

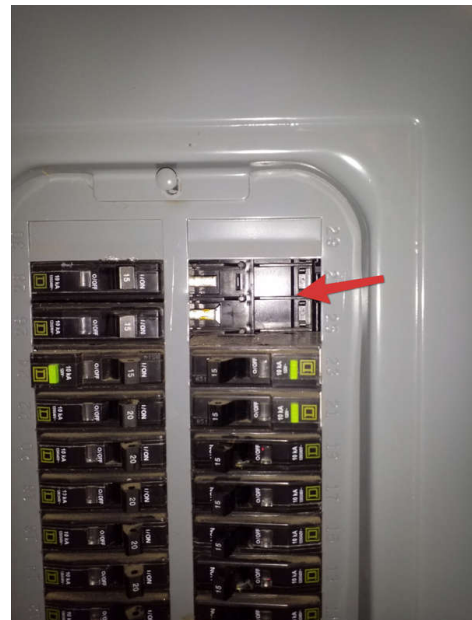
8.2.1 Service and Grounding Equipment, Main Overcurrent Device, Main and Distribution Panels

KNOCK COVER MISSING

Knockout cover on main panel is missing exposing the interior parts of the electrical panel. This poses a serious potential shock hazard to anyone working in or around the electrical panel. Recommend qualified electrician for repair as required.

Contact a qualified electrical contractor.

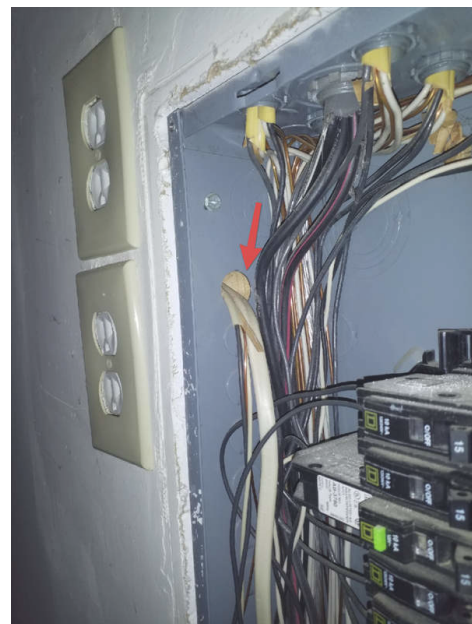
8.2.2 Service and Grounding Equipment, Main Overcurrent Device, Main and Distribution Panels

MISSING BUSHINGS

One or more bushings within the panel were noted as missing at the time of the inspection. These bushings are installed to protect conductors from being damaged as they pass through the metal panel. If left in the current condition could pose a shock hazard if conductors are damaged. This also exposes combustible material with in the wall to sparks if components were to malfunction. Recommend qualified electrician install appropriate bushing to ensure safety and increase protection.

Missing bushing

Recommendation
Contact a qualified electrical contractor.

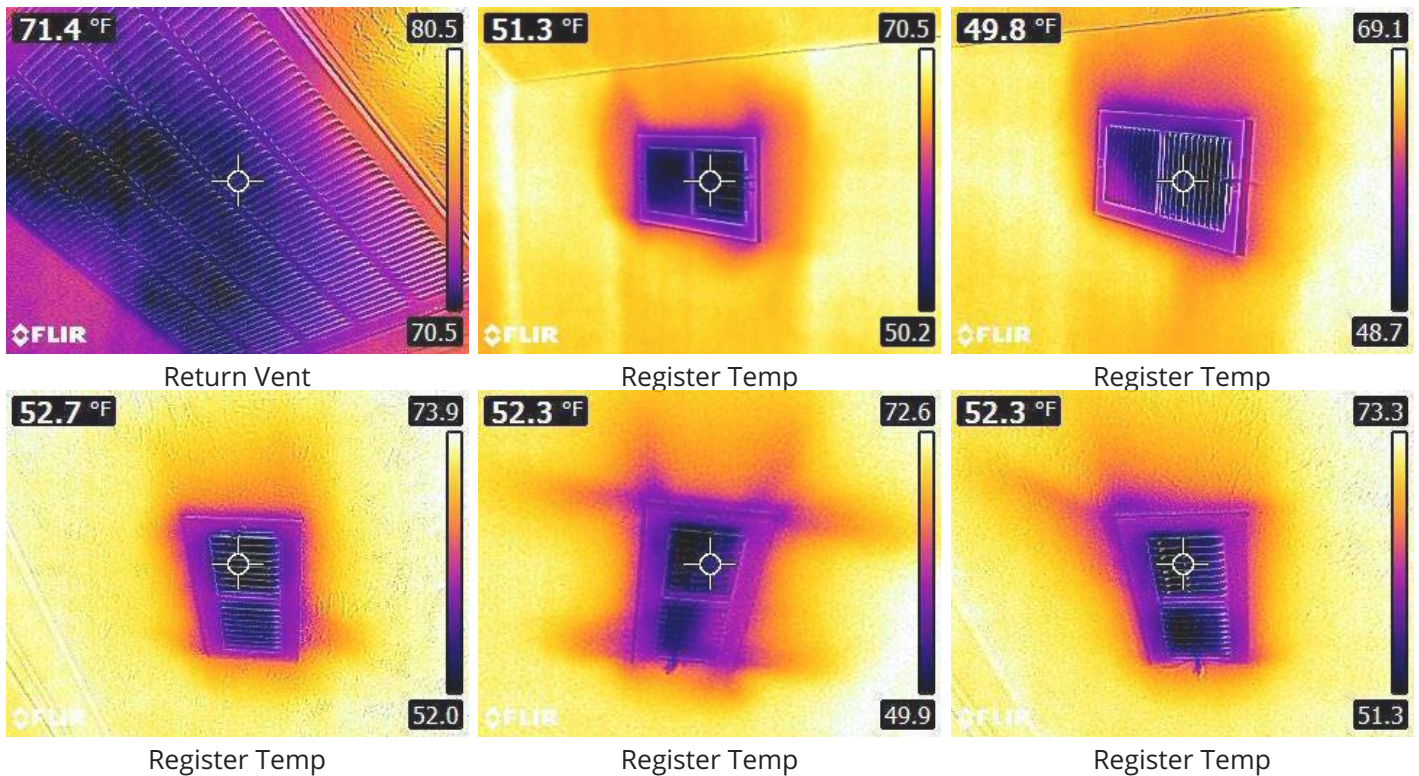
Normal Operating Controls: Cooling Temperature - Satisfactory

The temperature was taken from noted source using an IR thermometer; both register and ambient temps are measured. Temps differentials are within norms. Temps from register should be within 14-22 degrees from ambient room temps. Also measured is the condensation on the refrigerant line, heat transfer emitting from the condenser, and condensation moisture from the line. All factors are used to determine operating efficiency.

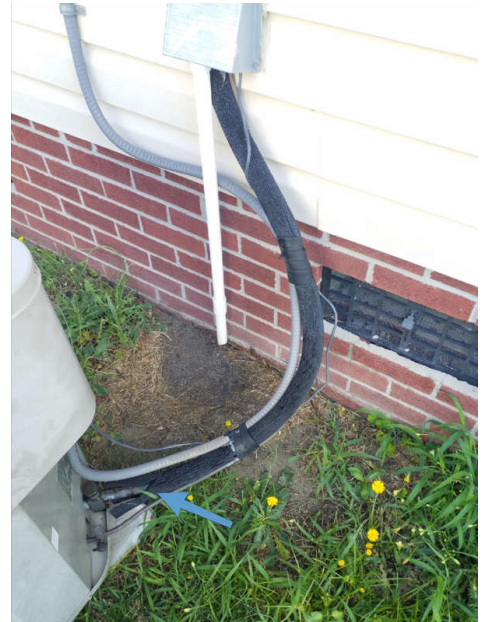
9.3.1 Air Conditioning Equipment

INSULATION MISSING OR DAMAGED

Missing or damaged insulation on refrigerant line can cause energy loss and condensation. Recommend replacement of line insulation.

Damaged/ Deteriorated Insulation

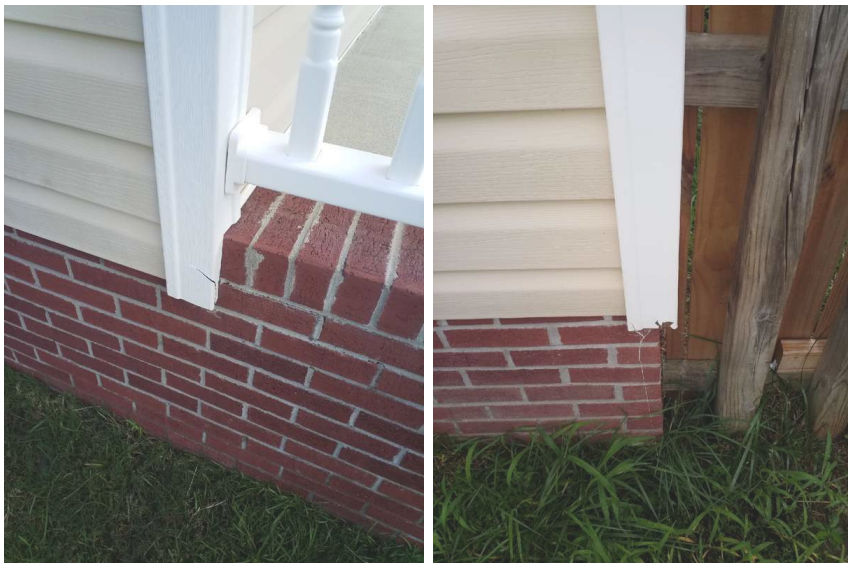
DAMAGED SIDING/TRIM (MINOR)

One or more areas of damage noted on siding/trim around the home. If these areas are left uncorrected further damage and deterioration may occur due to water being allowed behind coverings. Recommend qualified contractor for repair/seal as required.

Contact a handyman or DIY project

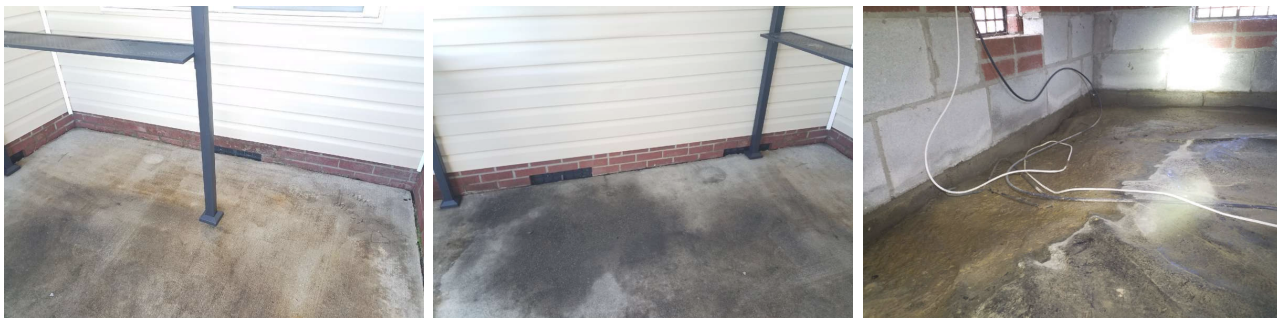
10.5.1 Vegetation, Grading, Drainage & Retaining Walls

It was noted that one or more crawlspace vents were located below grade. Crawlspace vents located below grade will be susceptible to water intrusion during wet weather. This will allow water to collect within the crawl space creating higher-than-normal moisture levels. Recommend a qualified contractor for further evaluation and set appropriate course of action to alleviate any further issues

Contact a qualified general contractor.

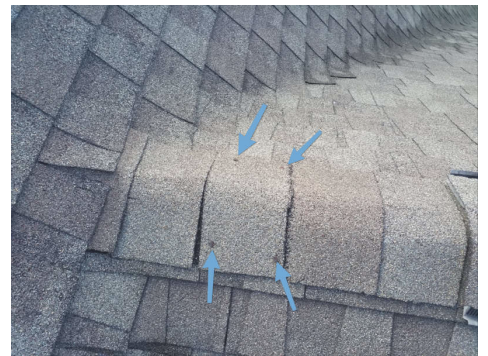
Under-driven or exposed nails were found in one or more roof coverings. If left uncorrected could potentially allow moisture intrusion overtime causing further damage to Interior wooden structure of the roof system. Recommend a qualified roofer or handy man evaluate and correct.

Exposed nail heads

Contact a handyman or DIY project

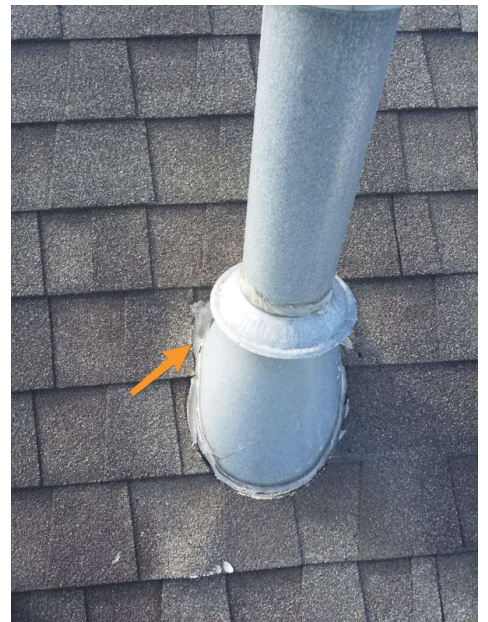
11.4.1 Skylights & Roof Penetrations

Deteriorated sealant around penetration flashing. If left in the current condition water will be allowed to run into the interior roof structure causing damage to interior structure. Recommend consulting with qualified roofer for further evaluation and repair as required.

Deteriorated sealant

Contact a handyman or DIY project

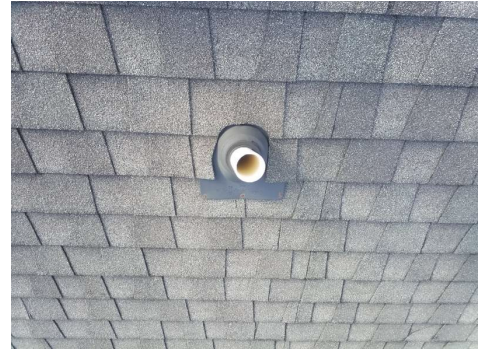
11.4.2 Skylights & Roof Penetrations

Vent boot flashing was missing sealant over exposed nail heads. The sealant is designed to stop water penetration around exposed nail heads and without it moisture penetration could occur over time due to lack of protection. Recommend sealing all exposed nail heads to alleviate possible moisture penetration.

Contact a handyman or DIY project

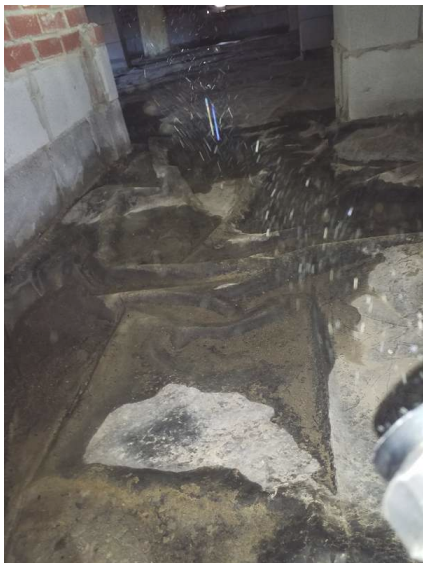
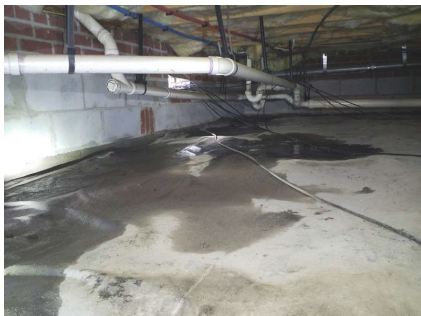
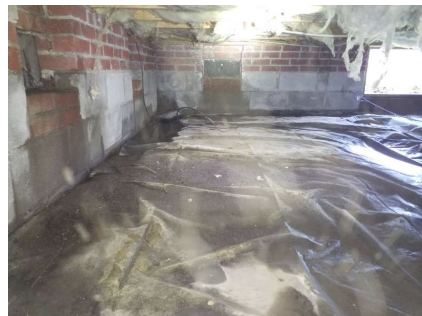
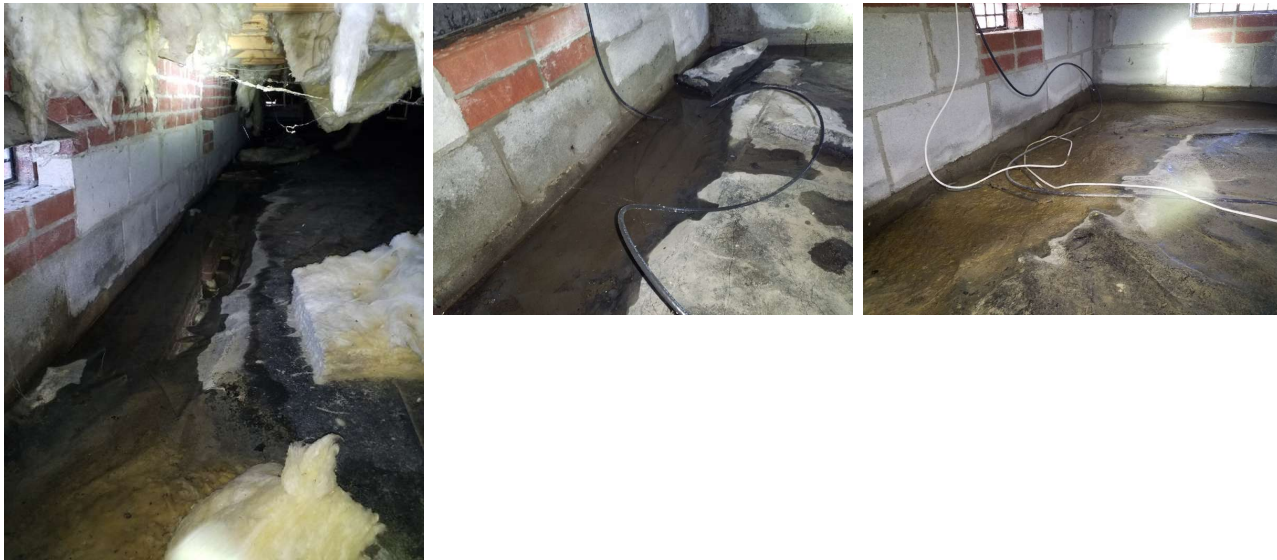
12.2.1 Foundation, Basement & Crawlspace

Water intrusion was evident on the surface of the crawlspace. It appears water is entering through vents and pooling around the perimeter of the crawlspace. This can compromise the soil's ability to stabilize the structure and could cause damage if left un-corrected as well as create an environment conducive to fungal growth. Recommend a qualified contractor to identify the source of moisture and remedy as required.

Contact a qualified general contractor.

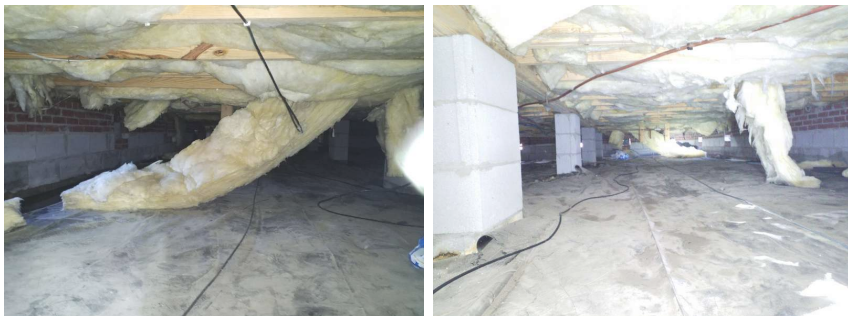
12.2.2 Foundation, Basement & Crawlspaces

Insulation was noted falling from joists in various locations in crawlspace. left in the current condition it will reduce the the homes efficiency and expose wood components to moisture. This is sometimes attributed to higher than normal moisture levels and failure to correct that will result in reoccurring issue. Recommend installing appropriate vapor barrier/control moisture levels and reattach/replace affected insulation by qualified professional.

Contact a handyman or DIY project

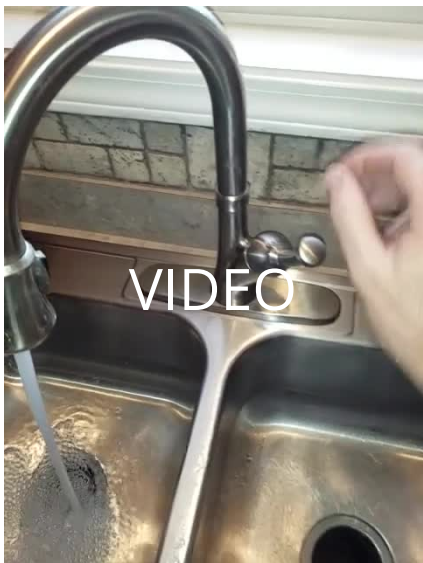
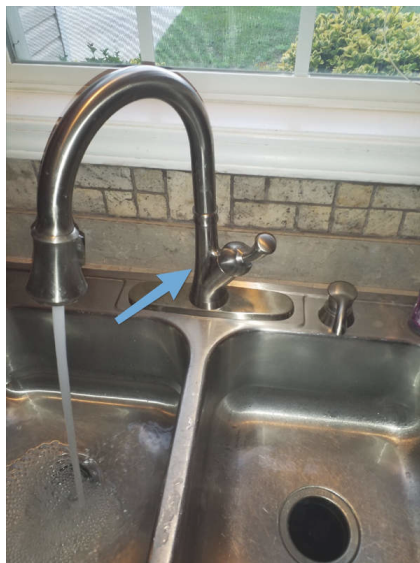
13.2.1 Fixtures / Faucets

KITCHEN SINK FIXTURE LOOSE

Kitchen sink fixture was noted as being loose at the time of the inspection. If left in the current condition could induce unnecessary strain on plumbing below the sink leading to leaks. Recommend correcting attachment to ensure it is secure.

Fixture loose

Contact a handyman or DIY project

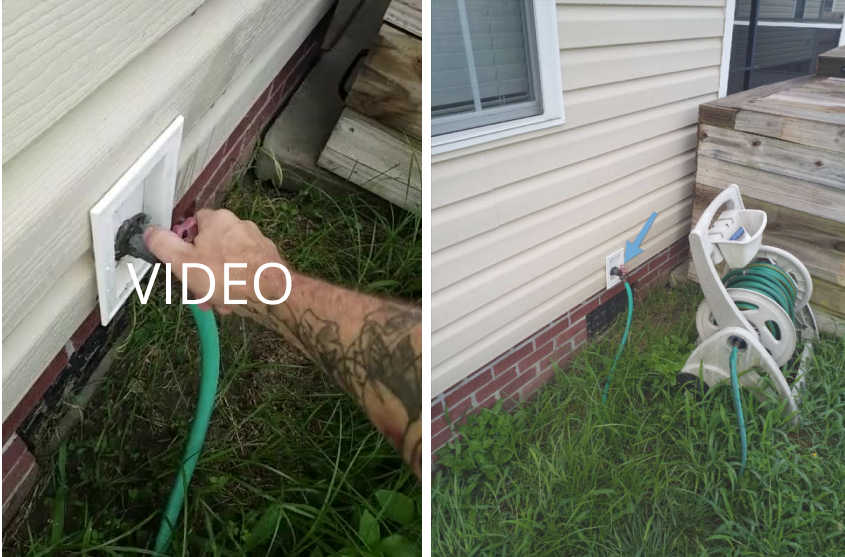
13.2.2 Fixtures / Faucets

HOSE BIB LEAKS

Hose bib on side of the home was noted as leaking when turned on. If left in the current condition could cause unnecessary water consumption during use. Recommend qualified plumbing technician to repair as required.

Contact a qualified plumbing contractor.
