CREPPS HOME INSPECTION LLC

## RESIDENTIAL REPORT

1234 Main St.  
Coxs Creek KY 40013

Buyer Name  
09/19/2018 9:00AM

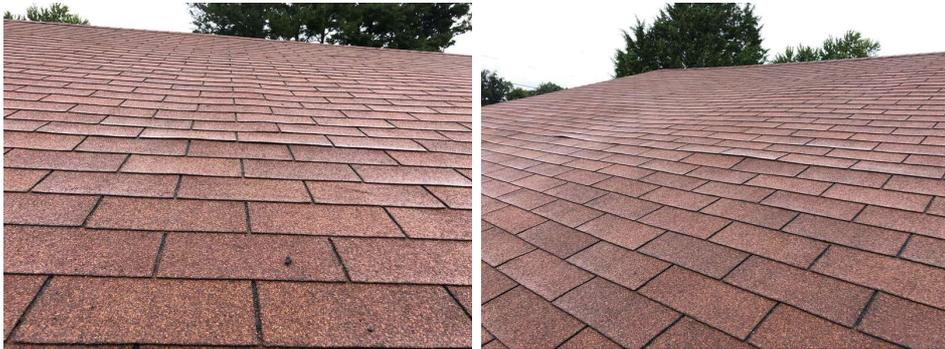
2.5.1 Structure

**SOFT SPOT(S) NOTED**

In localized areas of the roof, when it was walked on, sheathing deflected to a greater degree than on the rest of the roof. This can be the result of a number of conditions, including wood decay, and sheathing panels with damaged or defective sections. Roof sheathing was not directly visible from the exterior.

Recommendation

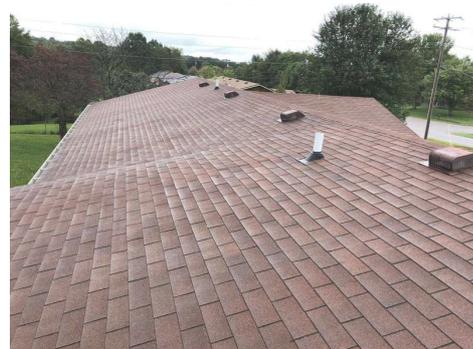
2.5.2 Structure

**SAGGING RAFTERS**

The rafters were sagging in one or more locations. This could indicate that they are either undersized or damaged. No damage observed from the attic.

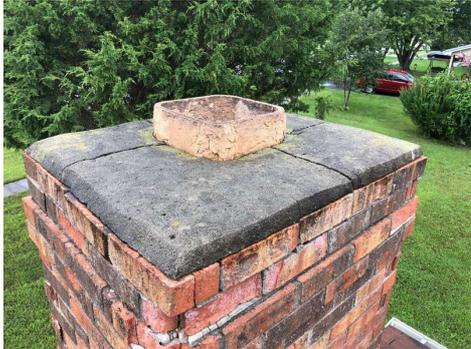
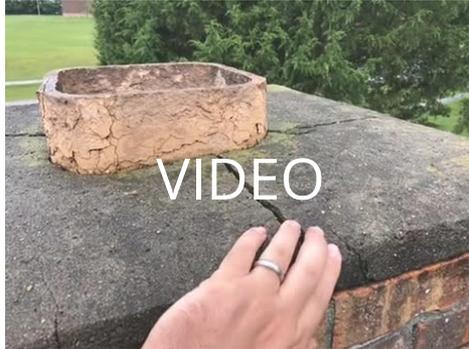
2.6.1 Chimney

**CHIMNEY CROWN - CRACKED**

Cracking visible in the chimney crown, and mortar joints, should be filled with an appropriate sealant to prevent continued damage from the freeze/thaw cycle. This can also be a source of moisture intrusion at the interior. Recommend further review. [Here is some more information about moisture intrusion and chimneys.](#)

Contact a qualified chimney contractor.

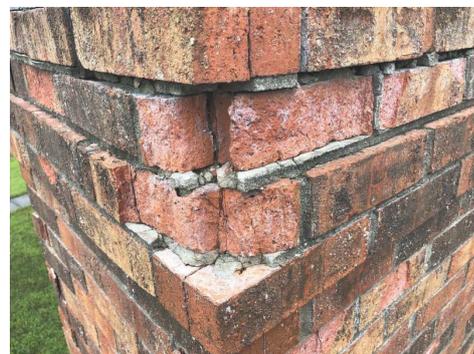
2.6.2 Chimney

**CHIMNEY REPOINT NEEDED**

Joints in the masonry have deteriorated and should be repointed. Repointing is the restoration of the mortar joints in the masonry. Moisture intrusion at chimneys can be problematic. [Here is some more information about moisture intrusion and chimneys.](#)

Contact a qualified chimney contractor.

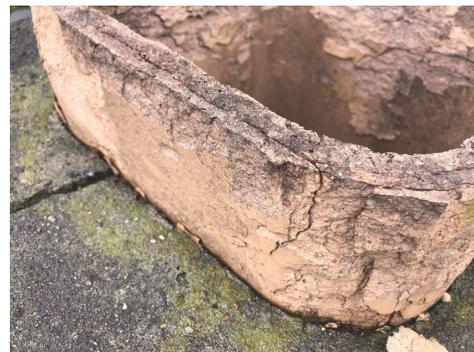
2.6.3 Chimney

**CHIMNEY FLUE CRACKED**

The chimney flue had one or more cracks, which can lead to further damage to the chimney structure. Recommend a qualified contractor repair.

Contact a qualified roofing professional.

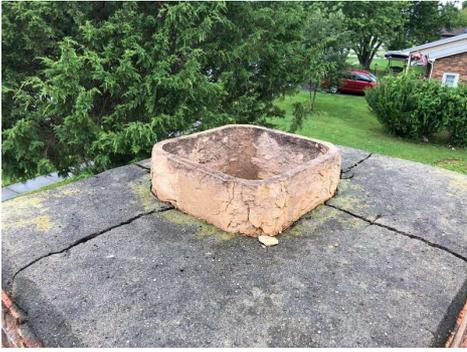
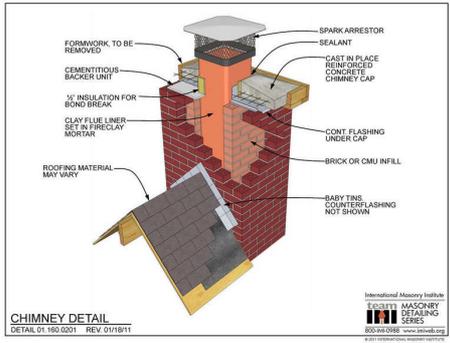
2.6.4 Chimney

**SPARK ARRESTOR**

Consider installing a spark arrestor to mitigate the moisture intrusion, the potential for sparks, and nesting. [See here for more information.](#)

Contact a qualified chimney contractor.

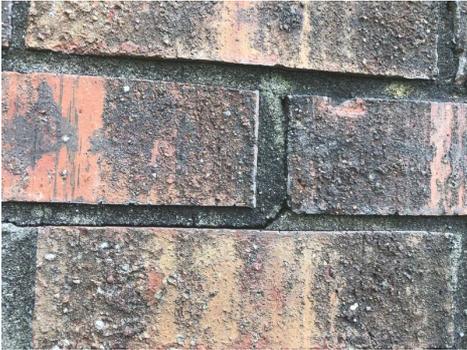
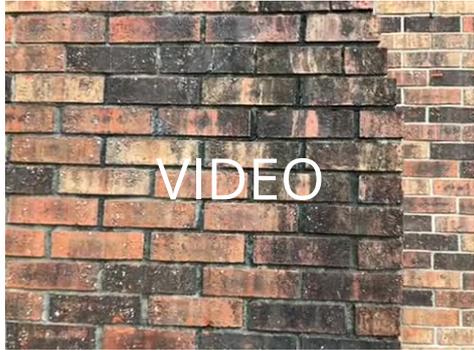
2.6.5 Chimney

**CRACKS - MINOR**

There were some visible cracks noted in the masonry. Recommend measures to seal any gaps to mitigate the risk of moisture intrusion.

Contact a qualified roofing professional.

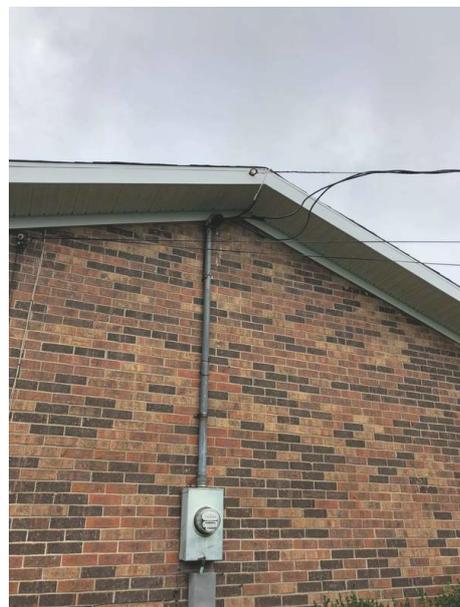
**Gas, Water, & Electric: Electrical Service**

Overhead

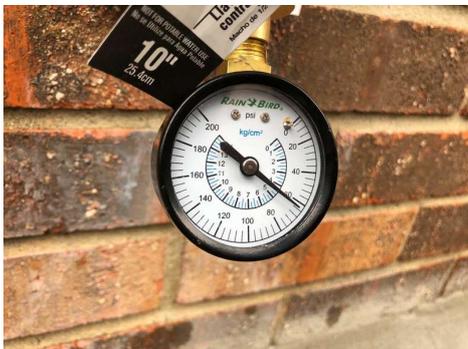
40-80 psi

Residential water pressure tends to range between 45 and 80 psi (pounds per square inch). Anything below 40 psi is considered low and anything below 30 psi is considered too low; the minimum pressure required by most codes is 20 psi. Pressures above 80 psi are too high. Whereas low water pressure is more of a nuisance than a serious problem (some fixtures, like washing machines, have minimum pressure requirements), high water pressure carries with it a significantly increased risk of damage to pipes, joints, fixtures and seals - not to mention increased water waste. [Here is a great article about water pressure in your home.](#)

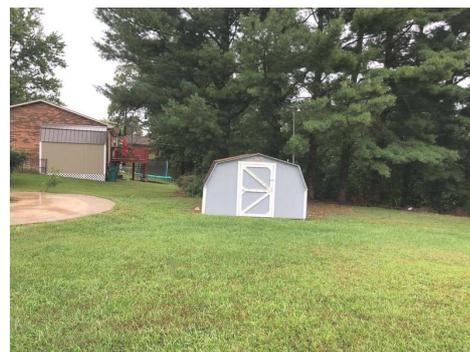
Shed

The shed was not inspected as part of this home inspection as per the agreement.

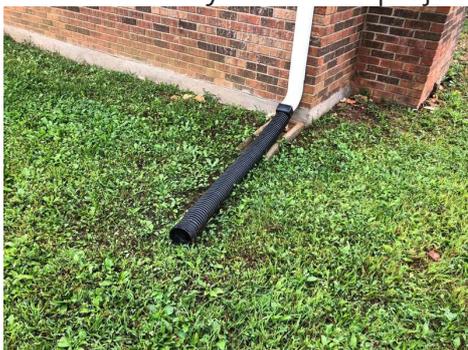
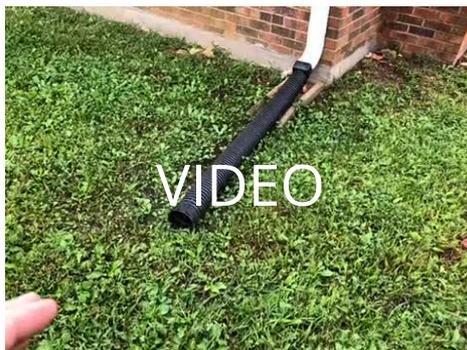
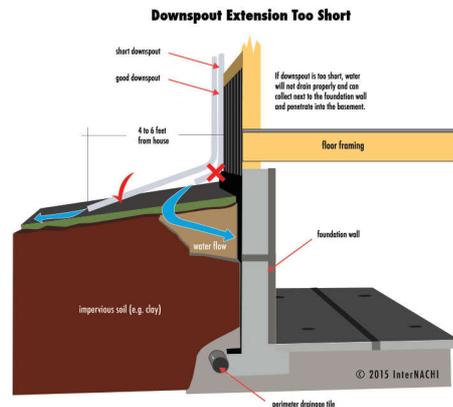
3.3.1 Vegetation, Grading, & Drainage

One or more downspouts drain too close to the home's foundation. This can result in excessive moisture in the soil at the foundation, which can lead to foundation/structural movement. Recommend a qualified contractor adjust downspout extensions to drain at least 6 feet from the foundation.

Contact a handyman or DIY project

Recommend extending the downspouts further away from the foundation.

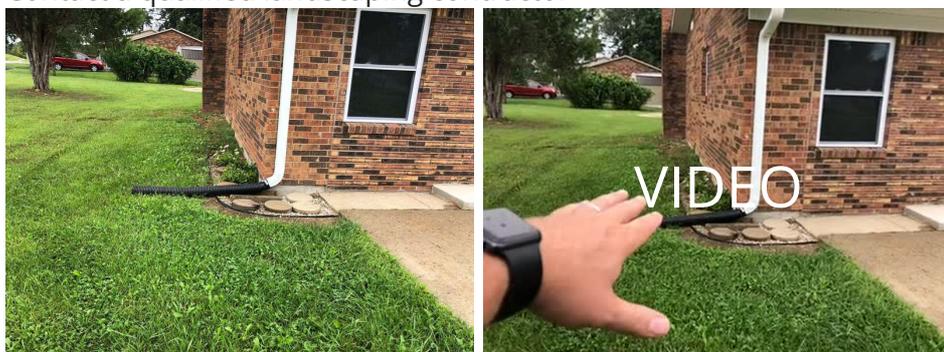
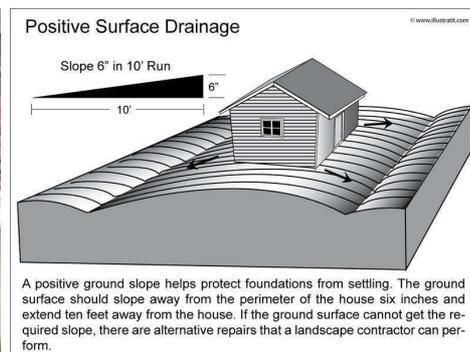
3.3.2 Vegetation, Grading, & Drainage

Grading is sloping towards the home in some areas. This could lead to water intrusion and foundation issues. Recommend qualified landscaper or foundation contractor regrade so water flows away from home.

Contact a qualified landscaping contractor

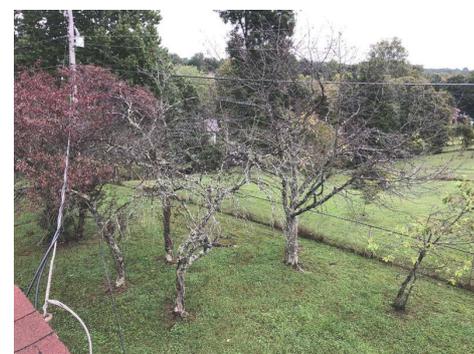
3.3.3 Vegetation, Grading, & Drainage

There was a dead tree or limb noted during the inspection. It could cause damage or injuries if not addressed.

Contact a qualified tree service company.

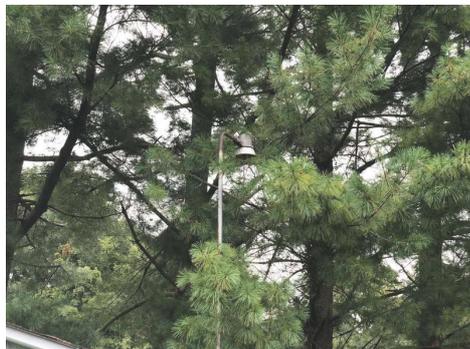
3.4.1 Gas, Water, & Electric

**FIXTURE DAMAGED**

One or more of the exterior fixtures were damaged or missing. Repair as needed.

Contact a qualified professional.

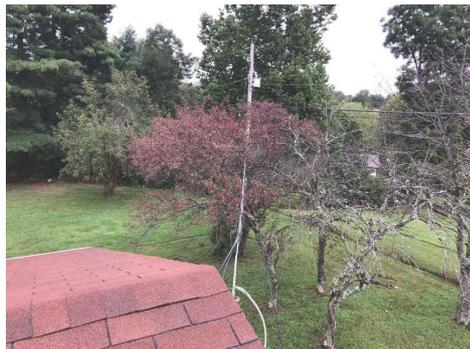
3.4.2 Gas, Water, & Electric

Branches around the service entrance may cause damage.

Contact a qualified professional.

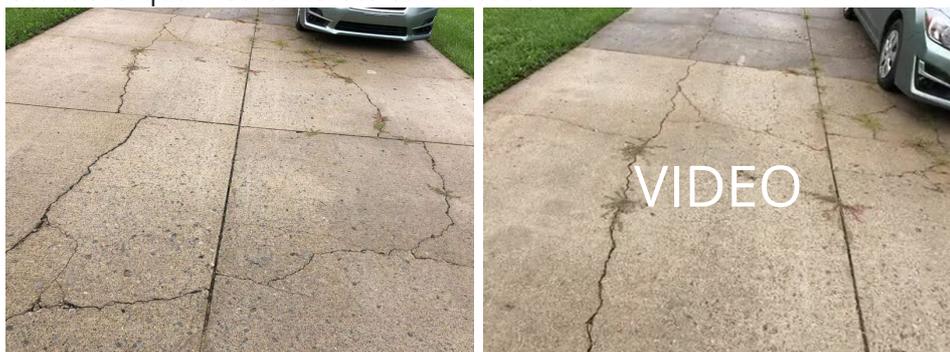
3.7.1 Driveways & Walkways

**CRACKING/SETTLING**

Major cracks and/or settling observed. This may indicate inadequate soil prep or erosion. It may be a lack of reinforcing bar. Some trip hazards may exist. Further review by a concrete contractor is recommended.

Contact a qualified concrete contractor.

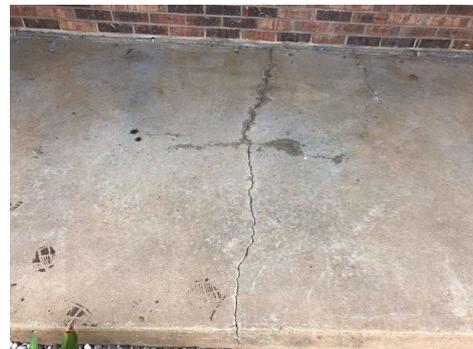
3.9.1 Porches & Patios

**TYPICAL CRACKING**

There was some typical cracking/settling noted at the concrete. I observed no significant concerns.

Recommend monitoring.

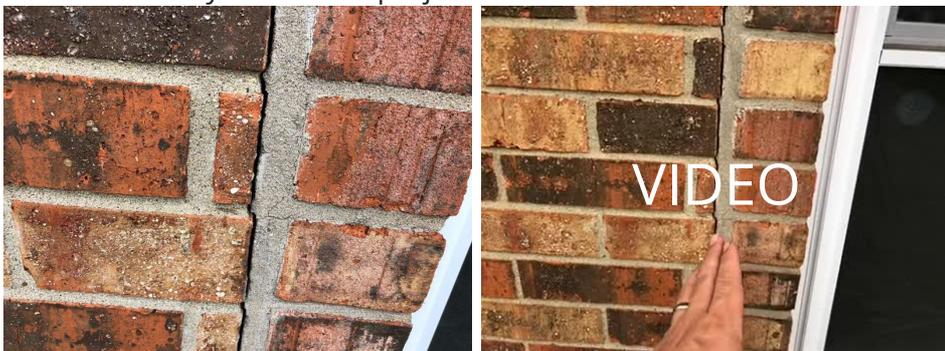
3.11.1 Masonry

**GAPS**

Recommend that any gaps or penetrations in the masonry exterior be sealed to mitigate moisture intrusion.

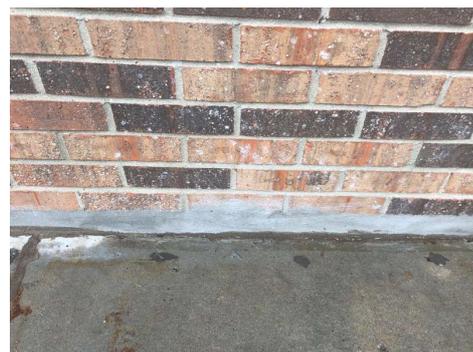
3.11.2 Masonry

**WEEP HOLES**

No means was provided for ventilating the air space behind the brick (weep holes). Good building practice requires ventilating the air space behind the brick to help prevent moisture problems.

Under certain circumstances, this condition can create moisture problems resulting from condensation and excessive moisture levels in wall assembly materials. This condition may also trap any moisture which finds its way into this space from roof or plumbing leaks. Excessive moisture levels in wall materials can also encourage the growth of microbes such as mold fungi.

There is not typically a way to correct this condition because it requires flashing that can not be installed after the fact. Recommend monitoring the area.

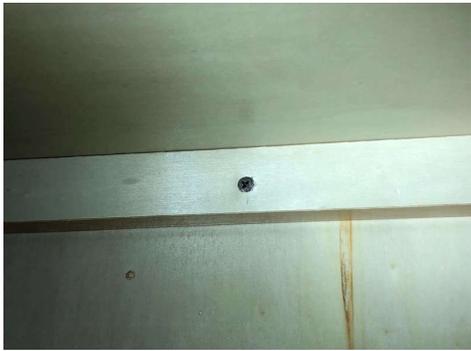
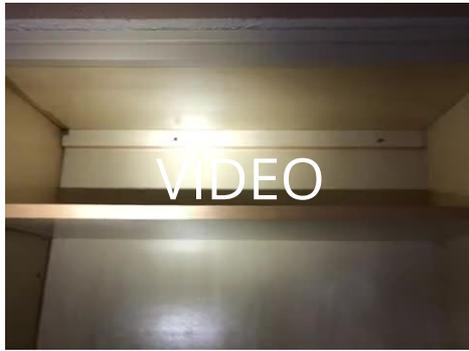
One or more cabinet screws are missing or the wrong type of screws were used. Recommend further review and installing as needed.

Contact a handyman or DIY project

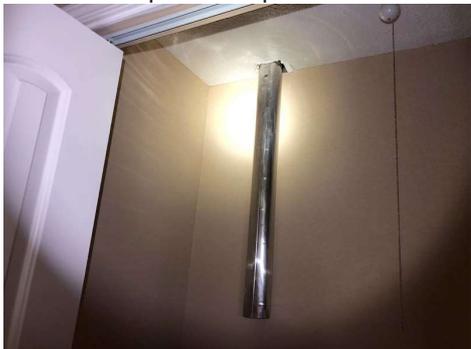
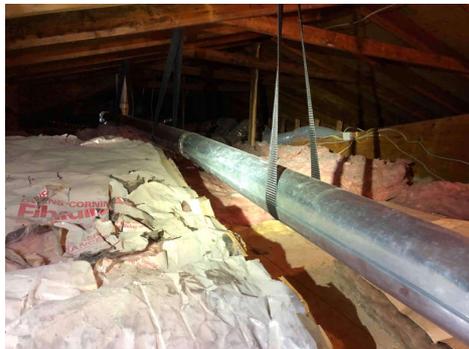
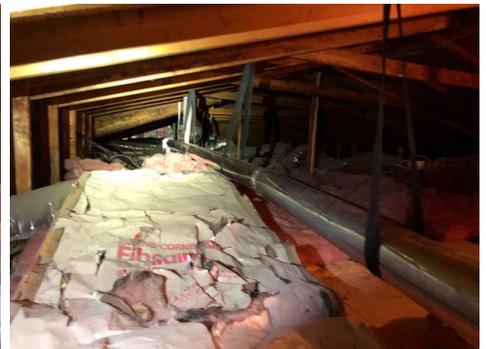
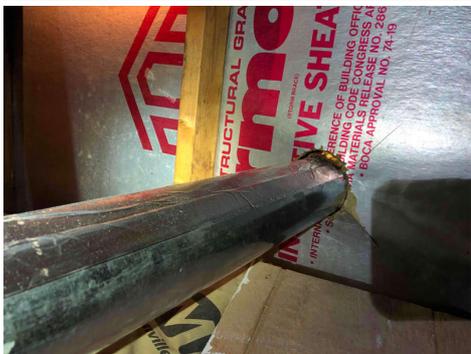
4.8.1 Laundry

**DRYER VENT IN ATTIC**

The metal dryer vent should be insulated. They are prone to clogging when the hot moist air hits the colder metal vent. Recommend making improvements.

Contact a qualified professional.

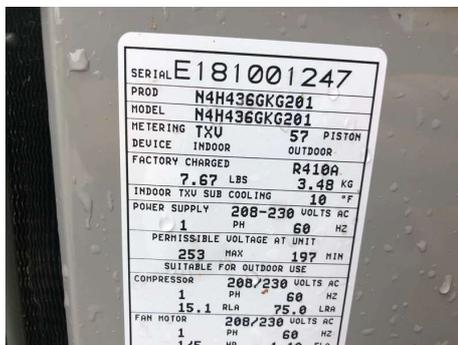
### Outside Unit: Type & Unit Info

Heat Pump

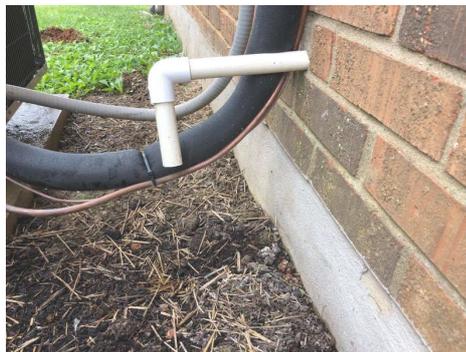
6.1.1 Outside Unit

The condensation drain should extend further away from the foundation.

Contact a handyman or DIY project

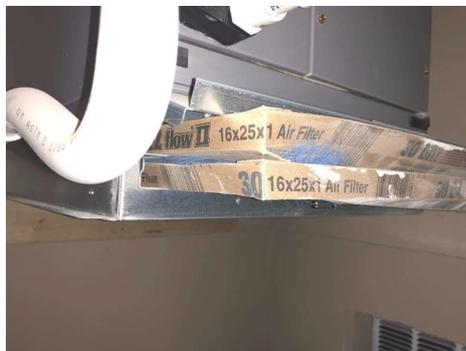
6.3.1 Filters

The filter installed was the wrong size or improperly fit. Replace with proper filter or size. There should not be two installed.

Recommended DIY Project

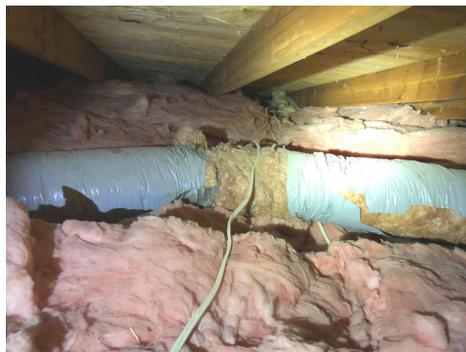
6.5.1 Distribution Systems

**DUCT DAMAGED**

Air supply duct was damaged. This can impact the efficiency of the system.

Contact a qualified HVAC professional.

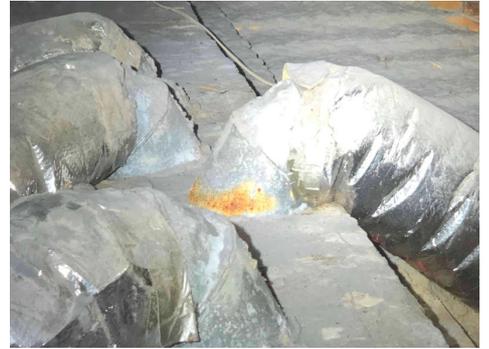
## 6.5.2 Distribution Systems

Sometimes when the boot is not insulated in an attic, the cold metal boot will cause condensation to form and some staining is the result. As seen here.

Contact a qualified HVAC professional.

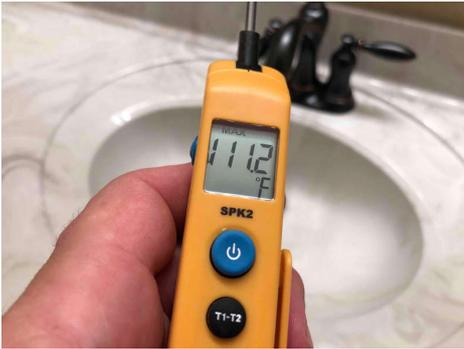
**\*Safety\*** When water temperature is much over 120 degrees the risk for scalding increases. When the temperature is below a certain temperature there is an increase of issues like [Legionella](#). There are some options out there that allow you to keep the water in the tank hot but avoid that elevated temperature at the outlet. Tempering devices such as [this](#).

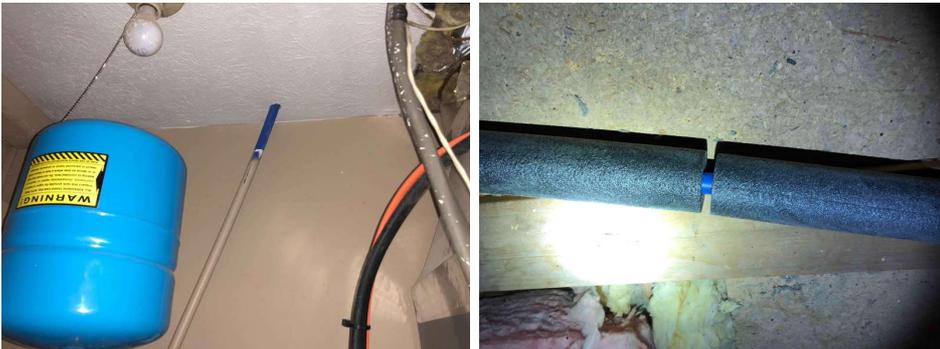
Some water lines run thru the attic. These appeared to be somewhat insulated but I could not confirm it was adequate to prevent the lines from freezing.

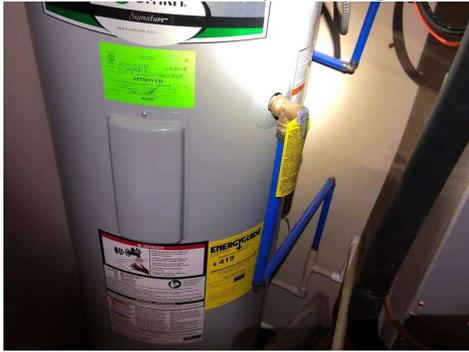
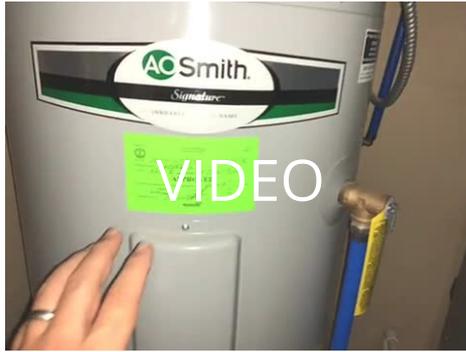
## 7.4.1 Hot Water - Tank

**FAULTY T&P DISCHARGE**

**\*SAFETY\*** Faulty T&P drain. Recommend further review and repair. Here are the guidelines. The drain pipe must be as short as possible and be the same size as the valve discharge connection throughout its entire length. Excessive length, over 15 long, or the use of more than two elbows can cause a restriction and reduce the discharge capacity of the valve. The drain pipe must pitch down from the valve and terminate a maximum of 6 above the floor drain, or outside ground level where any discharge will be clearly visible. The drain line shall terminate plain, not threaded, with a material serviceable for temperatures up to 250F or greater.

Contact a qualified plumbing contractor.

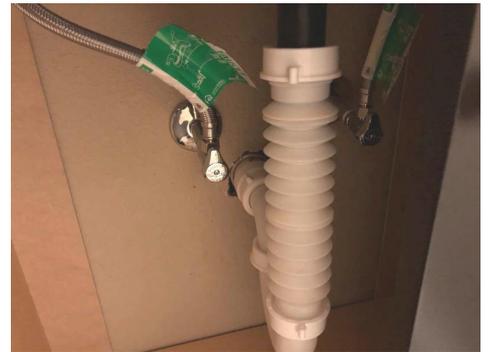
7.5.1 Sinks

**FLEXIBLE DRAIN**

The use of flexible drain is not recommended as they are prone to clogging.

Recommend monitoring.

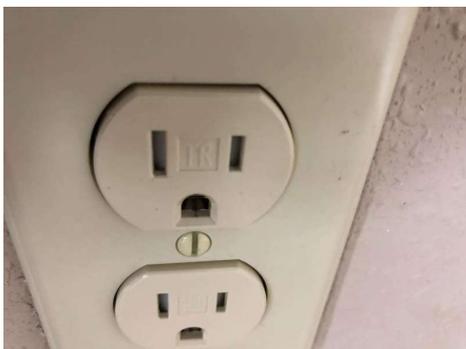
**Receptacles & Switches: Tamper-resistant electrical receptacles**

These receptacles have spring-loaded shutters that close off the contact openings, or slots, of the receptacles. When a plug is inserted into the receptacle, both springs are compressed and the shutters then open, allowing for the metal prongs to make contact to create an electrical circuit. Because both springs must be compressed at the same time, the shutters do not open when a child attempts to insert an object into only one contact opening, and there is no contact with electricity. Tamper-resistant receptacles are an important next step to making the home a safer place for children.

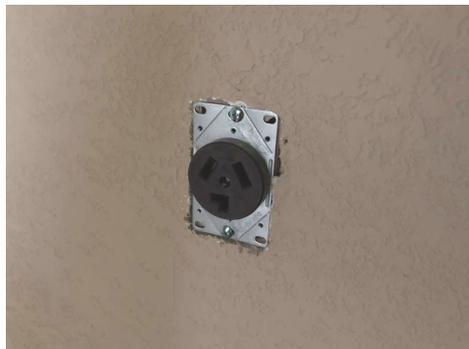
8.4.1 Receptacles & Switches

### COVER PLATES MISSING

**\*SAFETY\*** One or more receptacles are missing a cover plate or the cover was damaged/loose. This causes short and shock risk. Recommend installation of plates.

Contact a handyman or DIY project

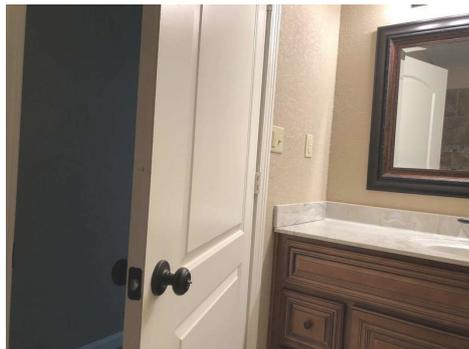
#### 8.4.2 Receptacles & Switches

### SWITCH BEHIND DOOR

Switch to was located behind the door.

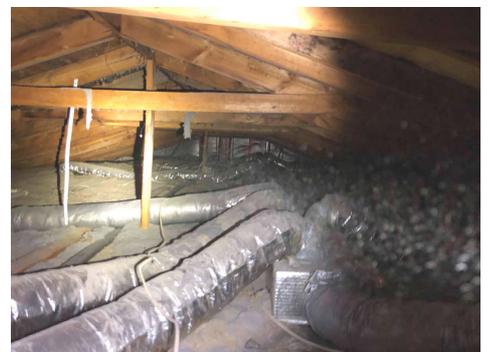
### INSPECTED FROM ACCESS ONLY

Because of safety considerations, or lack of access, the attic, in the inspectors opinion, could not be entered safely. It was just too shallow without a walkway.

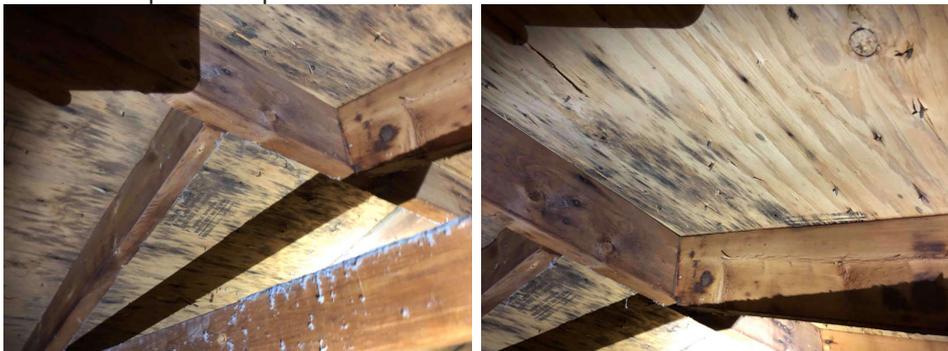
There was a substance noted in the attic that appeared to be microbial growth. Many times this is resulted from inadequate venting of the attic. It appeared as though the dryer vent had been terminated into the attic. Confirming the presence of mold lies beyond the scope of a home inspection.

Contact a qualified professional.

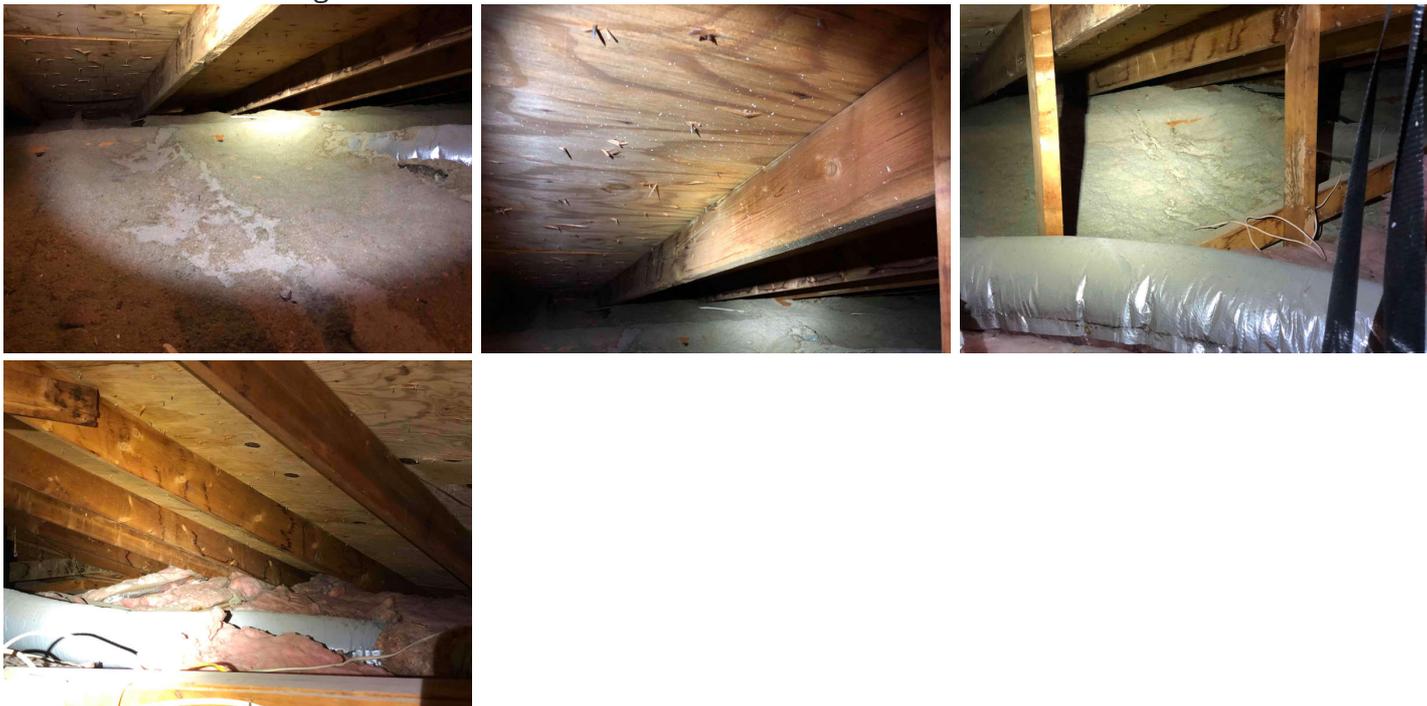
9.6.1 Leaks

**PREVIOUS LEAKS**

There was some water staining indicating previous water leaks. There were some signs of moisture intrusion at the insulation. No active moisture was observed however.

Recommend monitoring.

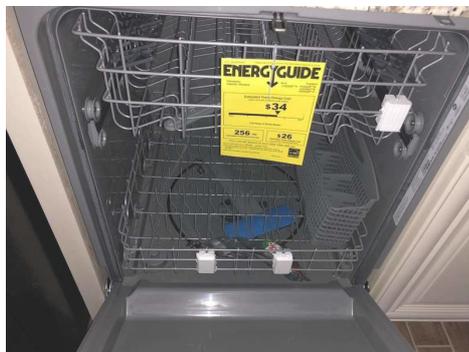
### PERSONAL BELONGINGS

Dishwasher could not be tested due to personal belongings or packing/shipping materials.

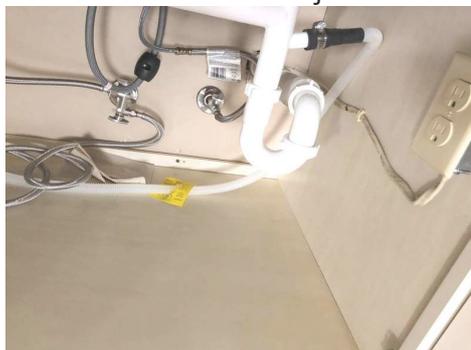
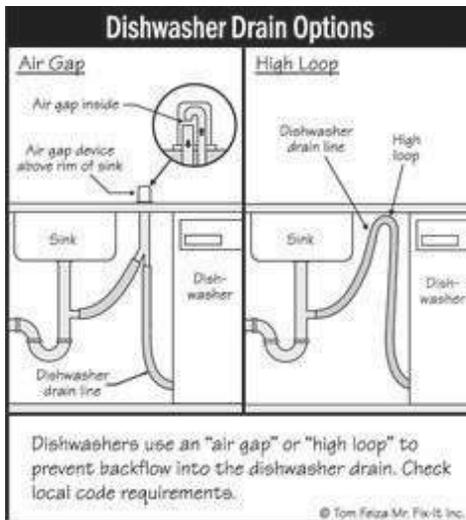
10.1.1 Dishwasher

### HIGH LOOP MISSING

Dishwasher drain pipe was installed improperly. Recommend a qualified plumber evaluate and repair.

Recommended DIY Project

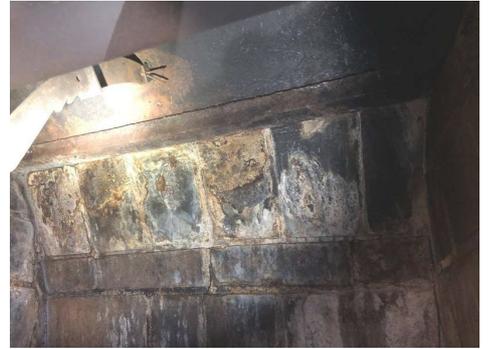
11.1.1 Vents, Flues & Chimneys

### RUST/CORROSION

There was some evidence the chimney needs to be cleaned. Signs of corrosion or buildup were noted in the attic. Recommend having a chimney sweep evaluate.

Contact a qualified chimney sweep.
