RENOVEE INSPECTION SERVICES, LLC

RESIDENTIAL REPORT

1234 Main St.
New Britain CT 06053

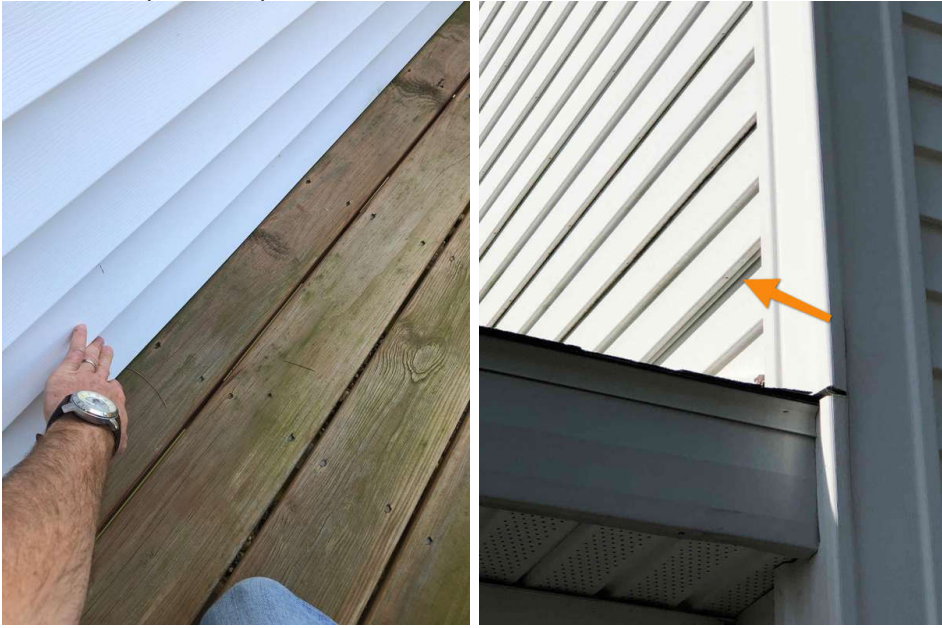
2.2.1 Exterior Wall Covering, Flashing & Trim

LOOSE BOARDS

One or more siding boards were loose, which could result in moisture intrusion. Recommend a qualified siding contractor secure and fasten.

Contact a qualified professional.

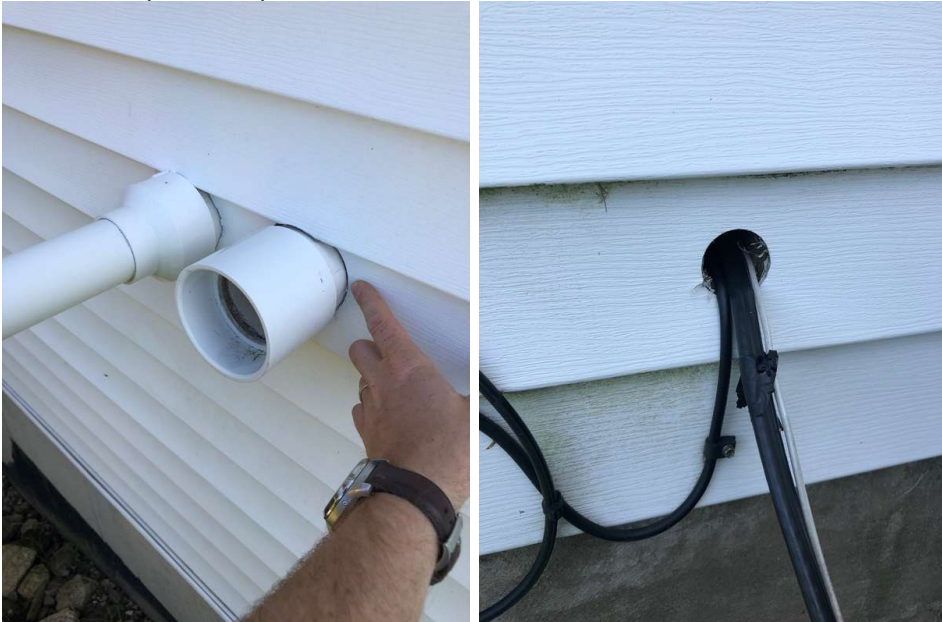
2.2.2 Exterior Wall Covering, Flashing & Trim

PENETRATIONS

Wall covering penetrations should be sealed to help keep water out.

Contact a qualified professional.

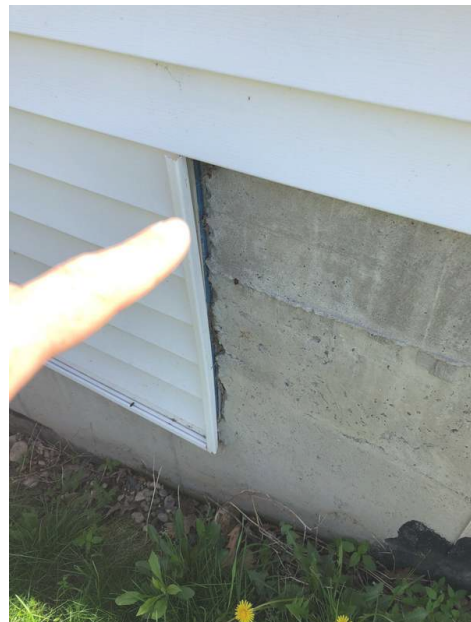
2.2.3 Exterior Wall Covering, Flashing & Trim

EXPOSED SHEATING

Exposed sheathing should be properly sealed off to prevent water intrusion and damage. Siding should be properly installed.

Contact a qualified professional.

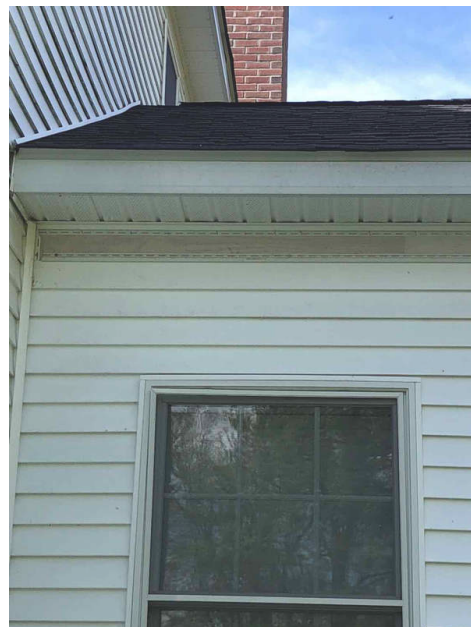
2.2.4 Exterior Wall Covering, Flashing & Trim

MISSING SIDING

Missing siding should be replaced to prevent water damage.

Contact a qualified professional.

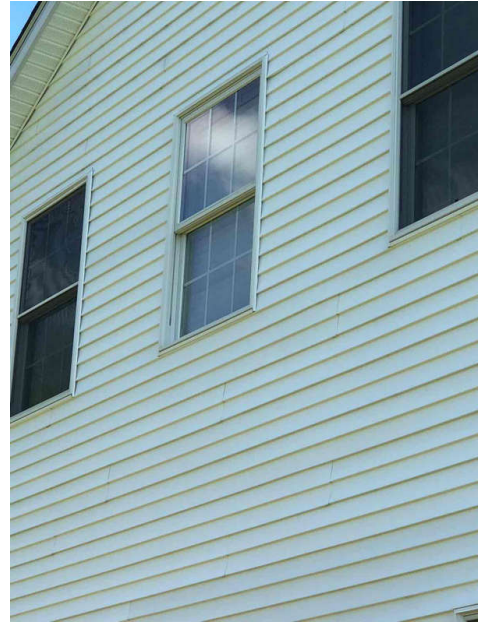
2.4.1 Windows

MISSING SCREENS

There was a missing screen in at several of the windows.

Contact a qualified professional.

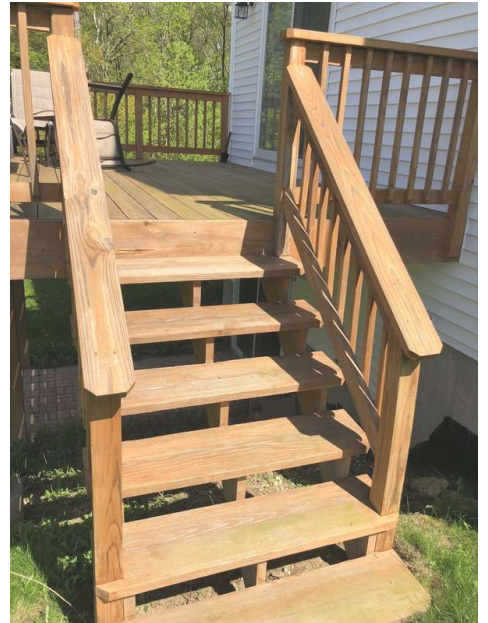
2.5.1 Decks, Balconies, Porches & Steps

GRASPABLE HANDRAIL

I suggest adding a graspable handrail to the exterior railing.

Contact a qualified professional.

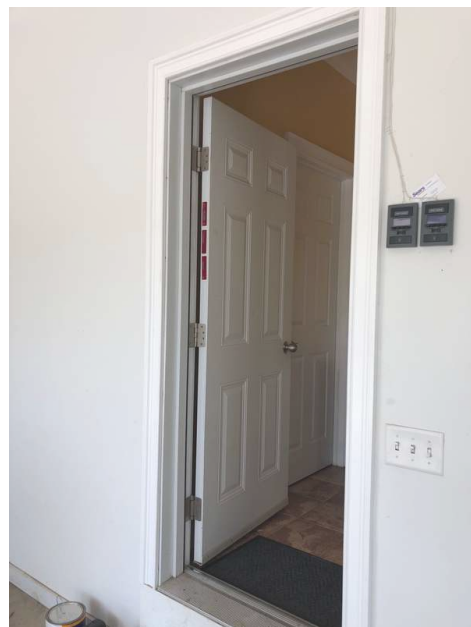
3.6.1 Occupant Door (From garage to inside of home)

NOT SELF-CLOSING

Door from garage to home should have self-closing hinges to help prevent spread of a fire to living space. Recommend a qualified contractor install self-closing hinges.

Contact a qualified door repair/installation contractor.

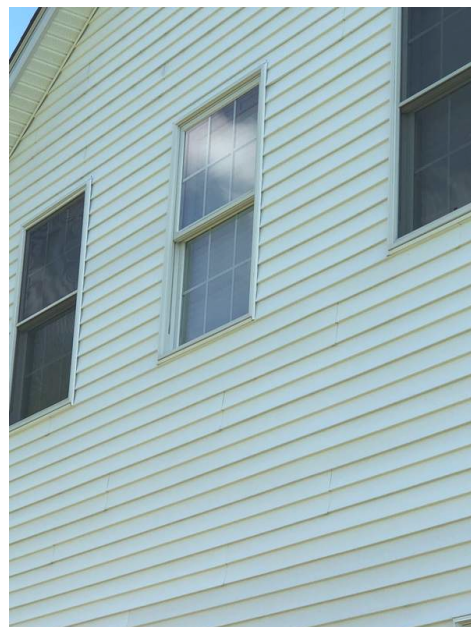
4.2.1 Windows

MISSING SCREEN

Window missing screen. Recommend replacement.

Contact a qualified window repair/installation contractor.

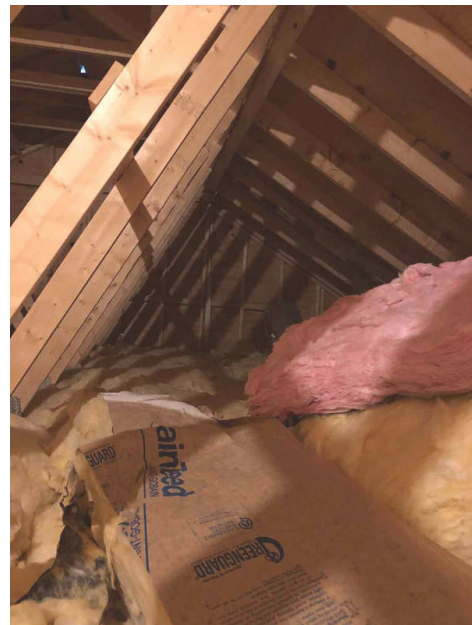
5.1.1 Insulation

LOOSE INSULATION

Some areas of the attic had loose insulation. The insulation needs to be properly replaced for energy efficiency.

Contact a qualified professional.

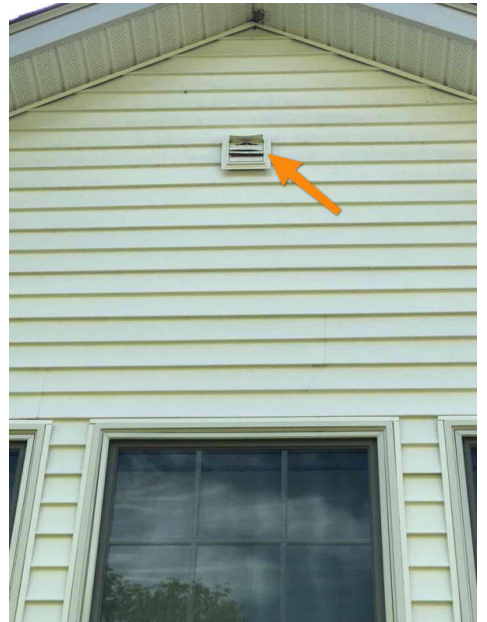
5.5.1 Dryer venting

OPEN DAMPER

The dryer vent damper was in the open position while not in use. The damper should be fixed to stay in the closed position when not in use, to prevent pests from entering.

Contact a qualified professional.

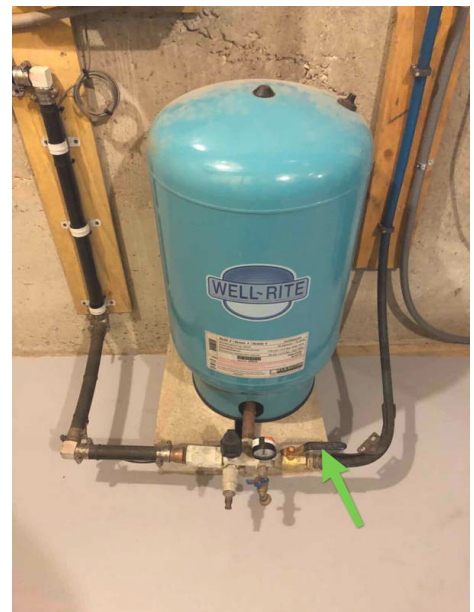
This is your main water shut off.

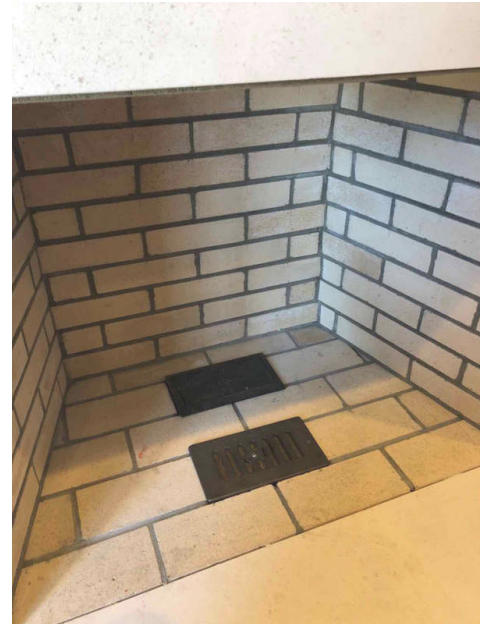
8.5.1 Gas/LP, Wood Fireplaces, & Stoves

CLEANING NEEDED

The fireplace does not appear to have been used. It should be checked by a licensed chimney sweep before first use.

Contact a qualified professional.

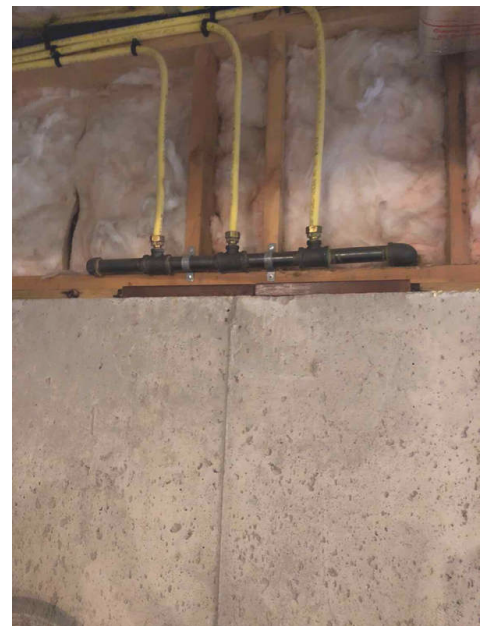
10.2.1 Main & Subpanels, Service & Grounding, Main Overcurrent Device

NO GROUND WIRE

The gas lines were not grounded. Recommend qualified electrician evaluate and install.

Contact a qualified electrical contractor.

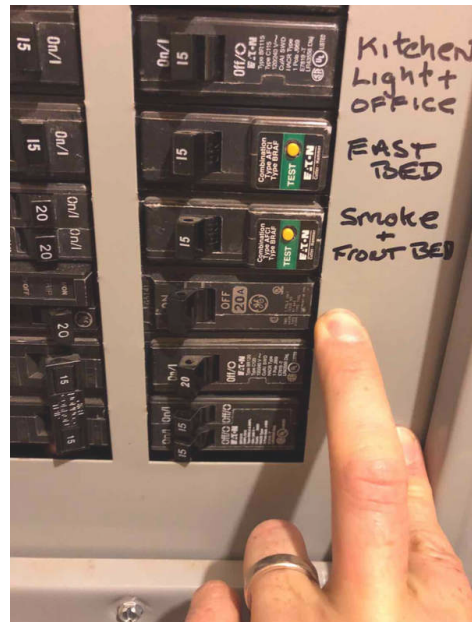
10.3.1 Branch Wiring Circuits, Breakers & Fuses

IMPROPER BREAKERS

General Electric breakers were used in this Cutler Hammer panel. The GE breakers are not meant for this panel and should be replaced with proper ones by a licensed electrician.

Contact a qualified professional.

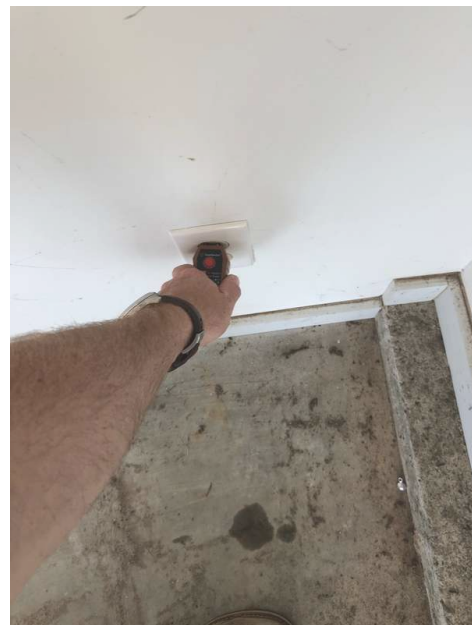
10.4.1 Lighting Fixtures, Switches & Receptacles

RECEPTACLES LOOSE

an outlet in the garage was loose and will need to be properly attached by a licensed electrician.

Contact a qualified professional.

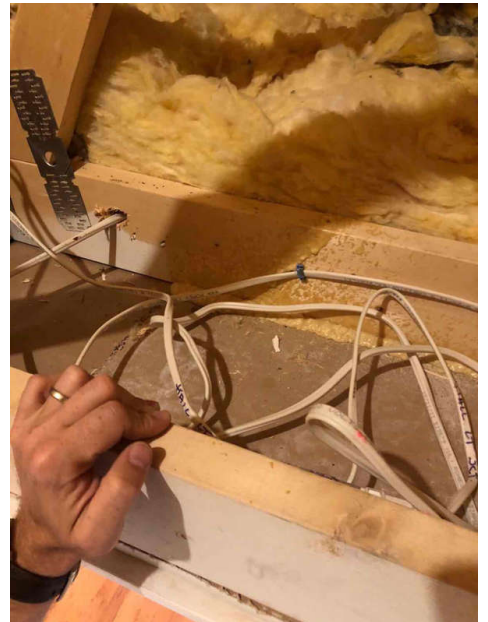
10.5.1 Visible wiring

ATTACHMENT

Electrical wires in the attic should be properly attached to framing members.

Contact a qualified professional.
