INTEGRITY INSPECTION SERVICES LLC

HOME INSPECTION REPORT

1234 Main St.
Naches WA 98937

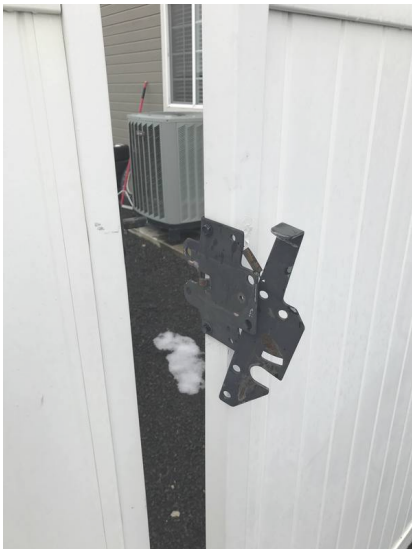
Fencing : Latch Not Operational

Fence gate latch was damaged or broken.

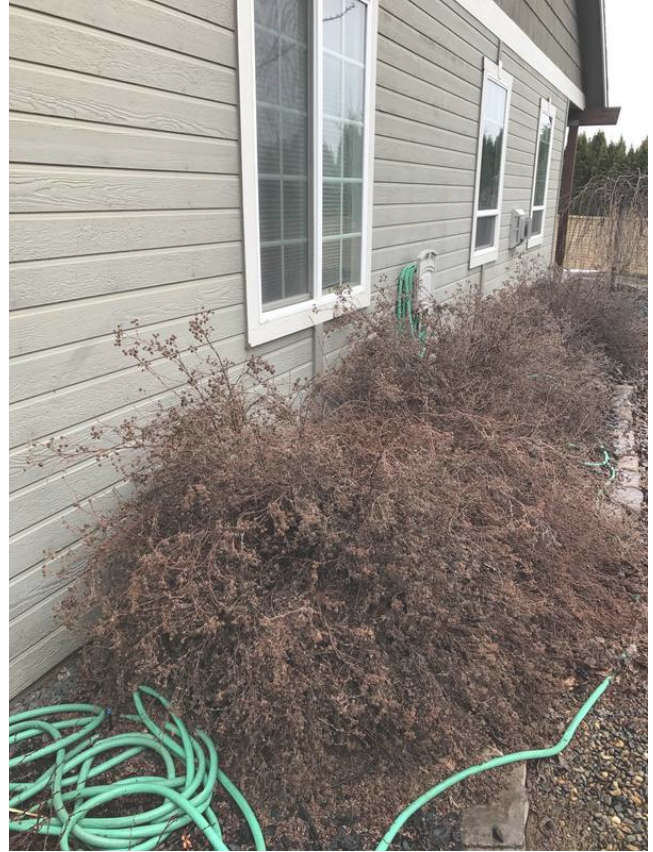
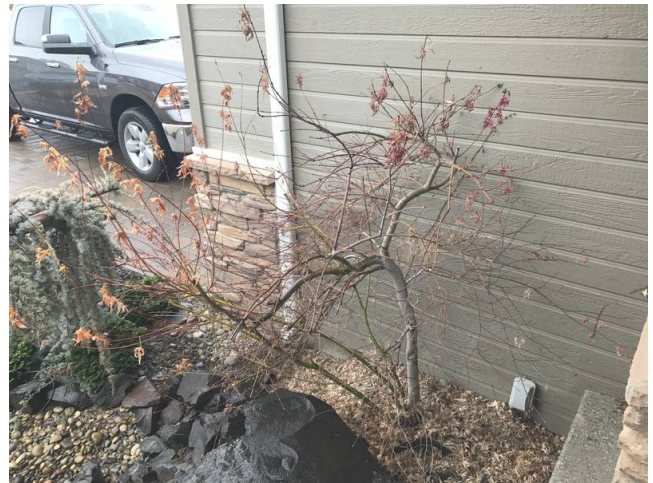
2.1.1 Vegetation, Grading & Drainage

VEGETATION AGAINST HOME

Trees, shrubs or vegetation in contact with exterior siding or trim will cause excessive wear and may lead to eventual deterioration. Recommend all vegetation be cleared and maintained with a minimum of 8" clearance from home and all other structures.

Contact a qualified landscaper or gardener.

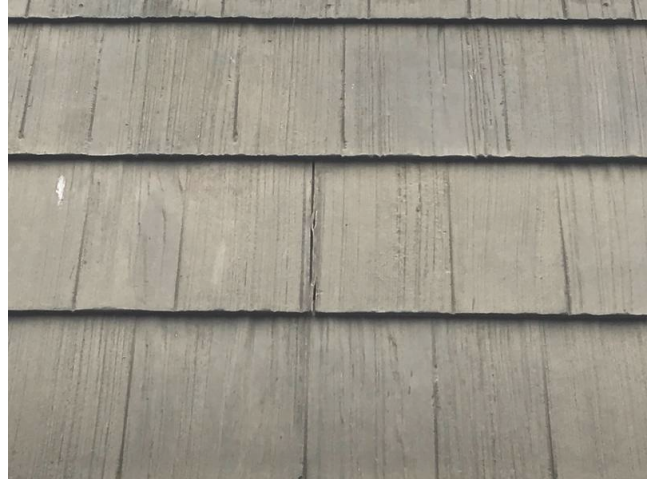
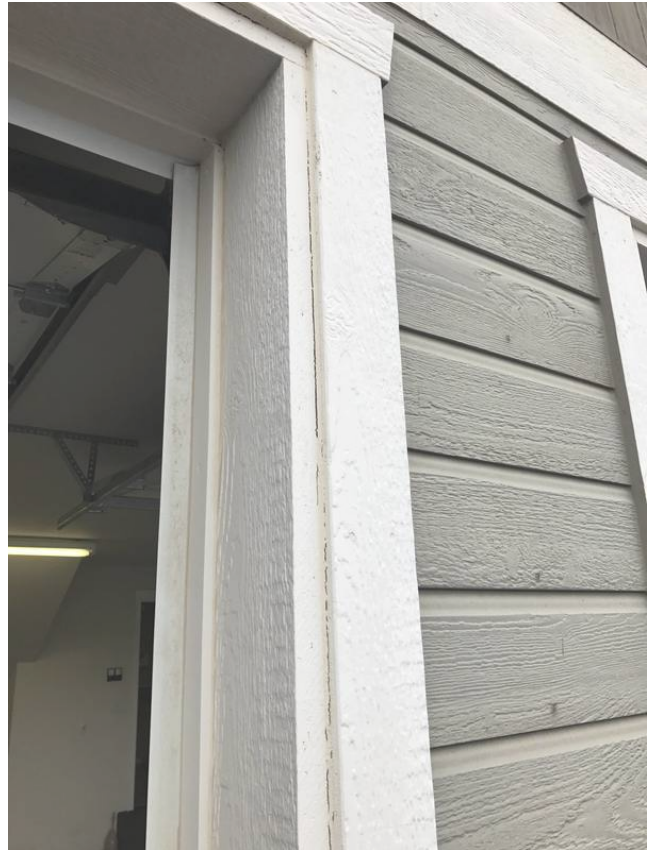
3.1.1 Siding, Flashing & Trim

CAULKING - MAINTENANCE

Exterior caulking shrinks with time and exposure. Siding butt joints, windows, doors and trim all require regular maintenance to prevent possible moisture intrusion.

Recommend maintaining a proper seal at all exterior caulked joints.

Contact a qualified siding specialist.

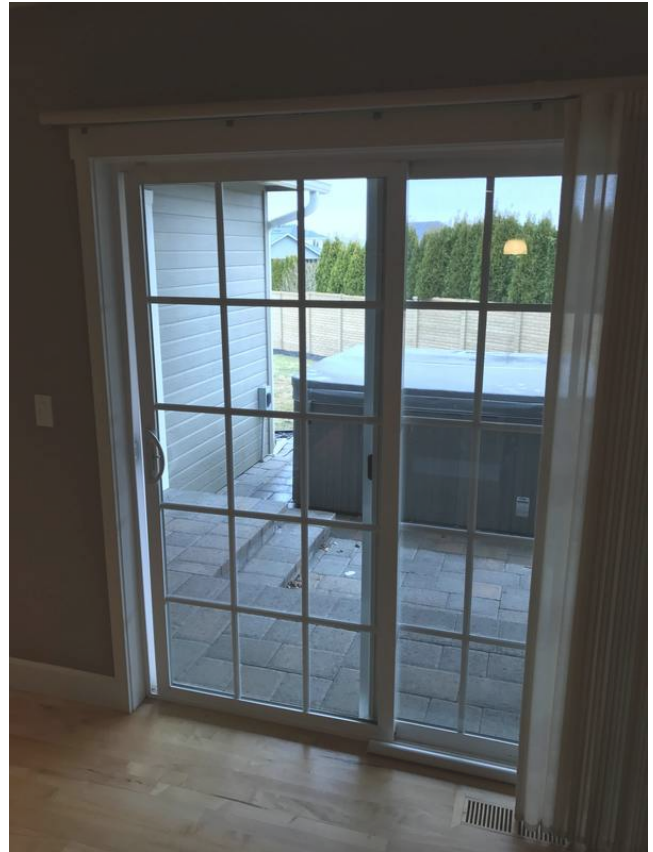
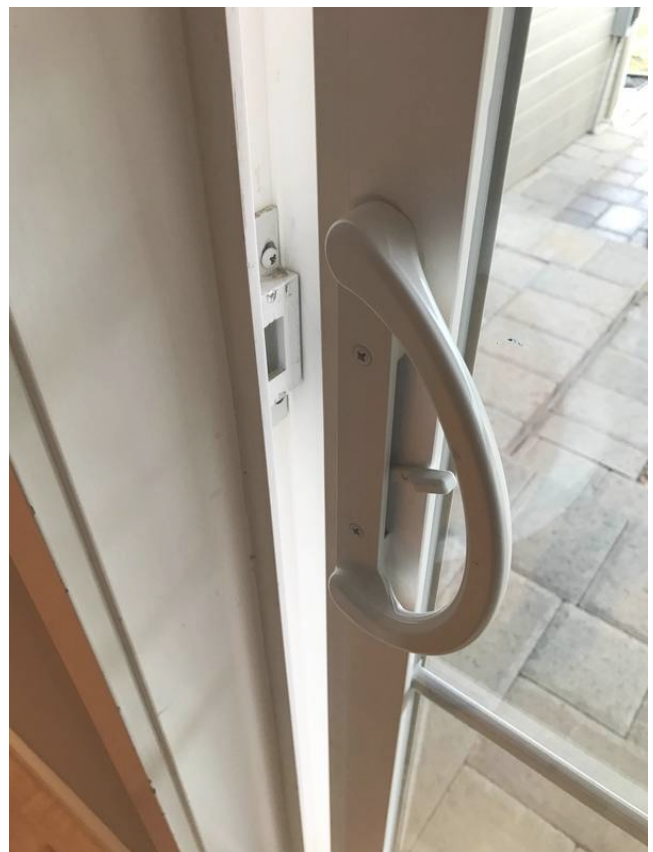
3.2.1 Exterior Doors & Windows

HARDWARE ADJUSTMENT NEEDED

DINING ROOM

Some entry door hardware was not operating properly and may be in need of adjustment or repair.

Contact a qualified door repair/installation contractor.

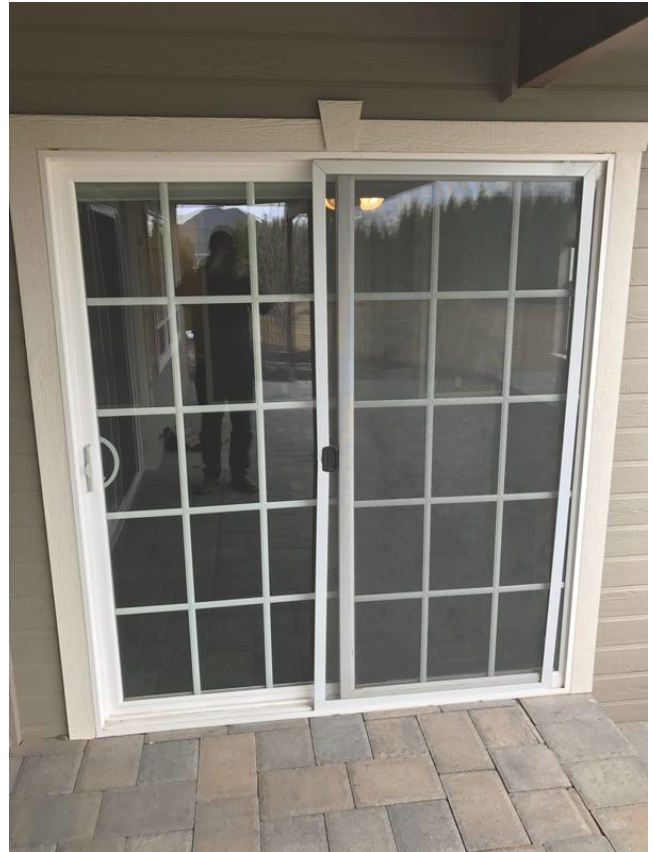
3.2.2 Exterior Doors & Windows

SCREEN DOOR

MASTER BEDROOM

Screen door damaged or not operating properly. Recommend repair.

Contact a qualified door repair/installation contractor.

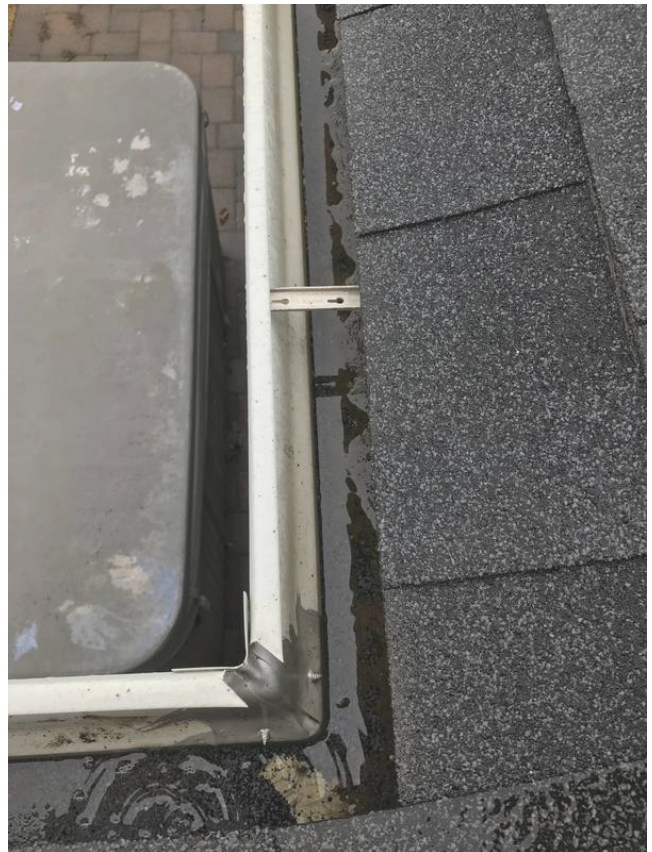
4.2.1 Gutter & Drainage Systems

DEBRIS

Debris has accumulated in the gutters. Recommend cleaning to facilitate water flow.

Contact a qualified roofing professional.

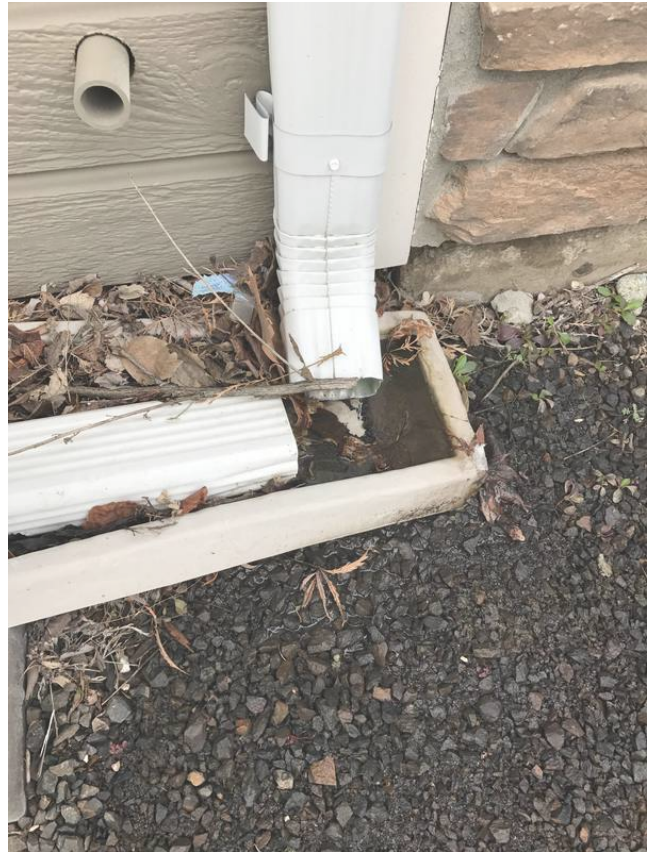
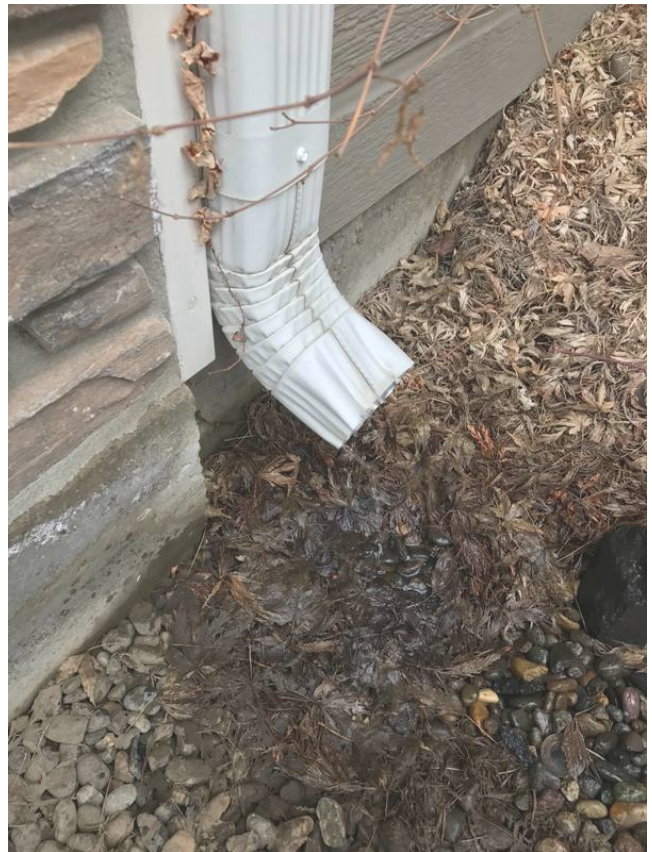
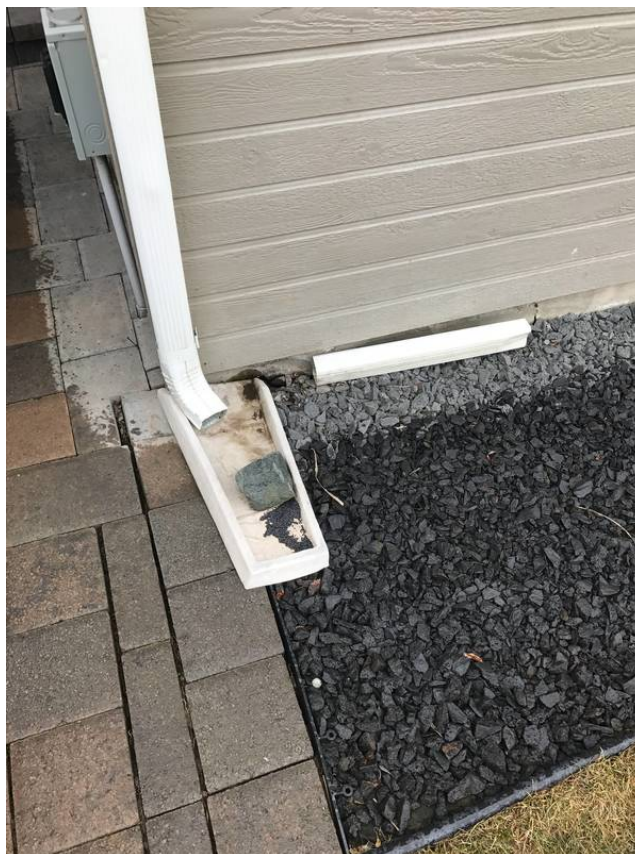
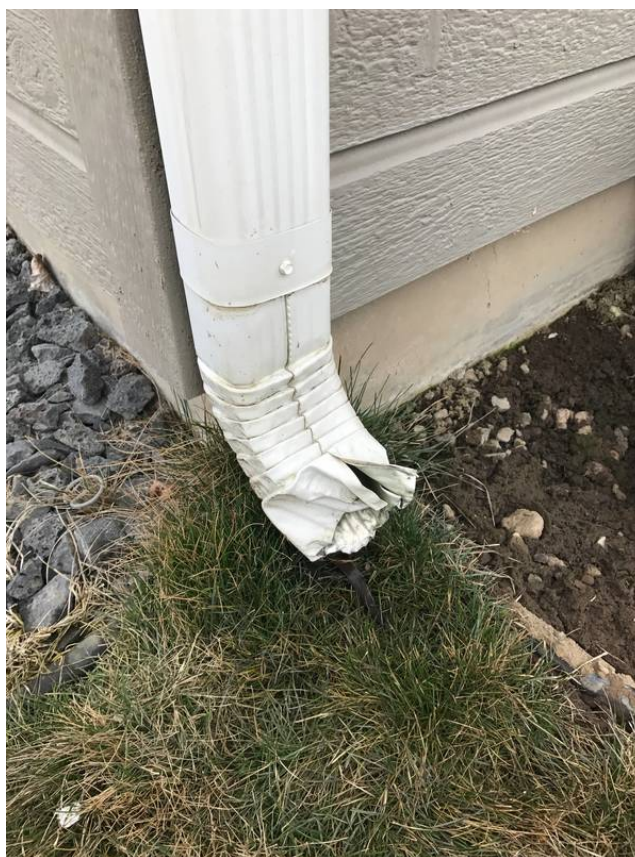
4.2.2 Gutter & Drainage Systems

DOWNPOUTS DRAIN NEAR HOUSE

One or more downspouts drain too close to the home's foundation. This can result in excessive moisture in the soil at the foundation, which could lead to eventual structural compromise. Recommend a qualified contractor adjust downspout extensions to drain at least 6 feet from the foundation.

Contact a qualified roofing professional.

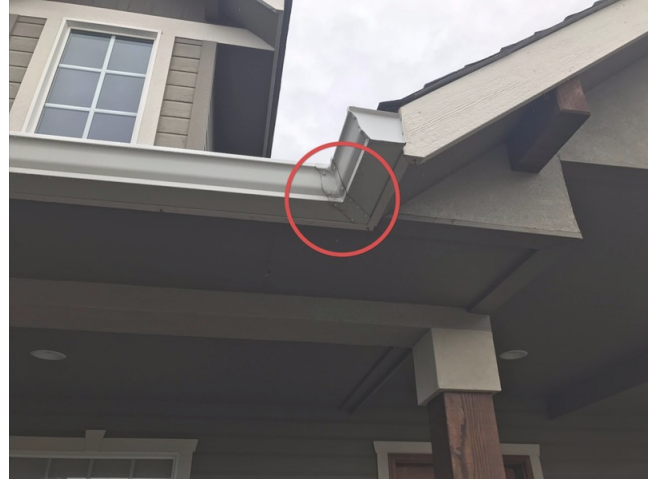
4.2.3 Gutter & Drainage Systems

GUTTER LEAKAGE

Gutters were observed to be leaking in one or more areas. This can result in excessive moisture in the soil at the foundation, which can lead to structural compromise.

Recommend a qualified professional further evaluate and repair.

Contact a qualified roofing professional.

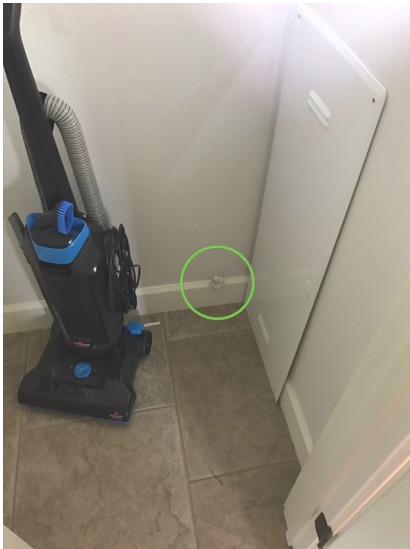
Entry Closet

Main Water Shut-Off Location

Interior Closet

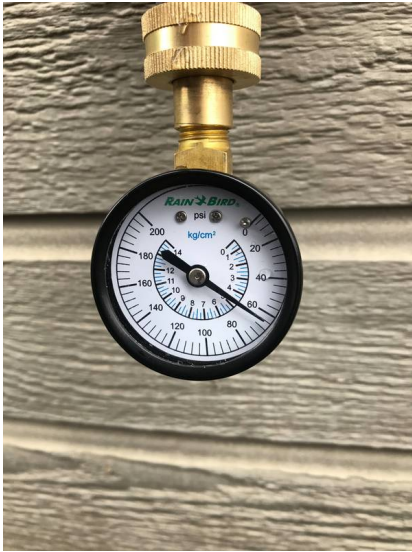
Water Pressure Tested / Recorded

Maximum recommended water pressure for most residential situations 60-80 P.S.I

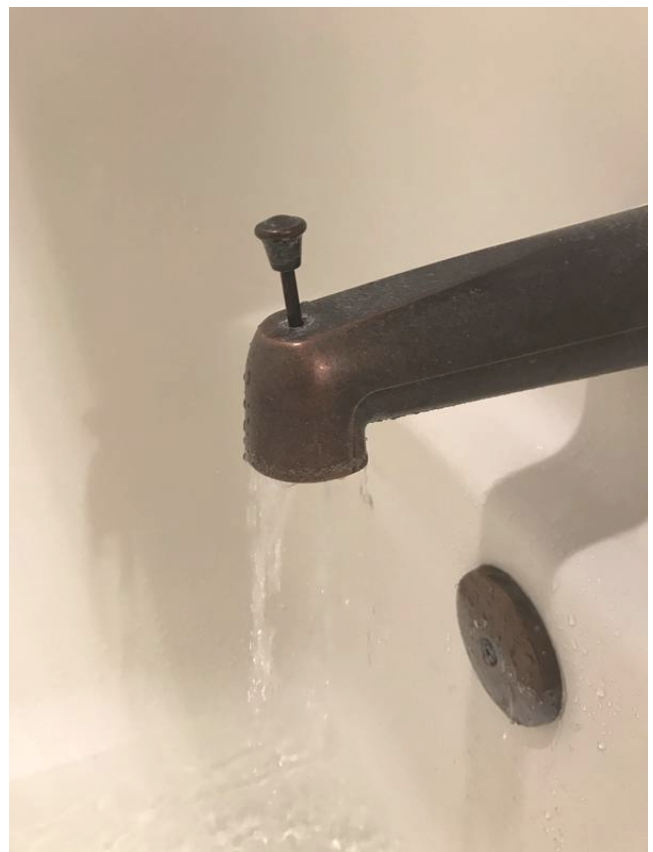
5.1.1 Fixtures / Faucets

**SHOWER DIVERTER
NOT OPERATING**

HALL BATHROOM

Shower diverter valve was not diverting water flow to shower head properly or completely. Recommend repair.

This may be a symptom of not being used and may self repair with time.

Contact a qualified plumber.

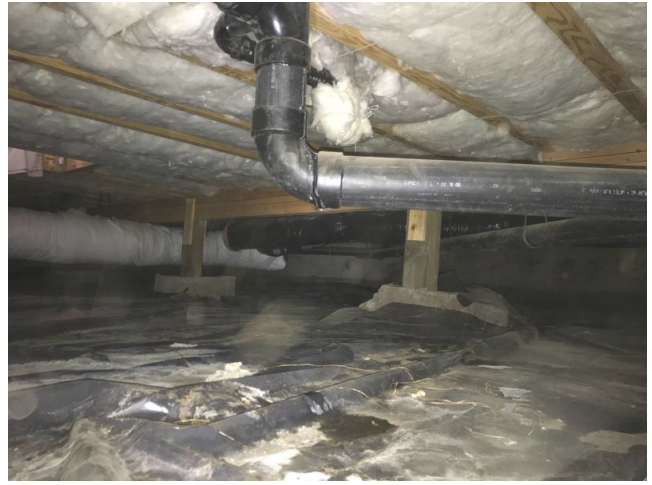
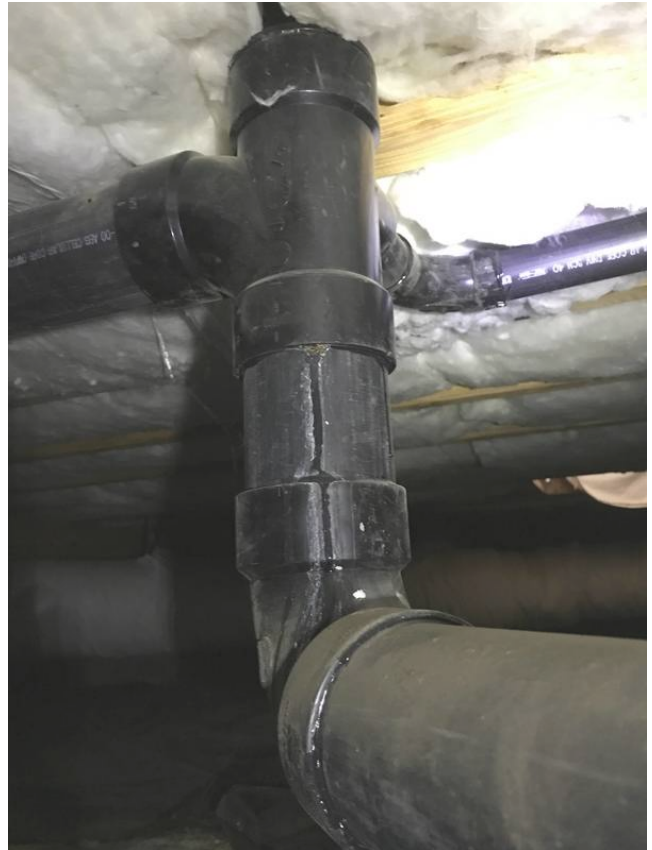
5.2.1 Drain / Waste, & Vent Systems

LEAK OBSERVED

CRAWLSPACE (HALL BATHROOM)

Leak observed at waste drain plumbing.
Condition conducive to moisture damage.
Recommend a qualified professional further
evaluate and repair.

Contact a qualified plumber.

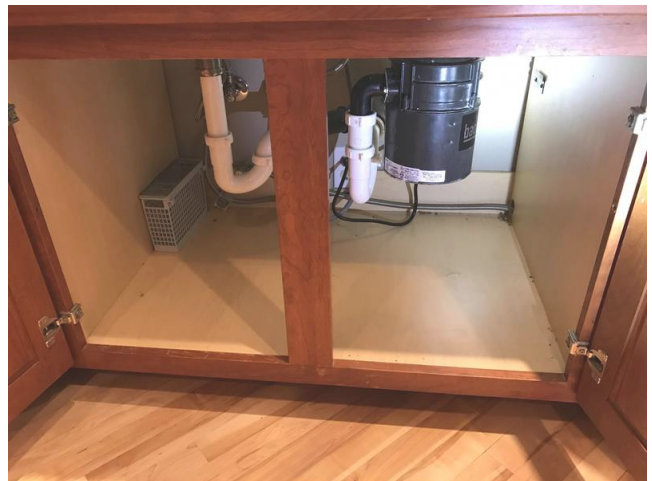
5.4.1 Appliances

GARBAGE DISPOSAL LEAKING

KITCHEN

Leak noted at garbage disposal. Condition
conductive to moisture damage.
Recommend a qualified professional further
evaluate and repair.

Contact a qualified plumber.

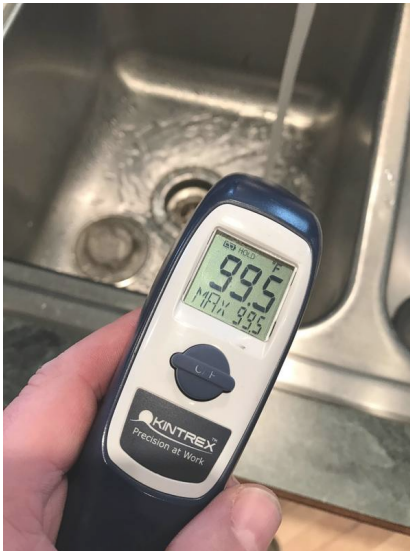
Water Temperature

Less than 120°F

Maximum safe water temperature to avoid potential scalding 120°F

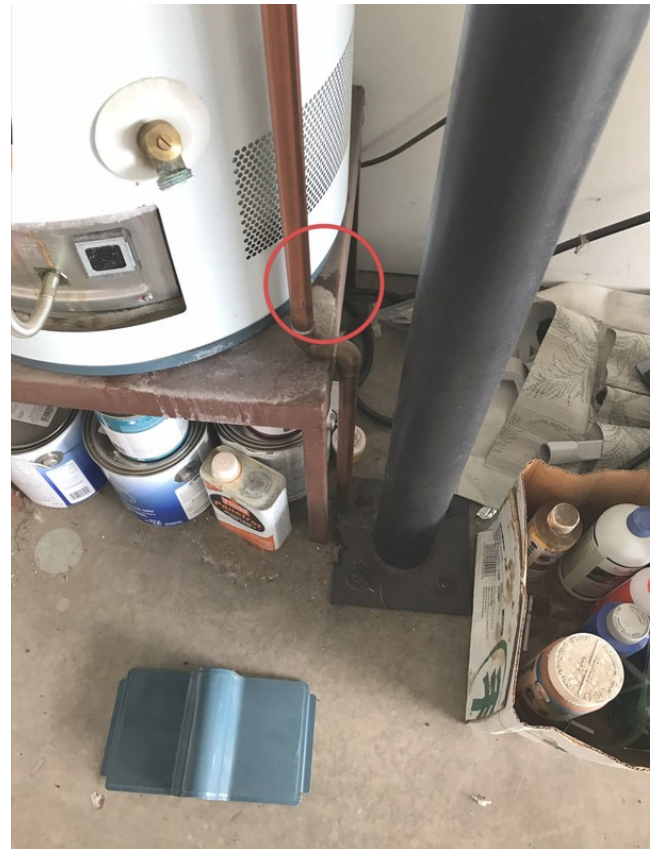
6.1.2 Condition

LEAK - MINOR

Possible (minor) leak noted at base of Hot Water Tank. Recommend a qualified professional further evaluate and repair as needed.

Contact a qualified plumber.

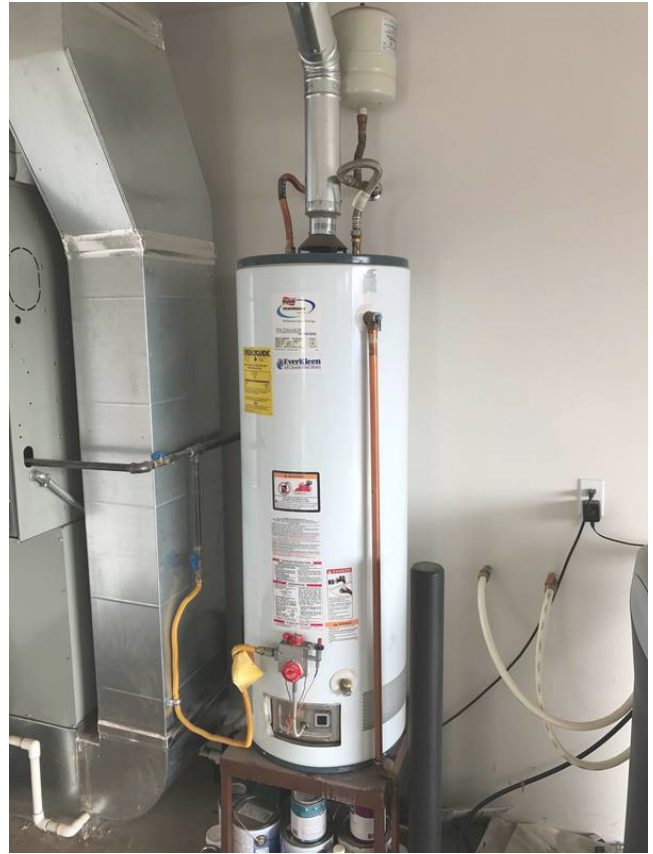
6.4.1 Seismic Strapping

SEISMIC STRAPPING NOT INSTALLED

⚠ Safety Hazard and/or Requires Immediate Attention

Modern code requires Hot Water Tank seismic strapping at top and bottom thirds of tank using an approved strapping and anchored to framing. Recommend qualified professional further evaluate and repair.

Contact a qualified appliance repair professional.

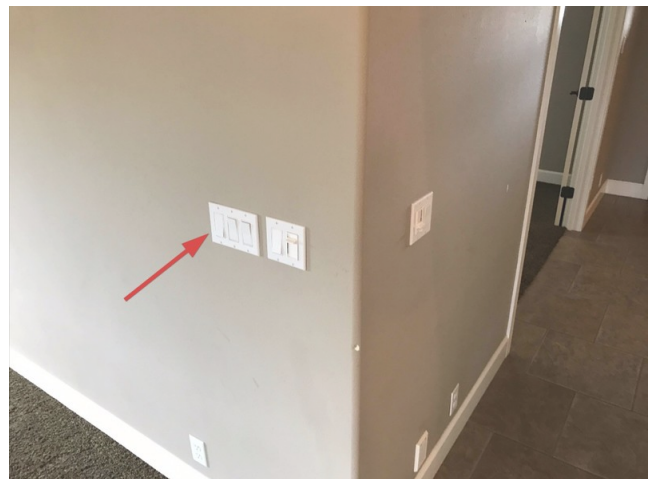
7.4.1 Connected Devices and Fixtures

UNKNOWN SWITCH / DEVICE

LIVING ROOM

Unknown switch/device noted. Recommend qualified electrician further evaluate.

Contact a qualified electrician.

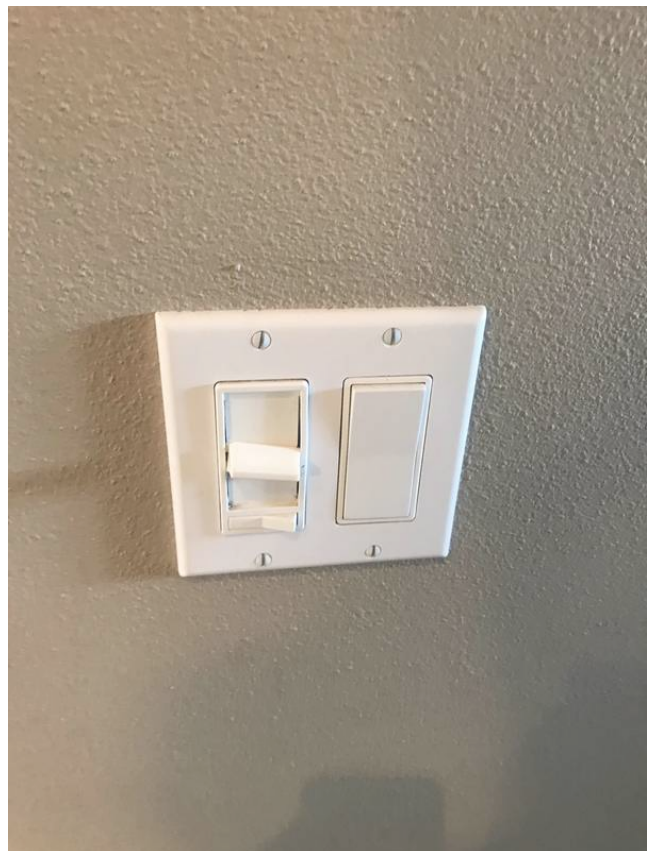
7.4.3 Connected Devices and Fixtures

DEVICE INTERMITTENT

LIVING ROOM

A switch or outlet was intermittent at time of inspection. Recommend a qualified professional further evaluate and repair.

Contact a qualified electrician.

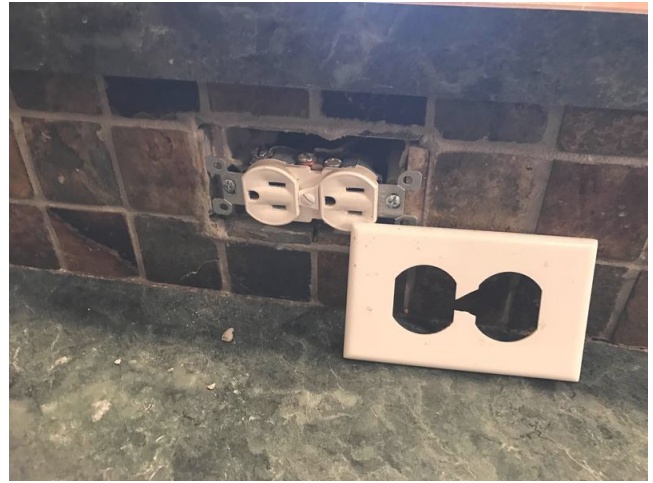
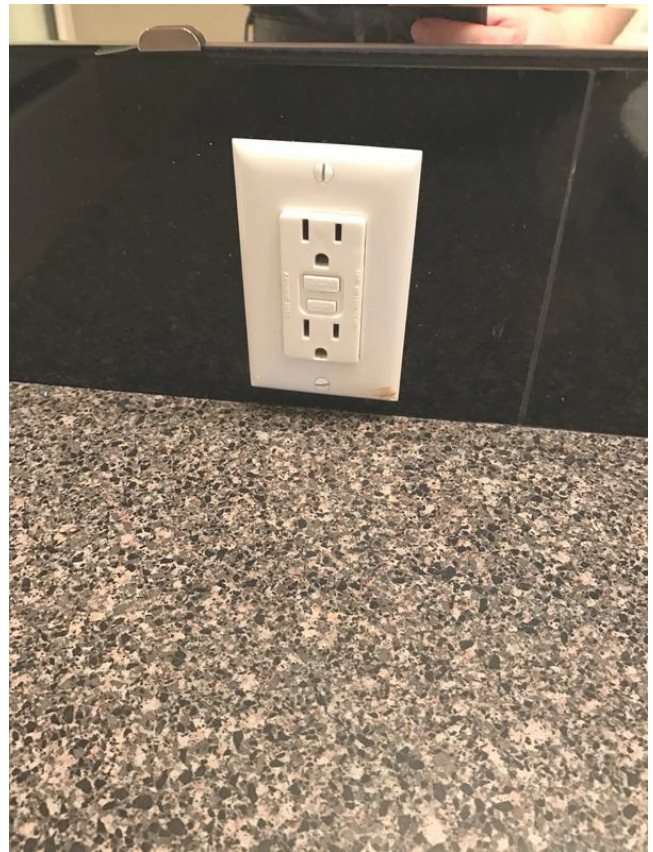
7.4.4 Connected Devices and Fixtures

LOOSE / UNSECURED OUTLETS

KITCHEN, HALL BATHROOM

⚠️ Safety Hazard and/or Requires Immediate Attention

Loose or unsecured outlets may risk short or possible electrical shock. Recommend a qualified electrician further evaluate and repair.

Contact a qualified electrician.

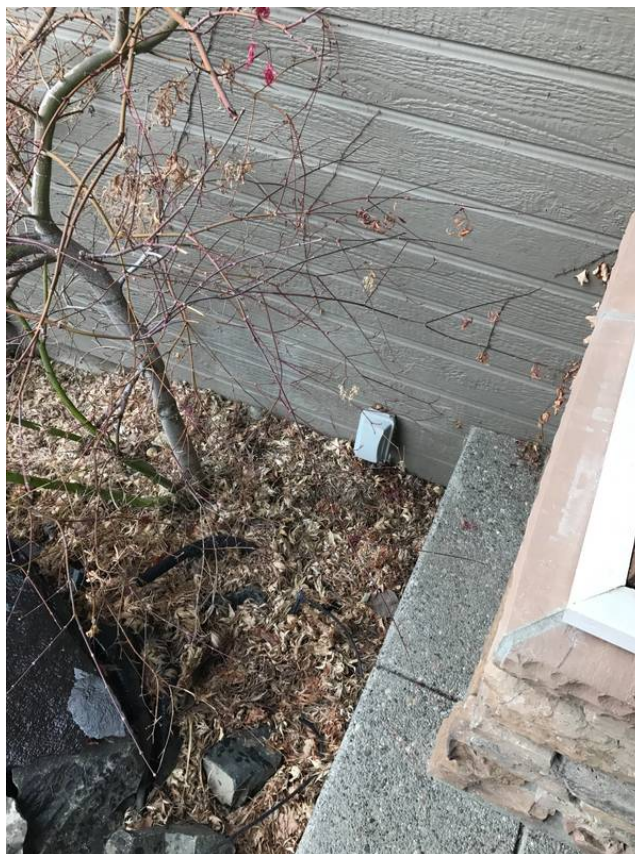
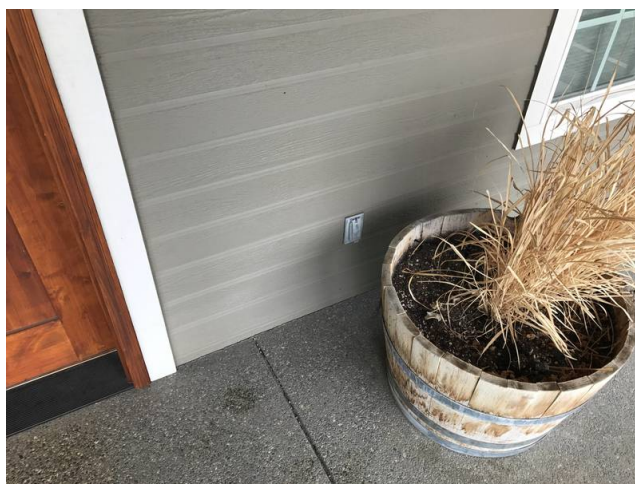
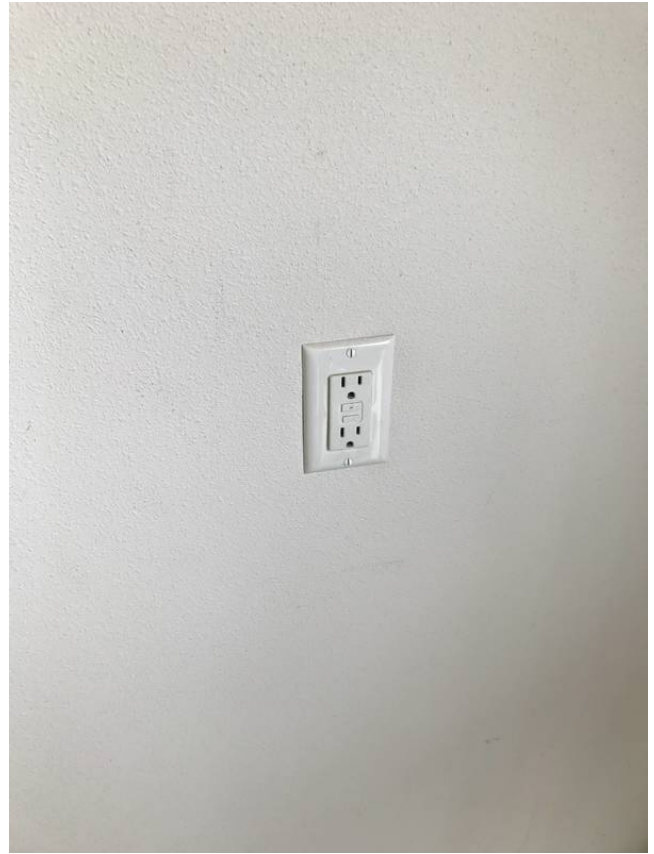
7.6.1 GFCI & AFCI

OUTLET(S) WON'T TRIP

EXTERIOR, GARAGE

⚠️ Safety Hazard and/or Requires Immediate Attention

One or more outlets won't "trip" when tested. Recommend a qualified electrician further evaluate all required GFCI locations and repair as needed.

Contact a qualified electrician.

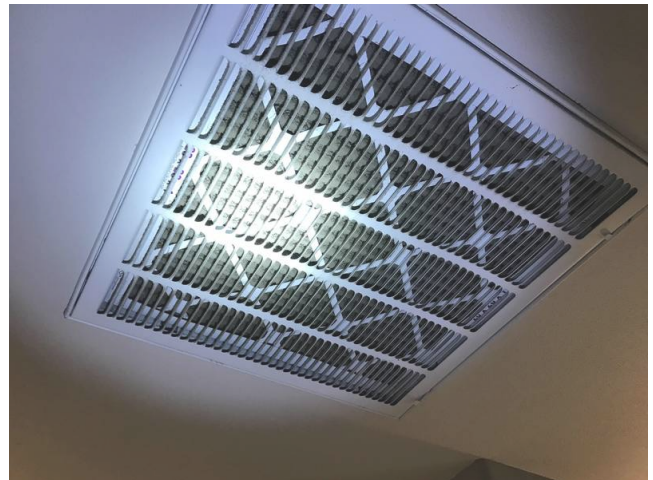
8.1.1 Heating Equipment

FILTER REQUIRES REPLACEMENT

HALLWAY

The furnace filter appears to be beyond its expected lifespan. A dirty Furnace Filter may cause excessive wear and undue maintenance to HVAC system.

Recommend replacement.

Contact a qualified HVAC professional.

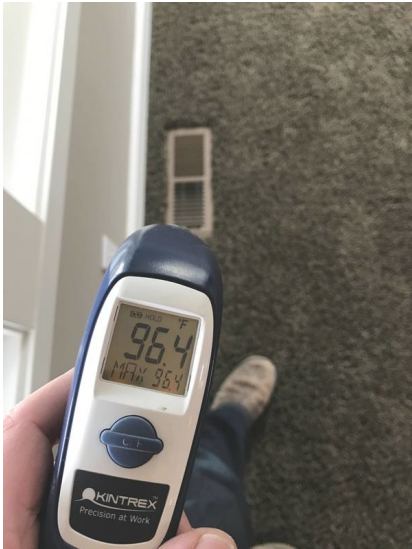
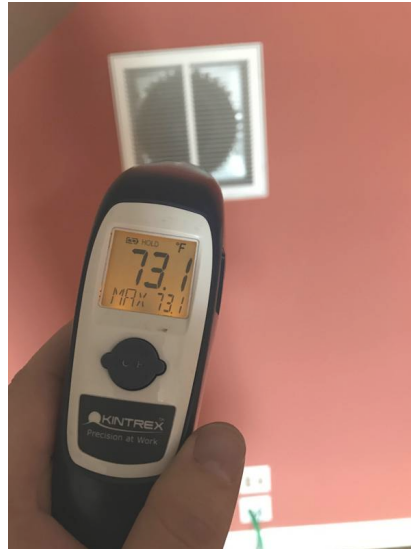
Temperature Split / Differential More Than 21°F

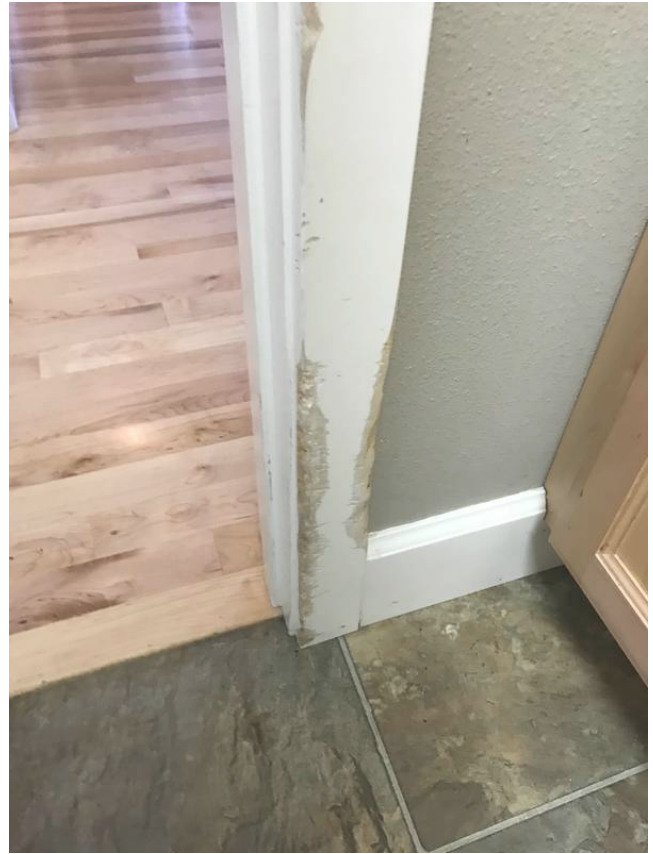
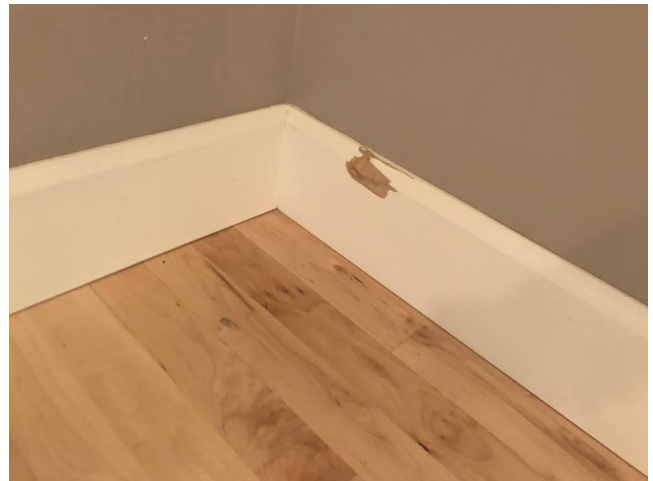
10.1.1 Walls

COSMETIC DAMAGE

Some interior cosmetic damage was noted at walls and/or ceilings.

Contact a qualified general contractor.

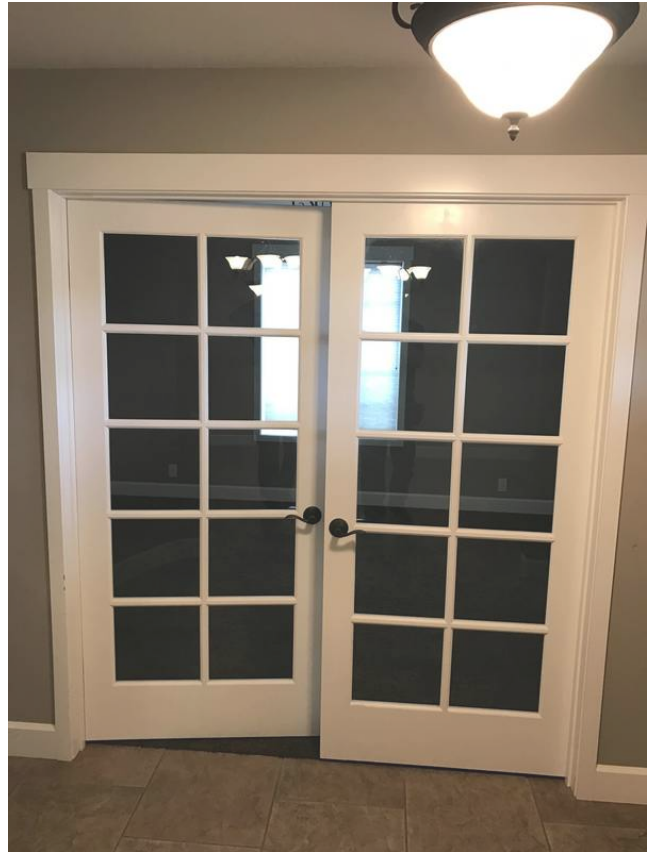
10.5.1 Doors

DOOR DOESN'T LATCH

Door/s doesn't latch properly and may be in need of adjustment or repair.

Contact a quality handyman.

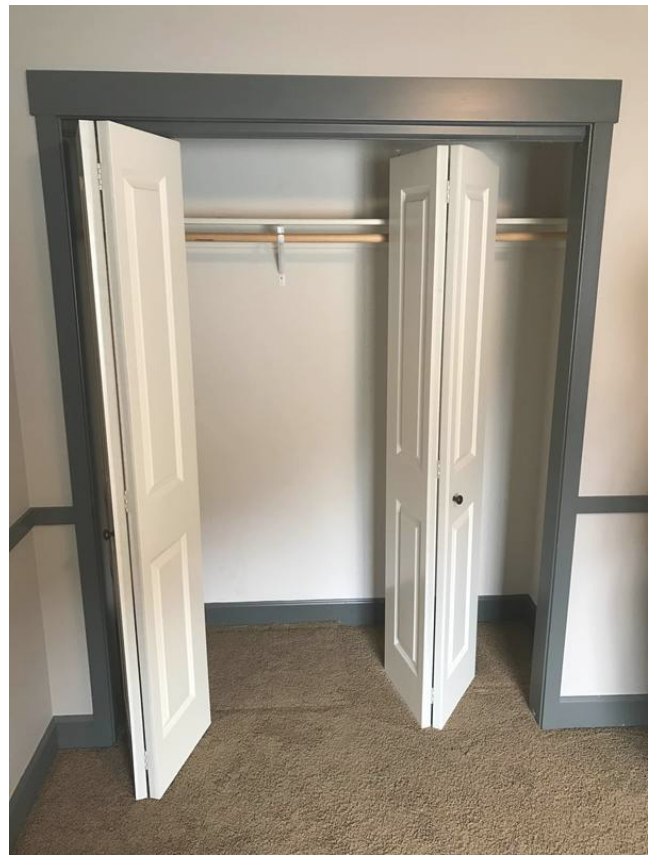
10.5.2 Doors

DOORS MISSING OR NOT INSTALLED

BEDROOM

Some interior doors and/or closet doors were missing or not installed at time of inspection. Recommend repair.

Contact a qualified door repair/installation contractor.

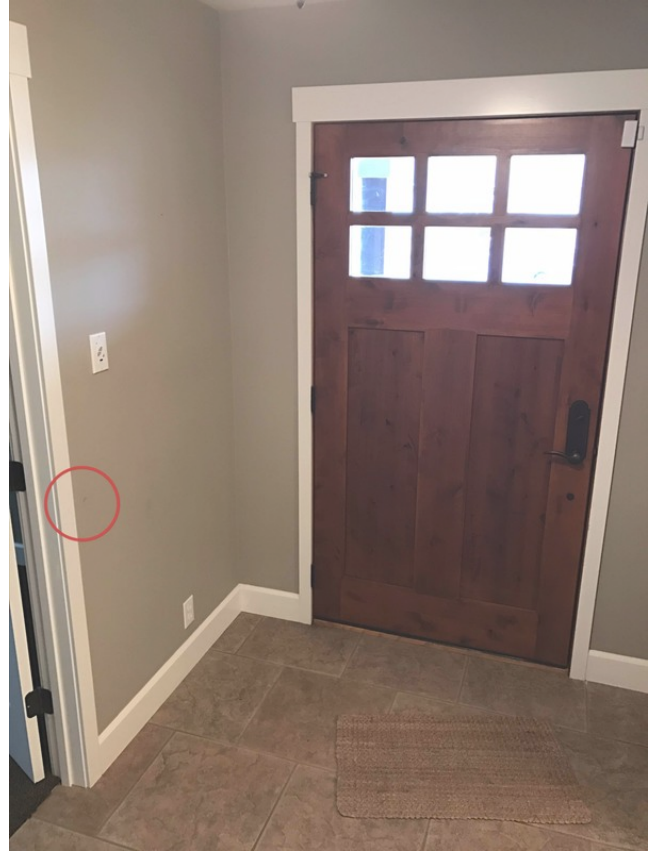
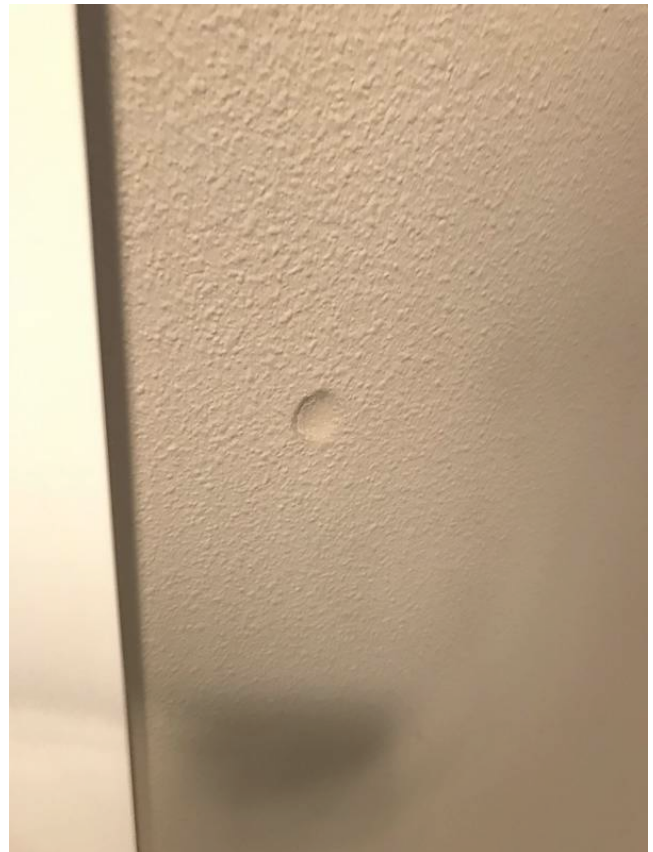
10.5.3 Doors

DOOR STOPS MISSING

Some interior or entry door Door Stops were missing or not installed. This may result in damage to walls and/or door hardware.

Recommended DIY Project

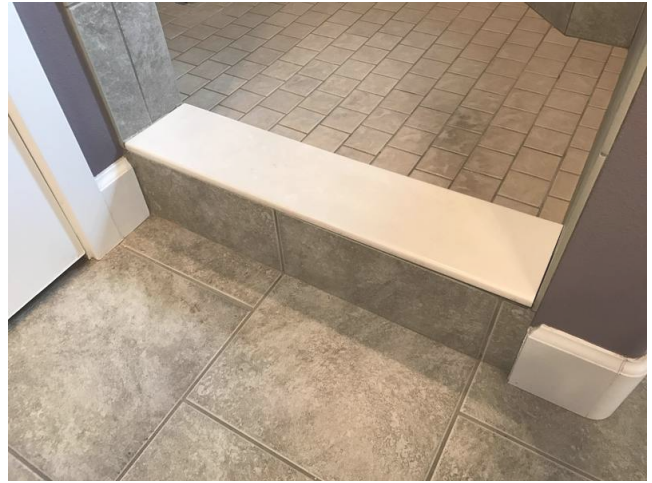
10.9.1 Bathroom

DAMAGED SHOWER CURB

MASTER BATHROOM

Shower curb was loose or damaged.
Condition conducive to moisture damage.
Recommend repair.

Contact a qualified general contractor.

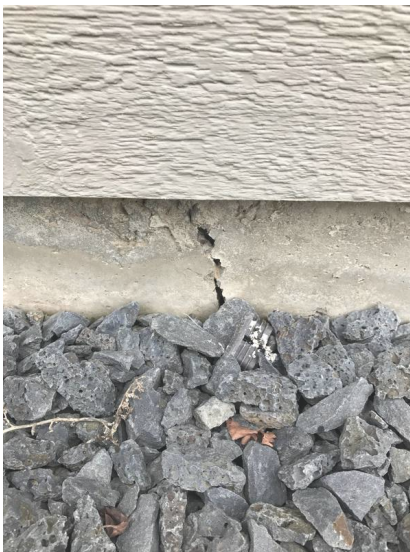
Foundation: Typical Cracks

Small vertical cracks known as shrinkage or typical cracks were noted. These vertical cracks are not typically considered to be any reason for concern. If any vertical cracks begin to grow then further evaluation would be required. Recommend monitor.

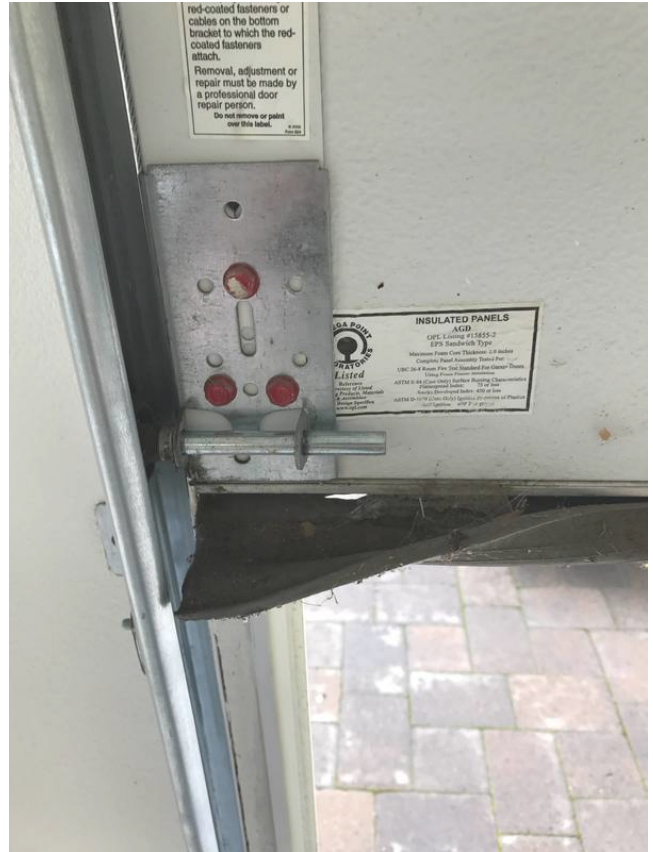
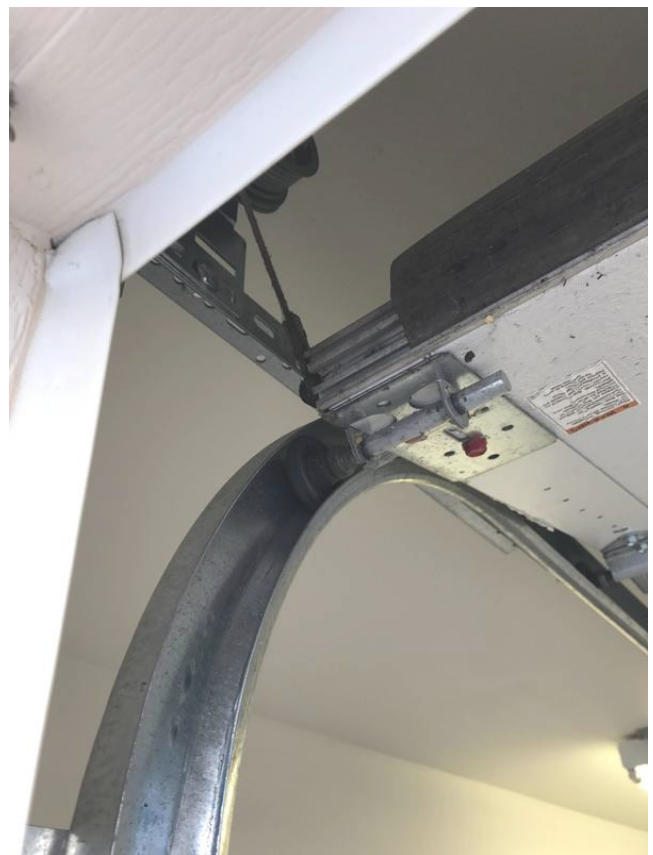
14.1.1 Garage Door

THRESHOLD SEAL

Garage door threshold seal was worn or damaged. Recommend repair.

Contact a qualified garage door contractor.
