TRUVIEW INSPECTIONS

## FULL RESIDENTIAL REPORT

1234 Main St.  
Miami Florida 33183

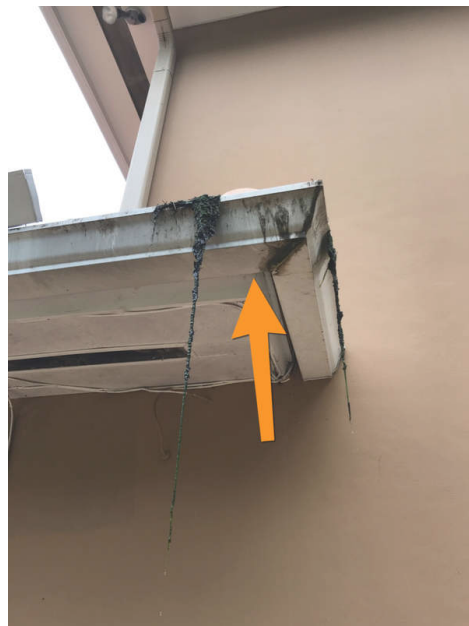
Debris has accumulated in the gutters. Recommend cleaning to facilitate water flow.

Contact a qualified gutter contractor

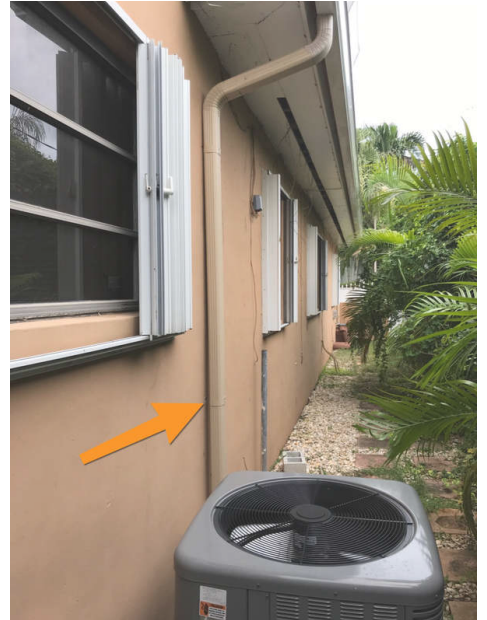
2.2.2 Roof Drainage Systems

**GUTTER DAMAGED**

Gutters were damaged. This can result in excessive moisture in the soil at the foundation, which can lead to foundation/structural movement. Recommend a qualified contractor evaluate and repair.

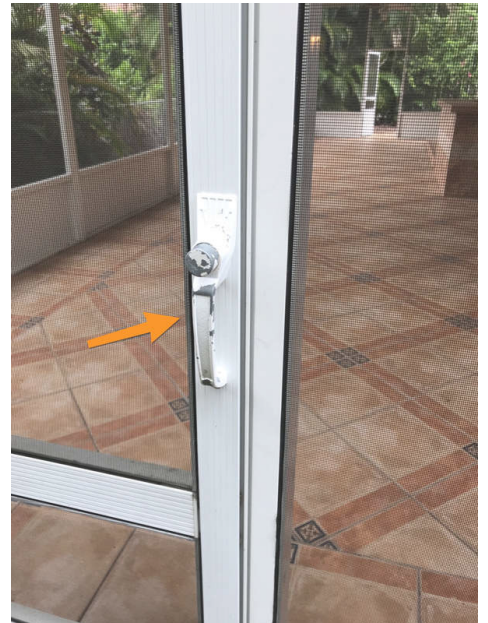
3.4.1 Decks, Balconies, Porches & Steps

Screen enclosure lock is damaged; repairs/replacement recommended.

Contact a qualified professional.

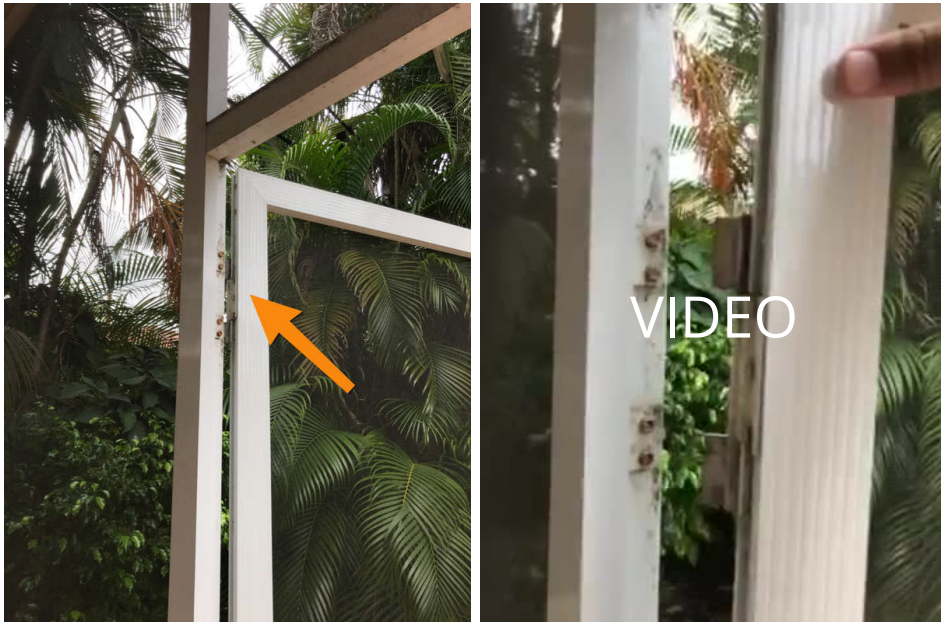
3.4.2 Decks, Balconies, Porches & Steps

**DAMAGED DOOR**

Screen enclosure door is damaged and needs repair.

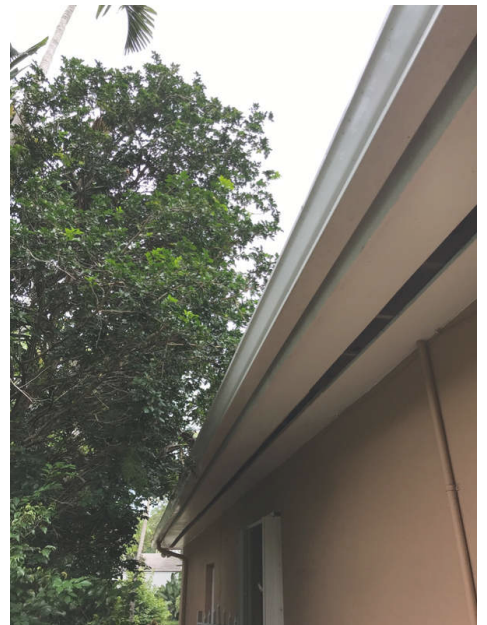
3.5.1 Vegetation, Grading, Drainage & Retaining Walls

Trees observed overhanging the roof. This can cause damage to the roof and prevent proper drainage. Recommend a qualified tree service trim to allow for proper drainage.

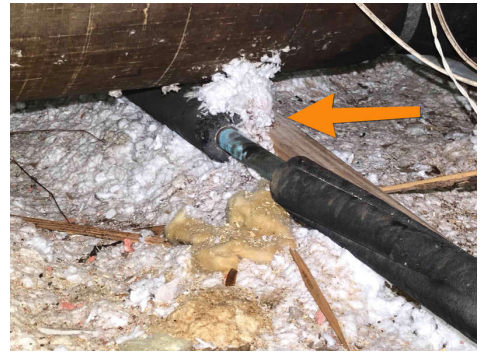
Wood destroying organisms evidence observed at the property.  
Treatment is recommended.

Contact a qualified pest control specialist.

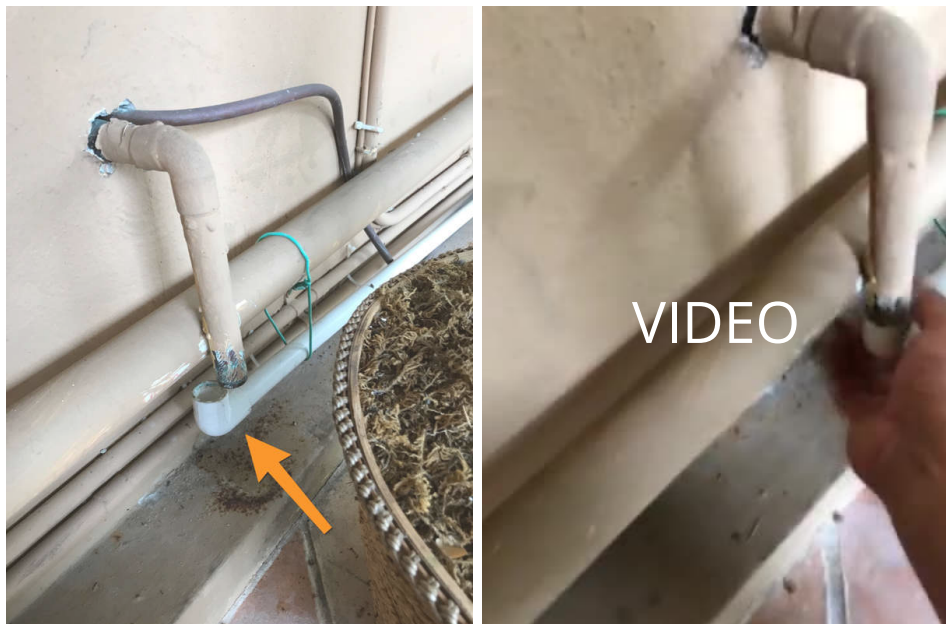
**CONDENSATE TUBE DAMAGED**

Condensate tube was damaged, which limits safe discharge of condensation produced by evaporator coils. Recommend a qualified HVAC technician repair.

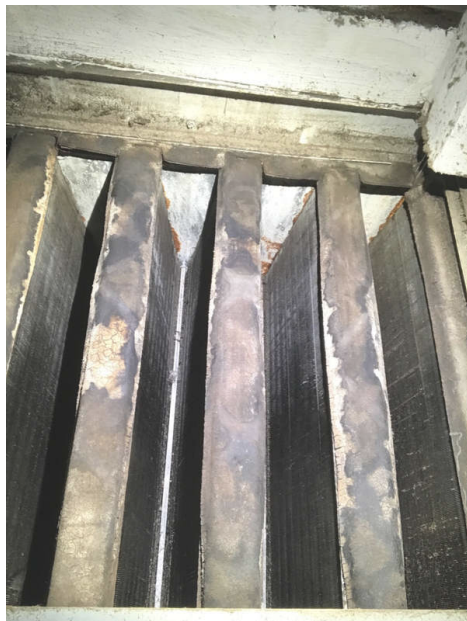
**MOLD OBSERVED ON COILS**

Visible mold observed on air handler coils. It is recommended that a mold test be performed. The apparent mold is located on the return air section and could be blowing mold spores in the air of the home through the ducts. The only way to check is to collect air samples inside the home along with a physical swab. These samples will be sent to a laboratory and a determination will be made whether you have a mold problem inside the house.

Contact a qualified mold inspection professional.

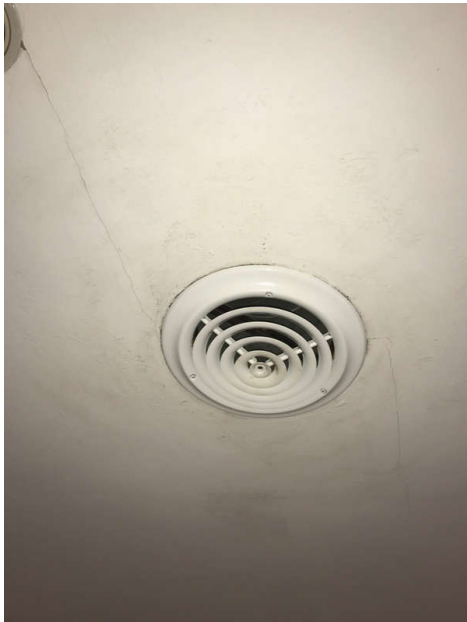
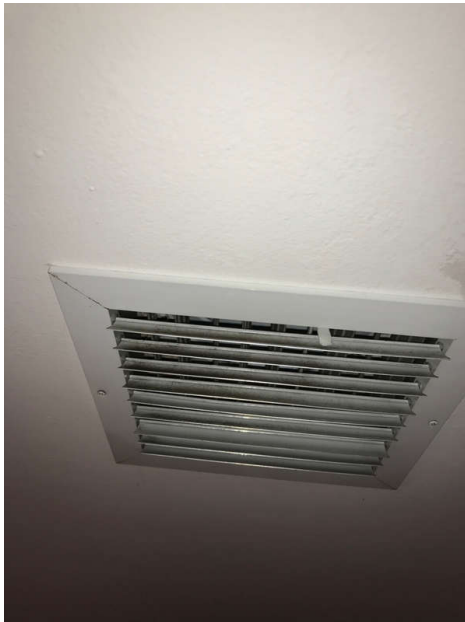
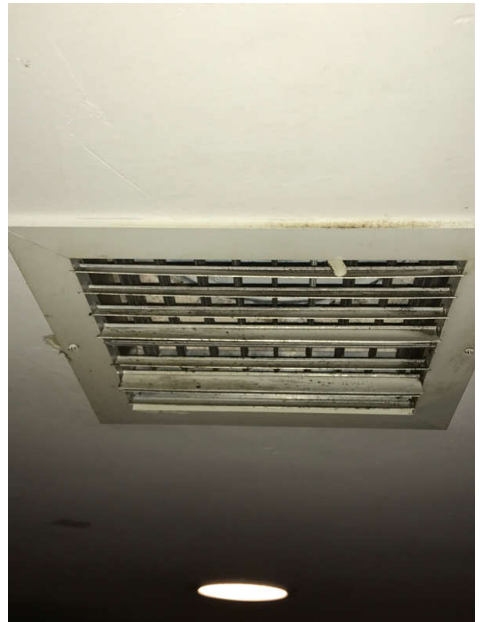
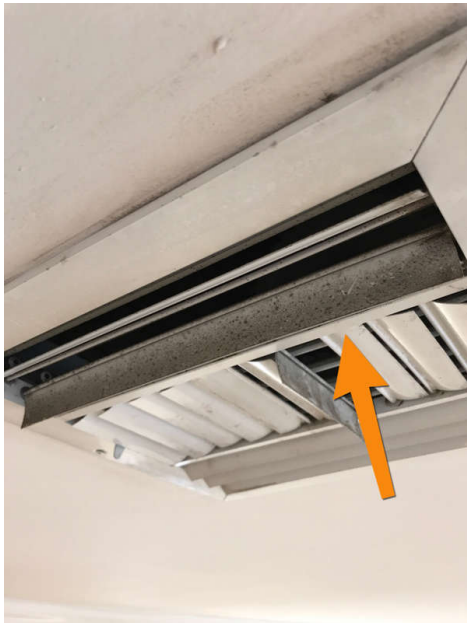
6.3.1 Distribution System

**COLD AIR RETURN LEAKING**

The cold air return is leaking at the unit. Recommend licensed HVAC contractor seal or patch ductwork. Visible mold and condensation observed.

Contact a qualified heating and cooling contractor

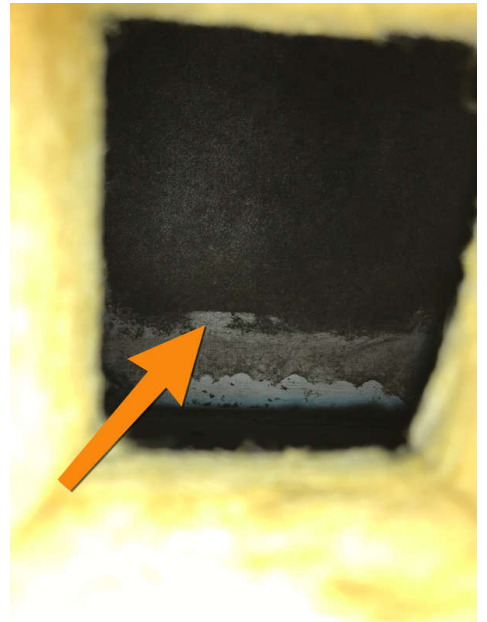
6.3.4 Distribution System

**MOLD OBSERVED SUPPLY PLENUM**

Observed mold on/inside supply plenum. A Mold Assessment is recommended for further evaluation and remediation protocol.

Contact a qualified mold inspection professional.

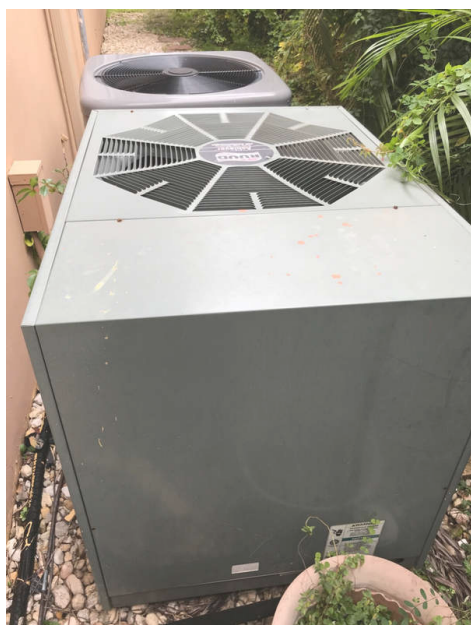
#### UNIT PAST LIFE EXPECTANCY; REPLACEMENT ANTICIPATED

Unit has exceeded it's life expectancy and replacement should be anticipated.

Contact a qualified heating and cooling contractor

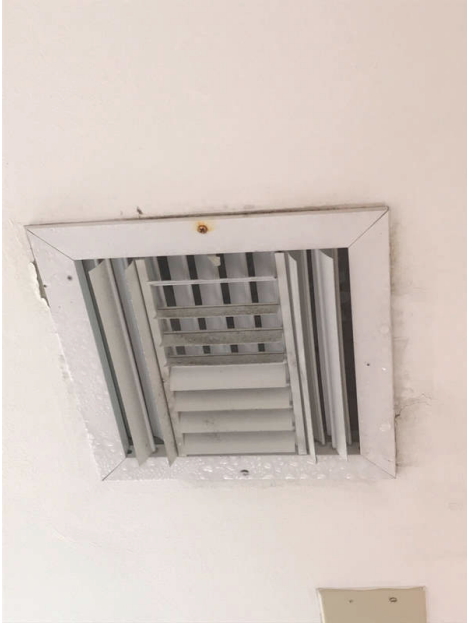
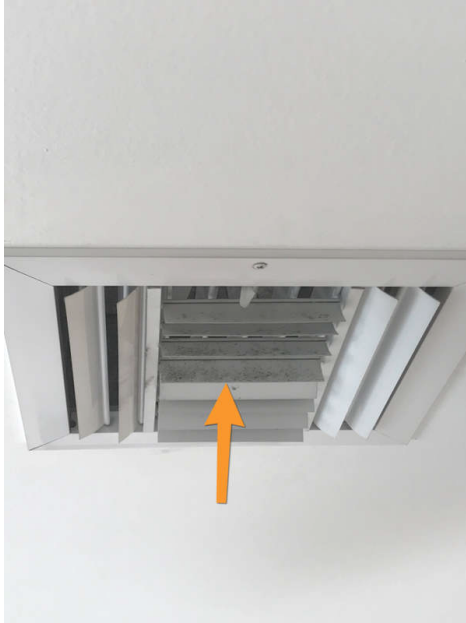
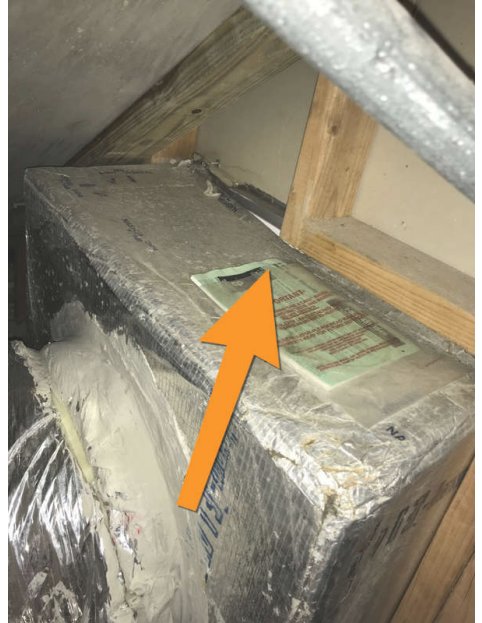
#### 7.3.1 Distribution System

#### COLD AIR RETURN LEAKING

The cold air return is leaking at the unit. Recommend licensed HVAC contractor seal or patch ductwork. There is visible mold and condensation observed on vent railings.

Contact a qualified heating and cooling contractor

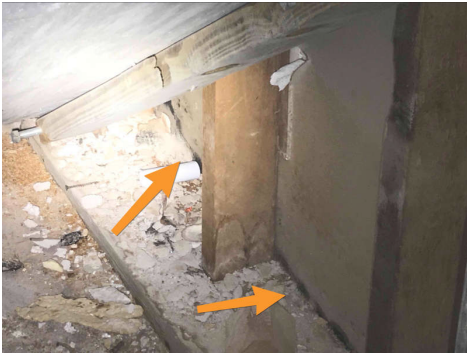
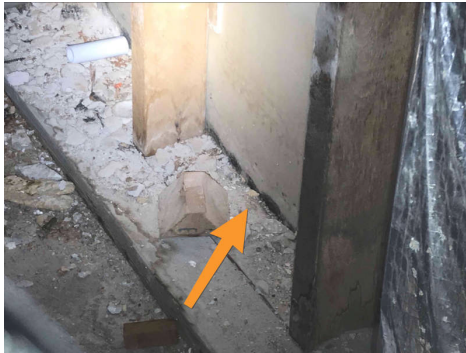
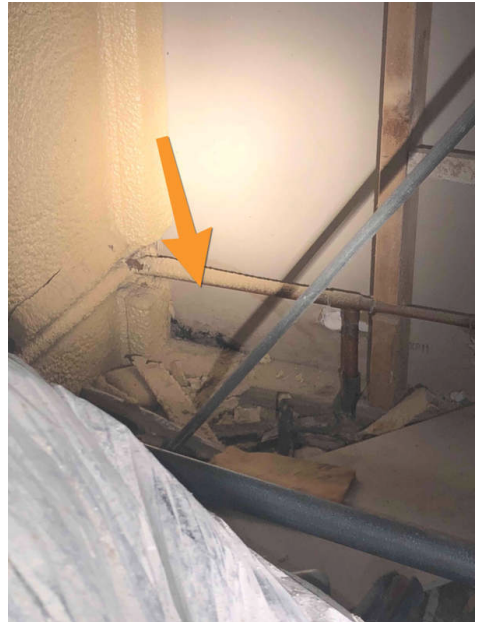
7.3.2 Distribution System

**MOLD**

Visible mold observed inside air handler closet. A mold inspection is recommended.

Contact a qualified mold inspection professional.

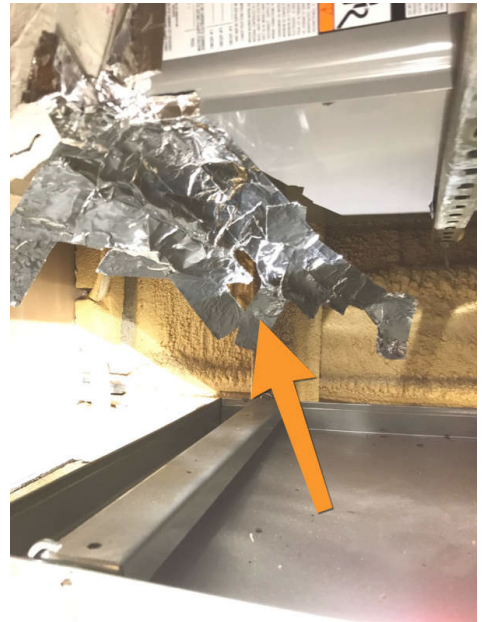
7.3.3 Distribution System

**SUPPLY PLENUM NOT SEALED CORRECTLY**

Air handler supply plenum is not sealed correctly and is leaking cold air. Cold air leaking can cause condensation which in turn causes mold growth.

Contact a qualified HVAC professional.

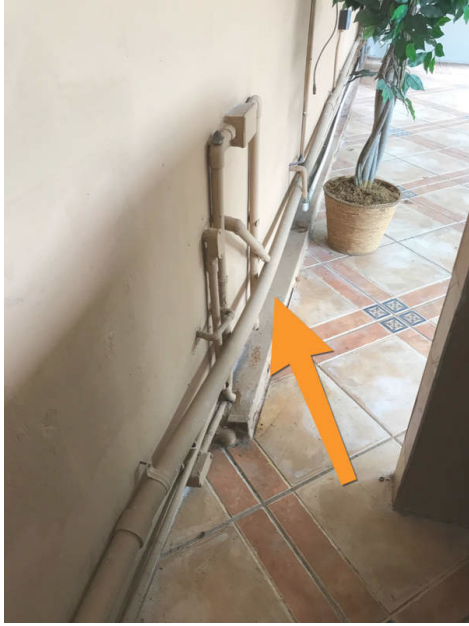
Drain line is not up to code and repairs need to be made.

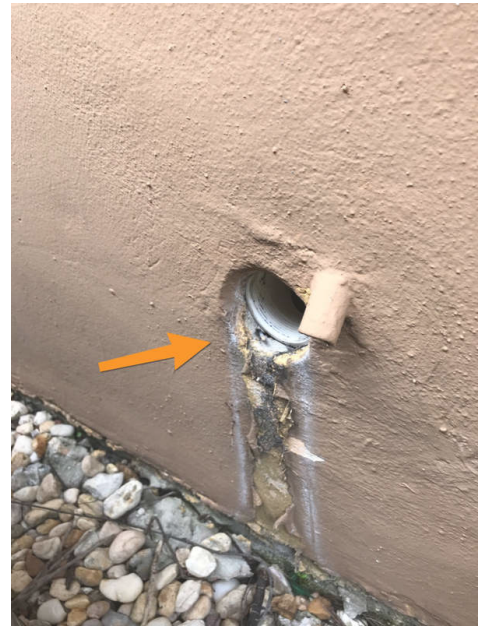
8.2.2 Drain, Waste, & Vent Systems

**DAMAGED CLEANOUT**

Clean out pipe is damaged and needs repair.

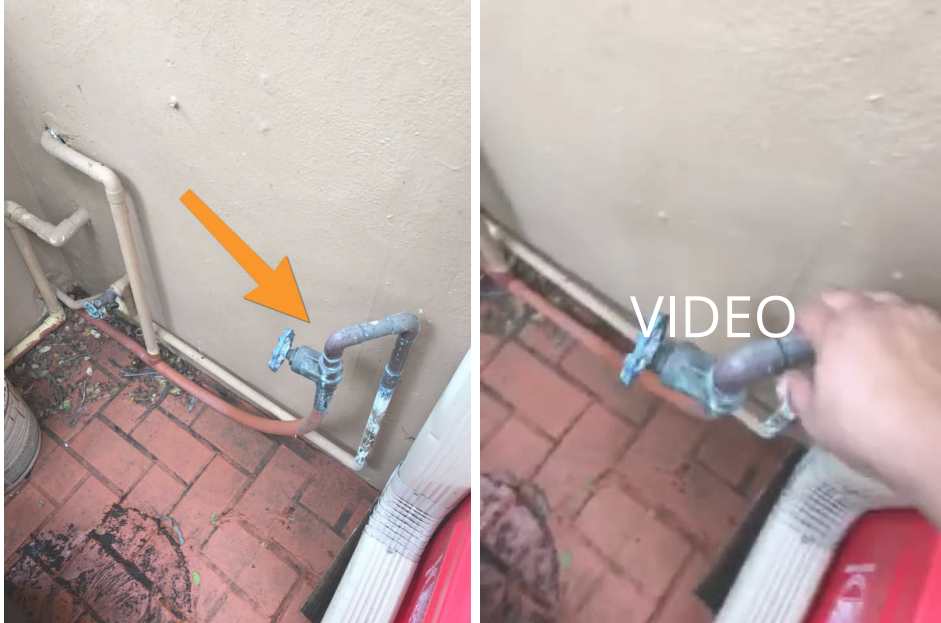
8.3.1 Water Supply, Distribution Systems & Fixtures

**IMPROPER INSTALLATION**

Distribution pipes were installed in a sub-standard way. Recommend a qualified plumber evaluate and properly fit and install pipes.

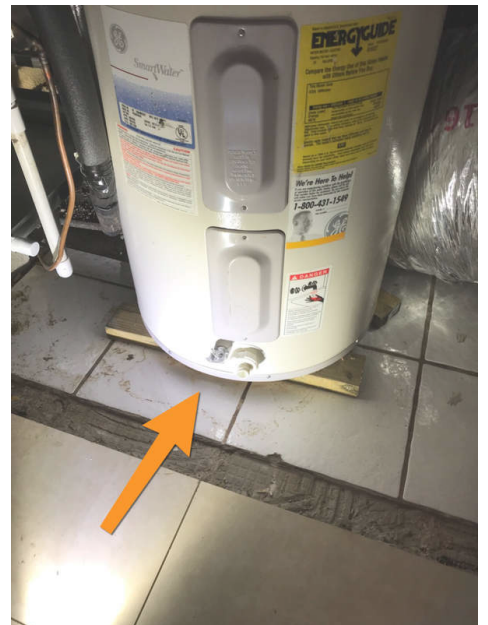
8.5.1 Hot Water Systems, Controls, Flues & Vents 2

No drip pan was present. Recommend installation by a qualified plumber.

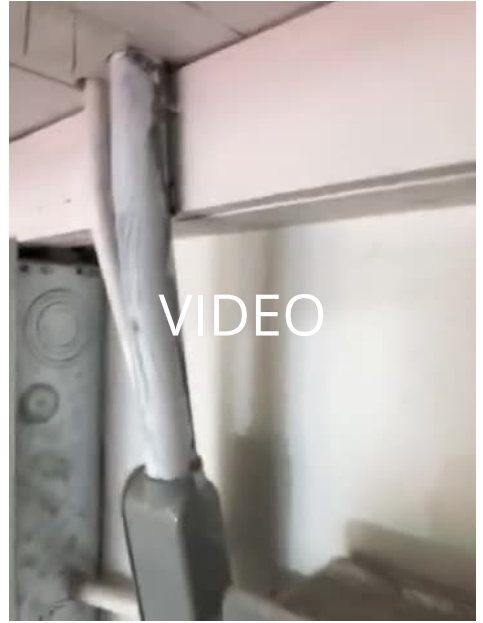
**IMPROPER WIRING**

Wires not installed up to code. A licensed electrician needs to be hired in order to make proper repairs.

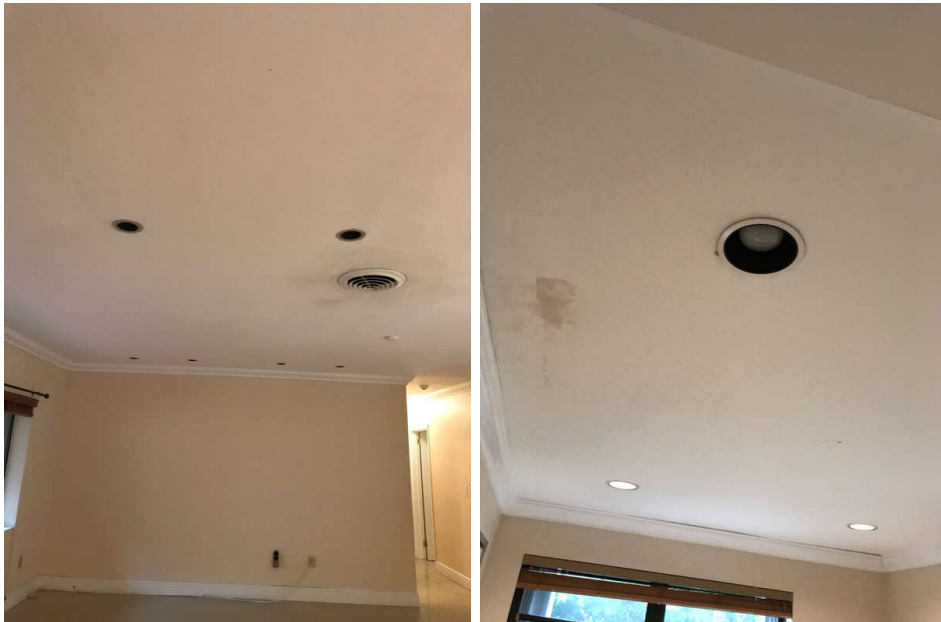
9.4.2 Lighting Fixtures, Switches & Receptacles

**INTERIOR LIGHT INOPERABLE**

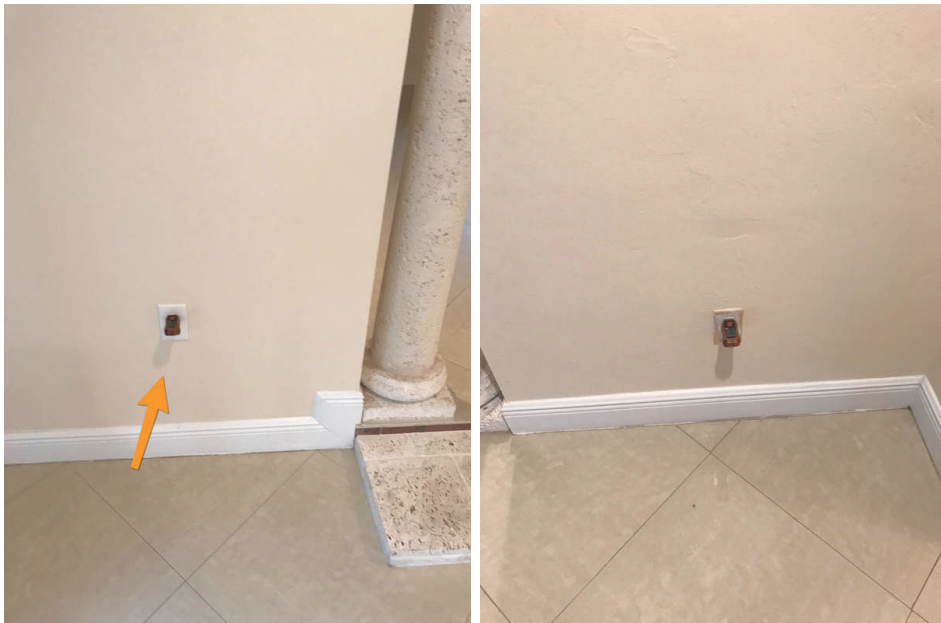
9.4.3 Lighting Fixtures, Switches & Receptacles

One or more outlets do not have power. A licensed electrician should be hired to make proper repairs.

Contact a qualified electrical contractor.

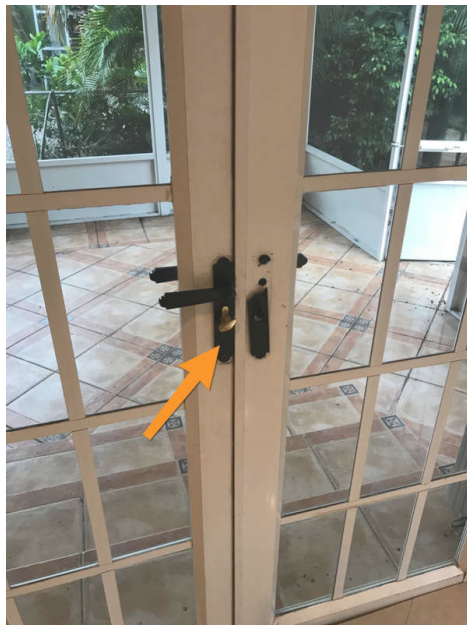
#### LOCK NEEDS REPAIR

Door locks need repair.

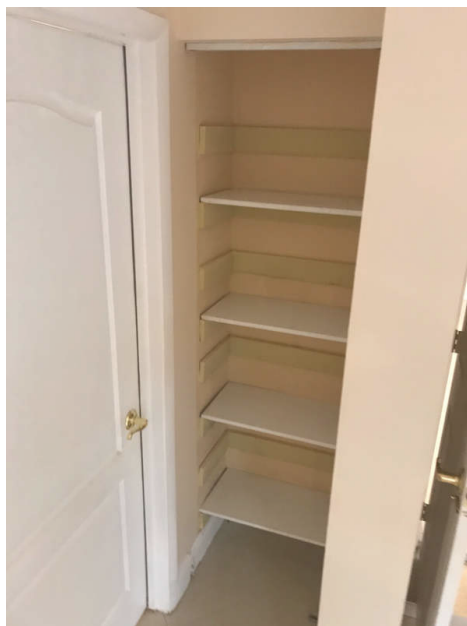
### 11.1.2 Doors

#### CLOSET DOORS MISSING

Observed one or more closet doors that are missing.

Contact a qualified door repair/installation contractor.

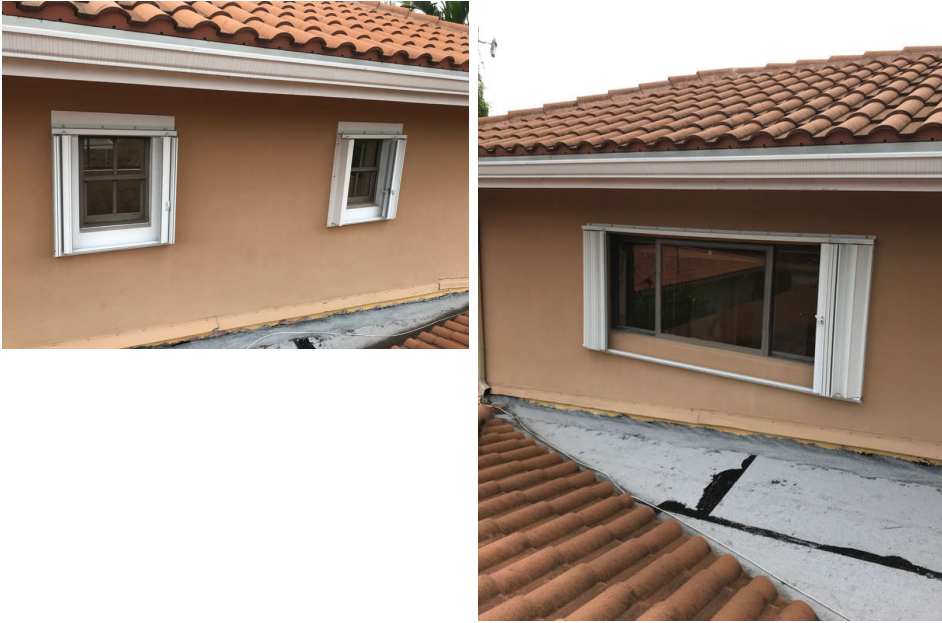
### 11.2.1 Windows

#### MISSING/DAMAGED SCREEN

Observed one or more windows with missing/damaged screens. Recommend replacement.

Contact a qualified window repair/installation contractor.

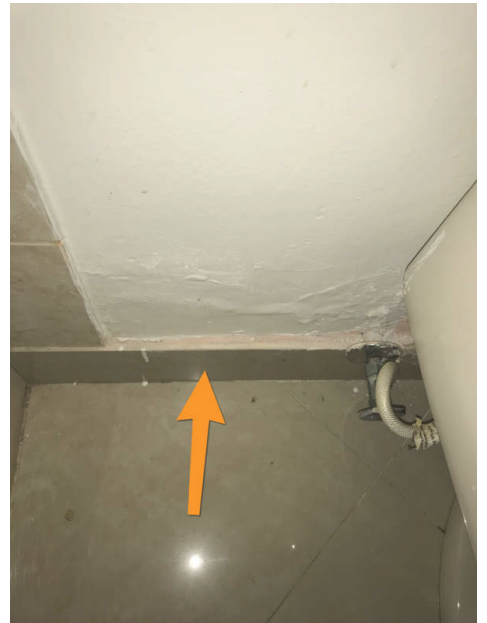
11.4.1 Walls

**MOISTURE DAMAGE**

Stains on the walls visible at the time of the inspection appeared to be the result of moisture intrusion. Recommend further examination by a Mold Inspector to provide further testing.

Contact a qualified mold inspection professional.

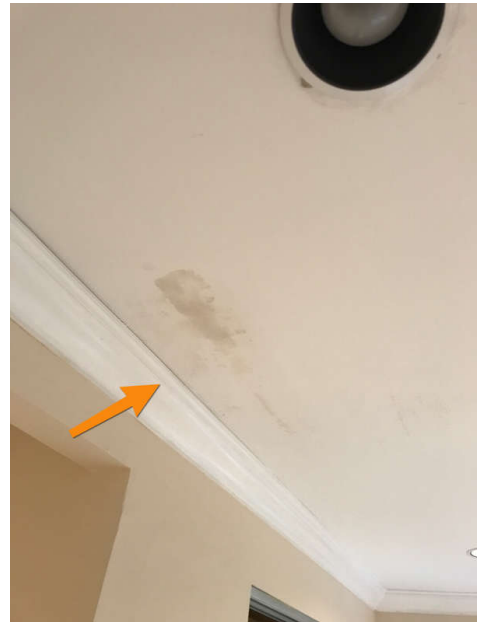
11.5.1 Ceilings

**STAIN(S) ON CEILING**

There is a stain on ceiling/wall that requires repair and paint. Source of staining should be determined.

Contact a qualified roofing professional.

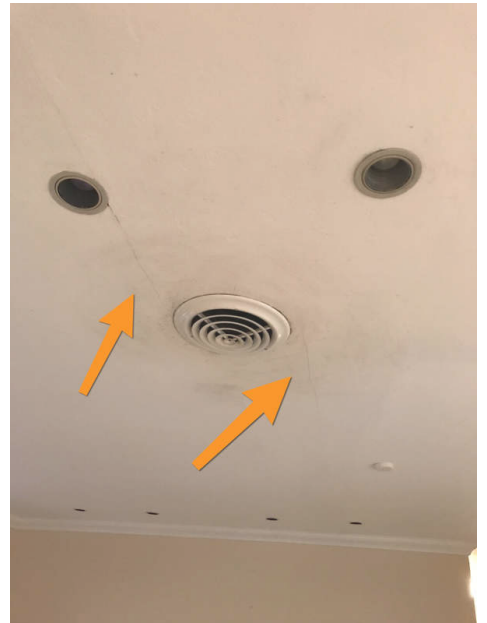
11.5.2 Ceilings

**CRACKS**

Cracks observed on interior ceilings.

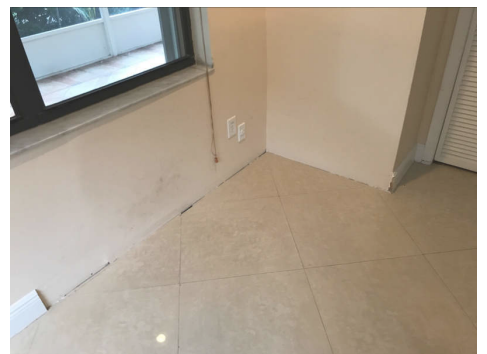
11.7.1 Baseboards

**MISSING BASEBOARDS**

Missing baseboards observed at the property.

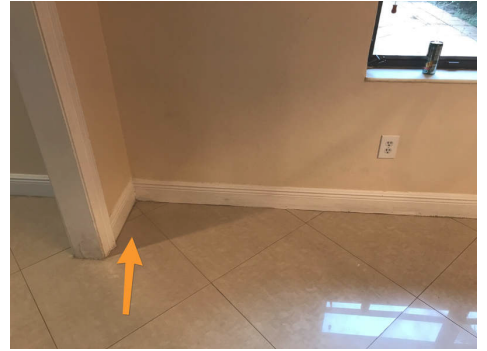
11.7.2 Baseboards

**WATER DAMAGE**

Water damage observed on baseboards is an indication of an active leak somewhere in the home. It is recommended that the source of the leak be located and repaired.

Contact a qualified mold inspection professional.

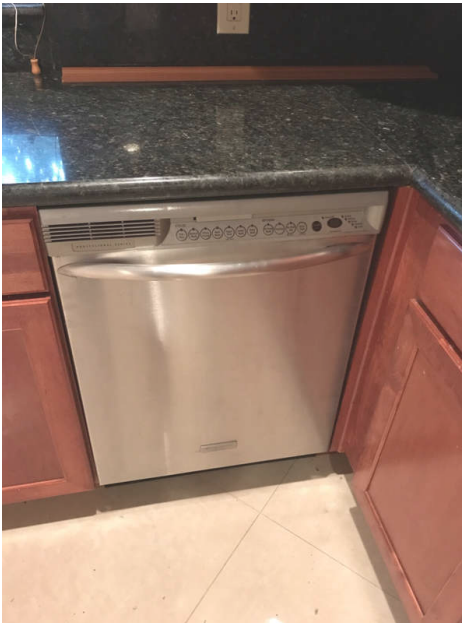
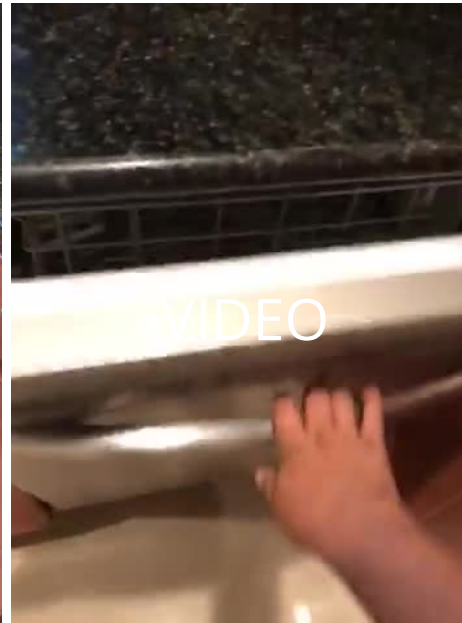
13.1.1 Dishwasher

Dishwasher was inoperable using standard controls. Recommend a qualified plumber or contractor evaluate.

Contact a qualified appliance repair professional.

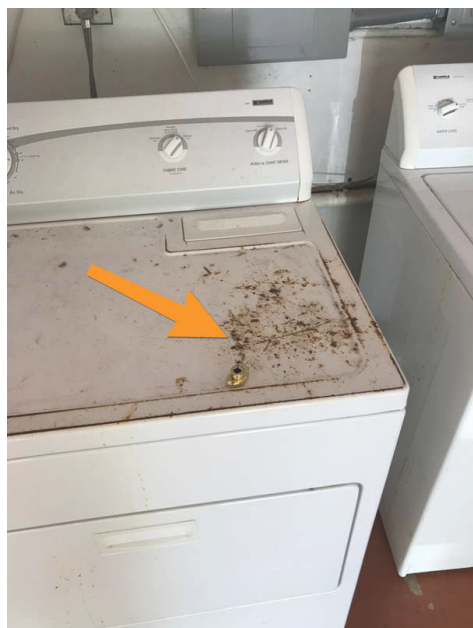
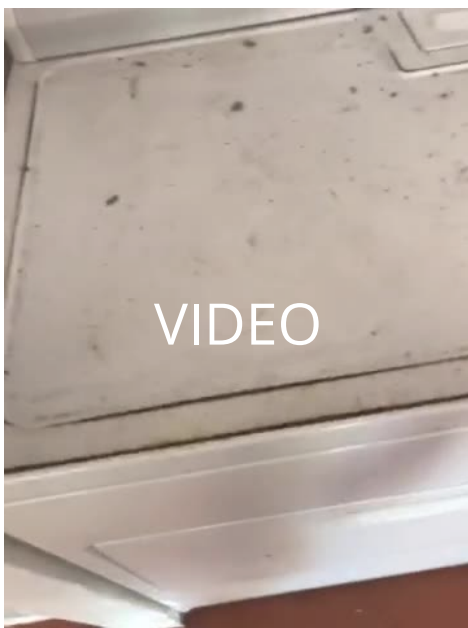
13.6.1 Dryer

**DAMAGE**

Damaged observed to drying machine.

Contact a qualified appliance repair professional.

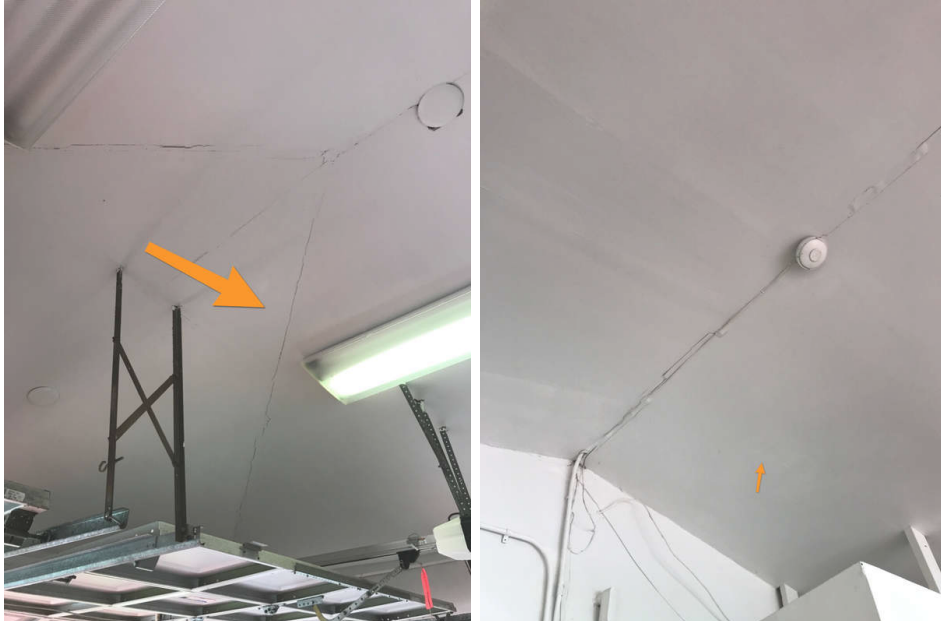
14.1.1 Ceiling

**CRACKS**

Observed ceiling cracks in garage area.

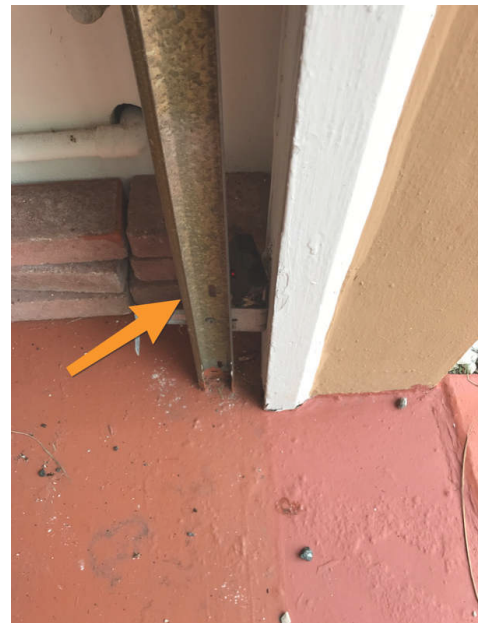
14.5.1 Garage Door Opener

**DAMAGED SENSOR**

Garage force sensitive sensor is damaged and needs repair/replacement.

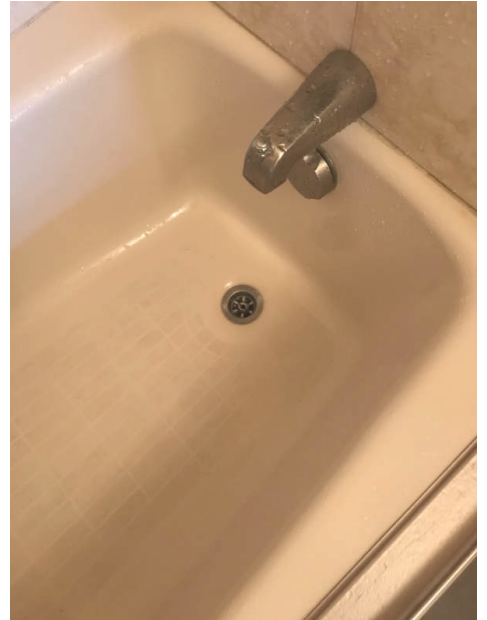
Bathtub drain cap is missing or damaged.

Contact a qualified plumbing contractor.

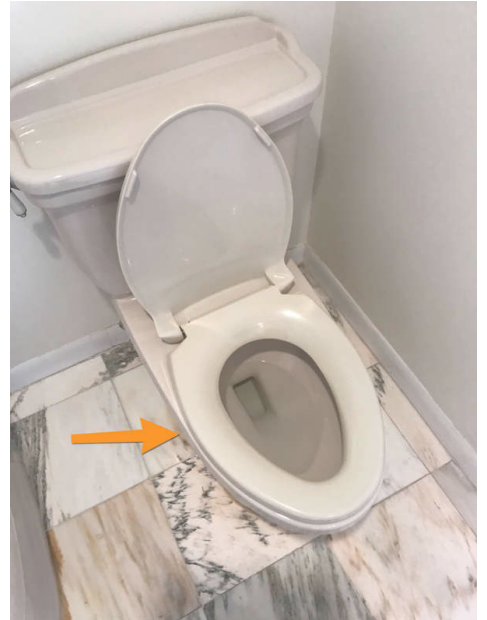
### TOILET IS LOOSE

Toilet is loose at the base and needs immediate repair. A loose toilet can cause it to leak.
