# SOUTHSIDE HOME INSPECTIONS

## RESIDENTIAL REPORT

1234 Main St.  
Virginia Beach Va 23455

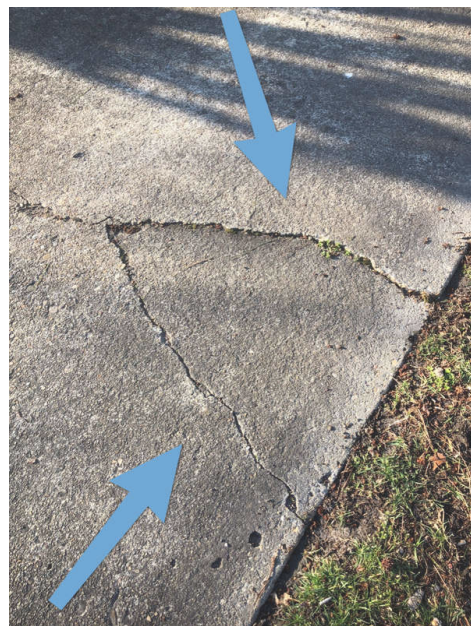
2.2.1 Driveway(s)/Parking

**DRIVEWAY CRACKING - MINOR**

FRONT

Minor cosmetic cracks observed, which may indicate movement in the soil. Recommend monitor and/or have driveway contractor patch/seal.

Contact a qualified driveway contractor.

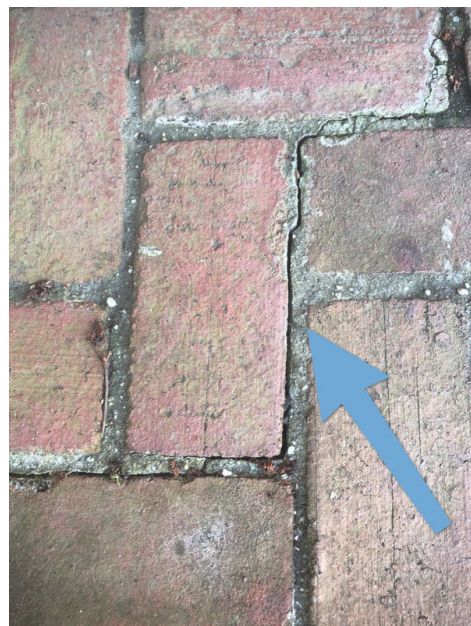
2.3.1 Porch

**MORTAR DETERIORATED**

FRONT

Mortar on front porch structure displays minor deterioration. Recommend repair

Contact a qualified concrete contractor.

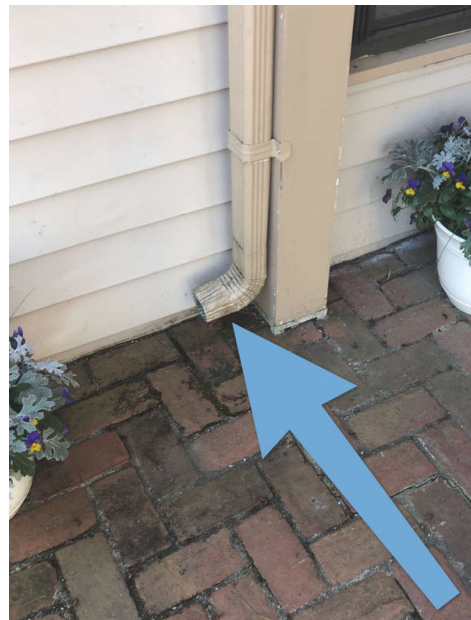
2.7.1 Vegetation, Grading, Drainage & Retaining Walls

**DOWNSPOUTS DRAIN NEAR HOUSE**

FRONT PORCH PHOTO- RECOMMEND EXTENSIONS AT ALL LOCATIONS

One or more downspouts drain too close to the home's foundation. This can result in excessive moisture in the soil at the foundation. Recommend a qualified contractor adjust downspout extensions to drain at least 6 feet from the foundation.

Contact a handyman or DIY project

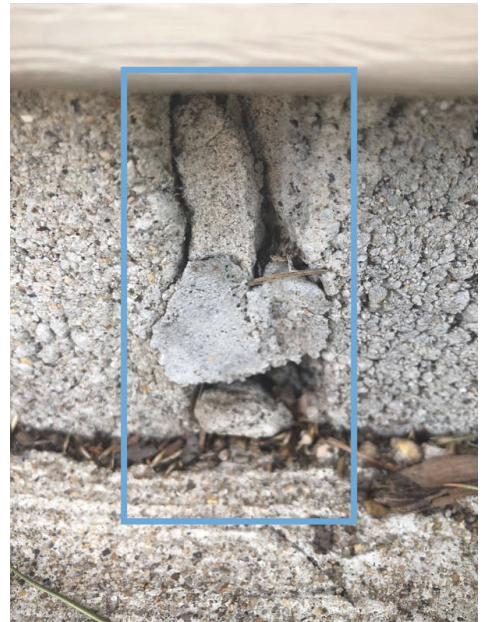
3.1.1 Visible Foundation

### FOUNDATION CRACKS - MINOR

REAR NEXT TO SLIDER

Minor cracking was noted at the foundation. This is common as concrete ages.

Contact a qualified professional.

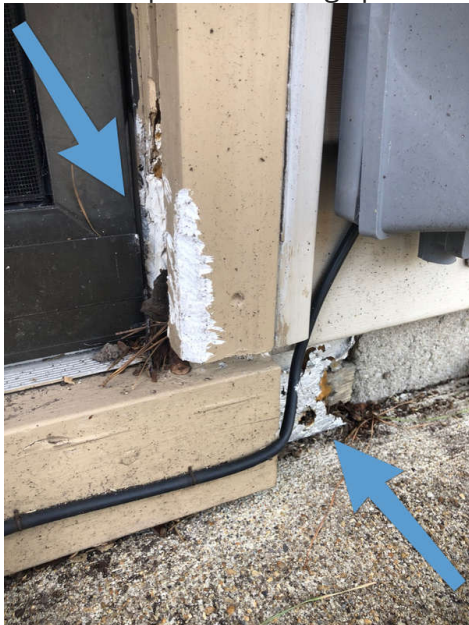
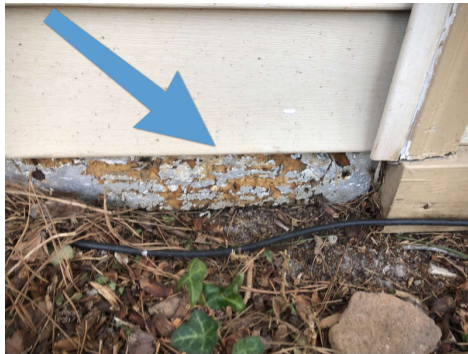
3.3.1 Trim

**EVIDENCE OF POTENTIAL WATER INTRUSION**

REAR

Siding showed signs of water intrusion. This could lead to further siding deterioration and/or mold. Recommend a qualified siding contractor evaluate and repair.

Contact a qualified siding specialist.

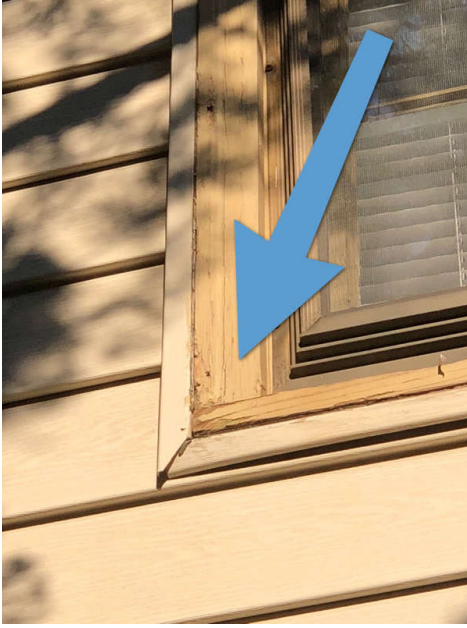
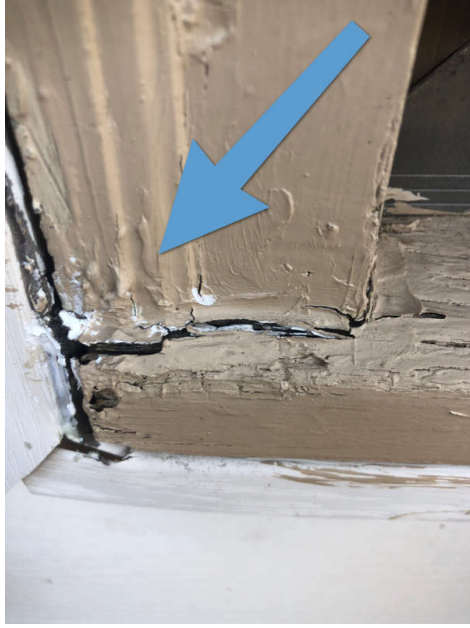
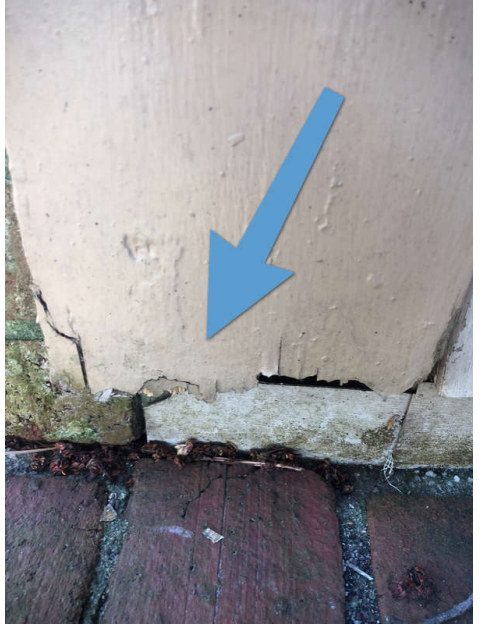
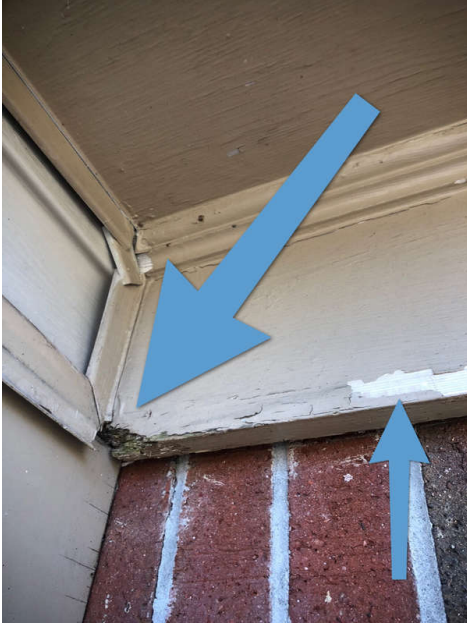
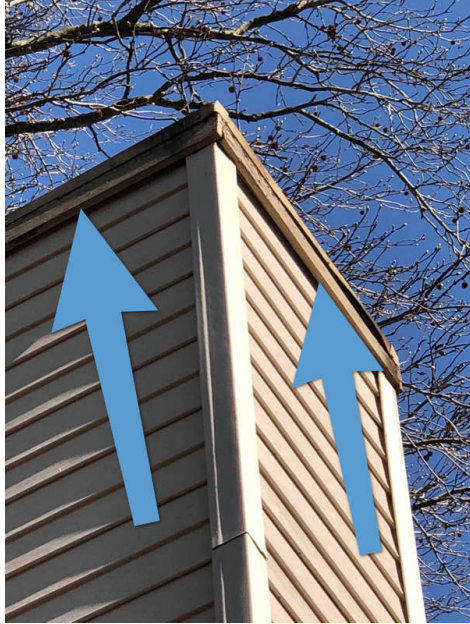
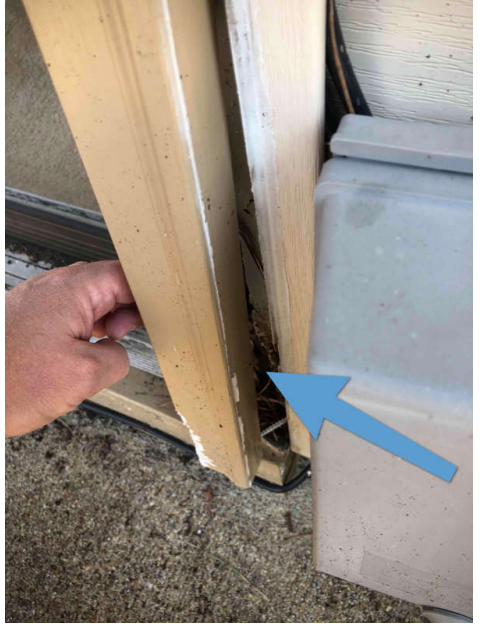
3.3.2 Trim

**PAINT NEEDED/ROT OBSERVED**

WINDOWS SURROUND, SLIDER SURROUNDS, CHIMNEY TOP TRIM

Area(s) of Trim were in need of paint maintenance or displayed rotted area(s) at the time of inspection. Recommend a qualified painter or siding specialist correct.

Contact a qualified siding specialist.

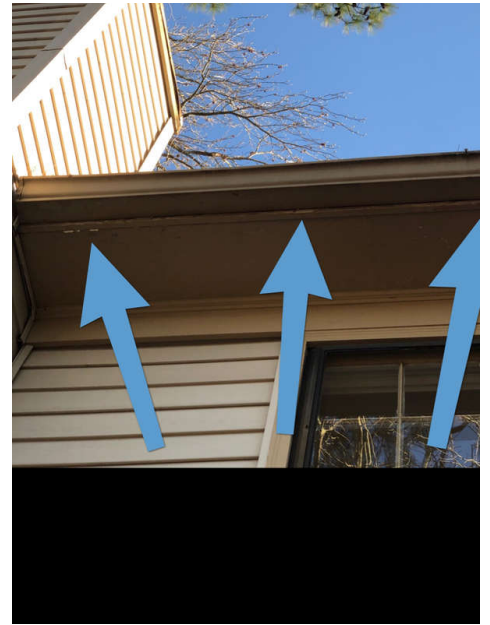
3.4.1 Soffits

**SOFFIT- PAINT RCOMMENDED**

VARIOUS

One or more sections of the fascia are rotted. Recommend qualified roofer evaluate & repair.

Contact a qualified roofing professional.

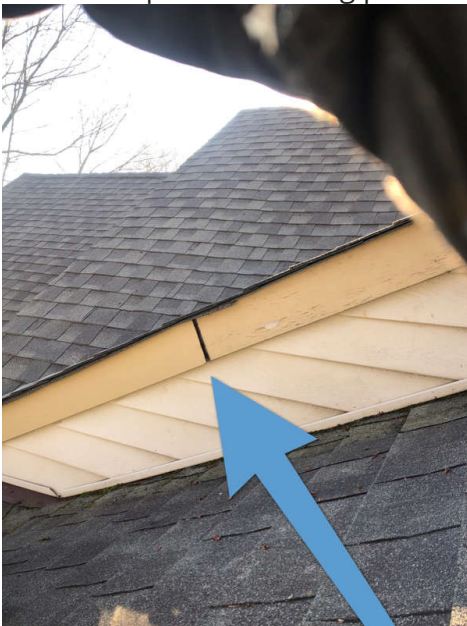
Right side

**FASCIA - LOOSE**

One or more sections of the fascia are loose. Recommend qualified roofer evaluate & repair.

Contact a qualified roofing professional.

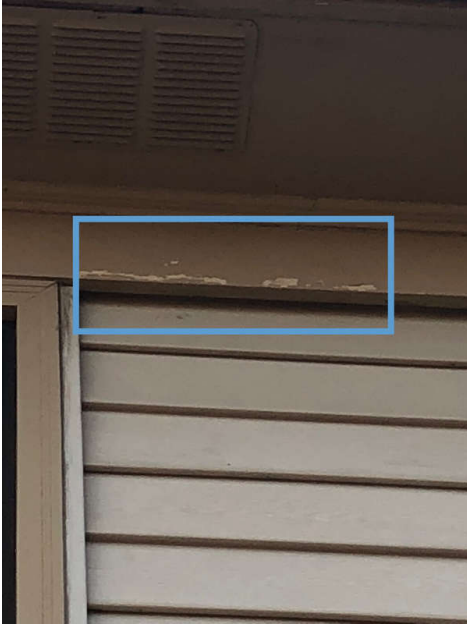
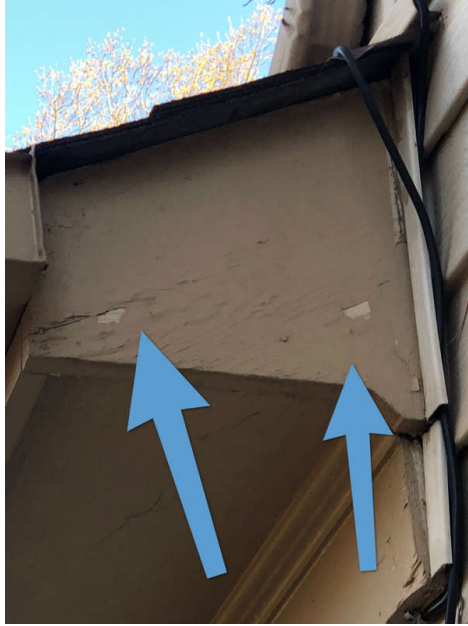
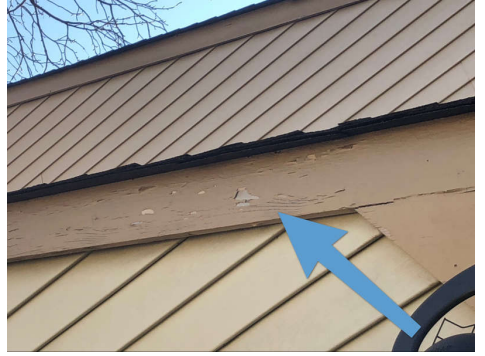
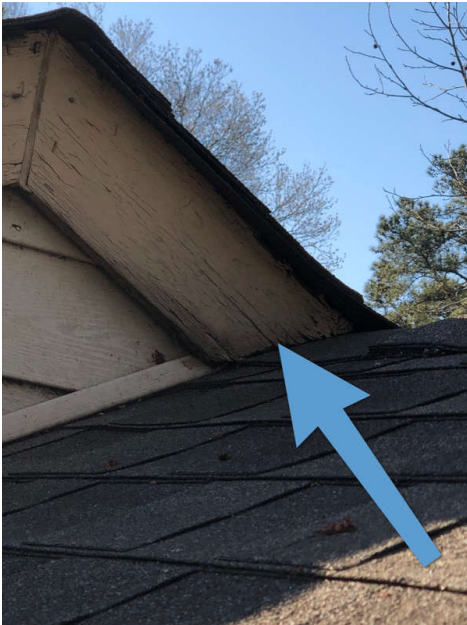
3.6.2 Fascia

**FASCIA - PAINT NEEDED/ROT OBSERVED**

VARIOUS LOCATIONS SURROUNDING HOME

One or more sections of the fascia are rotted. Recommend qualified roofer evaluate & repair.

Contact a qualified roofing professional.

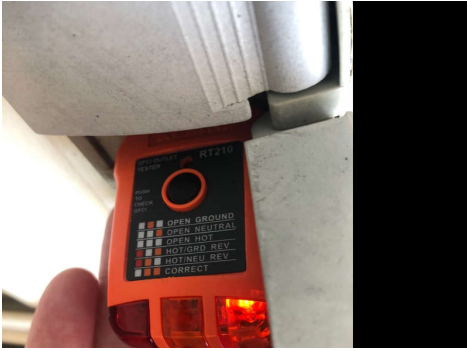
3.7.1 Exterior Electrical Receptacles

**GFCI RECEPTACLES RECOMMENDED/OPEN NEUTRAL**

REAR

No GFCI protection present in all locations. Recommend licensed electrician upgrade by installing ground fault receptacles in all locations.

Contact a qualified electrical contractor.

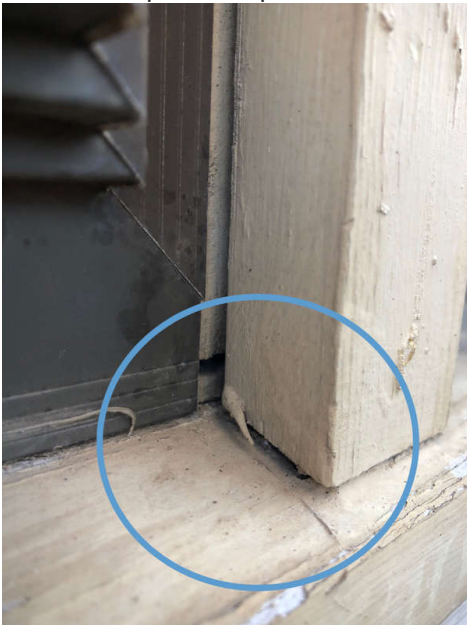
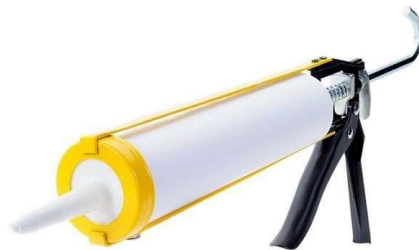
### 3.9.1 Caulking

## CAULKING RECOMMENDED-WINDOWS/DOORS/UTILITY PENETRATIONS

VARIOUS-EXAMPLE ABOVE

Caulking on a regular basis around windows, doors and utility penetrations can aid in moisture intrusion prevention and prolong the life of various areas around your home.

Contact a qualified professional.

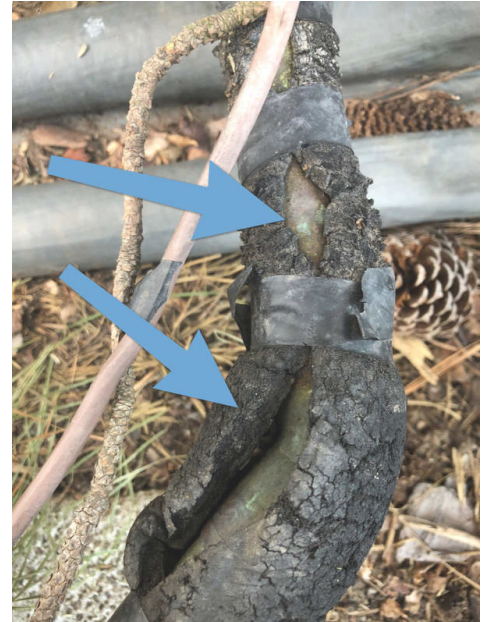
4.1.1 Air Conditioner-Cooling Equipment

### **INSULATION MISSING OR DAMAGED**

REAR AT AC UNIT

Missing or damaged insulation on refrigerant line can cause energy loss and condensation.

Contact a qualified HVAC professional.

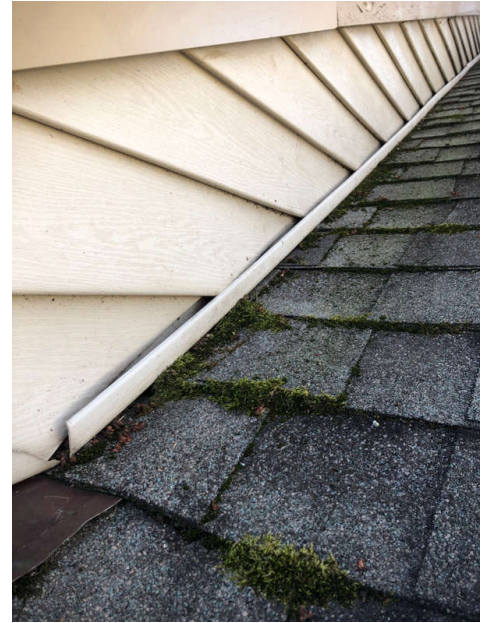
Roof shingles were discolored, which can be caused by moisture, rust or soot. Recommend a qualified roofing contractor evaluate and remedy with a roof cleaning or repair.

Contact a qualified roofing professional.

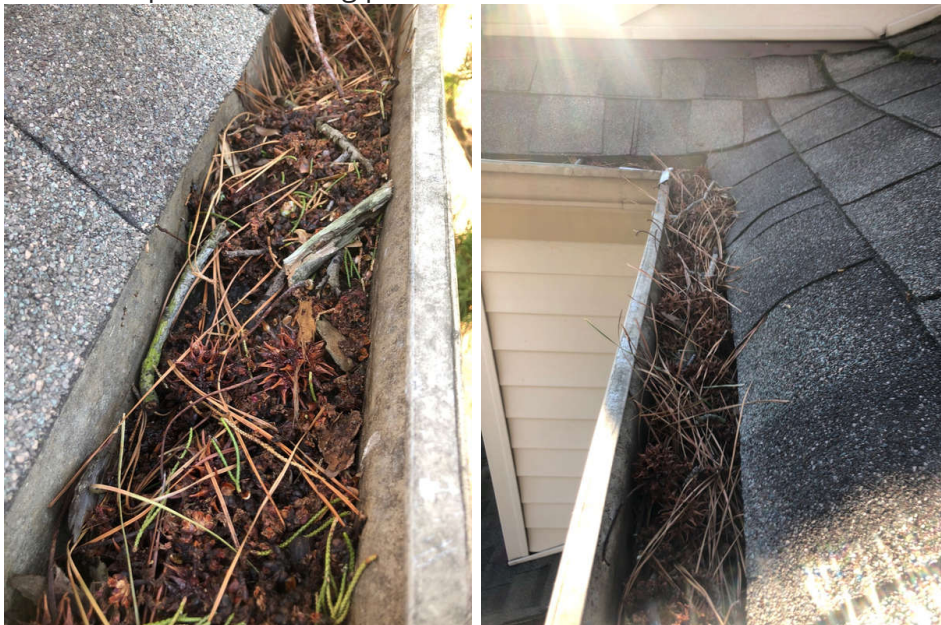
5.3.1 Gutters

**DEBRIS**

Debris has accumulated in the gutters. Recommend cleaning to facilitate water flow.

Contact a qualified roofing professional.

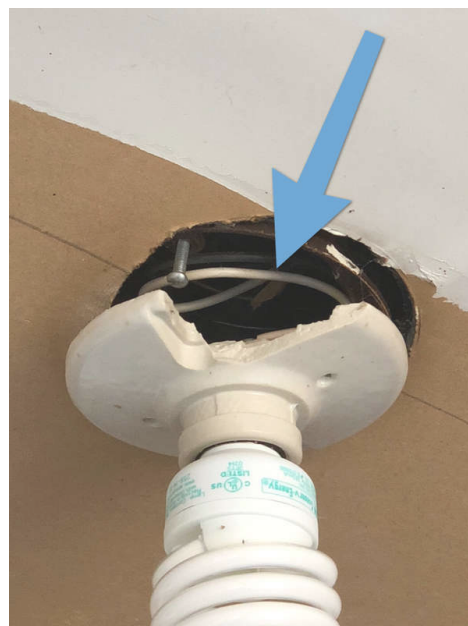
Open junction box observed. Recommend concealing or replacing.

Contact a qualified professional.

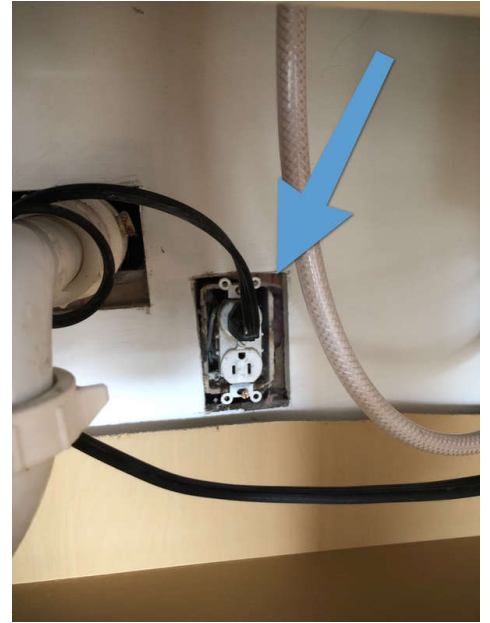
7.1.1 Connected Devices and Fixtures

**COVER PLATES MISSING**

One or more receptacles are missing a cover plate. This causes short and shock risk. Recommend installation of plates.

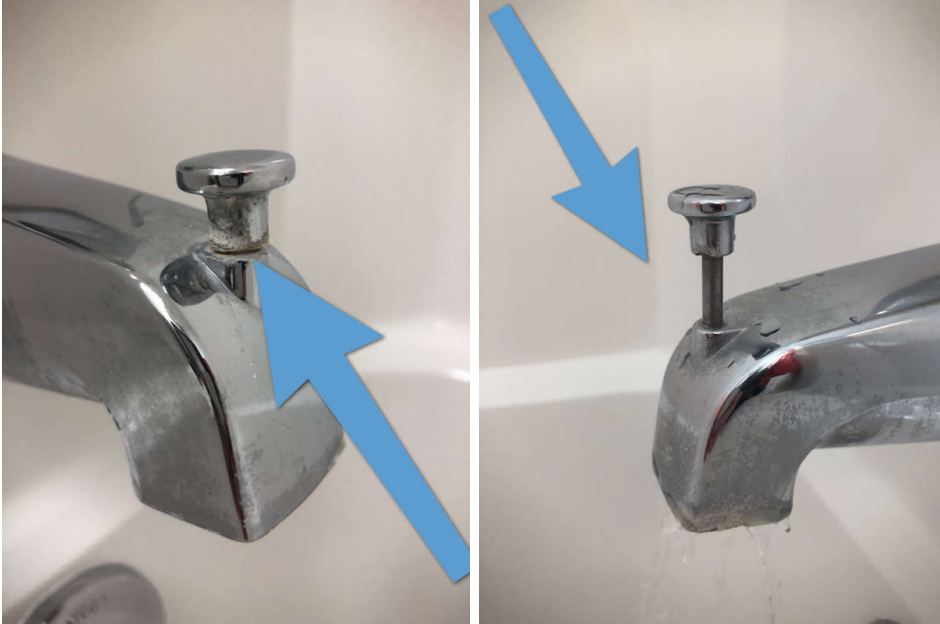
#### **DIVERTER CORRODED-INOPERABLE**

Shower/Bath diverters were corroded into one position only at the time of inspection. Recommend replacing to allow full functionality

Contact a qualified plumbing contractor.

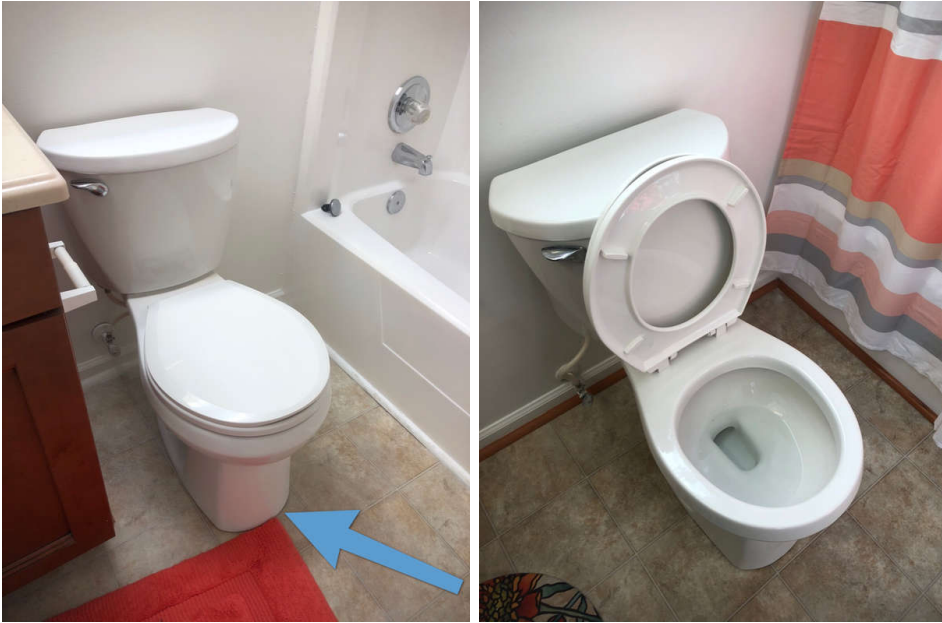
### 9.2.2 Fixtures / Faucets

#### **TOILET TO FLOOR CONNECTION LOOSE**

The connection of the toilet to the floor was noticeably loose at the time of inspection. This may lead to leaking. Recommend an evaluation of a licensed plumbing contractor. Repair as needed.

Contact a qualified plumbing contractor.

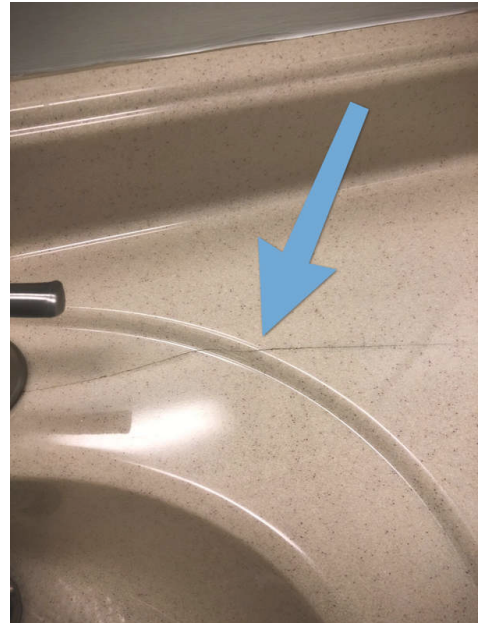
### 9.3.1 Countertops & Cabinets

#### **COUNTERTOP CRACKED/CHIPPED**

Countertop had one or more cracks or chips. Recommend qualified countertop contractor evaluate and repair.

Contact a qualified countertop contractor.

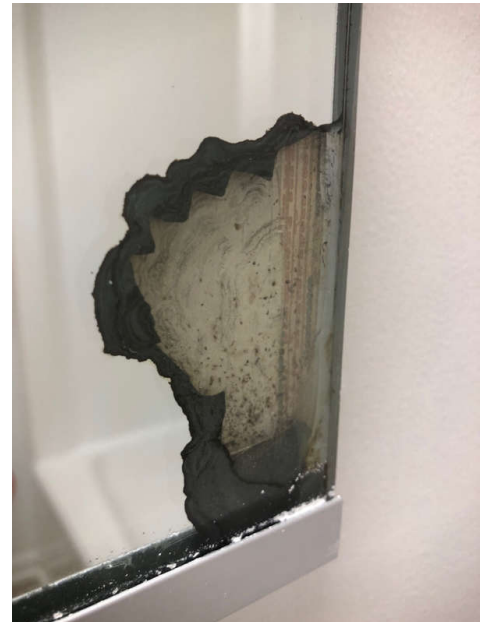
### 9.7.1 Walls

#### **MIRROR DAMAGED**

Damage was observed on the wall mirror at the time of inspection. Recommend repair/replace as needed.

Contact a qualified professional.

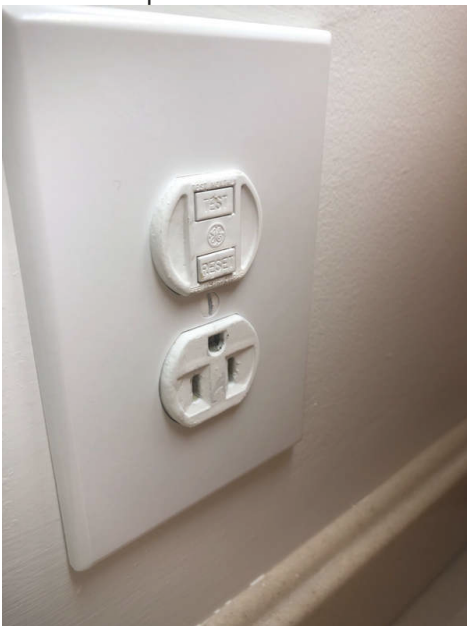
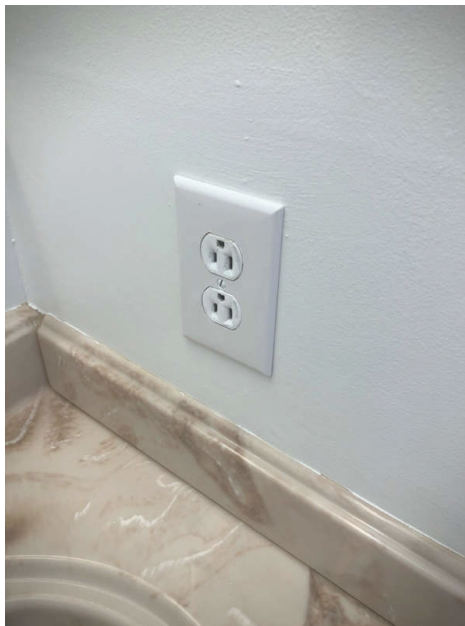
9.13.1 GFCI & AFCI

**GFCI RECEPTACLES RECOMMENDED IN BATHROOMS**

No GFCI protection present in all locations. Recommend licensed electrician upgrade by installing ground fault receptacles in all locations.

Contact a qualified electrical contractor.

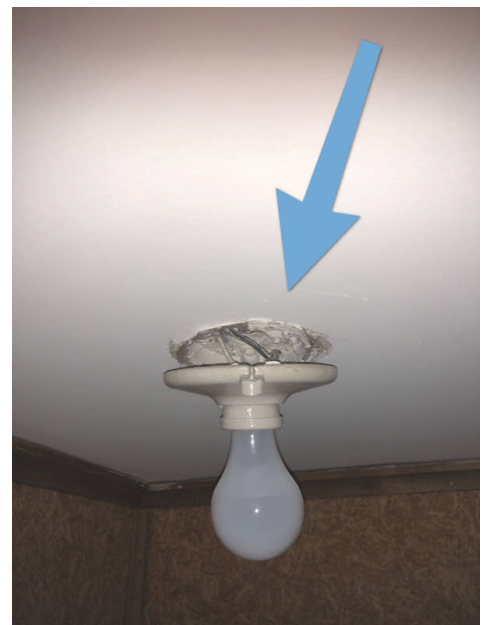
Open junction box at closet light to ceiling. Recommend qualified professional repair as needed

Contact a qualified electrical contractor.

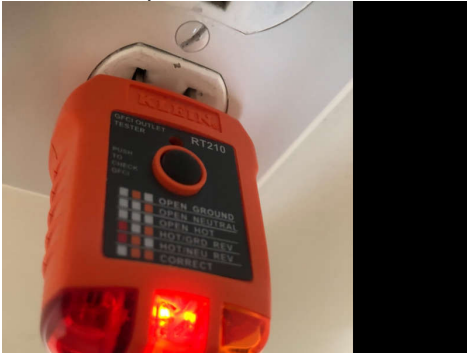
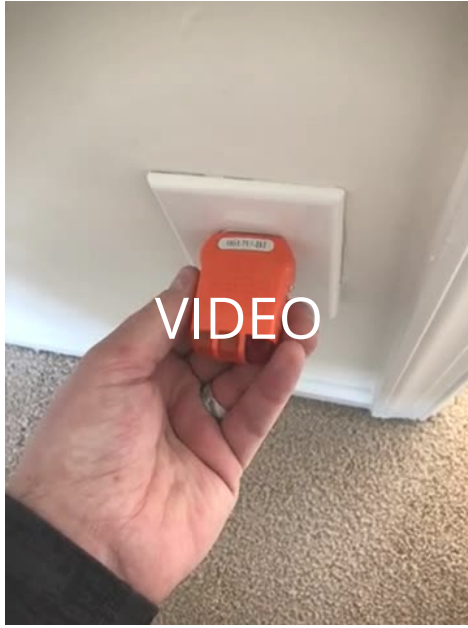
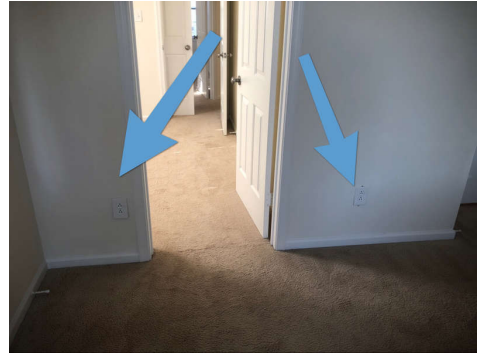
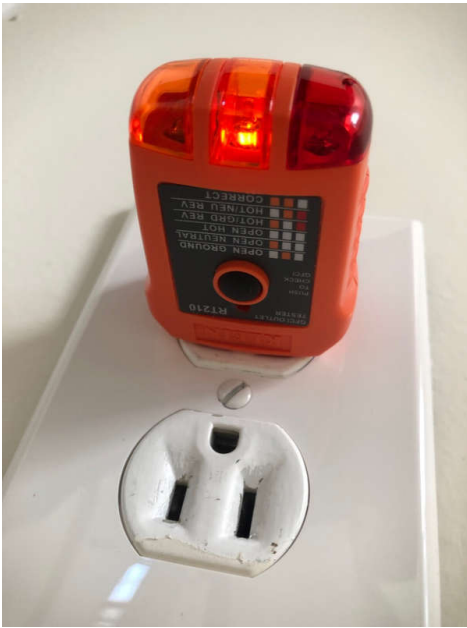
10.2.2 Polarity and Grounding of Receptacles

One or more outlets are not grounded. Recommend a qualified electrician replace non-grounded outlets with grounded ones.

Contact a qualified electrical contractor.

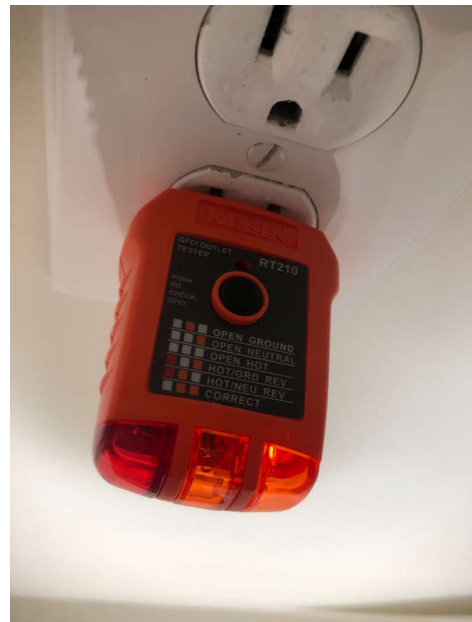
10.2.3 Polarity and Grounding of Receptacles

One or more receptacles have been wired with reverse polarity. This can create a shock hazard. Recommend licensed electrician evaluate & repair.

Contact a qualified electrical contractor.

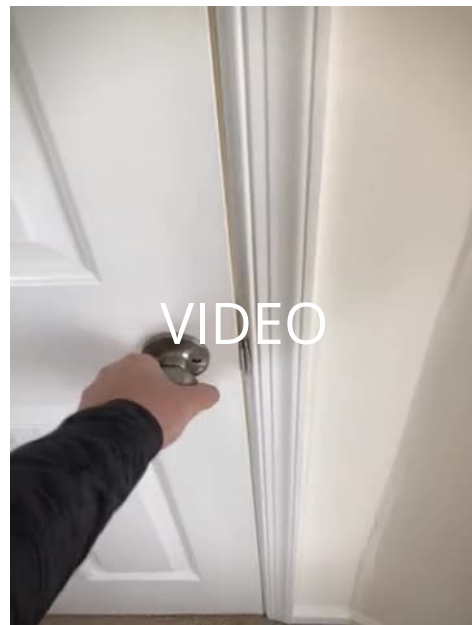
10.6.1 Doors

Door doesn't latch properly. Recommend handyman repair latch and/or strike plate.

Contact a qualified handyman.

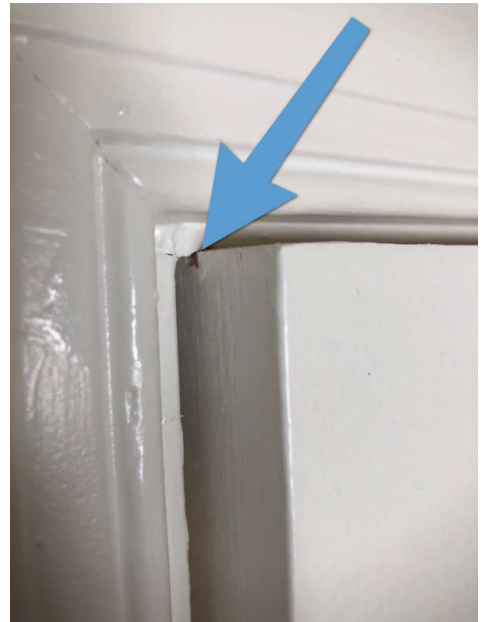
10.6.2 Doors

Door(s) sticks and is tough to open. Recommend sanding down offending sides.

Contact a handyman or DIY project

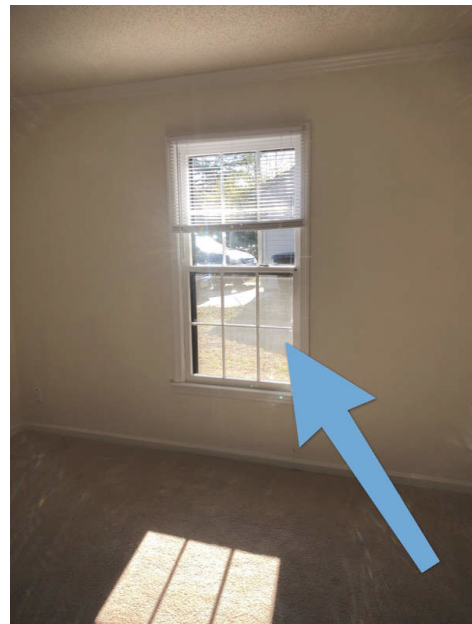
### ADJUSTMENT RECOMMENDED (WOULD NOT OPEN)

One or more windows appears to have general damage, but are operational. Recommend a window professional clean, lubricate & adjust as necessary.

Contact a qualified window repair/installation contractor.

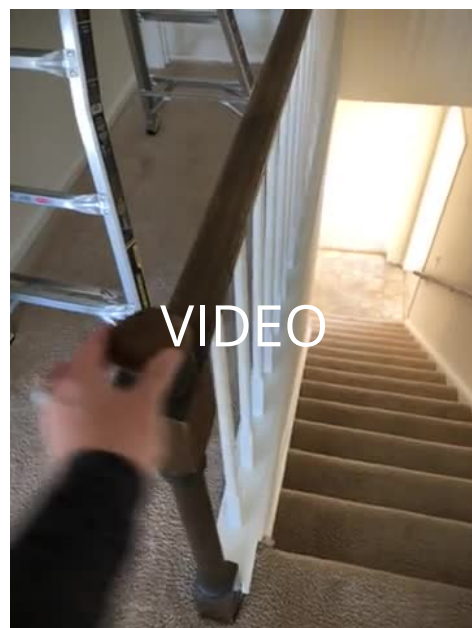
12.4.1 Steps, Stairways & Railings

**LOOSE RAILING**

Handrail was loose. This could pose a safety hazard. Recommend a qualified handyman evaluate and fasten.

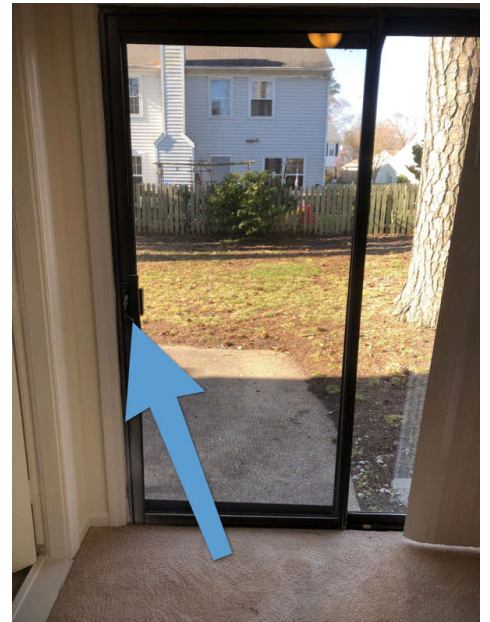
12.9.1 Doors-Access to Exterior

**SLIDING GLASS DOOR - HARDWARE DAMAGE**

Sliding glass door was showing its age and displayed poor functionality on its tracks, but was somewhat operable. Recommend repair or replace as needed.

Contact a qualified door repair/installation contractor.

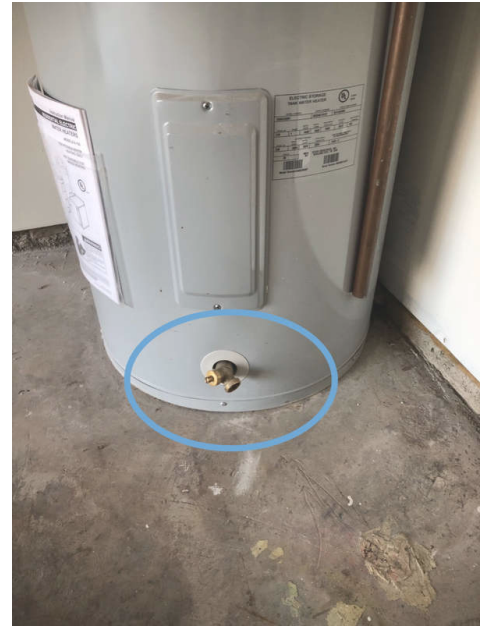
### 13.3.1 Water Heater

Water heaters should be flushed annually to prevent sediment buildup and maintain efficiency. Recommend a qualified plumber service and flush.

Contact a qualified plumbing contractor.

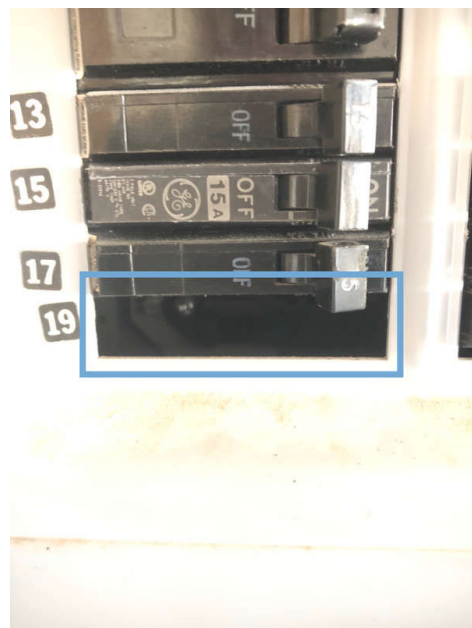
### PANEL BREAKER KNOCKOUT MISSING

Recommend a qualified electrician evaluate and repair.

Contact a qualified electrical contractor.

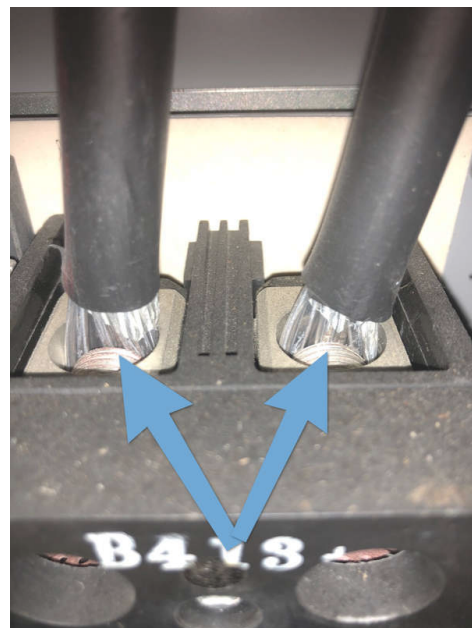
14.2.2 Service and Grounding Equipment, Main Overcurrent Device, Main and Distribution Panels

### RECOMMEND APPLYING NO-OXIDATION PASTE

Helps prevent corrosion at the main service wire entry point

Contact a qualified electrical contractor.

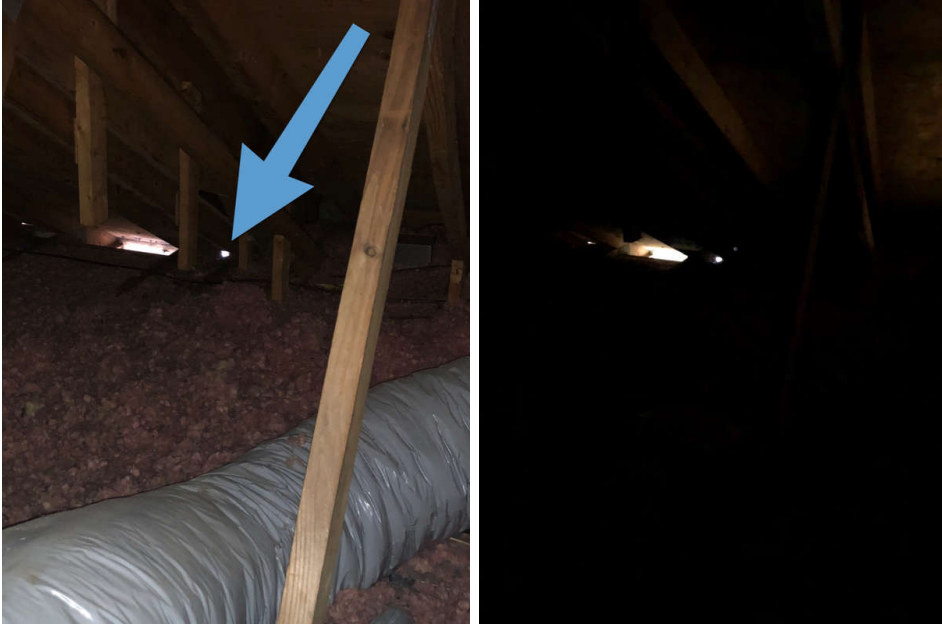
Hole to exterior was observed at the time of inspection. This can allow access for the elements and for wildlife. Recommend repair

Contact a qualified professional.
