PROPERTY INSPECTION REPORT

1234 Main St.
Fort Worth Texas 76126

Buyer Name
11/26/2018 9:00AM

Inspector
Kent Keith

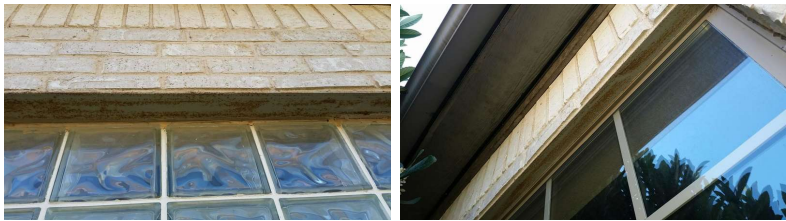
3: Rusting Lintels

The metal lintels above windows are starting to rust and should be painted with a rust inhibitor paint.

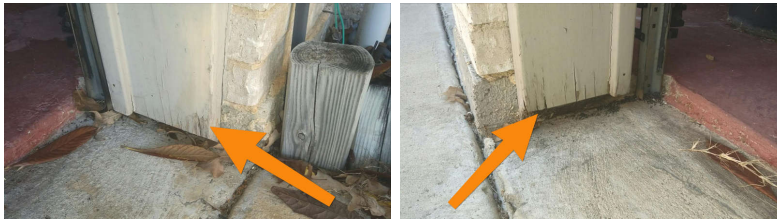
2: Wood Rot - Garage Door Jambs

The bottoms of the overhead garage door jambs have minor wood rot and needs repairs or replacements.

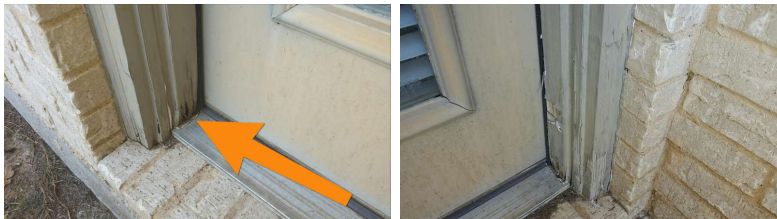
3: Door trim and jamb

The door jamb and trims to the exterior door in the master bedroom has wood rot and chipping paint.

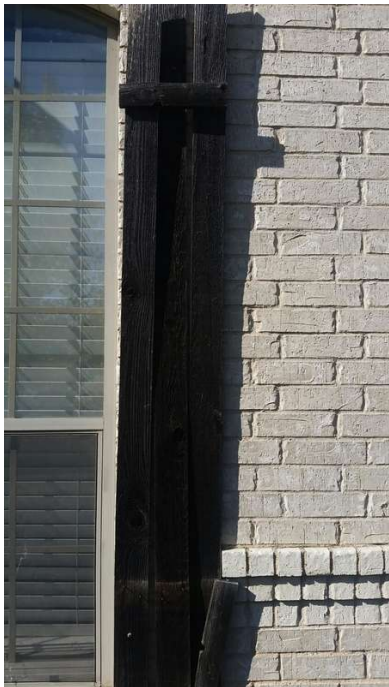
3: Shutter

There is a broke window shutter at the front right side of the house.

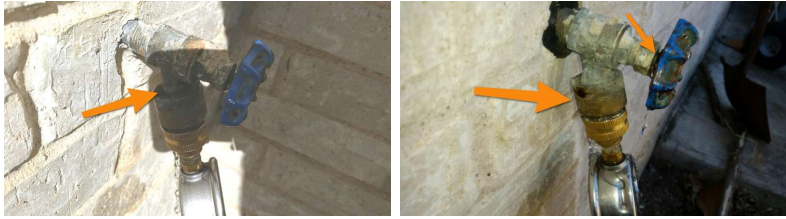
2: Hose Faucet Leaks When Pressurized

The left and right side hose faucets leak when pressurized and needs repairs.

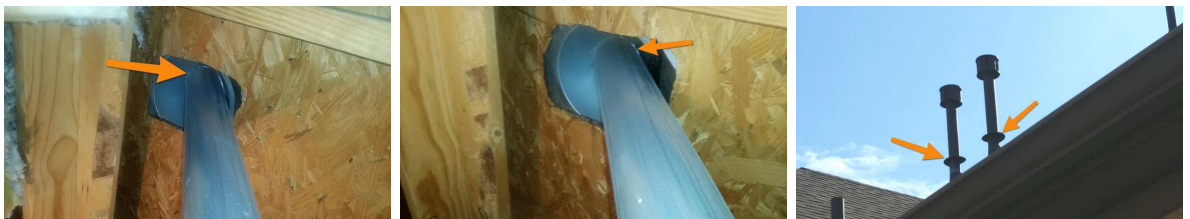
The rain diverter hoods for the water heater's flue pipes needs to be sealed to prevent water intrusion.

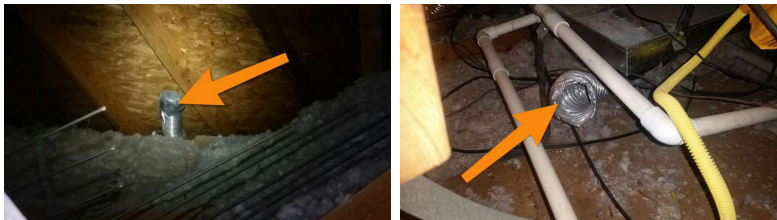
The bath exhaust fans are venting into the attic and should vent to the exterior of the house.

TREC standards of practice require the reporting as deficient ducts that do not terminate outside the home.
