BRUCE INSPECTIONS, LLC - RESIDENTIAL

1234 Main St.
Seymour TN 37865

04/23/2019 9:00AM

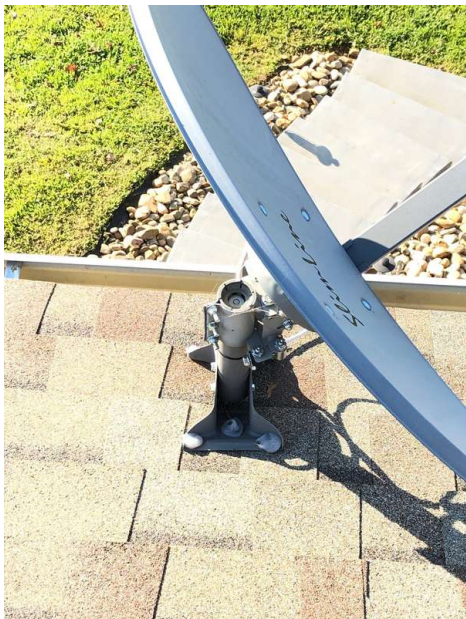
Coverings: Satellite Dish Penetration

Satellite dish mounts have penetrated roof coverings which could allow moisture intrusion if not kept sealed. Recommend periodic monitoring to ensure sealant used is in good condition and reapply as needed.

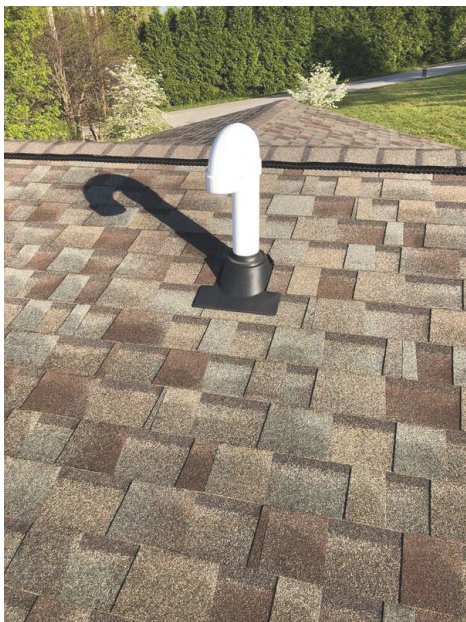
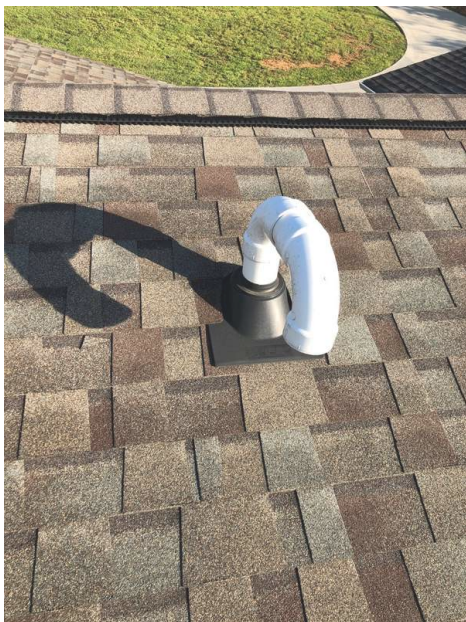
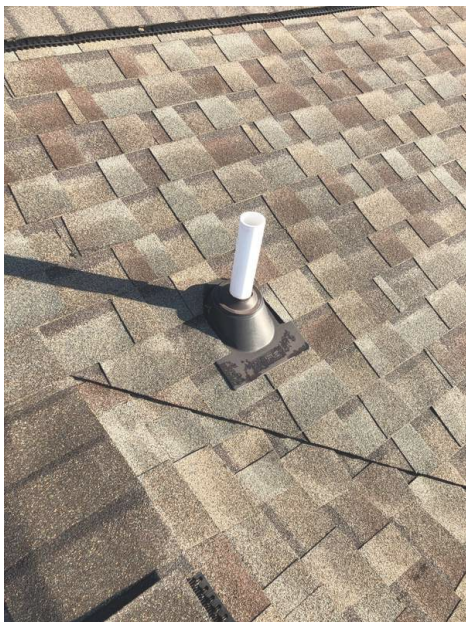
Vents: Boots - Satisfactory

Vents had proper flashing and the gaskets were in good condition. Only a few up close pictures for perspective on flashing/gaskets condition. Any deficiencies will be noted in the report.

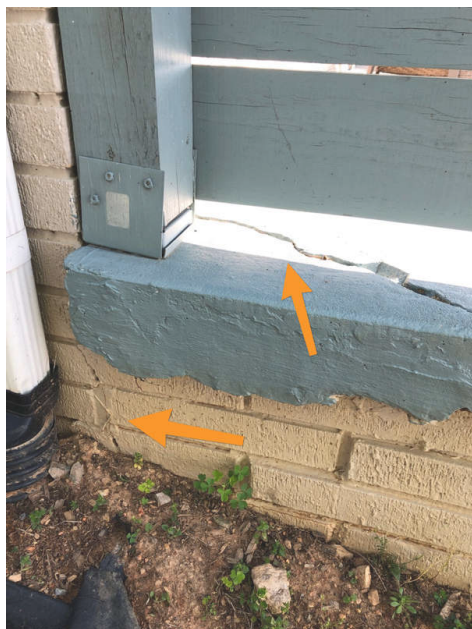
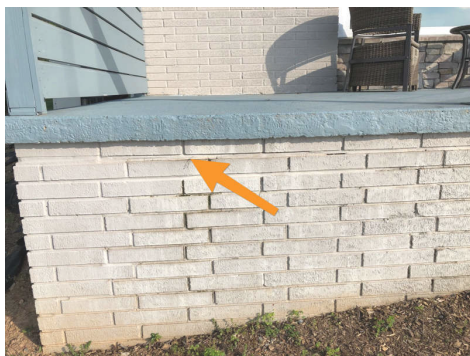
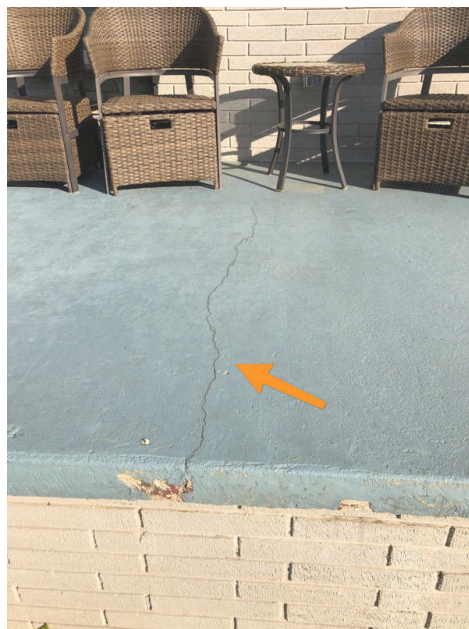
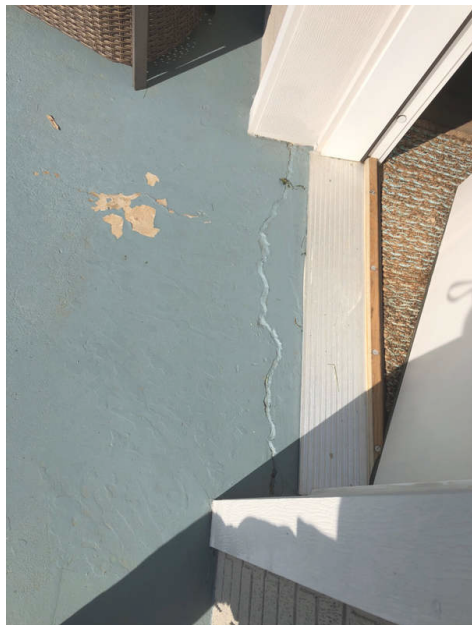
CONCRETE/ASPHALT CRACK

Concrete and/or asphalt areas had visible cracks in noted locations likely due to long term settlement and is commensurate with age of surface. It appears to have been addressed. Check with the current owner. Recommend fill and/or seal and monitors as needed.

Recommend monitoring.

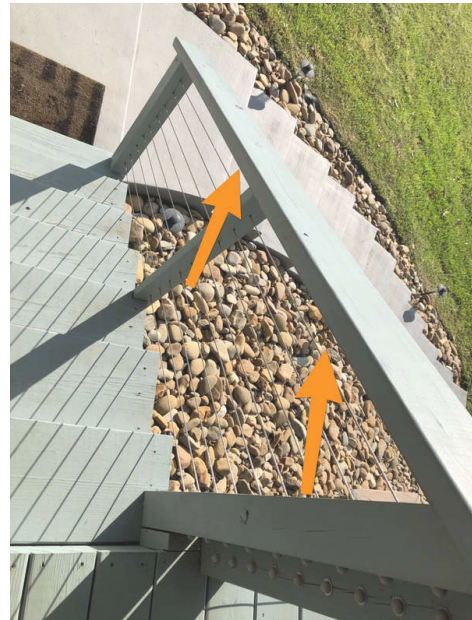
3.5.1 Decks, Balconies, Porches & Steps

Safety No handrails installed on in places with three or more steps. Recommend correction by installing a graspable handrail system. Similar to what you would see on interior stairs.

Contact a qualified carpenter.

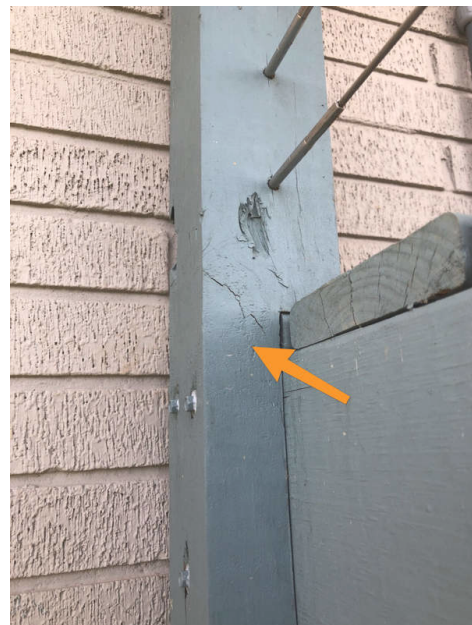
3.5.2 Decks, Balconies, Porches & Steps

BASE DEGRADED

Railing post degraded at the base. Appears to be a crack due to a knot in the wood. The railing post may snap when force is applied. Recommend further evaluation.

Contact a handyman or DIY project

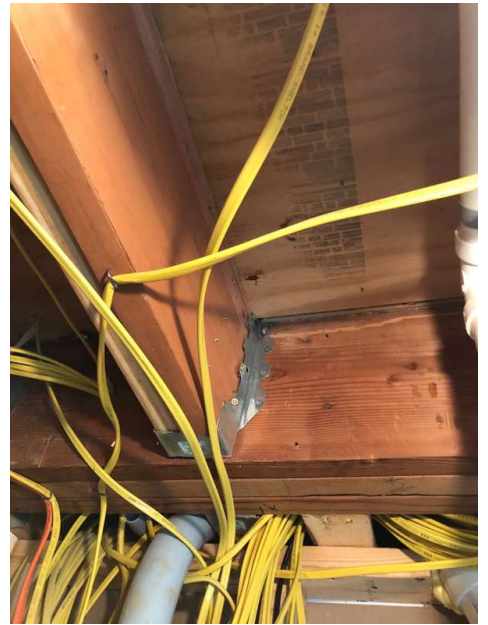
VISUAL LIMITATIONS - FLOORING

Due to joist installed batt insulation, the inspector had limited visibility of subflooring which limits the ability to detect moisture damage on subflooring.

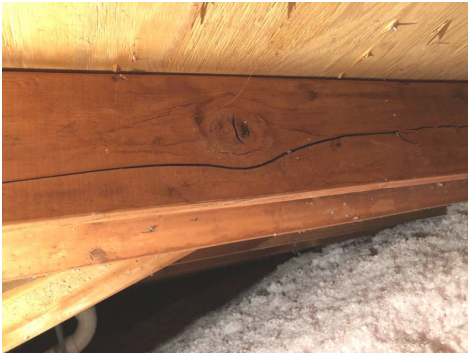
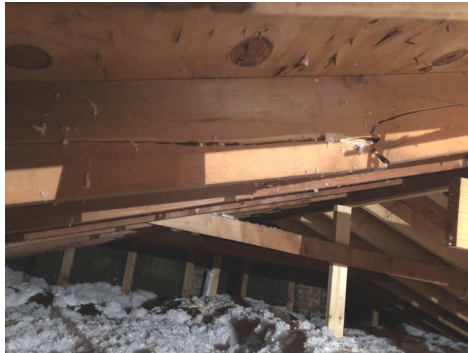
Rafter wood has split in multiple locations due to high heat and drying. The inspector walked the roof. There did not appear to be any "soft spots". Recommend sistering effected rafters.

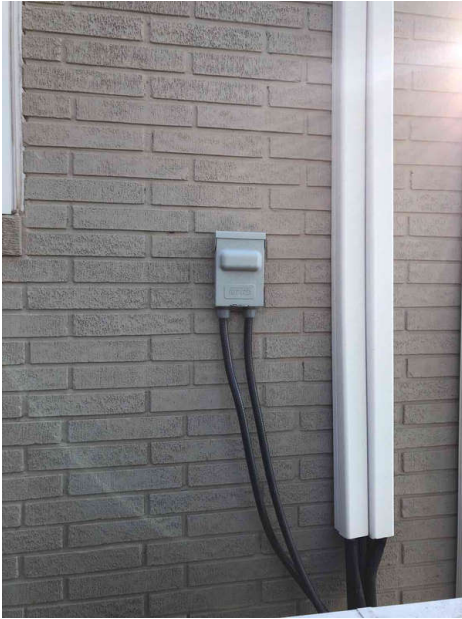
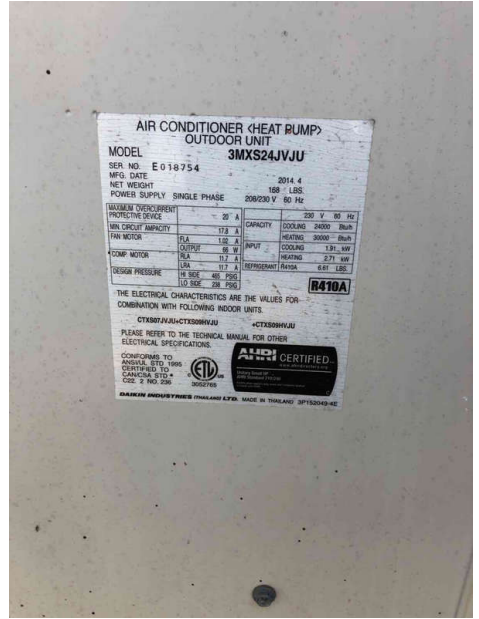
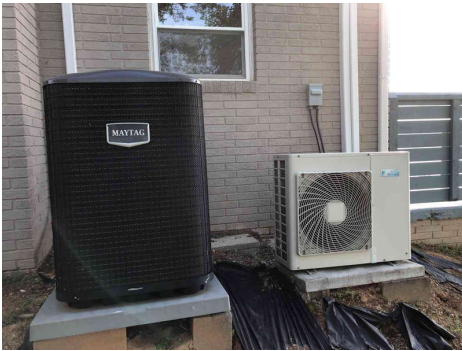
HVAC Heat Pump Equipment 2: Condenser Unit Brand Daikin

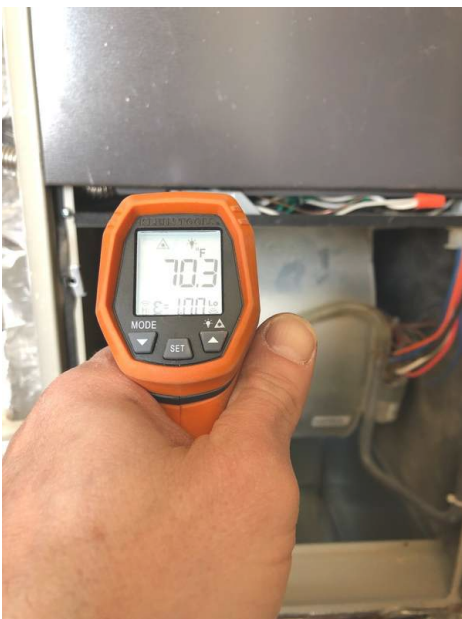
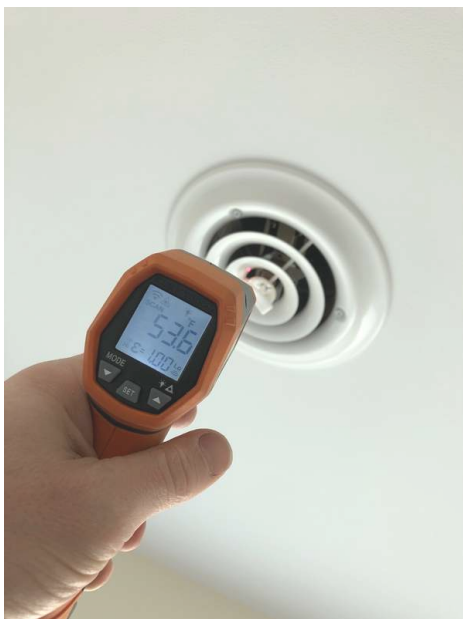
Normal Operating Controls: Cooling Temperature - Satisfactory

The temperature was taken from noted source using an IR thermometer; both register and ambient temps are measured. Temps differentials are within norms. Temps from register should be within at least 15 degrees or lower from ambient room temps. Also measured is the condensation on the refrigerant line, heat transfer emitting from the condenser, and condensation moisture from the line. All factors are used to determine operating efficiency.

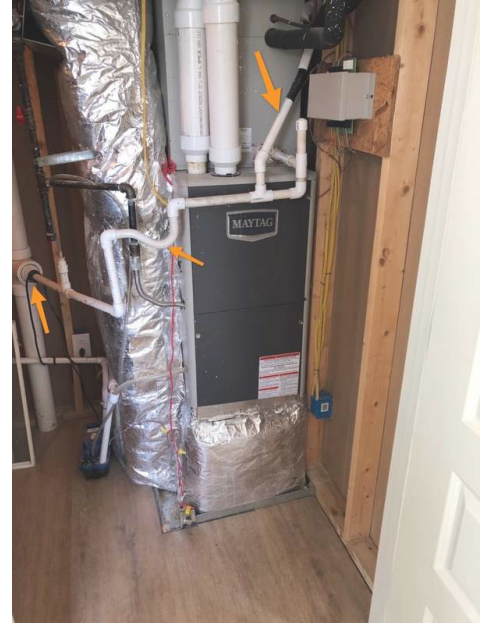
Condensate drain line ties directly into the waste line. There is a trap on the condensate line. However, a direct connection could allow sewage water to back up into the furnace. Recommend an air gap (post p-trap) between these two lines.

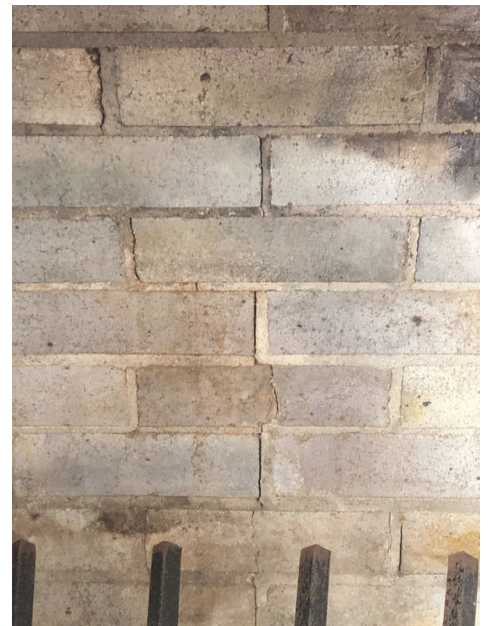
FIREWALL CRACKED

The brick lining of the fireplace was cracked in one or more places, which could lead to chimney damage or toxic fumes entering the home. Recommend a qualified fireplace contractor evaluate and repair.

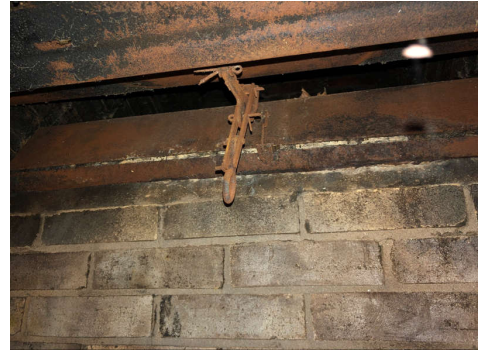
DAMPER INOPERABLE

Damper was inoperable. Recommend a qualified fireplace contractor repair.

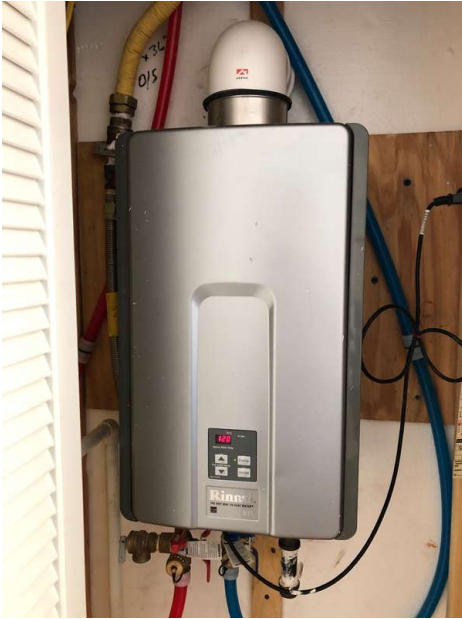
Hot Water Systems: Water Heater Tested

Water heater was tested during inspection and found to be functional. Inspection only verifies water heater is able to heat water above ambient temps. Water temperature can vary depending on settings.

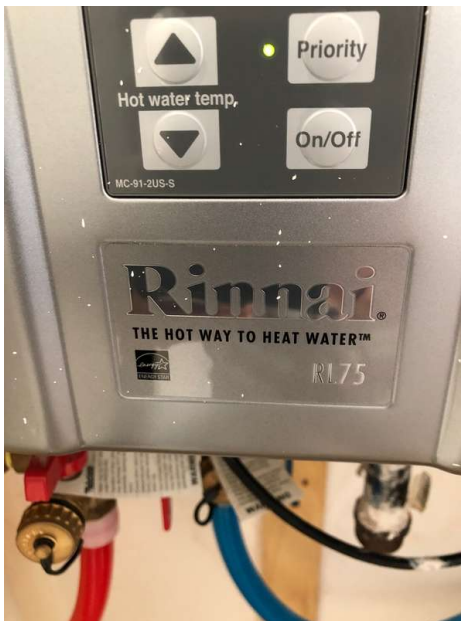
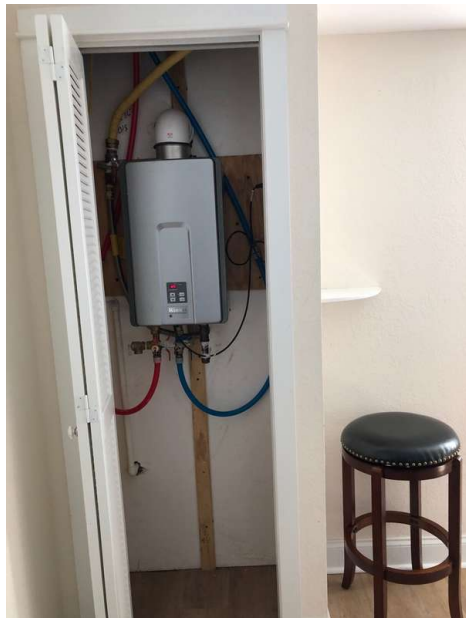
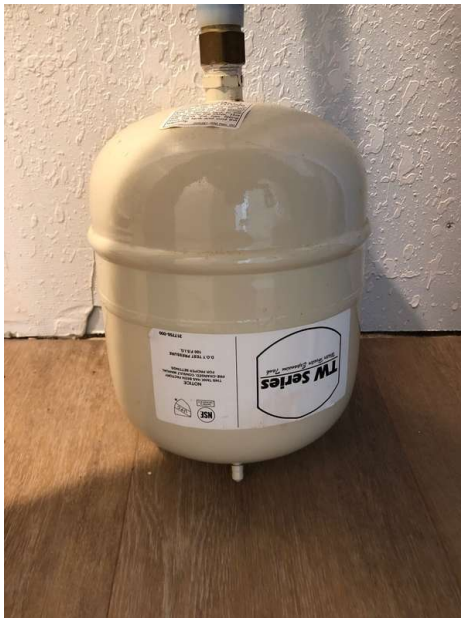
Hot Water Systems: Water Heater Photos

TPR DISCHARGE PIPE IMPROPERLY INSTALLED

The temperature/pressure relief (TPR) valve had a discharge pipe that was not properly installed. If the valve were to activate while a person was nearby, that person could be badly burned. Recommend correction by properly installing the discharge valve to point directly at ground and terminate no more than 6 inches from floor; preferably at a drip pan.

Recommendation
Contact a qualified plumbing contractor.

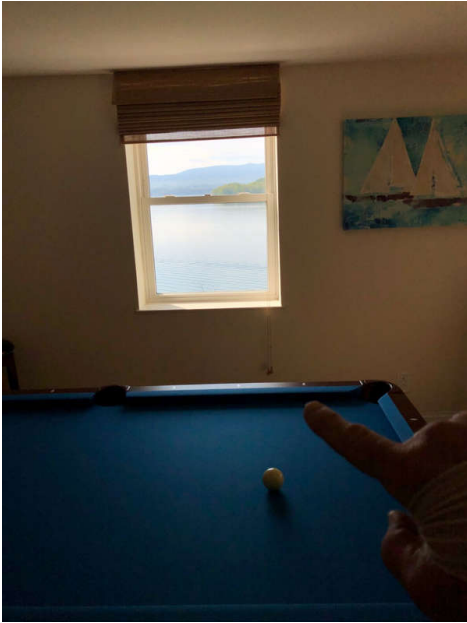
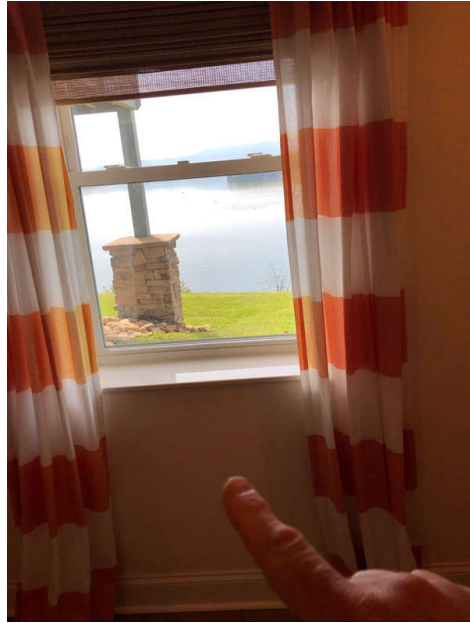
MISSING SCREEN

Window missing screens were missing in a few locations; not all windows may be pictured. Recommend correction by installation. Speak with owner/seller as usually screens are on property.

Recommended DIY Project

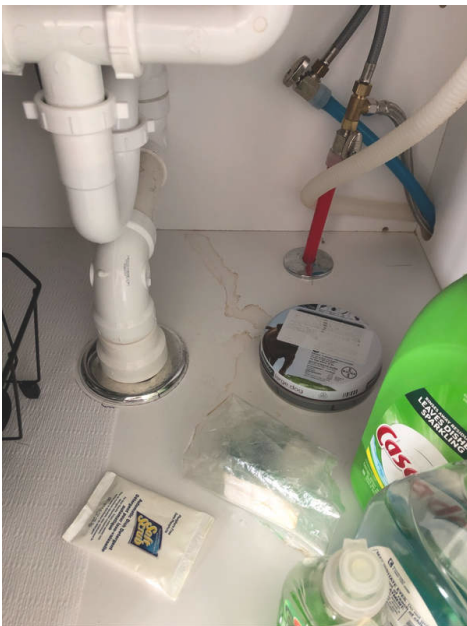
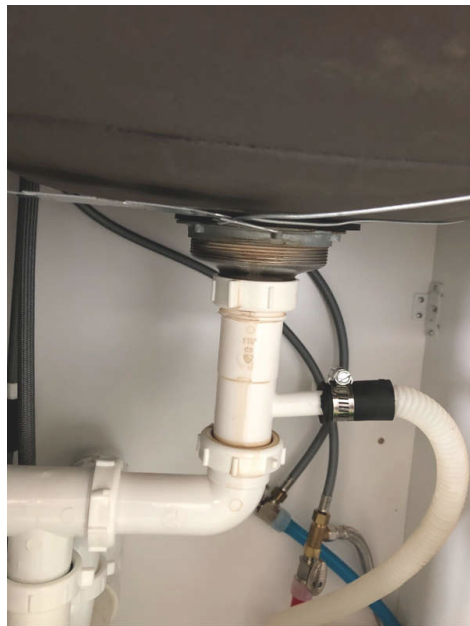
BELOW WATER DAMAGE

Water damage was found in shelving or cabinets below the sink. Recommend source of water damage is stopped (if active) and damaged area is corrected as necessary. Could not determine conduction of underlying material.

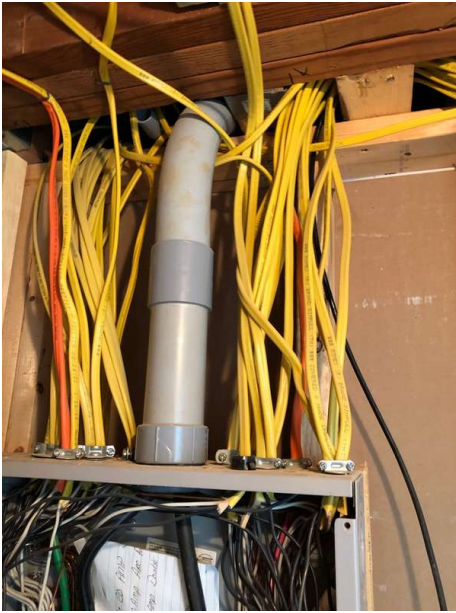
Branch Wiring Circuits, Breakers & Fuses: Wiring Method

Non-metallic Sheathed Cable

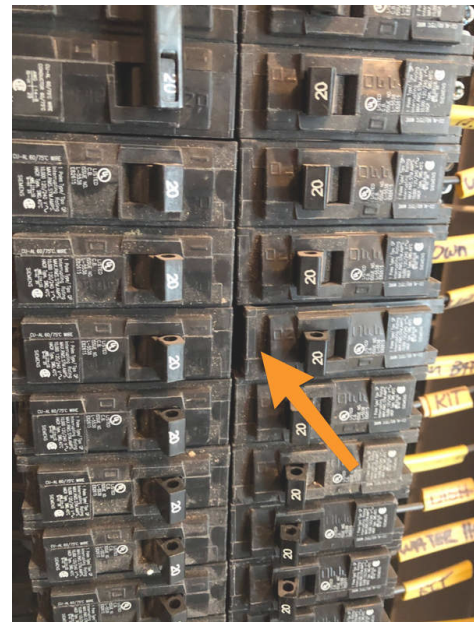
BREAKER LOOSE/DAMAGED

Breaker was noted as loose and/or damaged which allows excess movement possibly leading to arcing and degraded operation. Recommend correction by replacing breaker. Ensure proper brand (for panel type) and amp size for new breaker.

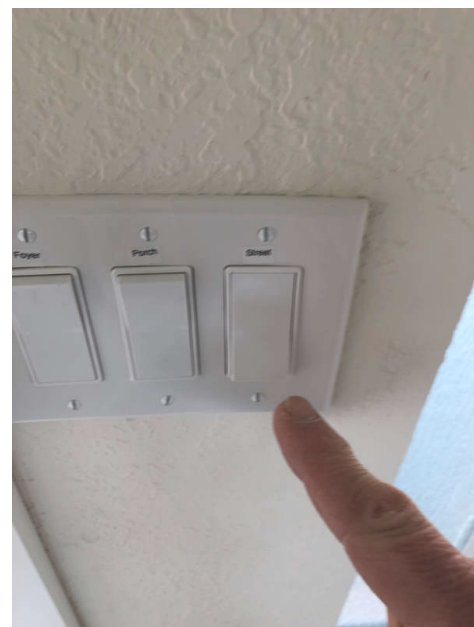
11.4.1 Lighting, Switches & Fans (All Accessible)

One or more lights are not operating. Recommend lightbulbs installed. *Possible electrical issues, recommend seller disclose if fixtures are known not to operate.

Recommended DIY Project

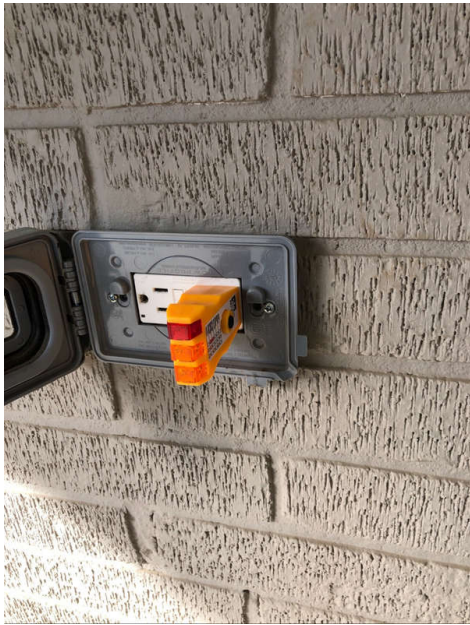
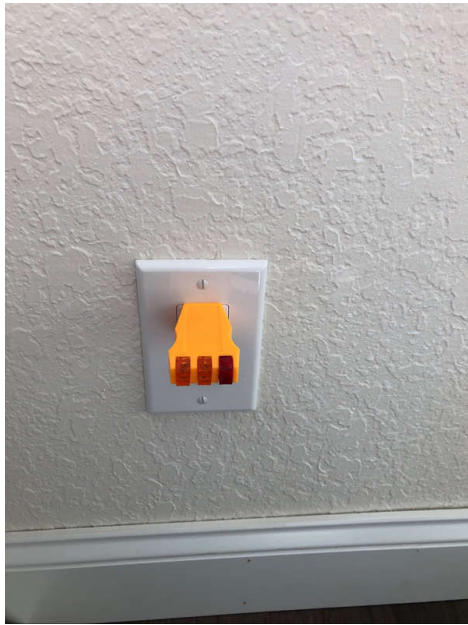
11.5.1 Receptacles (All Accessible)

Receptacles in noted locations did not operate when tested. Recommend qualified electrician evaluate and repair.

Contact a qualified electrical contractor.

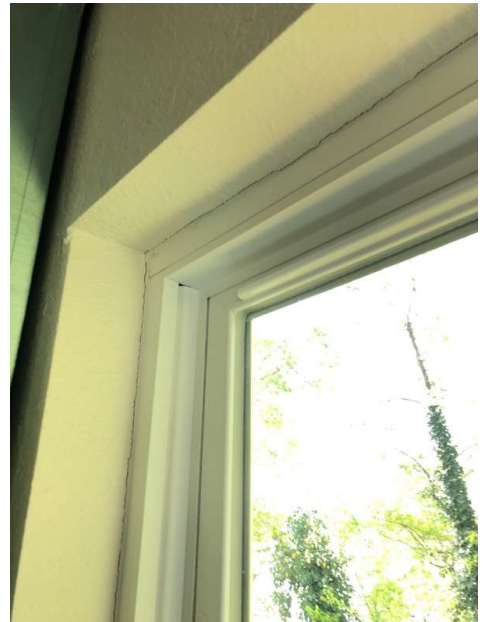
Paintable caulk has cracked. Re-caulk with flexible caulk

Recommended DIY Project
