INTEGRITY INSPECTION SERVICES LLC

HOME INSPECTION REPORT

1234 Main St.
Naches WA 98937

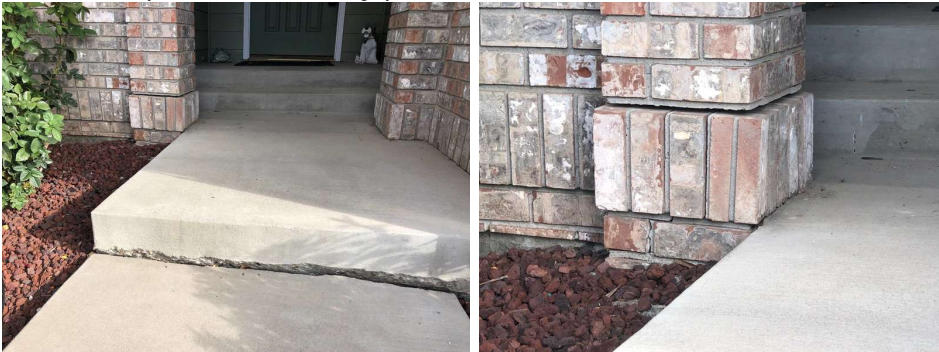
2.2.1 Driveways, Walkways & Patios

WALKWAY SETTLING

FRONT ENTRY

Settling noted at concrete walkway near entry stoop. Settling at walkway appears to be a cosmetic in nature only.

Some loose or damaged bricks noted at entry veneer near walkway. If not repaired/remedied further deterioration may occur.

Contact a qualified masonry professional.

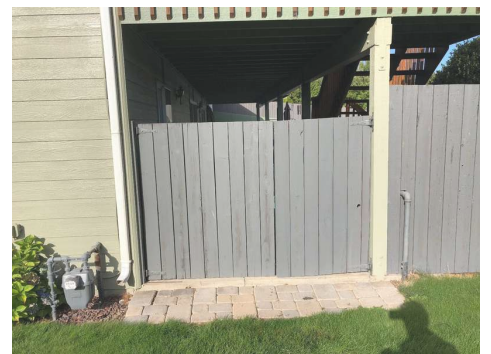
2.3.1 Fencing & Retaining Walls

GATE STICKS/RUBS

Fence Gate sticks/rubs and does not operate smoothly/properly and may be in need of adjustment or repair.

Contact a qualified handyman.

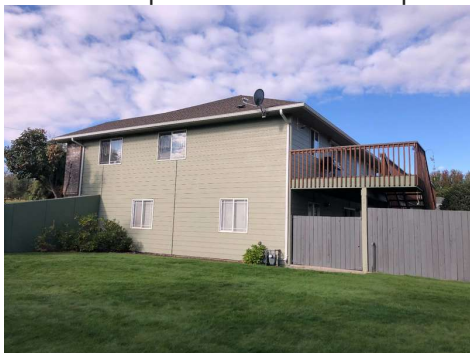
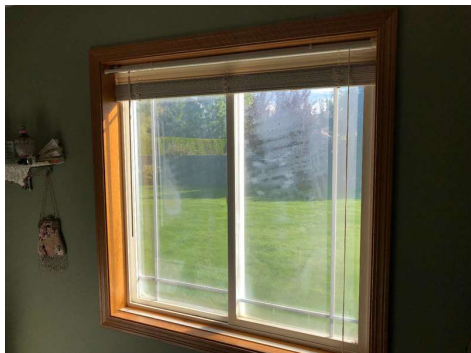
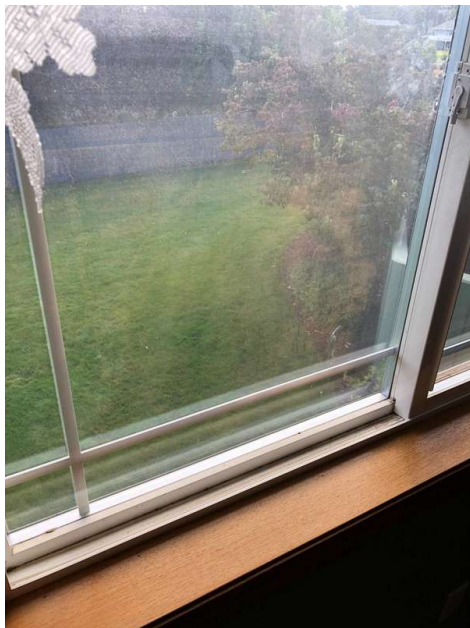
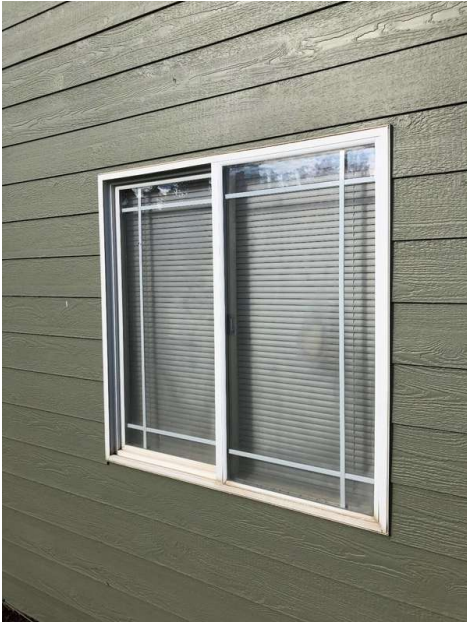
3.2.1 Exterior Doors & Windows

FAILED SEALS

EAST WINDOWS

Condensation or moisture staining noted between window panes may indicate a failed seal reducing visibility and thermal efficiency. Recommend qualified professional further evaluate and repair or replace as needed.

Contact a qualified window repair/installation contractor.

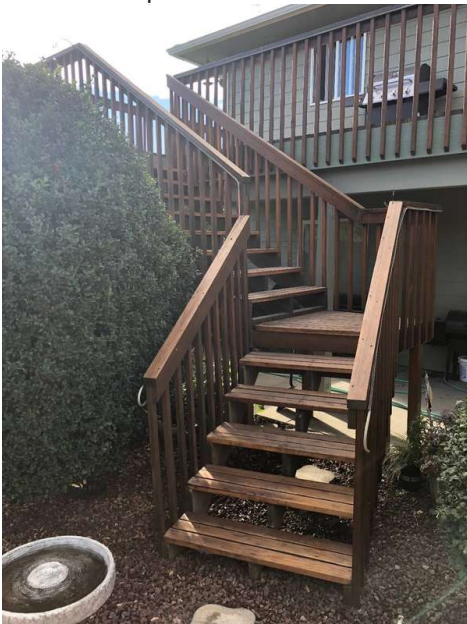
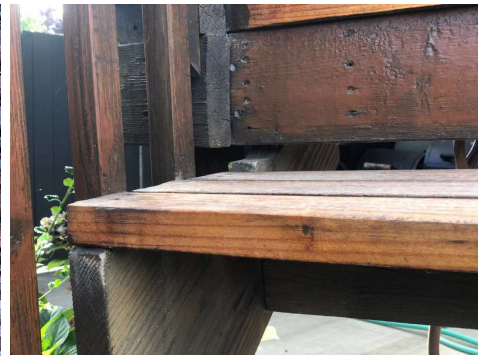
3.3.1 Decks, Porches & Steps

QUESTIONABLE CONSTRUCTION PRACTICES

DECK STAIRS

Lower section of deck stairs were not resting on a permanent footing and structural wood supports were in contact with soil. Deterioration and setting observed. Stairs were pitched and may be unsafe to walk on. Recommend further evaluation by a qualified professional and repair/remedy as needed.

Contact a qualified deck contractor.

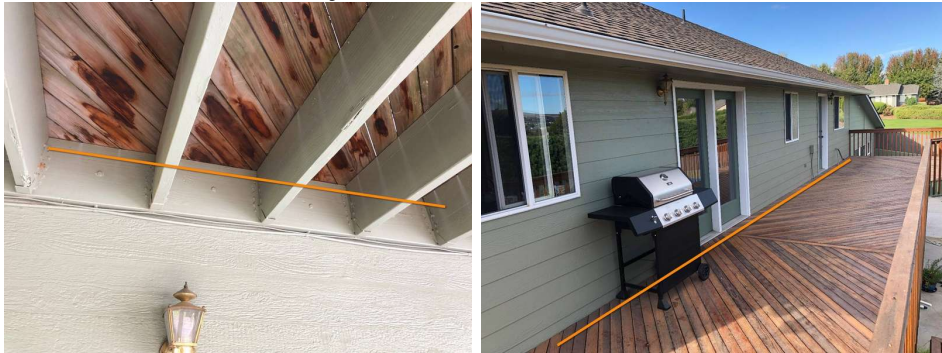
3.3.2 Decks, Porches & Steps

IMPROPER FLASHING

BACK DECK

Z-metal or ledger flashing not installed. Without a proper ledger flashing moisture may become trapped between ledger and home structure allowing for moisture damage and possible compromise. It is recommended that proper flashing be installed.

*No evidence of compromise was observed at time of inspection.

Contact a qualified handyman.

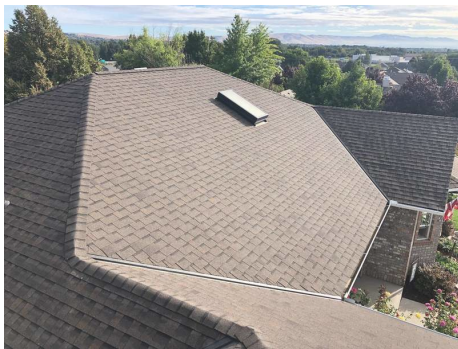
Coverings: Servicable

Roof covering appears to be in good serviceable condition.

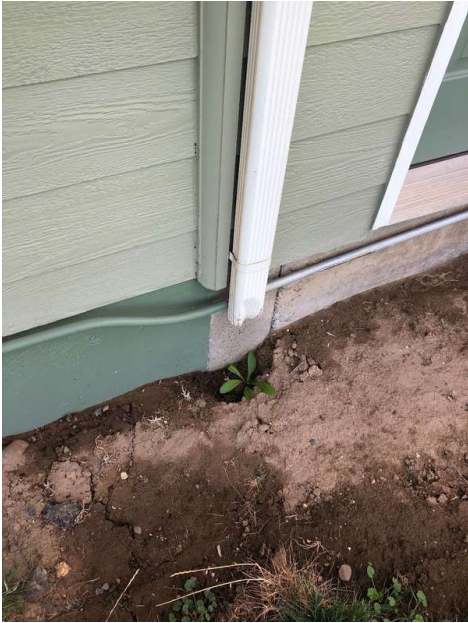
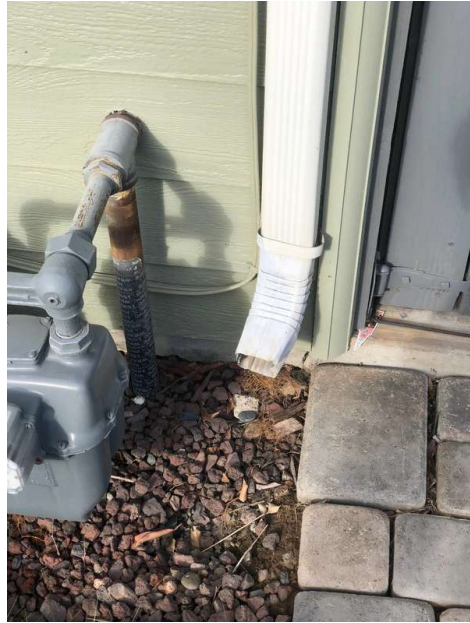
4.2.1 Gutter Systems

DOWNSPOUTS DRAIN NEAR HOUSE

THROUGHOUT EXTERIOR

One or more downspouts drain in close proximity to foundation. Recommend proper downspout extensions to drain a minimum of 4-6 feet from the foundation.

Contact a handyman or DIY project

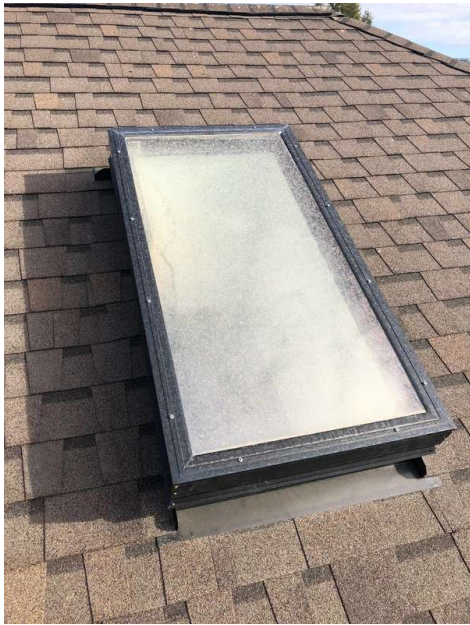
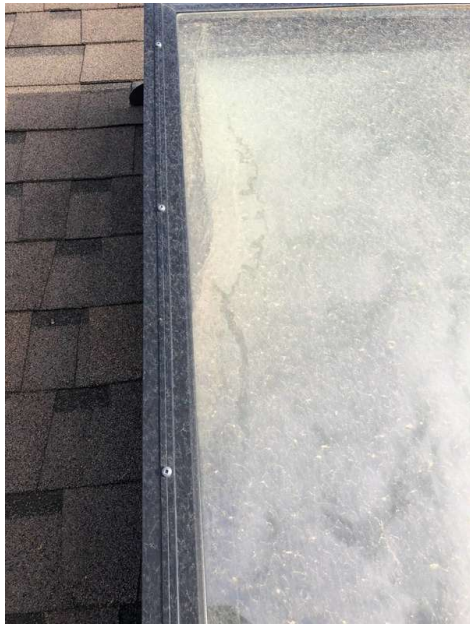
4.6.1 Skylights

FAILED SEAL

Condensation or moisture staining between window panes may indicate a failed seal. Recommend qualified professional further evaluate and repair or replace as needed.

Contact a qualified window repair/installation contractor.

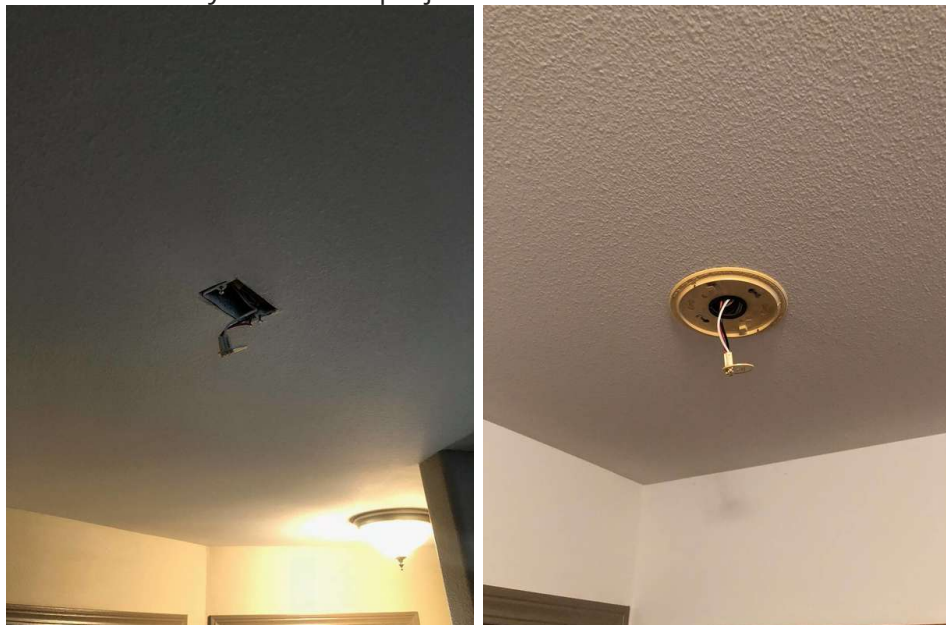
5.1.1 Safety Equipment

SMOKE AND CARBON MONOXIDE DETECTORS

THROUGHOUT INTERIOR

Smoke and Carbon monoxide detectors are required at minimum on each floor and outside all sleeping areas. Installed safety devices should be checked/tested regularly for proper operation. Inspector recommends confirming local safety codes and installing/maintaining any required safety devices as needed. Smoke detectors throughout were missing or not installed.

Contact a handyman or DIY project

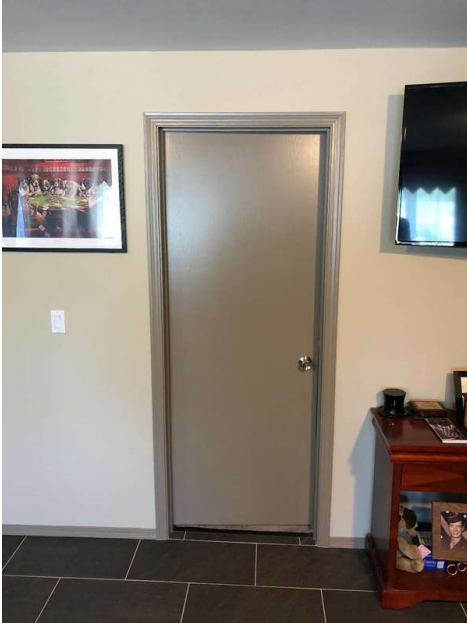
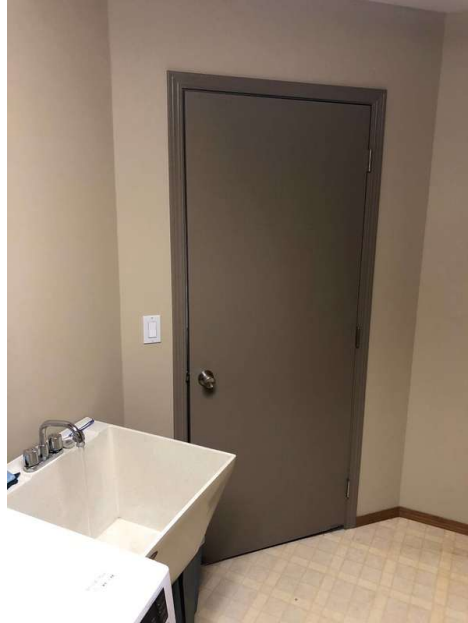
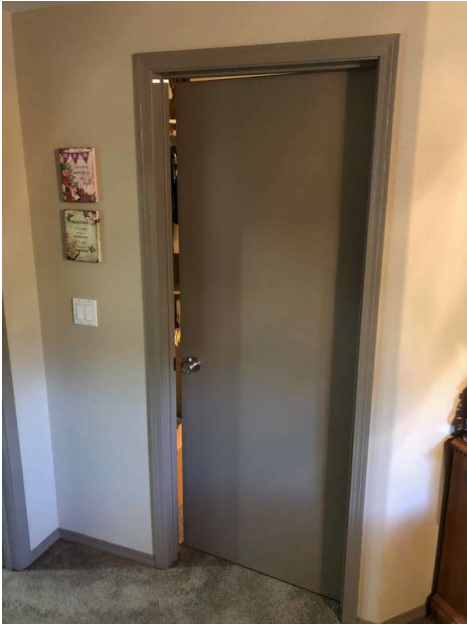
5.6.1 Doors

DOOR IN NEED OF ADJUSTMENT

THROUGHOUT INTERIOR

One or more interior doors and/or closet doors sticks/rub or do not latch smoothly/properly and may be in need of adjustment or repair.

*Master bathroom door was missing some hardware and may be difficult to operate.

Contact a qualified door repair/installation contractor.

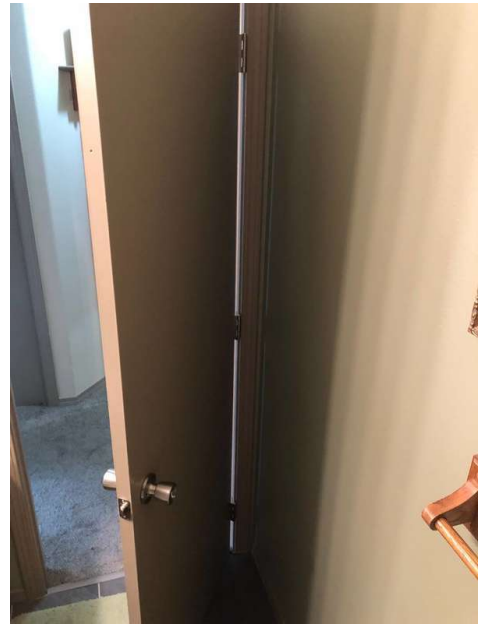
5.6.2 Doors

DOOR STOPS MISSING

THROUGHOUT INTERIOR

One or more interior door stops were missing or not installed at time of inspection. Door stops protect interior walls and door hardware from potential damage.

Contact a handyman or DIY project

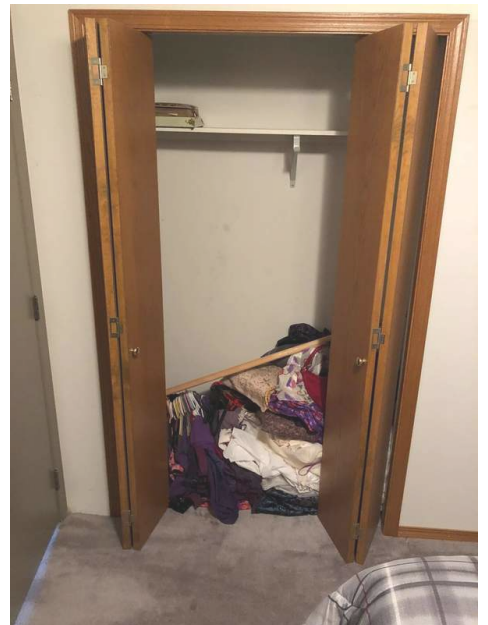
5.12.1 Bedrooms

DAMAGED CLOSET ROD

BASEMENT BEDROOM

Closet rod was fallen/compromised and in need of repair.

Contact a qualified handyman.

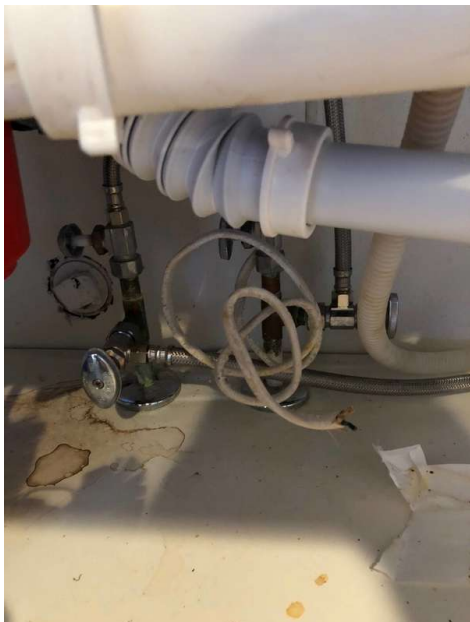
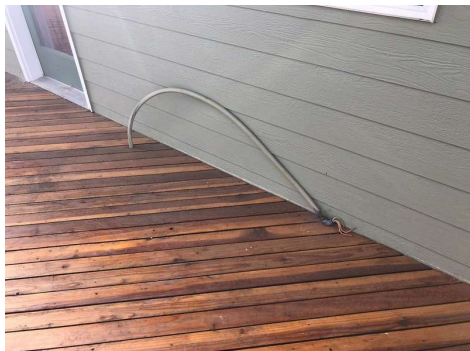
8.3.1 Branch Circuit Conductors

EXPOSED ENDS & SPLICES

KITCHEN, BACK DECK

Wire splices/connections and terminations must be secured/protected in an approved junction box. Potential safety hazard. Recommend a qualified professional repair as needed.

Contact a qualified electrical contractor.

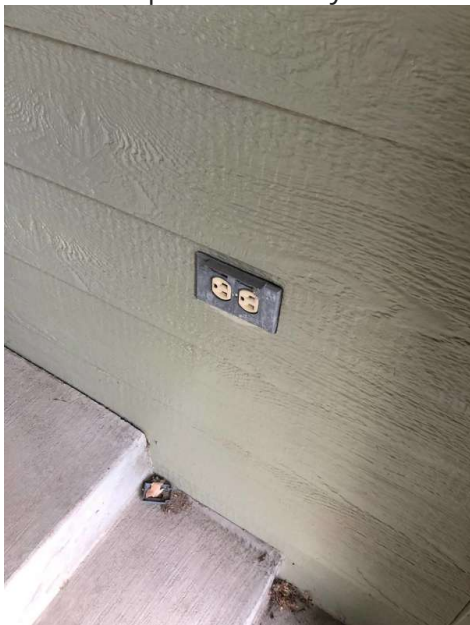
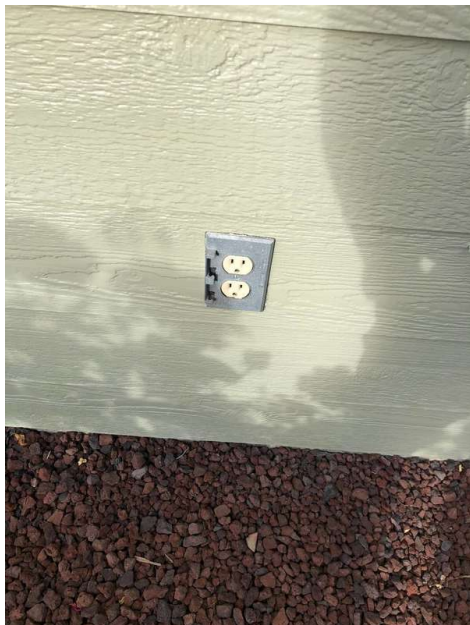
8.4.1 Connected Devices & Fixtures

EXTERIOR WEATHER COVERS DAMAGED OR MISSING
THROUGHOUT EXTERIOR

Some exterior switches or outlets did not have proper exterior weather covers. Recommend repair or replace as needed.

Contact a qualified handyman.

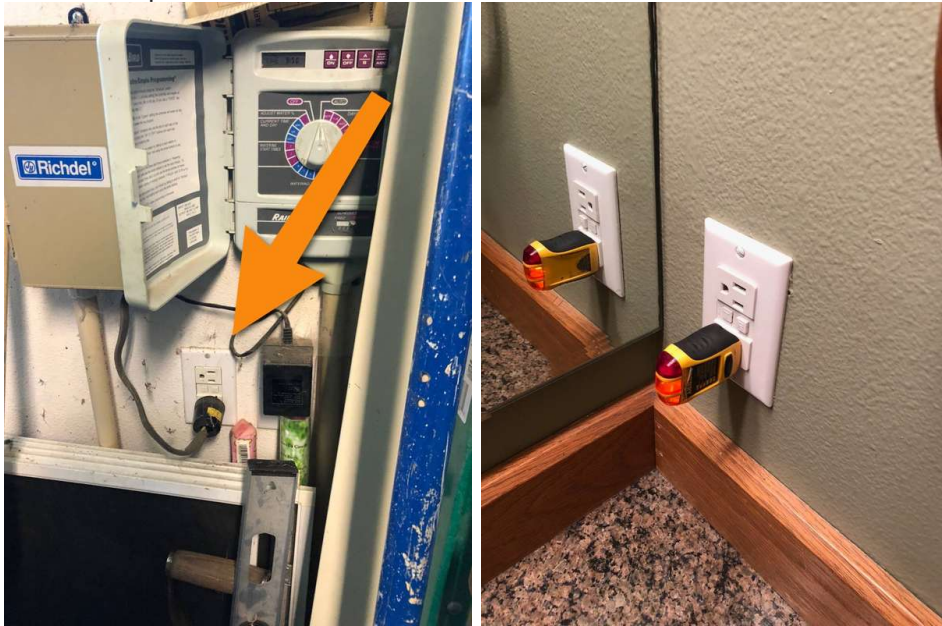
8.6.1 GFCI & AFCI

NOT OPERATING

GARAGE, HALL BATHROOM

Some GFCI outlets were not operating properly at time of inspection and may be in need of replacement. Recommend further evaluation by a qualified professional and repair or replace as needed.

Contact a qualified electrical contractor.

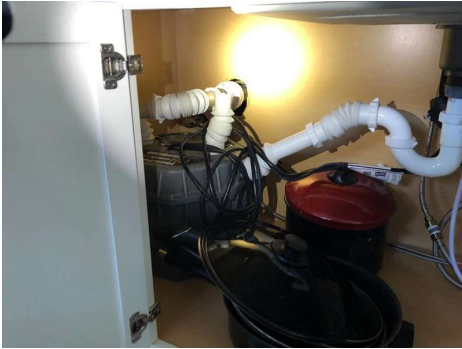
Game Room

Sump Pumps and Sewage Ejectors must be maintained and regularly inspected to ensure proper continuous operation. Ejector Pump was operating at time of inspection with no visible signs of defect. Recommend regular maintenance and inspection.

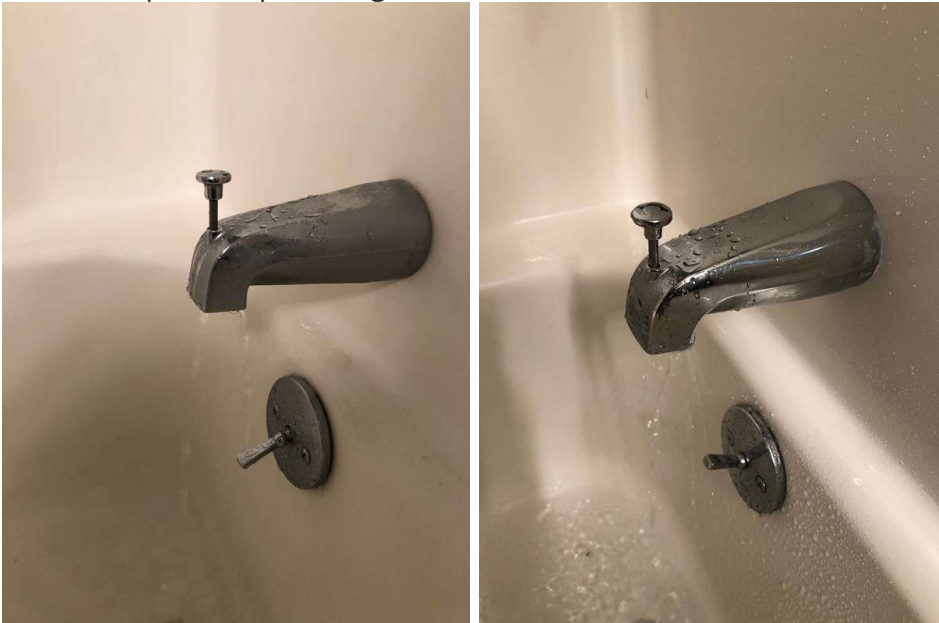
9.2.1 Fixtures & Faucets

SHOWER DIVERTER NOT OPERATING PROPERLY

BASEMENT BATHROOM, HALL BATHROOM

Shower diverter valve was not diverting water flow to shower head properly or completely. Recommend repair.

Contact a qualified plumbing contractor.

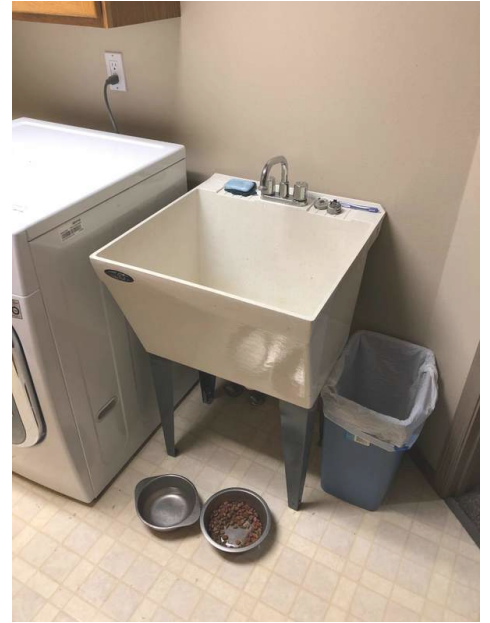
9.2.2 Fixtures & Faucets

SINK NOT SECURE

LAUNDRY ROOM

Sink not secured. Condition conducive to stress at plumbing fittings and possible leaks. Recommend securing/fastening sink to wall.

Contact a qualified handyman.

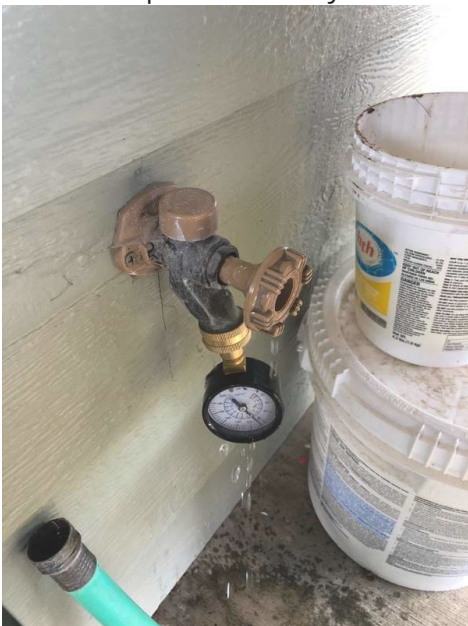
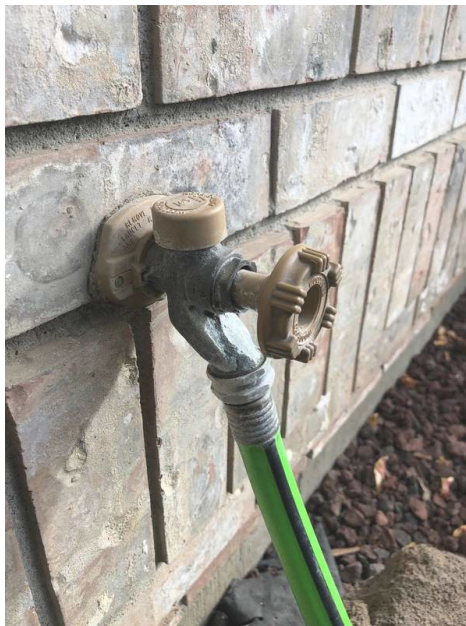
9.2.3 Fixtures & Faucets

SPIGOT LEAKING

FRONT, BACK EXTERIOR

Leak noted at exterior garden spigot/s. Recommend repair or replace as needed.

Contact a qualified handyman.

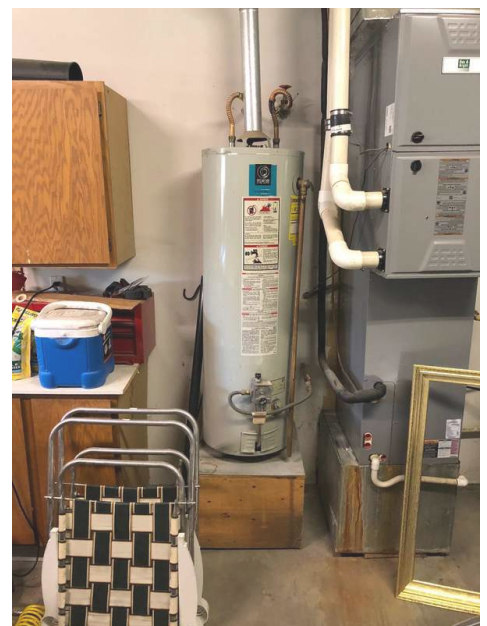
10.3.1 Safety Features

SEISMIC STRAPPING NOT INSTALLED OR IMPROPER

Modern safety standards requires seismic strapping at top and bottom thirds of installed Hot Water Tanks. See this helpful [link](#) for approved strapping and anchoring techniques. Recommend repair.

Contact a qualified appliance repair professional.

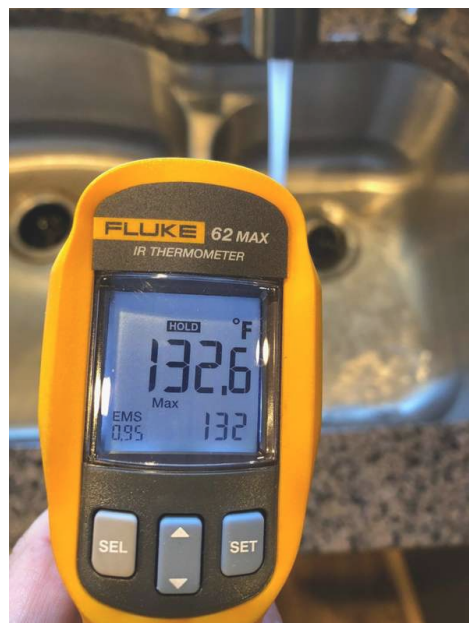
10.3.2 Safety Features

Safety Hazard**WATER TEMPERATURE HIGH**

Water temperature was measured above maximum recommended safe water temperature (120F) and may have the potential for scalding. Recommend adjusting water temperature to no more than 120F to prevent potential scaling.

Contact a qualified appliance repair professional.

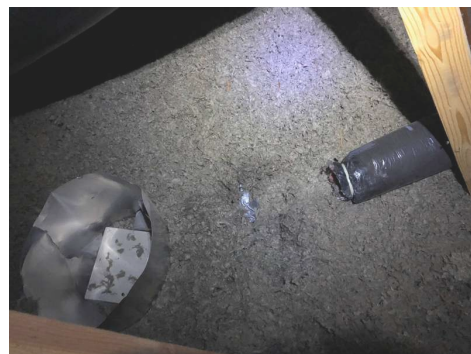
14.2.1 Exhaust Systems

EXHAUST VENT DISCONNECTED

Exhaust vent connection/s is disconnected and/or compromised and not properly terminating to exterior. Recommend reattaching with a more permanent method.

Contact a qualified HVAC professional.

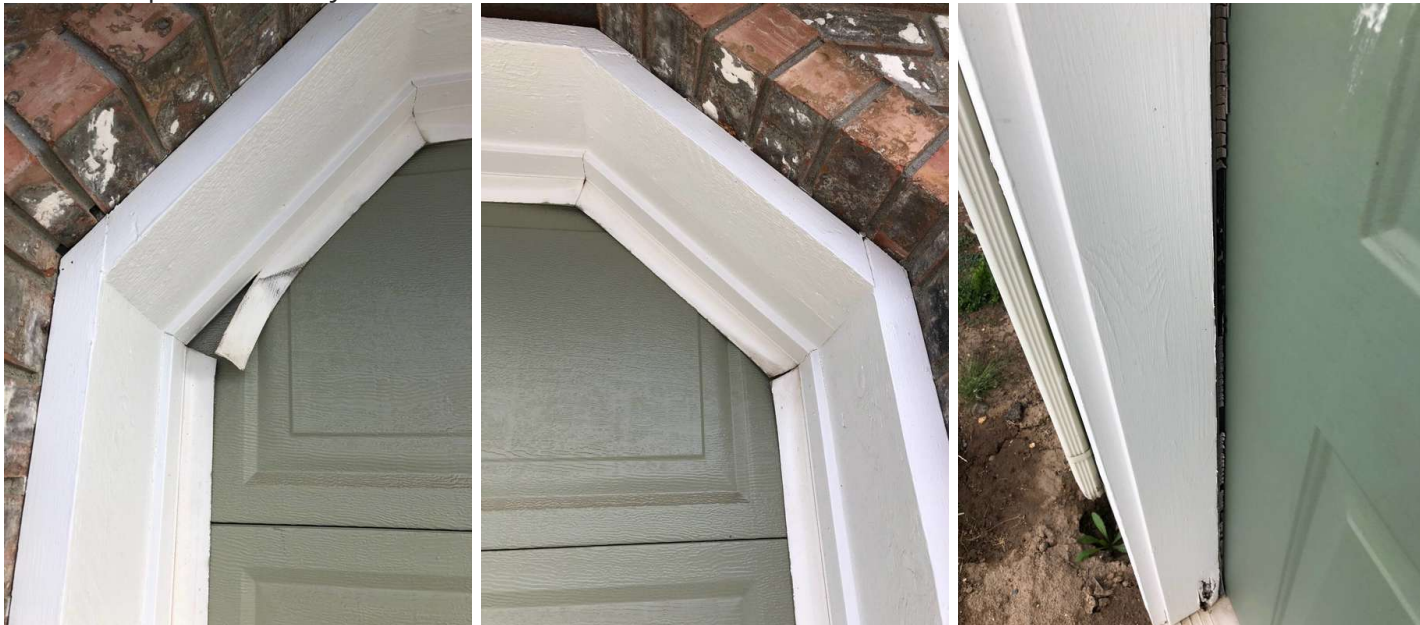
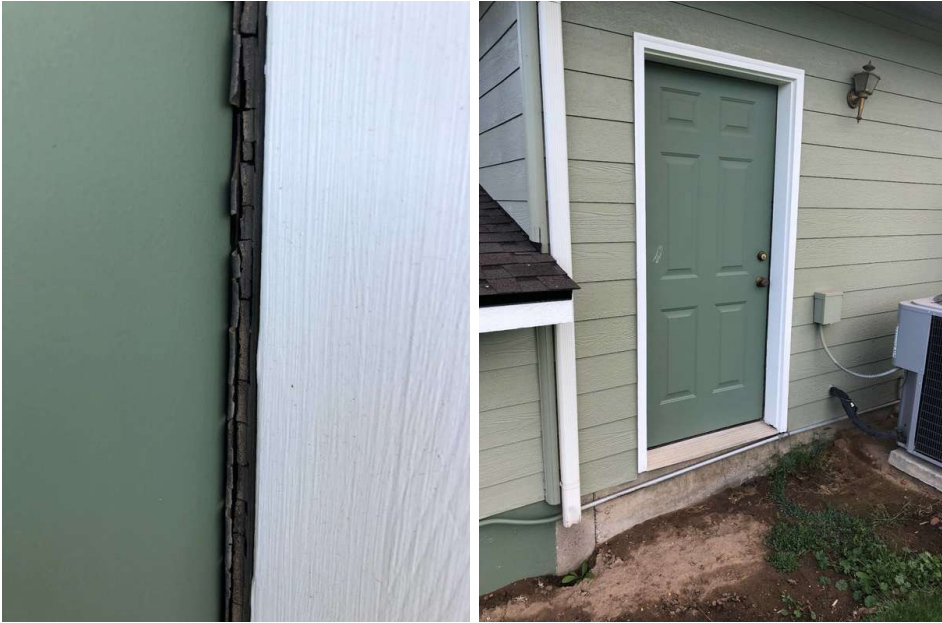
15.3.1 Garage Door

WEATHER SEAL DAMAGED

Damaged or deteriorated exterior seal may not provide adequate protection from weather.

*Also, garage entry door.

**No step/stoop installed at garage entry door. Possible fall/trip hazard. recommend installing a proper step or stoop.

Contact a qualified handyman.

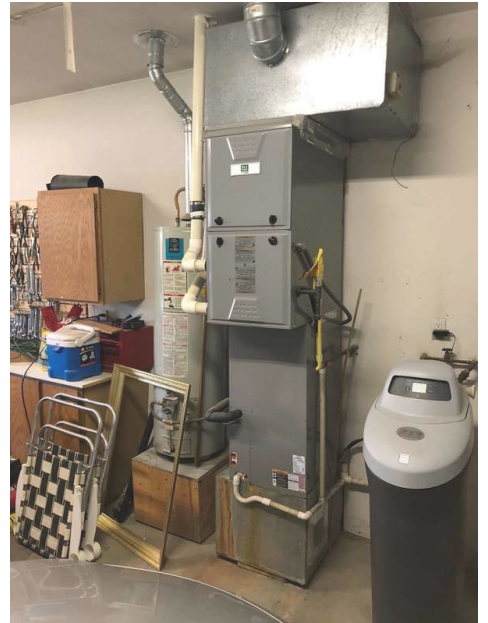
15.5.1 Safety Features

BULKHEAD

GARAGE

A bulkhead/barrier should be present/installed when gas appliances are located inline with the drive-path (back wall) of garage. In case of emergency the bulkhead is designed to protect gas appliances from impact and a potential safety hazard. Recommend qualified professional further evaluate and repair or replace as needed.

Contact a qualified general contractor.

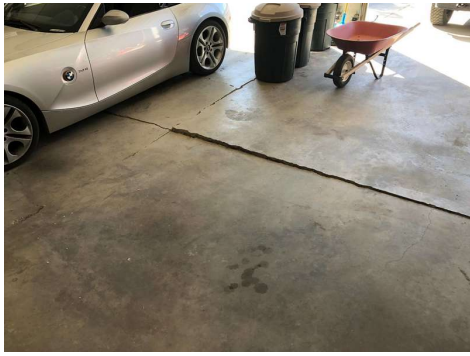
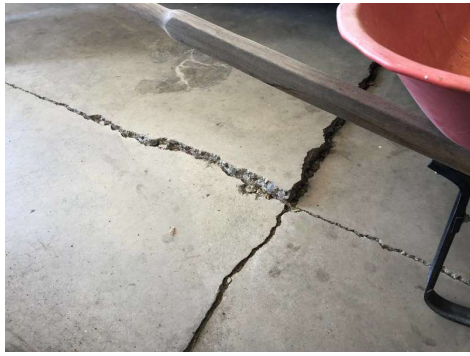
15.6.1 Interior

SIGNIFICANT CRACKING

Significant cracking observed at garage floor. Settling and heaving may simply be indication or poor initial compaction or evidence of significant ongoing compromise. Inspector recommends further inquiry as to recent activity and further evaluation by a qualified professional. Monitoring cracks over time is recommended.

Contact a qualified general contractor.

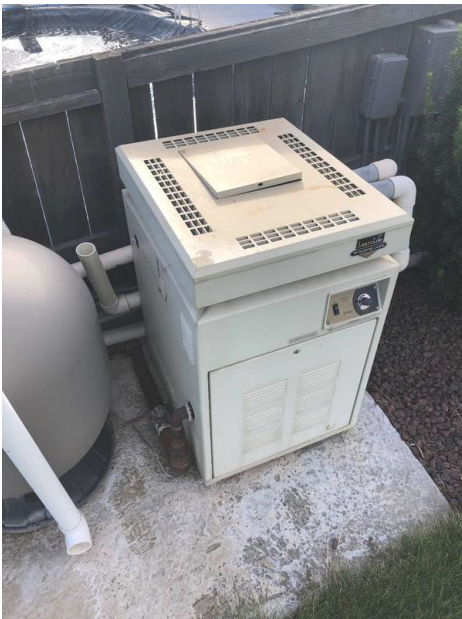
Installed Equipment : Pool Heater

Pool furnace or other heat source was disconnected, turned off or otherwise not operational and does not appear to be in use. Status/condition of gas furnace unknown.
