SLOPESIDE HOME INSPECTIONS

RESIDENTIAL REPORT

1234 Main St.
Vancouver WA 98685

04/30/2018 9:00AM

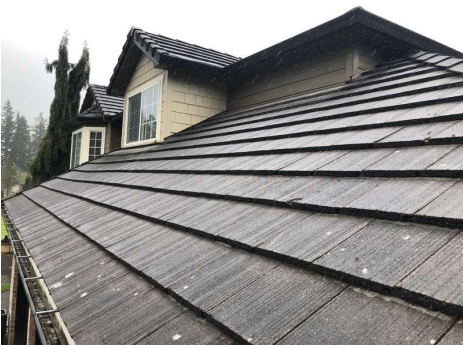
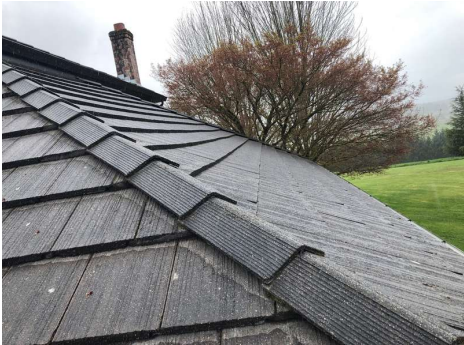
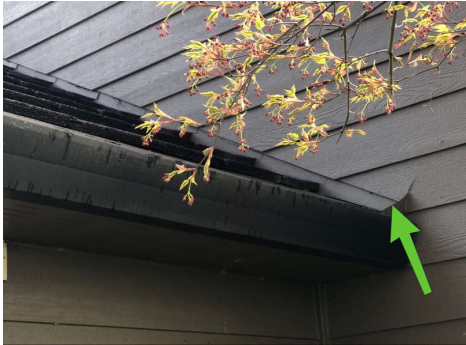
Kickout Flashing - Good

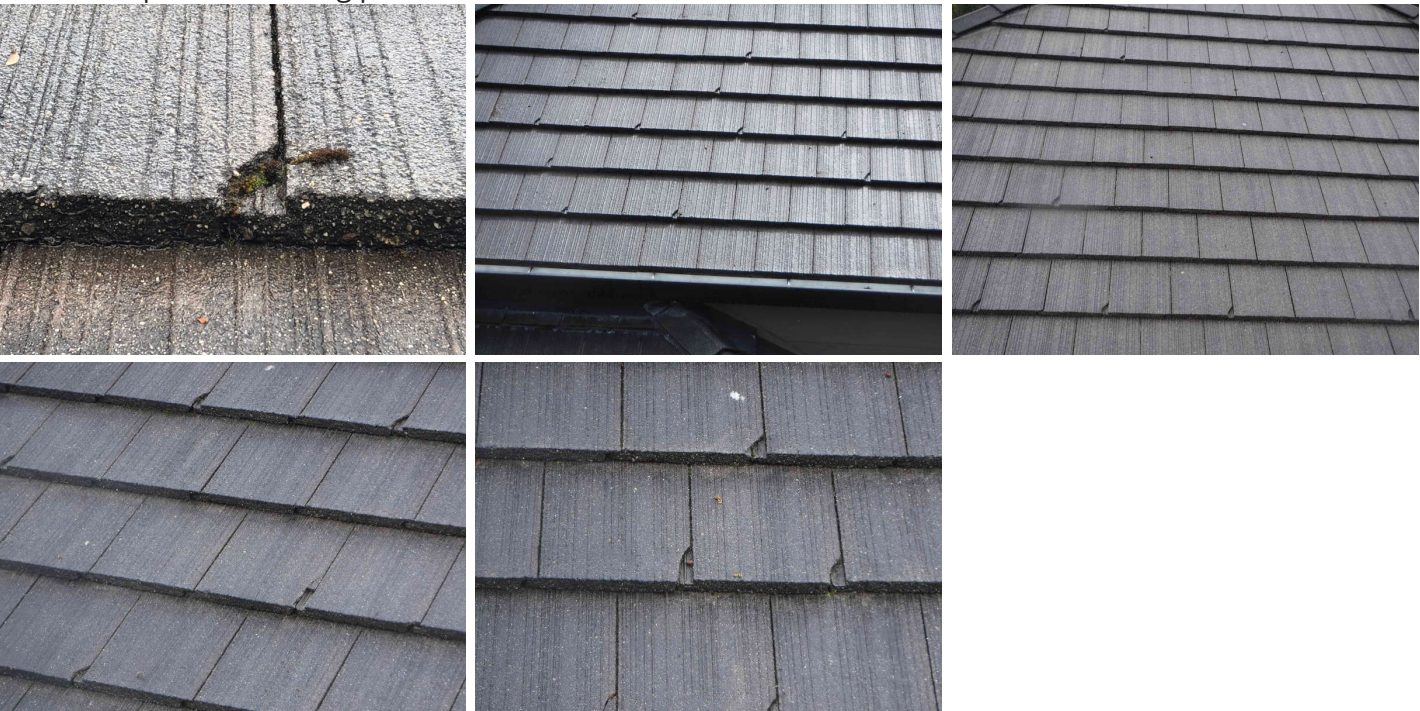
CRACKED/BROKEN TILES

Roof had cracked/broken tiles on many of the tiles throughout the entire roof surface. All broken pieces were on the lower right corner of the tiles. This makes sense as its the weakest point of interlocking tiles, known as the the cover lock or overlap. Its difficult to say for sure whether it was caused by a hail storm, or if its an older crack. Some signs of older cracks may be aggregate fracture, dirt accumulation, aging the the exposed aggregate material, or presence of moss, algae or other growth. If the crack is less than 3 inches (which they appear to be) its merely cosmetic. However, without walking the roof and being able to measure and know for sure, recommend further evaluation and/or correction by a qualified roofing contractor.

Contact a qualified roofing professional.

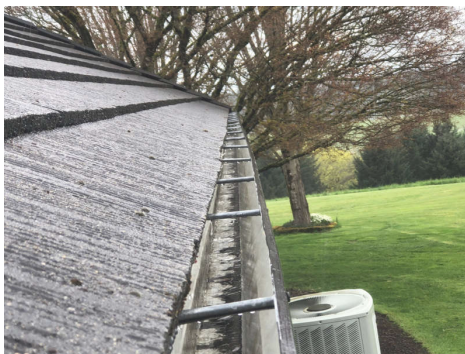
Northwest

2.3.3 Roof Drainage Systems

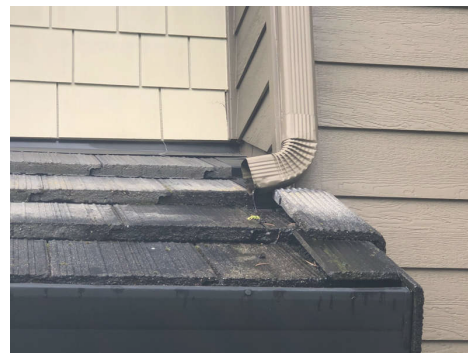
East

2.3.4 Roof Drainage Systems

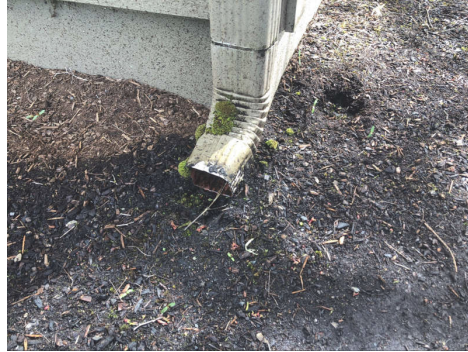
Northwest

One or more downspouts drain too close to the home's foundation. This can result in excessive moisture in the soil at the foundation, which can lead to foundation/structural movement. Recommend a qualified contractor adjust downspout extensions to drain at least 6 feet away from the foundation.

Contact a qualified gutter contractor

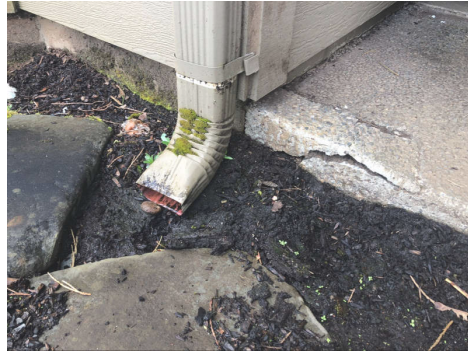
East

2.4.1 Skylights, Chimneys & Other
Roof Penetrations

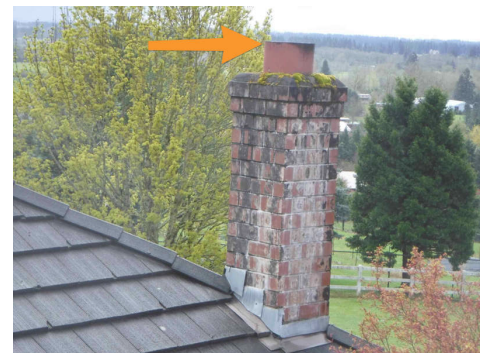
CHIMNEY CAP MISSING

Missing chimney cap. This is important to protect from moisture intrusion and all of the outdoor elements. Recommend a qualified chimney contractor install.

Contact a qualified chimney contractor.

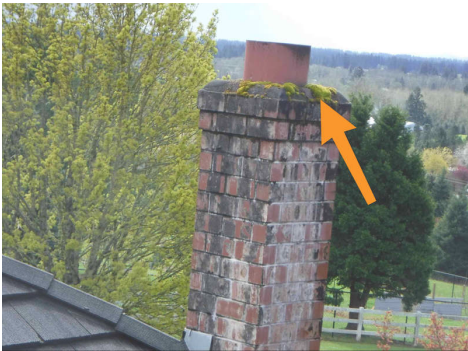
2.4.2 Skylights, Chimneys & Other
Roof Penetrations

Minor moss build-up was observed at one or more locations on the chimney. Once established, moss acts like a sponge, soaking up and storing rainwater. If left untreated, it can lead to damaging/deteriorating the mortar joints. Recommend removing moss by a qualified contractor.

Recommendation
Contact a qualified chimney contractor.

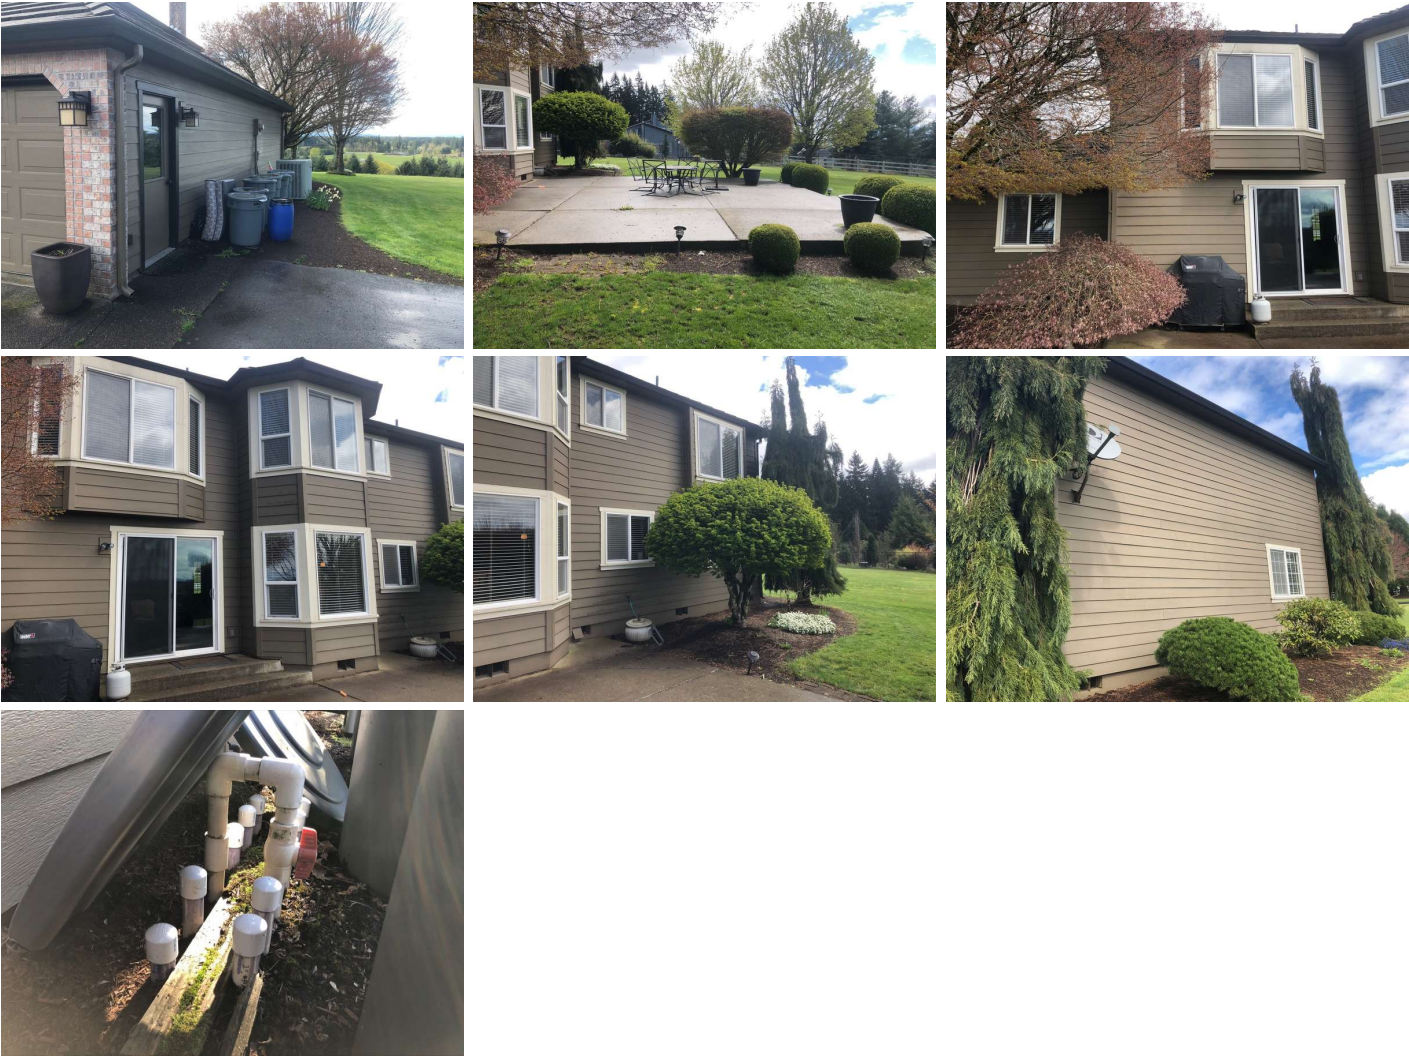
Unable to determine function

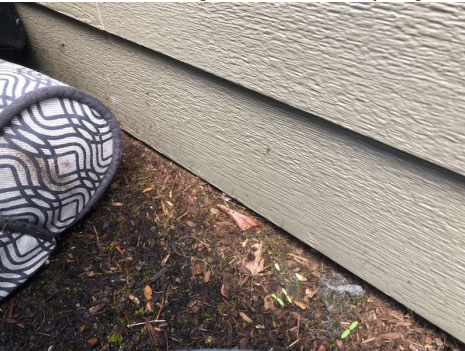
North

Minor - Maintenance Items

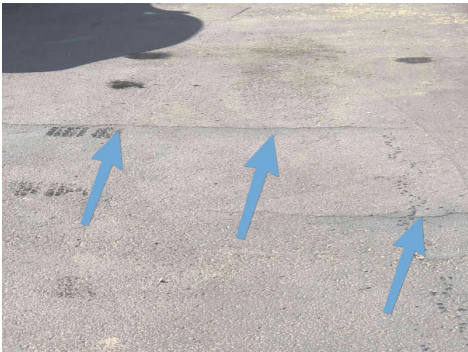
Northeast

Minor cosmetic cracks were observed. Recommend monitor and/or have a concrete contractor patch/seal.

Recommendation
Recommend monitoring.

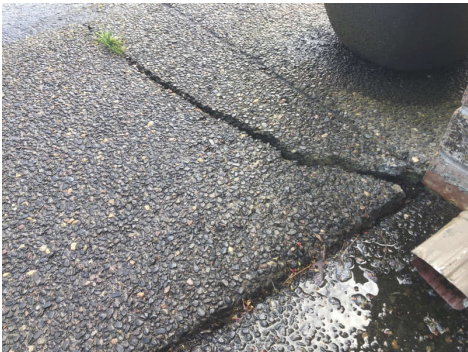
North

One or more moderate crack(s) were observed. Recommend having a concrete contractor evaluate and repair as needed.

Recommendation
Contact a qualified concrete contractor.

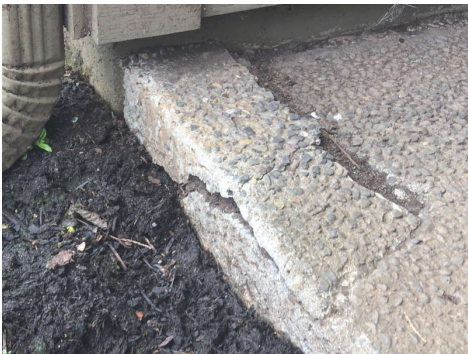
East

One or more moderate crack(s) were observed. Recommend having a concrete contractor evaluate and repair as needed.

Recommendation
Contact a qualified concrete contractor.

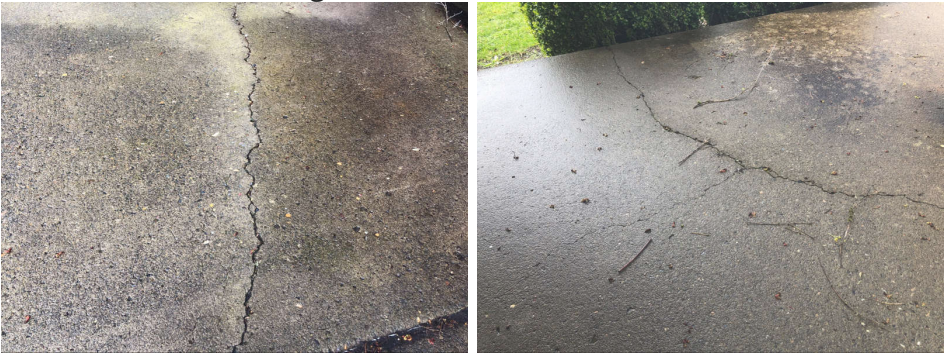
West

Normal settling & cracking observed on the patio. Recommend monitor and/or patch/seal.

Recommendation
Recommend monitoring.

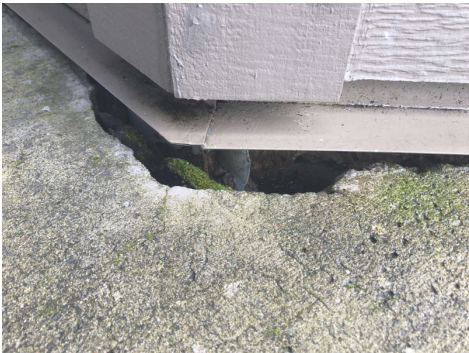
West

A very small portion of the back patio appeared to be deteriorating. Recommend repair as needed.

Recommendation
Contact a qualified concrete contractor.

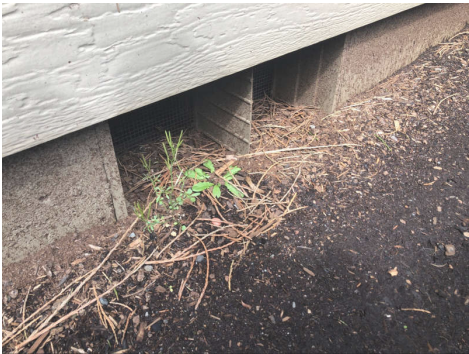
Southeast

Vegetation and/or debris was blocking foundation vent. Recommend keeping debris clear of foundation vents to allow for adequate venting of the crawlspace.

Recommendation
Contact a handyman or DIY project

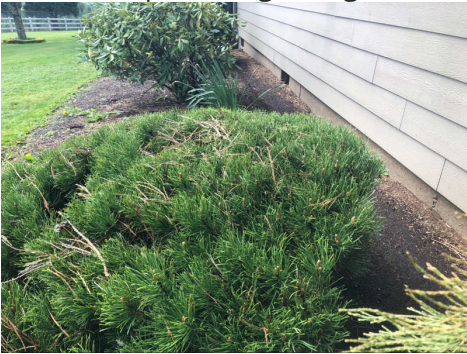
South

Grading appeared to be adequately sloping away from the homes foundation. The ground around your home should slope approximately 6 inches downhill away from the homes foundation over the first 10 feet. Improper grading can lead to water intrusion and foundation issues. Recommend further evaluation by a qualified grading contractor.

Recommendation
Contact a qualified grading contractor.

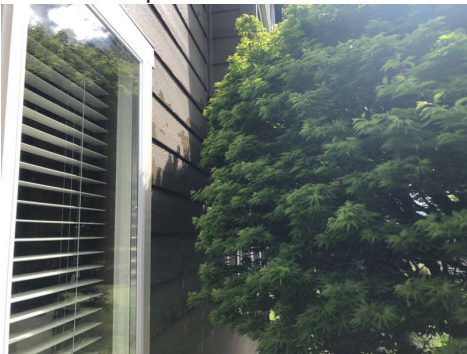
Southwest

Vegetation near/or in contact with the exterior walls. Water for plants will eventually soak into soil and may reach soil supporting the foundation. Excessively high moisture levels in soil supporting the foundation can effect its ability to support the weight of the structure above. In addition, vegetation in contact with siding can cause water damage by holding moisture against the home. Recommend removal of any vegetation near the foundation or in contact with the siding.

Recommendation
Contact a qualified tree service company.

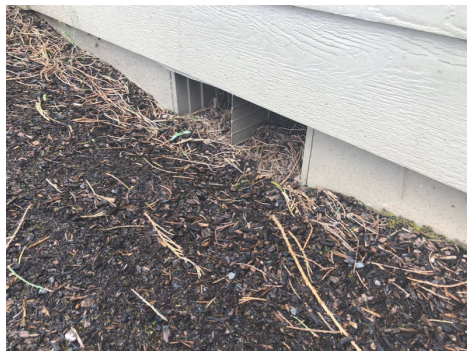
Southeast

3.6.4 Vegetation, Grading, Drainage & Retaining Walls

Contact a qualified grading contractor.

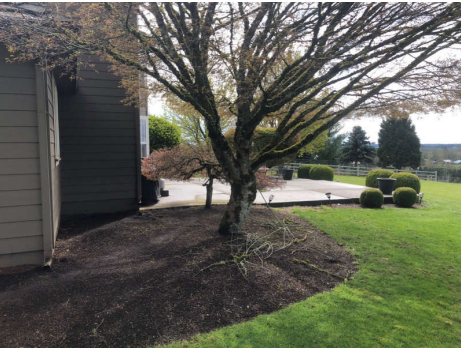
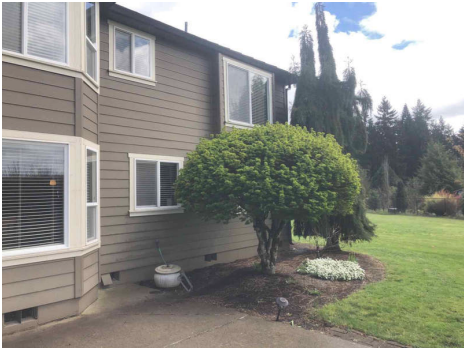
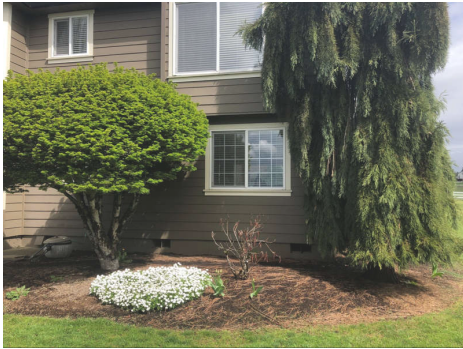
Foundation: Foundation Cracks Related to Tree Roots

Contrary to popular belief, InterNachi (International Association of Certified Home Inspectors) has found that tree roots cannot normally pierce through a bulidlings foundation. They can however, damage a foundation in the following ways:

- Roots can sometimes penetrate a buildings foundation through pre-existing cracks.
 - Large root systems that extend beneath a house can cause foundation uplift.
 - Roots can leech water from the soil beneath foundations, causing the structures to settle and sink unevenly.
- For these reasons, we recommend monitoring periodically.

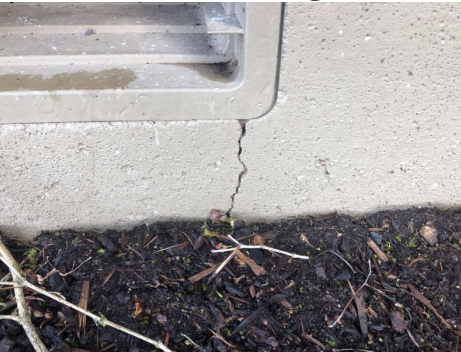
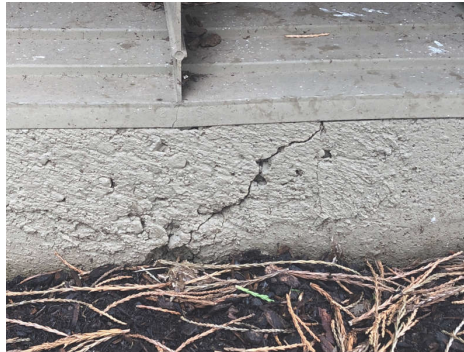
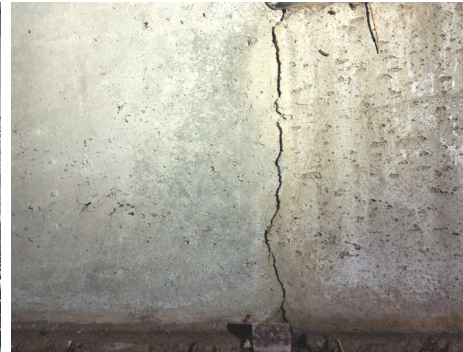
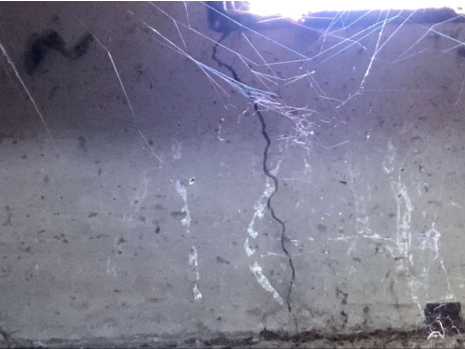
4.1.1 Foundation

FOUNDATION CRACKS - MINOR

Minor cracking was noted at the foundation. This is common as concrete ages and shrinkage surface cracks are normal. Recommend monitoring for more serious shifting/displacement.

Recommend monitoring.

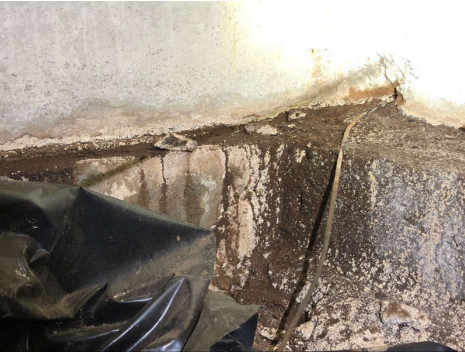
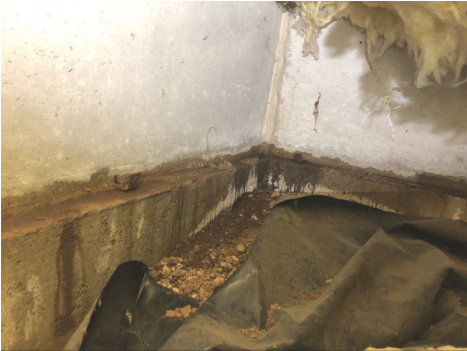
Southeast

Water intrusion was evident in many areas on or around the foundation wall. This appears to be directly related to all the downspouts around the home terminating next to the homes foundation, and improper grading in one or more areas around the home. Recommend further evaluation and correction by a qualified contractor.

Recommendation
Contact a qualified professional.

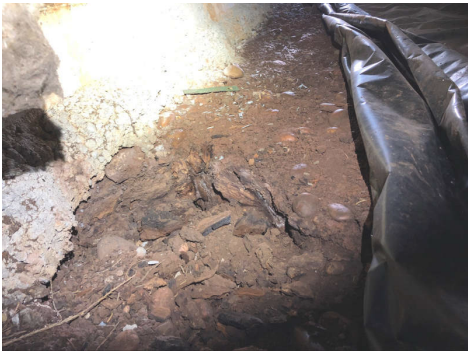
4.1.3 Foundation

The soil was soft throughout most of the crawl space, and appeared to be deteriorating in one or more areas. This appears to be directly related to all the homes downspouts terminating next to the homes foundation, and improper grading in one or more areas around the home. Recommend monitoring periodically.

Recommendation
Recommend monitoring.

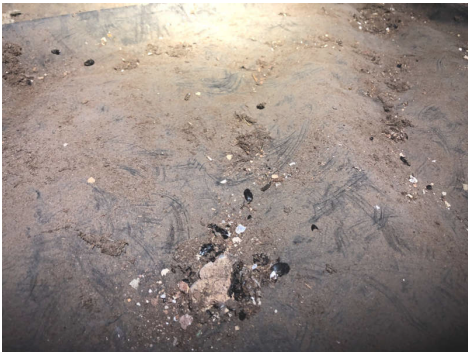
Southwest

One or more dead insects were observed in the crawl space. They did not appear to be part of the Wood Destroying Organism family, and no WDO damage was observed at the time of inspection. Recommend asking seller about any current or past issue. Recommend monitoring periodically, and/or contact a pest control company as needed.

Recommendation
Recommend monitoring.

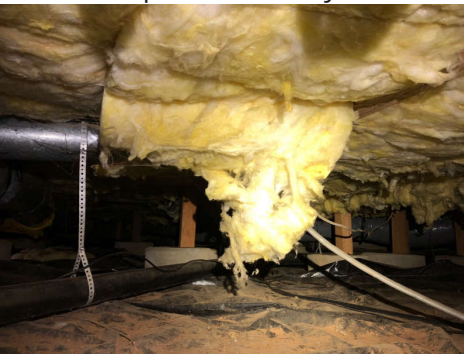
Southwest

Insulation was sagging in one or more areas. This is very common with as much rain as we get during the winter months. Over time, the insulation absorbs moisture and starts to sag. Recommend repair by a qualified handyman.

Recommendation
Contact a qualified handyman.

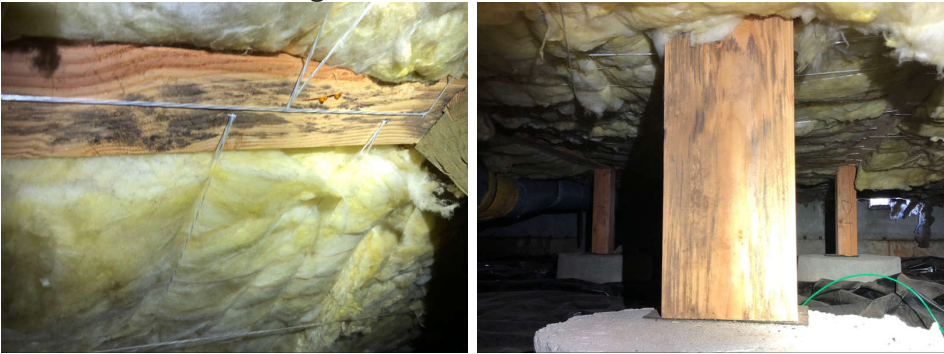
Observed signs of mold in one or more areas in the ceiling structure. Depending on how sensitive a person is to allergens, recommend monitoring periodically and/or contacting a mold contractor for further evaluation.

Recommendation
Recommend monitoring.

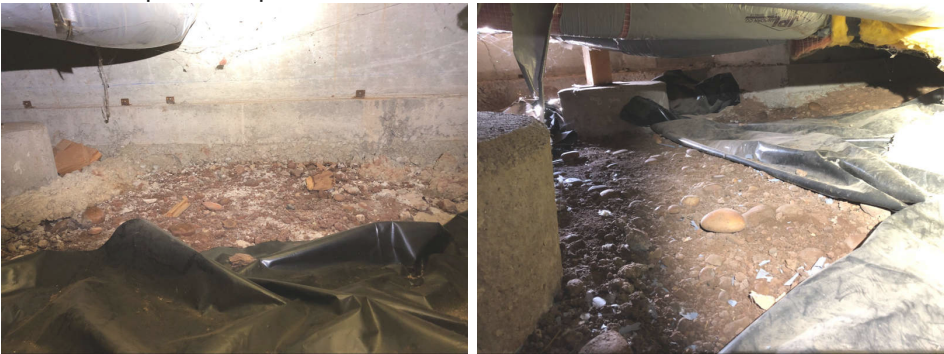
East

The vapor barrier was not adequately covering the soil or post footings at the time of the inspection. Soil covers help reduce humidity levels in crawlspaces by limiting moisture evaporation into the air from soil. Reducing humidity levels can help prevent conditions that encourage mold growth and wood decay. Recommend correction and/or further evaluation by a qualified professional.

Recommendation
Contact a qualified professional.

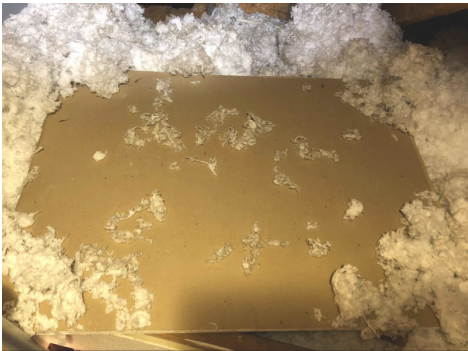
2nd Floor

Attic hatch (s) were missing insulation and/or weather stripping. This can lead to heat loss in the winter and cold air in the summer. Recommend correction.

Recommendation
Contact a handyman or DIY project

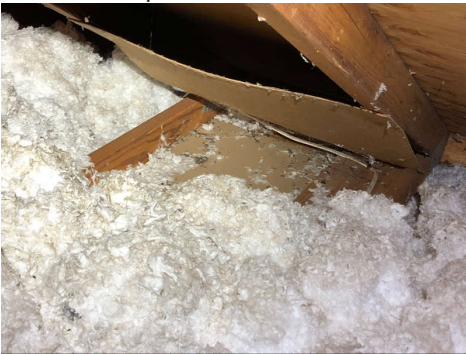
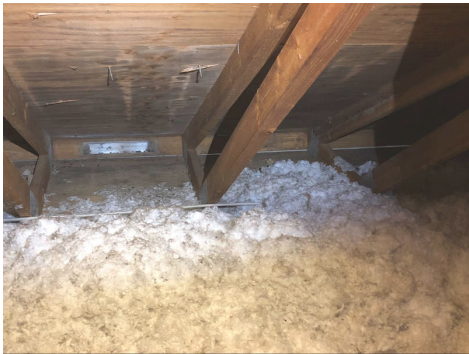
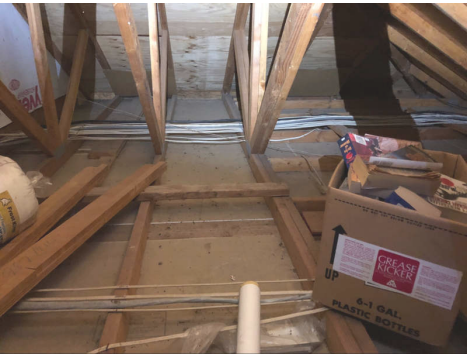
5.1.2 Attic Insulation

MISSING INSULATION

The attic was missing insulation over some areas . This condition can result in increased heating and cooling costs and reduced comfort levels. Recommend that insulation be properly distributed to cover all portions of the attic located above the home living space. All work should be performed by a qualified insulation contractor.

Recommendation
Contact a qualified insulation contractor.

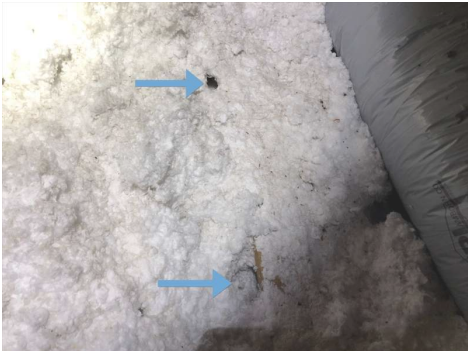
5.1.3 Attic Insulation

One or more mice/rat holes were observed in the insulation. Recommend asking seller if this is a current or past issue. Recommend monitoring periodically.

Recommendation
Recommend monitoring.

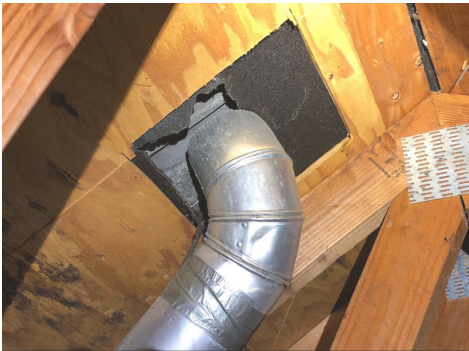
5.3.1 Exhaust Systems

One or more bathroom exhaust fan(s) terminate into the attic, which can cause excess moisture and mold. Recommend a qualified contractor properly install exhaust fan(s) to terminate to the exterior.

Recommendation
Contact a qualified HVAC professional.

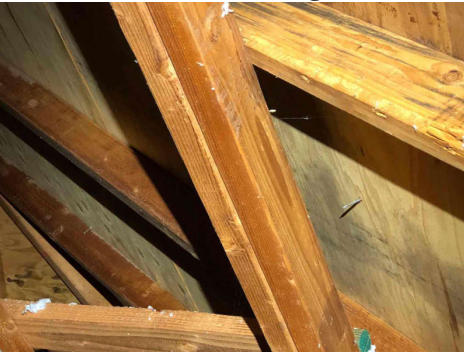
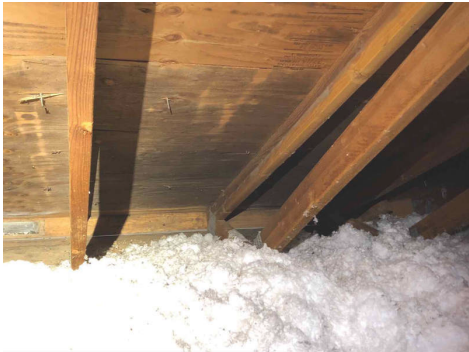
Attic showed areas of discoloration and possible mold growth in one or more areas. Depending on how sensitive a person is to allergens, recommend monitoring periodically and/or contacting a mold contractor for further evaluation.

Recommendation
Recommend monitoring.

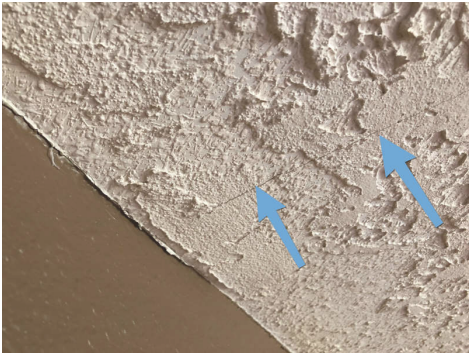
2nd Floor Master Bedroom West

DRYWALL/PLASTER - CRACKED

Drywall/plaster was cracked in one or more areas. This appeared to be the result of long term settling. Recommend monitoring periodically.

Recommendation
Recommend monitoring.

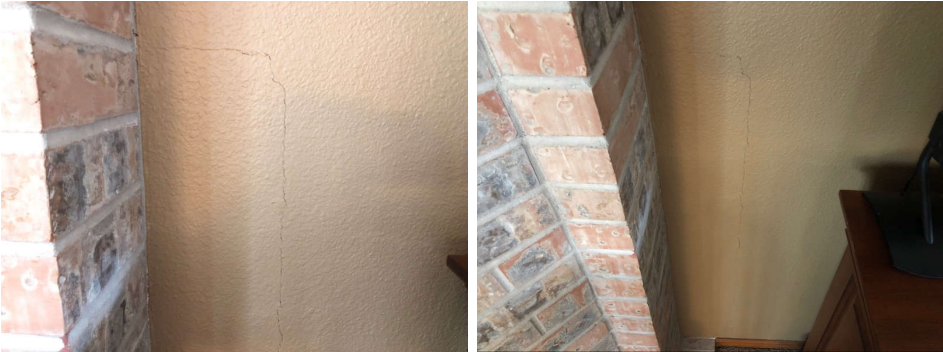
CRACKING - MINOR

Drywall was cracked in one or more areas. This appeared to be the result of long term settling. Recommend monitoring periodically.

Recommendation
Recommend monitoring.

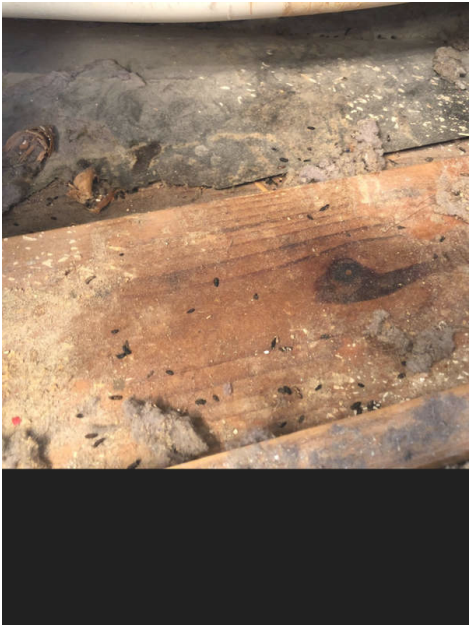
Mice droppings were observed under the bathtub in the master bathroom. Recommend asking seller if this is a current or past issue. Recommend monitoring periodically.

Recommendation
Recommend monitoring.

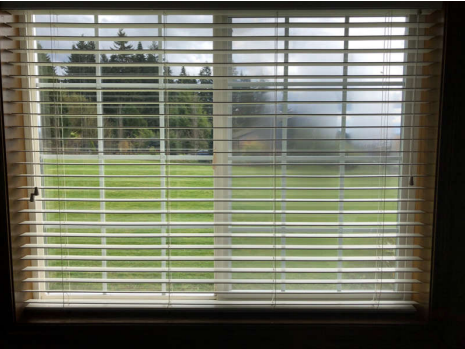
1st Floor Living Room Southeast

FAILED SEAL

Observed condensation between the window panes in one or more windows, which indicates a failed seal. Recommend a qualified window contractor evaluate & replace.

Recommendation
Contact a qualified window repair/installation contractor.

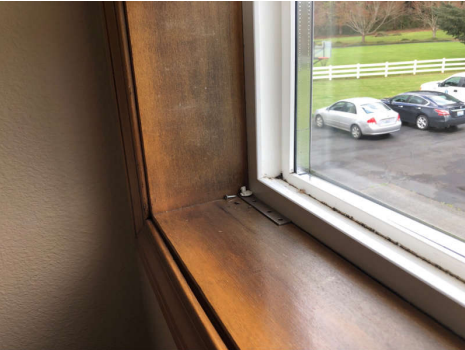
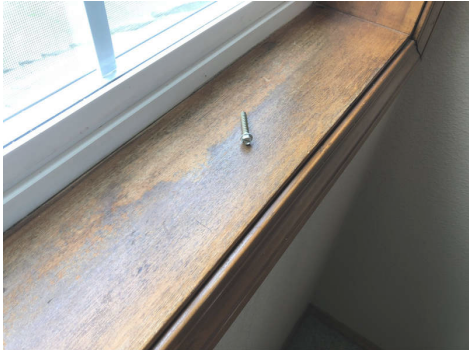
2nd Floor Northeast Bedroom

STAINING

Staining was observed on the trim in the 2nd floor northeast bedroom. Did not appear to be from moisture damage, merely cosmetic. However, recommend monitoring periodically.

Recommendation
Recommend monitoring.

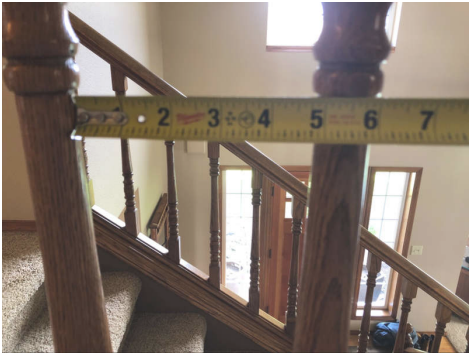
6.7.1 Steps, Stairways, Landings,
Railings & Ramps

The baluster spacing was not up to modern safety standards. The space between balusters should not allow passage of a 4 inch sphere for child safety. Recommend a qualified handyman repair and bring up to code.

Recommendation
Contact a qualified handyman.

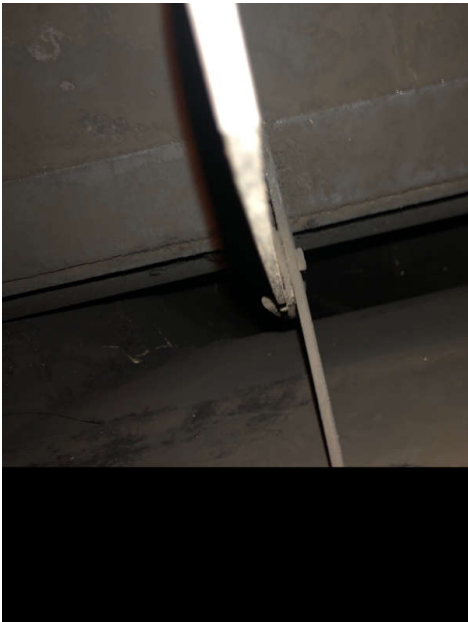
7.6.1 Fireplace, Woodstove

There was a notable amount of creosote buildup in the flue. Recommend a qualified fireplace or chimney contractor inspect and sweep on an annual basis.

Recommendation

Contact a qualified fireplace contractor.

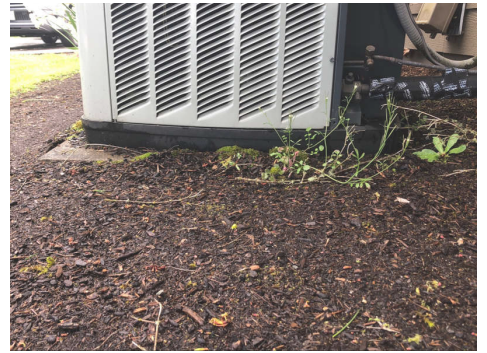
Concrete pad supporting the outdoor condensing unit was not level. This can cause accelerated deterioration of components. Recommend licensed HVAC contractor level the unit.

Recommendation

Contact a qualified HVAC professional.

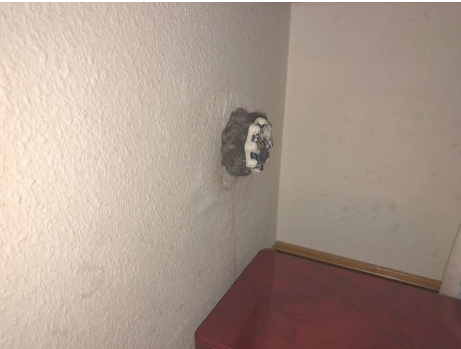
Drywall around handle appeared to have sustained water damage at some point, but was completely dry at the time of inspection. Recommend asking seller about this.

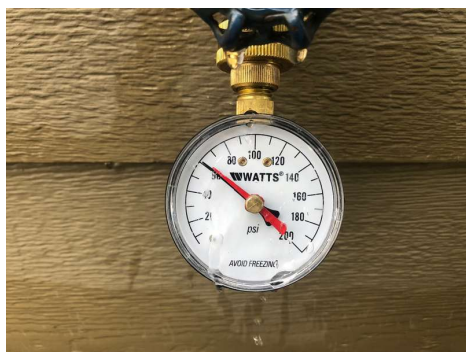
Water pressure was approximately 60 psi at the time of inspection, which is good. Recommended water pressure is between 40-80 psi.

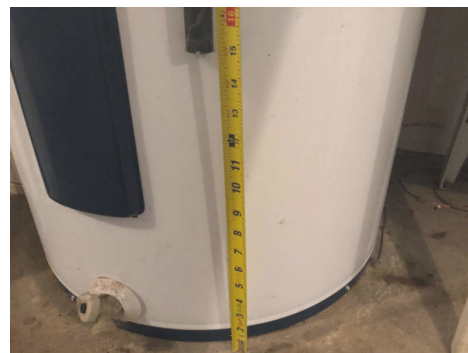
9.3.1 Hot Water Equipment, TPR Valve, Seismic Straps, Controls, Flues & Vents

The discharge pipe of this water heater temperature/pressure relief (TPR) valve was terminated more than 6 inches above the floor. This condition could result in scalding if the pressure relief valve were activated while a person was nearby. Recommend correction by a qualified plumber.

Recommendation

Contact a qualified plumbing contractor.

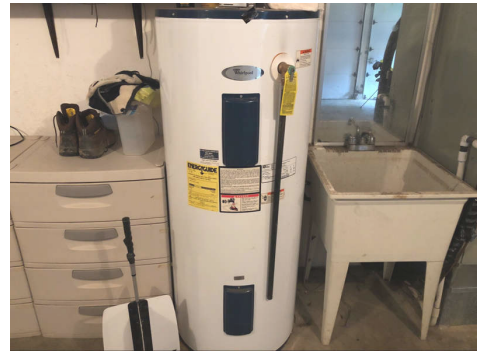
Water heater was not fastened securely. In the event of seismic activity, modern safety standards mandate one strap be installed on the upper third of the tank and one on the lower third. Recommend correction by a qualified plumbing contractor.

Recommendation

Contact a qualified plumbing contractor.

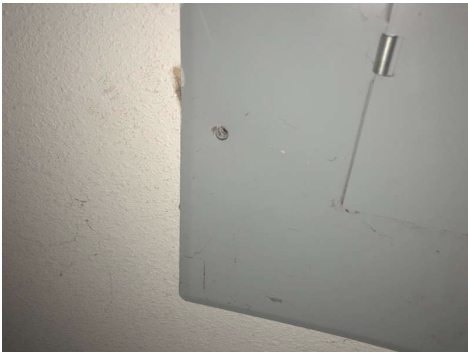
MISSING SCREW

Screw was missing on the bottom left-hand corner of the electrical panel. Recommend replacing.

Recommendation

Contact a handyman or DIY project

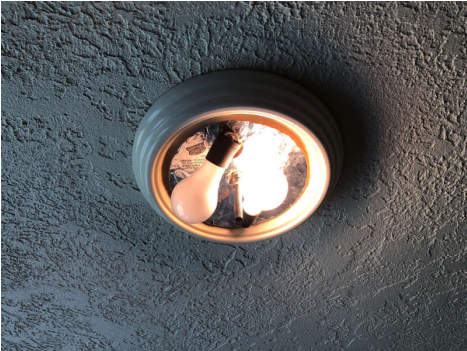
2nd Floor Bedroom Southeast

One or more lights were not operating. New light bulb possibly needed.

Recommendation
Contact a handyman or DIY project

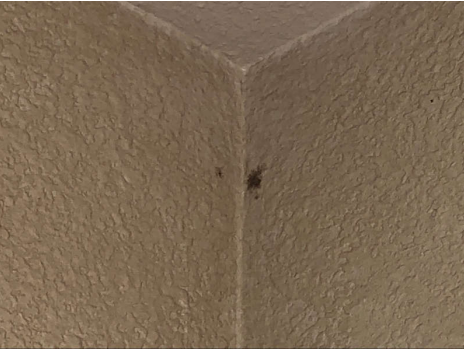
2nd Floor Bathroom Above Tub

There were signs of possible fungi growth on the ceiling and/or walls in one or more areas. It is unknown if this is a safety hazard. Recommend cleaning these areas with product such as Concrobium Mold Control.

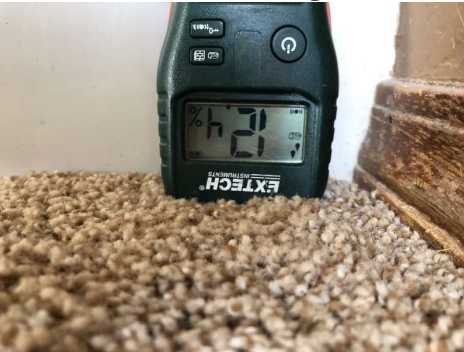
2nd Floor Master Bathroom

Carpet was used as the flooring material in the master bathroom. The pad beneath the carpet may soak up a fair amount of moisture, which can lead to the growth of decay fungi/mold on the sub-floor, causing the sub-floor to weaken. Mold also releases spores that can cause respiratory ailments, especially those with certain health problems. I also took a moisture reading next to the shower and it was approximately 12%, which is slightly elevated. Recommend monitoring periodically, or replacing carpet with tile, vinyl, or a more suitable material for a bathroom.

Recommendation
Recommend monitoring.

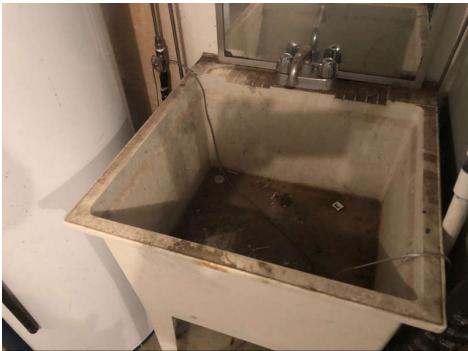
11.3.1 Toilets and Sinks

Sink in the garage did not work. Most likely shut-off valves were turned off. Recommend confirming with seller that sink does work.

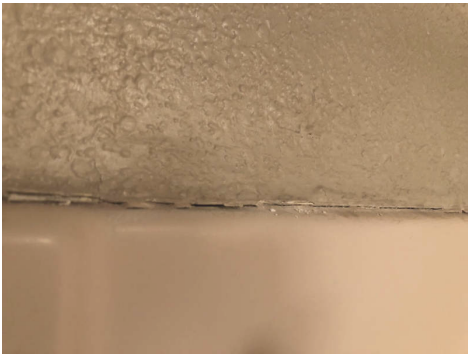
2nd Floor Bathroom Above Tub

Sealant was deteriorating in one or more areas. Recommend applying new sealant to prevent potential water damage to the underlying materials.

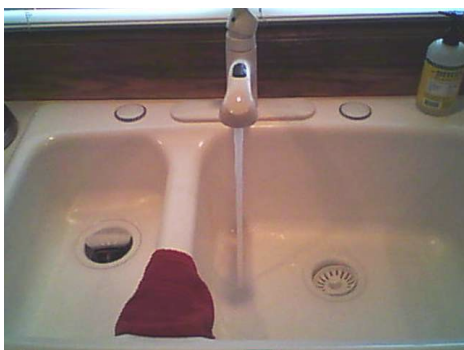
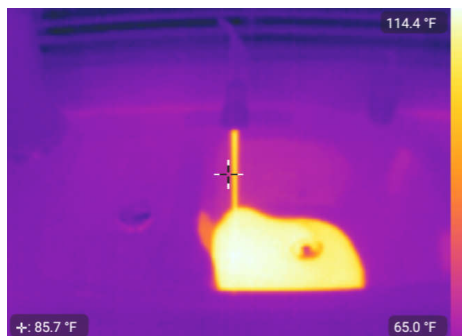
Water temperature tested at the kitchen sink was approximately 114 degrees Fahrenheit at the time of the inspection, which is good. Recommended water temperature throughout the home should be set at 120 degrees Fahrenheit or below, to avoid scald hazard.

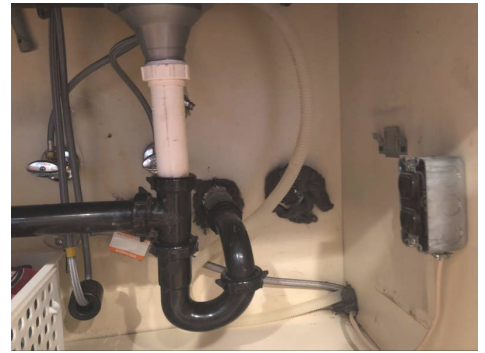
Dishwasher high loop did not appear to be correctly secured. The drain hose should either be looped up and securely fastened to the underside of the counter, or be connected to an air gap on top of the sink. Recommend correction by a qualified plumber.

Contact a handyman or DIY project

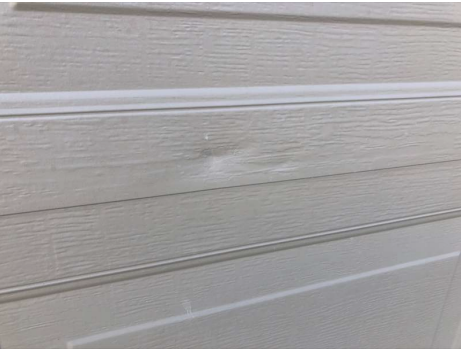
Middle door

Cosmetic Observations

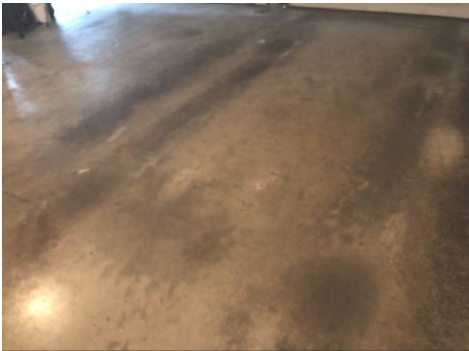
STAINING

Garage floor showed visible staining from oil/grease. Recommend scrubbing with a degreaser or cleaning solution.

Recommendation
Contact a handyman or DIY project

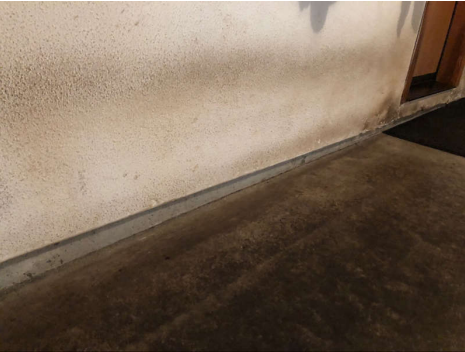
South

STAINING/DISCOLORATION

Staining and/or discoloration was observed on the south side of the garage. Unable to determine the cause. Recommend cleaning as needed.

Recommendation
Contact a handyman or DIY project

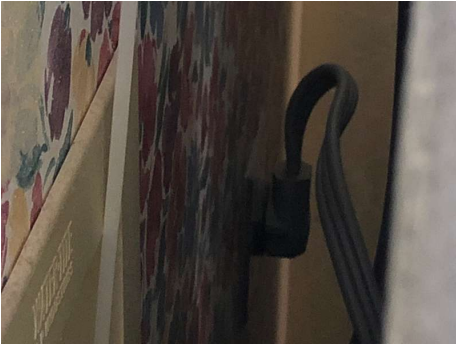
Dryer Power Source
220 Electric

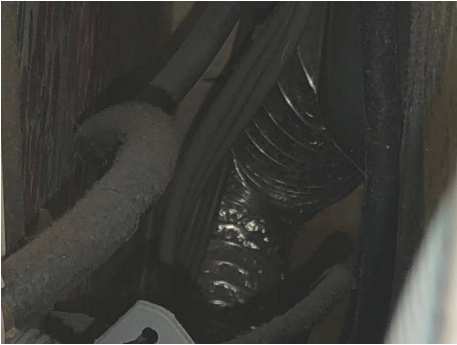
Dryer Vent
Vinyl (Flex)

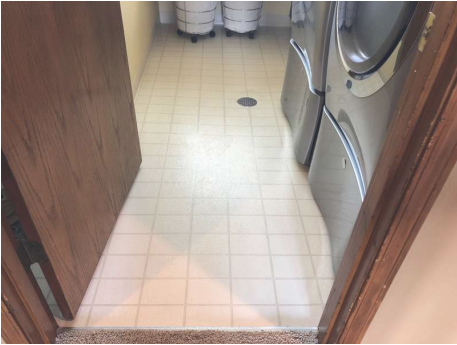
Floor Coverings
Linoleum
