ROYAL HOME INSPECTIONS, LLC

ROYAL INSPECTION

1234 Main St.
Anamosa IA 52205

05/19/2019 9:00AM

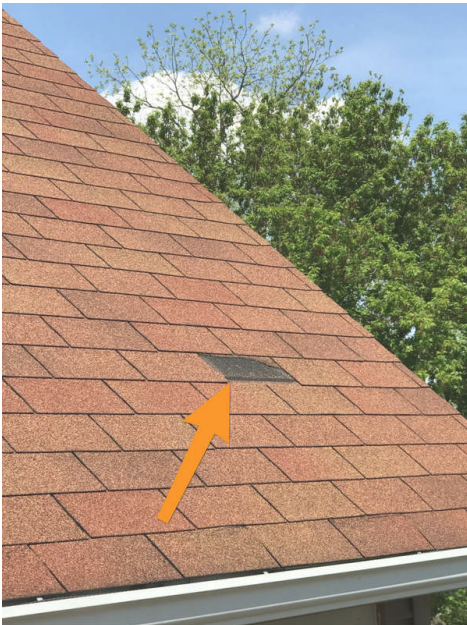
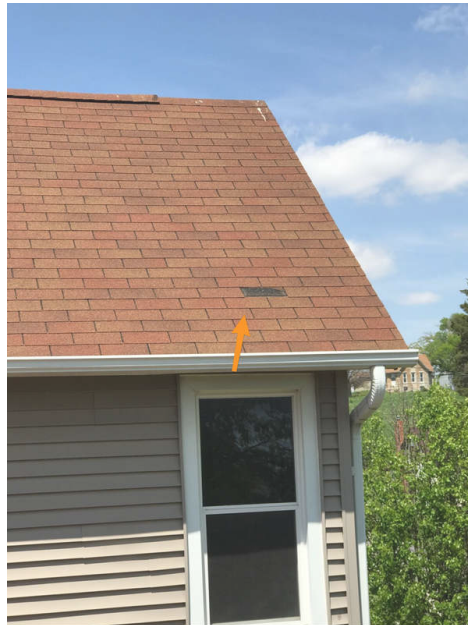
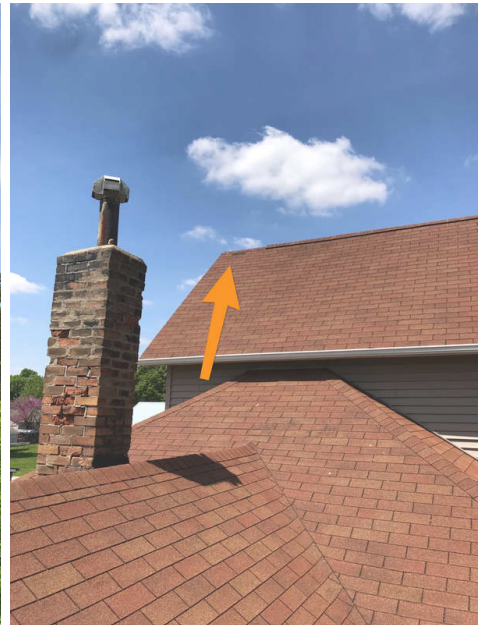
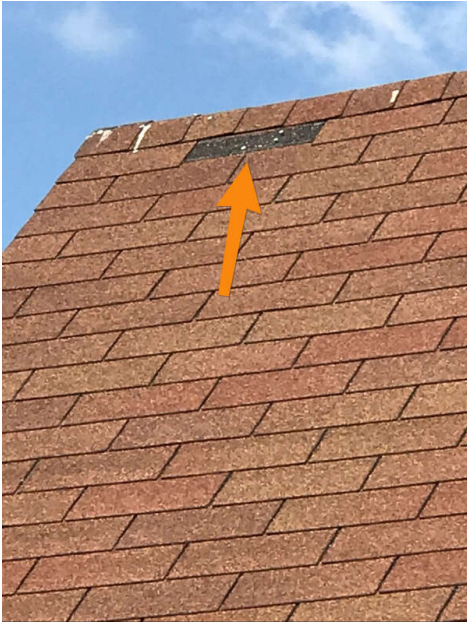
2.1.3 Roof Structure/Covering

MISSING SHINGLE.

Missing shingles observed at the time inspection. Recommend repair or replacement as a missing shingle could allow water penetration into structure

Contact a qualified roofing professional.

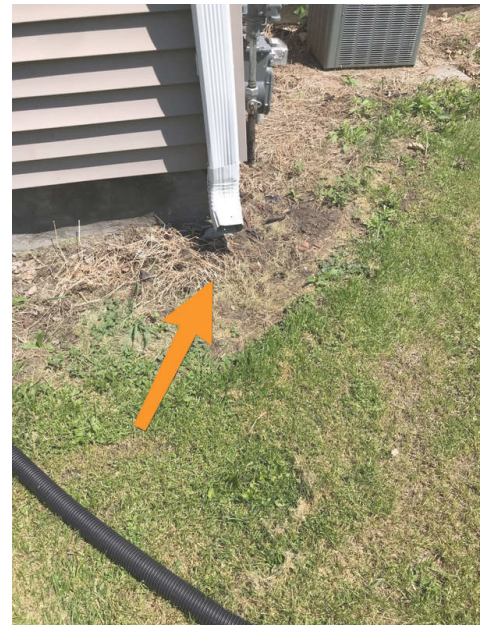
2.4.1 Roof Drainage System

GUTTERS, DISCHARGE TO FOUNDATION OR SLAB

One or more downspouts discharged roof drainage next to the foundation or slab. This condition can effect the ability of the soil to support the weight of the structure above and can cause damage related to soil/foundation movement. The Inspector recommends the installation of downspout extensions to discharge roof drainage 4 to 6 feet from the foundation.

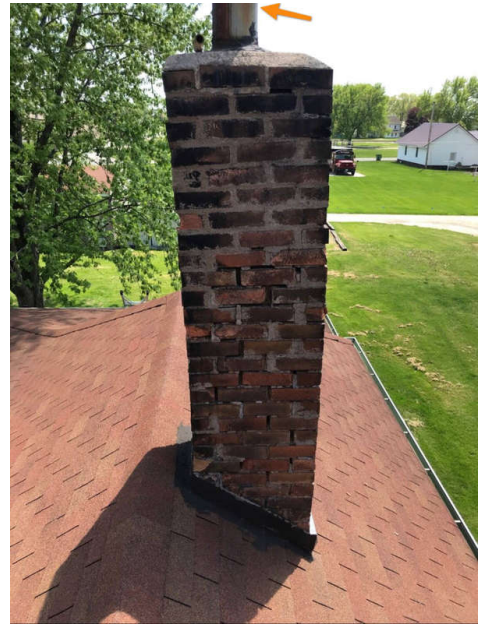
2.5.1 Chimney at Roof

ADD SPARK ARRESTOR

The chimney(s) had no spark arrestor. The Inspector recommends that all chimneys have an approved spark arrestor installed by a qualified contractor to prevent pest entry and to help protect the roof-covering materials from potential chimney-source ignition.

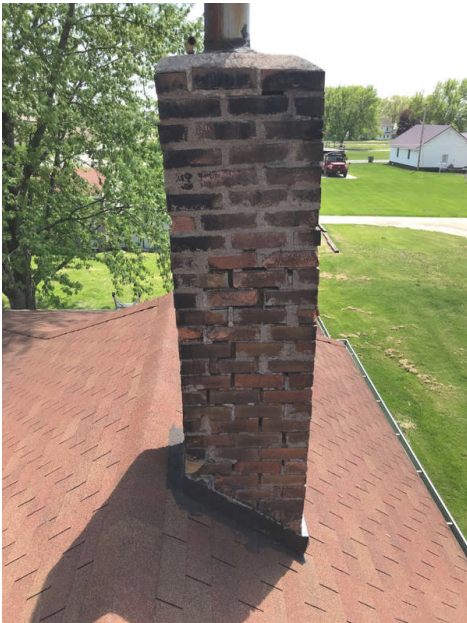
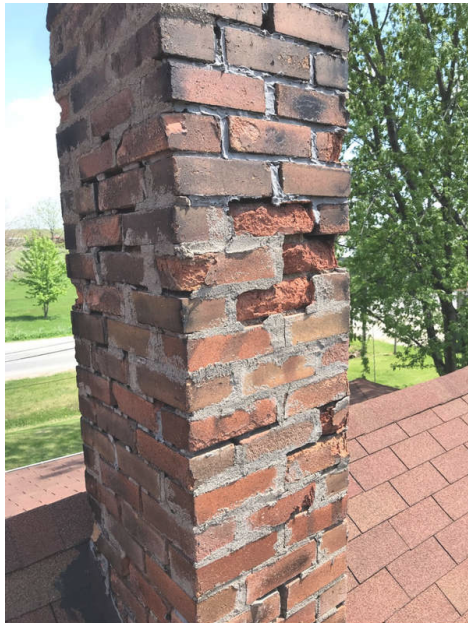
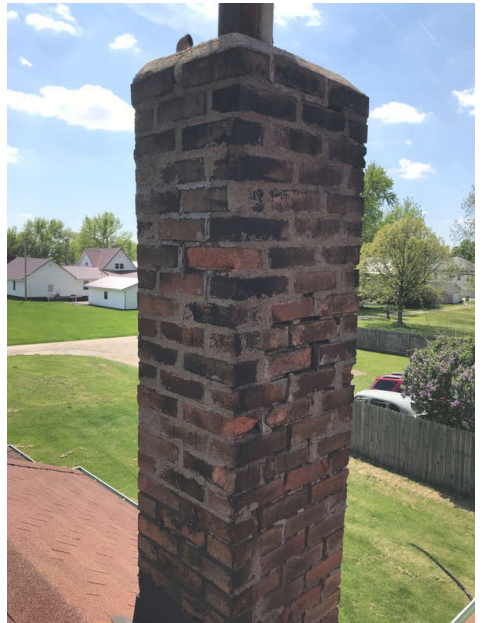
2.5.2 Chimney at Roof

SEVERELY DETERIORATED BRICK/MORTAR

The brick chimney had severely deteriorated brick and mortar. The Inspector recommends that an evaluation and any necessary work be performed by a qualified masonry contractor.

Contact a qualified chimney contractor.

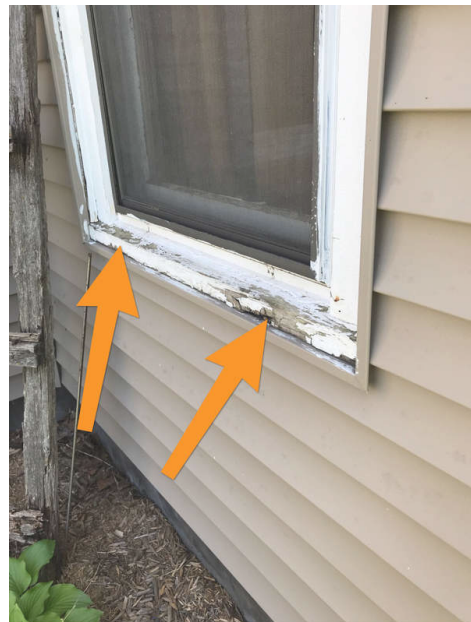
3.2.1 3 Window Exteriors

WINDOW FRAMING, MOISTURE DAMAGE PEELING PAINT.

Moisture damage/peeling paint. shown on window framing at the time of inspection. Moderate deterioration of wooden components. Recommend replacement of damaged areas and sealed to prevent future damage.

Contact a qualified professional.

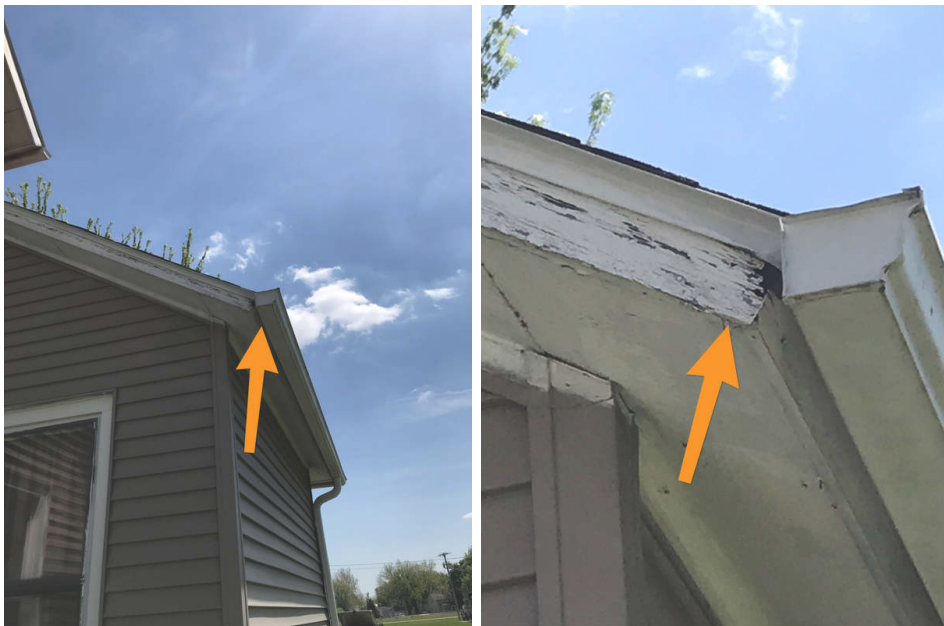
3.3.2 4 Soffits Facia and Trim

FACIA DETERIORATION

Facia deterioration Was observed at the time inspection. This deterioration can allow for waters, or birds/pest to enter the home. Recommend sealing exposed and Bare wood.

Contact a qualified professional.

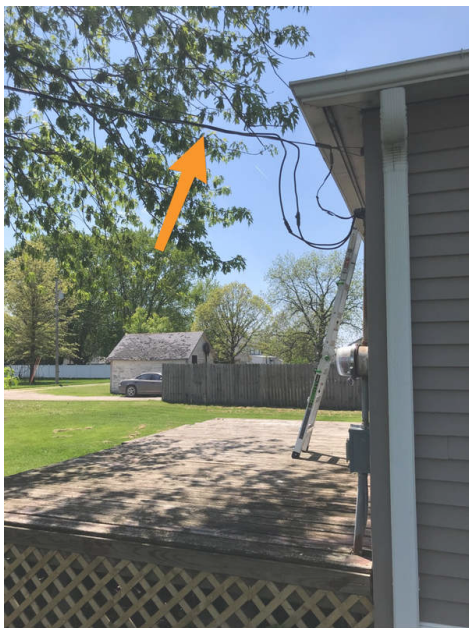
3.7.1 9 Electrical Service to property

The overhead service-drop conductors have inadequate height clearance above a walking surface. Safe building practices require 10 feet (3m) clearance above walking surfaces (including decks, stairs, and balconies). The Inspector recommends that before the expiration of your Inspection Objection Deadline, you consult with your electrical service provider to discuss options and costs for correction. Any work on the service conductors should be performed by a qualified personnel only.

Contact a qualified electrical contractor.

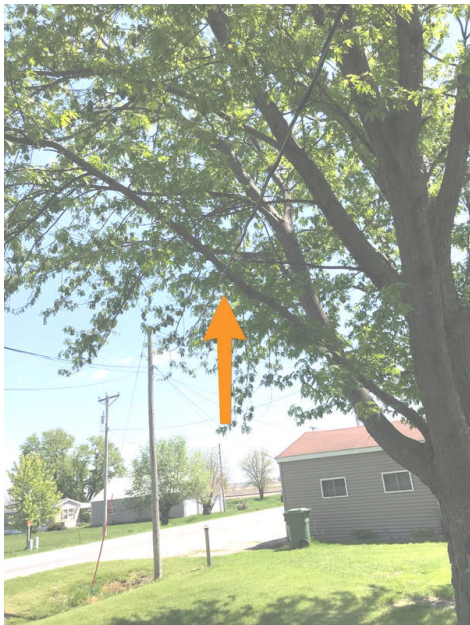
3.7.2 9 Electrical Service to property

The overhead service-drop conductors had inadequate clearance from tree branches. This condition should be corrected by a qualified contractor or the utility service provider to avoid abrasion and damage to the conductors. Work around the service conductors should be performed by a qualified personnel only. Injury or death may result from attempts at correction by those without proper qualifications.

Contact a qualified tree service company.

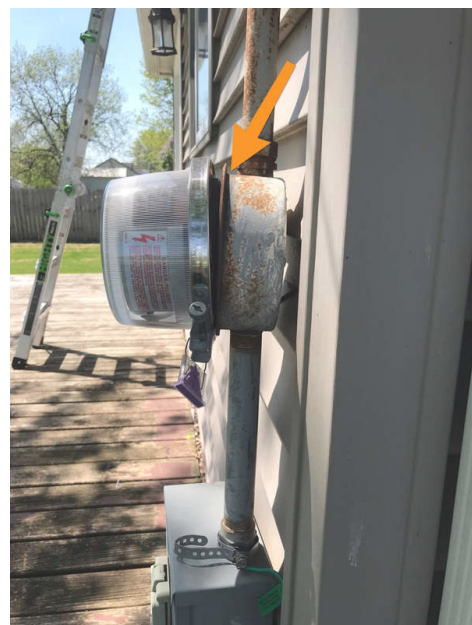
3.7.3 9 Electrical Service to property

METER LOOSE

The electric meter was loose and should be securely fastened. The Inspector recommends correction by the electric utility provider.

Contact a qualified professional.

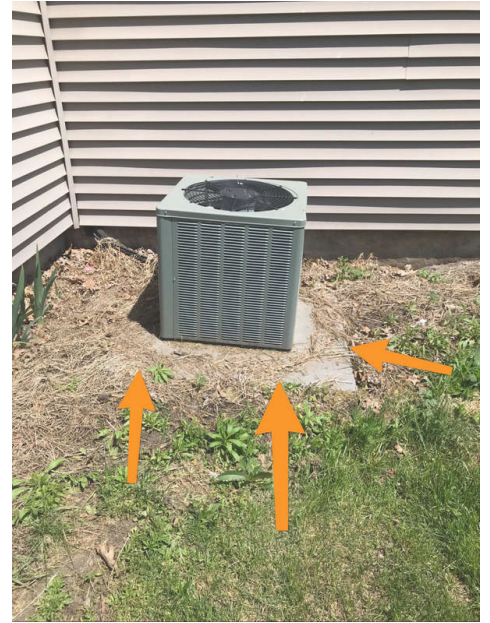
3.8.1 10 Central Air Conditioner

The pad supporting the air-conditioner compressor housing was not level. Over time, this may result in damage to the fan bearings and a shortened fan lifespan, or it may result in movement of the compressor housing which can stress the refrigerant lines resulting in e, damage and expensive service. The Inspector recommends that the compressor housing be leveled by a qualified HVAC contractor.

Contact a qualified HVAC professional.

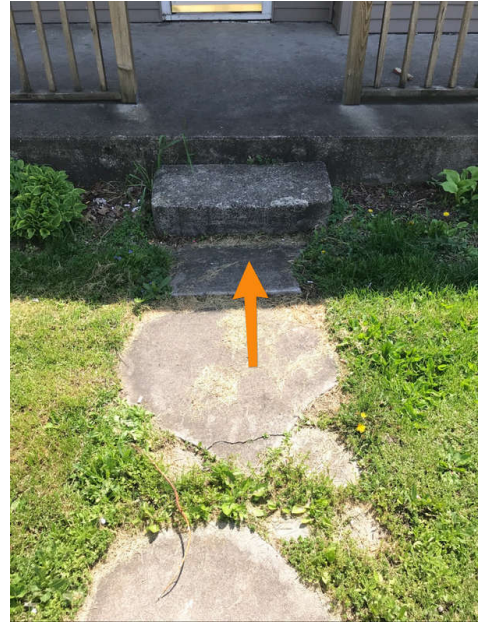
4.2.2 Walkways

At the time of the inspection, the walkways had areas of areas of moderate settling visible. This condition is typically the result of poor compaction practices during original construction. As time passes, settling continues until soil beneath the affected area reaches equal density with the surrounding soil and the affected portions of the walkway become stable. Chances that settling will continue are low.

Contact a qualified concrete contractor.

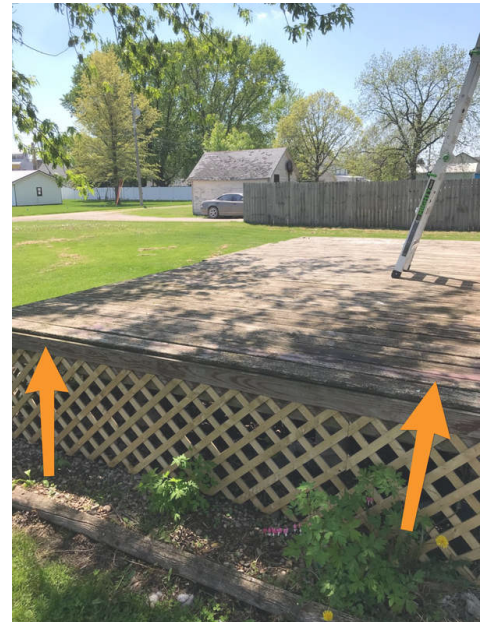
4.4.1 Deck, Balcony, Bridge and Porch,

Although the deck guardrails may have complied with the building safety standards in effect at the time of original construction, they do not meet generally-accepted current standards and may be hazardous to small children. Current standards include the following:

1. A 4 inch sphere may not pass through the guardrail at any point
2. The guardrail should not be climbable (especially by children).
3. Minimum guardrail height is 36 inches
4. Any walking surface 30 inches or more above grade should have a guardrail.

The deck failed to meet safety standard number *Safety Numbers*. The Inspector recommends that before the expiration of your Inspection Objection Deadline you consult with a qualified contractor to gain an idea of options and costs for updating this condition to comply with modern safety standards.

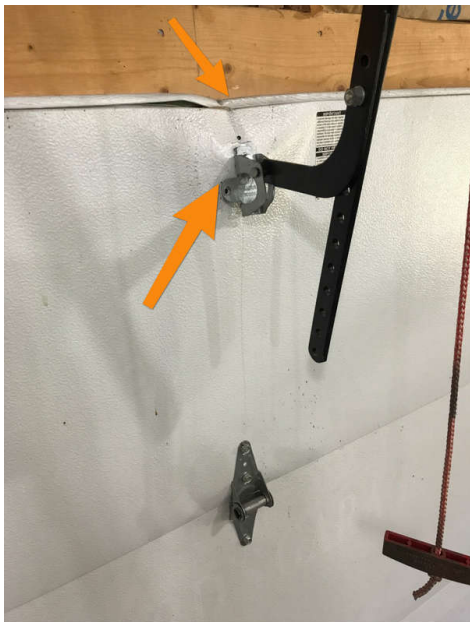
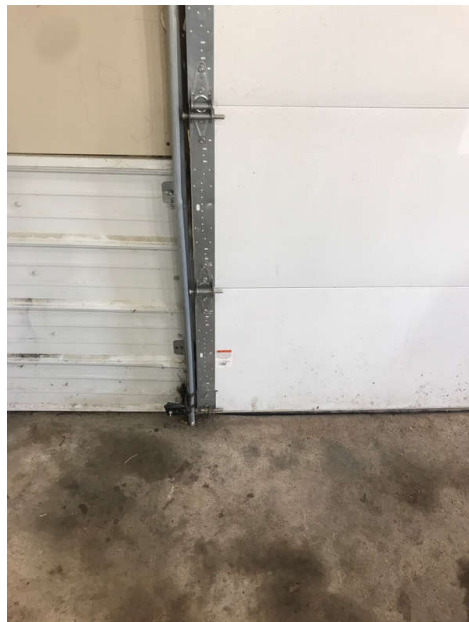
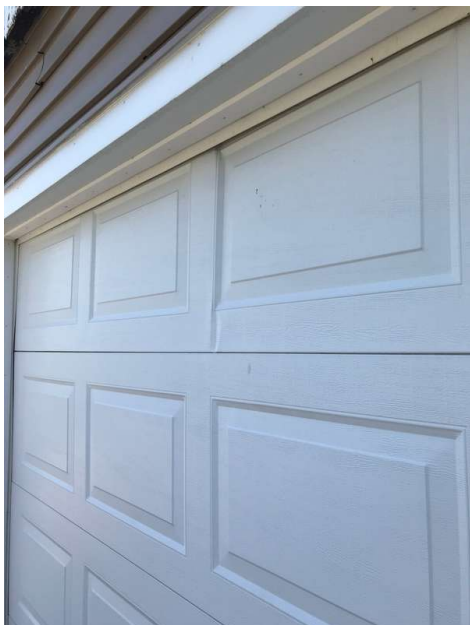
FAILED ANSI 2X4 REVERSE REQUIREMENTS

With testing it damaged the door. It appeared to have some alignment issues prior. As the bottom track is tight. Also Bolts were not installed correctly.

Contact a qualified garage door contractor.

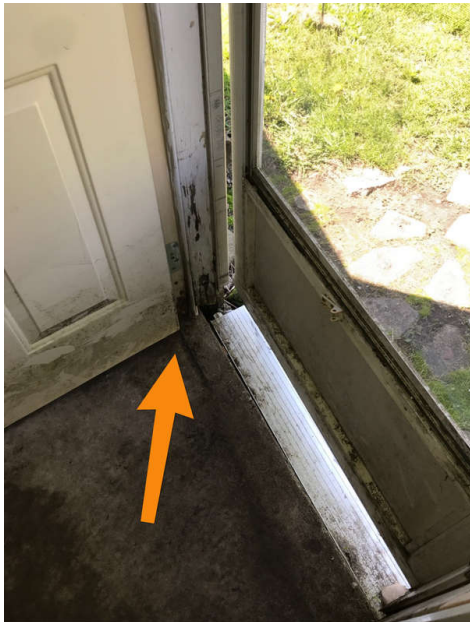
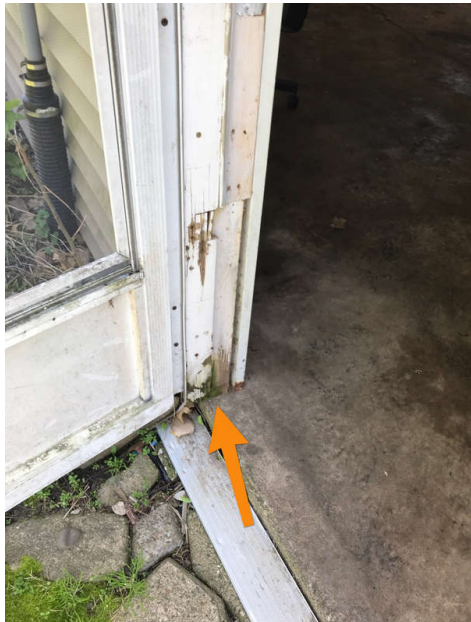
DOOR JAMB, MOISTURE ENTRY

Door jamb showed signs of moisture entry due to unsealed joint between jamb and threshold. Recommend repair by licensed general contractor.

Contact a qualified professional.

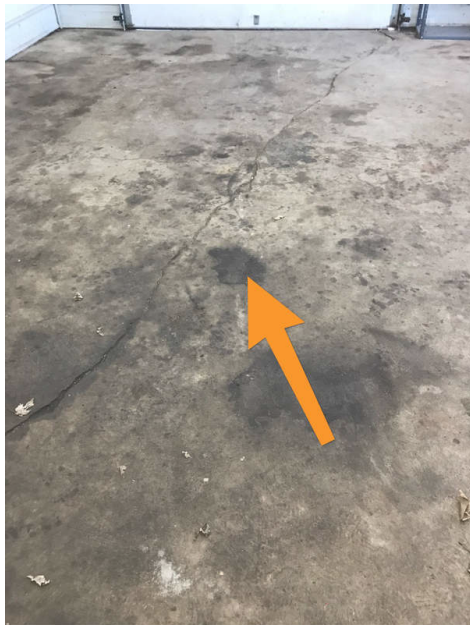
5.3.1 Floors

HEAVING- EXPANSIVE SOILS

The garage floor showed signs of heaving. It was not level or flat and had raised areas. This condition appeared to be the result of expansive soil beneath the slab. Expansive soils are those that expand to many times their original volume with increases in soil content. If expansive soils are the cause of this heaving, it may continue in the future.

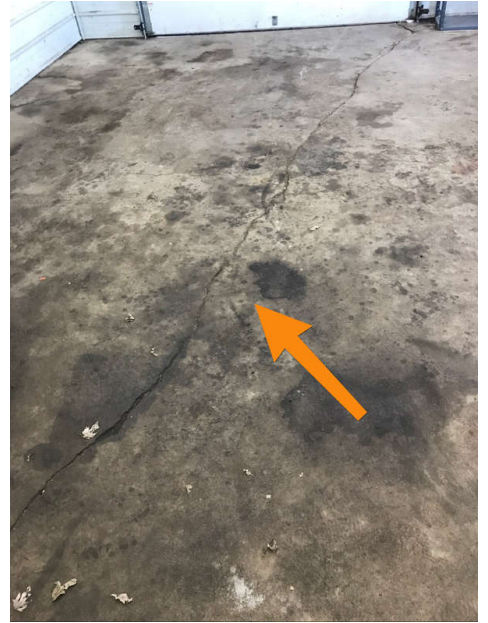
5.3.2 Floors

RANDOM CRACKING- NO CONTROL JOINTS

Random shrinkage cracking was visible in the garage floor slab. No control joints were installed in the concrete floor. Control joints are grooves or cuts in the floor designed to control the location of cracking taking place as part of the curing process.

Contact a qualified concrete contractor.

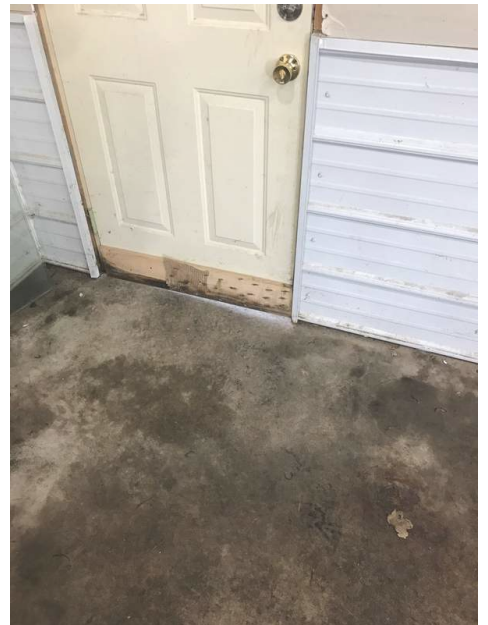
5.3.3 Floors

STAINING- MOISTURE INTRUSION- MOISTURE VISIBLE

Staining of the garage floor appeared to be the result of moisture intrusion. Moisture was visible in this area at the time of the inspection.

Contact a qualified general contractor.

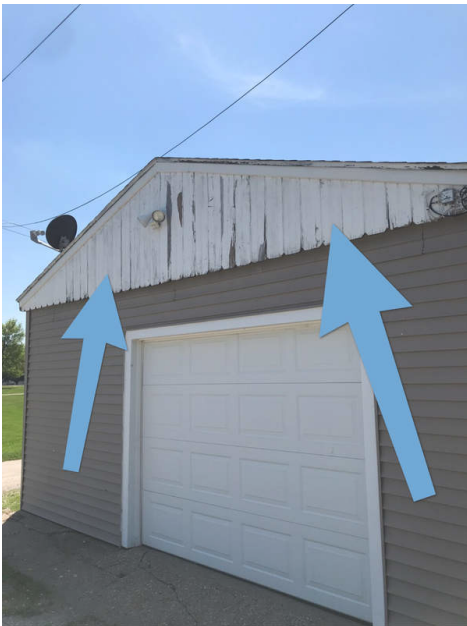
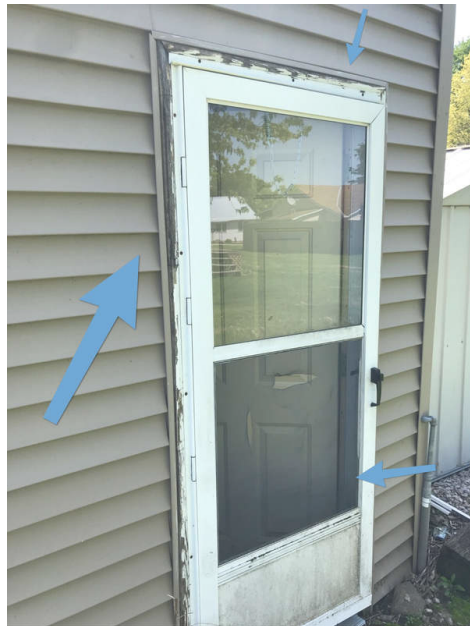
5.5.1 Exterior Walls

PAINT, MISSING OR PEELING

Areas of wood trim are missing or have peeling paint which should be corrected to alleviate moisture entry into the structure.

Contact a qualified professional.

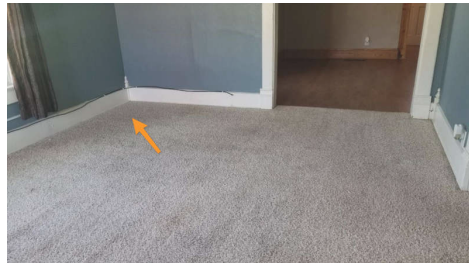
1st Floor Living Room

Walls in the home showed general minor deterioration commensurate with the age of the home.

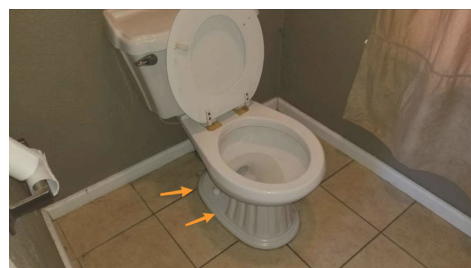
1st Floor Bathroom

TOILET LOOSE AT FLOOR

The toilet was loose at the floor and should be re-attached and new wax ring installed by a qualified plumbing contractor.

Contact a qualified plumbing contractor.

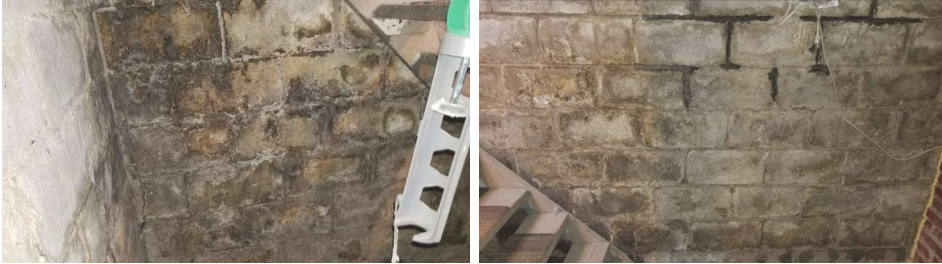
FOUNDATION WALL, EFFLORESCENCE, HEAVY DEPOSITS

In the basement, heavy deposits of efflorescence were visible at some of the interior surfaces of the foundation walls. Efflorescence is a white, powdery residue left by moisture seeping through the foundation wall and its presence indicates high moisture levels in soil near the foundation. Excessively high moisture levels in soil supporting the foundation can cause various structural problems related to soil movement. Long-term exposure to this condition can cause foundation damage. The Inspector recommends that the source of moisture be identified and the condition corrected.

Recommend tuck pointing done by licensed masonry contractor to help prevent moisture deterioration an entry into home.

Contact a qualified waterproofing contractor

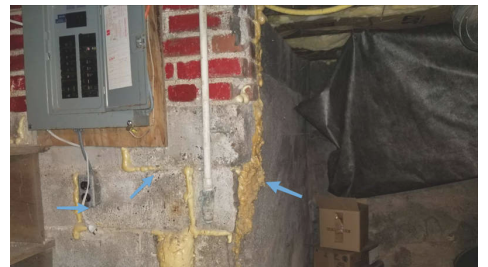
SPRAY FOAM USED TO SEAL AGAINST MOISTURE

Open cell spray foam is not designed to prohibit moisture or pest entry. These locations in the foundation should have correct sealant installed.

Contact a qualified professional.

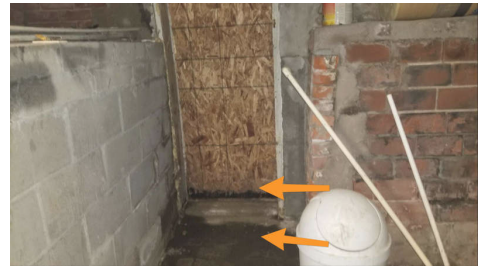
EXTERIOR ENTRANCE, MOISTURE ENTRY

Moisture entry from pre-existing exterior entry into basement. This has been crudely sealed off and is allowing moisture entry into basement.

Contact a qualified professional.

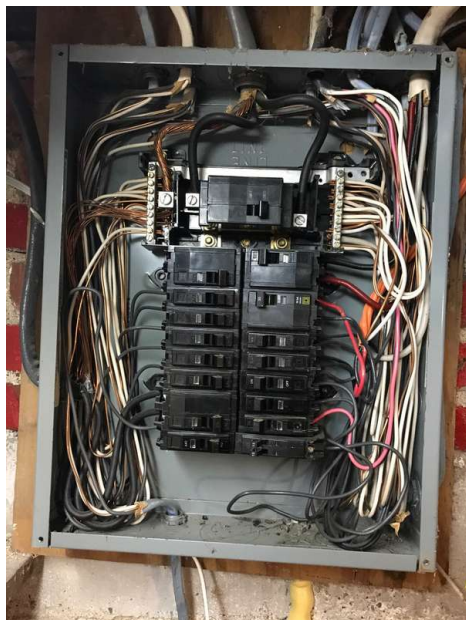
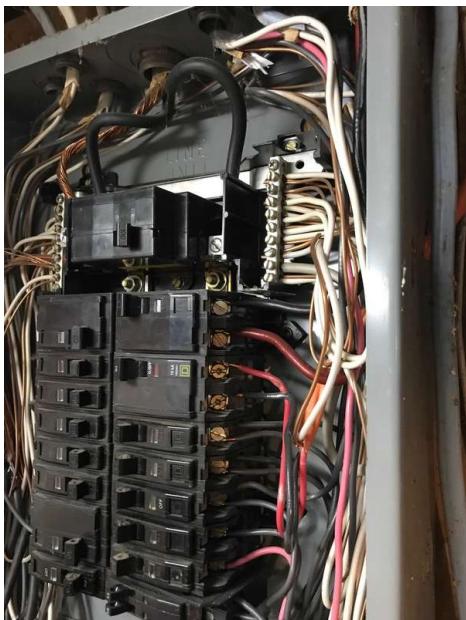
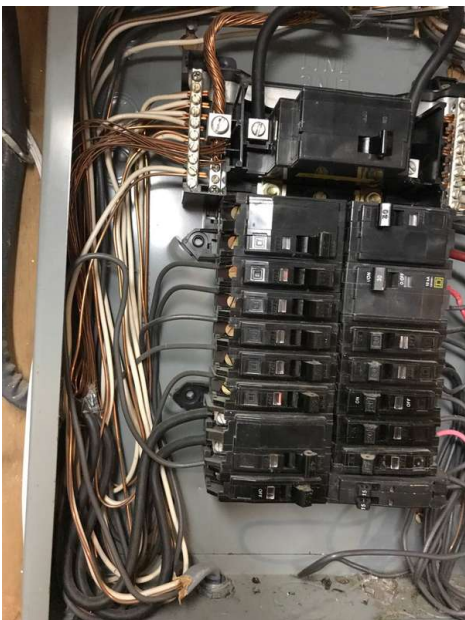
Service Panel Cabinet, Ampacity, and Cover (Pics of Panel Cover, Main Breaker, Internal of Cabinet): Photo documentation

Service Panel Cabinet, Ampacity, and Cover (Pics of Panel Cover, Main Breaker, Internal of Cabinet): No Deficiencies

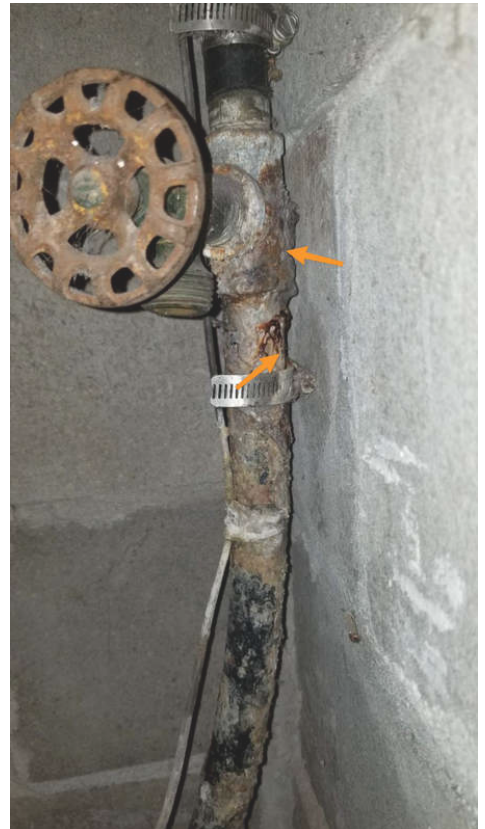
MAIN WATER SUPPLY PIPE HEAVY CORROSION (SHORTENED LIFESPAN)

Contact a qualified plumbing contractor.

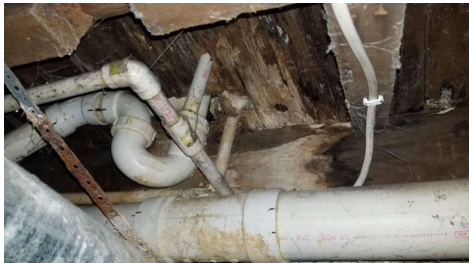
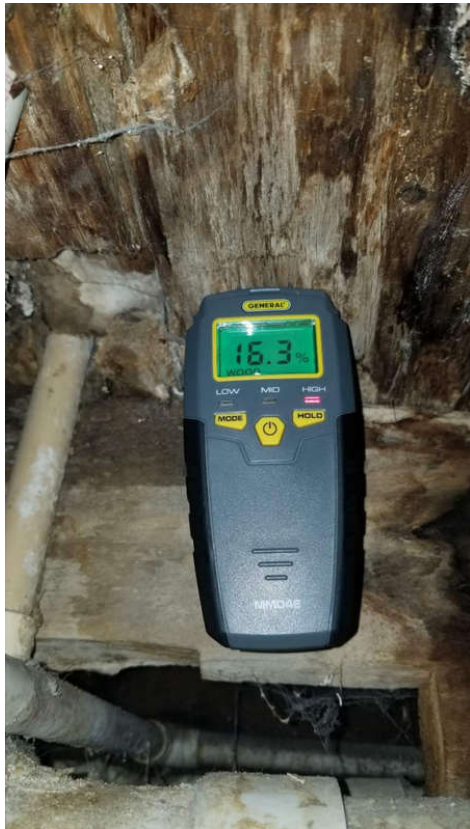
ACTIVE LEAKE

Contact a qualified professional.

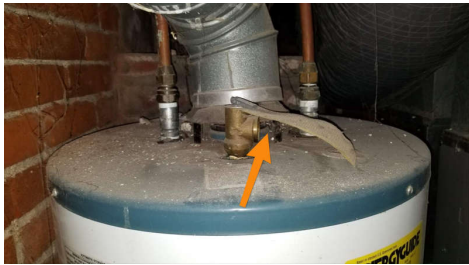
DISCHARGE PIPE ON TPR VALVE

TPR DISCHARGE PIPE NOT INSTALLED CORRECTLY

Incorrect discharge pipe was installed at the temperature/pressure relief (TPR) valve. The TPR valve is designed to open and release extremely hot water when water temperature or pressure inside the tank exceeds safe levels. With no discharge pipe installed, persons near the tank might be badly burned by hot water released by the TPR valve. The Inspector recommends that a properly-configured discharge pipe be installed by a qualified plumbing contractor.
