SEASIDE HOME INSPECTION SERVICES, LLC

RESIDENTIAL REPORT

1234 Main St.
HILTON HEAD ISLAND SC 29926

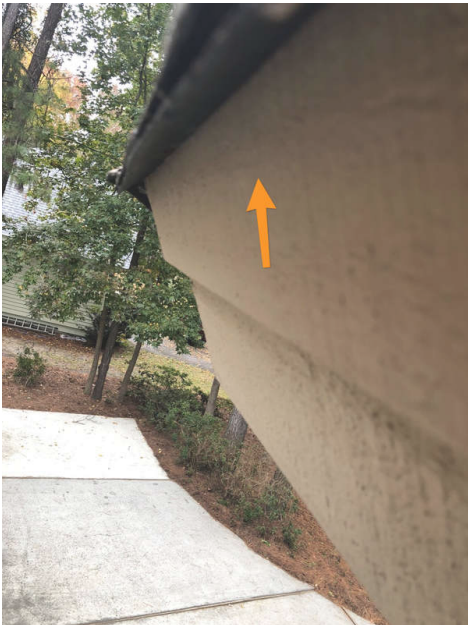
Drip edge flashing was not installed. Lack of roof edge flashing leaves the edges of roof sheathing and underlayment exposed to potential moisture damage from wood decay and/or delamination. Recommend a qualified contractor evaluate and repair as needed.

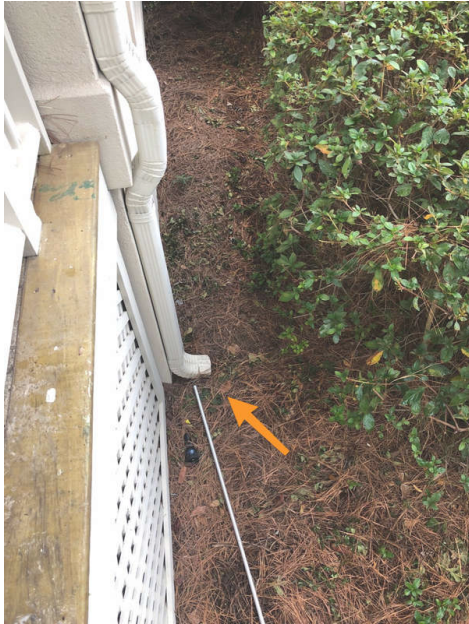
Rear Left Side

DOWNSPOUTS - DRAIN NEAR HOUSE

[Here is a helpful DIY link](#) and video on draining water flow away from your house.

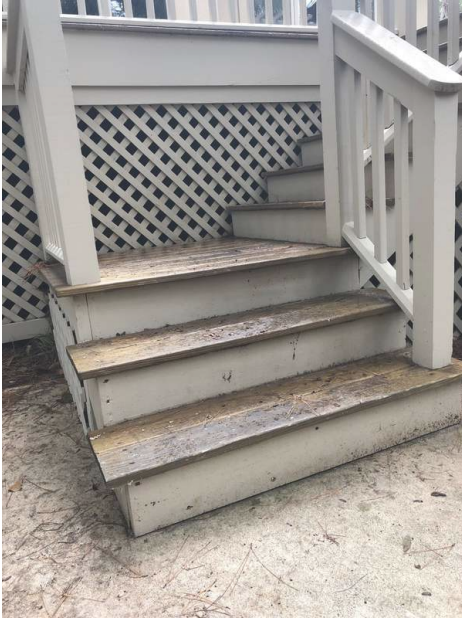
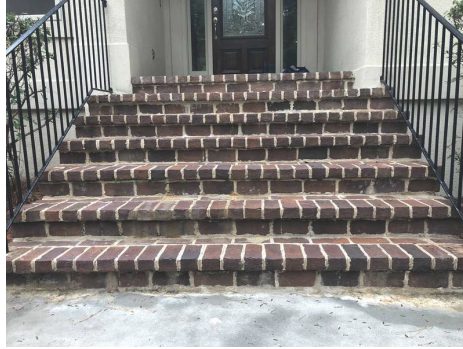
The staircase was older and will not comply with modern safety standards. Current safety standards require that treads are 10" in depth and 36" wide, and riser heights between the treads are no greater than 7 3/4" in height. There also shouldn't be more than a 3/8" variance between the individual riser heights. Any variances from these numbers can result in a potential trip hazard. If a concern, I recommend consulting a contractor who specializes in stairs.

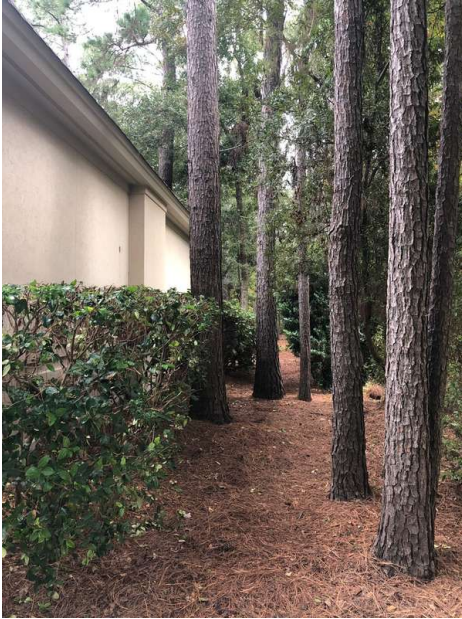
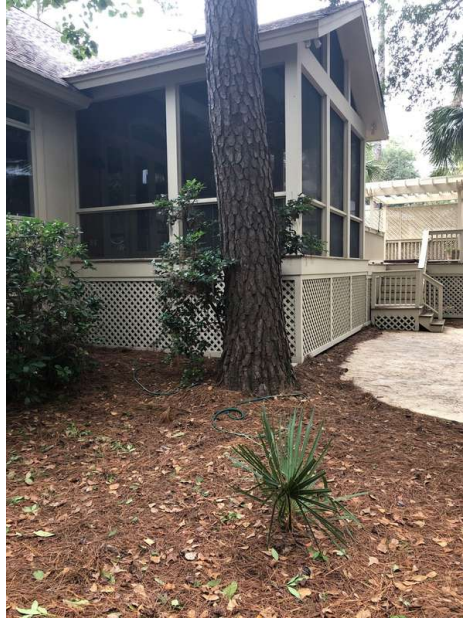
Trees were in contact with or were close to the building at one or more locations. Damage to the building can occur, especially during high winds. Recommend that a qualified tree service contractor or certified Arborist remove trees as necessary to prevent damage to the building exterior.

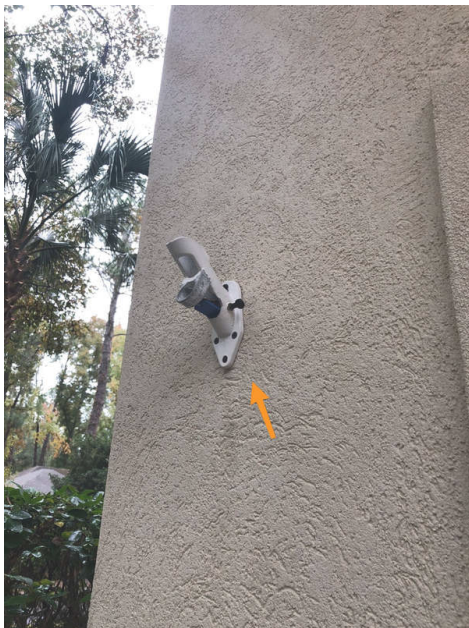
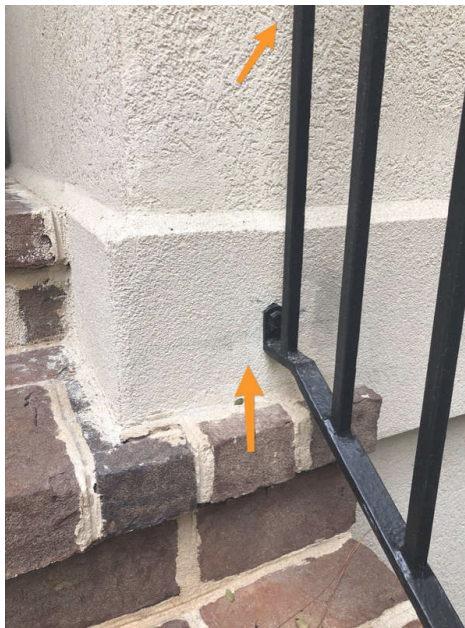
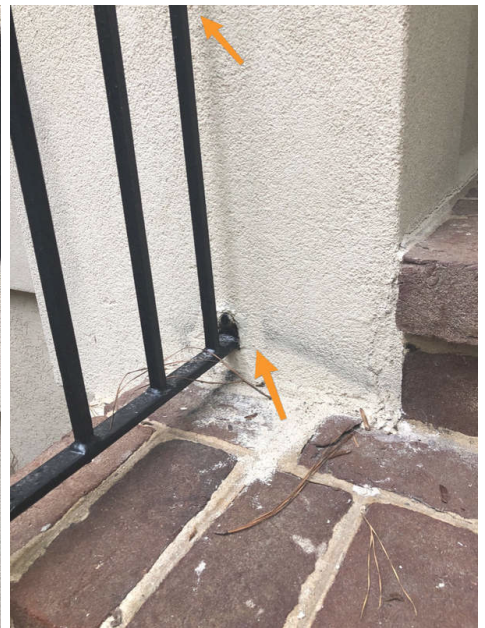
Front Porch

A penetration was not properly sealed. There are openings/gaps where water will enter the and get behind the stucco / EIFS causing deterioration. Recommend re-sealing the stucco at all penetrations to keep out moisture.

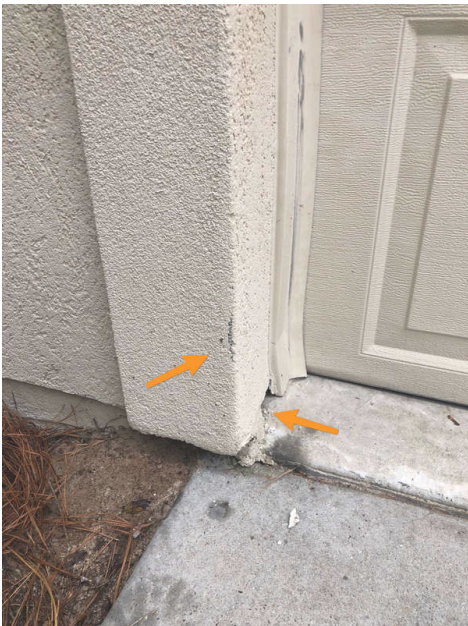
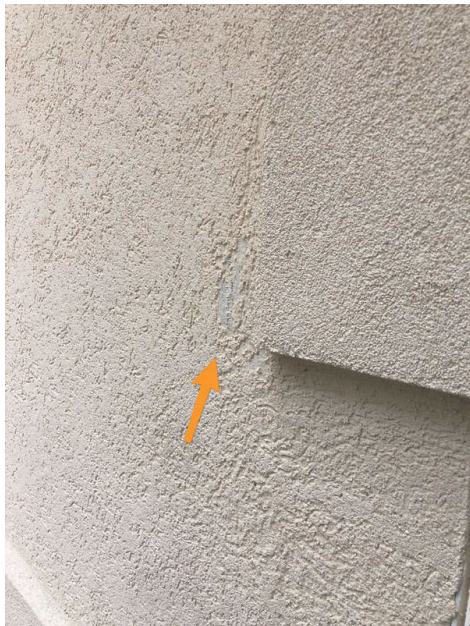
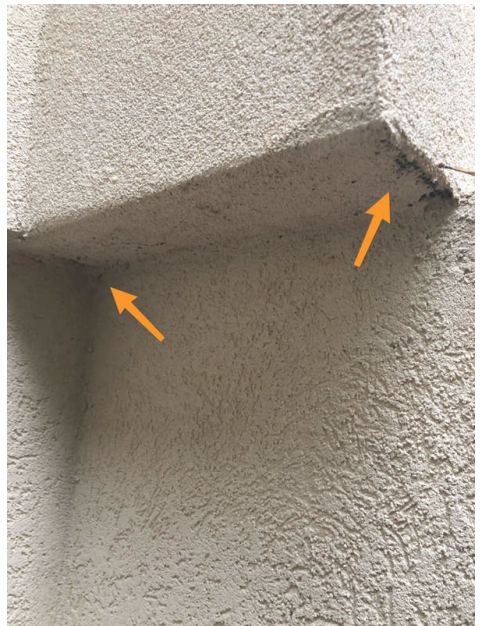
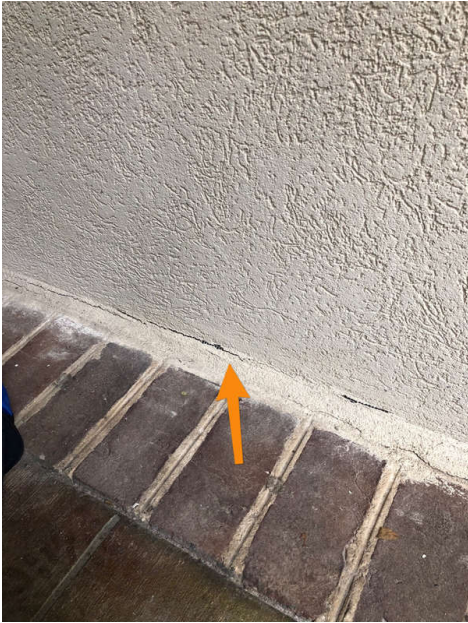
Front Porch

Stucco / EIFS covering exterior walls of the home had moderate visible damage that should be repaired to prevent possible moisture intrusion. All work should be performed by a qualified contractor.

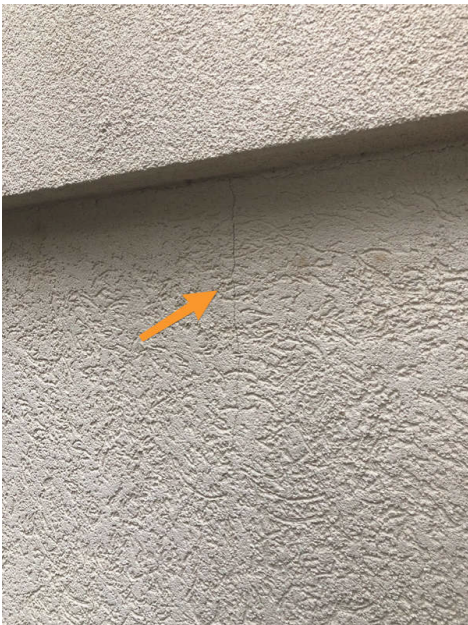
Right Side

Moderate localized cracking was observed in stucco / EIFS covering exterior walls of the home. This type of cracking, called "thermal cracking" is typically caused by stucco expansion and contraction that occurs with changes in temperature, made worse over time by exposure to freezing moisture. Cracks exceeding 1/16-inch in width should be filled with an appropriate material to minimize future damage.

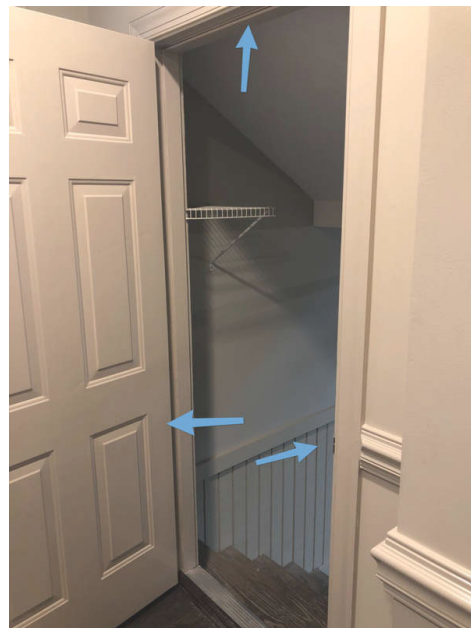
Door was missing standard weatherstripping. This can result in significant energy loss and moisture intrusion.

[Here is a DIY guide on weatherstripping.](#)

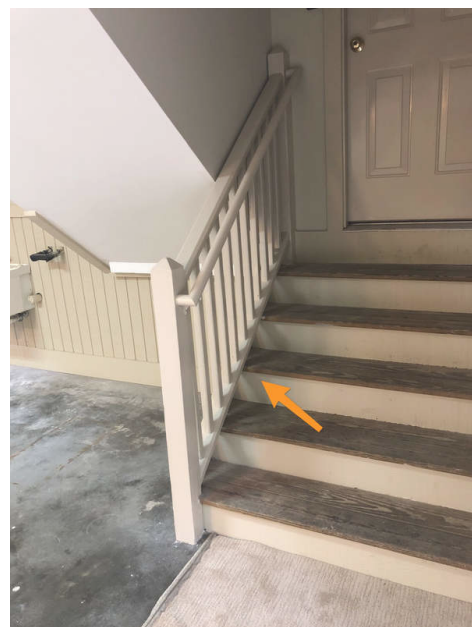
Garage

HANDRAIL - LOOSE

The garage handrail was loose and needed re-fastening. This condition is a potential fall hazard. All corrections should be made by a qualified contractor.

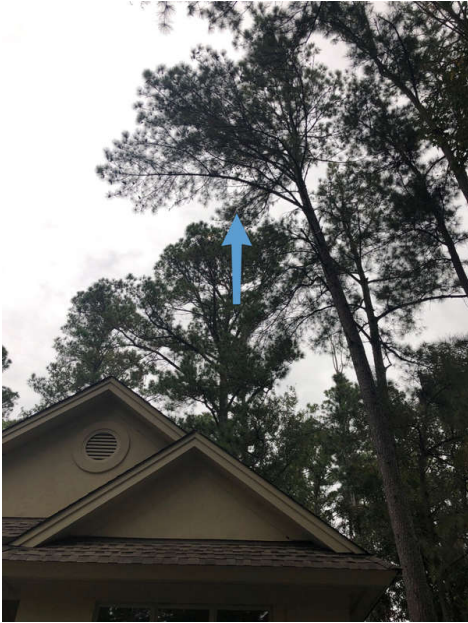
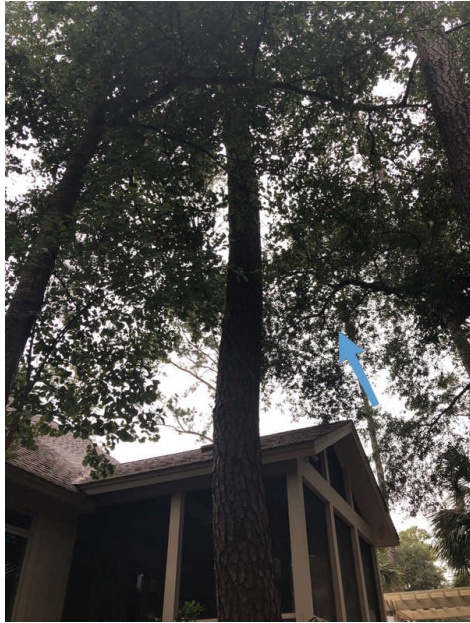
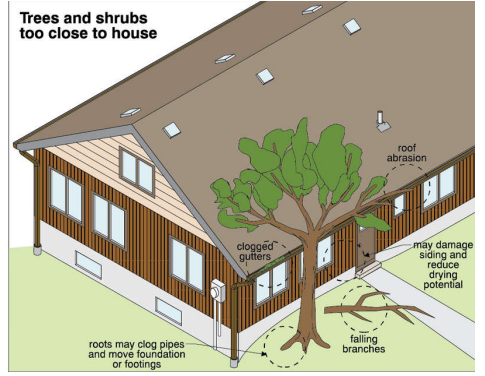
Large trees near the house have limbs that overhang the home. Falling limbs due to conditions such as wood decay, high winds or heavy snow loads may cause injury or damage. Consider having these trees evaluated by a qualified arborist.

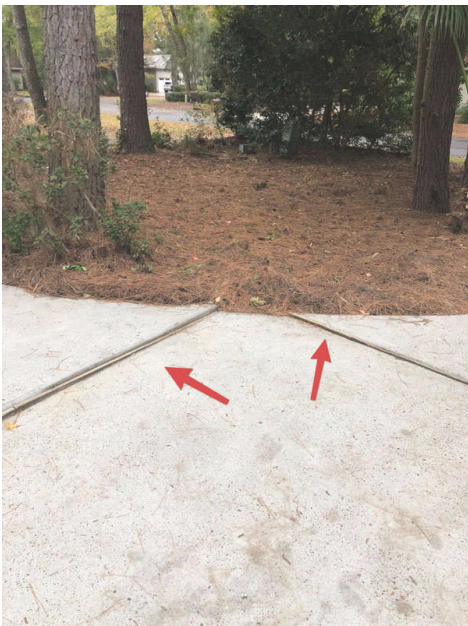
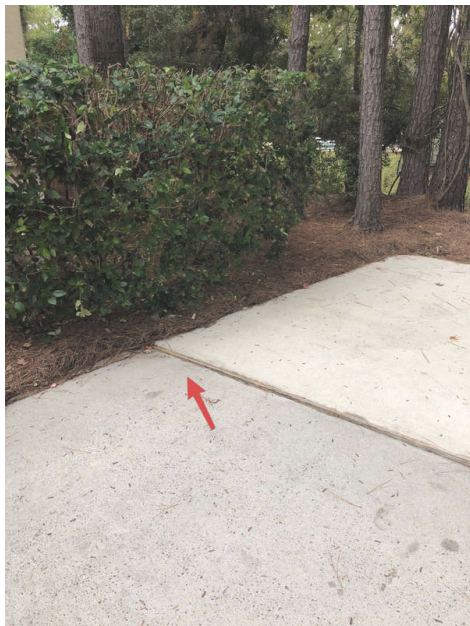
DRIVEWAY - UPHEAVAL

Trip hazards in the driveway appeared to be the result of the expansion or contraction (heaving or settling) of underlying soil.

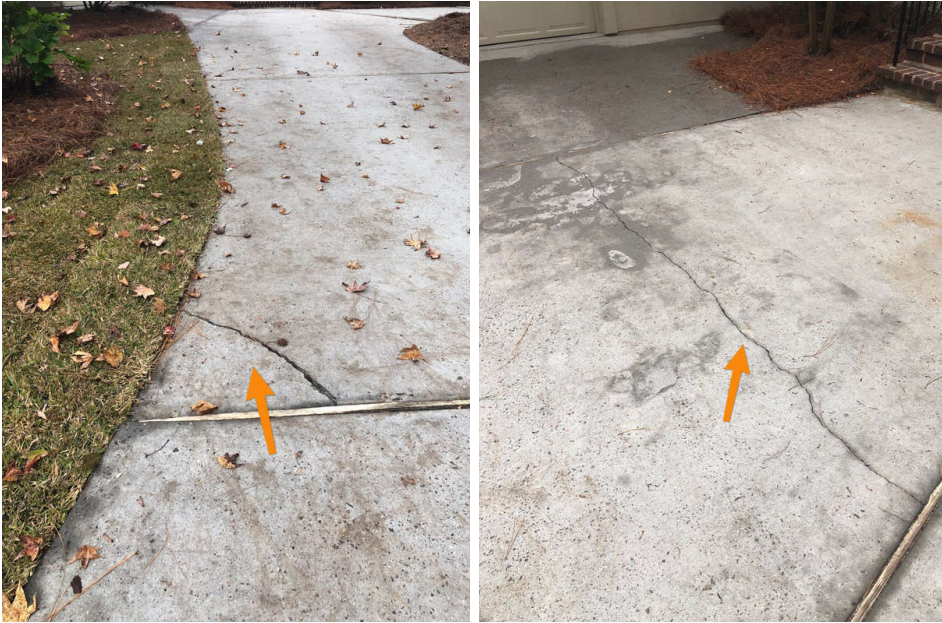
DRIVEWAY - SIGNIFICANT CRACKING

Significant cracks were observed in the driveway and should be filled with an appropriate material to avoid continued damage to the driveway surface.

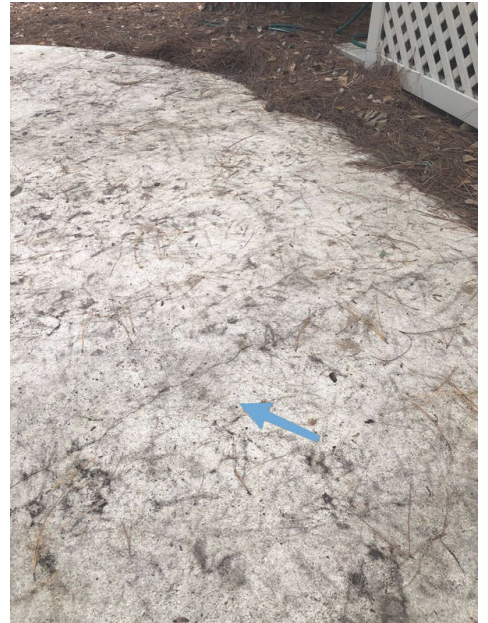
Rear

Normal settling & cracking observed at the patio. Recommend monitor and/or patch/seal.

[Here is a helpful article](#) on repairing cracked patios.

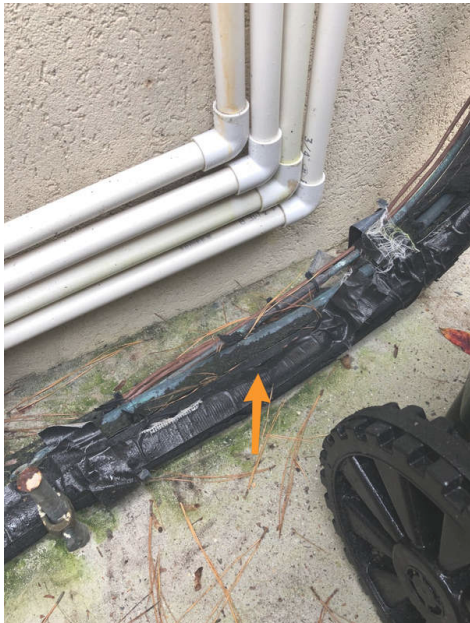
Front Left Side

Insulation on the air-conditioning suction (large, insulated) line was damaged or missing at areas, which can cause energy loss or condensation. Recommend both suction lines be repaired.

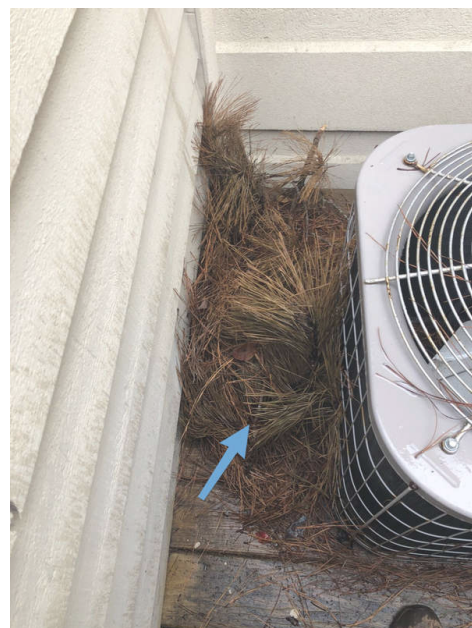
Central air systems should be cleaned and serviced annually. Recommend a qualified contractor clean, service and certify the outside unit (condensing coil, compressor, and/ or reversing valve) .

[Here is a resource](#) on the importance of central air systems maintenance.

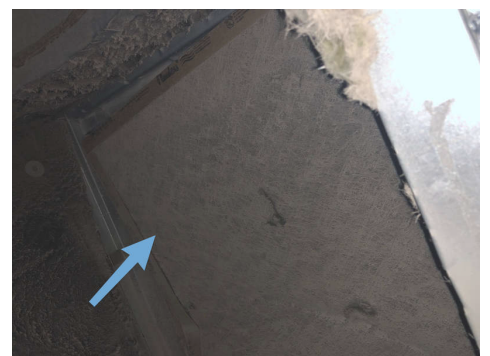
The air filter was beyond its expected lifespan. The purpose of the air filter is to remove dust and dirt from the air before it passes into the furnace where it can clog heat exchangers, air conditioner coils, ducts, and registers. Recommend replacement.

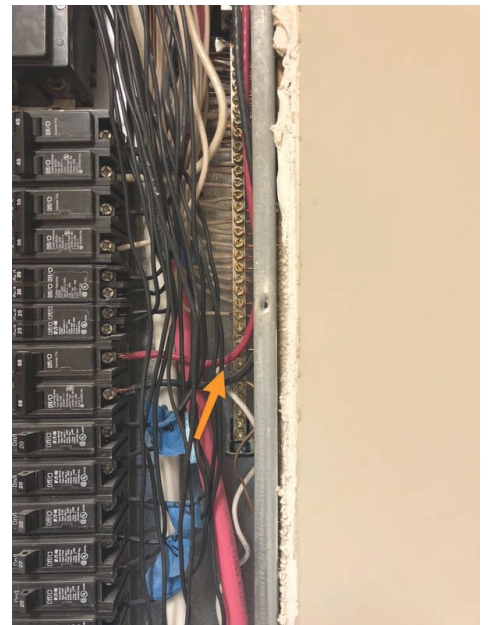
The grounding bus was not bonded to the distribution panel enclosure. Recommend repair by a qualified contractor.

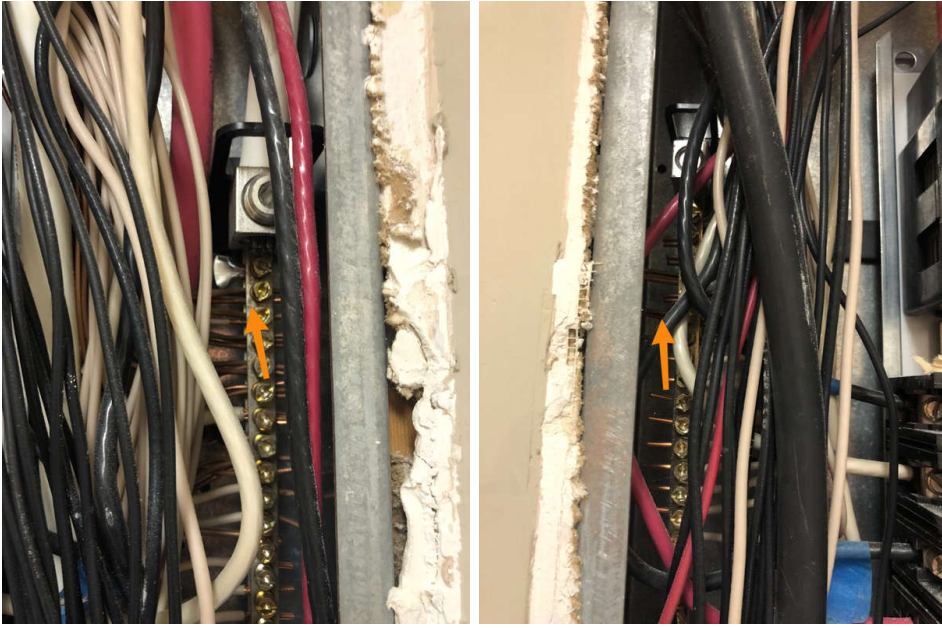
Grounding wires were doubled or bundled together on the grounding bus bar. This is unsafe as one of the ground wires could come loose from the lug, allowing the circuit to become ungrounded. A qualified electrician should evaluate and repair as necessary.

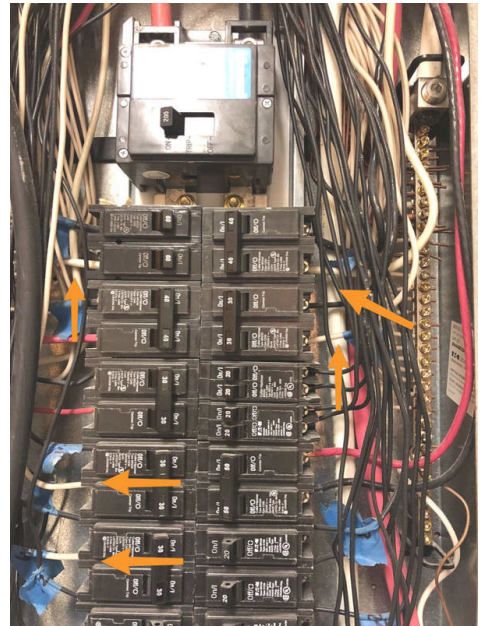
The neutral conductor was on a 240 volt (two-pole) circuit and was not permanently re-identified to indicate its use as an ungrounded "hot" conductor. It should be taped, typically using red or black tape (anything but white, green, or blue). Recommend correction by a qualified contractor.

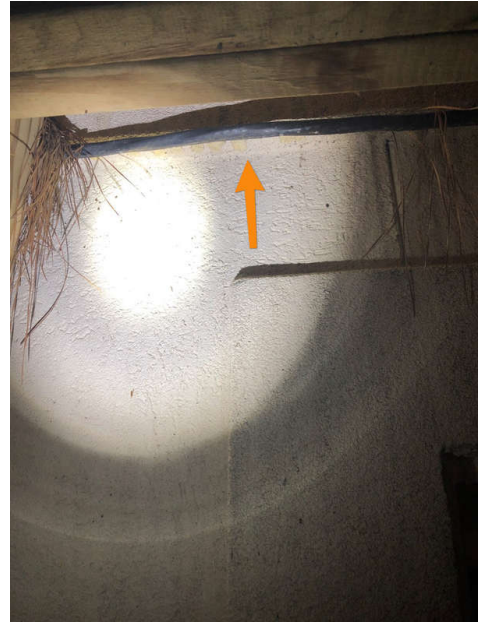
Rear Deck

One or more sections of outdoor wiring were exposed and not rated for exterior use. This is a potential shock hazard. Recommend that a qualified electrician repair per standard building practices (i.e. installing conduit, re-routing wires or replacing wiring).

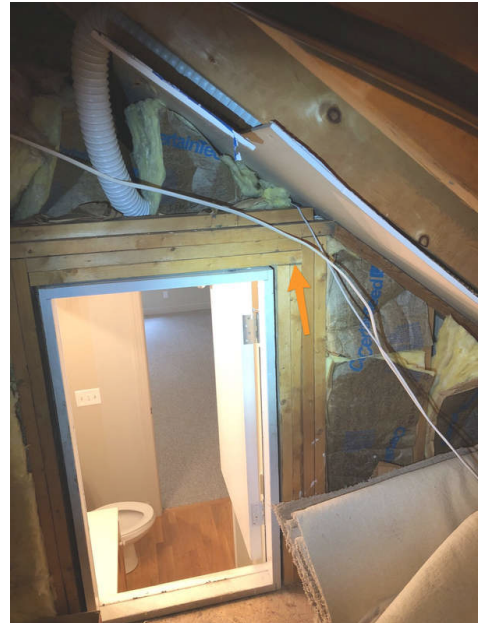
Attic wiring was not secured to joists. Recommend a qualified electrician properly secure all loose wiring to floor joists per standard building practices.

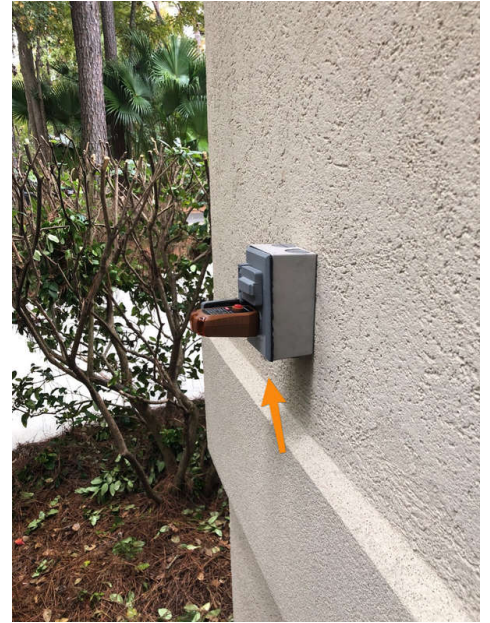
An electrical receptacle was inoperable at the time of the inspection. Recommend that an evaluation and any necessary corrections or repairs be performed by a qualified electrical contractor.

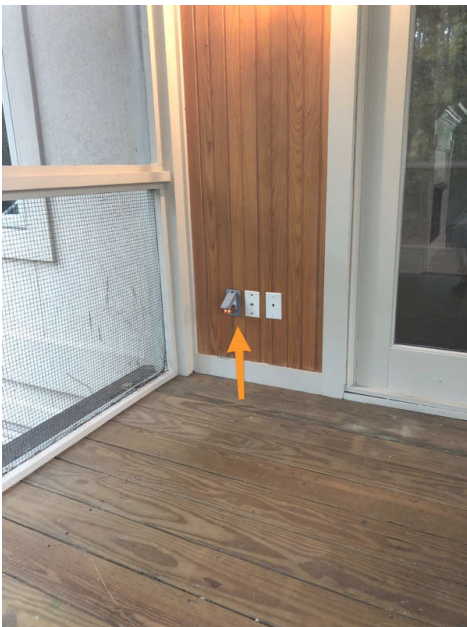
Rear Deck

No ground fault circuit interrupter (GFCI) was present in one or more areas inside and outside of the home. Recommend a licensed electrician upgrade outlets by installing GFCI receptacles located within 6 feet of a water source or in damp locations.

[Here is a link](#) to read about how GFCI receptacles keep you safe.

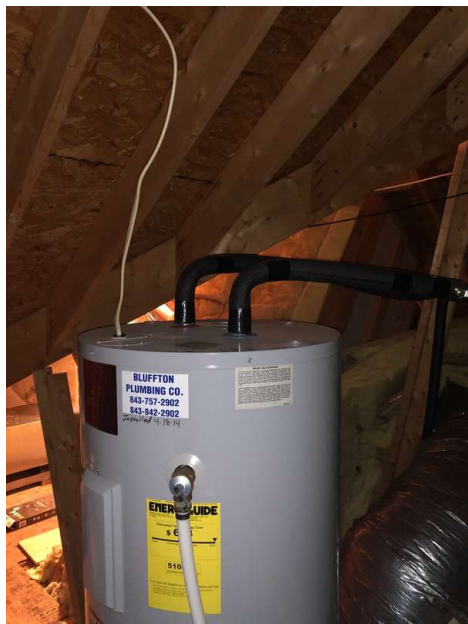
No expansion tank was present. Expansion tanks allow for the thermal expansion of water in the pipes. These have been required in certain areas for new installs or replacement since 2012. Recommend a qualified plumber upgrade the system and install.

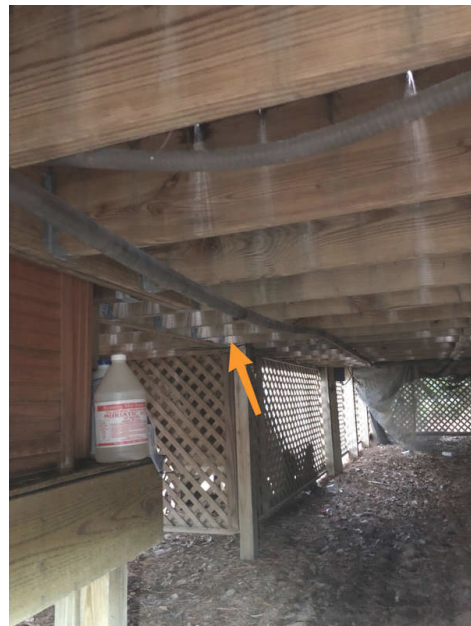
Rear Deck

Chlorinated Poly Vinyl Chloride (CPVC) water distribution pipes were poorly supported. This condition puts excessive strain on fittings and may result in premature failure. Horizontally-oriented CPVC supply pipes should be supported at least every 3 feet. Recommend installation of additional supports by a qualified contractor.

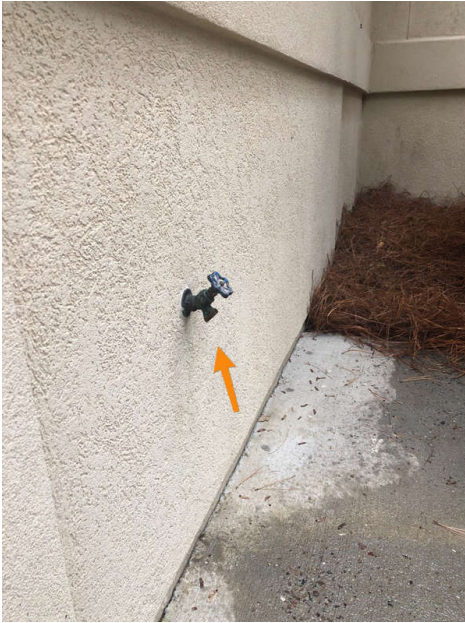
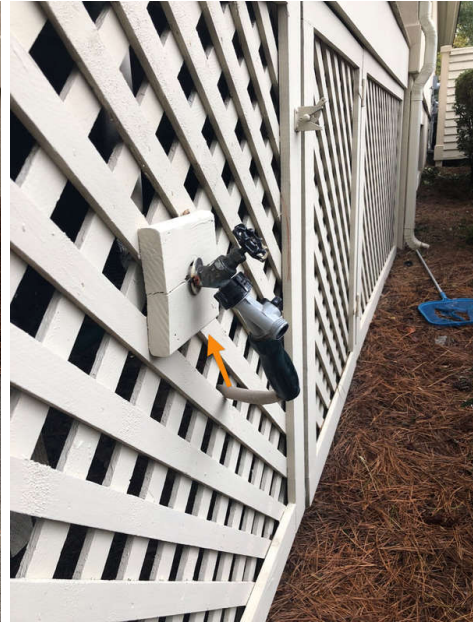
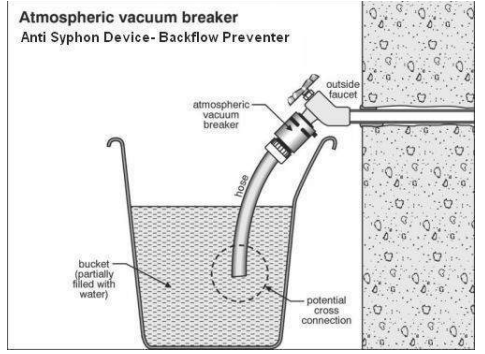
Rear Left Side

Install anti-siphon devices on exterior hose bibbs to prevent cross contamination into the house's drinking water. Recommend installation by a qualified contractor.

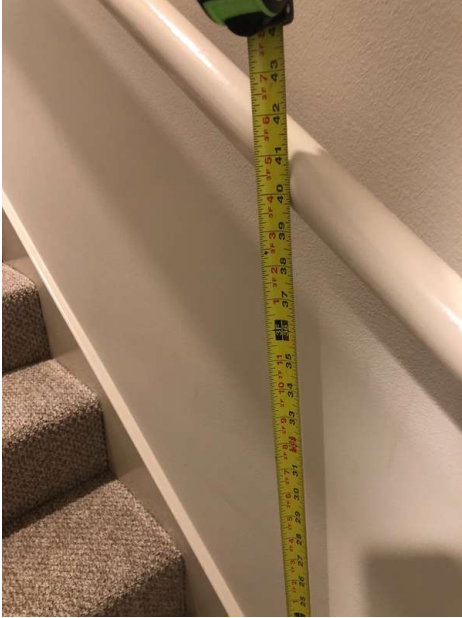
Handrails at one or more flights of stairs were not continuous or did not extend the full length of the stairs.

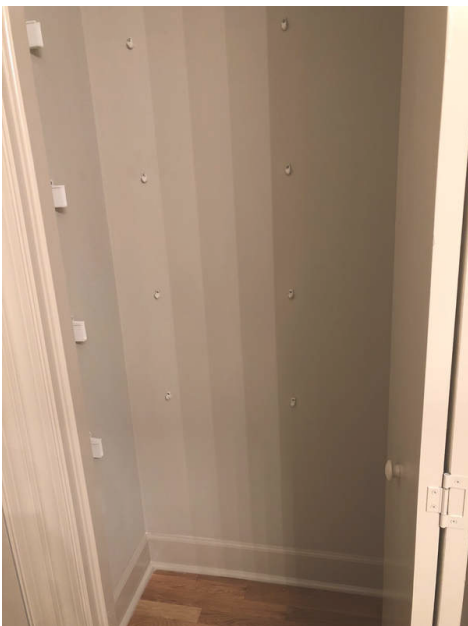
2nd Floor Bathroom

CLOSET SHELF - MISSING

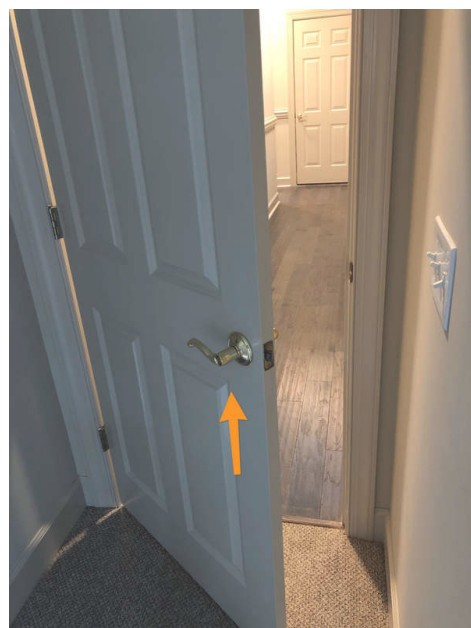
Lockset was not operating properly and should be adjusted or replaced as need.

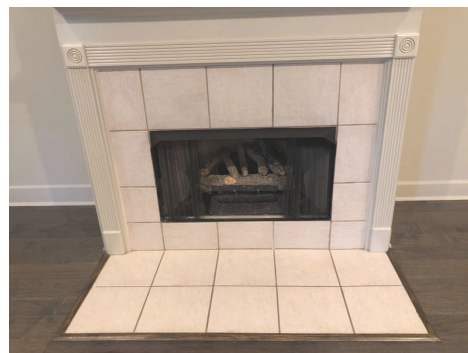
FIREPLACE - INOPERABLE

The gas fireplace was not functioning at the time of the inspection and should be serviced by a qualified contractor.

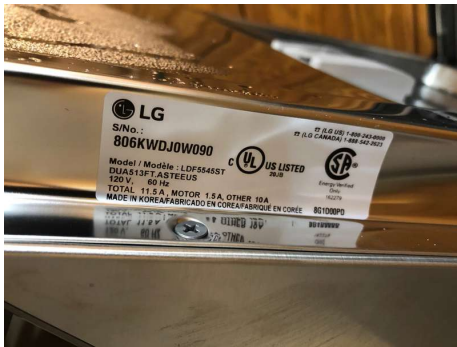
Dishwasher: Brand

LG

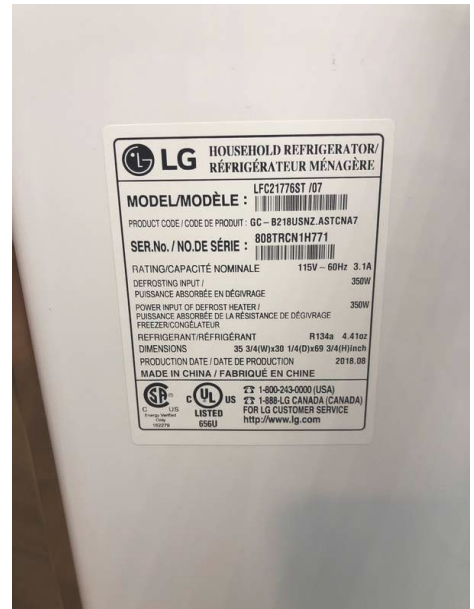
Refrigerator: Brand

LG

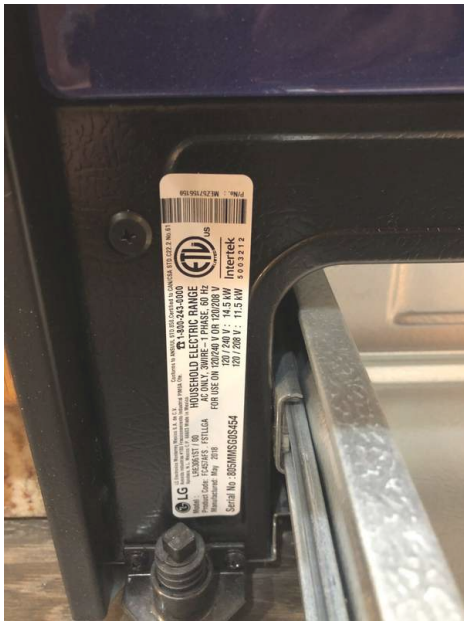
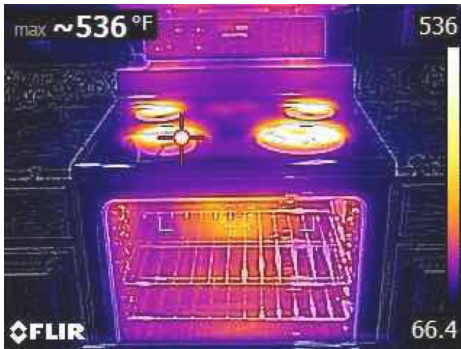
Range/Oven/Cooktop: Range/ Oven Information

The range/ oven/ cooktop was operated and appeared to be in serviceable condition at time of inspection unless otherwise noted in the report below.

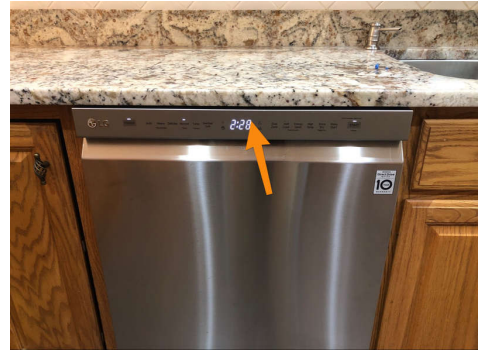
Kitchen

The dishwasher door was difficult to open and close, and is need of adjustment.

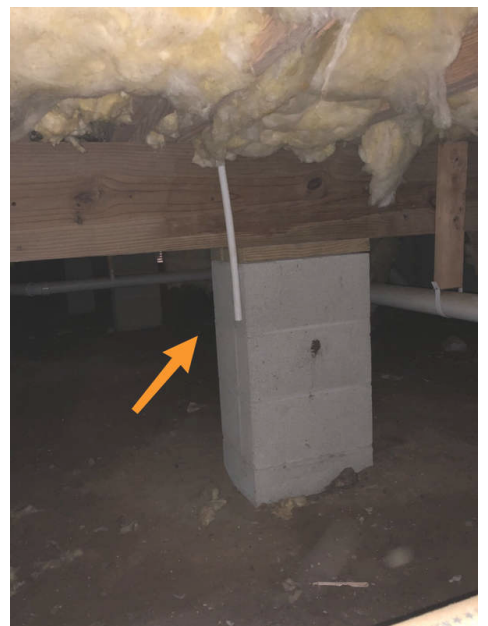
12.4.1 Crawlspace Ventilation
TPR VALVE - IMPROPER DISCHARGE

The temperature-pressure relief valve was routed to empty into the crawl space. Water may accumulate in the crawlspace if the valve develops a leak. A qualified plumber should re-route the drain to the outside.

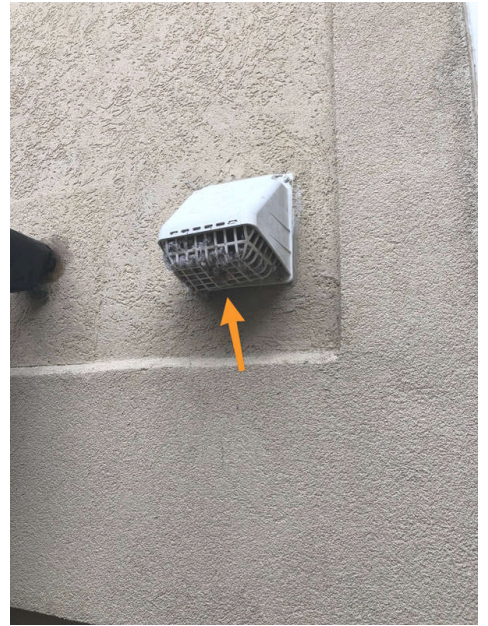
Front Left Side

The clothes dryer exhaust duct appears to need cleaning. Significant amounts of lint build up was found. This is a safety hazard due to the risk of fire from decreased air flow. This duct should be cleaned now and at least annually in the future.

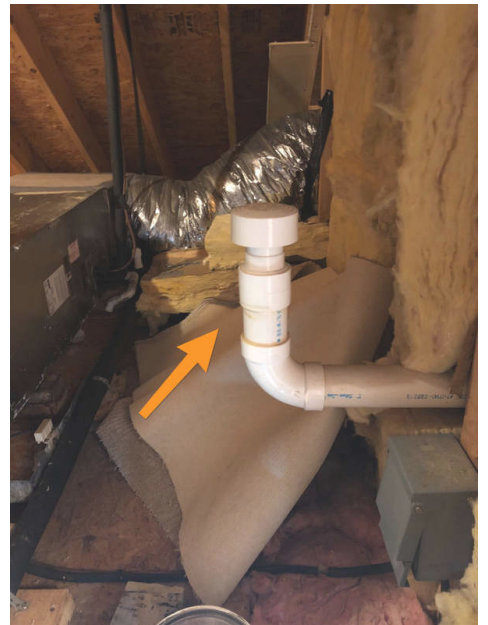
Attic

A bathroom plumbing vent terminated in the attic instead of at the home exterior. This condition can raise moisture vapor levels in the attic to the point at which home materials are damaged or unhealthy conditions related to mildew develop. Recommend correction by a qualified contractor.
