## RESIDENTIAL REPORT

1234 Main St.  
FISHERS IN 46037

Buyer Name  
02/25/2019 9:00AM

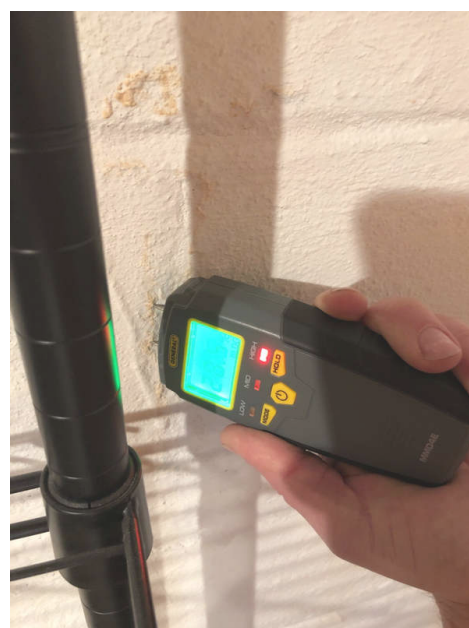
Northeast storage room

**HIGH MOISTURE LEVELS**

High levels of moisture were noted in areas of the basement. Recommend finding source of moisture intrusion and making necessary repairs to prevent damage or further damage to the structure.

Contact a qualified professional.

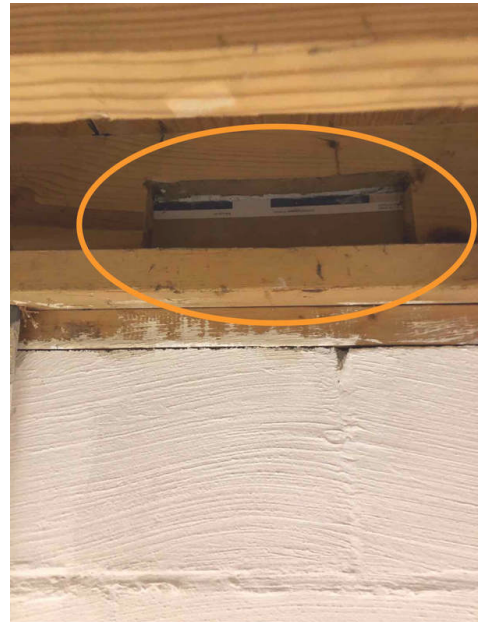
Northwest work room North wall

**EXCESSIVE NOTCHING**

Excessive notching was noted on a structural member of the floor. This could weaken the floor in this area. Recommend qualified professional to make necessary repairs to ensure stability.

Contact a qualified professional.

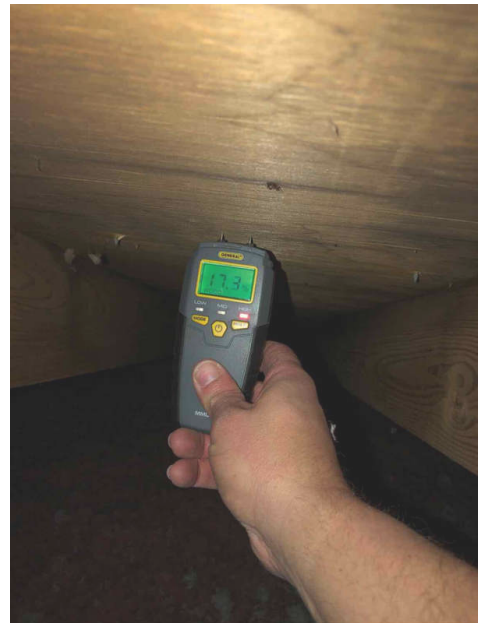
Attic

**HIGH MOISTURE LEVELS**

High moisture levels were noted in the roof decking. This is potentially due to either a ventilation problem or a failure of the material covering the roof. Recommend qualified roofing professional for evaluation and repair.

Contact a qualified professional.

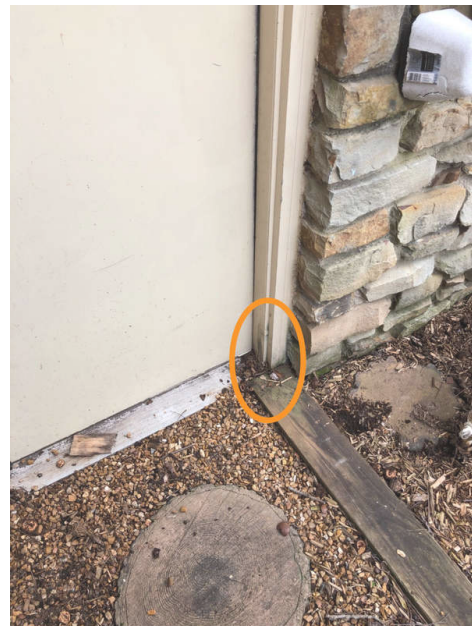
West lower door

#### WOOD ROT

Wood rot was noted in one or more places. Recommend qualified handyman to repair or replace all affected areas.

Contact a qualified handyman.

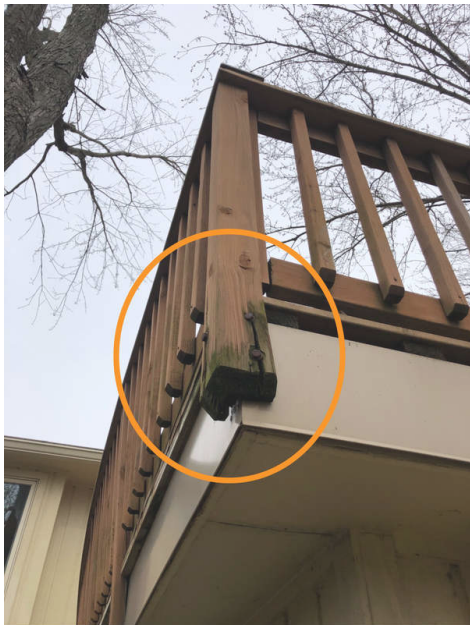
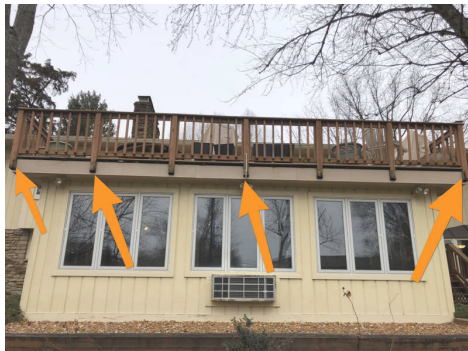
Southwest corner

#### DECK- WATER DAMAGE ON POSTS

Water damage was noted on the post(s). This could eventually lead to failure of the railing. Recommend qualified professional for repair.

Contact a qualified professional.

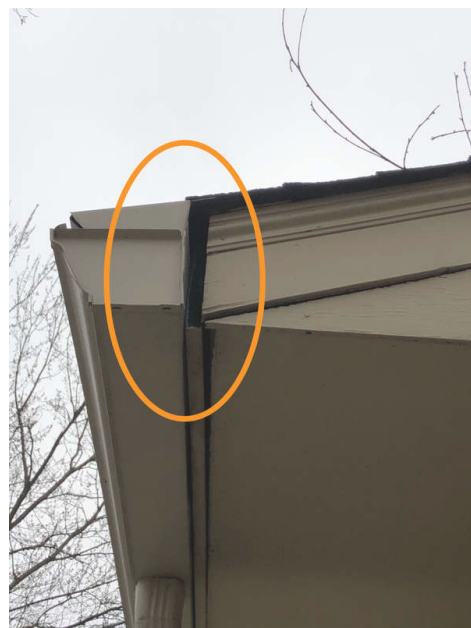
North Garage

**FASCIA - LOOSE**

One or more sections of the fascia are loose. This could lead to water penetration if not corrected. Recommend qualified professional to evaluate & repair.

Contact a qualified professional.

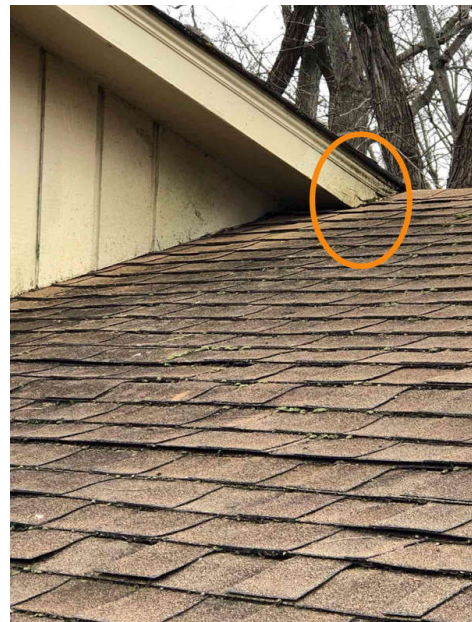
North center

**FASCIA - ROTTED**

One or more sections of the fascia are rotted. Recommend qualified professional evaluate & repair.

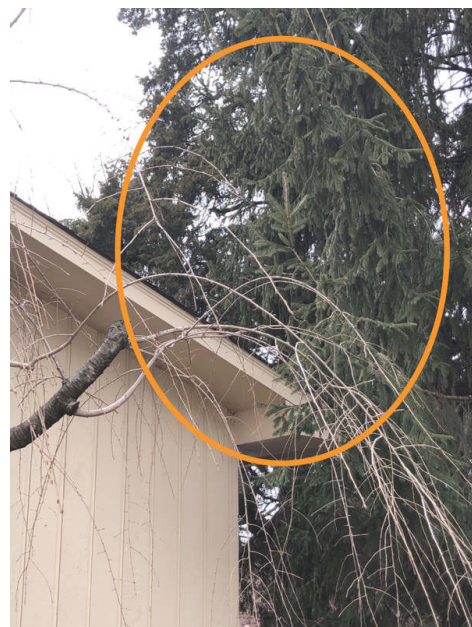
West Garage

**TREE OVERHANG**

Trees observed overhanging the roof. This can cause damage to the roof and prevent proper drainage. Recommend a qualified tree service trim to allow for proper drainage.

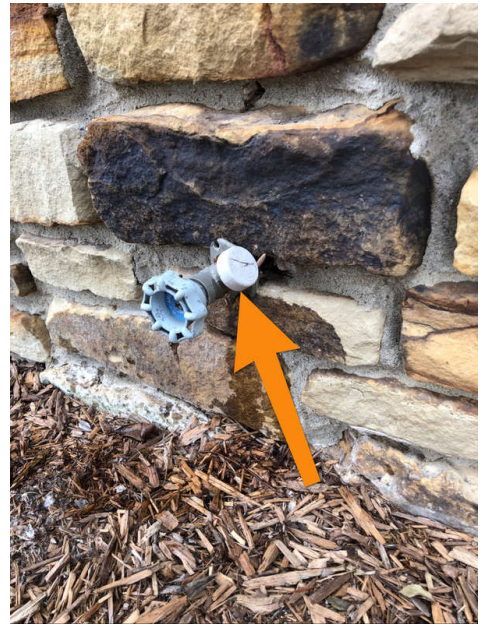
North

**FAUCET-LEAKING**

Exterior faucet was leaking. Recommend qualified plumber for evaluation and repair.

Contact a qualified plumbing contractor.

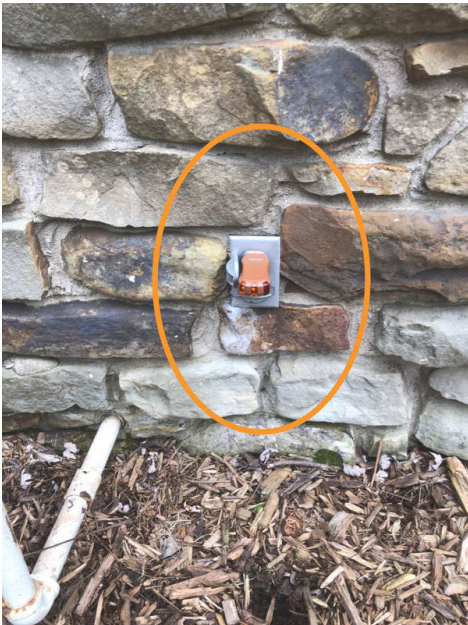
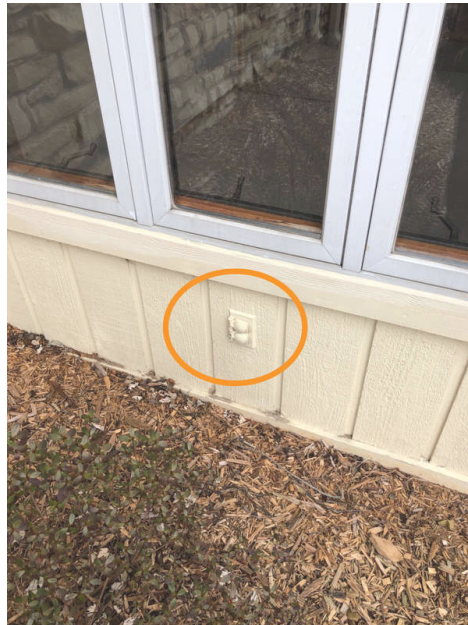
West

**NO GFCI PROTECTION**

Exterior outlet(s) were not GFCI protected. All exterior outlets should be GFCI protected for safety. Recommend qualified electrician for repair.

Contact a qualified electrical contractor.

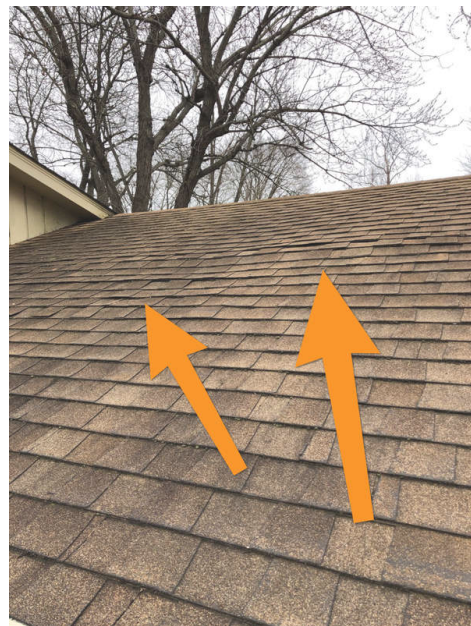
North above front door

#### DAMAGED COVERINGS

Roof coverings exhibited general damage that could affect performance. Recommend a qualified roofer evaluate and repair.

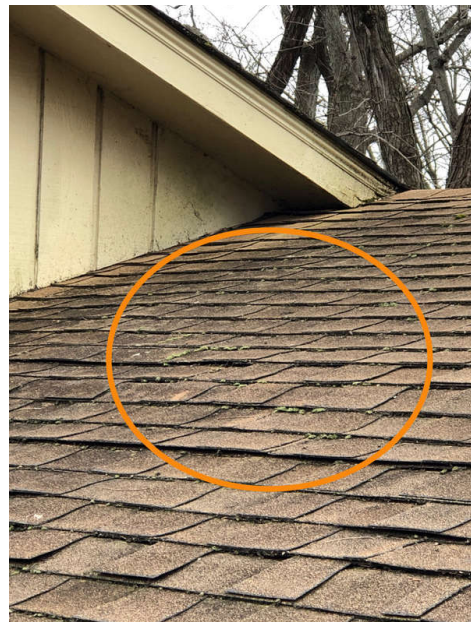
North

#### VEGETATION GROWTH

The growth of vegetation on the roof covering can lead to premature deterioration and water leaks. Recommend qualified professional to clean and regular maintenance is recommended.

Contact a qualified professional.

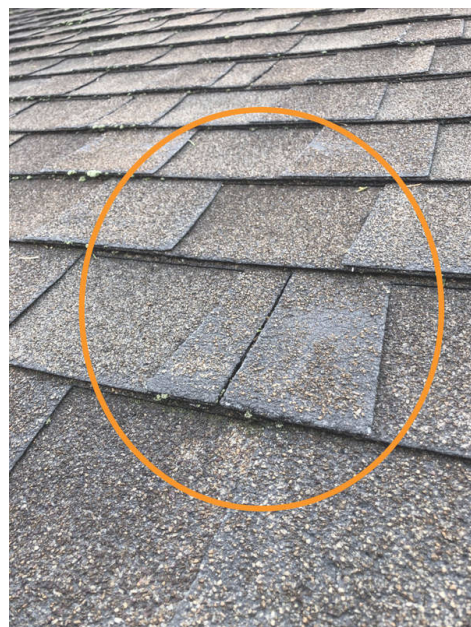
**AT OR NEAR DESIGN LIFE**

The roof covering is at or near its design life. Recommend monitoring for proper function and budgeting for replacement.

Recommend monitoring.

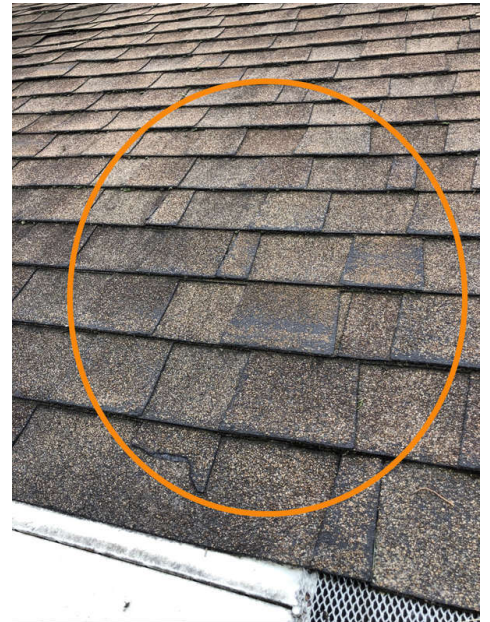
Several places

**EXCESSIVE GRANULAR LOSS**

There was excessive granular loss noted on the roof covering. This is an indication that the roof is near or at the end of its design life. Recommend qualified roofing professional for evaluation and repair.

Contact a qualified roofing professional.

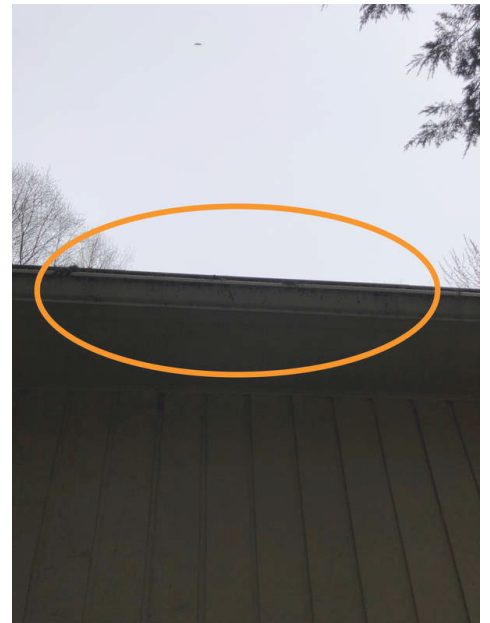
West Garage

**DEBRIS**

Debris has accumulated in the gutters. Recommend cleaning to facilitate water flow.

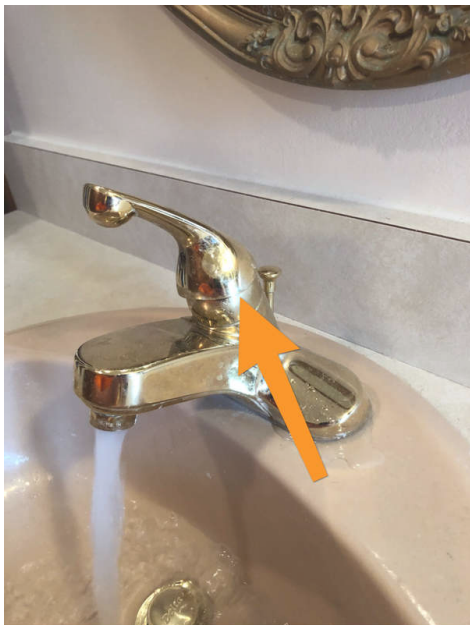
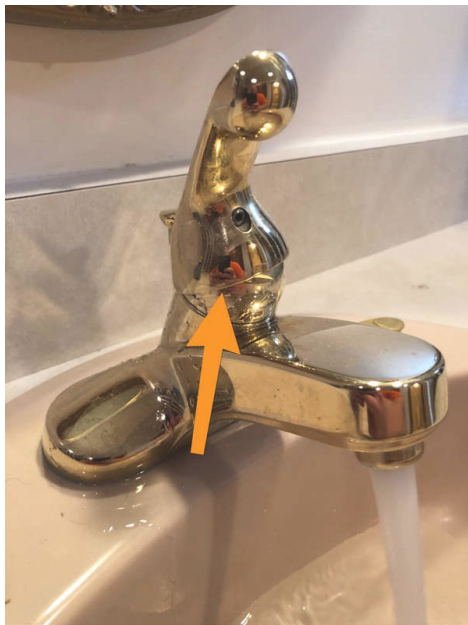
Master Bathroom left sink

#### FIXTURE LEAKING

A leak was noted coming from the plumbing fixture. Recommend qualified plumber for repair.

Contact a qualified plumbing contractor.

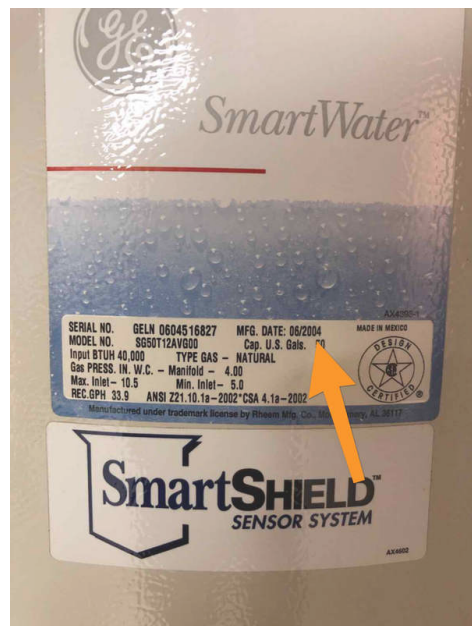
#### AT OR NEAR DESIGN LIFE

The water heater is at or near it's design life. The water heater functioned properly at the time of inspection. Recommend continued monitoring for proper function.

Recommend monitoring.

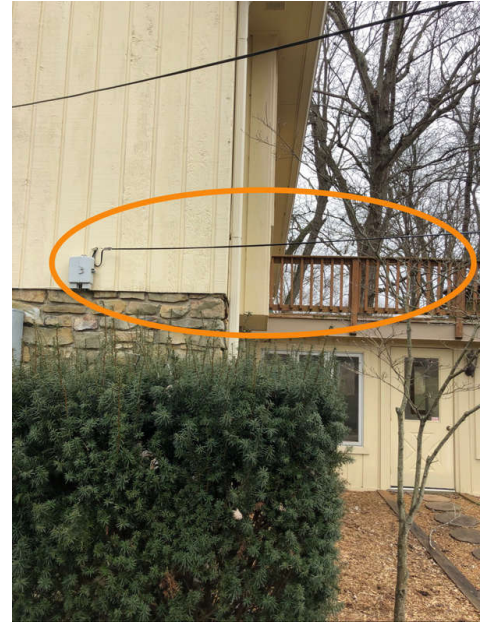
Southwest

**CABLE/PHONE WIRE**

The cable/phone wire is too low and could easily be grabbed. Recommend relocating the wire.

Contact a qualified professional.

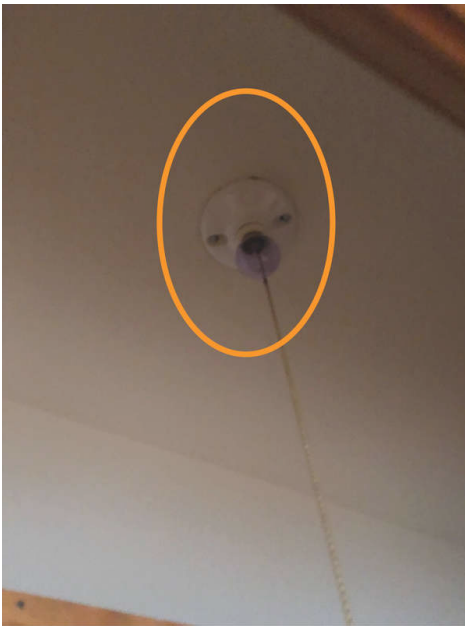
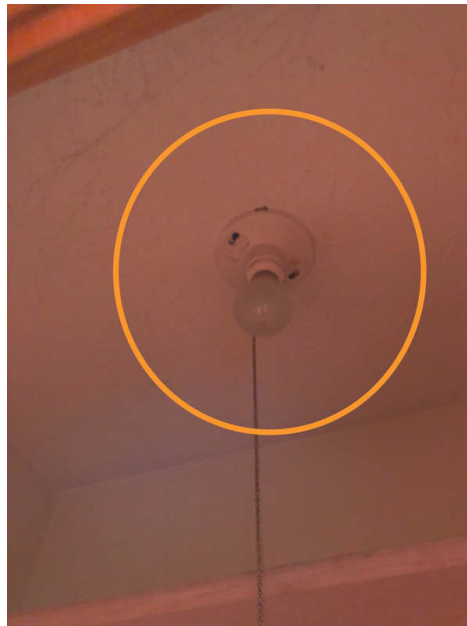
Northeast Bedroom closet

**LIGHT INOPERABLE**

One or more lights are not operating. New light bulb possibly needed.

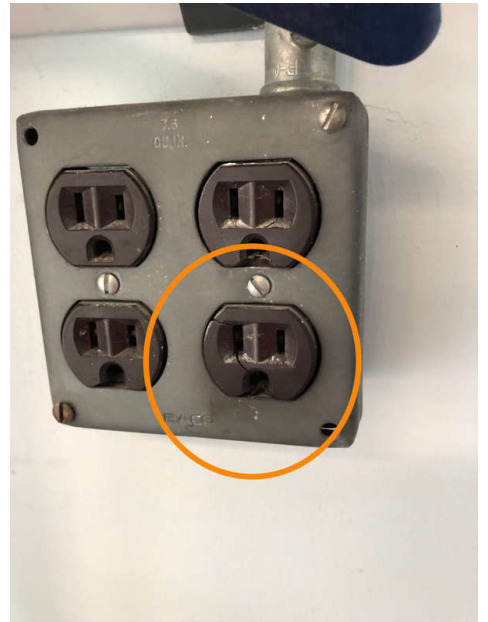
Garage

**OUTLET DAMAGED**

Outlet was damaged. This could eventually effect the performance of the receptacle. Recommend qualified electrician for replacement.

Contact a qualified electrical contractor.

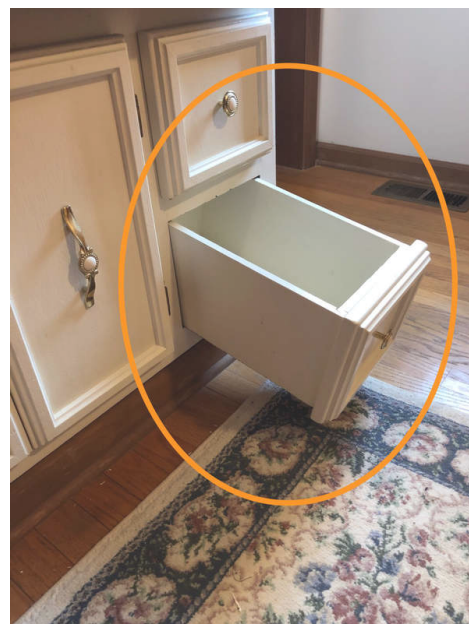
Master Bathroom

**DRAWER- BROKEN OR OFF TRACK**

A drawer was broken or off of the track. Recommend qualified professional for repair.

Contact a qualified professional.

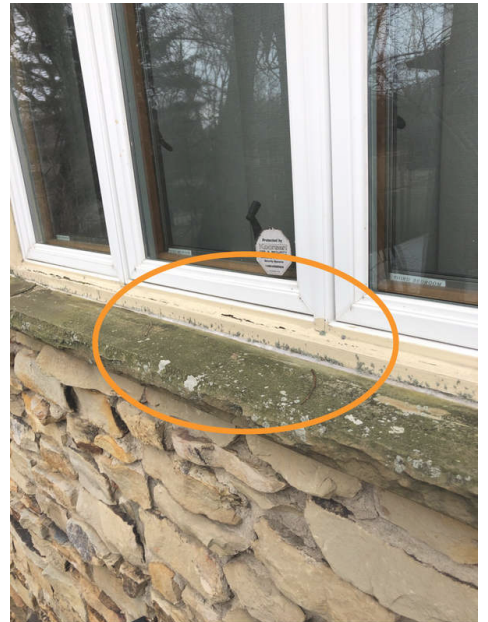
Northeast

**WOOD ROT**

Wood rot was noted on the exterior trim. Recommend repairing and replacing all affected materials.

Contact a qualified professional.

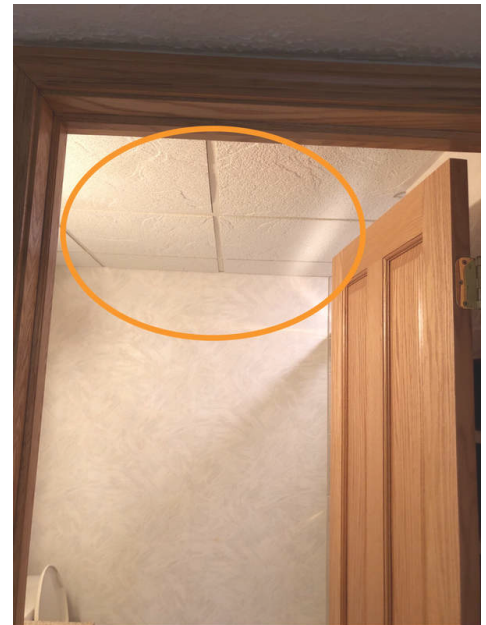
Basement Bathroom

### EXHAUST FAN

No exhaust fan. A bathroom needs either an exhaust fan or a window or both.

Contact a qualified professional.

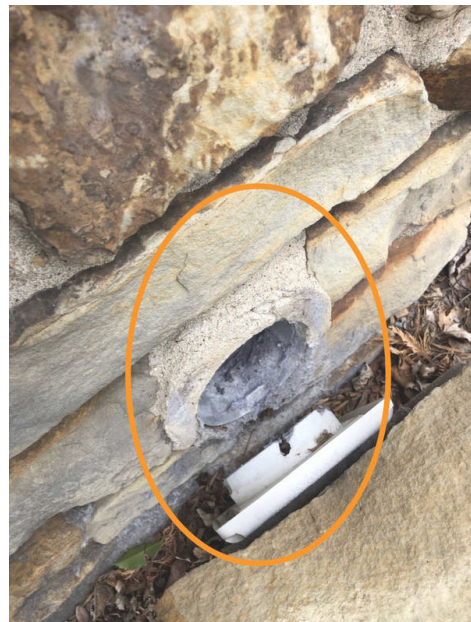
North

### COVER-LOOSE

Vent cover is loose. This can lead to insects and varmint intrusion. Recommend qualified handyman for repair.

Recommendation  
Contact a qualified professional.

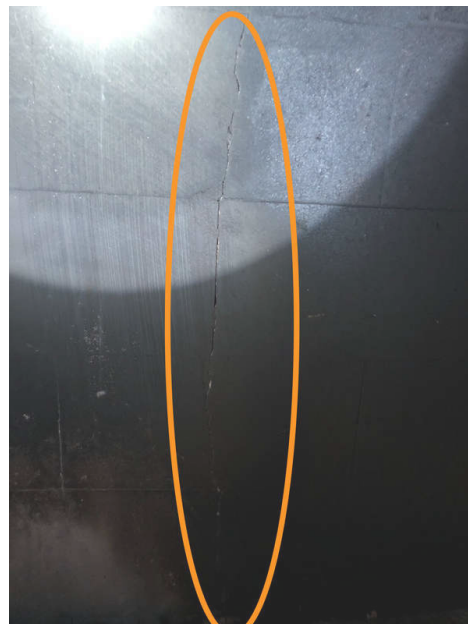
Fireplace

### FIREWALL CRACKED

The brick lining of the fireplace was cracked in one or more places, which could lead to chimney damage or toxic fumes entering the home. Recommend a qualified fireplace contractor evaluate and repair.
