## MOKAN HOME INSPECTIONS

### MOKAN NEW

1234 Main St.  
Blue Springs MO 64015

09/06/2018 9:00AM

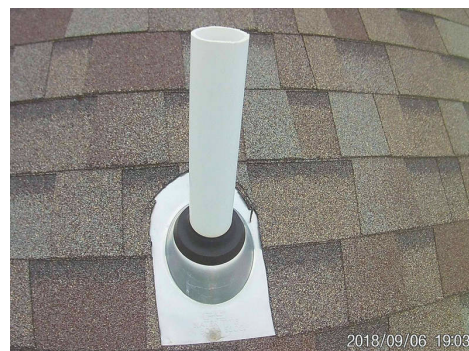
#### 2.3.1 Flashing/Vents

One or more plumbing vents on the roof do not have screens installed. This is a common practice. It is recommended to have screens installed at the top of plumbing vent stacks to reduce the chance of access to the plumbing system by small animals/rodents.

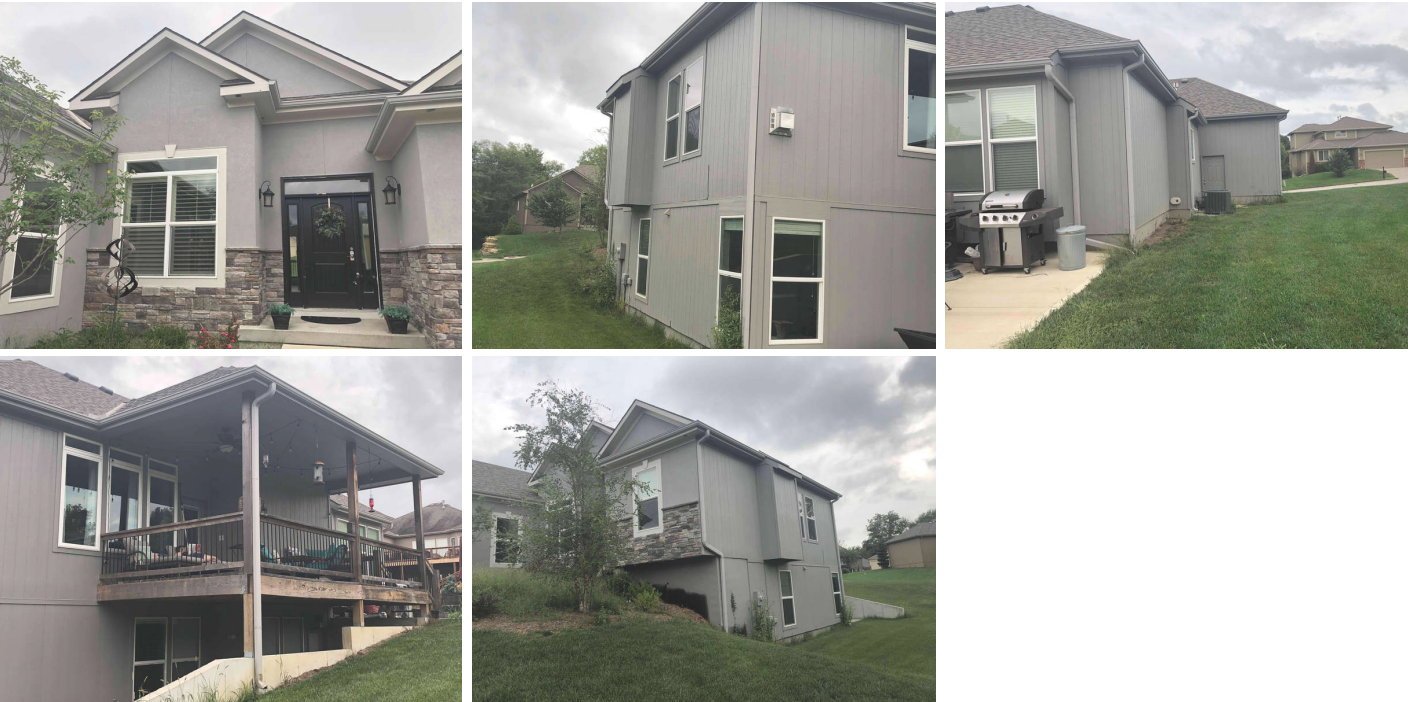
### General: Exterior Photos

General photos of the exterior for reference

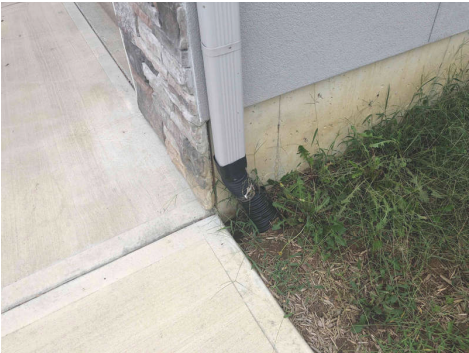
NORTHEAST GARAGE

Underground termination or operation can not be tested for operation or function.

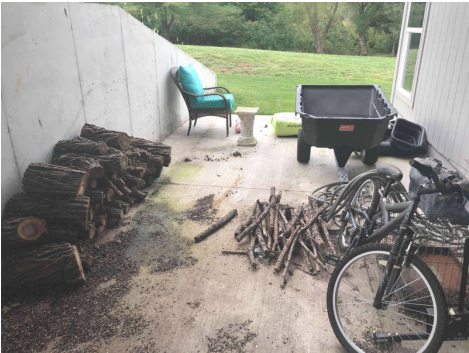
3.3.1 Exterior issues

Firewood was stored so that it was in contact with or close to the building exterior. This is a conducive condition for wood-destroying organisms. Recommend storing firewood outdoors in an open area, and as far away from buildings as practical to keep insects away from buildings.

Recommended DIY Project

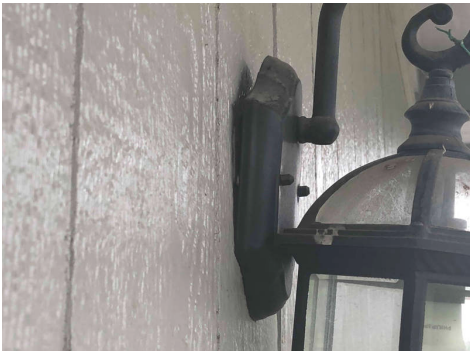
3.4.1 Electrical

NO CAULK LIGHT

One or more wall-mounted exterior light fixtures had no caulk or deteriorated sealant at the back plate. Water can enter the space behind the back plate and contact wiring. Recommend that a qualified person apply caulk above and around the back plate per standard building practices. A gap should be left at the bottom of the plate so that condensation can drain out.

Recommendation  
Contact a handyman or DIY project

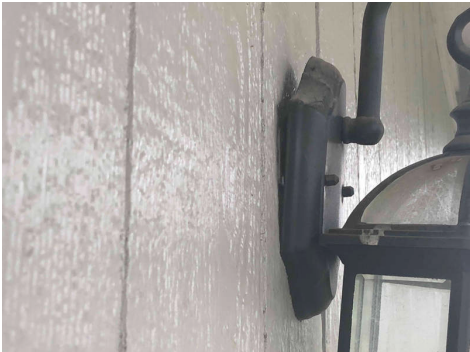
3.4.2 Electrical

**LIGHT LOOSE/SUBSTANDARD**

One or more light fixtures are loose or installed in a substandard way. A qualified contractor or electrician should evaluate and make repairs as necessary so light fixtures are securely mounted and installed in accordance with the manufacturer's installation instructions.

Recommendation  
Contact a qualified electrical contractor.

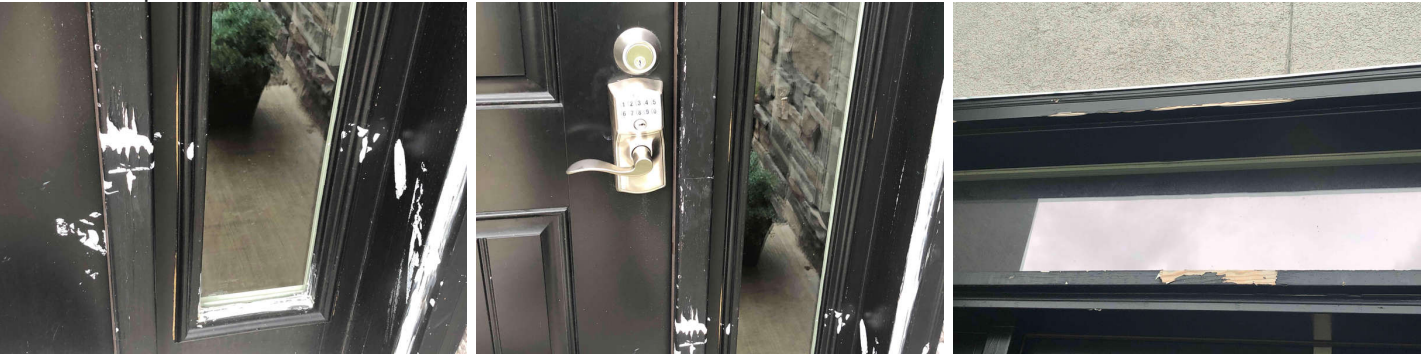
3.5.1 Windows and Door

**DOOR DAMAGE/DETERIORATION**

One or more exterior doors had minor damage and/or deterioration. Although serviceable, the client may wish to repair or replace such doors for appearances' sake and to help prevent future deterioration.

Recommendation  
Contact a qualified professional.

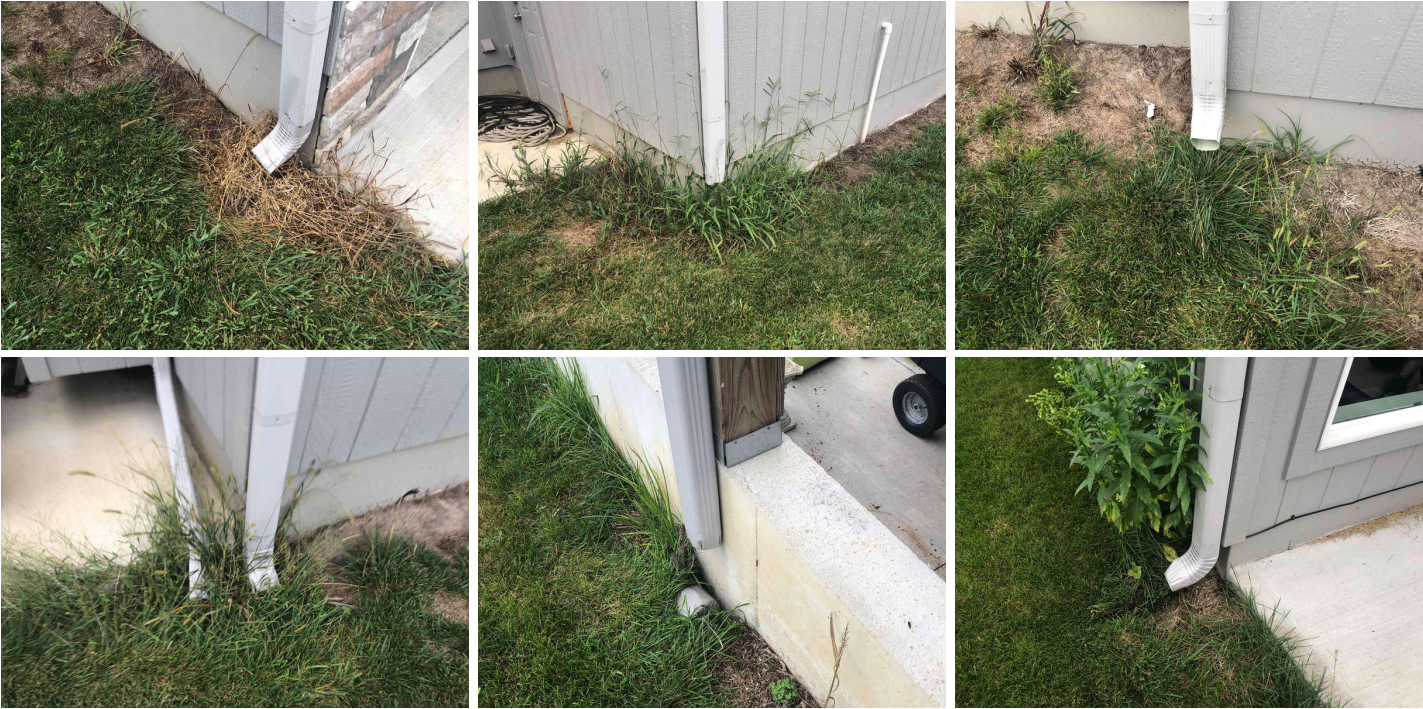
3.7.1 Gutters and Flashing

**DOWNSPOUT EXTENSIONS**

Extensions such as splash blocks or drain pipes for one or more downspouts were *missing / poorly sloped / misaligned / clogged / substandard / damaged*. Water can accumulate around the building foundation or inside crawl spaces or basements as a result. Recommend that a qualified person install, replace or repair extensions as necessary so rainwater drains away from the structure.

Recommendation  
Contact a qualified professional.

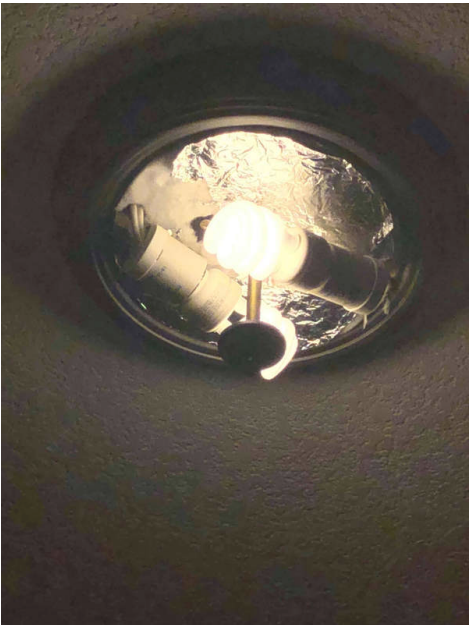
**LIGHT FIXTURE-OPEN LAMP**  
PANTRY  
Lamp holders or light fixtures with fully or partially exposed bulbs are installed in one or more closets. This is a safety hazard due to the risk of fire. Flammable stored items may come into contact with hot bulbs, and hot fragments from broken bulbs may fall on combustible materials. Standard building practices require closet lighting to use fluorescent light fixtures, or to use fully enclosed incandescent fixtures. Installing a compact fluorescent lamp in a lamp holder is not an acceptable practice. A qualified electrician should replace closet lights as necessary and as per standard building practices.  
Recommendation  
Contact a qualified electrical contractor.

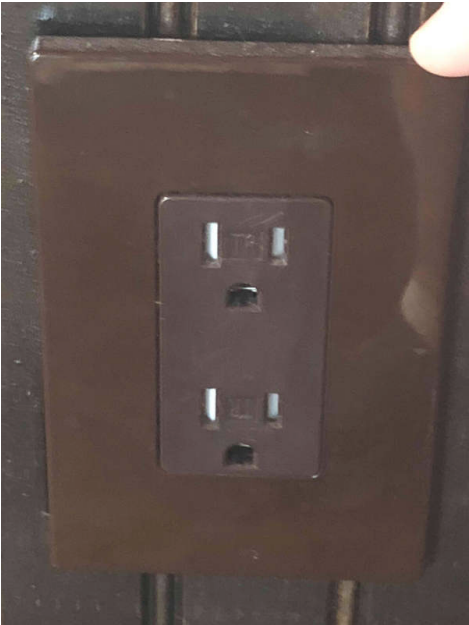
4.1.2 Electrical

**LOOSE PLUG/COVER**  
KITCHEN ISLAND  
One or more electric receptacles and/or the boxes in which they were installed were loose and/or not securely anchored. Wire conductors can be damaged due to repeated movement and/or tension on wires, or insulation can be damaged. This is a shock and fire hazard. Recommend that a qualified electrician repair as necessary.  
Recommendation  
Contact a qualified electrical contractor.

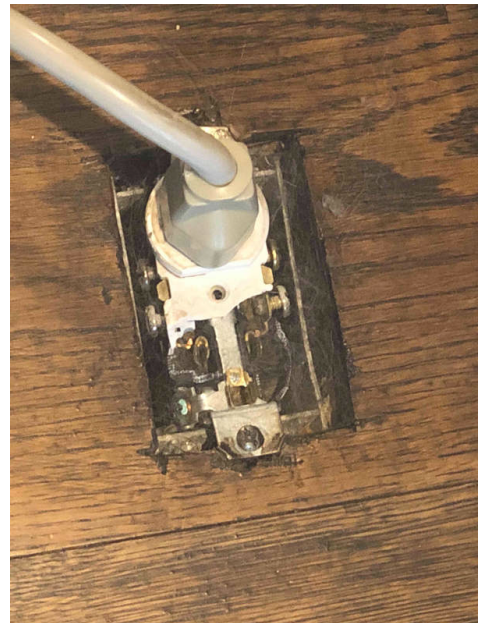
## 4.1.4 Electrical

**RECEPTACLE DAMAGE**

One or more receptacles were broken or damaged. This is a potential shock or fire hazard. Recommend that a qualified electrician replace such receptacles as necessary.

Contact a qualified electrical contractor.

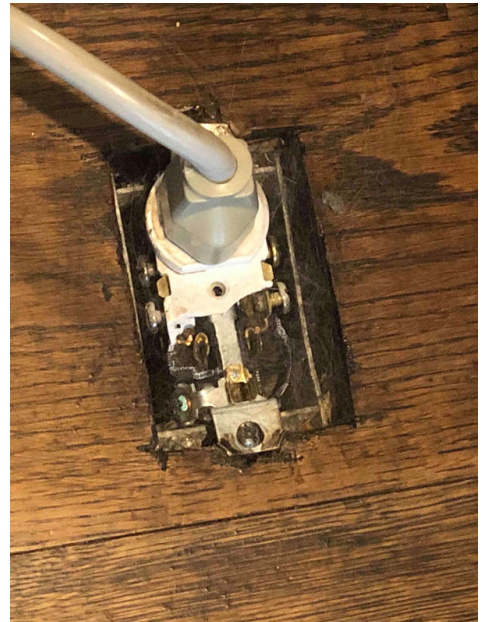
## 4.1.5 Electrical

**COVER PLATE MISSING**

Cover plate(s) are missing from one or more electric boxes, such as for receptacles, switches and/or junction boxes. They are intended to contain fire and prevent electric shock from exposed wires. This is a safety hazard due to the risk of fire and shock. Cover plates should be installed where missing.

Contact a qualified electrical contractor.

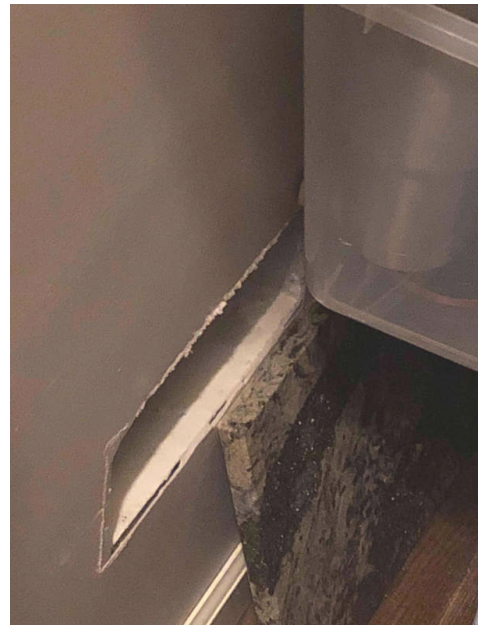
#### 4.2.1 Floors, Walls, Ceilings

### REGISTERS MISSING

One or more air supply registers are missing. The air flow cannot be controlled as a result. Registers should be installed where missing.

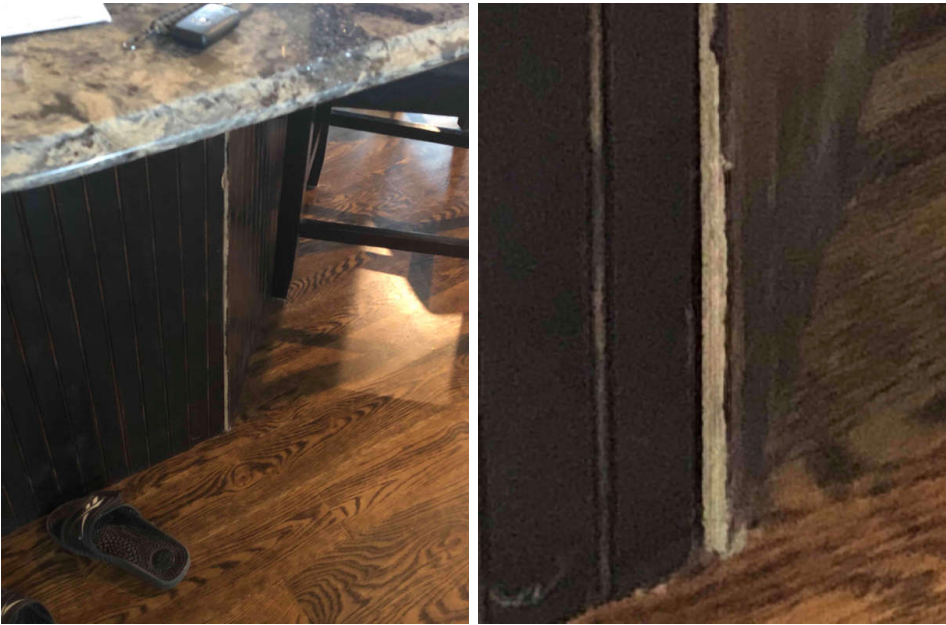
#### 4.2.2 Floors, Walls, Ceilings

### TRIM MISSING

Trim is missing in one or more areas. Recommend having a qualified contractor install trim where missing.

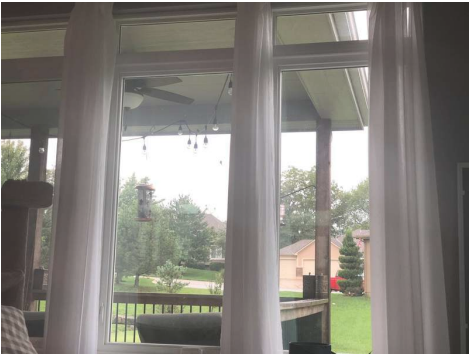
4.4.1 Windows and Door

**WINDOW-SCREENS MISSING**

Screen(s) in one or more windows are missing. The client(s) should ask the property owner(s) about this. Screens are often removed for window cleaning and they may be stored somewhere. If not, then recommend installing screens where missing.

Contact a qualified window repair/installation contractor.

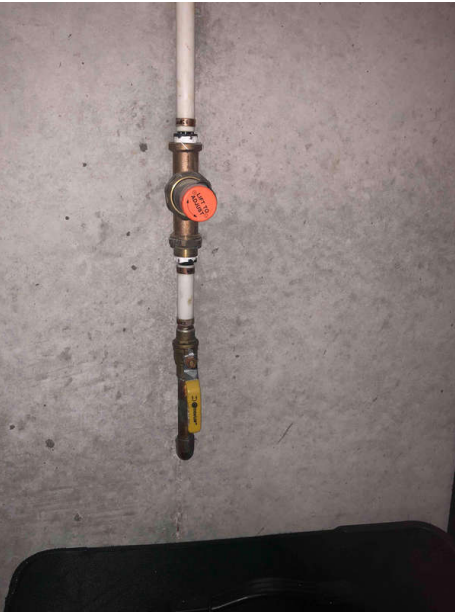
<b>General: Location of Main Shut off</b> Basement Utility room	<b>General: Water Pressure</b> 0 Unverified	<b>General: Location of Water meter</b> Not Found

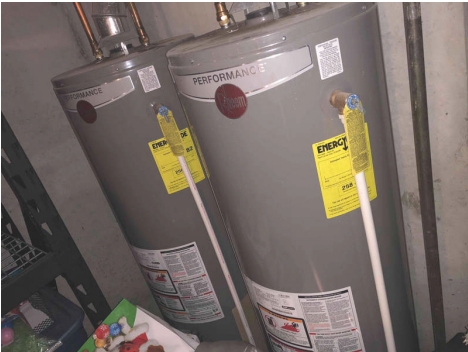
### 6.1.1 Water Heater

#### TPR IMPROPER MATERIAL

The TPR drain line was made of an improper material. These drains lines are to be made of either CPVC, Copper, or Galvanized piping to prevent melting when hot water or gases escape. Recommend qualified plumber repair.

Contact a qualified plumbing contractor.

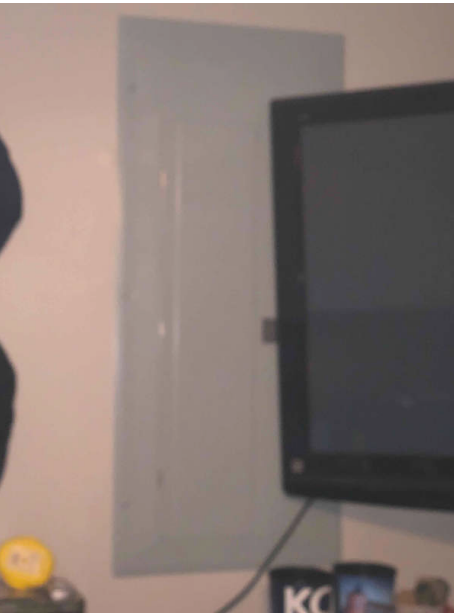
Electric Panel: Panel pictures

<b>Electric Panel: Amperage</b> 200	<b>Electric Panel: Panel Manufacturer</b> Unverified due to Limitations	<b>Electric Panel: Protection</b> Breakers
<b>Electric Panel: Service Type</b> Underground	<b>Electric Panel: Service Voltage</b> 120/240	<b>Electric Panel: Branch Wiring</b> Copper

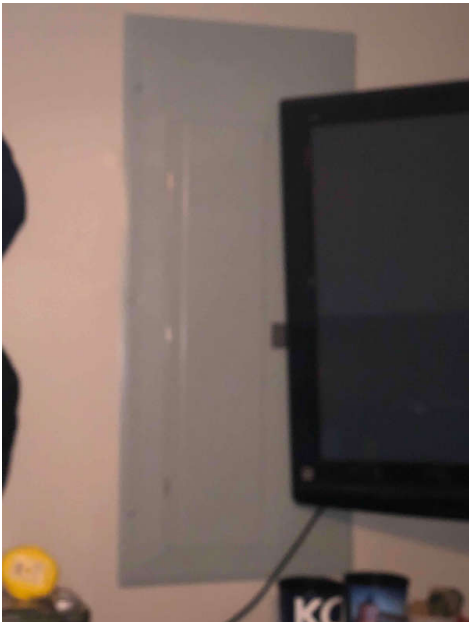
#### SHELVING/STRUCTURE, COVER NOT REMOVED

The main service panel cover couldn't be removed due to lack of access from shelving, cabinets, walls and/or ceilings. This panel wasn't fully evaluated. Repairs should be made so the panel cover can be easily removed.

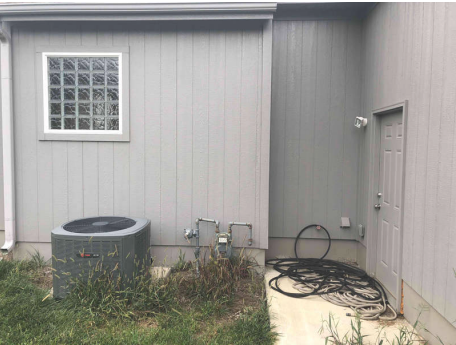
<b>General: Cooling source</b> Electric	<b>General: Heat Source</b> Natural Gas	<b>General: Distribution</b> Sheet Metal Duct
<b>General: A/C Type</b> Split System	<b>General: Heat Type</b> Forced Air	<b>General: Last Service Date</b> Unknown
<b>Condensing Unit: Estimated Age</b> <b>Condensing Unit</b> 4 Year(s)	<b>Condensing Unit: Condenser Serial #</b> See Pics	<b>Condensing Unit: Manufacturer</b> Trane

<b>Condensing Unit: Good condition</b> The condensing unit appeared to be in good condition.	<b>Air Handler: Estimate Age Air Handler</b> 4 Year(s)	<b>Air Handler: Air Handler Model #</b> See pics
<b>Air Handler: Air Handler Serial #</b> See pics	<b>Air Handler: Filter Location</b> Side of unit	<b>Air Handler: Manufacturer</b> Trane

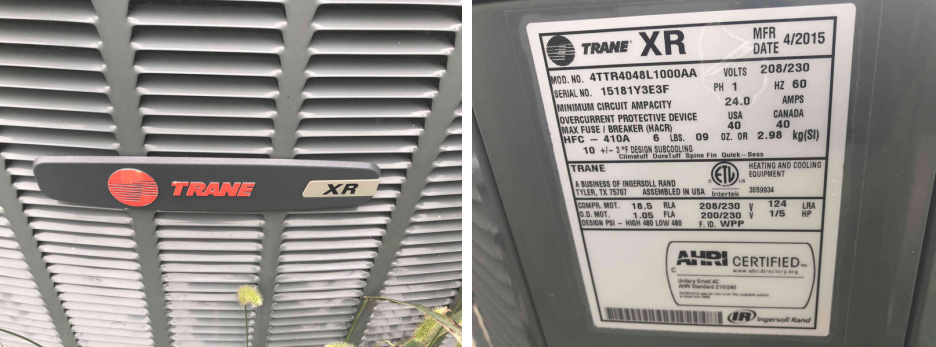
Condensing Unit: Condenser Model #

See pics

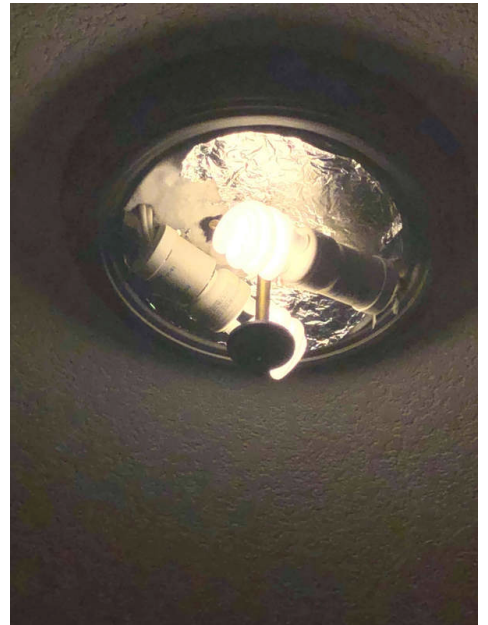
Lamp holders or light fixtures with fully or partially exposed bulbs are installed in one or more closets. This is a safety hazard due to the risk of fire. Flammable stored items may come into contact with hot bulbs, and hot fragments from broken bulbs may fall on combustible materials. Standard building practices require closet lighting to use fluorescent light fixtures, or to use fully enclosed incandescent fixtures. Installing a compact fluorescent lamp in a lamp holder is not an acceptable practice. A qualified electrician should replace closet lights as necessary and as per standard building practices.

Contact a qualified electrical contractor.

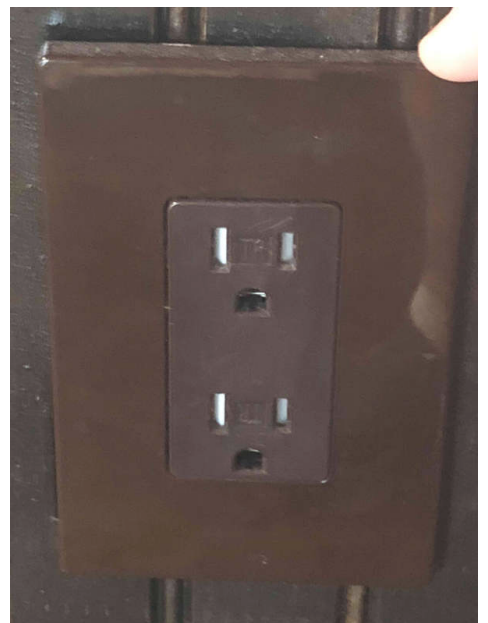
#### 9.3.2 Electrical

##### RECEPTACLE LOOSE

One or more electric receptacles and/or the boxes they are installed in are loose and/or not securely anchored. Wire conductors may be damaged due to repeated movement and/or tension on wires, or insulation may be damaged. This is a safety hazard due to the risk of shock and fire. A qualified electrician should evaluate and repair as necessary.

Contact a qualified electrical contractor.

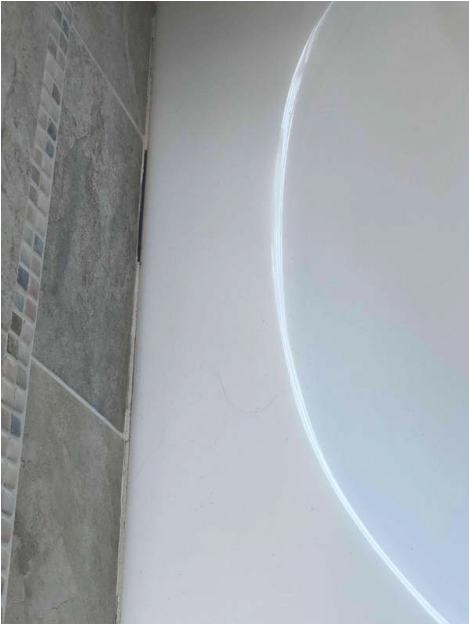
### GROUT DETERIORATED

Grout at the tiles around the bathtub is damaged or deteriorated. This can allow water to intruded behind the tiles cause loose tiles and microbial growth issues behind tiles. For example, deteriorated or missing grout, cracked, missing or loose tiles, etc. A qualified contractor should evaluate and repair tile and/or grout as necessary.

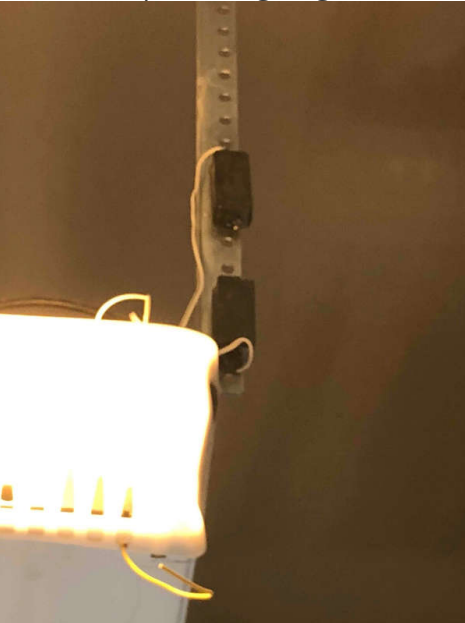
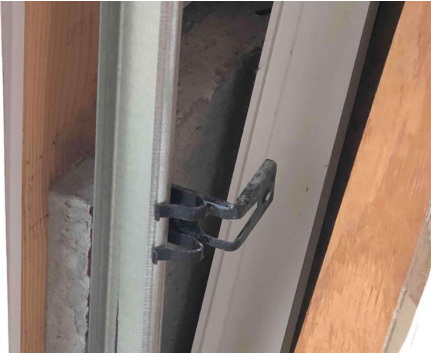
One or more garage vehicle doors wouldn't close with the automatic opener because the opener auto-reversed while the door was closing. This can be caused by photoelectric sensors being out of adjustment, the door binding, the mechanical auto-reverse sensor having problems, etc. Note that because of this, the inspector was unable to verify that the auto-reverse functions for the automatic opener were operable. A qualified person should evaluate, repair as necessary and verify that auto-reverse functions are working.

Contact a qualified garage door contractor.

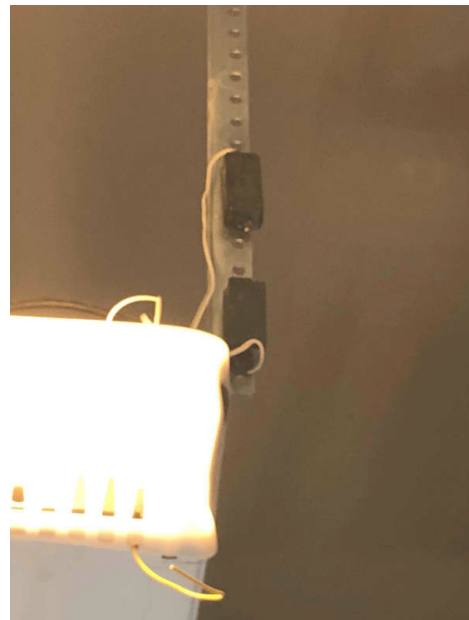
### 11.4.2 Vehicle door

The infrared "photo eye" devices that trigger the vehicle door opener's auto-reverse feature are located higher than 4 to 6 inches from the floor. This is a potential safety hazard. A qualified contractor should relocate these devices so they're 4 to 6 inches from the floor.

Contact a qualified garage door contractor.

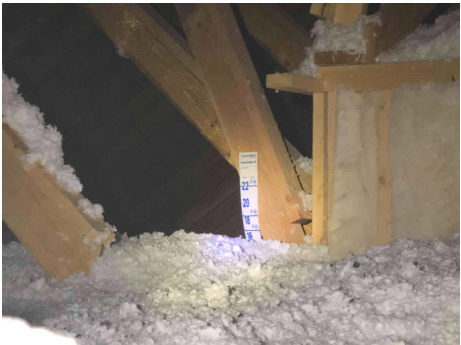
<div><div>General: Ceiling Structure</div><div>Beams</div></div>	<div><div>General: Inspection Method</div><div>Viewed from access</div></div>	<div><div>General: Insulation Depth</div><div>R30</div></div> <div>

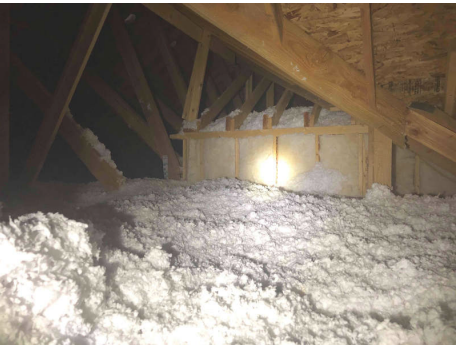
</div>
<div><div>General: Insulation Material</div><div>Cellulose loose</div></div> <div>

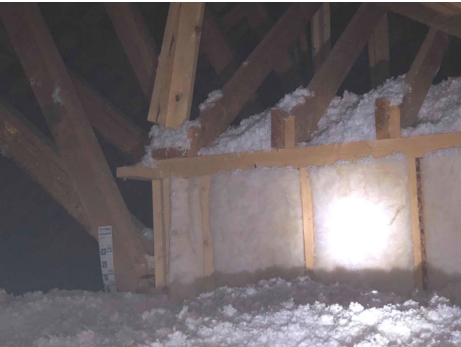
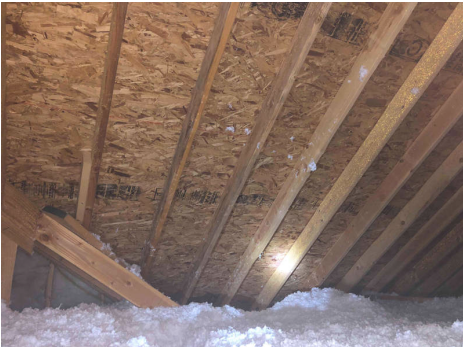
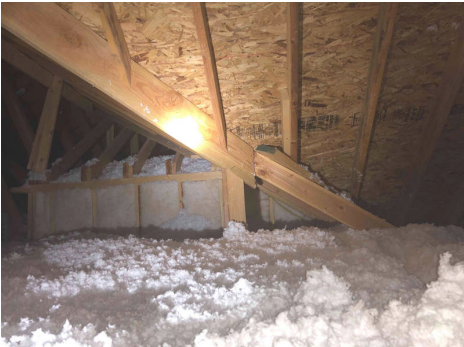
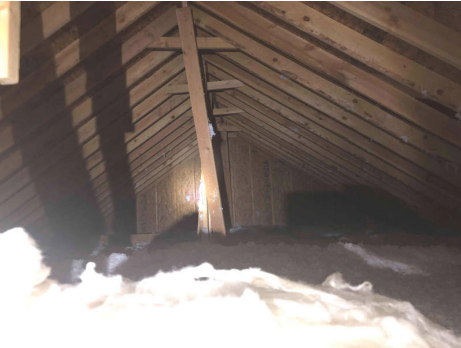
</div>	<div><div>General: Roof Structure</div><div>Rafters</div></div>	
<div><div>General: Attic pictures</div><div><div>
