CAL-SPEC RESIDENTIAL

1234 Main St.
Rancho Mirage, CA 92270

Buyer Name
06/06/2019 9:00AM

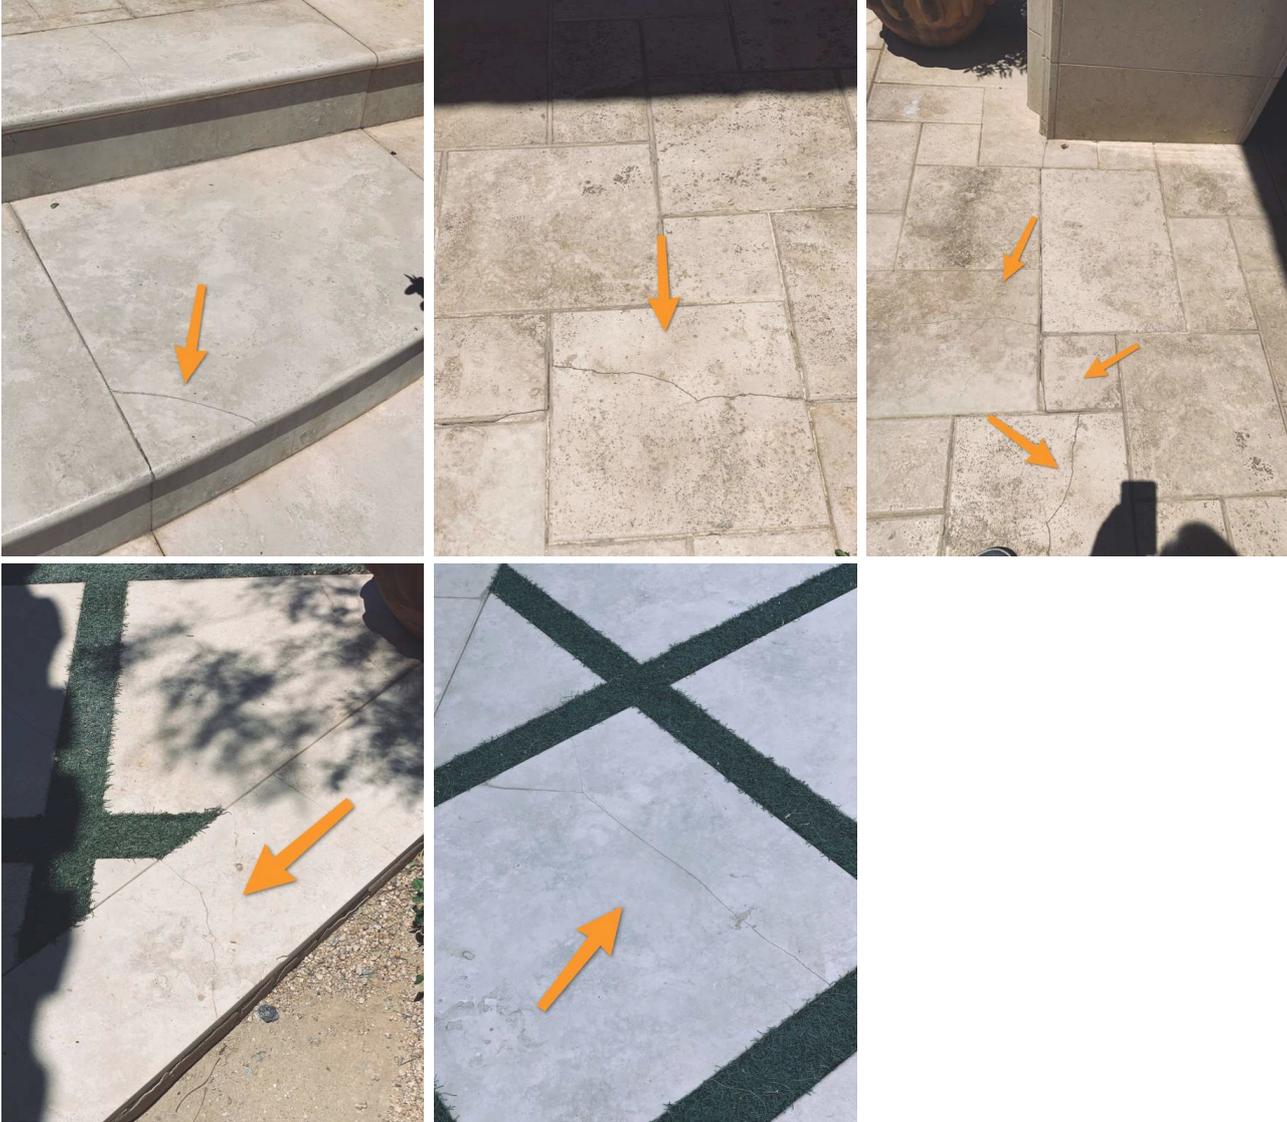
PATIO WALKWAY CRACKING - MINOR

We observed several cracked tiles at the front exterior entry, posterior patios, and walkways. This condition does not pos a trip or safety hazards at this time, However, we recommend monitoring.

Recommendation

Contact a qualified tile contractor

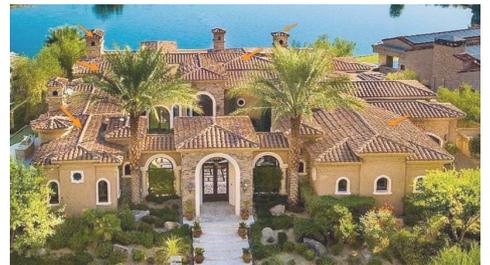
LOOSE & DISPLACED TILES

We noticed several loose and displaced tiles, This is a common condition and roofs with this type of system need periodic adjustments/repairs. There was no evidence of interior water intrusion or visible interior damage at this time

Attached is a sample photo highlighting areas where we observed this condition.

Recommendation

Contact a qualified roofing professional.

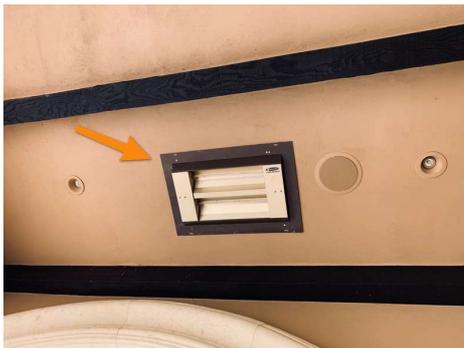
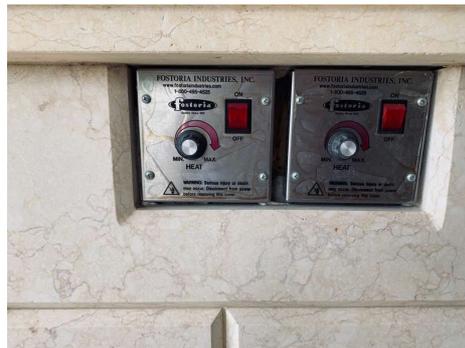
Ceiling Heaters: Ceiling Heaters

The units did light, however, there was considerable dirt and dust on the units and possibly the inner components. We recommend further evaluation and service.

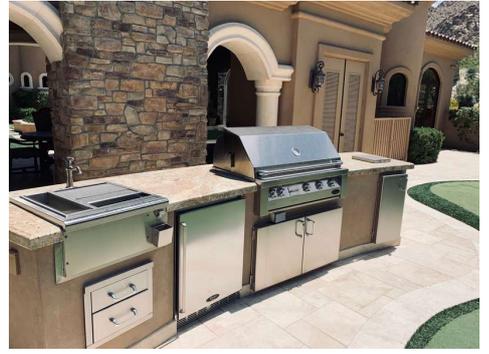
We recommend verification before the close of your escrow if this unit is of concern to you.

Recommendation

Contact a qualified appliance repair professional.

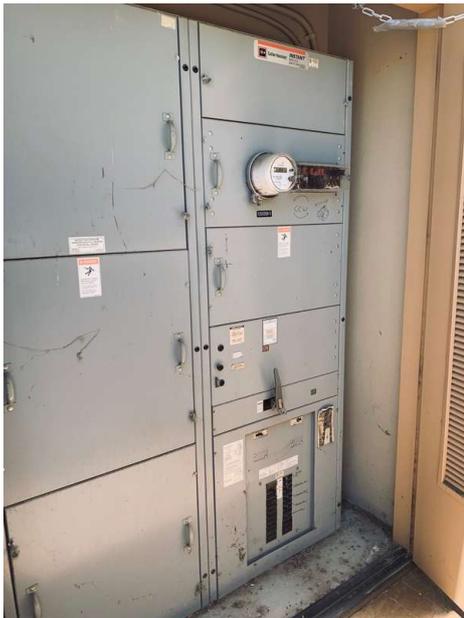
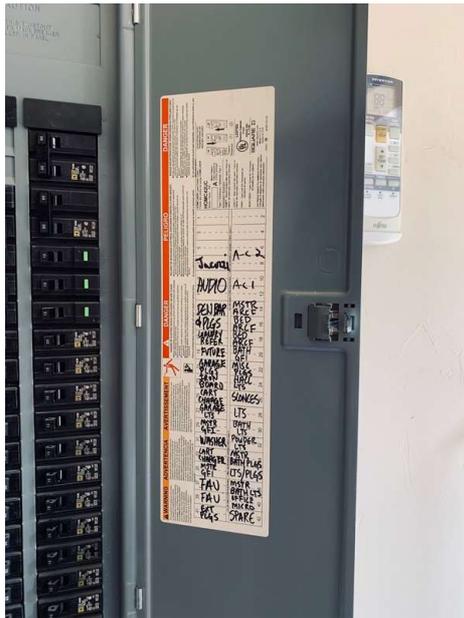
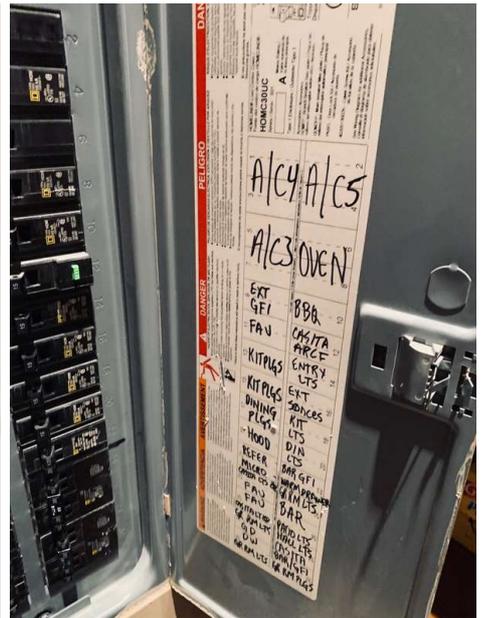
Panel is in servicable condition.

Main 400 AMP Service with 2 interior sub-panels.

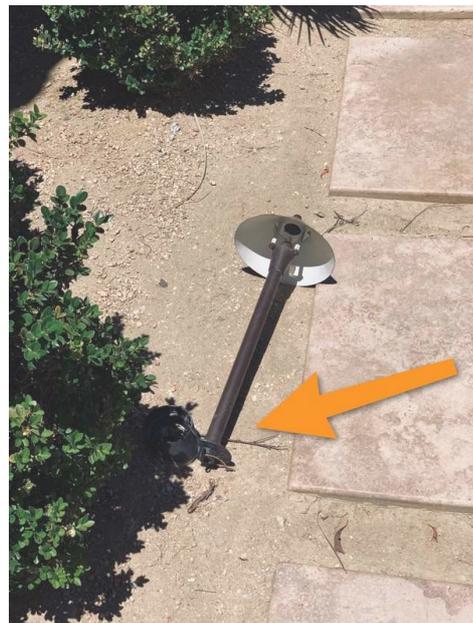
SEVERAL LIGHTS ARE INOPERABLE.

This could be as simple as replacing bulbs, we recommend verification.

Also, we observed broken fixtures at the side yard and posterior.

Recommendation

Contact a qualified electrical contractor.

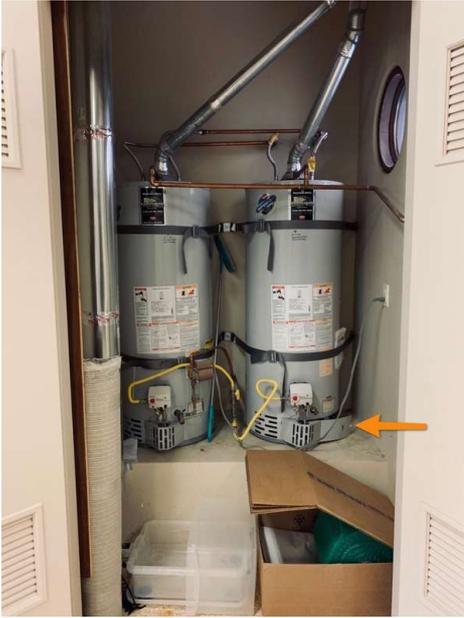
Hot Water Heater(S): Servicable

The hot water heater/systems are all serviceable and comply with the latest seismic bracing requirements. We recommend service/ draining the units due to the unusually mineral content in the water supply in this area. We did observe a loose control panel at one of the 50-gallon units and recommend correction and service.

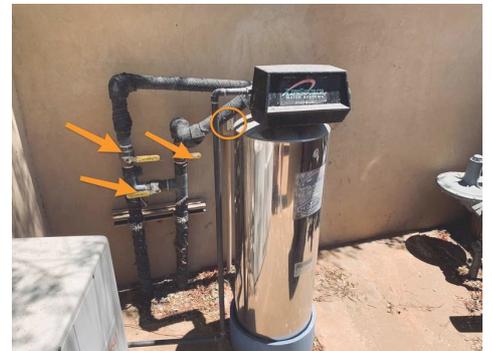
WATER SOFTENER

The water softener equipment has been turned off and unplugged by the present owners. Since there may have been a problem or reason why this system was turned off, we recommend further evaluation before the close of your escrow. Also, the electrical cover to this unit is missing its protective cover.

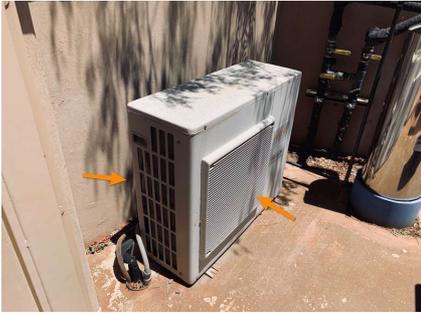
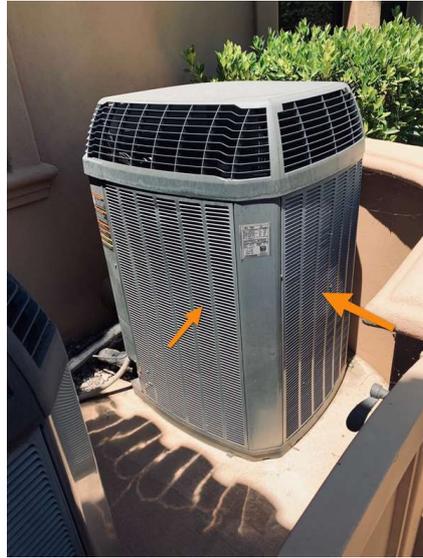
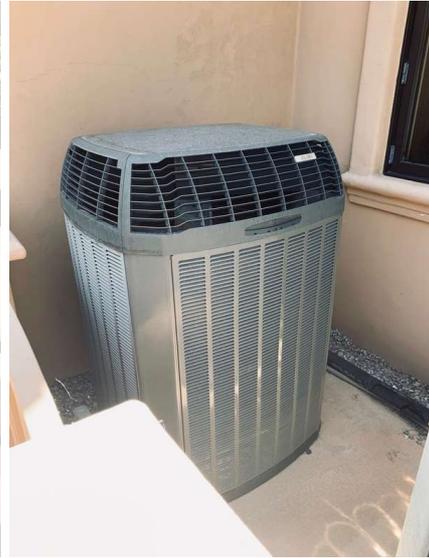
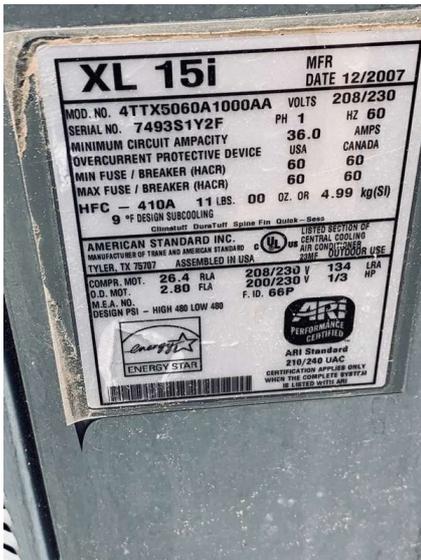
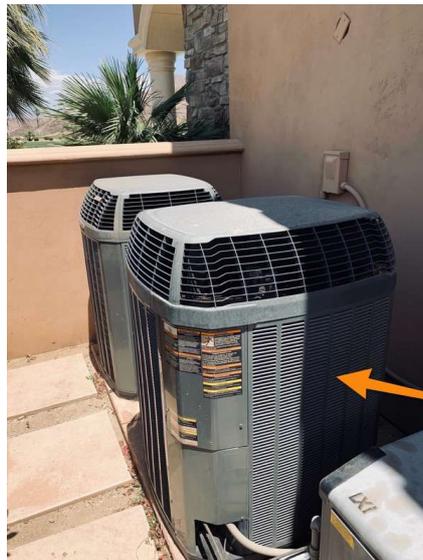
7.3.1 Central Air Conditioning System(s)

*HVAC units are operational at time of inspection. However, due to age, variable conditions & use of these units, we recommend service and verification by an HVAC specialist. We observed Dirty exterior coils and dirty interior filters.

Recommendation

Contact a qualified HVAC professional.

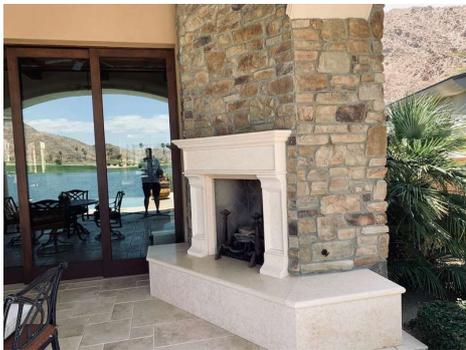
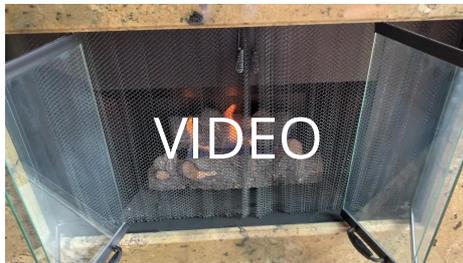
Fireplace(s): 5 Units, 3 Interior, 2 Exterior

All units are serviceable at this time.

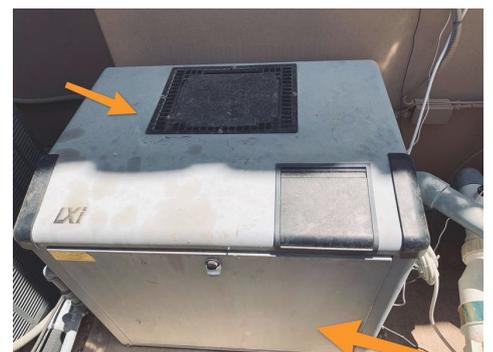
Unit is operational, However we detected dirt and debris on the burner trau assembly as well as the heat exchanger.

We recommend further evaluation by a licensed swimming contractor.

Recommendation

Contact a qualified Swimming Pool Contractor

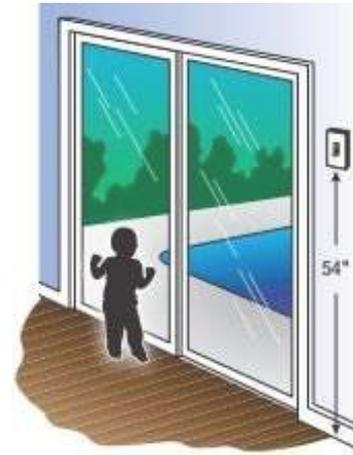
California Pool Owners As of January 1, 2018, pool owners will need to install at least 2 of 7 specified drowning prevention safety features to reduce the serious risk of drowning. We strongly recommend consulting a licensed pool contractor for details and corrections to this new building and safety code.

Recommendation

Contact a qualified professional.
