CONFIDENTIAL PROPERTY INSPECTION REPORT

1234 Main St.
CHARLESTON sc 29412

Buyer Name
05/25/2018 9:00AM

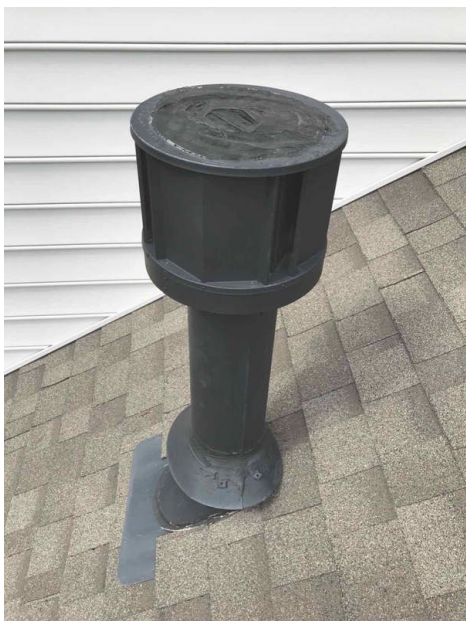
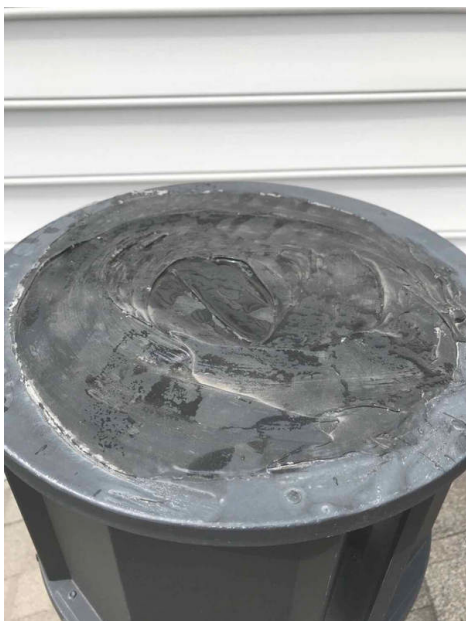
Flue vents were on the roof for gas appliances in the home like the furnace. The chimney flue vent had a sealant on top of it that seemed like it could easily melt due to heat. I recommend having a roofer check this vent to make sure that the material will not melt and to make sure it is not covering any holes or prior damage.

Chimney flue vents had a soft sealant applied to the top of it. Overview of flue with sealant over it.

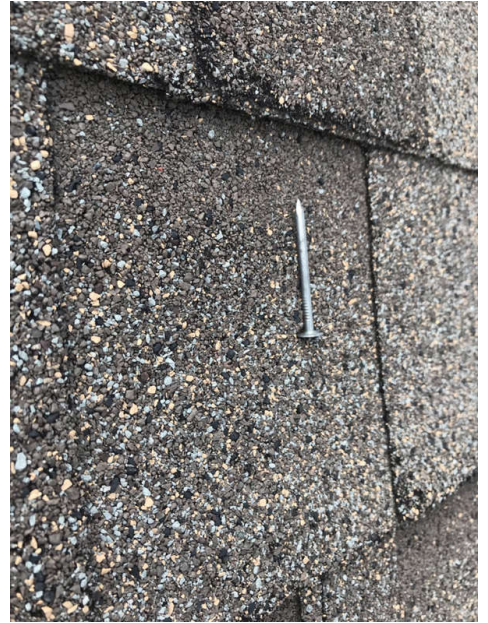
Nail were left on roof from either siding installation or roofing installation. I was able to pick up most nails. This nail had already melted into shingle tab. I recommend having nail removed and area repaired.

Nail on Front Slope 1 story

Contact a qualified roofing professional.

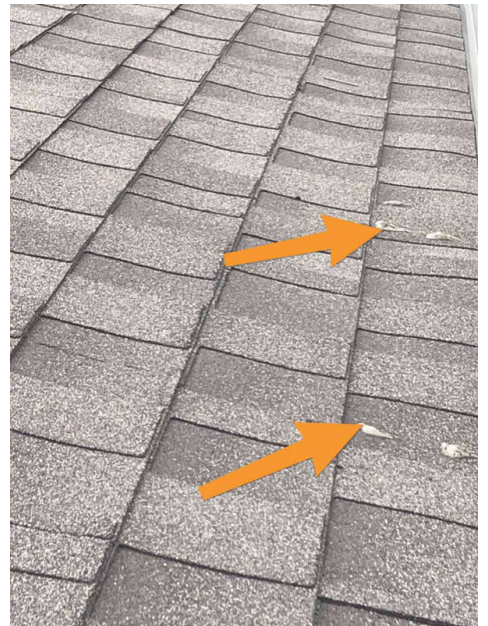
Roof coverings showed signs of improper installation and fastening. Nail should not be exposed and nailed through the top of the shingle tab. The contractors covered the nails with a silicone sealant. This is a temporary repair. Recommend a qualified roofing contractor evaluate and repair.

Silicone sealant covered nails through shingle tabs from installation

Contact a qualified roofing professional.

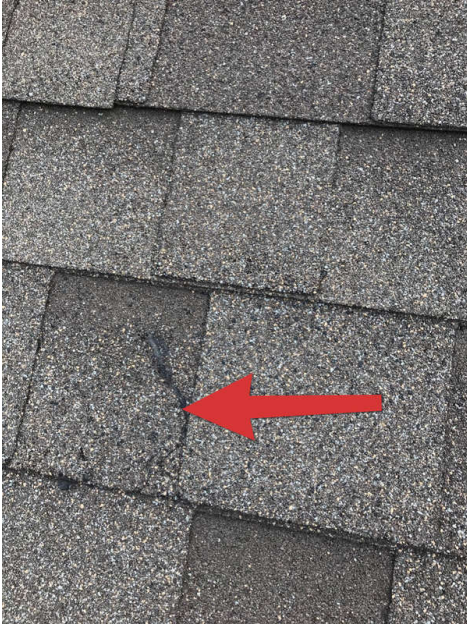
Cracks from installation for defective shingles found on right slope over the garage. I recommend replacement of shingle shingle by a roofer.

Crack shingle on right elevation towards front of home

Contact a qualified roofing professional.

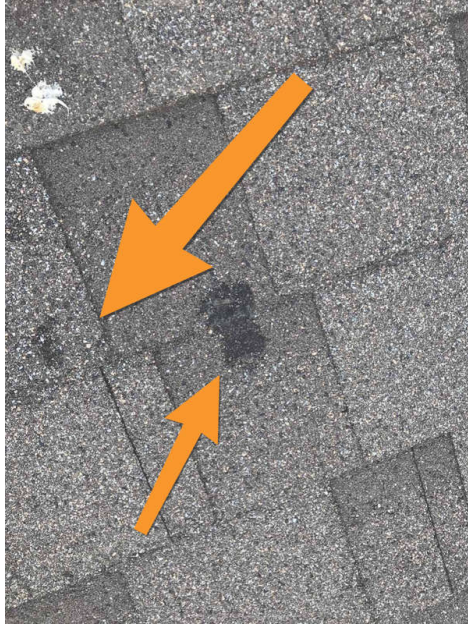
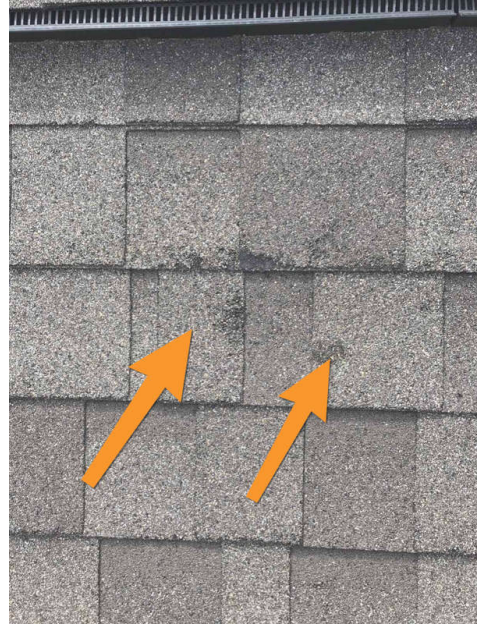
There were some defective shingles found on the roof that showed signs of granules loss. This is a common find on a lot of roofs as some granules are affected when they are shipped in packaging on foot traffic on the roof can cause granule loss.

Missing Granules

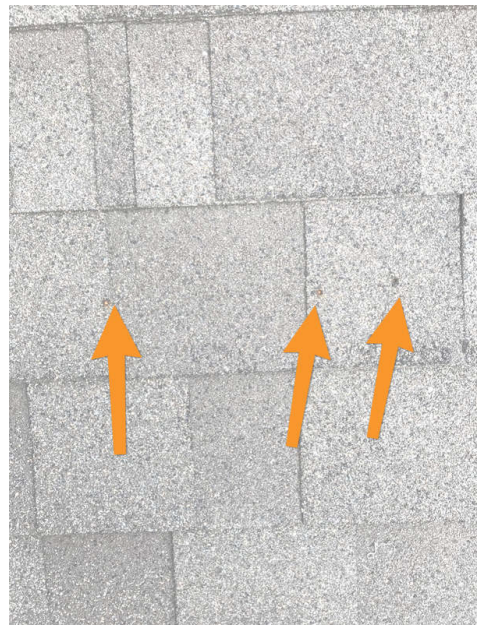
Nail hole left in roof from the installation process. Recommend having a roofer repair or replace shingle.

Nail holes left from where roof was beig installed.

Contact a qualified roofing professional.

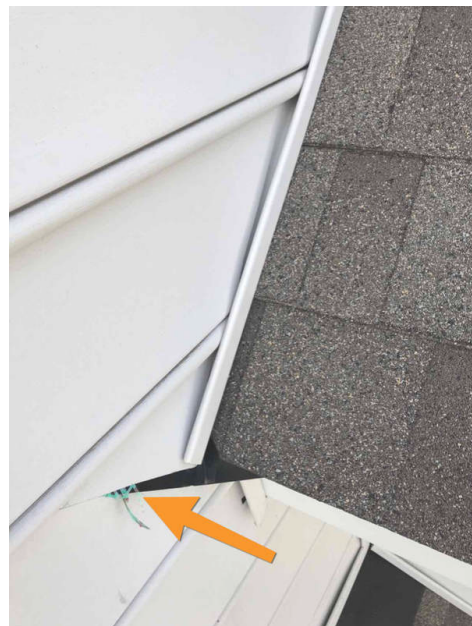
Exterior wall had penetration or gaps that should to be sealed with an appropriate sealant to prevent moisture and insect entry. All work should be performed by a qualified contractor. This penetration is from. Installation of siding and roofing where they intersect due to installation.

Contact a qualified professional.

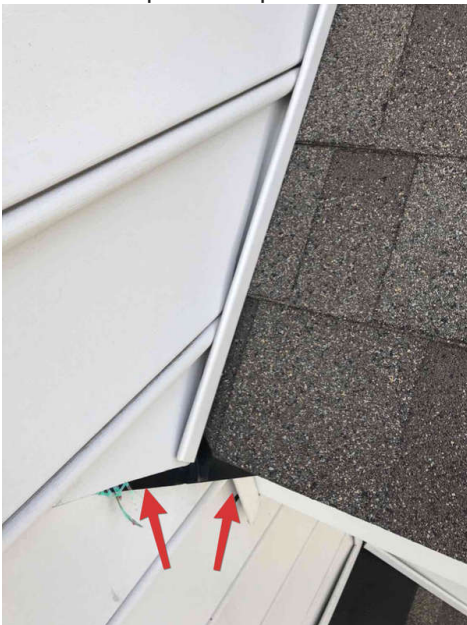
Gaps between the soffit and exterior walls may allow insect entry and water penetration. I recommend that appropriate measures be taken to prevent insect entry at these areas. I also recommend appropriate measures being taken to prevent water penetration as if water leaks in this area will go unknown until there is rotting **pieces of framing around this area.**

The siding has a crack in it from the installation.

Cut in siding

Contact a qualified professional.

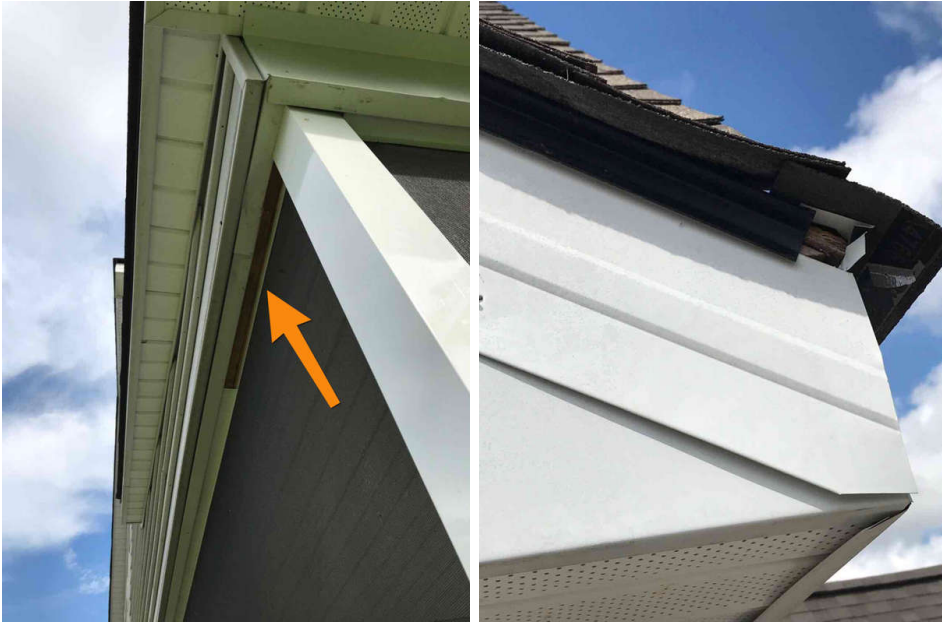
Barewood was found on both sides of the back porch. The space needs to be sealed and painted. I recommend a painter ceiling and painting all the areas around the perimeter trim that shows bare wood. These areas can show signs of rot at early ages in the tear ration without being sealed.

Bare wood needs to be covered with flashing

Contact a qualified painter.

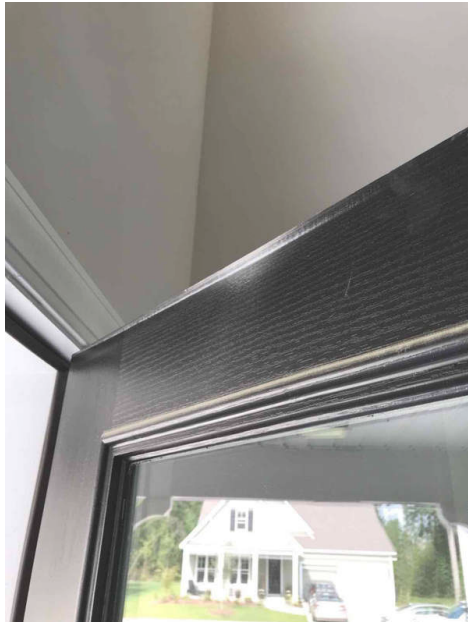
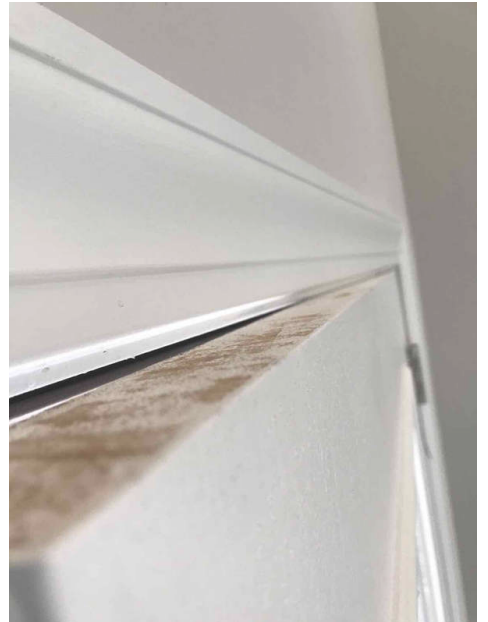
The front exterior door is rubbing on top sill making it difficult to close. I recommend correction by a qualified pro.

Front door had paint on it

The top of the door has been shaved once

Contact a qualified professional.

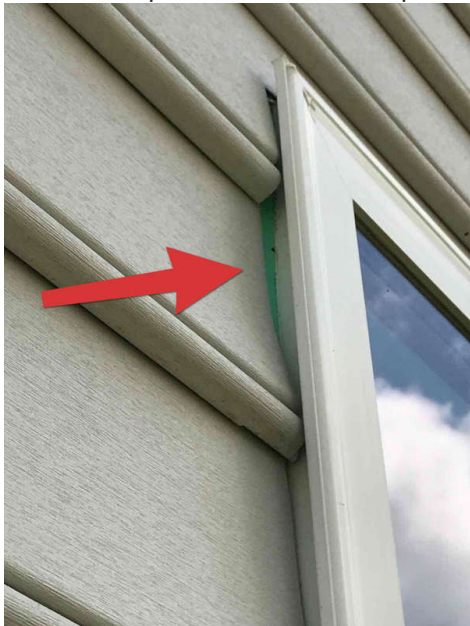
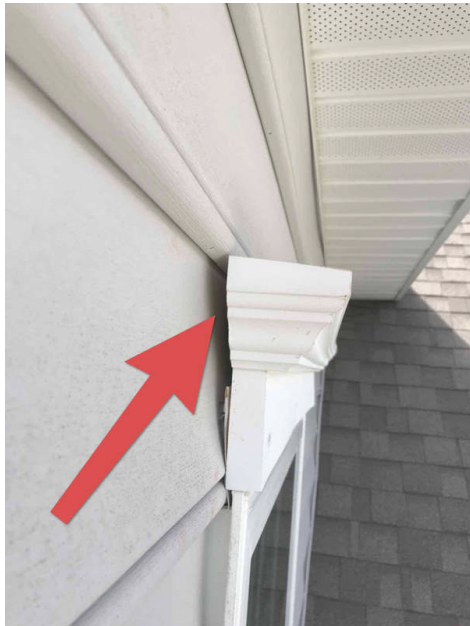
It is recommended that window and door openings with vinyl siding be sealed with a high-quality sealant to help prevent moisture intrusion. you can see the vapor barrier. Window may not be properly flashed. I recommend having a window specialist advise.

Sealant needed around exterior if windows or the windows are not properly flashed or trimmed

Trim above window in left elevation had an area where water can get trapped. Recommend window repair man review

Contact a qualified window repair/installation contractor.

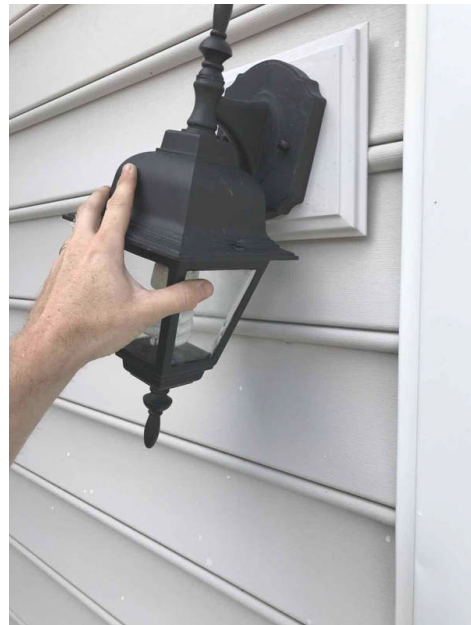
One or more light fixtures were loose.

Contact a qualified electrical contractor.

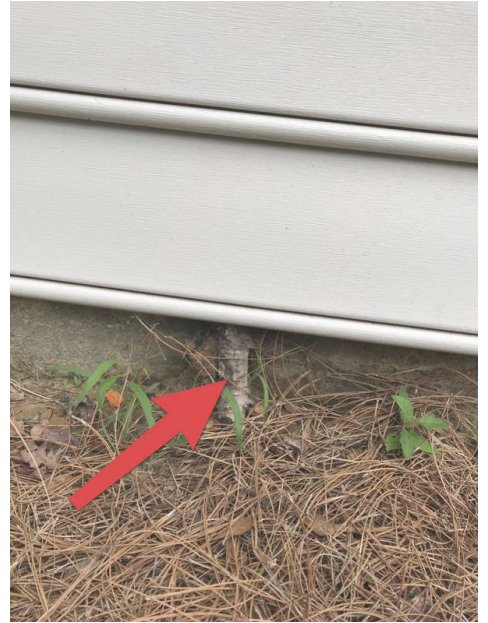
A new tree had started to grow on the property. It was growing under the siding which can cause significant amount of damages. I recommend cutting the tree and having a siding installer detach and reset the siding in this area to make sure there is no vapor barrier damage under the siding.

The vegetation or beds is also really close to the bottom of the siding. It is recommended that the siding have a 6" clearance to prevent moisture from damaging the wood under the siding. I recommend monitoring the wood beneath the siding for rot every 6 months.

Tree growing under siding

Contact a qualified professional.

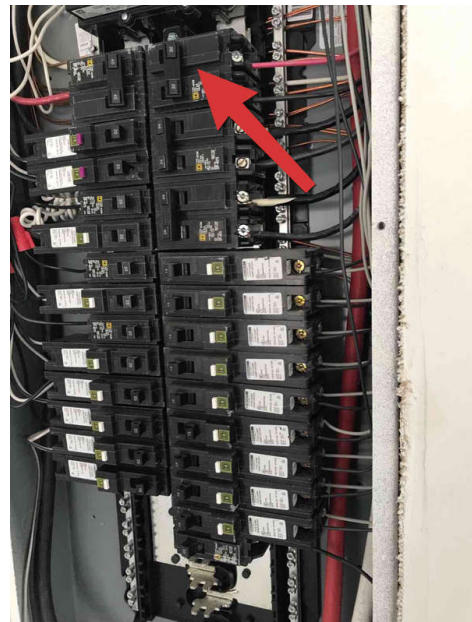
Kitchen switches by the oven were not operable for kitchen lighting. All switches fro, kitchen to the laundry room were not working at the time of inspection.

Breaker would flip when switches were hot,

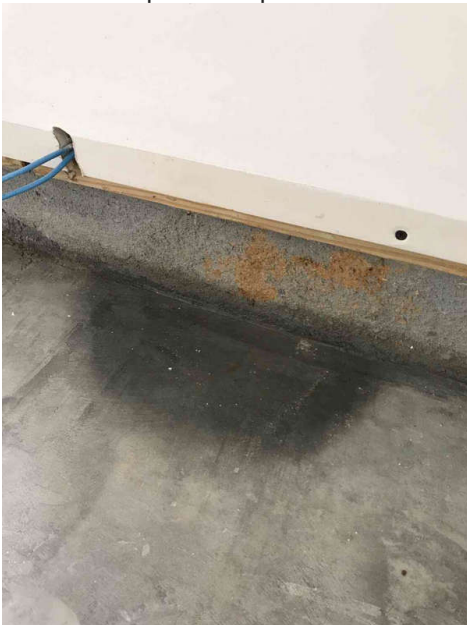
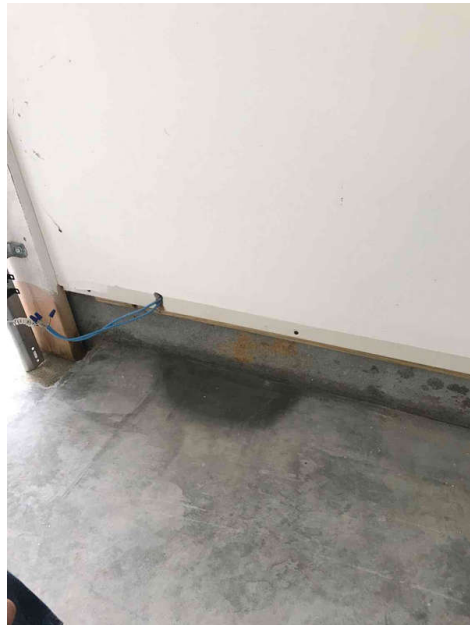
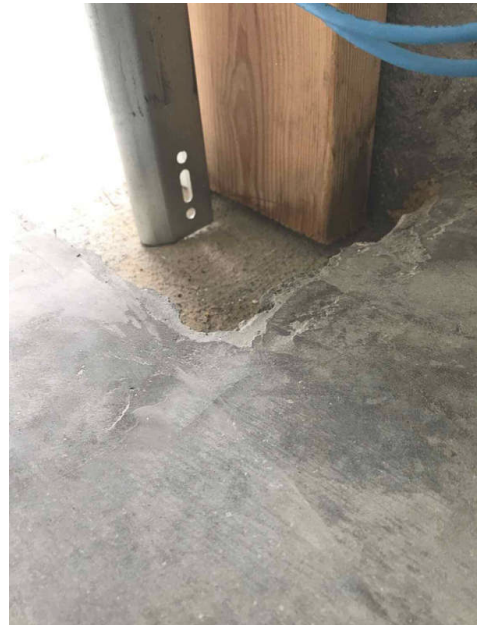
At the time of the inspection there was some water on the interior of the garage. I advise asking builder if it leaks every time and is it can be repaired.

Water puddle in the garage

Base of wood framing showed light water stain

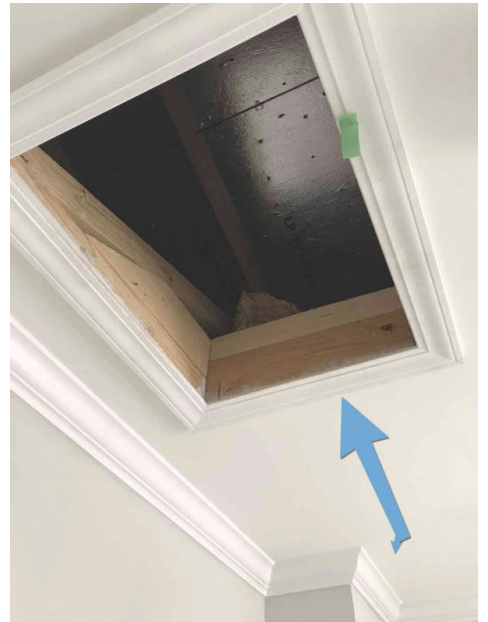
Down stairs master bathroom closet was missing a hatch at the time of the inspection. I recommend asking builder if their is one.

Contact a handyman or DIY project

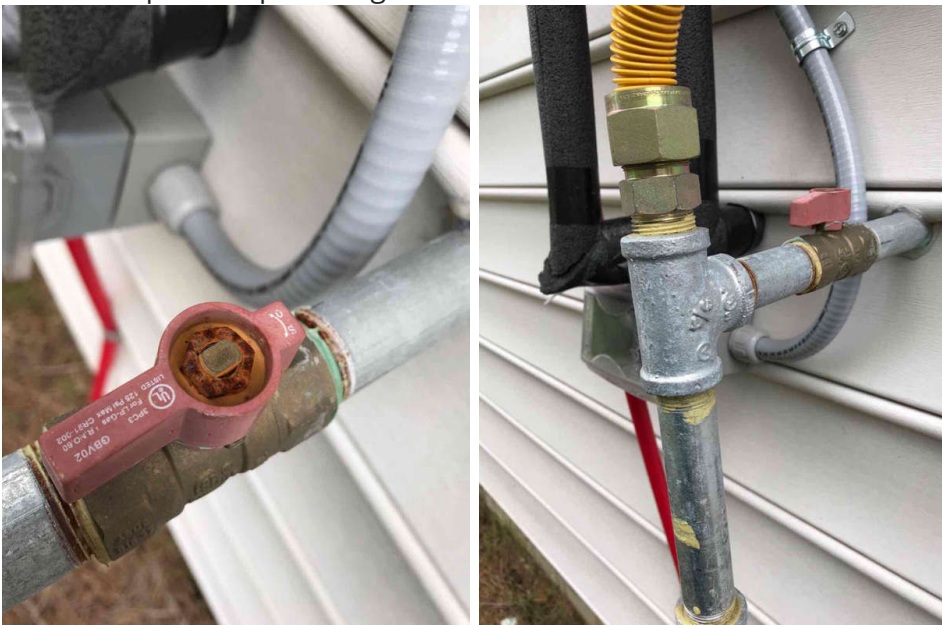
Pipe corrosion found on fittings. I recommend monitoring and if problem gets bad call the gas company to evaluate and repair.

If corrosion gets bad it could mean 2 metals like copper and galvanized are connected and causing electrolysis.

Contact a qualified plumbing contractor.

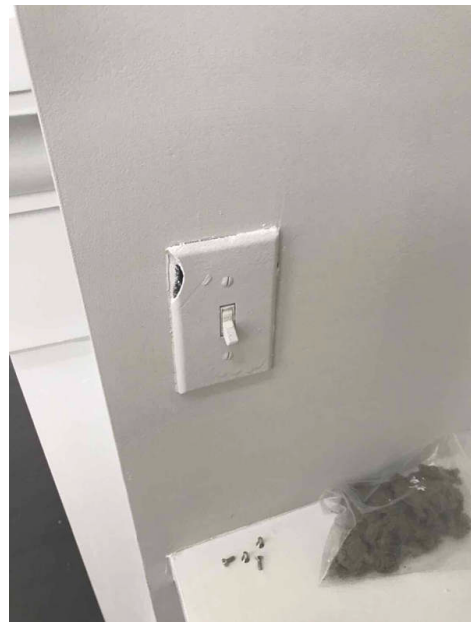
An Improper cover plate was noted at the time of the inspection. This safety hazard should be corrected by a qualified electrical contractor.

Contact a qualified professional.

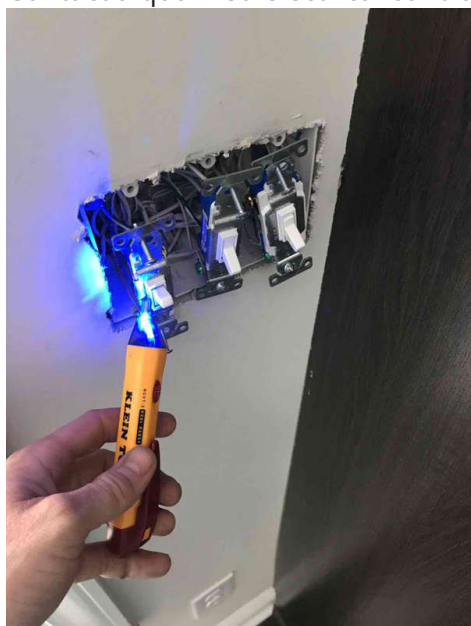
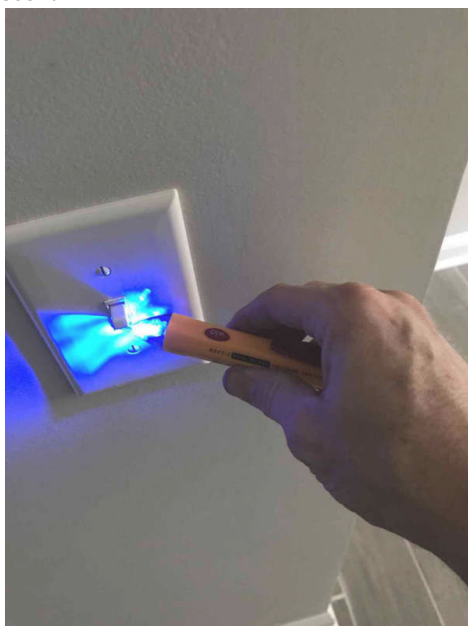
A electrical switches next to the oven were Improperly operating at the time of the inspection and this can be a potential fire hazard. You should ask the seller about its operation. If you are unable to accurately confirm its functionality, you should have it examined by a qualified electrical contractor.

Cover needs to be placed over switches and they were not hot at the time of the inspection.

Switches are not hot

Contact a qualified electrical contractor.

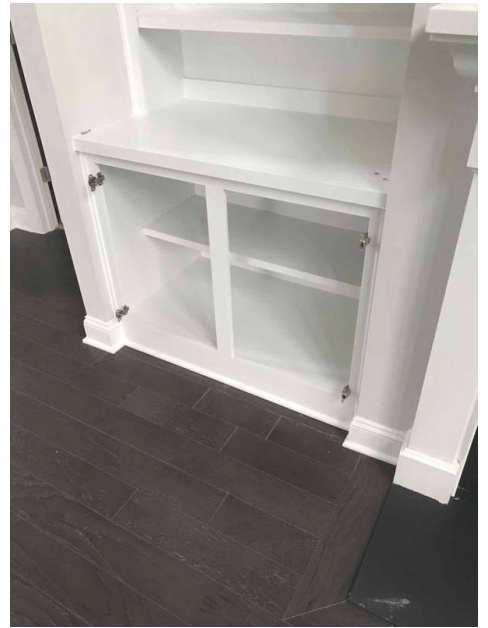
One or more cabinet doors were missing. Recommend replacement.

Cabinet Door are Missing in Living Room

Contact a qualified cabinet contractor.

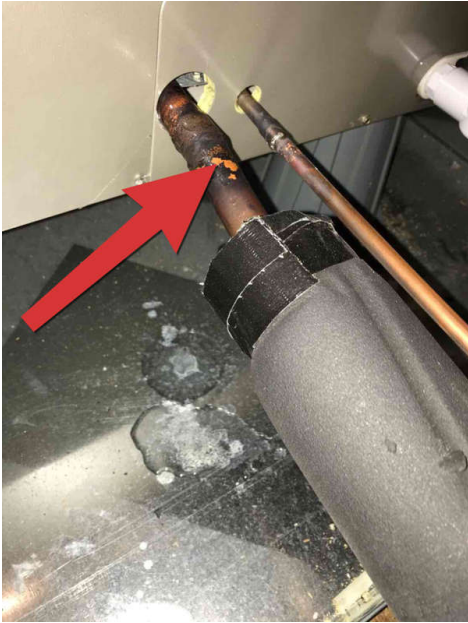
Copper line actively leaking into pan at time of inspection when AC was functioning. Recommend having build review and repair.

Water in pan from leaking copper. Piping

Contact a qualified HVAC professional.

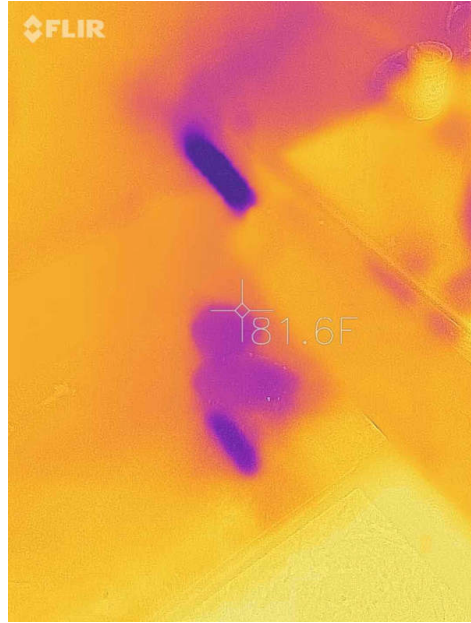
Thermal Image of leak

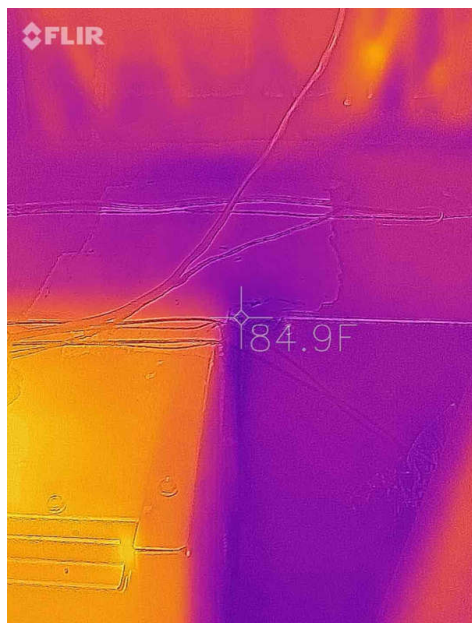
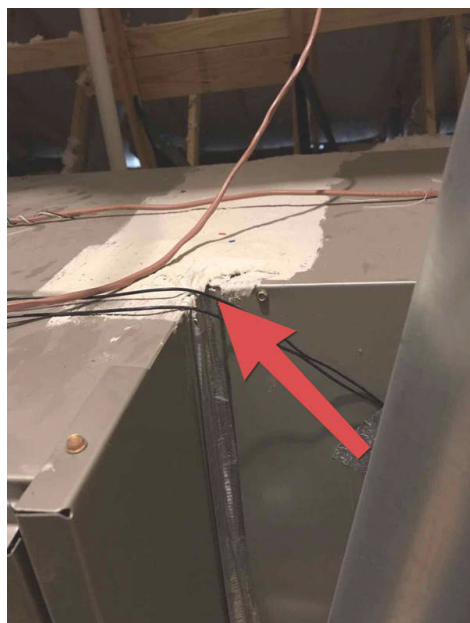
There is a loose connection on central air handler and cool air was leaking. This can cause rust. Recommend HVAC tech repair.

LEaking air can cause rust

Loose Connection that needs to be sealed due to cold air leaking

Contact a qualified HVAC professional.
