BLUE SKY HOME INSPECTIONS

## BLUE SKY RESIDENTIAL

1234 Main St.  
Salt Lake City Utah 84106

05/01/2018 9:00AM

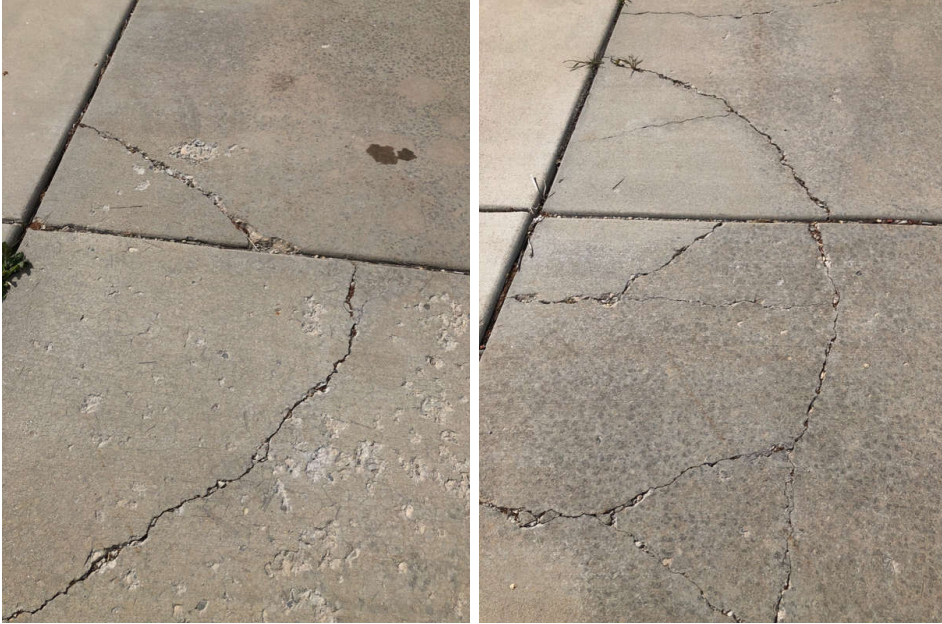
2.2.1 Driveway

Minor deterioration (e.g. cracks, holes, settlement, heaving) was found in the driveway, but no trip hazards were found. The client may wish to have repairs made for cosmetic reasons.

Recommendation

Contact a qualified professional.

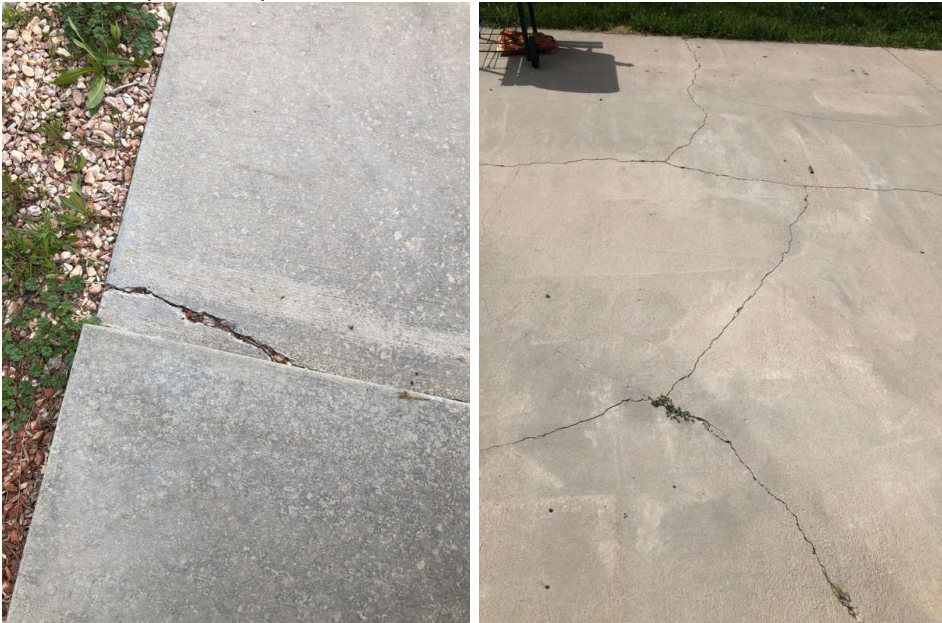
2.3.1 Sidewalks / Patios

Minor deterioration (e.g. cracks, holes, settlement, heaving) was found in sidewalks or patios, but no trip hazards were found. The client may wish to have repairs made for cosmetic reasons.

Recommendation

Contact a qualified professional.

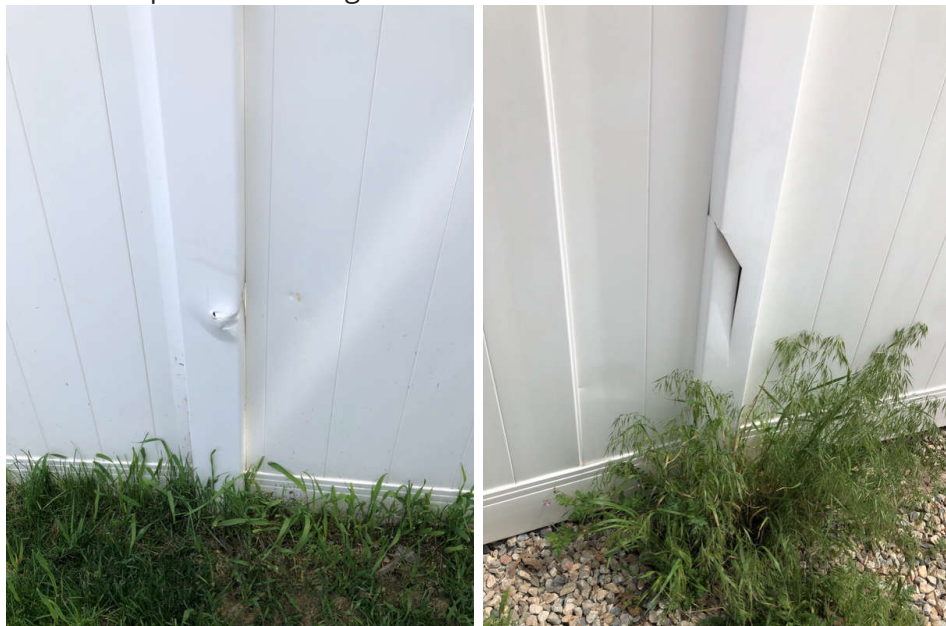
2.6.1 Fence

**DAMAGE**

Fence is damaged.

Recommendation

Contact a qualified fencing contractor

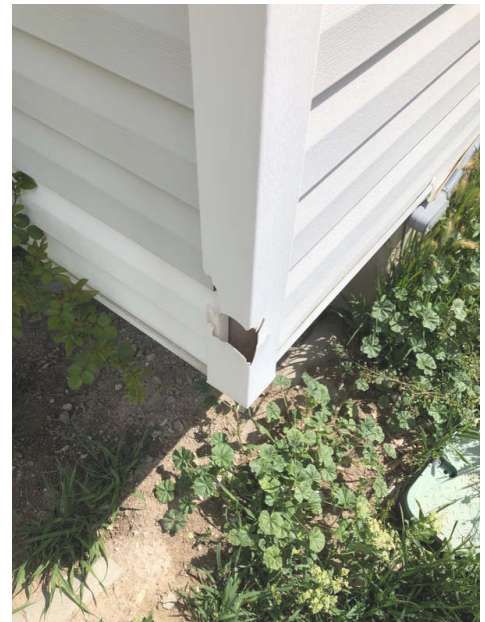
#### SIDING/TRIM DAMAGE

*Some / Many* sections of siding and/or trim were *deteriorated / loose / split / warped / missing / damaged / substandard*. Recommend that a qualified person repair, replace or install siding or trim as necessary.

Recommendation

Contact a qualified professional.

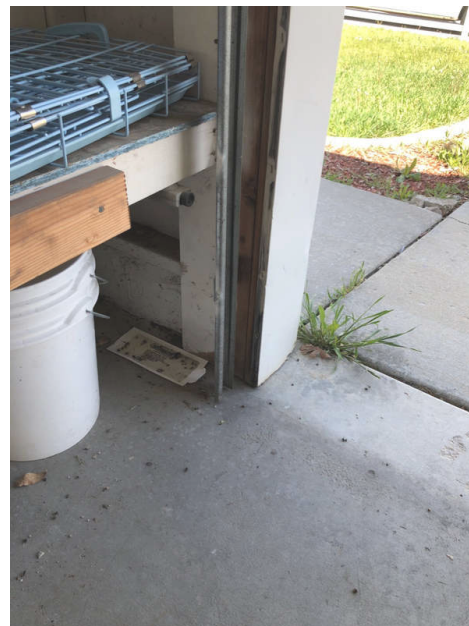
The photoelectric sensors that trigger the auto-reverse feature on one or more garage vehicle doors' automatic openers were located higher than 4-6 inches from the floor. This is a potential safety hazard. A qualified person should relocate sensors so they are 4-6 inches from the floor per standard building practices. For more information on garage door safety issues, visit: [GDPES](#)

Recommendation

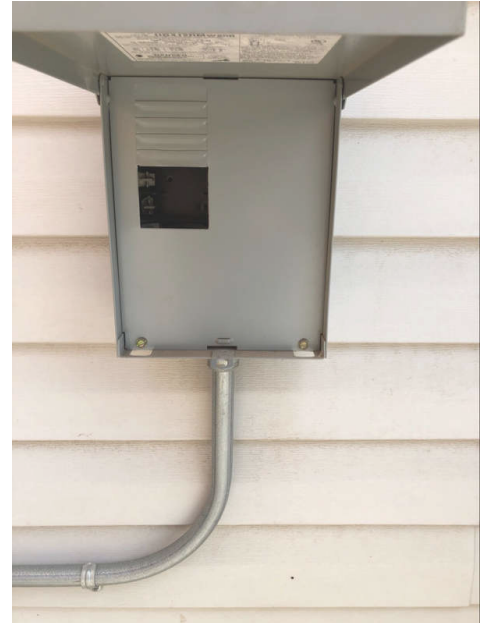
#### MISSING KNOCKOUT

One or more knockouts were missing from panel(s) # A / B / C / D / E. Holes in panels are a potential fire hazard if a malfunction ever occurs inside the panel. Rodents can also enter panels through holes. Recommend that a qualified person install knockout covers where missing and per standard building practices.

Recommendation

Contact a qualified electrical contractor.

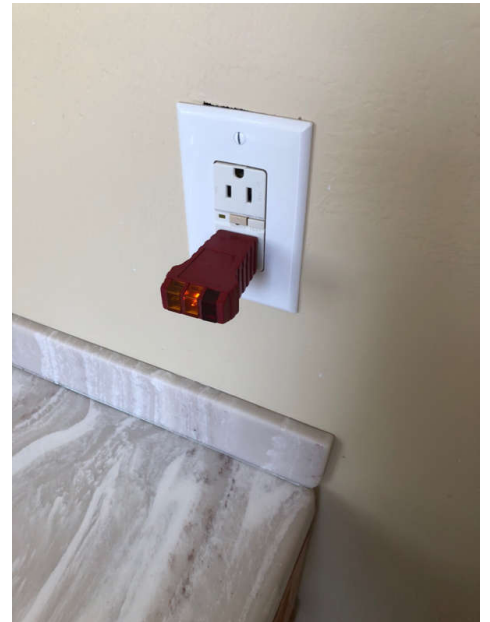
### 8.4.1 Receptacles

One or more modern, 3-slot electric receptacles were found with an open ground. This is a shock hazard when appliances that require a ground are used with these receptacles. Examples of such appliances include computers and related hardware, refrigerators, freezers, portable air conditioners, clothes washers, aquarium pumps, and electrically operated gardening tools. Recommend that a qualified electrician repair as necessary so all receptacles are grounded per standard building practices.

Recommendation

Contact a qualified electrical contractor.

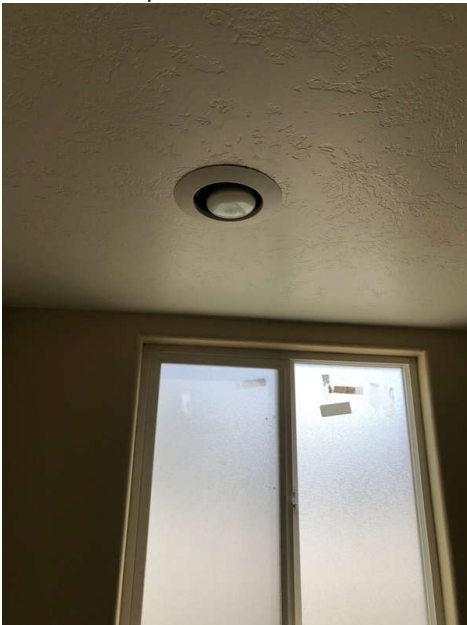
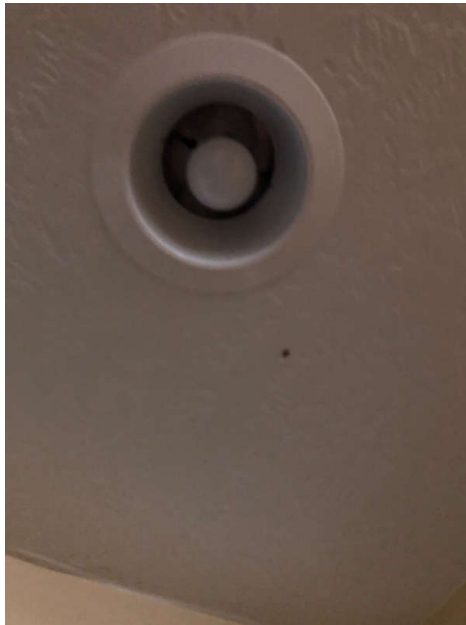
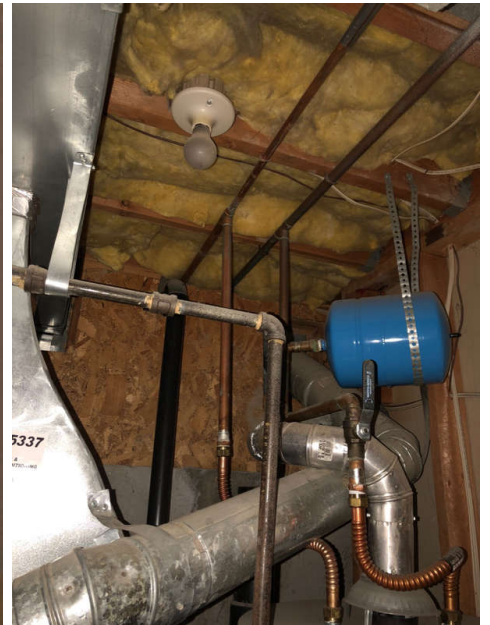
8.6.1 Lighting

**BULBS MISSING OR BROKEN**

Bulbs in one or more light fixtures were missing or broken. These light fixtures couldn't be fully evaluated. If replacement bulbs are inoperable, then recommend that a qualified electrician evaluate and repair or replace light fixtures as necessary.

Recommendation

Contact a qualified electrical contractor.

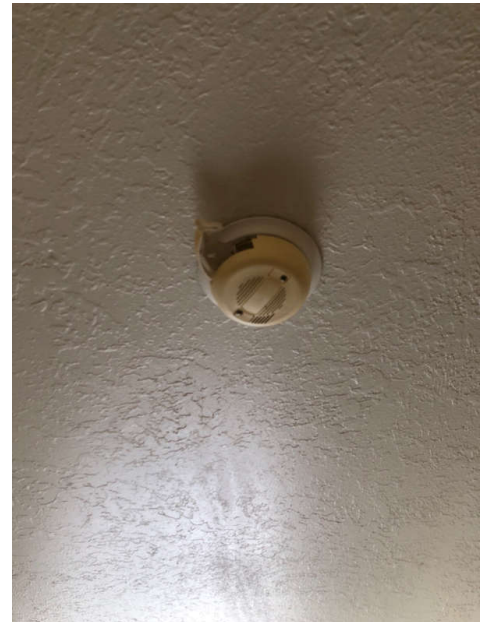
### 8.8.2 Smoke and CO alarms

#### MISSING OR LOW BATTERIES

For home buyers, batteries in all the smoke alarms should be replaced after taking occupancy. Batteries should be replaced annually in the future. "Chirping" noises emitted from smoke alarms typically indicate that batteries need replacing. For more information, visit:

Recommendation

Recommended DIY Project

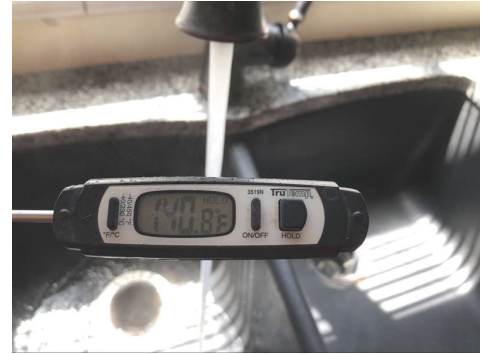
The hot water temperature was greater than 120 degrees Fahrenheit. This is a safety hazard due to the risk of scalding. The thermostat should be adjusted so the water temperature doesn't exceed 120 degrees. If the water heater is powered by electricity, a qualified person should perform the adjustment, since covers that expose energized equipment normally need to be removed. For more information on scalding dangers, visit:

Recommendation

Recommended DIY Project

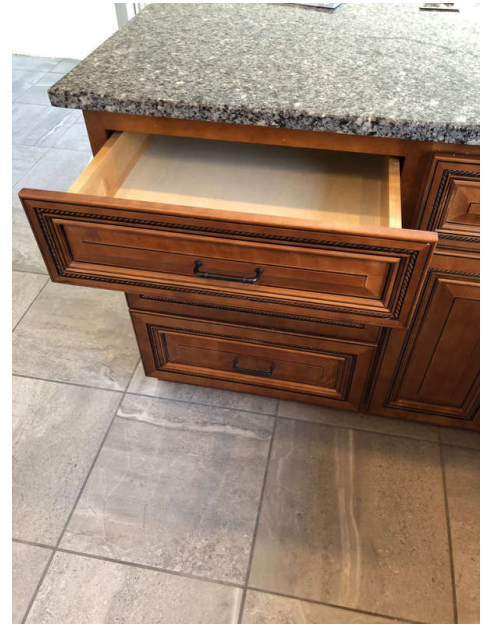
12.2.1 Cabinets

**DRAWERS**

Inspector had difficulty getting this drawer closed. Recommend that a qualified person repair as necessary.

Recommendation

Contact a qualified handyman.

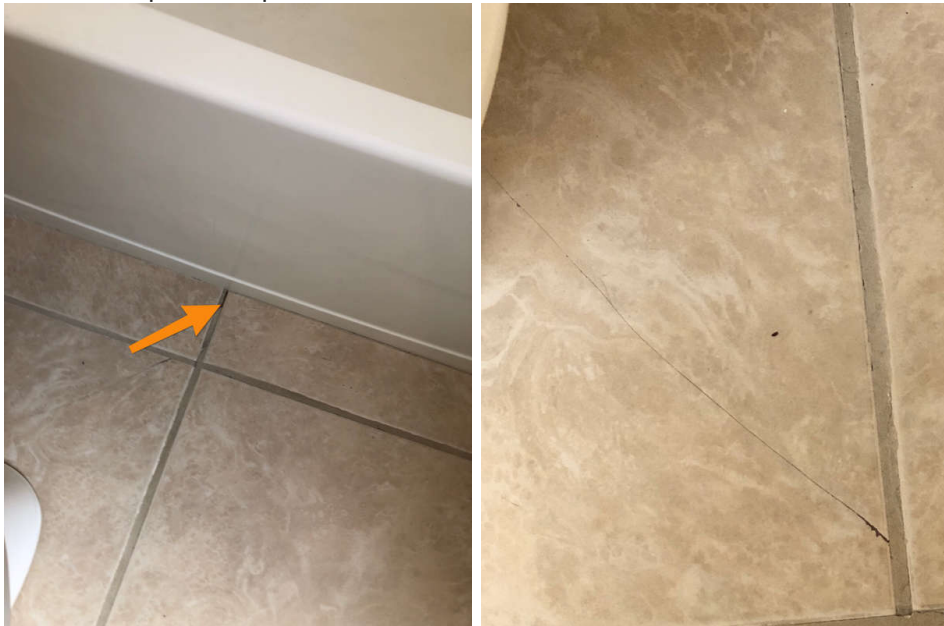
### 13.3.1 Floors

#### **TILE, STONE, GROUT DETERIORATED, SUBSTANDARD**

Tile, stone and/or grout in the flooring was deteriorated (e.g. loose or cracked tiles, missing grout) or substandard. Water can damage the sub-floor as a result. Recommend that a qualified contractor repair as necessary.

Recommendation

Contact a qualified professional.

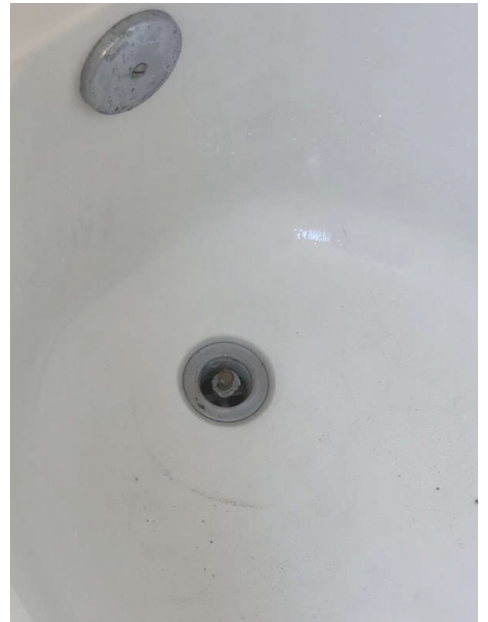
The bathtub drain stopper mechanism was damaged. Recommend that a qualified person repair or replace as necessary.

Recommendation

Contact a qualified professional.

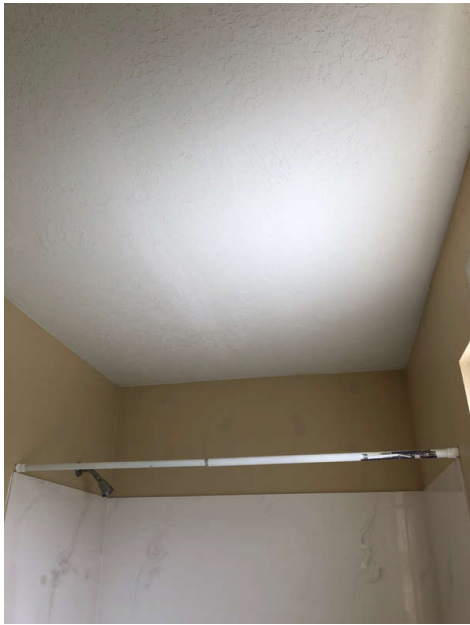
## 13.8.1 Ventilation

The bathroom with a shower or bathtub at location(s) # A didn't have an exhaust fan installed. Moisture can accumulate and result in mold, bacteria or fungal growth. Even if the bathroom has a window that opens, it may not provide adequate ventilation, especially during cold weather when windows are closed or when wind blows air into the bathroom. Recommend that a qualified contractor install exhaust fans per standard building practices where missing in bathrooms with showers or bathtubs.

Recommendation

Contact a qualified professional.

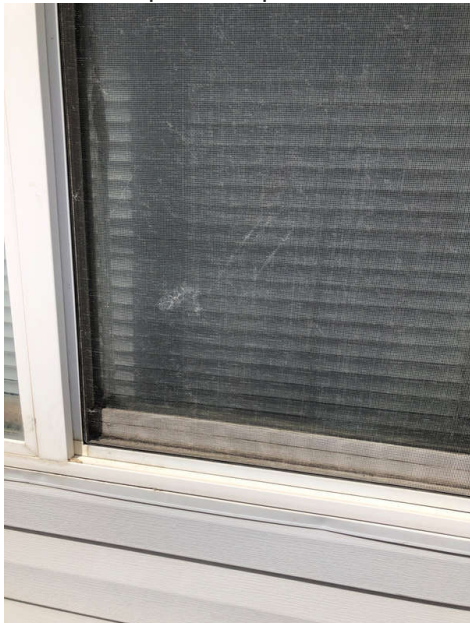
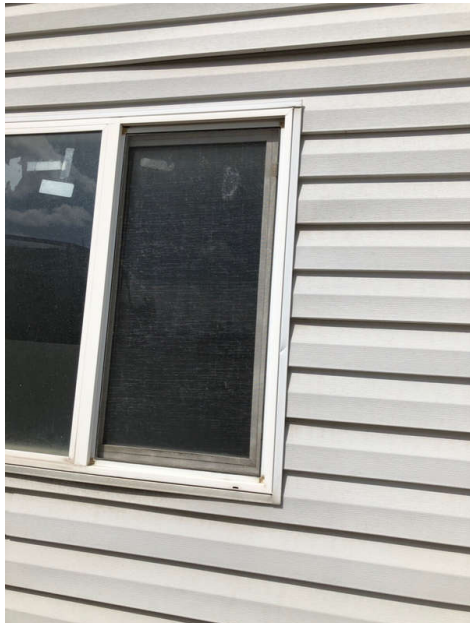
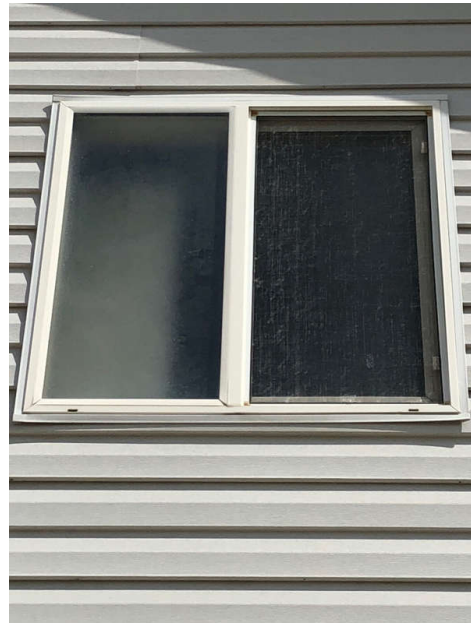
### 14.3.2 Windows & Skylights

#### **SCREENS DAMAGED, DETERIORATED**

One or more window screens were damaged or deteriorated. These window(s) may not provide ventilation during months when insects are active. Recommend replacing window screens as necessary.

Recommendation

Contact a qualified professional.

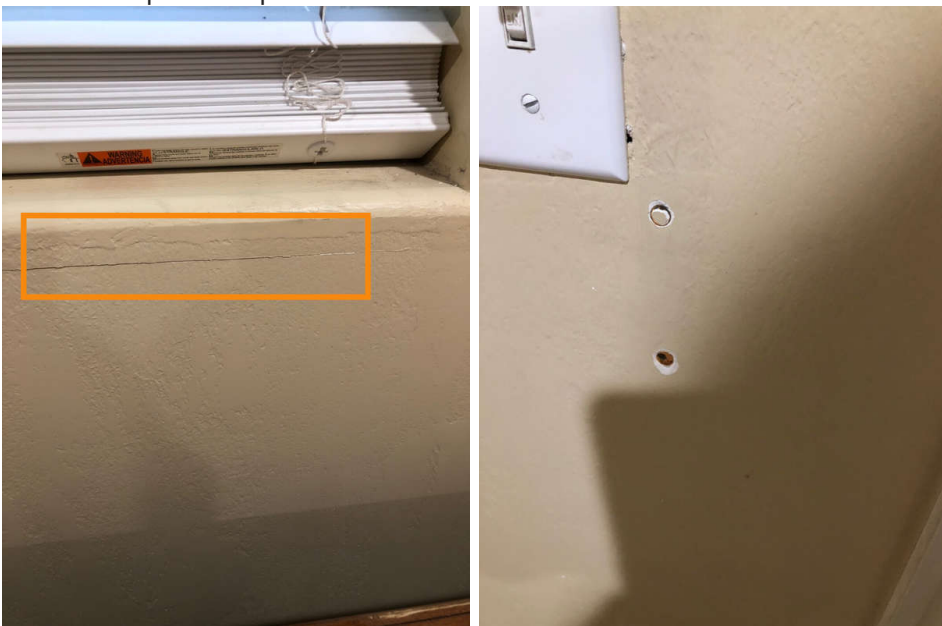
14.4.1 Walls, Ceilings and Fixtures

**MINOR CRACKS, NAIL POPS**

Minor cracks, nail pops and/or blemishes were found in walls and/or ceilings in one or more areas. Cracks and nail pops are common, are often caused by lumber shrinkage or minor settlement, and can be more or less noticeable depending on changes in humidity. They did not appear to be a structural concern, but the client may wish to repair these for aesthetic reasons. For recurring cracks, consider using an elastic crack covering product:

Recommendation

Contact a qualified professional.

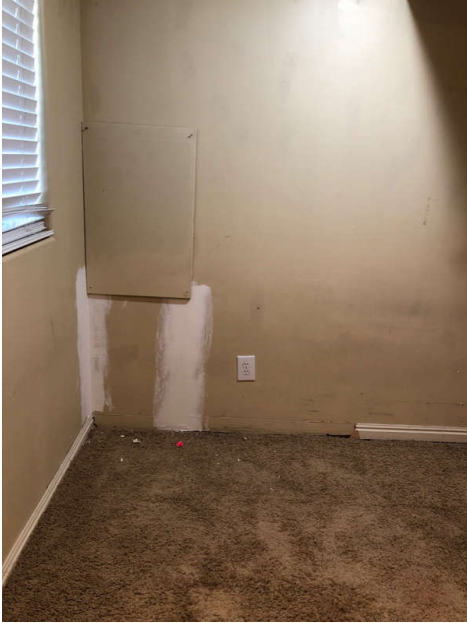
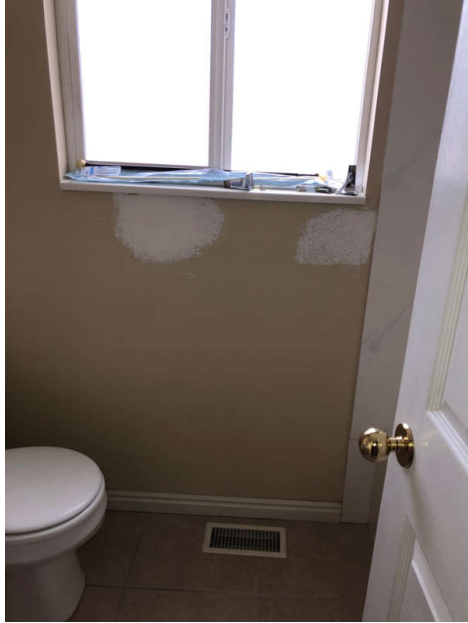
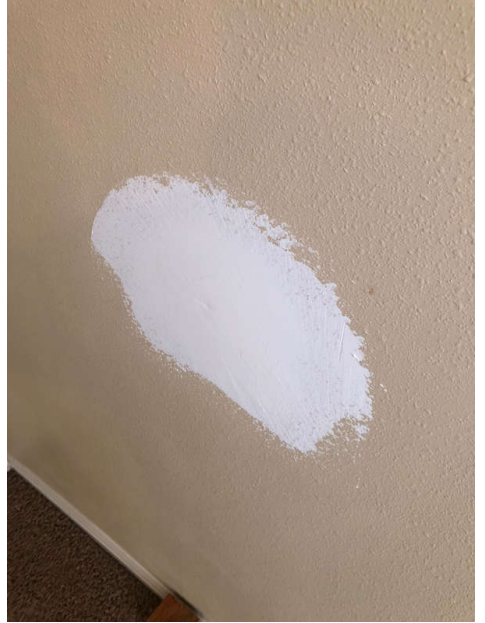
14.4.2 Walls, Ceilings and Fixtures

**NEEDS REPAIR**

One or more *walls / ceilings were damaged / were cracked / had substandard repairs*. Recommend that a qualified person repair as necessary.

Recommendation

Contact a qualified professional.

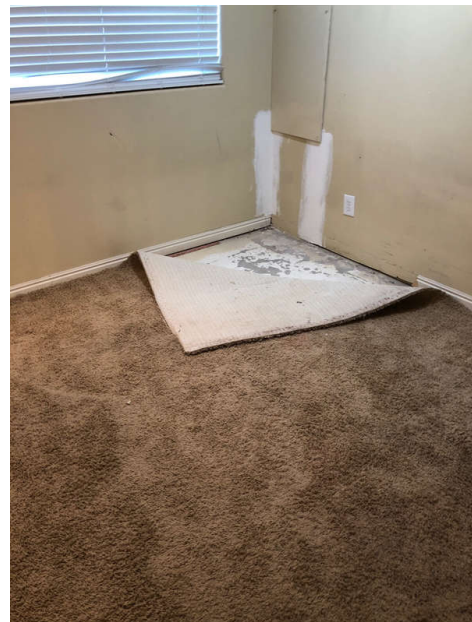
14.5.1 Floors

**CARPET DAMAGED OR DETERIORATED**

Carpeting in one or more areas was damaged or deteriorated. Recommend that a qualified contractor replace as necessary.

Recommendation

Contact a qualified flooring contractor

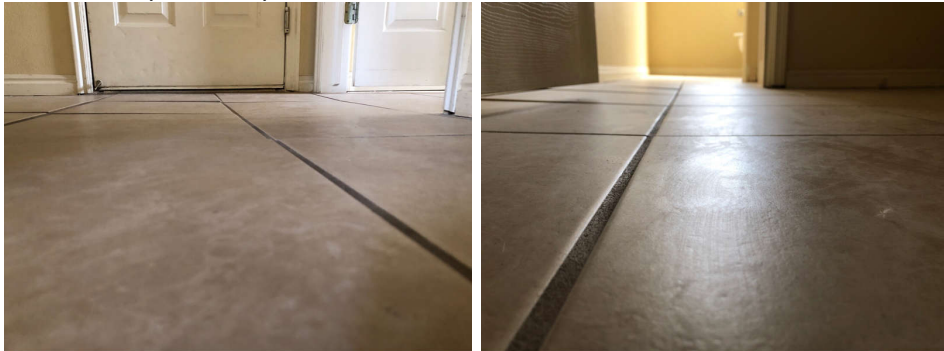
14.5.2 Floors

Floors in one or more areas were not level. This can be caused by foundation settlement or movement of the foundation, posts and/or beams. Significant repairs may be needed to make floors level. Recommend that a qualified contractor and/or engineer evaluate further. Repairs should be performed by a qualified contractor.

Recommendation

Contact a qualified professional.
