1ST CALL HOME INSPECTIONS

## RESIDENTIAL REPORT

1234 Main St.  
Komoka ON N0L 1R0

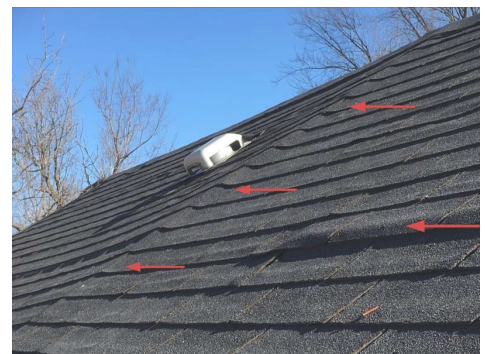
2.1.1 Coverings

### DAMAGED (GENERAL)

Roof coverings showed damage. Recommend a qualified roofing professional evaluate and repair. Expect replacement within 0-1 years

Contact a qualified roofing professional.

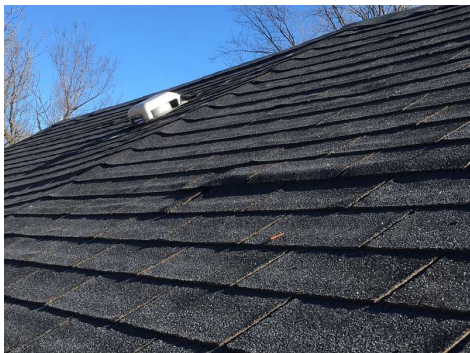
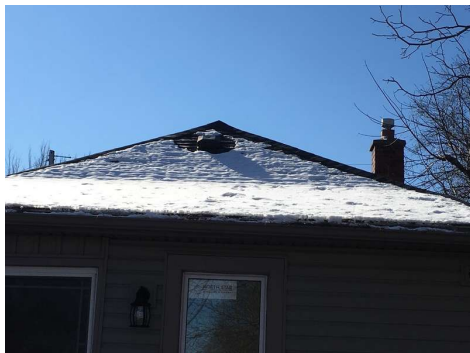
2.1.2 Coverings

### AGING

Budget for replacement.

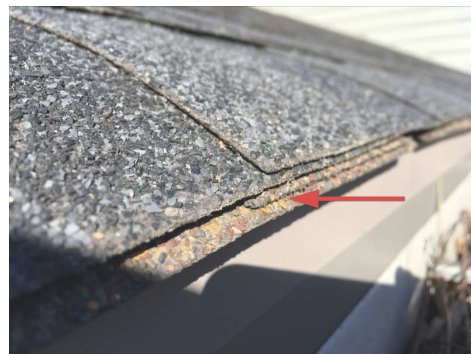
2.1.3 Coverings

**NEW LAYER INSTALLED ON OLD SHINGLES**

Reduced life span approx 10 years max

Contact a qualified professional.

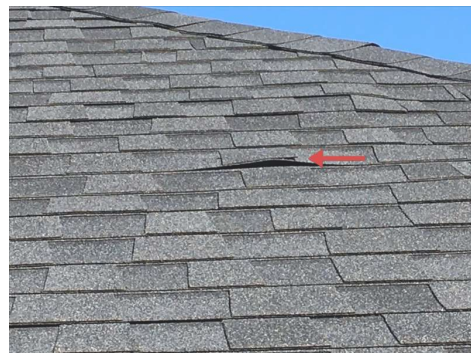
2.1.4 Coverings

**SHINGLES LIFTING**

FRONT

Repair

Contact a qualified professional.

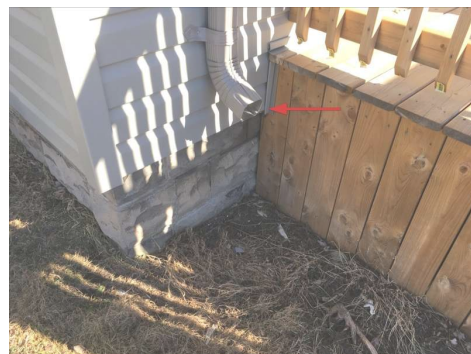
2.2.1 Roof Drainage Systems

**DOWNSPOUTS DRAIN NEAR HOUSE**

One or more downspouts drain too close to the home's foundation. This can result in excessive moisture in the soil at the foundation, which can lead to foundation/structural movement. Recommend a qualified contractor adjust downspout extensions to drain at least 6 feet from the foundation.

Contact a qualified roofing professional.

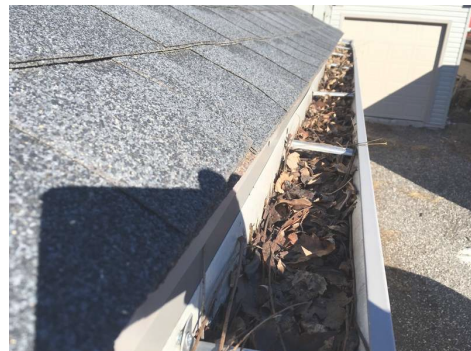
2.2.2 Roof Drainage Systems

**DEBRIS**

Debris has accumulated in the gutters. Recommend cleaning to facilitate water flow.

Contact a qualified roofing professional.

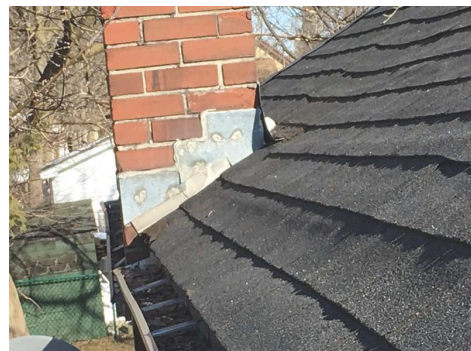
2.3.1 Flashings

**OLD**

Replace

Contact a qualified roofing professional.

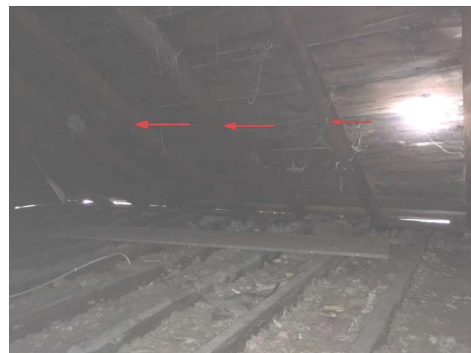
2.5.1 Structure

**ROOF SUPPORTS MISSING**

Additional roof supports may be required; roof on exterior shows signs of damage; see other roof shingle report.

Kneewall supports may be required to support roof and snow loading

Contact a qualified roofing professional.

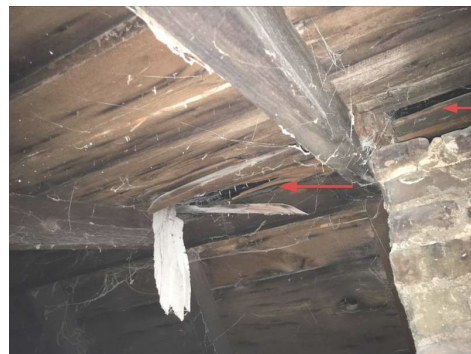
2.5.2 Structure

**SHEATHING DAMAGED**

Sheathing damaged; repairs required in several locations of roof

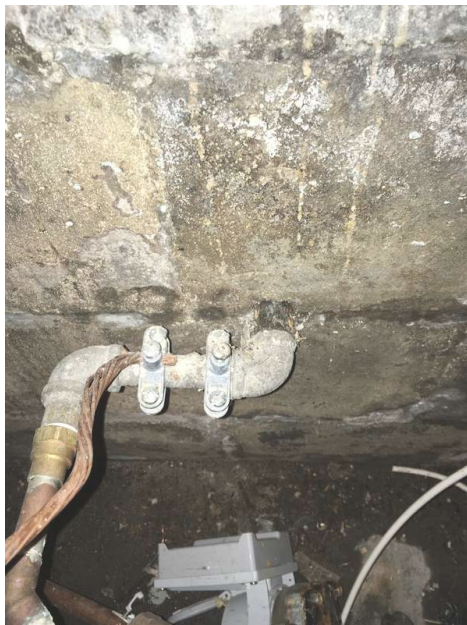
### 6.3.1 Water Supply, Distribution Systems & Fixtures

#### **LEAD PIPING**

Main water supply lead pipe material. Recommend replacement

Contact a qualified professional.

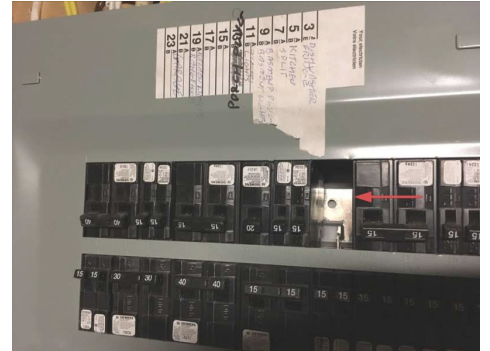
7.2.1 Main & Subpanels, Service & Grounding,  
Main Overcurrent Device

### **KNOCKOUTS MISSING**

"Knockouts" are missing on the electric panel. This poses a safety hazard and it is recommended that the opening in the panel caused by the missing knockout(s) be properly sealed by a licensed electrician.

Contact a qualified electrical contractor.

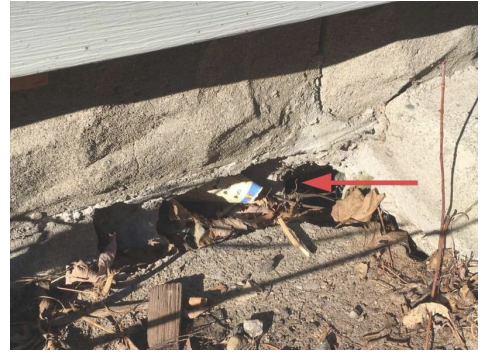
### 8.1.1 Foundation

#### FOUNDATION - SEVERE STRUCTURAL ISSUES

Severe structural issues noted at the foundation. Recommend a structural engineer evaluate and provide a report on course of action and remedy.

Contact a qualified structural engineer.

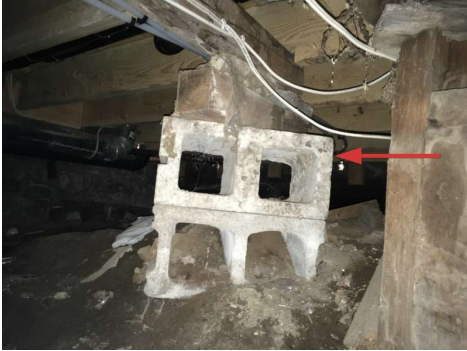
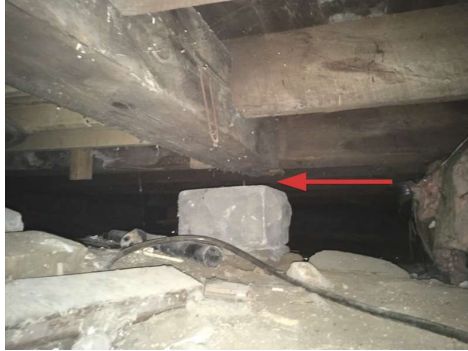
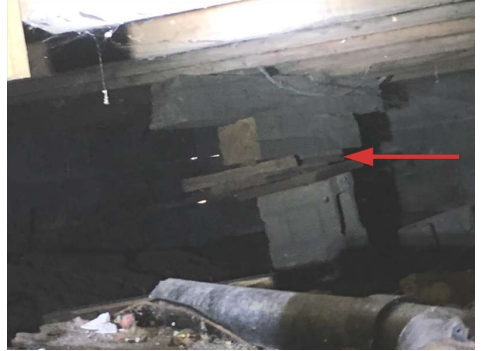
8.1.2 Foundation

**IMPROPER STRUCTURAL SUPPORTS**

Improper or sub-standard construction practices were noted at the foundation wall or slabs/piers. Recommend a structural engineer evaluate and advise on how to bring the construction up to standards.

Contact a qualified professional.

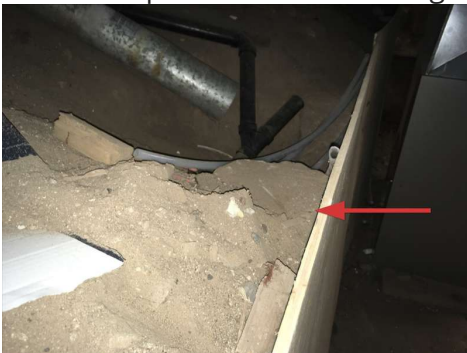
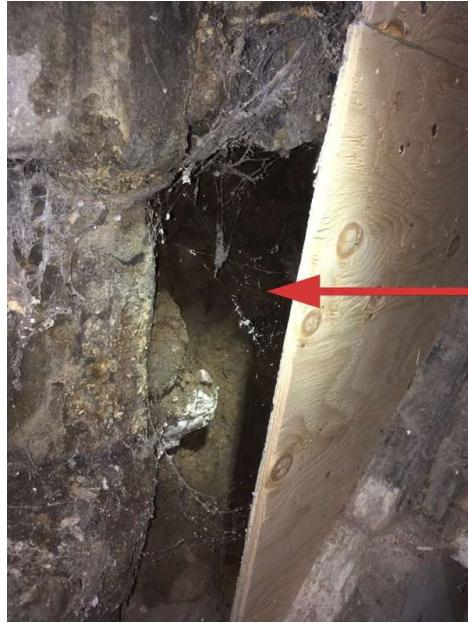
8.1.3 Foundation

Foundation wall requires substantial structural support; expect new concrete foundation to be required in this area.

side of stairs; no able to check other side of stairs due to inaccessibility

Contact a qualified structural engineer.

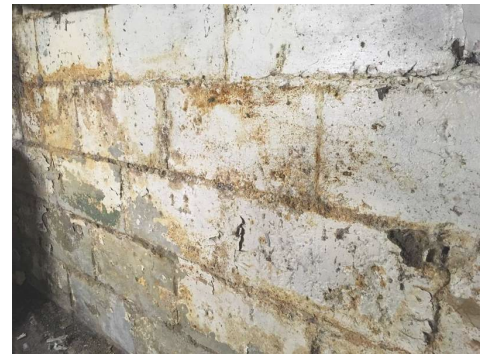
### 8.2.1 Basements & Crawlspaces

#### **EFFLORESCENCE**

Efflorescence noted on the wall surface. This a white, powdery deposit that is consistent with moisture intrusion. This can compromise the soil's ability to support the home structure and/or lead to mould growth. This condition results from poor water management on exterior of home. Newer homes have a "weeping tile" system which controls water on the foundation exterior; older homes do not have this system, hence the water penetrates through the concrete or block wall foundation. Water penetration through wall will continue of time with increased damage to foundation wall. Recommend a qualified contractor identify source of moisture and correct.

Contact a qualified professional.

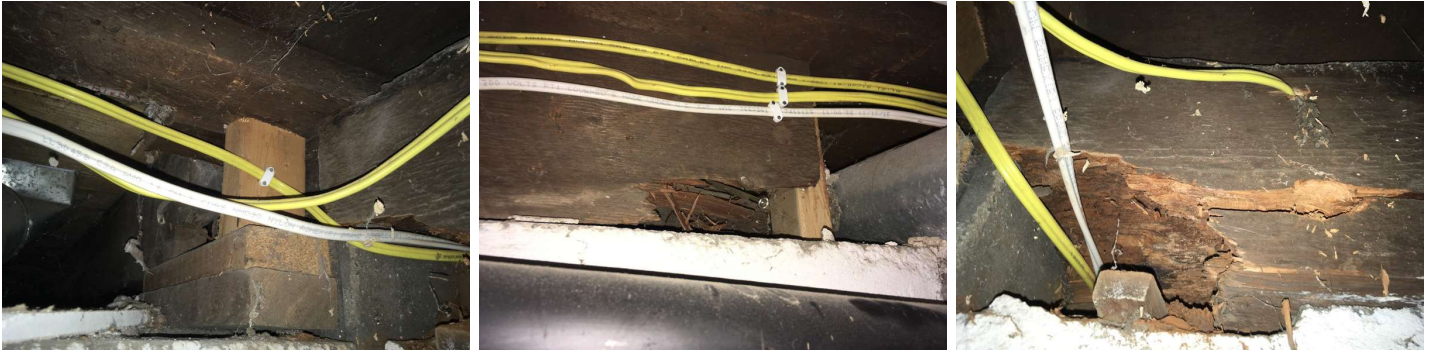
#### **EVIDENCE OF STRUCTURAL DAMAGE**

Structural damage was observed in the underlying floor structure. Recommend a structural engineer evaluate.

Contact a qualified structural engineer.

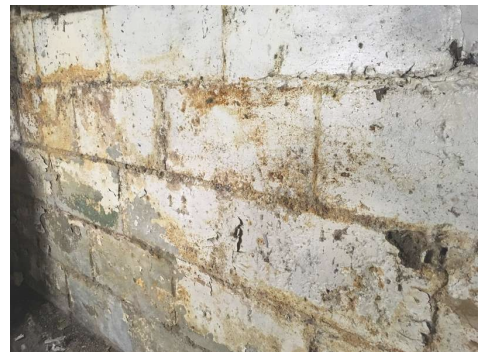
## 8.4.1 Wall Structure

**EVIDENCE OF WATER INTRUSION**

Wall structure showed signs of water intrusion, which could lead to more serious structural damage. Recommend a qualified contractor identify source or moisture and remedy.

Contact a qualified structural engineer.

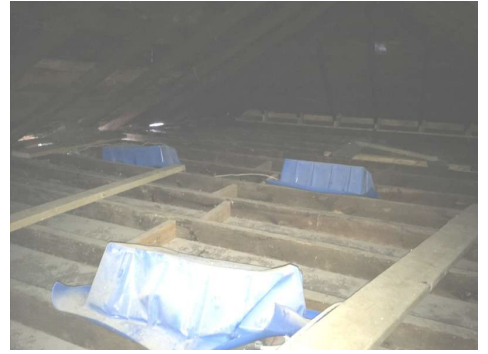
No insulation. Recommend a qualified attic insulation contractor install insulation.

Contact a qualified insulation contractor.

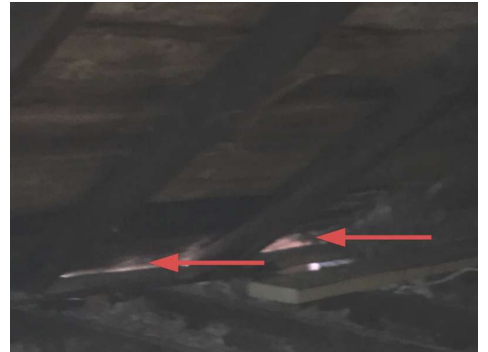
9.3.1 Ventilation

**SOFFIT VENTING LIMITED / MISSING**

Recommend adding or upgrading soffit vents by a qualified contractor. Soffit vents promote attic ventilation and effectively reduces probability of ice damming, mould, premature wearing of shingles and roof structure.

Contact a qualified roofing professional.
