RESIDENTIAL REPORT

1234 Main St.
FISHERS IN 46037

Buyer Name
12/09/2018 9:00AM

Inspector
Cameron Heflin
317-376-2769
cheflinhomes@gmail.com

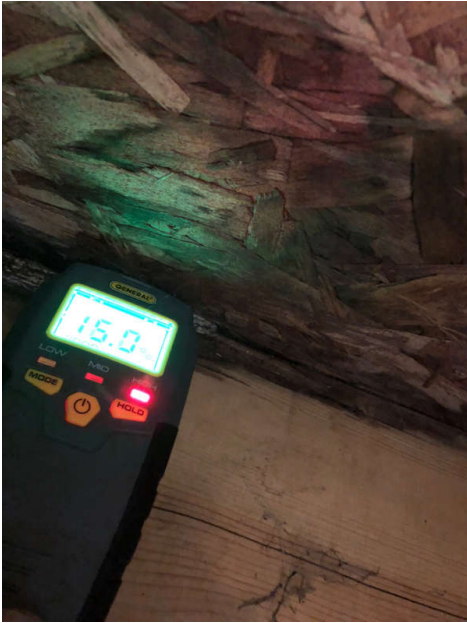
2.1.1 Foundation, Basement & Crawlspace

HIGH MOISTURE LEVELS

High levels of moisture were noted in areas of the basement. Recommend finding source of moisture intrusion and making necessary repairs to prevent damage or further damage to the structure.

Contact a qualified professional.

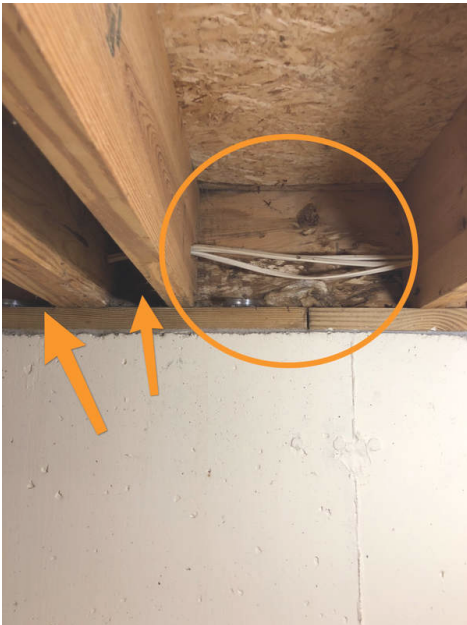
2.1.2 Foundation, Basement & Crawlspaces

BIOLOGICAL GROWTH-BASEMENT

Possible biological growth noted in areas of the basement. Recommend qualified professional for testing.

Contact a qualified professional.

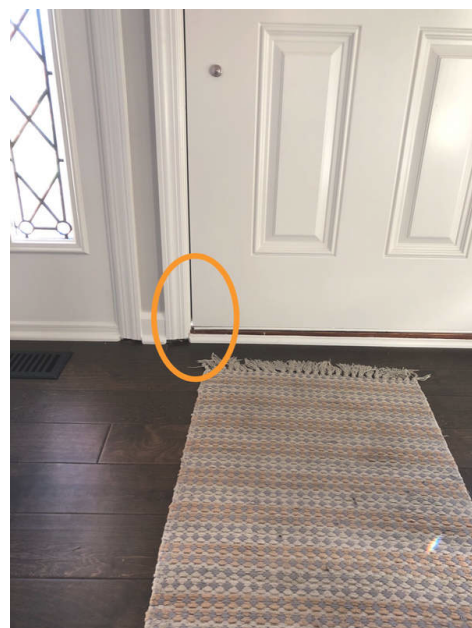
3.2.1 Exterior Doors

WEATHERSTRIPPING- ADDED

A small area of weatherstripping needs to be added to ensure proper efficiency. Recommend handyman for repair.

Contact a handyman or DIY project

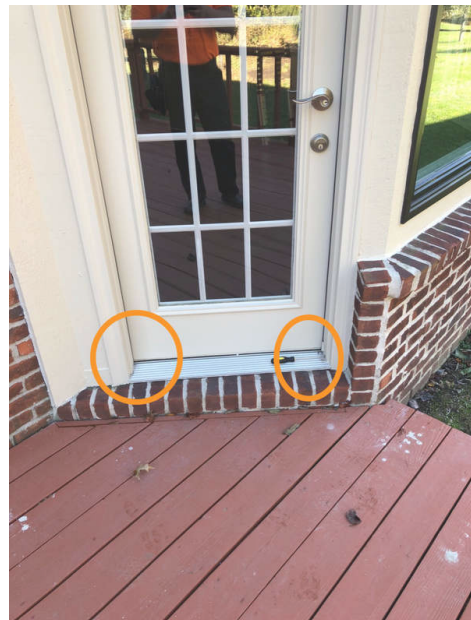
3.2.2 Exterior Doors

WOOD ROT

Wood rot was noted in one or more places. Recommend qualified handyman to repair or replace all affected areas.

Contact a qualified handyman.

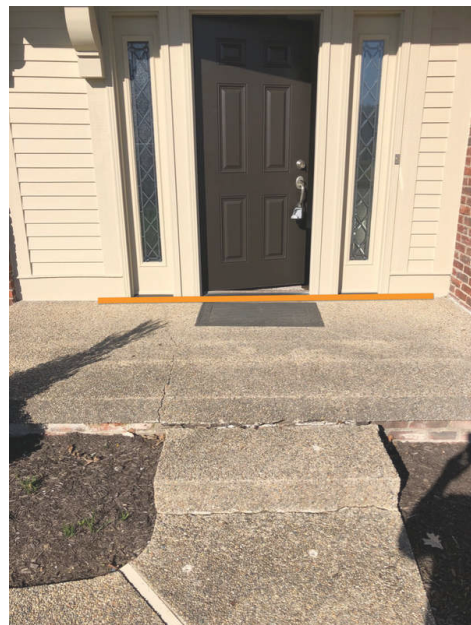
3.3.1 Decks, Balconies, Porches & Steps

CONCRETE SETTLED

The concrete has settled which has caused a crack and a gap to form along the house. Recommend qualified professional to make necessary repairs.

Contact a qualified professional.

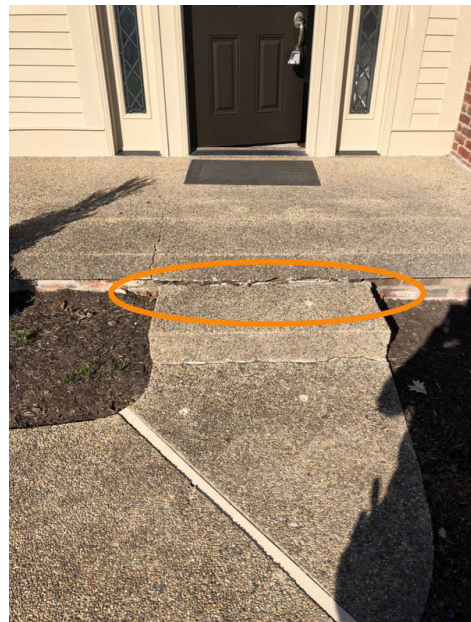
3.3.2 Decks, Balconies, Porches & Steps

STEPS-SETTLED

The step(s) have settled significantly and caused a large gap to form. Recommend a qualified professional to evaluate and make necessary repairs.

Contact a qualified professional.

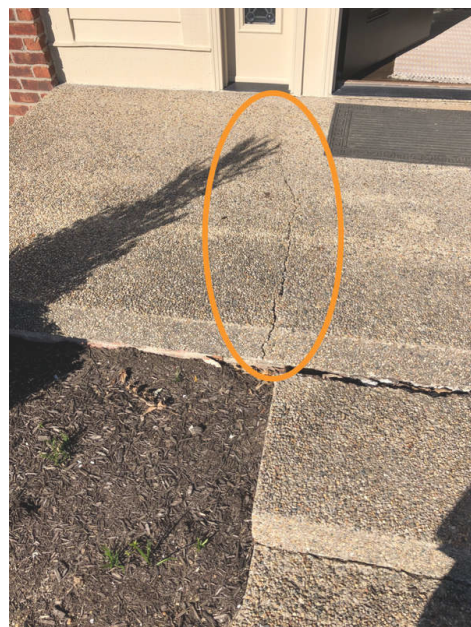
3.3.3 Decks, Balconies, Porches & Steps

CONCRETE-CRACK

There is a crack in the porch concrete. This can allow water to infiltrate and settle next to the foundation and cause further damage. Recommend qualified professional to evaluate and make repairs.

Contact a qualified professional.

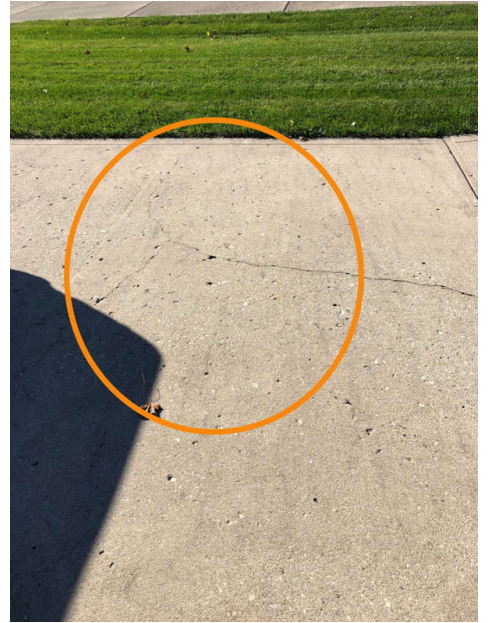
3.4.1 Walkways, Patios & Driveways

DRIVEWAY CRACKING - MINOR

Minor cosmetic cracks observed, which may indicate movement in the soil. Recommend monitor and/or have driveway contractor patch/seal.

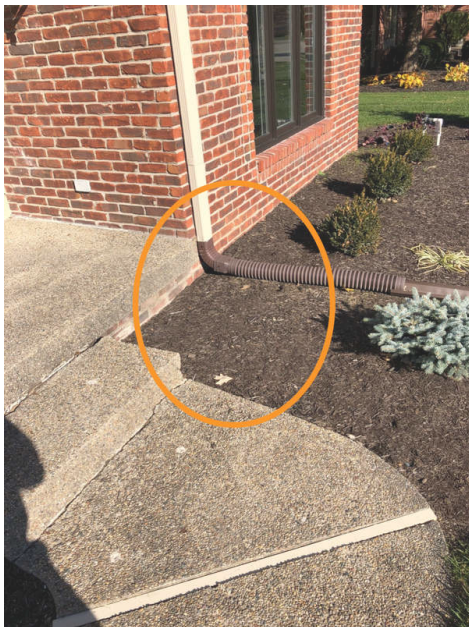
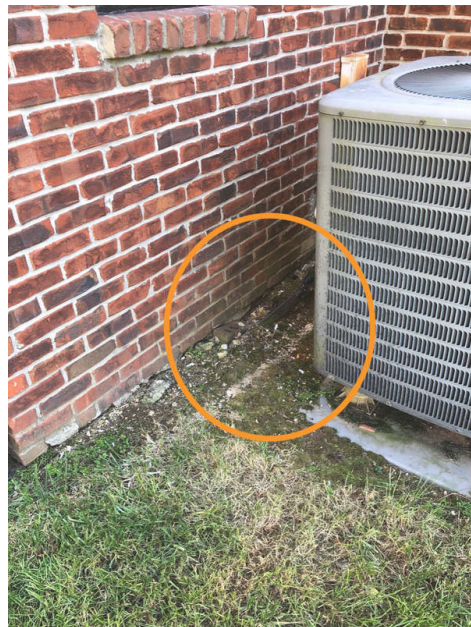
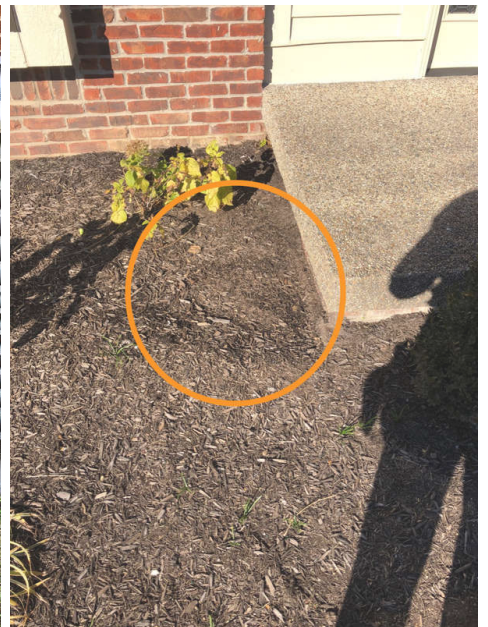
3.6.1 Vegetation, Grading, Drainage & Retaining Walls

NEGATIVE GRADING

Grading is sloping towards the home in some areas. This could lead to water intrusion and foundation issues. Recommend qualified landscaper or foundation contractor regrade so water flows away from home.

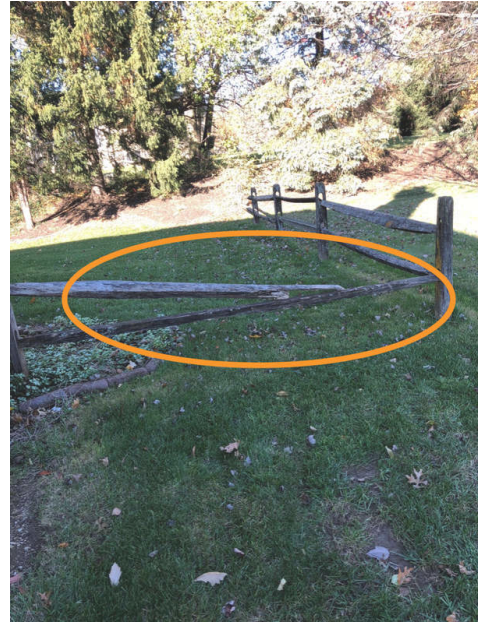
3.6.2 Vegetation, Grading, Drainage & Retaining Walls

FENCE DAMAGE

The fence was damaged. Recommend replacing affected boards.

Recommendation
Contact a qualified professional.

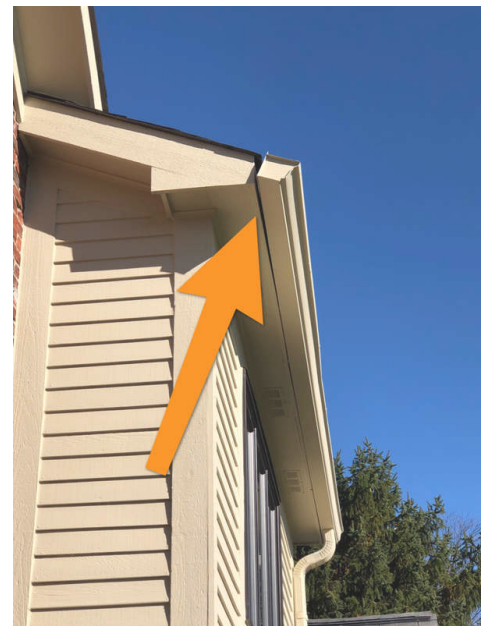
4.3.1 Roof Drainage Systems

GUTTER-SEPARATED FROM HOUSE

Gutter is separated from the house. This will cause water to run down the fascia and collect near the foundation. Recommend qualified roofing professional for repair.

Contact a qualified professional.

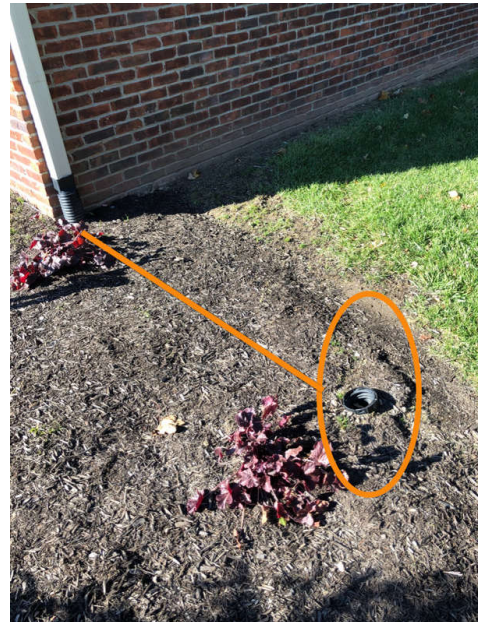
4.3.2 Roof Drainage Systems

DRAIN CLOGGED

Downspout landscape drain is clogged with debris. This will cause water to back up and run out near the foundation. Recommend qualified handyman to remove debris.

Contact a handyman or DIY project

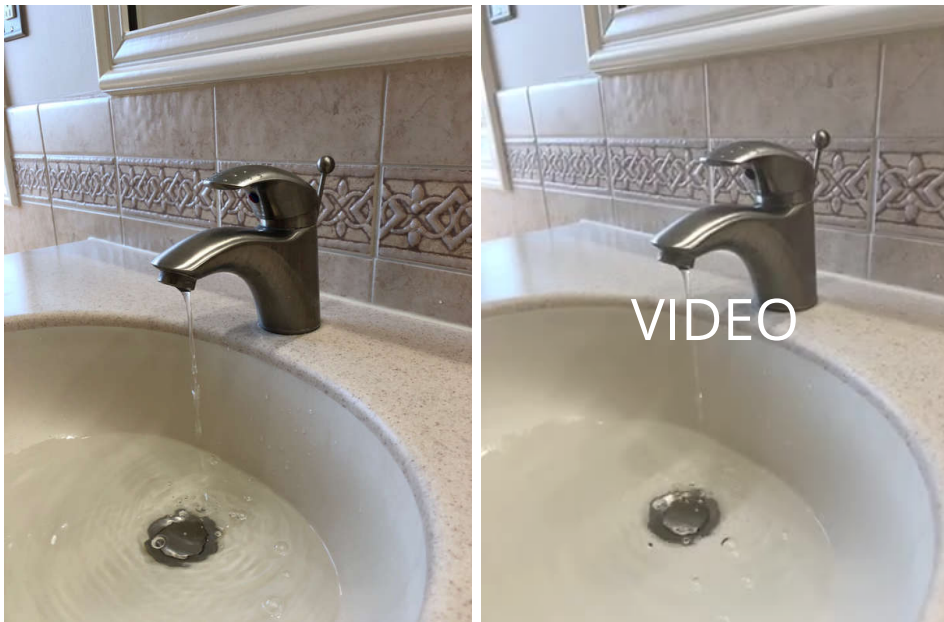
5.1.1 Fixtures / Faucets

FAUCET DRIP

A faucet is dripping. Recommend qualified handyman or plumber evaluate and repair.

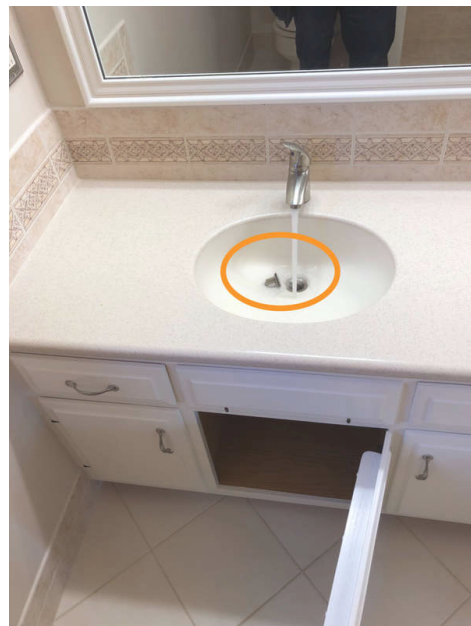
5.1.2 Fixtures / Faucets

SINK DRAIN STOPPER

The sink drain stopper is missing or broken. Recommend handyman for replacement.

Contact a qualified handyman.

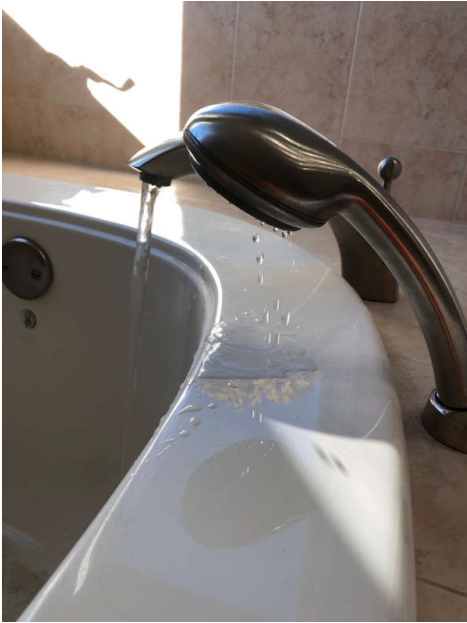
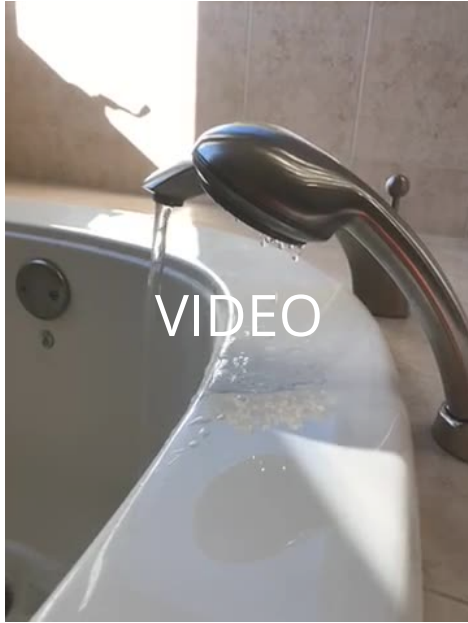
5.1.3 Fixtures / Faucets

SHOWER HEAD - DRIPPING

The shower head continued to drip (run) long after the diverted valve was changed back to faucet only. Recommend qualified plumber to check for buildup of minerals which may cause this.

Contact a qualified plumbing contractor.

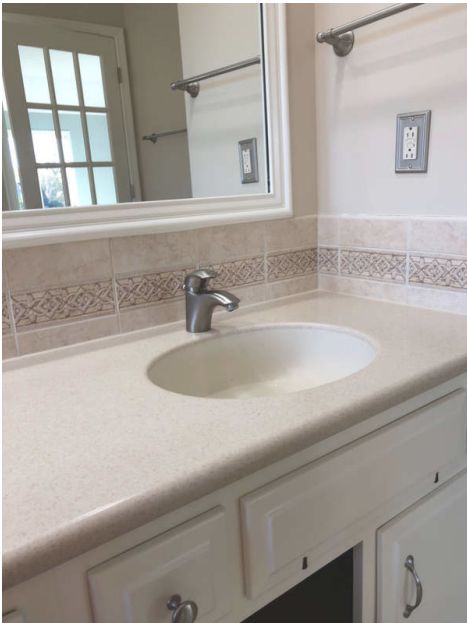
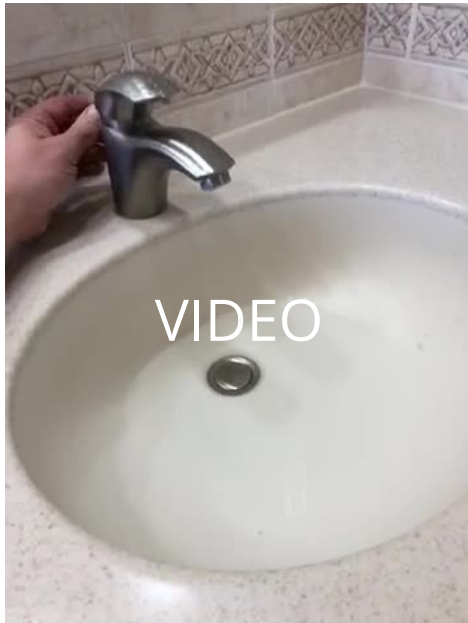
5.1.4 Fixtures / Faucets

SINK DRAIN STOPPER

The sink drain stopper does not properly operate. Recommend qualified handyman for adjustments.

Contact a qualified handyman.

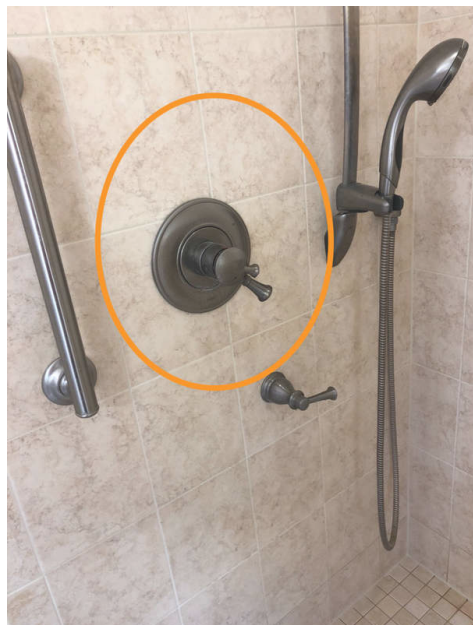
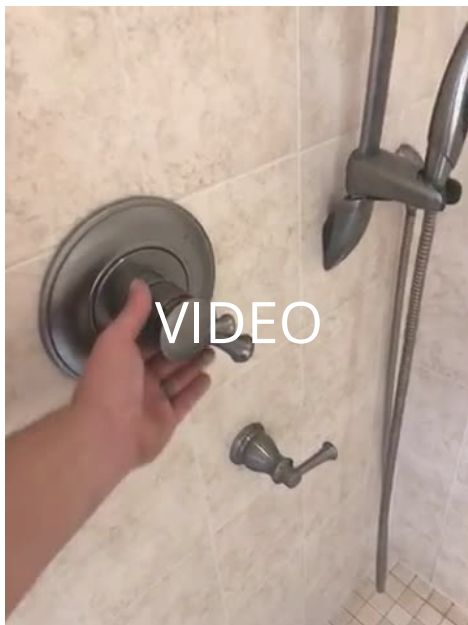
5.1.5 Fixtures / Faucets

SHOWER VALVE-LOOSE

The shower mixer valve is not secure in the wall. This can lead to a leak. Recommend qualified plumber for repair.

Contact a qualified plumbing contractor.

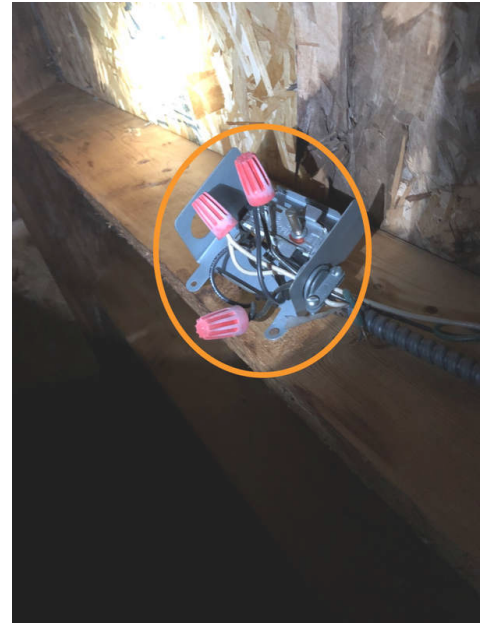
6.4.1 Branch Circuit Conductors, Overcurrent Devices and Compatibility of Their Amperage & Voltage

EXPOSED ENDS & SPLICES

All wire connections & charged wires with exposed ends and splices should be covered in junction boxes for safety. Recommend a qualified electrician correct.

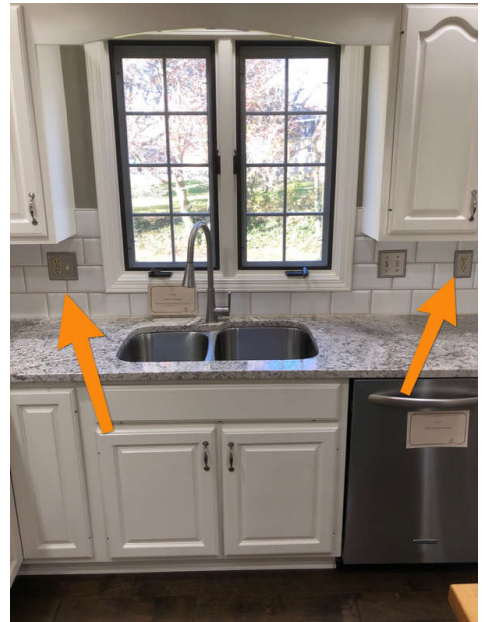
6.6.1 GFCI & AFCI

KITCHEN GFCI

Outlets within 6 feet of a water source need to be GFCI protected. Recommend qualified electrician for repair.

Contact a qualified professional.

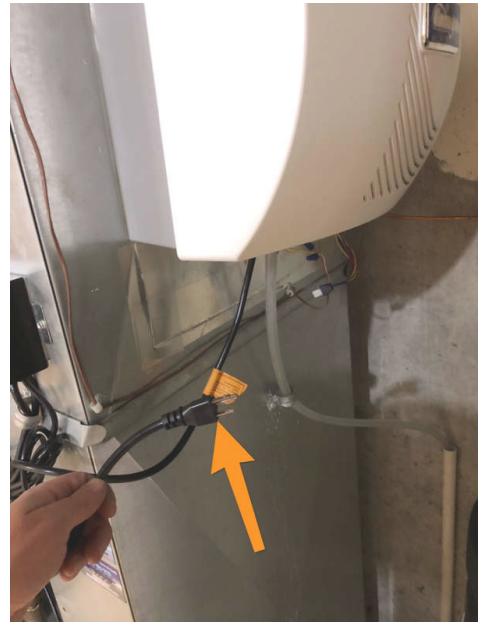
7.1.1 Heating Equipment

HUMIDIFIER- UNPLUGGED

The humidifier was unplugged at the time of inspection. Recommend confirming with HVAC technician that the humidifier is in working order.

Contact a qualified HVAC professional.

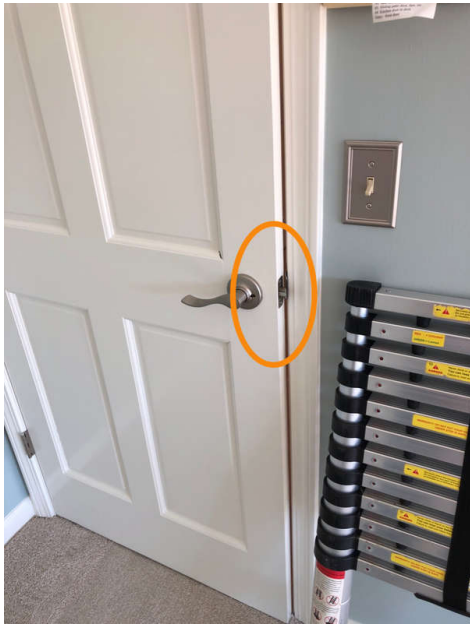
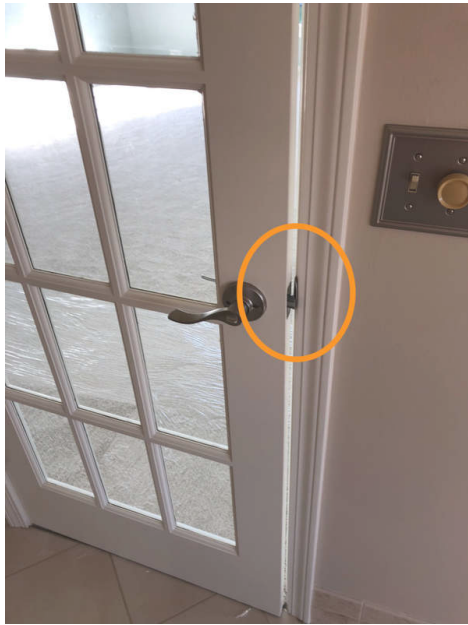
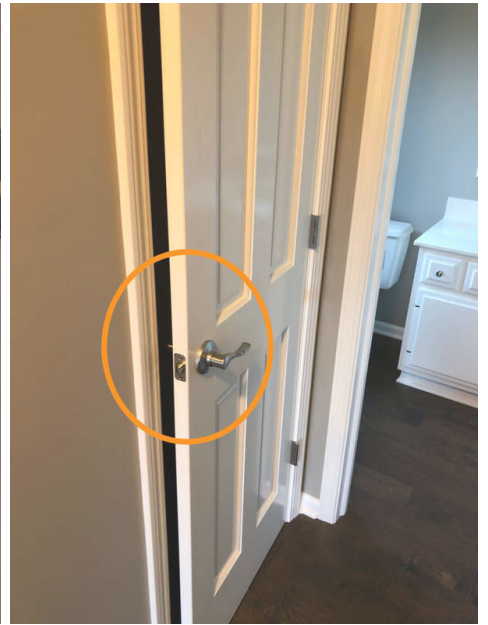
8.6.1 Doors

DOOR DOESN'T LATCH

Door doesn't latch properly. Recommend handyman repair latch and/or strike plate.

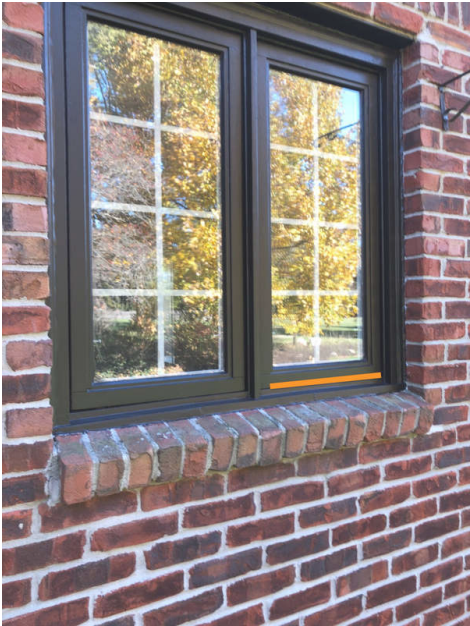
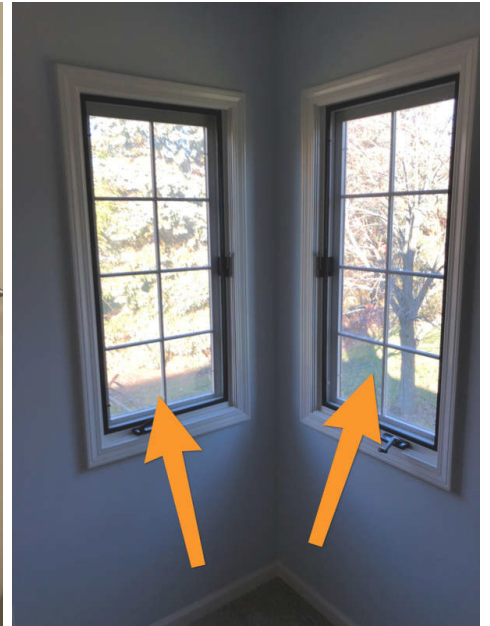
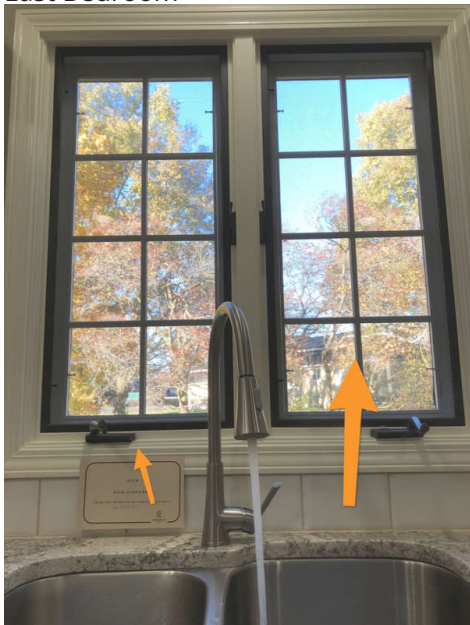
8.7.1 Windows

PAINTED SHUT

One or more windows are painted shut. Recommend windows be restored to functional use.

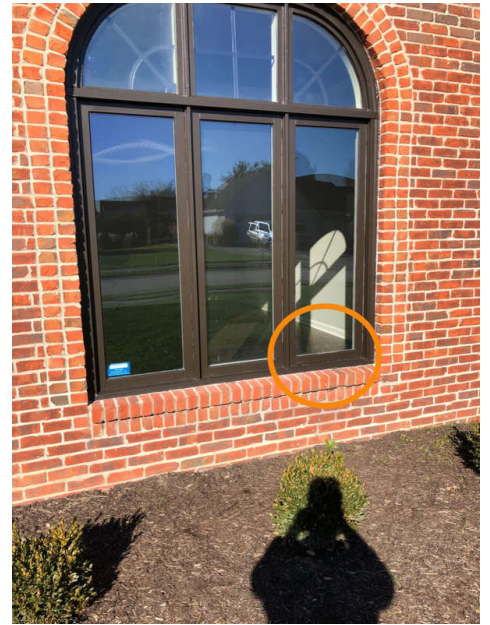
8.7.2 Windows

WOOD ROT

Wood rot was noted on the exterior trim. Recommend repairing and replacing all affected materials.

Contact a qualified professional.

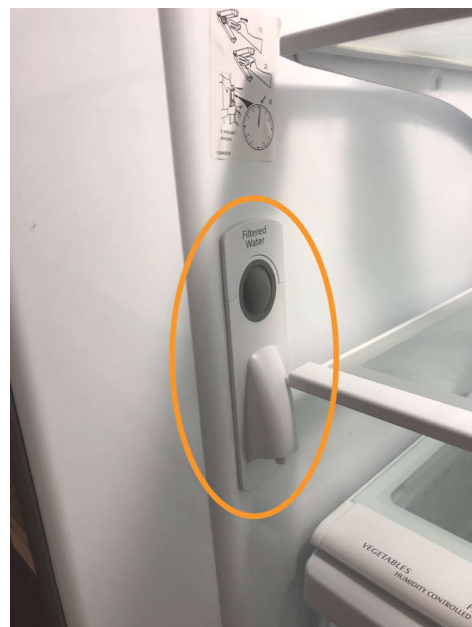
10.2.1 Refrigerator

WATER OFF

Contact a qualified professional.

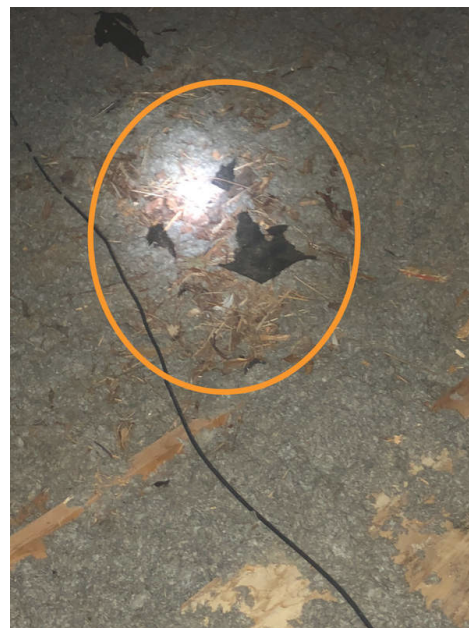
11.1.1 Attic Insulation

STRAW

Straw or other organic material noted in the attic. This is usually a sign of birds making it into the attic. Recommend qualified pest control professional for evaluation.

Contact a qualified pest control specialist.

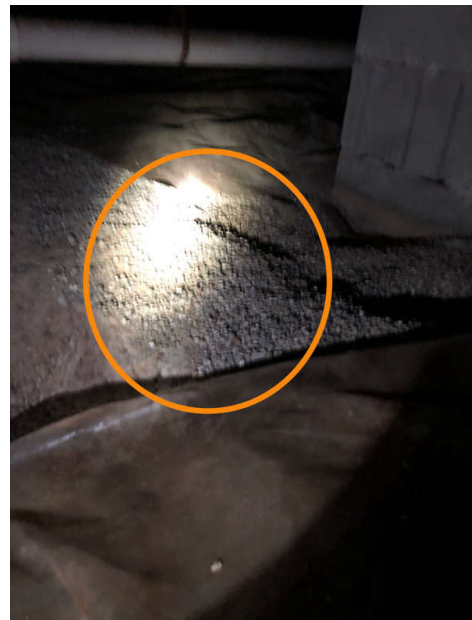
11.2.1 Vapor Retarders

VAPOR BARRIER DAMAGED

Vapor barrier is damaged in one or more areas. Recommend insulation contractor repair or replace.

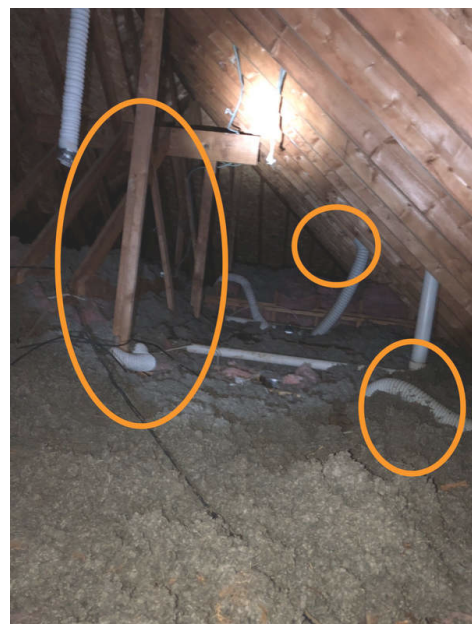
11.4.1 Exhaust Systems

BATHROOM VENTS INTO ATTIC

Bathroom fan vents into the attic, which can cause moisture and mold. Recommend a qualified attic contractor property install exhaust fan to terminate to the exterior.

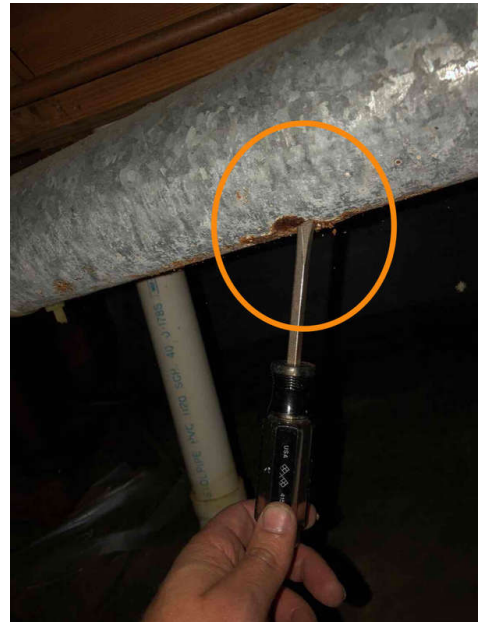
11.4.2 Exhaust Systems

CORRODED METAL VENT

The metal vent pipe is corroded and developing holes. Recommend replacing the pipe.

Contact a qualified professional.
