BLUE LOBSTER HOME INSPECTION INC

PROPERTY INSPECTION REPORT

1234 Main St.
Saco Maine 04072

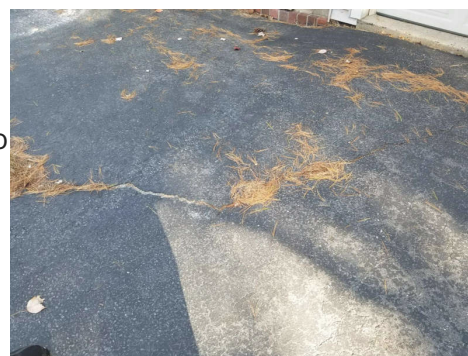
2.3.1 Driveway

MINOR CRACKS

Contact a qualified driveway contractor.

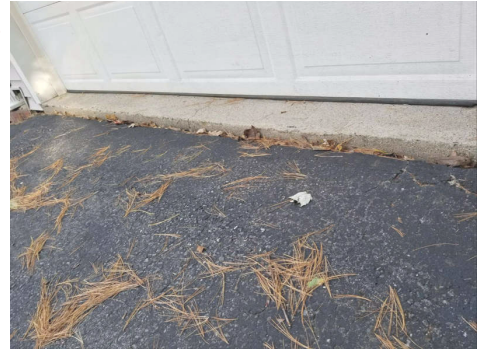
2.3.2 Driveway

TRIP HAZARD

One or more trip hazards were found in the driveway due to cracks, settlement and/or heaving. Recommend having a qualified contractor evaluate and repair or replace driveway sections as necessary to eliminate trip hazards.

Contact a qualified driveway contractor.

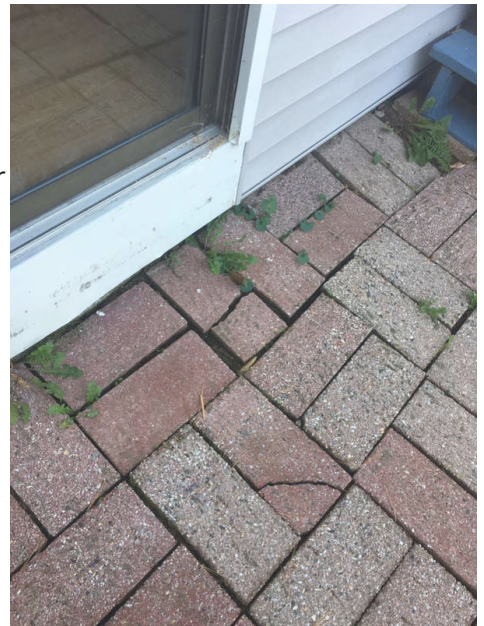
REPAIR - REPLACE

Sidewalks and/or patios have significant cracks and/or deterioration in one or more areas. A qualified contractor should evaluate and repair or replace sidewalk and/or patio sections as necessary.

Contact a qualified concrete contractor.

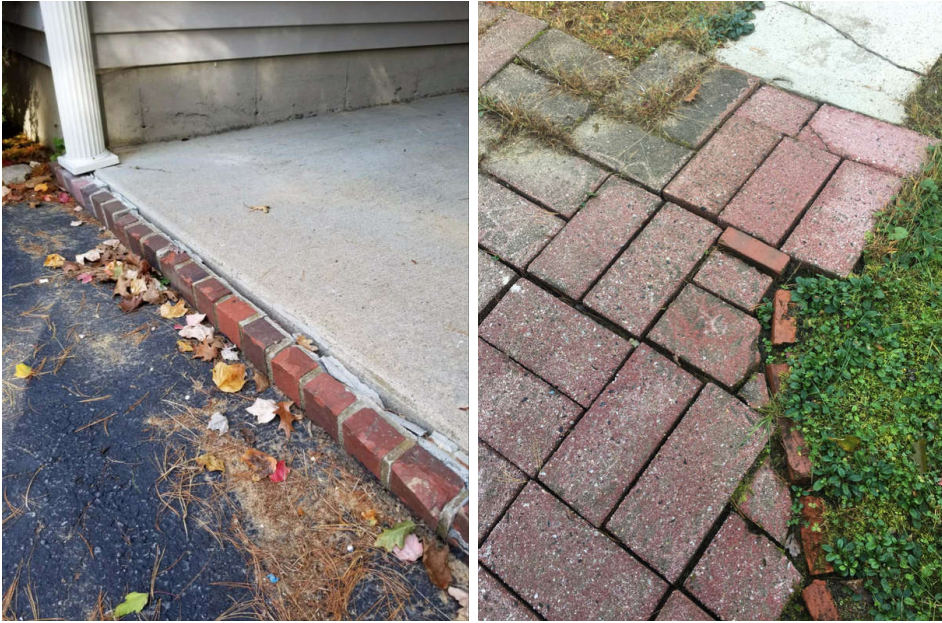
TRIP HAZARD

One or more trip hazards were found in sidewalk and/or patio sections due to cracks, settlement and/or heaving. A qualified contractor should evaluate and repair or replace sidewalk and/or patio sections as necessary to eliminate trip hazards.

Contact a qualified concrete contractor.

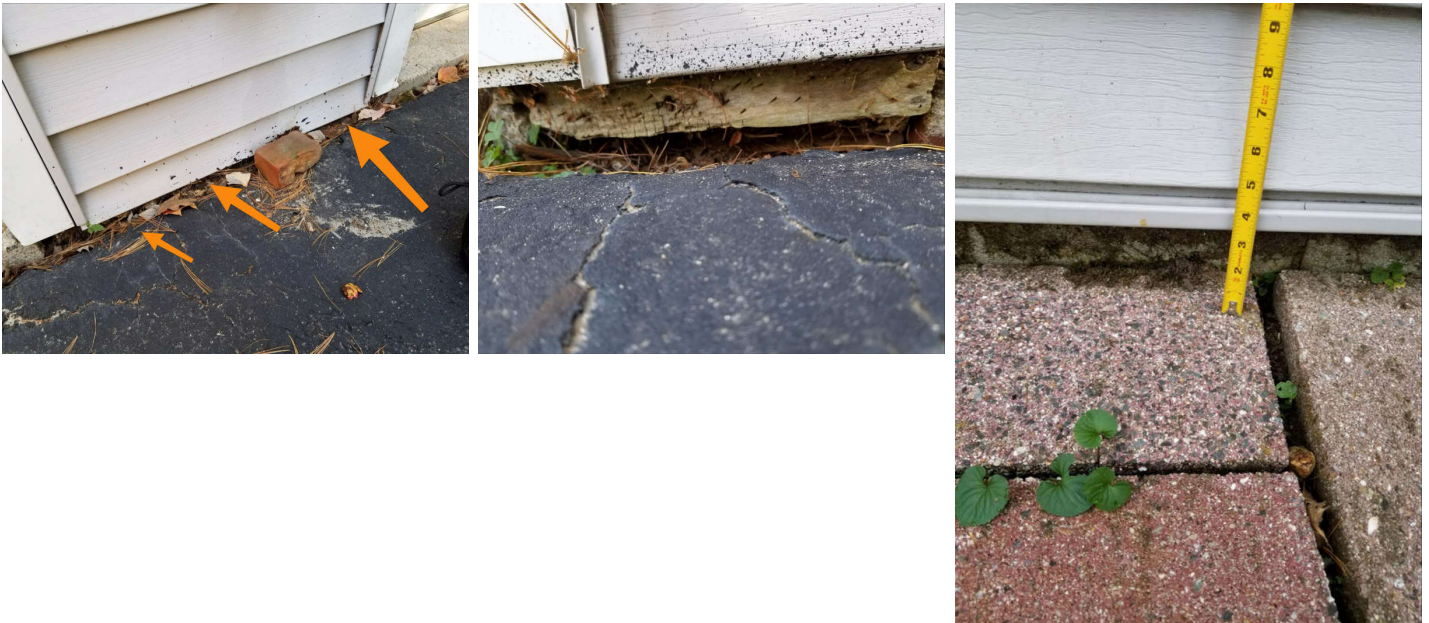
2.5.1 Soil Contact

SOIL WITHIN 6" OF SIDING/TRIM, ROT

Soil is in contact with or less than six inches from siding and/or trim. This is a conducive condition for wood destroying insects and organisms. Wood siding and/or trim is rotten in some areas as a result. A qualified contractor should evaluate and repair as necessary, replacing all rotten wood. Also, the soil should be graded and/or removed as necessary so there are at least six inches of space between the siding and trim and the soil below.

Contact a qualified professional.

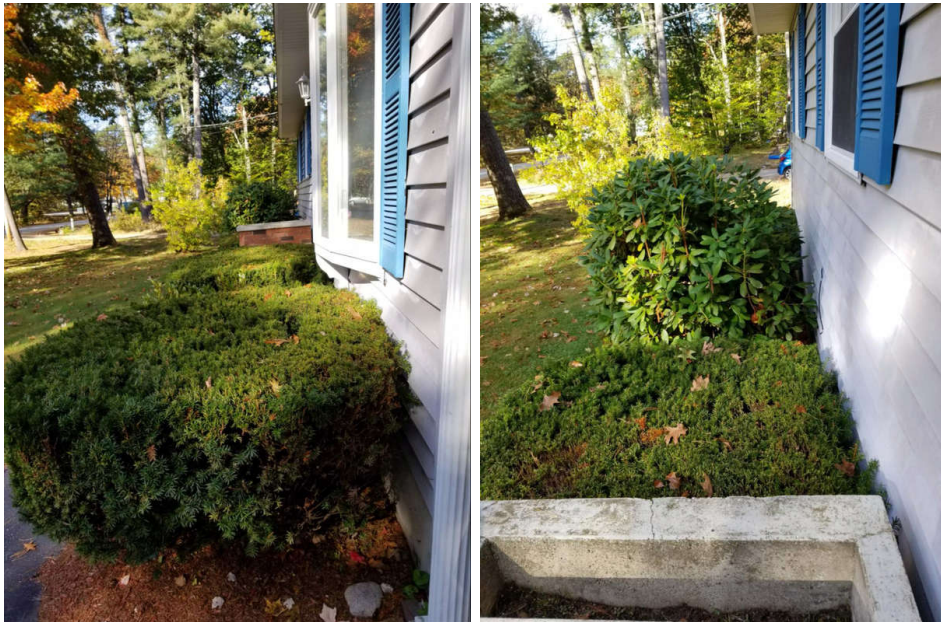
2.6.1 Vegetation

Vegetation such as trees, shrubs and/or vines are in contact with or less than one foot from the structure's exterior. Vegetation can serve as a conduit for wood destroying insects and may retain moisture against the exterior after it rains. Vegetation should be pruned and/or removed as necessary to maintain a one foot clearance between it and the structure's exterior.

Contact a qualified landscaper or gardener.

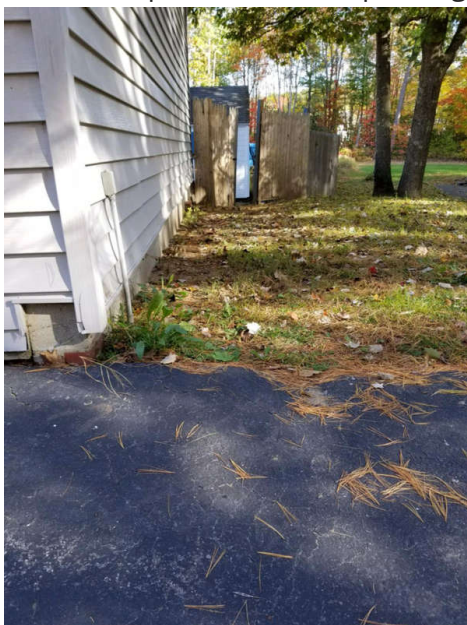
2.7.1 Drainage

NEGATIVE PERIMETER SLOPE - SOIL

The perimeter grading slopes towards the structure in one or more areas. This can result in water accumulating around the structure's foundation, or in basements and crawl spaces if they exist. Accumulated water is a conducive condition to wood destroying insects and organisms. Wet soil may also cause the foundation to settle and possibly fail over time. Recommend grading soil so it slopes down and away from the structure with a slope of at least 5% (10% or better is optimal) for at least 6 feet.

Contact a qualified landscaper or gardener.

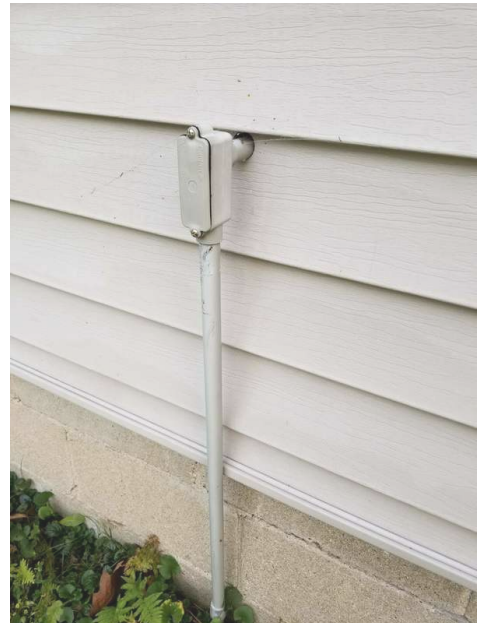
Gaps exist at one or more openings around the exterior, such as those where outside faucets, refrigerant lines, and/or gas supply pipes penetrate the exterior. Gaps should be sealed as necessary to prevent moisture intrusion and entry by vermin.

Contact a qualified handyman.

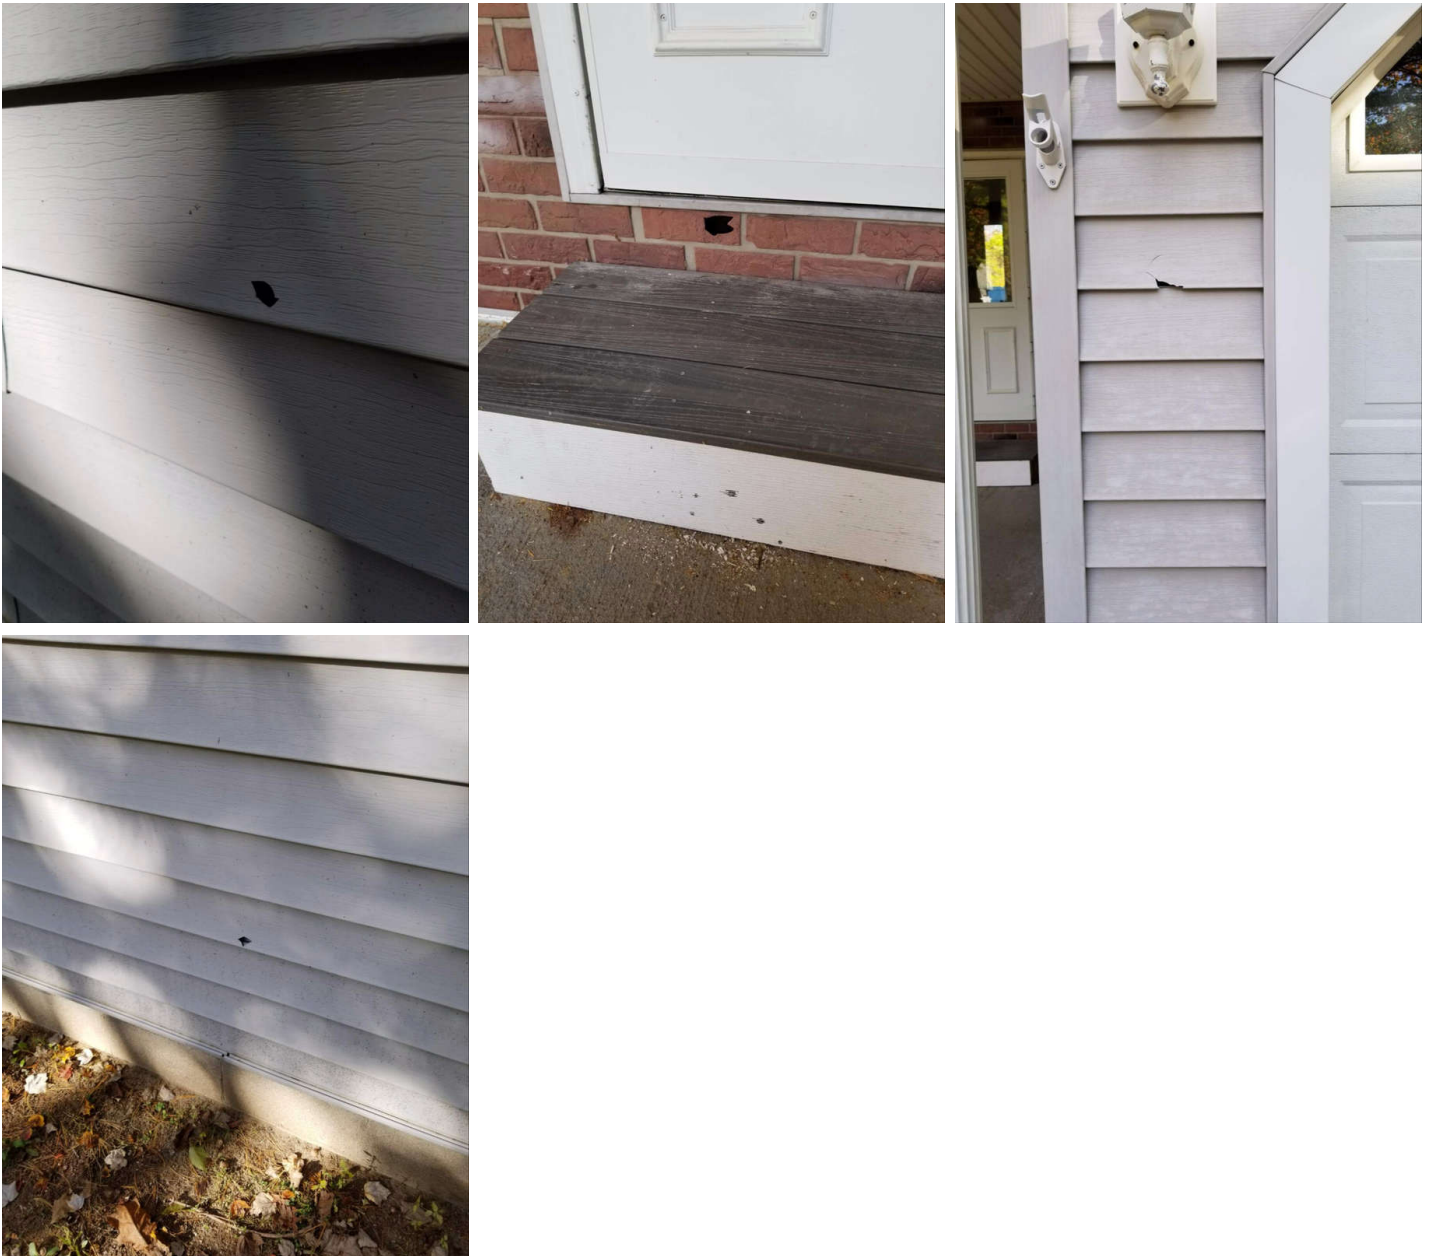
2.10.2 Siding

SIDING BROKEN

There are several places that the siding is broken leading to areas that water can enter the building envelope and cause damage. Recommend replacing the broken sections of siding.

Contact a qualified siding specialist.

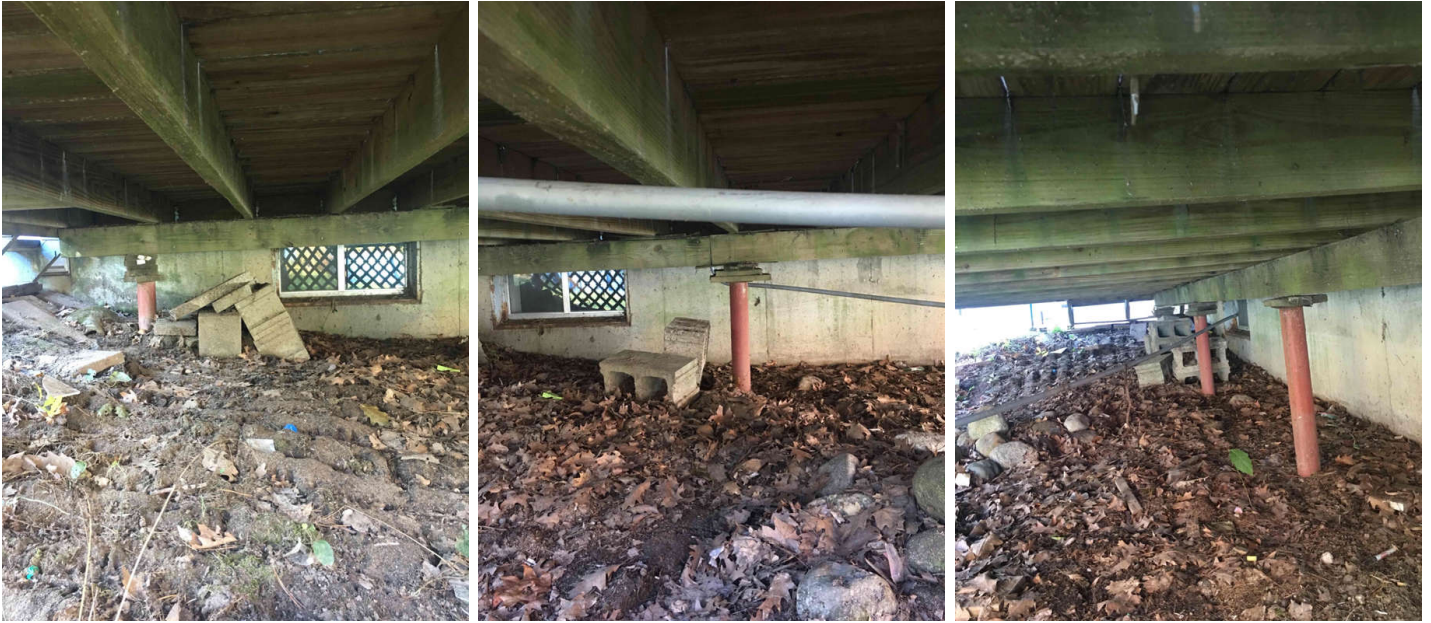
2.13.1 Deck/Patio Cover

DECK/PATIO COVER WRONG

One or more deck, patio and/or porch covers were non-standard. Recommend that a qualified person repair or replace as necessary, and per standard building practices.

Contact a qualified deck contractor.

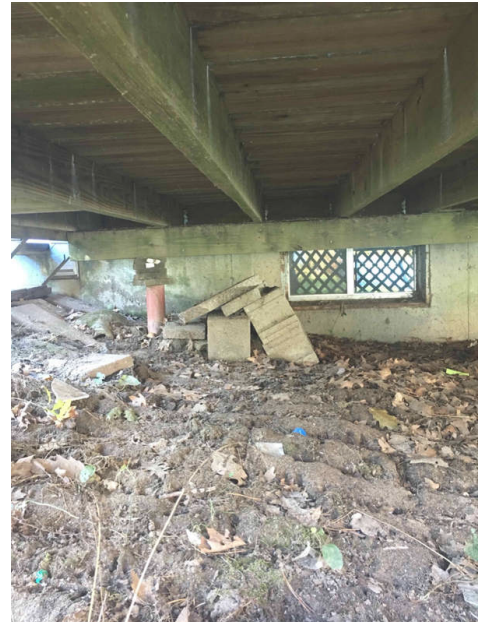
2.13.2 Deck/Patio Cover

SUBSTRUCTURE - NEEDS BRACING

The deck is unstable in one or more areas due to lack of diagonal bracing. This is a safety hazard since severe movement may cause the deck to collapse. A qualified contractor should evaluate and make repairs as necessary.

Contact a qualified deck contractor.

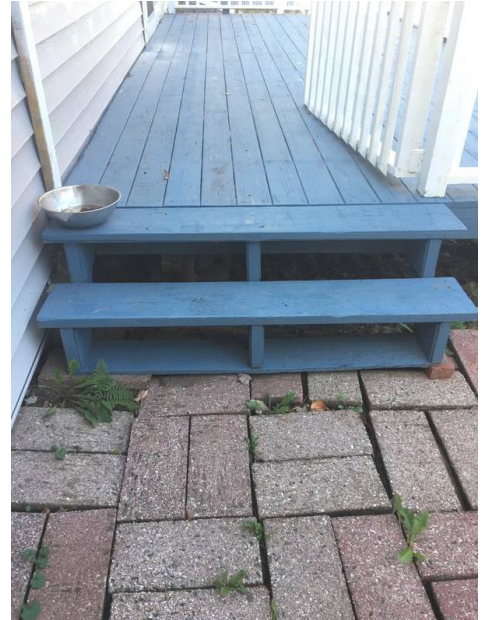
2.14.1 Stairs

NON-STANDARD - WARNING

Stairs are unsafe due to a non-standard configuration, such as too-high riser heights and/or too-narrow tread depths. Standard building practices call for riser heights not to exceed eight inches and tread depths to be at least nine inches but preferably 11 inches. Riser heights should not vary more than 3/8 inch on a flight of stairs. At a minimum, the client(s) should be aware of this hazard, especially when guests who are not familiar with the stairs are present. Ideally a qualified contractor should repair or replace stairs so they conform to standard building practices.

Contact a qualified deck contractor.

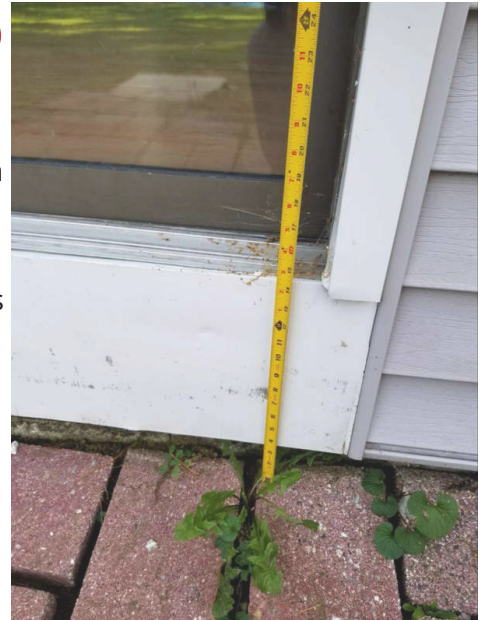
2.14.2 Stairs

NON-STANDARD - REPAIR

Stairs are unsafe due to a non-standard configuration, such as too-high riser heights and/or too-narrow tread depths. Standard building practices call for riser heights not to exceed eight inches and tread depths to be at least nine inches but preferably 11 inches. Riser heights should not vary more than 3/8 inch on a flight of stairs. A qualified contractor should repair or replace stairs so they conform to standard building practices.

Contact a qualified deck contractor.

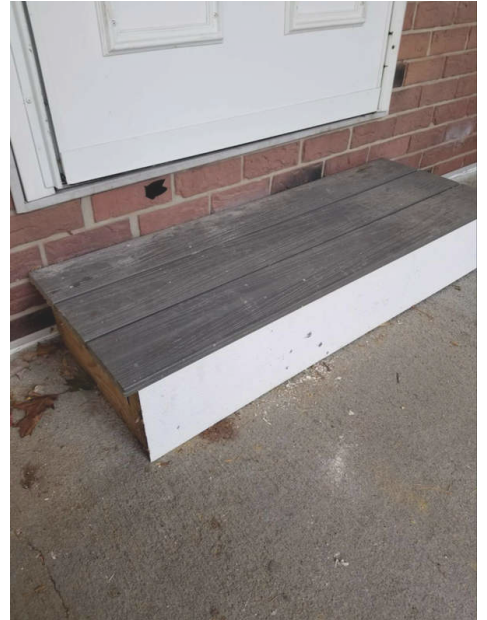
2.14.3 Stairs

NON-UNIFORM RISERS - WARNING

Trip hazard(s) exist at stairs due to non-uniform riser heights. Standard building practices call for riser heights not to vary more than 3/8 inch on a flight of stairs. At a minimum, the client(s) should be aware of this hazard, especially when guests who are not familiar with the stairs are present. Ideally a qualified contractor should evaluate and repair or replace stairs so all riser heights are within 3/8 inch of each other.

Contact a qualified deck contractor.

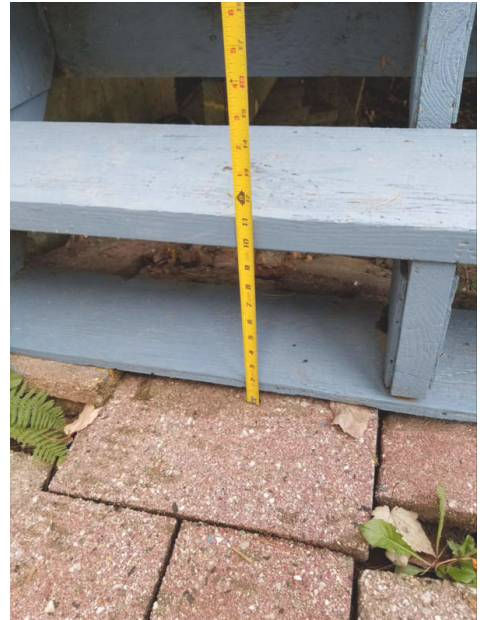
2.14.4 Stairs

NON-UNIFORM RISERS - REPAIR

Trip hazard(s) exist at stairs due to non-uniform riser heights. Standard building practices call for riser heights not to vary more than 3/8 inch on a flight of stairs. A qualified contractor should repair or replace stairs so all riser heights are within 3/8 inch of each other.

Contact a qualified deck contractor.

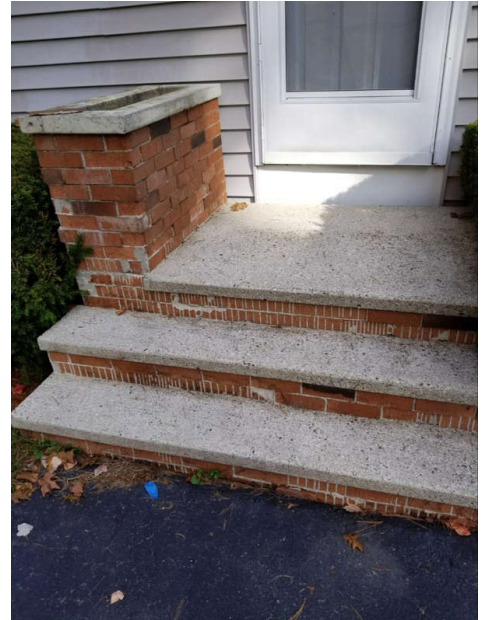
2.15.1 Handrails

MISSING

One or more flights of stairs with more than two risers have no handrail installed. This is a safety hazard. A qualified contractor should install graspable handrails that your hand can completely encircle at stairs where missing, and as per standard building practices.

Contact a qualified professional.

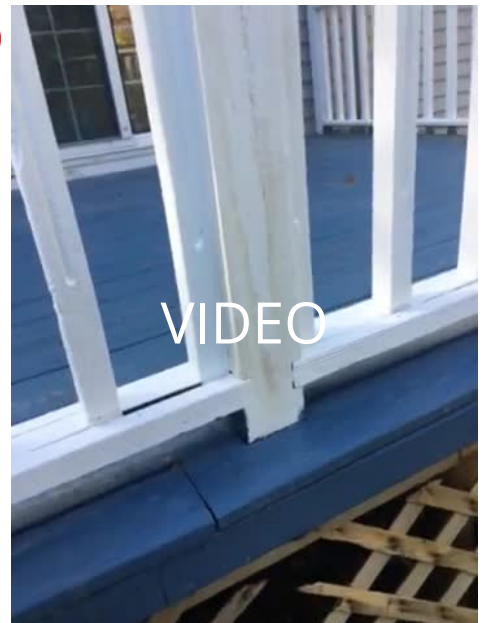
2.16.1 Guardrails

Guardrails are loose and/or wobbly in one or more areas. This is a safety hazard. A qualified contractor should evaluate and make repairs as necessary, such as installing new fasteners or hardware, installing additional fasteners and/or installing additional railing components as necessary so they are securely attached.

Contact a qualified professional.

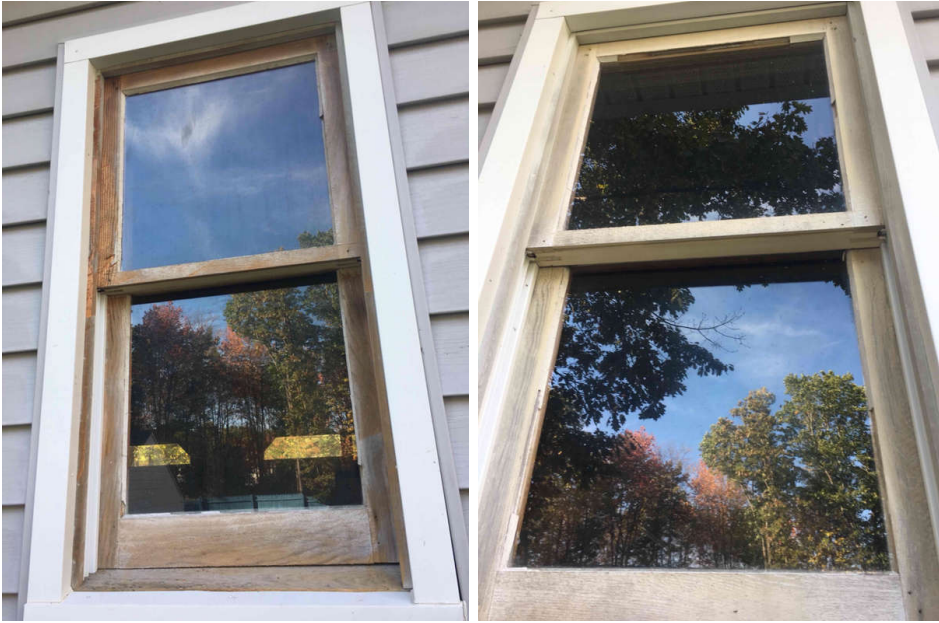
2.18.1 Paint & Caulk

WOOD WINDOW IS MISSING PAINT

One or more wood windows is missing paint. Recommend having a handyman address in order to prevent potential wood rot.

Contact a qualified handyman.

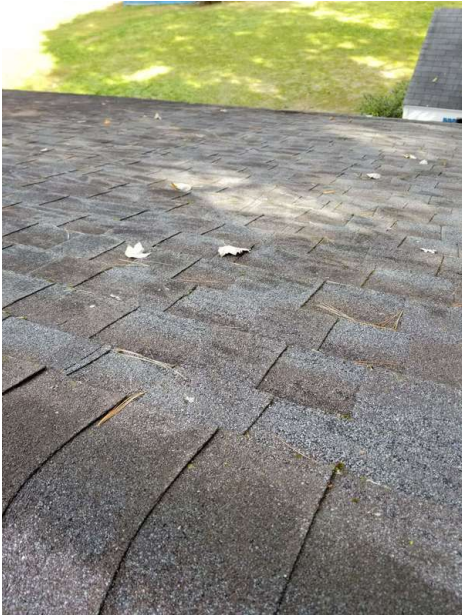
Roof Design: Unlevel Sheathing

Across entire house where entry porch aligns with thw house

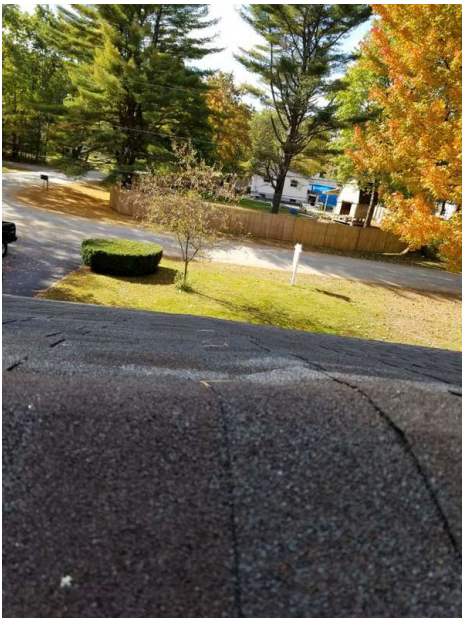
One or more areas of the roof appear to have uneven sheathing beneath them.

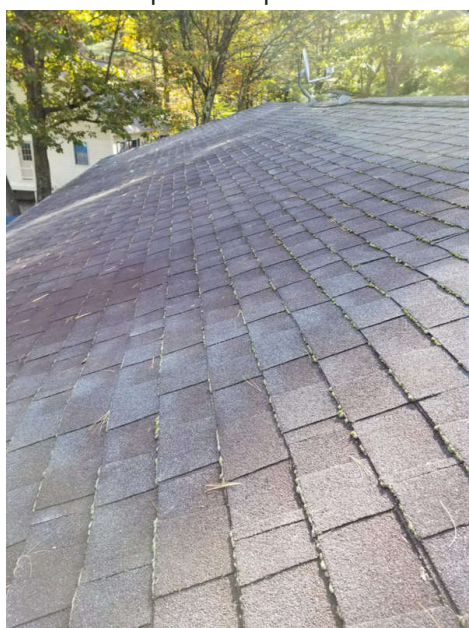
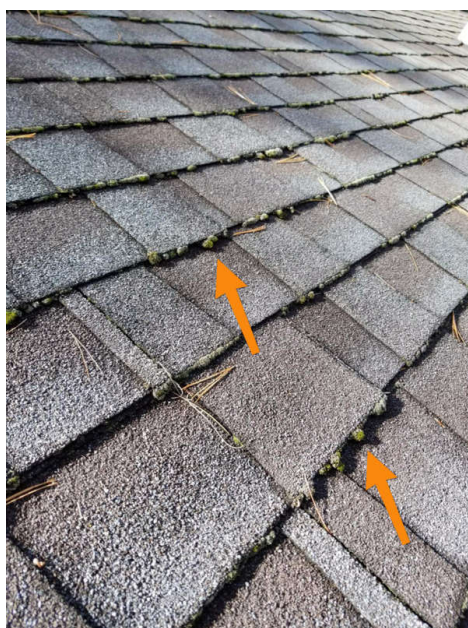
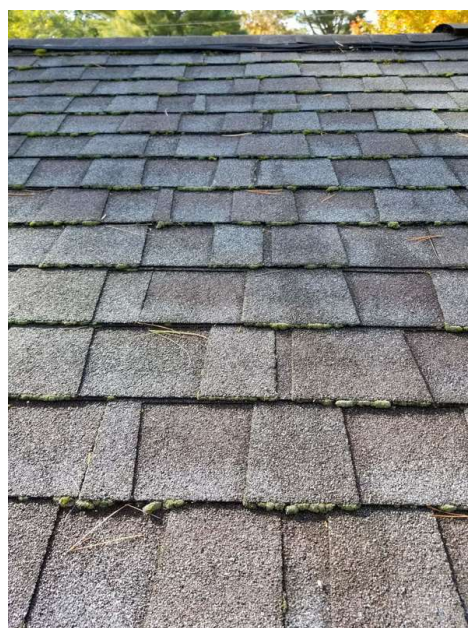
3.2.2 Vegetation and Maintenance

MOSS

Contact a qualified professional.

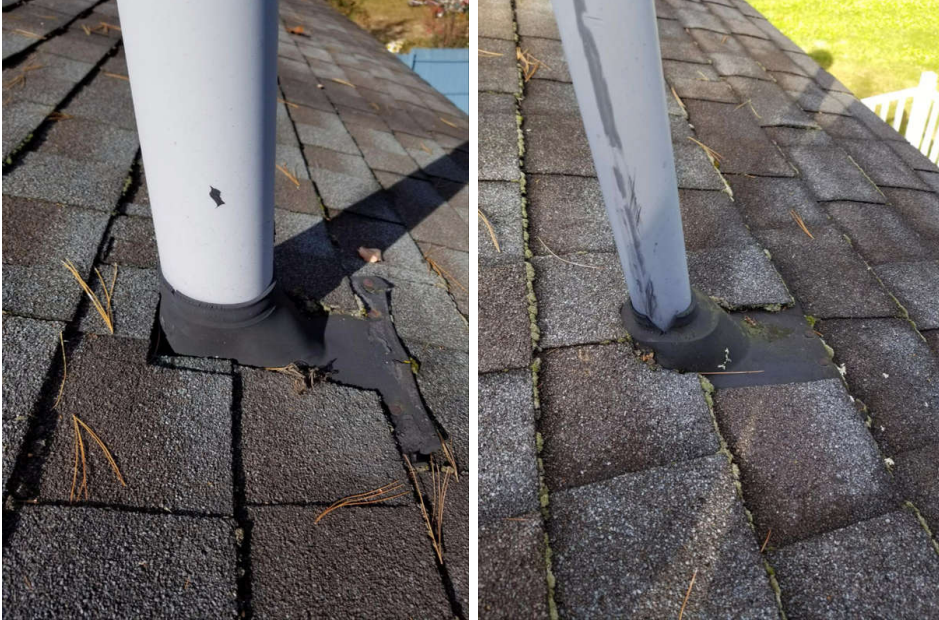
3.4.1 Flashing

DETERIORATED

Contact a qualified roofing professional.

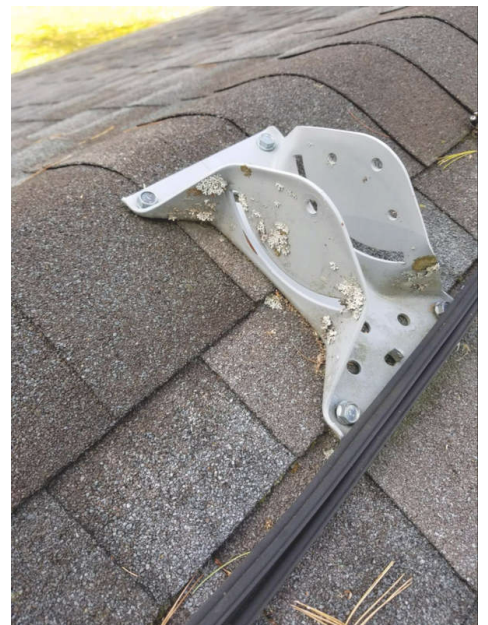
3.4.2 Flashing

NO SEALANT ON FASTENERS

Contact a qualified handyman.

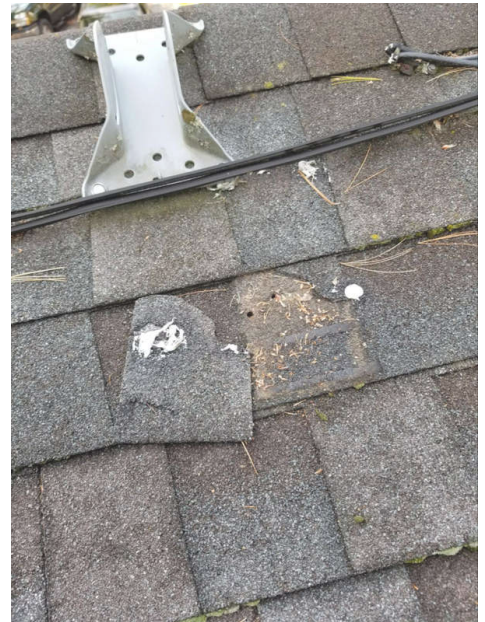
3.6.1 Composition

DETERIORATED OR MISSING

Contact a qualified roofing professional.

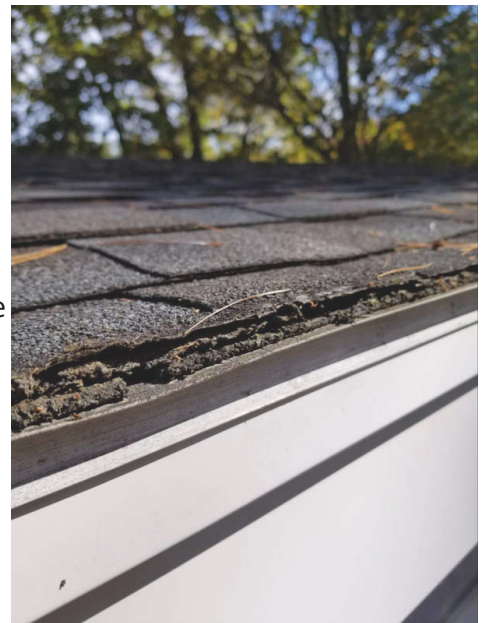
3.6.2 Composition

MULTIPLE LAYERS

Contact a qualified roofing professional.

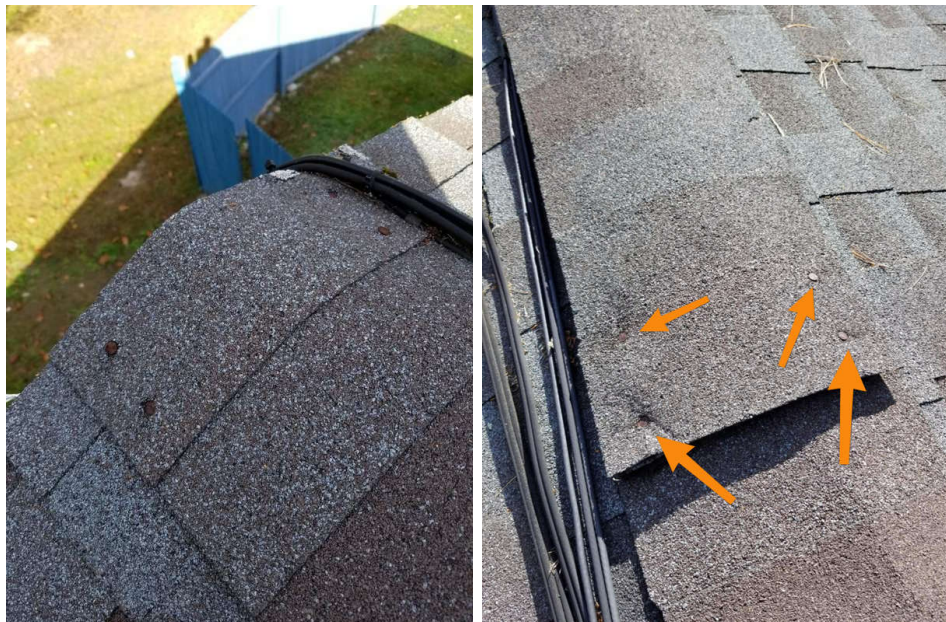
3.6.3 Composition

EXPOSED NAIL HEADS

Contact a qualified roofing professional.

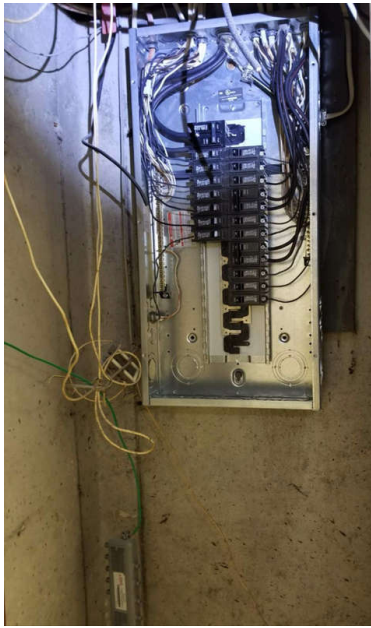
4.8.2 Service and/or Panel

INADEQUATE WORKING SPACE

Contact a qualified electrical contractor.

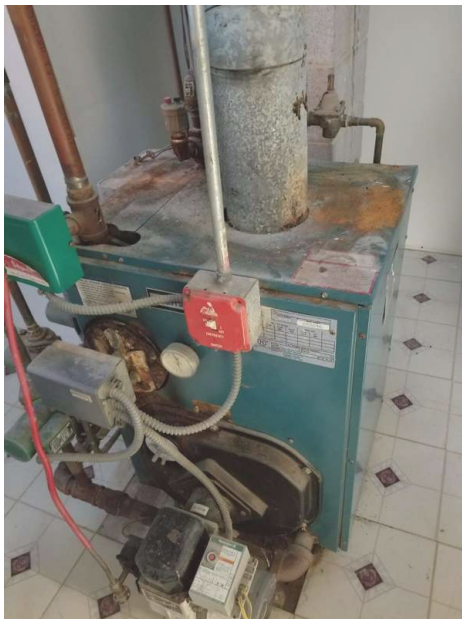
Heating Estimated Age

20 to 25 years

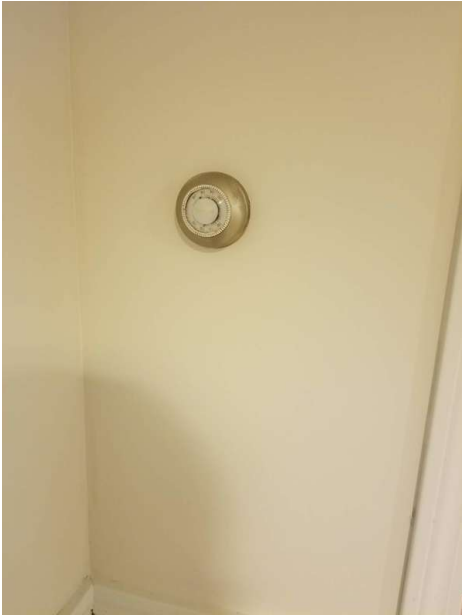
Thermostat - Old?

The property appears to be using an older, inefficient and outdated thermostat. Recommend replacing thermostat with a more economical digital set back thermostat.

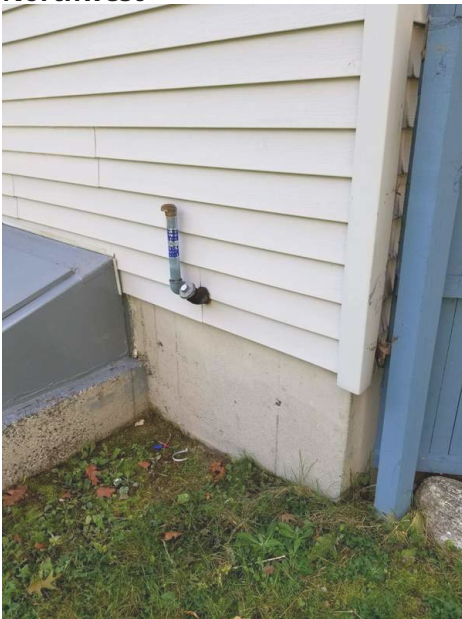
Hot Water Off Oil Boiler

There is no separate hot water heater for the house. The hot water is provided by a mixing valve on the heating system boiler.

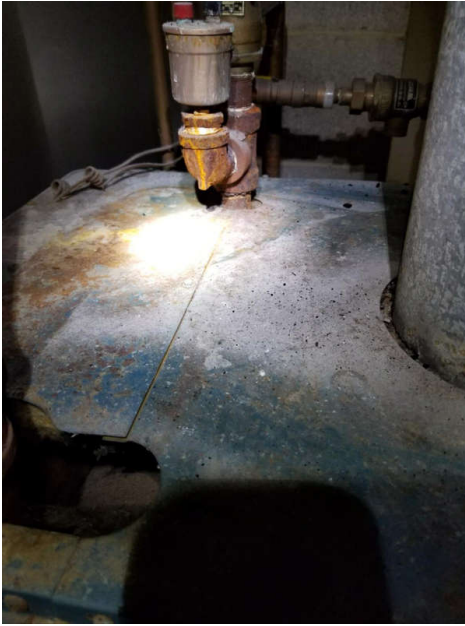
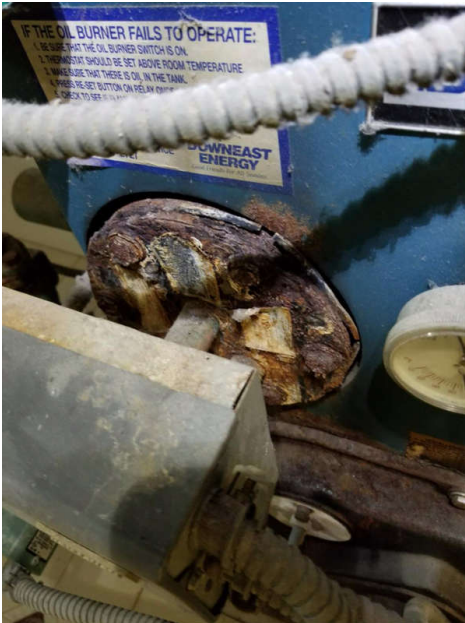
6.2.1 Age

The estimated useful life for most boilers is approximately 20-25 years. This furnace appears to be at this age or older and may need replacing at any time. Recommend budgeting for a replacement in the near future. I contacted Burnham Boilers with the serial number of the boiler and was told it was manufactured in December of 1993. This would place the boiler at 24 years old and near the end of its expected life.

Recommend monitoring.

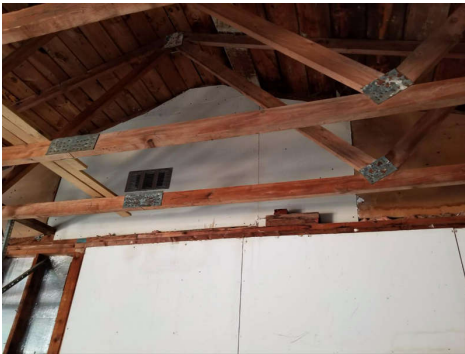
7.2.1 Garage Deficiencies

One or more wall and/or ceiling surfaces between the attached garage and interior living spaces have gaps, holes, or missing or inadequate surface materials. These surfaces are intended to prevent vehicle fumes from entering living spaces, and to slow the spread of fire from the garage to living spaces. A qualified contractor should evaluate and make repairs as necessary so the attached garage wall and ceiling surfaces that adjoin living spaces are tightly sealed and fire rated as per standard building practices. Typically these surfaces require a one-hour fire rating.

Contact a qualified drywall contractor.

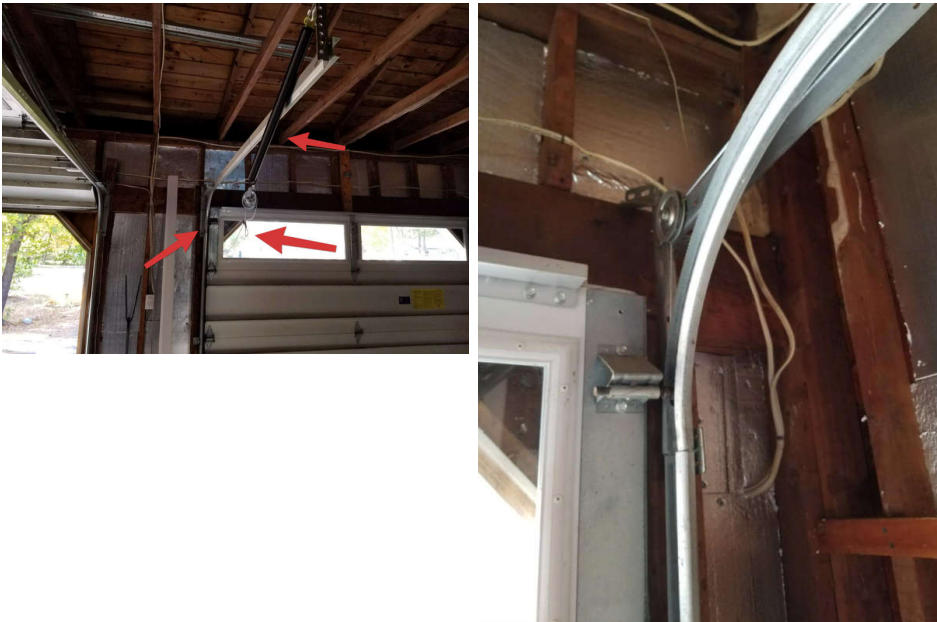
Door could not be operated due to one or more of the garage door lift cables being off the track. Recommend a Garage Door Contractor to come and repair or replace as necessary.

Contact a qualified garage door contractor.

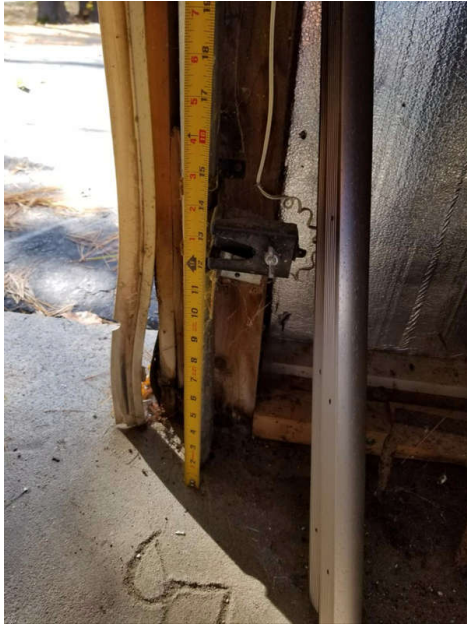
7.5.1 Vehicle Door Opener

INFRARED PHOTO EYES - TOO HIGH

The infrared "photo eye" devices that trigger the vehicle door opener's auto-reverse feature are located higher than 4 to 6 inches from the floor. This is a potential safety hazard. A qualified contractor should

Contact a qualified garage door contractor.

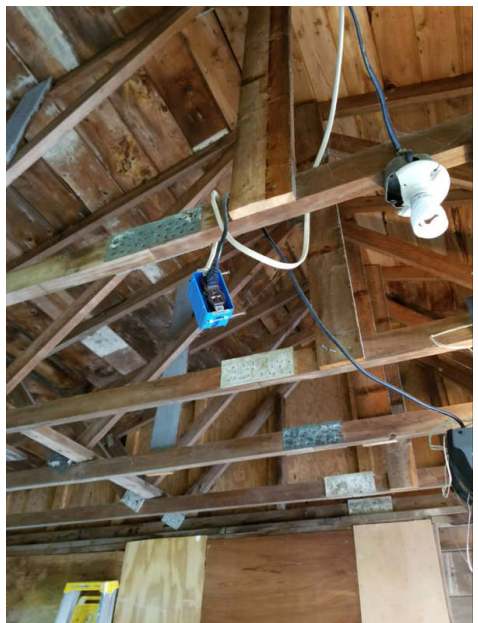
7.11.1 Electrical

COVER PLATES MISSING

Cover plate(s) are missing from one or more electric boxes, such as for receptacles, switches and/or junction boxes. They are intended to contain fire and prevent electric shock from exposed wires. This is a safety hazard due to the risk of fire and shock. Cover plates should be installed where missing.

Recommended DIY Project

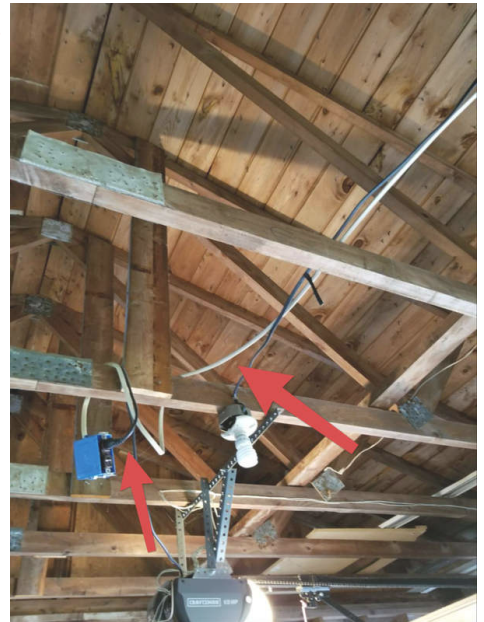
7.11.2 Electrical

**WIRING - LOOSE**

Some wiring is loose, unsupported, or inadequately supported. Standard building practices require non-metallic sheathed wiring to be trimmed to length, attached to runners or to solid backing with fasteners at intervals of 4-1/2 ft. or less. Fasteners should be installed within 12 inches of all enclosures. A qualified, licensed electrician should evaluate and repair as necessary. For example, trim wire to length and/or install staples as needed.

Contact a qualified electrical contractor.

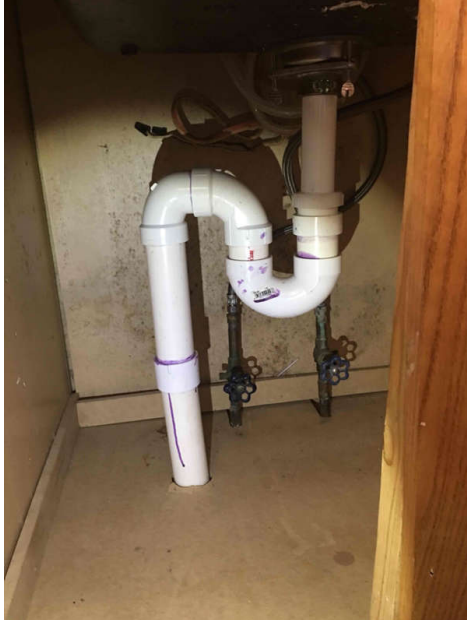
8.14.1 Sink Drains

S-TRAP

One or more sink drains use an s-trap rather than a vented p-trap. Water seals (the water lying in the bottom of the u-shaped pipe) may be lost when discharges occur in the system, resulting in sewer gases entering the structure. Recommend having a qualified plumber evaluate and replace s-traps with vented p-traps where necessary.

Contact a qualified plumbing contractor.

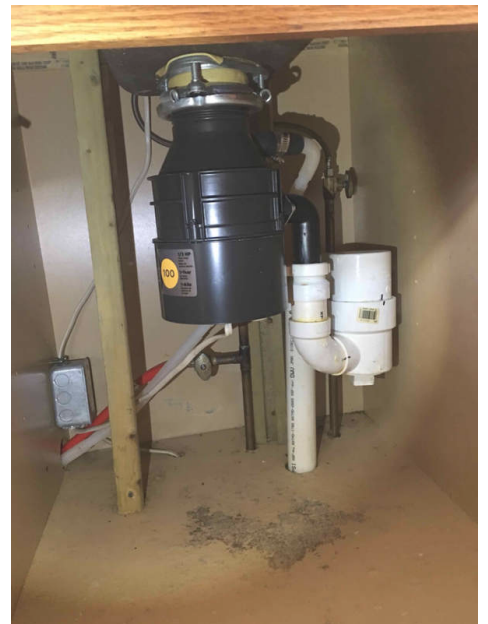
The sink drain was not properly vented. Recommend having a plumber fix it repair as needed.

Contact a qualified plumbing contractor.

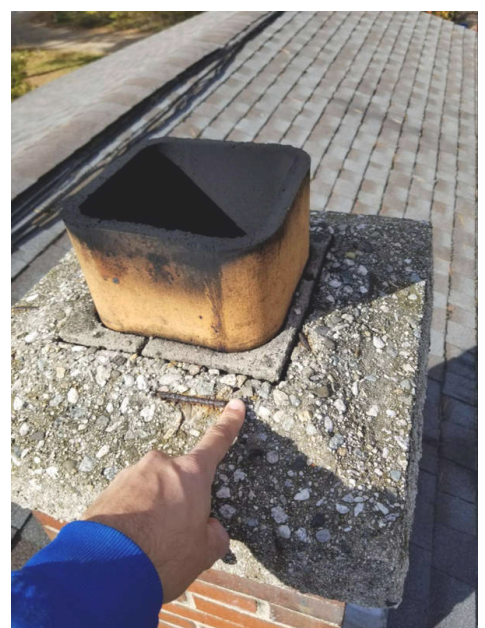
Not directly contact the flue liner (if installed), and this gap should be filled with flexible caulk

Have flashing installed between the bottom of the crown and the top of

the brick chimney

A qualified chimney service contractor or mason should evaluate and repair or replace the crown as necessary.

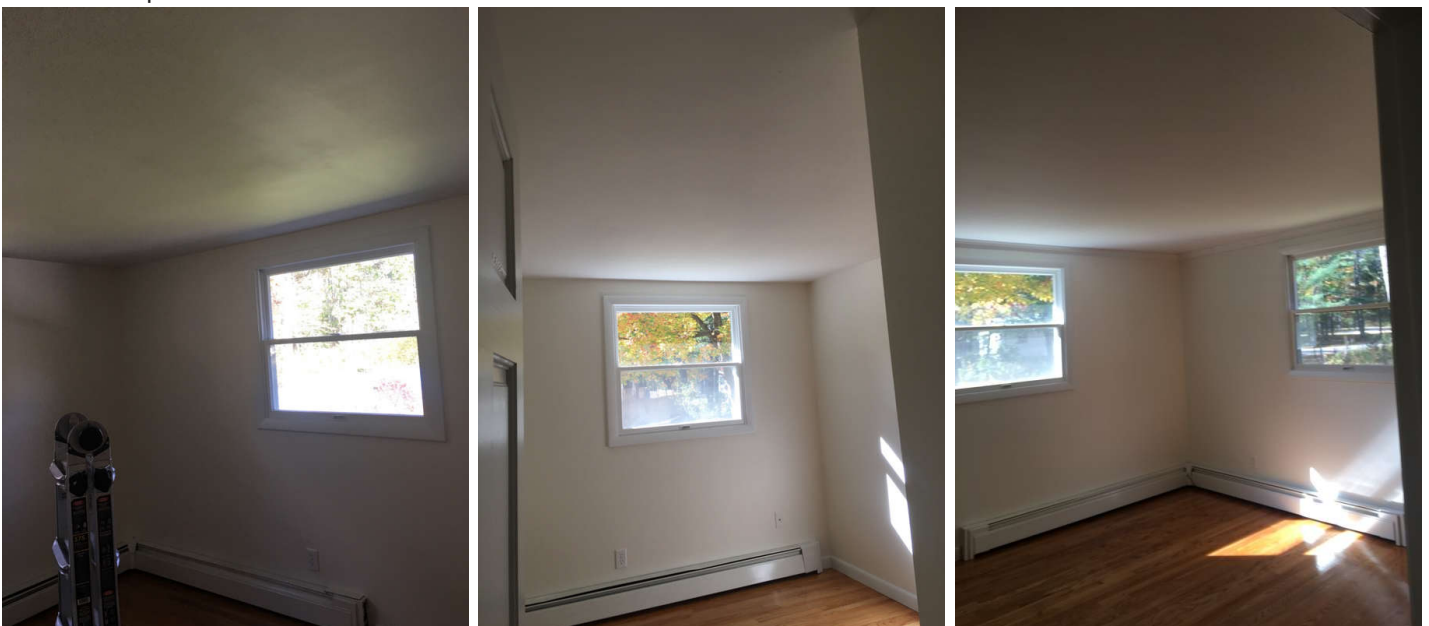
There is no light source or switched outlets in one or more rooms. Recommend having an electrician repair or fix as needed.

Contact a qualified electrical contractor.

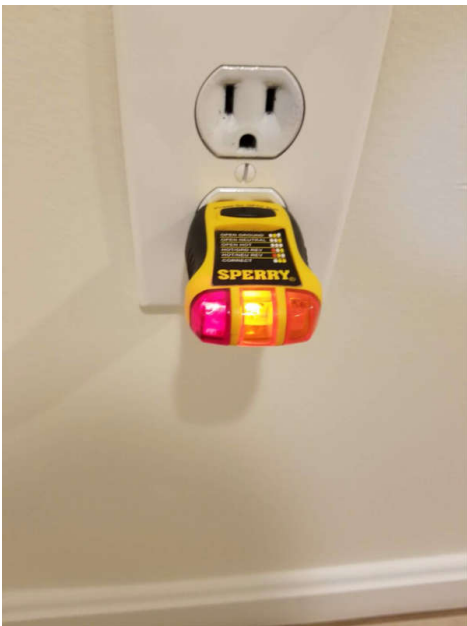
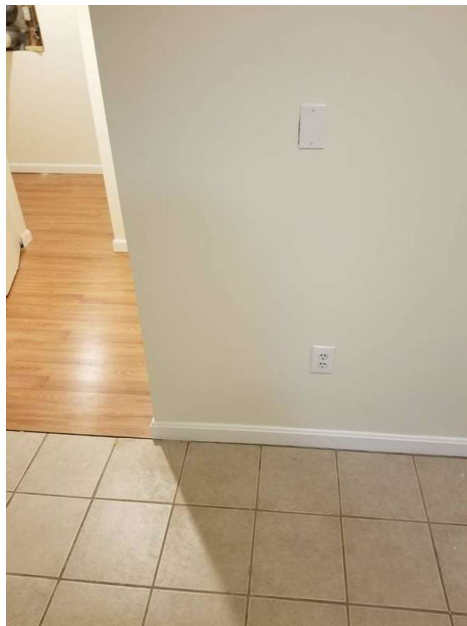
10.3.1 Receptacles

RECEPTACLES - HOT NEUTRAL REVERSE

One or more electric receptacles have reverse-polarity wiring, where the hot and neutral wires are reversed. This is a safety hazard due to the risk of shock. A qualified electrician should evaluate and make repairs as necessary.

Contact a qualified electrical contractor.

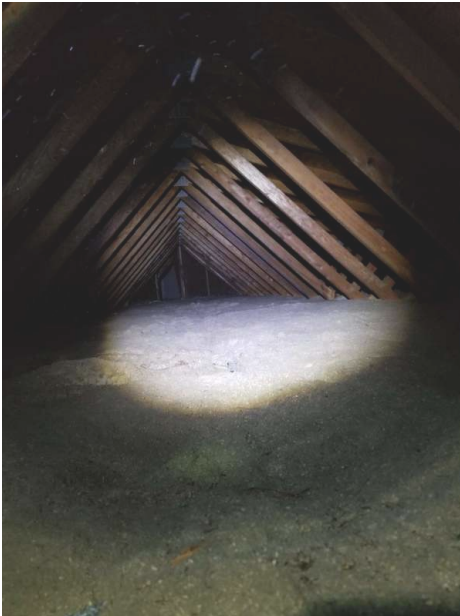
Ceiling Structure

Trusses

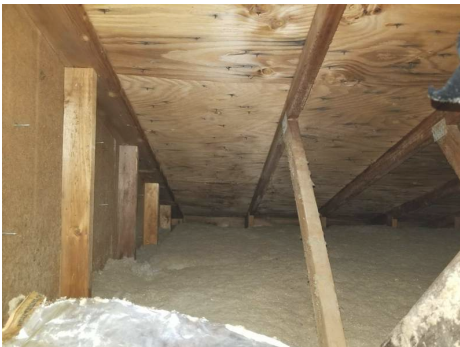
Insulation Material

Fiberglass Roll/Batt, Mineral Wool Loose

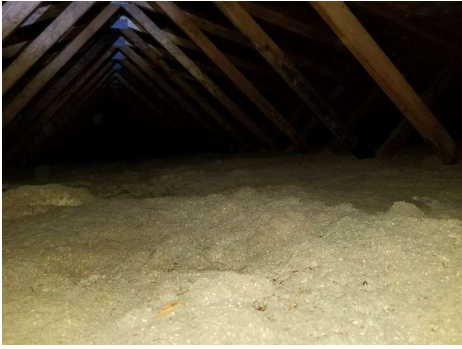
Roof Structure

Trusses

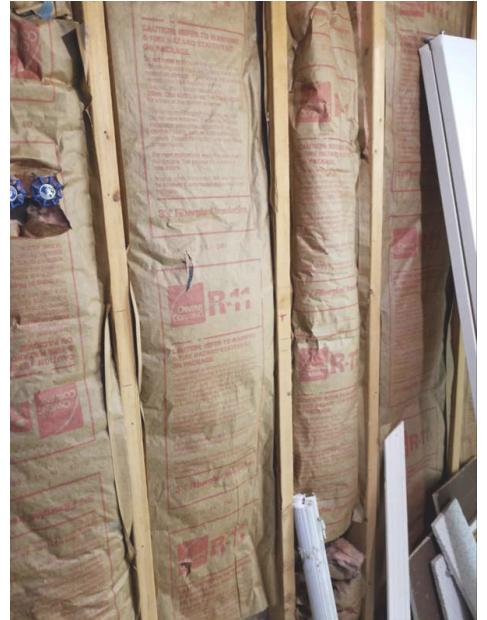
A qualified contractor should evaluate and make repairs as necessary, and as per standard building practices and the insulation manufacturer's recommendations to eliminate the fire hazard.

Also, the paper facing also acts as a vapor barrier, and if located away from the interior surfaces, can trap moisture from condensation in the cavity between the paper facing and the interior spaces. This is a conducive condition for wood destroying insects. The inspector was unable to evaluate the structure obscured by the insulation. When repairs are made, the exposed structure should be evaluated for damage by wood destroying insects and/or organisms, and repairs should be made if necessary.

Contact a qualified insulation contractor.

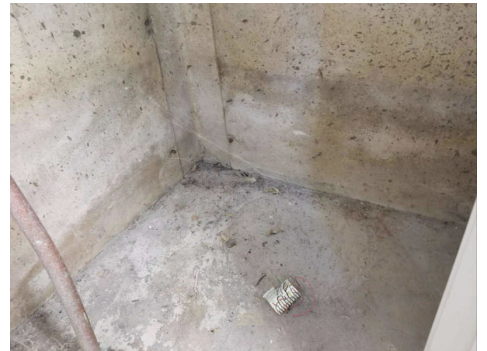
Ideally, water should not enter basements/crawl spaces, but if water must be controlled after it enters the basement/crawl space, then typical repairs include installing trenches, gravity drains and/or sump

pump(s) in the crawl space.
