SLOPESIDE HOME INSPECTIONS

## RESIDENTIAL REPORT

1234 Main St.  
Vancouver WA 98685

07/10/2017 9:00AM

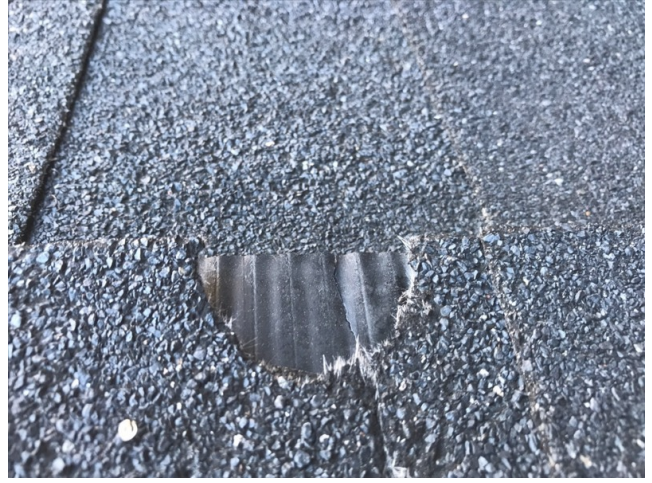
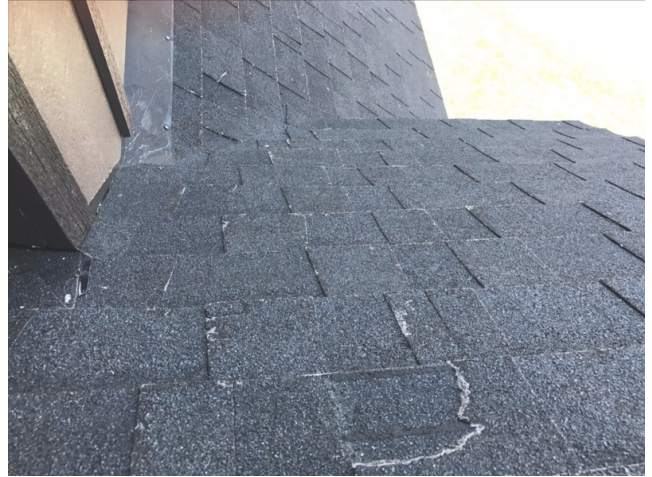
Roof coverings showed moderate to sever damage at this area. Gutters may need to be installed to direct excess moisture away from this area of the roof surfaces. Recommend a qualified roofing professional evaluate and repair.

Contact a qualified roofing professional.

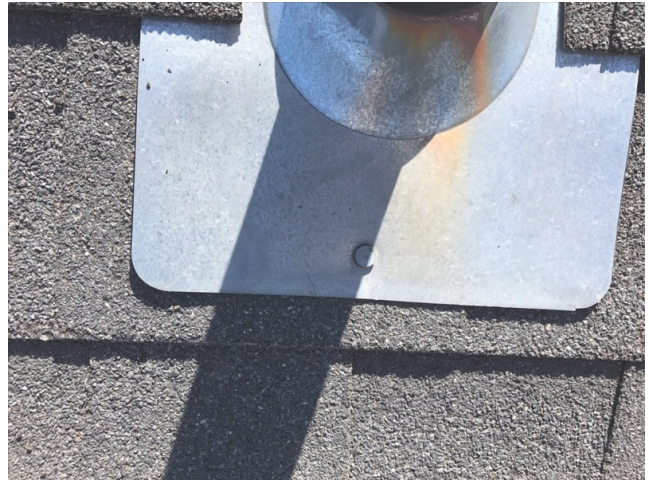
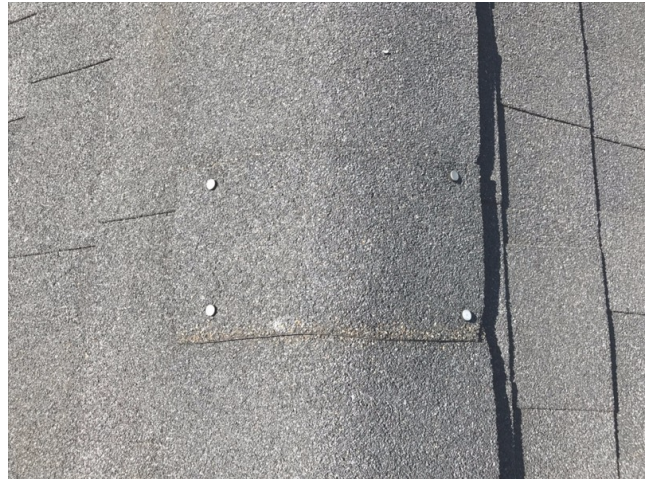
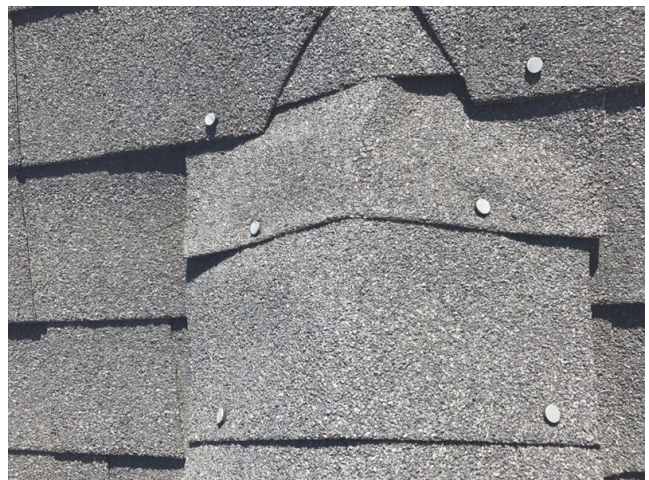
2.1.2 Coverings

# EXPOSED FASTENERS/NAILS

Exposed fasteners observed at one or more locations. Exposed fasteners will corrode over time, and expansion and contraction may eventually expand the nail holes enough to allow leakage. Recommend correction or further evaluation by a qualified professional.

Contact a qualified roofing professional.

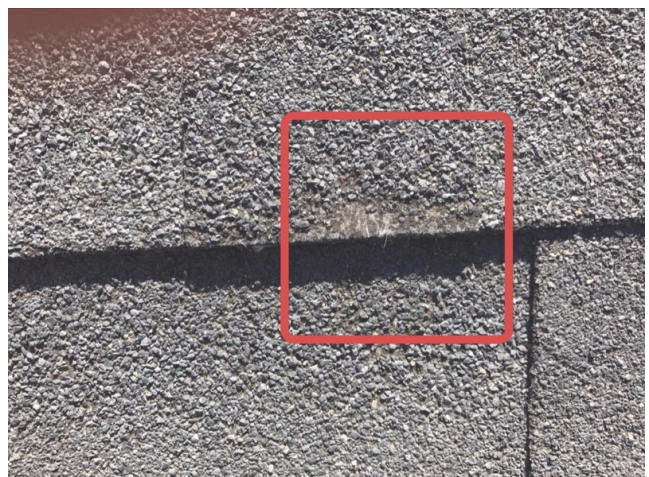
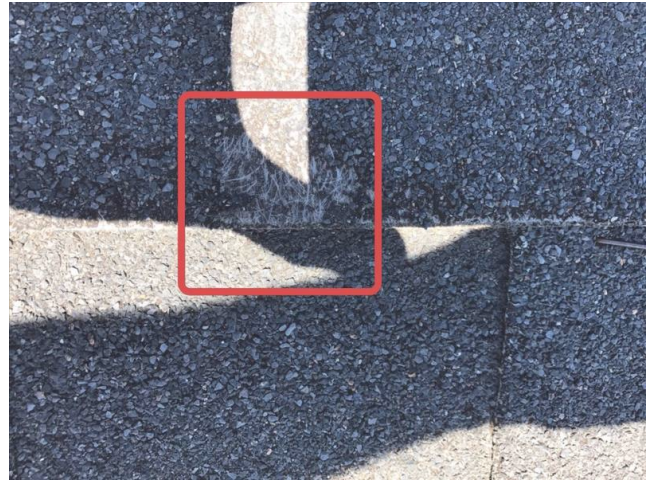
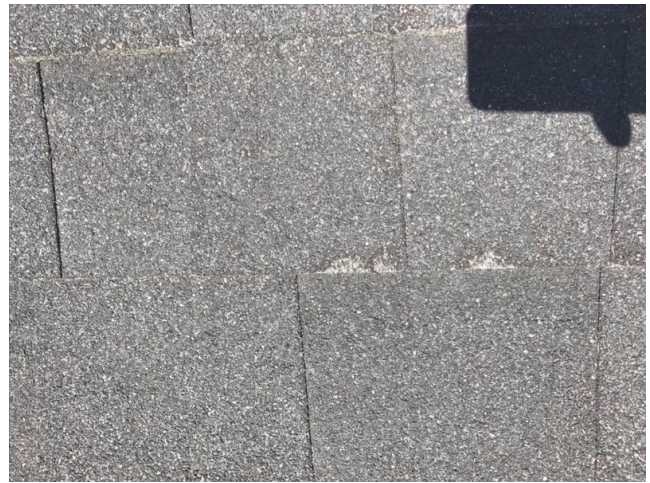
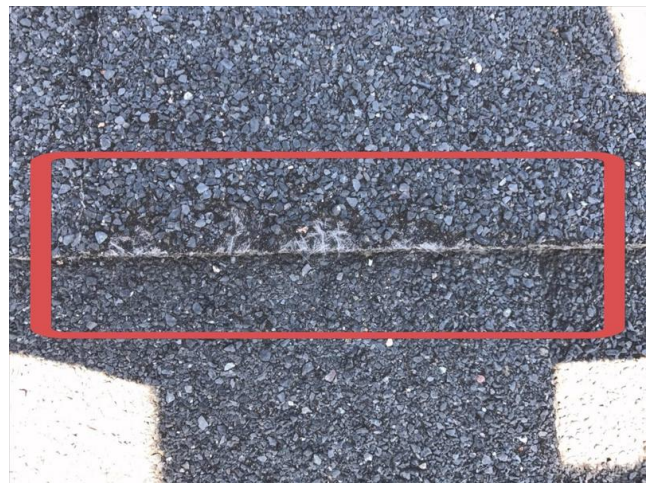
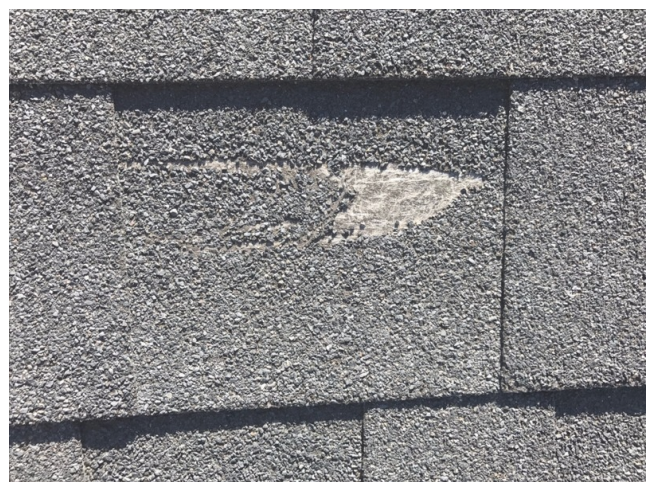
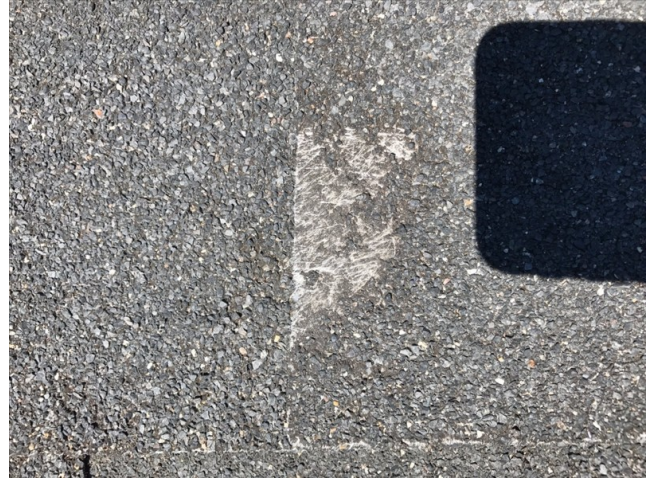
2.1.3 Coverings

# GRANULE EROSION

There was visible erosion of the granular surface of the asphalt shingles, indicating its older age. The shingles may start to deteriorate quickly at this point.

Replacement of the shingles in the near future is recommended. Recommend correction or further evaluation by a

qualified roofing contractor.

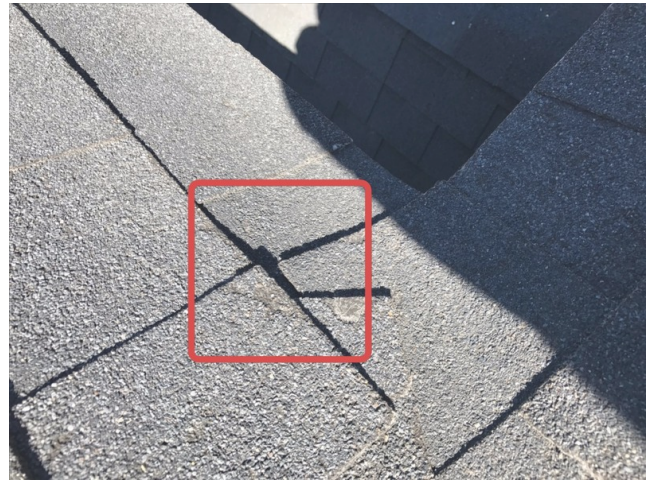
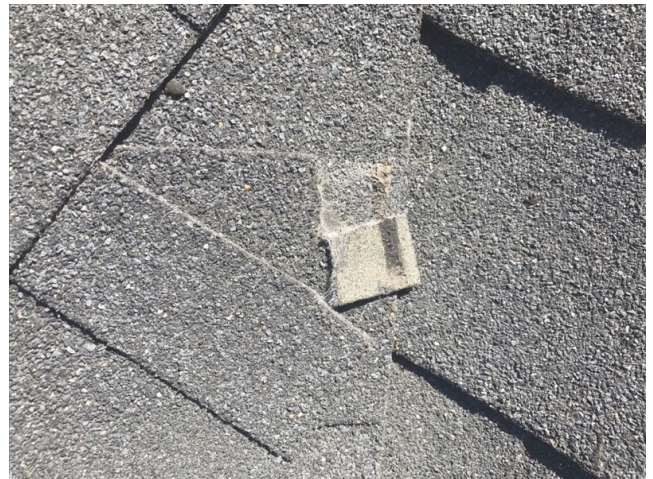
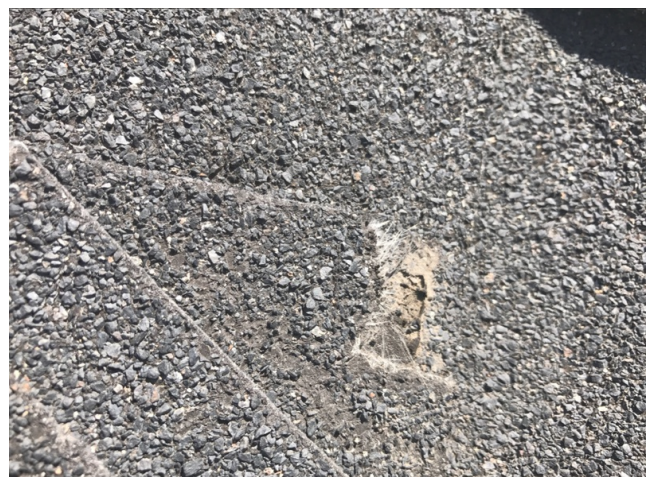
2.1.4 Coverings

## DAMAGED SHINGLES ROOF VALLEY

Damaged shingles noted in roof valley. This area is prone to leaking. Recommend repair by a qualified roofing contractor.

Contact a qualified roofing professional.

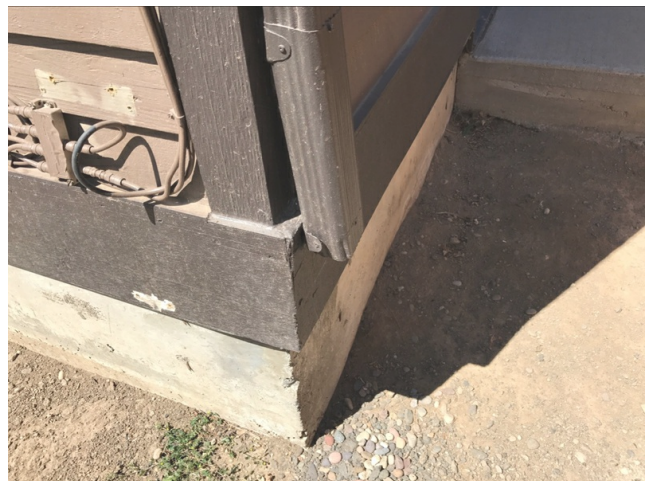
One or more downspouts drain too close to the home's foundation. This can result in excessive moisture in the soil at the foundation, which can lead to foundation/structural movement.

Recommend a qualified contractor adjust downspout extensions to drain at least 6 feet from the foundation.

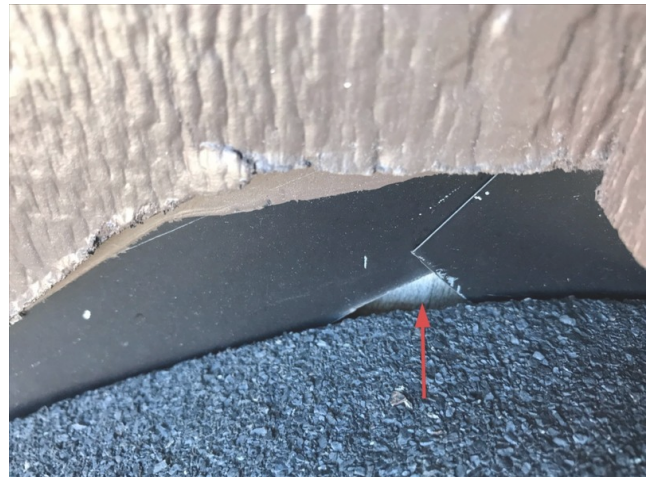
There is a small gap in the flashing where the ridge meets the siding. This is a potential water entry point. Recommend correction or repair by qualified roofing contractor.

Contact a qualified roofing professional.

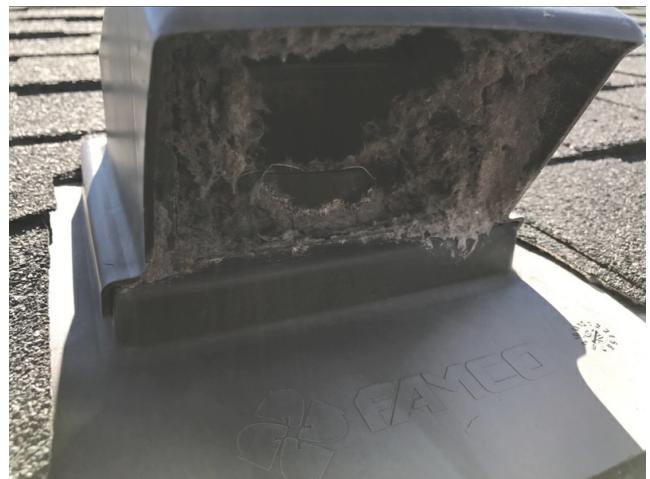
## 2.4.1 Skylights, Chimneys &amp; Other Roof Penetrations

## DRYER VENT DEBRIS

The dryer vent exhaust has excessive lint build-up. Recommend cleaning.

Contact a qualified professional.

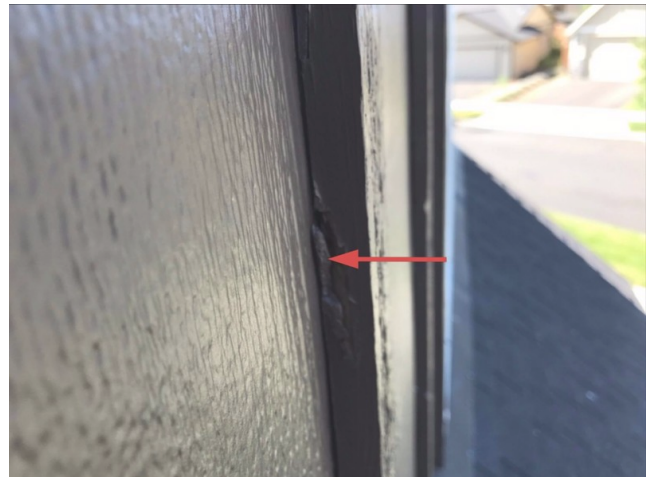
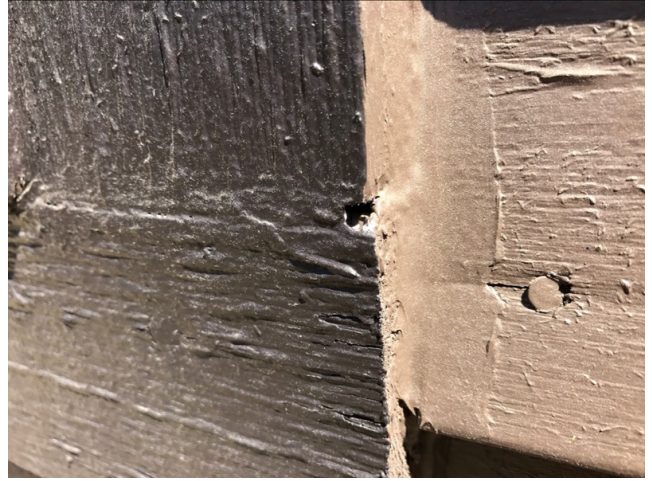
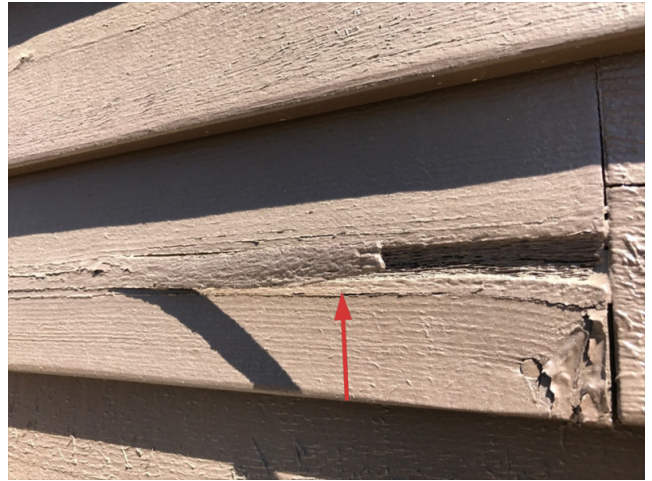
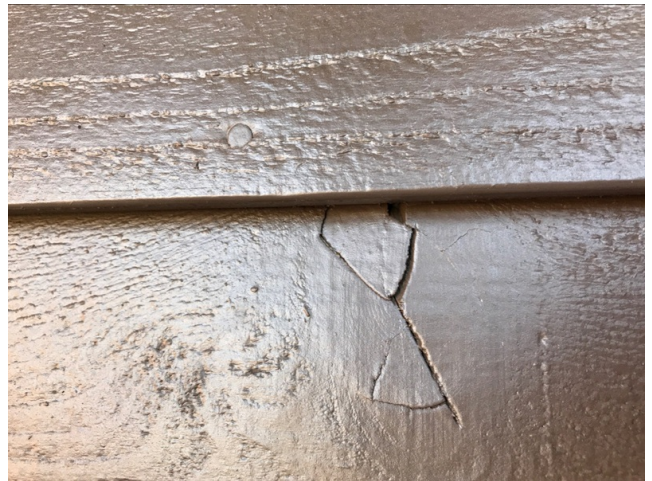
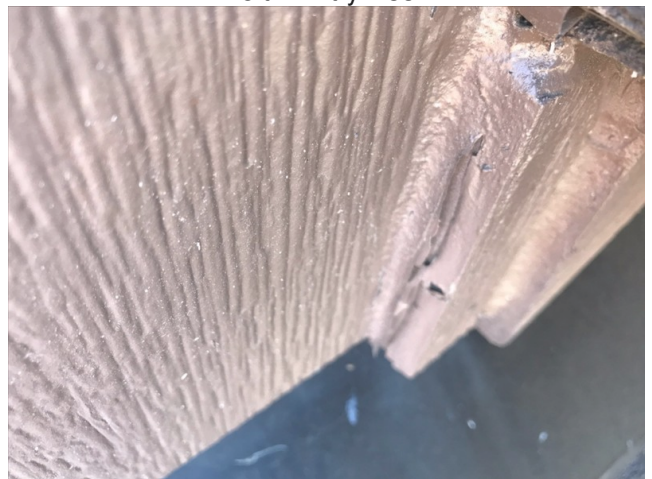
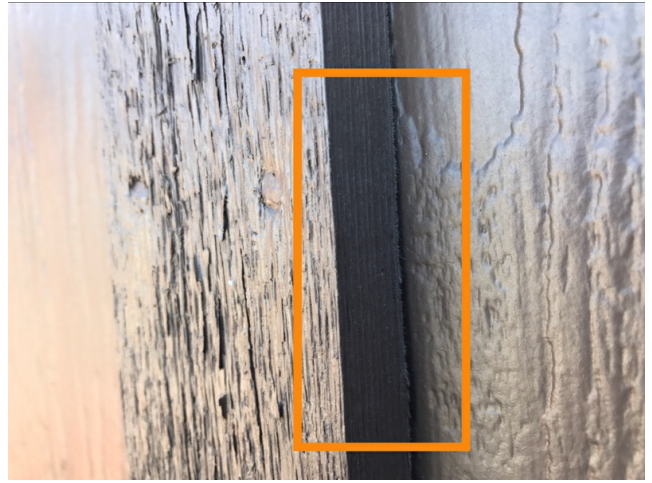
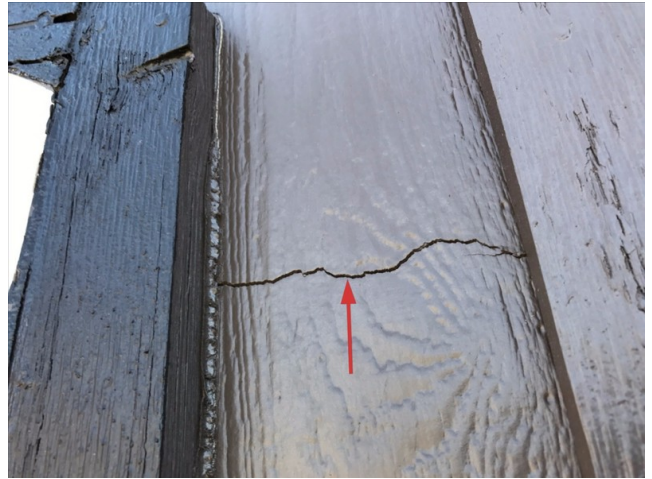
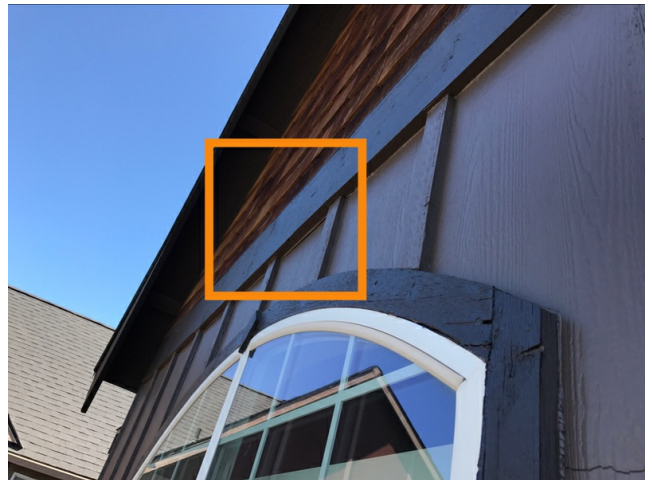
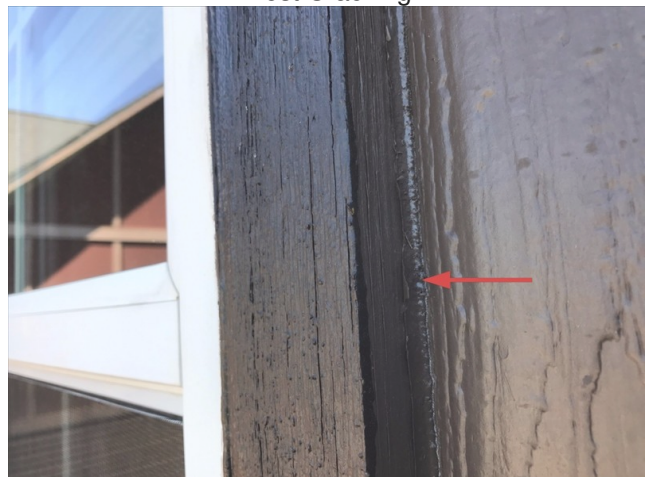
**CRACKING - MINOR**

Siding and trim had cracking or minor damage in one or more areas. These areas are a potential water entry points. Recommend resealing and or repair.

Left if Entry Door

West Cracking

West - Needs resealing

Recommended DIY Project

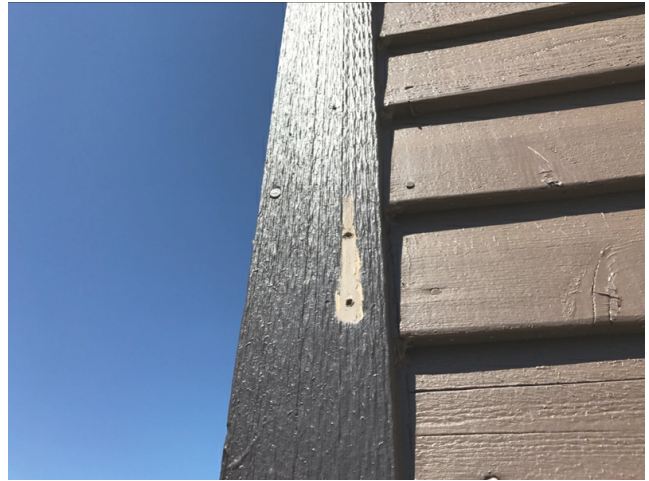
Trim had peeling paint and bare wood exposed to weather. To avoid the need for replacement, repair and paint this trim soon.

Recommended DIY Project

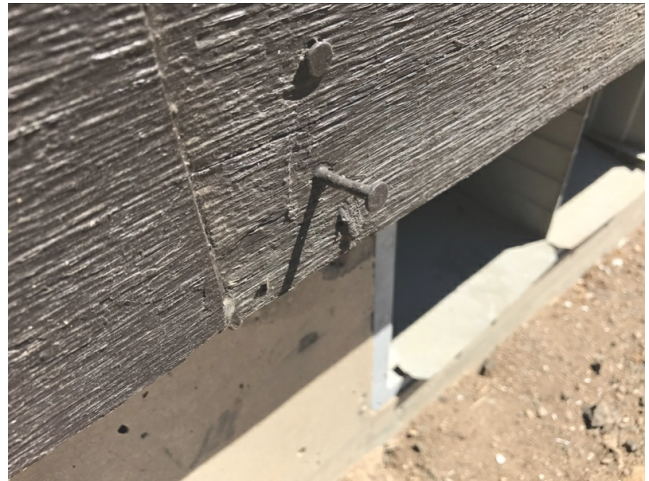
## 3.1.3 Siding, Flashing &amp; Trim

## UNDERDRIVEN NAILS

Underdriven nails were observed at one or more locations. This can be a safety issue do to cuts if contact is made with bare skin. In addition the siding rim board needs to be securely fastened to the wall. Recommend correction by a qualified professional.

Contact a qualified professional.

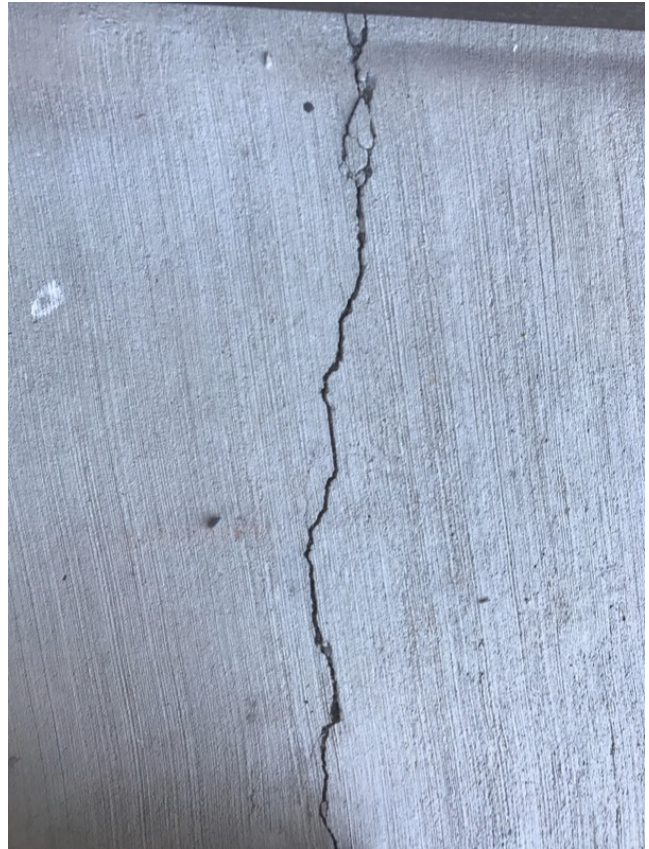
West Front Walkey

## WALKWAY CRACKING - MINOR

A crack in the front patio was observed at the time of inspection. If not sealed, moisture can damage the concrete through freezing and expanding during seasonal temperature changes. Recommend sealing to prevent further damage. In addition, the sprinkler system was directing water towards the house in this area. Recommend adjusting.

Recommended DIY Project

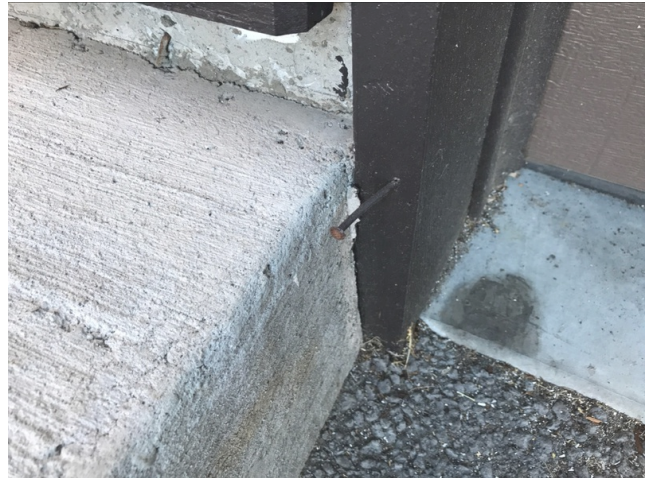
An underdriven nail was observed on the trim of the garage. Recommend correction by a qualified professional.

Contact a qualified professional.

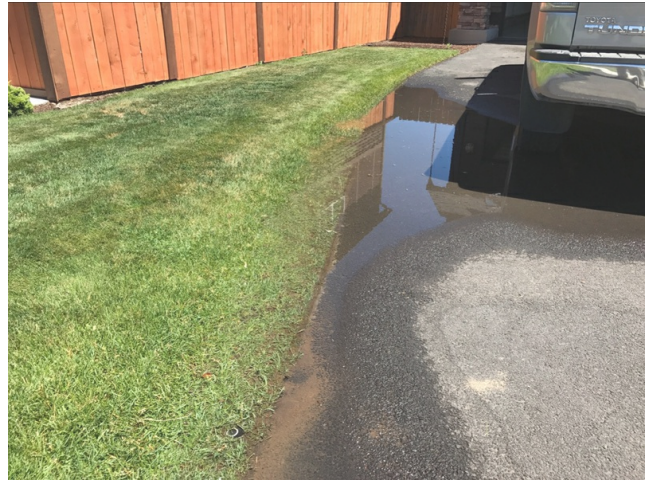
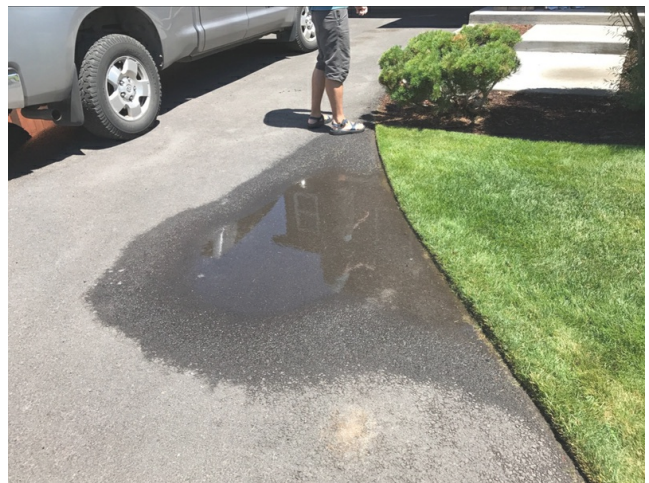
3.3.3 Walkways, Patios & Driveways

## WATER POOLING

Water was pooling on the driveway. Excess water can shorten the lifespan of the asphalt material. Recommend directing sprinkler heads away from the driveway.

Contact a qualified professional.

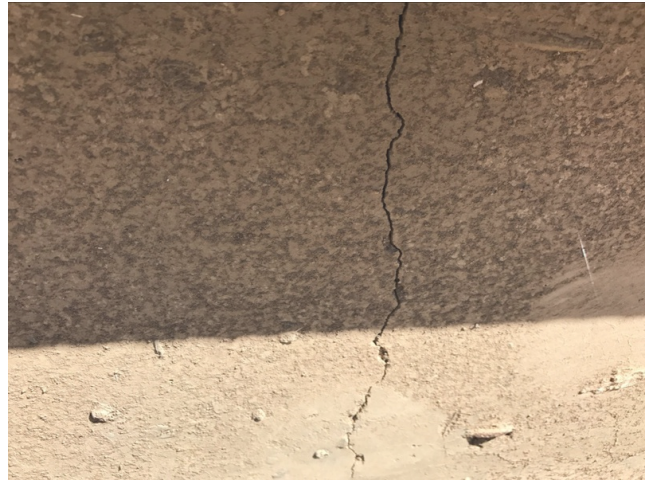
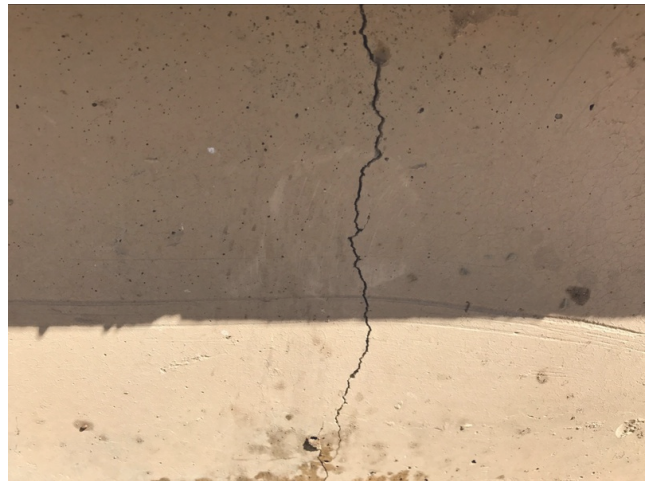
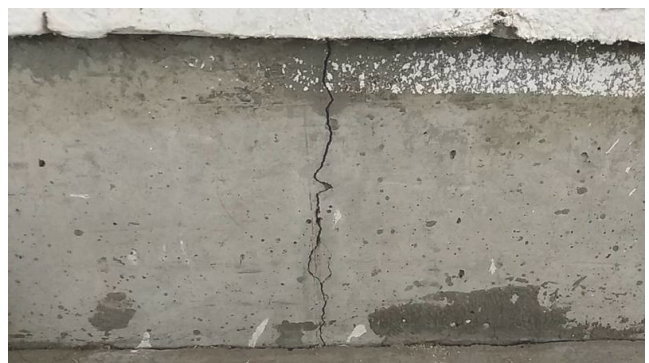
Garage South East

# FOUNDATION CRACKS - MINOR

Minor cracking was noted at the foundation. This is common as concrete ages and shrinkage surface cracks are normal. Recommend monitoring for more serious shifting/displacement.

Contact a qualified structural engineer.

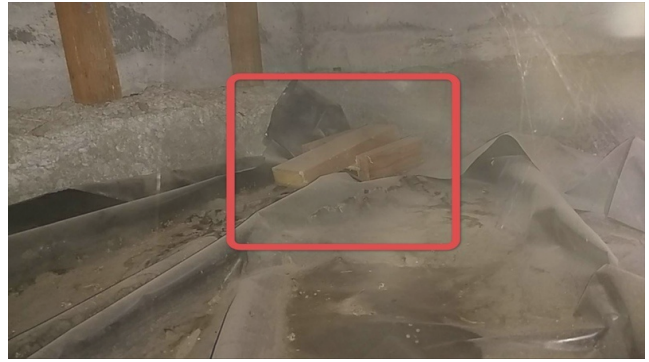
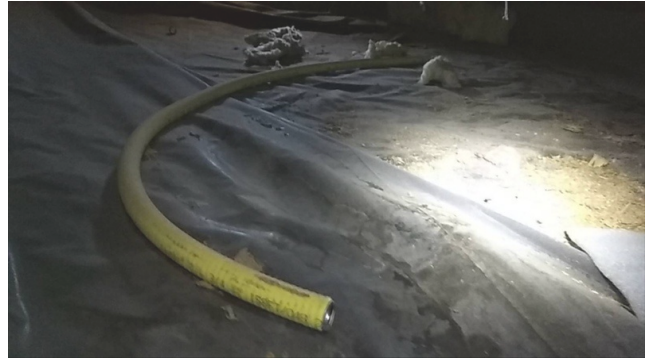
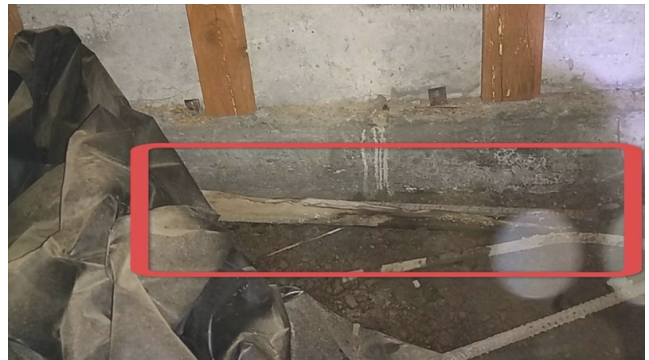
Debris in crawlspace should be removed. Wood debris is a conducive condition for wood destroying organism. Recommend removing.

Contact a qualified professional.

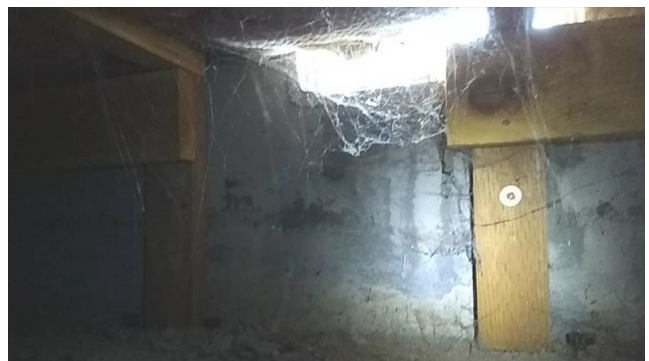
EAST CRAWLSPACE

# CUT 2X6

A portion of a 2x6 had been cut near one of the east vents. Recommend correction or further evaluation by a qualified contractor.

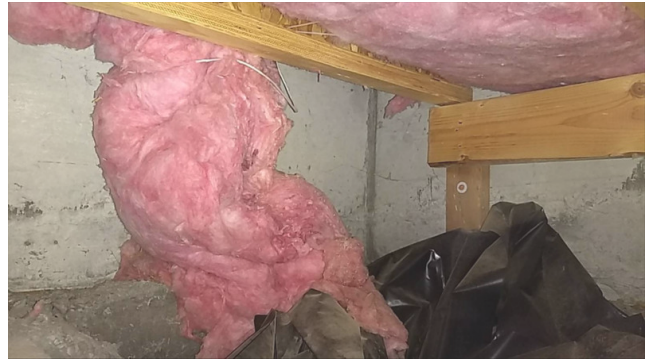
South West Corner

# LOOSE INSULATION

Insulation has fallen loose. Recommend reinstalling.

Contact a qualified professional.

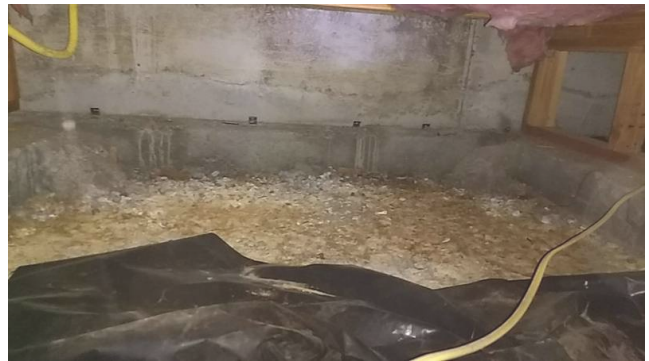
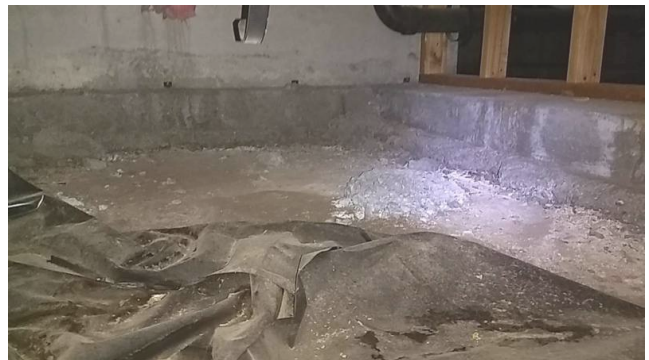
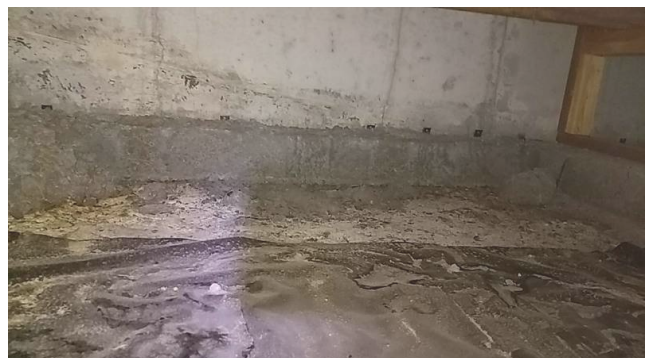
The vapor barrier was not adequately covering the soil or post footings at the time of the inspection. Soil covers help reduce humidity levels in crawlspaces by limiting moisture evaporation into the air from soil. Reducing humidity levels can help prevent conditions that encourage mold growth and wood decay. Recommend correction or further evaluation by a qualified professional.

Contact a qualified professional.

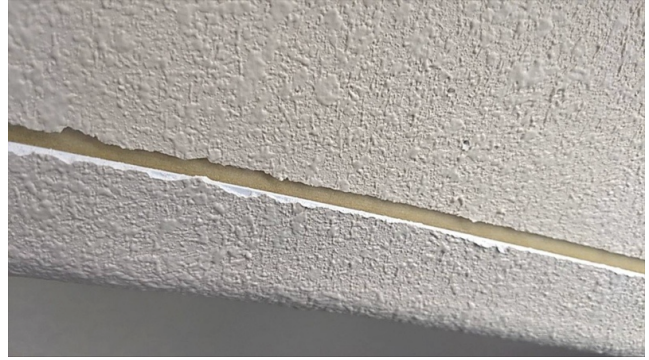
## MINOR DAMAGE

Seam in the drywall above the window had pulled apart and left a sizable crack, most likely due to normal settling. No moisture damage was observed at the time of inspection. Recommend correction or further evaluation by a qualified professional.

Contact a qualified professional.

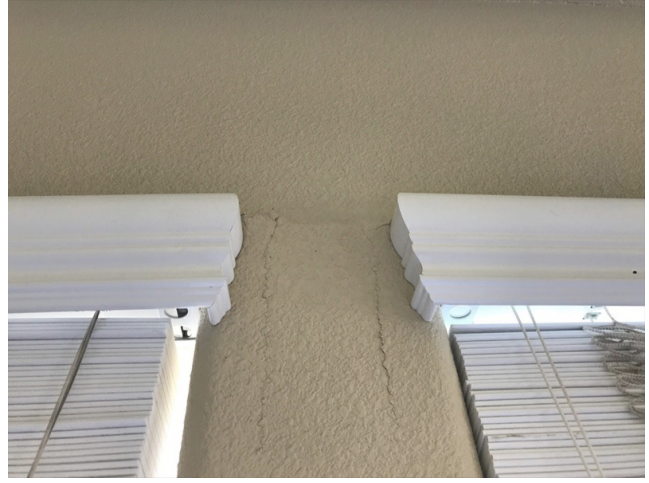
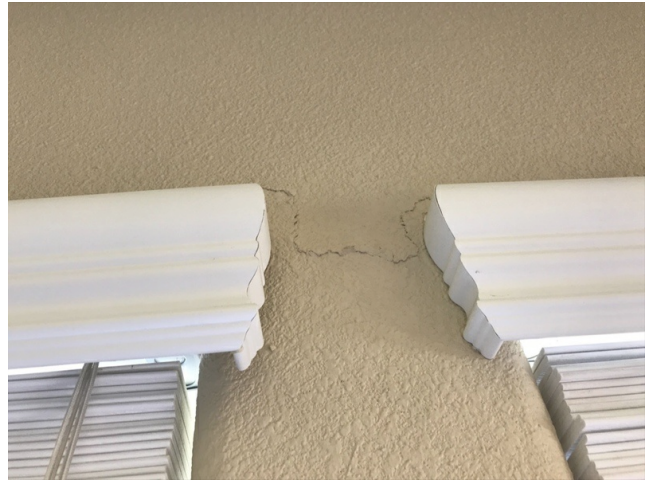
## CRACKING

Cracking in the drywall was visible at the time of inspection. Unable to determine the cause. Recommend asking seller about prior damage/moisture intrusion.

Contact a qualified professional.

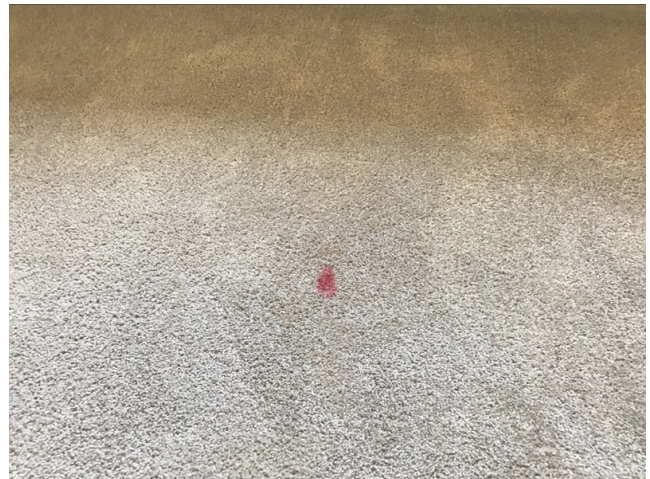
# CARPET STAINS

Carpet had areas of staining or discoloration. Recommend a thorough steam clean by a qualified carpet cleaning company

Contact a qualified cleaning service.

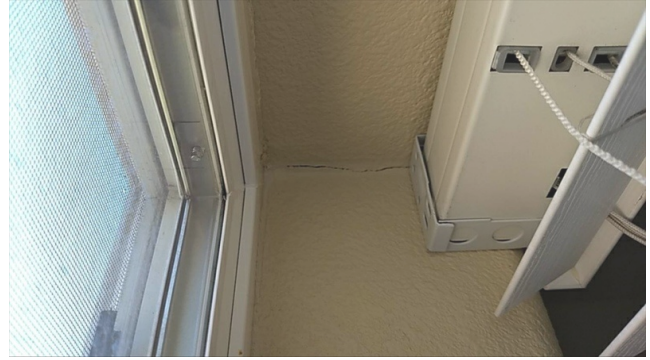
## 6.5.1 Windows

## MINOR CORNER CRACKS

Minor cracks at the corners of doors and windows in walls. Appeared to be the result of long-term settling. Some settling is not unusual in a home of this age and these cracks are not a structural concern.

Contact a qualified professional.

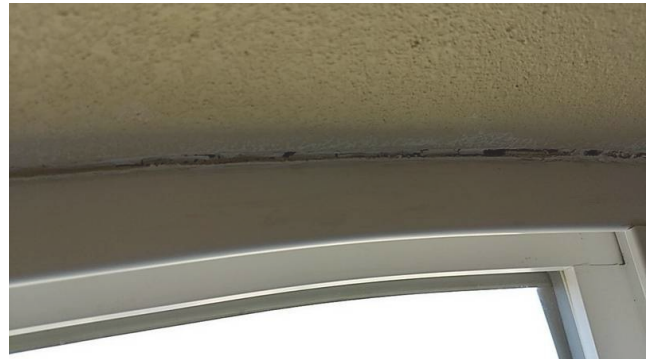
## 6.5.2 Windows

## WINDOW SEAL DETERIORATING

Window seal on one or more windows was deteriorating. Recommend resealing as needed.

Contact a qualified professional.

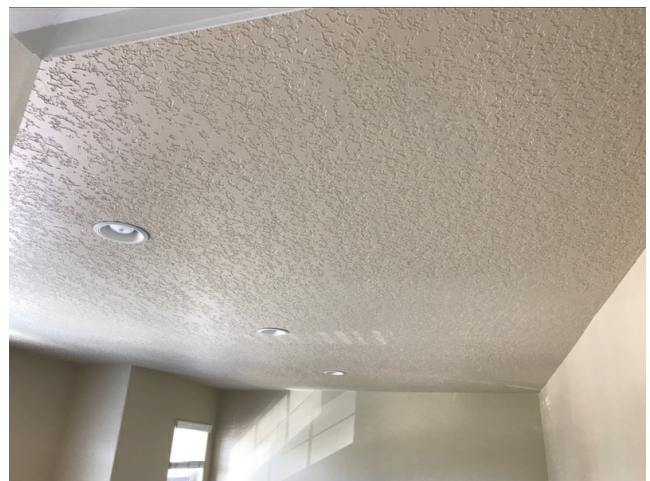
## 6.8.1 Smoke Detectors

## MISSING SMOKE DETECTOR

No smoke detector was in the room above the garage. This is not considered a bedroom but we recommend a smoke detector on each floor and in each livable room of the house.

Contact a qualified professional.

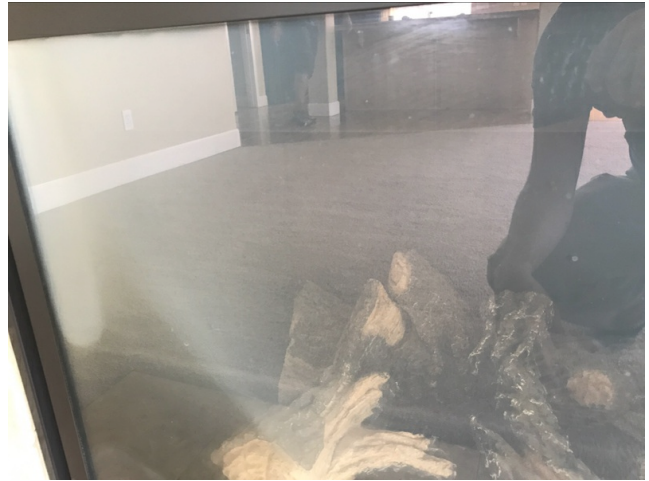
Fireplace glass is cloudy. Recommend cleaning or replacing.

Contact a qualified professional.

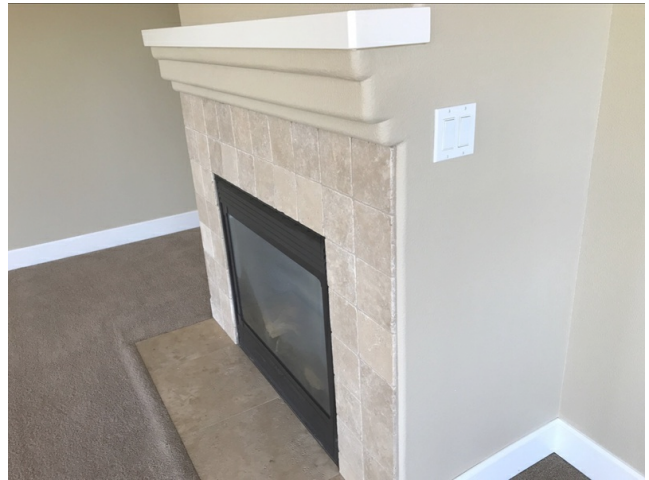
7.5.2 Fireplace, Woodstove

## FAN

The fireplace fan did not appear to be either present or operable. Recommend asking seller about this condition or further evaluation by a professional.

Contact a qualified professional.

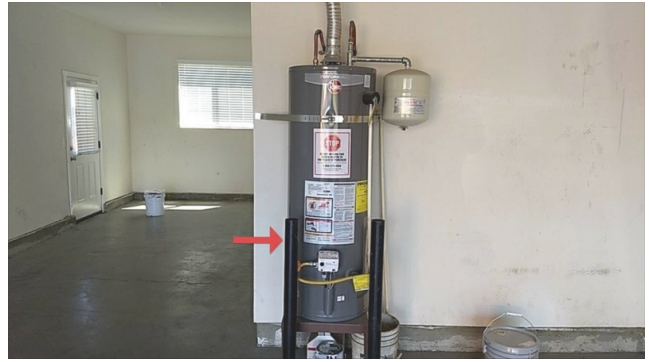
GARAGE

# MISSING SEISMIC STRAP

Missing seismic strap on lower third portion of water heater. Recommend installation by a qualified professional.

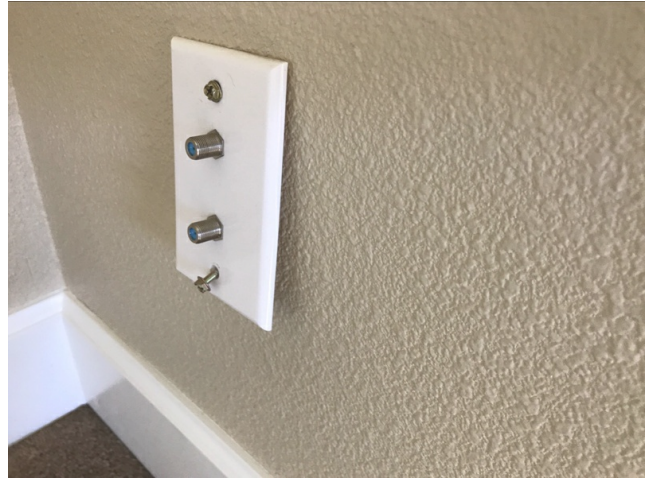
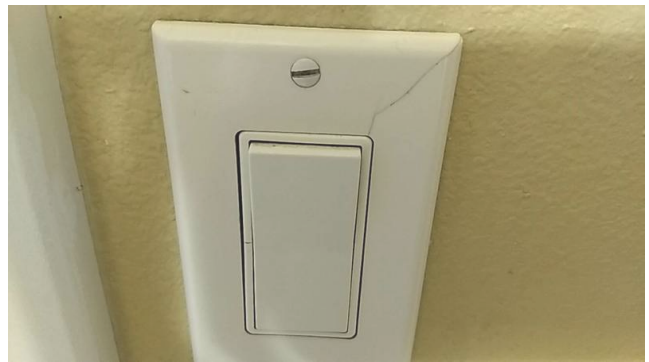
2nd Floor Bathroom

## COVER PLATE DAMAGE

One or more receptacles have a damaged cover plate. Recommend replacement.

Contact a qualified electrician.

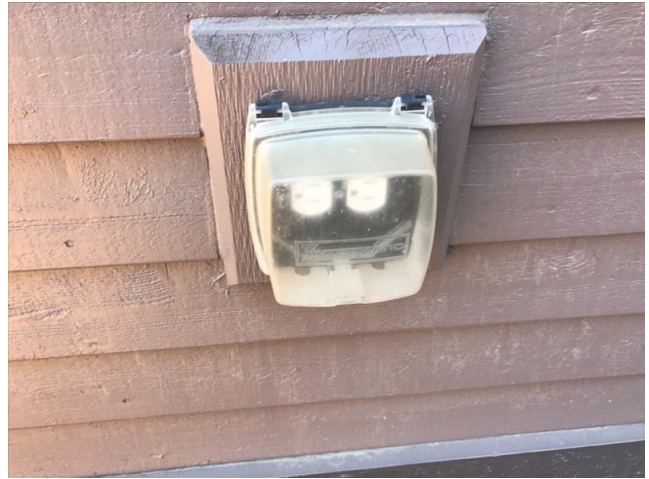
Exterior West

No GFCI protection present at one or more locations in the home. Recommend licensed electrician upgrade by installing ground fault receptacles in all locations.

Contact a qualified electrician.

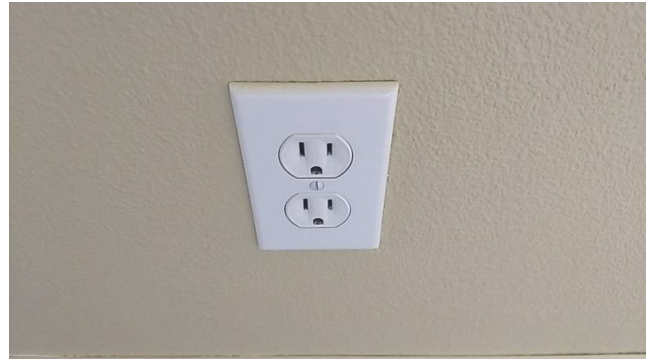
2nd Floor Hallway

# COVER PLATE LOOSE

One or more cover plates were loose at the time of the inspection on the first floor.

Contact a qualified professional.

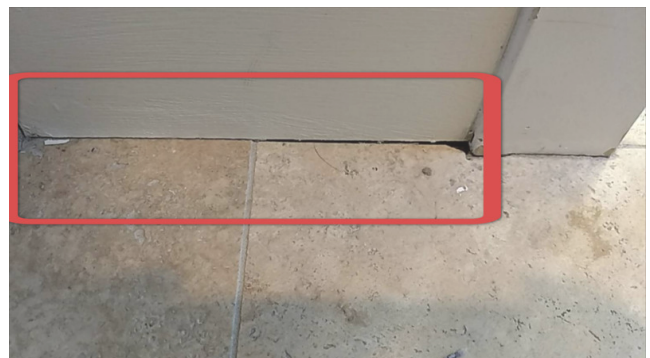
### MISSING SEALANT

Recommend sealant.

Recommended DIY Project

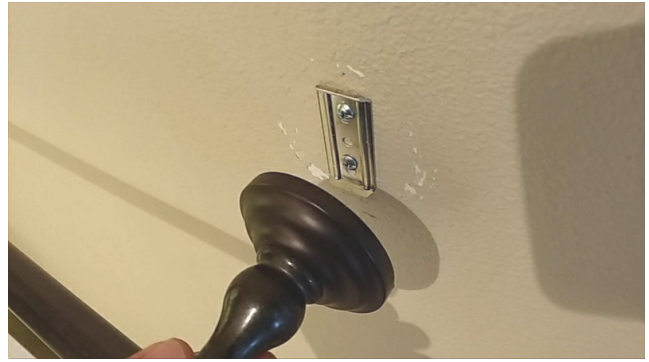
11.1.2 Floors, Walls and Ceilings

## TOWEL RACK LOOSE

Right side of towel rack is not secured properly. Recommend tightening to properly secure to the wall.

Recommended DIY Project

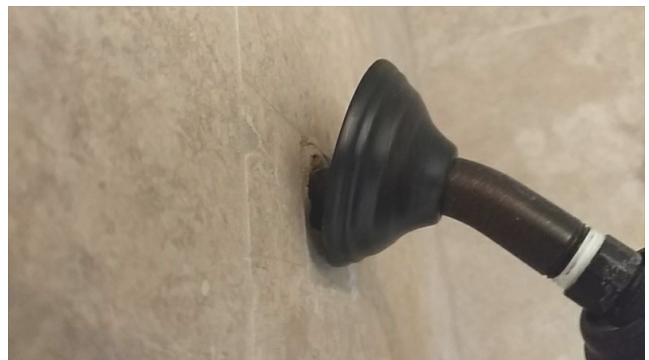
Master Bathroom

## SHOWER HEAD PIPE LOOSE

Shower head pipes were loose in both upstairs bathrooms. Recommend correction by a qualified professional.

Contact a qualified professional.

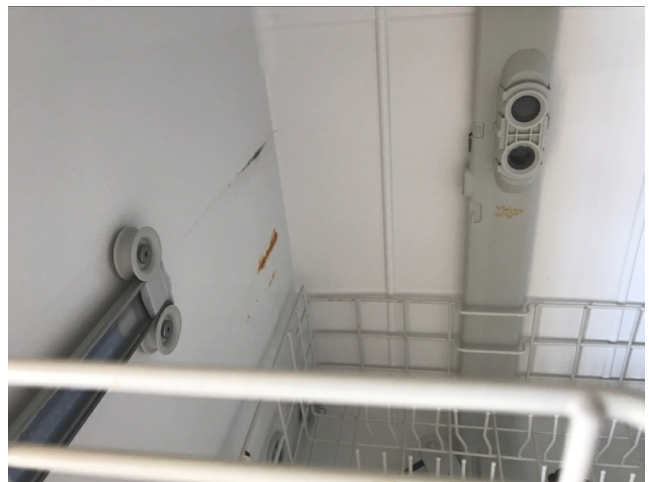
# RUST

Rust stains from objects placed inside the dishwasher can usually be lightened or removed with a citric acid treatment. To remove these stains, you can treat with citric acid crystals following the steps below:

1. Fill the detergent cup with three to four ounces of citric acid crystals and close the cup.
2. Run the dishwasher through a normal cycle.
3. Rinse thoroughly by running the dishwasher through another cycle without the crystals but with a full cup of detergent.
4. Repeat the process if one treatment did not completely remove the staining.

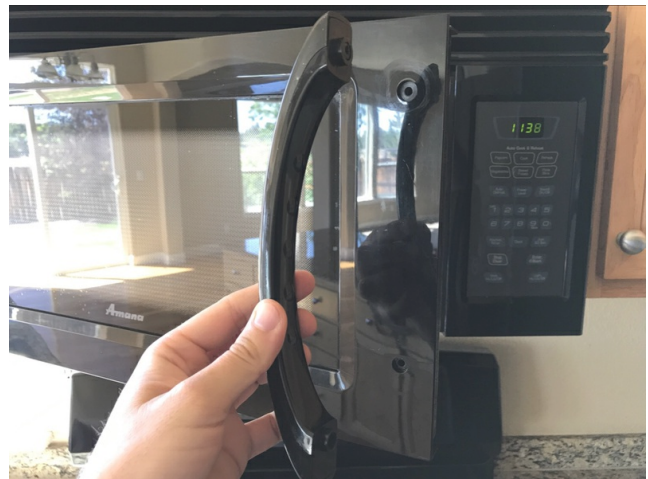
## BROKEN HANDLE. RECOMMEND REPAIR

Contact a qualified professional.

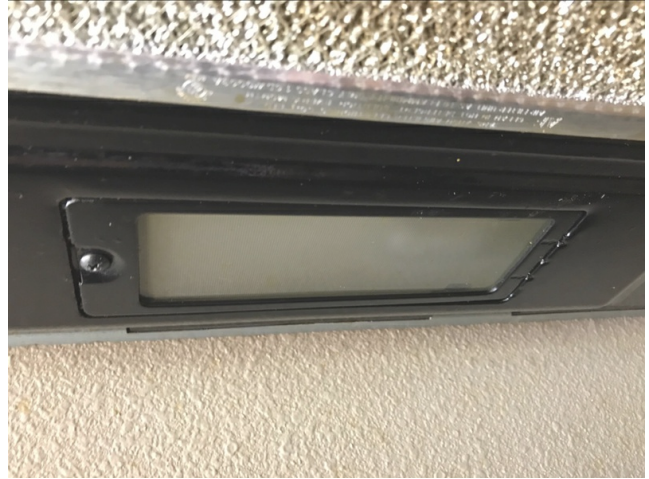
12.6.2 Built-in Microwave

## LIGHTS NOT WORKING

Contact a qualified professional.

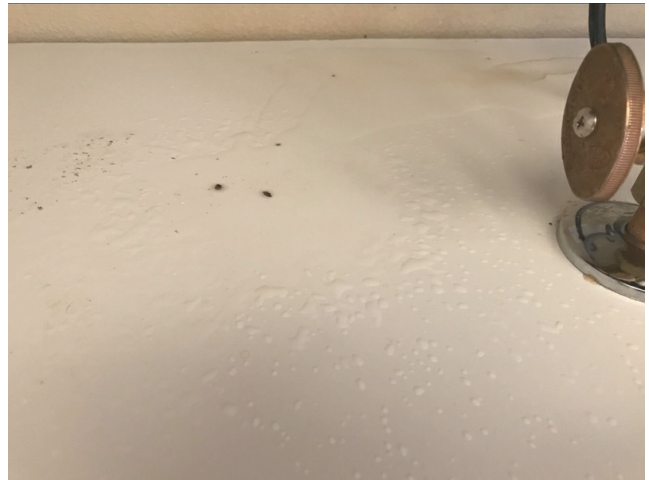
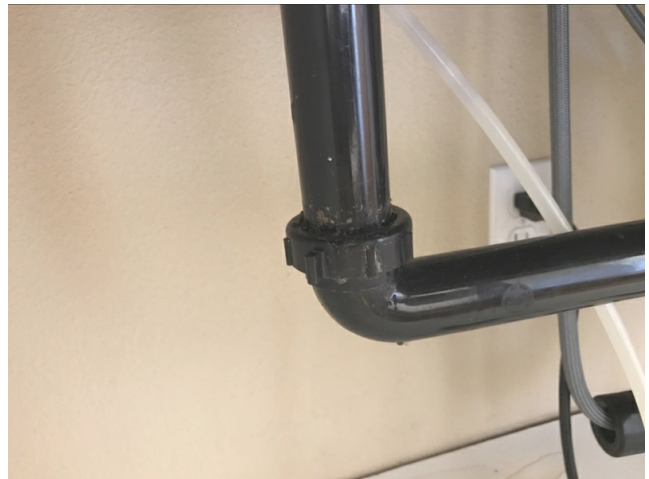
12.8.1 Sink (s) & Plumbing

## LEAK

There is an active water leak underneath the kitchen sink. The seal at the elbow appears to be broken. Recommend correction or further evaluation by a qualified professional.

Contact a qualified plumber.

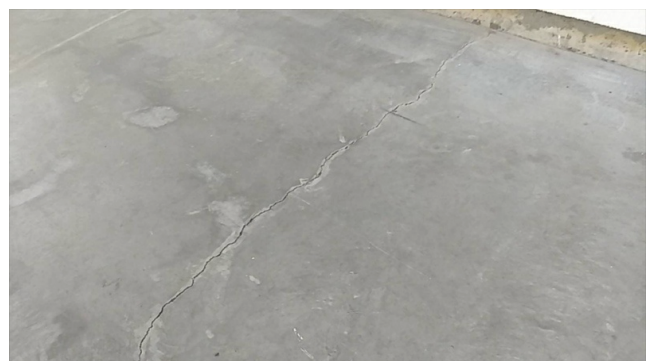
GARAGE

### CRACKING

Crack was observed towards the back of the garage. Most likely due to concrete shrinkage and normal settling. Recommend monitor and/or have concrete contractor patch/seal.

Contact a qualified professional.

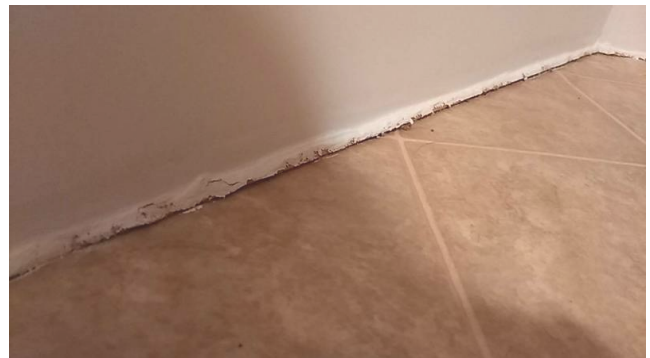
### MOISTURE DAMAGE

Trim opposite the sink cabinet appeared to have moisture damage. Washing machine may have leaked at some point. Recommend asking sellers about this.

Contact a qualified professional.
