PGR HOME INSPECTIONS

RESIDENTIAL HOME INSPECTION REPORT

1234 Main St.
Charleston SC 29414

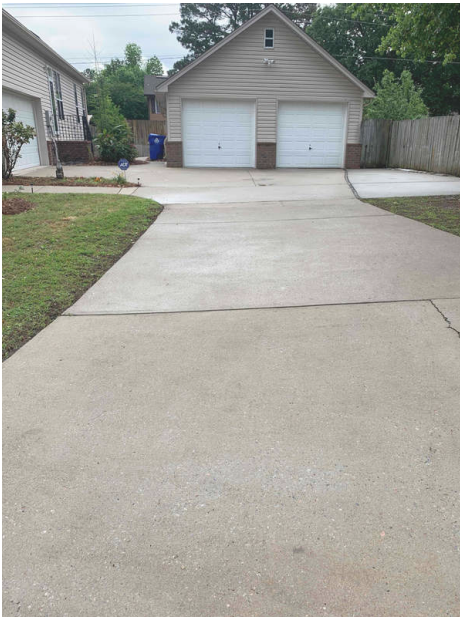
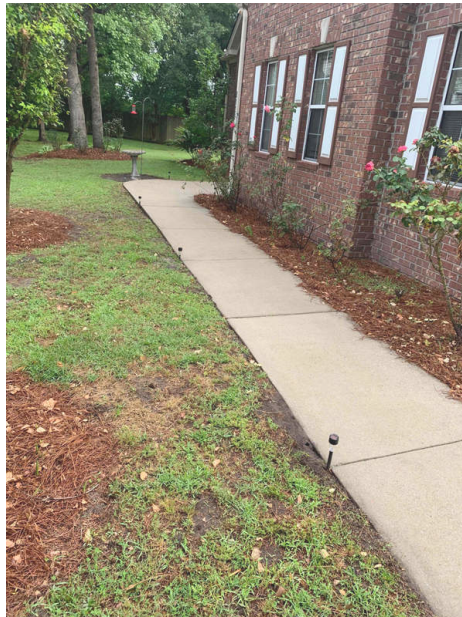
Driveway, Walkway, Patio: Driveway/ Walkway/ Patio Condition Inspection Method

Driveways, sidewalks, patios/porches are inspected to determine their condition and effect on the structure of the home, reporting on any visual deficiencies that may be present such as cracking, displacement, etc.No deficiencies observed at inspection time unless noted in this report.

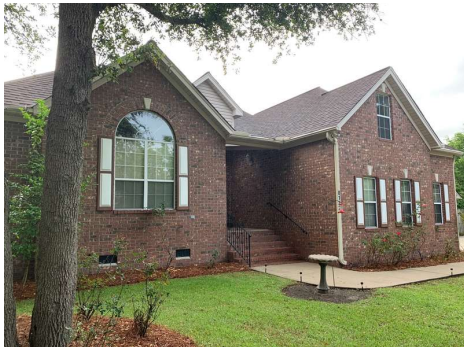
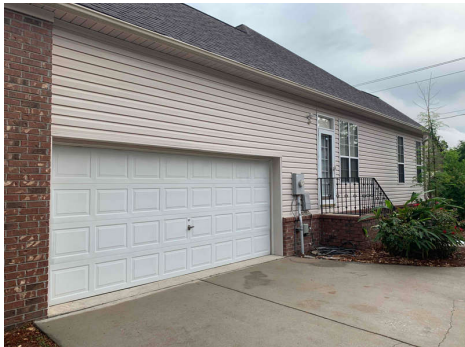
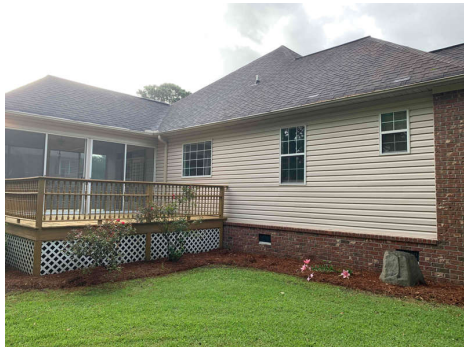
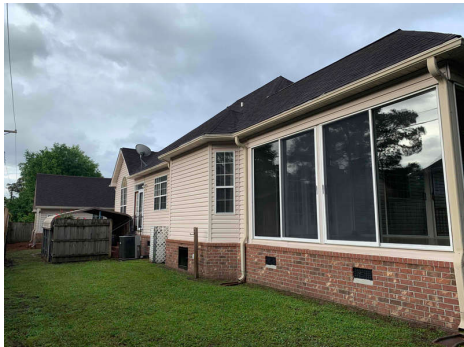
Exterior Components: Siding, Eaves/Rake, Soffit, Fascia, Trim, Flashing Inspection Method

- The exterior components were inspected looking for damage, potential water entry points, missing/ loose pieces, rot, improper installation etc.No deficiencies observed at inspection time unless noted in this report.

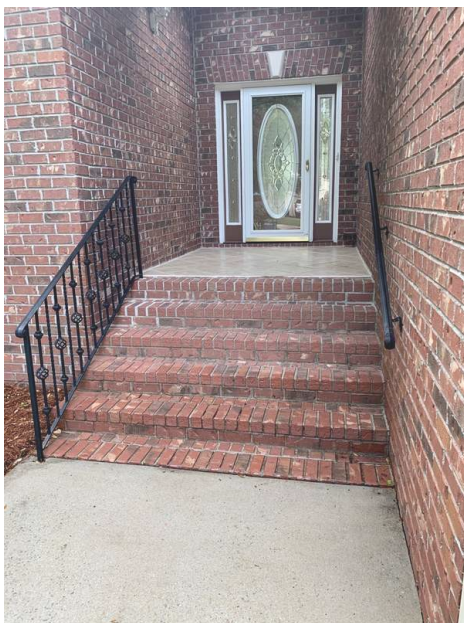
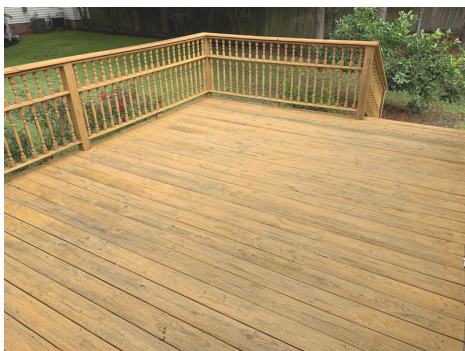
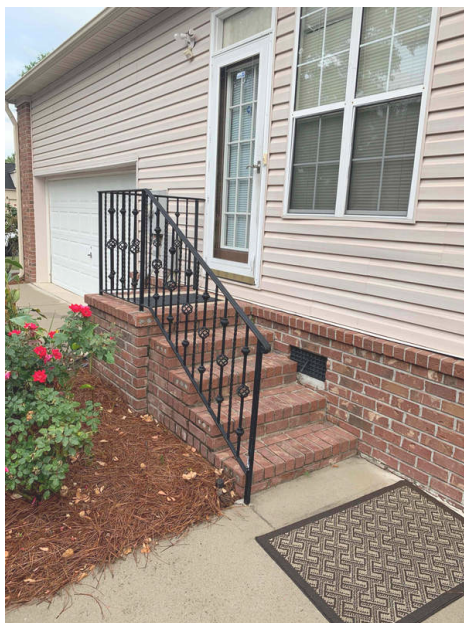
- Decks are inspected looking for water related damage, construction related deficiencies, and safety hazards.
- Slab porch(es) are inspected looking for damage or any other significant defects and to determine that they adequately slope away from the structure.
- The steps were inspected by looking at their construction, attachment, risers and treads, applicable railings, etc.

No deficiencies observed at inspection time unless noted in this report.

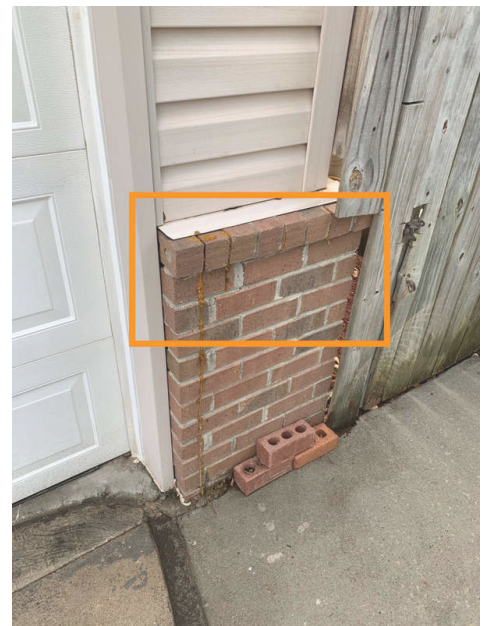
BRICK VENEER LOOSE

Brick veneer right of the garage door is loose. Recommend a qualified professional repair.

Recommendation

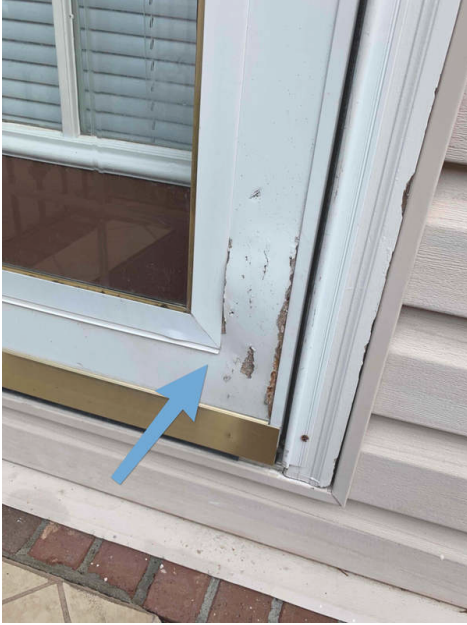
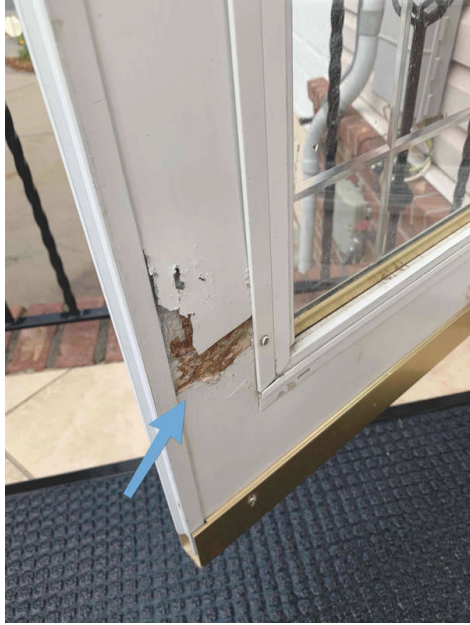
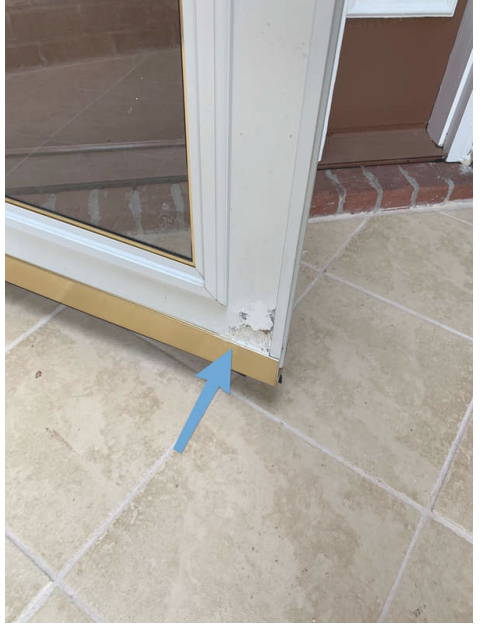
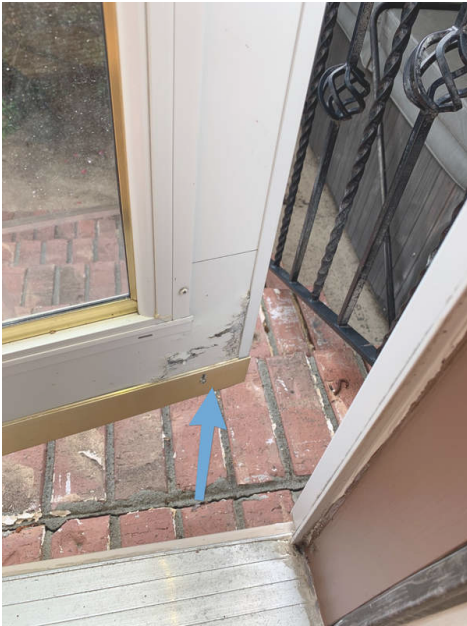
2.3.1 Exterior Doors

DAMAGED STORM DOOR

Visible damage to storm door. Damage is not affecting proper operation of the door. Recommend repair or replace as needed.

Recommendation

Contact a qualified door repair/installation contractor.

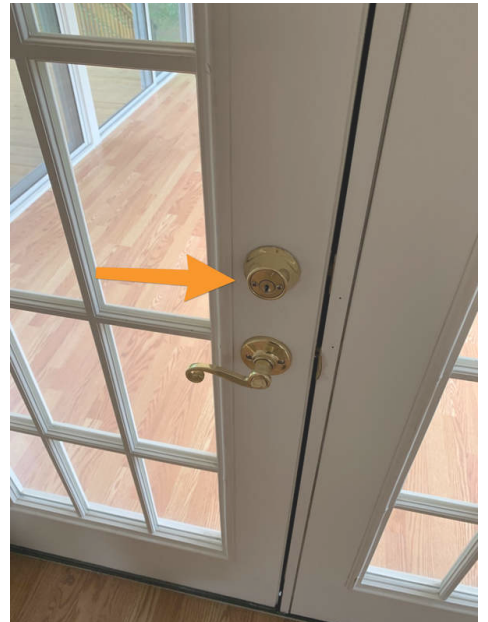
2.3.2 Exterior Doors

Moderate Deficiency**REPLACE LOCK**

Highly recommend replacing the key lock with a deadbolt for safety reasons. In an emergency situation the key may not be readily available putting you at risk.

Recommendation

Contact a qualified professional.

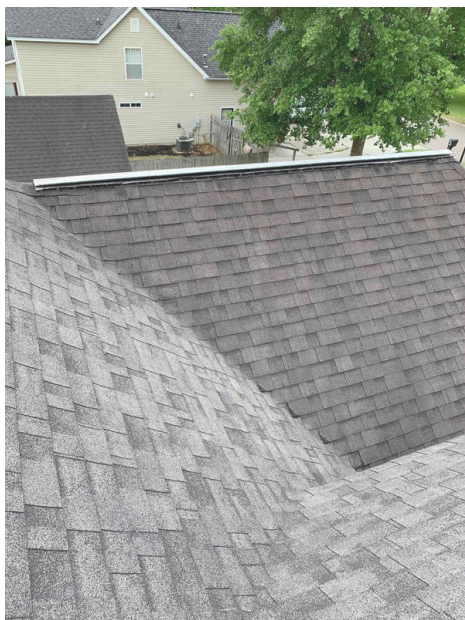
Roofing Material: Roofing Material Condition Information

The roofing material was inspected at visible portions for proper roof connections, excessive granule loss, signs of curling or delamination, loss of adhesion between the shingles (if applicable), and any other signs of damage or excessive age. No deficiencies observed at inspection time unless noted in this report.

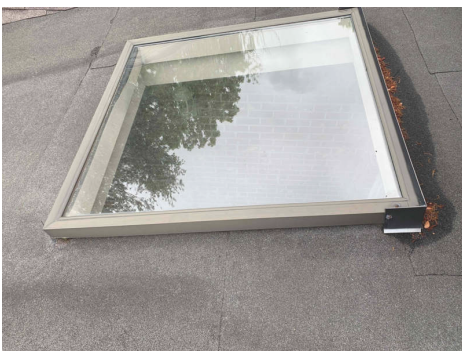
Skylights: Skylight Inspection Method

Skylights are inspected looking for possible water intrusion points due to inadequate/ improper flashing and/or damage to the skylight that could result in water intrusion. Many times not all flashings are readily visible. No deficiencies were observed on day of inspection unless otherwise noted in the report.

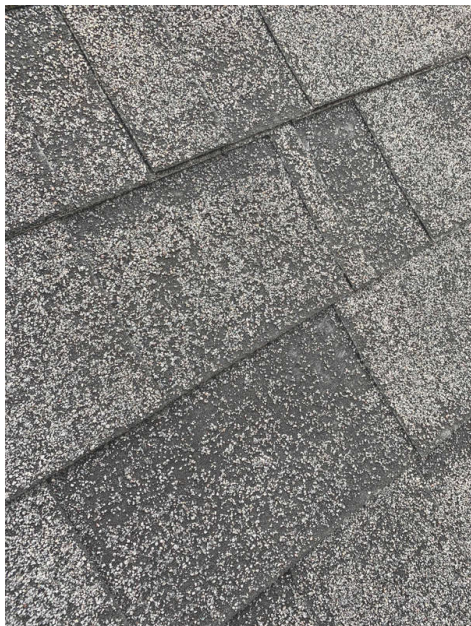
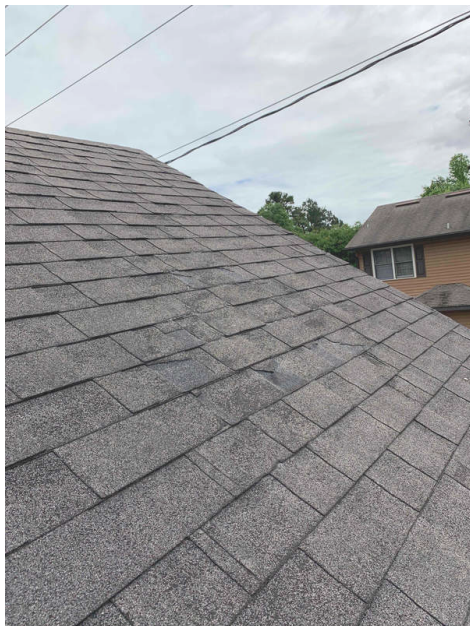
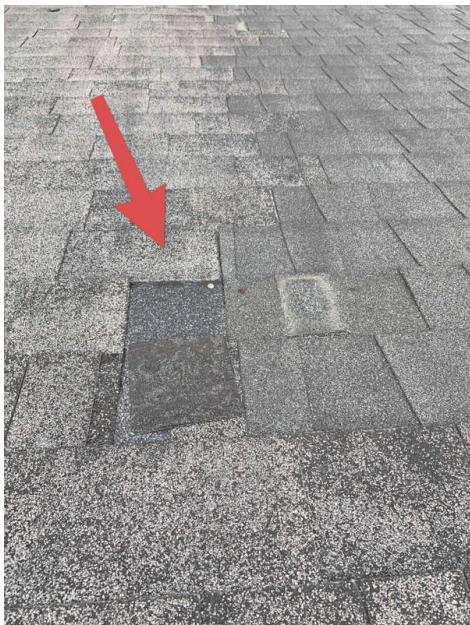
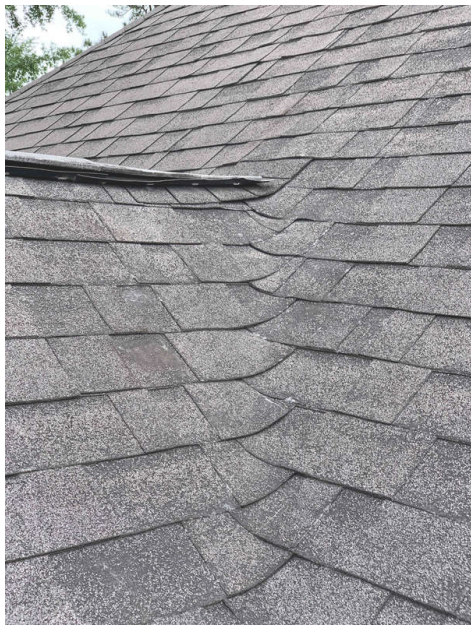
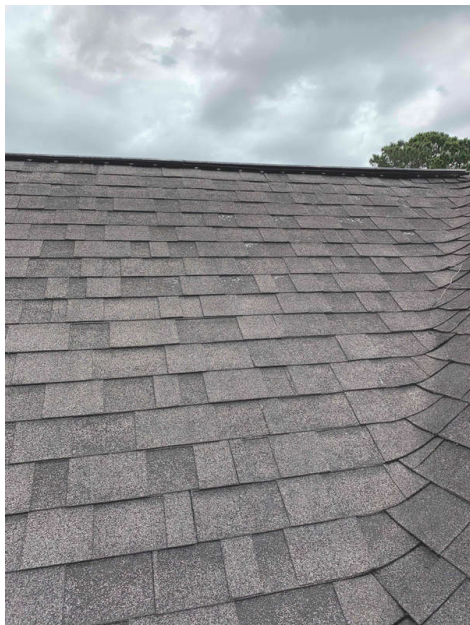
Significant Deficiency/ Safety Hazard

AGED ROOFING MATERIAL - DAMAGED SHINGLES

The roofing material showed signs of significant aging. Significant granule loss, exposed fiberglass in the shingles, moss growth are all signs of aging. One or more areas of damaged shingles were present as well. Recommend a qualified roofing contractor provide a more thorough evaluation, repair and damaged shingles and exposed nailhead on ridges/vents and budget for replacement in the near future.

Recommendation

Contact a qualified roofing professional.

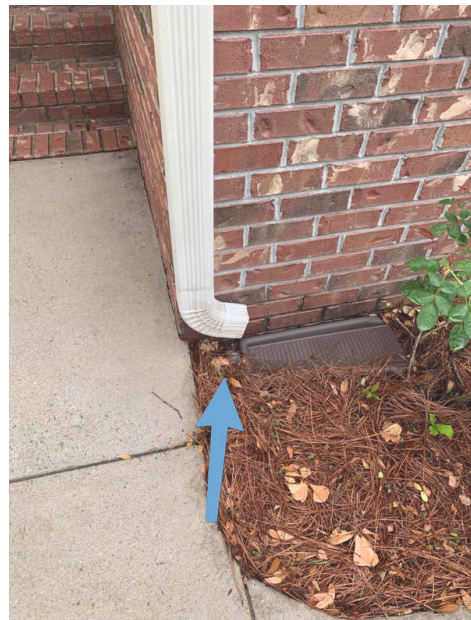
3.2.1 Gutters, Downspouts

**RECOMMEND
DIVERTING DOWNSPOUT**

Downspout terminates near foundation. Recommend diverting and/or extending the downspout to to ensure the water drains away from the foundation/ exterior wall.

Recommendation

Contact a handyman or DIY project

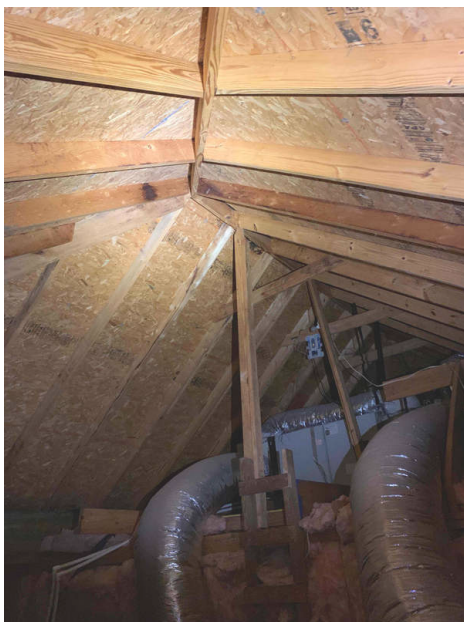
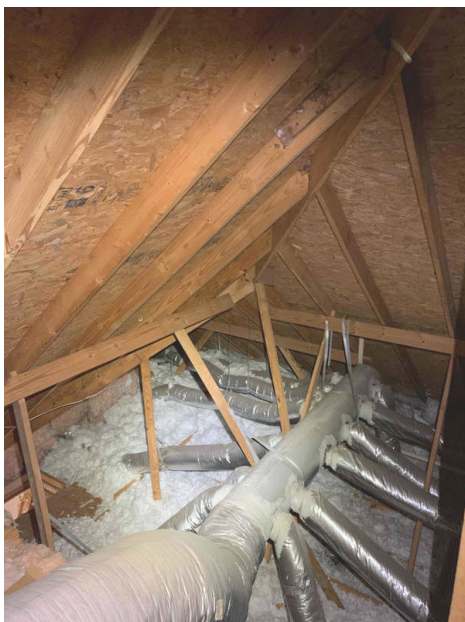
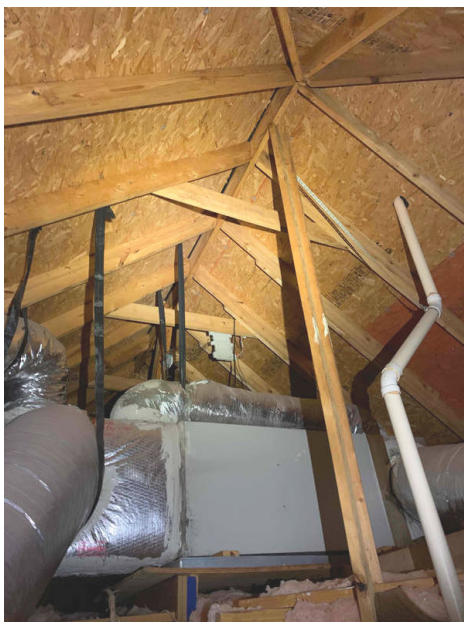
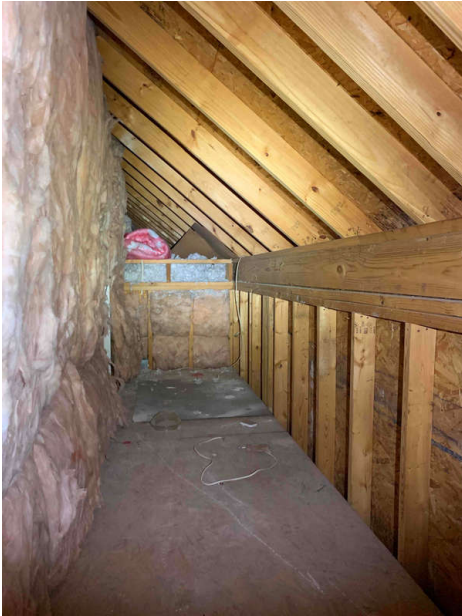
Roof Structure & Attic: Roof Structure Inspection Method

The roof structure was inspected at visible portions looking for any structural deficiencies, signs of moisture intrusion damage, or other deficiencies. No deficiencies observed at inspection time unless noted in this report.

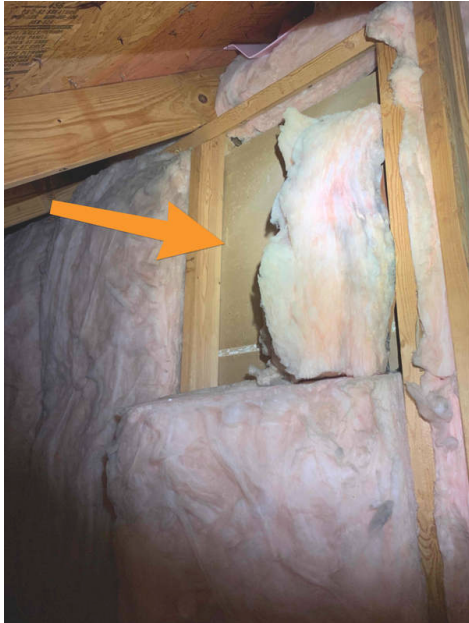
FROG

Insulation was out of place resulting in reduced efficiency. Recommend a qualified professional repair the fallen insulation.

Recommendation

Contact a qualified professional.

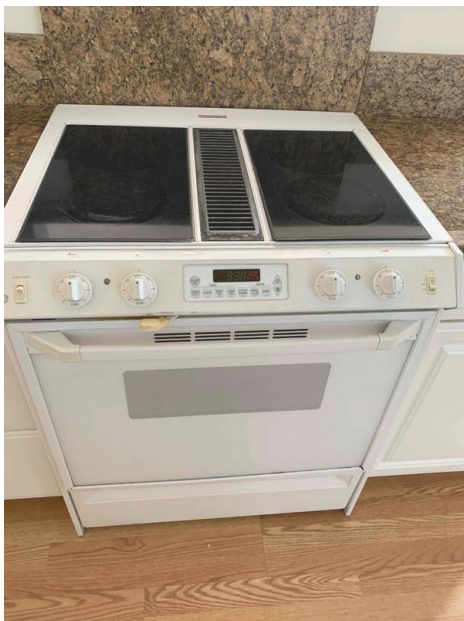
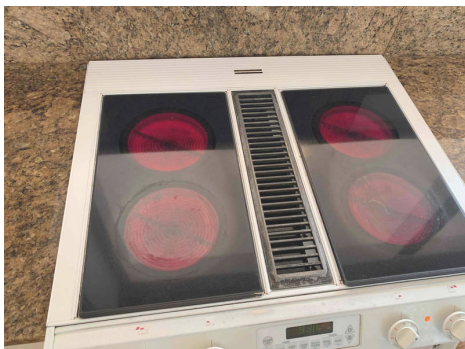
Range/Oven/Cooktop: Oven, Range Inspection Method

All of the heating elements on the range were turned to High, and the oven set to 350 degrees in Bake mode. Thermal imaging used to show all the heating elements are operating at time of inspection. No other stove/oven functions are tested. No deficiencies observed at inspection time unless noted in this report.

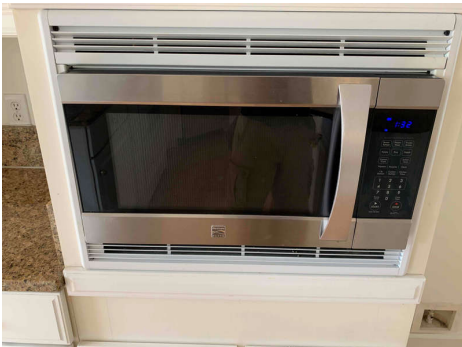
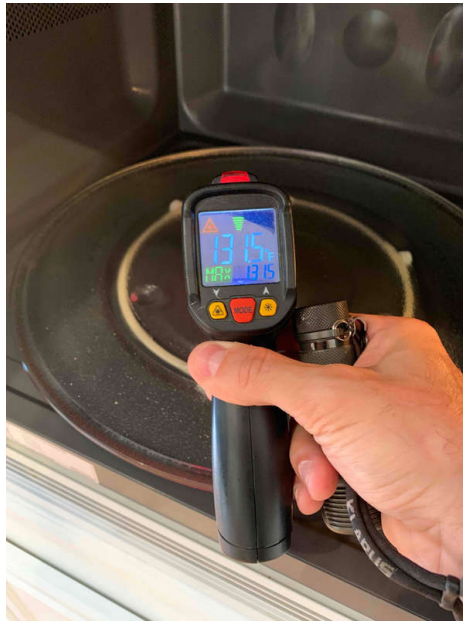
Built-in Microwave: Microwave Inspection Method

The microwave was tested by running on "Cook" mode for 90 seconds, and a thermal image is provided showing the microwave is operating accordingly. Other microwave functions are not tested. No deficiencies observed at inspection time unless noted in this report.

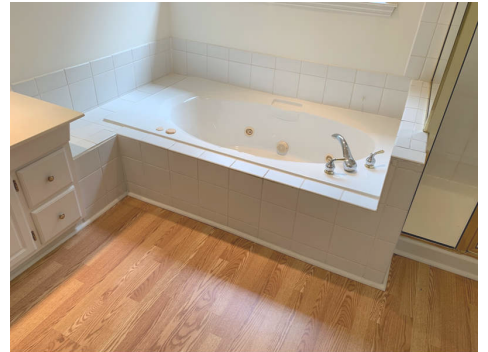
7.4.1 Whirlpool Tub

No access panel for the jetted tub for the motor and plumbing components. These are needed to perform maintenance on the components if needed. Unable to determine if any leaks are present and if there is GFCI protection in place. Recommend a qualified professional install an access panel and verify no issues are present and repair any issues prior to closing.

Contact a qualified professional.

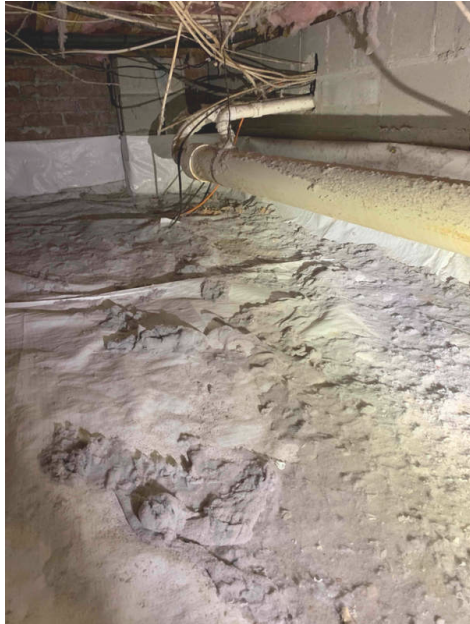
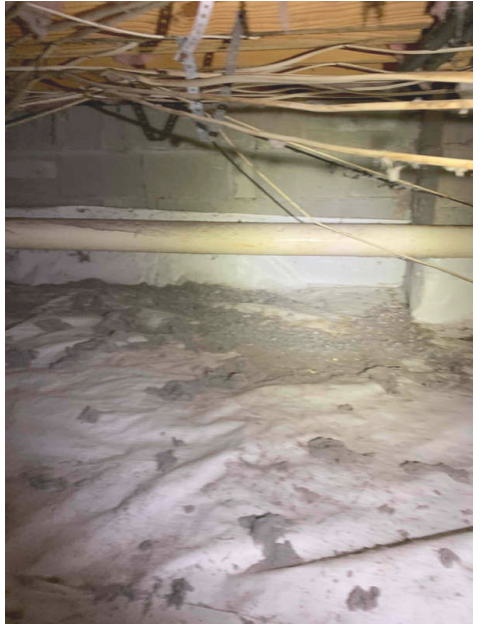
Dryer lint buildup

The dryer vent terminates into the crawlspace. No exterior termination found. Which ultimately results in releasing a significant amount of humidity and moisture into the crawl. Recommend a qualified professional terminate the dryer vent extension to the exterior.

Contact a qualified professional.

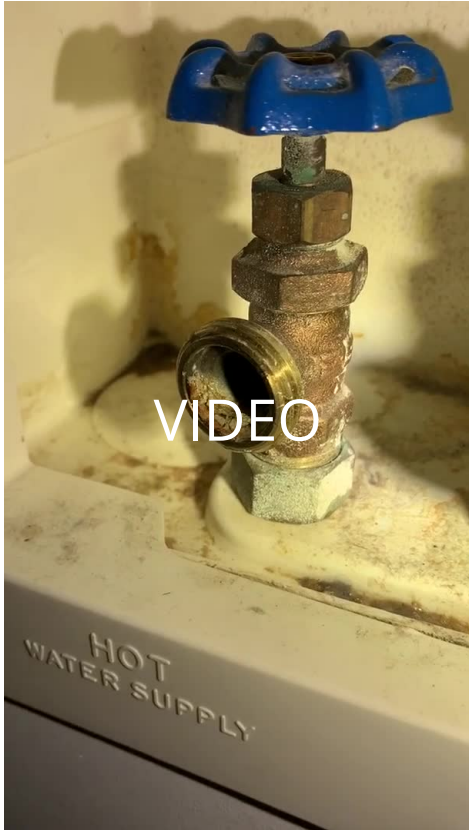
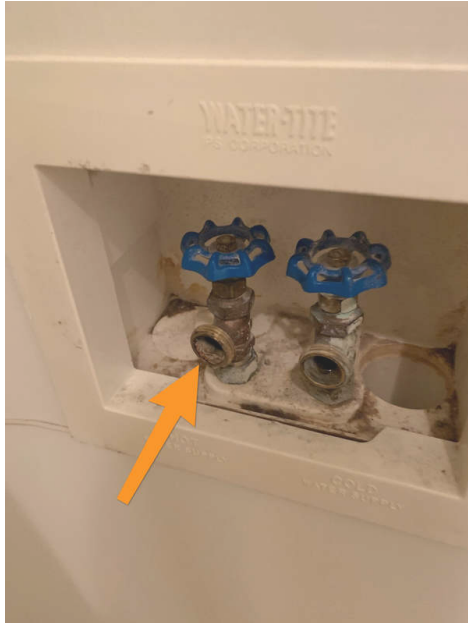
8.1.2 Laundry Room

Slow drip notice coming from the water valve. Recommend a licensed plumbing contractor evaluate and repair or replace.

Contact a qualified plumbing contractor.

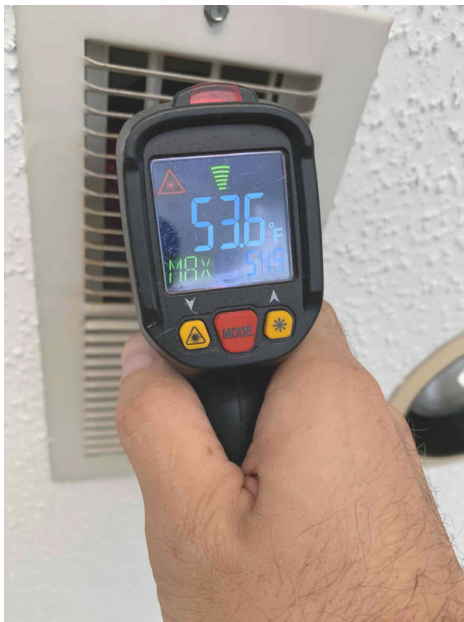
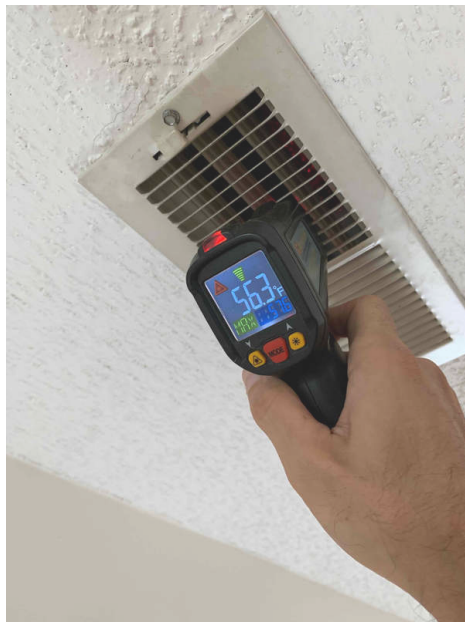
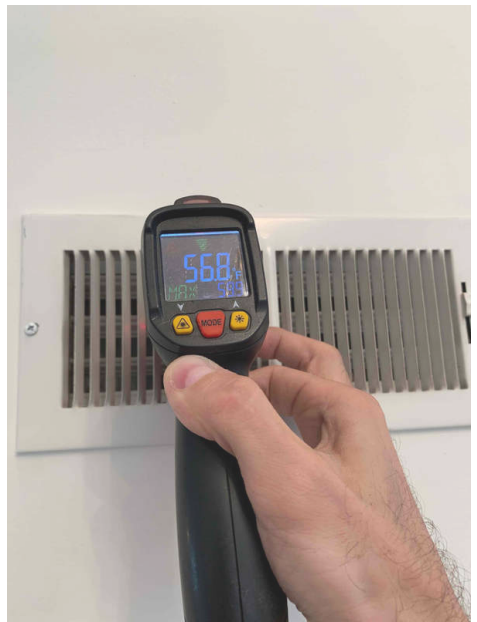
Air Supply (F) Cooling Mode

55.5

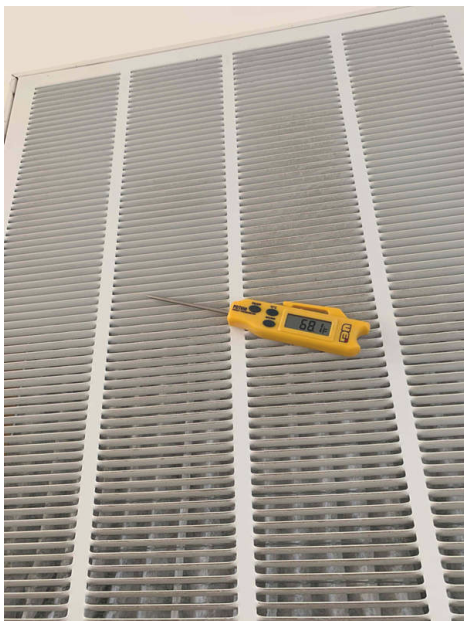
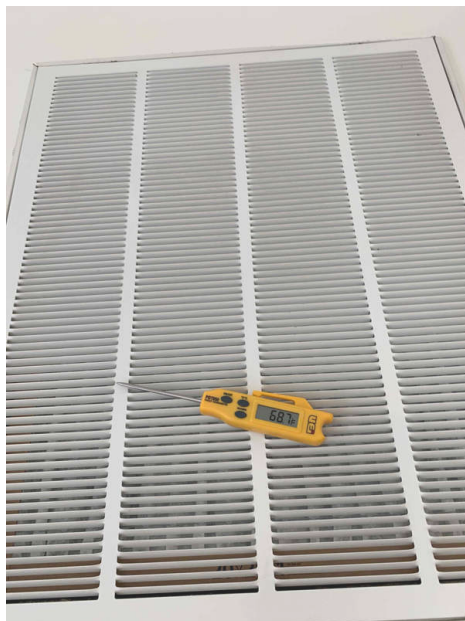
Return Air (F) Cooling Mode

68.4

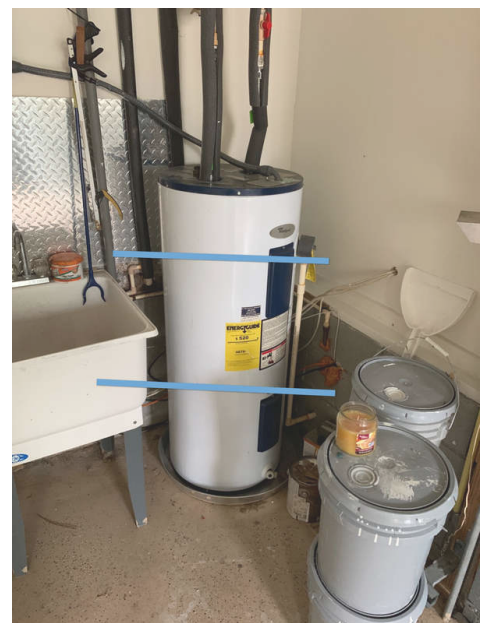
SEISMIC STRAPS MISSING

Water heater is missing seismic straps which are recommended for the area. Recommend a qualified professional install on the top and bottom third of the tank.

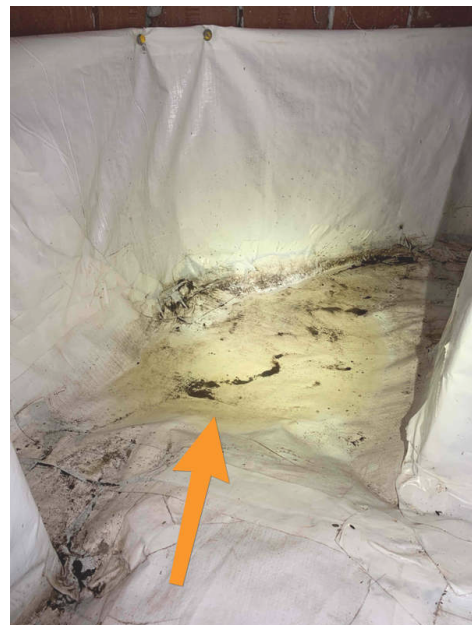
Left of crawlspace access panel

Observed signs that standing water may have been present on basement floor. Recommend a qualified professional evaluate and determine the water source and repair as needed. No signs of leaking at time of inspection.

Contact a qualified professional.

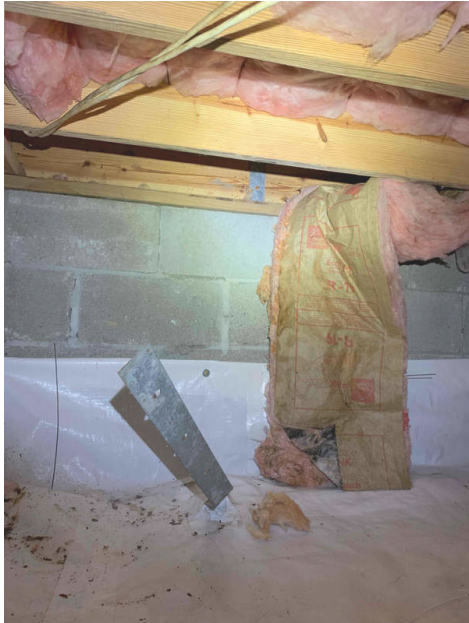
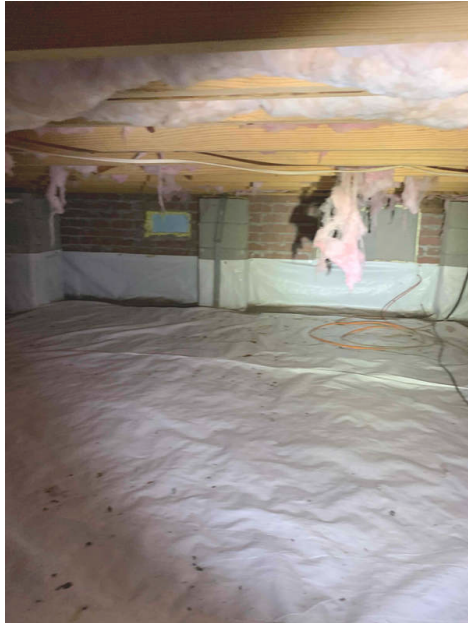
DAMAGED INSULATION

Insulation falling down in one or more areas. Recommend a qualified professional repair.

Contact a qualified professional.

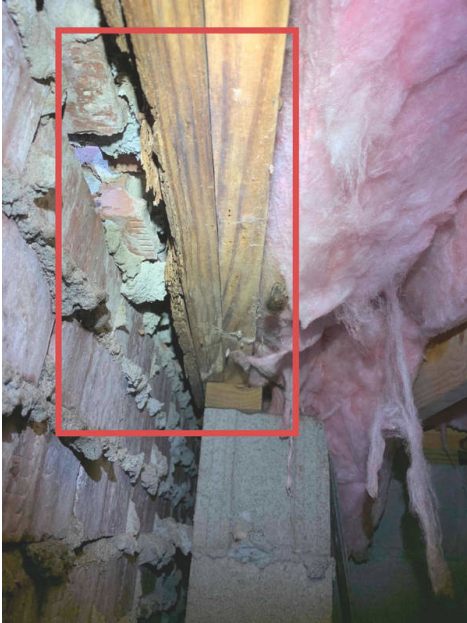
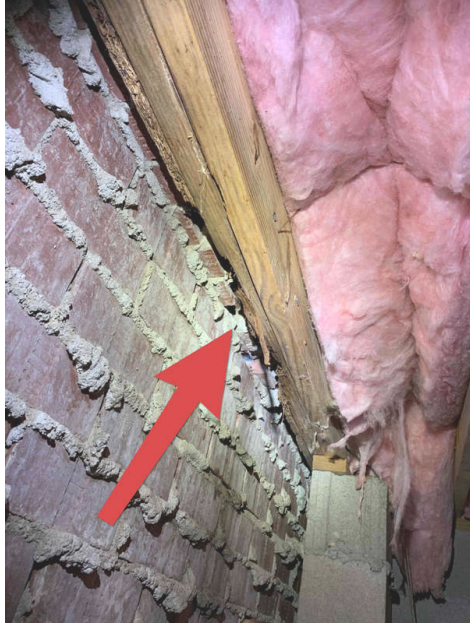
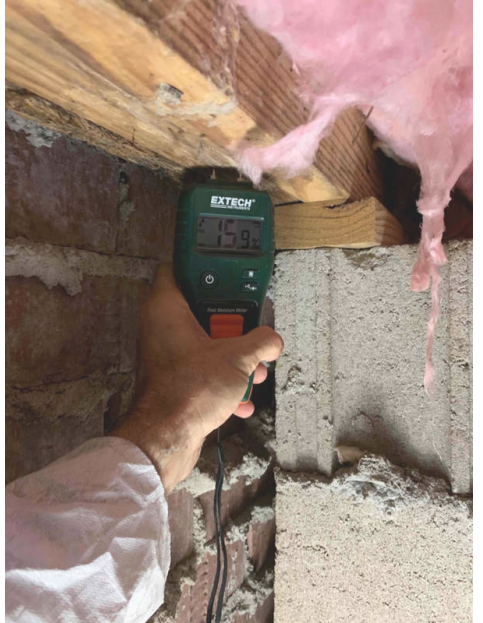
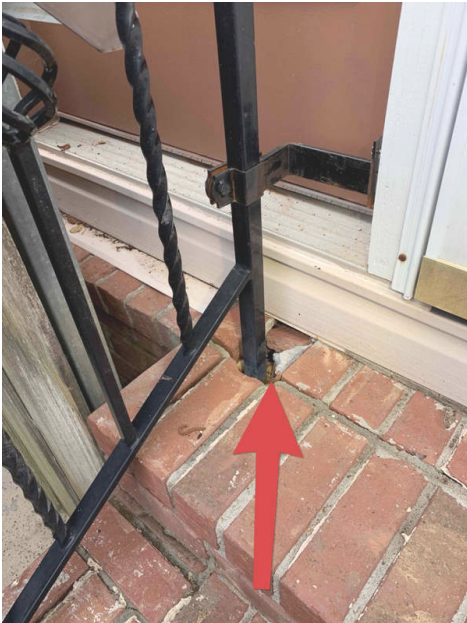
Back of the home

MOISTURE INTRUSION/ WOOD ROT

Observed one or more areas where there were signs of moisture intrusion and rotting on the band joist. Recommend a qualified contractor evaluate the extent of the rot, repair the moisture intrusion point and repair as needed.

Contact a qualified general contractor.
