DOBBINS HOME INSPECTION, LLC

HOME INSPECTION REPORT

1234 Main St.
Blackwood NJ 08012

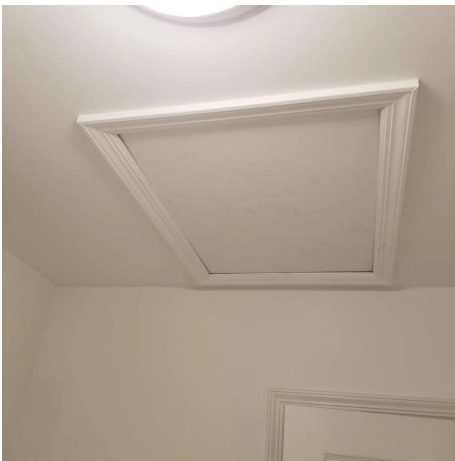
LIMITATION - NO ATTIC FLOORING

A majority of the ceiling/attic floor was not covered with sheathing/flooring and was covered with insulation. This prevented a full and thorough inspection of the roof/ceiling structure. Hidden, inaccessible, or latent issues may exist.

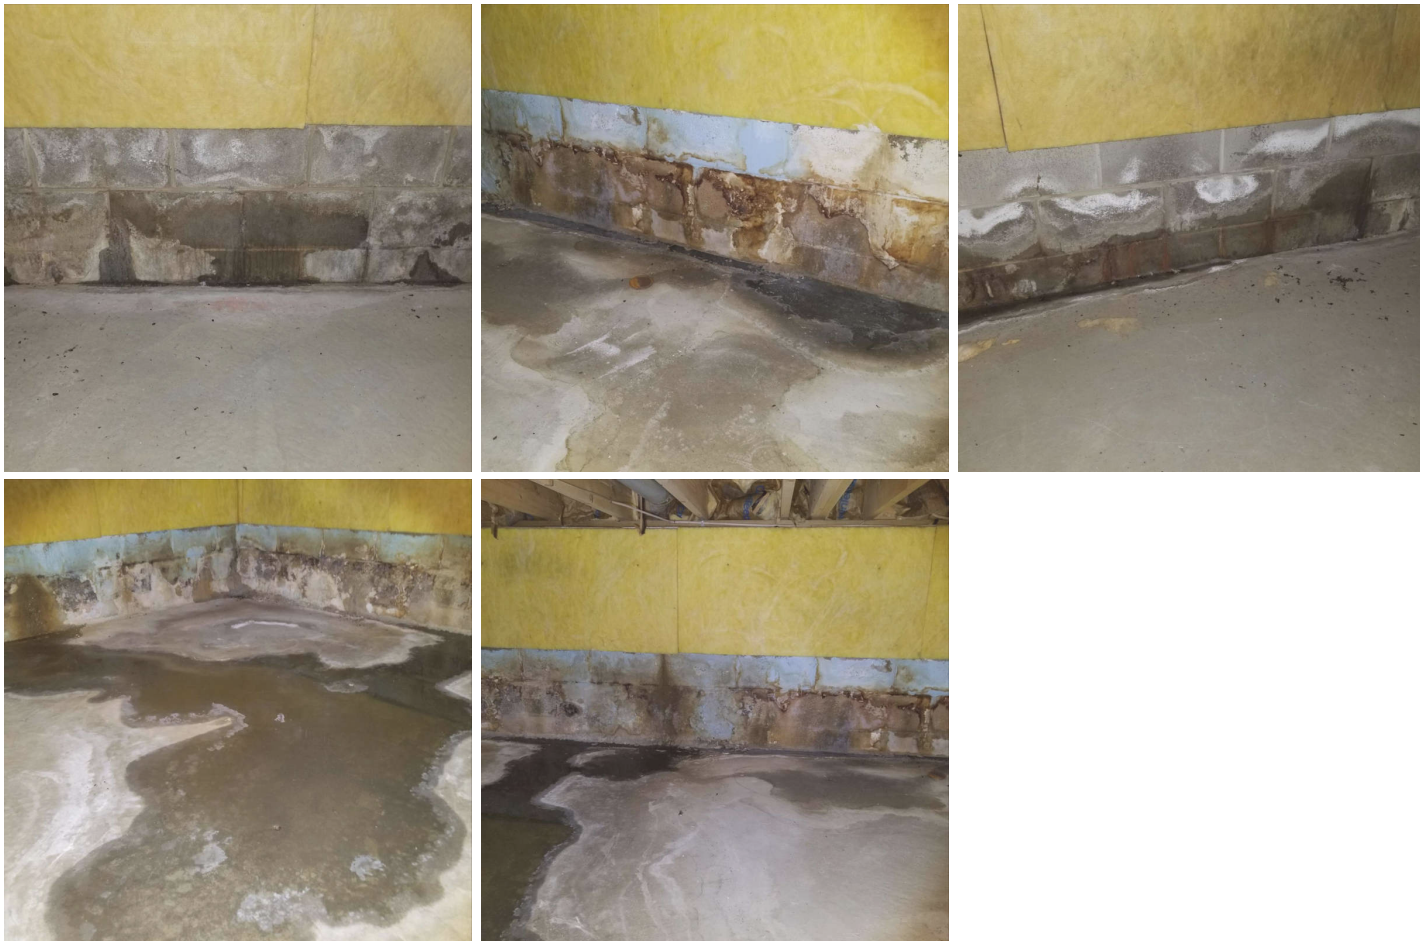
2.2.1 Foundation

FOUNDATION - MOISTURE INTRUSION

CRAWLSPACE

The foundation wall had multiple areas of moisture staining and active moisture intrusion. Moisture on the walls can be common and is typically directed to the sump pit. However, some water was observed pooling on a portion of the crawlspace floor. Continued moisture intrusion may result in damage to the home. Recommend a qualified waterproofing contractor to evaluate and repair.

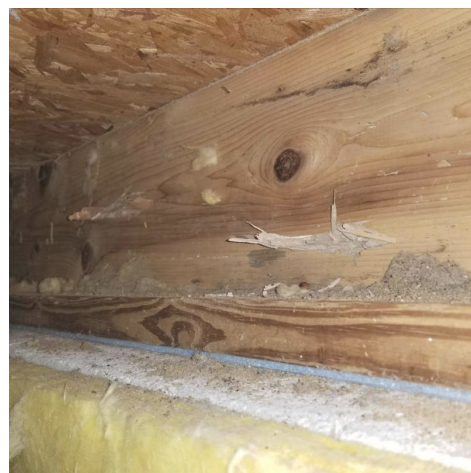
2.4.1 Floor

TERMITE DAMAGE

REAR RIM JOIST

While no active insects were observed, termite damage was noted on the rear rim joist. It appears this area has been inspected previously and the home has received a treatment. Recommend obtaining all records from the seller.

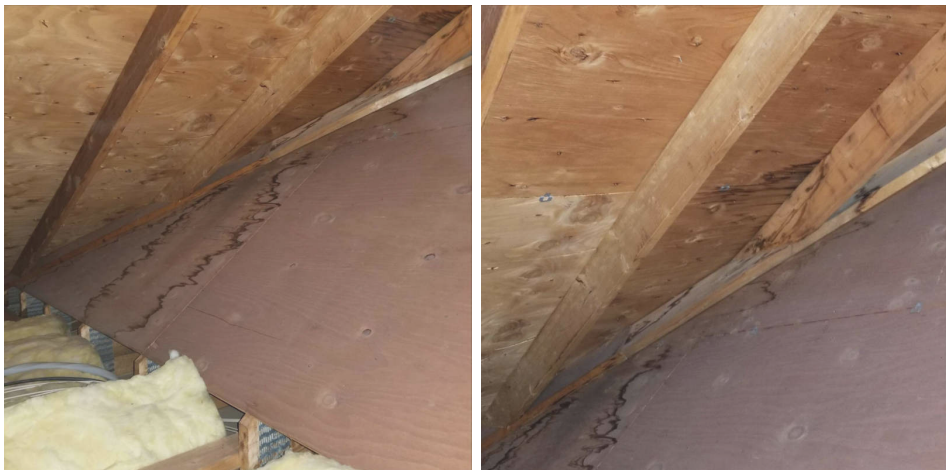
2.7.1 Roof

ROOF - MOISTURE STAINING

ATTIC

The roof structure and sheathing has moisture staining. The source of this staining may have been previously repaired as this area was dry at the time of inspection or may only occur under certain circumstances. Regardless, continued moisture intrusion may cause further damage to the home as well as the home's contents. Recommend continuing to monitor this area. If an active leak is observed, recommend a licensed roofing contractor to evaluate and repair.

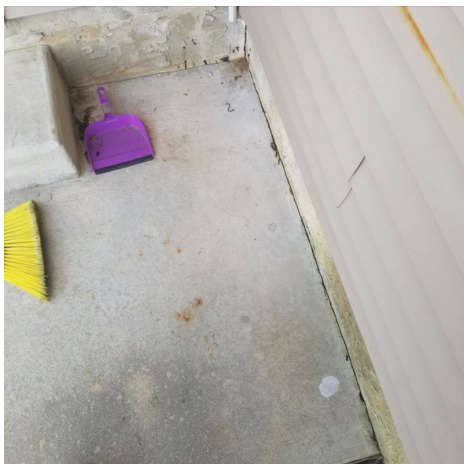
Evidence of Previous Termite Treatment

The home had drill marks which often indicates a previous termite treatment. Recommend obtaining all records from the current homeowner. Also, recommend continuing annual preventative wood destroying insect inspections/treatments at the discretion of a licensed pest control company.

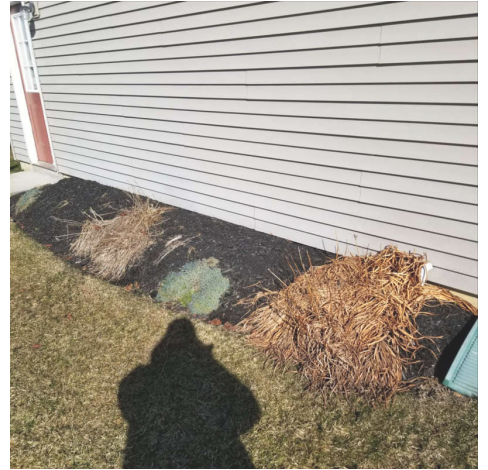
3.1.1 Exterior Wall Surface

SIDING - INADEQUATE GROUND CLEARANCE

LEFT SIDE OF HOME

The siding had inadequate clearance between siding and the ground. Siding in contact or close to the ground or soil is a serious concern because it can provide direct access for moisture and wood destroying insects. Recommend removing as much mulch/landscaping as reasonably possible to allow a space. Otherwise, recommend monitoring this area for signs of pests, rodents, or water intrusion.

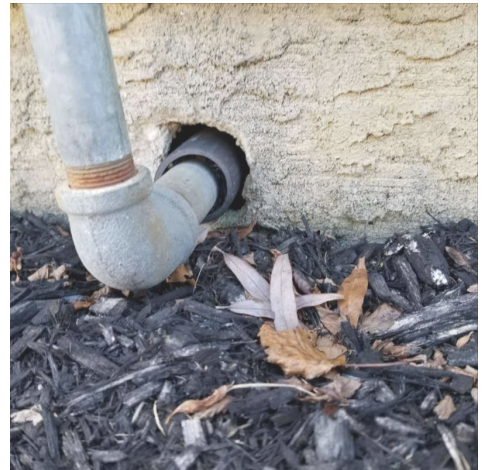
3.1.2 Exterior Wall Surface

GAS METER PIPING

A protrusion through the exterior wall was found to have damaged or missing sealant. Deteriorated or missing sealant could allow water intrusion causing damage to the exterior and interior components of home. Recommend sealing these gaps.

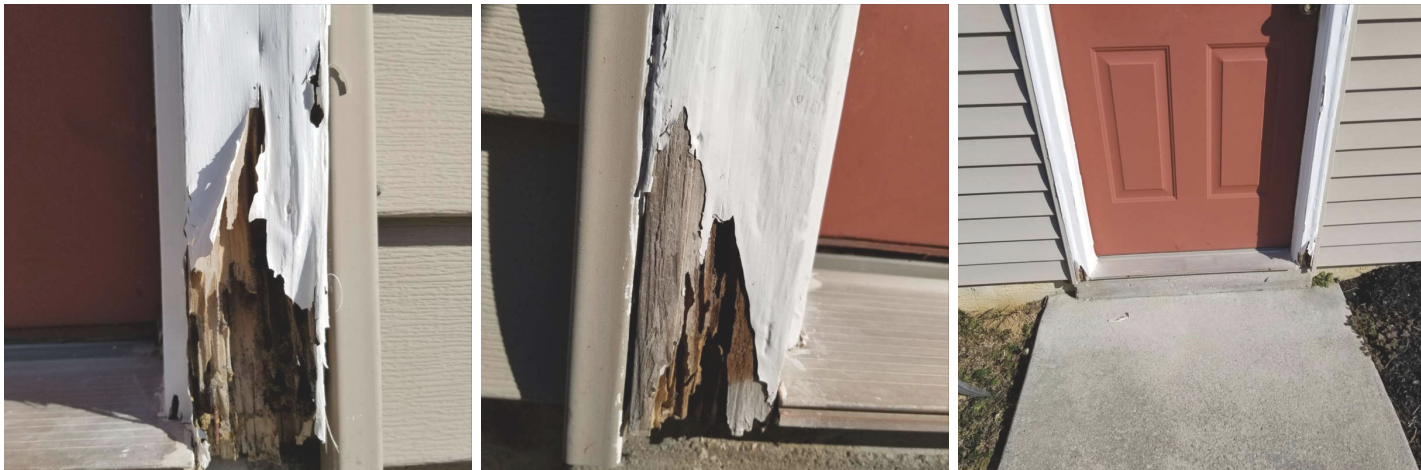
3.2.1 Exterior Doors

DOOR SILL/TRIM - DETERIORATION

LEFT SIDE DOOR

The door sill/trim has missing paint, termite damaged wood, and missing sealant. This could allow water intrusion into the home, further damage to the wood, and damage to the home. Recommend replacing the trim.

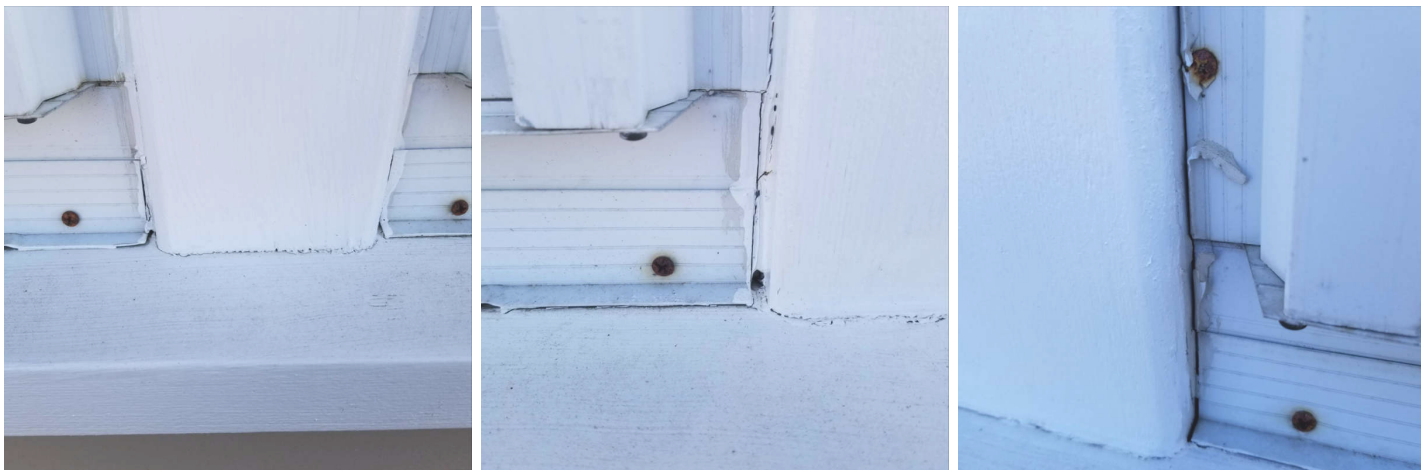
3.3.1 Windows

REAR SUN ROOM

The sealant/caulking around the windows is deteriorating. This is common and should be actively maintained throughout the life of the home. Failure to maintain could allow water intrusion into the home causing damage to the structural, exterior, and interior components. Recommend sealing this area on all windows with a flexible, waterproof sealant.

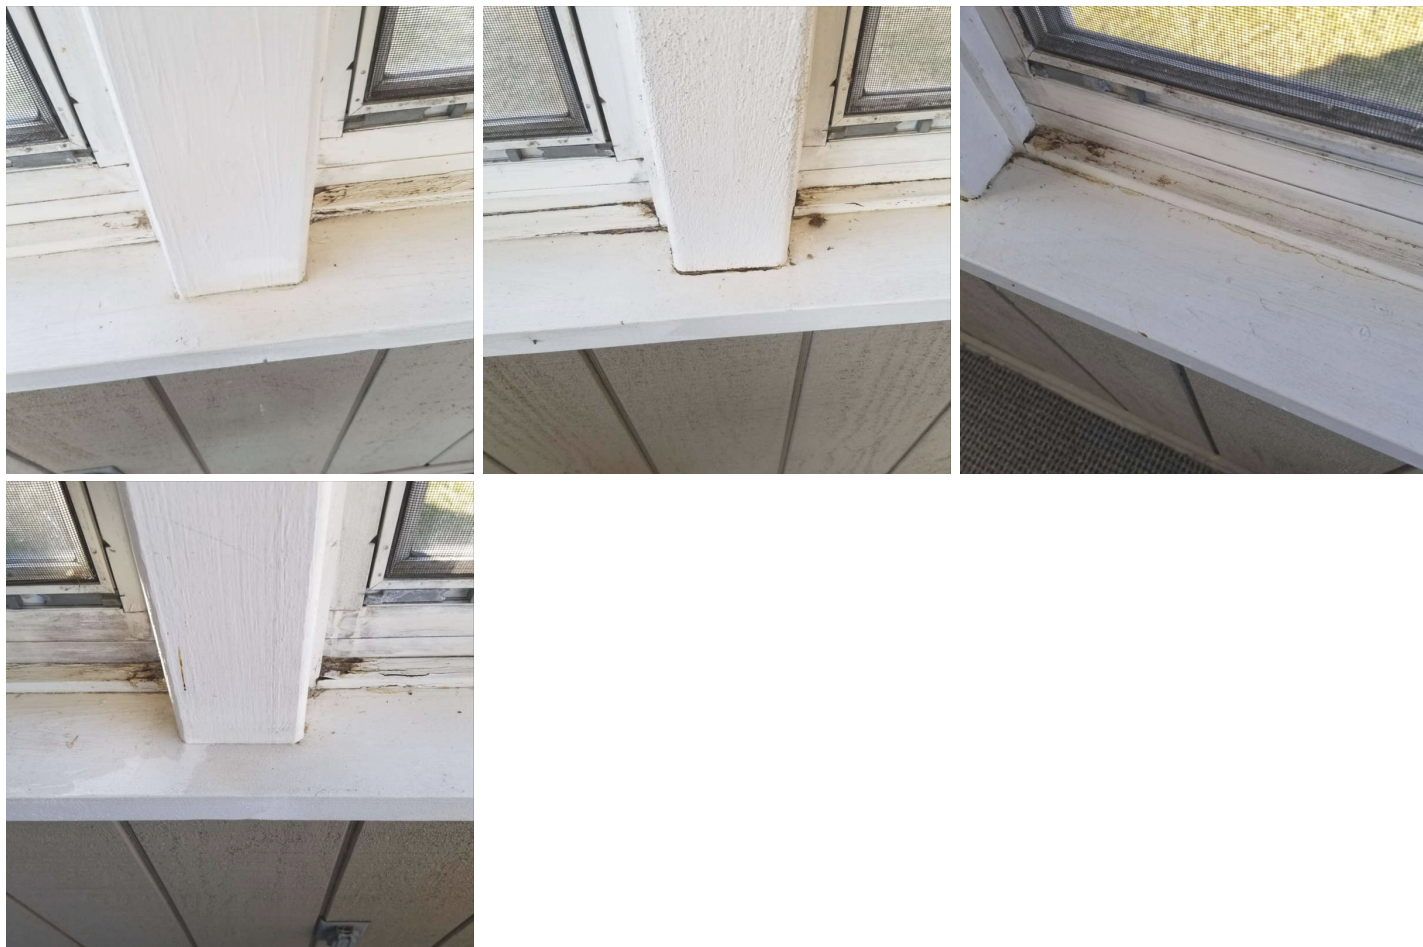
3.3.2 Windows

WINDOW - MOISTURE STAINING

REAR SUN ROOM

The windows have water staining on the interior window sill/wall. This is fairly common for "exterior-type" sun rooms. Recommend closely monitoring this area, especially during rain storms, for any leaking or active moisture. If active moisture is observed, recommend a qualified contractor to repair.

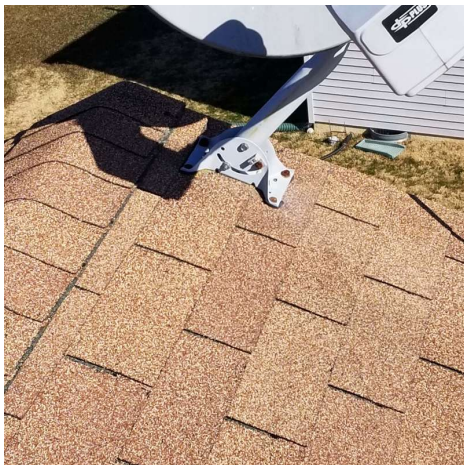
Satellite Dish Penetration

Satellite dish mounts have penetrated roof coverings which could allow moisture intrusion if not kept sealed. Recommend periodic monitoring to ensure sealant used is in good condition and reapply as needed.

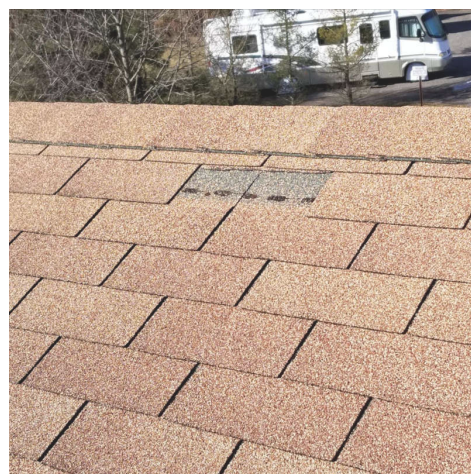
4.1.1 Roof Surface

SHINGLES - BROKEN/CHIPPED

One of the asphalt shingles on the roof of the home is broken or chipped. This could lead to water intrusion which may cause damage to the structure and interior components of the home. Recommend a licensed roofing contractor to repair.

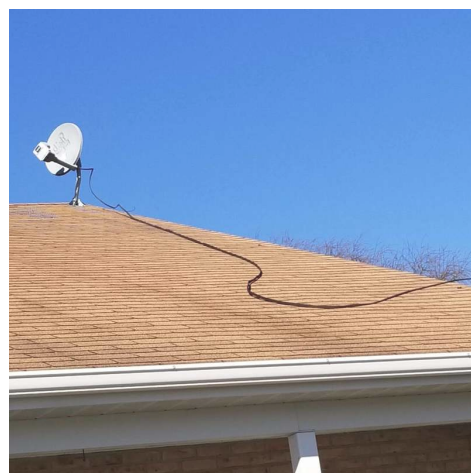
4.1.2 Roof Surface

SATELLITE DISH WIRE - RESTING ON ROOF

The wire for the satellite dish is resting on the roof surface. This wire is unsecured and could blow around lifting/damaging shingles. Recommend securing the wire to prevent movement and damage.

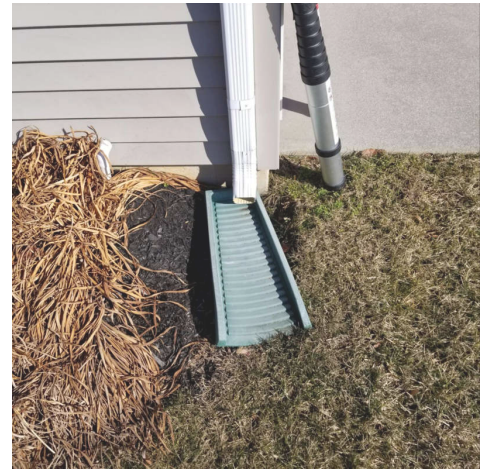
4.2.1 Roof Drainage Systems

DOWNSPOUTS - DRAIN NEAR FOUNDATION

The gutter downspout drains too close to the home's foundation. This can result in excessive moisture in the soil around the foundation, which can lead to foundation/structural movement and water intrusion into the home. Recommend adding downspout extensions so they drain at least six feet from the foundation.

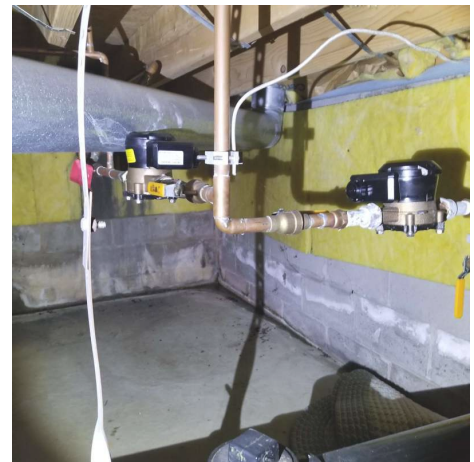
Water Meter Location

Crawlspace

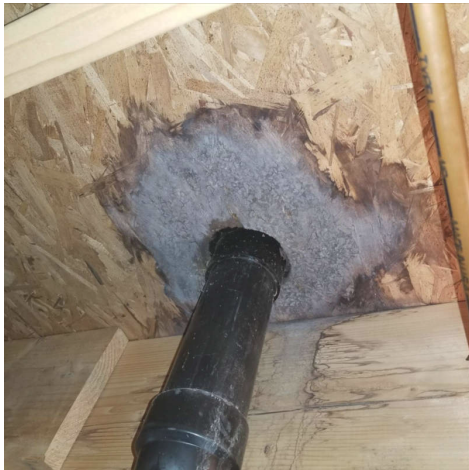
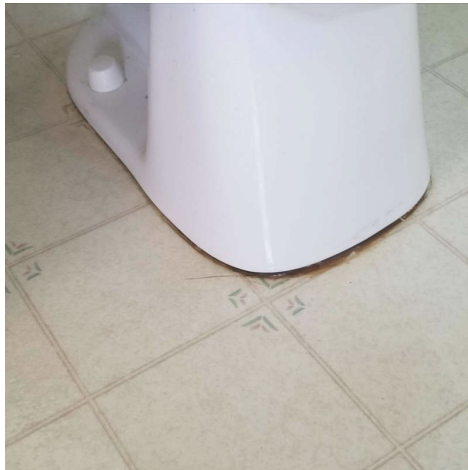
5.2.1 Fixtures & Faucets

TOILET - LEAKING

MASTER BATHROOM

A toilet was observed that is leaking at the base. This could result in sewage entering the home and causing damage. Recommend a licensed plumber to repair or replace.

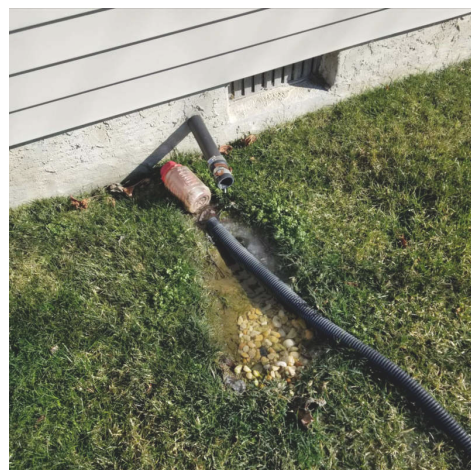
Due to the disconnected extension, the sump pump discharges directly next to the foundation. This could result in high levels of moisture in the soil surrounding the foundation which could lead to moisture intrusion into the basement. Recommend reconnecting the extension so the water discharges further from the foundation.

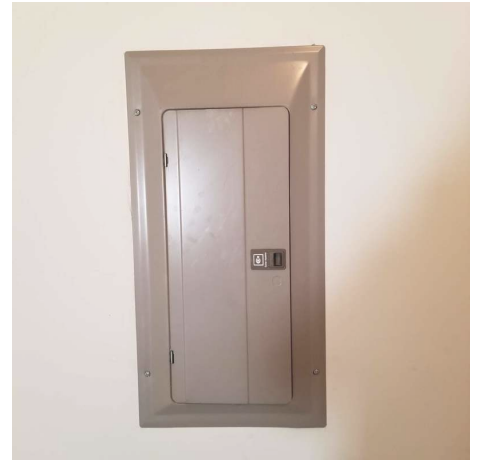
Service Capacity
150 AMP

Service Entrance Conductors:
Type
Aluminum

Branch Wiring, Breakers &
Fuses: Branch Wire Material
Copper

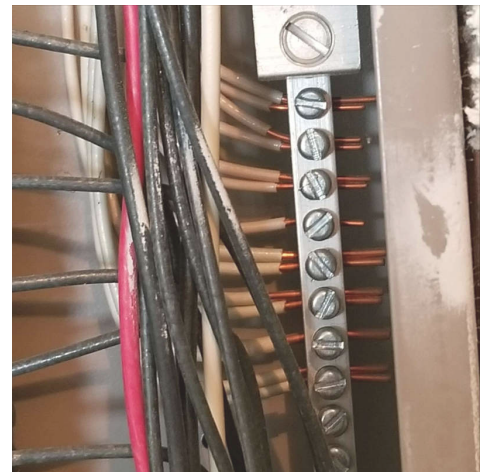
6.2.1 Main & Subpanels

The electrical panel had more than one neutral conductor inserted under a single bus bar screw. The bus bar is designed to accept only one conductor per screw. This could lead to electrical system malfunction and creates a fire hazard. Recommend a licensed electrical contractor to repair.

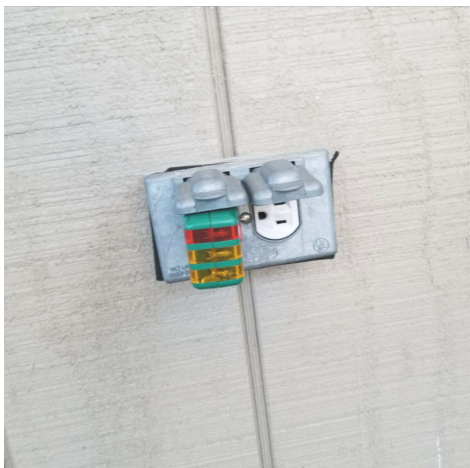
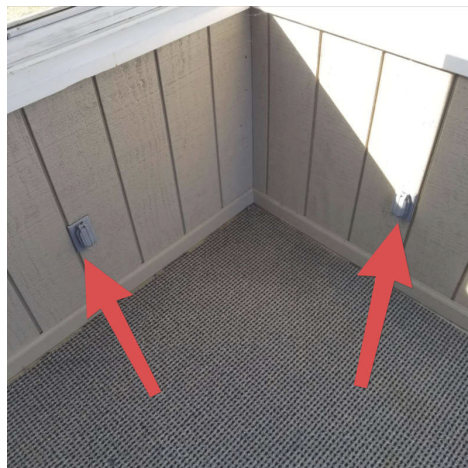
6.5.1 Light Fixtures, Switches & Receptacles

RECEPTACLE - INOPERABLE

The electrical receptacle was not working at the time of inspection. Recommend a licensed electrical contractor to repair all broken or inoperable receptacles.

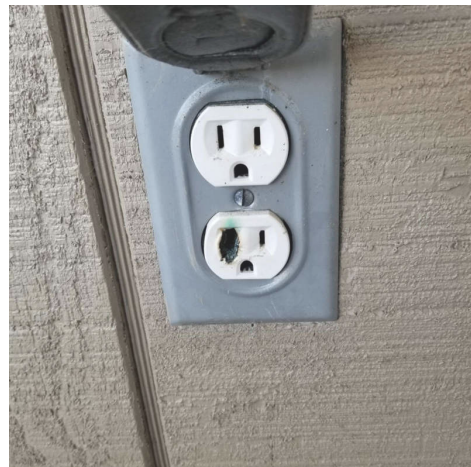
6.5.2 Light Fixtures, Switches & Receptacles

RECEPTACLE - DAMAGED

The electrical receptacle is damaged and broken. It appears to have had an electrical malfunction. This creates an electrical shock and fire hazard. Recommend a licensed electrical contractor to evaluate and replace.

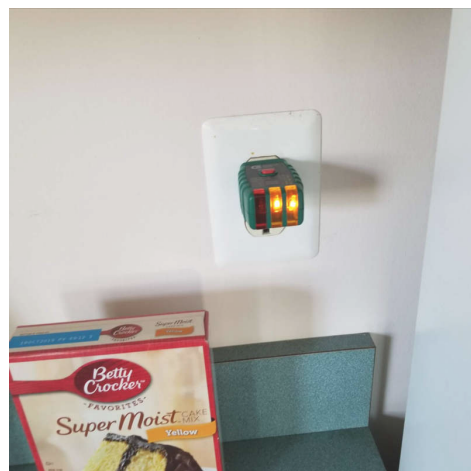
6.6.1 GFCI & AFCI

NO GFCI PROTECTION INSTALLED

An interior electrical outlet was observed without GFCI protection. This could lead to an electrical shock. Recommend a licensed electrical contractor to repair/replace.

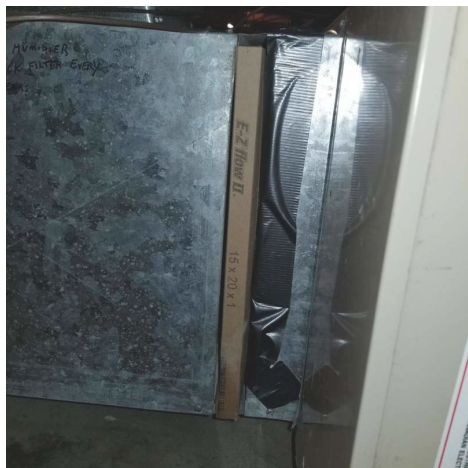
Equipment: Filter

The furnace has a filter inside of the cabinet. This must be changed regularly in order for the unit to function properly and efficiently. Recommend monitoring this filter and changing it every 3 months or per manufacturers recommendations.

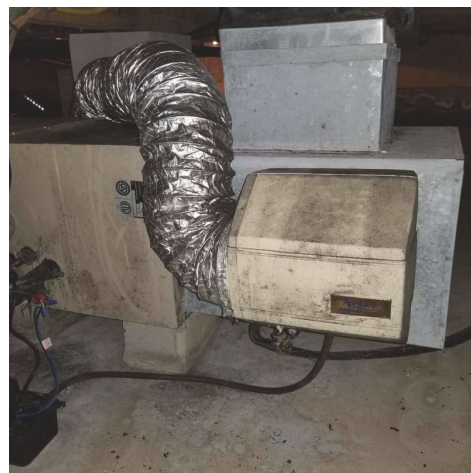
EXCLUDED - HUMIDIFIER

The furnace had a humidifier which is beyond the scope of this inspection and thus is excluded from the inspection. Recommend a licensed HVAC contractor to evaluate and repair, as necessary.

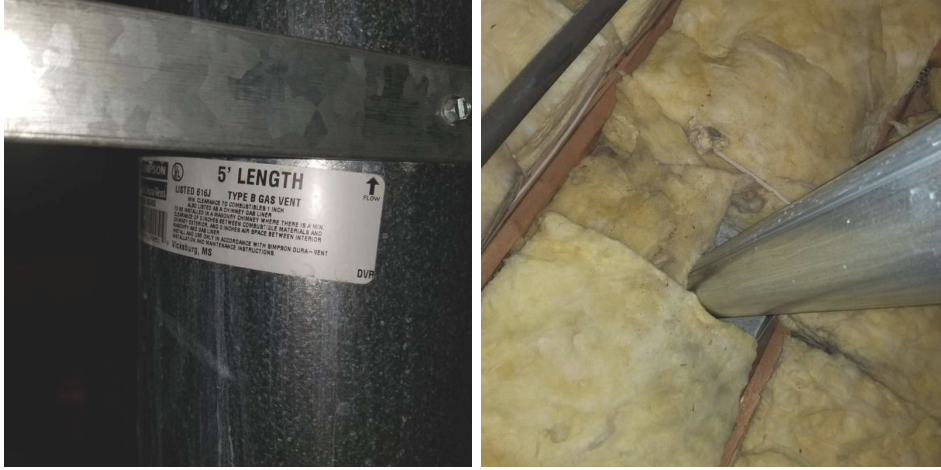
INADEQUATE CLEARANCES

Several pieces of fiberglass insulation are in contact with the metal B-vent. This is a fire hazard. The manufacturer of the B-vent recommends a 1 inch clearance for all combustible materials. Recommend removing all combustible materials from within 1 inch around the vent and secure all insulation and other combustible materials to prevent this problem from reoccurring.

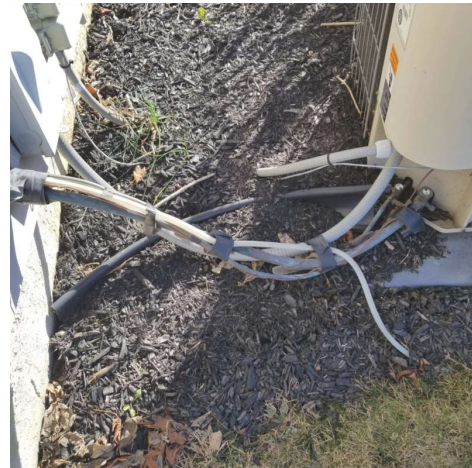
SUCTION LINE INSULATION - MISSING OR DAMAGED

EXTERIOR CONDENSER UNIT

The suction line attached to the outdoor coil has deteriorated insulation. This could lead to decreased efficiency of the air conditioner and higher cooling costs. Recommend replacing this insulation.

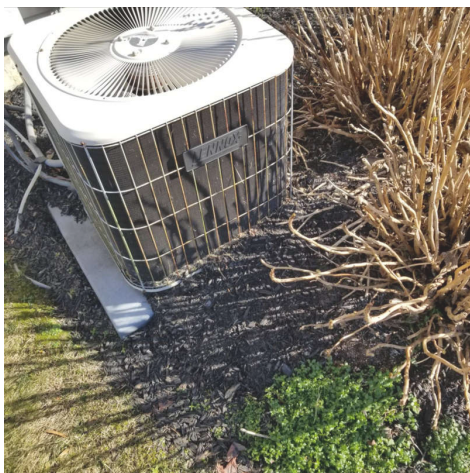
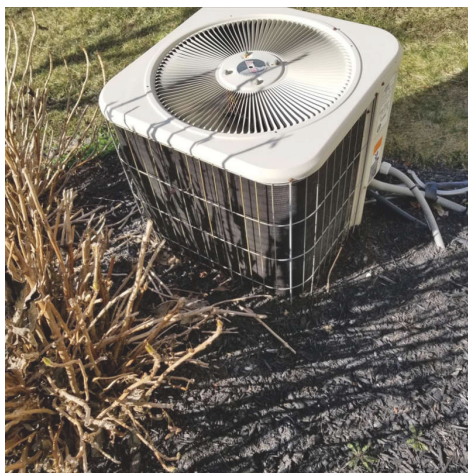
AIR CONDITIONER - COILS DAMAGED/DIRTY

CONDENSER UNIT

The air conditioning coils around the bottom of the condenser unit are dirty and have damaged fins. This could lead to a restricted airflow, decreased efficiency, and increased cooling costs. Recommend a licensed HVAC contractor to service, clean, and repair.

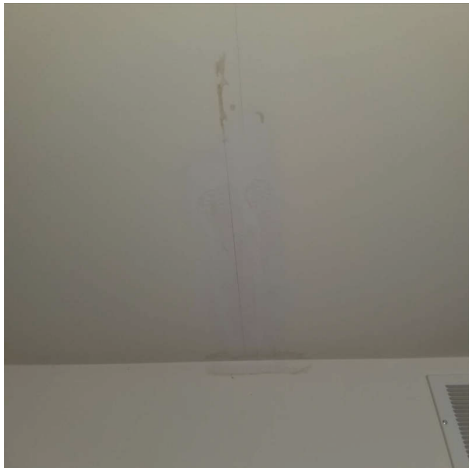
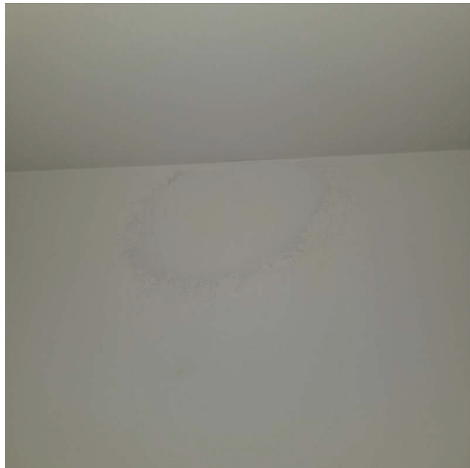
CEILING - PREVIOUS REPAIR

LIVING ROOM

Previous repairs were observed on the ceiling. This may be an area of moisture intrusion or damage that has since been repaired. Recommend monitoring this area for any changes. If changes occur, recommend a licensed contractor to evaluate and complete necessary repairs.

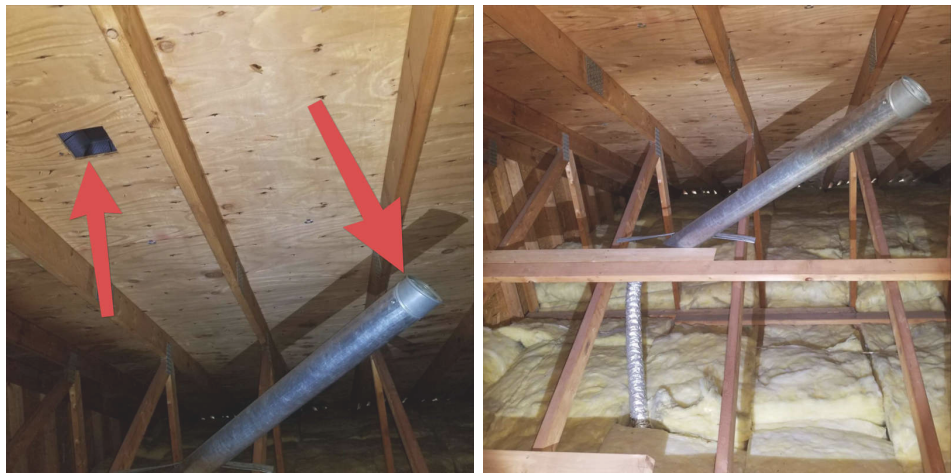
BATHROOM EXHAUST FAN VENT - DISCONNECTED

ATTIC
The bathroom exhaust fan vent is disconnected. This can cause moisture from the bathroom to vent into the attic resulting in damage to the wood, insulation and/or mold development. Recommend reconnecting this vent.

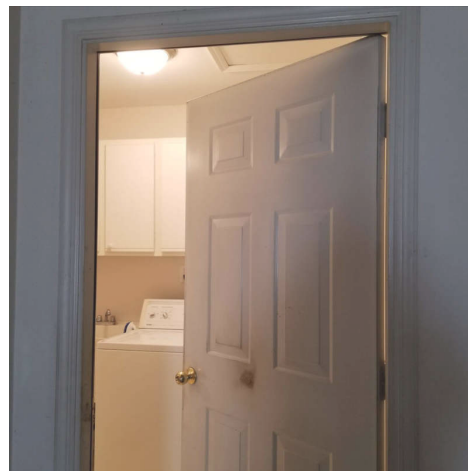
GARAGE

The door from the garage to the interior of the home is missing a self-closing system. These hinges keep the door closed to help prevent the spread of fire and toxic gases to living space should they occur. Recommend a licensed contractor to install a self-closing system.
