22 HOME INSPECT LLC

RESIDENTIAL HOME INSPECTION

1234 Main St. Tempe AZ 85284

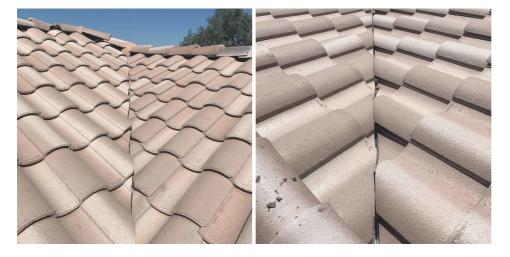
Tile in the roof valley(s) appeared to lack proper spacing and debris was noted at the time of inspection. Recommend a Qualified roofing professional and make corrections to the tile spacing 2 inches is recommended.

Contact a qualified roofing professional.

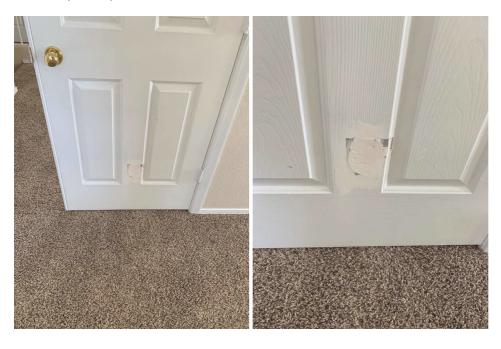
DOOR - DAMAGE

One or more Door(s) was observed to have mechanical damage. Recommend repairing or replacing. Realigning and hanging doors can be challenging recommend contacting a qualified professional to ensure proper function and quality repairs.

Contact a qualified professional.

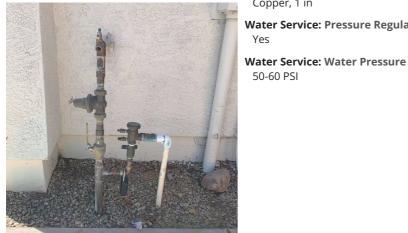
Water Service: Main Line: Shut-Off Location Water Service: Main Line: Type - Size Copper, 1 in

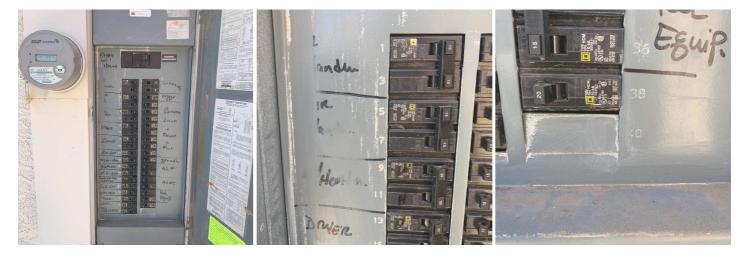
PANEL MISSING LABELS

At the time of inspection, the panel was missing labeling. If in an emergency a breaker may need to be quickly identified to shut down. Recommend a qualified electrician or person identify and map out locations.

Recommended DIY Project
