OHANA INSPECTIONS

RESIDENTIAL REPORT

1234 Main St.
Coral Springs FL 33071

05/21/2019 9:00AM

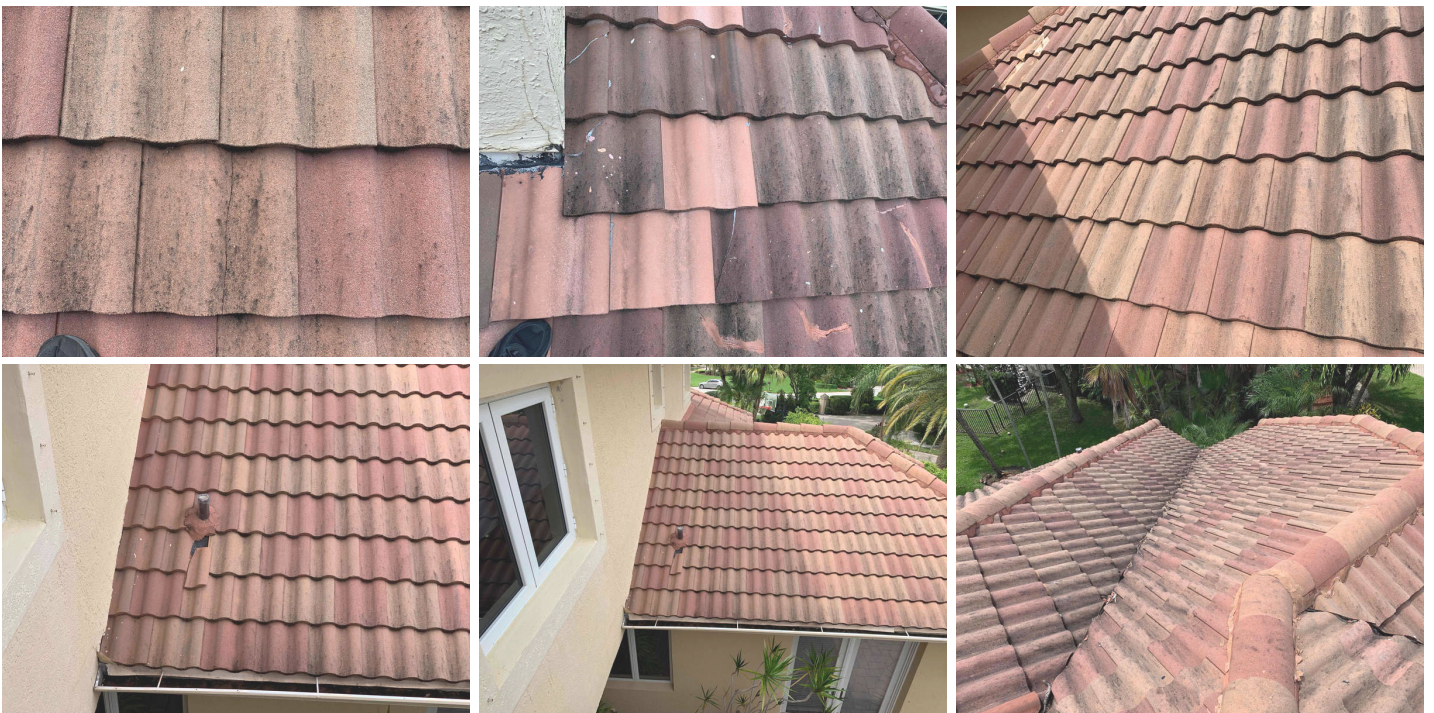
2.1.2 Coverings

TILES CRACKED/BROKEN AND MISSING

Roof had cracked/broken tiles. Inspector recommends a licensed roofing contractor repair or replace to prevent moisture intrusion and/or mold.

Contact a qualified roofing professional.

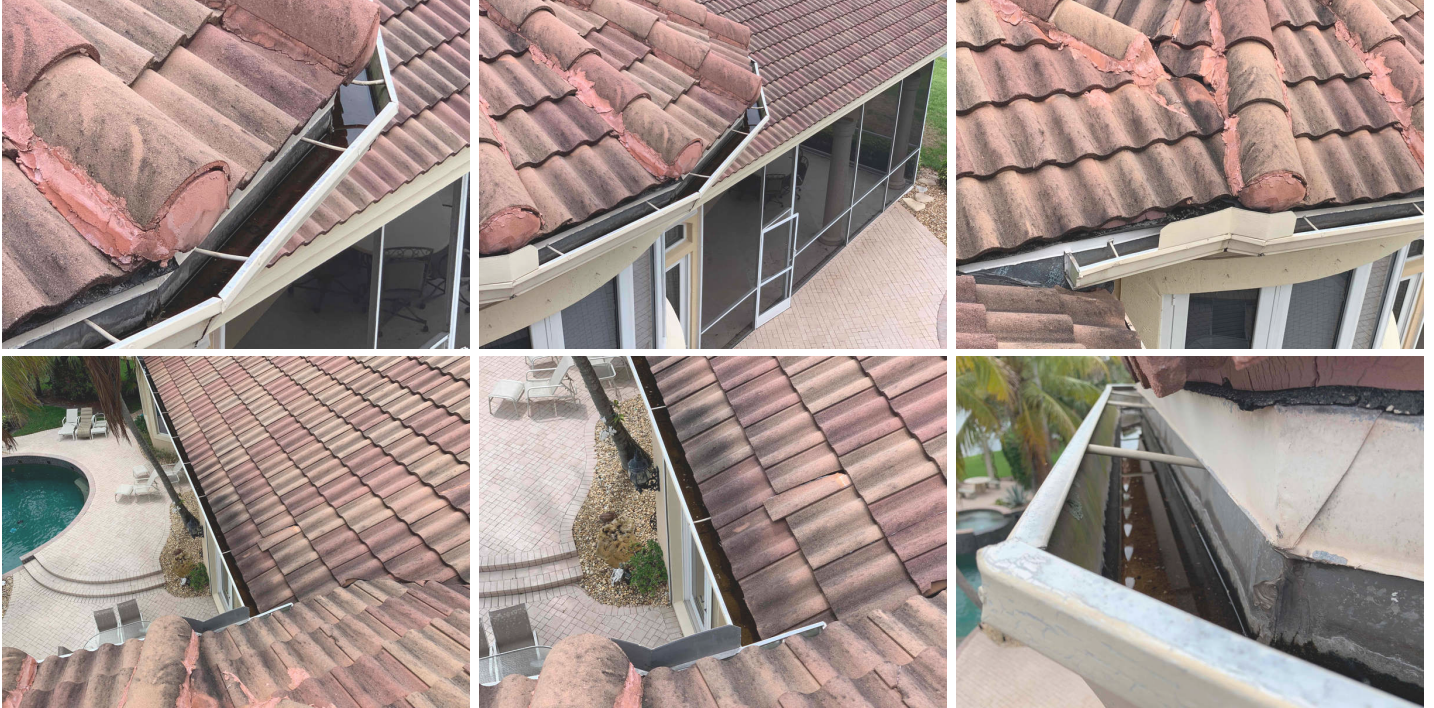
2.2.1 Roof Drainage Systems

DEBRIS

Debris has accumulated in the gutters. Recommend cleaning to facilitate water flow.

Contact a qualified roofing professional.

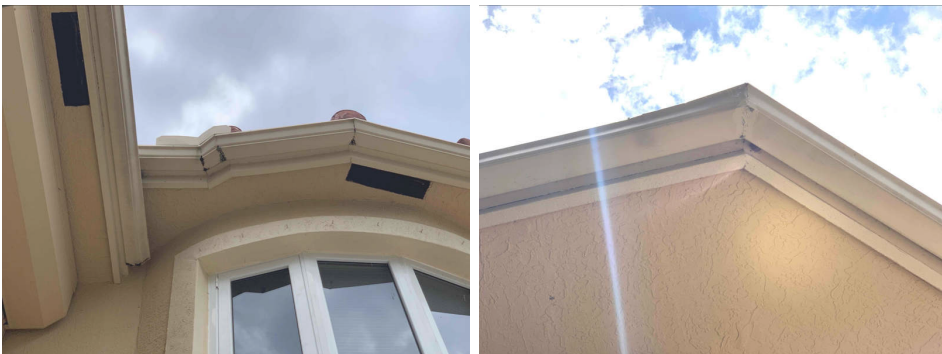
2.2.2 Roof Drainage Systems

GUTTER LEAKAGE

Gutters were observed to be leaking in one or more areas. This can result in excessive moisture in the soil at the foundation, which can lead to foundation/structural movement. Recommend a qualified contractor evaluate and repair gutters to proper functionality.

Contact a qualified roofing professional.

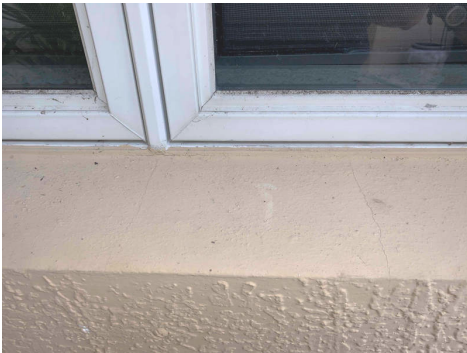
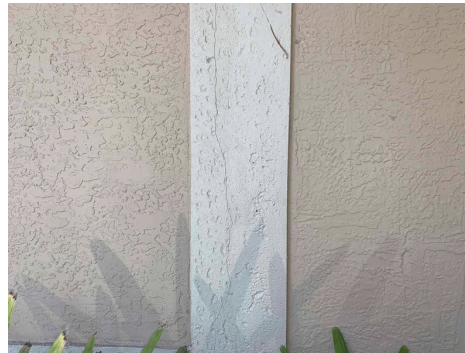
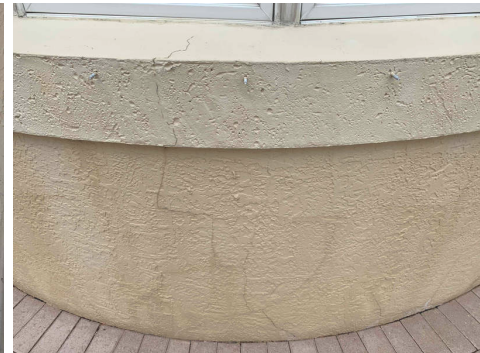
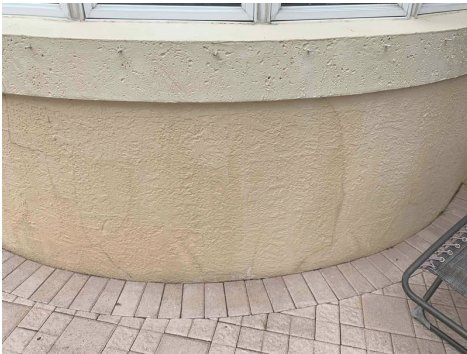
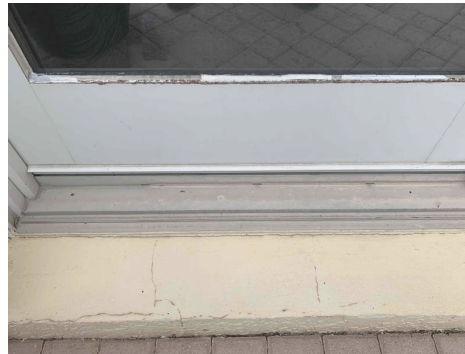
CRACKING - MINOR

Siding showed cracking in one or more places. This is a result of temperature changes, and typical as homes with stucco age. Stucco cracking is not a normal symptom of a new construction home. Recommend repair and monitoring.

Recommended DIY Project

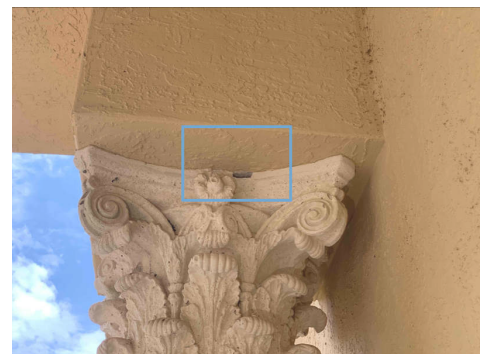
3.1.3 Siding, Flashing & Trim

MISSING TRIM

Contact a qualified professional.

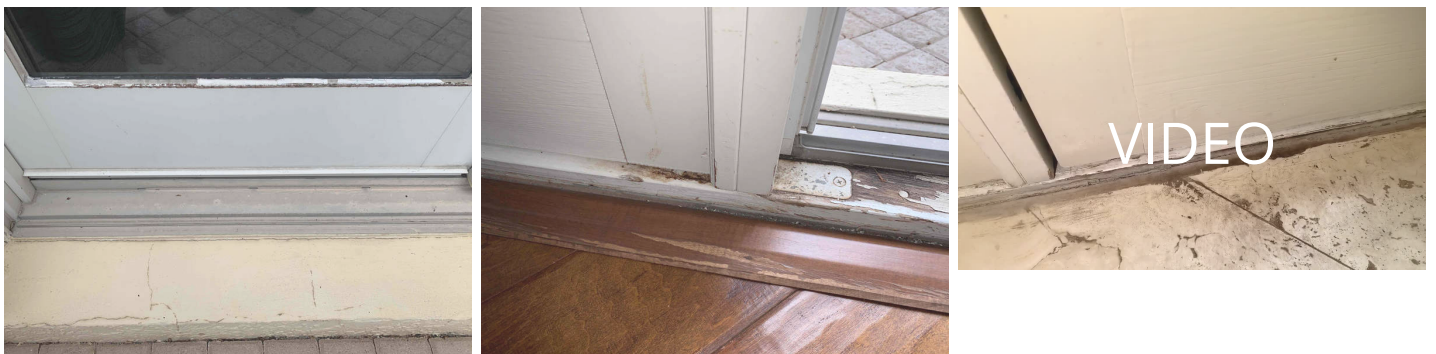
3.2.1 Exterior Doors

DOOR SILL/TRIM

Door sill and/or trim is loose, deteriorated or worn and repair or replacement should be considered.

Contact a qualified door repair/installation contractor.

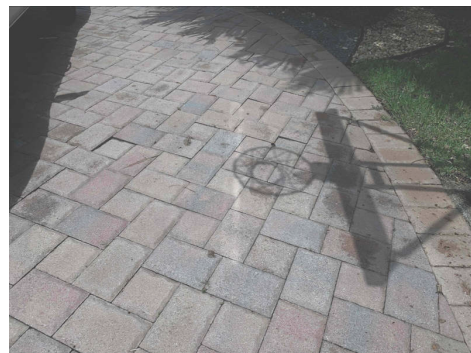
3.3.1 Walkways, Patios & Driveways

WALKWAY TRIP HAZARD

Trip hazards observed. Patch or repair recommended.

Contact a qualified professional.

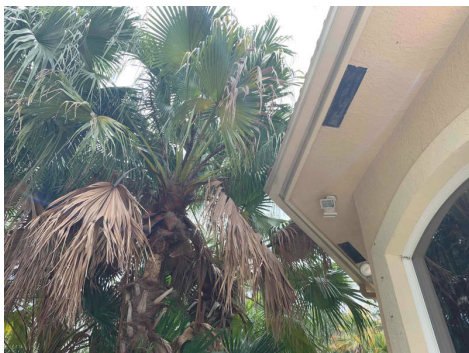
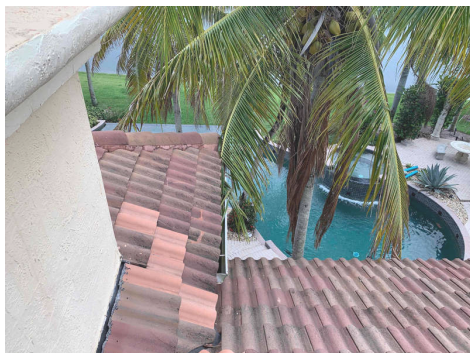
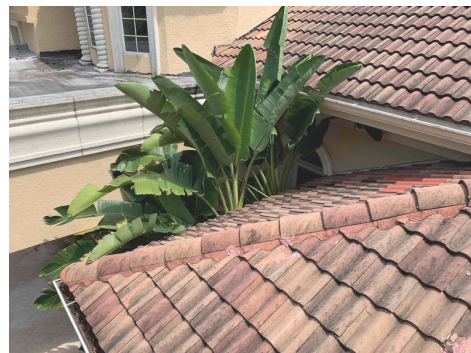
3.6.1 Vegetation, Grading, Drainage & Retaining Walls

TREE OVERHANG

Trees observed overhanging the roof. This can cause damage to the roof and prevent proper drainage. Recommend a qualified tree service trim to allow for proper drainage.

Contact a qualified tree service company.

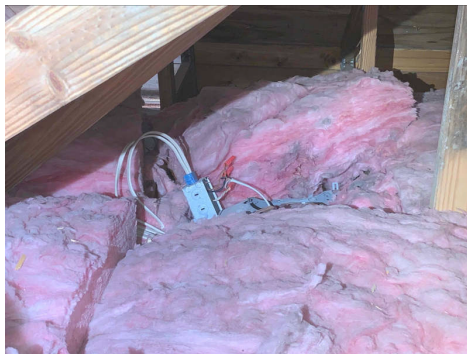
COVER PLATE MISSING

Cover plate(s) are missing from one or more electric boxes, such as for receptacles, switches and/or junction boxes. They are intended to contain fire and prevent electric shock from exposed wires. This is a safety hazard due to the risk of fire and shock. Cover plates should be installed where missing.

Contact a qualified electrical contractor.

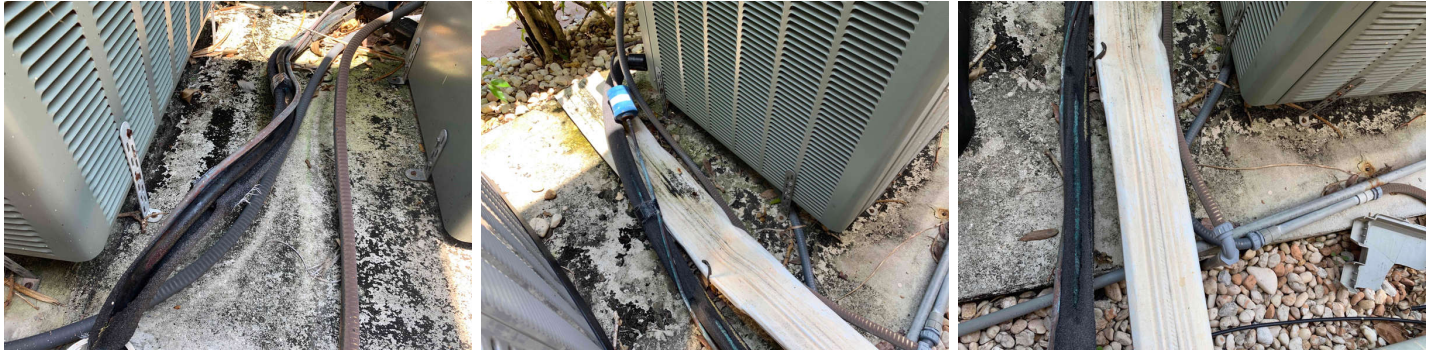
INSULATION MISSING OR DAMAGED

Missing or damaged insulation on refrigerant line can cause energy loss and condensation.

Contact a qualified HVAC professional.

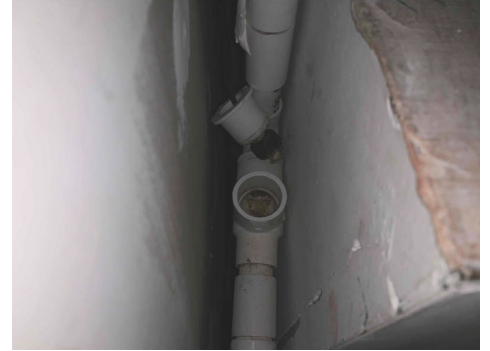
5.2.1 Normal Operating Controls
FLOAT SWITCH NOT IN PLACE
Recommendation
Contact a qualified professional.

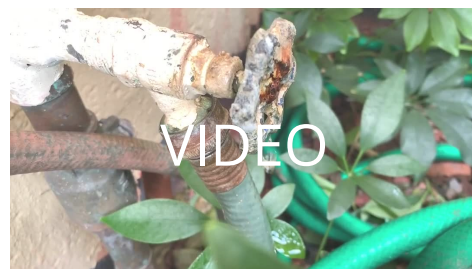
MINOR LEAK

Minor leak coming from spicket at house main shut off.

Contact a qualified professional.

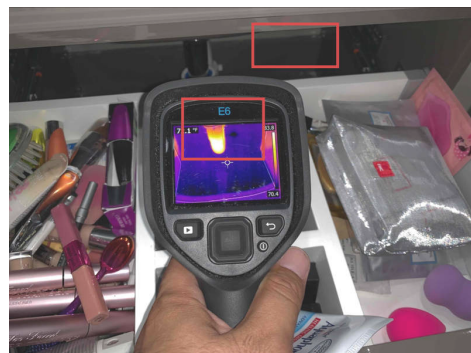
LEAK UNDER SINK

Leak detected under bathroom sink. Inspector recommends hiring a qualified plumbing professional to repair. Monitor for possible mold growth.

Contact a qualified plumbing contractor.

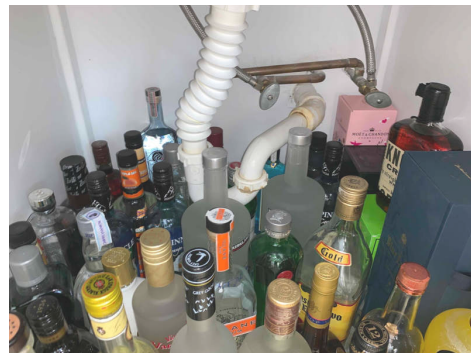
Flexible drain pipe was installed under sinks. Inspector recommends they be replaced with smooth PVC to avoid build up and unpleasant odors.

Contact a qualified professional.

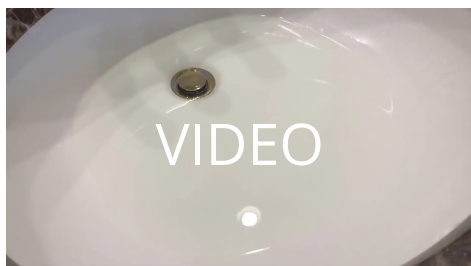
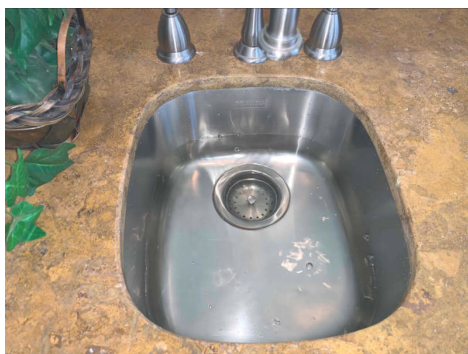
6.3.7 Water Supply, Distribution Systems & Fixtures

SLOW DRAIN

Contact a qualified professional.

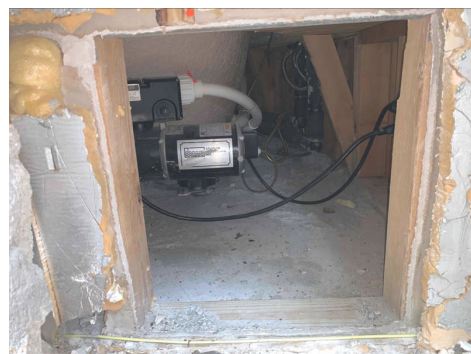
6.3.8 Water Supply, Distribution Systems & Fixtures

BATHTUB ACCESS COVER OPEN

Inspector recommends locking to avoid unwanted guests.

Contact a qualified professional.

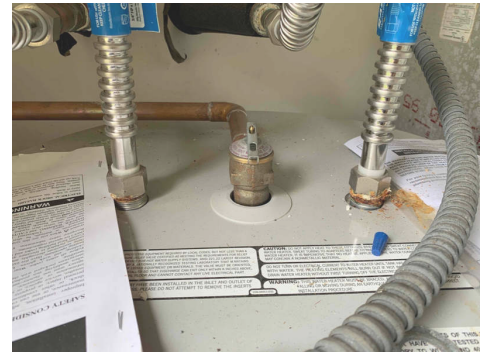
CORROSION

Corrosion was noted at the burn chamber or pipe fittings.
Recommend a qualified plumber evaluate for repair/replacement.

Contact a qualified plumbing contractor.

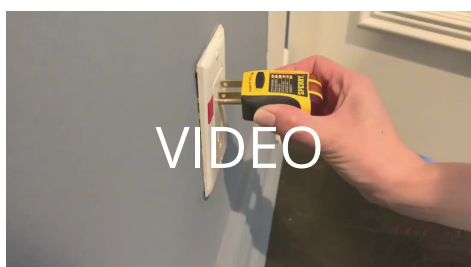
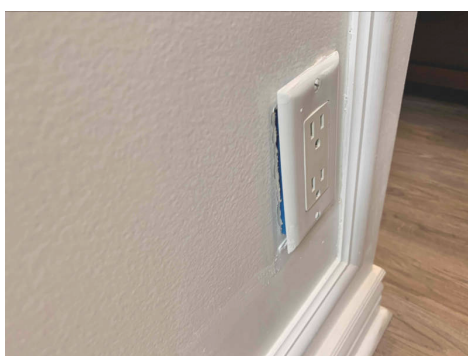
7.4.1 Lighting Fixtures, Switches & Receptacles

COVER PLATES DAMAGED

One or more receptacles have a damaged cover plate. Recommend replacement.

Contact a qualified electrical contractor.

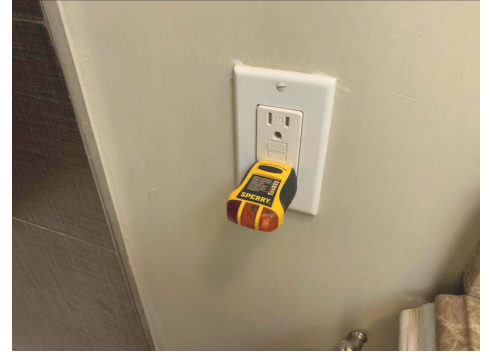
7.5.1 GFCI & AFCI

GFCI NOT FUNCTIONAL

Contact a qualified professional.

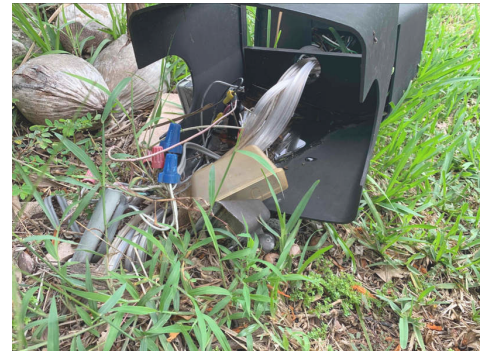
7.7.1 External Components

EXPOSED WIRES

Contact a qualified electrical contractor.

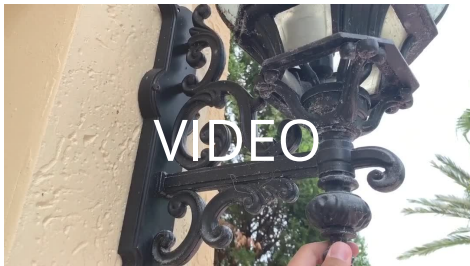
7.7.2 External Components

EXTERIOR LIGHT FIXTURE IN NEED OF REPAIR

Contact a qualified professional.

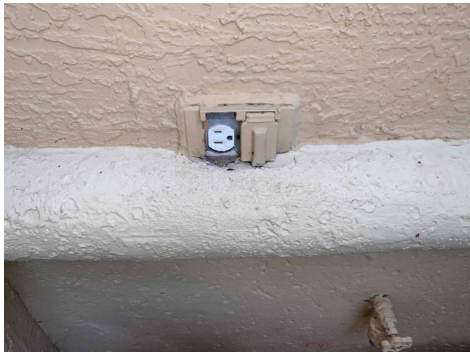
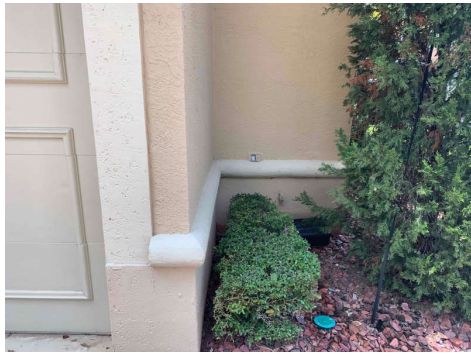
7.7.3 External Components

MISSING COVER

Contact a qualified professional.

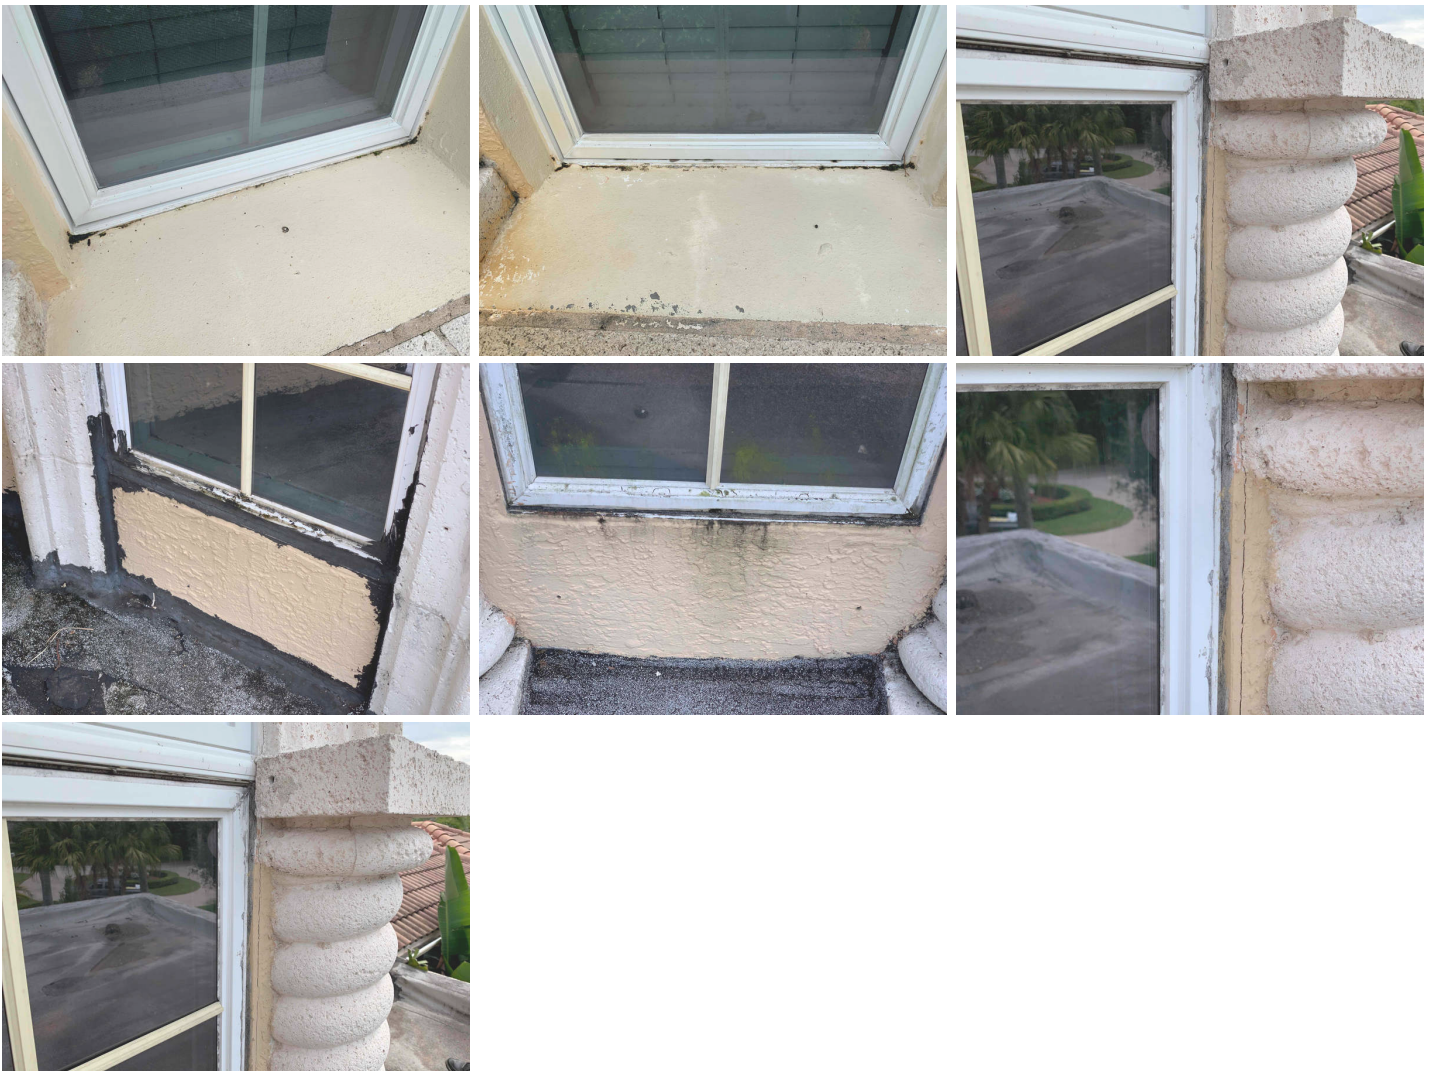
Windows show signs of dry caulking recommend repair to prevent water intrusion.

Contact a qualified professional.

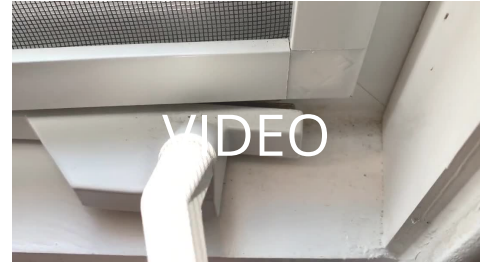
8.2.2 Windows

HARDWARE DAMAGE

Locking mechanism was damaged at time of inspection.

Contact a qualified professional.

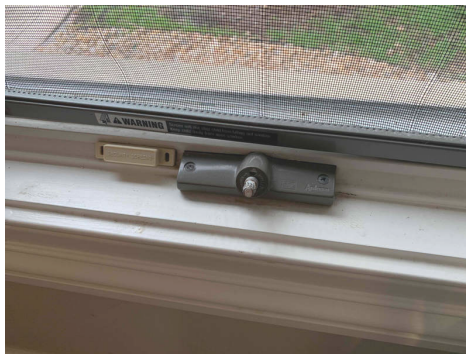
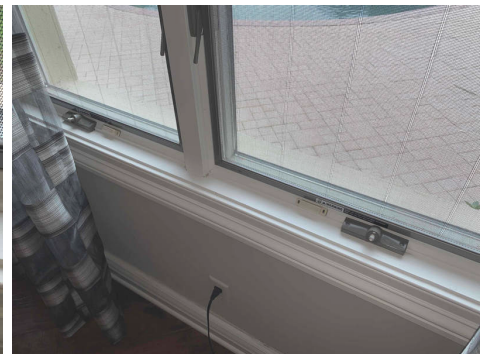
8.2.4 Windows

WINDOW HARDWARE MISSING

Contact a qualified professional.

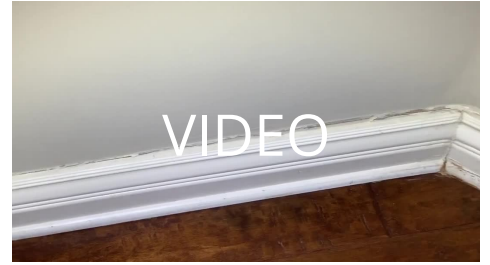
8.3.1 Floors

BASEBOARD DAMAGE

Contact a qualified professional.

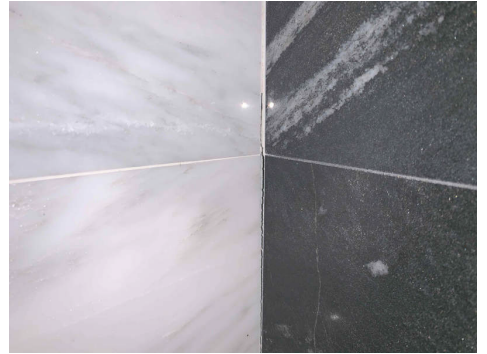
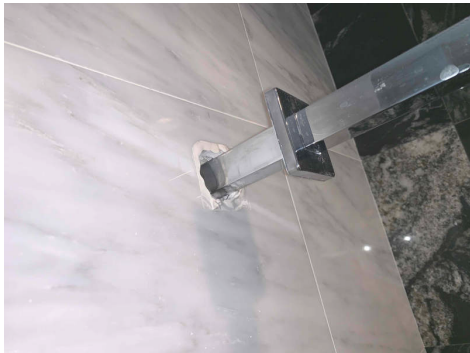
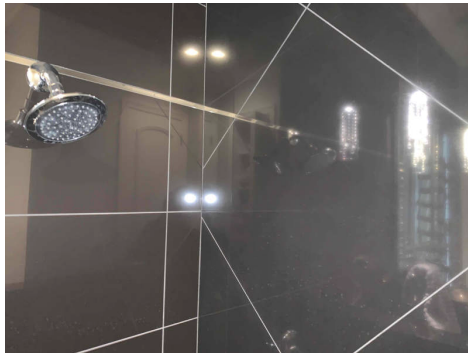
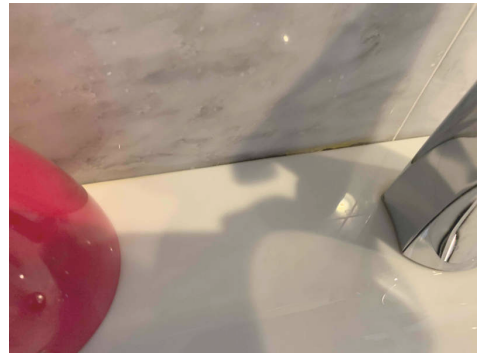
8.4.1 Walls

SHOWER NEEDS GROUT

Certain areas of the showers need more grout. Inspector recommends fixing immediately to avoid water damage.

Contact a qualified professional.

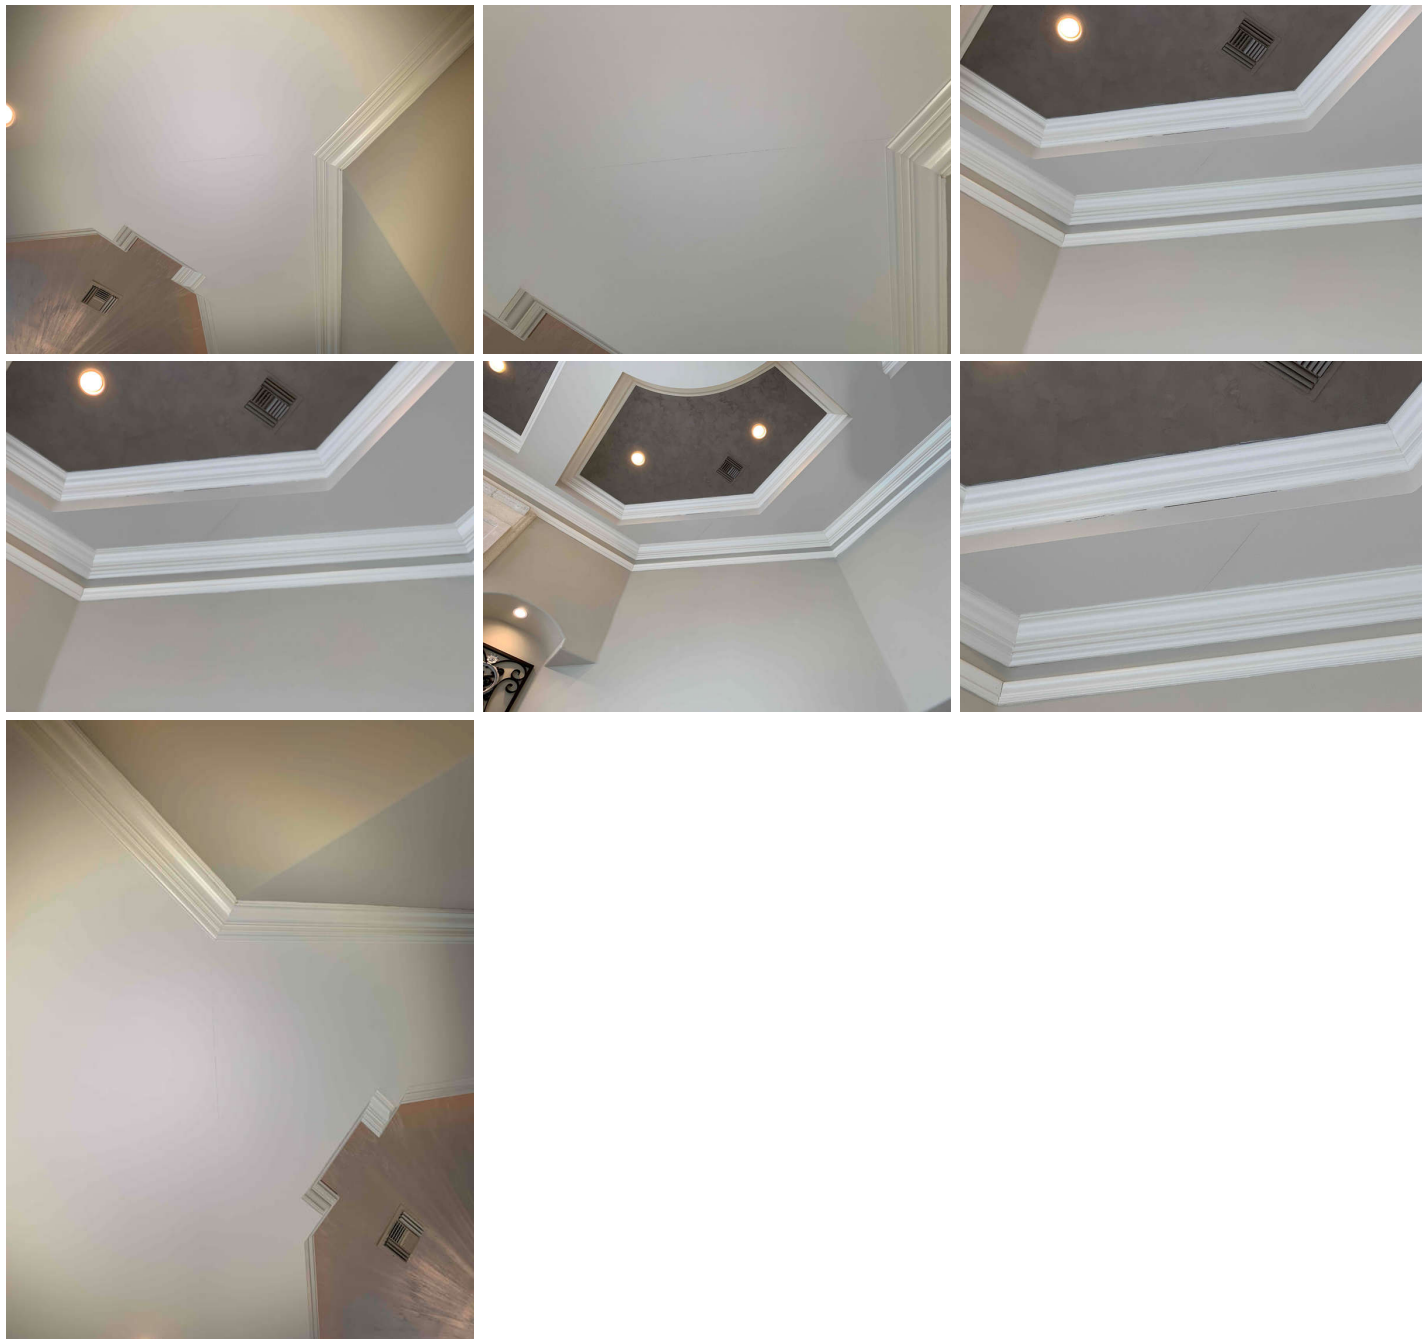
8.5.1 Ceilings

CRACKS ON CEILING

Cracks were discovered on interior ceiling. This could be indication of water intrusion, structural issues, settlement or excess weight on trusses in the attic. Inspector recommends determining the cause of the cracking and evaluating for repairs.

Contact a qualified professional.

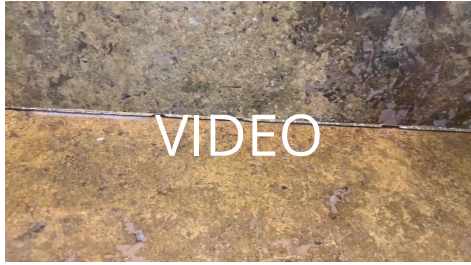
8.7.1 Countertops & Cabinets

POOR/MISSING CAULK

Bathroom shower and Kitchen are missing sufficient caulk/sealant at the wall. This can lead to water damage. Recommend adding sealant at sides and corners where counters touch walls.

Recommended DIY Project

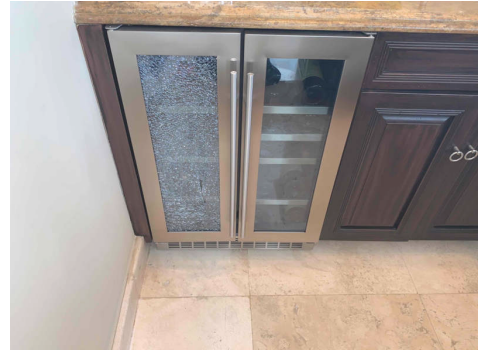
BROKEN GLASS

Recommendation
Contact a qualified professional.

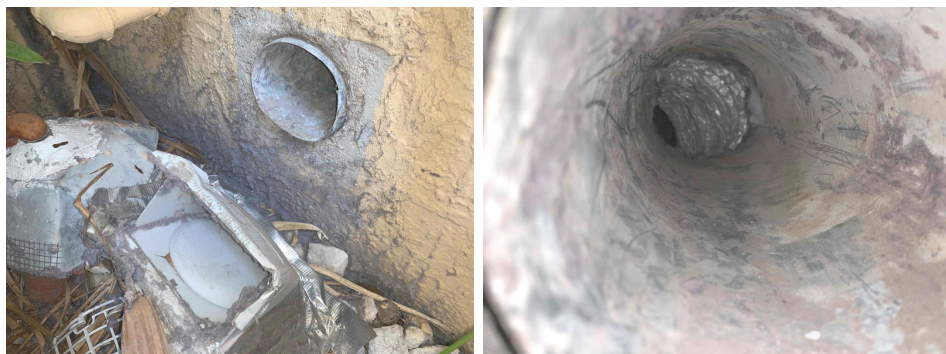
DRYER VENT COVER DAMAGE

Contact a qualified professional.

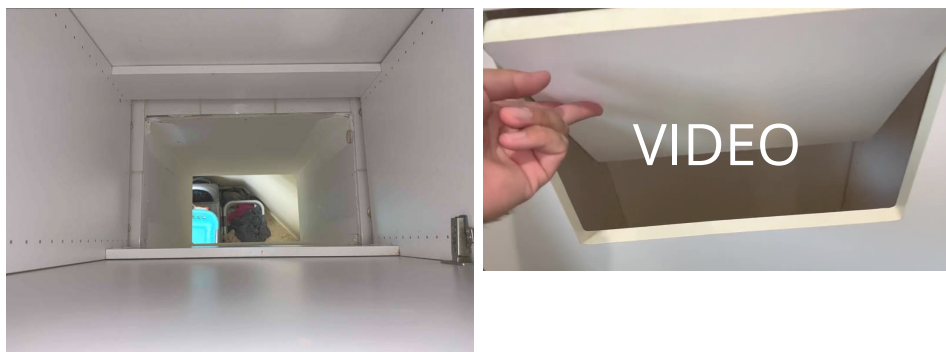
10.1.2 General

THE LAUNDRY CHUTE

Contact a qualified professional.

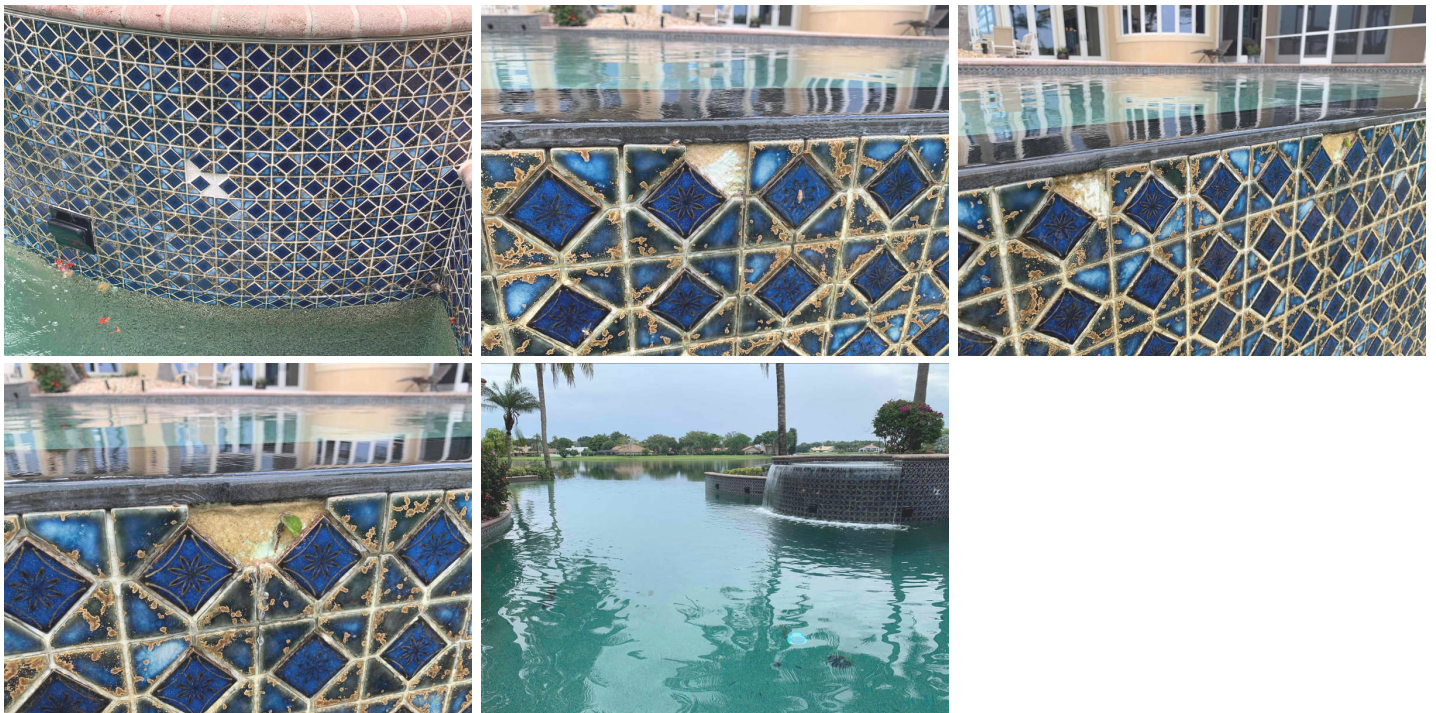
11.5.1 Pool and decking

TILE AND GROUT DETERIORATION

Several of the tiles and grout around the pool and/or spa are deteriorated. The tiles and the grout should be repaired to help prevent water intrusion behind the tile work which can cause them to loosen up.

Contact a qualified Swimming Pool Contractor

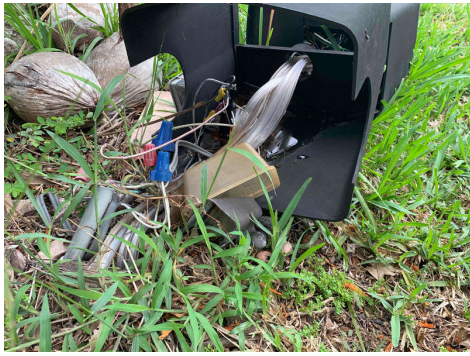
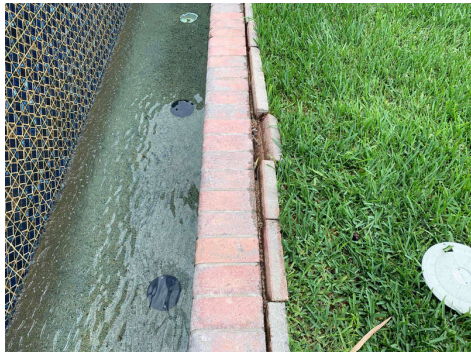
11.5.2 Pool and decking

PAVERS NEED TO BE EVALUATED

Contact a qualified professional.

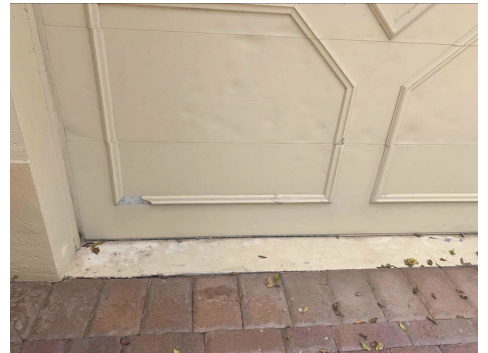
TRIM DAMAGE

Garage door trim showed signs of damage at time of inspection.

Contact a qualified professional.
